East Park Energy

Environmental Statement

Appendix 8-3: Watercourse Crossing Assessment

September 2025

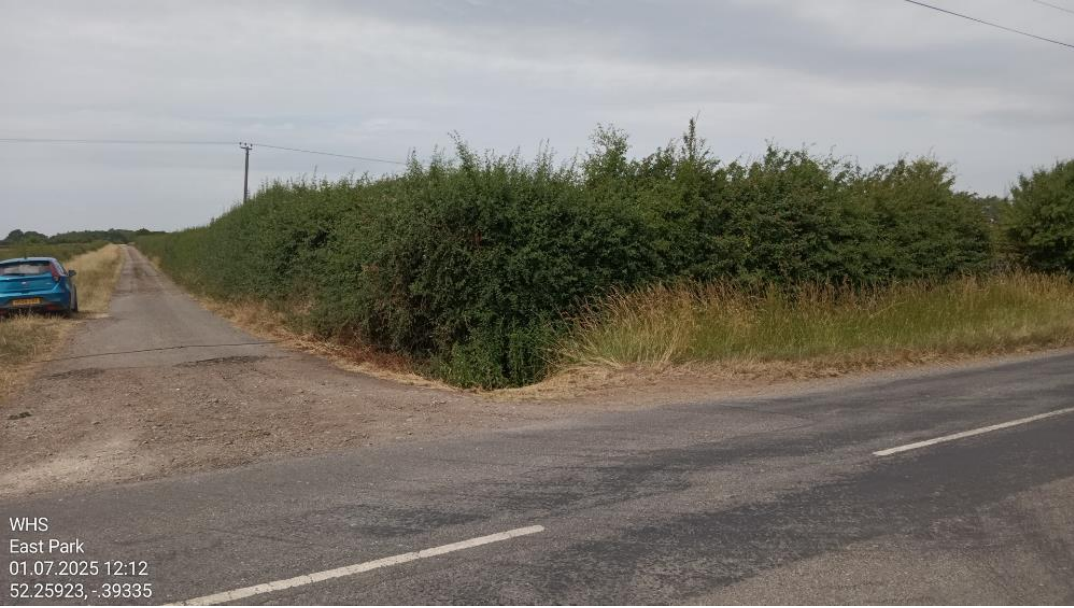
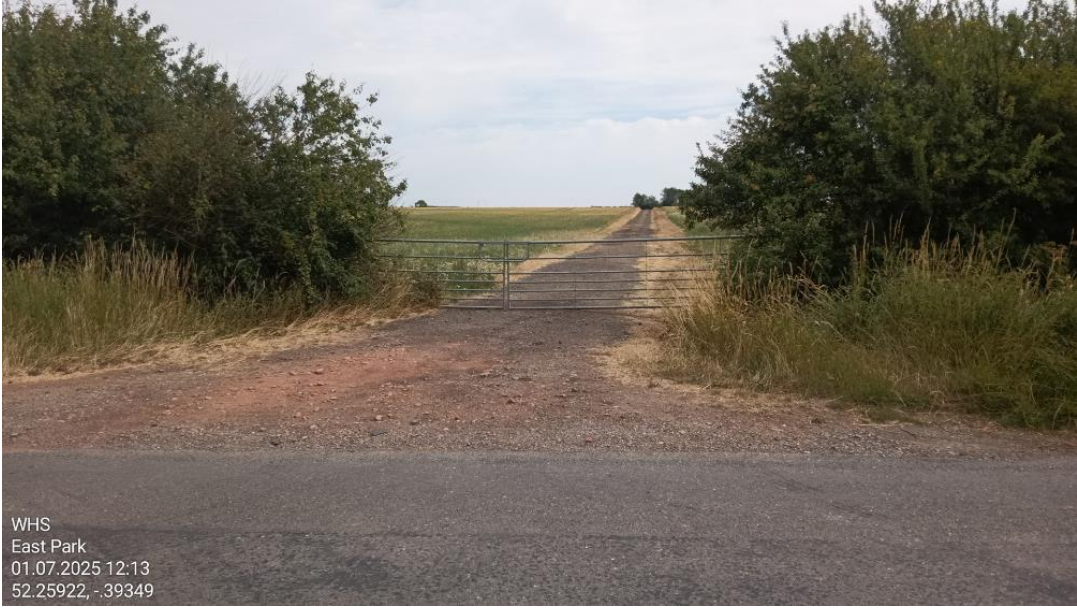
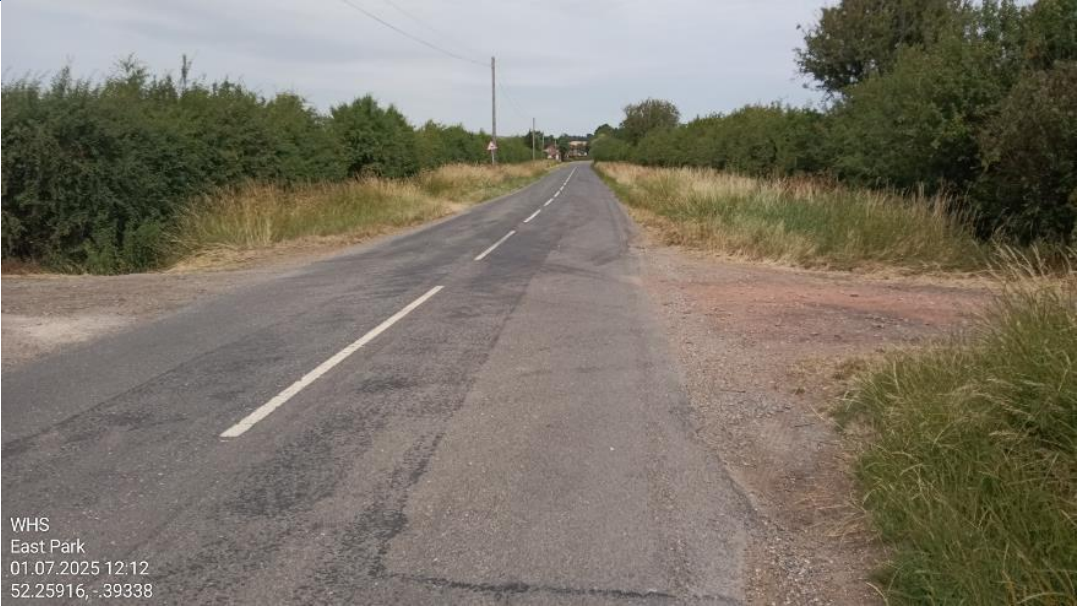
Crossing C13

Crossing	Valley Shape	Wetted Width (m)	Bankfull Width (m)	Channel Max Depth (m)	Bank Profile and Stability	Channel Planform	Pool Riffle Development	Comments
C13	Expansive fields, relatively flat	n/a – dry at time of visit	~4.0 (both)	~1.0 (both)	Soft soil banks stabilised by long grass	Straight sections of channel. Very small catchment for both, less than 0.5km ²	n/a.	Existing circular culverts under both crossings

<div>WHS East Park 01.07.2025 12:13 52.25922, -1.39349</div>	
West ditch crossing							East ditch crossing

<div>WHS East Park 01.07.2025 12:12 52.25916, -1.39338</div>							Looking downstream from existing crossings over both east and west ditches

<p>WHS East Park 01.07.2025 12:12 52.25923, -39333</p>		  <p>WHS East Park 01.07.2025 12:13 52.25922, -39353</p>	
East ditch looking downstream		West ditch looking upstream	
Proposed Crossing Type	Horizontal drill under watercourses for 33kV cabling.

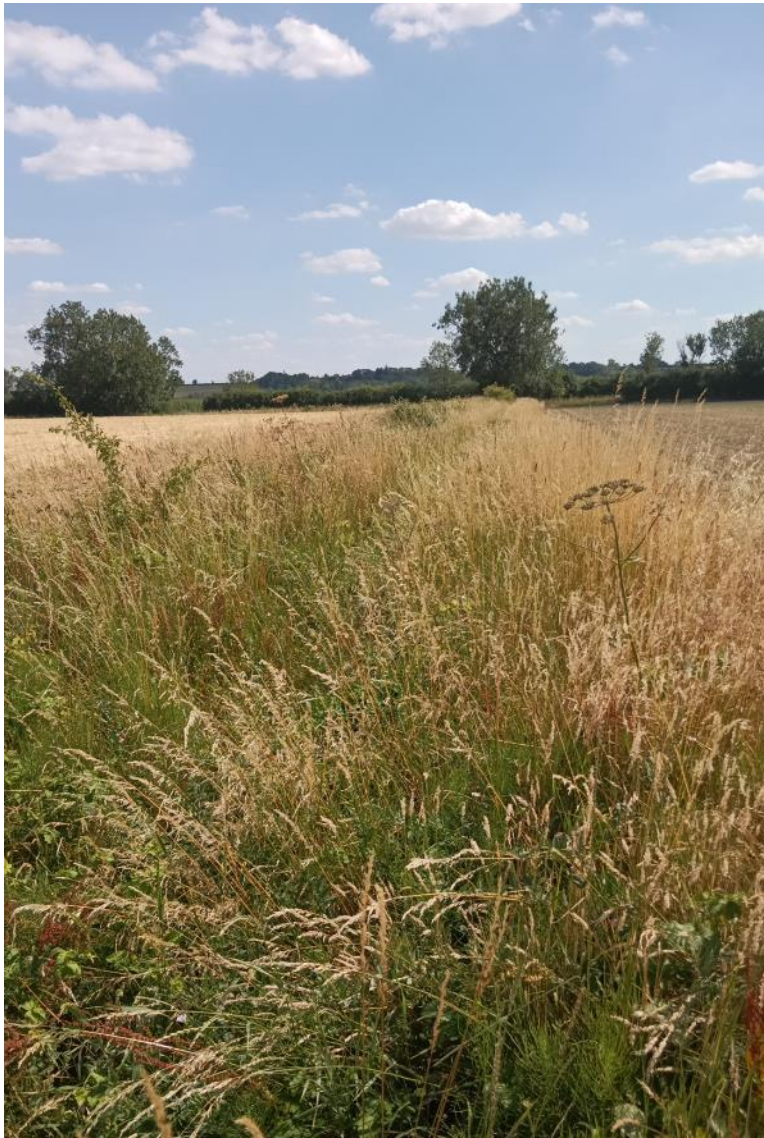
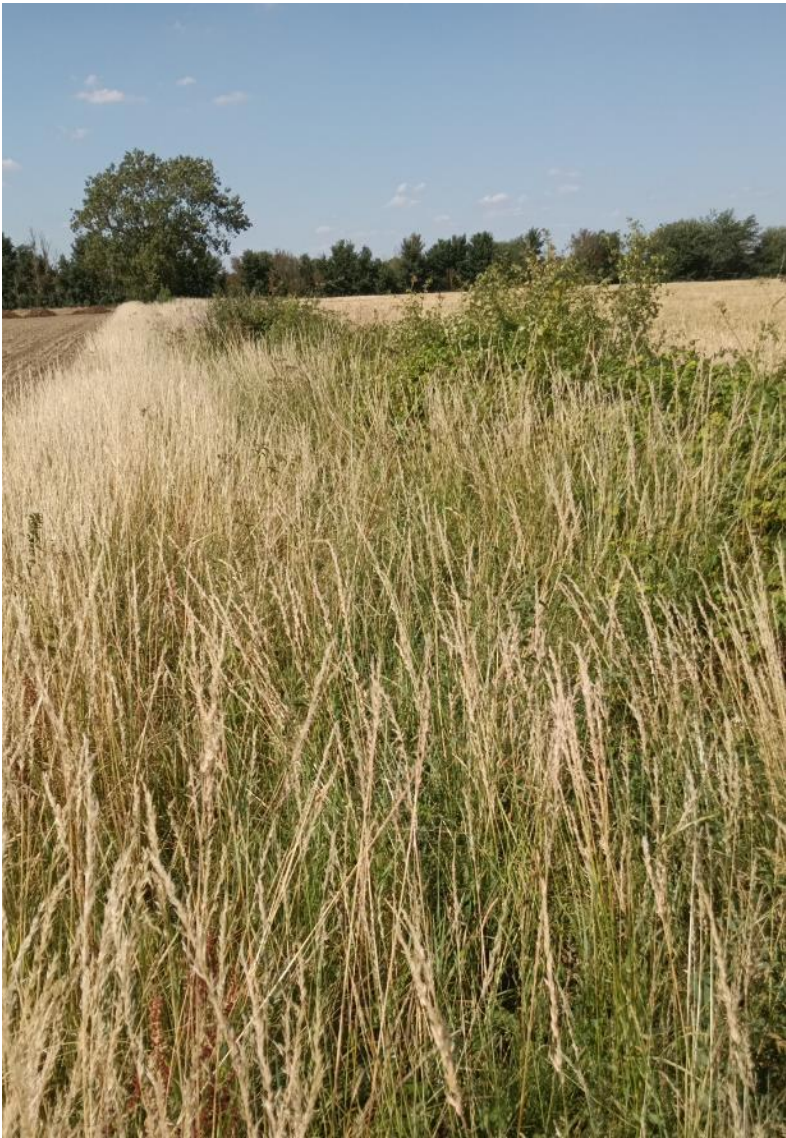
Crossing C16

Crossing	Valley Shape	Wetted Width (m)	Bankfull Width (m)	Channel Max Depth (m)	Bank Profile and Stability	Channel Planform and upstream catchment	Pool Riffle Development	Comments
C16	Expansive fields, relatively flat	n/a - dry at time of visit	2.2	1.2	Very shallow banks, mostly obscured by vegetation. Soft soil bed.	Single channel, straight field drain, banks reinforced by vegetation. Complex upstream network of drains, though catchment likely less than 1km ² and almost entirely rural (arable farmland).	n/a.	-

Upstream view					Downstream view

<div>WHS East Park 30.06.2025 15:43 52.26710, -38999</div>		  <div>WHS East Park 30.06.2025 15:44 52.26710, -38999</div>	
Channel bed		Proposed Crossing location	
Proposed Crossing Type:	Proposed access track (and 33kV Cabling), open span crossing to maintain natural bed and banks

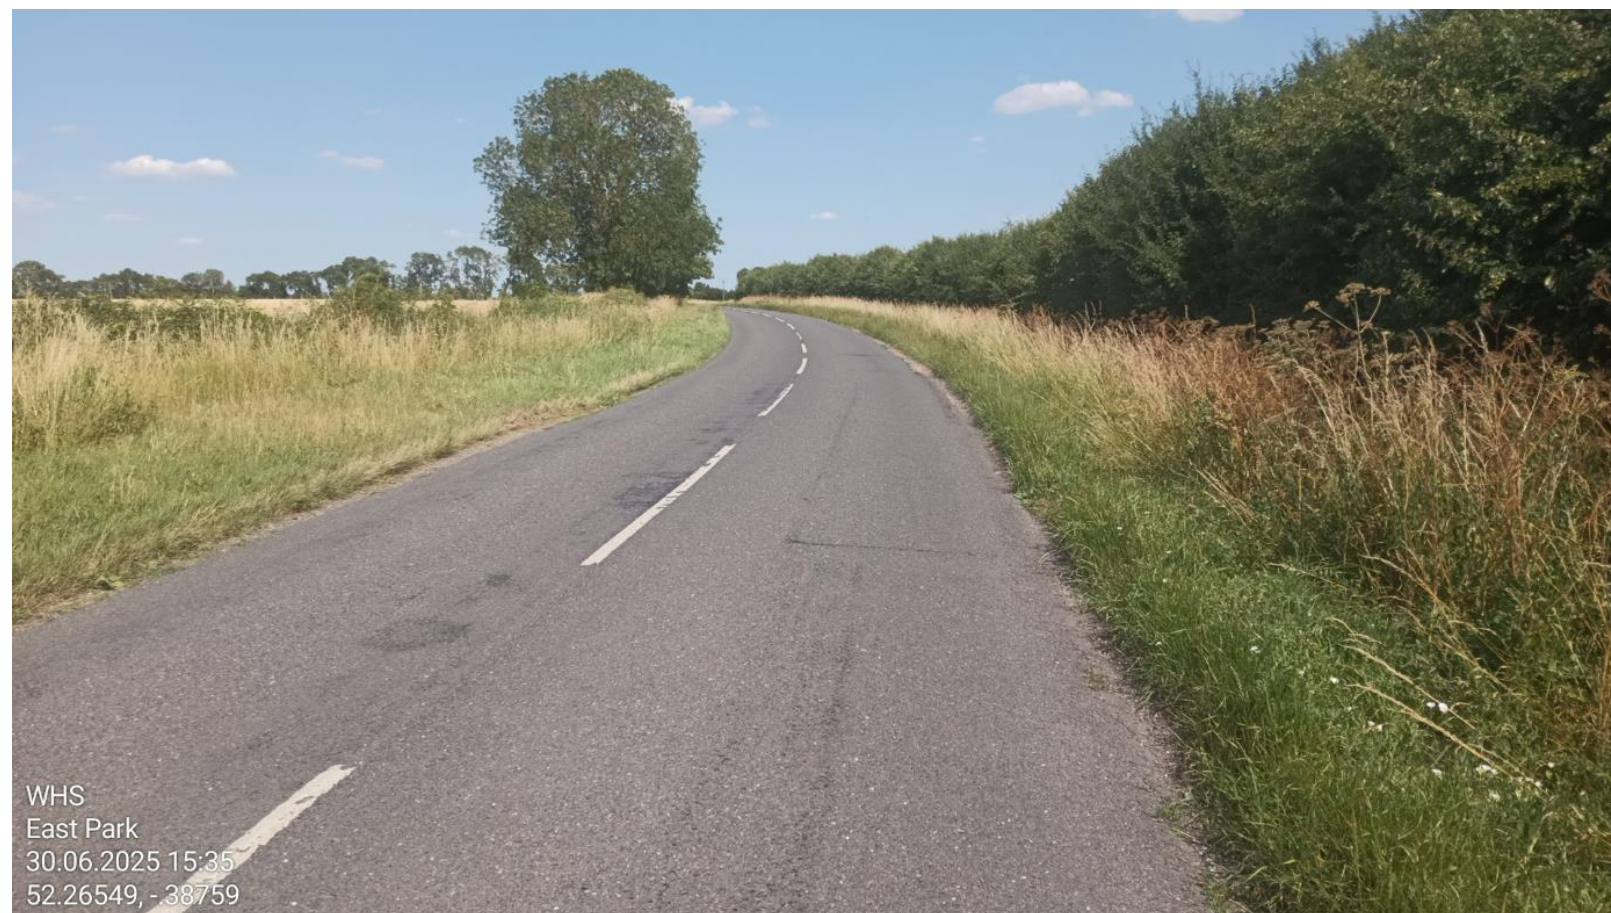
Crossing C17

Crossing	Valley Shape	Wetted Width (m)	Bankfull Width (m)	Channel Max Depth (m)	Bank Profile and Stability	Channel Planform	Pool Riffle Development	Comments
C17	Expansive fields, relatively flat	n/a – dry at time of visit	2.0	1.0	Shallow stable banks	Field drain, banks reinforced by vegetation. Complex network of drains mean the catchment is extremely difficult to define, likely less than 0.5km ²	n/a.	Ditches either side of road. Existing crossing over northern ditch (culverted).
  <div> <div>WHS</div> <div>East Park</div> <div>North</div> <div>30.06.2025 15:34</div> <div>52.26559, -38747</div> </div>			  <div> <div>WHS</div> <div>East Park</div> <div>North</div> <div>30.06.2025 15:34</div> <div>52.26559, -38747</div> </div>			  <div> <div>WHS</div> <div>East Park</div> <div>North</div> <div>30.06.2025 15:34</div> <div>52.26559, -38747</div> </div>		
Downstream view			Channel			Upstream view

Crossing Site	
Proposed Crossing Type	Existing track crossing to be maintained.

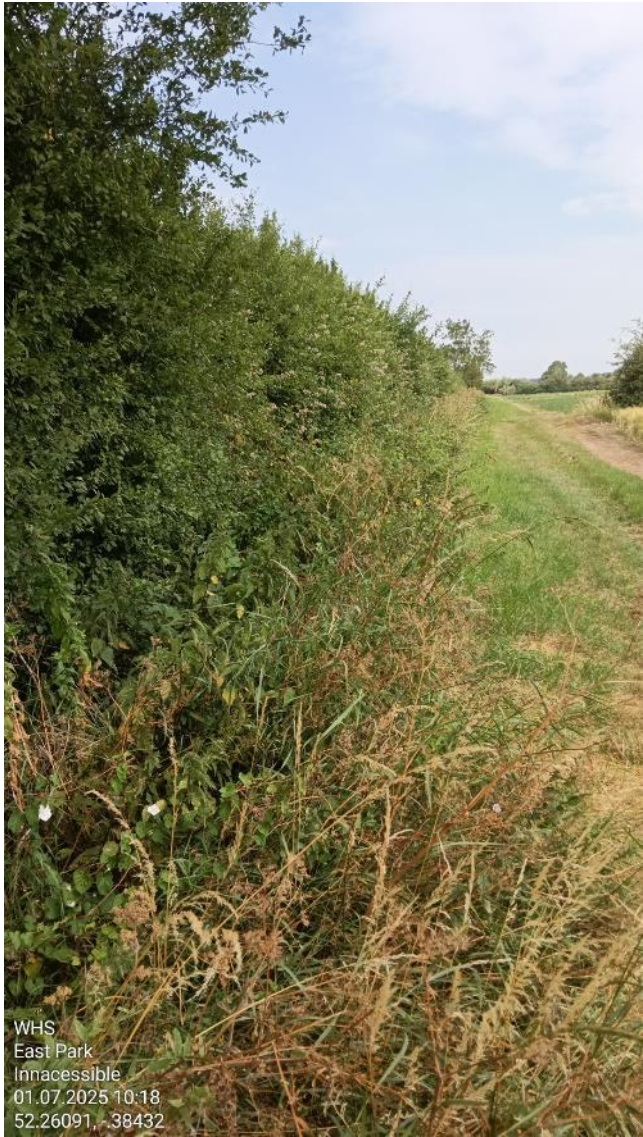
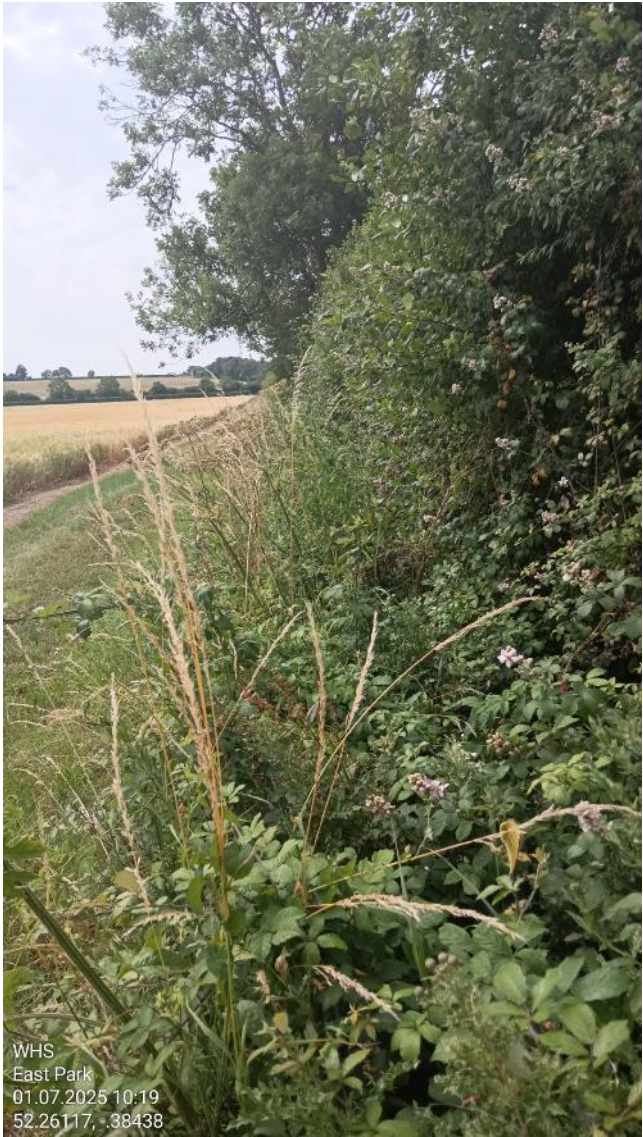
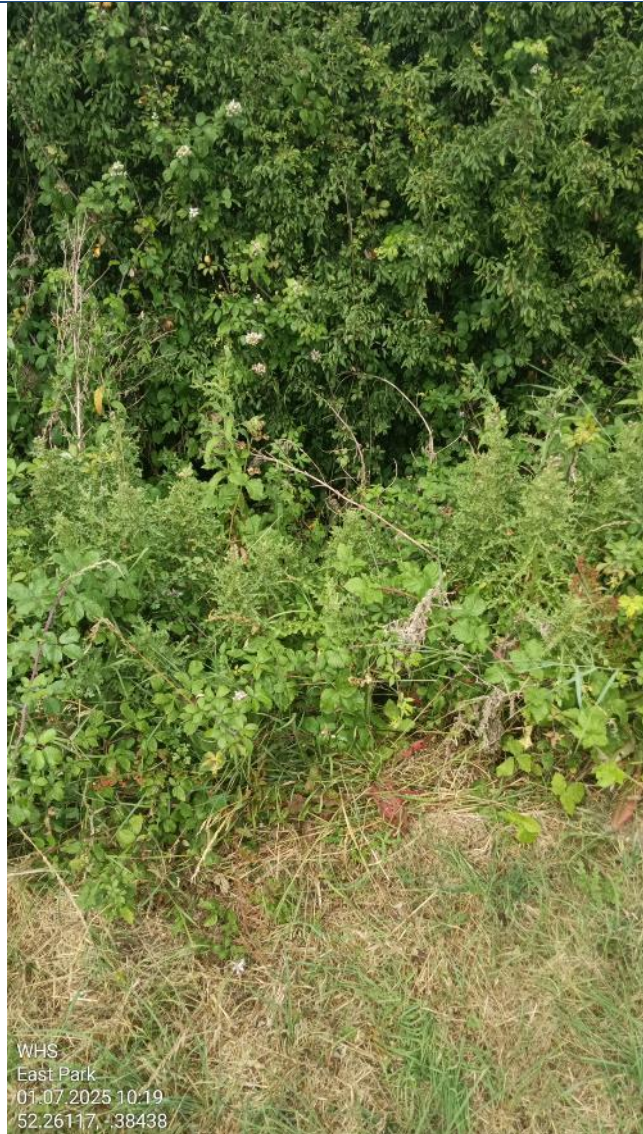
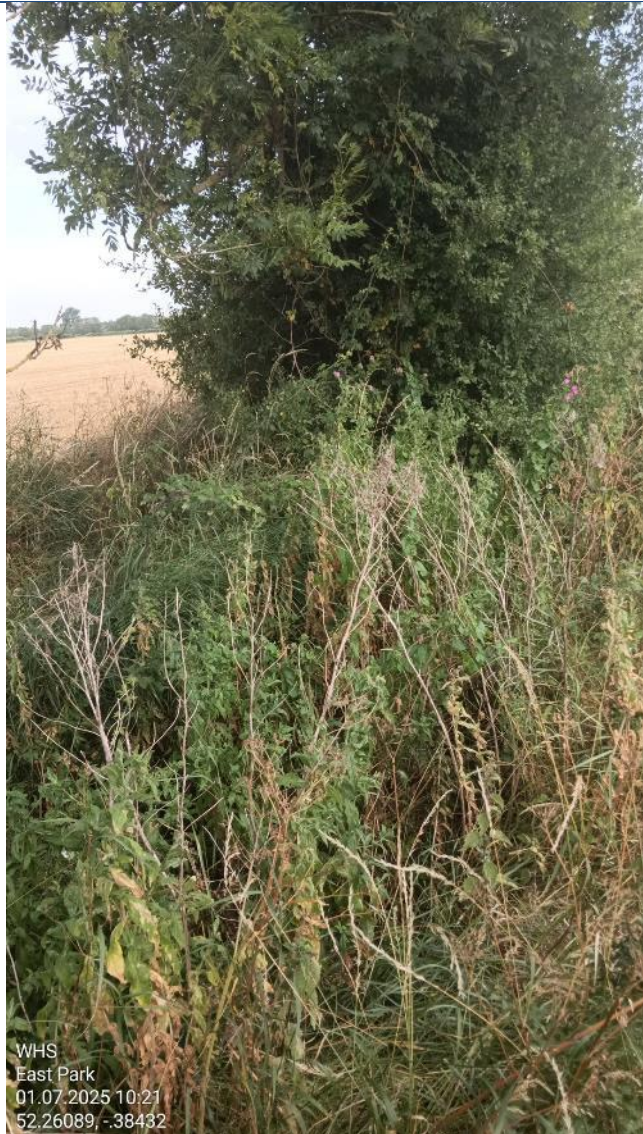
Crossing C20

Crossing	Valley Shape	Wetted Width (m)	Bankfull Width (m)	Channel Max Depth (m)	Bank Profile and Stability	Channel Planform and upstream catchment	Pool Riffle Development	Comments
C20	Expansive fields, relatively flat	n/a	~3.0	~1.8	Shallow stable banks. Soft soil bed.	Single channel field drain, banks reinforced by vegetation. Complex upstream network of drains, however catchment likely less than 1km² and largely rural (arable farmland), though likely drains the northern part of the village of Little Staughton.	n/a.	Channel inaccessible due to dense vegetation. Channel dry at time of visit

<div> <div>WHS</div> <div>East Park</div> <div></div> <div>01.07.2025 10:19</div> <div>52.26117, -38438</div> </div>		
Downstream view						Upstream view

<p>WHS East Park 01.07.2025 10:21 52.26089, -38432</p>	
Crossing Site		View of channel	
Proposed Crossing Type:	Open span crossing for access track, maintaining natural channel

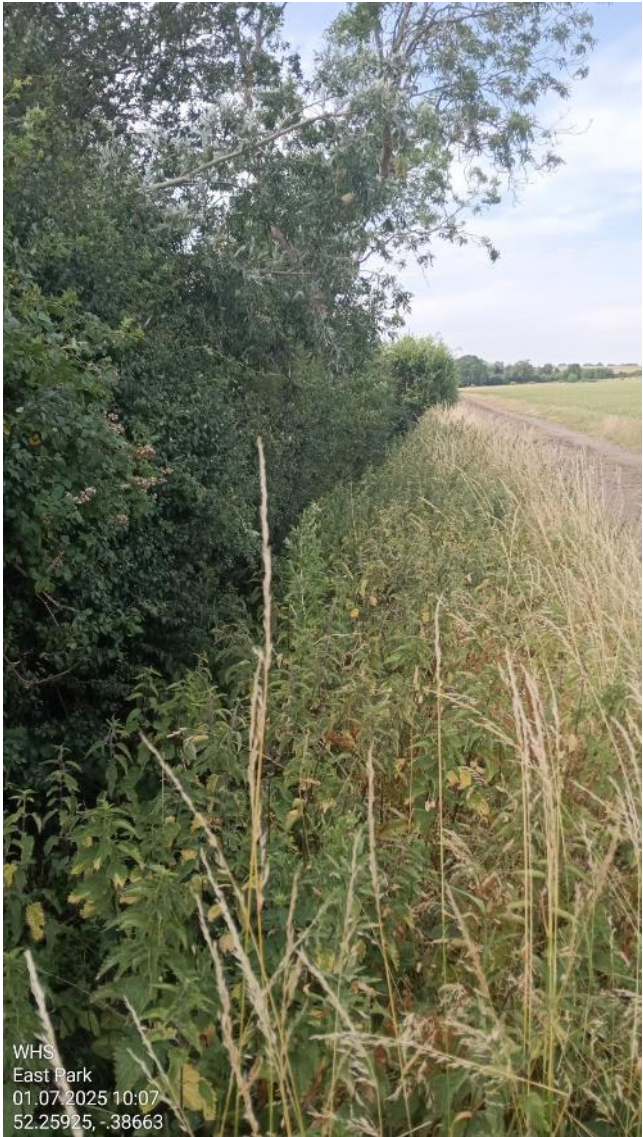
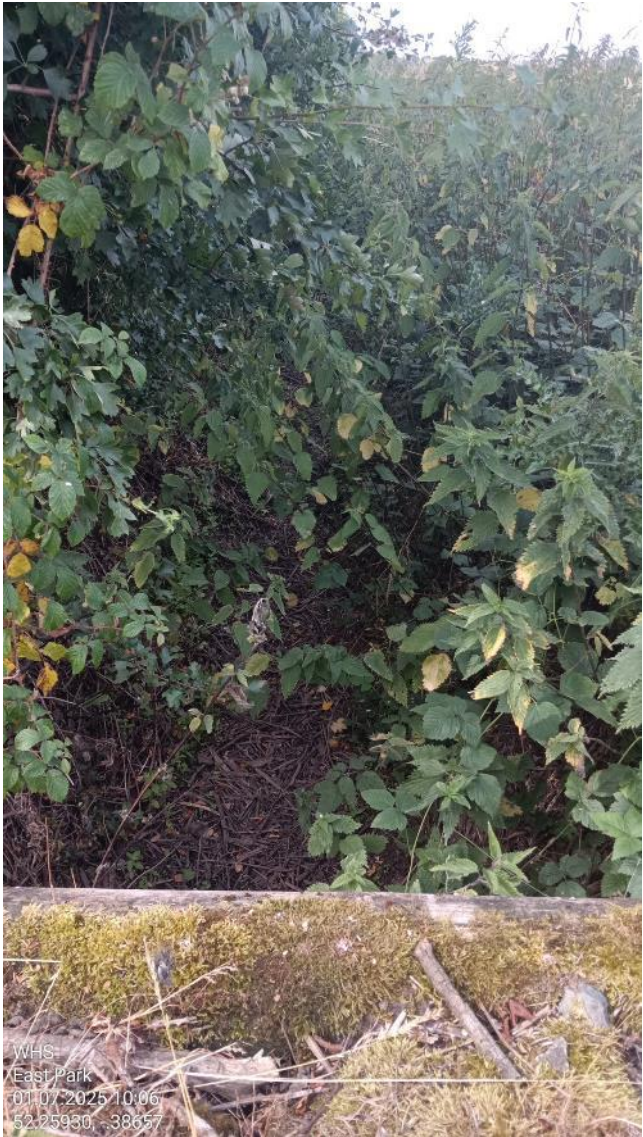
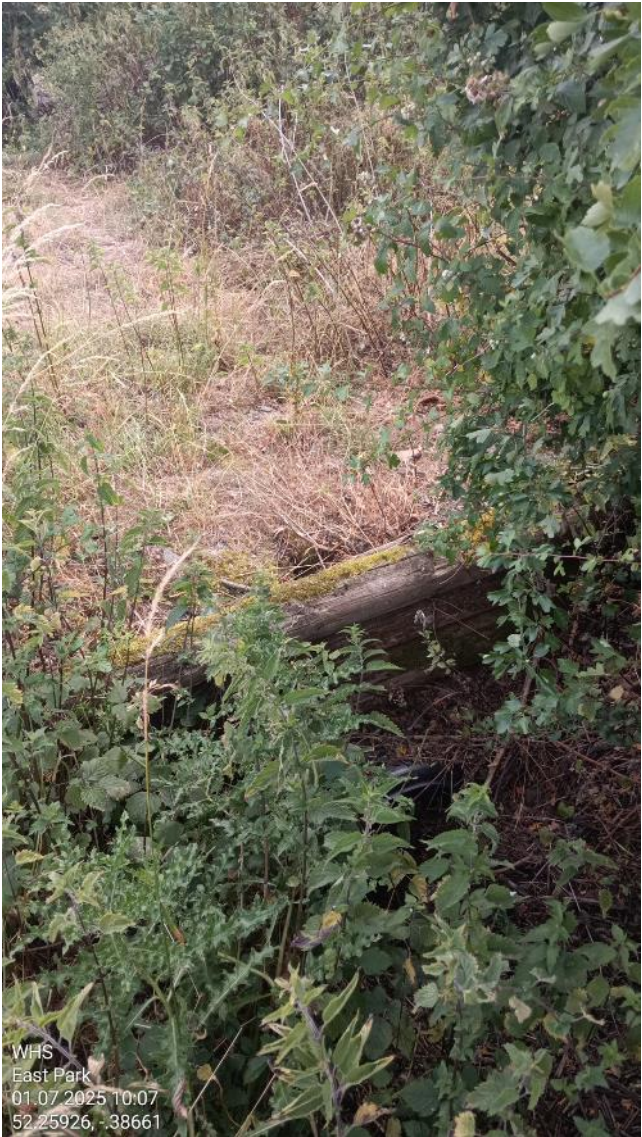
Crossing C21

Crossing	Valley Shape	Wetted Width (m)	Bankfull Width (m)	Channel Max Depth (m)	Bank Profile and Stability	Channel Planform and upstream catchment	Pool Riffle Development	Comments
C21	Expansive fields, relatively flat	n/a – dry at time of visit	2.0	1.2	Relatively shallow gradient banks up to existing track on left bank, trees line right bank	Single channel, field drain, banks reinforced by vegetation. Soft soil bed. Complex upstream network of drains, however catchment less than 1km ² and largely rural (arable farmland), though likely drains the northern part of the village of Little Staughton.	n/a.	Existing culverted crossing. 600mm diameter circular culvert. Existing deck width of 5.2m.

Upstream			Upstream Channel			Upstream headwall

Downstream Channel		Culvert outlet	Downstream view
Proposed Crossing Type:	Propose to retain existing crossing (existing deck over 600mm circular culvert)

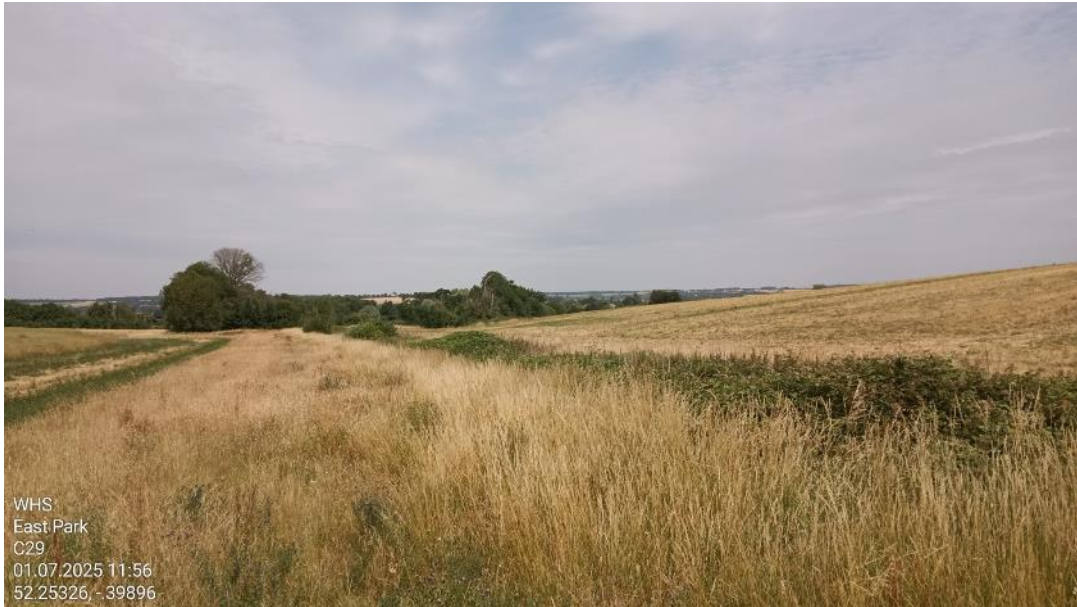
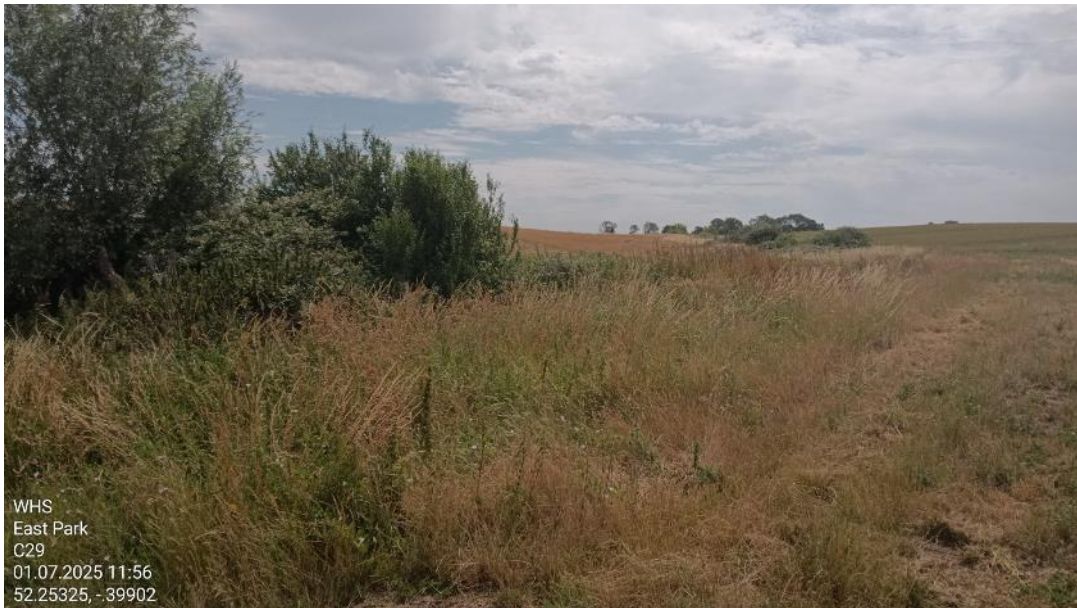
Crossing C29

Crossing	Valley Shape	Wetted Width (m)	Bankfull Width (m)	Channel Max Depth (m)	Bank Profile and Stability	Channel Planform and upstream catchment	Pool Riffle Development	Comments
C29	Expansive fields, gently sloping northwards	n/a – dry at time of visit	Could not be measured at time of visit.	Could not be measured at time of visit.	Shallow banks stabilised by vegetation	Single channel, field drain. Straight channel on gentle gradient. Very small upstream catchment, less than 1km², largely rural (arable farmland)	n/a.	Channel inaccessible due to overgrowth. Existing deck width ~6m.

<div> <div>WHS</div> <div>East Park</div> <div>C29 overgrown</div> <div>01.07.2025 11:57</div> <div>52.25328, -39888</div> </div>		
Downstream view

<div> <div>WHS</div> <div>East Park</div> <div>C29</div> <div>01.07.2025 11:56</div> <div>52.25325, -39902</div> </div>						Upstream channel from deck

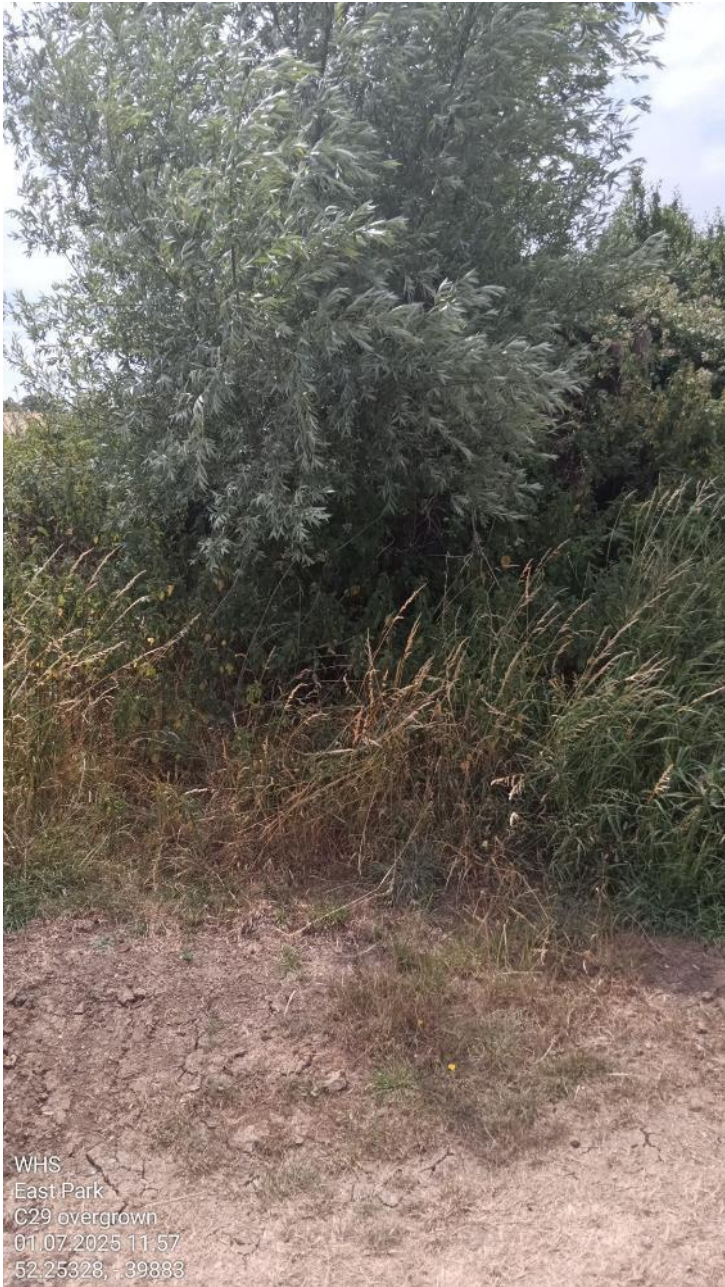
Existing Crossing view from West		Existing Crossing view from East	
Proposed Crossing Type:	Existing Crossing to be retained.

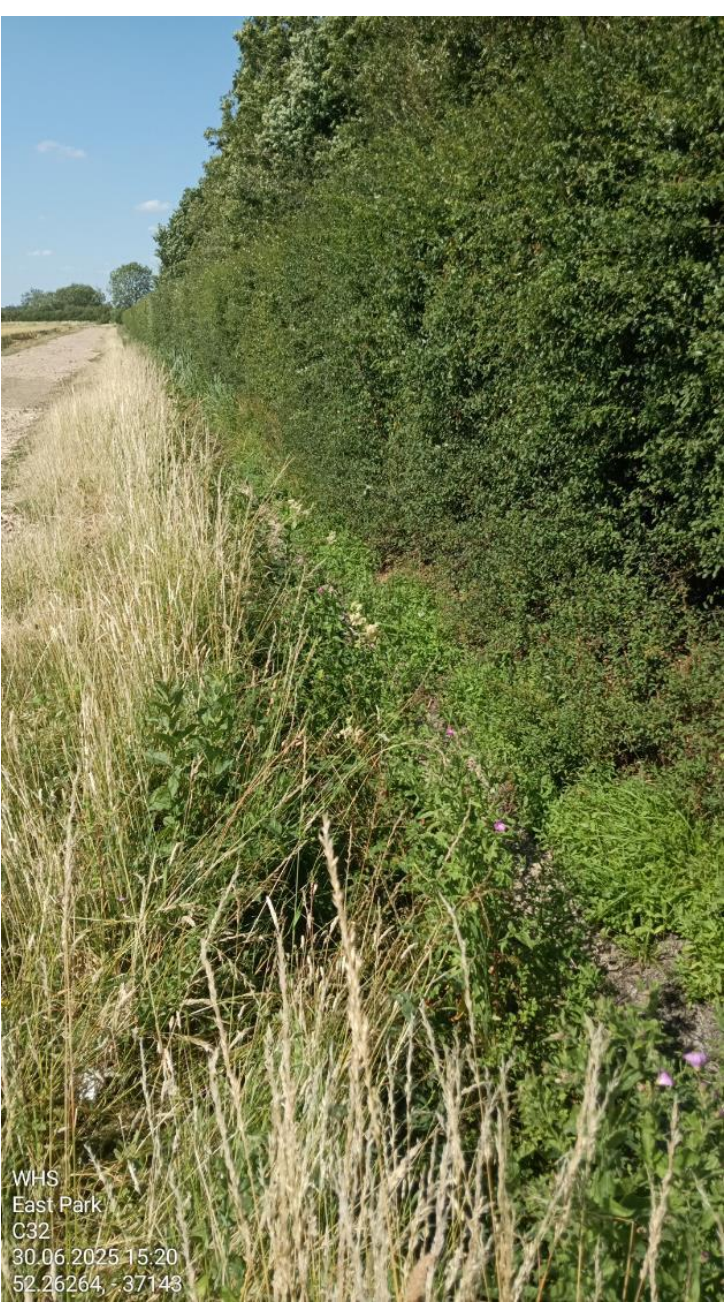
Crossing C32

<p>WHS East Park C32 30.06.2025 15:20 52.26264, -37143</p>		  <p>WHS East Park C32 30.06.2025 15:20 52.26264, -37143</p>				
Upstream view taken from downstream side of crossing		View looking Downstream		Channel bed downstream from crossing

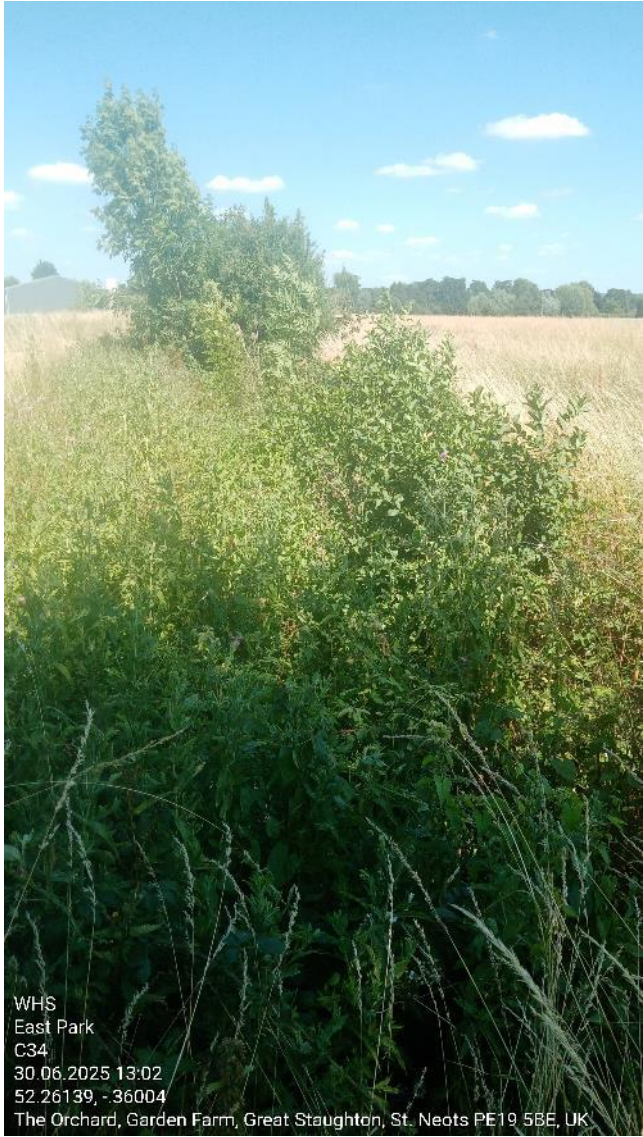
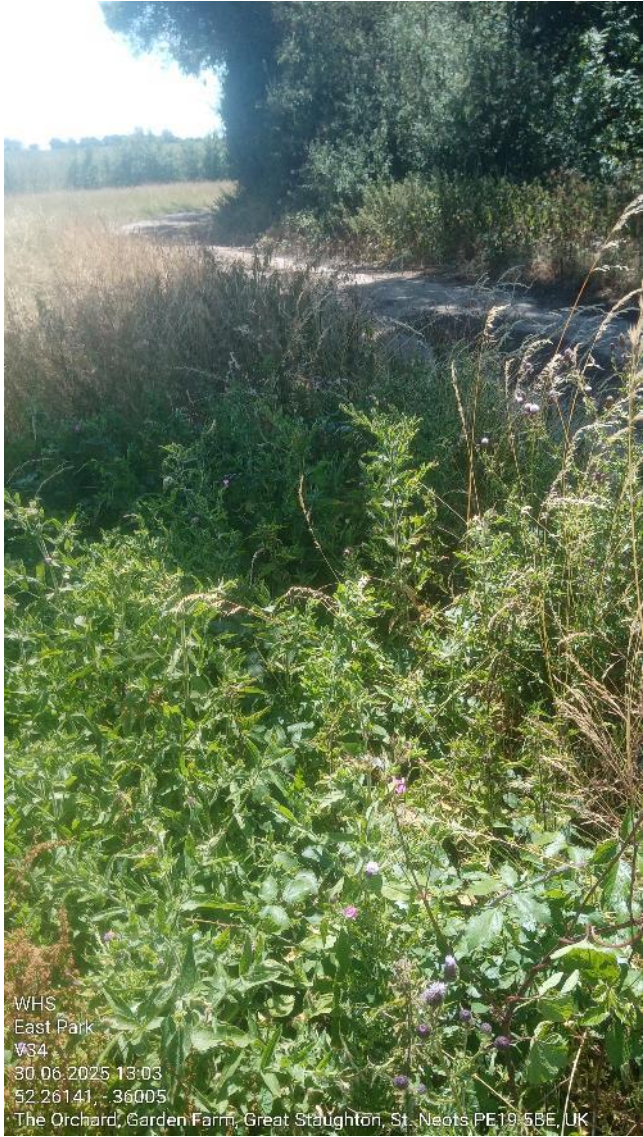
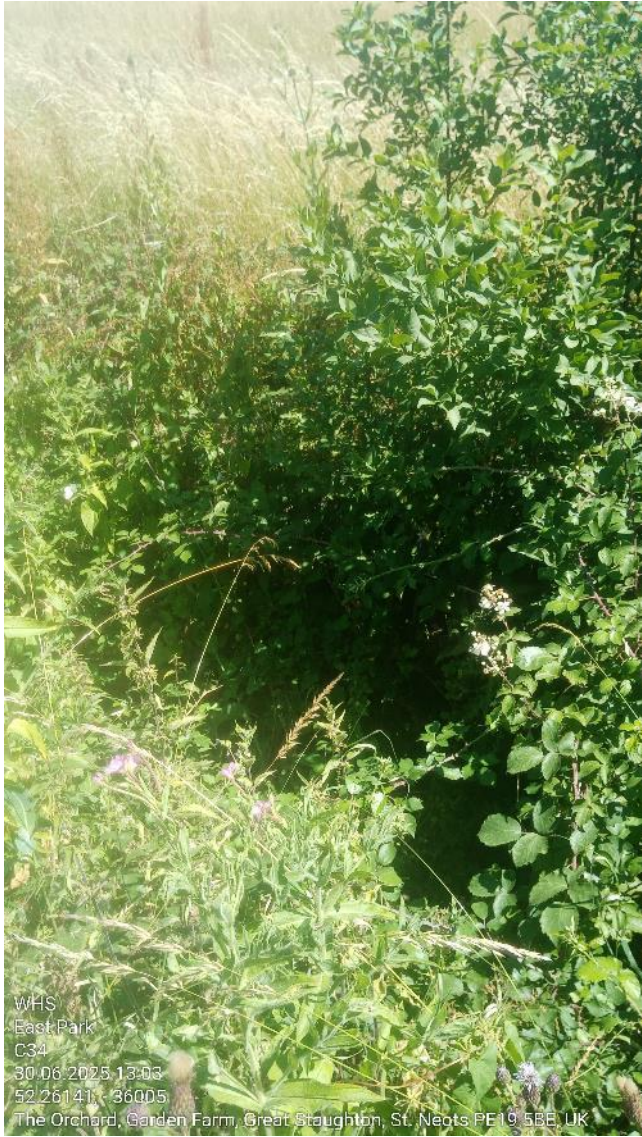
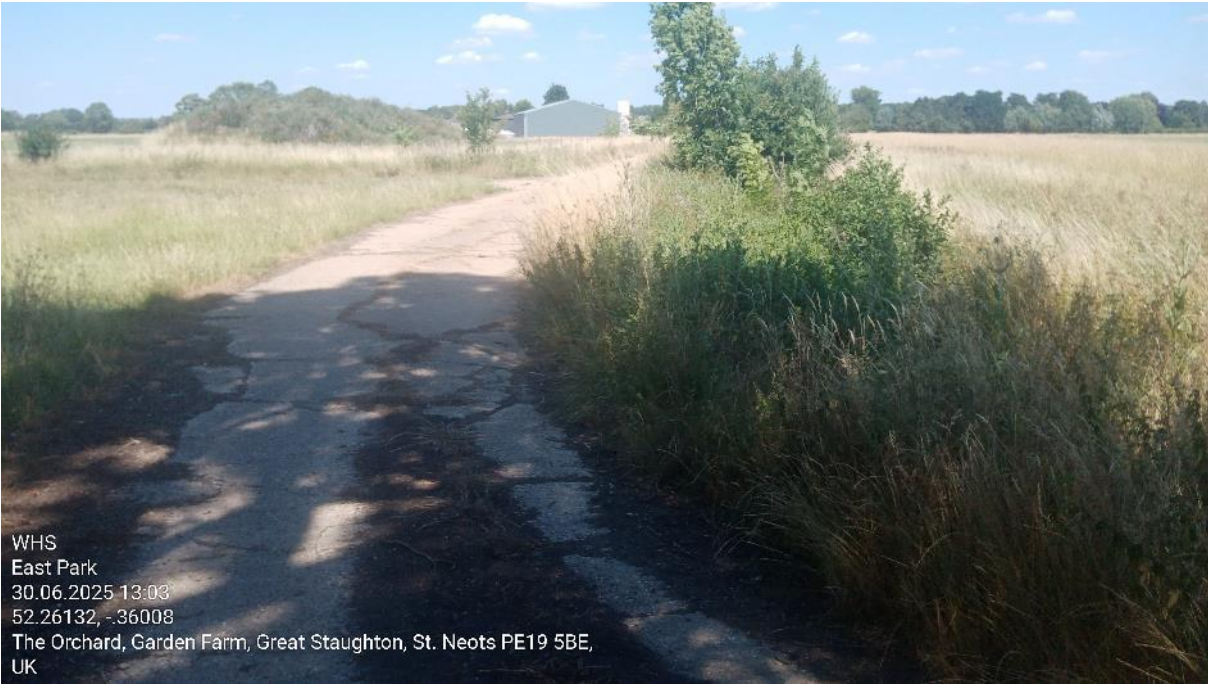
Crossing C33 / C34

Upstream view			Downstream view			Channel view

<div><div>WHS</div><div>East Park</div><div>30.06.2025 13:03</div><div>52.26132, -1.36008</div><div>The Orchard, Garden Farm, Great Staughton, St. Neots PE19 5BE,</div><div>UK</div></div></div>	
View from existing track crossing, downstream of proposed crossing	
Proposed Crossing Type:	Open span crossing to maintain existing bed and banks.

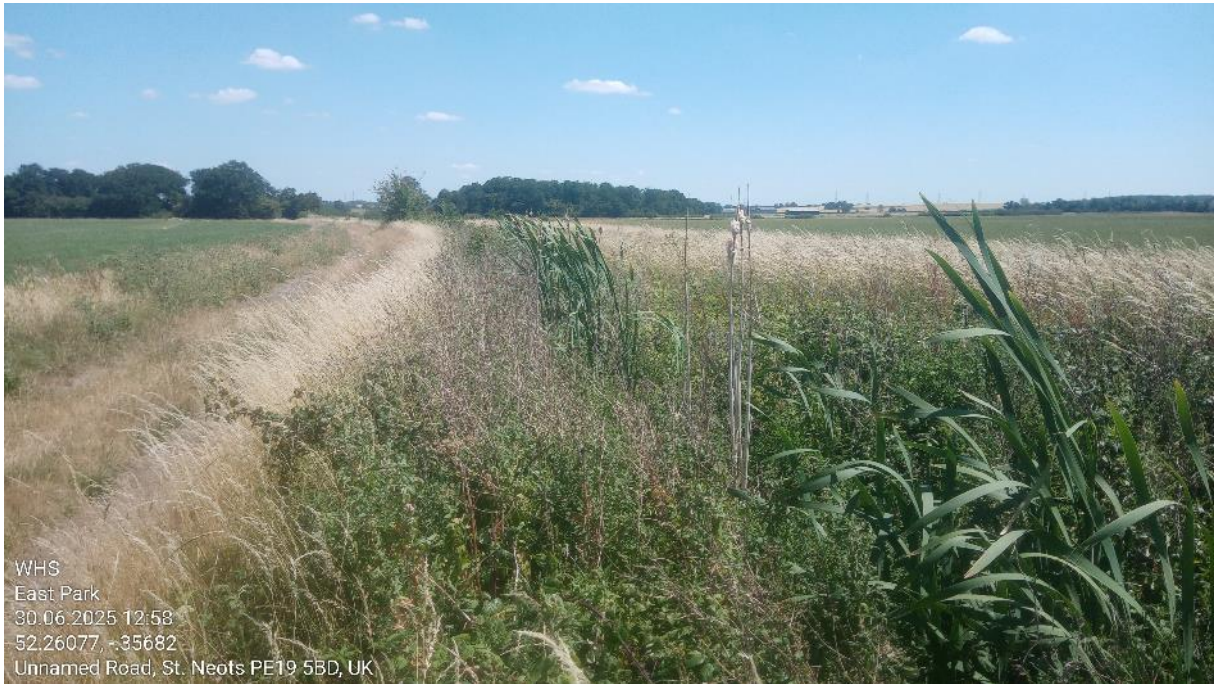
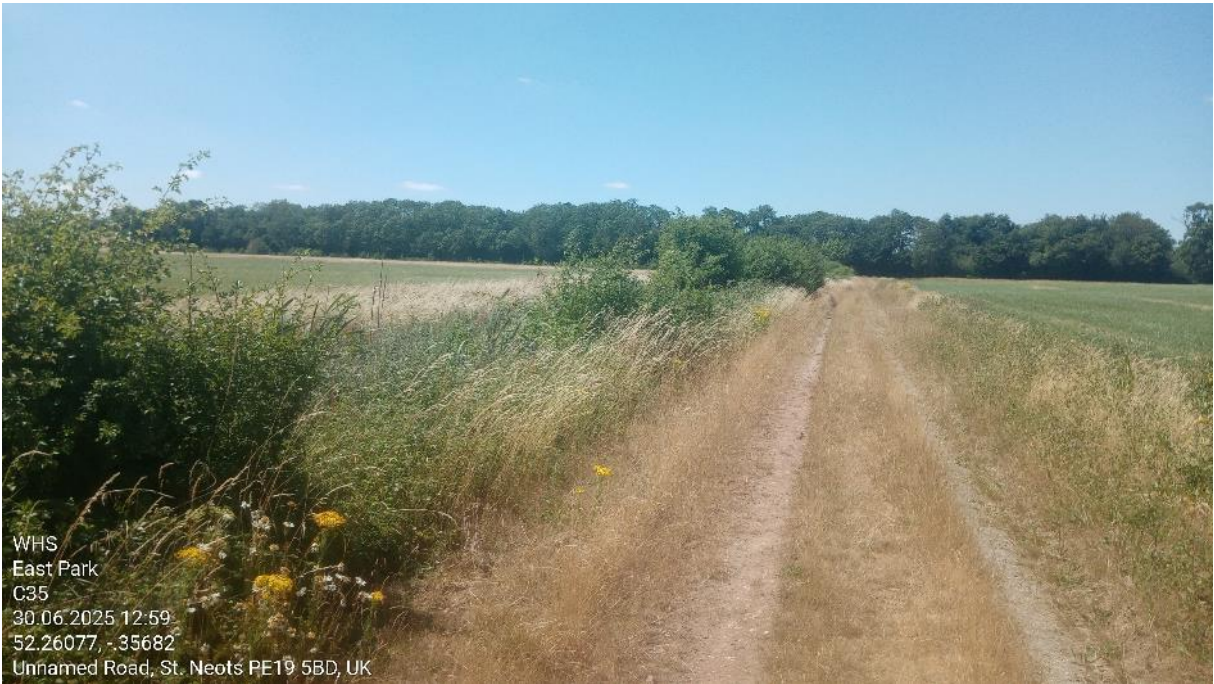
Crossing C35

<p>WHS East Park C35 30.06.2025 12:59 52.26077, -35682 Unnamed Road, St. Neots PE19 5BD, UK</p>			
Downstream view					Upstream view

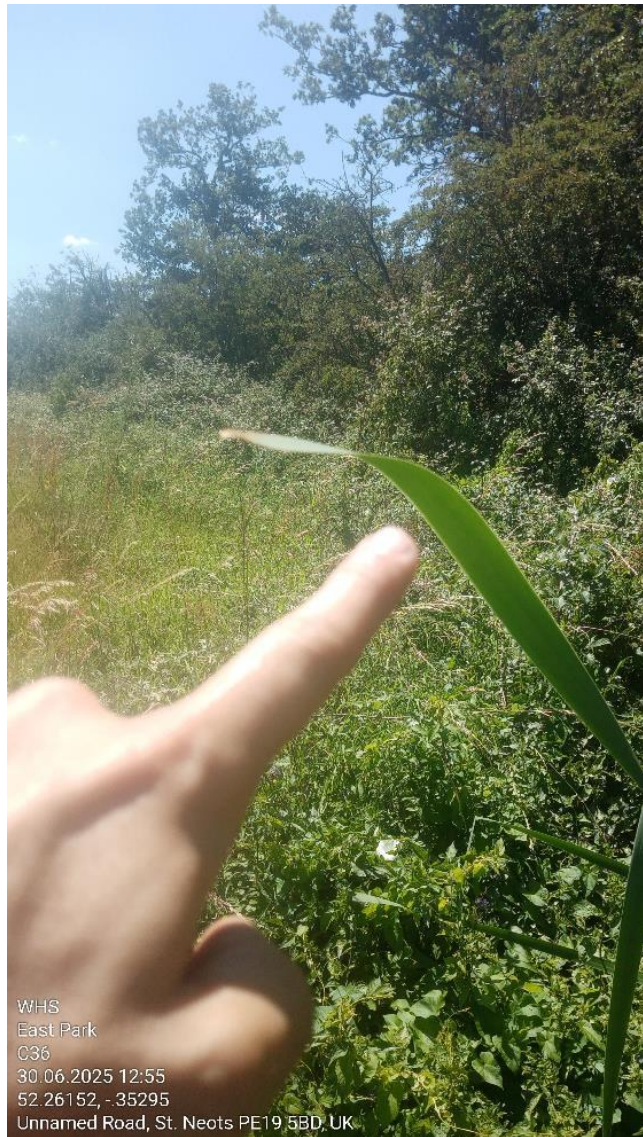
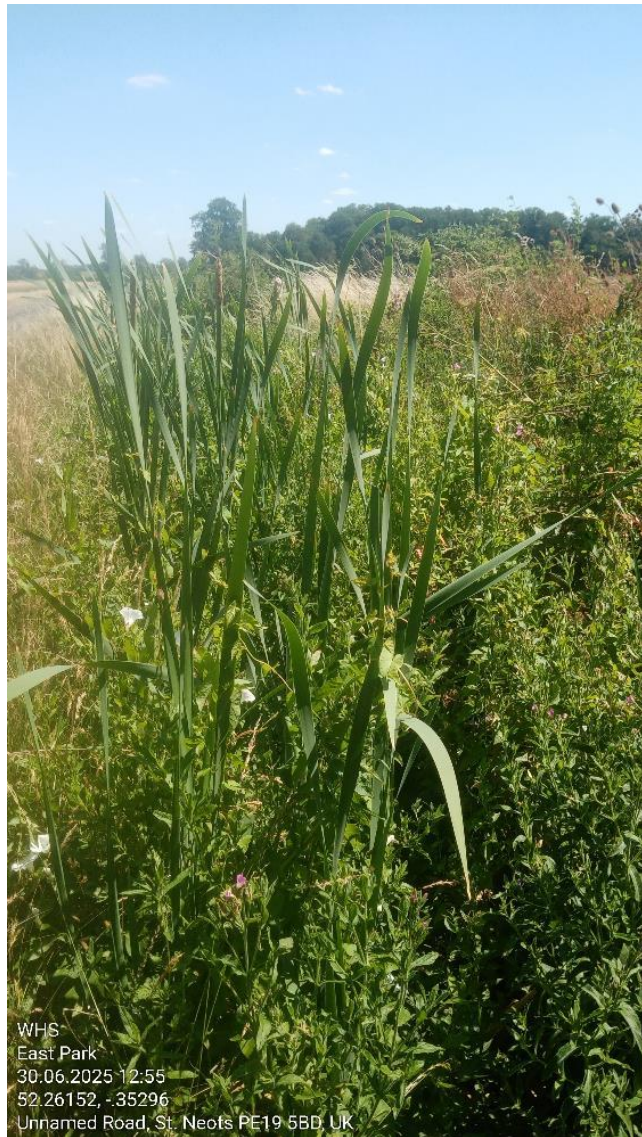
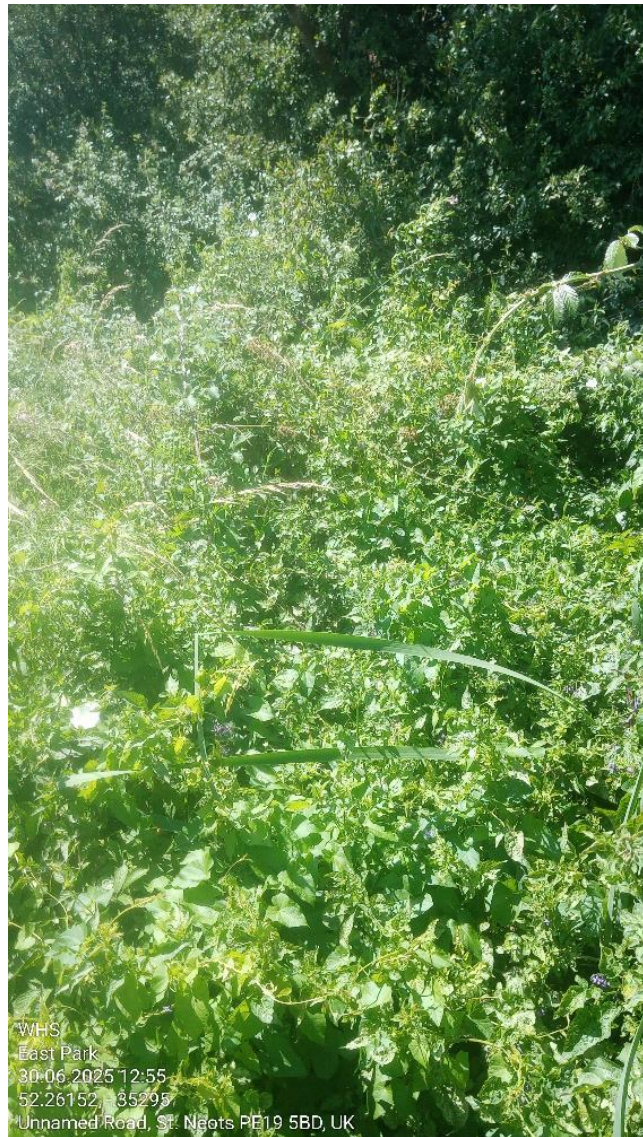
Crossing C36

<p>WHS East Park 30.06.2025 12:55 52.26152, -35295 Unnamed Road, St. Neots PE19 5BD, UK</p>		
Channel view from right bank			Channel looking downstream			Obscured channel		
Proposed Crossing Type			Trenching required at this location for 33kV cabling.
