East Park Energy

Environmental Statement

Appendix 8-3: Watercourse Crossing Assessment

September 2025

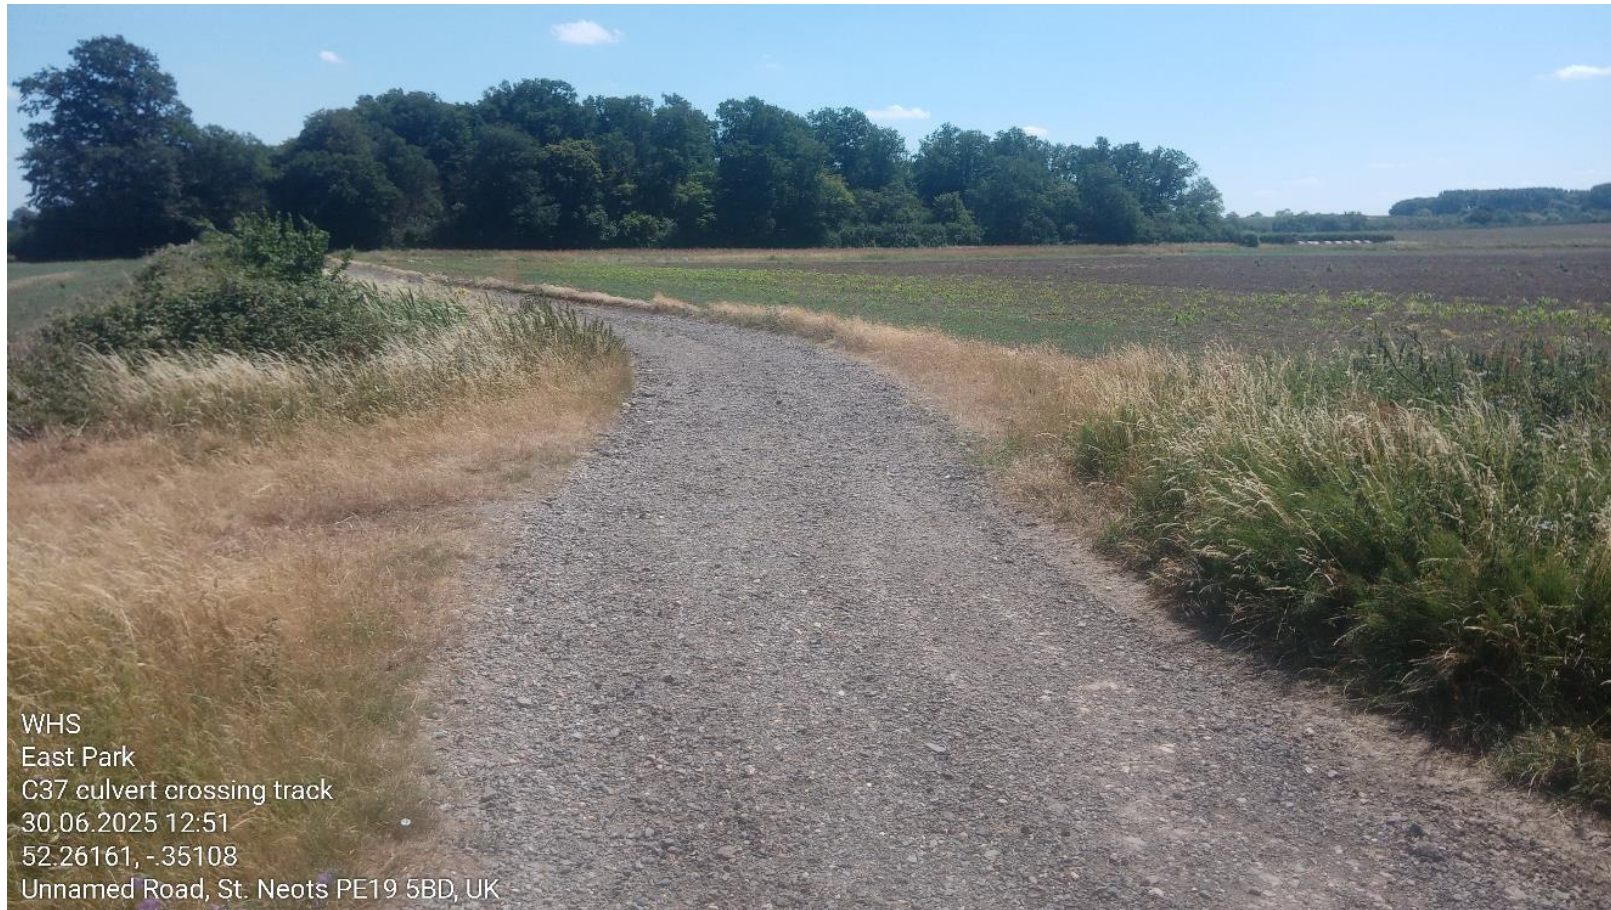
Overgrown culvert inlet			Downstream view			Obscured Channel downstream of crossing

WHS
East Park
C37 culvert crossing track
30.06.2025 12:51
52.26161, -35108
Unnamed Road, St. Neots PE19 5BD, UK

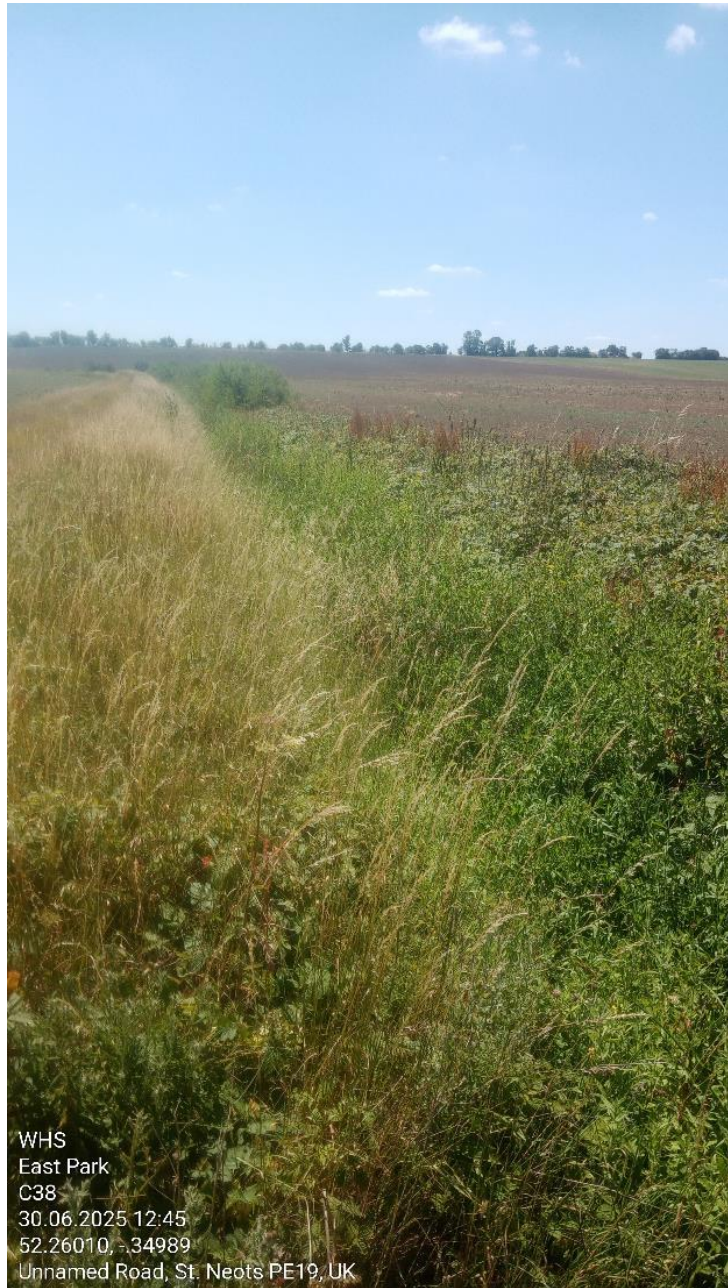
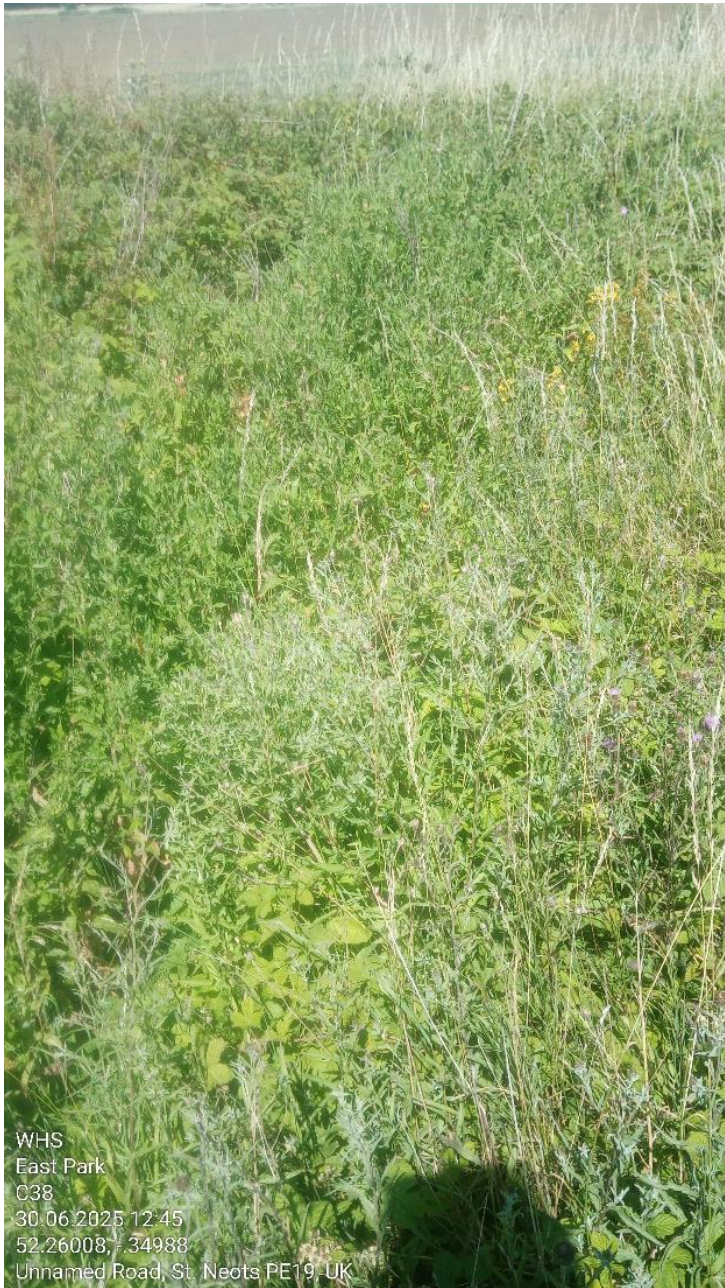
<p>WHS East Park C38 30.06.2025 12:45 52.26008, -34988 Unnamed Road, St. Neots PE19, UK</p>		
View looking Upstream						Looking across Channel

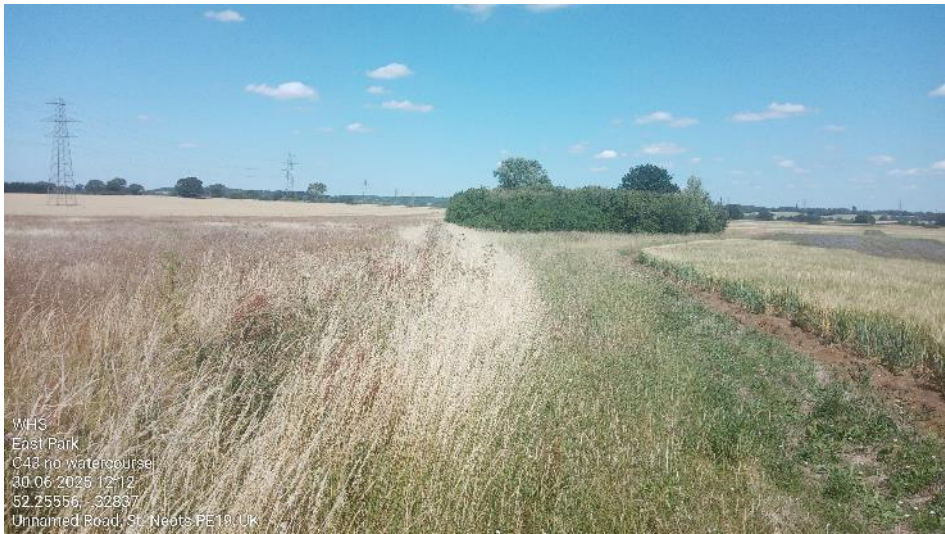
Crossing	Valley Shape	Wetted Width (m)	Bankfull Width (m)	Channel Max Depth (m)	Bank Profile and Stability	Channel Planform and upstream catchment	Pool Riffle Development	Comments
C42	-	-	-	-	-	-	-	No channel observed during visit at this location, neither is any channel distinguishable by LiDAR at this location. Mapped channel likely filled-in.

<div>WHS East Park C42 no watercourse 30.06.2025 12:12 52.25556, -0.28337 Unnamed Road, St Neots PE19, UK</div>

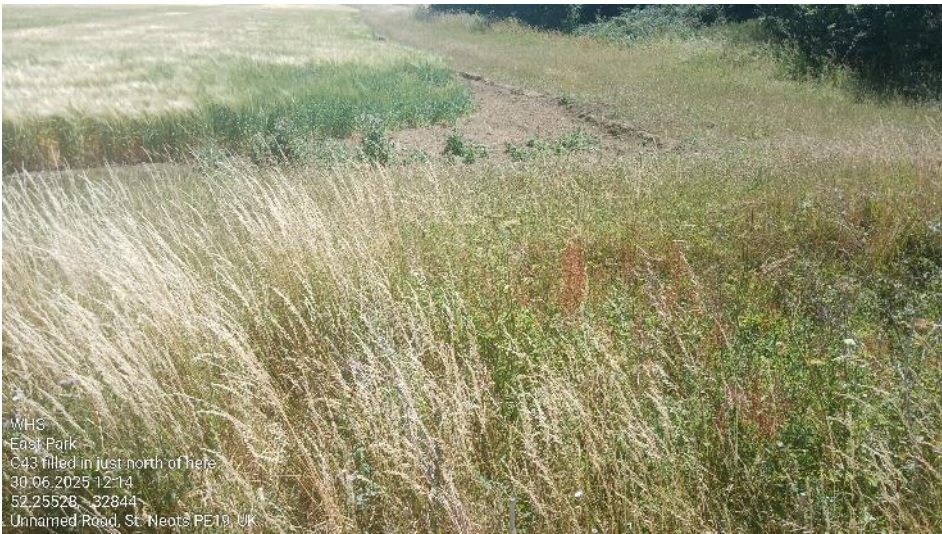
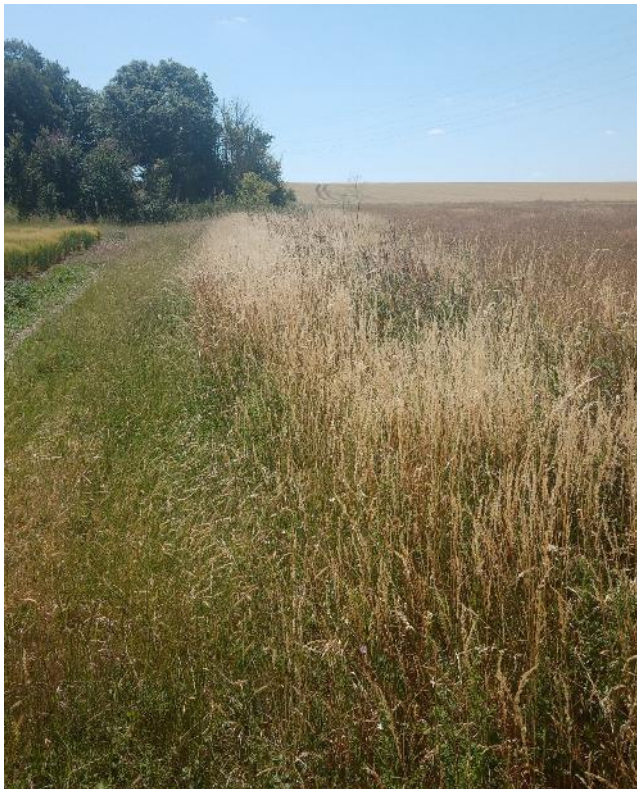
<div>WHS East Park C43 filled in just north of here 30.06.2025 12:14 52.25526, -0.28444 Unnamed Road, St Neots PE19, UK</div>

View North				View East				View South
Proposed Crossing Type:		Temporary tracks proposed at this location however no watercourse crossing required, since mapped watercourse has been filled in.

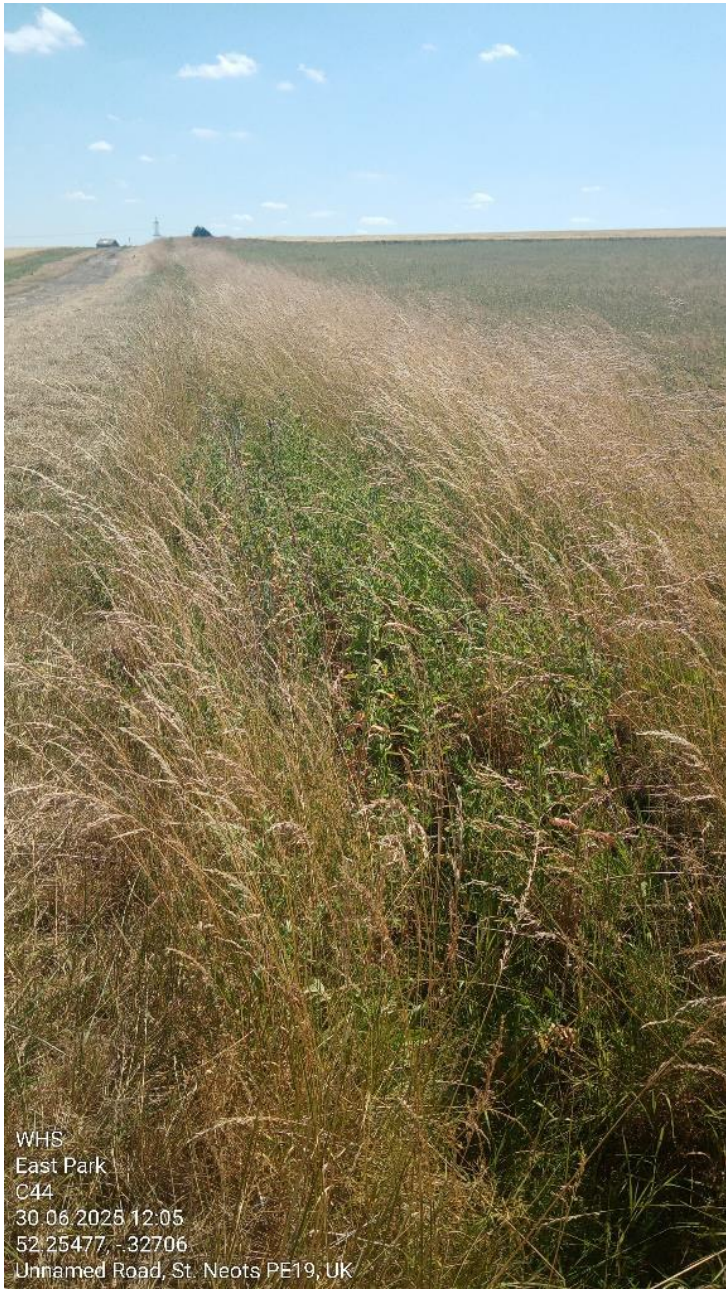
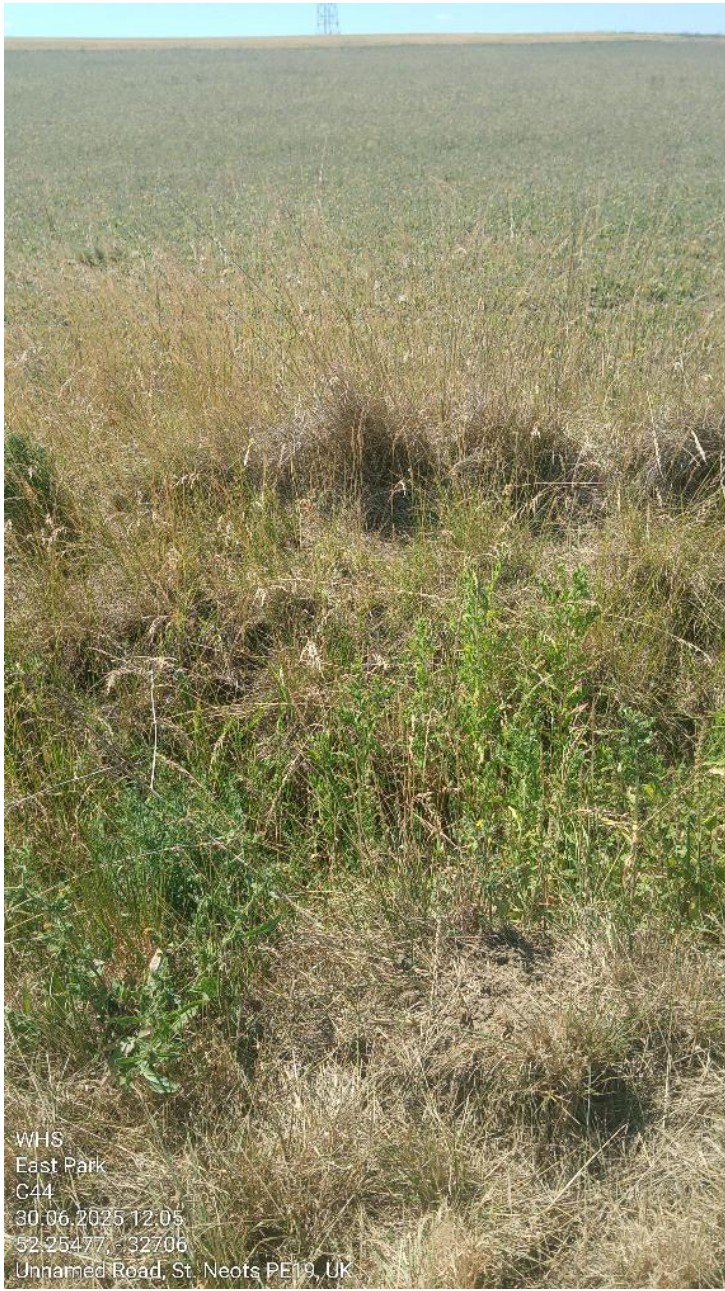
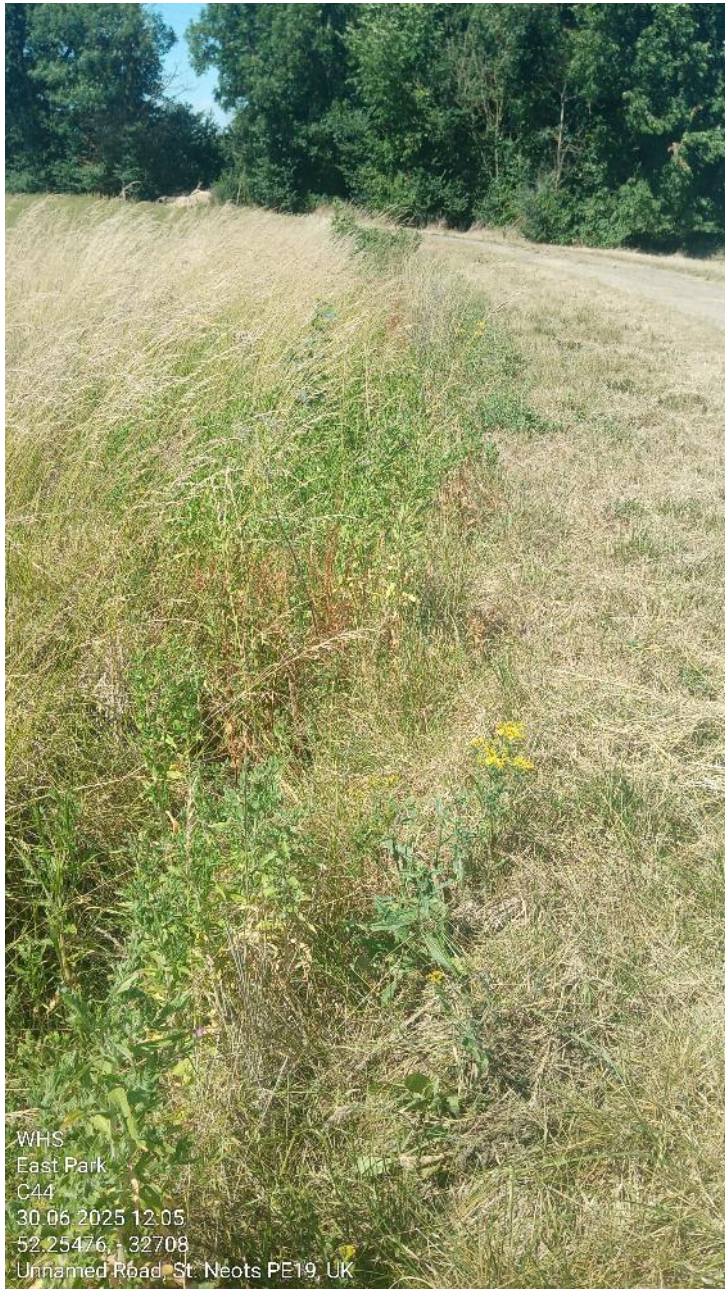
<p>WHS East Park C44 30.06.2025 12:05 52.25476, -32708 Unnamed Road, St. Neots PE19, UK</p>		
Upstream view of channel from inlet			Existing culvert inlet location			Culvert inlet

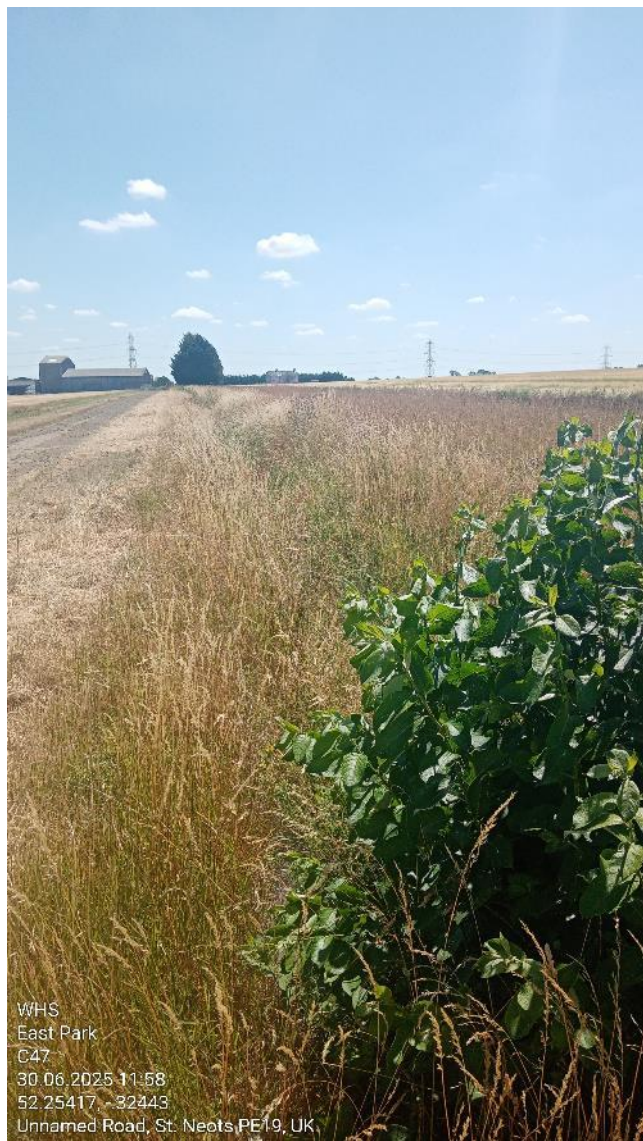
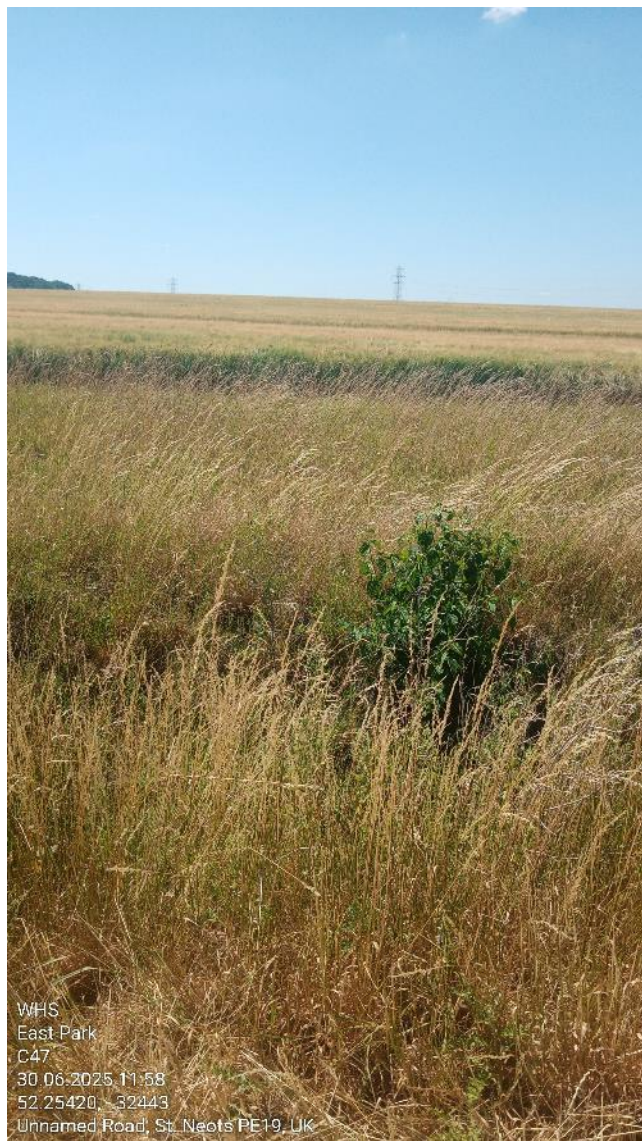
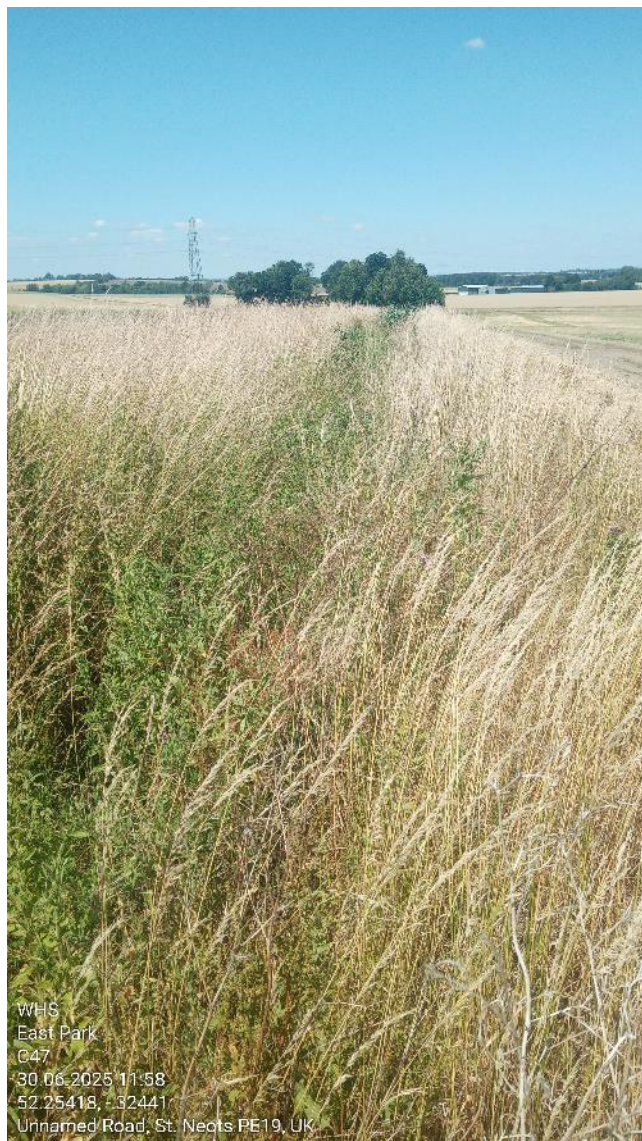
<p>WHS East Park C47 30.06.2025 11:58 52.25418, -32441 Unnamed Road, St. Neots, PE19, UK</p>		
Upstream			Channel at Proposed Crossing Site			Downstream		
Proposed Crossing Type:		Open span crossing to preserve natural bed and banks

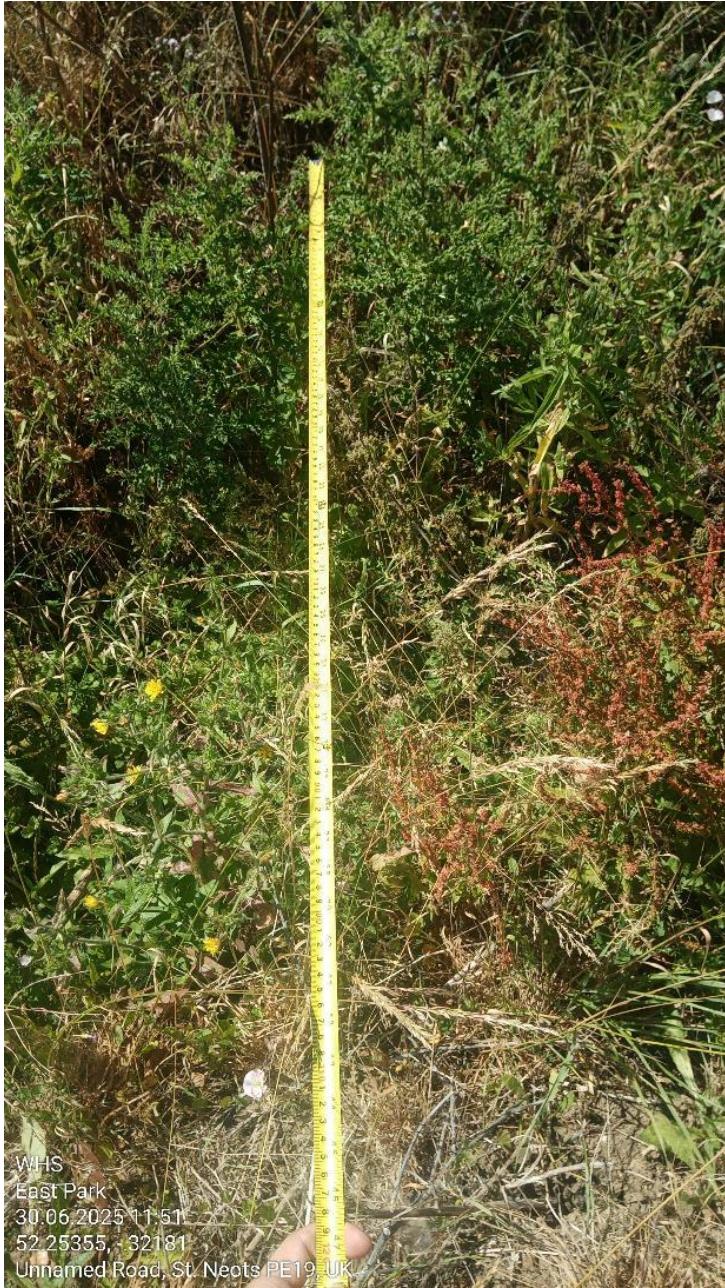
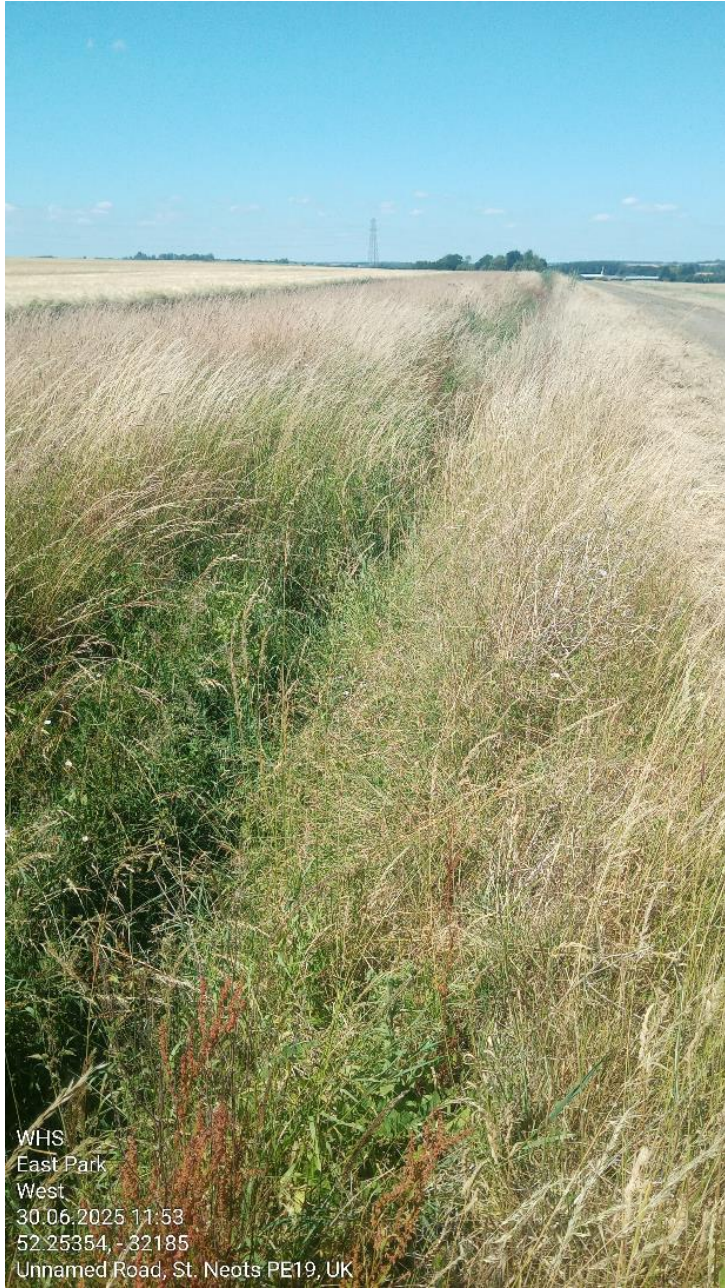
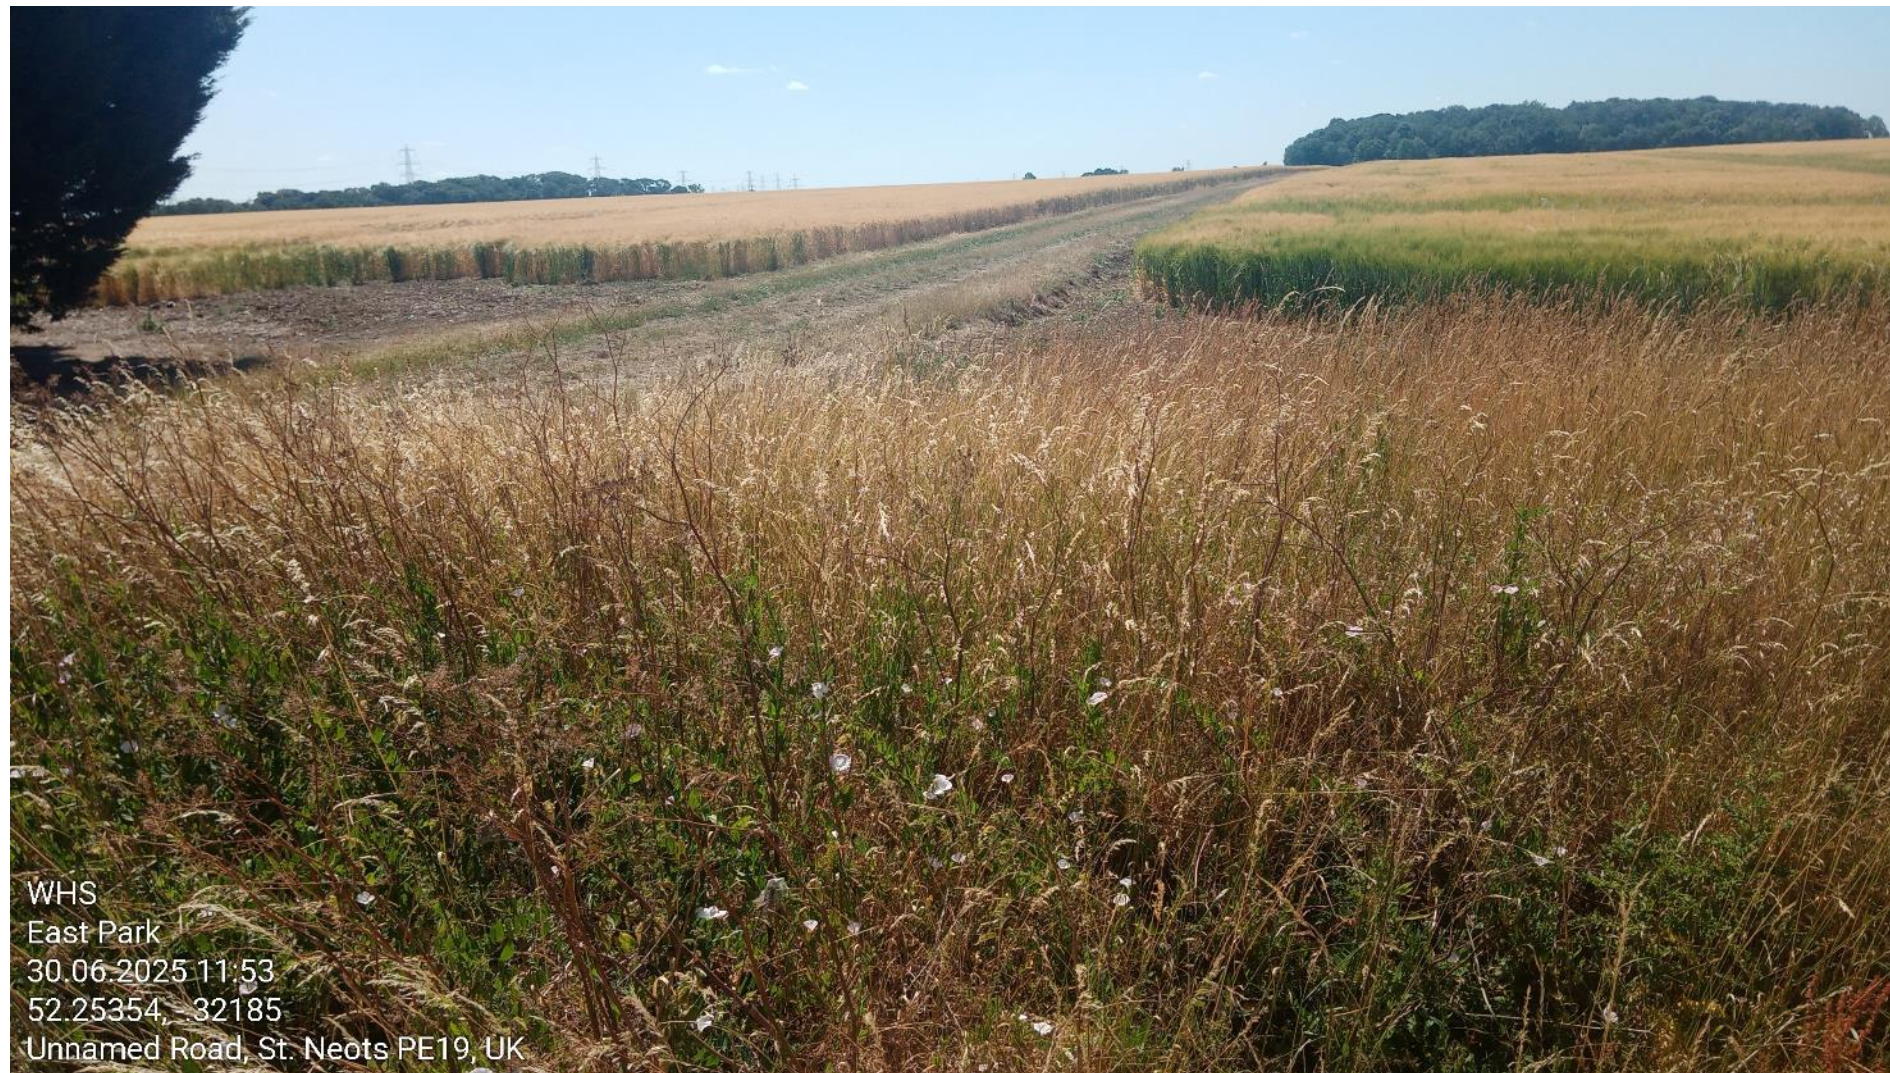
<p>WHS East Park West 30.06.2025 11:53 52.25354, -32185 Unnamed Road, St. Neots PE19, UK</p>			
Channel bed at Proposed Crossing Site					View looking Downstream

Proposed crossing viewed looking south	
Proposed Crossing Type	Trenching for 400kV Grid Connection cable crossing.

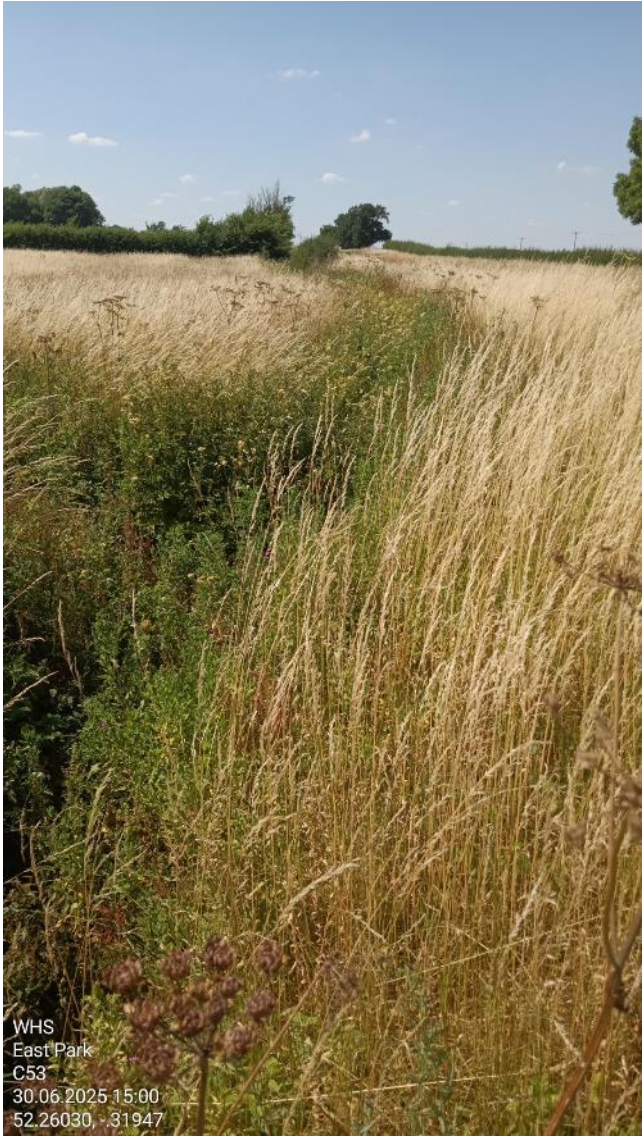
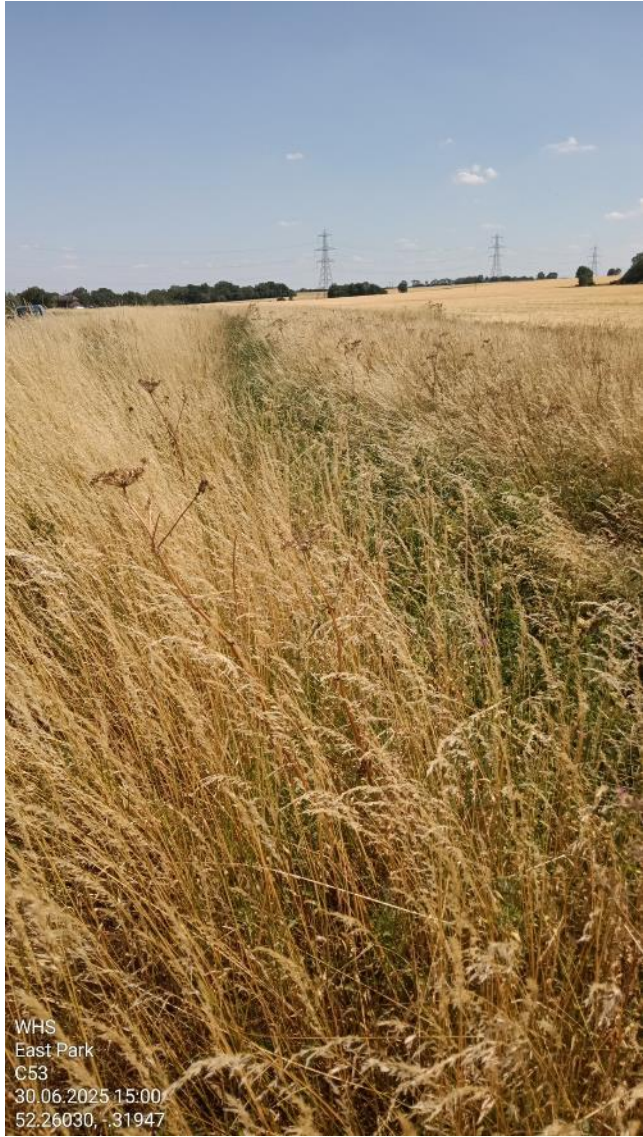
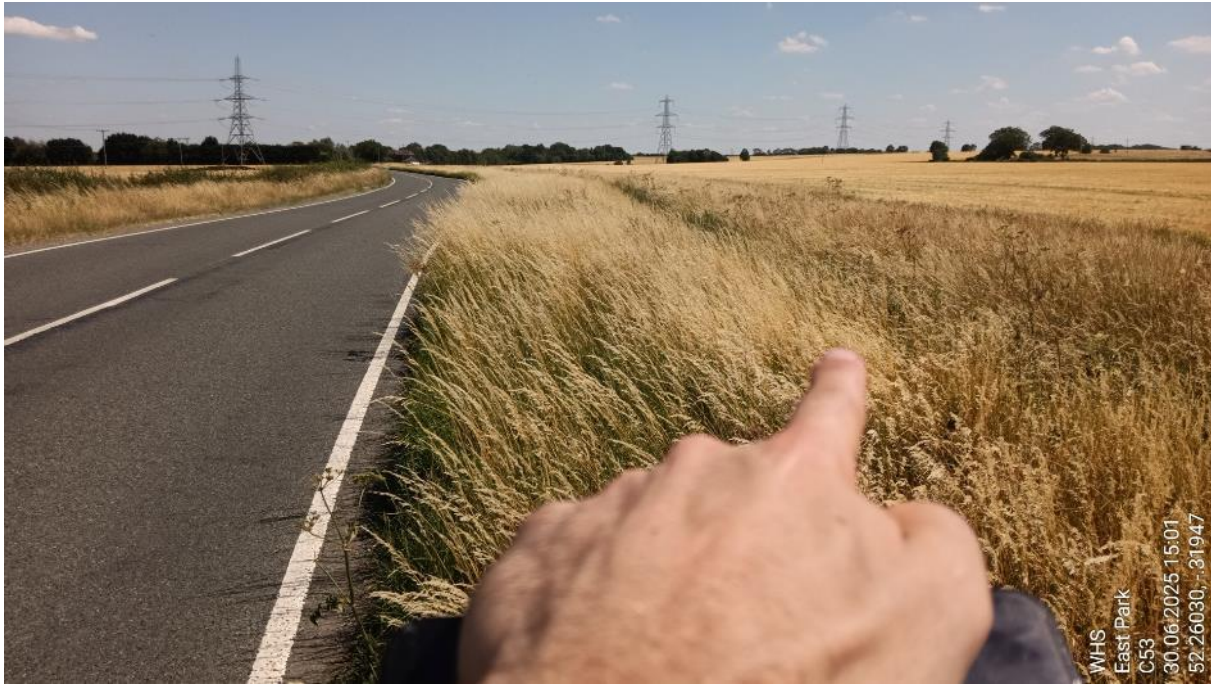
Upstream view			Channel at crossing			Downstream

<div> <div>Proposed Crossing view from northwest (B645)</div> </div>	
<div> <div>Proposed Crossing Type:</div> </div>	<div> <div>Bottomless arch culvert, maintaining natural channel bed</div> </div>

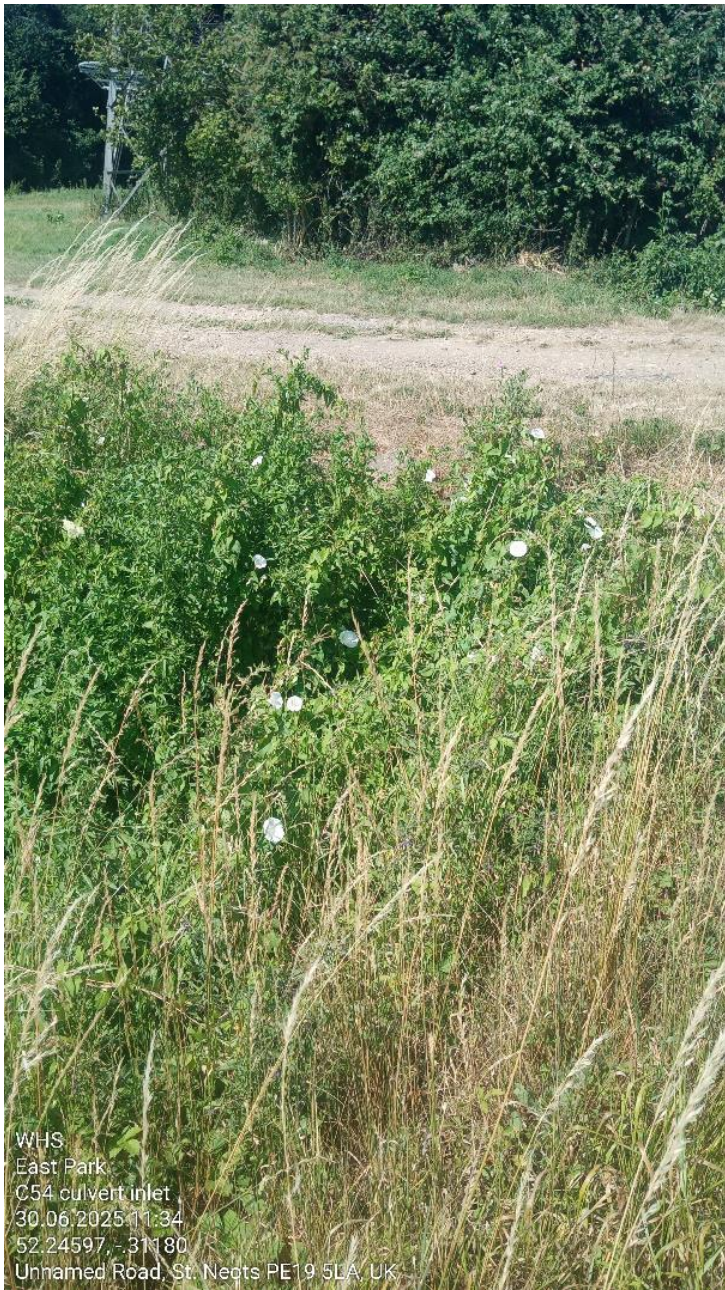
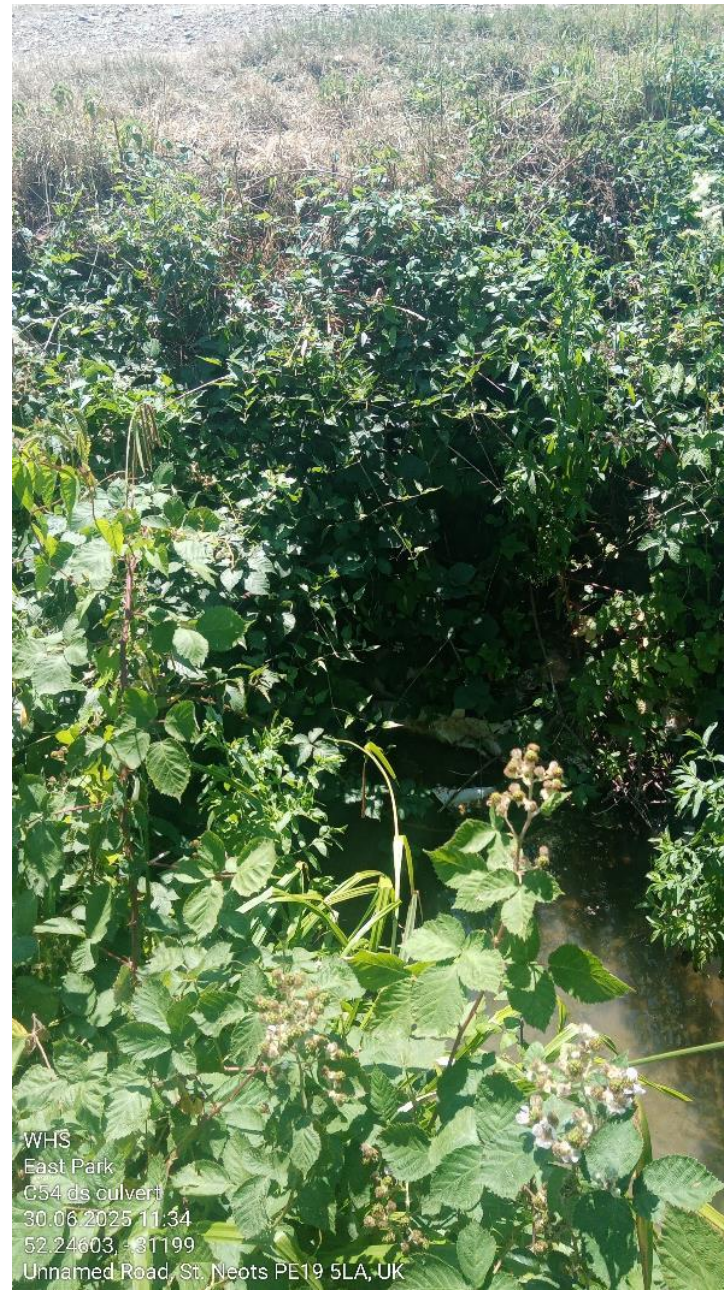
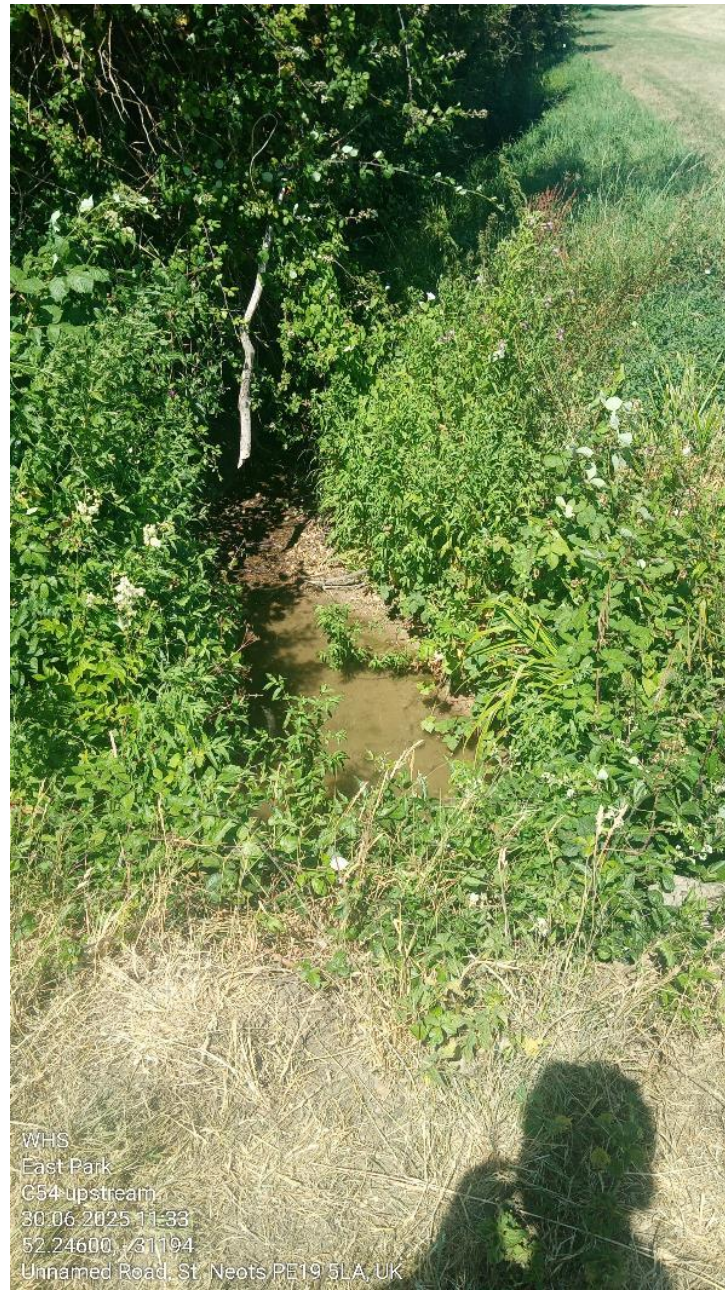
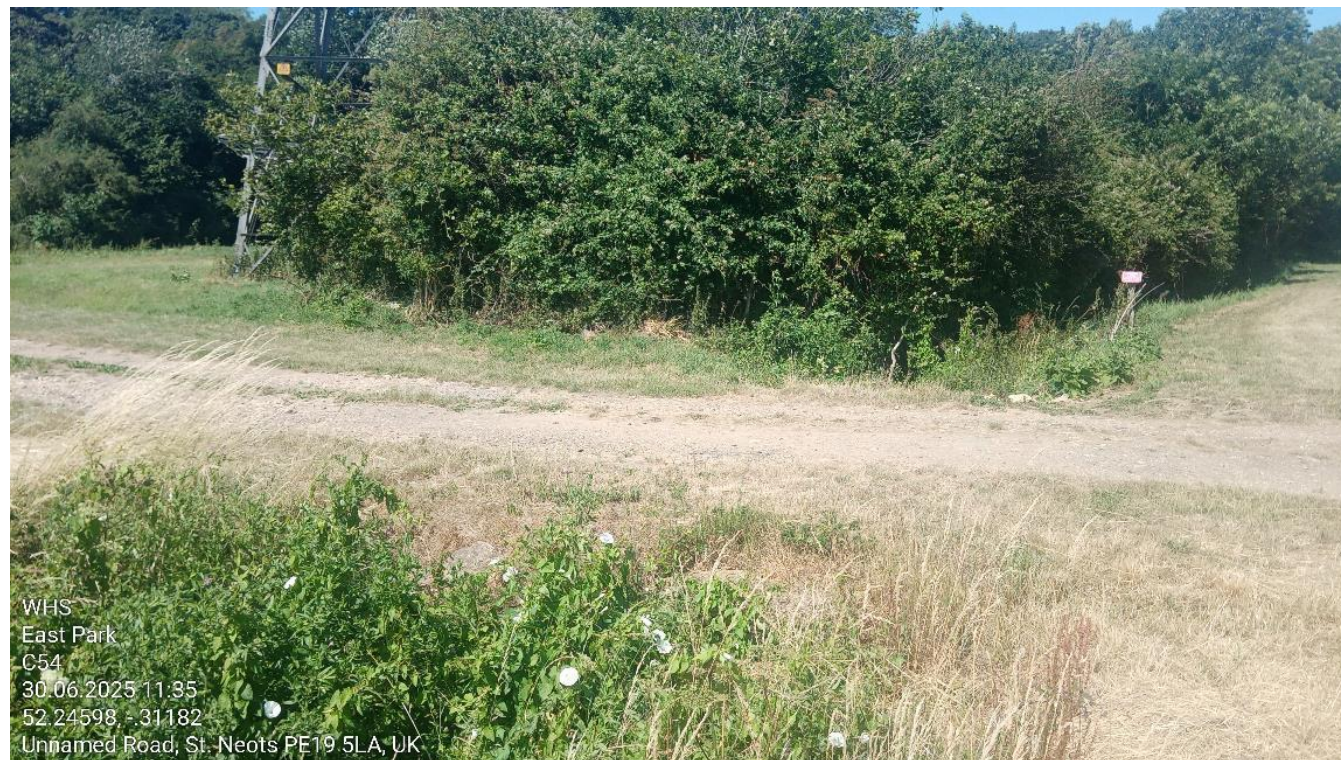
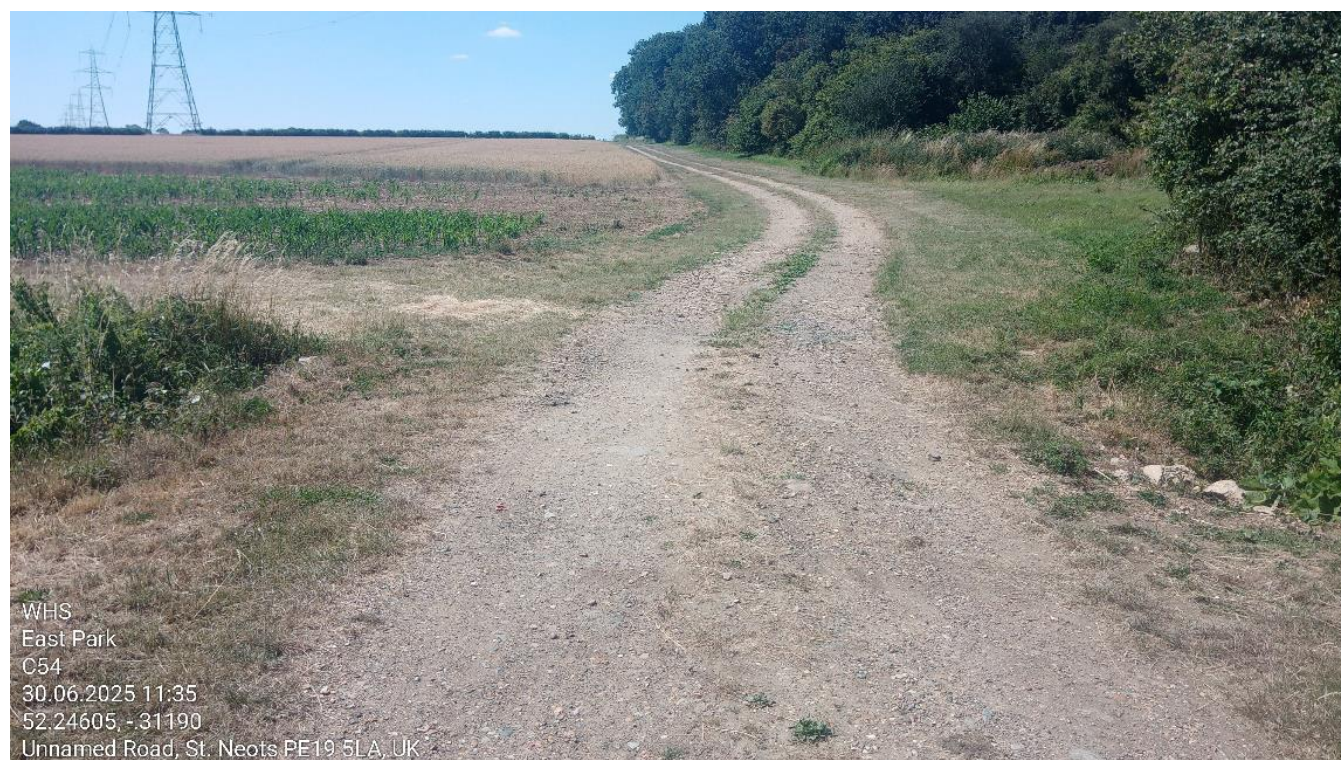
Inlet				Outlet				Upstream view of channel from deck

Existing crossing from east

Existing crossing from north

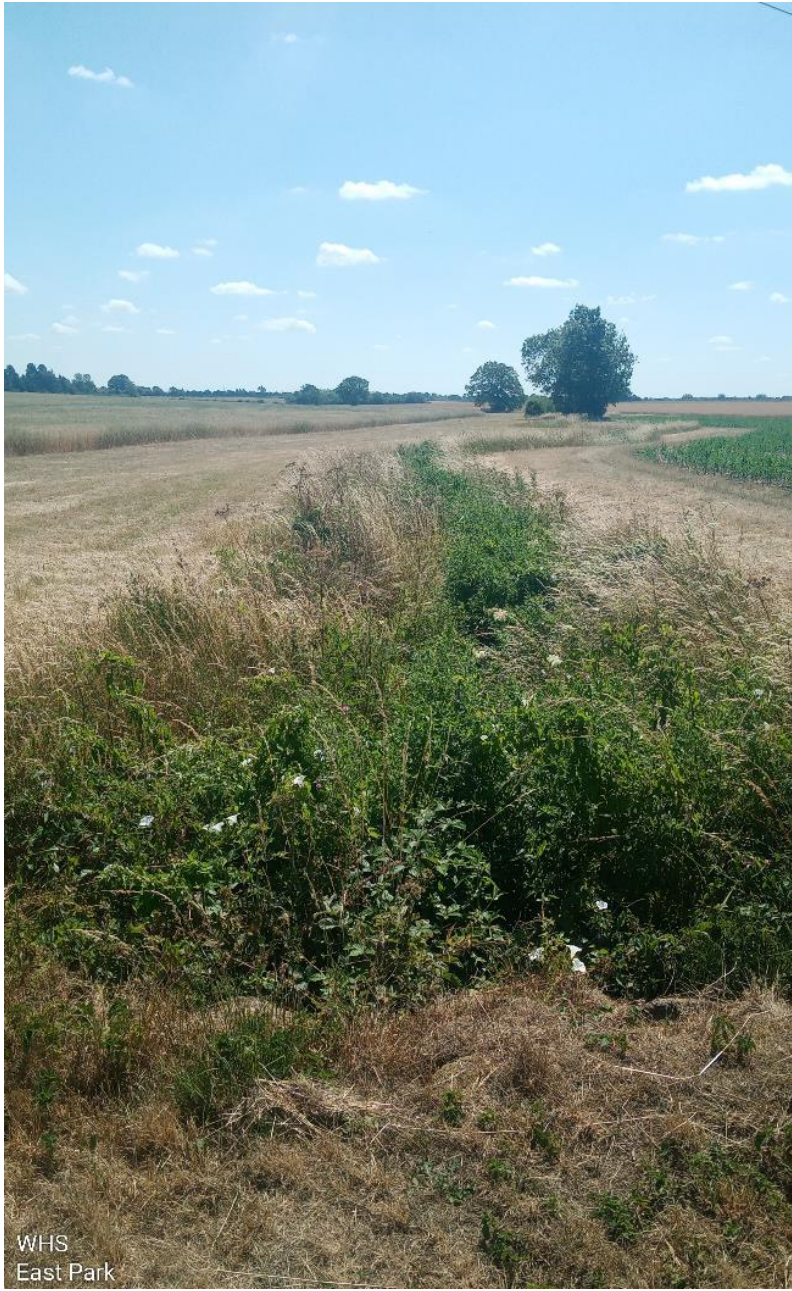
<div>WHS East Park</div>								
View downstream from existing track crossing								
Proposed Crossing Type			Horizontal drill for 400kV grid connection cabling.
