East Park Energy

Environmental Statement

Appendix 8-3: Watercourse Crossing Assessment

September 2025

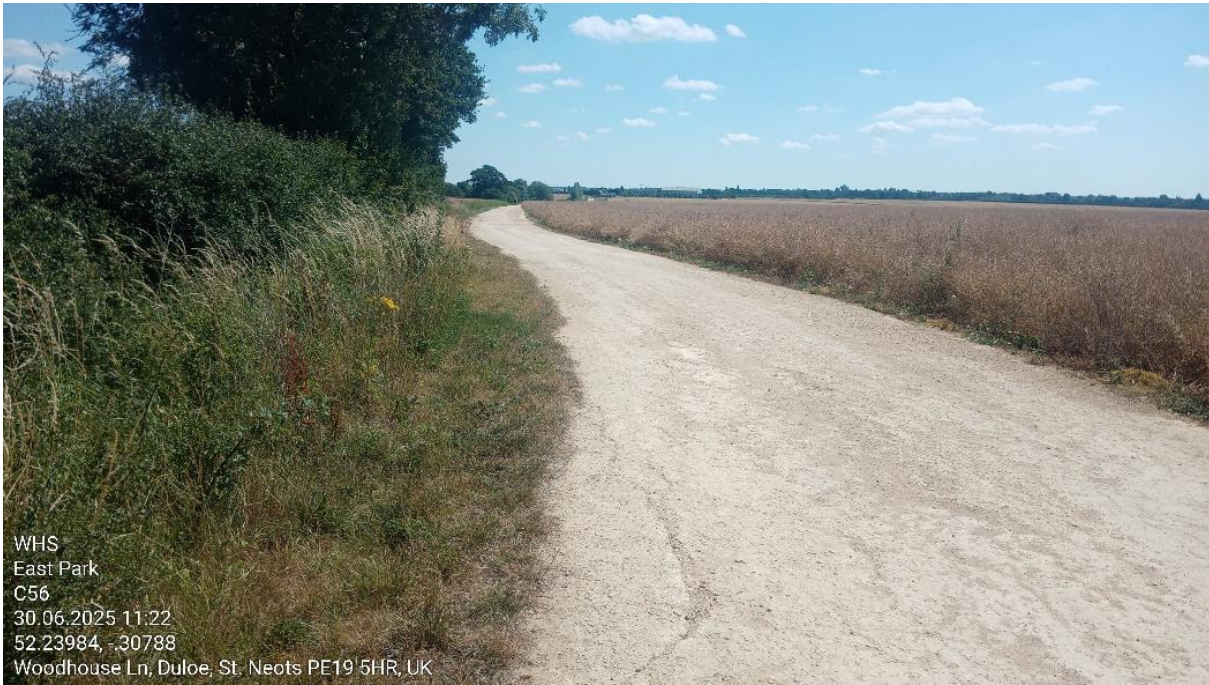
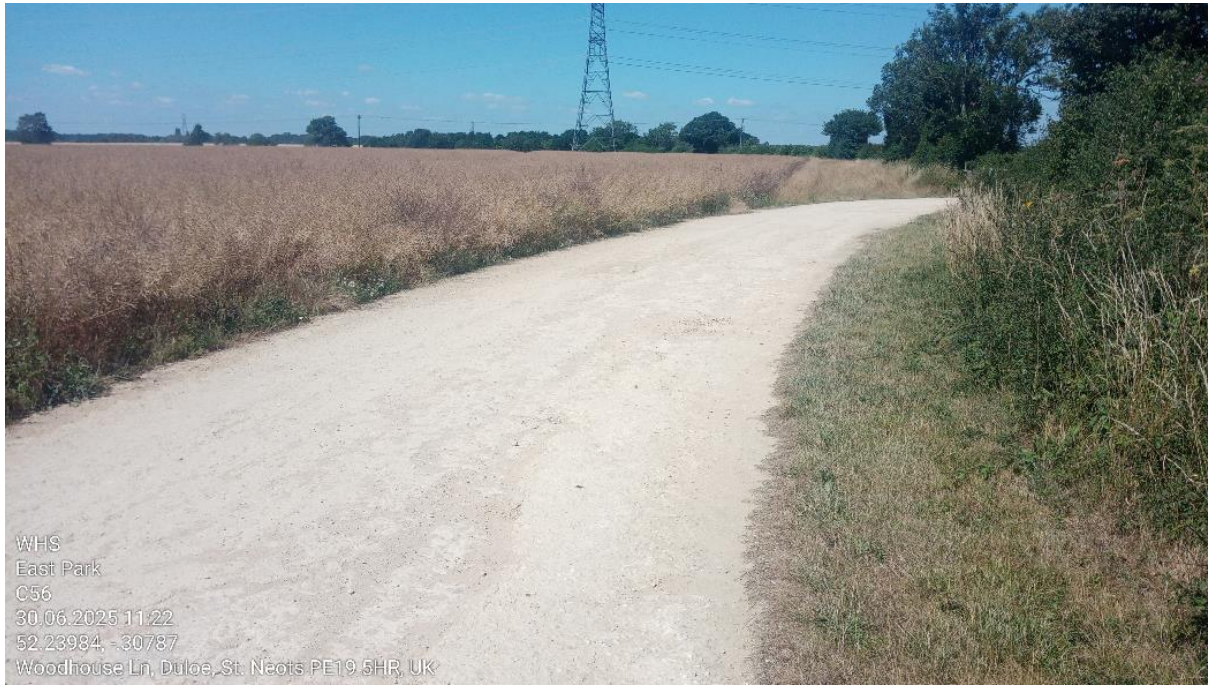
<p>WHS East Park C56 30.06.2025 11:22 52.23984, -30787 Woodhouse Ln, Duloe, St. Neots PE19 5HR, UK</p>			
View upstream of proposed crossing (watercourse underneath hedge planting to left of track)					View downstream of proposed crossing (watercourse underneath hedge planting to right of track)

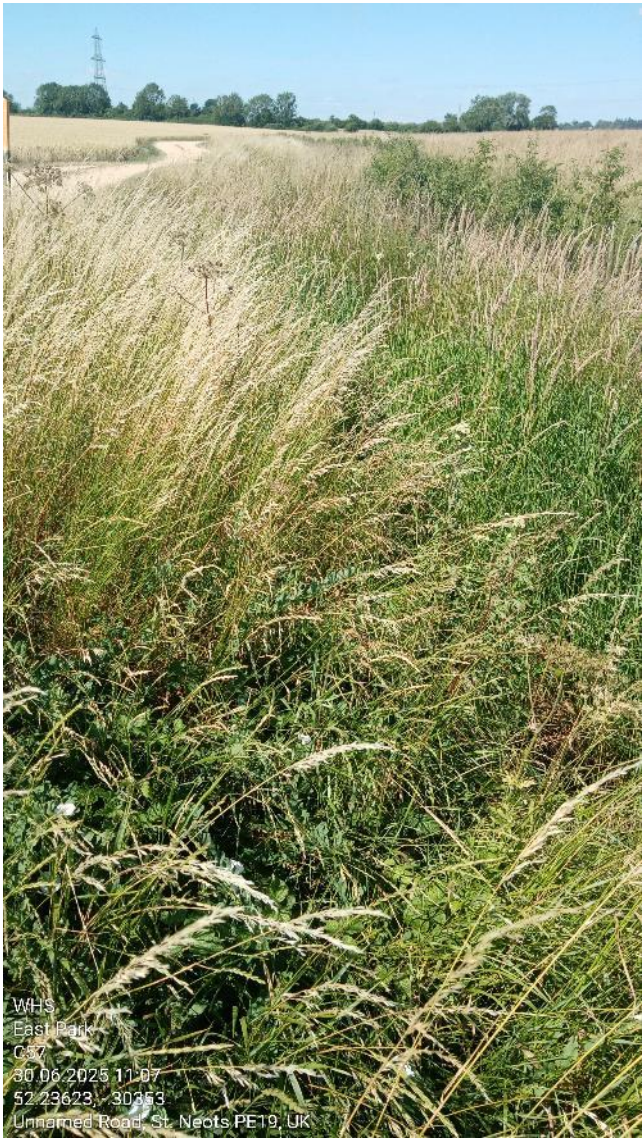
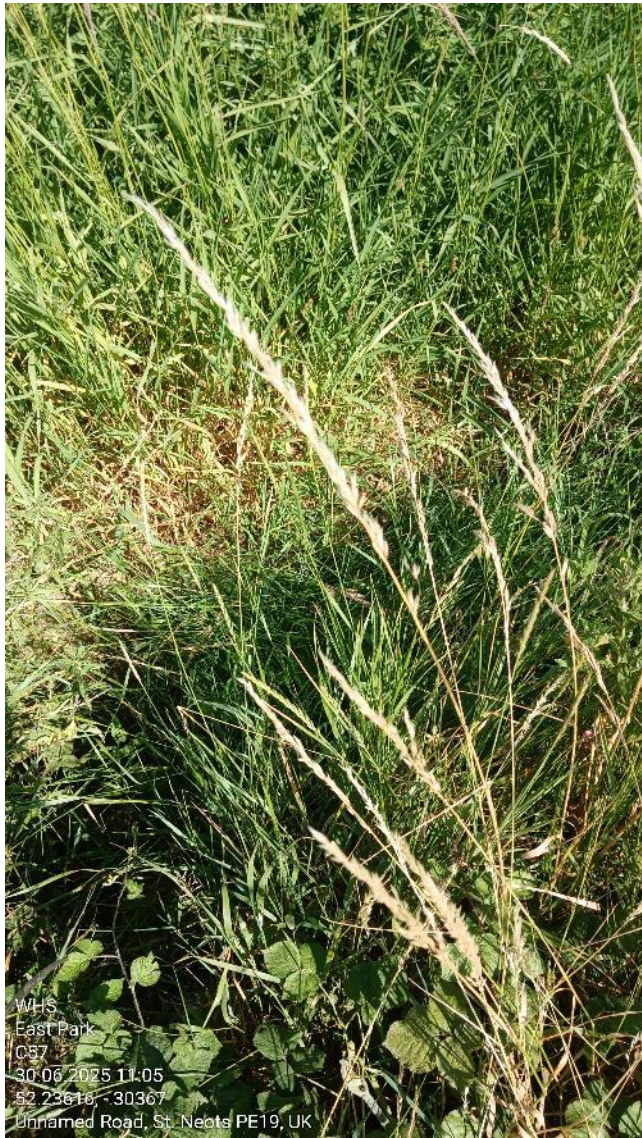
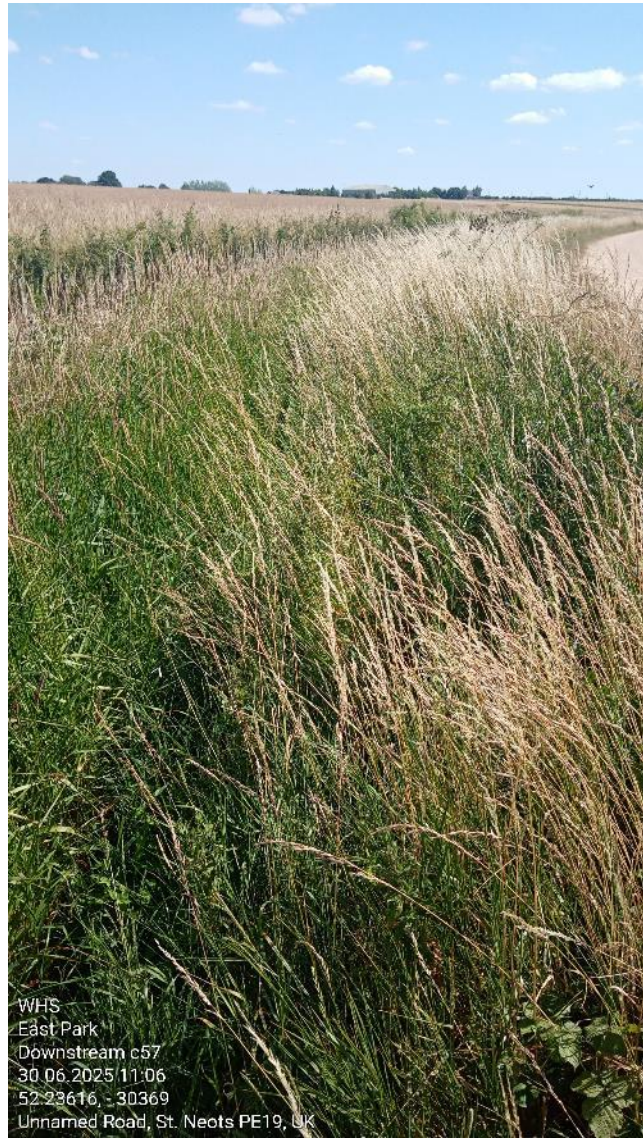
<p>WHS East Park Downstream c57 30.06.2025 11:06 52.23616, -30369 Unnamed Road, St. Neots PE19, UK</p>		
Upstream view			Channel bed at crossing			Downstream view		
Proposed Crossing Type:		Bottomless arch culvert, maintaining natural channel bed for access track. Trenching proposed for 400kV grid connection cable.

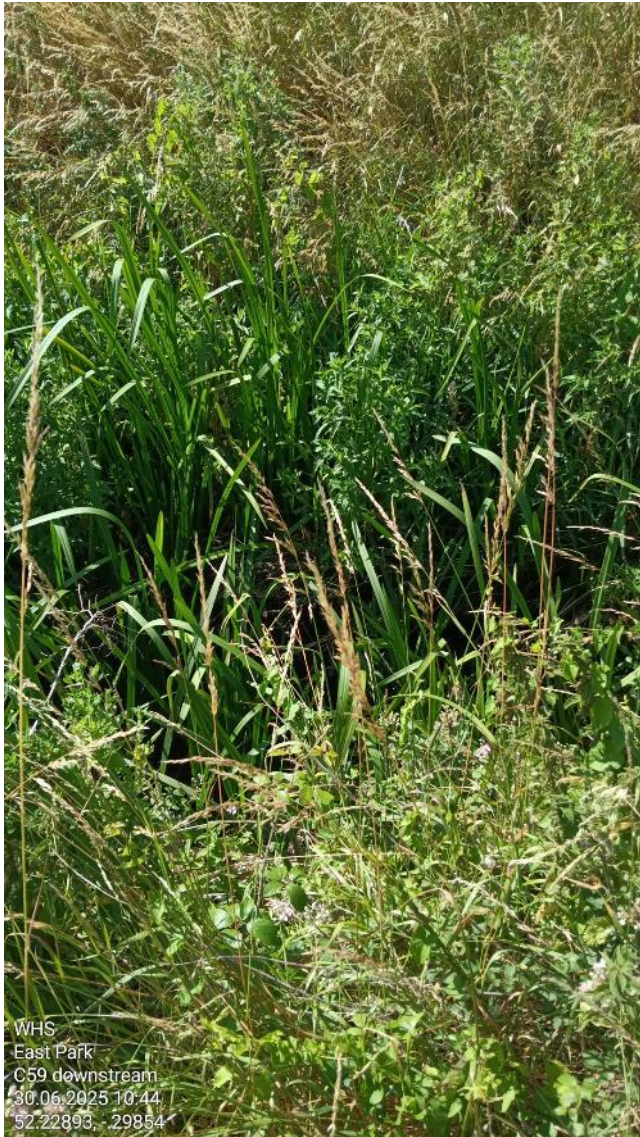
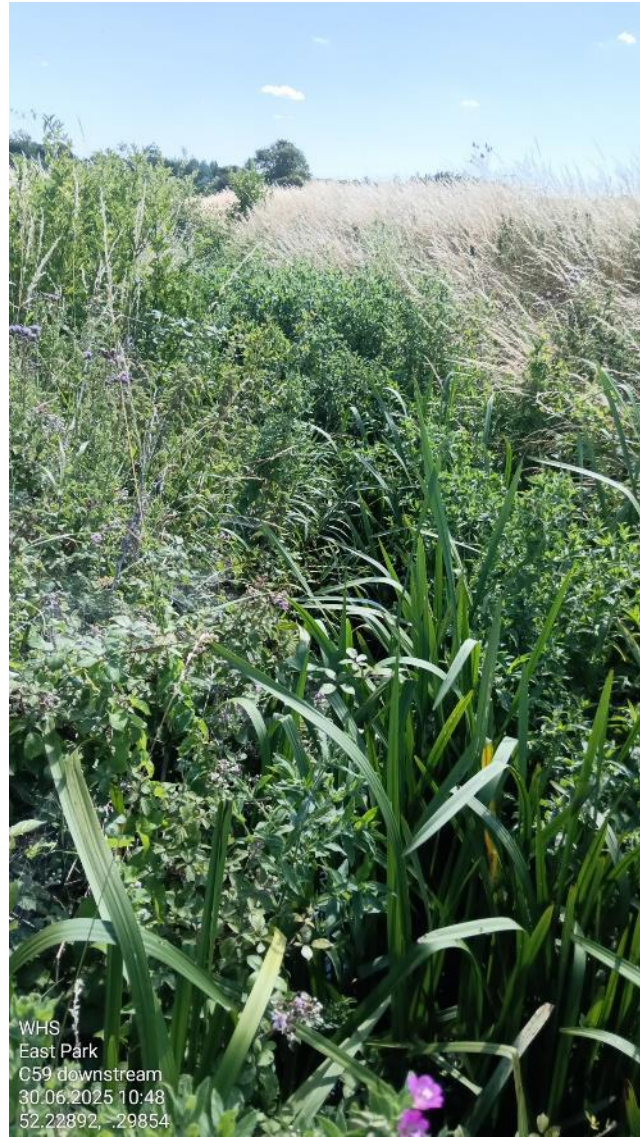
Cross channel view			Channel bed at crossing			Downstream view		
Proposed Crossing Type:		Temporary crossing using Bailey Bridge, maintaining both natural channel bed and banks
