# Tween Bridge Solar Farm

## Environmental Statement Appendix 8.1: Heritage Baseline Assessment

# Heritage Technical Baseline.

## Tween Bridge, Thorne Moors.

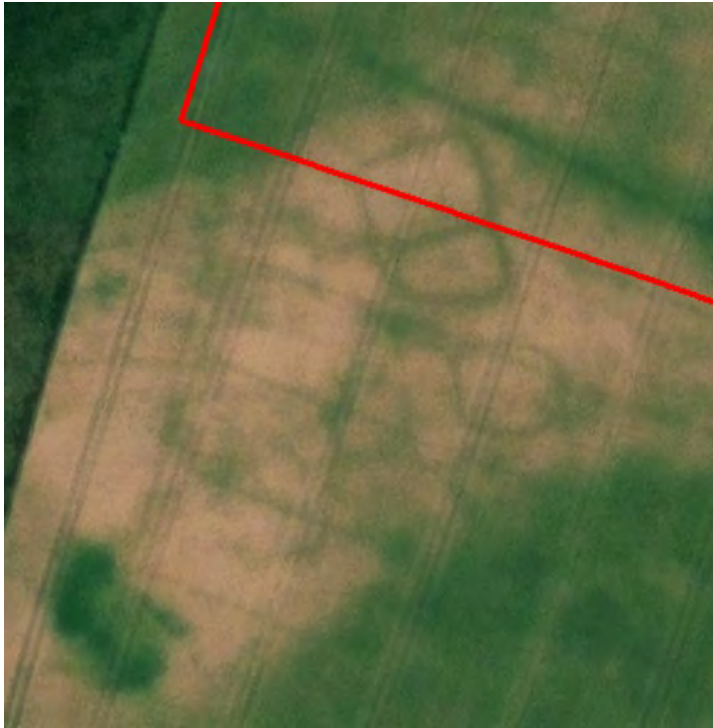
*Plate 5: Cropmark enclosures south-east of Grove House Farm*

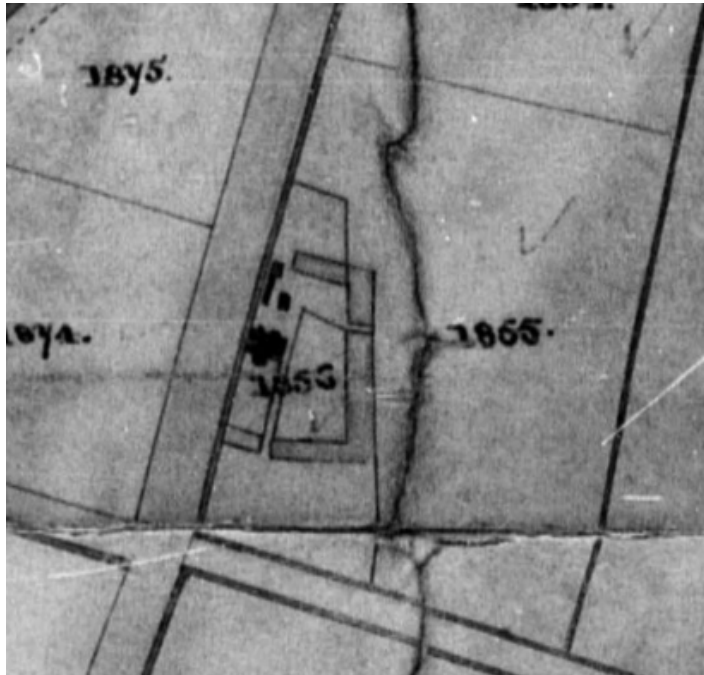
Plate 7: Extract from Thorne Tithe Map, 1840, showing Double Bridges Moat

- 5.124. The 1853 OS map shows that the northern arm and part of the eastern arm of the moat had been infilled, and a new range of farm buildings constructed.

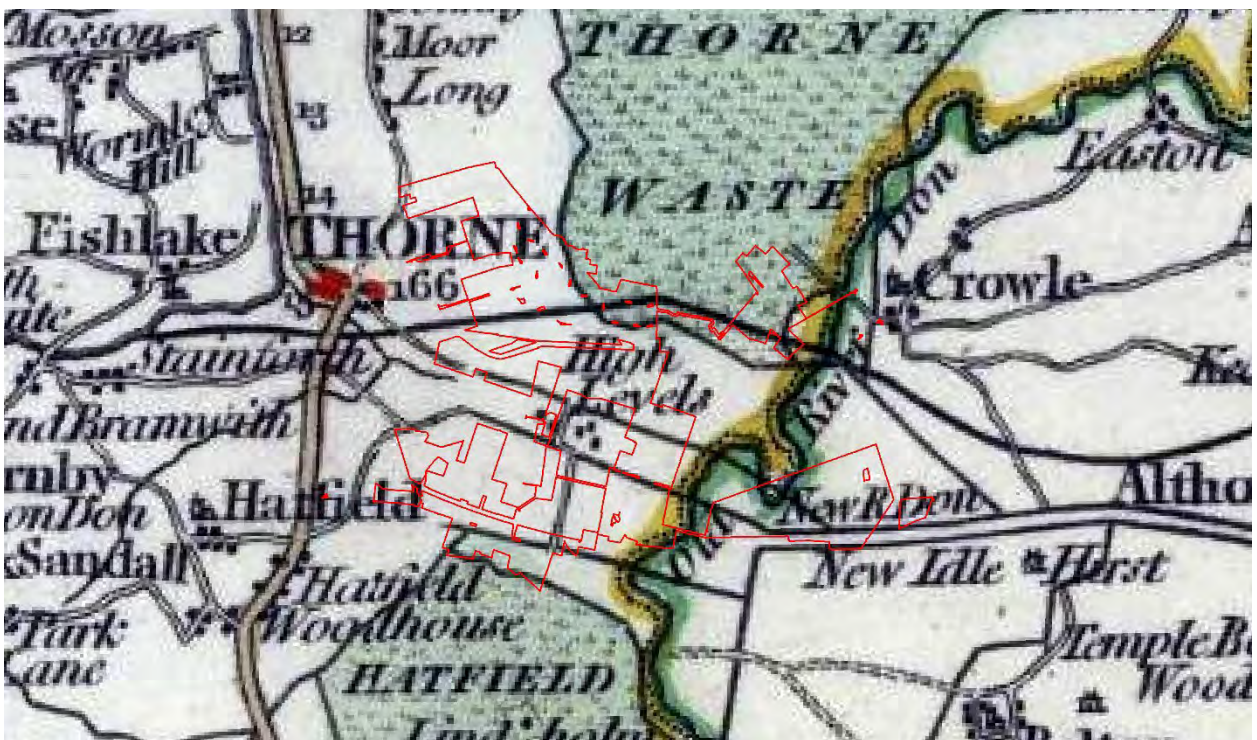
Plate 11: Extract of Cary's 1794 Map

- 5.133. Cary's 1794 Map (Plate 11) records the presence of the Stainforth and Keadby Canal and also indicates the extent of Thorne Waste and Hatfield Moor. The scheme covers small areas of both the waste and the moor. The grade II listed Grove House Farmhouse and Sandhill Farmhouse both appear to be recorded as

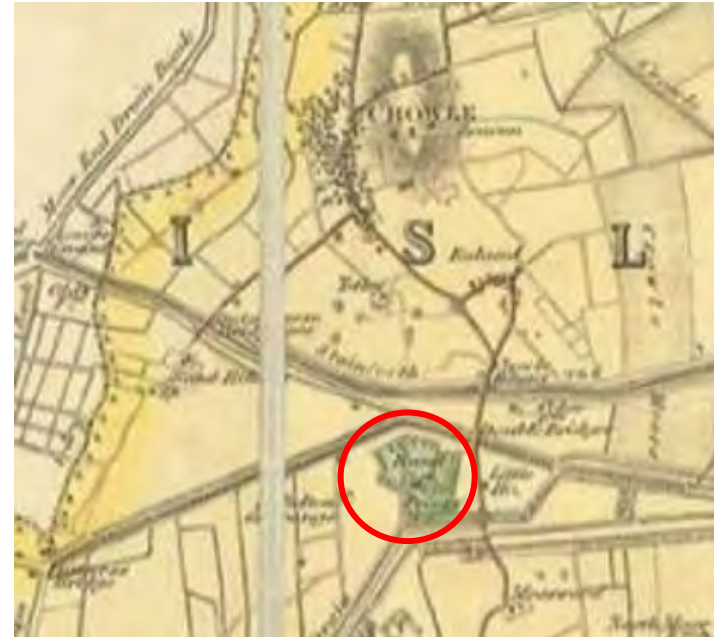
Plate 14: Extract of Bryant's 1828 Map showing Hirst Priory

5.140. Bryant's 1828 map of the Isle of Axholme (Plate 14) records the extent of the park surrounding Hirst Priory being smaller, and less regular, than it is at the present day. The park is recorded as being accessed via a drive that lies further north than the present access.

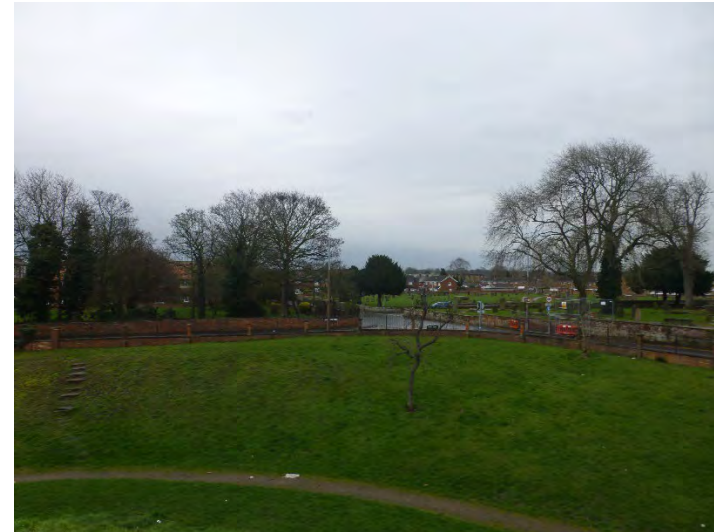
Plate 17: View from the top of Peel Hill Motte towards the Order Limits, looking east

- 6.12. Peel Hill has no relationship with the land within the Order Limits either at the present day or historically, it does not lie within the ZTV and is not intervisible with the Scheme.
- 6.13. The majority of the conservation area of Thorne lies to the west of the castle and church and lie on a westward facing slope that is wholly screened from the Order Limits that lie to the east.
- 6.14. Views from the eastern parts of the conservation area effectively screened from the Order Limits by the presence of modern

built-form and substantial hedgerows which screen views eastwards from adjacent to the Church of St Nicholas and even from the top of the Peel Hill Motte (Plate 17) the Conservation Area is no longer within the ZTV following revisions to the Scheme.

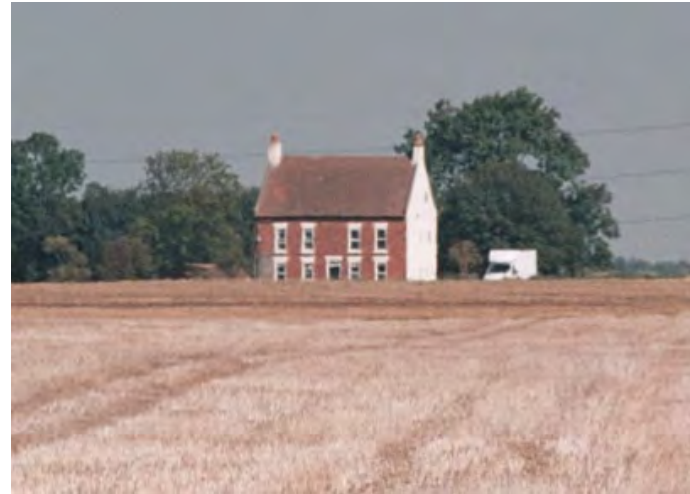
Plate 18: View of Sandhill Farmhouse<sup>67</sup>

- 6.24. The farmhouse is located on level ground within a garden surrounded by agricultural land. The western boundary of the garden is defined by a mature hedge. A tree clump lies immediately to the north of the house and the southern and eastern boundaries of the garden are defined by very sparse, remnant hedgerows with substantial gaps. A barn lies to the east of the farmhouse which restricts views from the house in this direction.

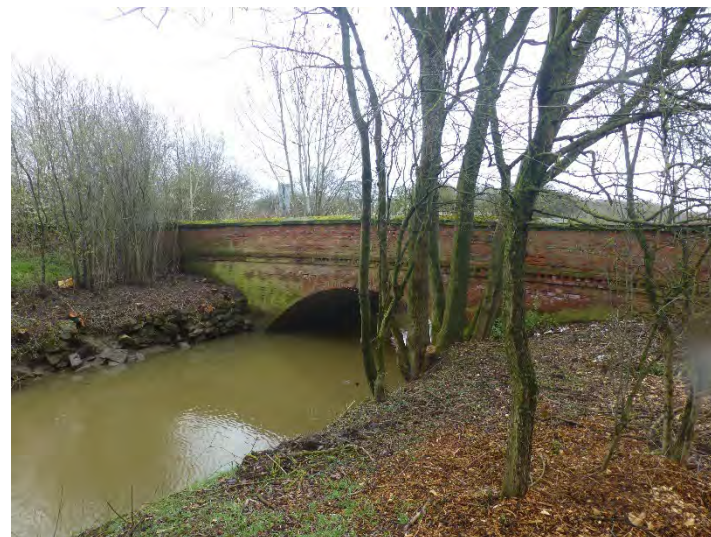
Plate 22: View of bridge adjacent to Dirtness Cottage

- 6.36. The cottage lies in a secluded location adjacent to the former south drive to, the now demolished, Sand Hall. A contemporary bridge, which forms part of the drive also survives. To the north the cottage has been extended. To the west of the cottage a modern house has been erected. To the south the cottage is bounded by the new river Idle and a deciduous hedge.

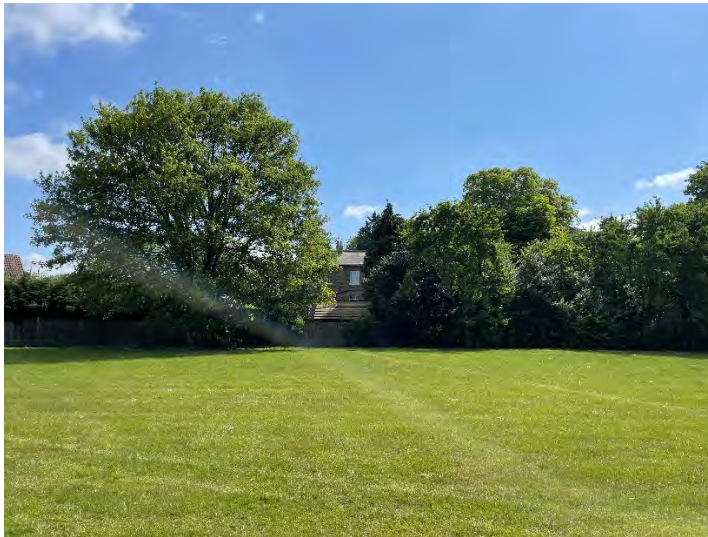
*Plate 30: View of western elevation of Old Rectory*

- 6.72. There is intervisibility between a single first storey window in the western, rear elevation of the Old Rectory and parts of Land Parcel F.

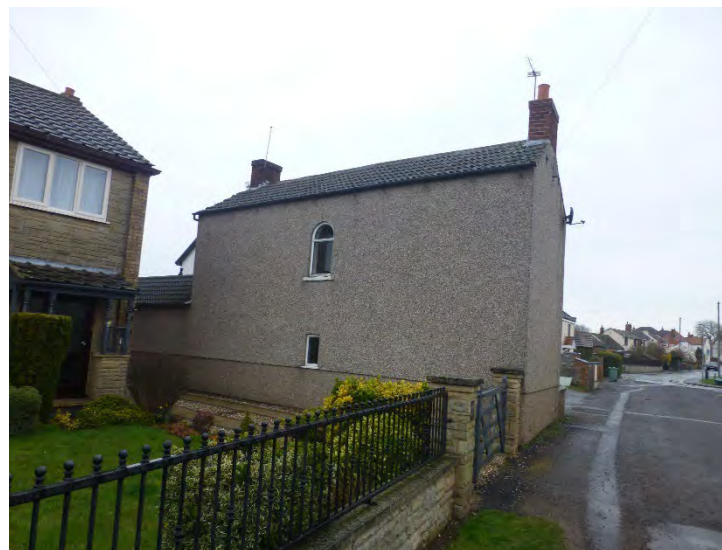
Plate 33: View of 6 Marsh Road looking east

6.79. Views from the western elevation of the house are restricted to two windows. The ground floor window has limited views as it is screened by a hedgerow. Views from the window on the first floor will encompass the fields to the west of Crowle and will distantly include parts of the Order Limits.

6.80. The principal elevation of the cottage faces east, looking towards Crowle and away from the Order Limits.

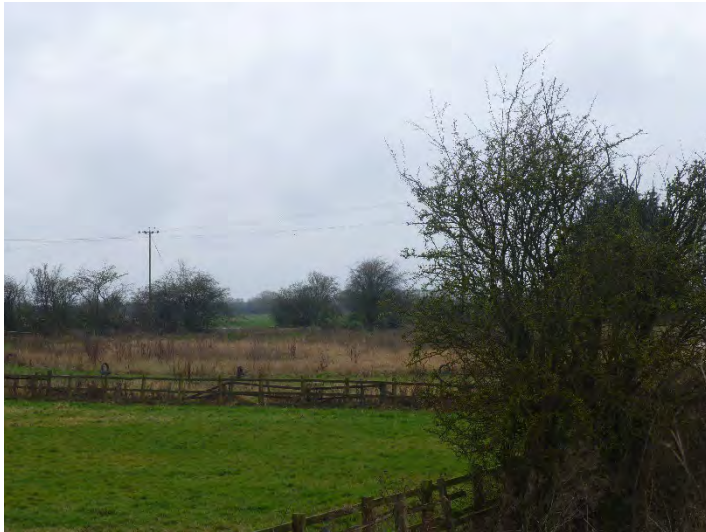
Plate 38: View west from Long Barn looking towards Order Limits

- 6.105. Views west from the asset are screened by trees and hedges meaning that the Order Limits are not intervisible from the asset at ground level. There will be views from first floor windows that include limited parts of the Order Limits in the distance.
- 6.106. The Order Limits are not considered to contribute to the heritage significance of Long Barn through its setting. The land within the Order Limits does not appear to have had a functional relationship to the asset and is only visible in the distance from the first floor.

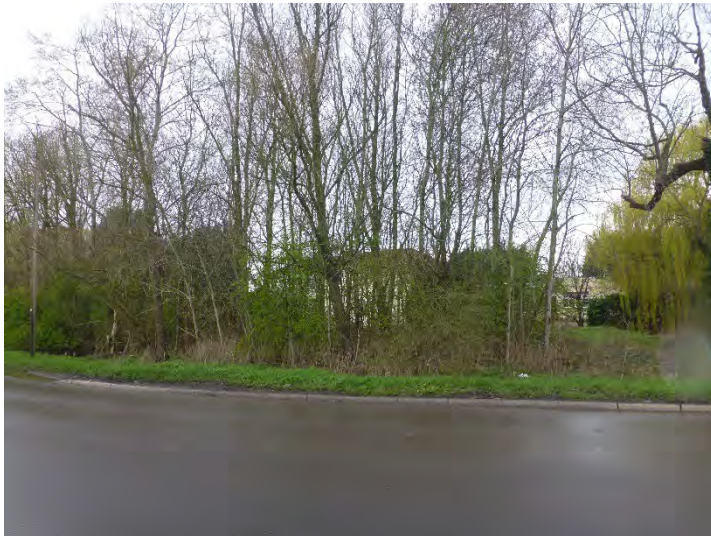
Plate 40: View of the Grove looking west

- 6.114. The Order Limits are screened from the asset during the summer and visible through screen planting during the winter from the eastern façade.

6.115. The land within the Order Limits is not considered to contribute to the heritage significance of the Grove as part of its setting. The land within the Order Limits does not appear to have had a functional relationship to the asset and is only visible in heavily filtered views from the eastern façade in the winter.

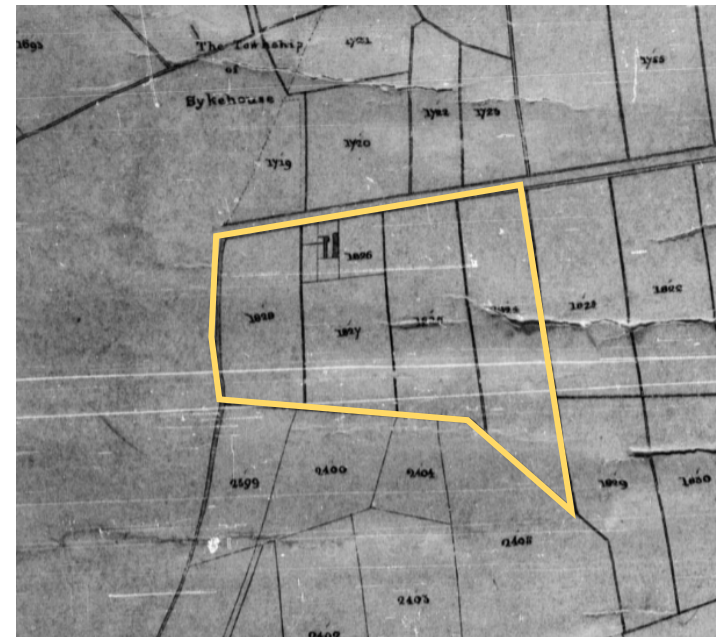
Plate 44: Extract from 1841 Hatfield Tithe showing land associated with Stoupersgate Farm

- 6.137. There is no historical association between the land within the Order Limits and the asset. In 1841, the Hatfield tithe map indicates that the land farmed lay to the west, south and east of the farmhouse and did not include any of the land within the Scheme boundary (Plate 45).

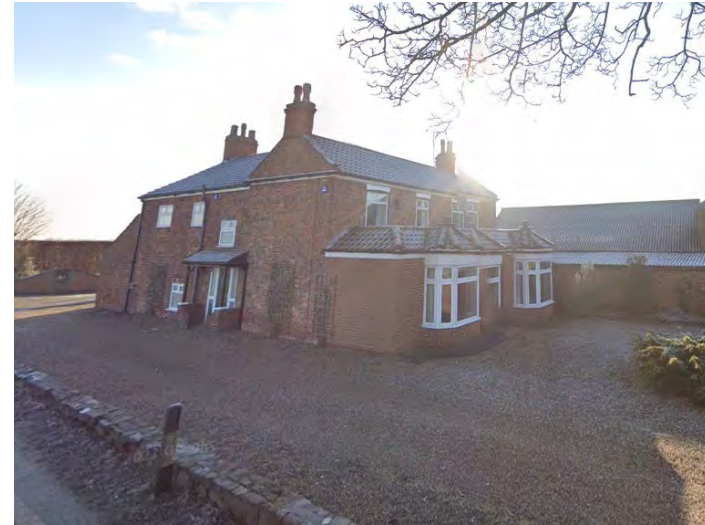
Plate 47: View of Levels Farm, looking south-east

- 6.152. Levels Farm is a non-designated asset that dates to the late-18<sup>th</sup> or early-19<sup>th</sup> century and is built of red brick with a pantile roof. The house was extended in the 19<sup>th</sup>-century and further extended in the late-20<sup>th</sup> century.
- 6.153. The principal elevation of the farmhouse faces north, although historically it seems clear that the western façade was the front. A 20<sup>th</sup>-century extension on the former west front has removed the original central door and a new

porch has been constructed to the north. A more detailed description of the asset is provided in **Appendix 9** of this document.

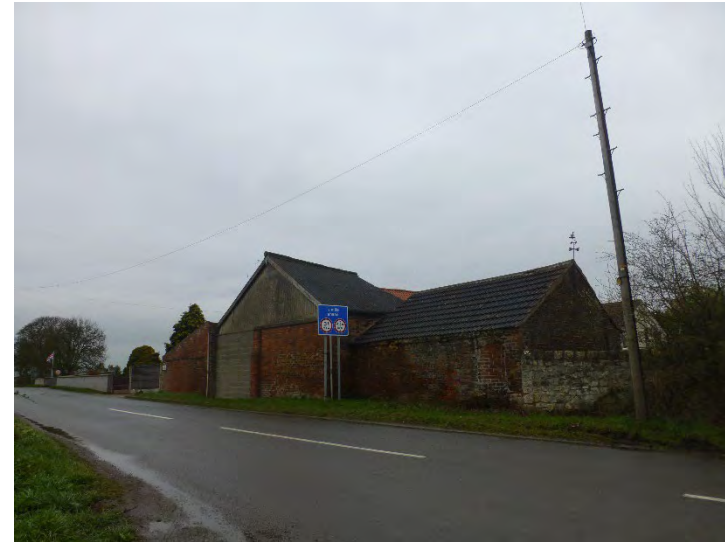
Plate 49: View of Old Laith House, looking north-east

- 6.160. Old Laith House is a non-designated farmstead with a series of 18<sup>th</sup>- and 19<sup>th</sup>-century brick farm buildings. A more detailed description of the asset is provided in **Appendix 9** of this document.

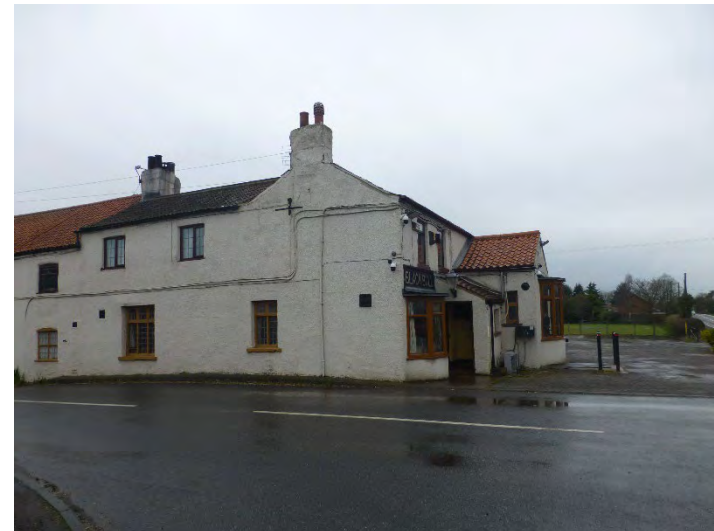
Plate 51: View of the Black Bull Inn, looking west

- 6.167. The Black Bull is a non-designated late-18<sup>th</sup> or early-19<sup>th</sup> century public house. It has rendered

walls with quoin detailing and a pantile roof. The principal elevation of the inn faces north, towards the A18. The Inn has been extended to in the 19<sup>th</sup> century and again in the 20<sup>th</sup> century. A more detailed description of the asset is provided in **Appendix 9** of this report.

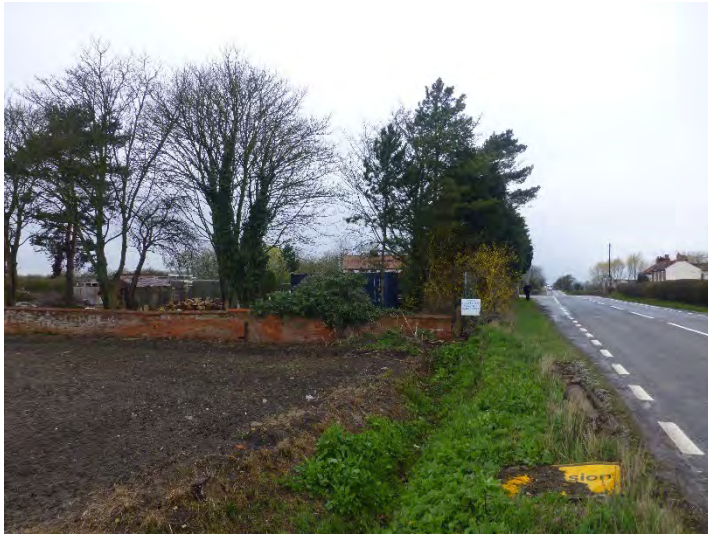
Plate 52: View of the Black Bull Inn from Order Limits, looking west

- 6.172. Parts of the Order Limits lie to north, south, east and west. The nearest part of the Order Limits lies to the east of the asset. Views of the portions of the Order Limits to the north, south and west are screened by interceding buildings and hedgerows. The majority of views to the east, from the asset, are screened by the former chapel that is situated to the east of the inn. However, the first-floor windows of part of the eastern elevation are intervisible with part of the Order Limits.

- 6.173. Although a part of the Order Limits and the eastern façade of the inn are intervisible, no part of the Order Limits forms part of the setting of the asset as the agricultural land that surrounds the inn does not contribute to its significance as the inn was located at a junction on a major road between the market towns of Thorne and Crowle to maximise passing trade.

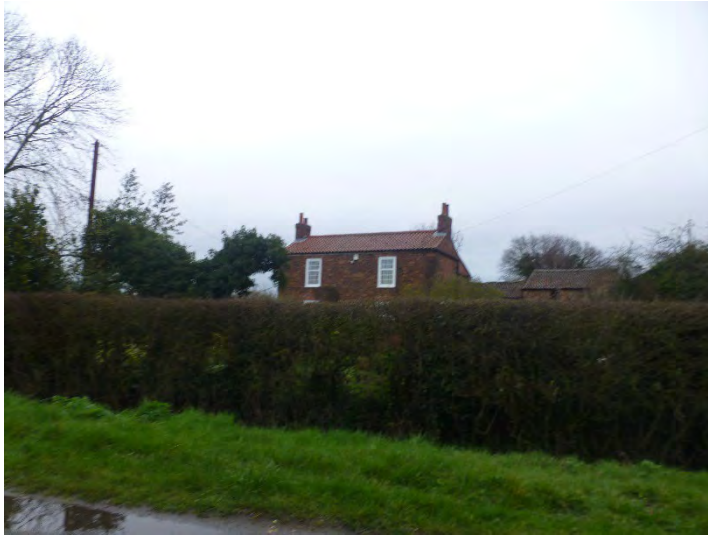
Plate 53: View of Nunmoor Cottage, looking east

Nunmoor Cottage is a 19<sup>th</sup>-century cottage built of red brick with a pantile roof and end stacks, and an outshut to rear. A range of outbuildings lie to the east and are contemporary with the cottage. A more detailed description of the asset is provided in **Appendix 9** of this report.

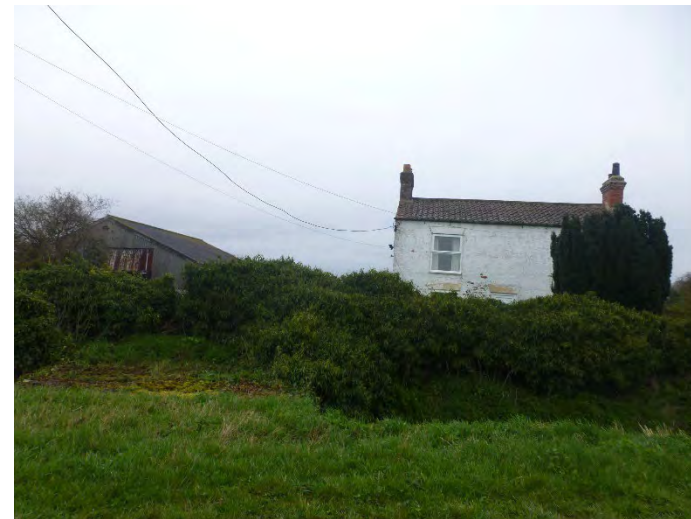
Plate 54: View of Moor Farm, looking east

- 6.183. Moor Farm is a 19<sup>th</sup>-century farmhouse that is brick built with a pantile roof and end stacks. It has casement windows which are likely replacements for earlier sashes. The house has been extended to the rear. The asset was not accessible. A more detailed description of the asset is provided in **Appendix 9** of this report.

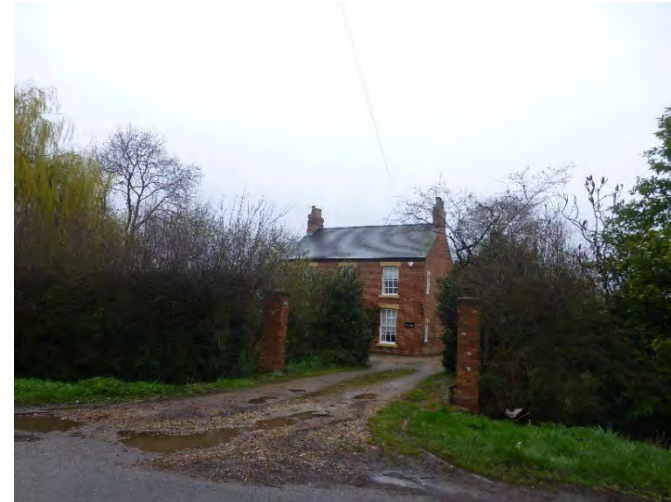
Plate 55: View of Meaburns, looking east

6.191. Meaburns is a 19<sup>th</sup>-century house built of red brick with a slate roof and end stacks. The house is of three bays and has 6 over 6 sashes on the principal, western elevation, and 4-pane casements on the southern gable end. All windows have stone lintels and ledges. A more detailed description of the asset is provided in **Appendix 9** of this report.

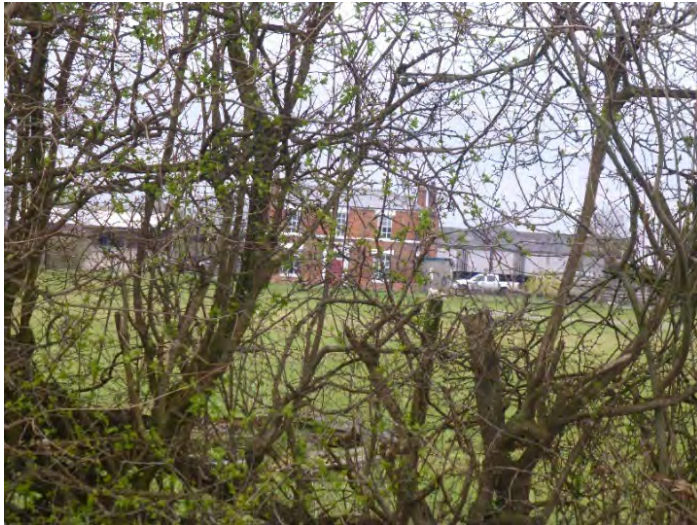
Plate 56: View of Beckendale Farm, looking east

- 6.197. Beckendale Farm is a double-stack 19<sup>th</sup>-century farmhouse built of red brick with a pyramidal slate roof and twin end stacks. The house is of 3 bays with 6 over 6 sashes, and a central 2-panel timber door with a scroll moulded hood over it. A more detailed description of the asset is provided in **Appendix 9** of this report.

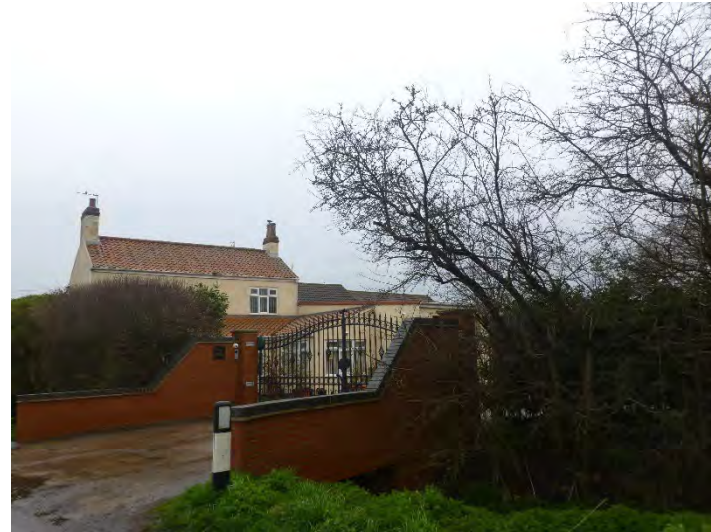
Plate 57: View of The Willows, looking north-east

- 6.204. The Willows is an early 19th-century farmhouse that is rendered with a pantile roof and end stacks. A more detailed description of the asset is provided in **Appendix 9** of this document.
