# Springwell Solar Farm

Environmental Statement Appendix 11.2: Preliminary Risk Assessment Part 1

EN010149/APP/6.3 November 2024 Springwell Energyfarm Ltd APFP Regulation 5(2)(a)
Planning Act 2008

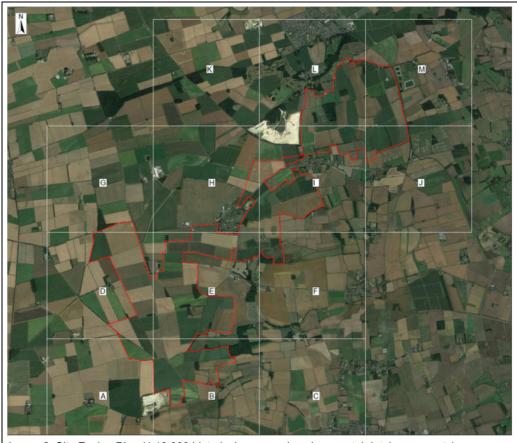
Image 2: Site Zoning Plan (1:10,000 historical maps and environmental database reports)

The zones have been categorised as zones A to M as shown below and on <u>Figures 3</u> and <u>4</u>.

The site is split into four development parcels denoted A1, A2, B and C (Figure 2). To support this assessment, the site has been subdivided further into 13No zones (A to M), with each zone split even further into a maximum of sixteen subzones (as shown on Figures 3 and 4).

# FIGURE 3 SITE ZONING PLAN (ENVIRONMENTAL ASSESSMENT)

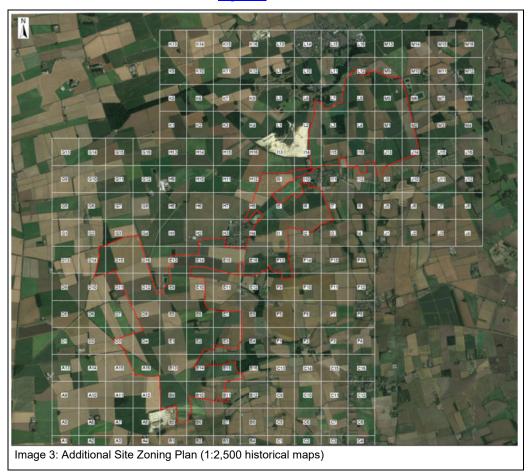
The 1:2,500 historical OS maps each cover an even smaller area and are individually referenced within the historical summary and site reconnaissance chapter to aid locating features within the larger zones. A plan showing the further subdivision of each of the 13No zones is shown below and on Figure 4.

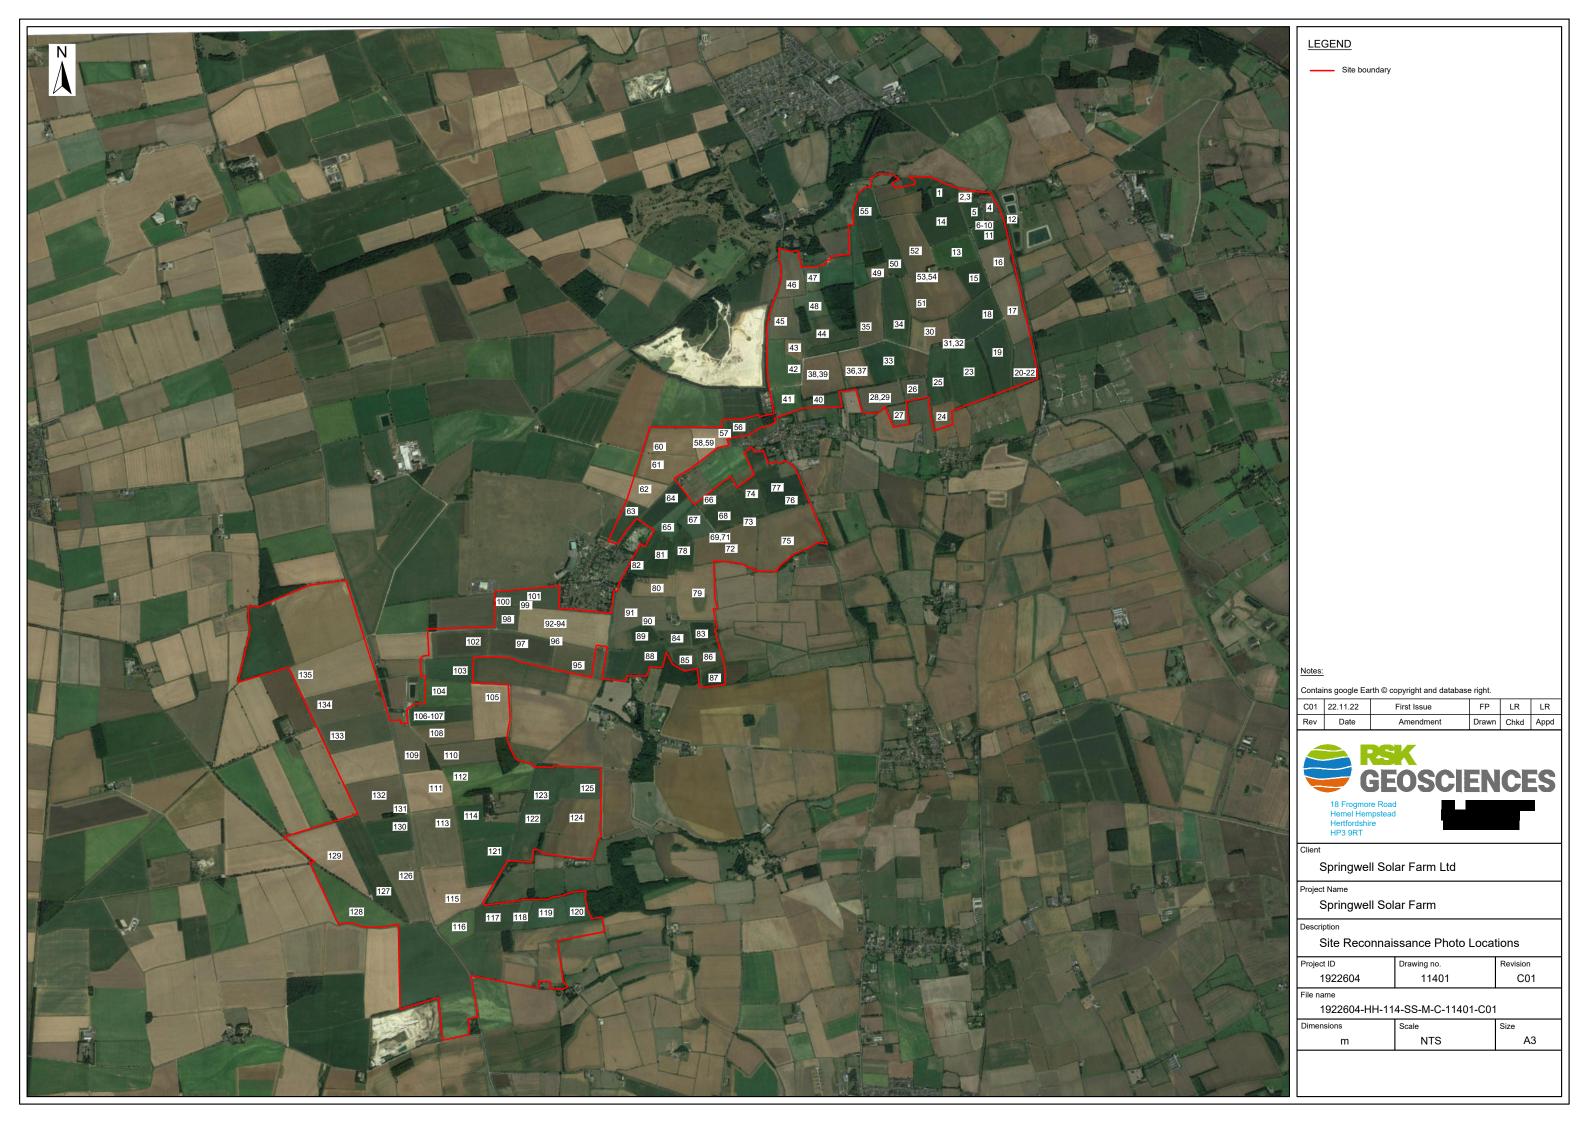
## FIGURE 6 SITE RECONNAISSANCE PHOTOGRAPH PLAN

Site reconnaissance findings	No obvious signs or sources of on-site contamination were identified during the site walkover. Considering the agricultural nature of the site and the sheer size of the site area, there may be small volumes of chemicals and other materials stored on site which were not directly observed during the reconnaissance survey.
Geotechnical constraints assessment	<ul> <li>The following potential geotechnical constraints were identified:</li> <li>Silt rich and shrinkable clay soils associated with all strata except granular superficial soils and unweathered limestone;</li> <li>Potential compressible and low bearing capacity soils associated with superficial Head Deposits and Tidal Flat Deposits;</li> <li>Potential running sand associated with saturated granular deposits;</li> <li>Karstic dissolution features within limestone strata;</li> <li>Potentially waterlogged ground and/or localised high groundwater table;</li> <li>Potential for geological faults within underlying bedrock geology;</li> <li>Infilled ponds, quarries and gravel pits as well as potential for unrecorded extraction pits, shafts and adits;</li> <li>Adverse ground chemistry associated with Oxford Clay, Blisworth Clay and Kellaway Formation; and</li> <li>Lateral variation in ground conditions.</li> </ul>
