# BEACON FEN ENERGY PARK

Planning Inspectorate Reference: EN010151

Appendix 11.3 Summary of Watercourse Crossings and Photographs

Document Reference: 6.3 ES Volume 2, 6.3.83

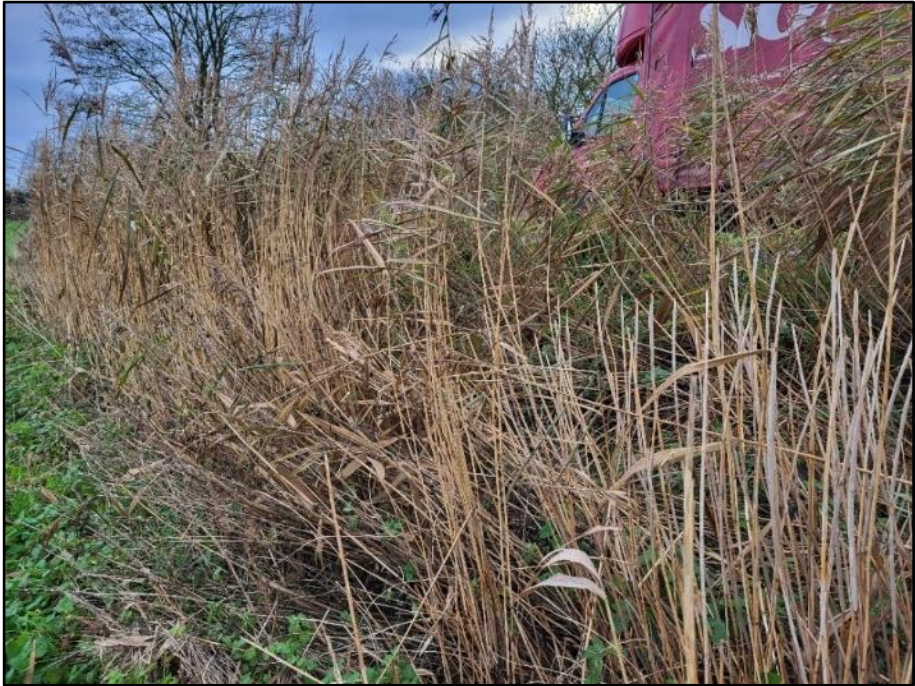
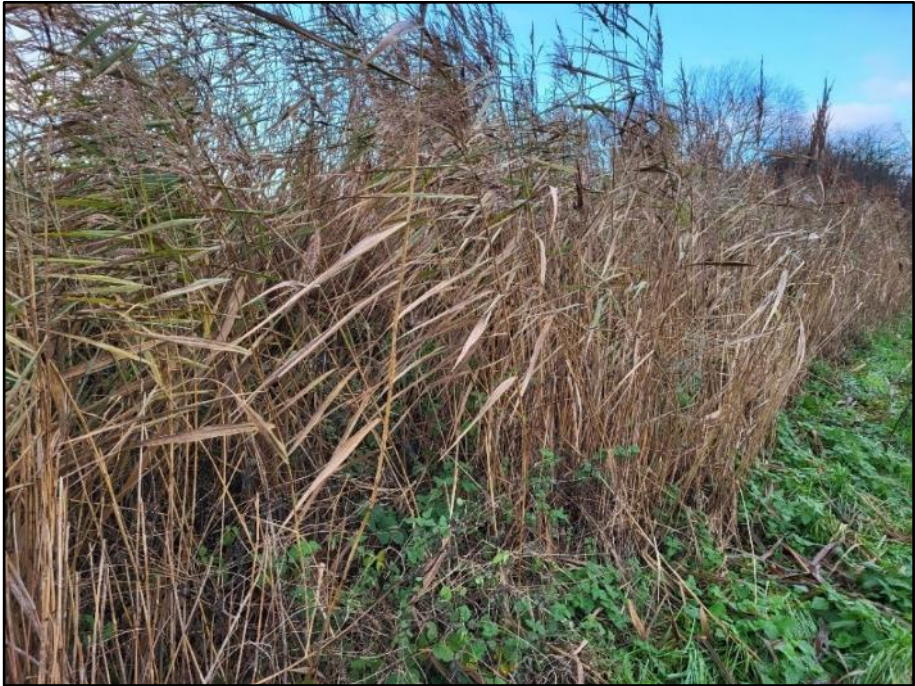
Photograph Sheet: 01  
NGR: TF 11156 45185  
Photograph Date: 3 December 2024

Description: Location of WX01. Unnamed drain, with overgrown vegetation throughout bank, left bank; with overgrown vegetation throughout bank, looking downstream left bank c.0.4m, right bank c.0.8m, width c.0.9m, water depth c.0.0m

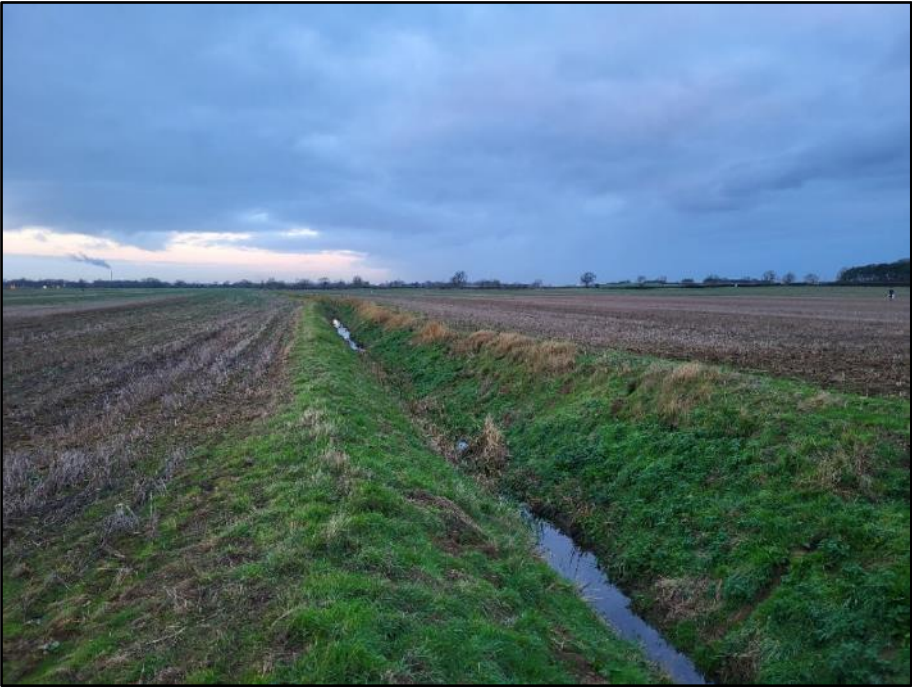
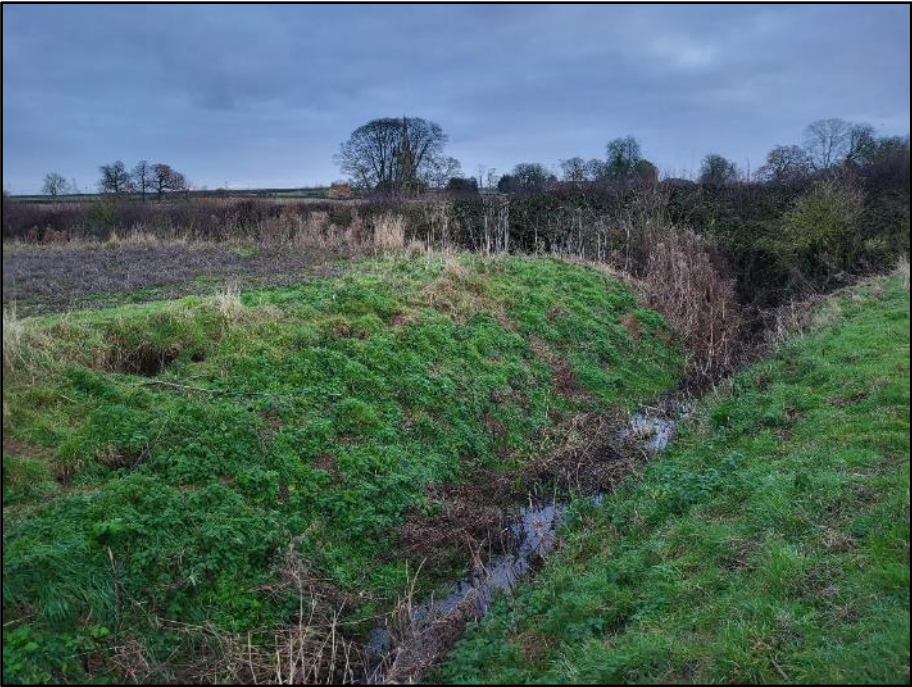
Photograph Sheet: 02  
NGR: TF 11280 45344  
Photograph Date: 3 December 2024

Description: Location of WX02. Unnamed drain, slightly overgrown looking downstream, left bank c.1.2m, right bank c.1.2m, width c.2.0m, water depth c.0.4m.

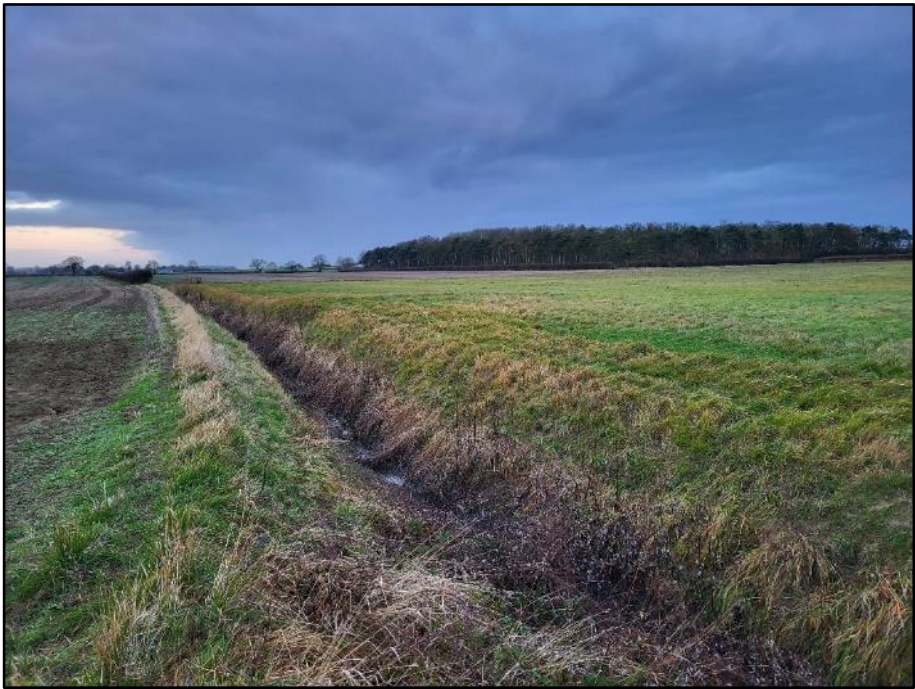
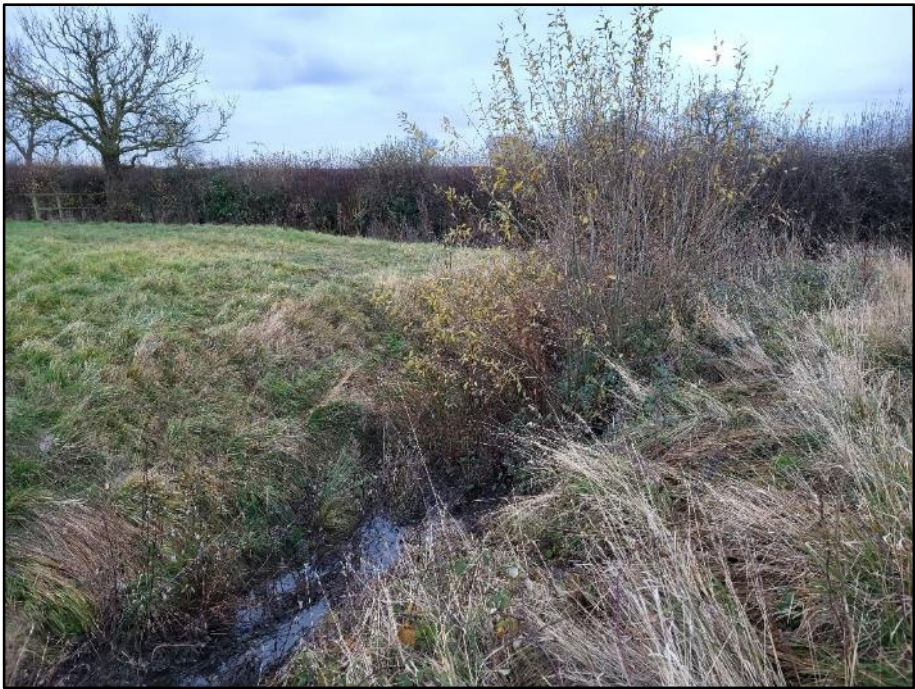
Photograph Sheet: 03  
NGR: TF 11385 45551  
Photograph Date: 3 December 2024

Description: Location of WX03. Unnamed drain, with overgrown vegetation throughout channel, left bank c.1.2m, right bank c.1.5m, width c.2.5m, Water depth c.0.1m. Facing upstream.

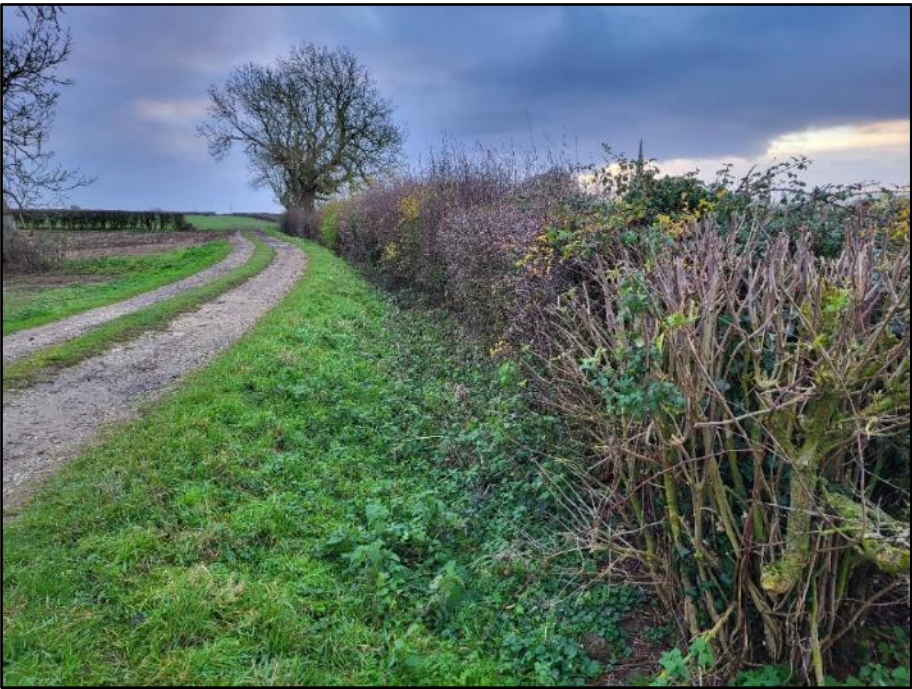
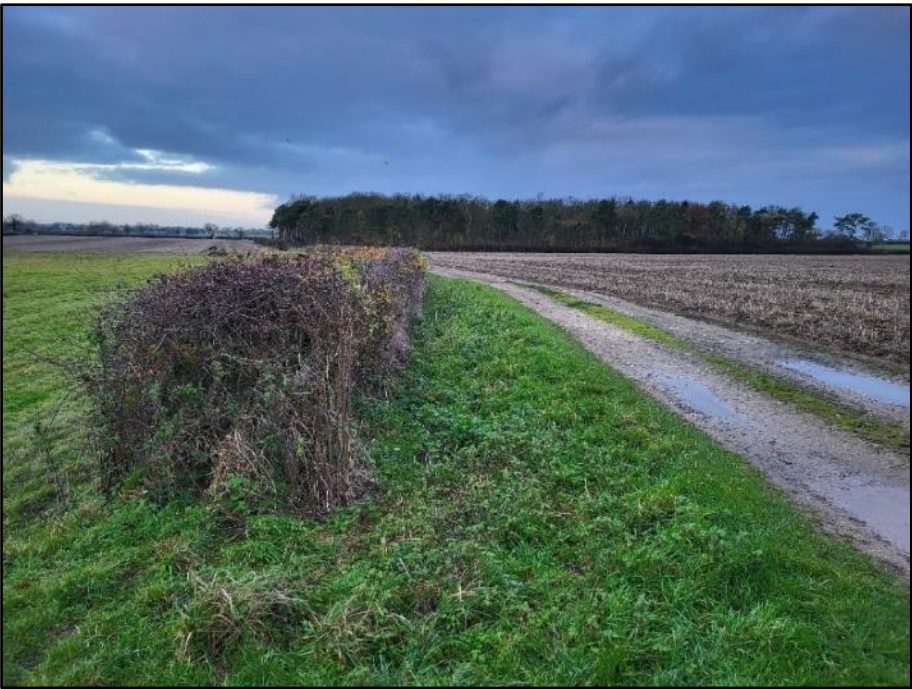
Photograph Sheet: 04  
NGR: TF 11452 45676  
Photograph Date: 3 December 2023

Description: Location of WX04. Unnamed drain, with a hedge and overgrown vegetation throughout channel, left bank c.0.8m, right bank c.0.5m, width c.1.5m, Water depth c.0.0m. Facing upstream.

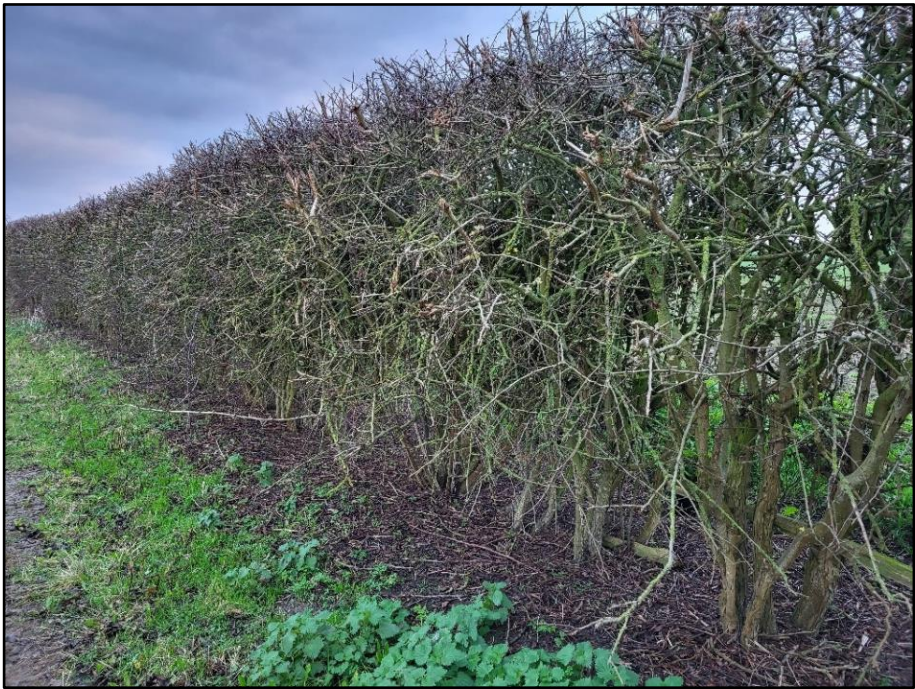
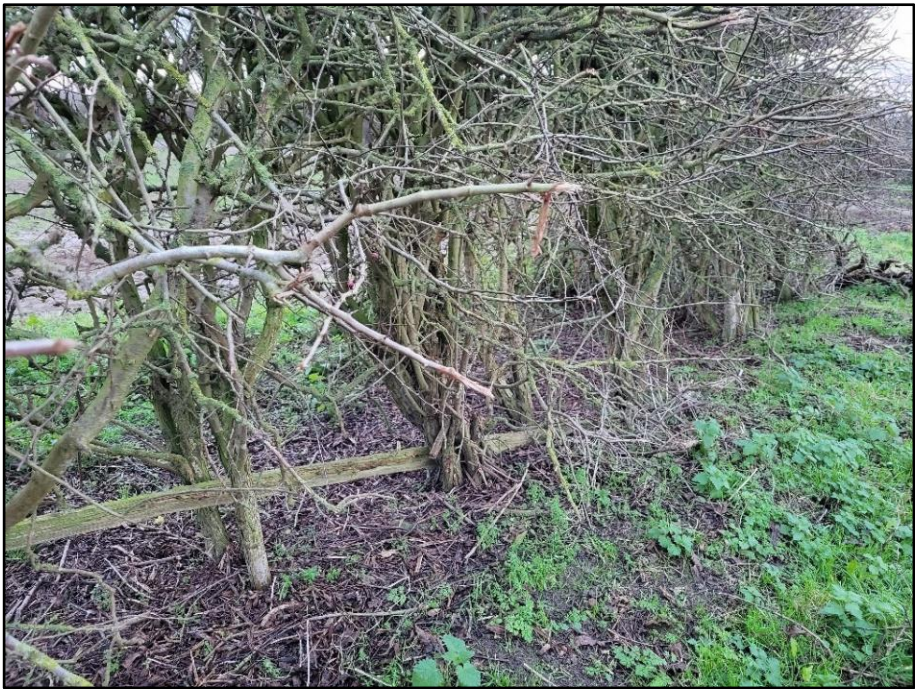
Photograph Sheet: 05  
NGR: TF 11533 45649  
Photograph Date: 3 December 2024

Description: Location of WX05. Unnamed drain, with a hedge and overgrown vegetation throughout channel, left bank c.0.01m, right bank c.0.01m, width c.0.1m, Water depth c.0.0m. Facing Upstream.

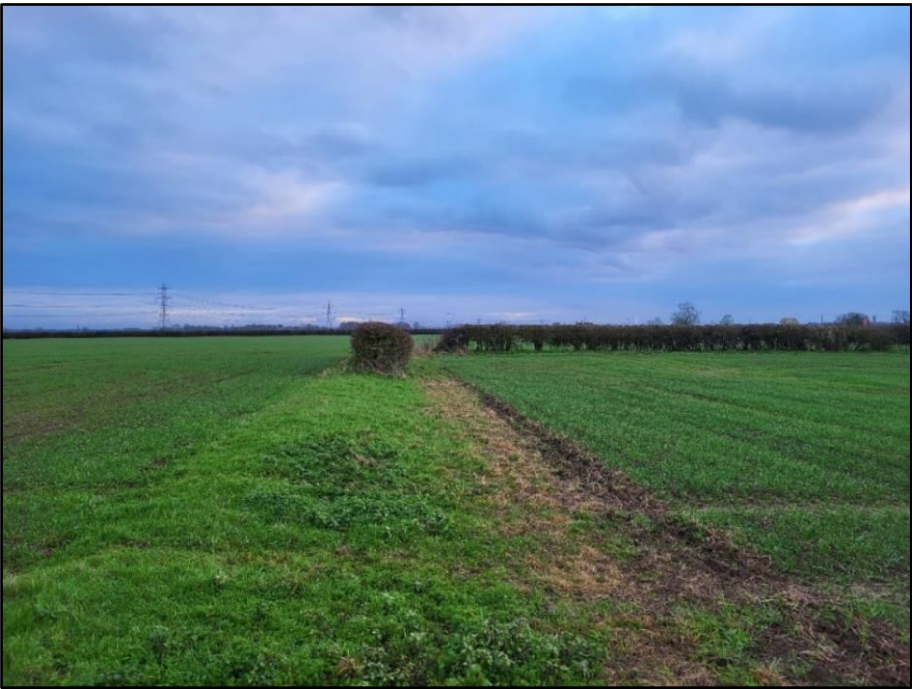
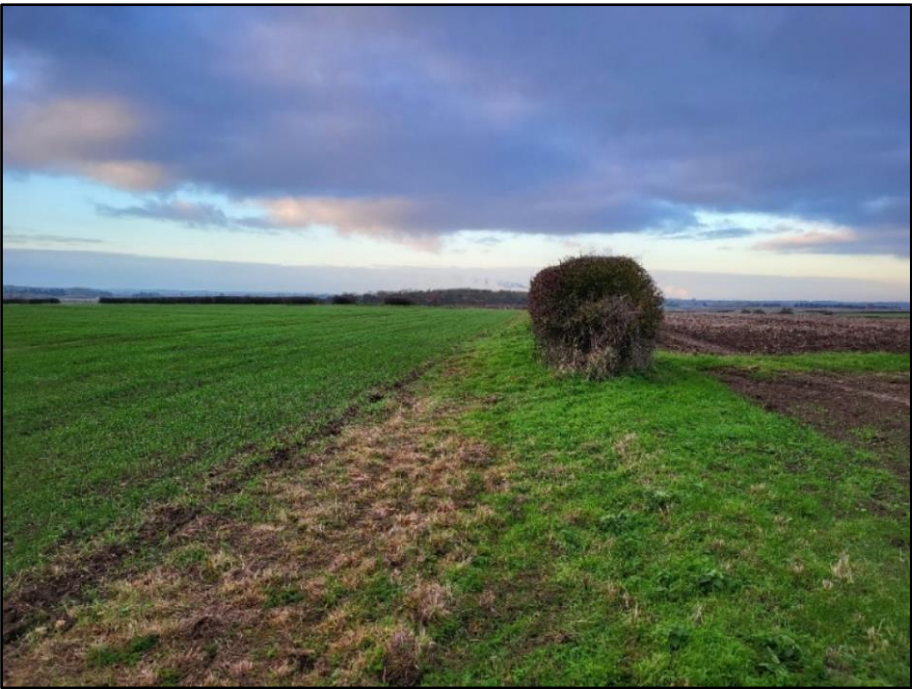
Photograph Sheet: 06  
NGR: TF 11828 45964  
Photograph Date: 3 December 2024

Description: Location of WX06. Unnamed drain, with a hedge and overgrown vegetation throughout channel, left bank c.0.01m, right bank c.0.01m, width c.0.5m, Water depth c.0.0m. Facing east.

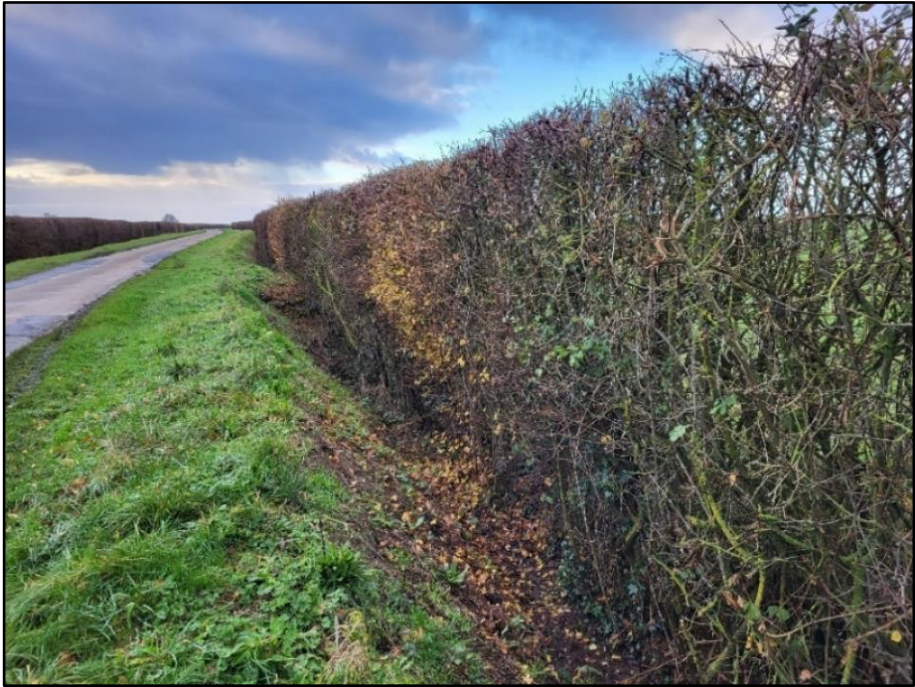
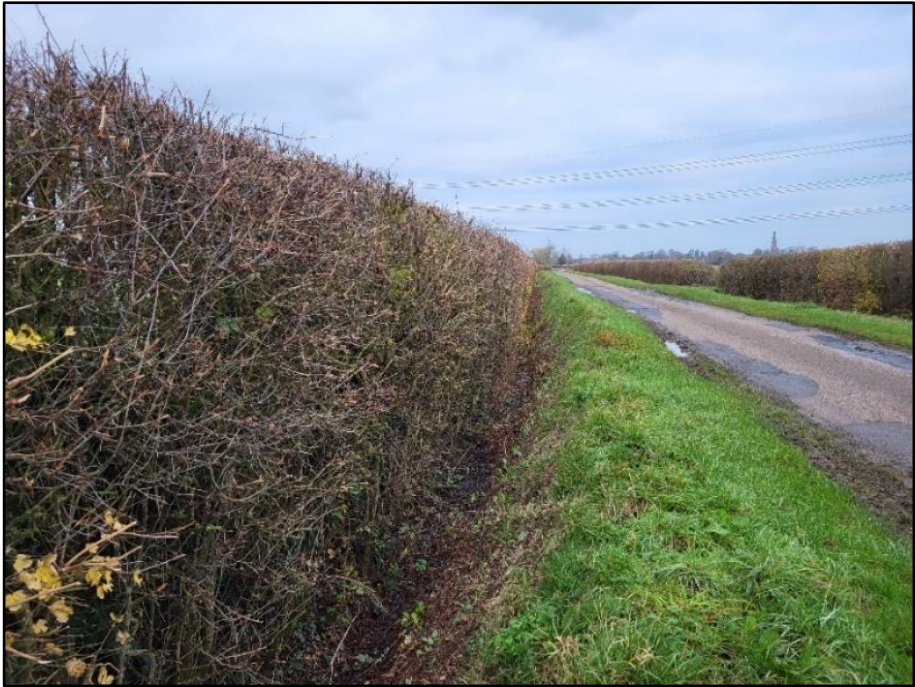
07

Location of WX07. Unnamed drain, with overgrown vegetation throughout channel, left bank c.1.0m, right bank c.1.0m, width c.1.2m, Water depth c.0.0m. Facing Upstream.

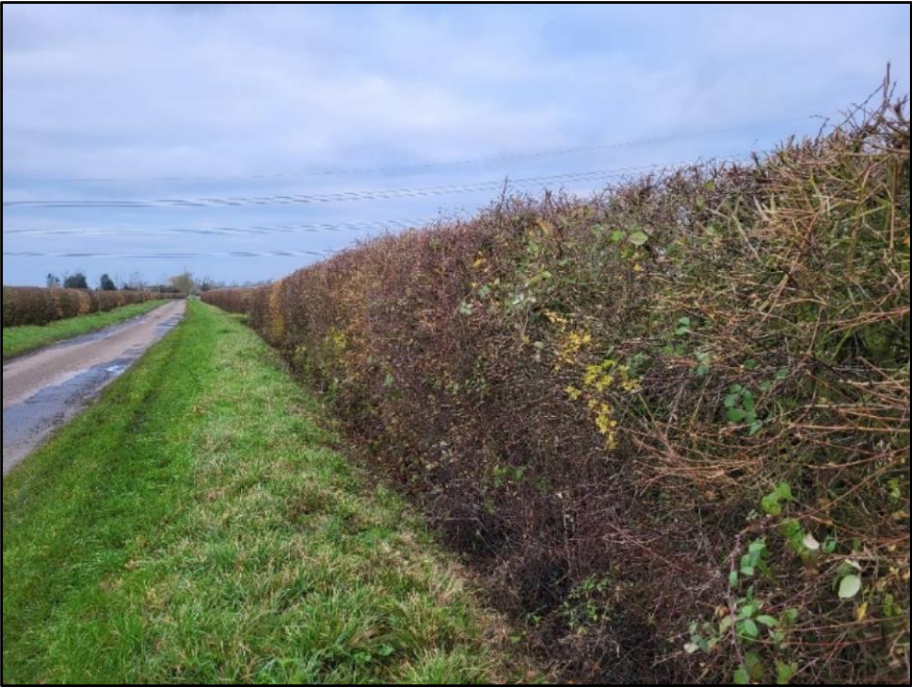
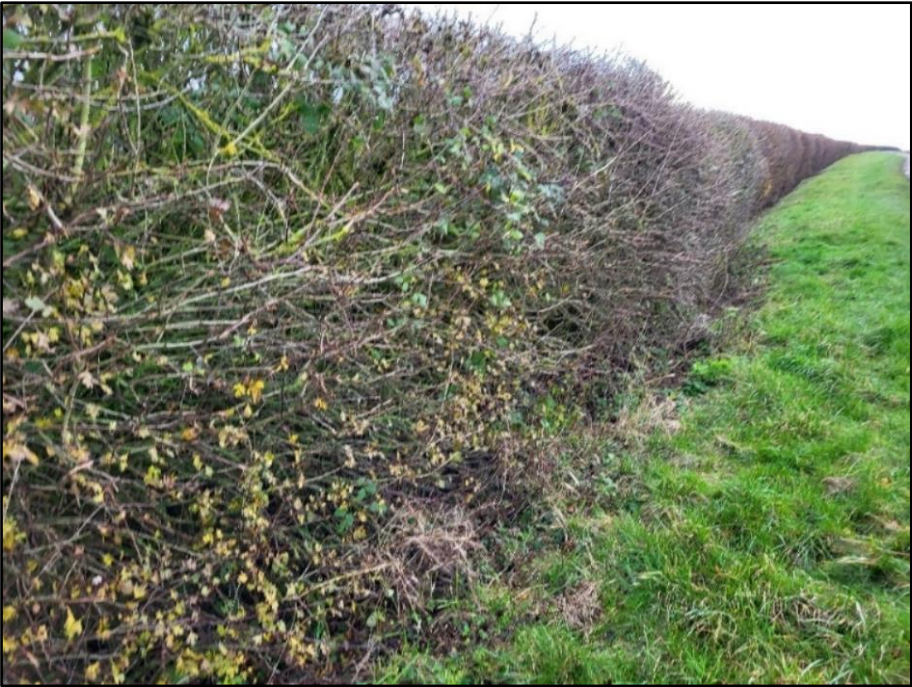
08

Location of WX08. Unnamed drain, with overgrown vegetation throughout channel, left bank c.0.8m, right bank c.0.5m, width c.0.9m, water depth c.0.0m no visible flow.

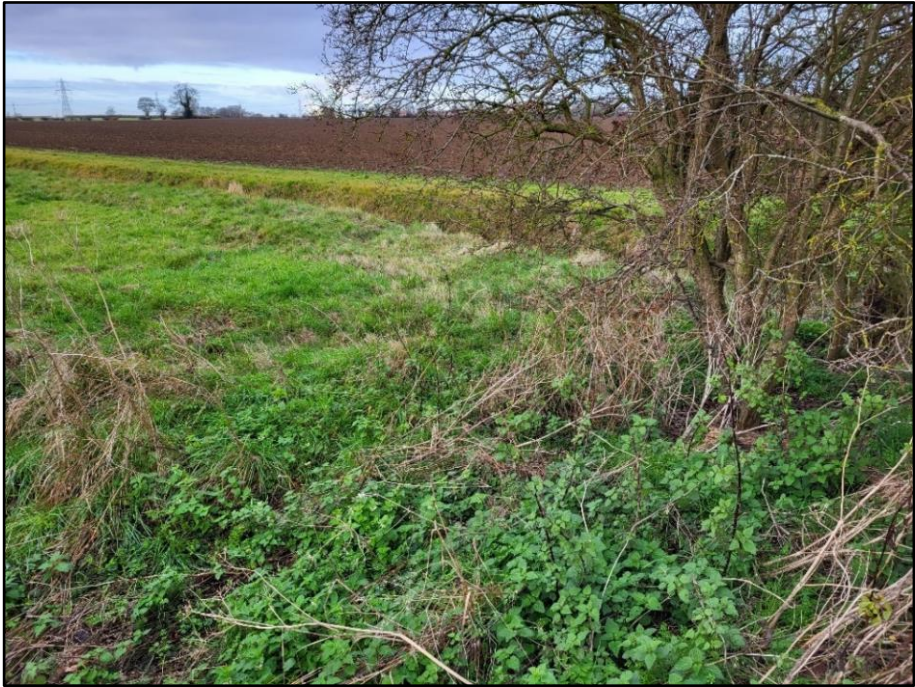
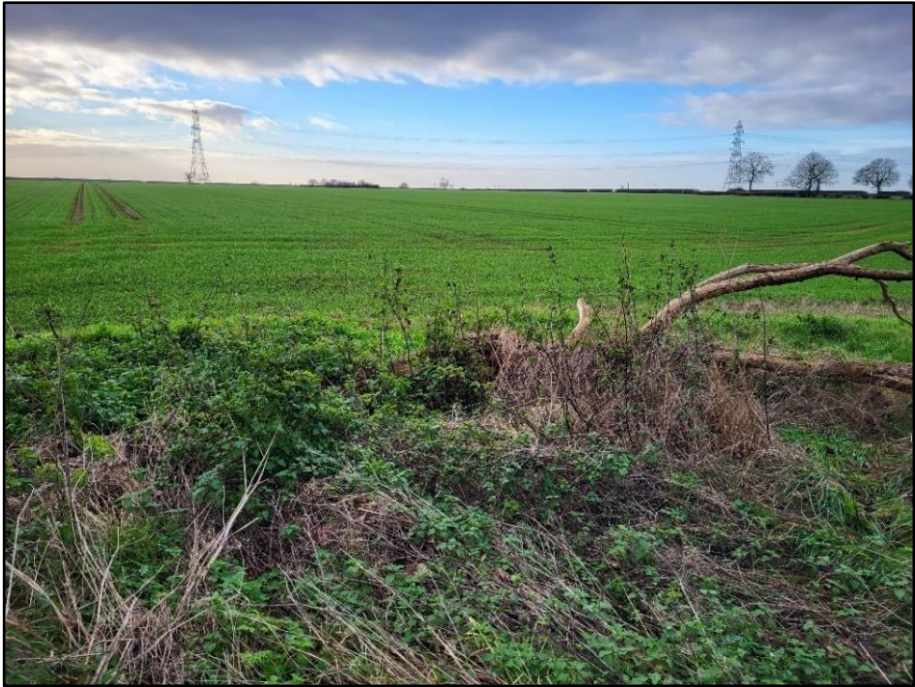
**Photograph Sheet:** 09  
**NGR:** TF 12632 46729  
**Photograph Date:** 3 December 2024

**Description:** Location of WX09. No drain present, overgrown vegetation. Drain present to the east of watercourse crossing location

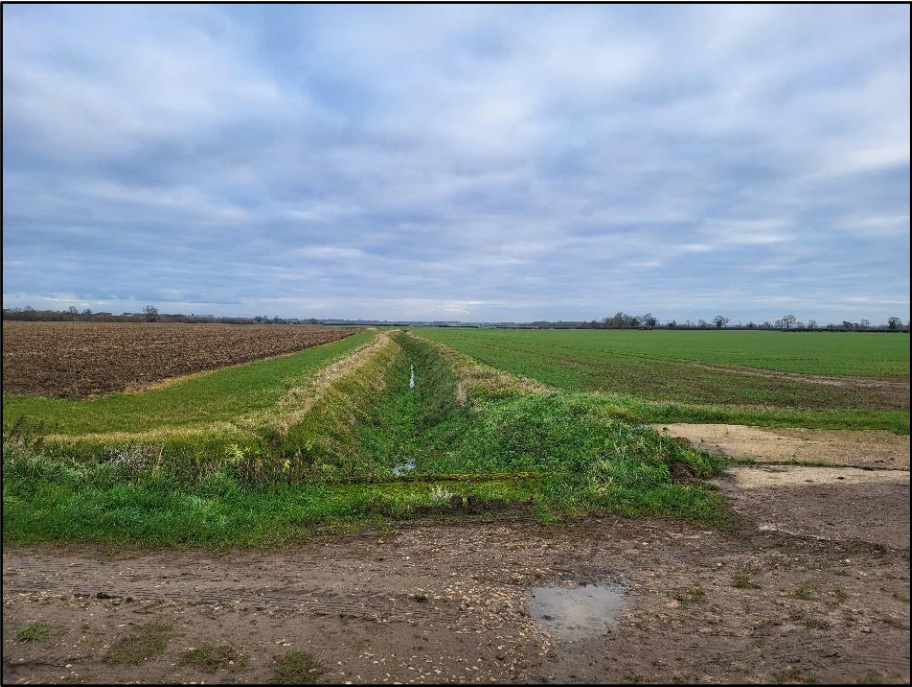
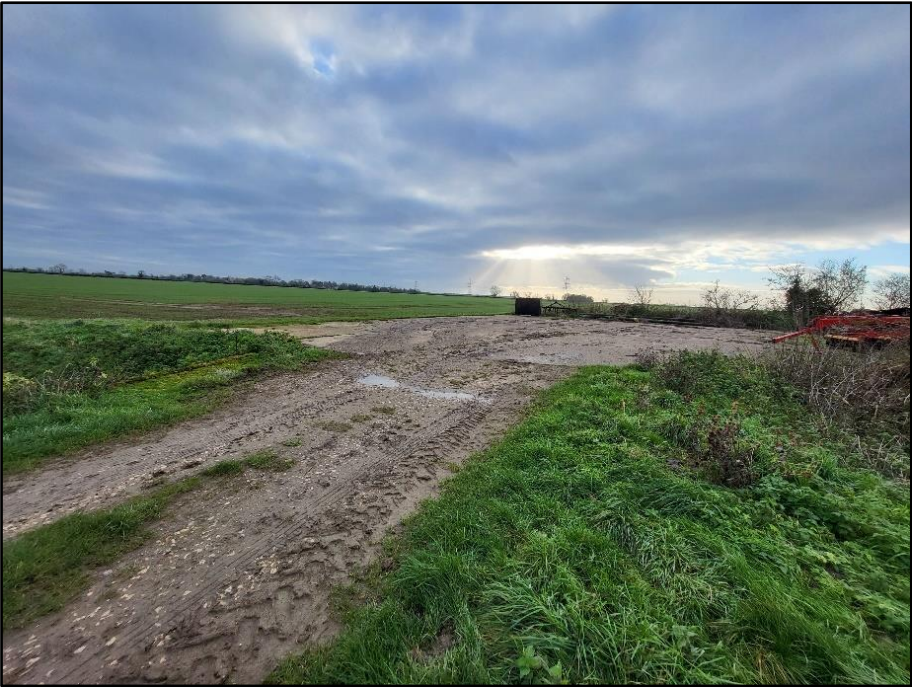
**Photograph Sheet:** 10  
**NGR:** TF 12679 46765  
**Photograph Date:** 3 December 2024

**Description:** Location of WX11. Unnamed drain, with vegetation throughout channel, left bank c.1.3m, right bank c.1.3m, width c1.5m. Water depth is c.0.02m in the channel. No culvert present through concrete area to WX11.

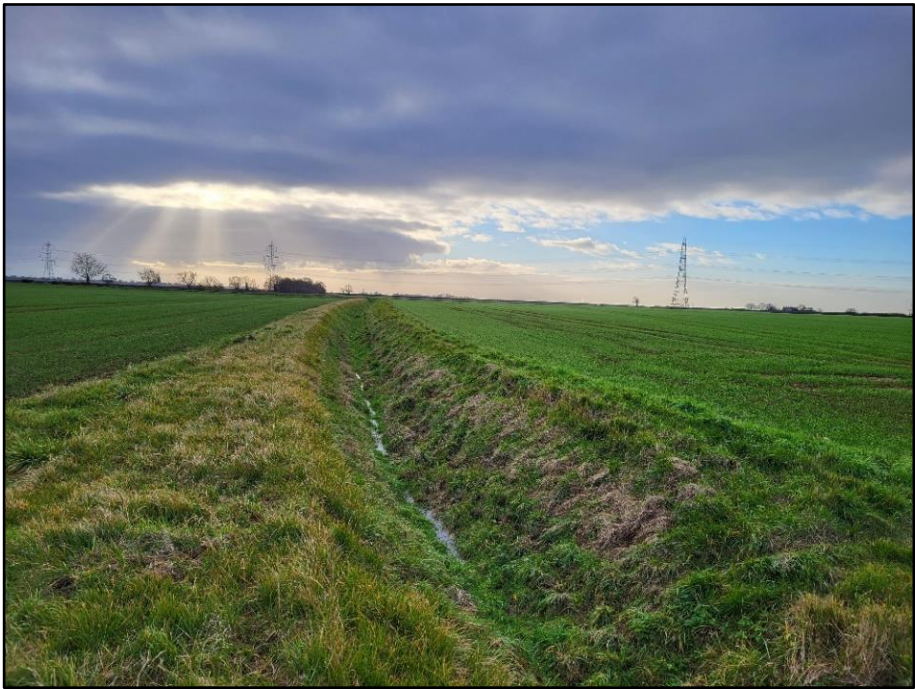
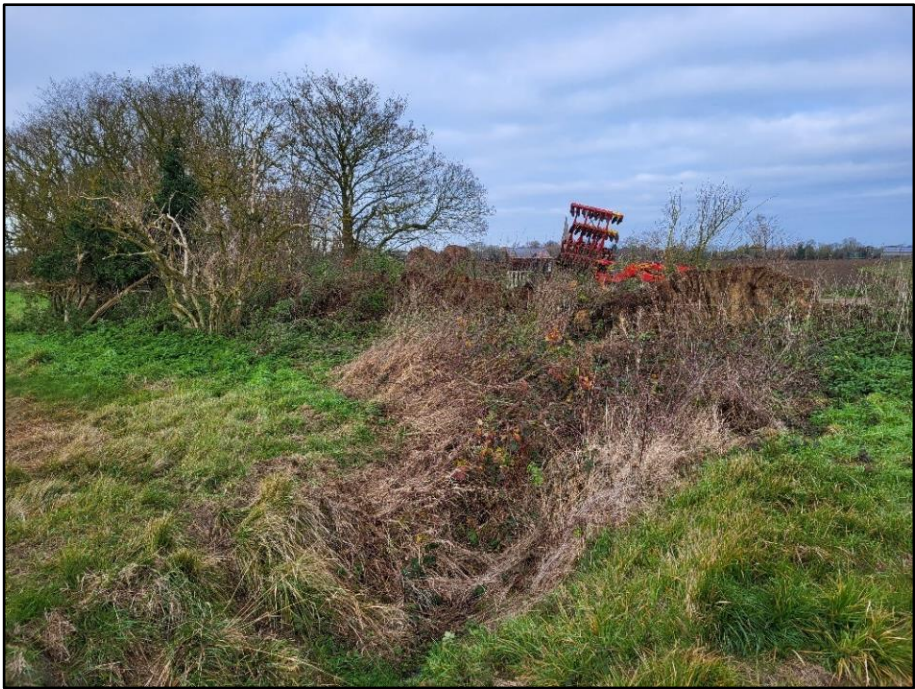
**Photograph Sheet:** 11  
**NGR:** TF 12690 46734  
**Photograph Date:** 3 December 2024  
**Description:** Location of WX11. Unnamed drain, with vegetation throughout channel, left bank c.1.3m, right bank c.1.3m, width c1.5m. Water depth is c.0.02m in the channel.

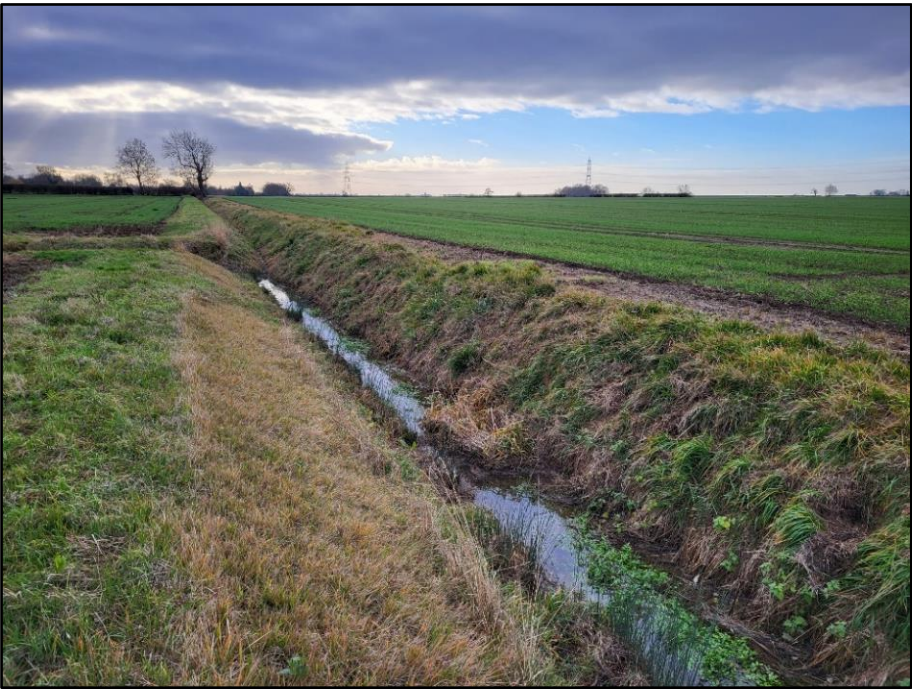
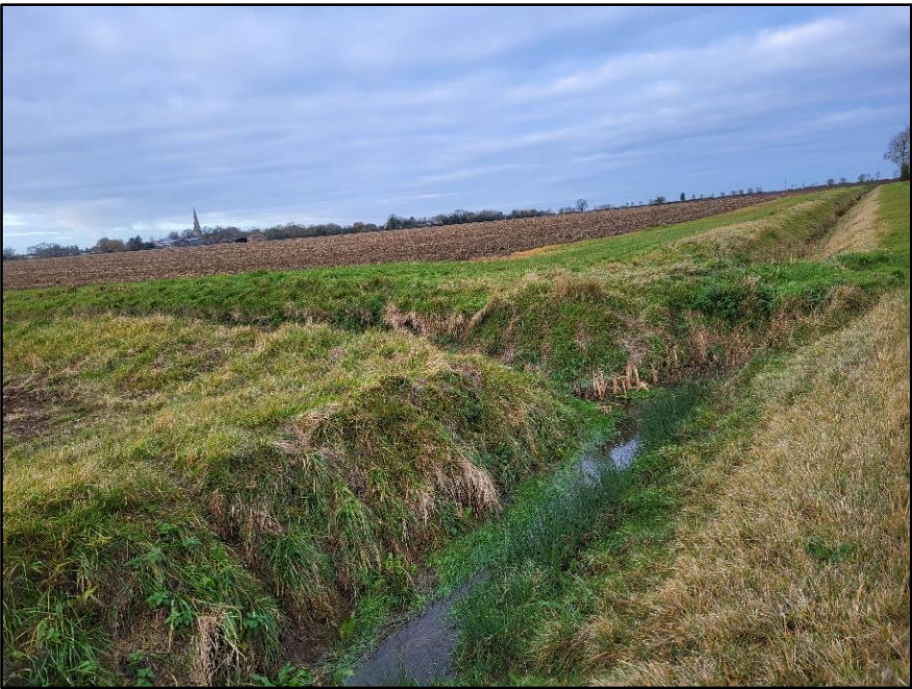
**Photograph Sheet:** 12  
**NGR:** TF 13121 47001  
**Photograph Date:** 3 December 2024  
**Description:** Location of WX12. Unnamed drain, with vegetation throughout channel, left bank c.1.0m, right bank c.1.0m, width c2.4m. Water depth is c.0.05m in the channel.

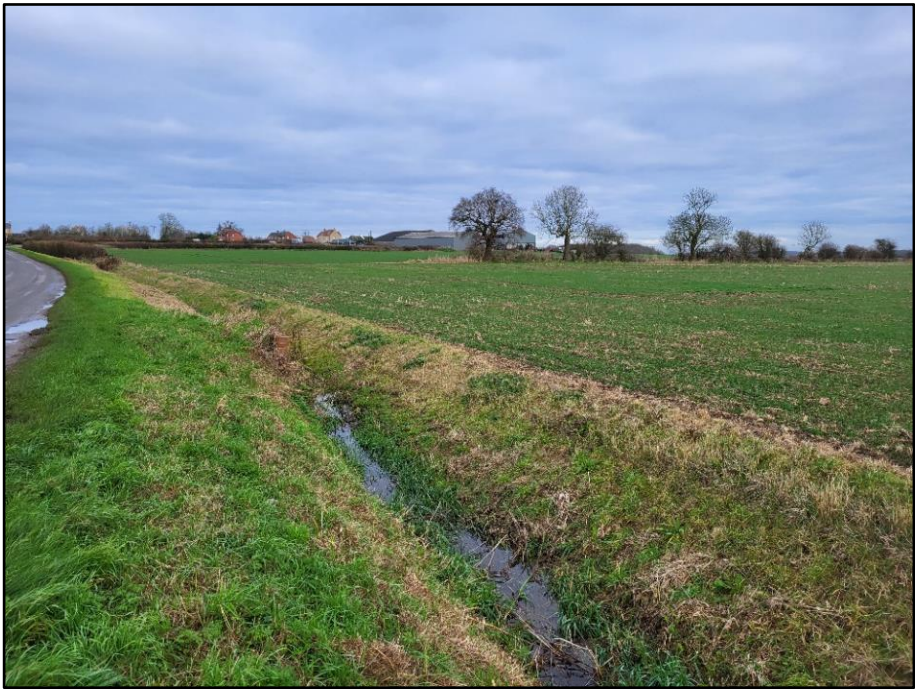
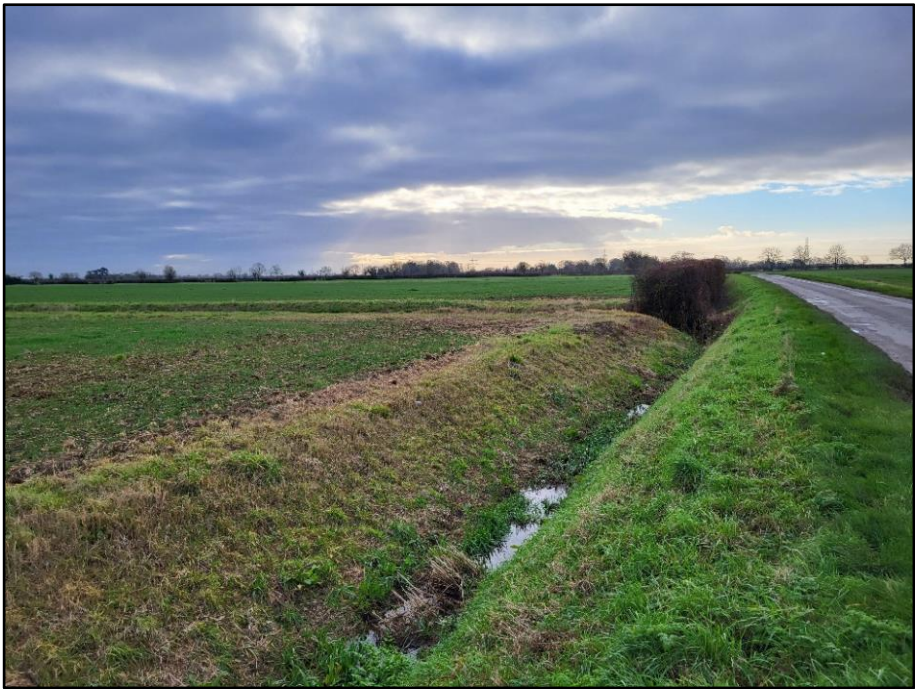
**Photograph Sheet:** 13  
**NGR:** TF 13393 47291  
**Photograph Date:** 3 December 2024  
**Description:** Location of WX13. Unnamed drain, with vegetation throughout channel, left bank c.1.4m, right bank c.1.4m, width c2.0m. Water depth is c.0.05m in the channel.

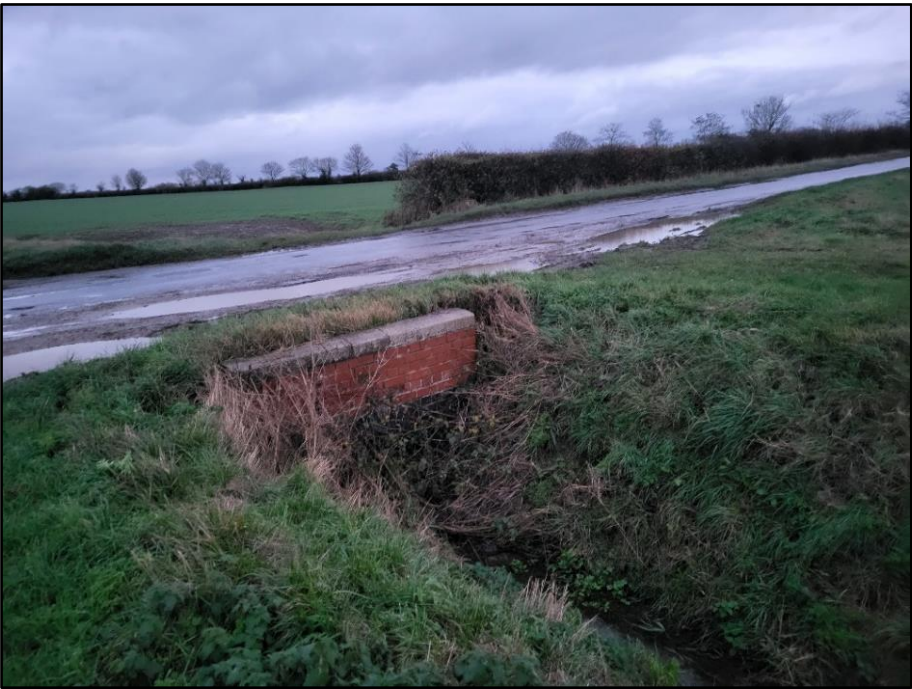
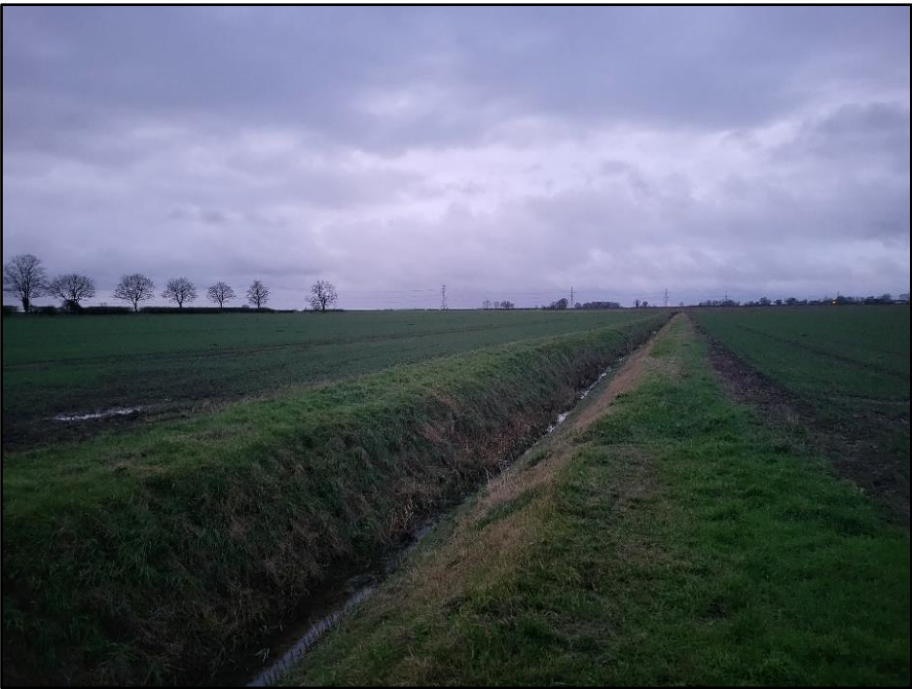
**Photograph Sheet:** 14  
**NGR:** TF 13400 47043  
**Photograph Date:** 3 December 2024  
**Description:** Location of WX14. Unnamed drain, with vegetation throughout channel, left bank c.1.5m, right bank c.1.5m, width c2.0m. Water depth is c.0.05m in the channel and culverted across road.

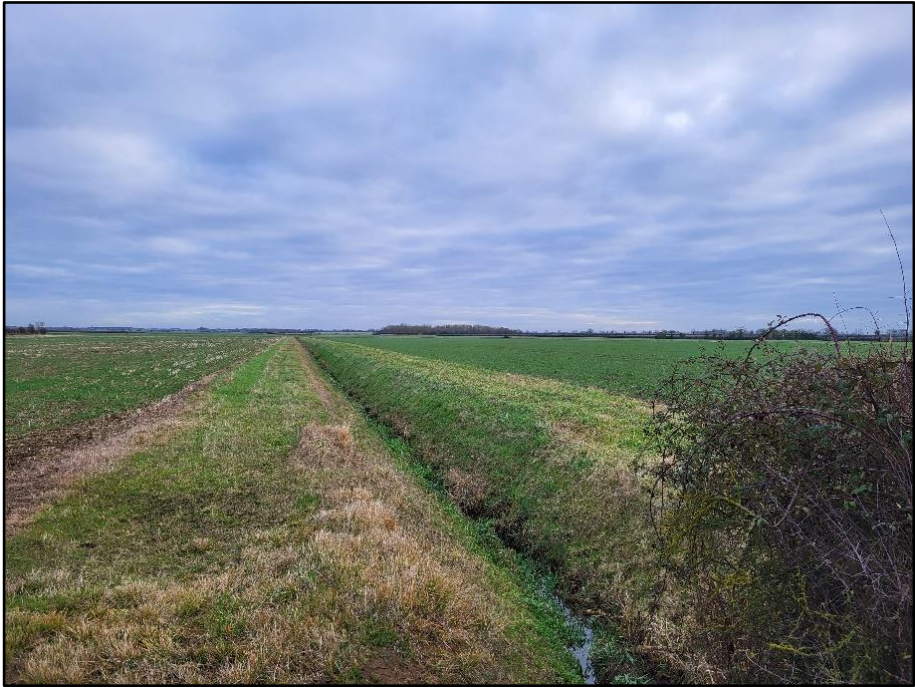
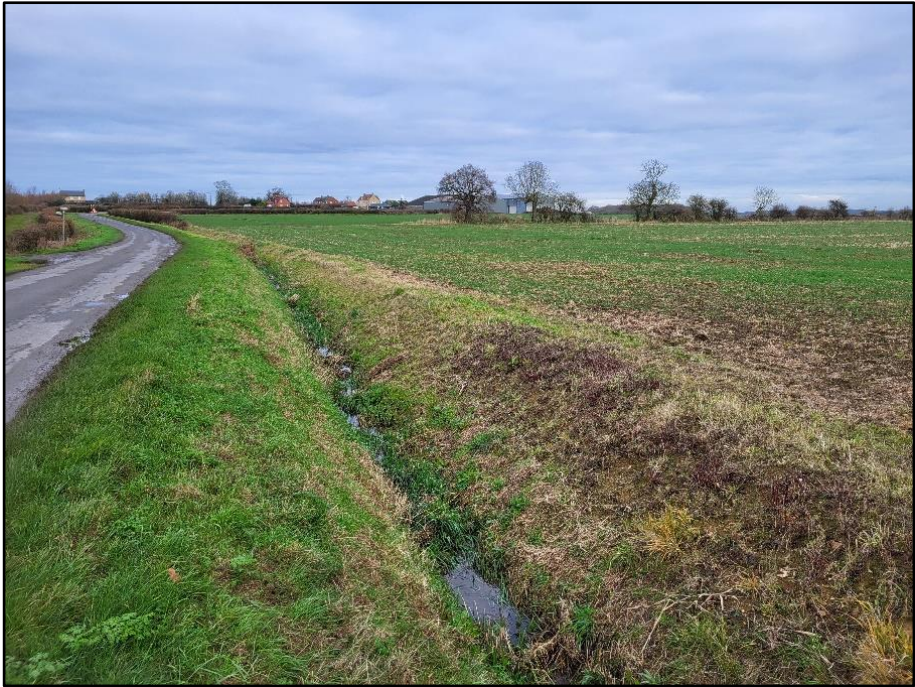
Photograph Sheet: 15  
NGR: TF 13411 47043  
Photograph Date: 3 December 2024

Description: Location of WX15. Unnamed drain, with overgrown vegetation throughout channel, left bank c.1.2m, right bank c.1.2m, width c.2.5m. Water depth is c.0.5m in the channel and culverted across road.

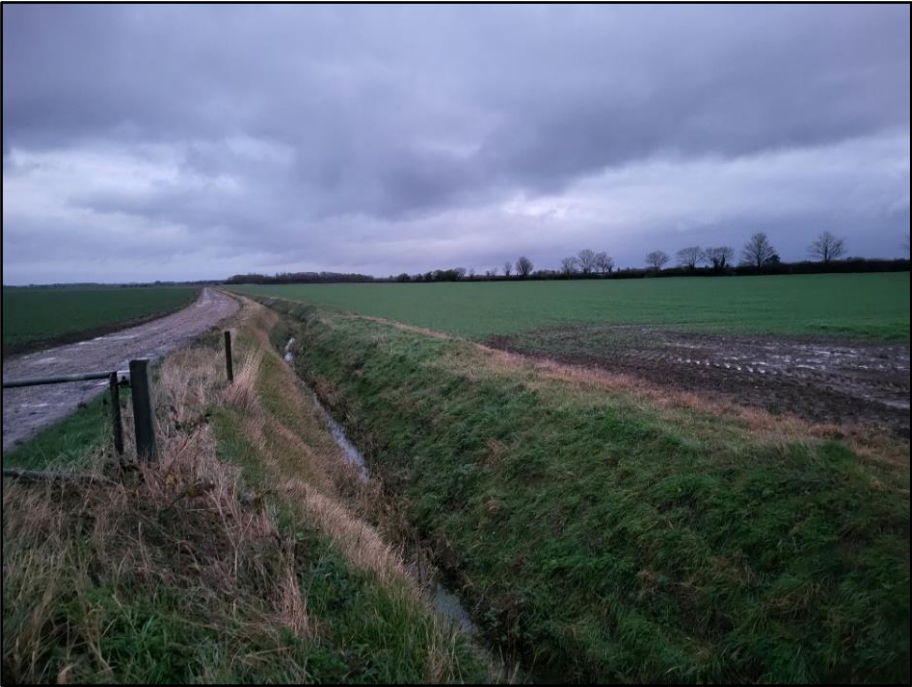
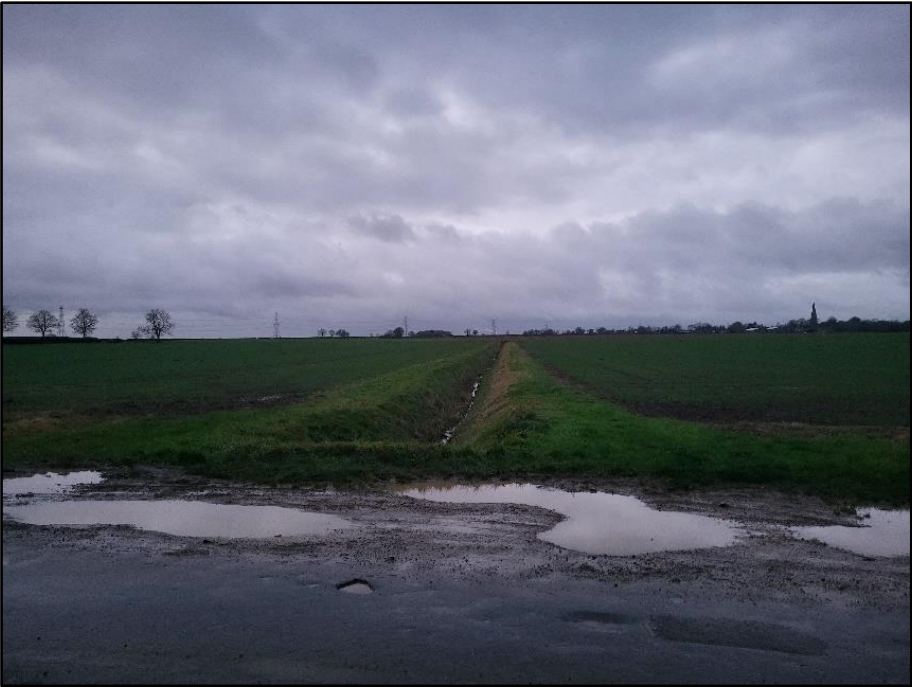
Photograph Sheet: 16  
NGR: TF 13411 47043  
Photograph Date: 3 December 2024

Description: Location of WX16. Unnamed drain, with banks comprised of earth material, left bank c.2.0m, right bank c.2.0m, width c.2.0m. Water depth is c.0.05m in the channel and culverted across road.

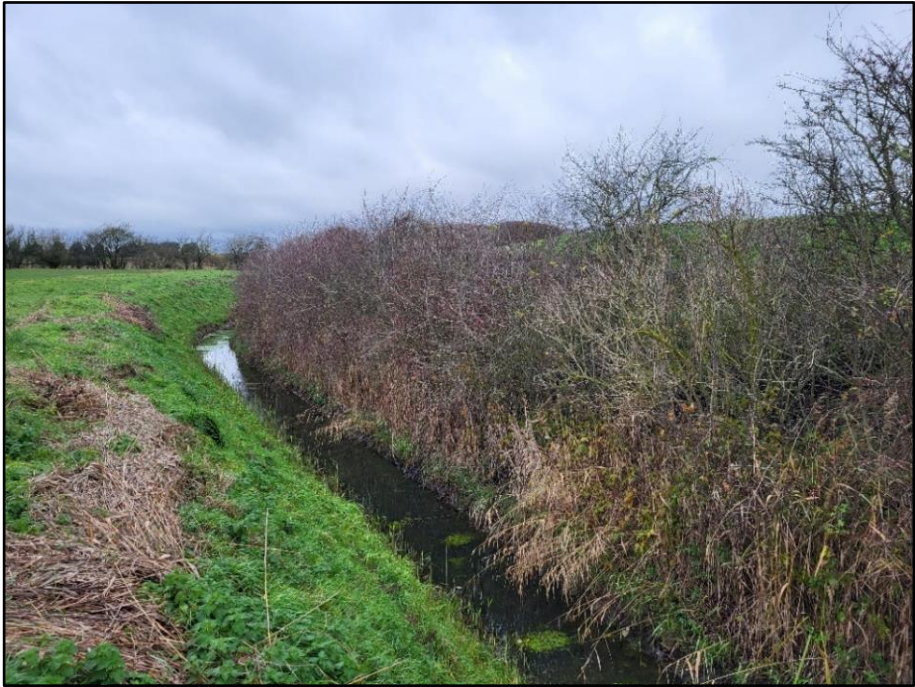
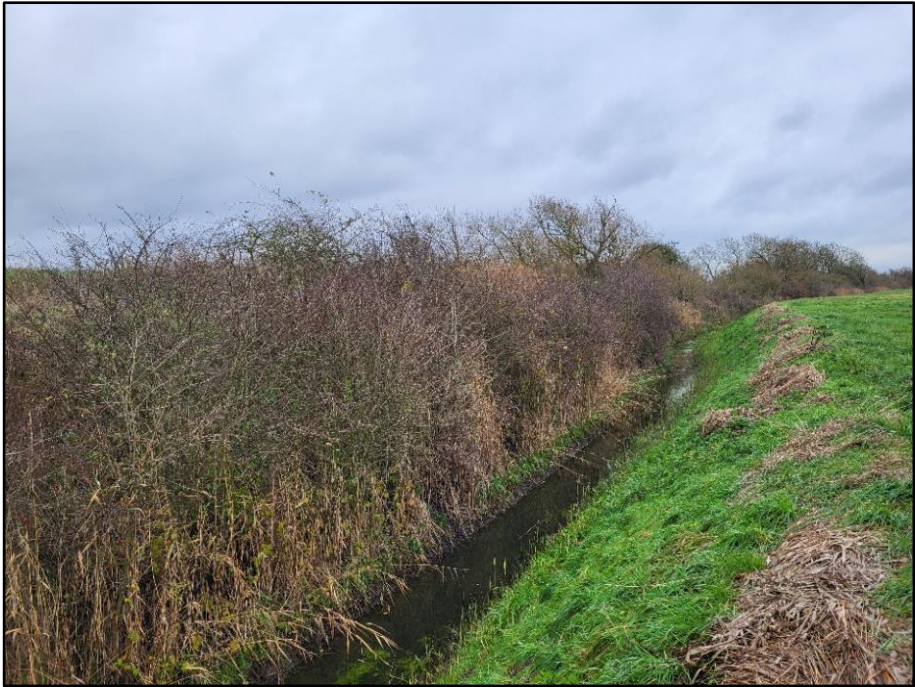
**Photograph Sheet:** 17  
**NGR:** TF 15329 49752  
**Photograph Date:** 3 December 2024

**Description:** Location of WX17. Unnamed drain, with hedge and overgrown vegetation throughout channel, left bank c.2.0m, right bank c.1.8m, width c.2.0m. Water depth is c.0.2m in the channel.
