# BEACON FEN ENERGY PARK

Planning Inspectorate Reference: EN010151

Appendix 11.3 Summary of Watercourse Crossings and Photographs

Document Reference: 6.3 ES Volume 2, 6.3.83

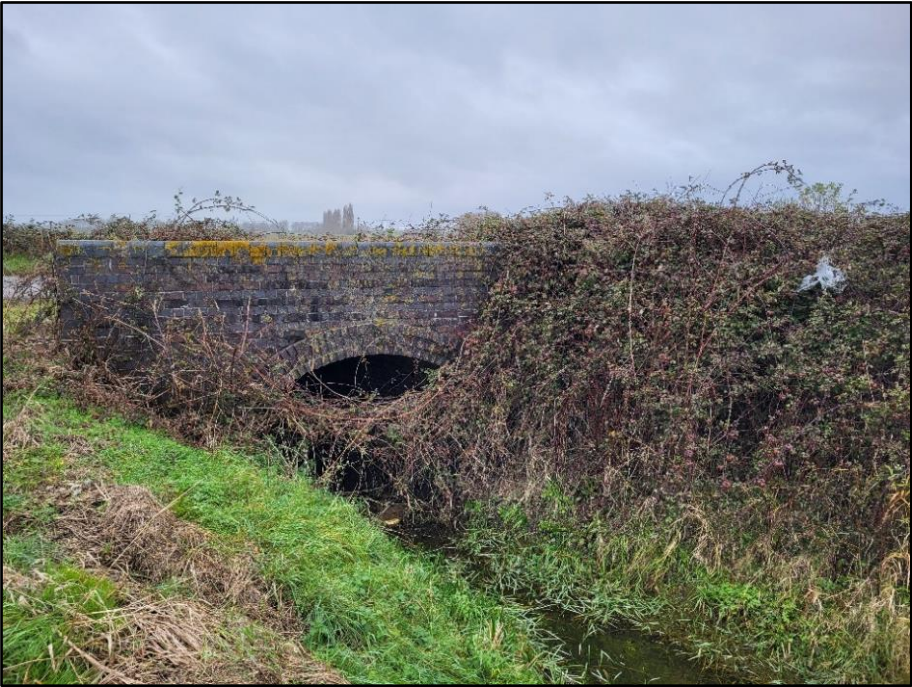
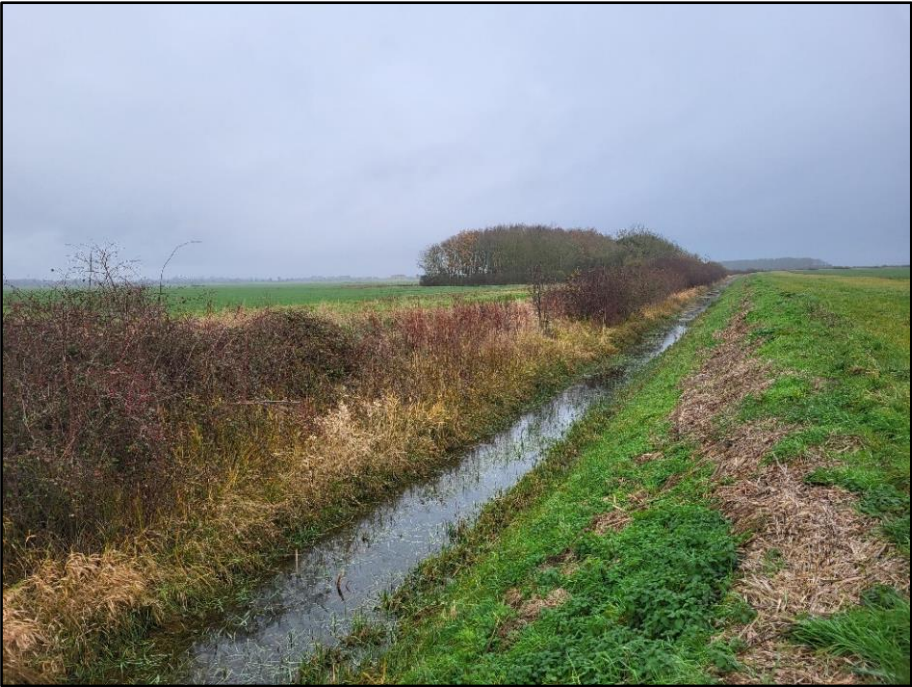
**Photograph Sheet:** 18  
**NGR:** TF 14065 48857  
**Photograph Date:** 3 December 2024

**Description:** Location of WX18. Passing place and Catchwater Drain, with hedge and overgrown vegetation throughout channel, left bank c.1.5m, right bank c.1.5m, width c.2.0m. Water depth is c.0.3m in the channel.

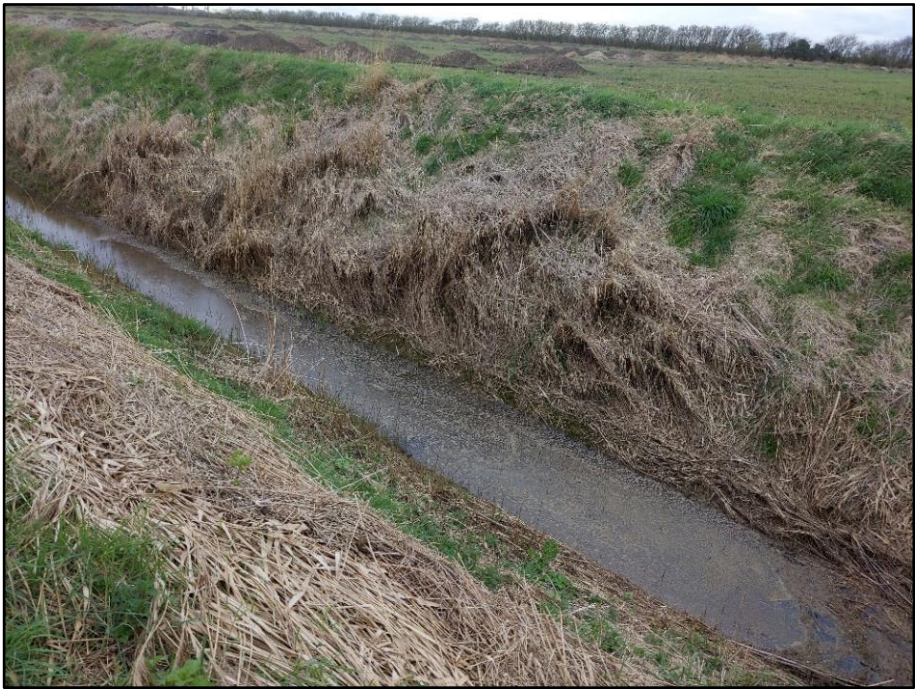
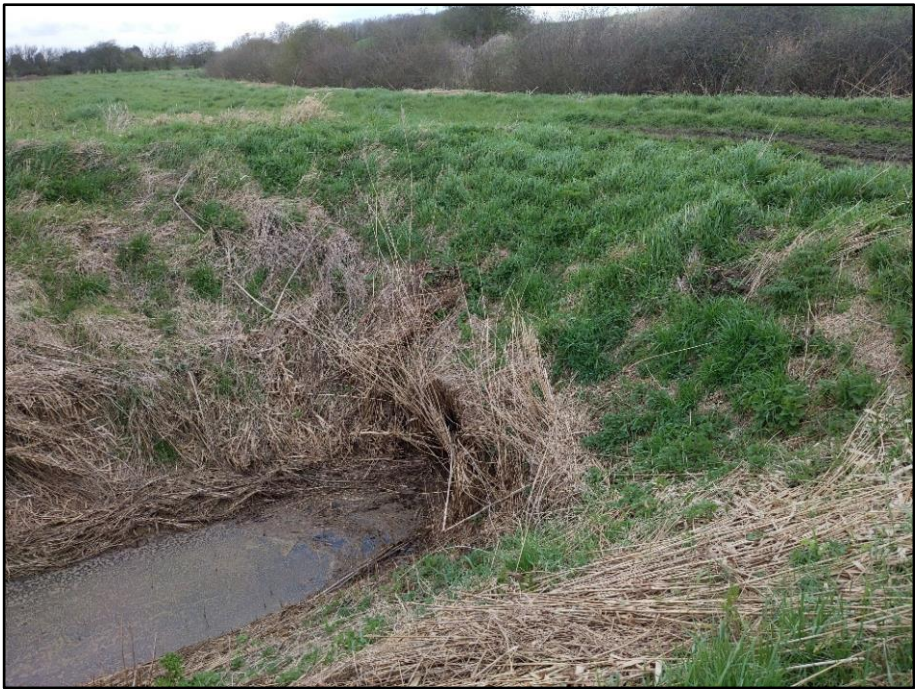
**Photograph Sheet:** 19  
**NGR:** TF 15218 48969  
**Photograph Date:** 19 March 2024  
**Description:** Location of WX19. Passing place and unnamed drain, with hedge and overgrown vegetation throughout channel, left bank c.1.5m, right bank c.1.5m, width c.2m..

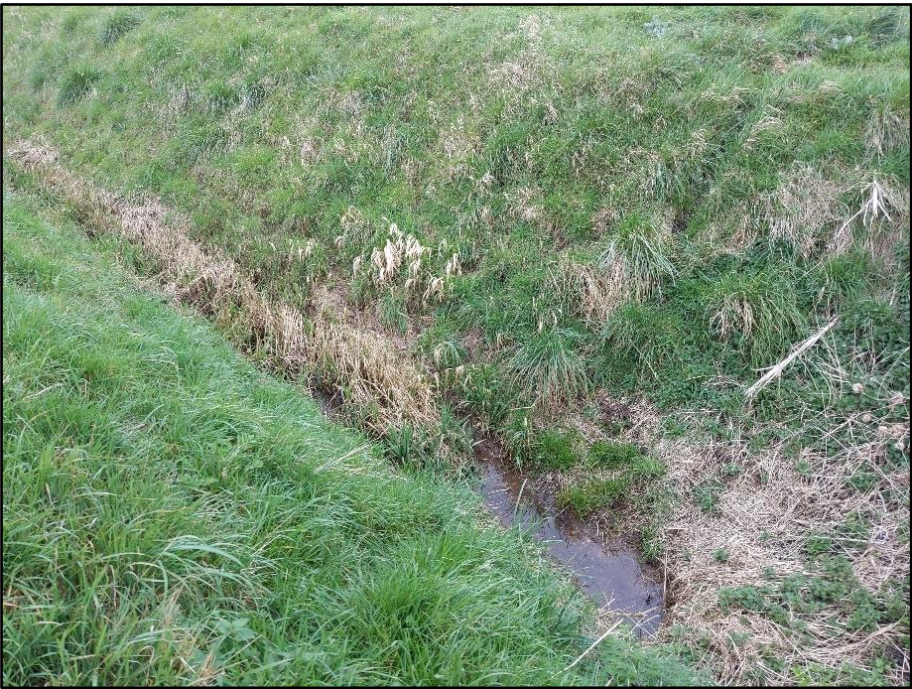
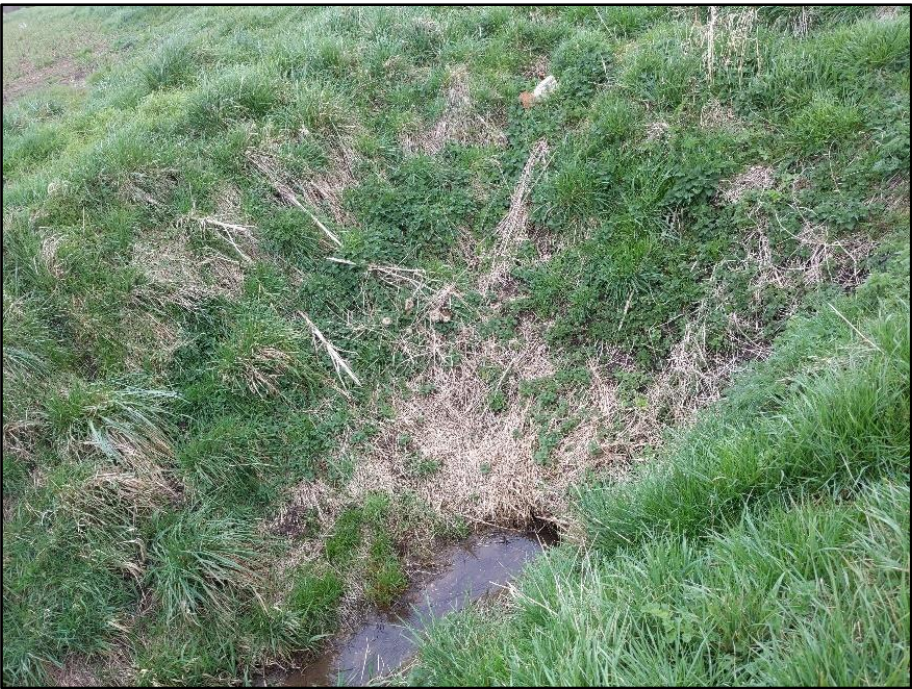
**Photograph Sheet:** 20  
**NGR:** TF 15408 49574  
**Photograph Date:** 19 March 2024  
**Description:** Location of WX20. Unnamed drain, with overgrown vegetation throughout channel, left bank c.1.2m, right bank c.1.2m, width c.3m. Water depth is c.0.05m in the channel.

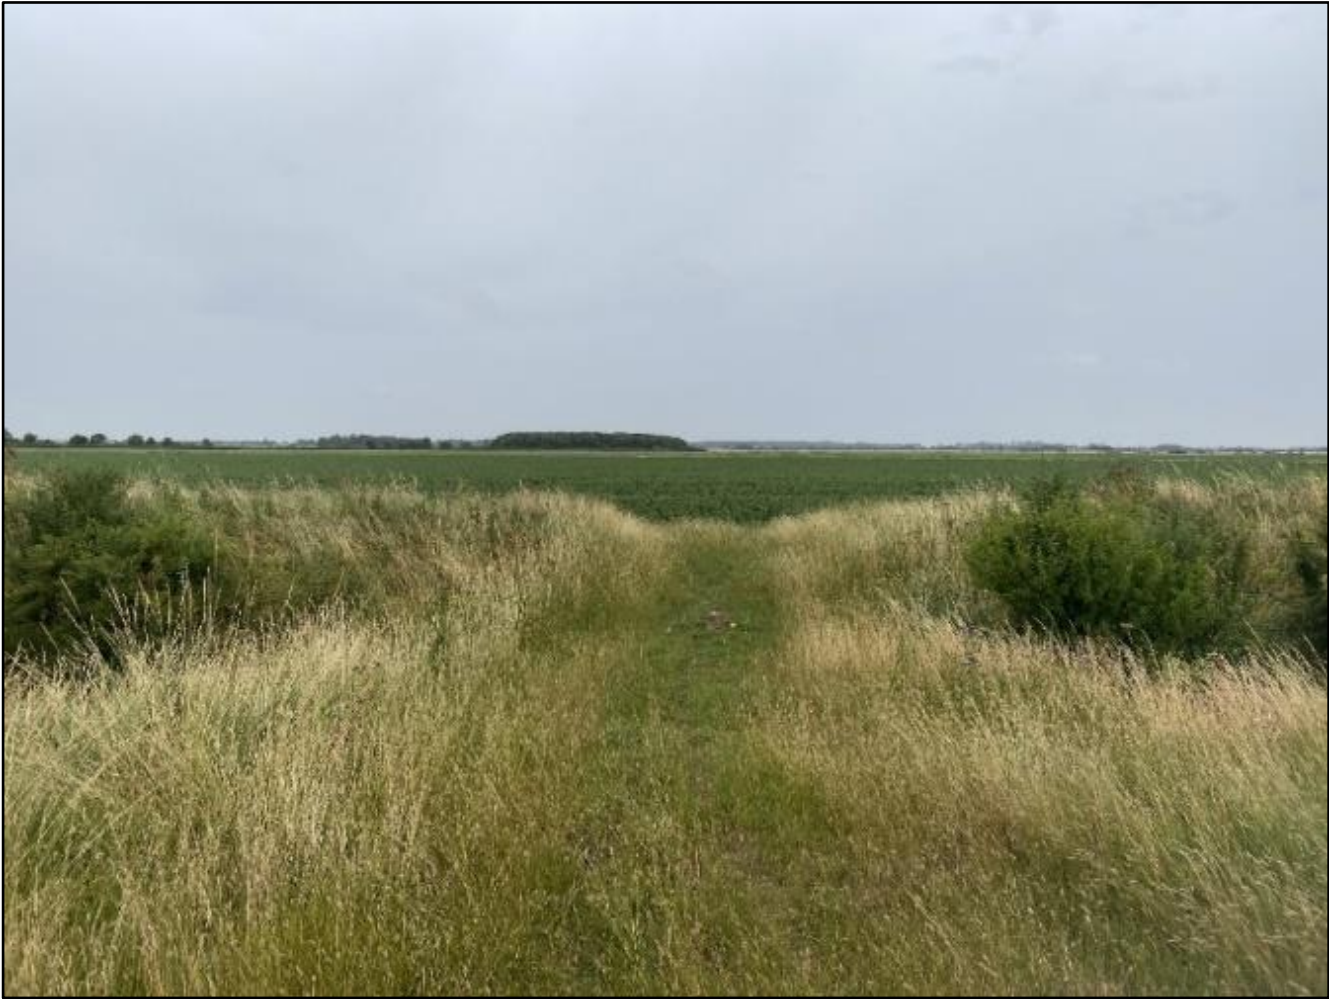
**Photograph Sheet:** 21  
**NGR:** TF 13793 48313  
**Photograph Date:** 14 July 2023  
**Description:** Location of WX21. Passing place over unnamed drain, width c.3m.

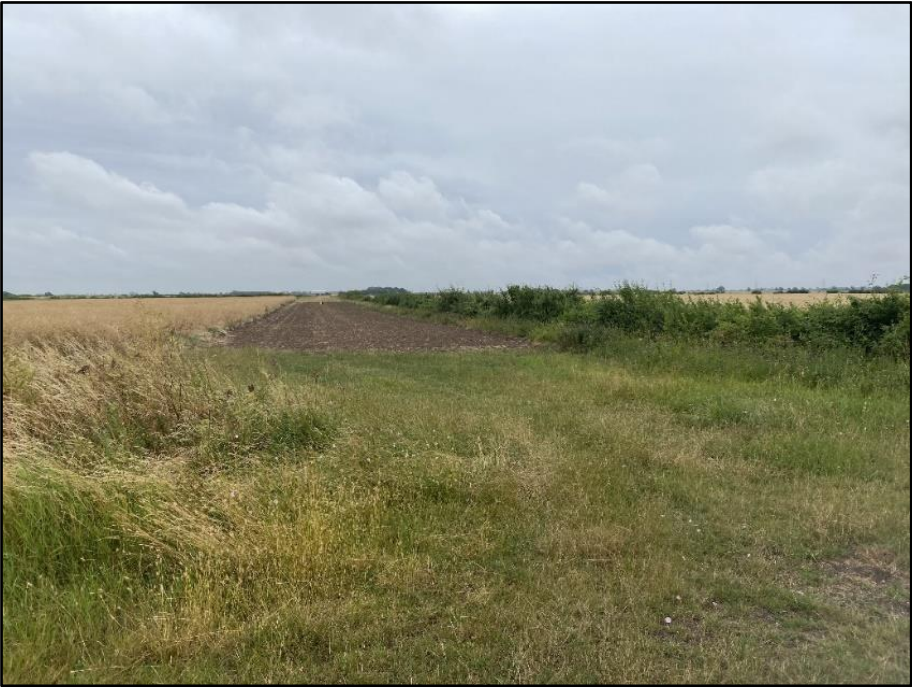
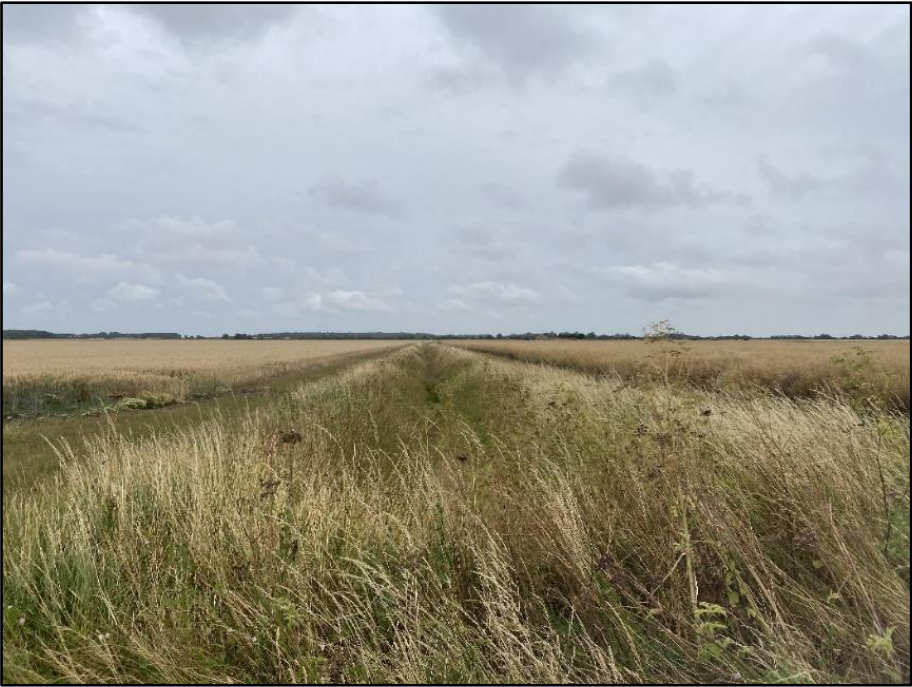
**Photograph Sheet:** 22  
**NGR:** TF 14481 48557  
**Photograph Date:** 14 July 2023  
**Description:** Location of WX22. Unnamed drain, with overgrown vegetation throughout channel, left bank c.1m, right bank c.1m, width c.3m. No water is present in the channel.

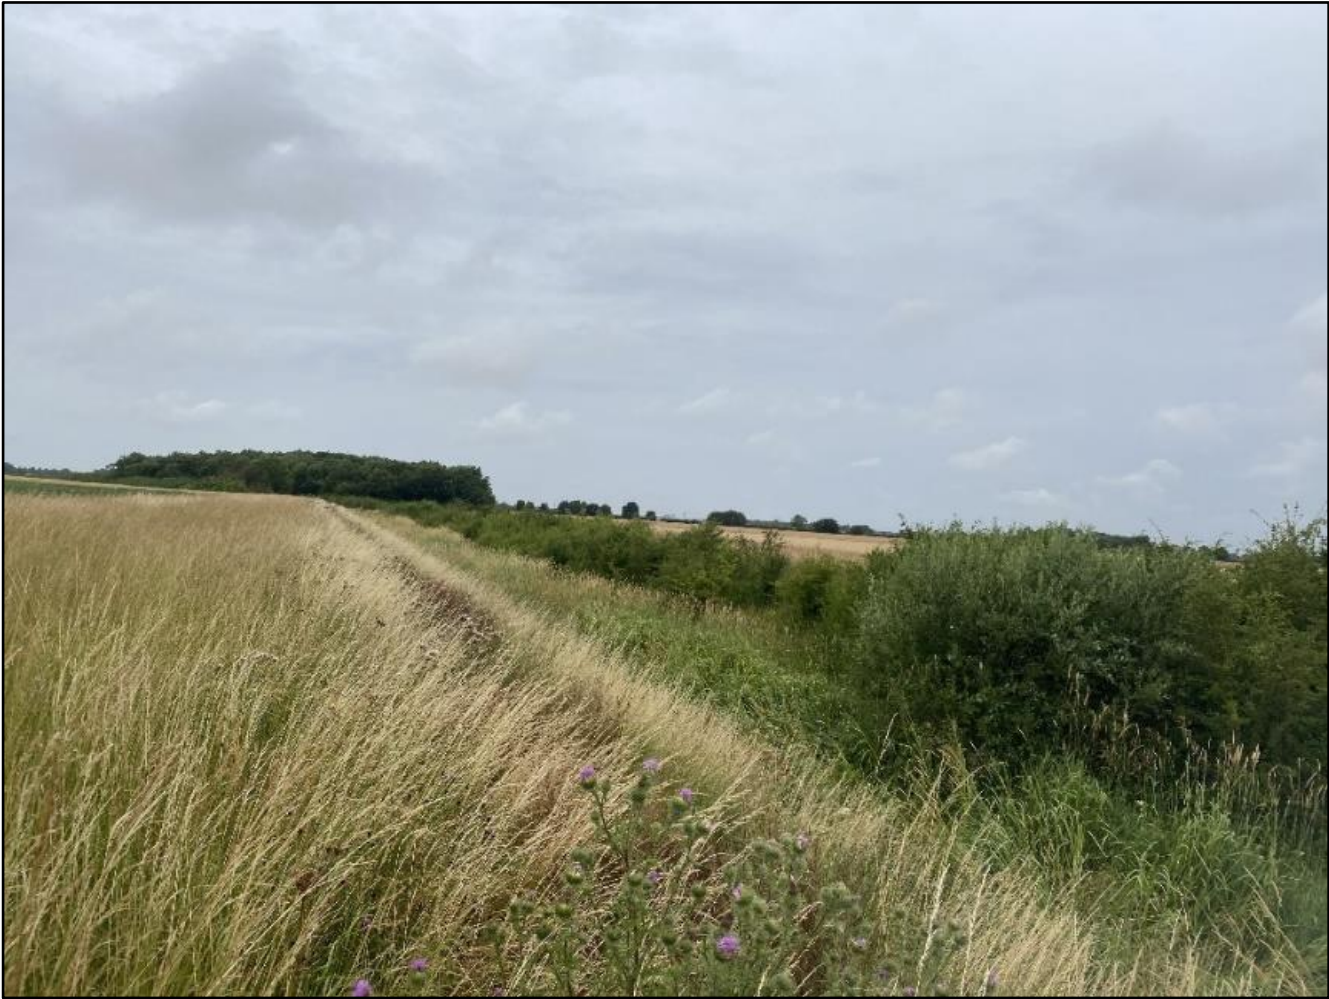
**Photograph Sheet:** 23  
**NGR:** TF 14481 48557  
**Photograph Date:** 14 July 2023  
**Description:** Location of WX23. Unnamed drain, with hedge and overgrown vegetation throughout channel, left bank c.1.5m, right bank c.1.5m, width c.4.0m. No water is present in the channel. No water is present in the channel..

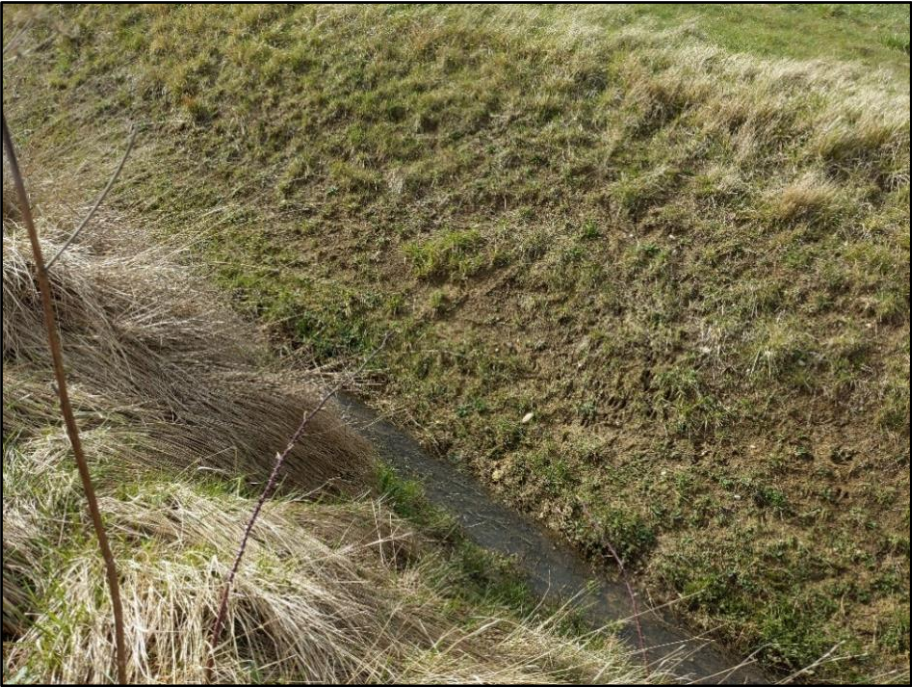
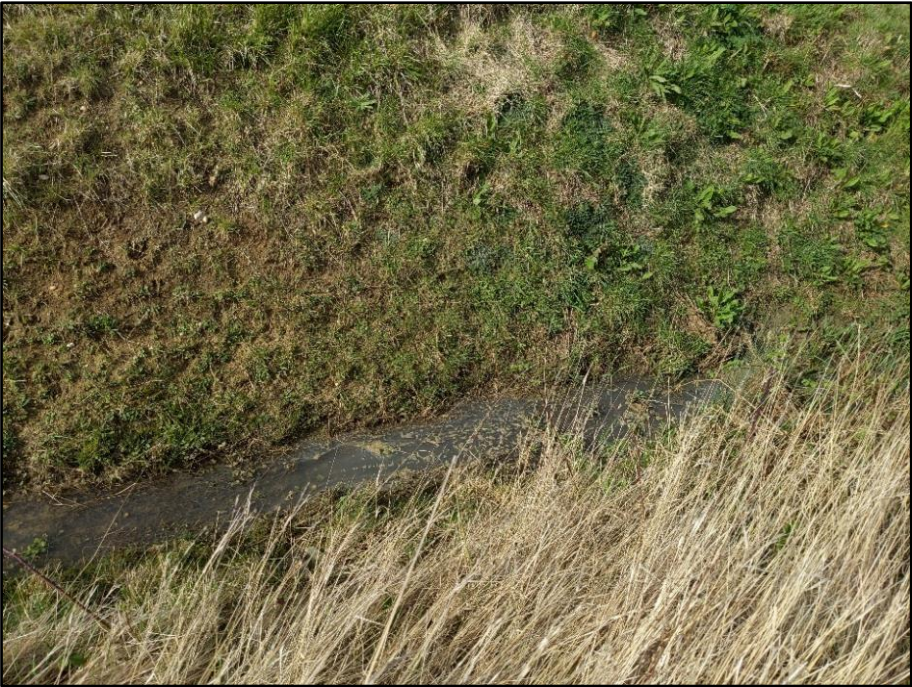
**Photograph Sheet:** 24  
**NGR:** TF 13989 48009  
**Photograph Date:** 19 March 2024  
**Description:** Location of WX24. Unnamed drain, with overgrown vegetation throughout the channel and banks composed of earth material. The left bank c.1.5m, right bank c.1.5m, width c. 2.5m. Water depth is c.0.1m in the channel.

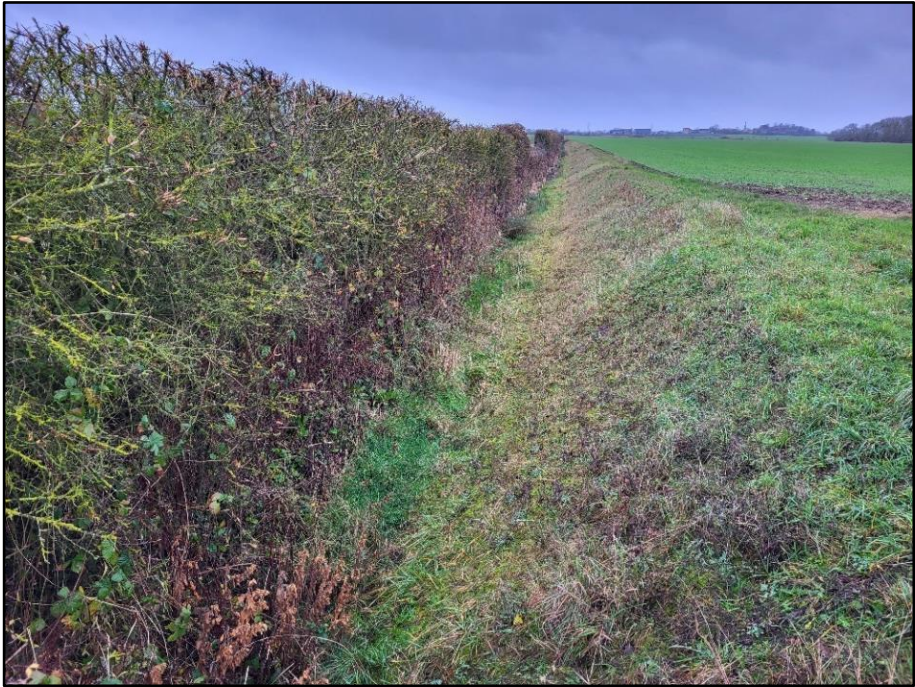
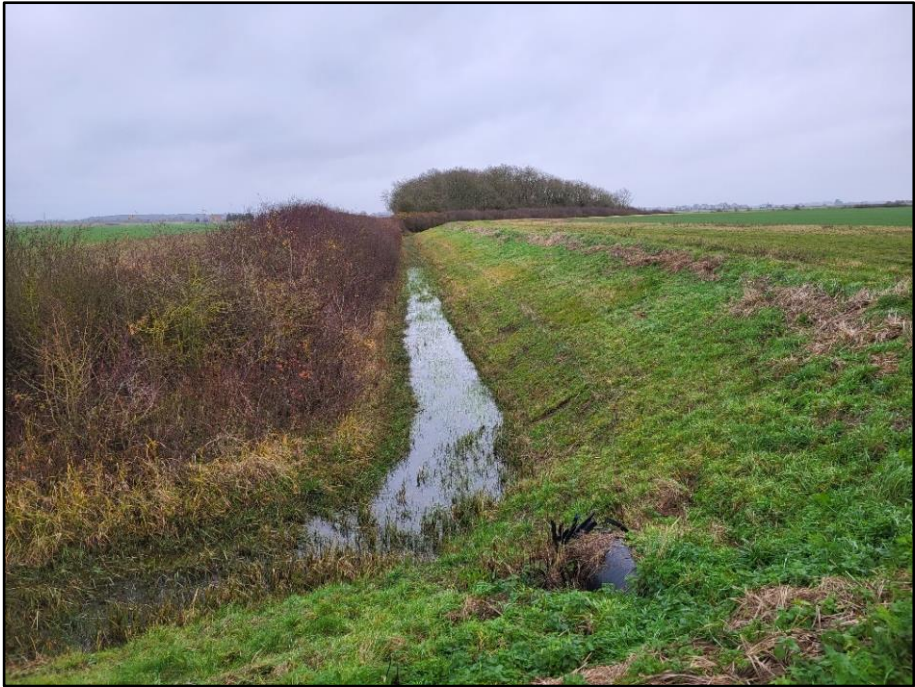
**Photograph Sheet:** 25  
**NGR:** TF 14729 48250  
**Photograph Date:** 4 December 2024

**Description:** Location of WX25. Unnamed drain, with overgrown vegetation throughout the channel and banks composed of earth material. The left bank c.1.5m, right bank c.1.5m, width c. 1.2m. Water depth is c.0.2m in the channel and culverted downstream.

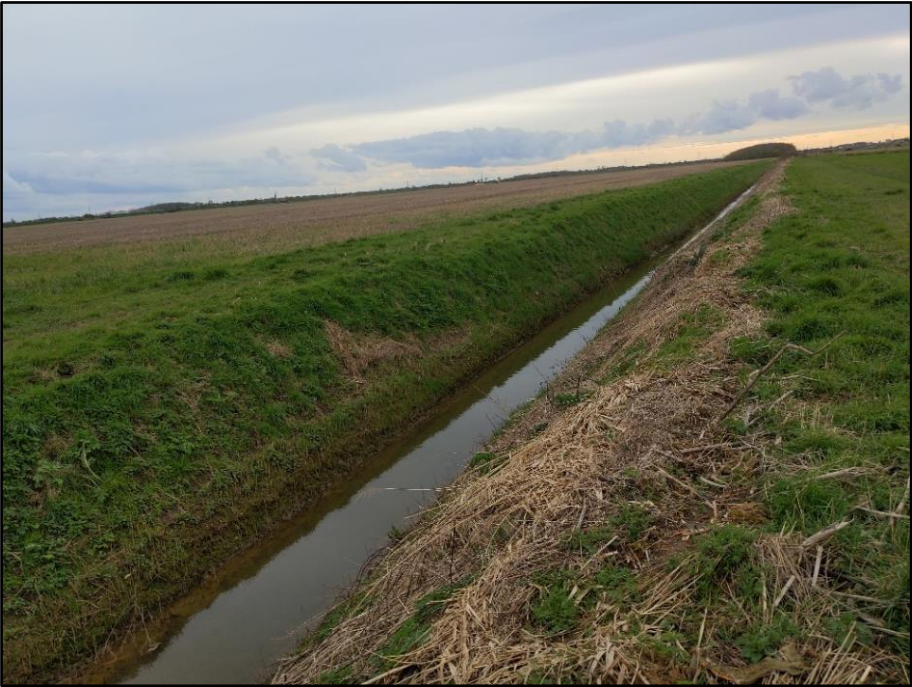
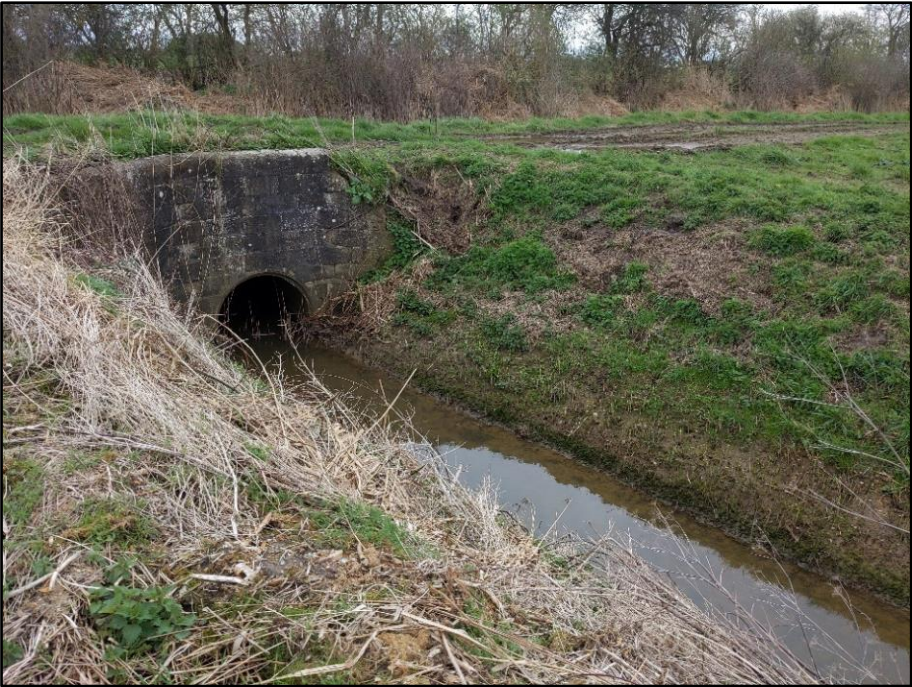
**Photograph Sheet:** 26  
**NGR:** TF 15704 48911  
**Photograph Date:** 19 March 2024

**Description:** Location of WX26. Unnamed drain, with banks composed of earth material. The left bank c.1.5m, right bank c.1.5m, width c. 4.0m. Water depth is c.0.4m in the channel and culverted downstream.

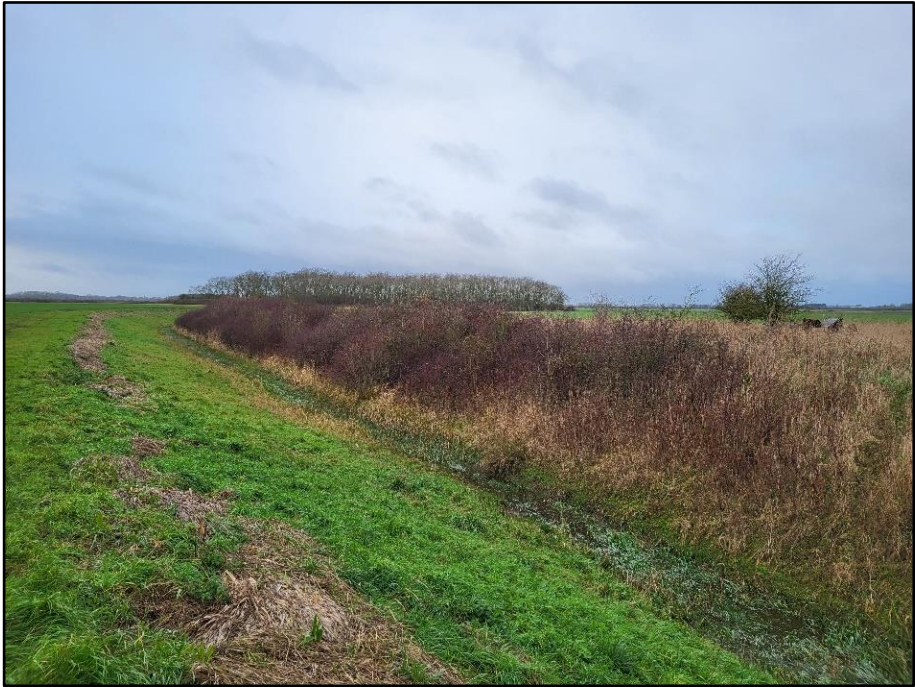
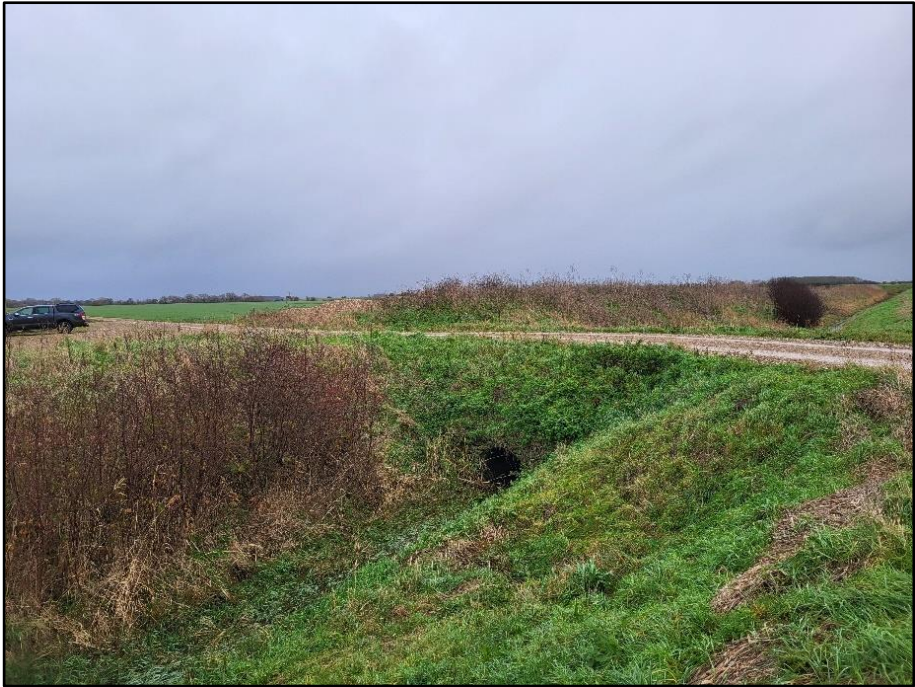
Photograph Sheet: 27  
NGR: TF 15147 48129  
Photograph Date: 3 December 2024

Description: Location of WX27. Unnamed drain, with overgrown vegetation in the channel and banks composed of earth material. The left bank c.3.0m, right bank c.3.0m, width c. 5.0m. Water depth is c.0.04m in the channel.

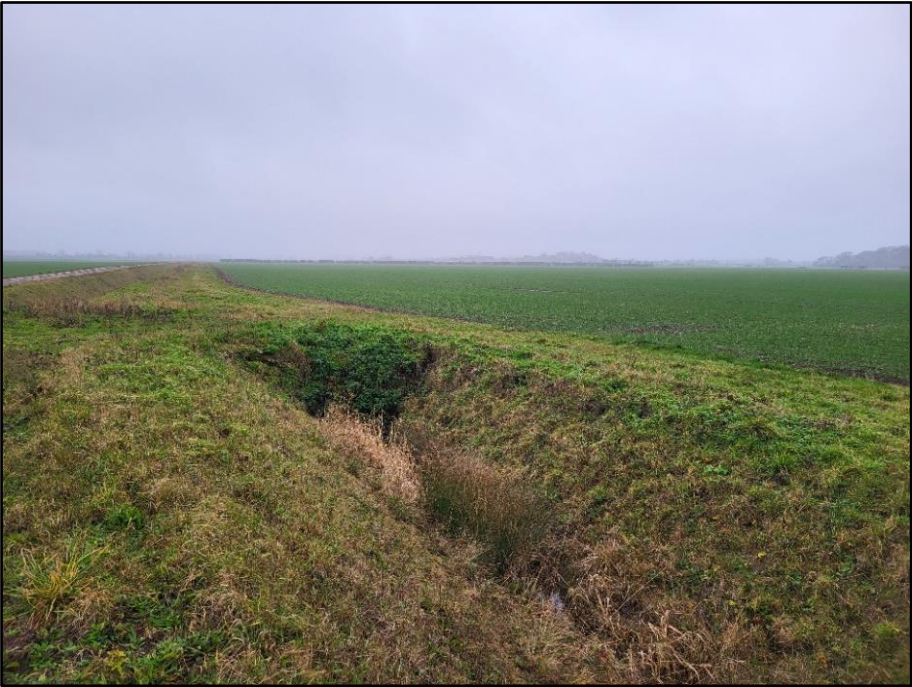
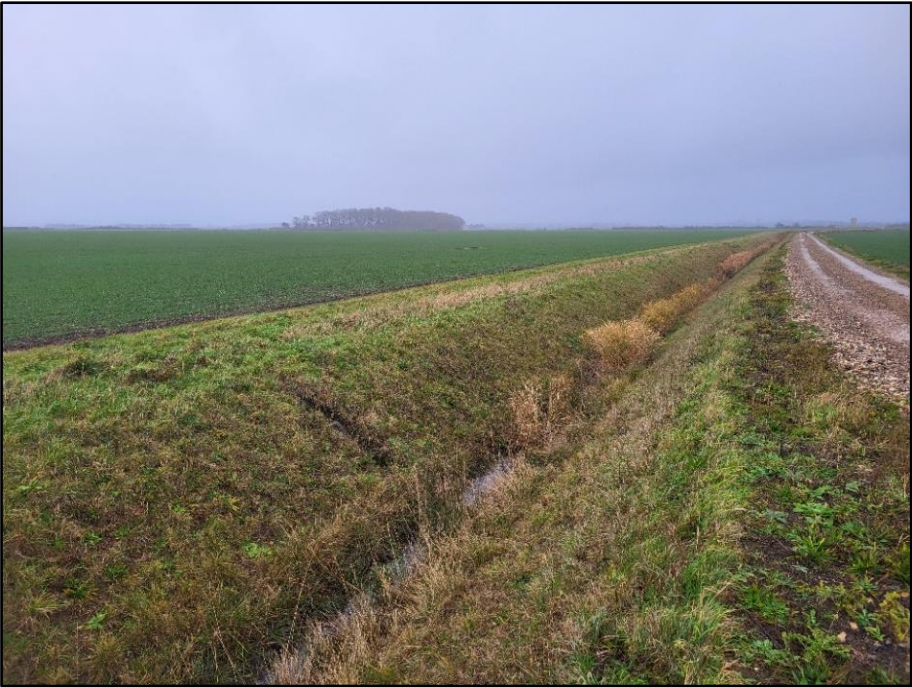
Photograph Sheet: 28  
NGR: TF 14762 47880  
Photograph Date: 3 December 2024

Description: Location of WX28. Unnamed drain, with overgrown vegetation in the channel and banks composed of earth material. The left bank c.1.2m, right bank c.1.2m, width c. 2.2m. Water depth is c.0.05m in the channel and culverted upstream.

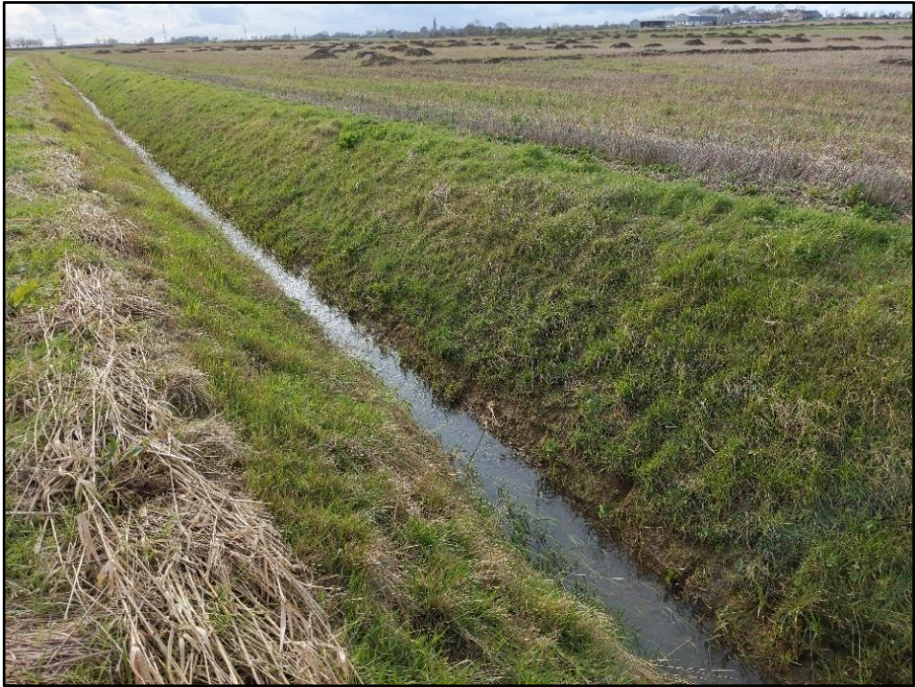
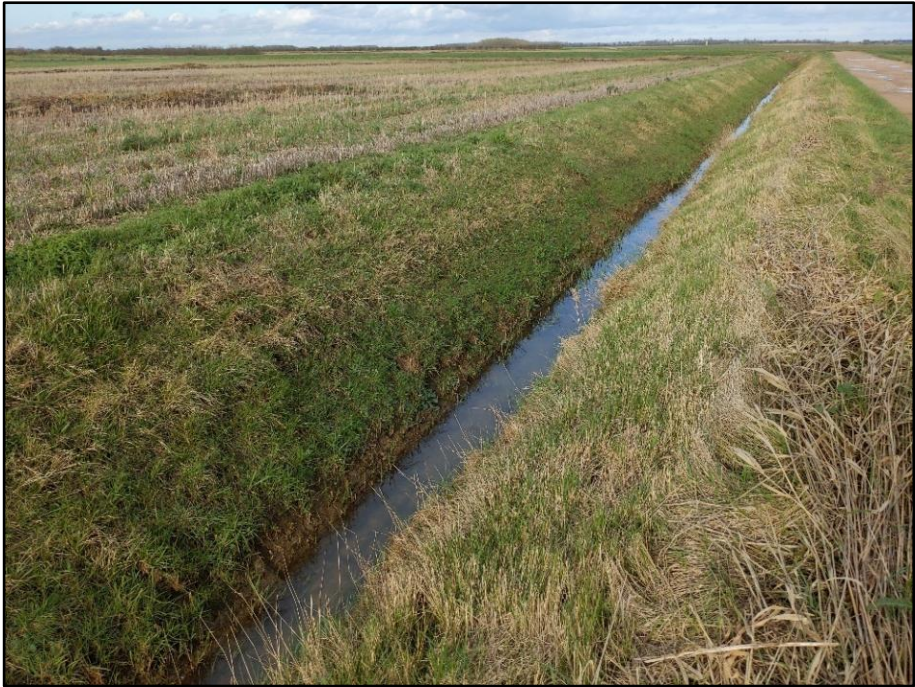
**Photograph Sheet:** 29  
**NGR:** TF 14438 47630  
**Photograph Date:** 3 February 2024

**Description:** Location of WX29. Unnamed drain, with banks composed of earth material. The left bank c.1.5m, right bank c.1.5m, width c. 3.0m. Water depth is c.0.2m in the channel.

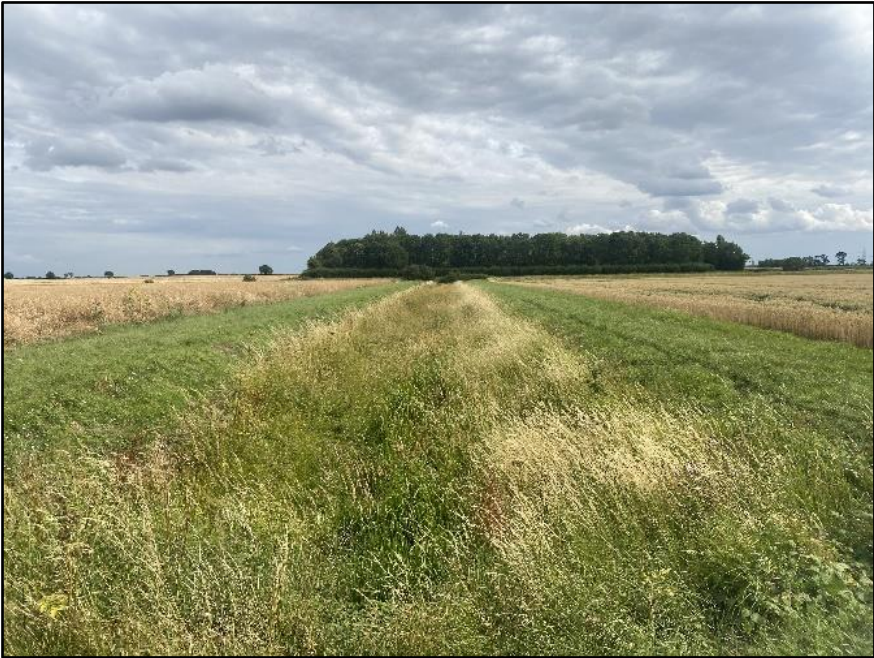
**Photograph Sheet:** 30  
**NGR:** TF 14294 47454  
**Photograph Date:** 13 July 2023

**Description:** Location of WX30. Unnamed drain, connecting to Hodge Dike by the reservoir, with overgrown vegetation throughout channel, left bank c.1.5m, right bank c.1.5m, width c.3m. No water is present in the channel.

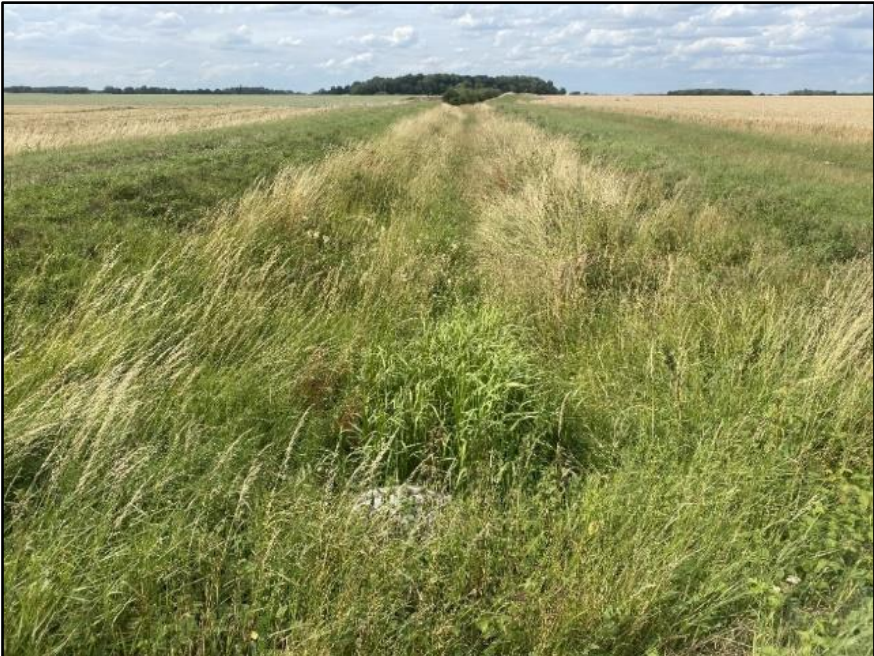
**Photograph Sheet:** 31  
**NGR:** TF 14294 47454  
**Photograph Date:** 13 July 2023

**Description:** Location of WX31. Unnamed drain, with overgrown vegetation throughout channel, left bank c.1.5m, right bank c.1.5m, width c.3m. No water is present in the channel.

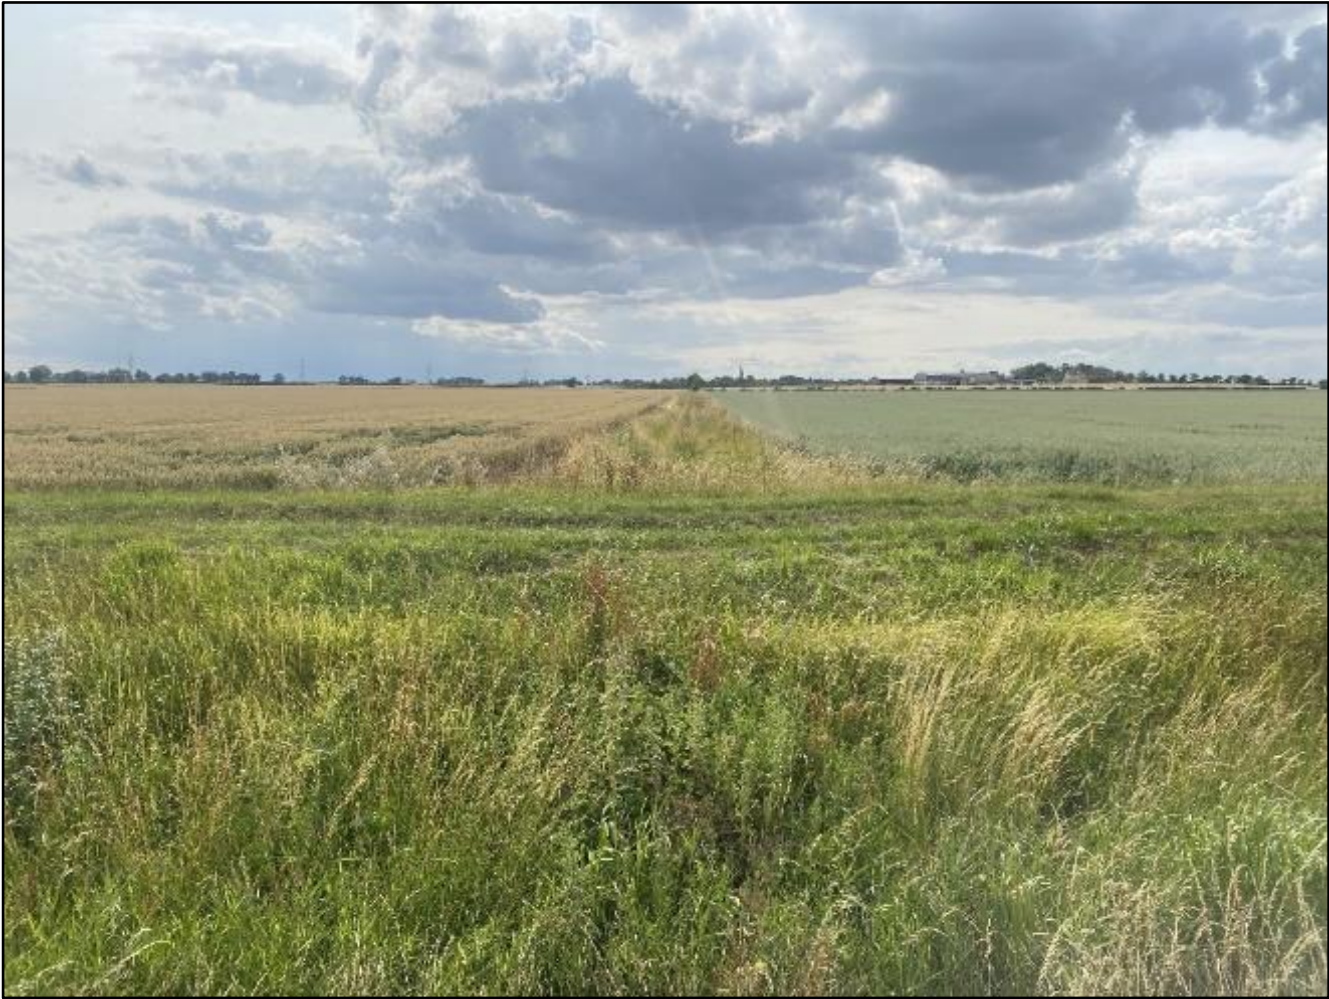
**Photograph Sheet:** 32  
**NGR:** TF 14267 47521  
**Photograph Date:** 13 July 2023  
**Description:** Location of WX32. Unnamed drain, with overgrown vegetation throughout channel, left bank c.1.5m, right bank c.1.5m, width c.2m. No water is present in the channel.

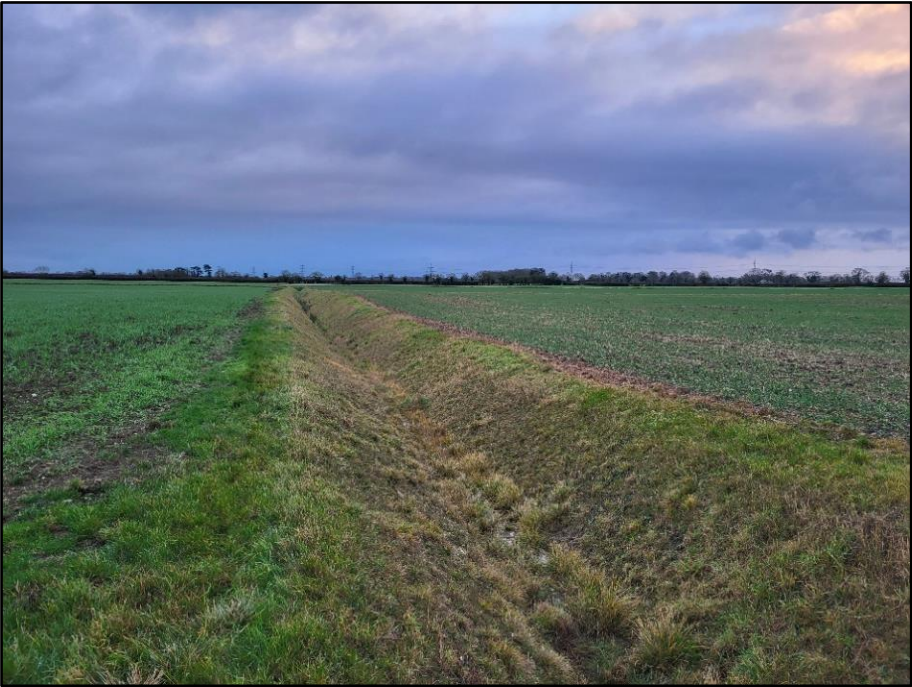
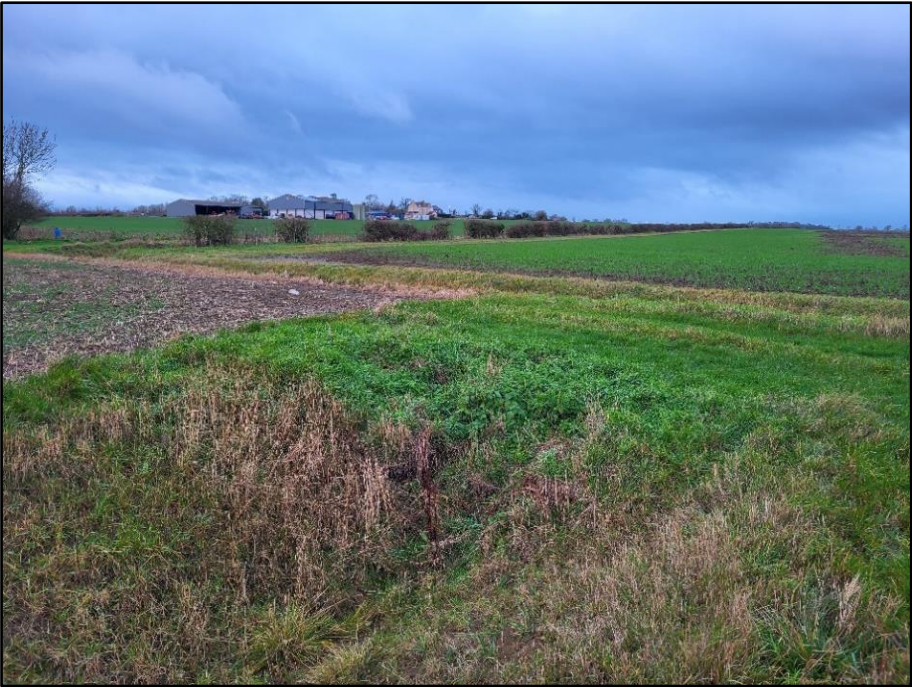
**Photograph Sheet:** 33  
**NGR:** TF 13808 47438  
**Photograph Date:** 3 December 2024  
**Description:** Location of WX33. Unnamed drain, with overgrown vegetation in the channel and banks composed of earth material. The left bank c.1.5m, right bank c.1.5m, width c. 3.0m. No water is present in the channel.

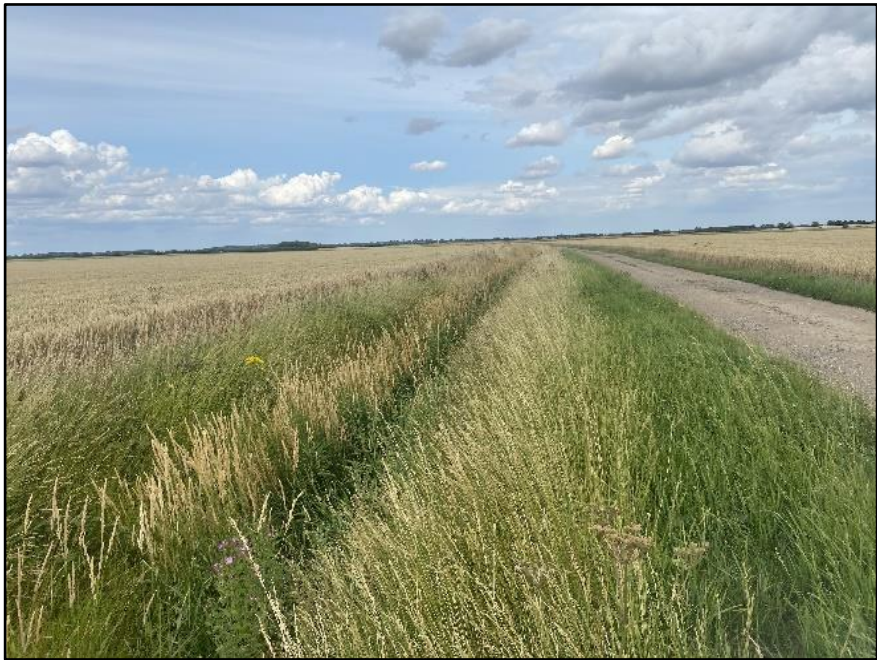
34

Location of WX34. Unnamed drain, with overgrown vegetation throughout channel, left bank c.1.5m, right bank c.1.5m, width c.2m. No water is present in the channel.

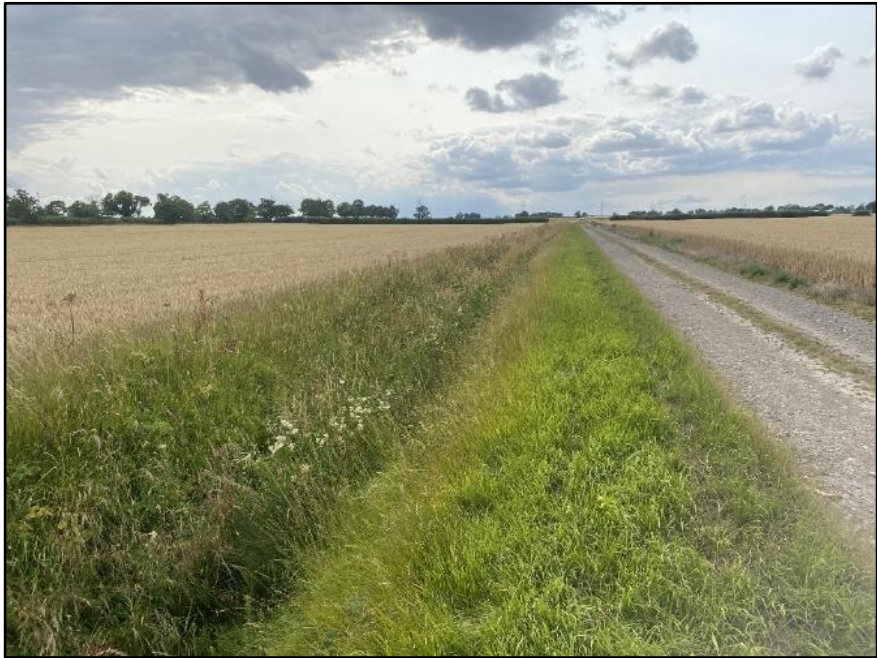
35

Location of WX35. Unnamed drain, with overgrown vegetation throughout the channel, estimated bank heights of c1.5m, and width of c.2m.

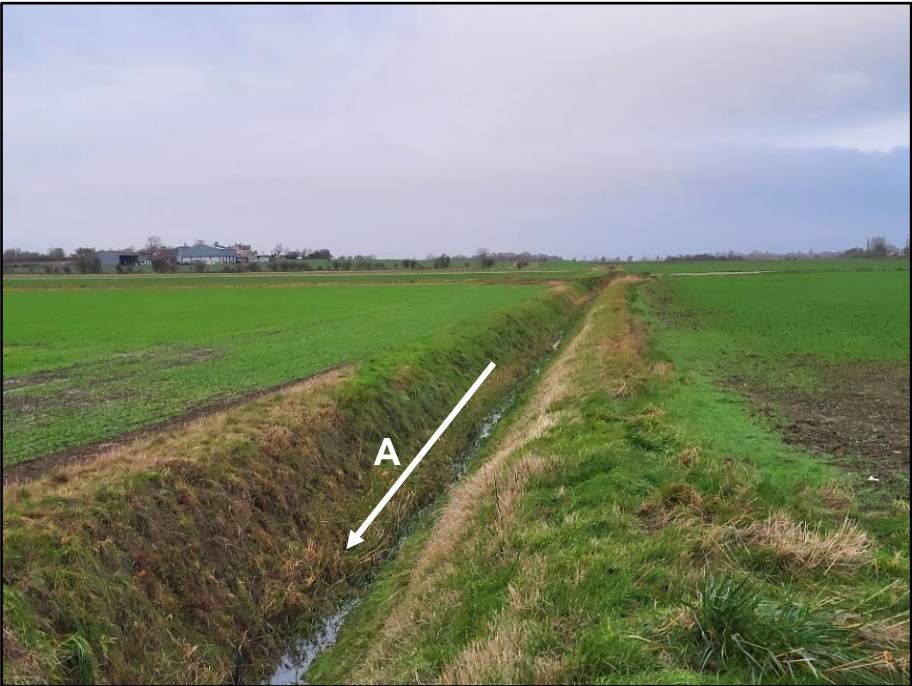
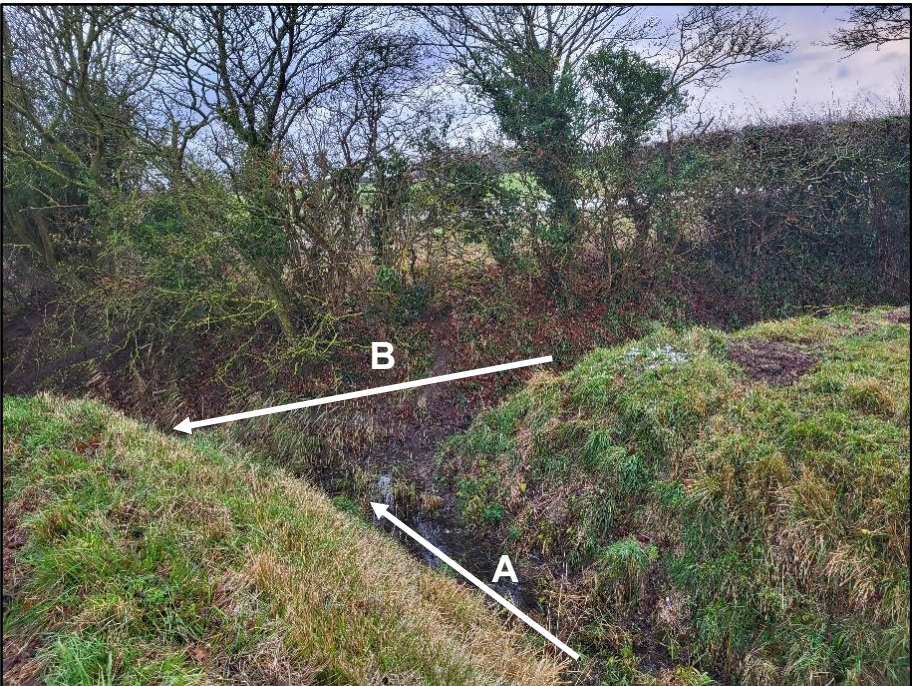
36

Location of WX36 within channel A. Channel A is an unnamed drain, with overgrown vegetation in the channel and banks composed of earth material. The left bank c.1.5m, right bank c.1.5m, width c. 1.8m. Water depth is c.0.1m in the channel. Location of WX37 within channel B. Channel B is an unnamed drain, with overgrown vegetation in the channel and banks composed of earth material. The left bank c.1.2m, right bank c.1.2m, width c. 1.3m. Water depth is c.0.08m in the channel.
