# BEACON FEN ENERGY PARK

Planning Inspectorate Reference: EN010151

Appendix 11.3 Summary of Watercourse Crossings and Photographs

Document Reference: 6.3 ES Volume 2, 6.3.83

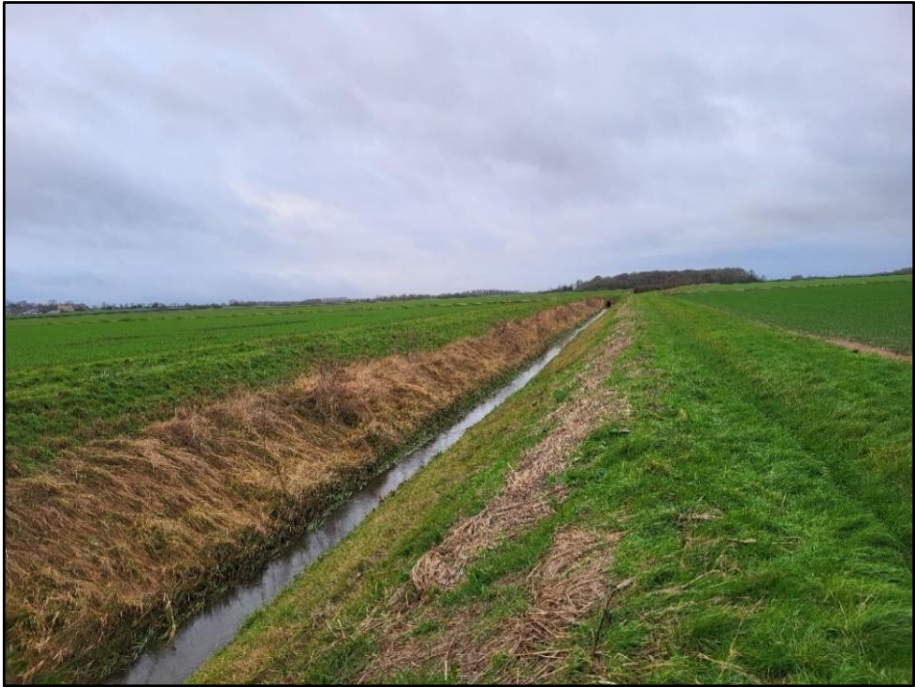
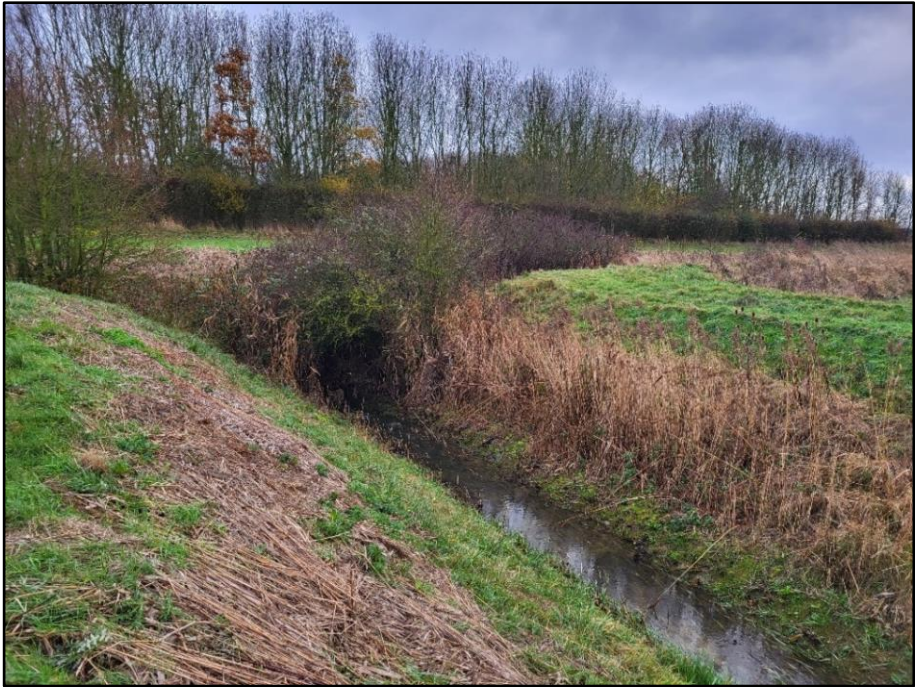
Location of WX36 within channel A. Channel A is an unnamed drain, with overgrown vegetation in the channel and banks composed of earth material. The left bank c.1.5m, right bank c.1.5m, width c. 1.8m. Water depth is c.0.1m in the channel. Location of WX37 within channel B. Channel B is an unnamed drain, with overgrown vegetation in the channel and banks composed of earth material. The left bank c.1.2m, right bank c.1.2m, width c. 1.3m. Water depth is c.0.08m in the channel.

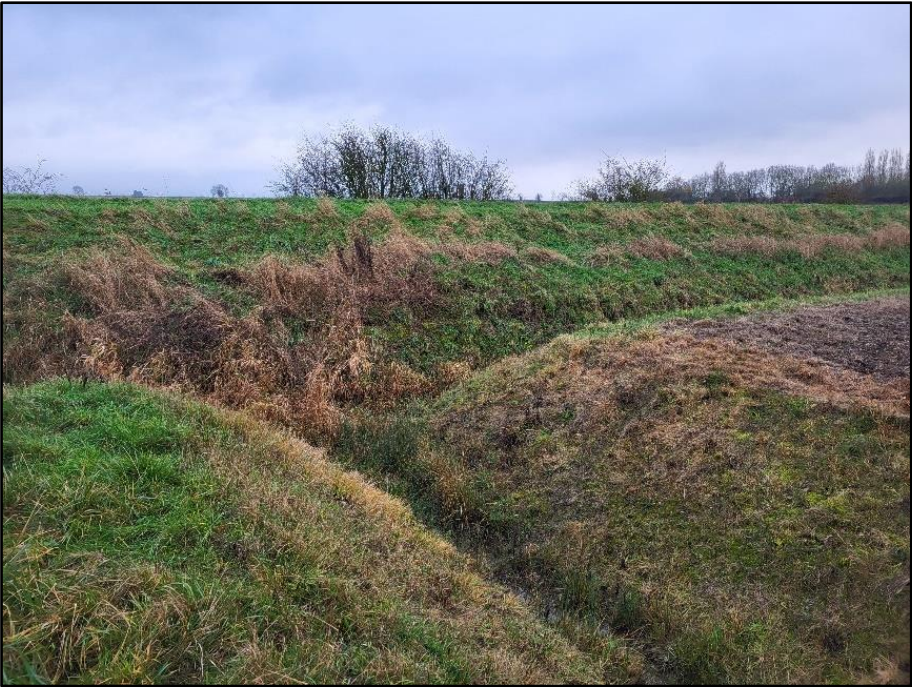
Downstream Viewpoint

**Description:** Location of WX39. Unnamed drain, with overgrown vegetation in the channel and banks composed of earth material. The left bank c.1.3m, right bank c.1.3m, width c. 2.4m. Water depth is c.0.01m in the channel.

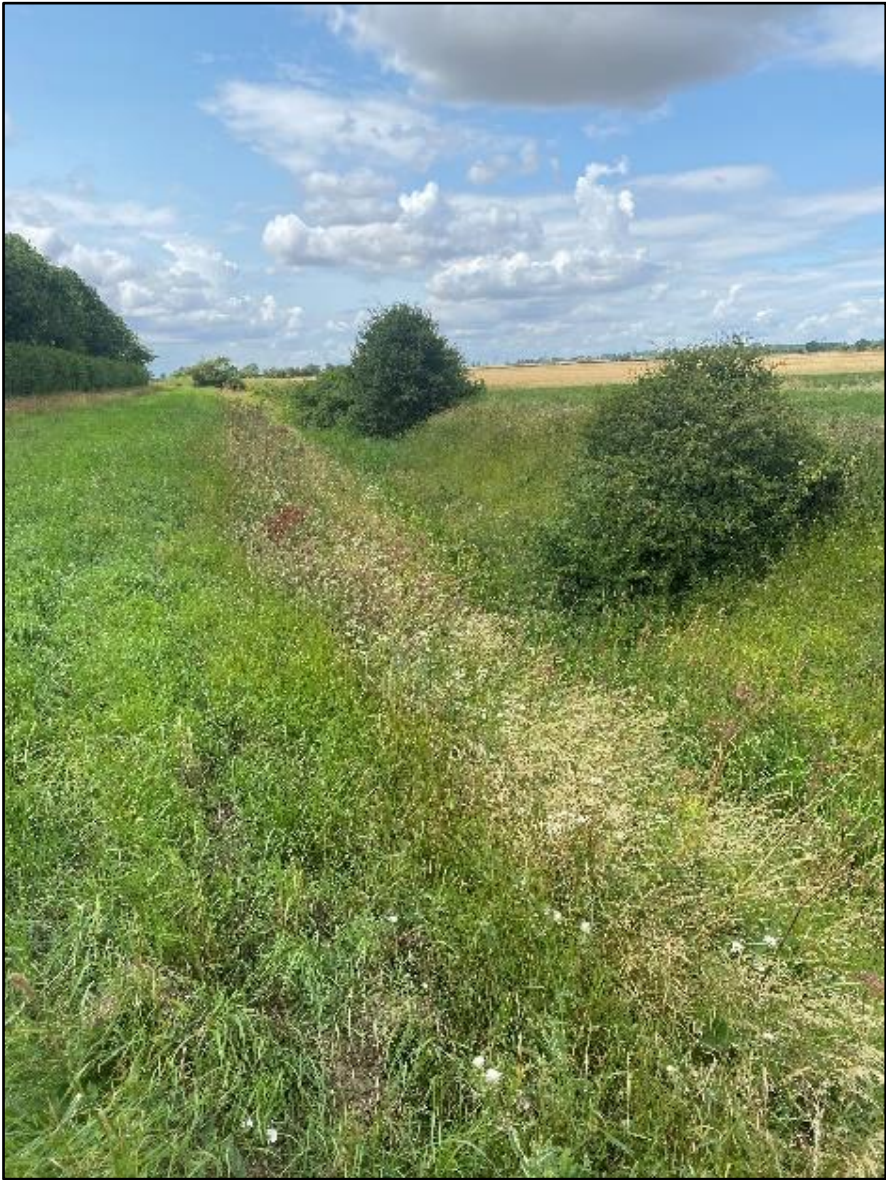
**Photograph Sheet:** 39  
**NGR:** TF 15382 47989  
**Photograph Date:** 3 December 2024  
**Description:** Location of WX41. Unnamed drain, with banks composed of earth material. The left bank c.1.8m, right bank c.1.8m, width c. 3.5m. Water depth is c.0.4m in the channel.

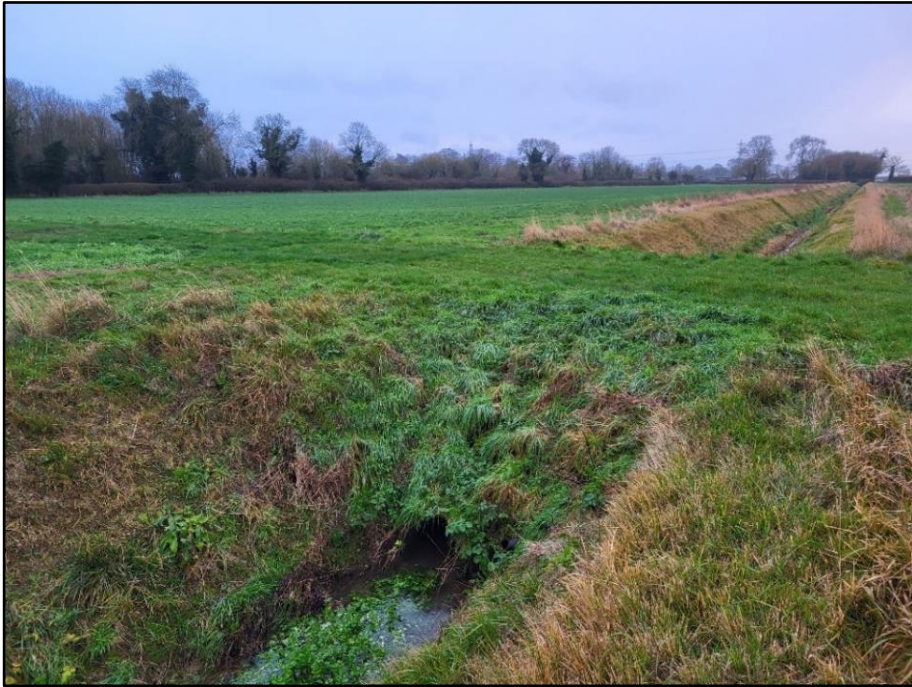
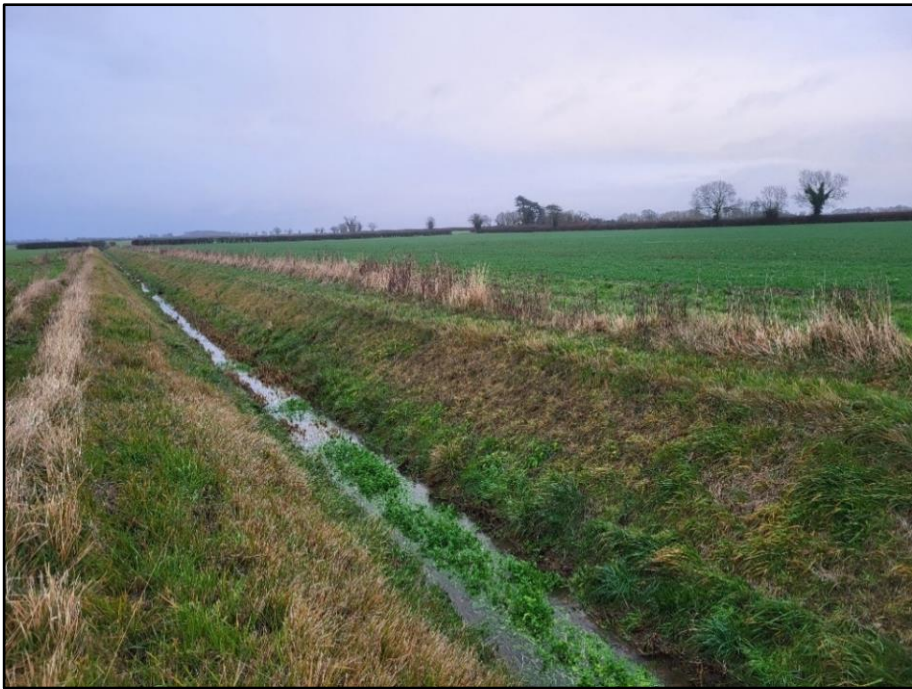
**Photograph Sheet:** 41  
**NGR:** TF 13827 46648  
**Photograph Date:** 3 December 2024

**Description:** Location of WX42. Unnamed drain, with overgrown vegetation in channel and banks composed of earth material. The left bank c.1.4m, right bank c.1.4m, width c. 2.5m. Water depth is c.0.2m in the channel.

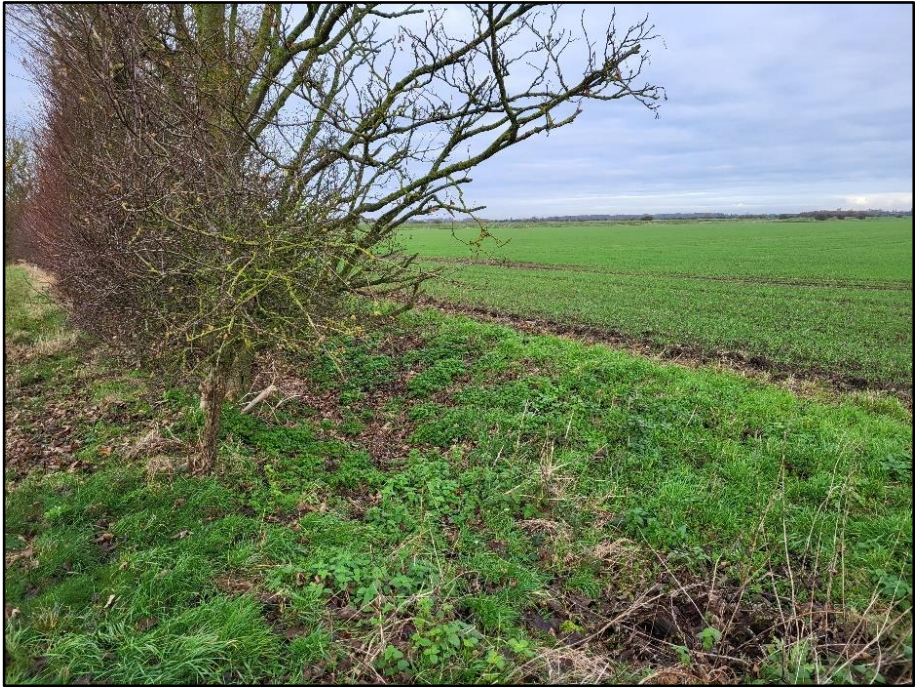
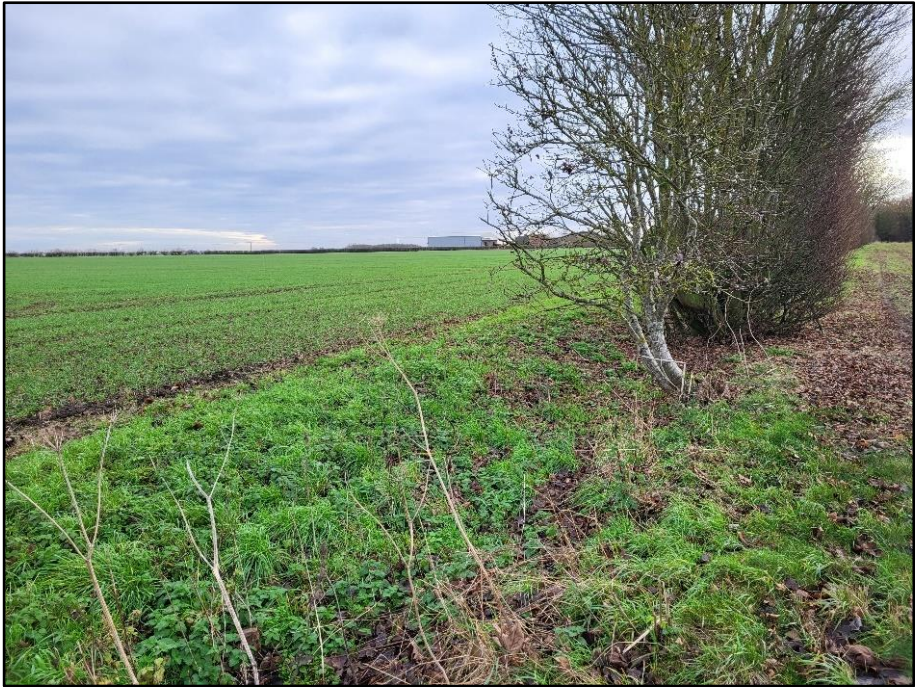
**Description:** Location of WX43. Unnamed drain, with overgrown vegetation throughout channel, left bank c.1.5m, right bank c.1.5m, width c.2m. No water is present in the channel.

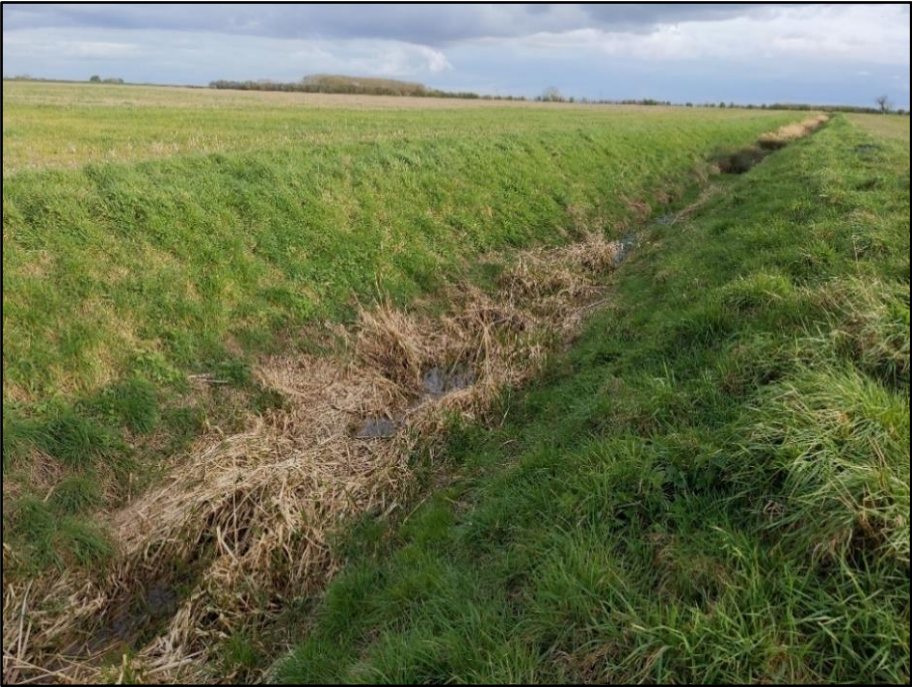
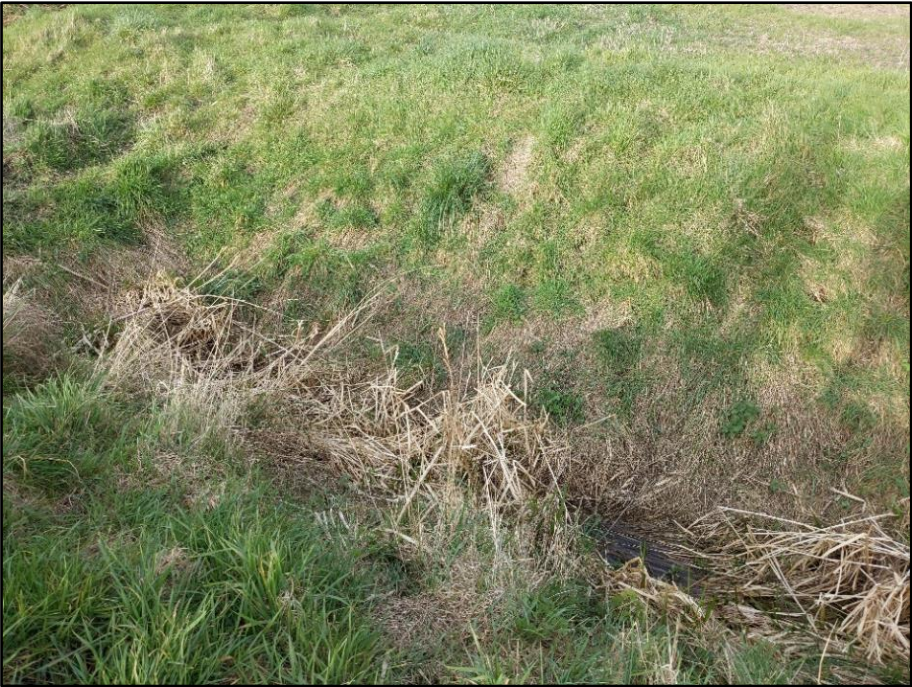
**Photograph Sheet:** 44  
**NGR:** TF 15525 48004  
**Photograph Date:** 19 March 2024

**Description:** Location of WX45. Unnamed drain, with overgrown vegetation in channel and banks composed of earth material. The left bank c.2.0m, right bank c.2.0m, width c. 3.0m. Water depth is c.0.1m in the channel.

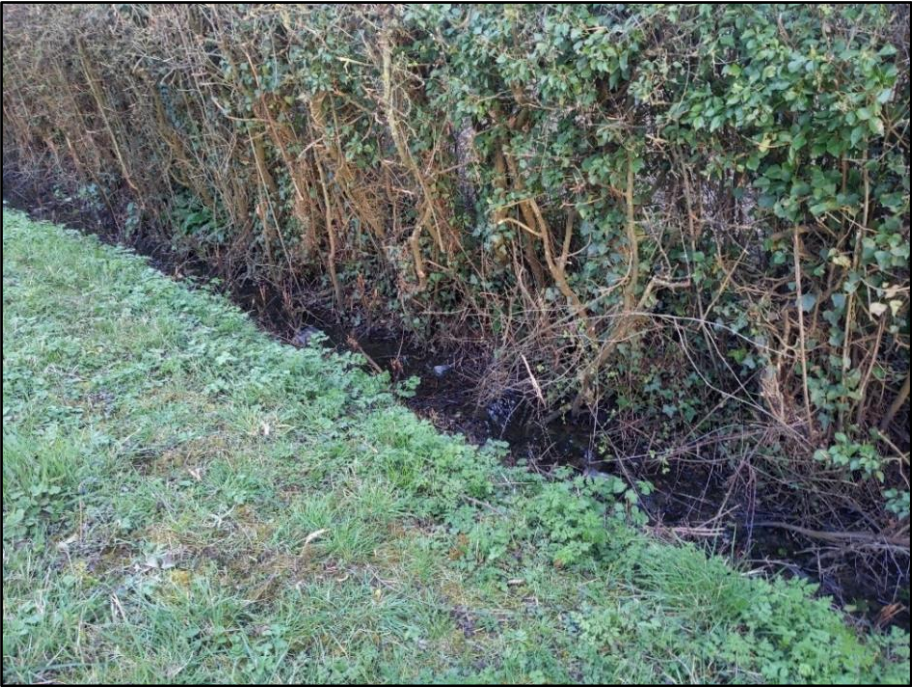
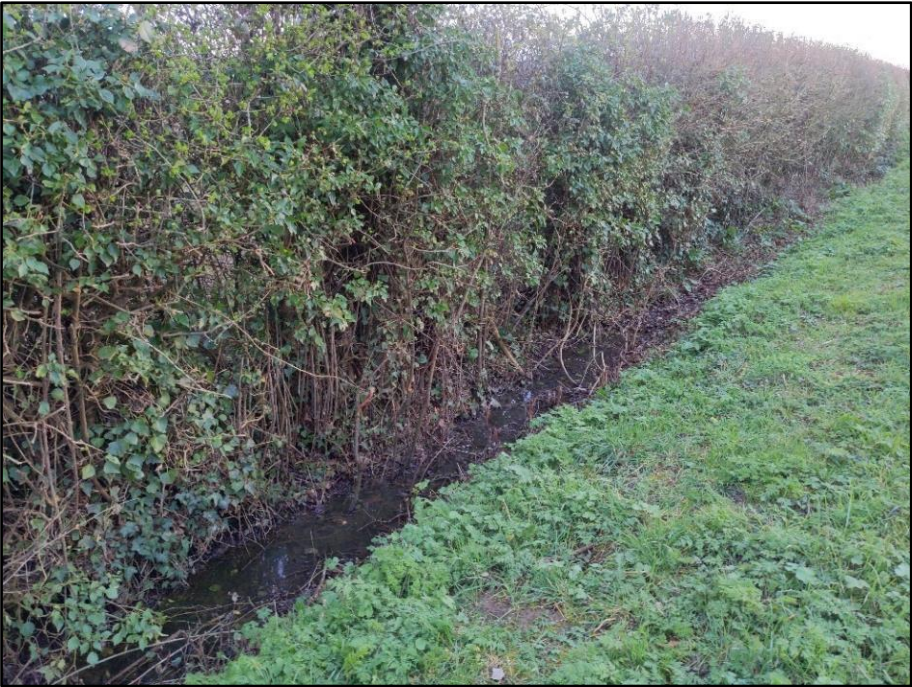
**Photograph Sheet:** 46  
**NGR:** TF 15022 46977  
**Photograph Date:** 19 March 2024

**Description:** Location of WX47. Unnamed drain, with hedgerow along bank and banks composed of earth material. The left bank c.0.8m, right bank c.0.5m, width c. 0.8m. Water Depth is c. 0.1m in channel with a silty substrate.

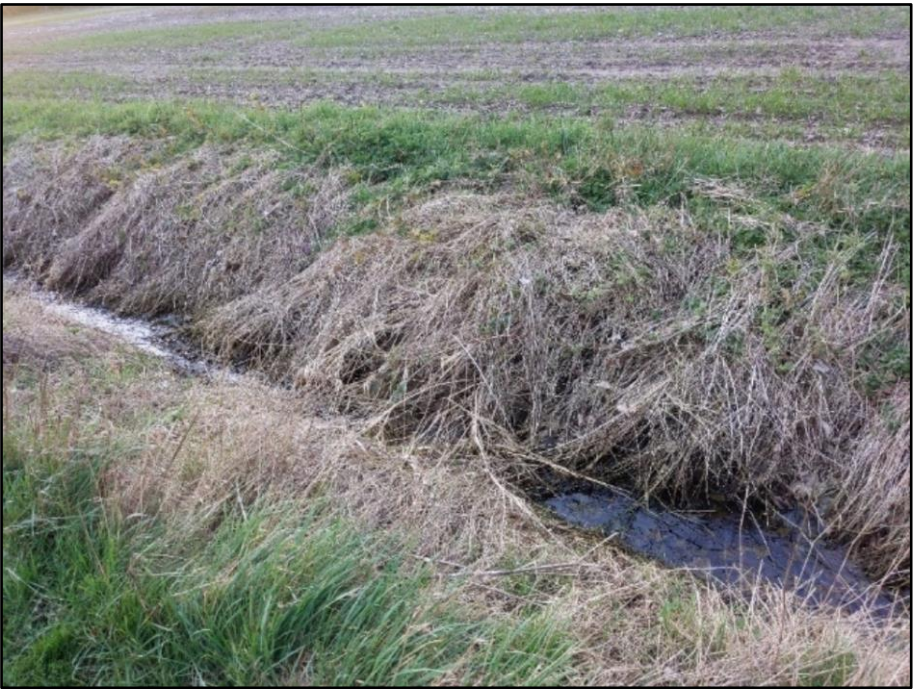
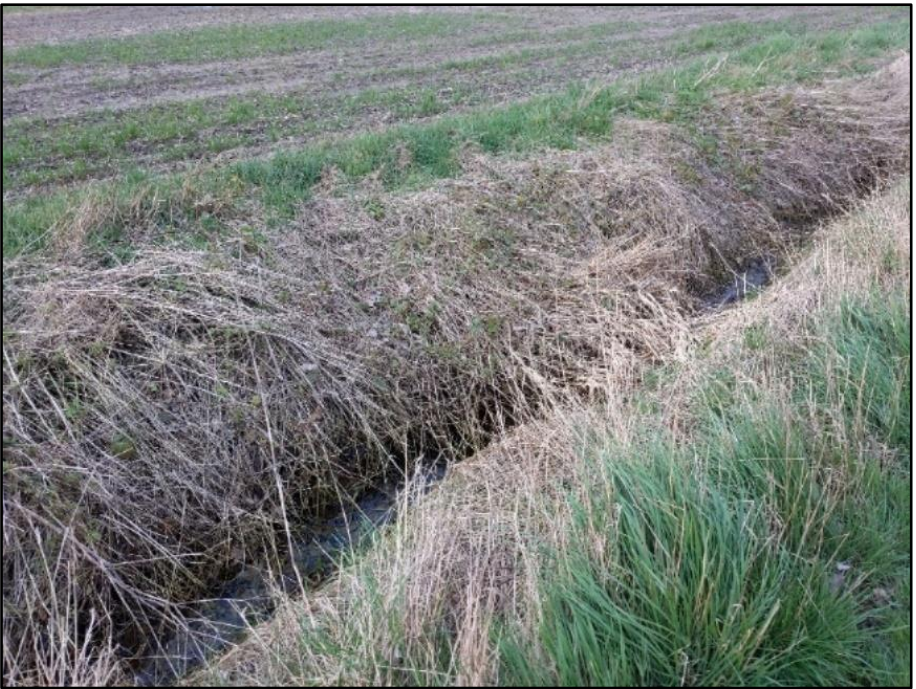
**Photograph Sheet:** 47  
**NGR:** TF 15425 46490  
**Photograph Date:** 19 March 2024  
**Description:** Location of WX48. Unnamed drain, with banks composed of earth material. The left bank c.0.8m, right bank c.0.8m, width c. 1.2m. Water Depth is c. 0.2m in channel with a silty substrate.

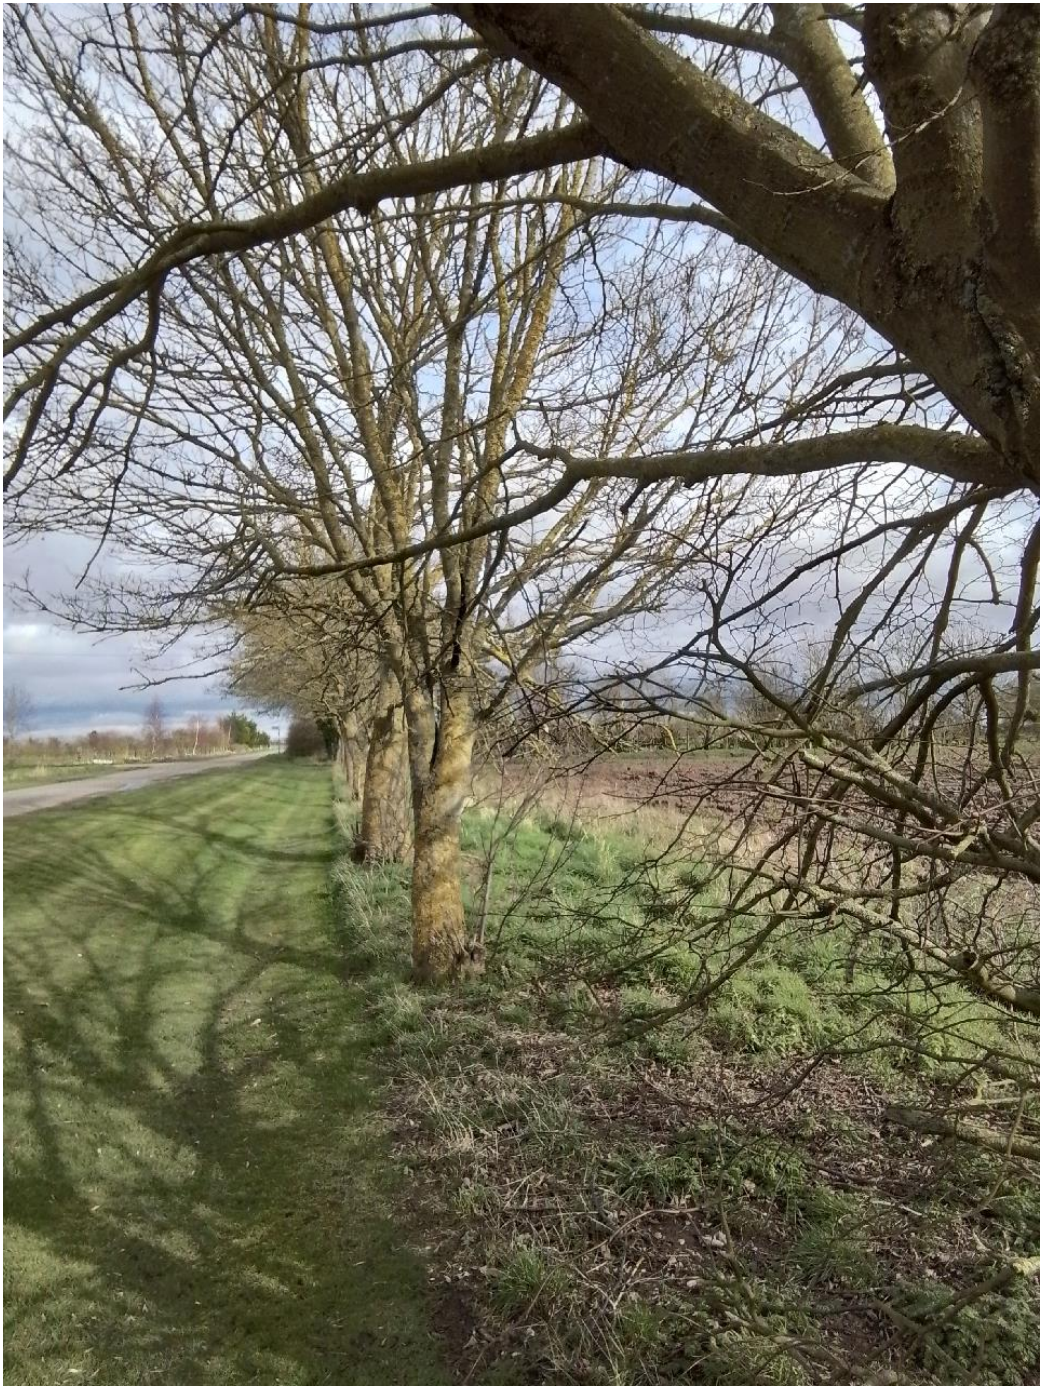
**Photograph Sheet:** 48  
**NGR:** TF 15975 45286  
**Photograph Date:** 19 March 2024  
**Description:** Location of WX50. Unnamed drain, with banks composed of earth material. The left bank c.0.8m, right bank c.0.8m, width c. 1.2m. Water Depth is c. 0.2m in channel with a silty substrate.

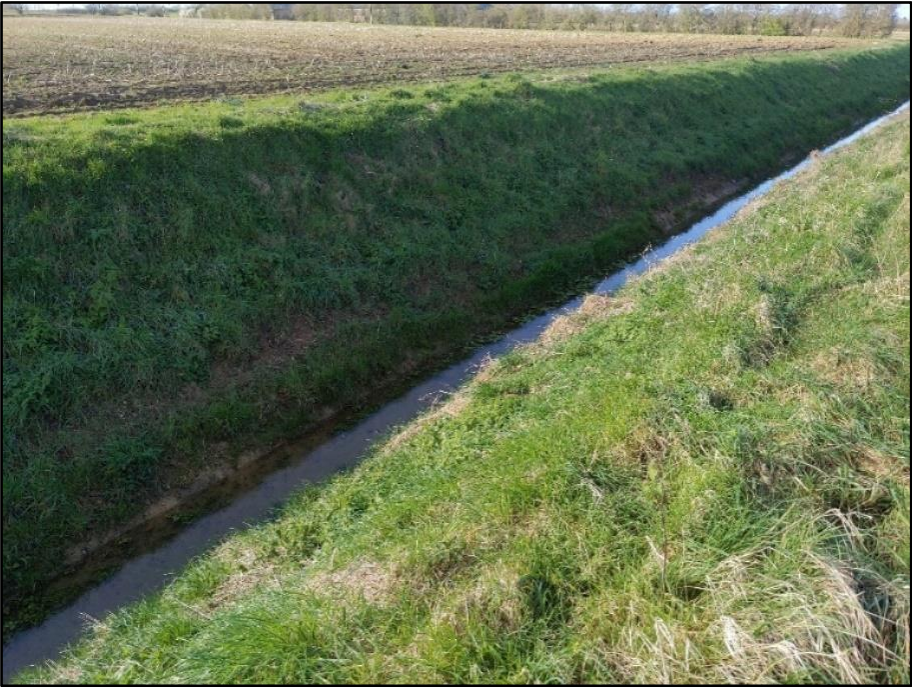
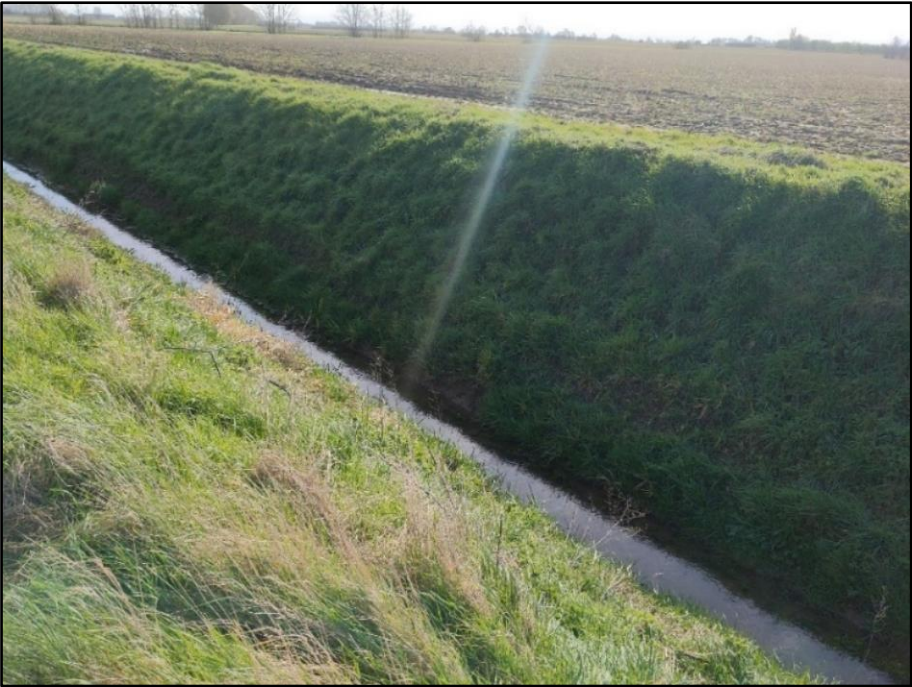
50

Location of WX52. Unnamed drain, with banks composed of earth material. The left bank c.1.5m, right bank c. 1.5m, width c. 3.0m. Water Depth is c. 0.25m in channel with a silty substrate.

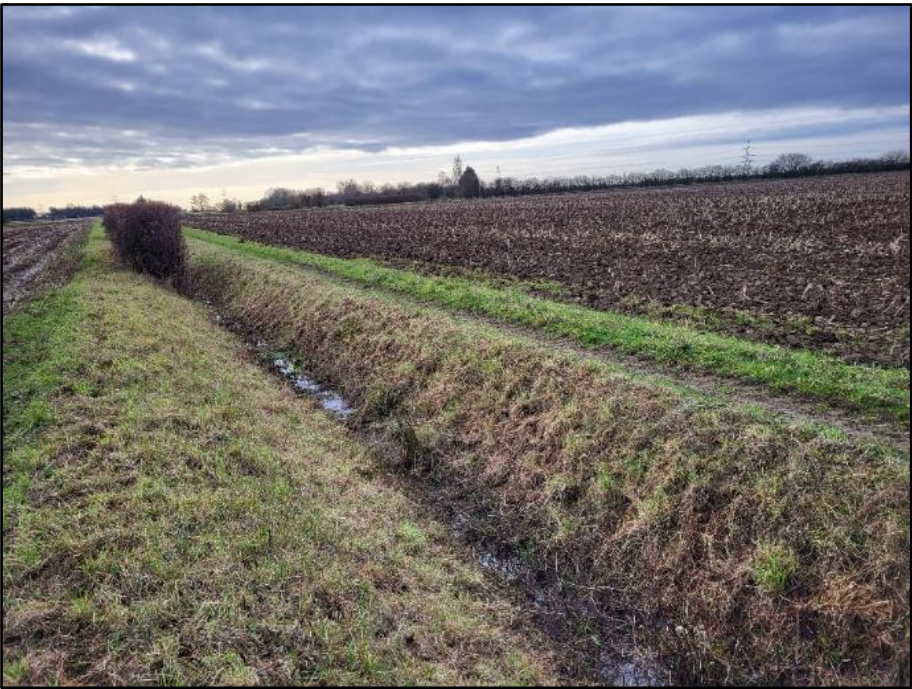
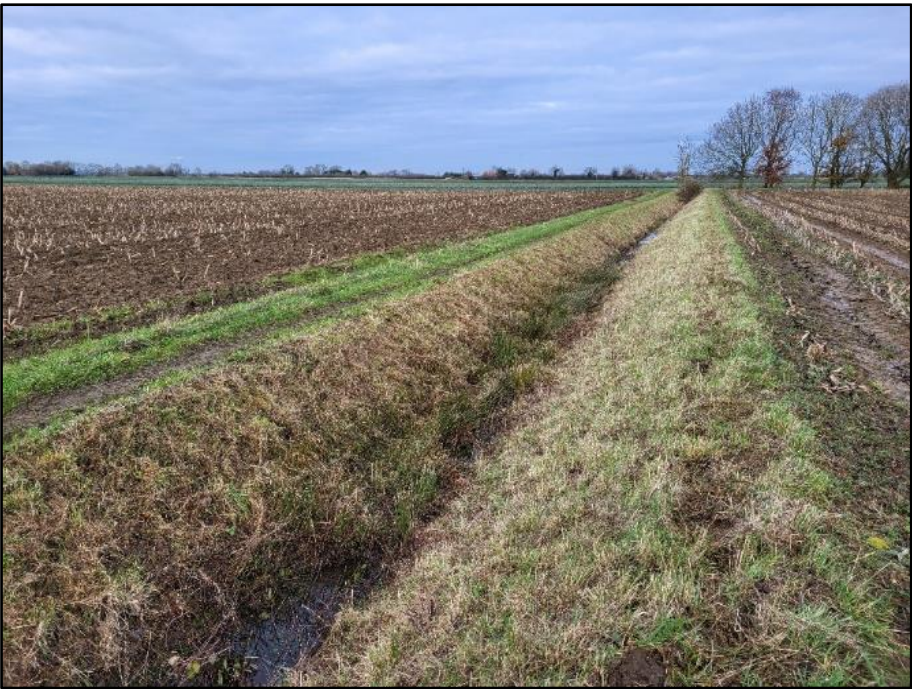
**Photograph Sheet:** 52  
**NGR:** TF 16442 44783  
**Photograph Date:** 3 December 2024

**Description:** Location of WX54. Unnamed drain, with overgrown vegetation throughout channel and banks composed of earth material. The left bank c.1.0m, right bank c. 1.0m, width c. 1.5m. Water Depth is c. 0.02m in channel with a silty substrate.

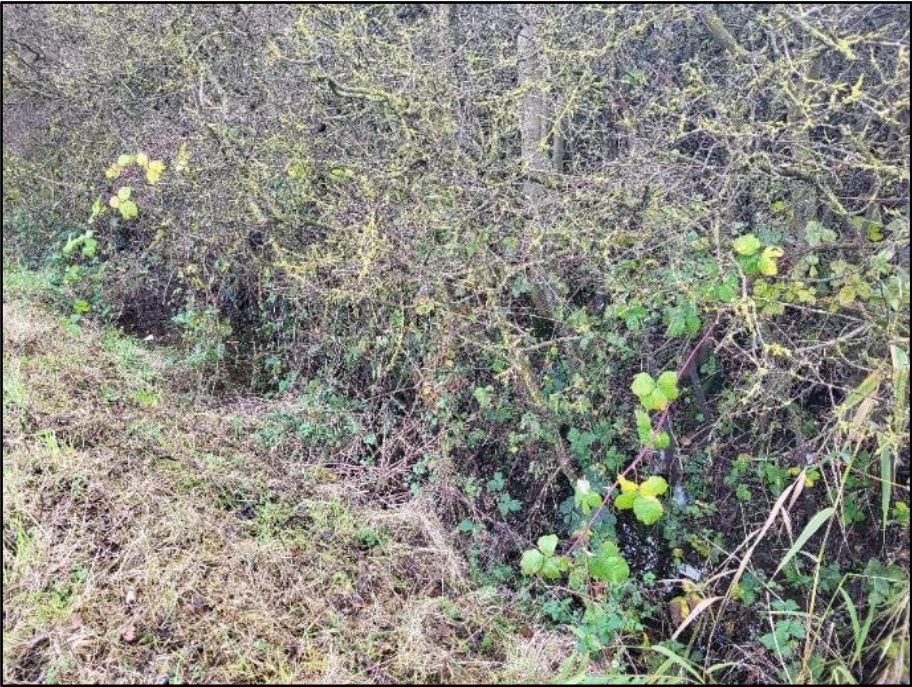
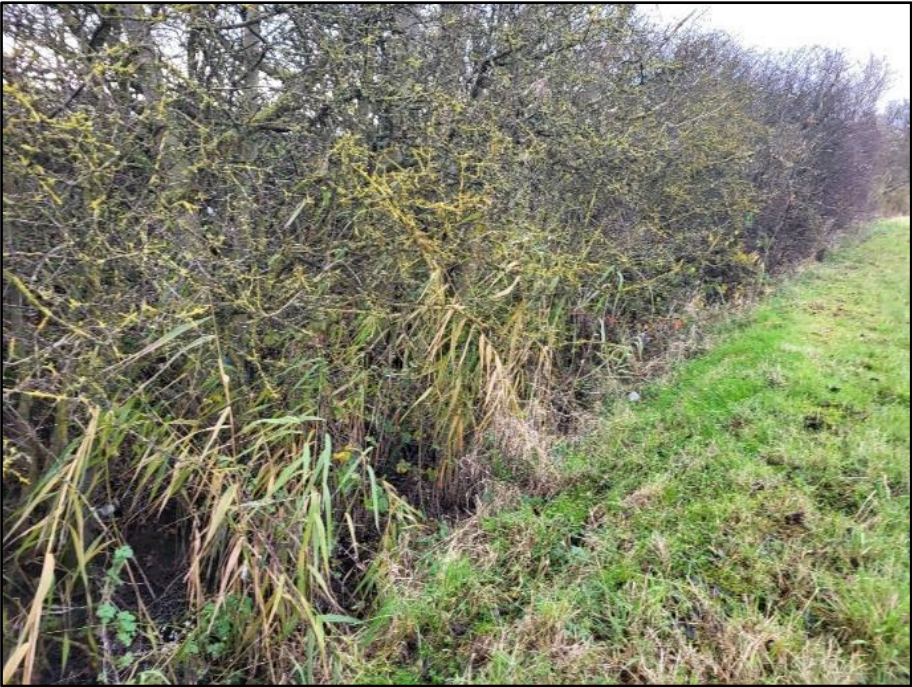
**Photograph Sheet:** 54  
**NGR:** TF 16798 44032  
**Photograph Date:** 3 December 2024

**Description:** Location of WX56. Unnamed drain, with overgrown vegetation throughout channel and banks composed of earth material. The left bank c.0.8m, right bank c. 1.4m, width c. 2.0m. No water present in channel.

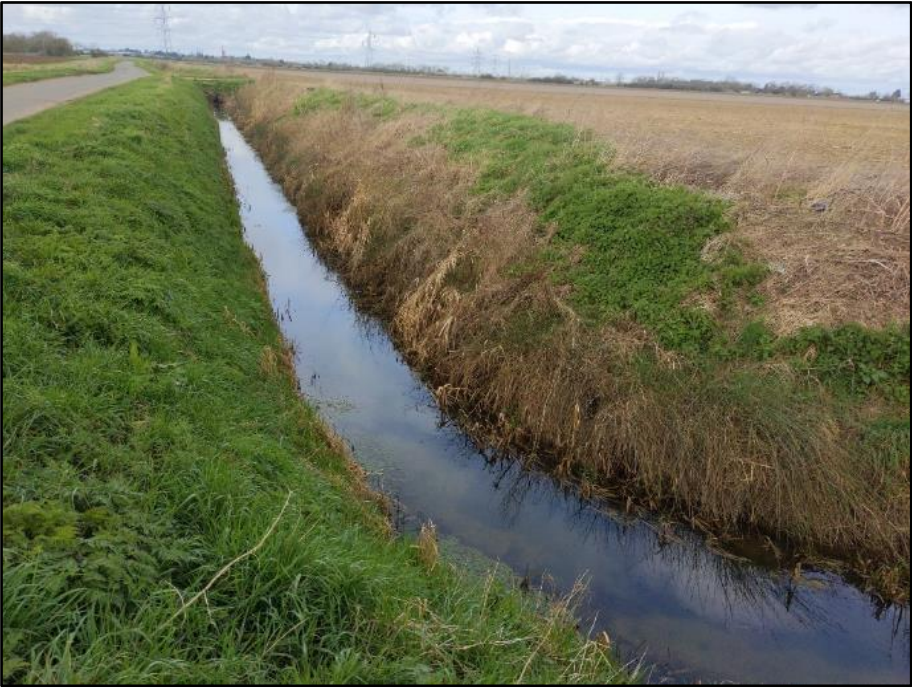
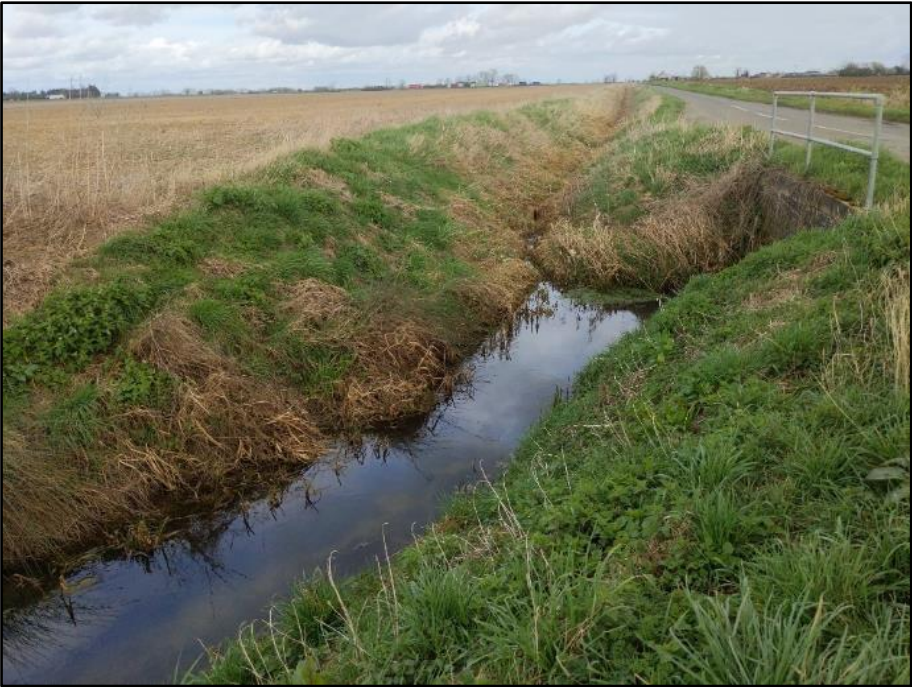
**Photograph Sheet:** 56  
**NGR:** TF 16720 43221  
**Photograph Date:** 19 March 2024

**Description:** Location of WX58. Unnamed drain, with banks composed of earth material. The left bank c.1.5m, right bank c. 1.5m, width c. 2.5m. The water depth is c. 0.7m.

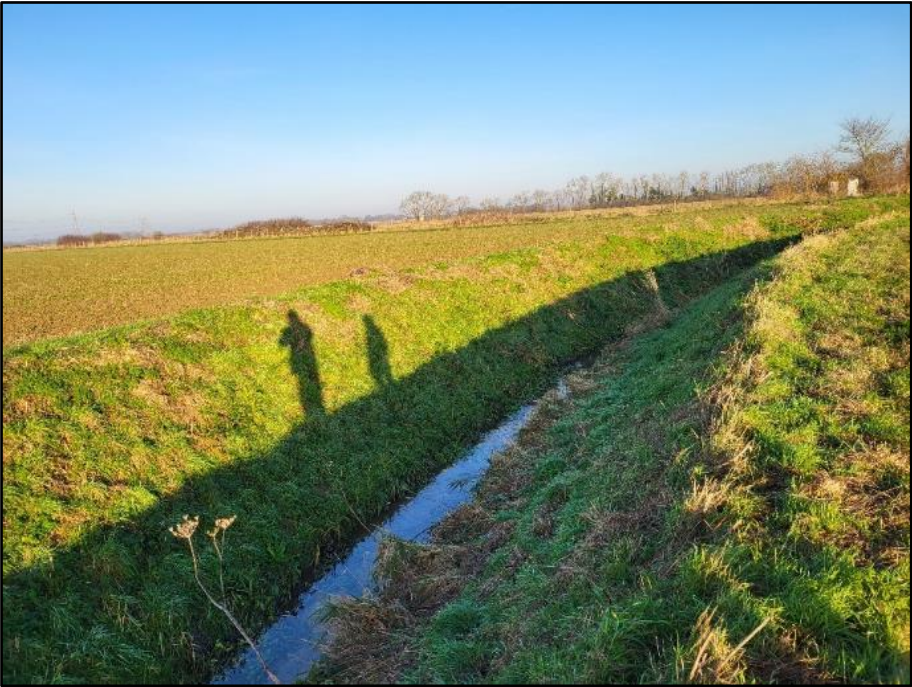
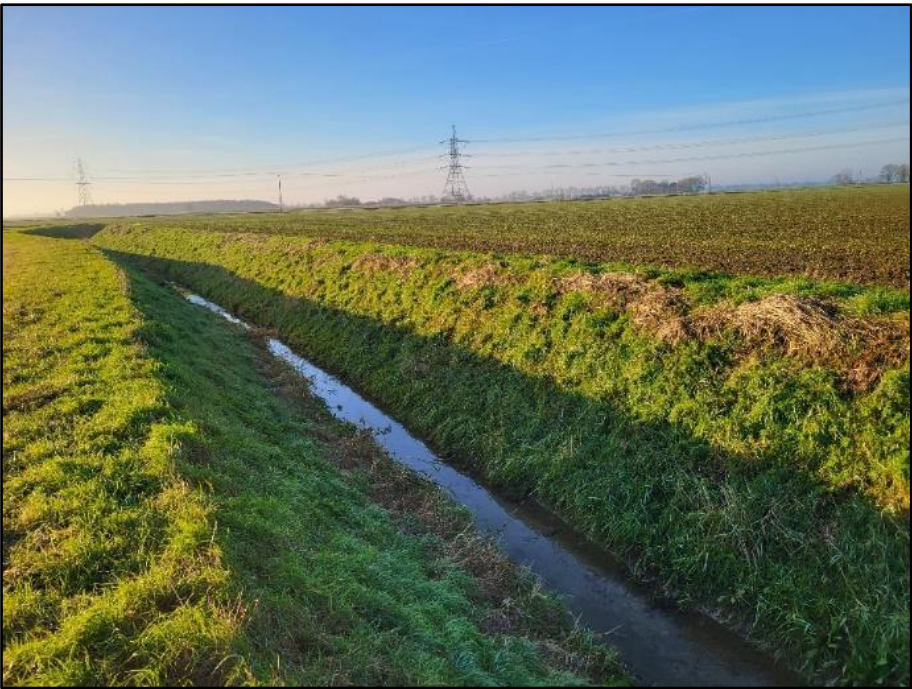
**Photograph Sheet:** 58  
**NGR:** TF 16870 42888  
**Photograph Date:** 3 December 2024  
**Description:** Location of WX60. Unnamed drain, with banks composed of silt and earth material. The left bank c.2.0m, right bank c. 2.0m, width c3.0m. The water depth is c0.4m and is culverted downstream.

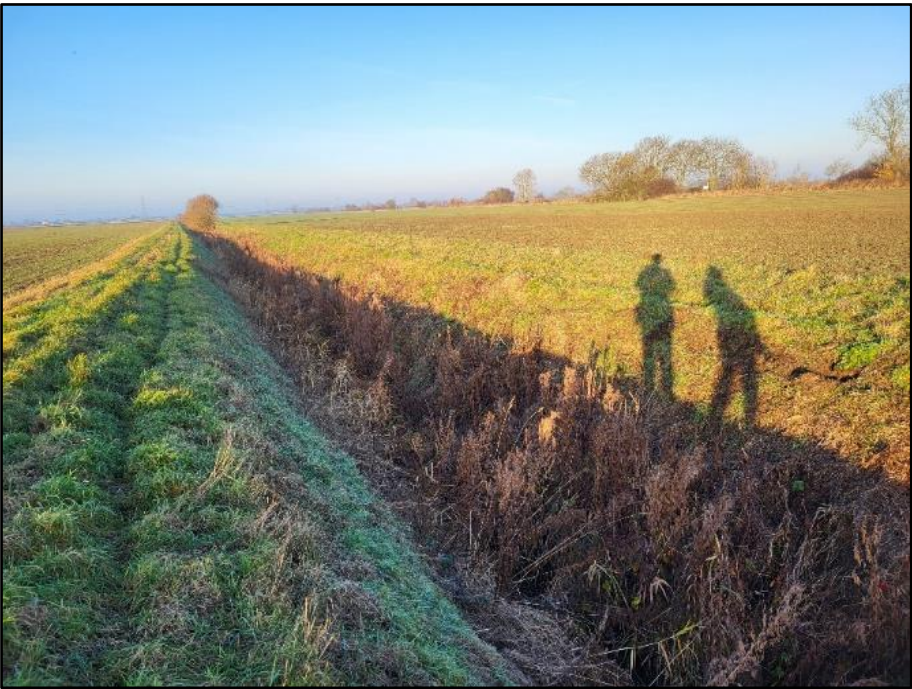
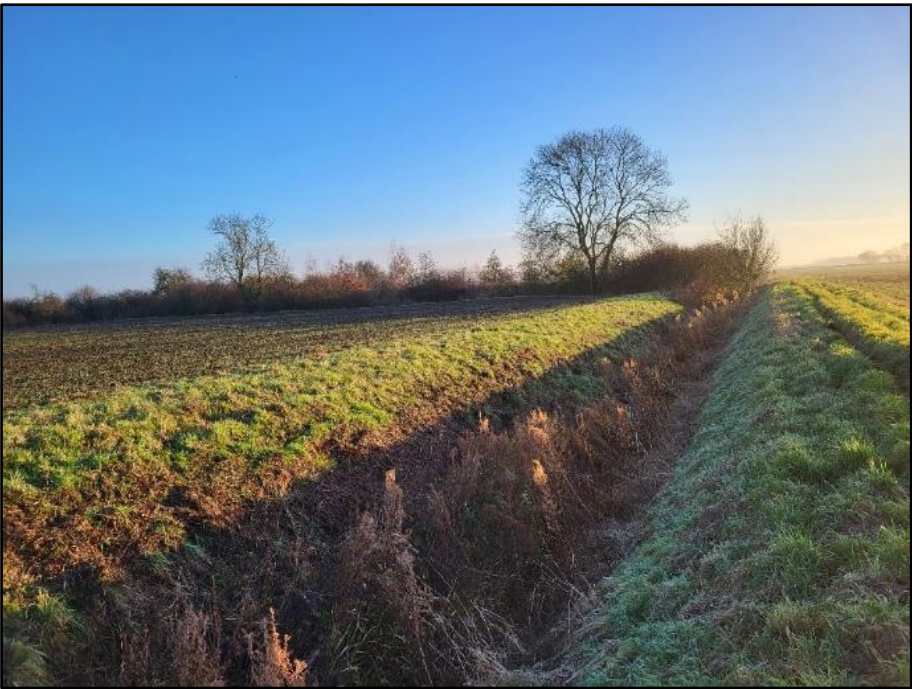
Photograph Sheet: 60  
NGR: TF 18234 42499  
Photograph Date: 3 December 2024

Description: Location of WX62. Unnamed drain, with banks composed of silt and earth material. The left bank c.2.0m, right bank c. 2.0m, width c3.0m. The water depth is c0.06m.

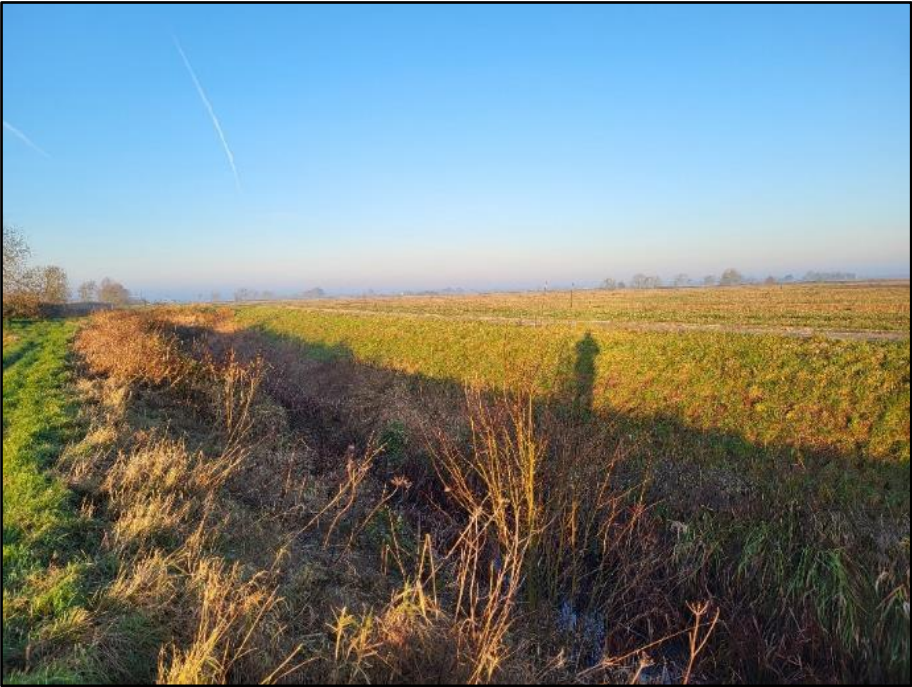
**Photograph Sheet:** 62  
**NGR:** TF 19449 42105  
**Photograph Date:** 3 December 2024  
**Description:** Location of WX64. Unnamed drain, with banks composed of silt and earth material. The left bank c.3.0m, right bank c.3.0m, width c4.5m. The water depth is c0.2m.

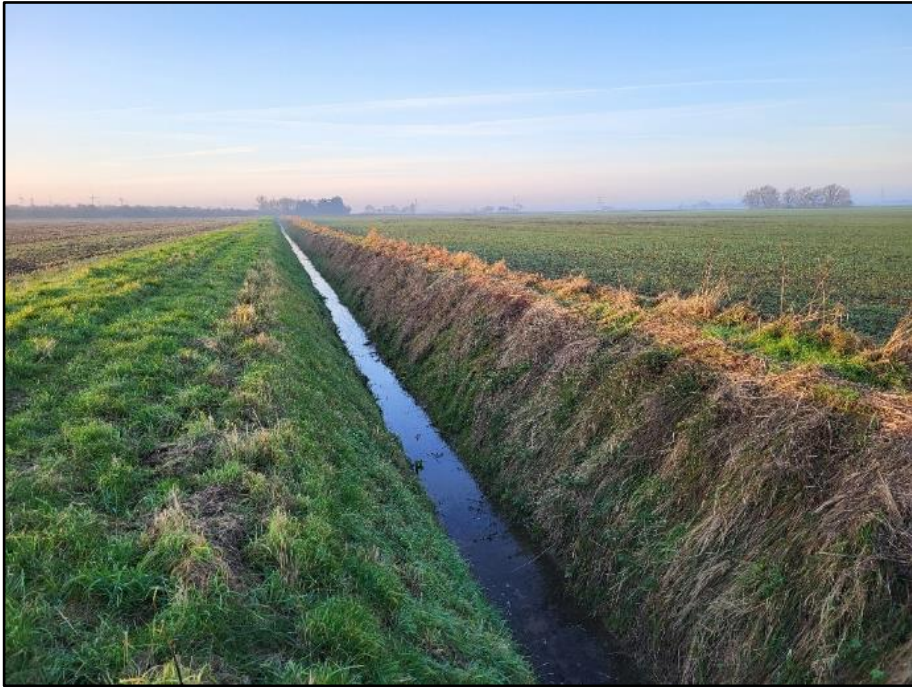
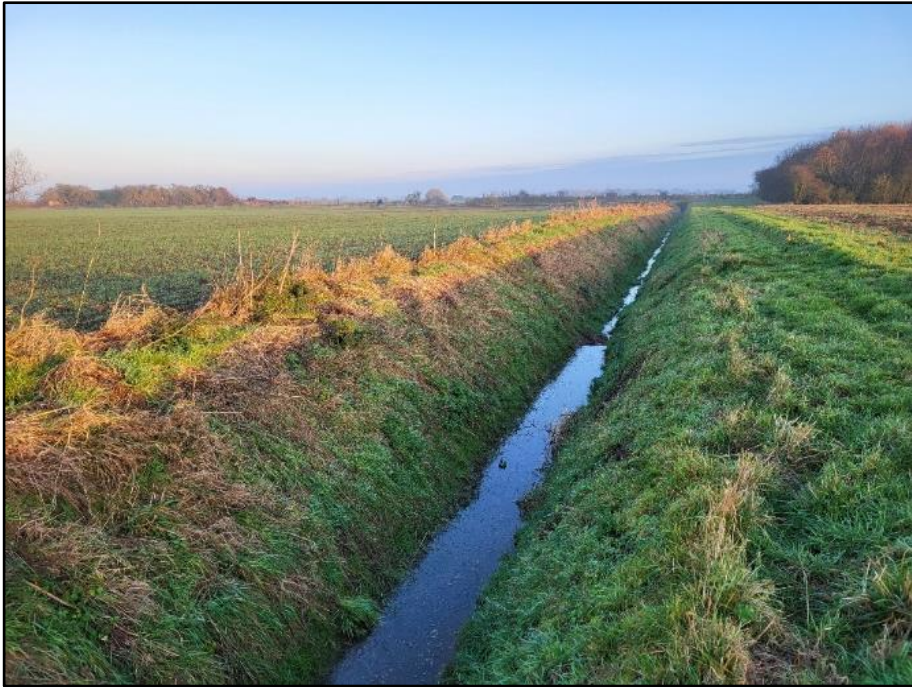
**Photograph Sheet:** 63  
**NGR:** TF 19634 41927  
**Photograph Date:** 3 December 2024  
**Description:** Location of WX65. Unnamed drain, with banks composed of silt and earth material. The left bank c.1.5m, right bank c.1.5m, width c2.0m. The water depth is c0.1m.

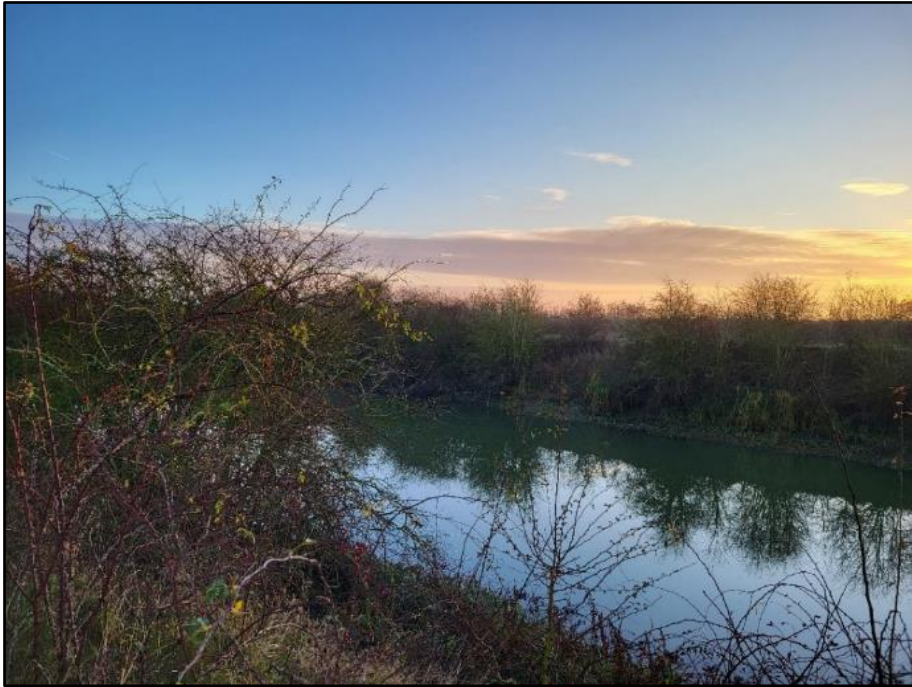
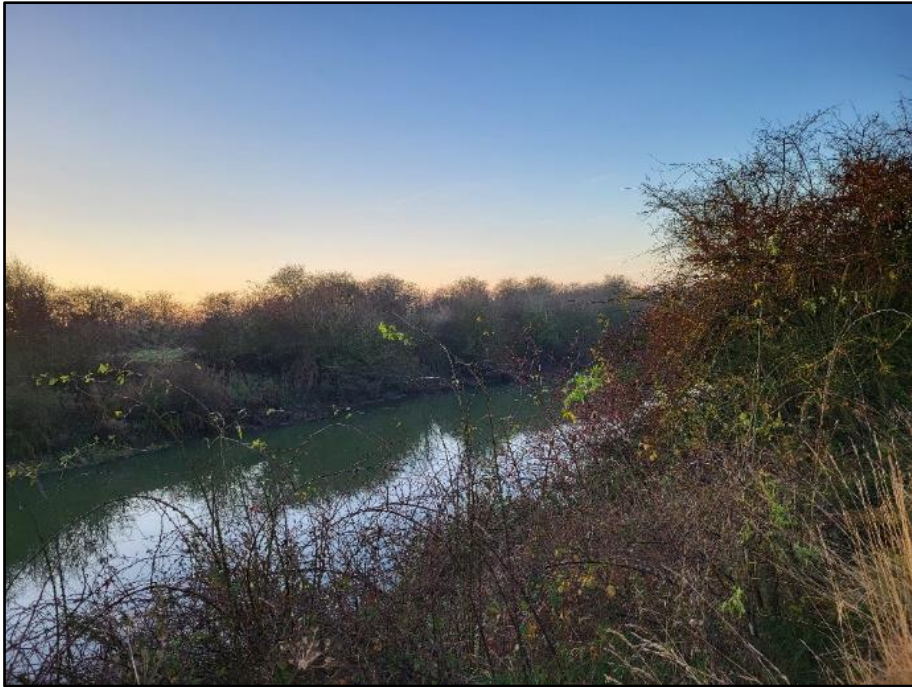
**Photograph Sheet:** 64  
**NGR:** TF 19827 41738  
**Photograph Date:** 3 December 2024  
**Description:** Location of WX66. South Forty Foot Drain, with banks composed of silt and earth material. The left bank is c.6.0m, right bank c.6.0m, width c10.0m.
