# BEACON FEN ENERGY PARK

Planning Inspectorate Reference: EN010151

Appendix 11.3 Summary of Watercourse Crossings and Photographs

Document Reference: 6.3 ES Volume 2, 6.3.83

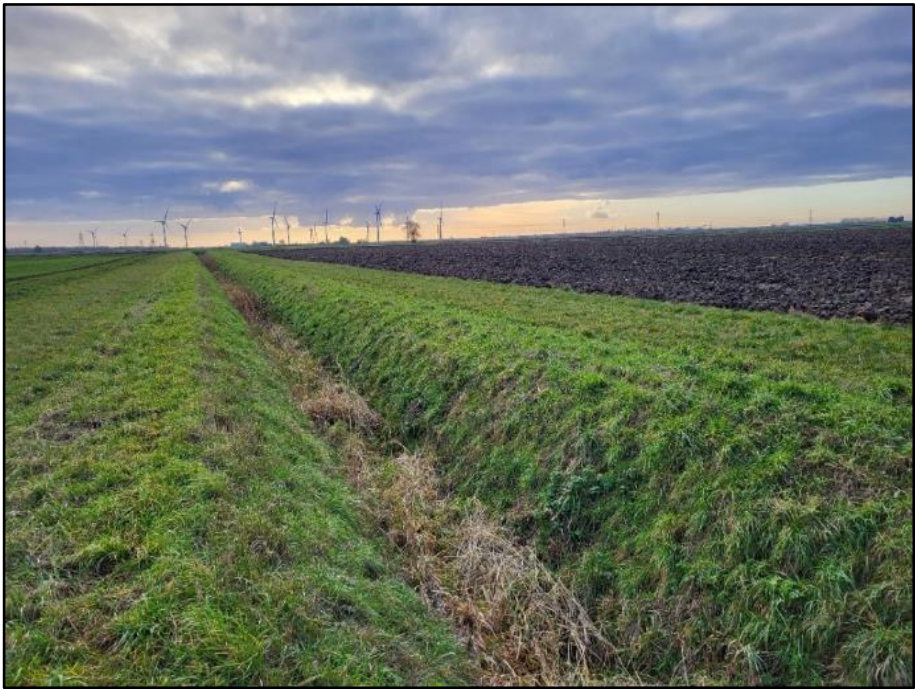
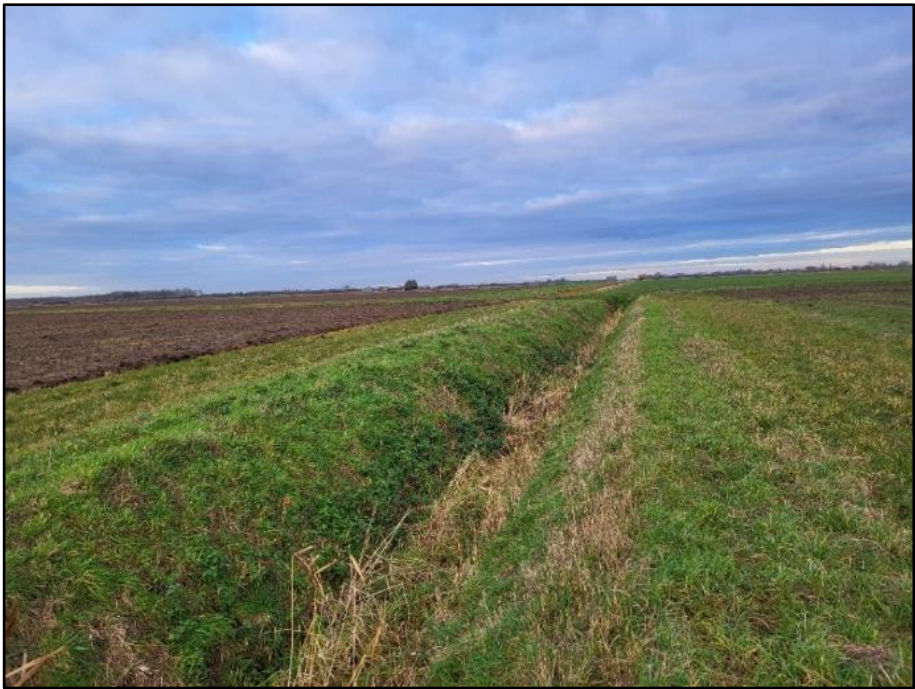
**Photograph Sheet:** 64  
**NGR:** TF 19827 41738  
**Photograph Date:** 3 December 2024  
**Description:** Location of WX66. South Forty Foot Drain, with banks composed of silt and earth material. The left bank is c.6.0m, right bank c.6.0m, width c10.0m.

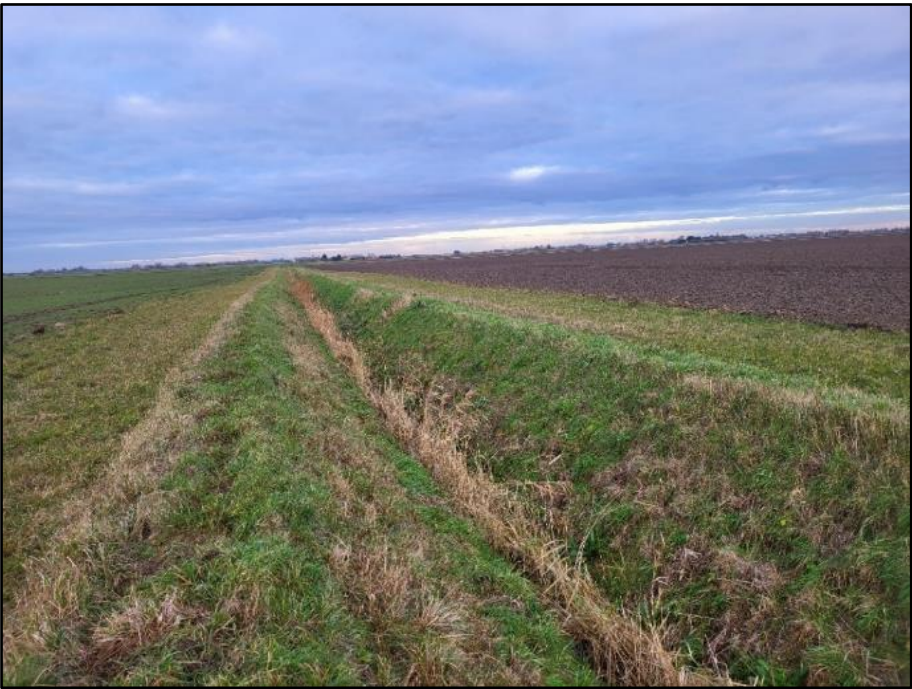
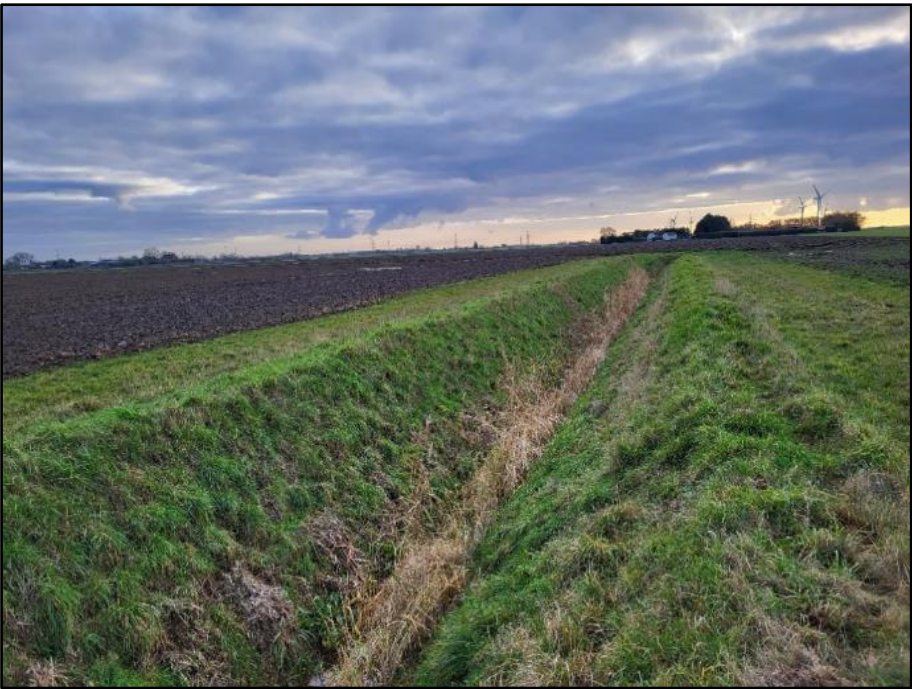
Photograph Sheet: 66  
NGR: TF 20528 40395  
Photograph Date: 3 December 2024

Description: Location of WX68. Unnamed drain, with banks composed of silt and earth material. The left bank c.2.0m, right bank c.2.0m, width c3.5m. Water depth of c.0.2m in the channel.

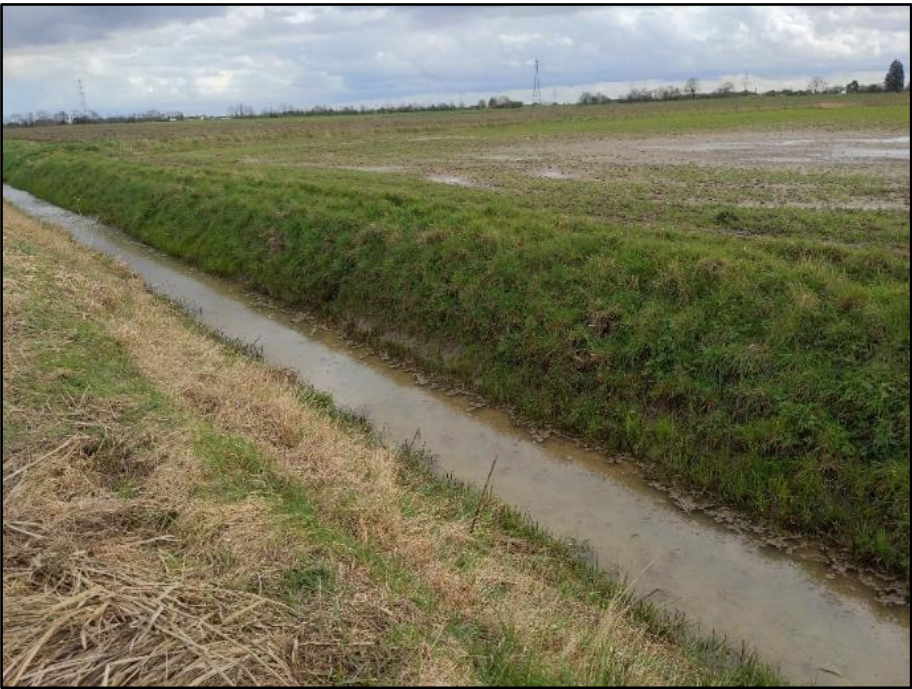
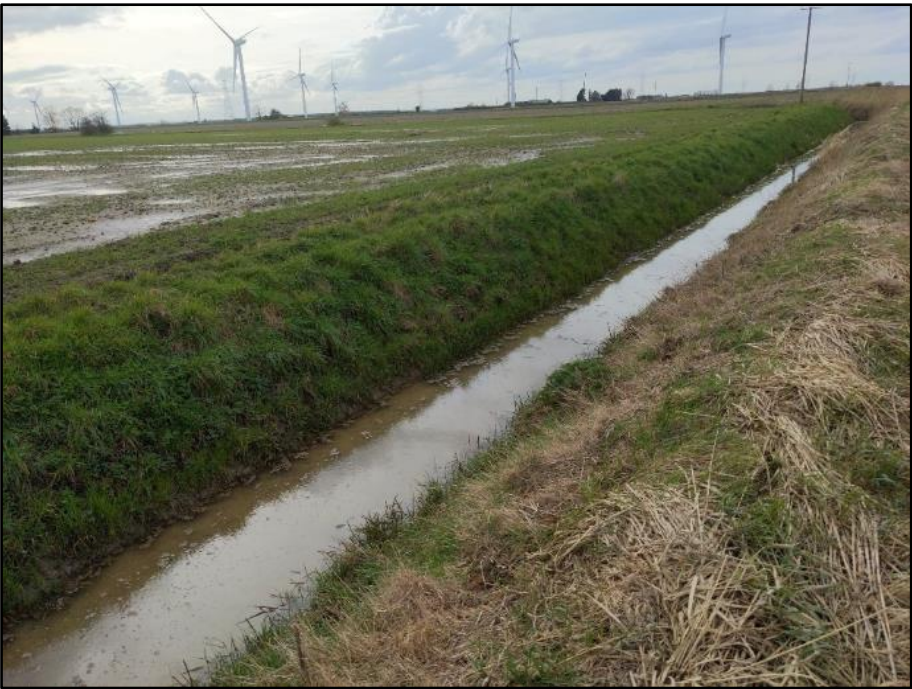
**Photograph Sheet:** 68  
**NGR:** TF 20364 39432  
**Photograph Date:** 19 March 2024  
**Description:** Location of WX70. Unnamed drain, with banks composed of silt and earth material. The left bank c.2.0m, right bank c.2.0m, width c2.5m. Water depth of c.0.3m in the channel.

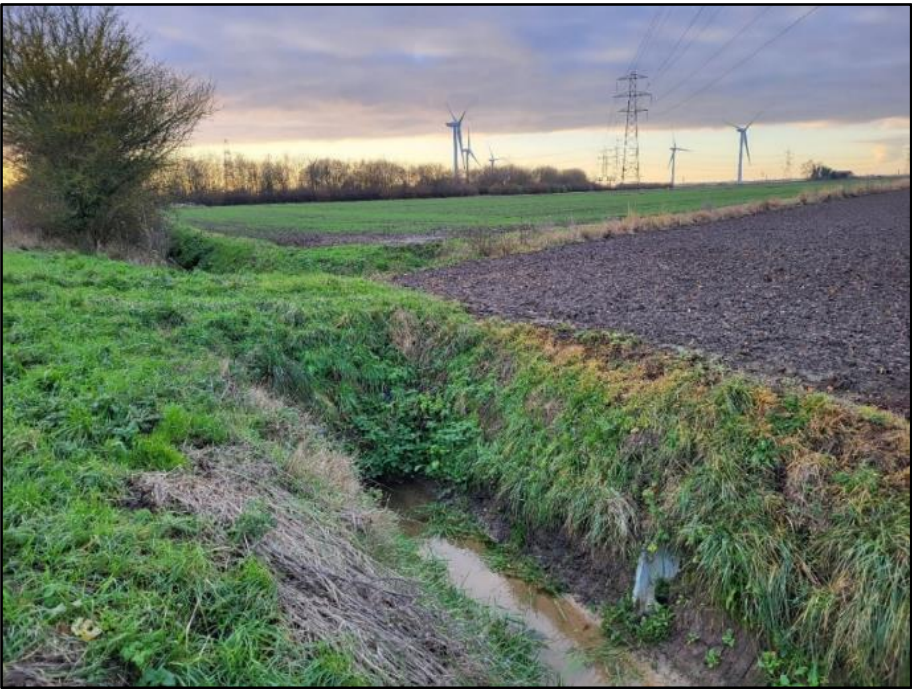
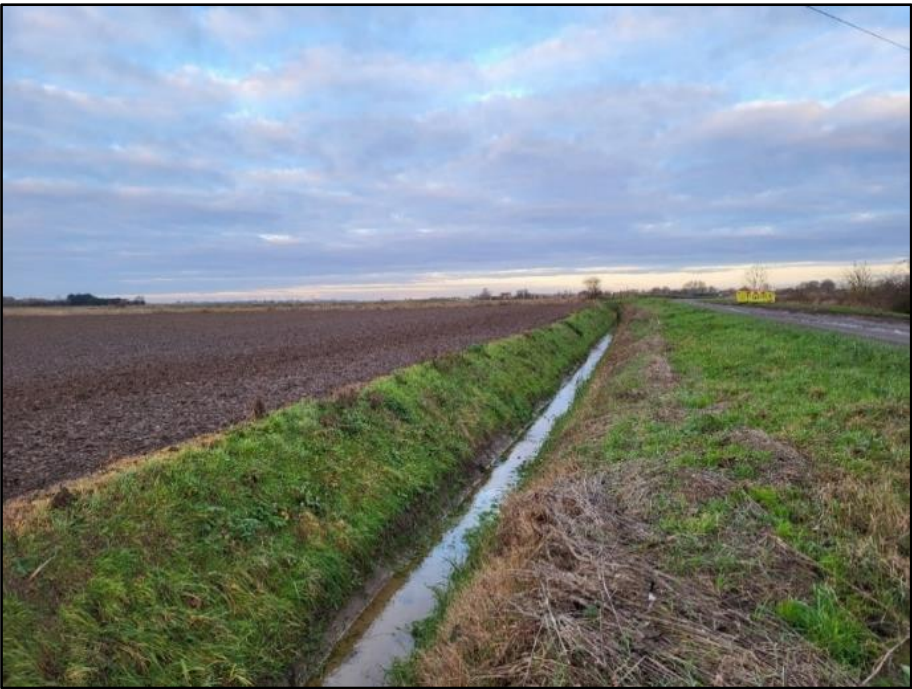
Photograph Sheet: 70  
NGR: TF 20170 38941  
Photograph Date: 3 December 2024

Description: Location of WX72. Unnamed drain, with banks composed of earth material and a silty and earth channel substrate. The left bank c.1.2m, right bank c.1.3m, width c.2.0m. Water depth of c.0.08m in the channel and culverted.

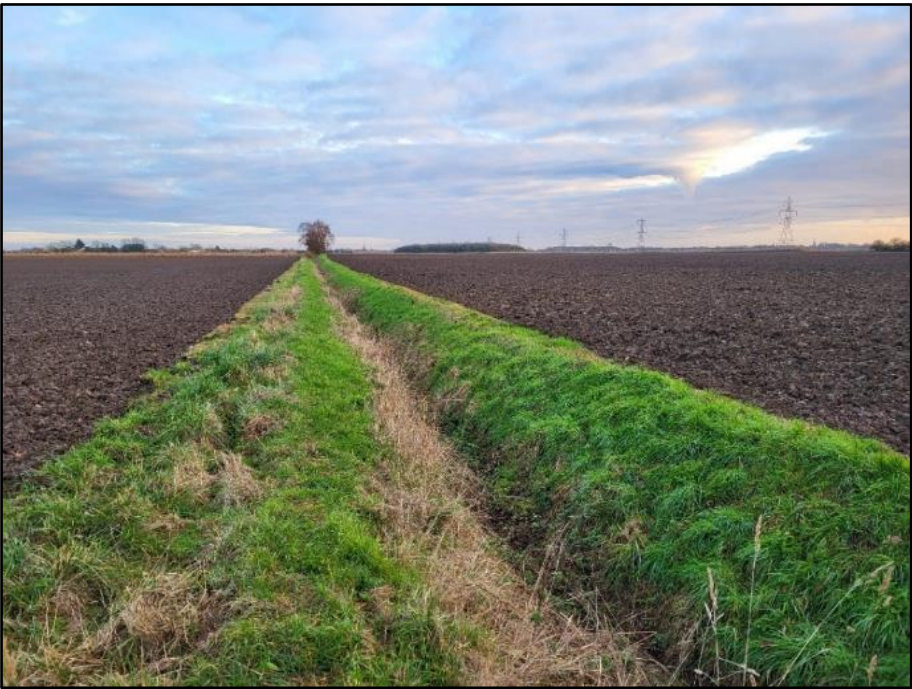
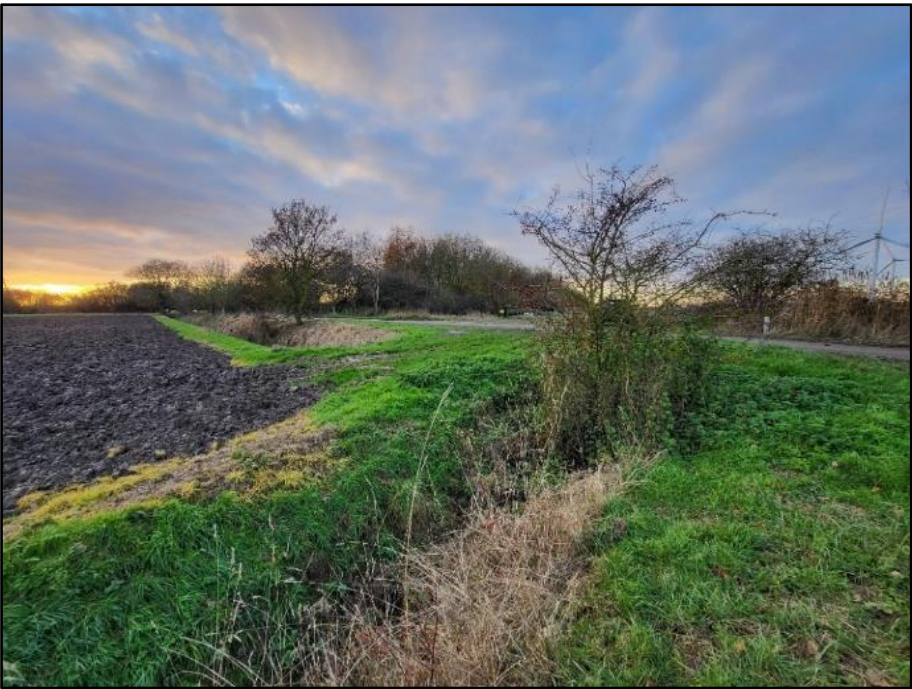
Photograph Sheet: 72  
NGR: TF 20063 38834  
Photograph Date: 3 December 2024

Description: Location of WX74. Unnamed drain, with vegetation throughout the channel and banks composed of earth material. The left bank c.1.0m, right bank c.1.0m, width c.1.5m. No water present in channel.

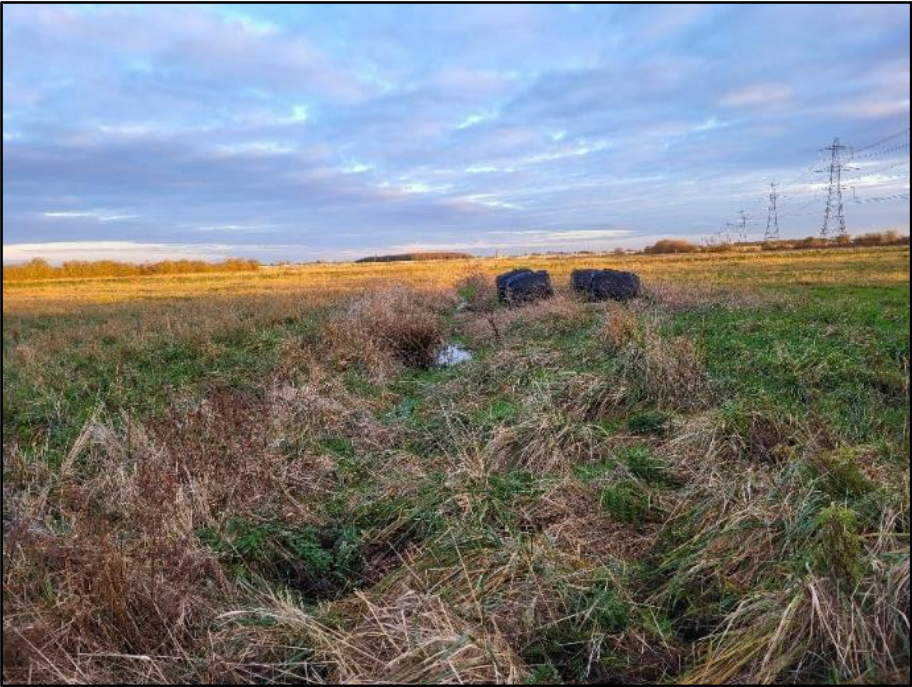
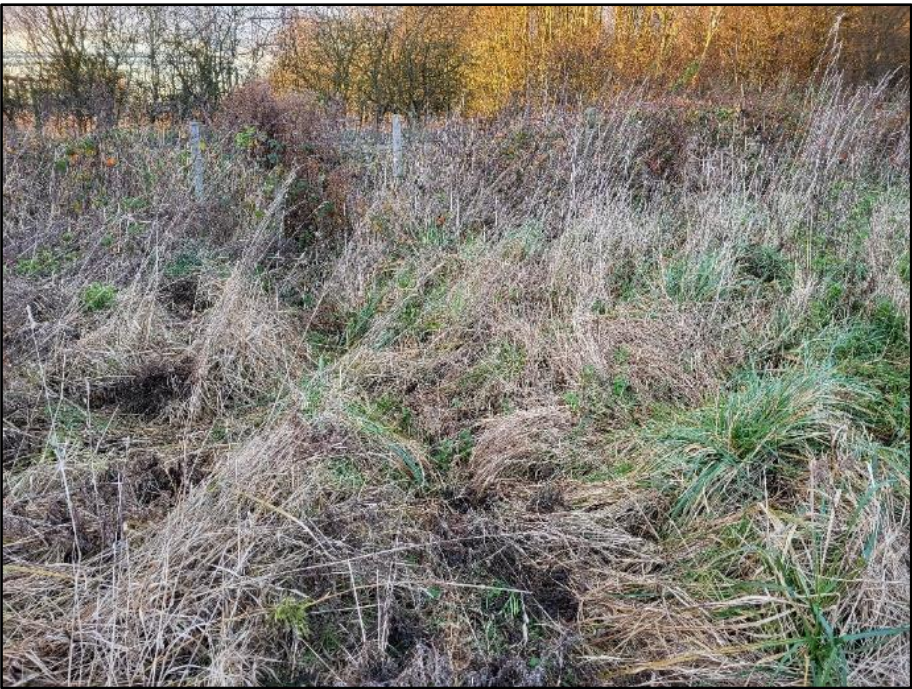
Photograph Sheet: 74  
NGR: TF 19826 38469  
Photograph Date: 3 December 2024

Description: Location of WX76. Unnamed drain, with overgrown vegetation throughout the channel. The left bank c.0.6m, right bank c.0.6m, width c.1.0m. No water present in channel.

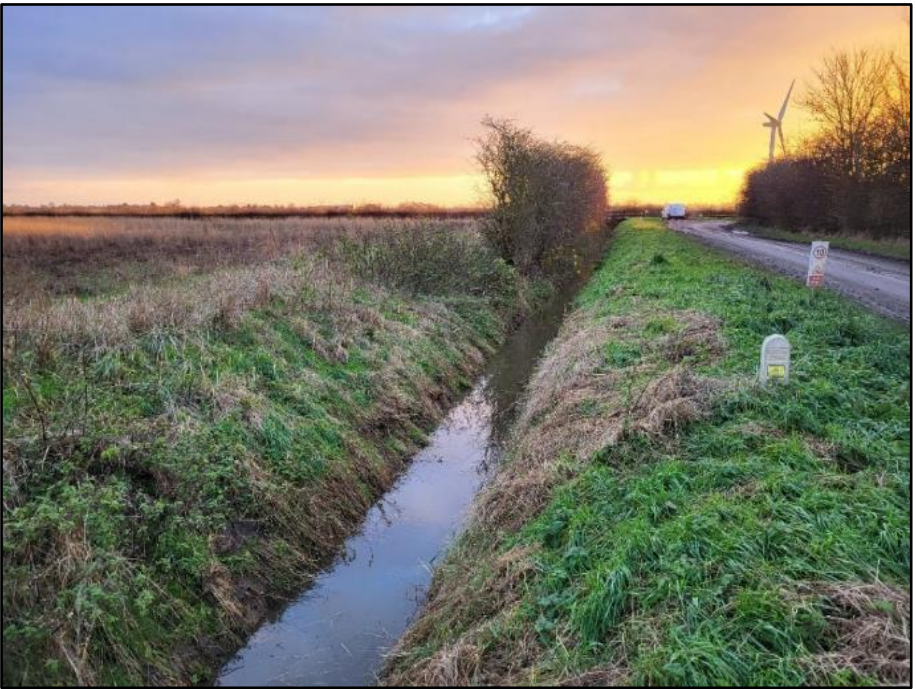
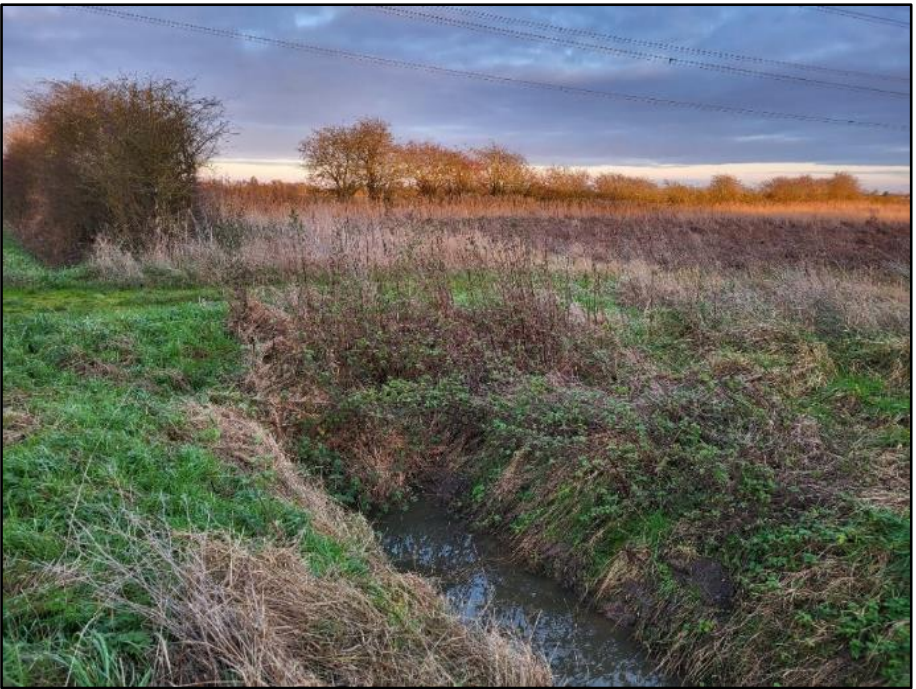
**Description:** Location of WX77. Unnamed drain, with banks composed of earth material and channel substrate not visible earth and silt. The left bank c.0.9m, right bank c.0.8m, width c.2.0m. Water depth is approximately c.0.4m with no perceivable flow.

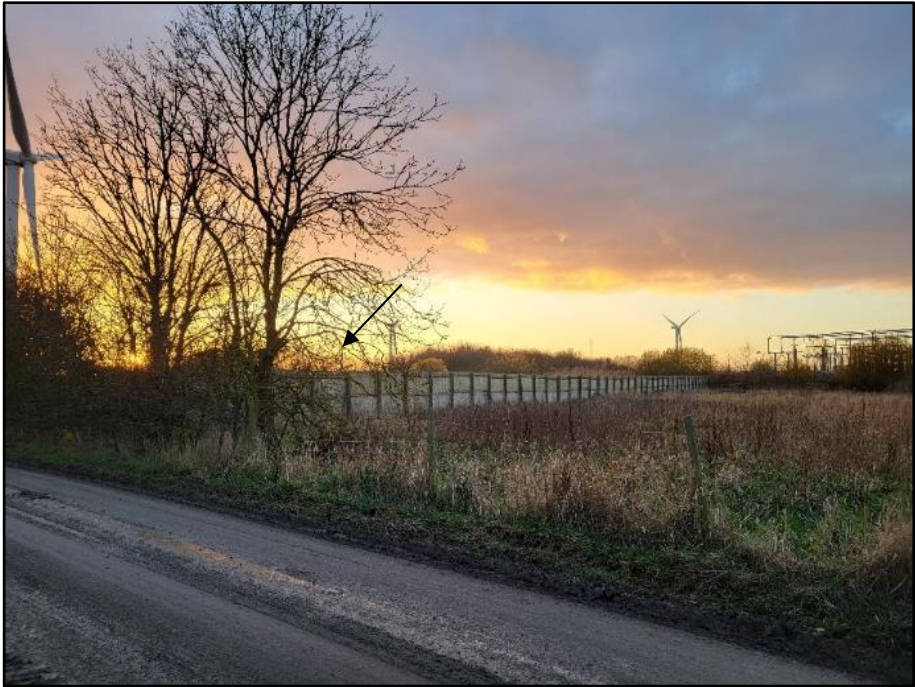
**Photograph Sheet:** 77  
**NGR:** TF 19740 38340  
**Photograph Date:** 3 December 2024  
**Description:** Location of WX79. Unable to access watercourse due to fencing.
