BEACON FEN

ENERGY PARK

Appendix 17.1 Ground Conditions Desk Study – Part 1

Document Reference: 6.3 ES Volume 2, 6.3.102a

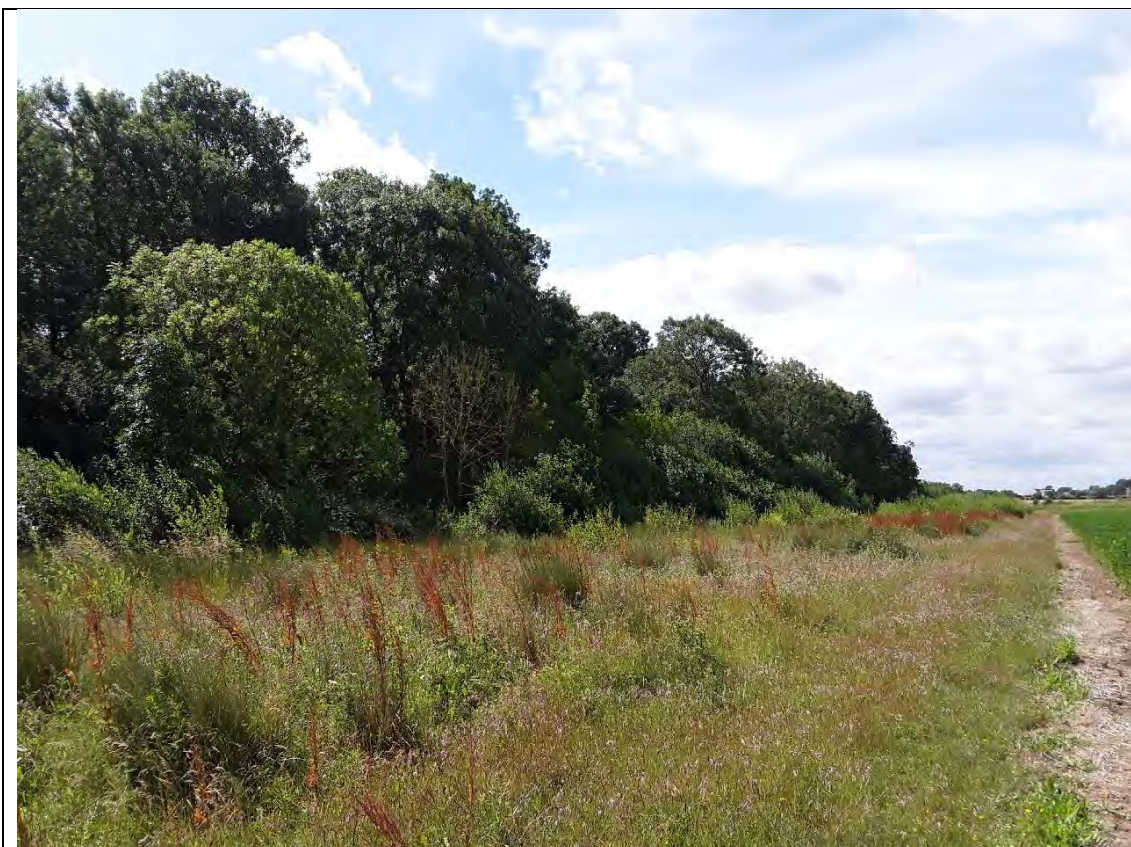
Figure 1. View of footpath showing overgrown drainage ditch and wooded area.

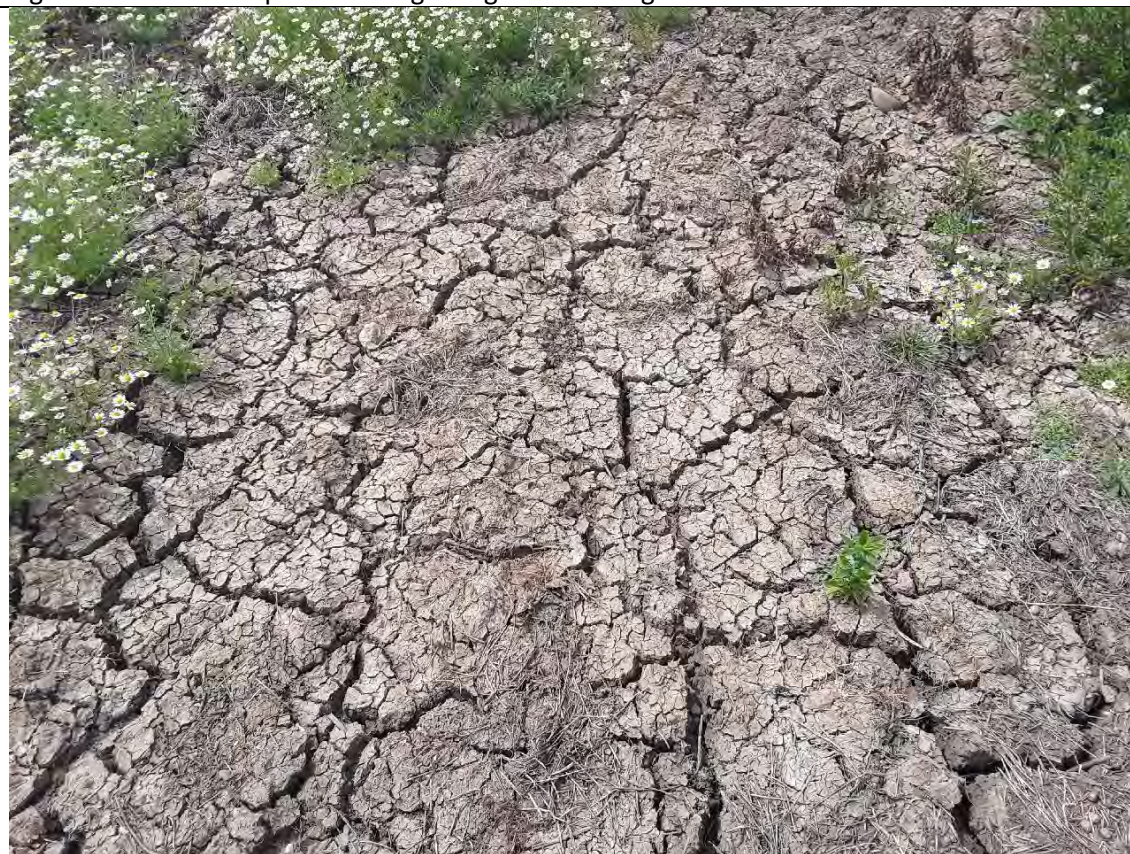
Figure 2. Desiccation cracks within footpaths.

- 2.1.13 The perimeter of the Solar Array Area was lined with dense hedgerows and trees, with roads along the northern, western and southern site boundaries. The edges of the field parcels and drainage ditches were generally overgrown with weeds and vegetation, but the majority of the open field areas appeared to be maintained in good condition. Where clay was exposed at surface along the access tracks, desiccation cracks were present, considered to be a result of extended hot weather prior to the walkover survey.

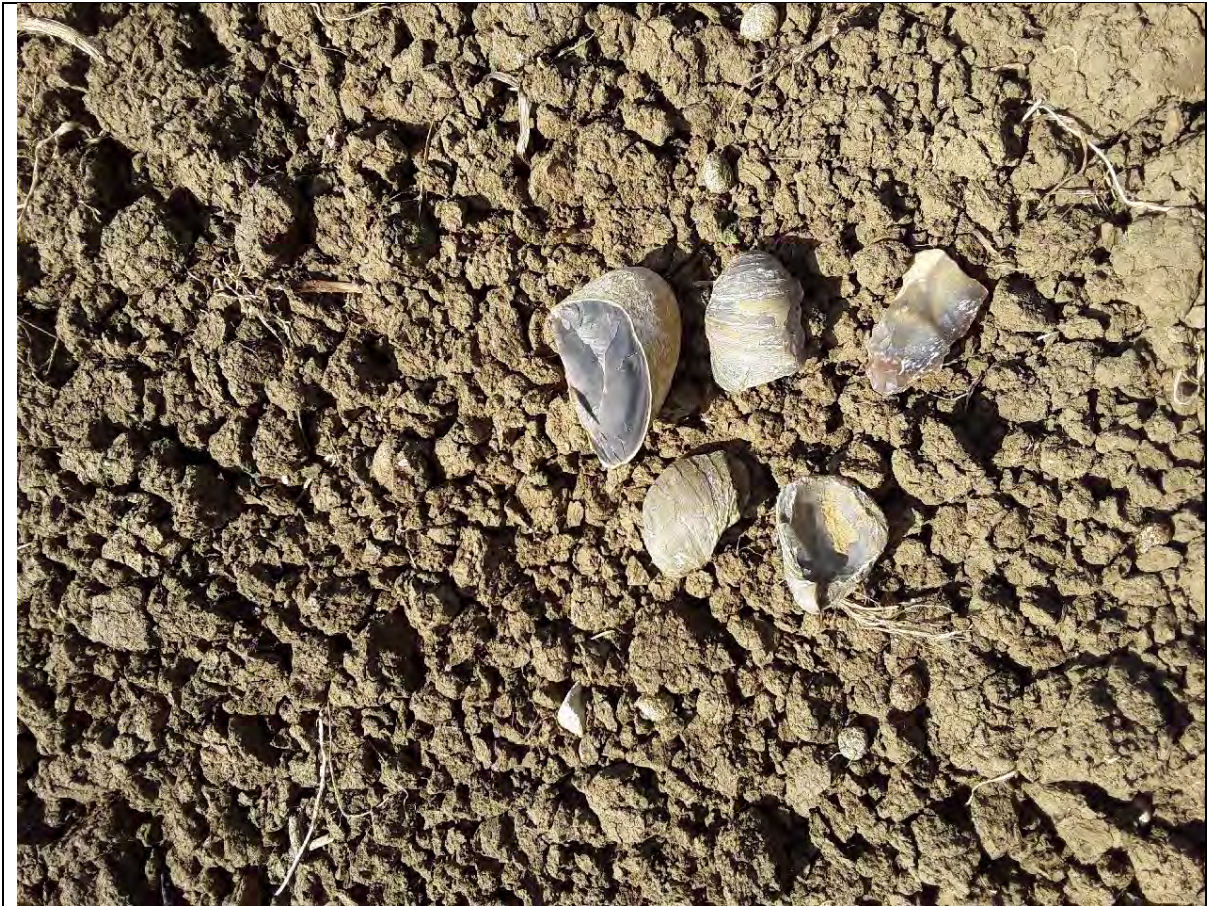
Figure 9. Flint gravel and fossils identified within the topsoil along a footpath.

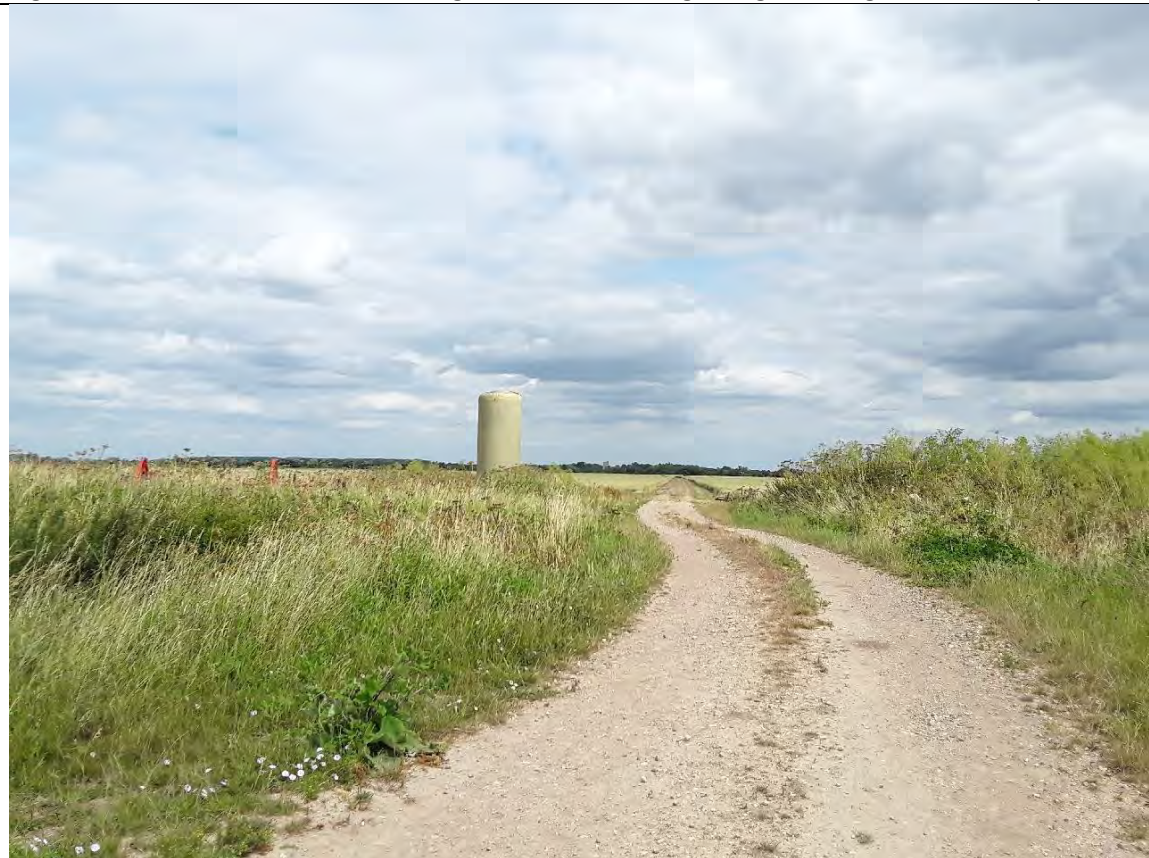
Figure 12. View looking east along the access track in the centre of the Solar Array Area, showing the storage tank.

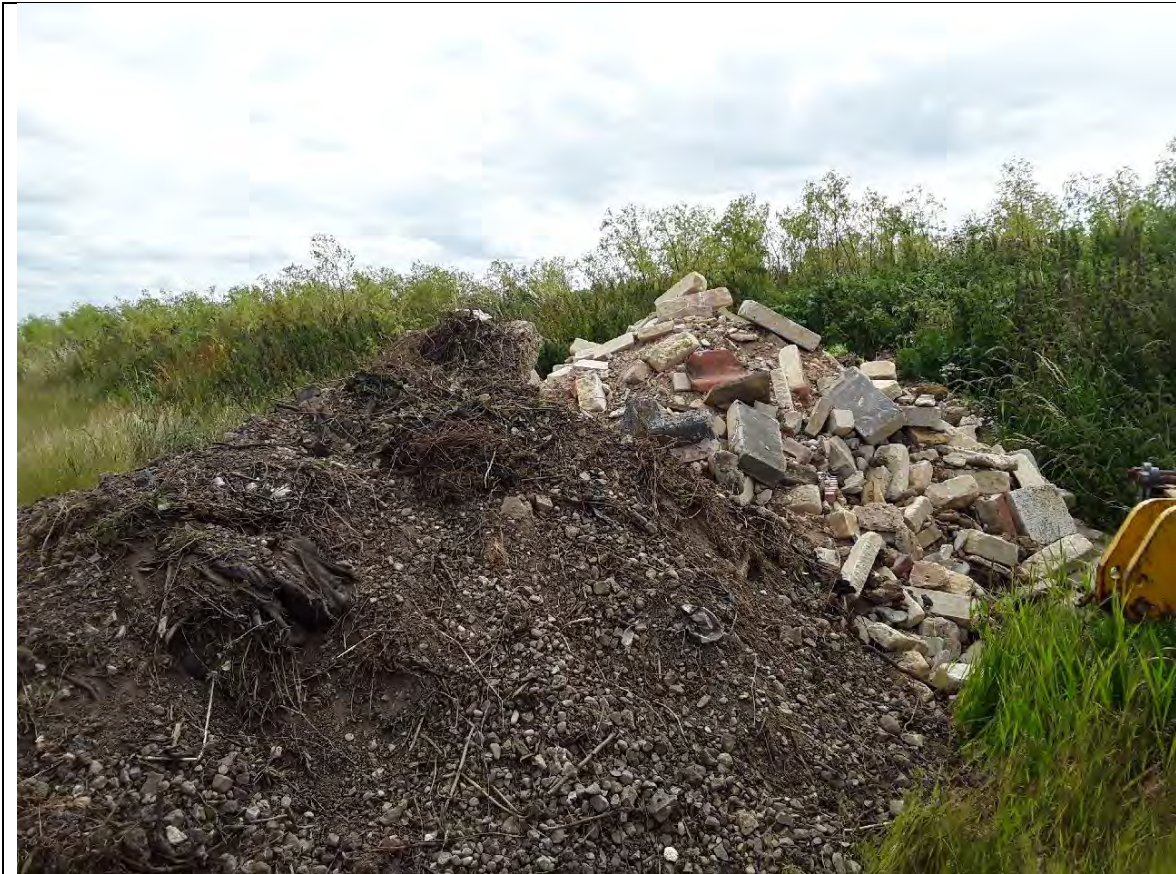
Figure 15. Waste and rubble stockpile in the centre of the Solar Array Area.

- 5.1.9 During the walkover survey that was undertaken in the Solar Array Area, no evidence of previous or current built development was identified. The walkover survey identified one area of surface Made Ground within the centre of the Solar Array Area, near to an above ground fertiliser storage tank where a stockpile of materials (including brick, cement and ceramics, etc.) was identified. No obvious evidence of asbestos was noted within this stockpile, but it should be noted that this statement is a general observation and does not represent a formal assessment by a qualified asbestos surveyor. Owing to the nature of the stockpile, the presence of asbestos could not be discounted without further information on its source and / or testing of the material.

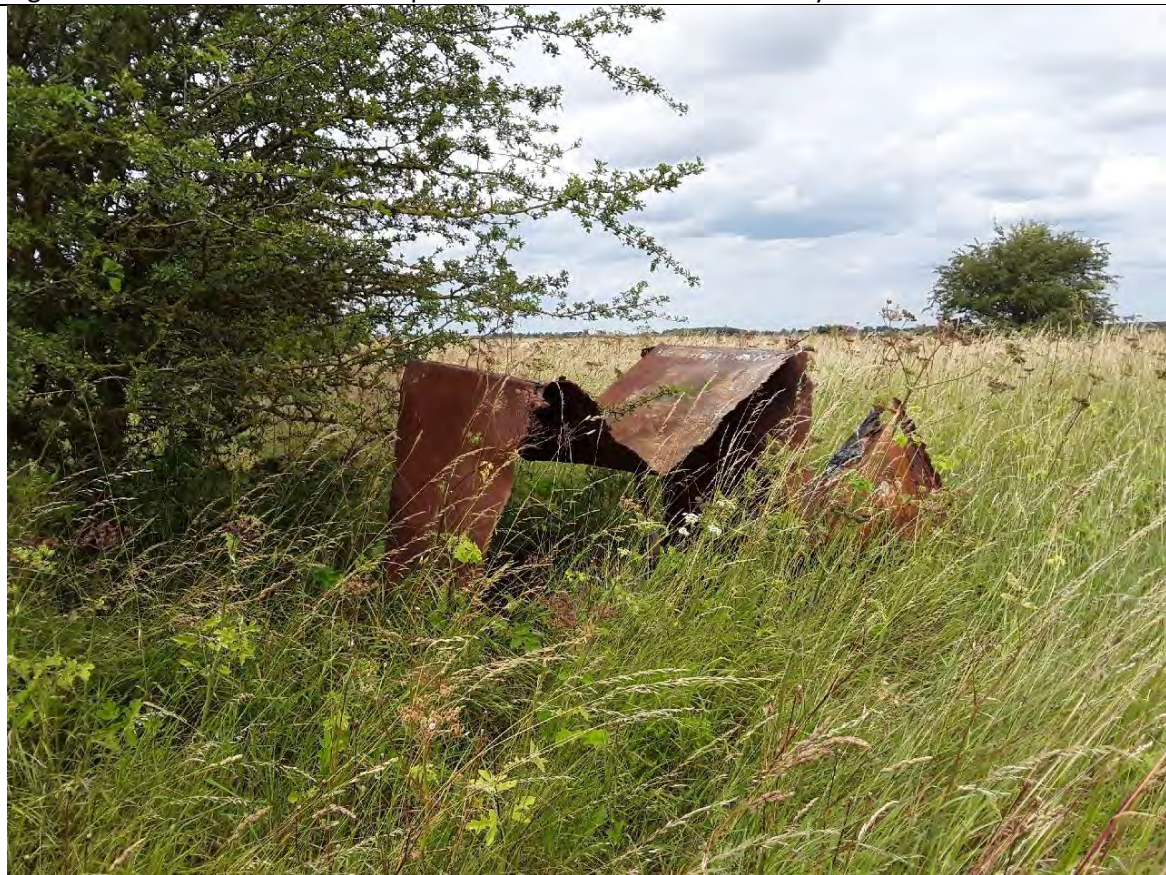
Figure 16. Scrap metal stored in the centre of the Solar Array Area.

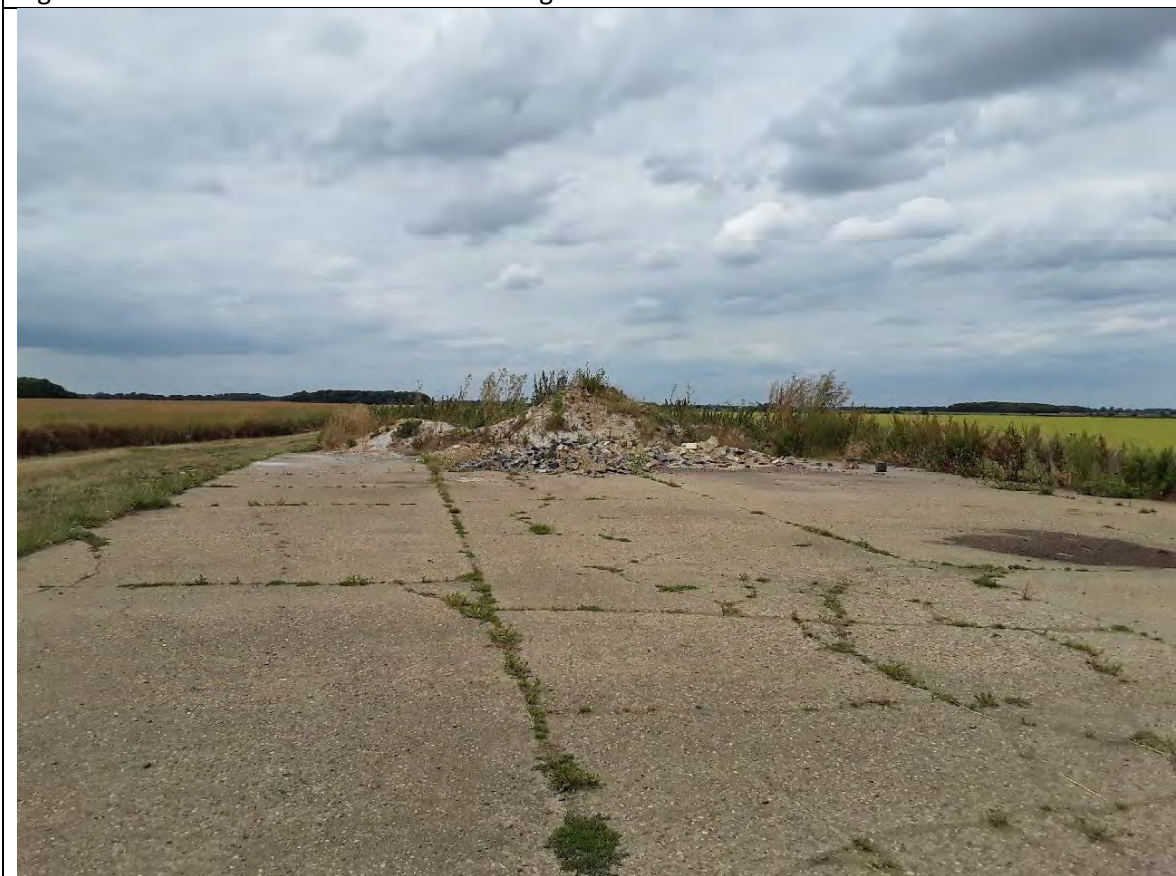
Figure 18. Area of hardstanding in the south of the Solar Array Area.

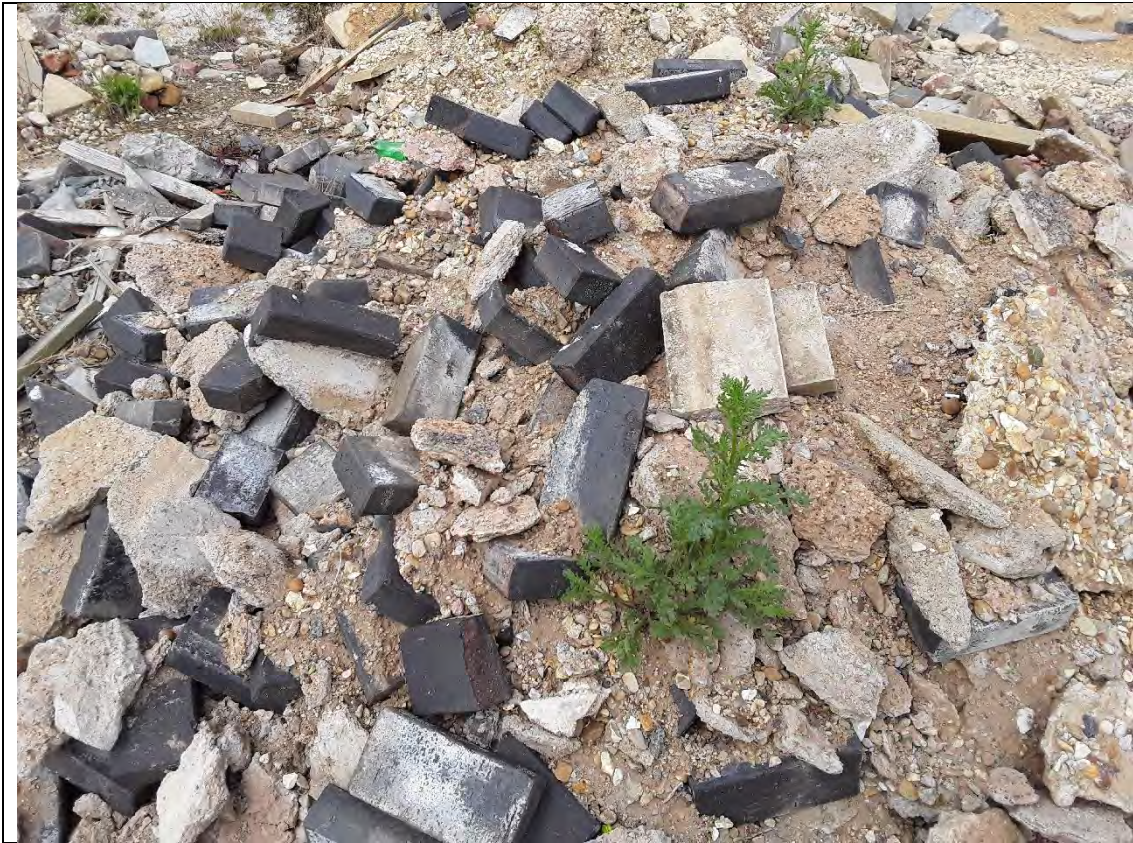
Figure 19. Stockpile in the south of the Solar Array Area on the hardstanding in Figure 18.

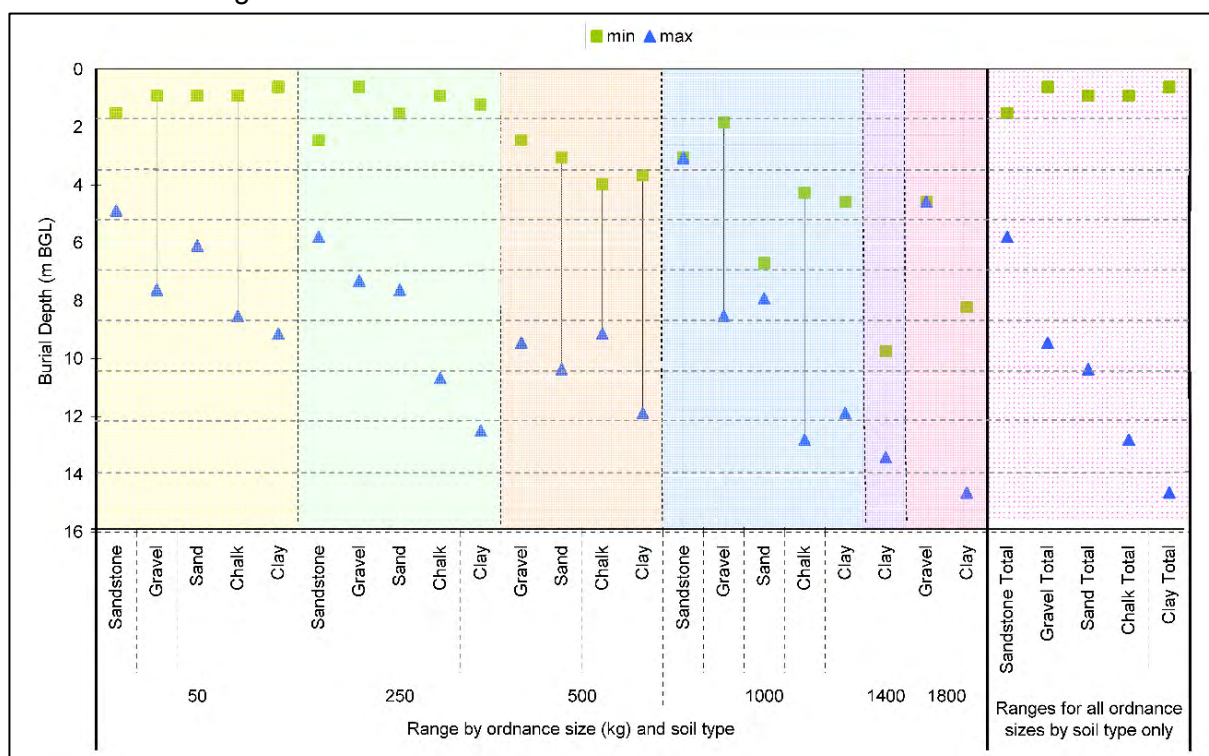
The chart to below shows the observed variation in burial depths of various sizes of air-delivered UXO for different ground conditions.

As stated within C681, the ground conditions at any individual site are likely to be highly variable and this results in a large range of burial depths for each different size bomb.

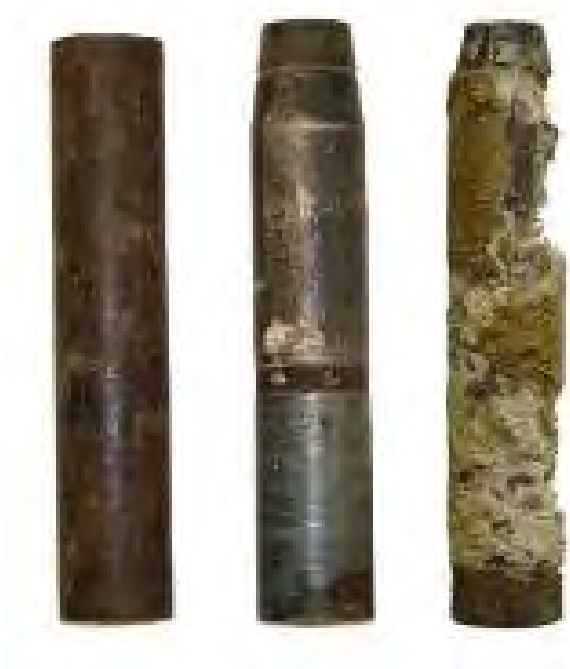
Left: ordinary scaffold pipe
Centre: 1kg incendiary bomb
Right: incendiary bomb found on site in UK
