# BEACON FEN ENERGY PARK

Appendix 11.3 Summary of Watercourse Crossings and Photographs

Document Reference: 6.3 ES Volume 2, 6.3.83

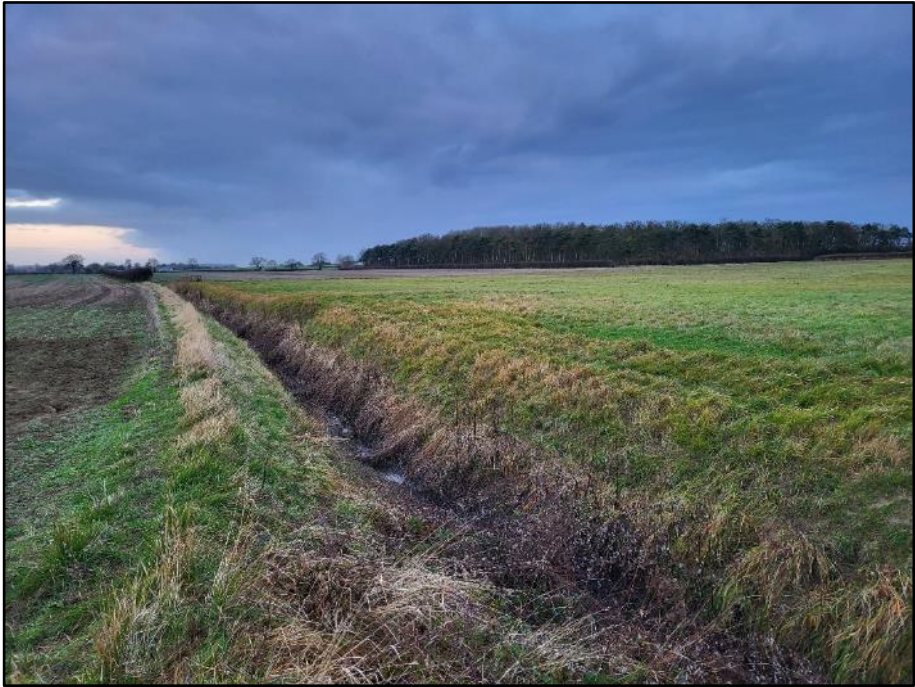
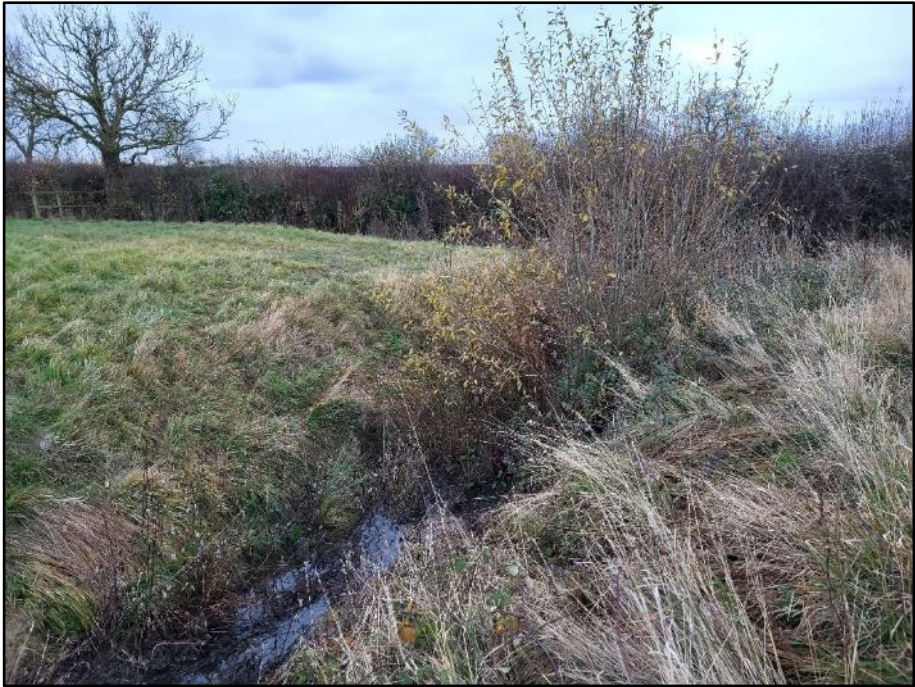
Description: Location of WX02. Unnamed drain, slightly overgrown looking downstream, left bank c.1.2m, right bank c.1.2m, width c.2.0m, water depth c.0.4m.

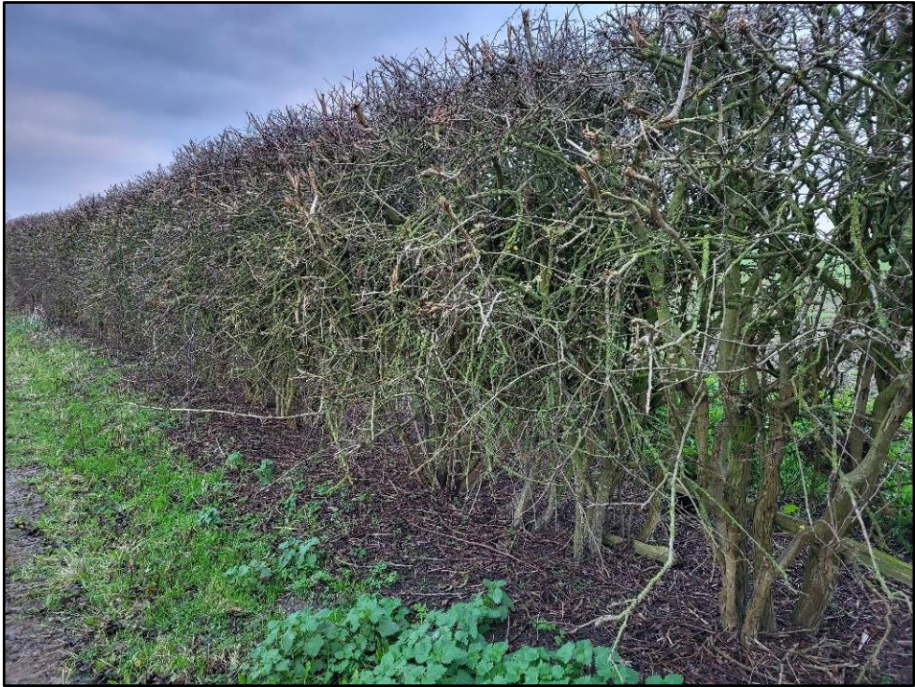
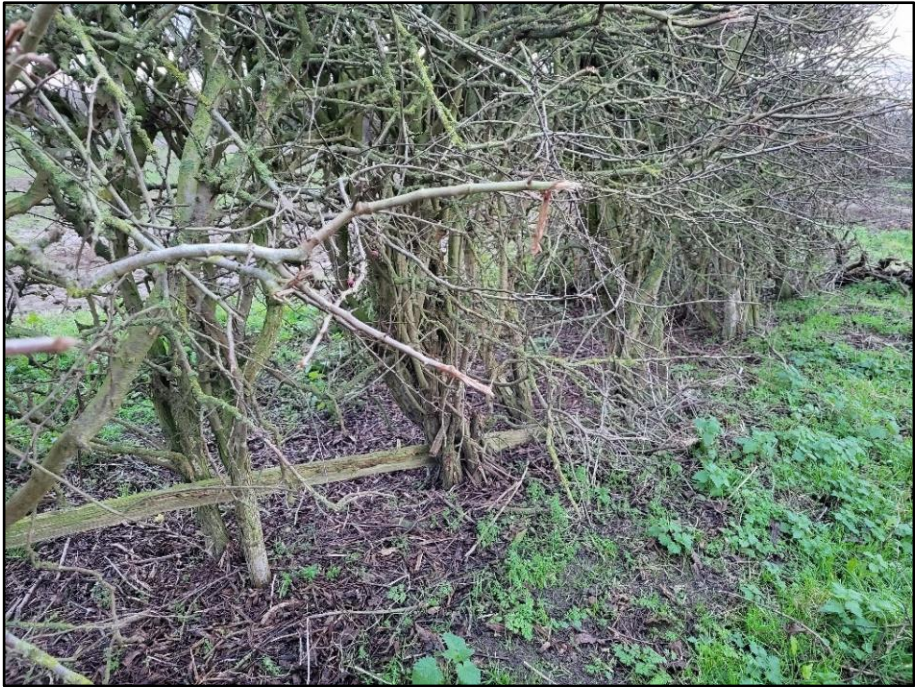
**Description:** Location of WX04. Unnamed drain, with a hedge and overgrown vegetation throughout channel, left bank c.0.8m, right bank c.0.5m, width c.1.5m, Water depth c.0.0m. Facing upstream.

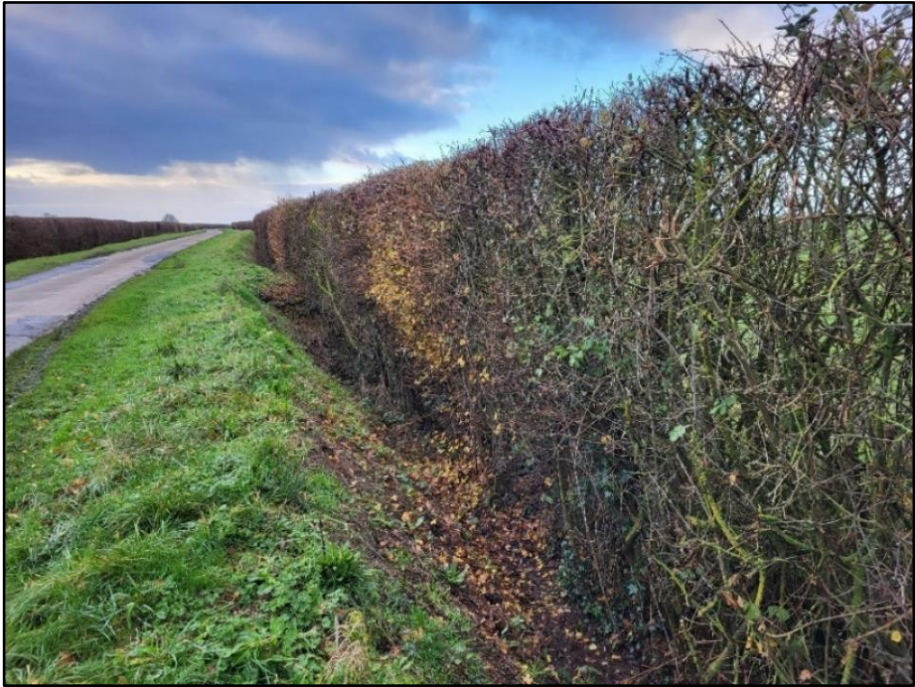
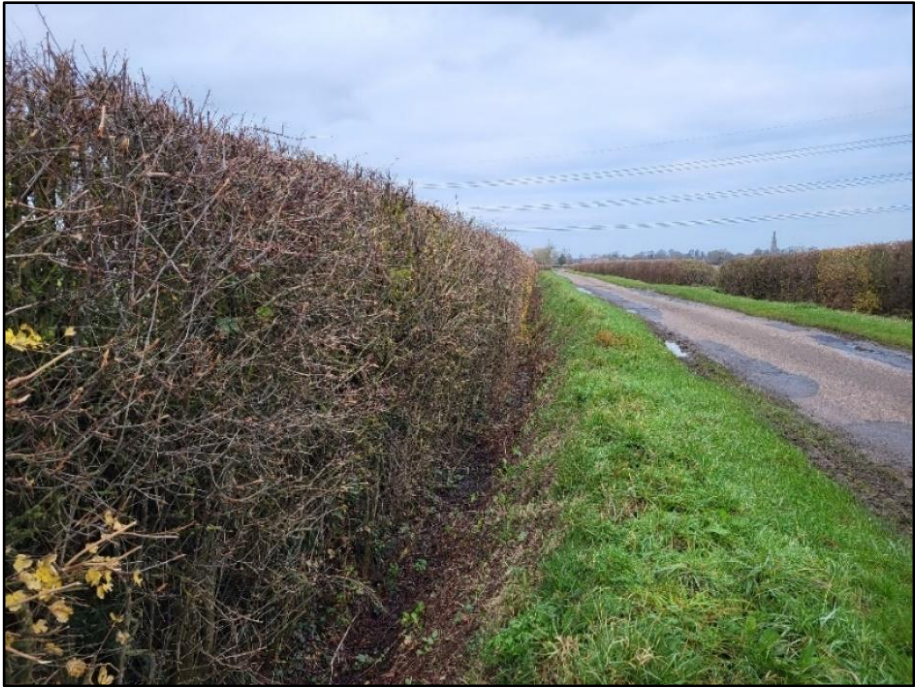
Description: Location of WX06. Unnamed drain, with a hedge and overgrown vegetation throughout channel, left bank c.0.01m, right bank c.0.01m, width c.0.5m, Water depth c.0.0m. Facing east.

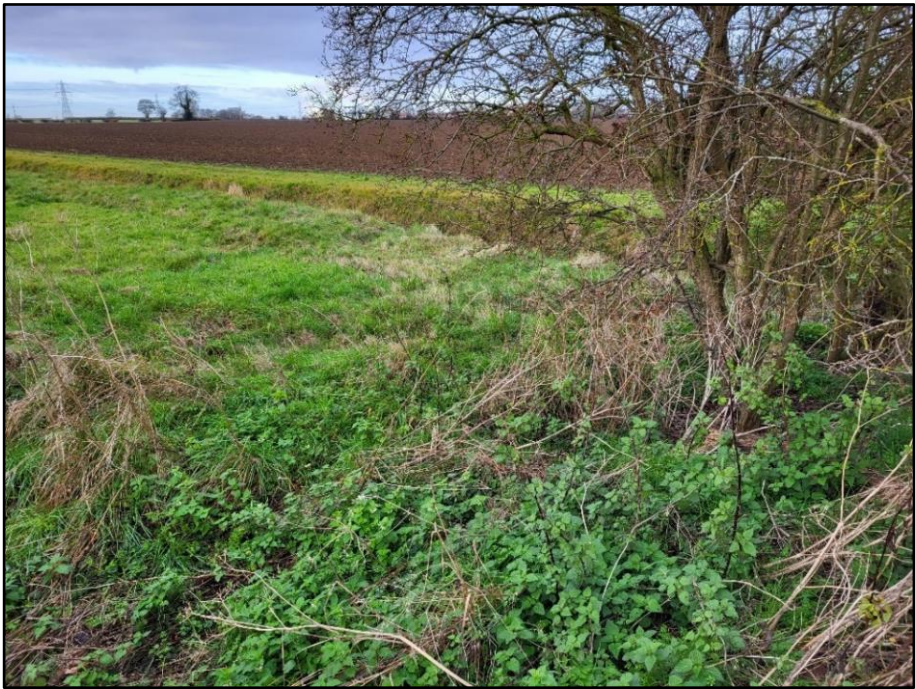
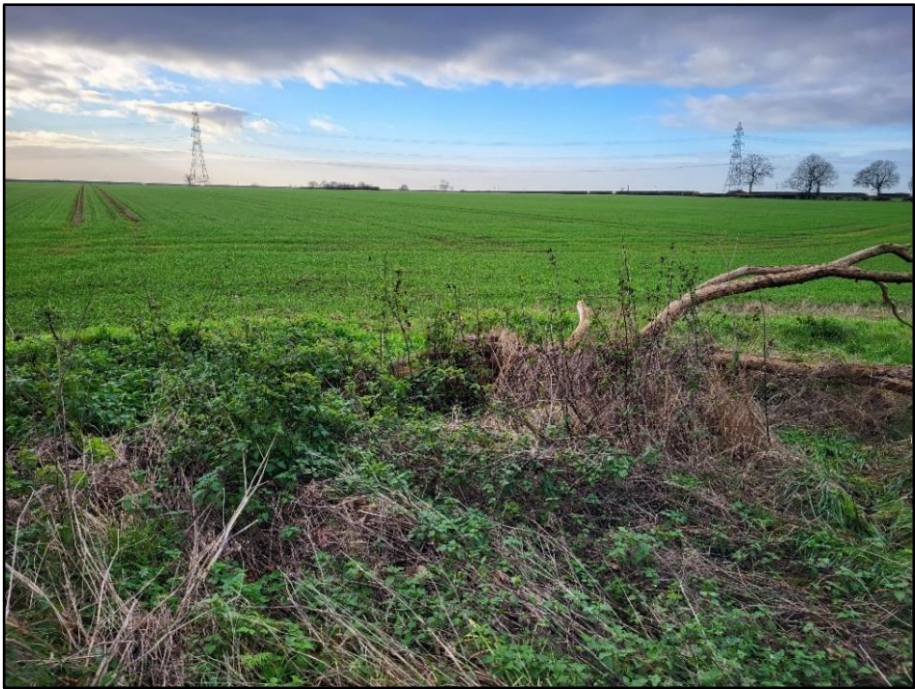
**Photograph Sheet:** 08  
**NGR:** TF 12052 46148  
**Photograph Date:** 3 December 2024  
**Description:** Location of WX08. Unnamed drain, with overgrown vegetation throughout channel, left bank c.0.8m, right bank c.0.5m, width c.0.9m, water depth c.0.0m no visible flow.

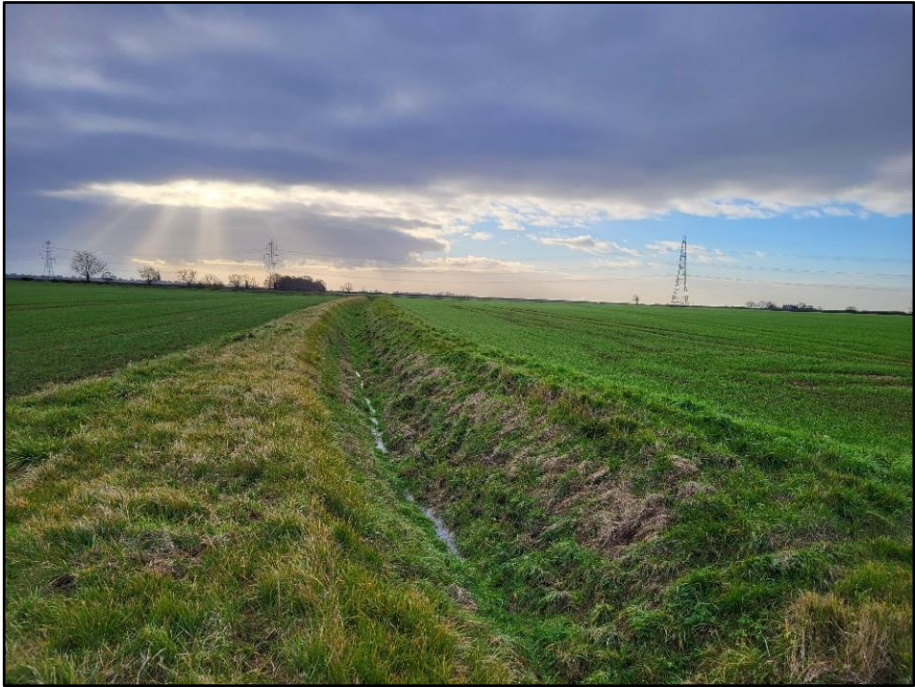
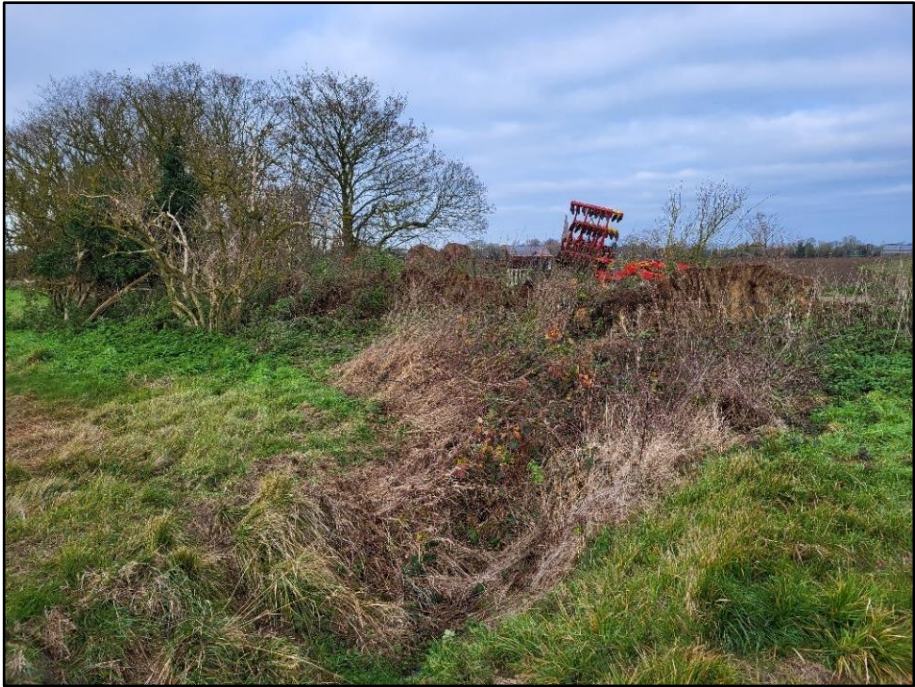
**Description:** Location of WX11. Unnamed drain, with vegetation throughout channel, left bank c.1.3m, right bank c.1.3m, width c1.5m. Water depth is c.0.02m in the channel. No culvert present through concrete area to WX11.

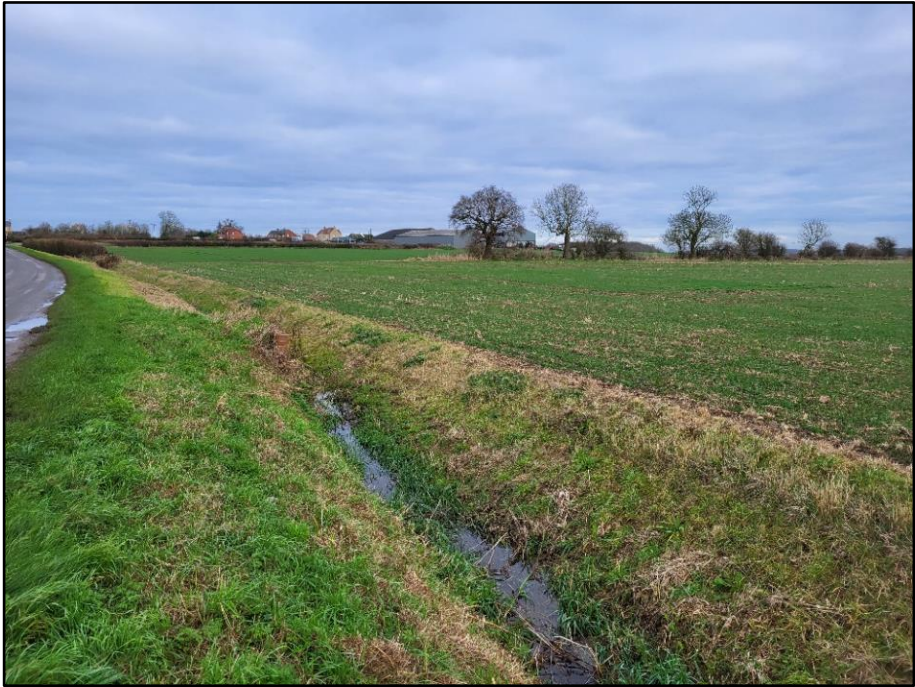
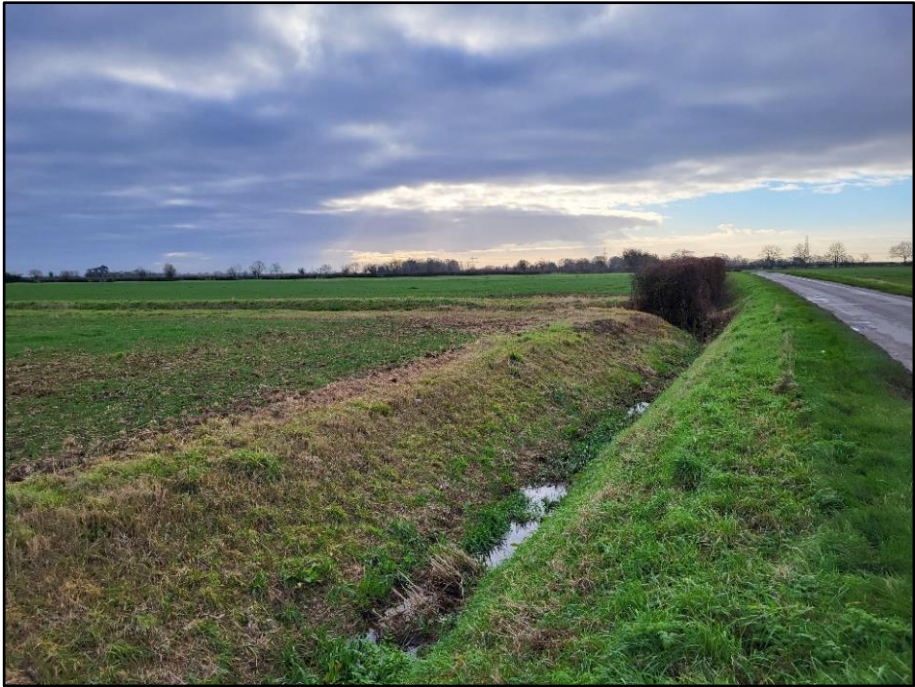
**Photograph Sheet:** 12  
**NGR:** TF 13121 47001  
**Photograph Date:** 3 December 2024  
**Description:** Location of WX12. Unnamed drain, with vegetation throughout channel, left bank c.1.0m, right bank c.1.0m, width c2.4m. Water depth is c.0.05m in the channel.

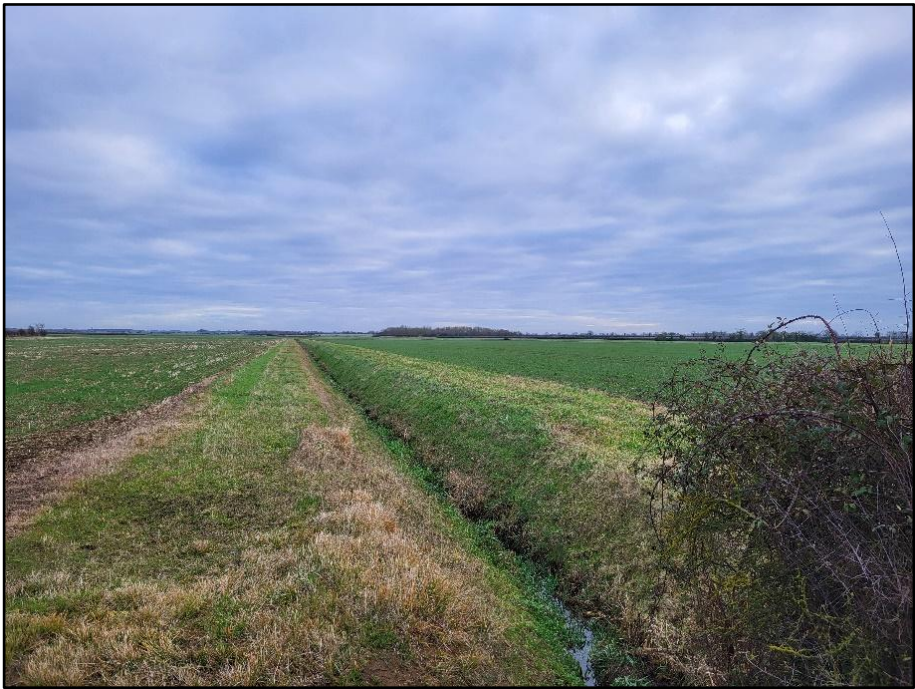
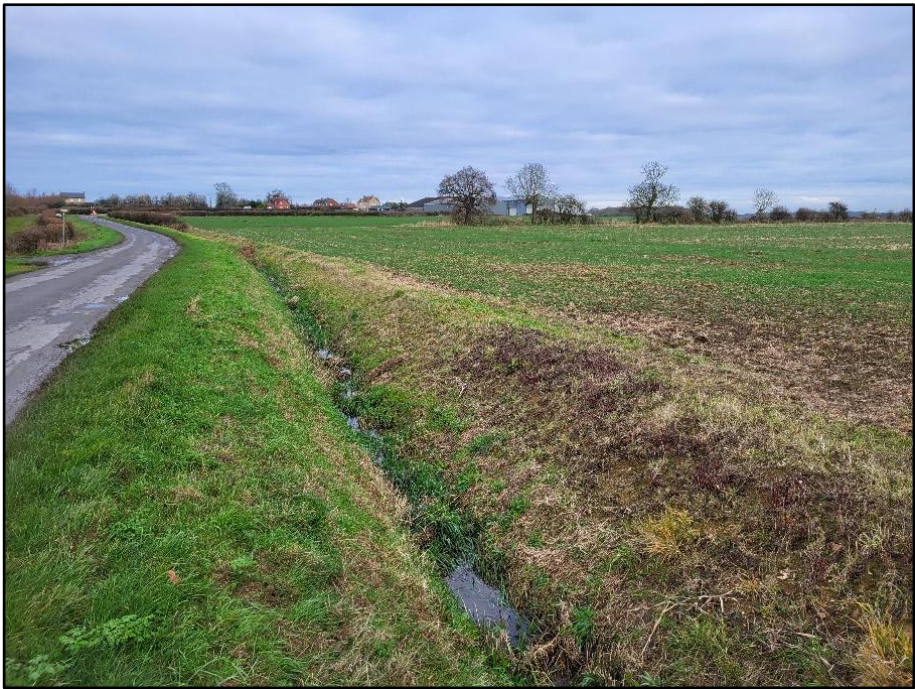
**Photograph Sheet:** 14  
**NGR:** TF 13400 47043  
**Photograph Date:** 3 December 2024  
**Description:** Location of WX14. Unnamed drain, with vegetation throughout channel, left bank c.1.5m, right bank c.1.5m, width c2.0m. Water depth is c.0.05m in the channel and culverted across road.

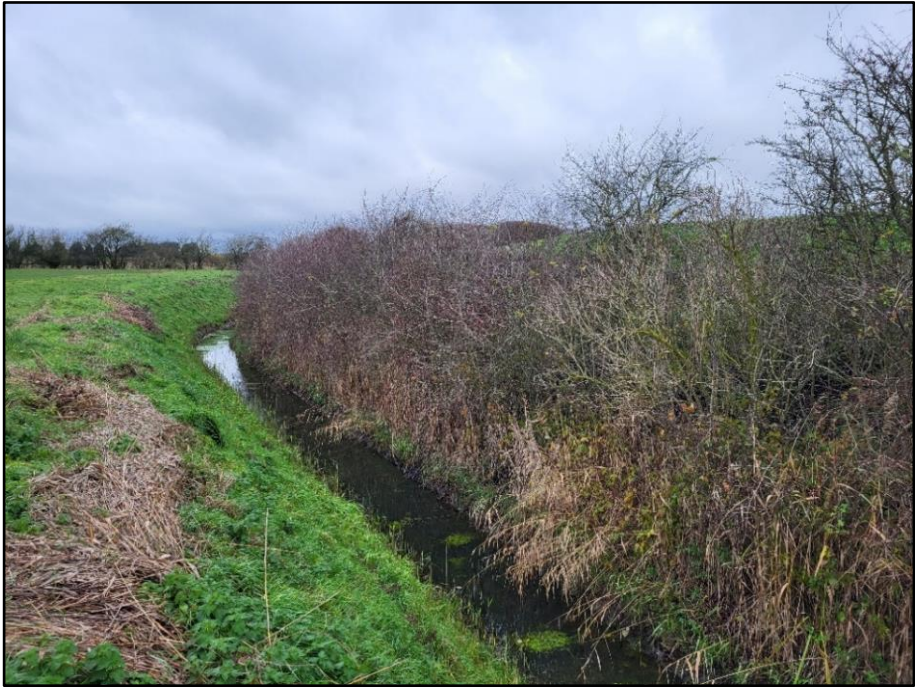
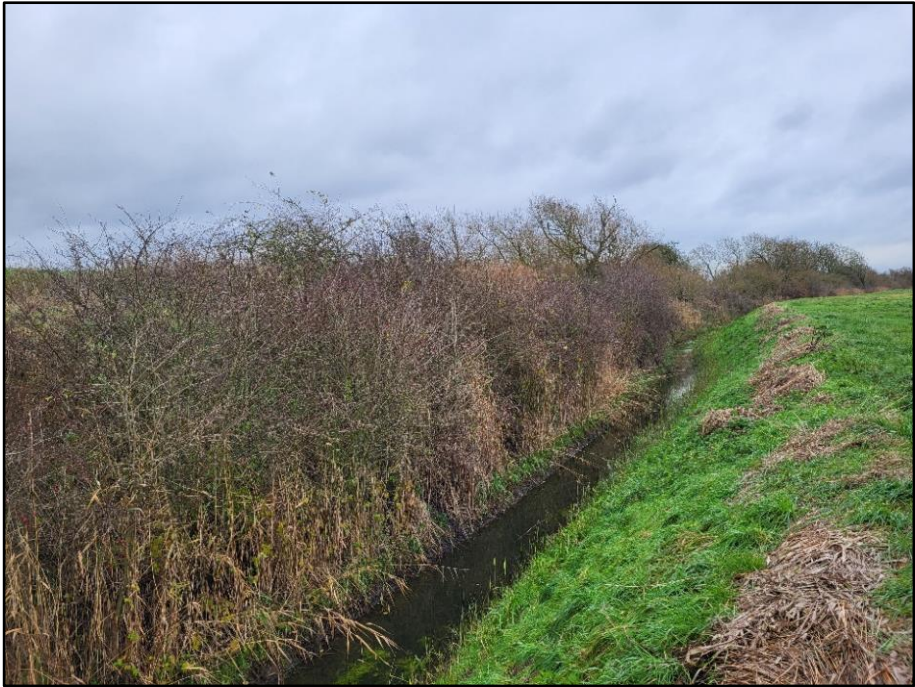
Description: Location of WX16. Unnamed drain, with banks comprised of earth material, left bank c.2.0m, right bank c.2.0m, width c.2.0m. Water depth is c.0.05m in the channel and culverted across road.

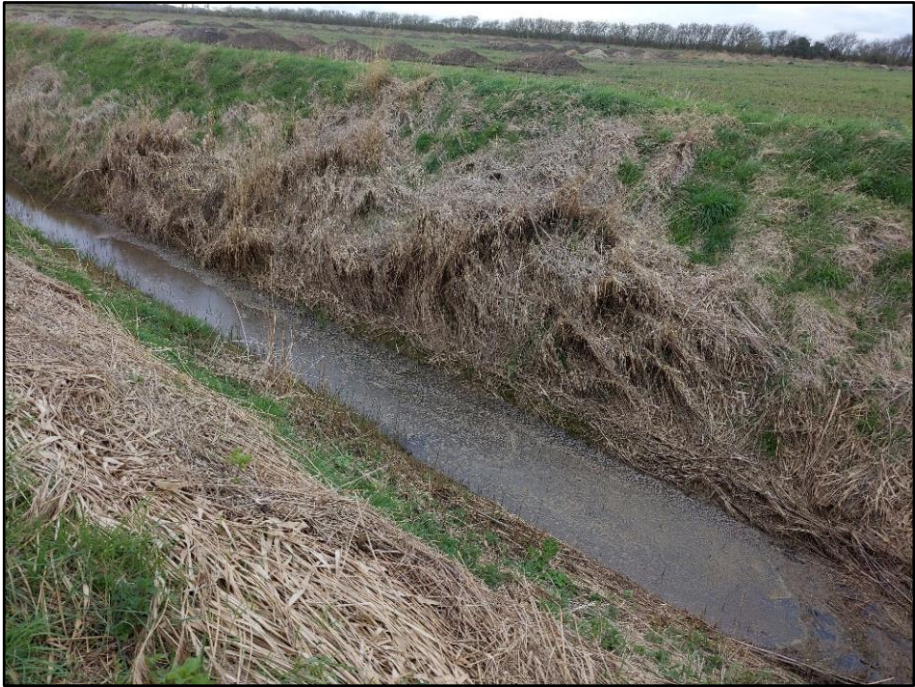
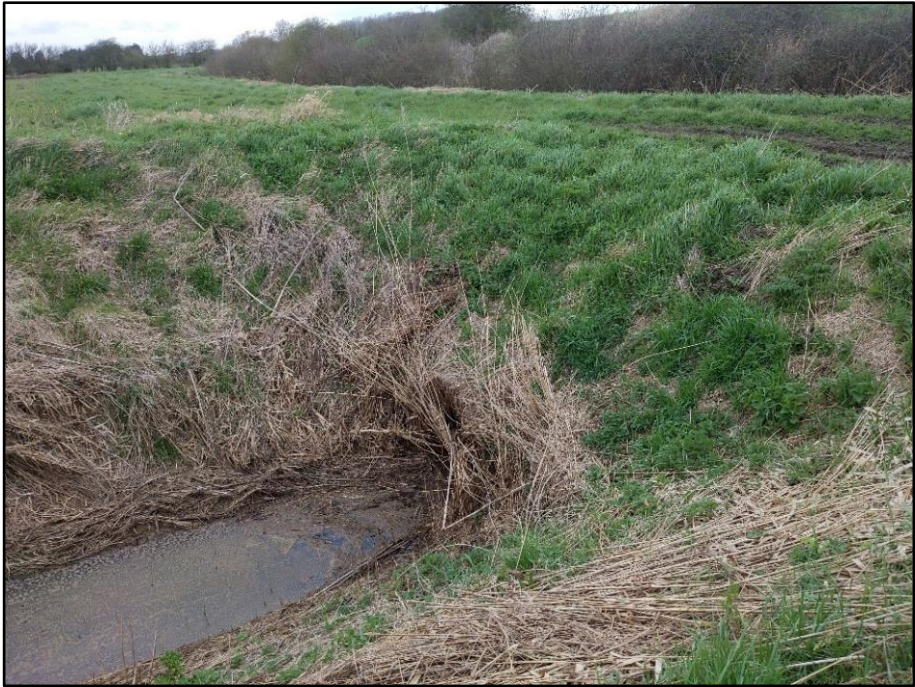
**Description:** Location of WX18. Passing place and Catchwater Drain, with hedge and overgrown vegetation throughout channel, left bank c.1.5m, right bank c.1.5m, width c.2.0m. Water depth is c.0.3m in the channel.

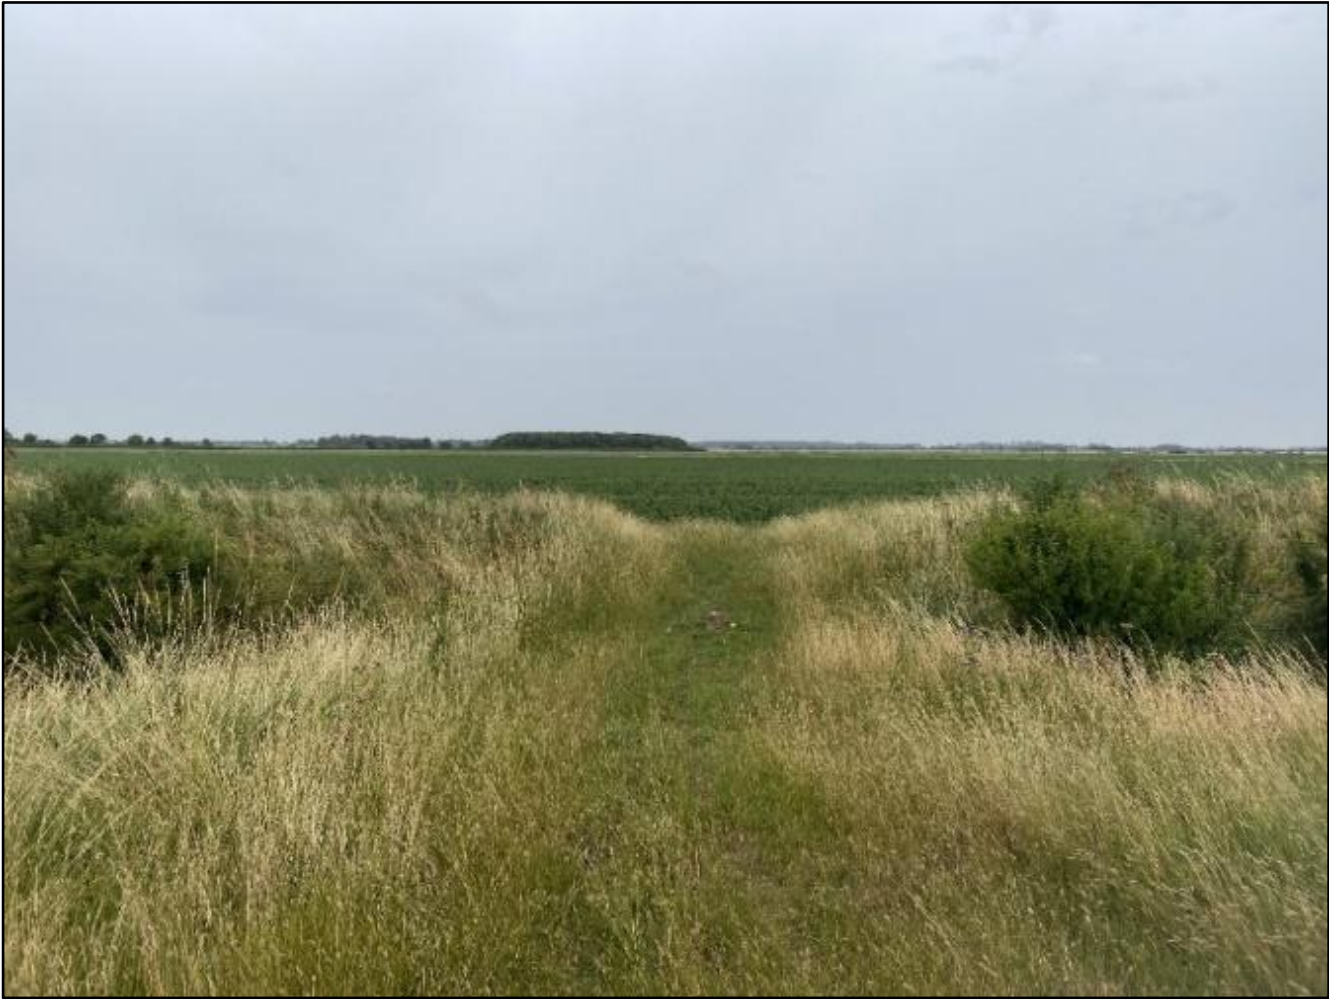
**Photograph Sheet:** 20  
**NGR:** TF 15408 49574  
**Photograph Date:** 19 March 2024  
**Description:** Location of WX20. Unnamed drain, with overgrown vegetation throughout channel, left bank c.1.2m, right bank c.1.2m, width c.3m. Water depth is c.0.05m in the channel.

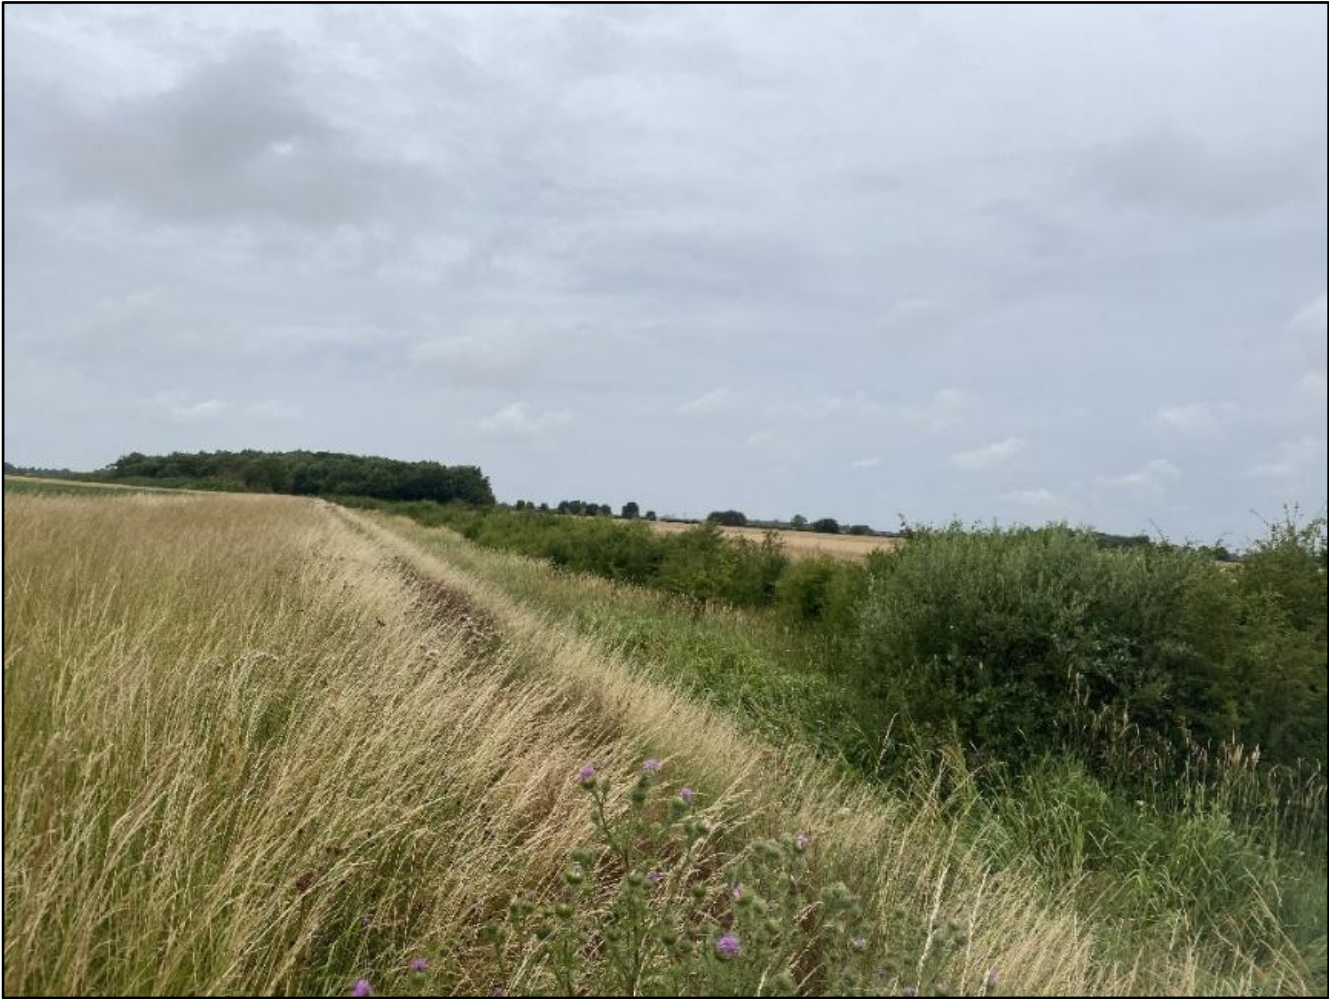
**Photograph Sheet:** 22  
**NGR:** TF 14481 48557  
**Photograph Date:** 14 July 2023  
**Description:** Location of WX22. Unnamed drain, with overgrown vegetation throughout channel, left bank c.1m, right bank c.1m, width c.3m. No water is present in the channel.

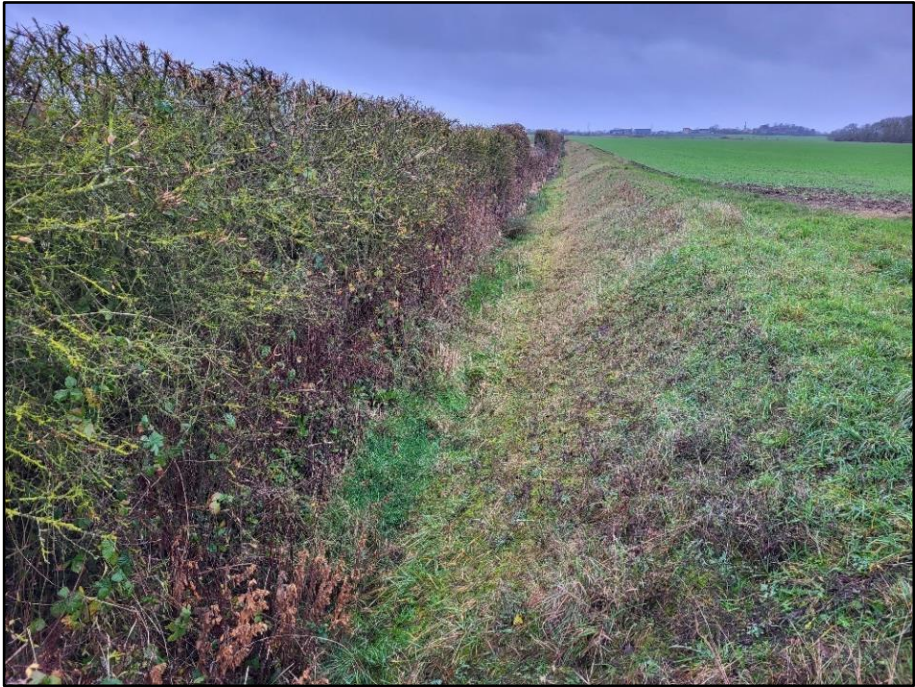
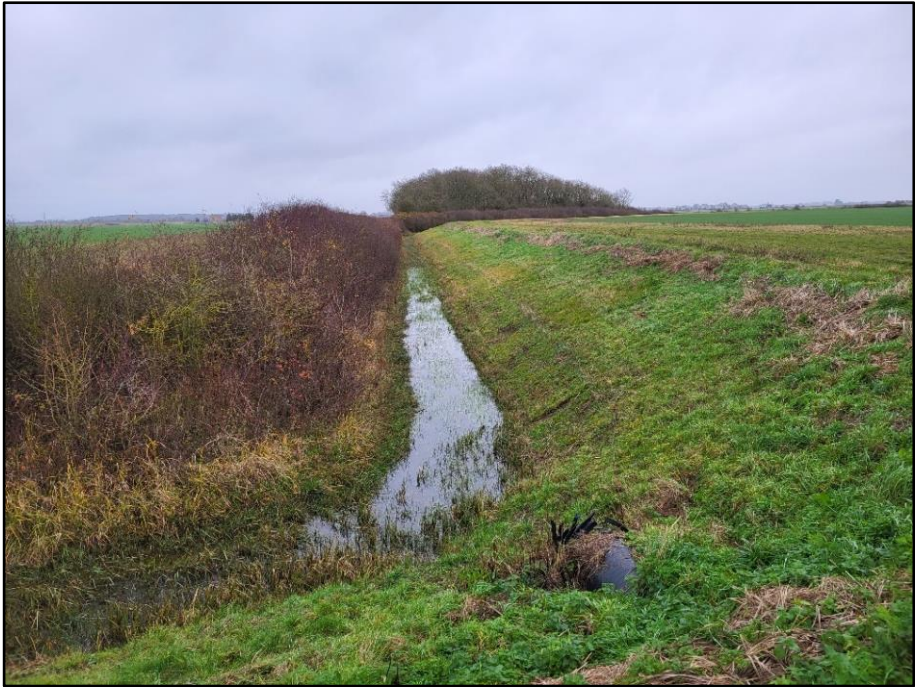
**Photograph Sheet:** 24  
**NGR:** TF 13989 48009  
**Photograph Date:** 19 March 2024  
**Description:** Location of WX24. Unnamed drain, with overgrown vegetation throughout the channel and banks composed of earth material. The left bank c.1.5m, right bank c.1.5m, width c. 2.5m. Water depth is c.0.1m in the channel.

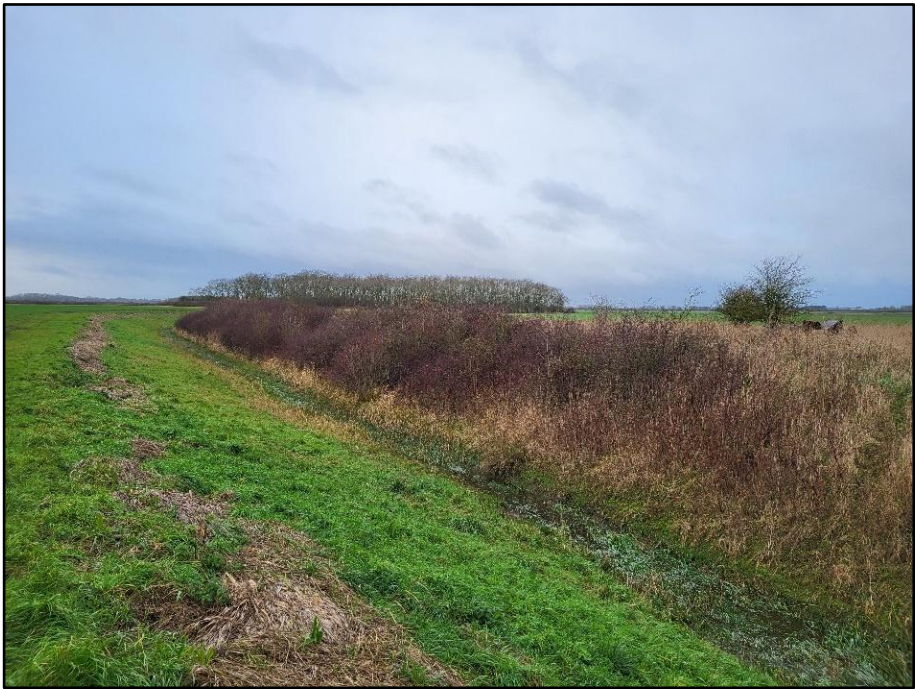
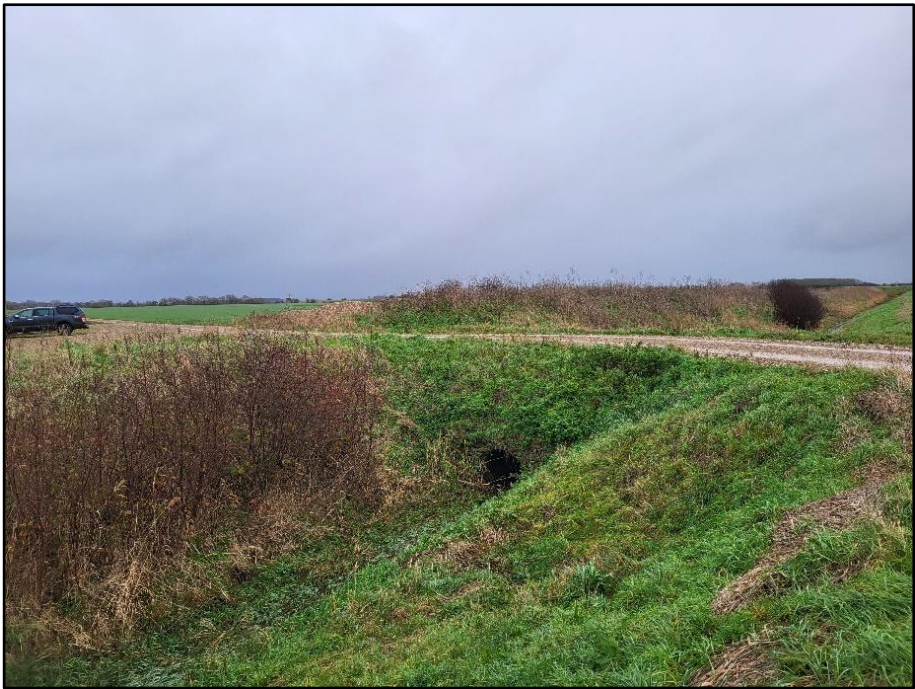
**Description:** Location of WX26. Unnamed drain, with banks composed of earth material. The left bank c.1.5m, right bank c.1.5m, width c. 4.0m. Water depth is c.0.4m in the channel and culverted downstream.

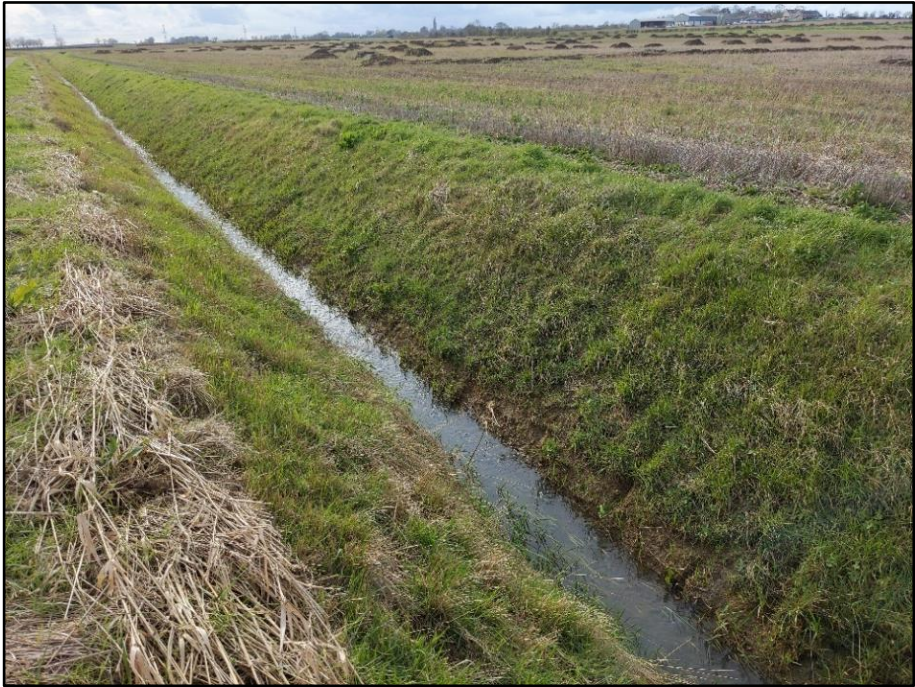
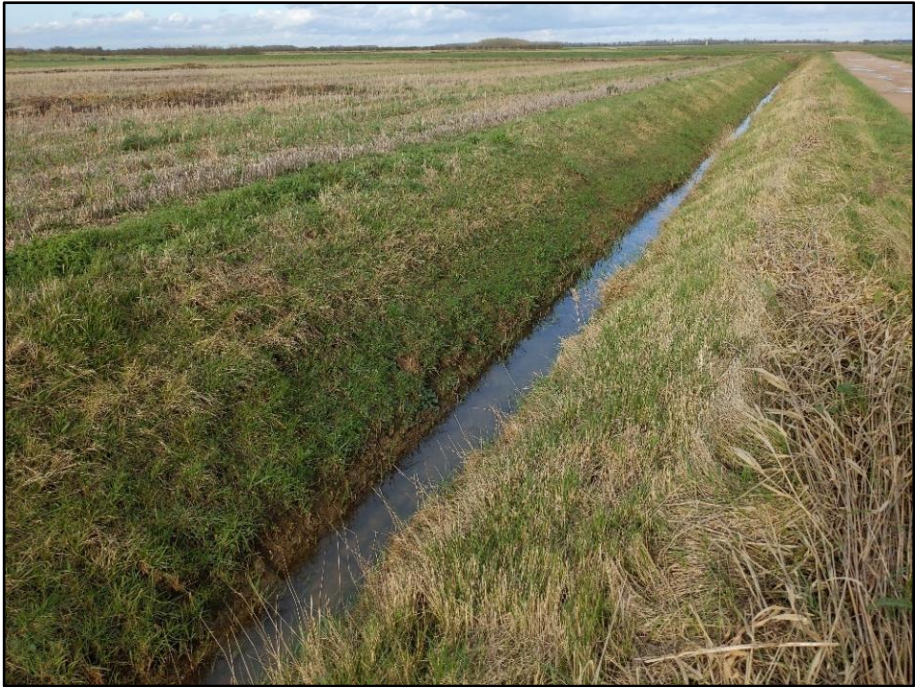
Description: Location of WX28. Unnamed drain, with overgrown vegetation in the channel and banks composed of earth material. The left bank c.1.2m, right bank c.1.2m, width c. 2.2m. Water depth is c.0.05m in the channel and culverted upstream.

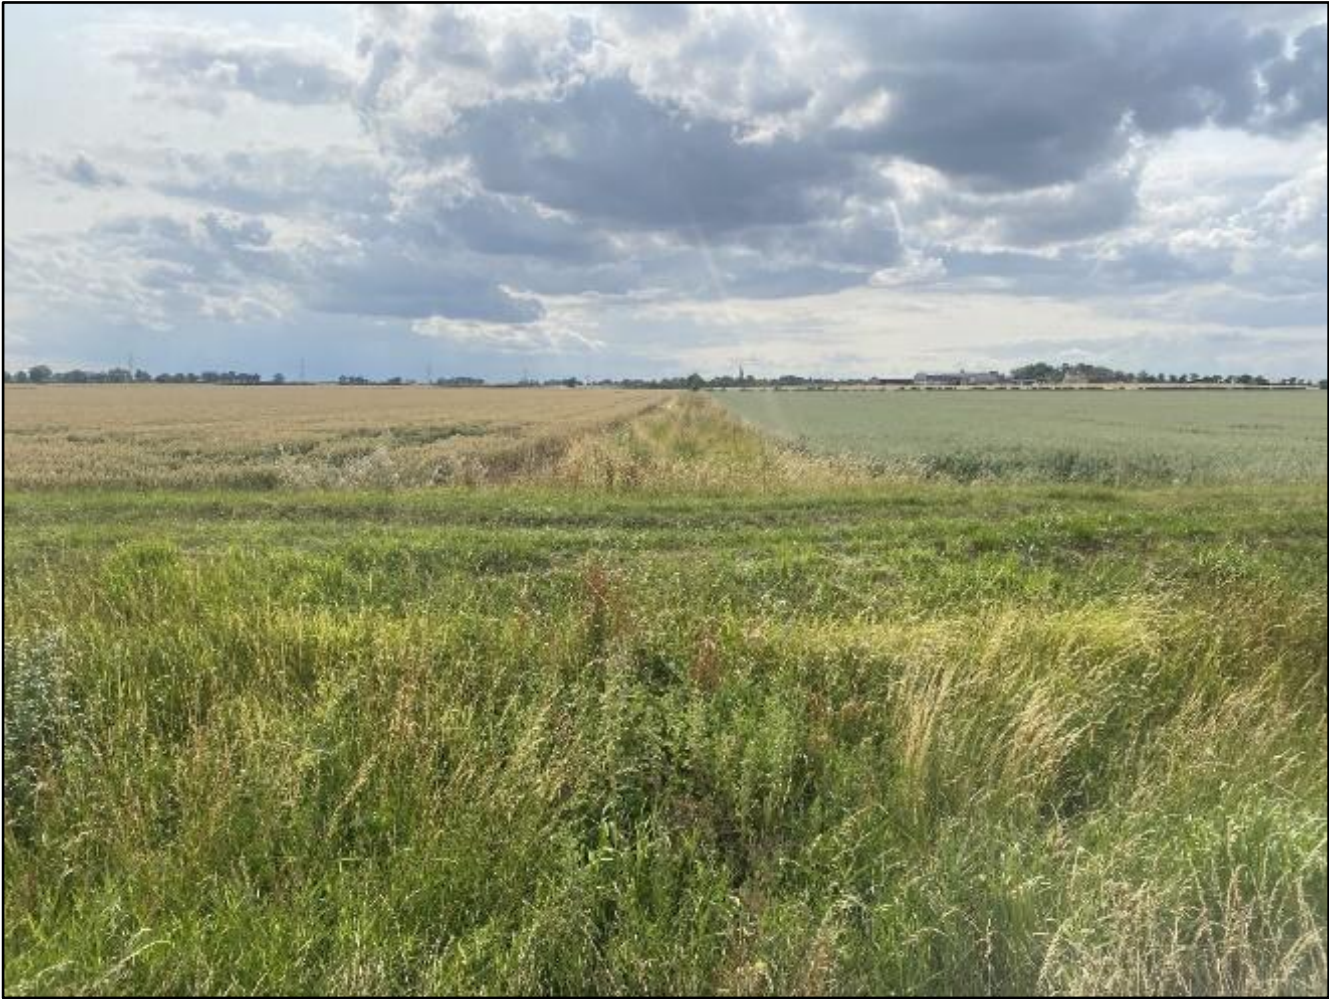
Location of WX31. Unnamed drain, with overgrown vegetation throughout channel, left bank c.1.5m, right bank c.1.5m, width c.3m. No water is present in the channel.

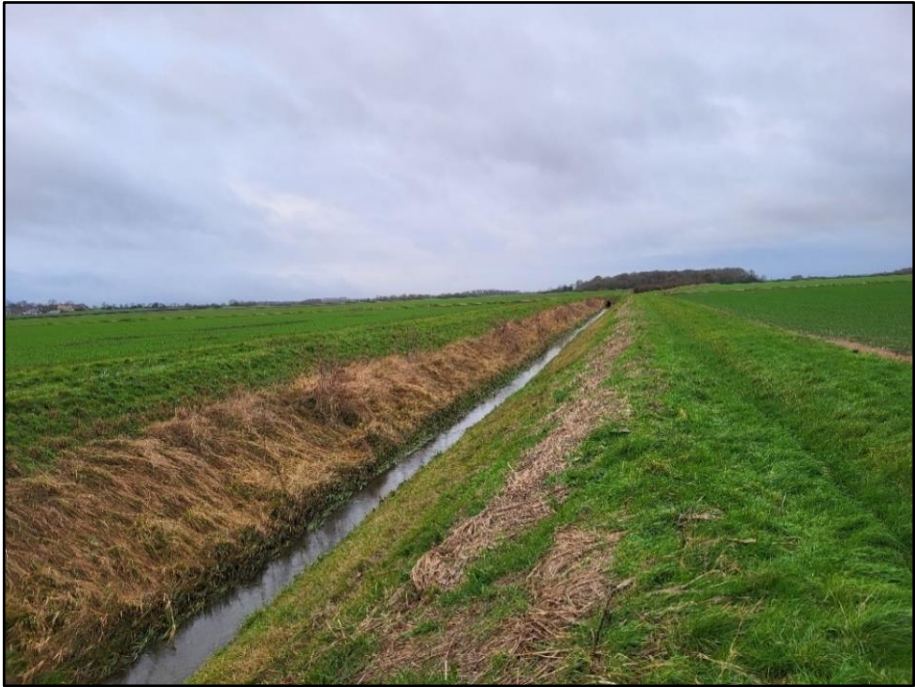
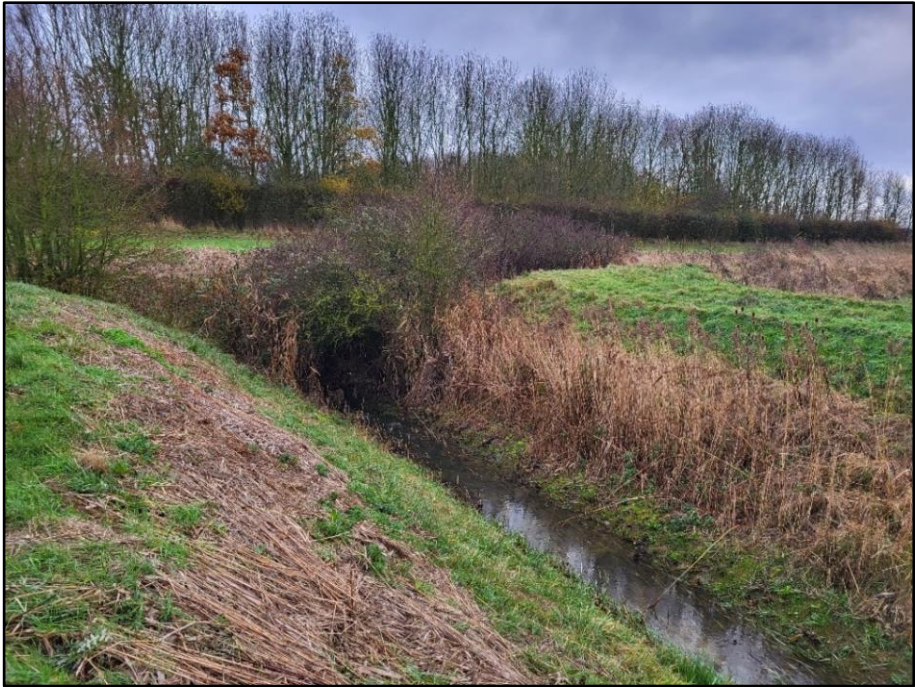
Location of WX36 within channel A. Channel A is an unnamed drain, with overgrown vegetation in the channel and banks composed of earth material. The left bank c.1.5m, right bank c.1.5m, width c. 1.8m. Water depth is c.0.1m in the channel. Location of WX37 within channel B. Channel B is an unnamed drain, with overgrown vegetation in the channel and banks composed of earth material. The left bank c.1.2m, right bank c.1.2m, width c. 1.3m. Water depth is c.0.08m in the channel.

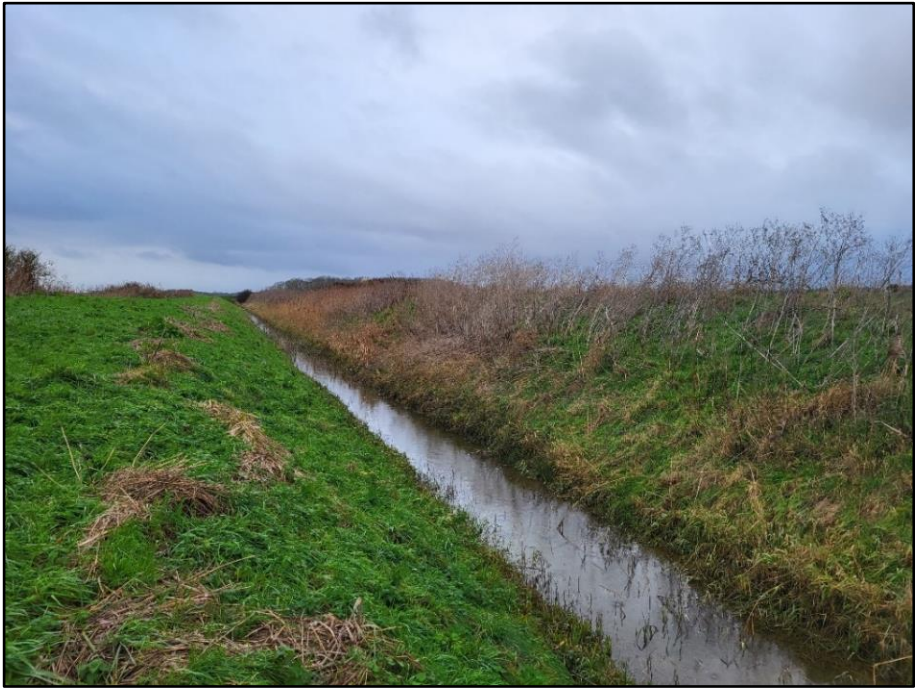
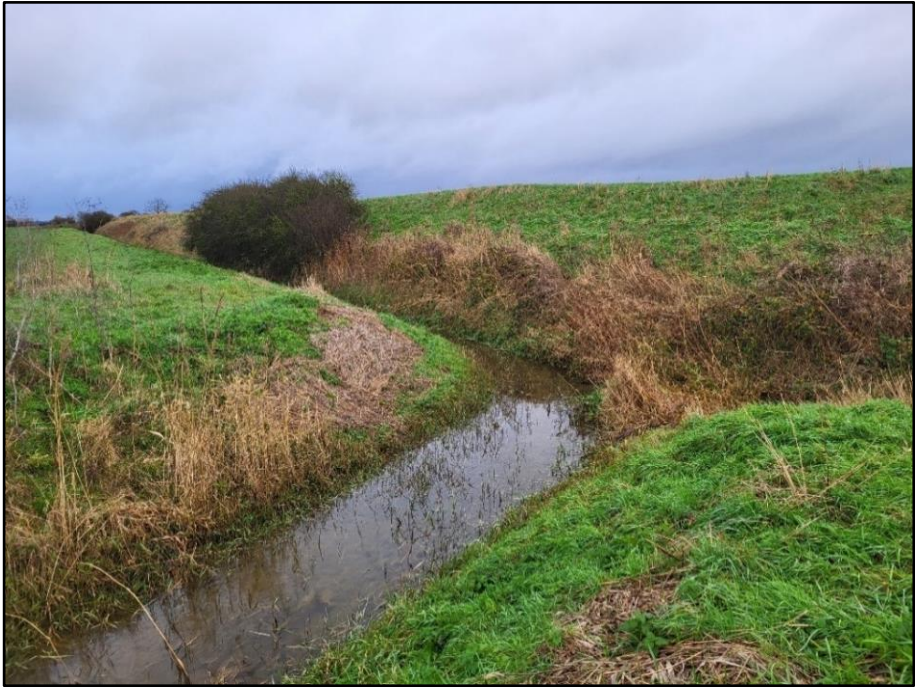
**Description:** Location of WX39. Unnamed drain, with overgrown vegetation in the channel and banks composed of earth material. The left bank c.1.3m, right bank c.1.3m, width c. 2.4m. Water depth is c.0.01m in the channel.
