# BEACON FEN ENERGY PARK

Appendix 11.3 Summary of Watercourse Crossings and Photographs

Document Reference: 6.3 ES Volume 2, 6.3.83

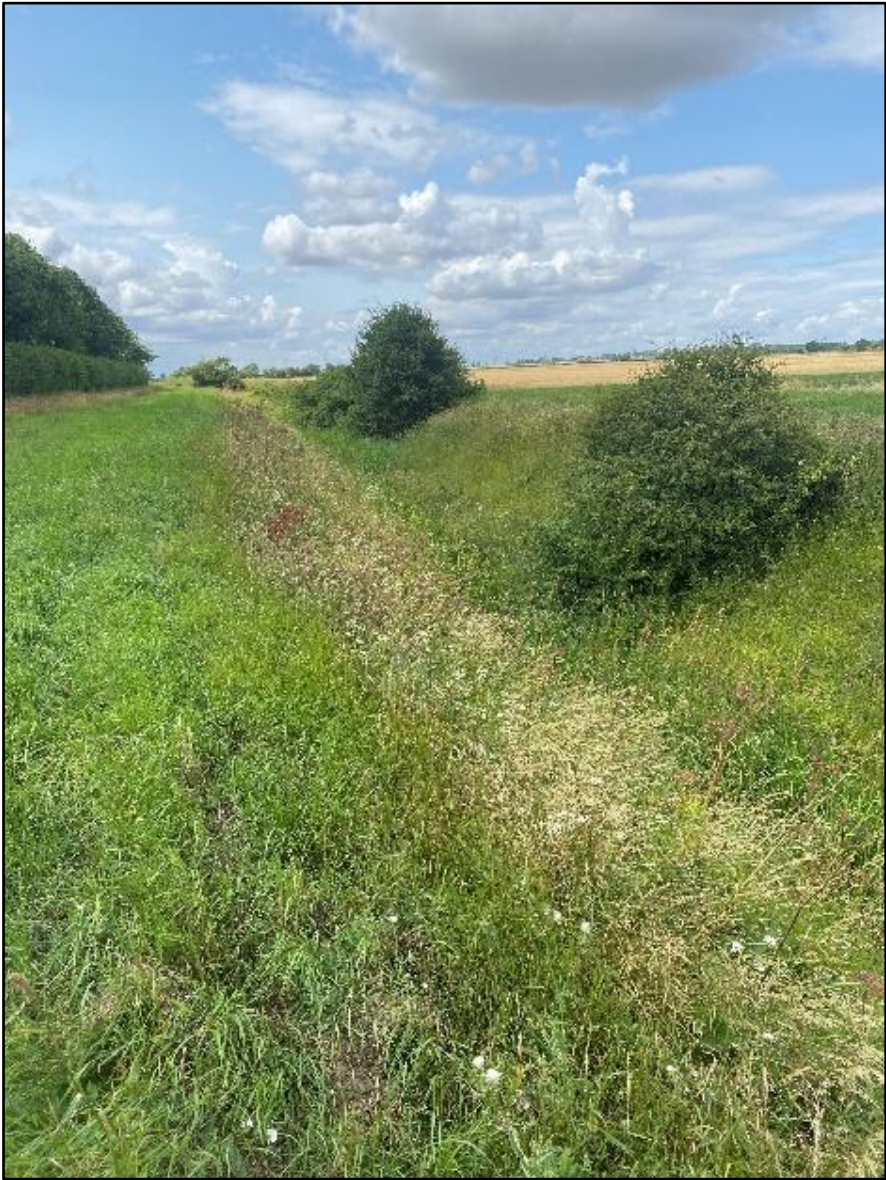
**Photograph Sheet:** 39  
**NGR:** TF 15382 47989  
**Photograph Date:** 3 December 2024  
**Description:** Location of WX41. Unnamed drain, with banks composed of earth material. The left bank c.1.8m, right bank c.1.8m, width c. 3.5m. Water depth is c.0.4m in the channel.

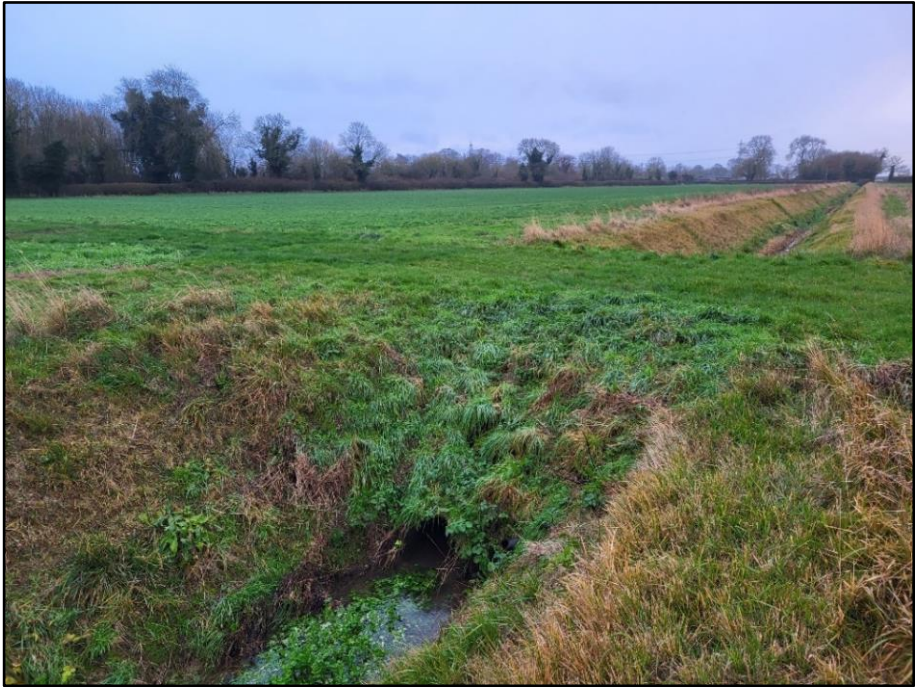
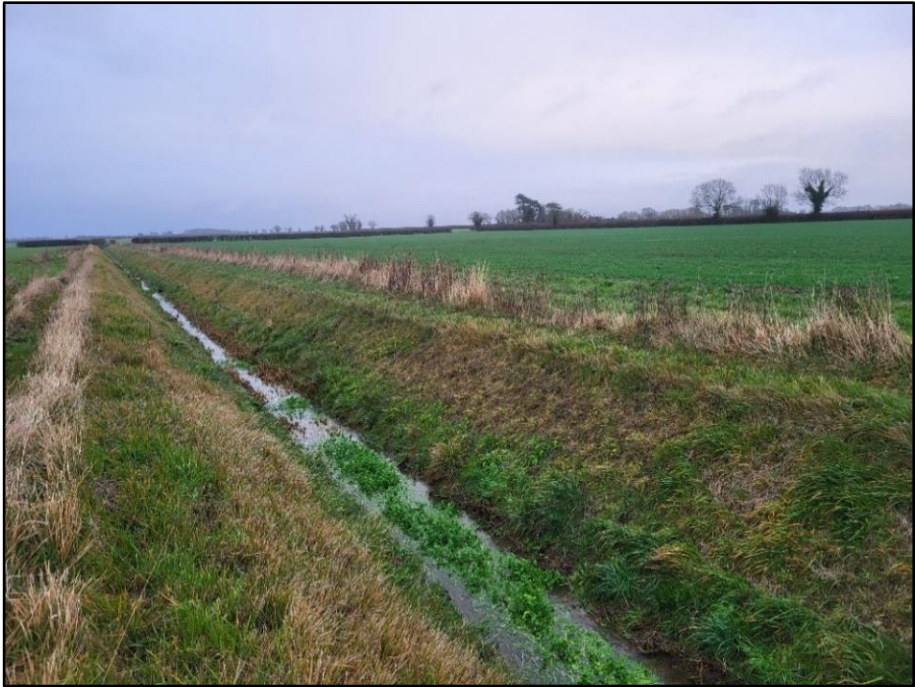
**Photograph Sheet:** 40  
**NGR:** TF 14528 47399  
**Photograph Date:** 13 July 2023  
**Description:** Location of WX40. Hodge Dyke, with overgrown vegetation throughout bank, left bank c.2m, right bank c.2m, width c.5m, depth c.0.3m

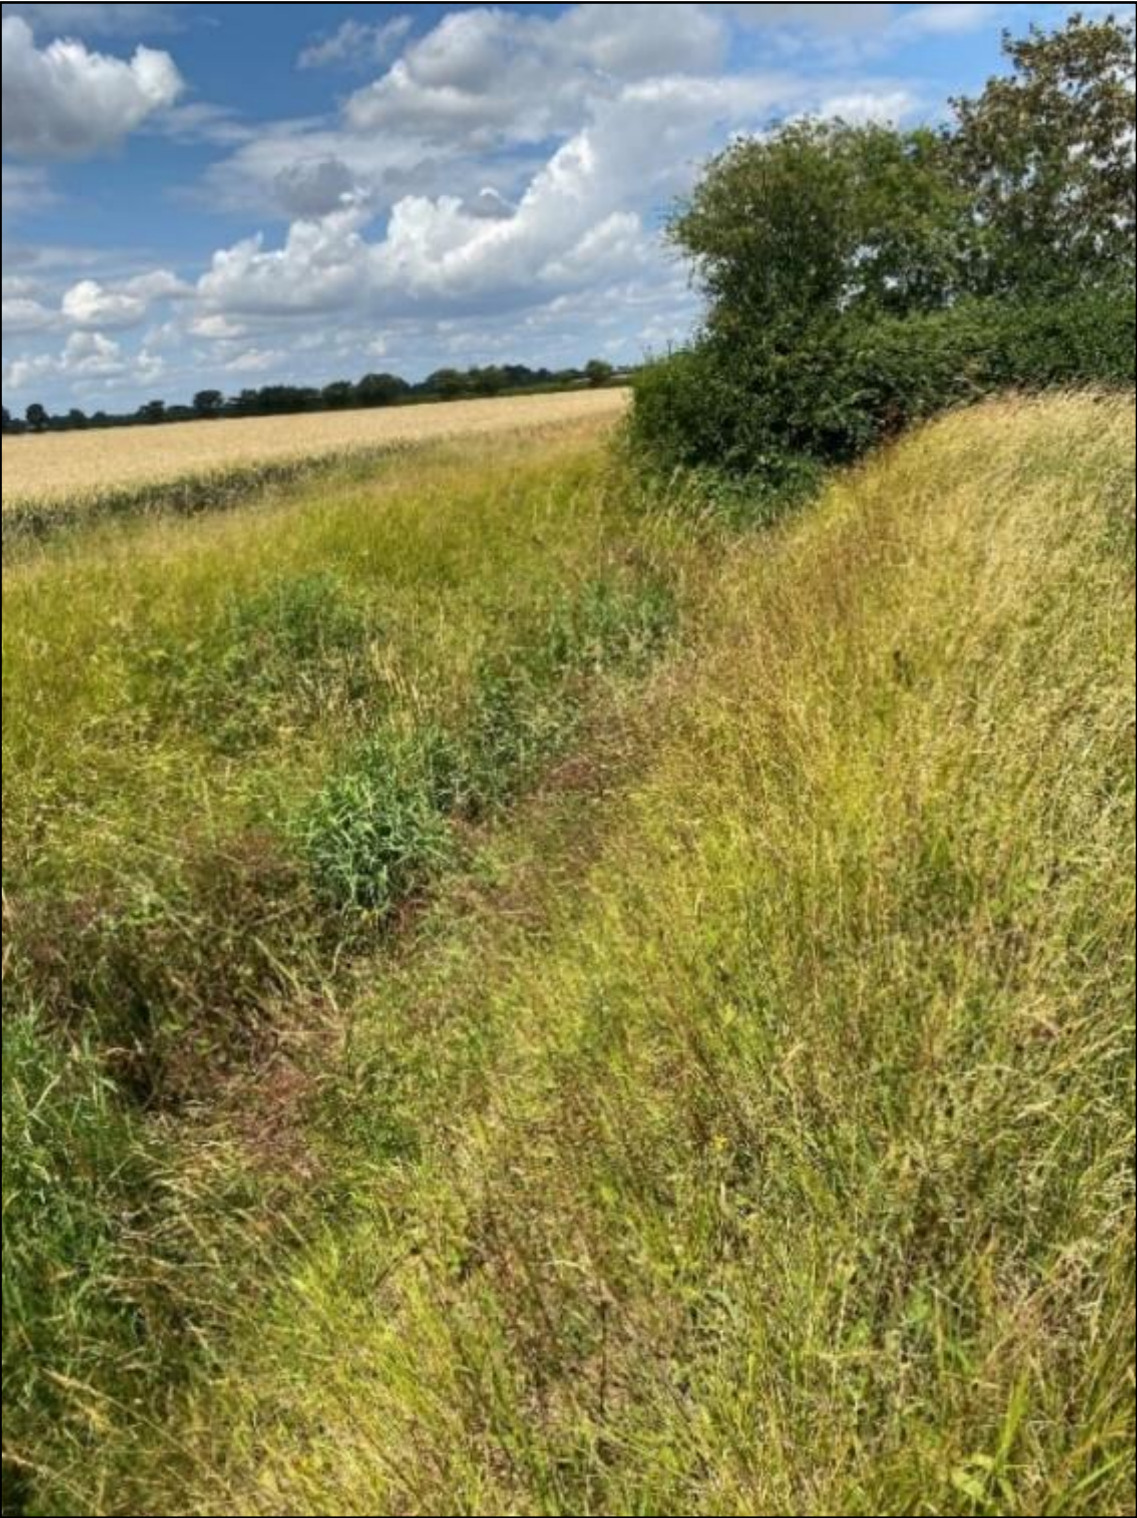
**Description:** Location of WX42. Unnamed drain, with overgrown vegetation in channel and banks composed of earth material. The left bank c.1.4m, right bank c.1.4m, width c. 2.5m. Water depth is c.0.2m in the channel.

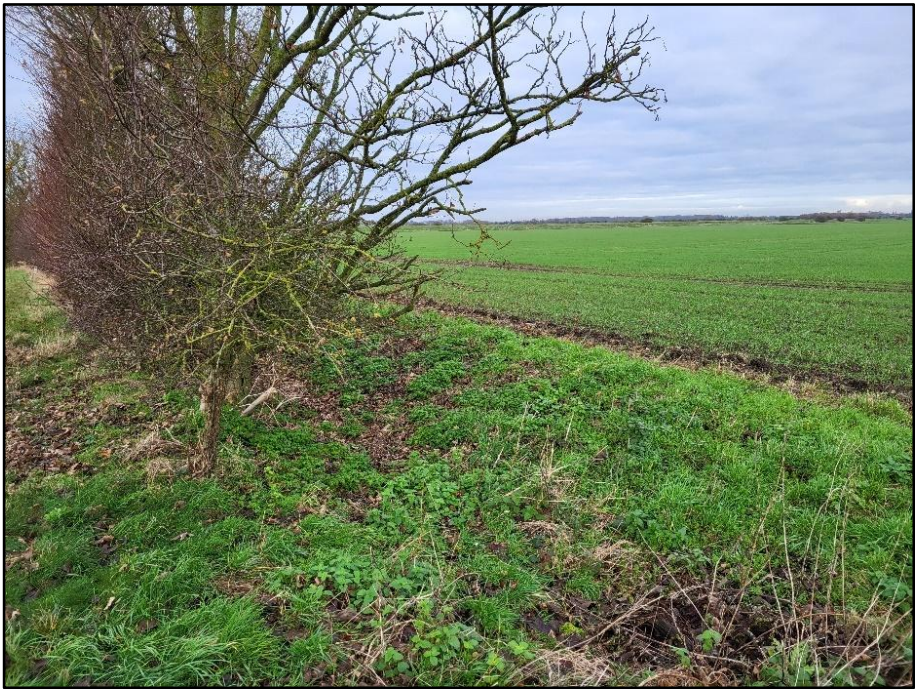
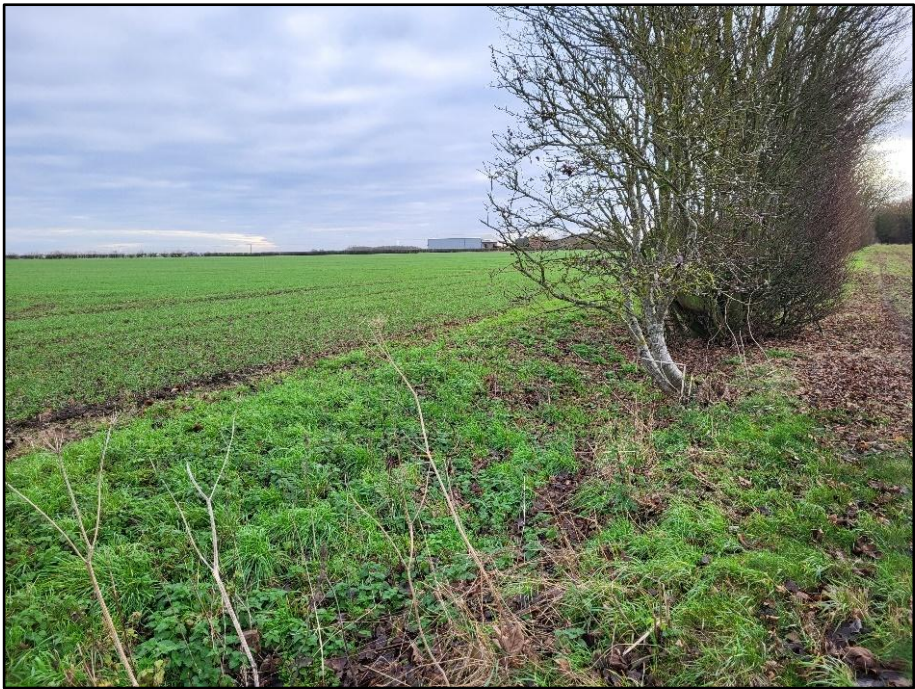
**Description:** Location of WX43. Unnamed drain, with overgrown vegetation throughout channel, left bank c.1.5m, right bank c.1.5m, width c.2m. No water is present in the channel.

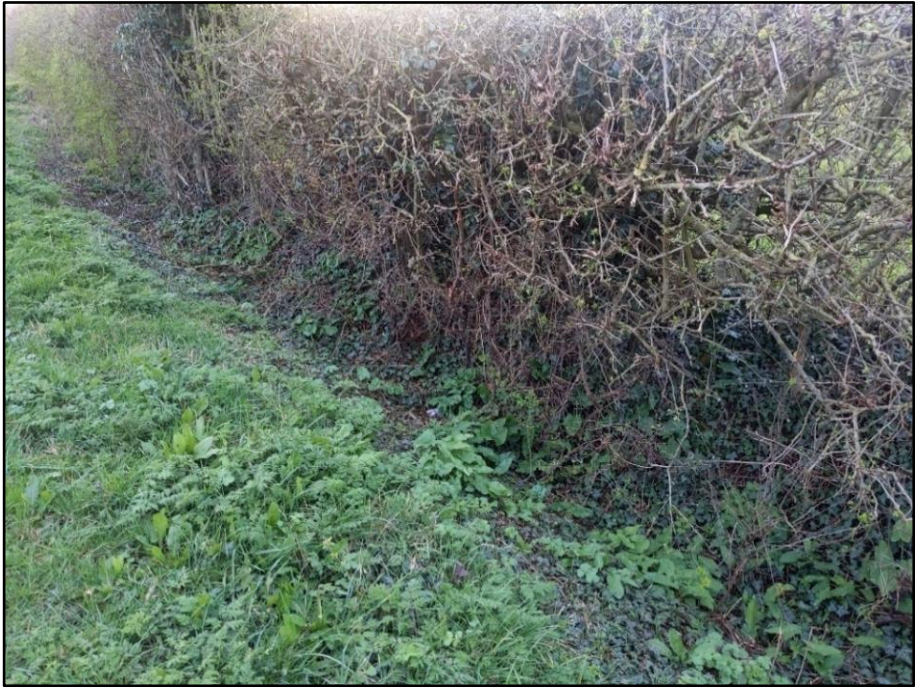
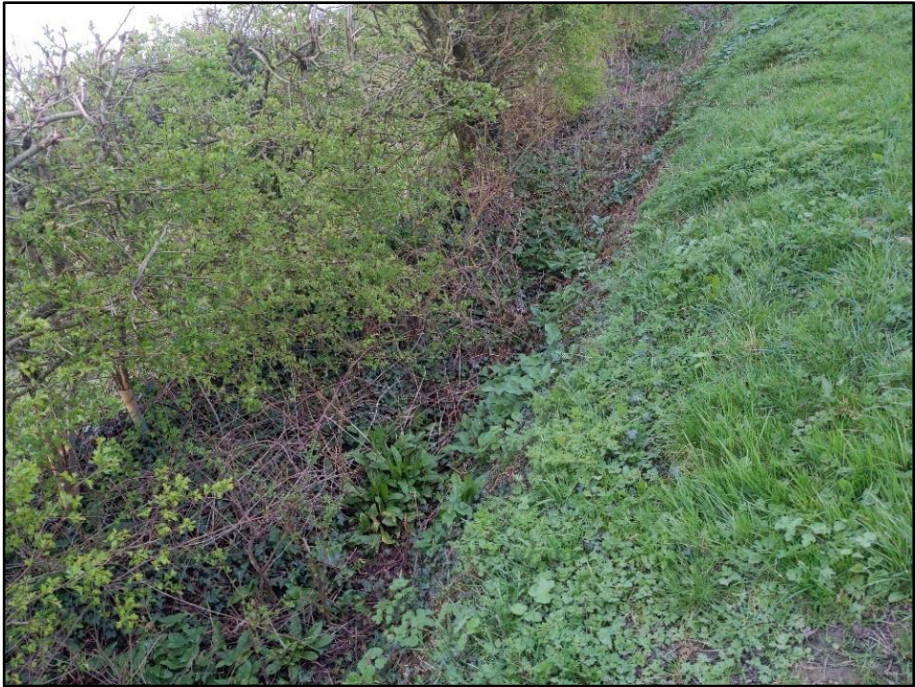
**Description:** Location of WX45. Unnamed drain, with overgrown vegetation in channel and banks composed of earth material. The left bank c.2.0m, right bank c.2.0m, width c. 3.0m. Water depth is c.0.1m in the channel.

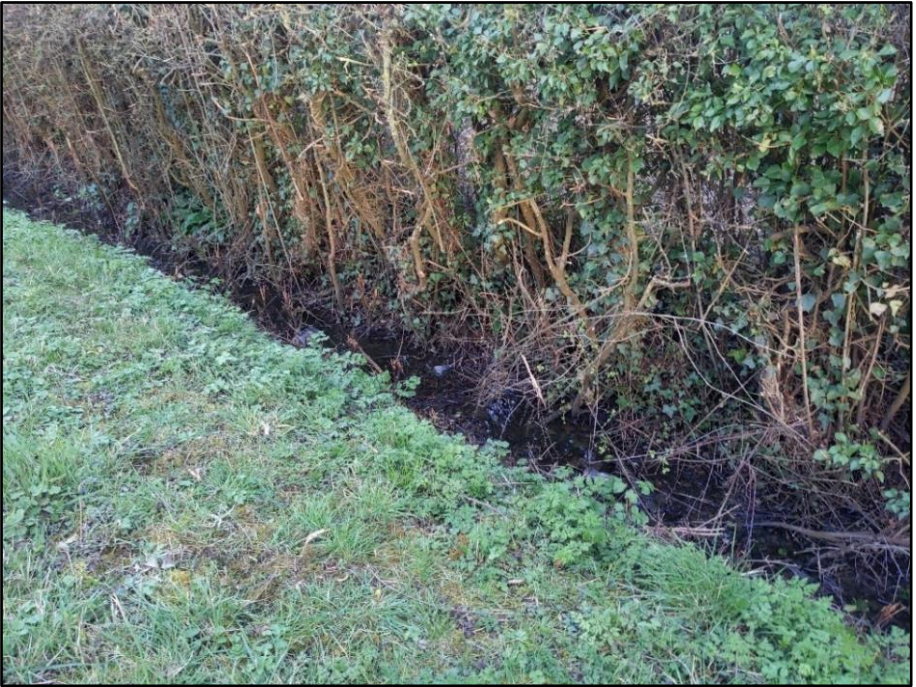
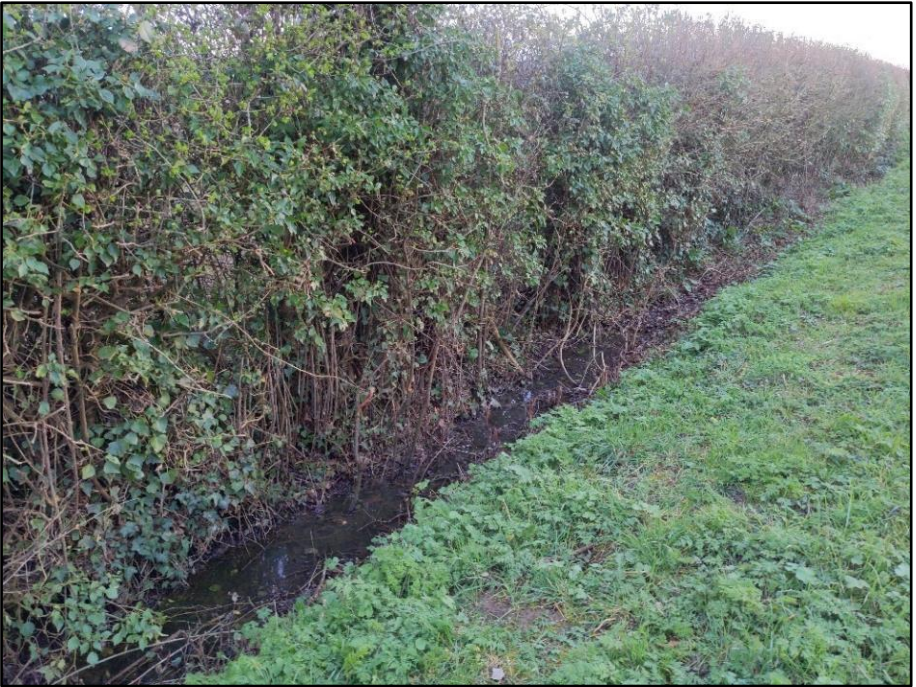
**Description:** Location of WX46. Unnamed drain, with hedgerow along bank and banks composed of earth material. The left bank c.1.0m, right bank c.1.0m, width c. 0.8m. No water present in channel.

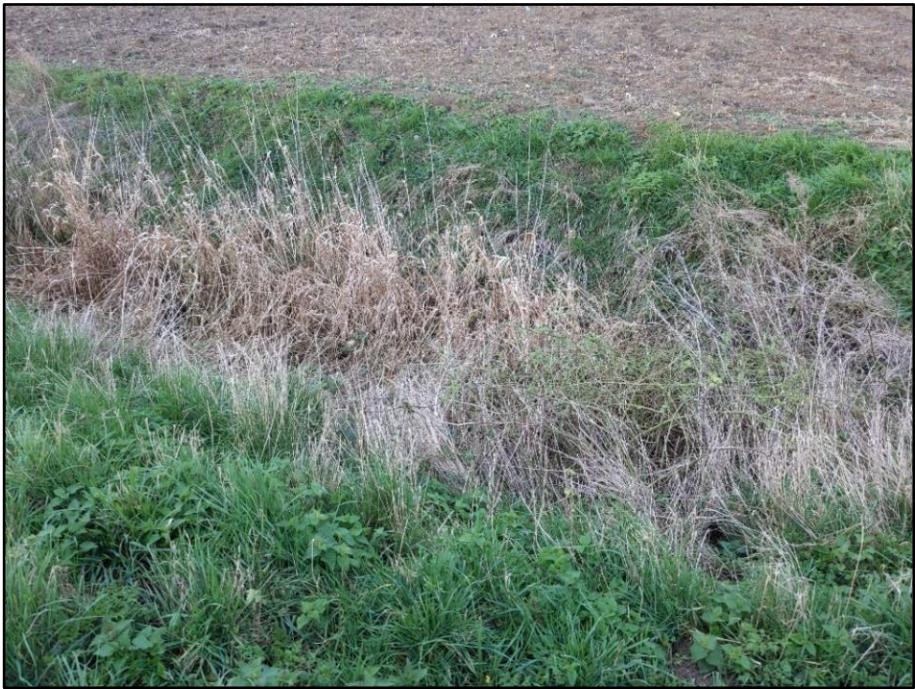
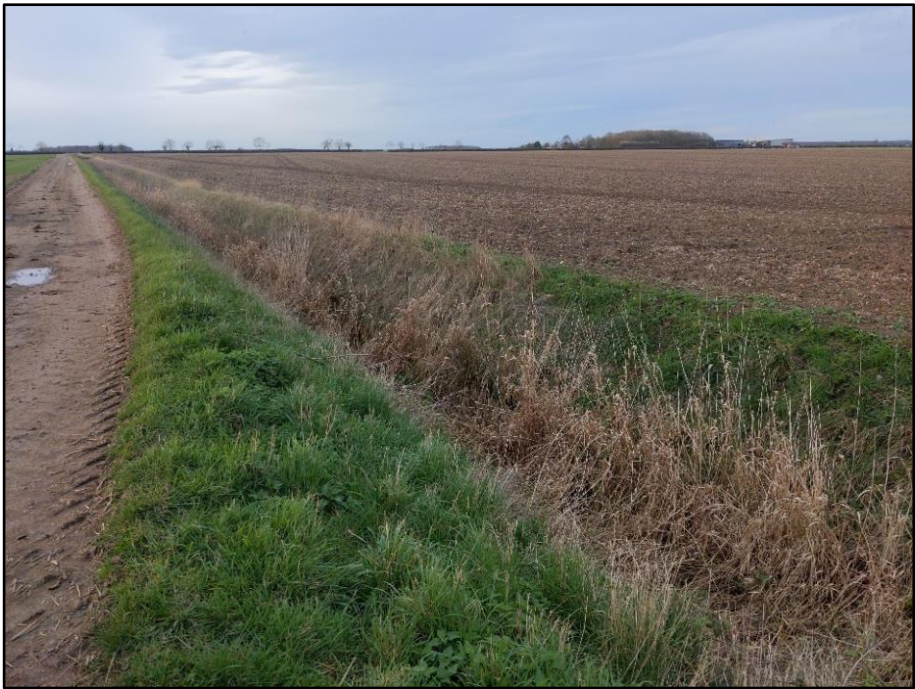
**Description:** Location of WX47. Unnamed drain, with hedgerow along bank and banks composed of earth material. The left bank c.0.8m, right bank c.0.5m, width c. 0.8m. Water Depth is c. 0.1m in channel with a silty substrate.

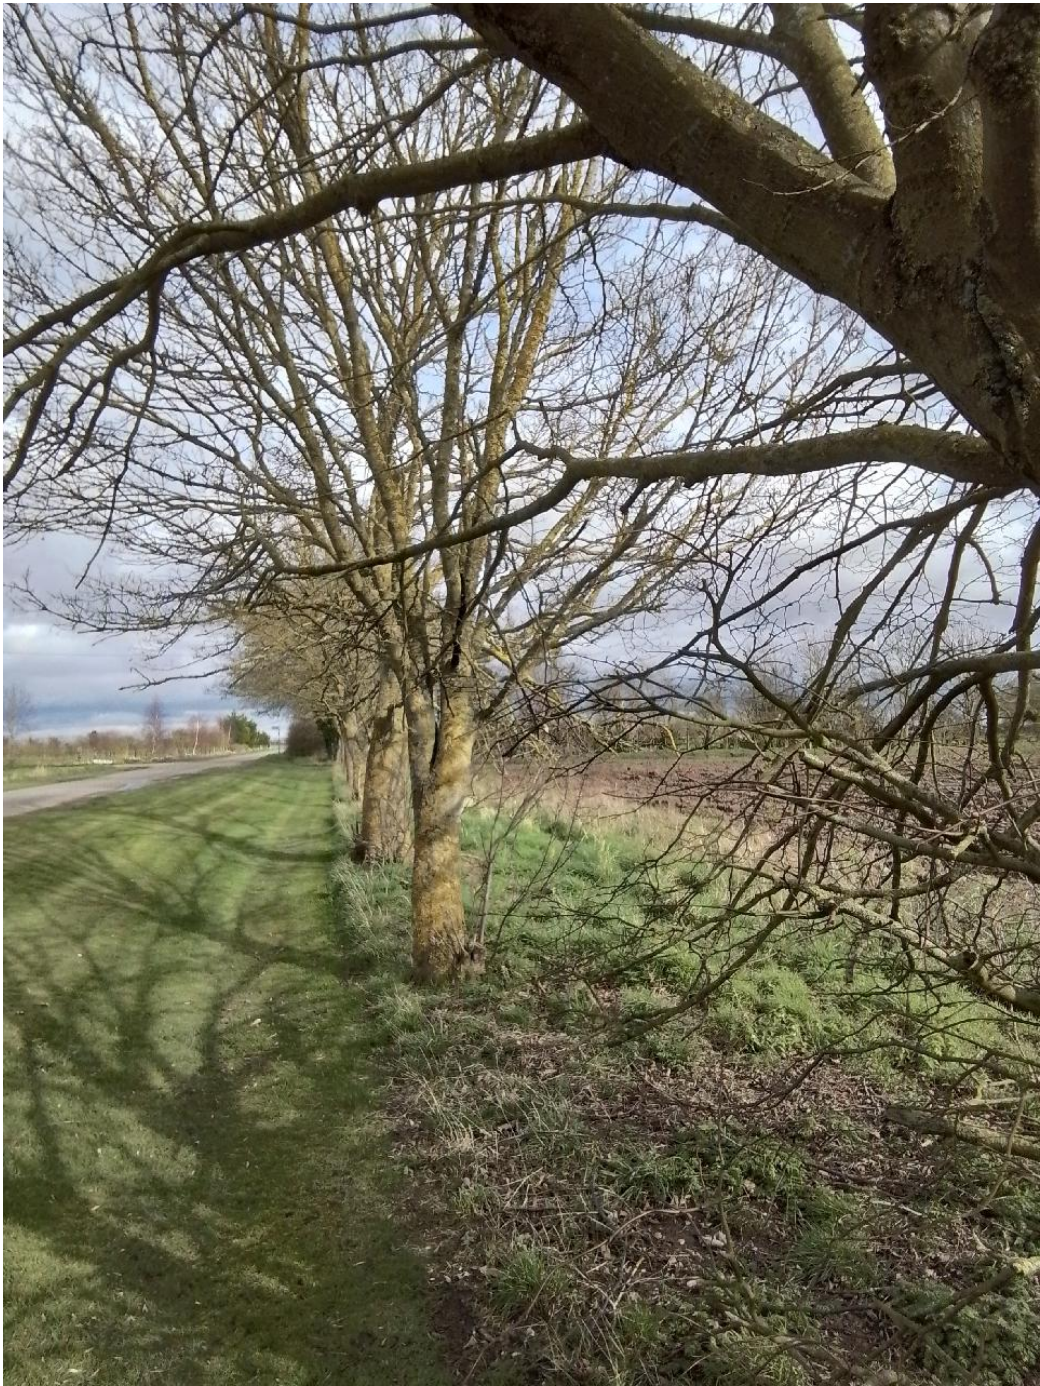
**Photograph Sheet:** 48  
**NGR:** TF 15975 45286  
**Photograph Date:** 19 March 2024  
**Description:** Location of WX50. Unnamed drain, with banks composed of earth material. The left bank c.0.8m, right bank c.0.8m, width c. 1.2m. Water Depth is c. 0.2m in channel with a silty substrate.

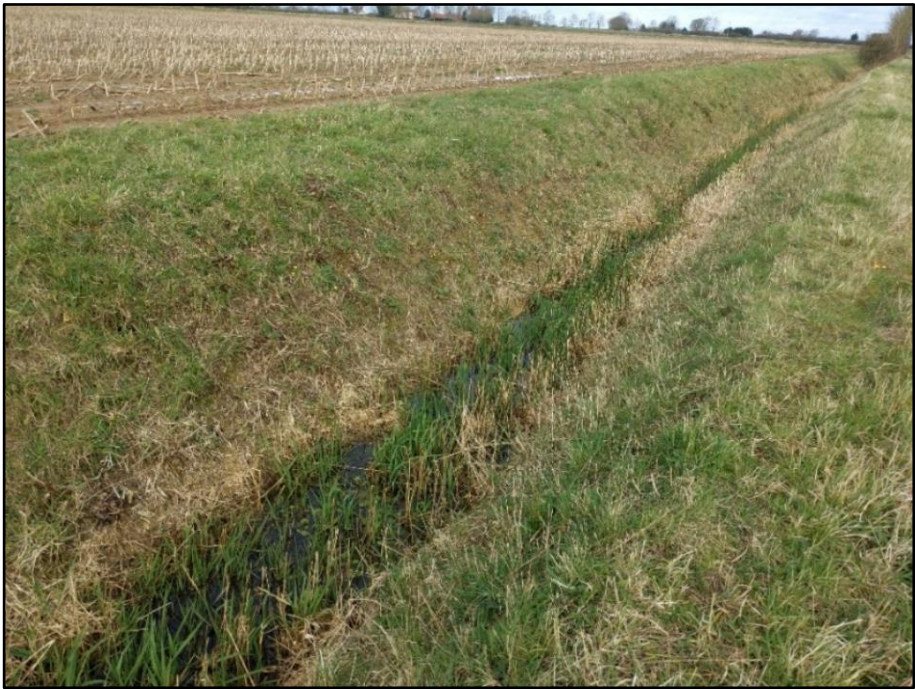
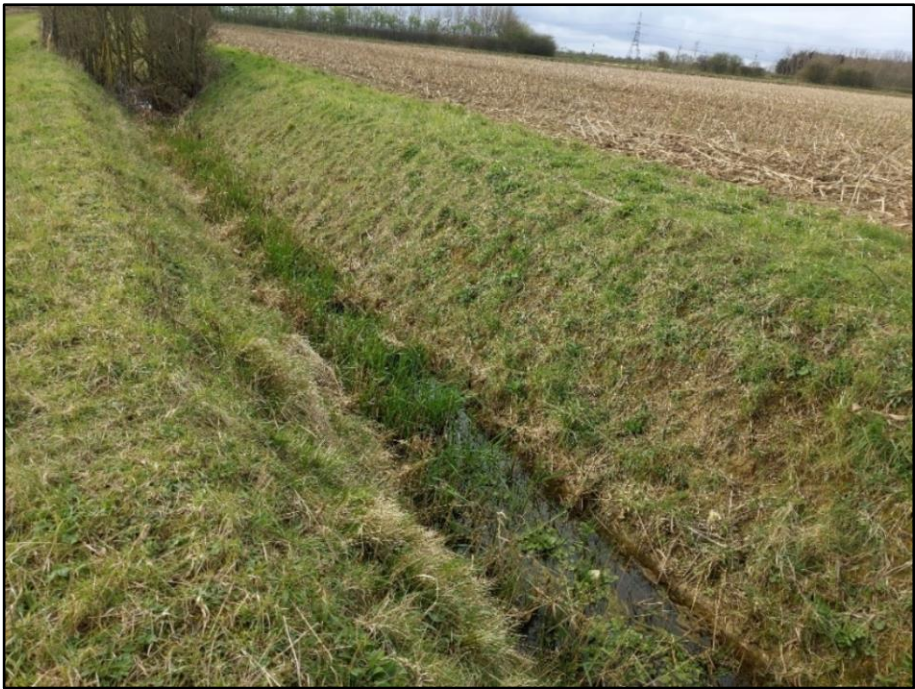
**Photograph Sheet:** 50  
**NGR:** TF 16051 44943  
**Photograph Date:** 19 March 2024  
**Description:** Location of WX52. Unnamed drain, with banks composed of earth material. The left bank c.1.5m, right bank c. 1.5m, width c. 3.0m. Water Depth is c. 0.25m in channel with a silty substrate.

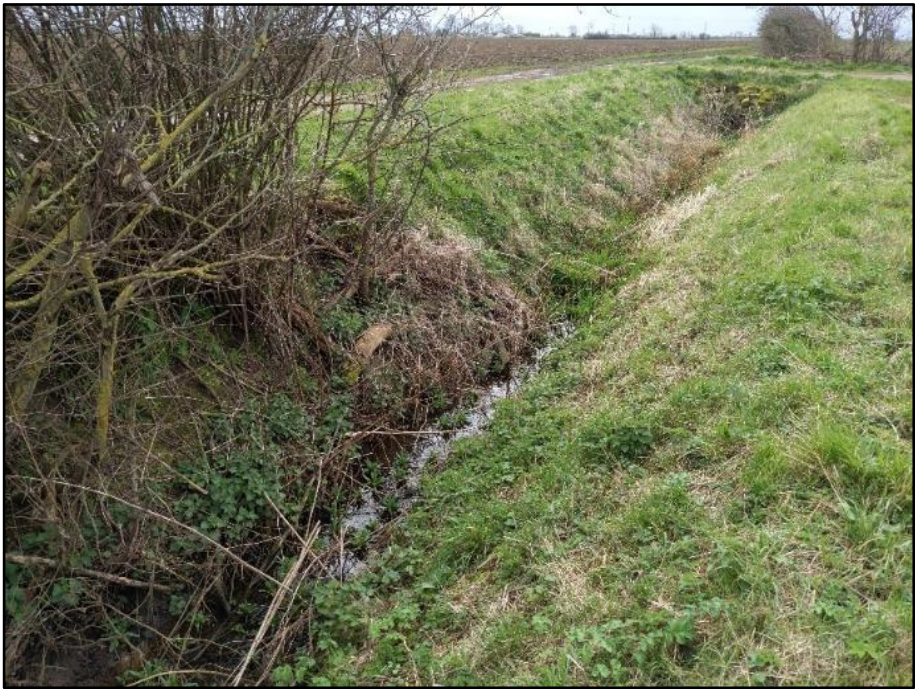
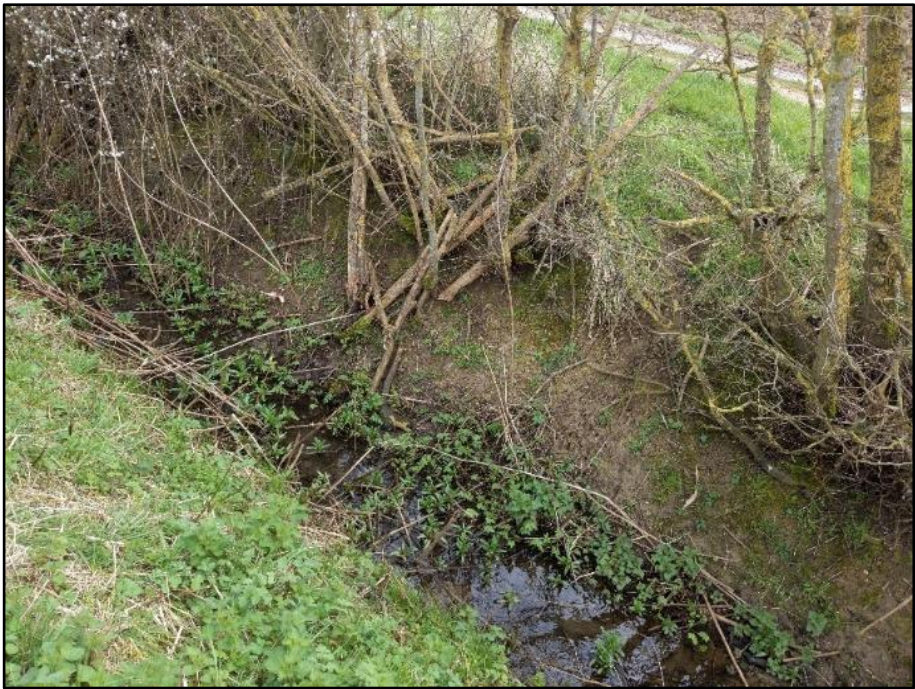
**Description:** Location of WX54. Unnamed drain, with overgrown vegetation throughout channel and banks composed of earth material. The left bank c.1.0m, right bank c. 1.0m, width c. 1.5m. Water Depth is c. 0.02m in channel with a silty substrate.

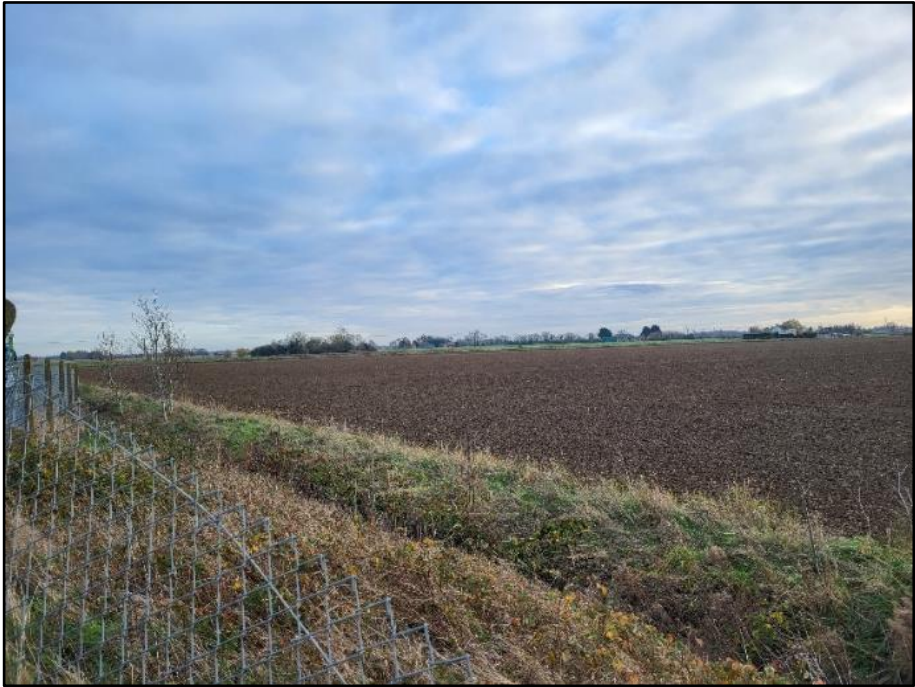
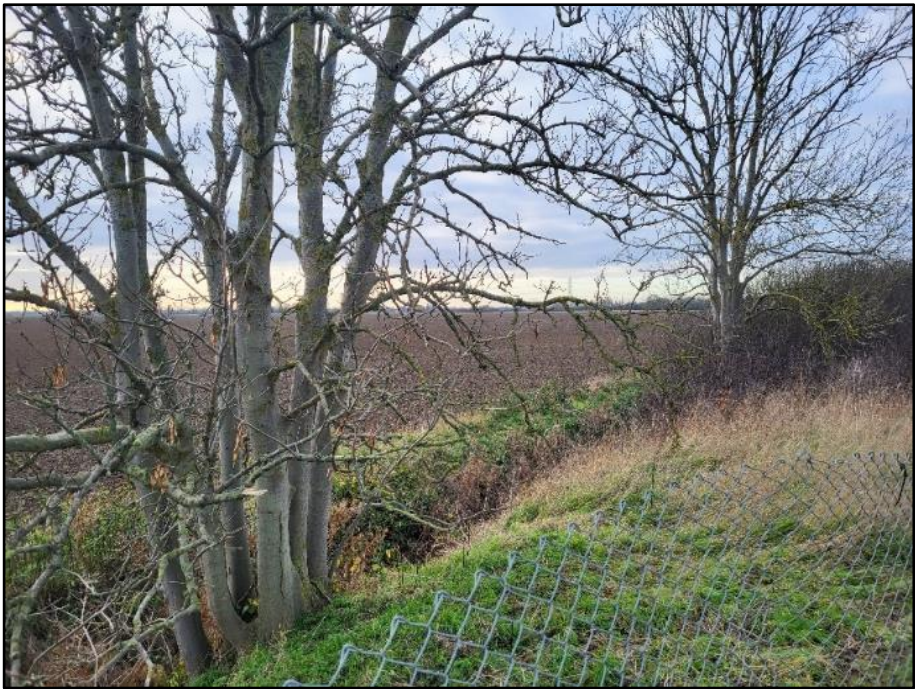
**Description:** Location of WX56. Unnamed drain, with overgrown vegetation throughout channel and banks composed of earth material. The left bank c.0.8m, right bank c. 1.4m, width c. 2.0m. No water present in channel.

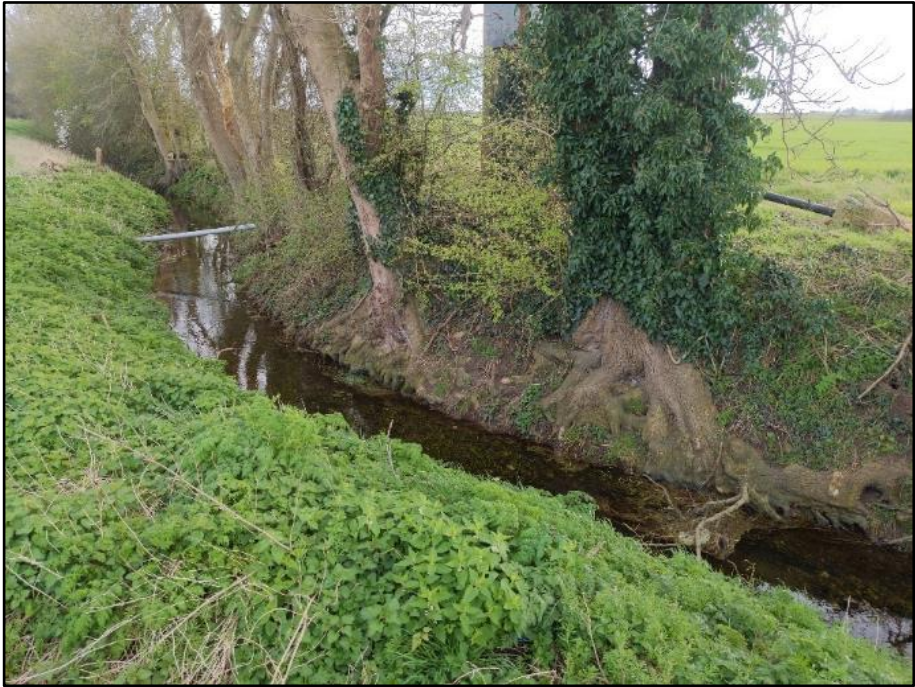
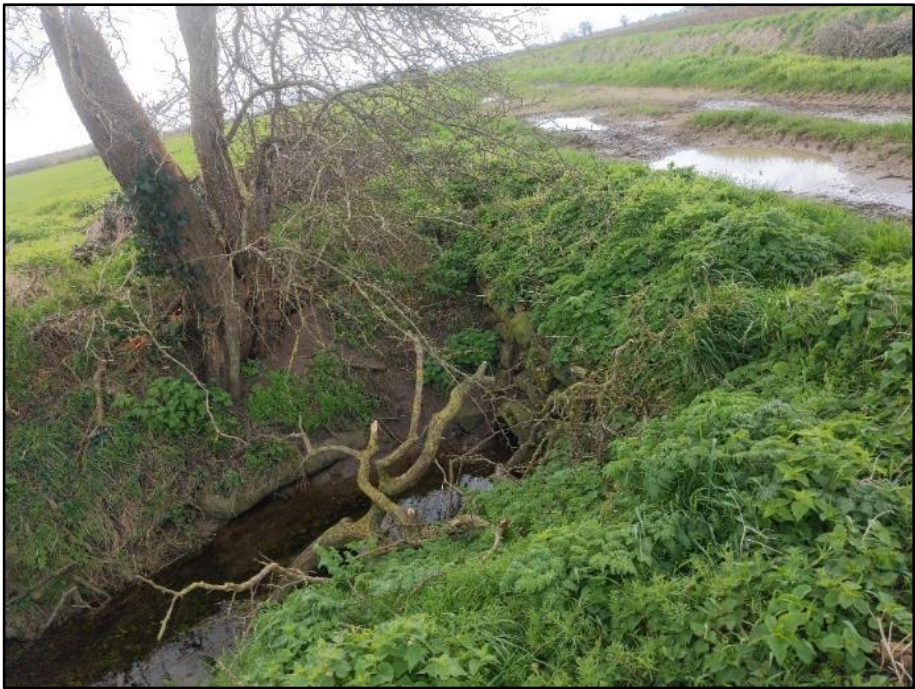
**Description:** Location of WX58. Unnamed drain, with banks composed of earth material. The left bank c.1.5m, right bank c. 1.5m, width c. 2.5m. The water depth is c. 0.7m.

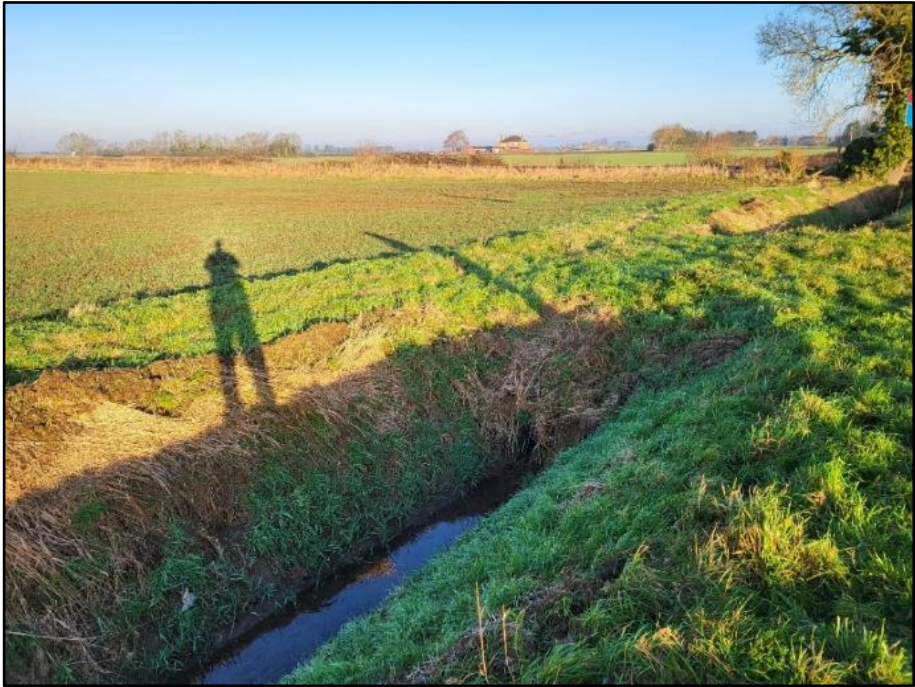
**Description:** Location of WX60. Unnamed drain, with banks composed of silt and earth material. The left bank c.2.0m, right bank c. 2.0m, width c3.0m. The water depth is c0.4m and is culverted downstream.

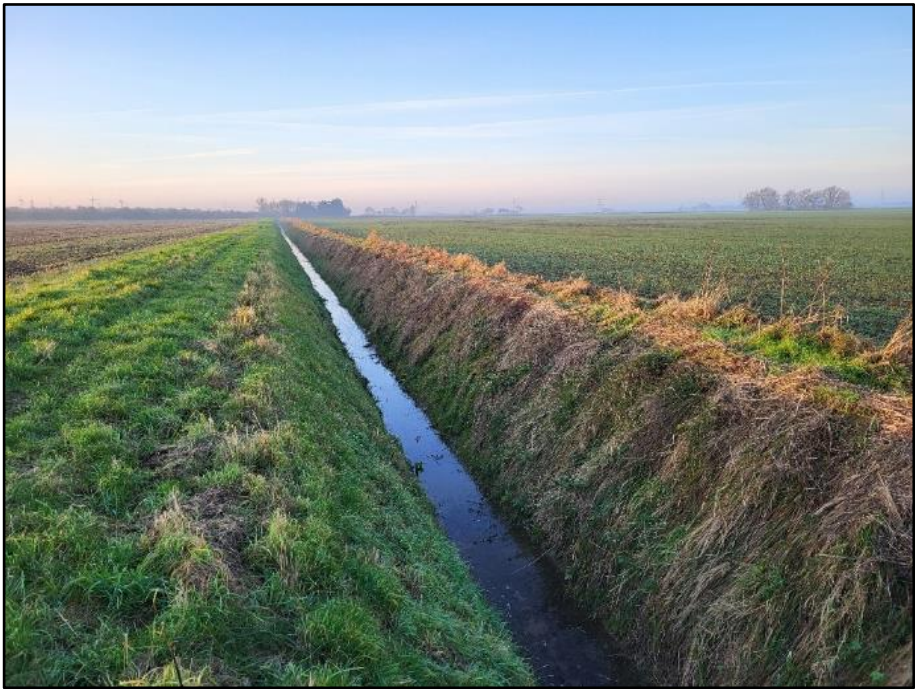
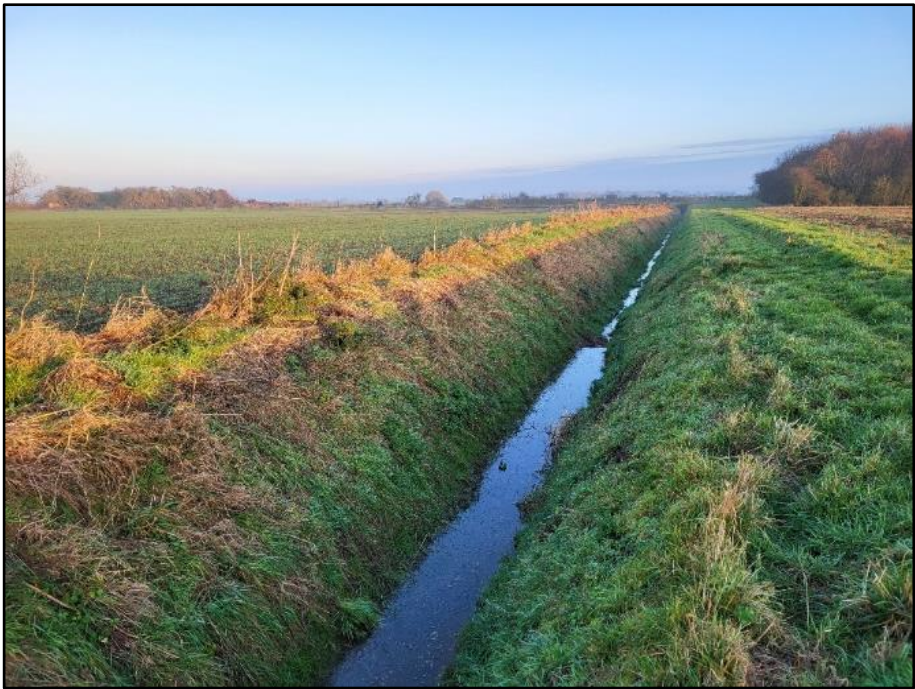
**Photograph Sheet:** 62  
**NGR:** TF 19449 42105  
**Photograph Date:** 3 December 2024  
**Description:** Location of WX64. Unnamed drain, with banks composed of silt and earth material. The left bank c.3.0m, right bank c.3.0m, width c4.5m. The water depth is c0.2m.

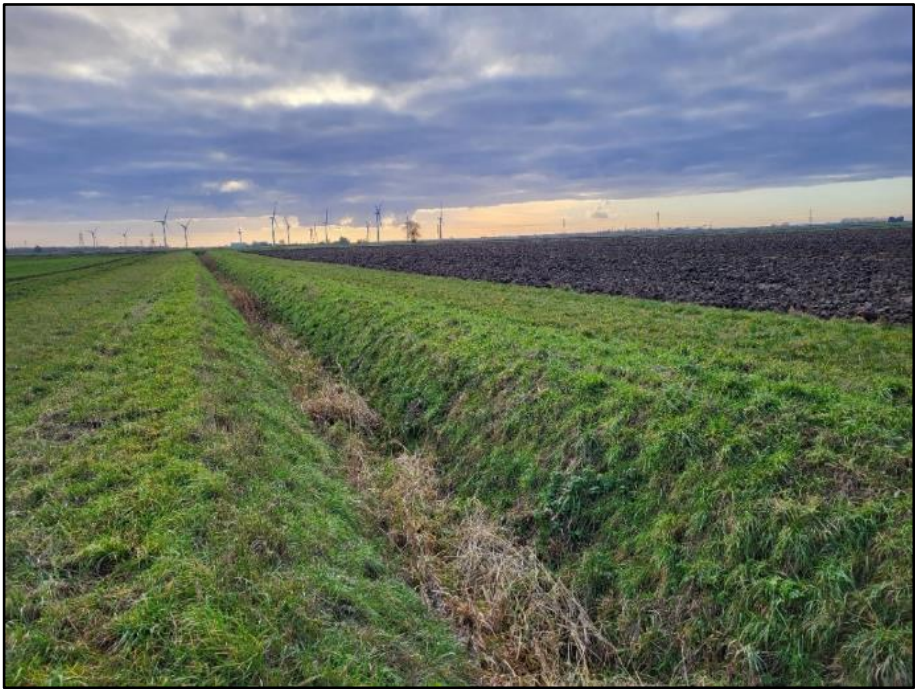
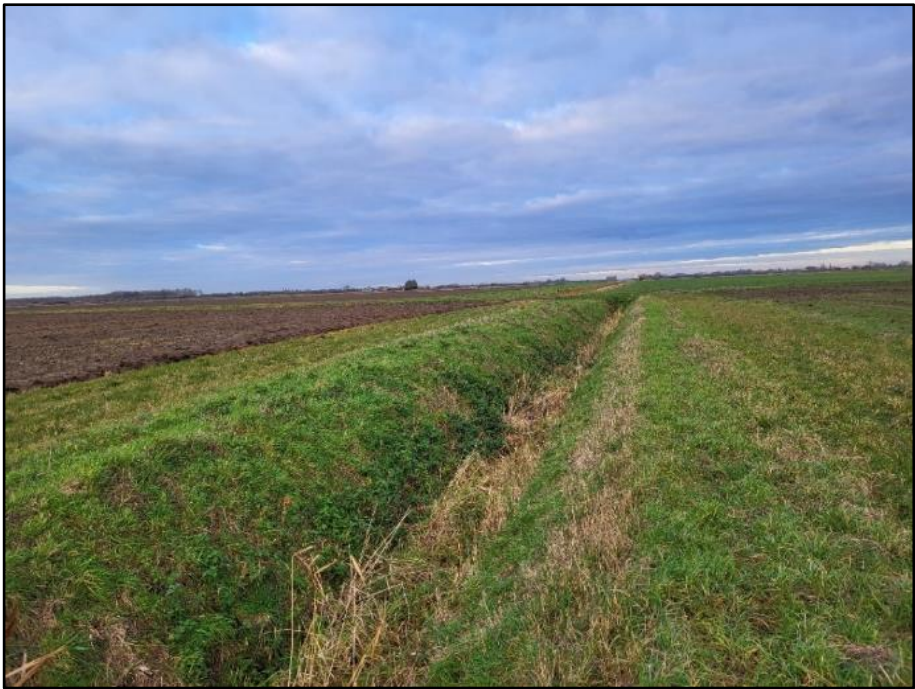
**Photograph Sheet:** 64  
**NGR:** TF 19827 41738  
**Photograph Date:** 3 December 2024  
**Description:** Location of WX66. South Forty Foot Drain, with banks composed of silt and earth material. The left bank is c.6.0m, right bank c.6.0m, width c10.0m.

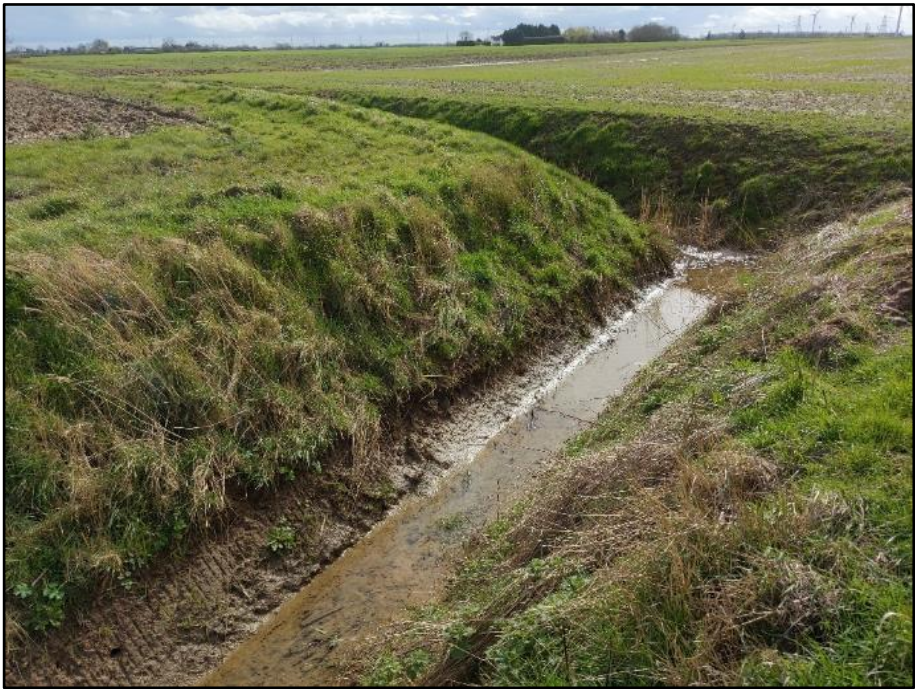
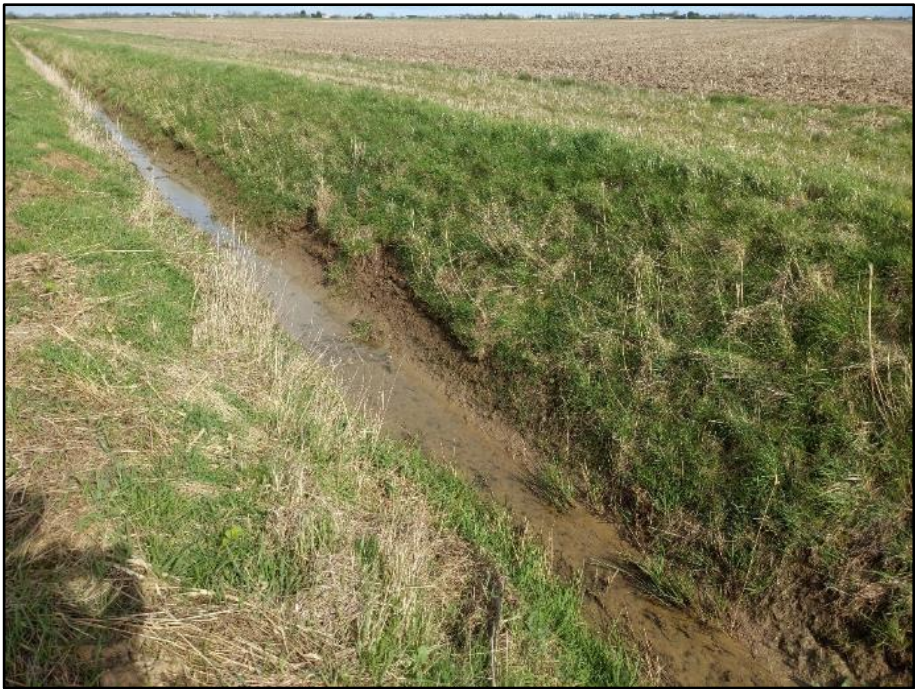
**Photograph Sheet:** 66  
**NGR:** TF 20528 40395  
**Photograph Date:** 3 December 2024  
**Description:** Location of WX68. Unnamed drain, with banks composed of silt and earth material. The left bank c.2.0m, right bank c.2.0m, width c3.5m. Water depth of c.0.2m in the channel.

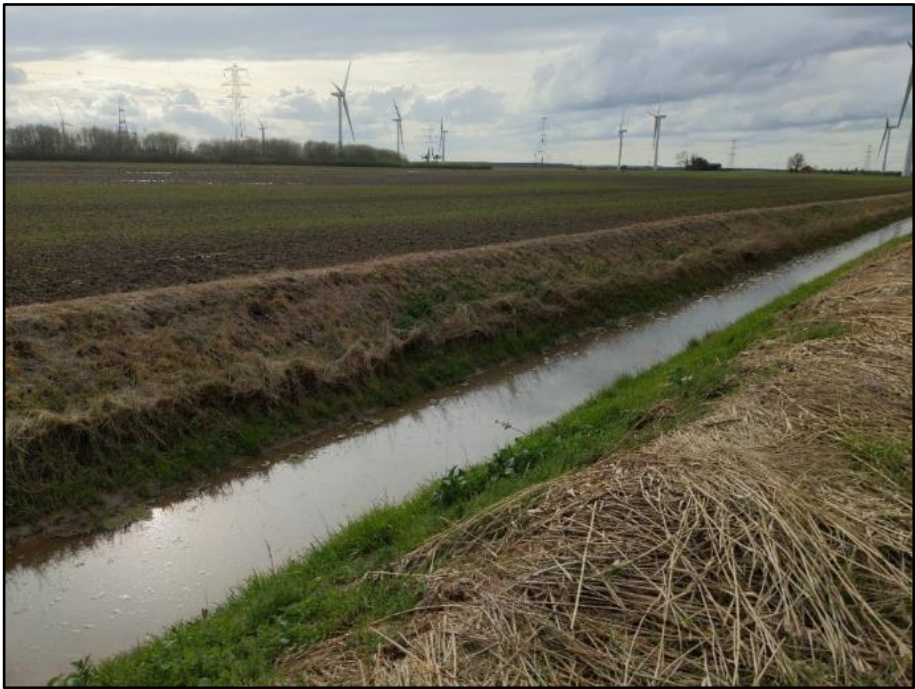
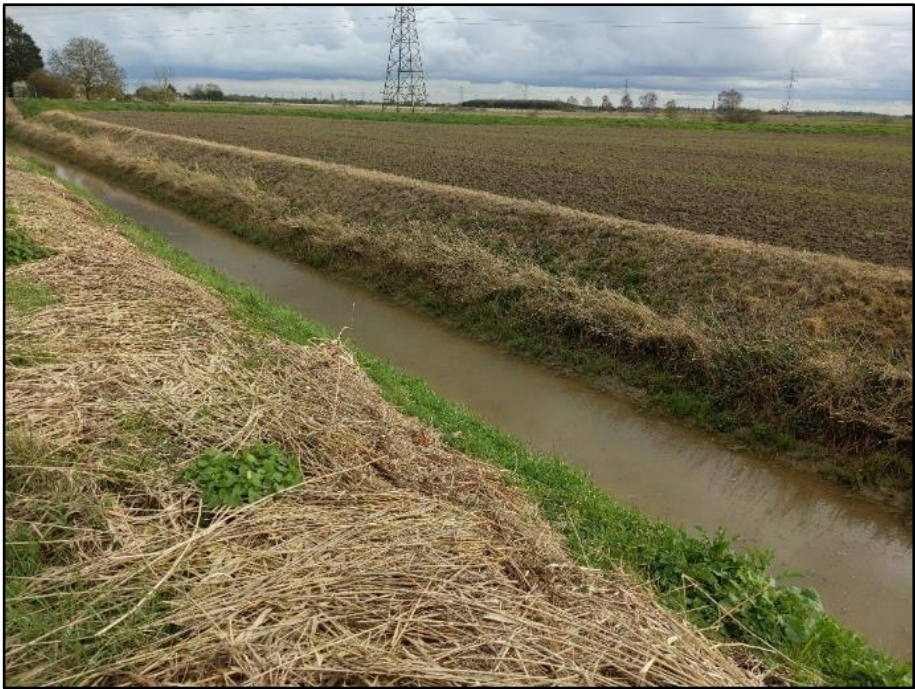
**Photograph Sheet:** 68  
**NGR:** TF 20364 39432  
**Photograph Date:** 19 March 2024  
**Description:** Location of WX70. Unnamed drain, with banks composed of silt and earth material. The left bank c.2.0m, right bank c.2.0m, width c2.5m. Water depth of c.0.3m in the channel.
