# BEACON FEN ENERGY PARK

Appendix 11.3 Summary of Watercourse Crossings and Photographs

Document Reference: 6.3 ES Volume 2, 6.3.83

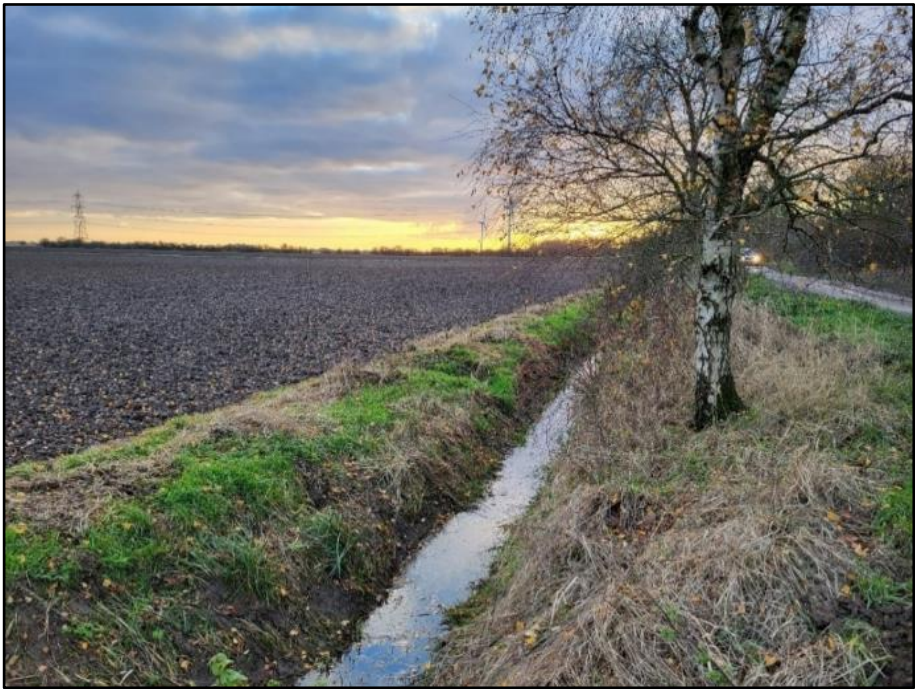
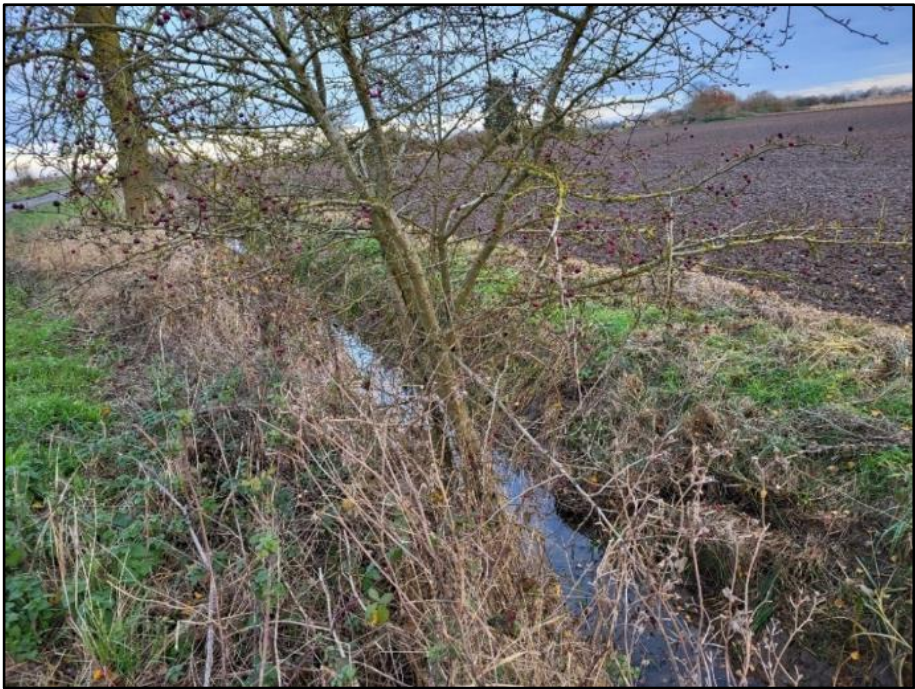
Description: Location of WX72. Unnamed drain, with banks composed of earth material and a silty and earth channel substrate. The left bank c.1.2m, right bank c.1.3m, width c.2.0m. Water depth of c.0.08m in the channel and culverted.

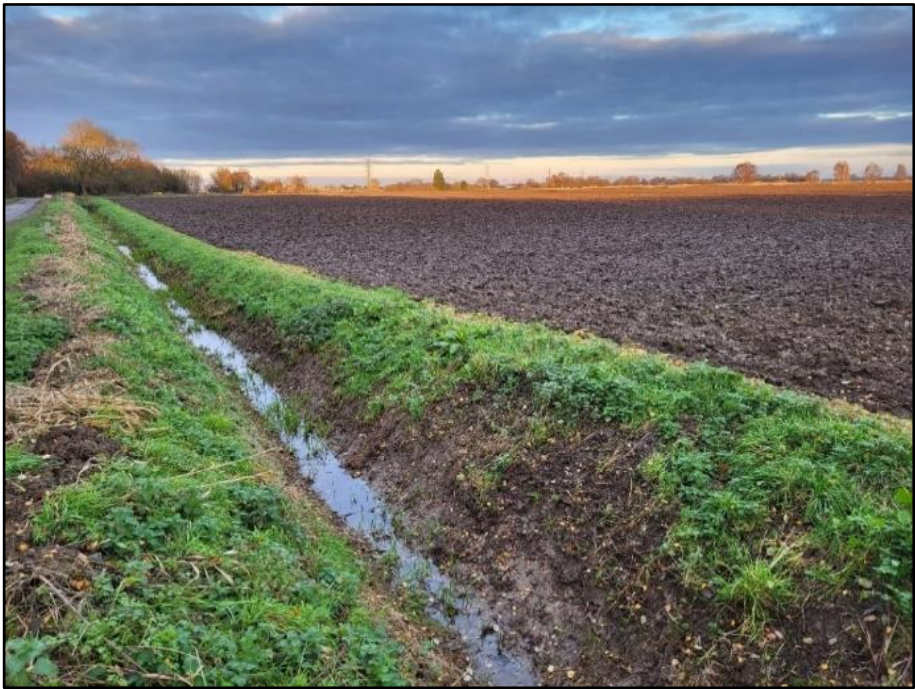
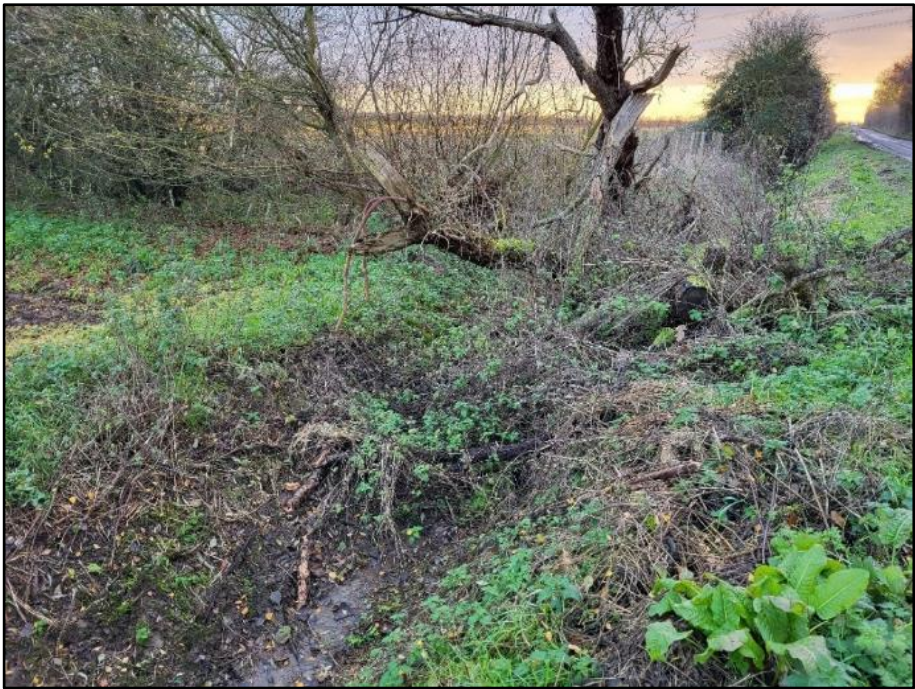
Description: Location of WX74. Unnamed drain, with vegetation throughout the channel and banks composed of earth material. The left bank c.1.0m, right bank c.1.0m, width c.1.5m. No water present in channel.

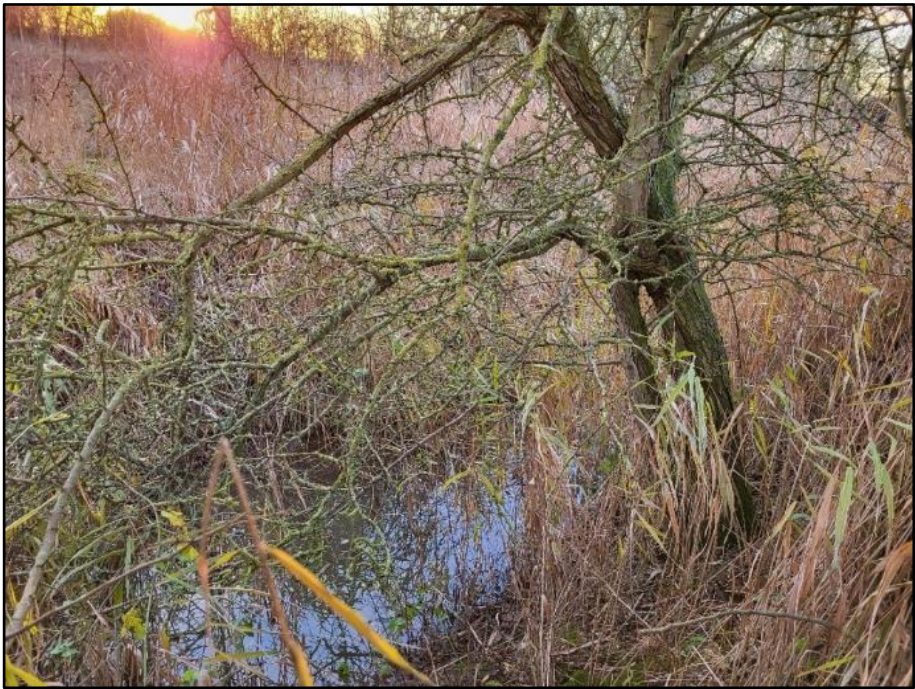
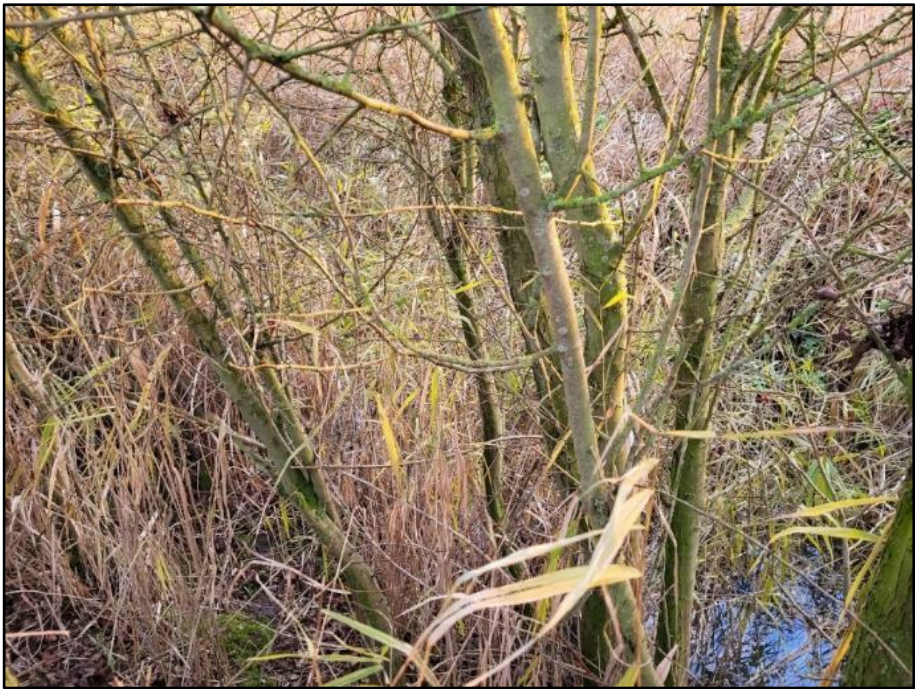
Description: Location of WX76. Unnamed drain, with overgrown vegetation throughout the channel. The left bank c.0.6m, right bank c.0.6m, width c.1.0m. No water present in channel.

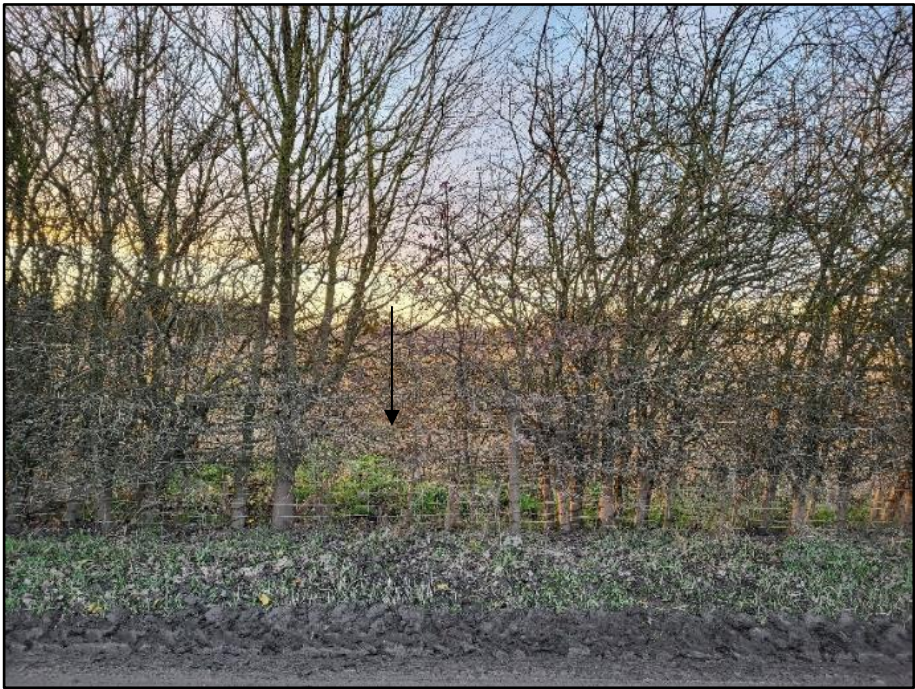
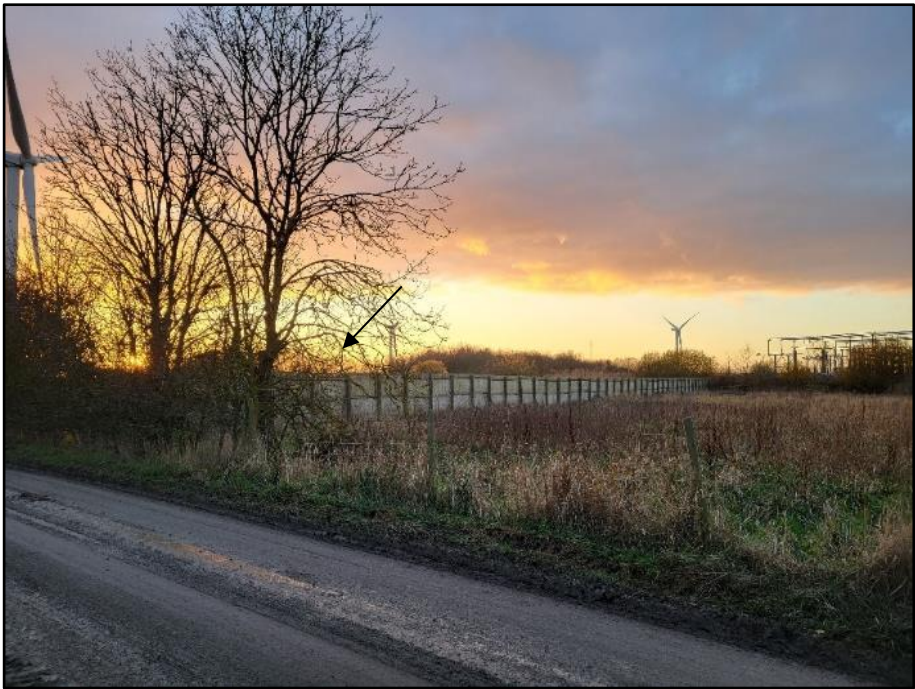
**Description:** Location of WX78. Unnamed drain, with banks composed of earth material and earth and silt substrate in the channel. The left bank c.1.2m, right bank c.1.2m, width c.3.0m. Water depth is approximately c.0.3m with no perceivable flow.
