Planning Inspectorate Reference: EN010151

Appendix 11.3 Summary of Watercourse Crossings and Photographs

Document Reference: 6.3 ES Volume 2, 6.3.83

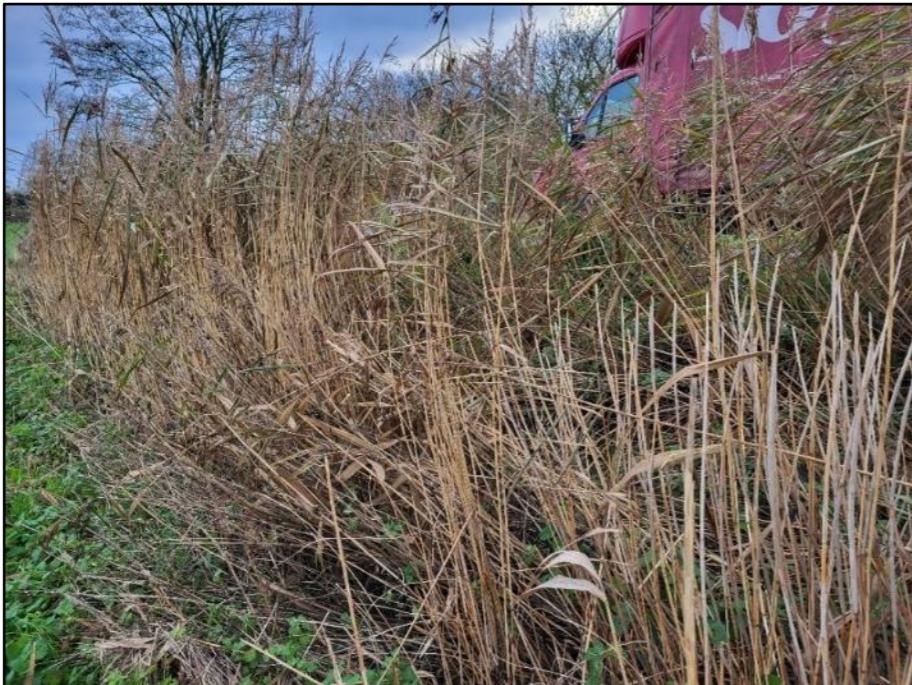
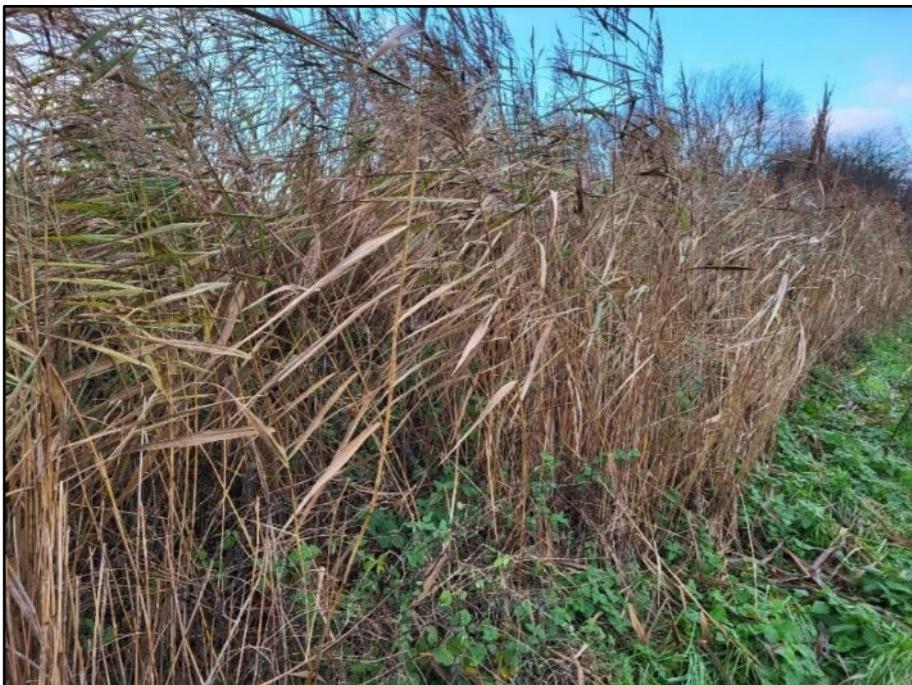
01

Location of WX01. Unnamed drain, with overgrown vegetation throughout bank, left bank; with overgrown vegetation throughout bank, looking downstream left bank c.0.4m, right bank c.0.8m, width c.0.9m, water depth c.0.0m

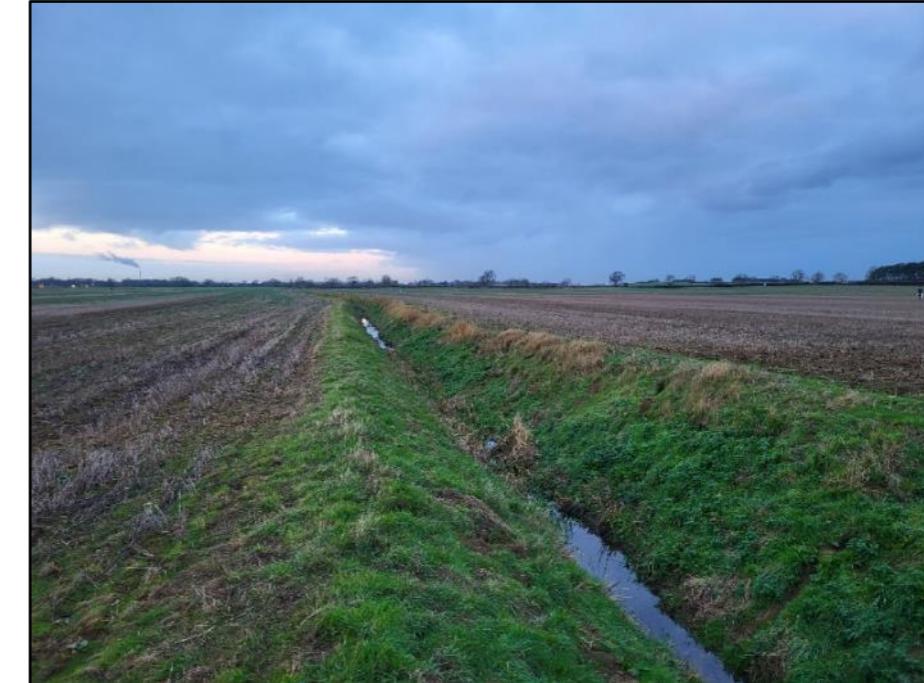
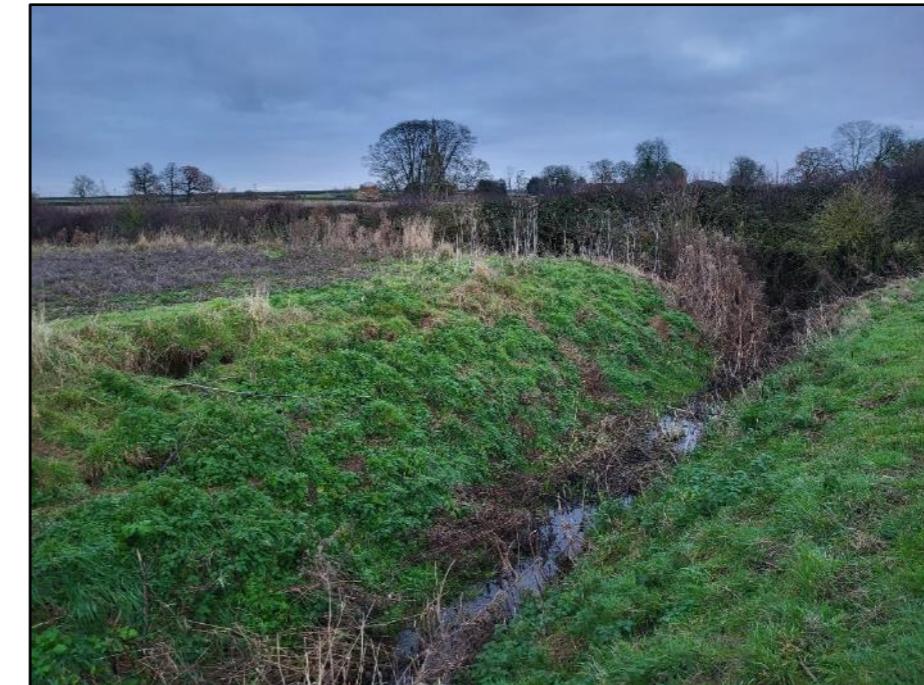
02

Location of WX02. Unnamed drain, slightly overgrown looking downstream, left bank c.1.2m, right bank c.1.2m, width c.2.0m, water depth c.0.4m.

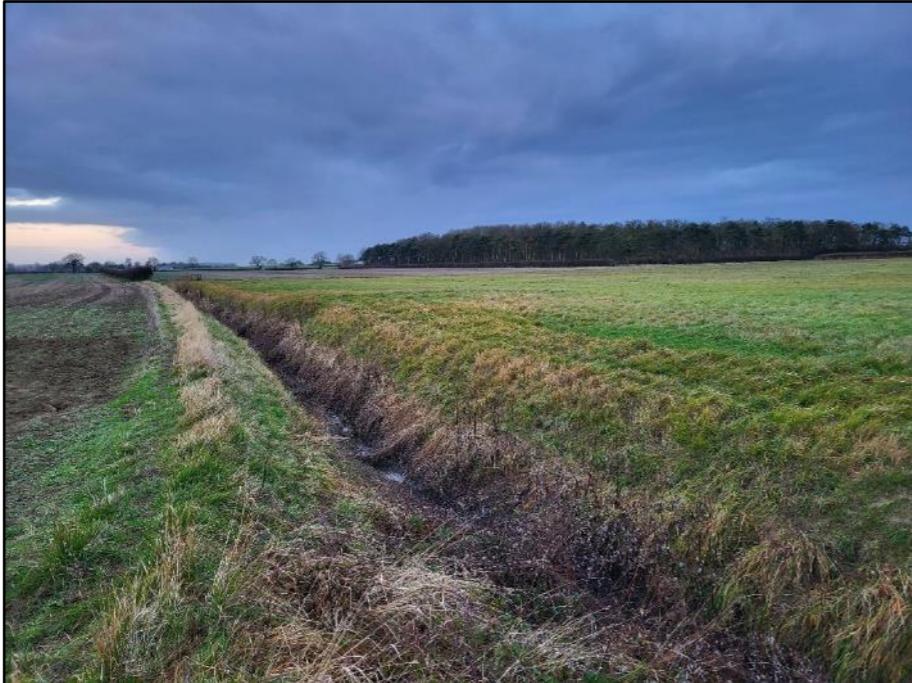
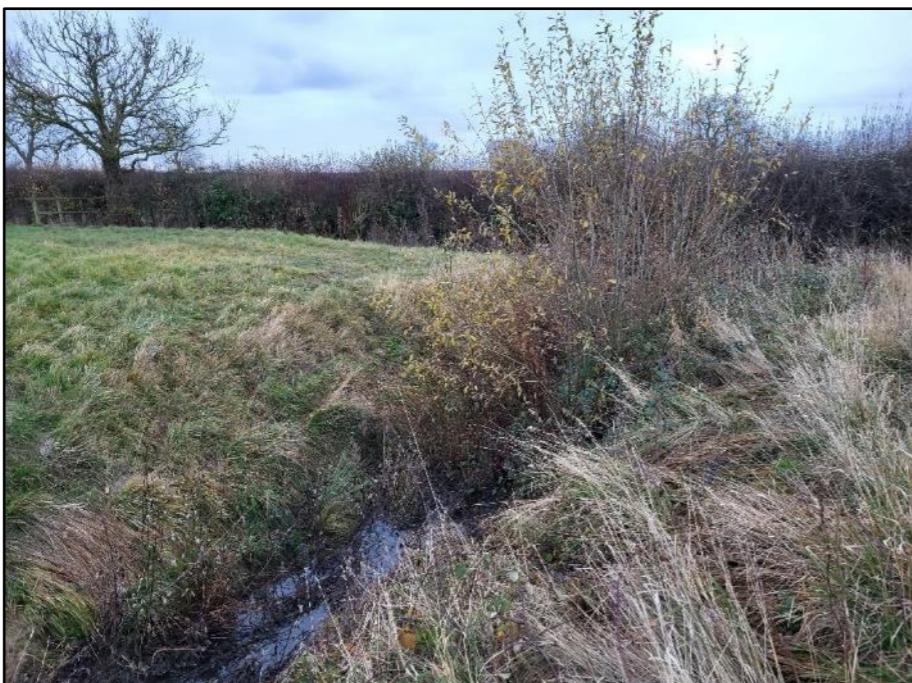
03

Location of WX03. Unnamed drain, with overgrown vegetation throughout channel, left bank c.1.2m, right bank c.1.5m, width c.2.5m, Water depth c.0.1m. Facing upstream.

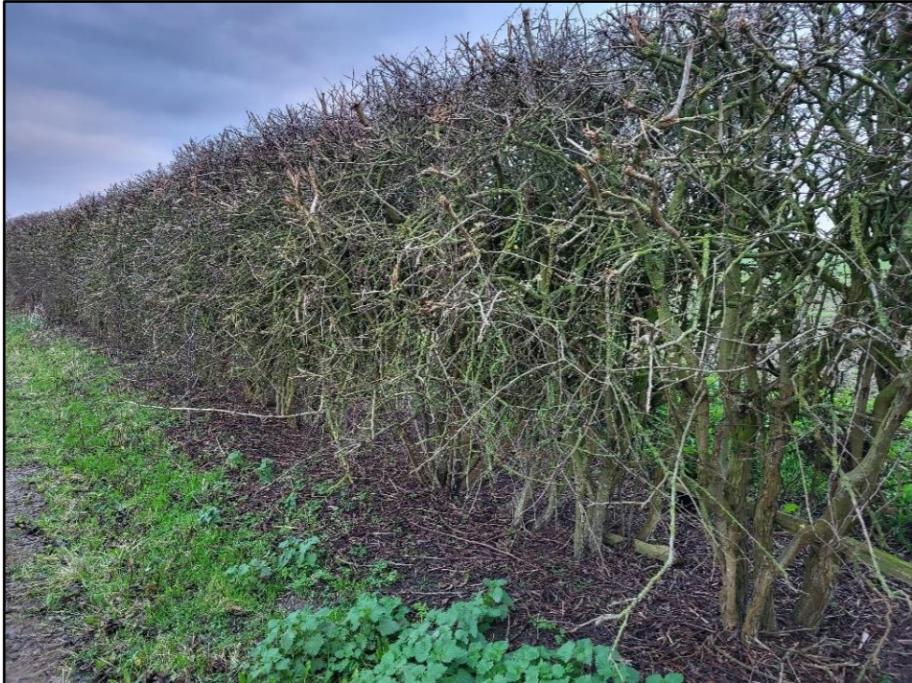
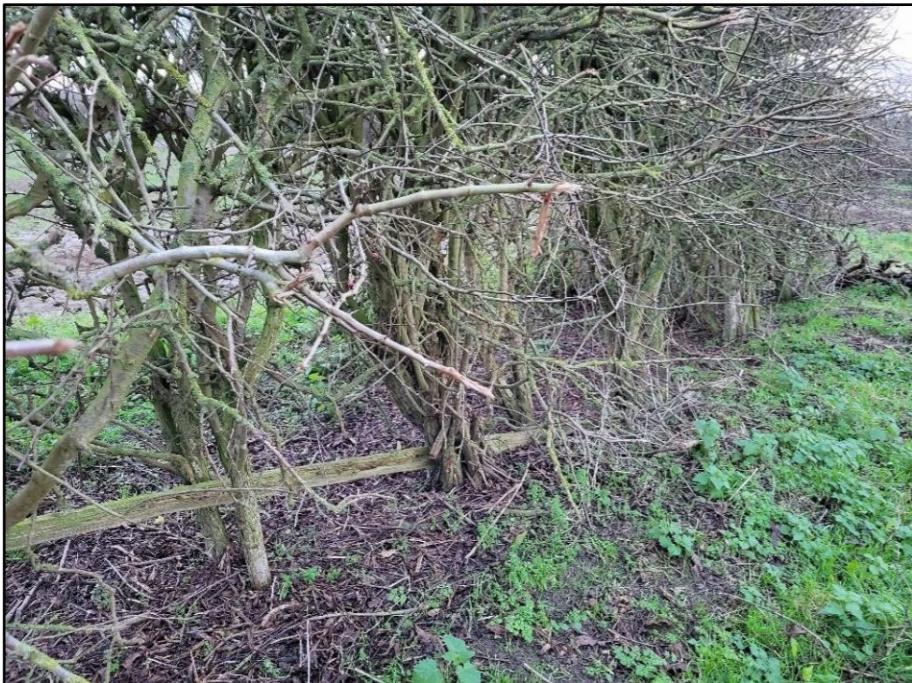
05

Location of WX05. Unnamed drain, with a hedge and overgrown vegetation throughout channel, left bank c.0.01m, right bank c.0.01m, width c.0.1m, Water depth c.0.0m. Facing Upstream.

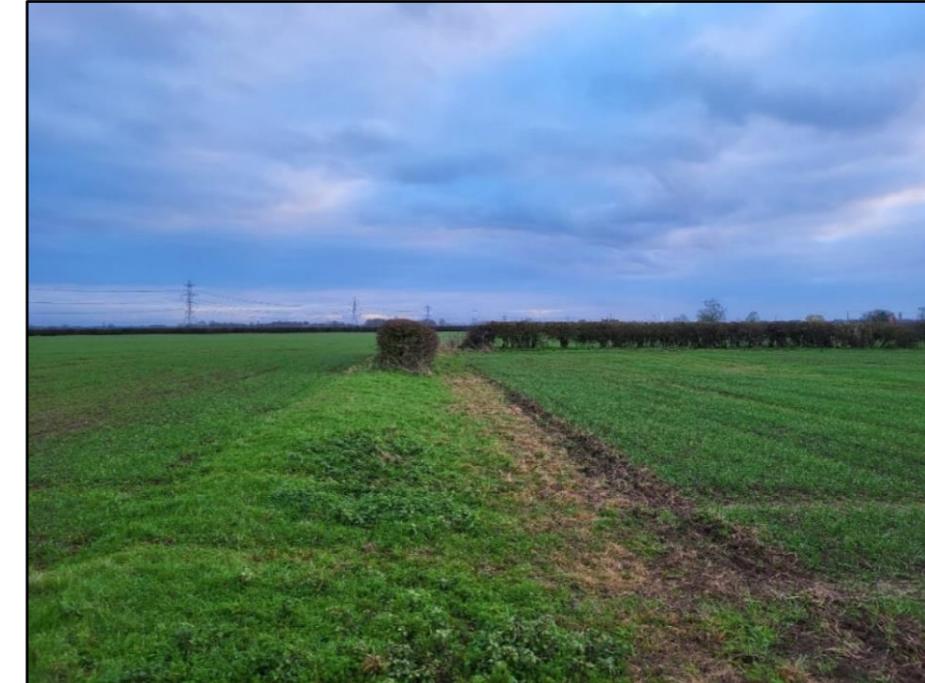
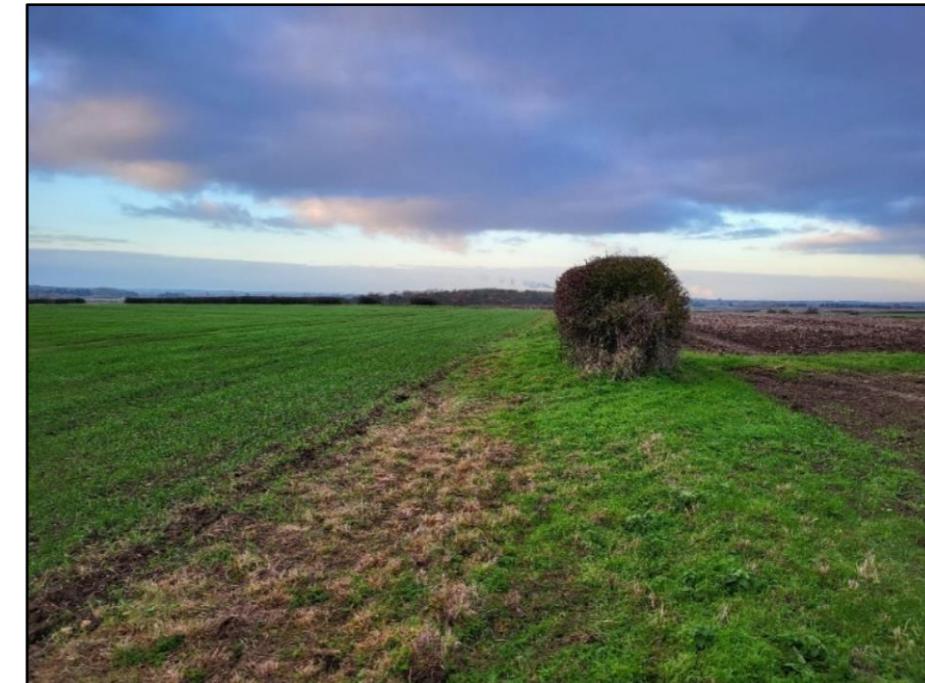
06

Location of WX06. Unnamed drain, with a hedge and overgrown vegetation throughout channel, left bank c.0.01m, right bank c.0.01m, width c.0.5m, Water depth c.0.0m. Facing east.

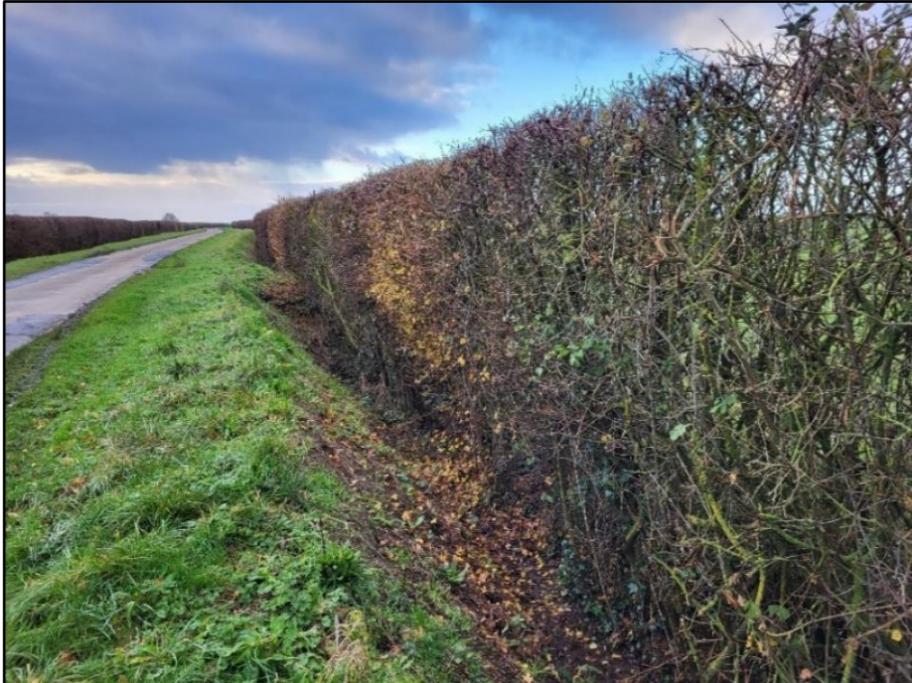
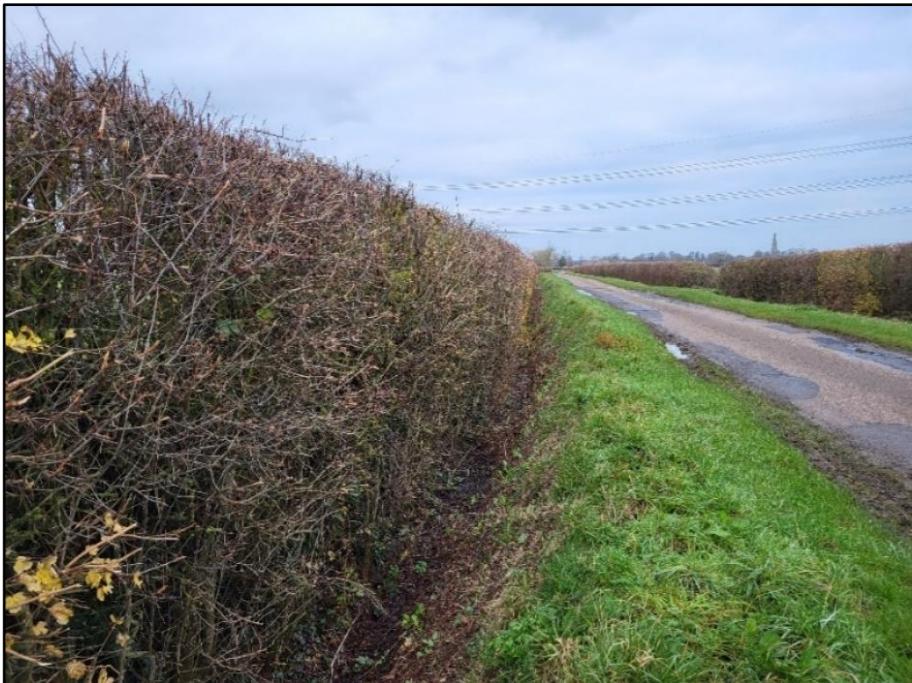
07

Location of WX07. Unnamed drain, with overgrown vegetation throughout channel, left bank c.1.0m, right bank c.1.0m, width c.1.2m, Water depth c.0.0m. Facing Upstream.

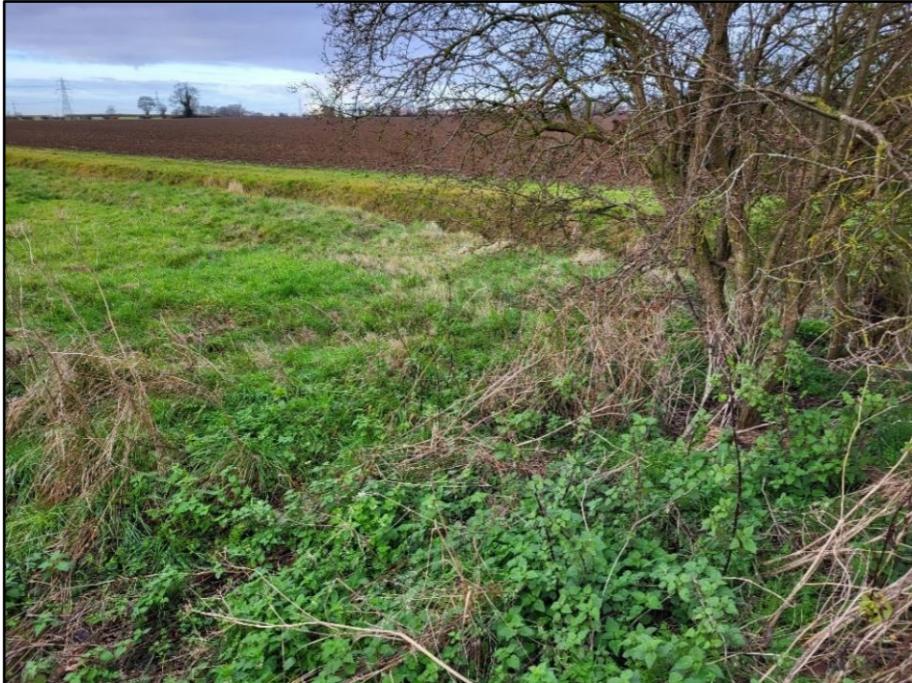
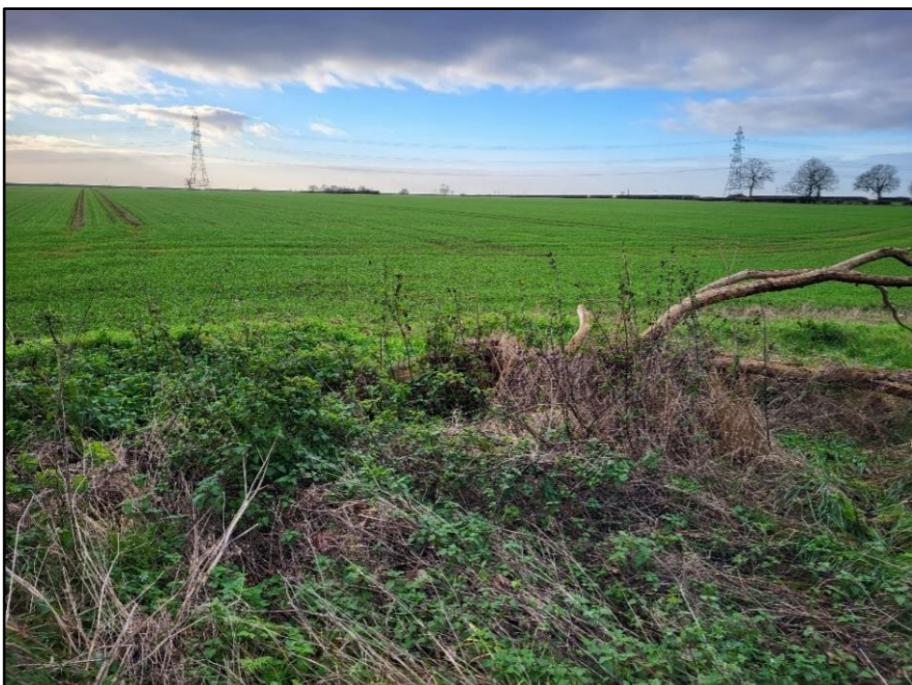
Photograph Sheet: 09
NGR: TF 12632 46729
Photograph Date: 3 December 2024

Description: Location of WX09. No drain present, overgrown vegetation. Drain present to the east of watercourse crossing location

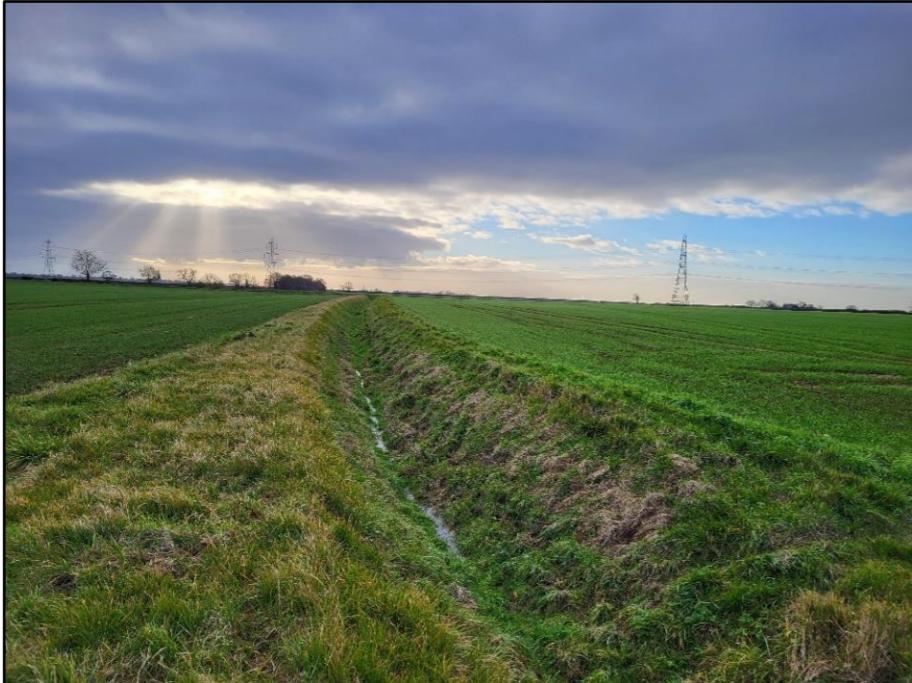
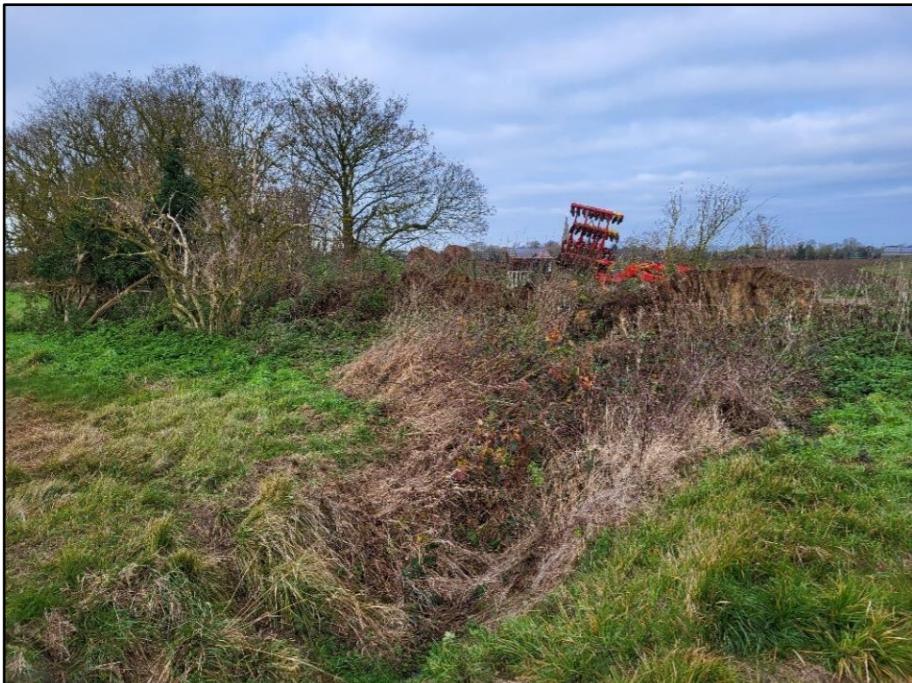
11

Location of WX11. Unnamed drain, with vegetation throughout channel, left bank c.1.3m, right bank c.1.3m, width c1.5m. Water depth is c.0.02m in the channel.

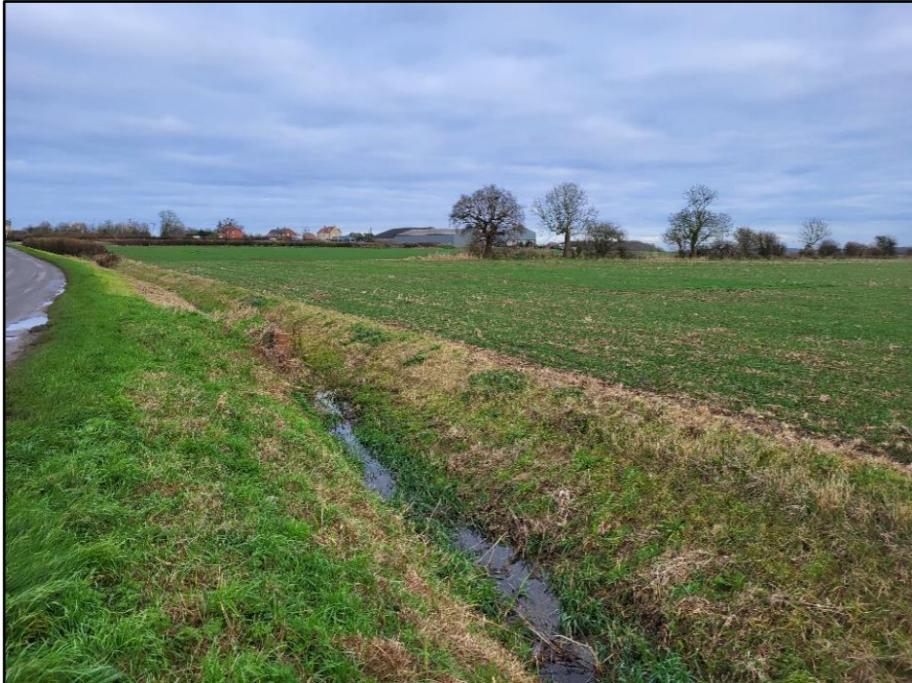
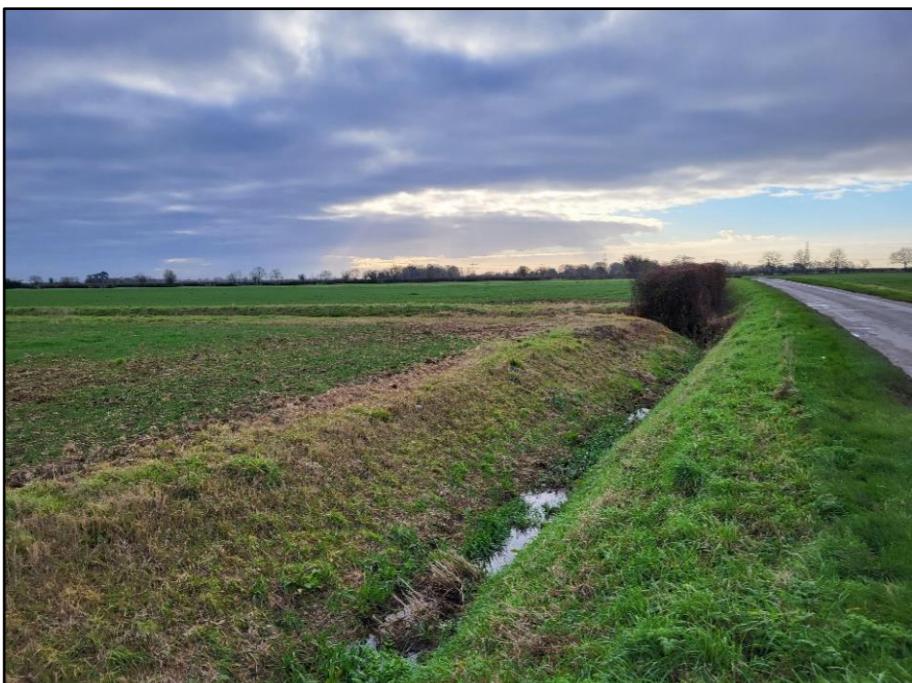
13

Location of WX13. Unnamed drain, with vegetation throughout channel, left bank c.1.4m, right bank c.1.4m, width c2.0m. Water depth is c.0.05m in the channel.

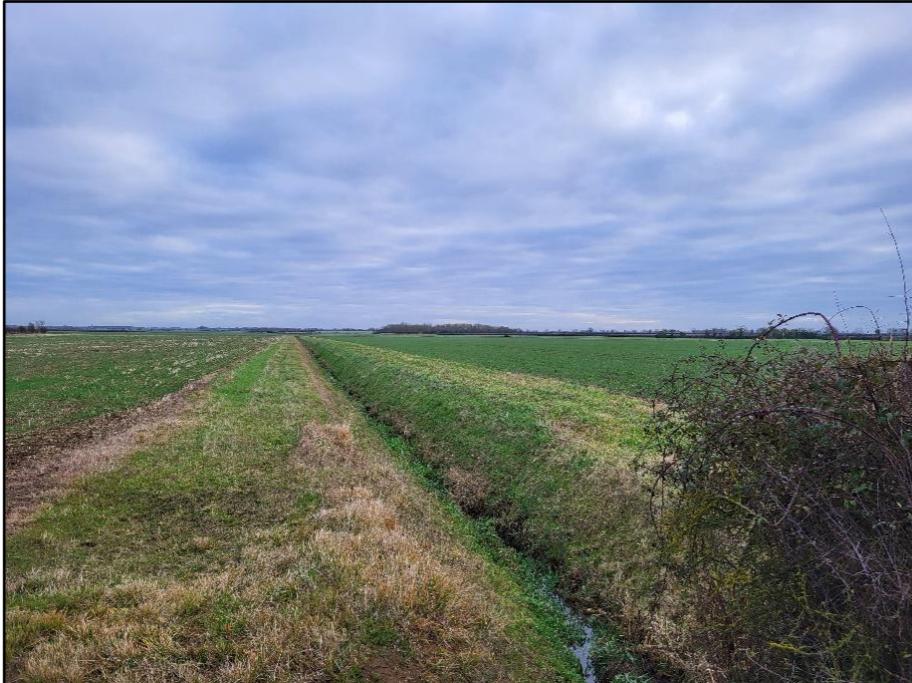
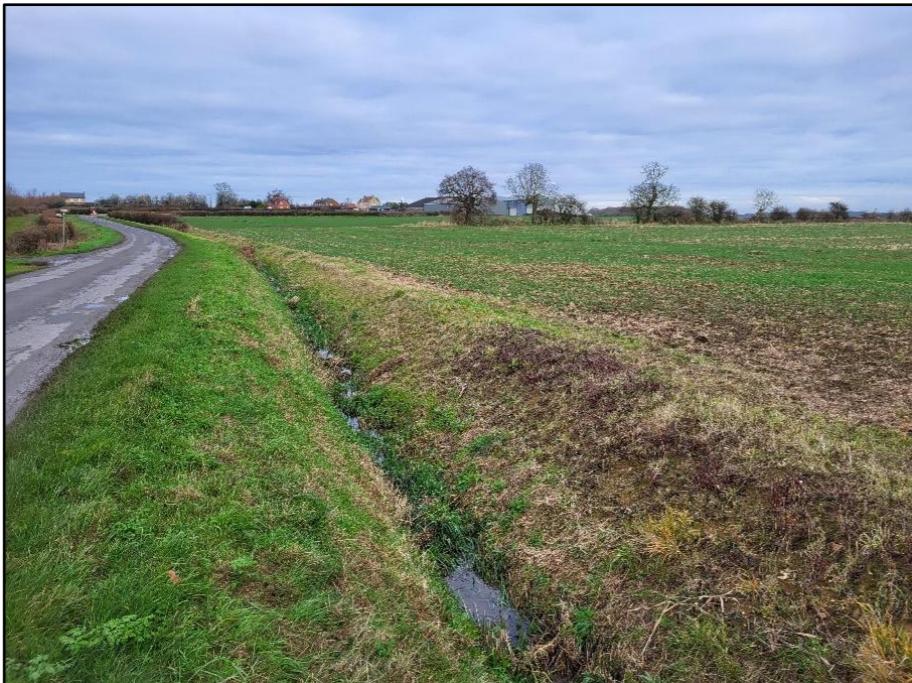
Location of WX16. Unnamed drain, with banks comprised of earth material, left bank c.2.0m, right bank c.2.0m, width c.2.0m. Water depth is c.0.05m in the channel and culverted across road.

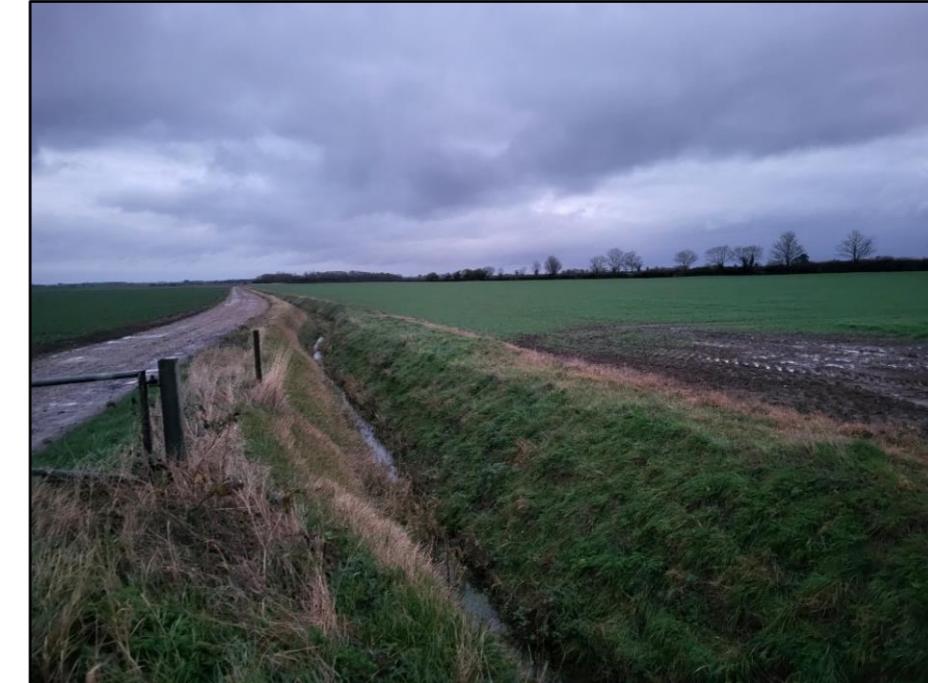
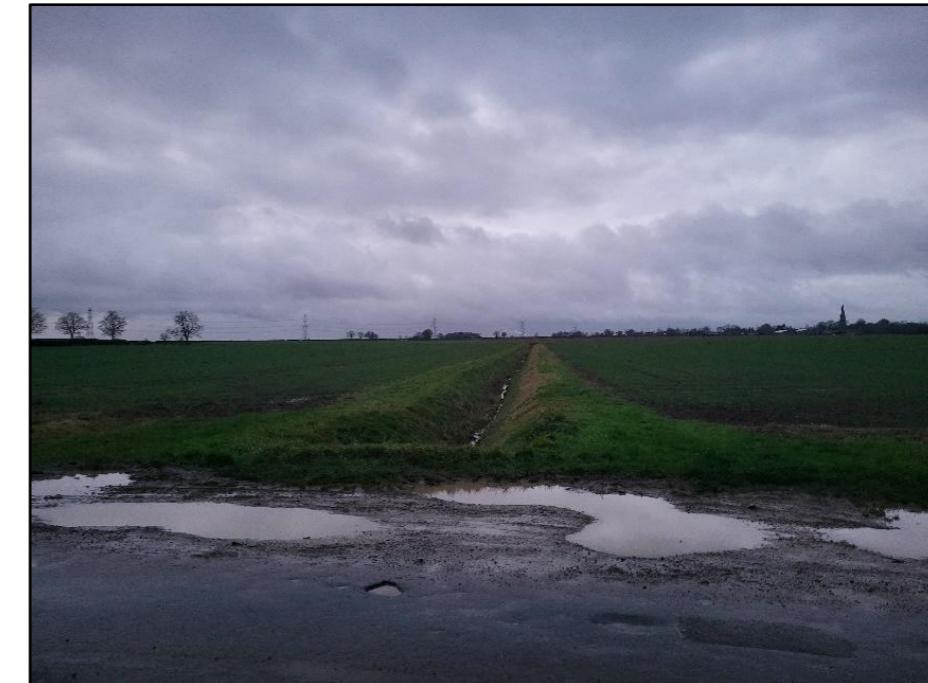
15

Location of WX15. Unnamed drain, with overgrown vegetation throughout channel, left bank c.1.2m, right bank c.1.2m, width c.2.5m. Water depth is c.0.5m in the channel and culverted across road.

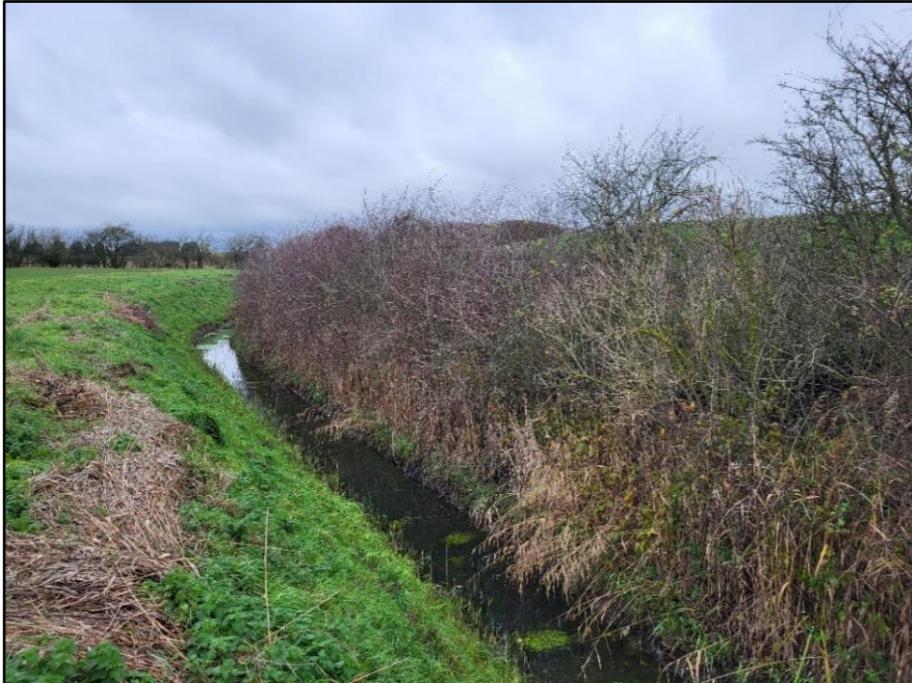
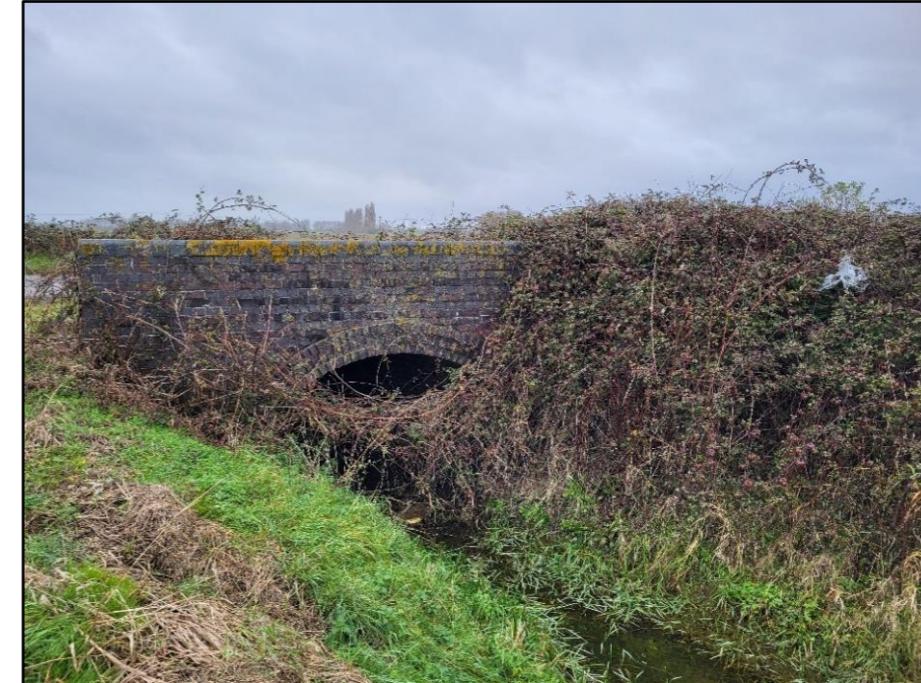
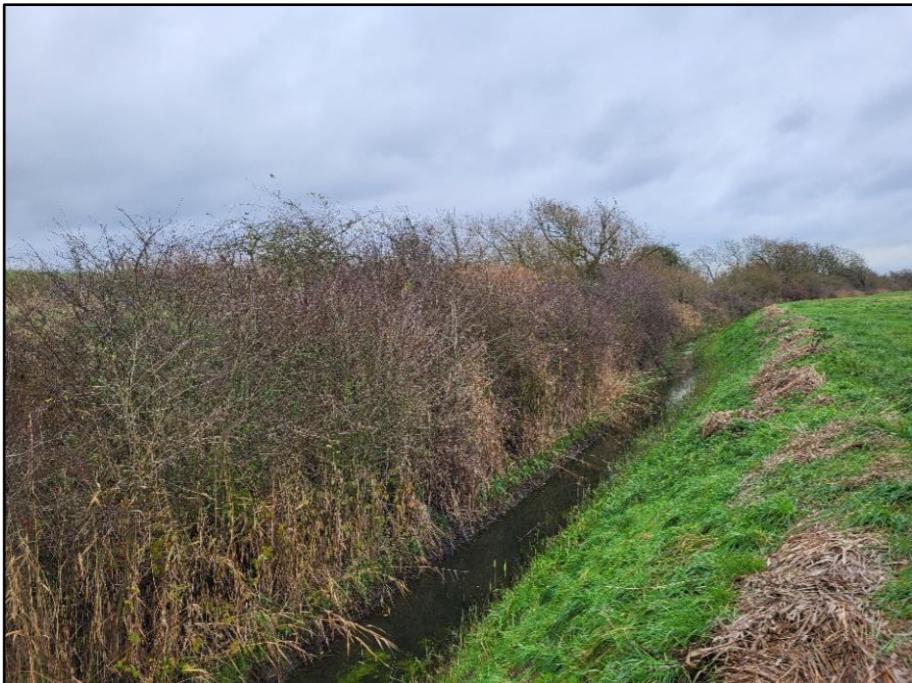
Location of WX17. Unnamed drain, with hedge and overgrown vegetation throughout channel, left bank c.2.0m, right bank c.1.8m, width c.2.0m. Water depth is c.0.2m in the channel.

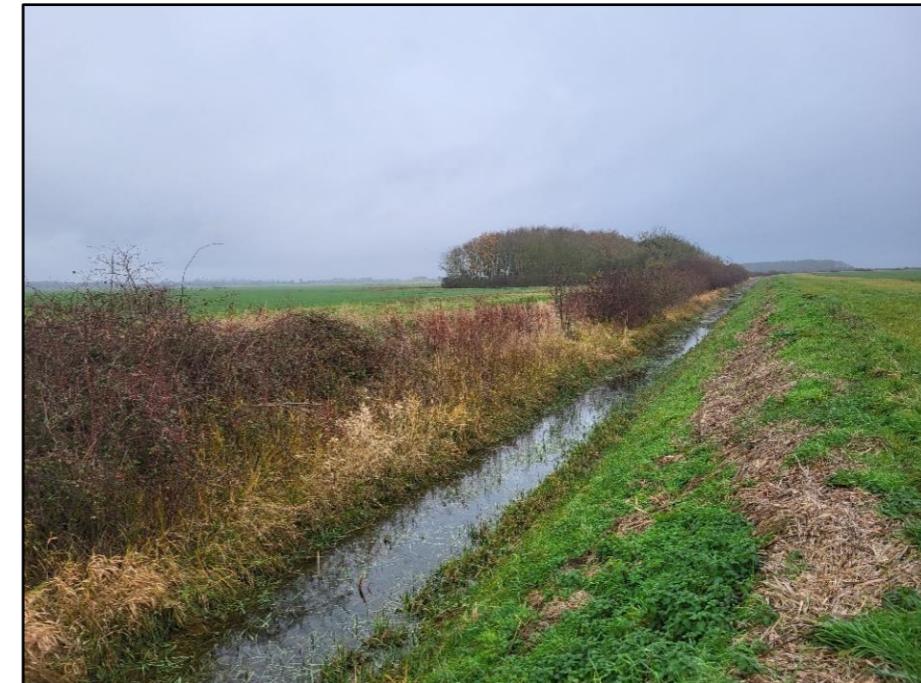
Location of WX18. Passing place and Catchwater Drain, with hedge and overgrown vegetation throughout channel, left bank c.1.5m, right bank c.1.5m, width c.2.0m. Water depth is c.0.3m in the channel.

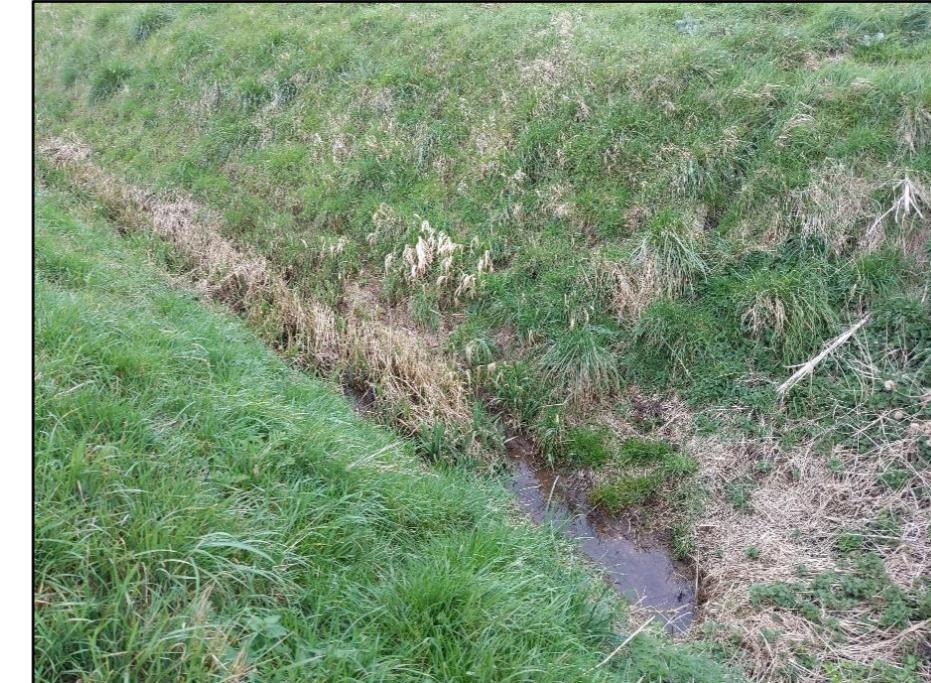
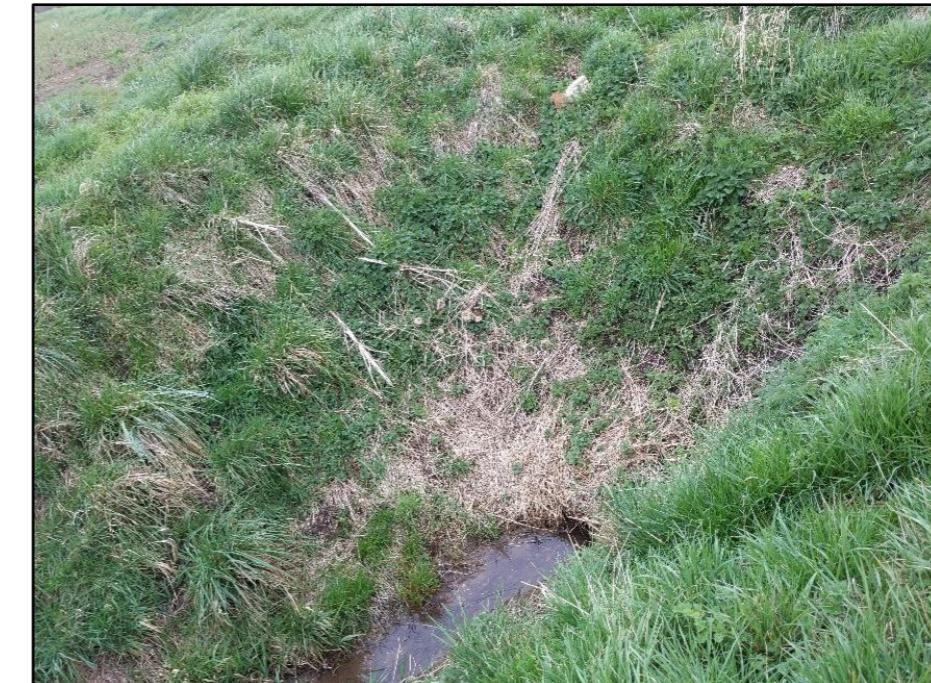
19

Location of WX19. Passing place and unnamed drain, with hedge and overgrown vegetation throughout channel, left bank c.1.5m, right bank c.1.5m, width c.2m..

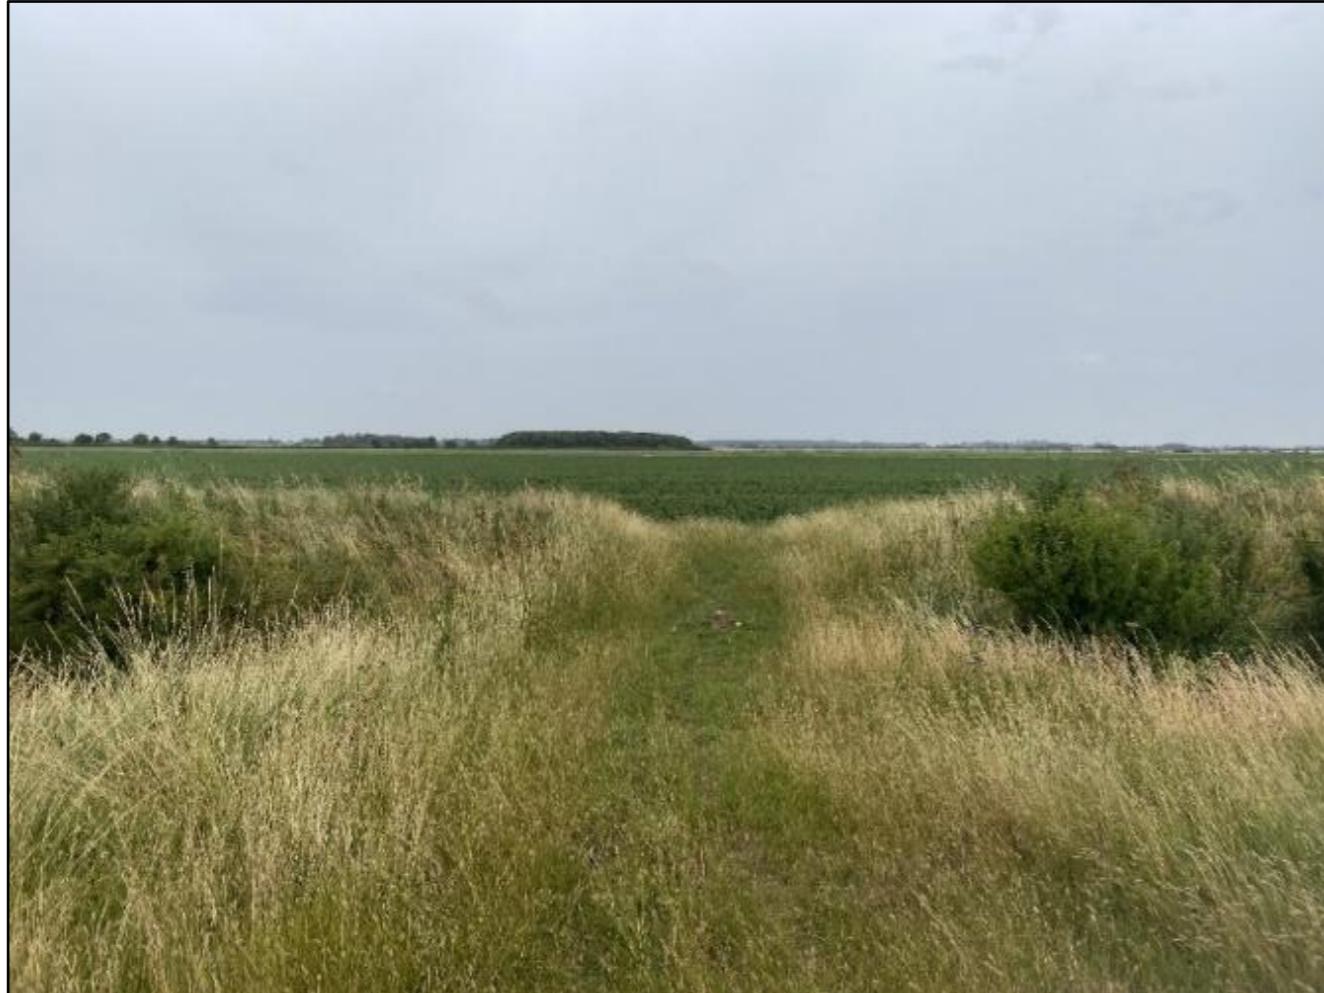
21

Location of WX21. Passing place over unnamed drain, width c.3m.

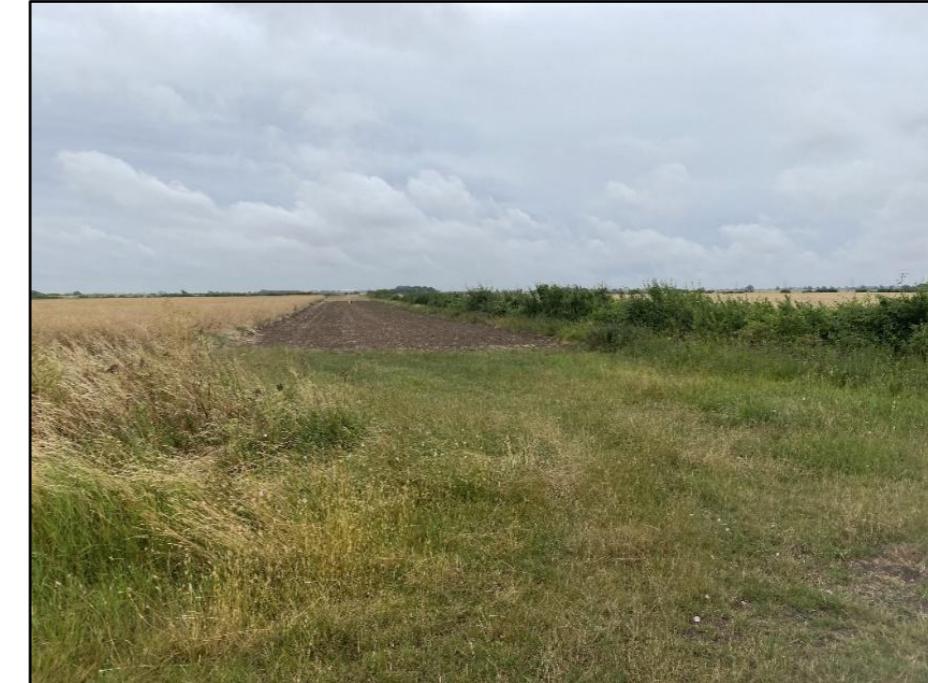
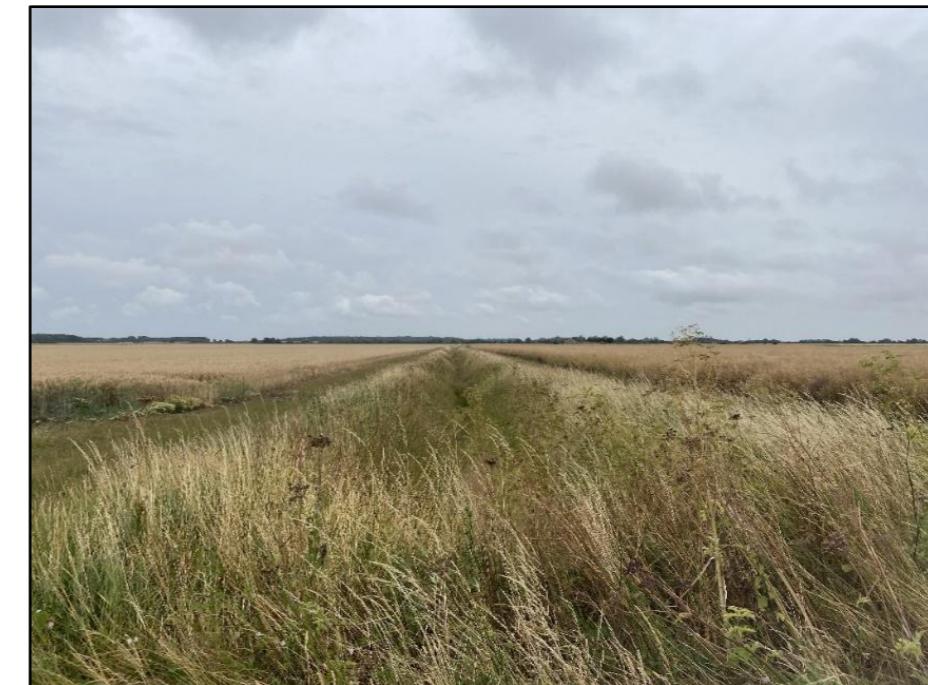
22

Location of WX22. Unnamed drain, with overgrown vegetation throughout channel, left bank c.1m, right bank c.1m, width c.3m. No water is present in the channel.

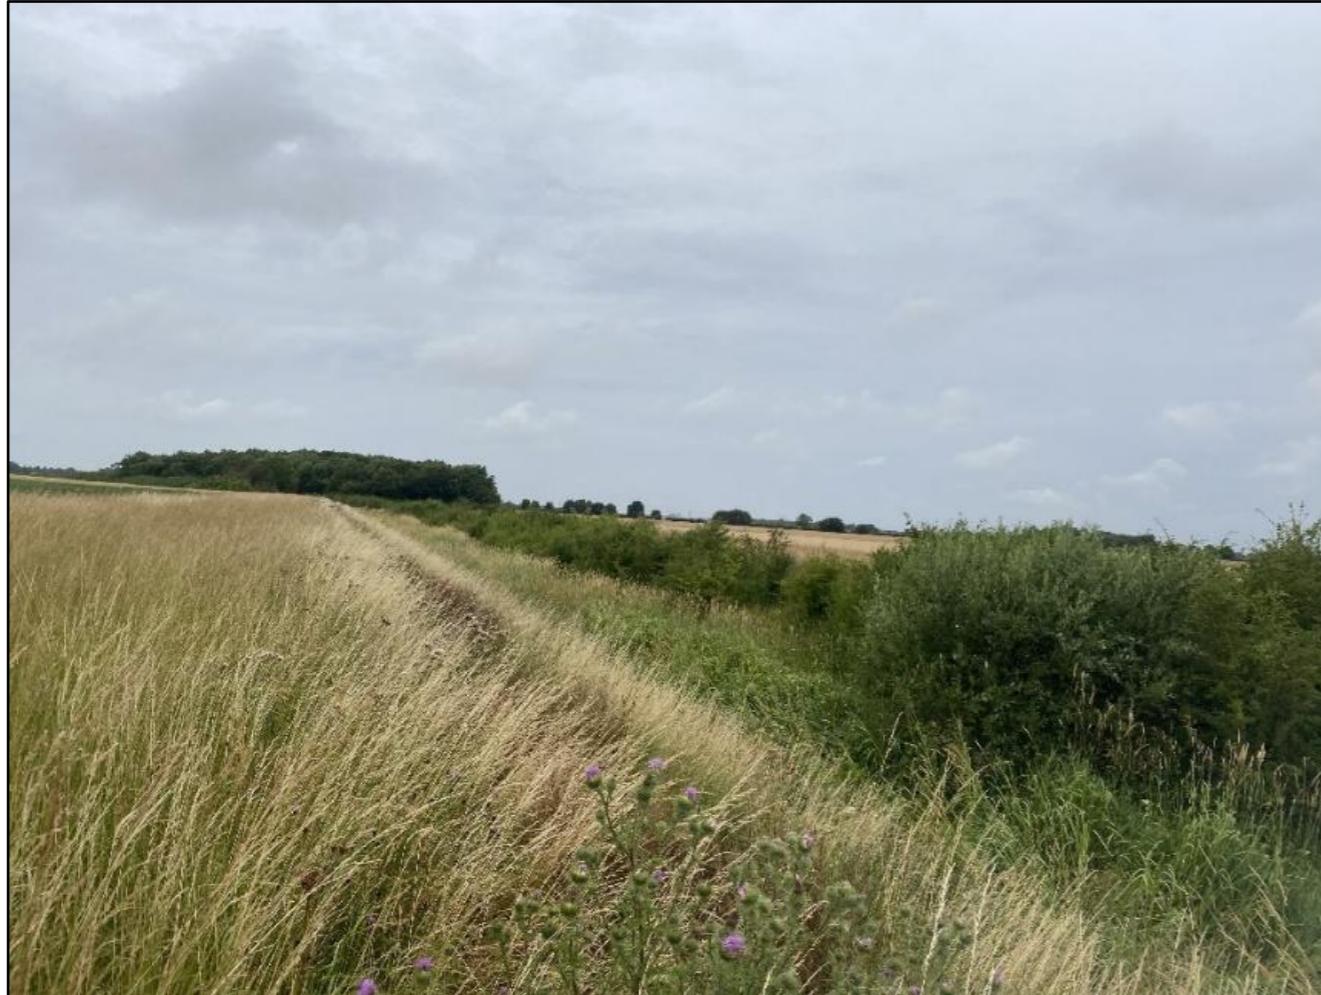
23

Description: Location of WX23. Unnamed drain, with hedge and overgrown vegetation throughout channel, left bank c.1.5m, right bank c.1.5m, width c.4.0m. No water is present in the channel. No water is present in the channel..
