Planning Inspectorate Reference: EN010151

Appendix 11.3 Summary of Watercourse Crossings and Photographs

Document Reference: 6.3 ES Volume 2, 6.3.83

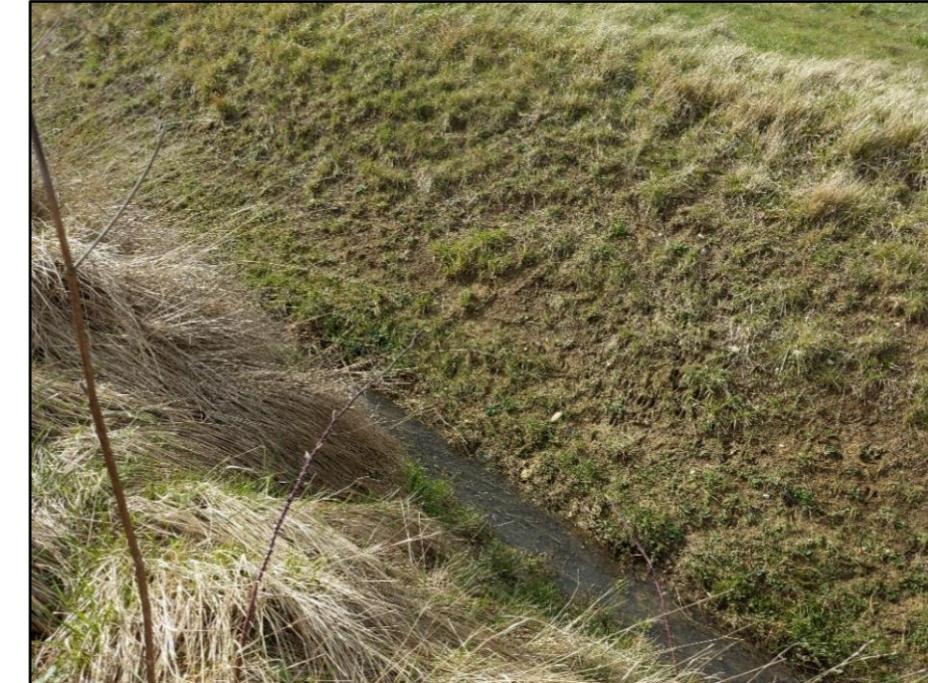
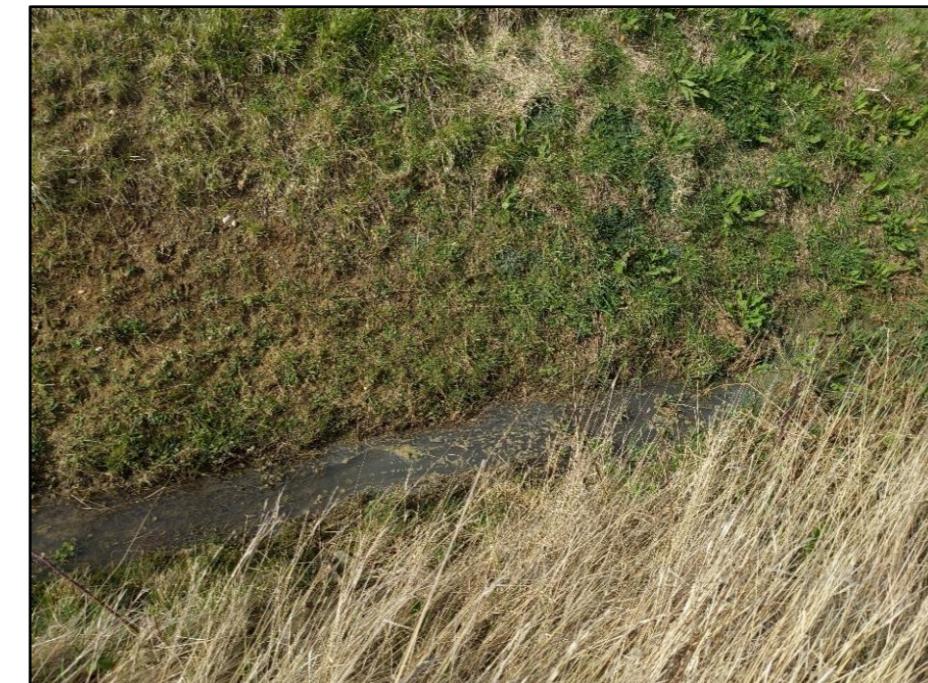
24

Description: Location of WX24. Unnamed drain, with overgrown vegetation throughout the channel and banks composed of earth material. The left bank c.1.5m, right bank c.1.5m, width c. 2.5m. Water depth is c.0.1m in the channel.

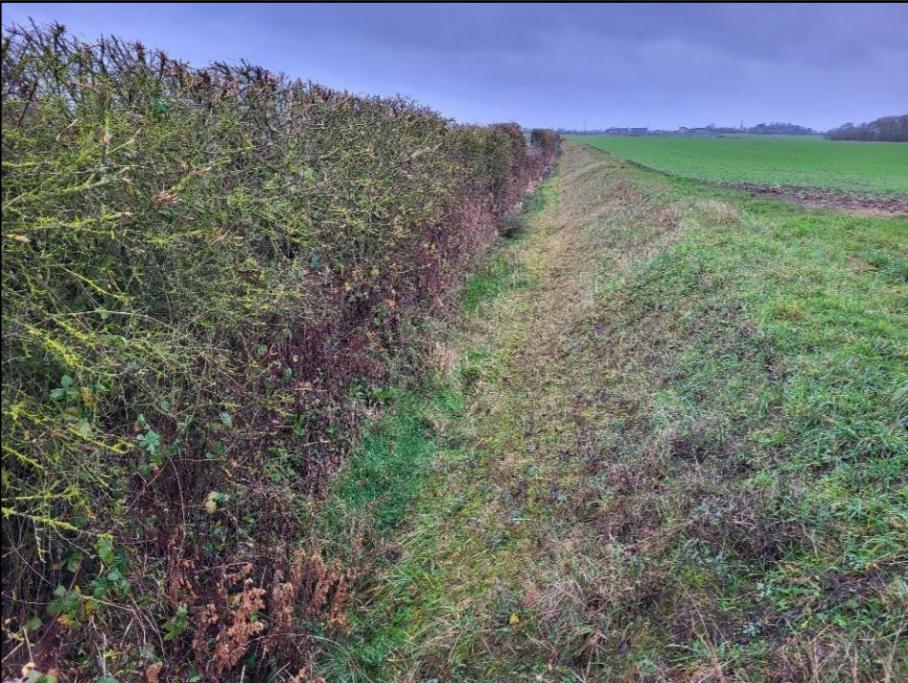
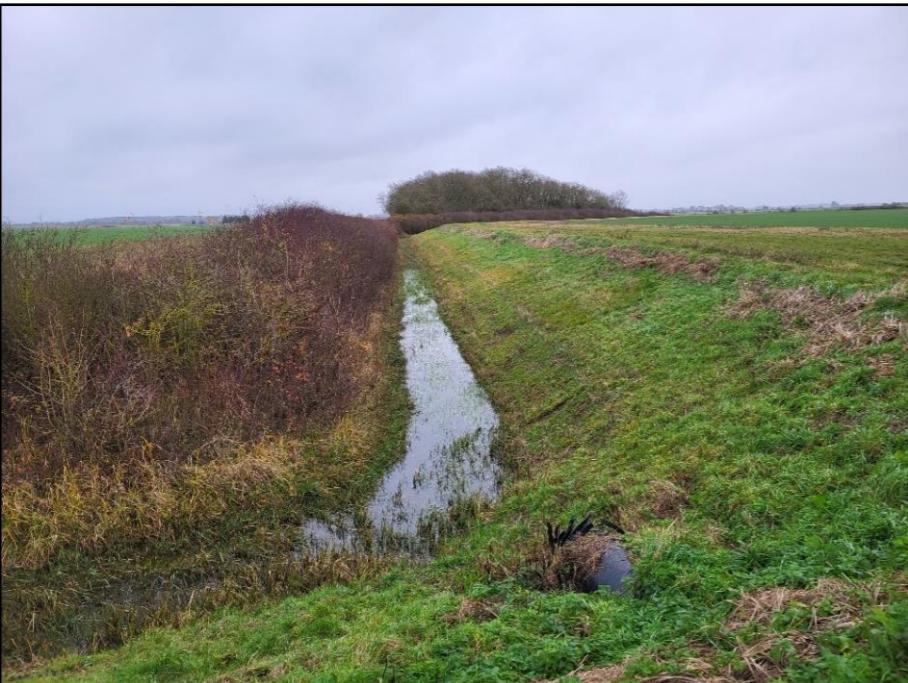
Location of WX26. Unnamed drain, with banks composed of earth material. The left bank c.1.5m, right bank c.1.5m, width c. 4.0m. Water depth is c.0.4m in the channel and culverted downstream.

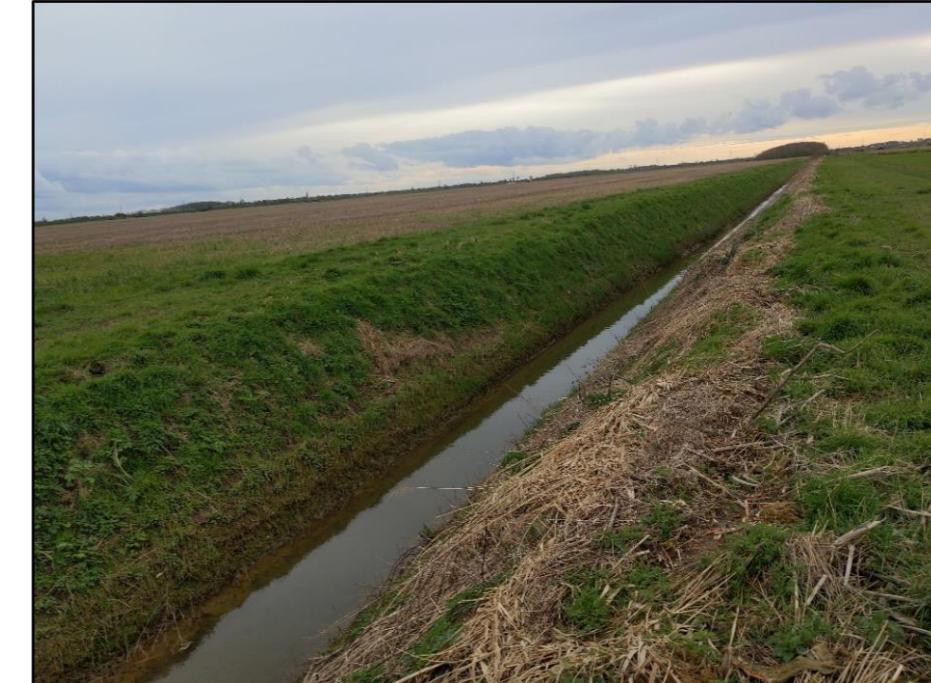
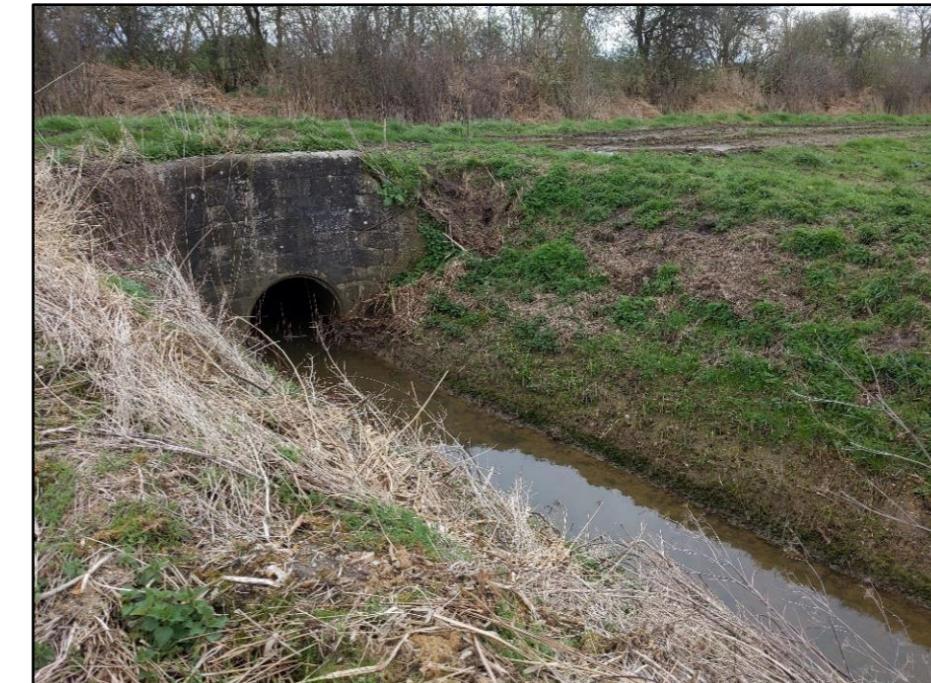
25

Location of WX25. Unnamed drain, with overgrown vegetation throughout the channel and banks composed of earth material. The left bank c.1.5m, right bank c.1.5m, width c. 1.2m. Water depth is c.0.2m in the channel and culverted downstream.

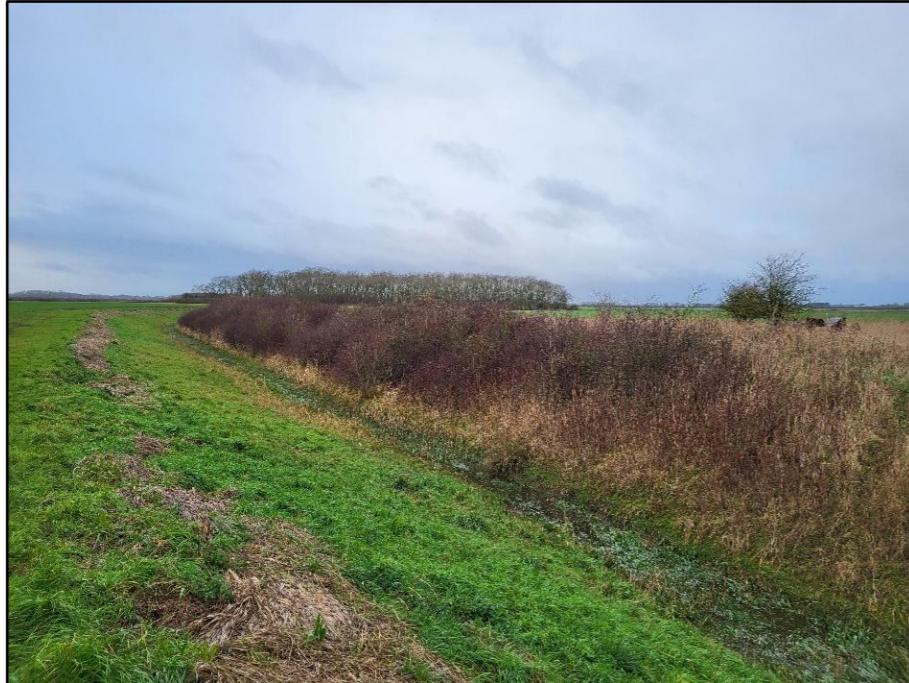
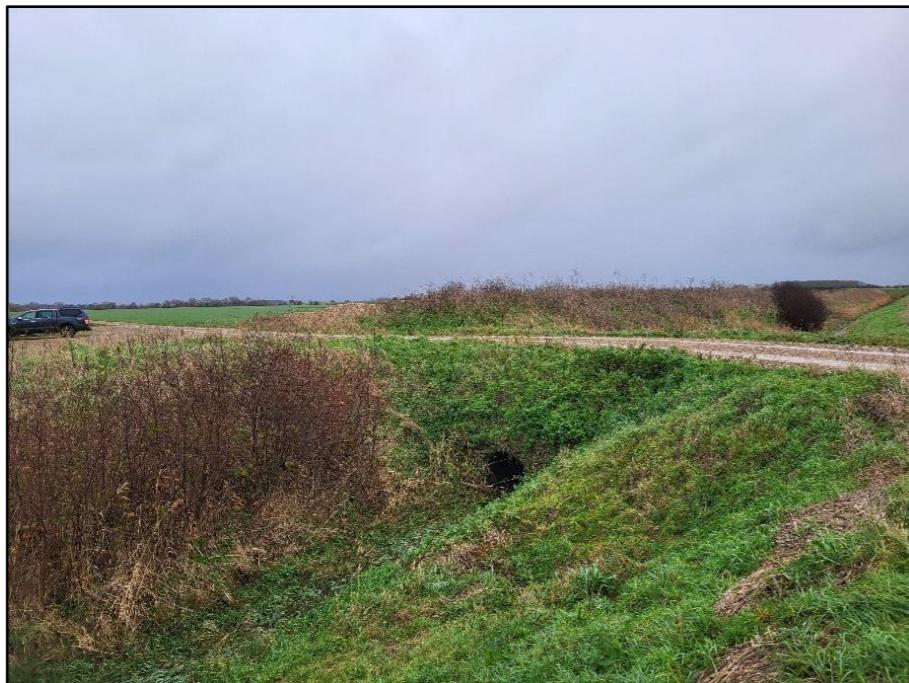
Location of WX28. Unnamed drain, with overgrown vegetation in the channel and banks composed of earth material. The left bank c.1.2m, right bank c.1.2m, width c. 2.2m. Water depth is c.0.05m in the channel and culverted upstream.

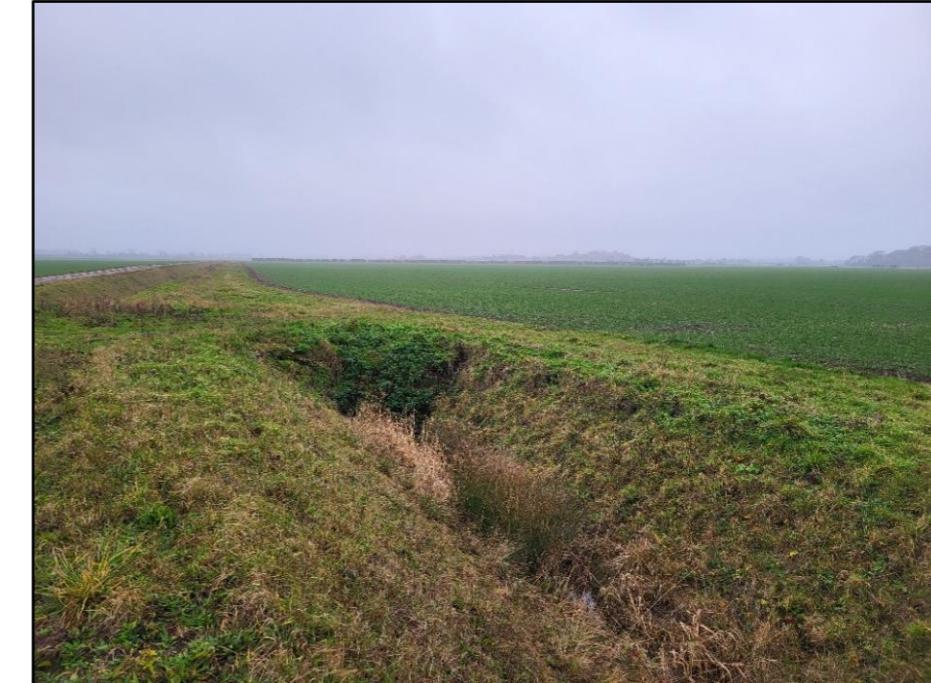
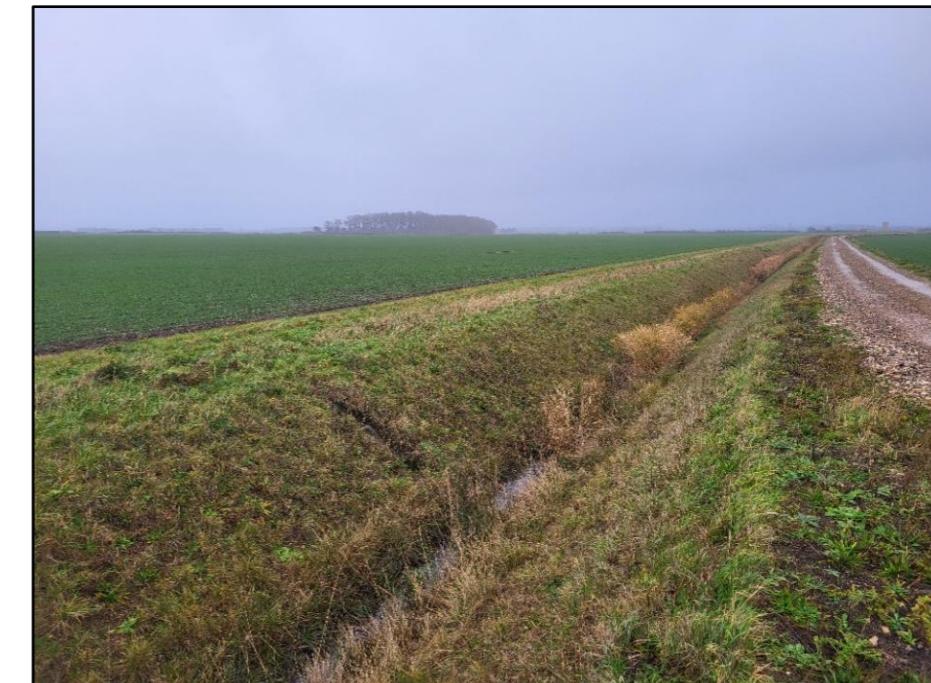
27

Location of WX27. Unnamed drain, with overgrown vegetation in the channel and banks composed of earth material. The left bank c.3.0m, right bank c.3.0m, width c. 5.0m. Water depth is c.0.04m in the channel.

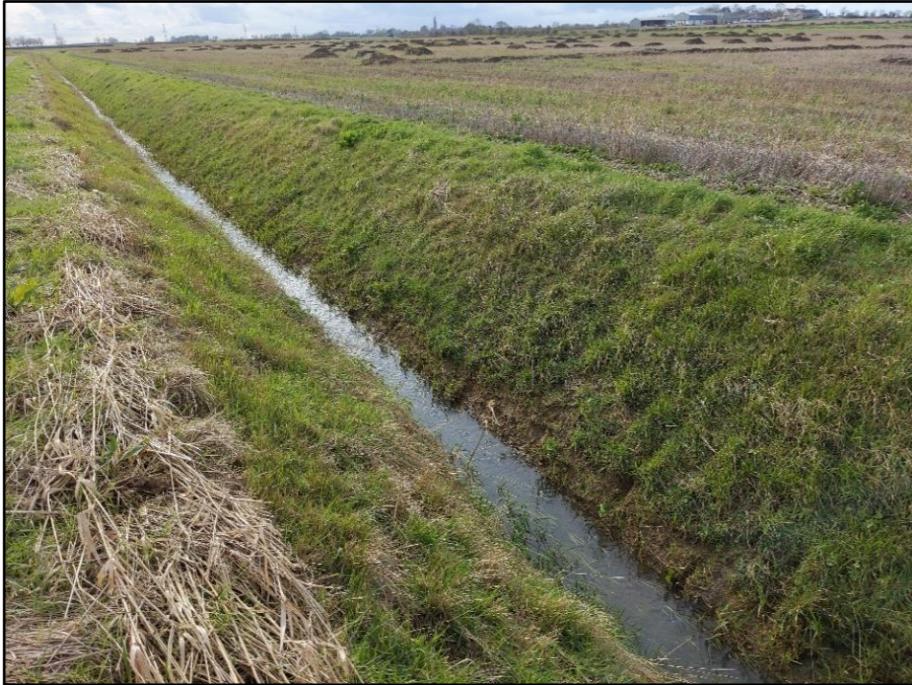
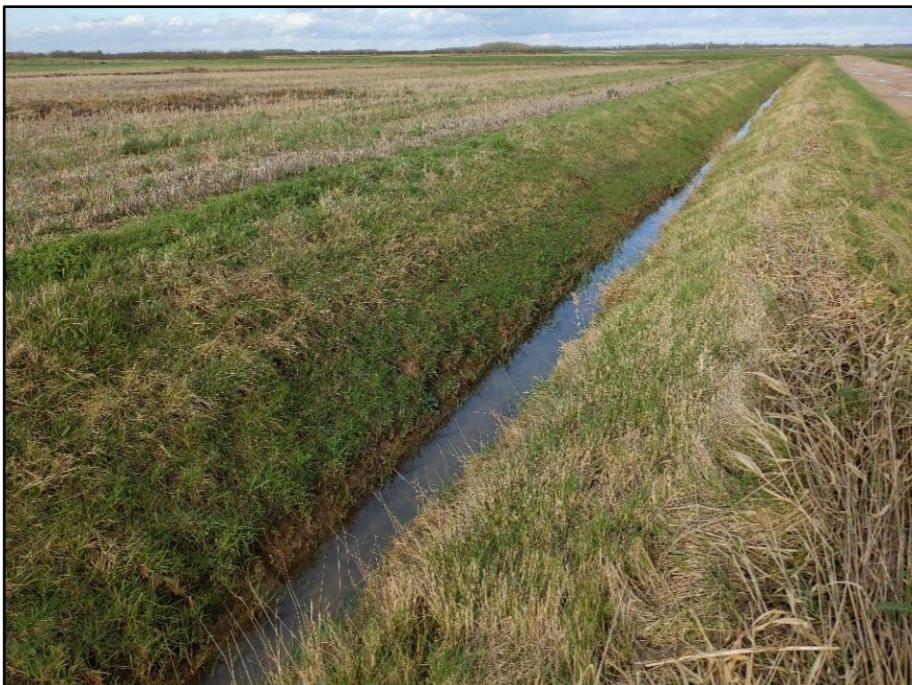
Location of WX29. Unnamed drain, with banks composed of earth material. The left bank c.1.5m, right bank c.1.5m, width c. 3.0m. Water depth is c.0.2m in the channel.

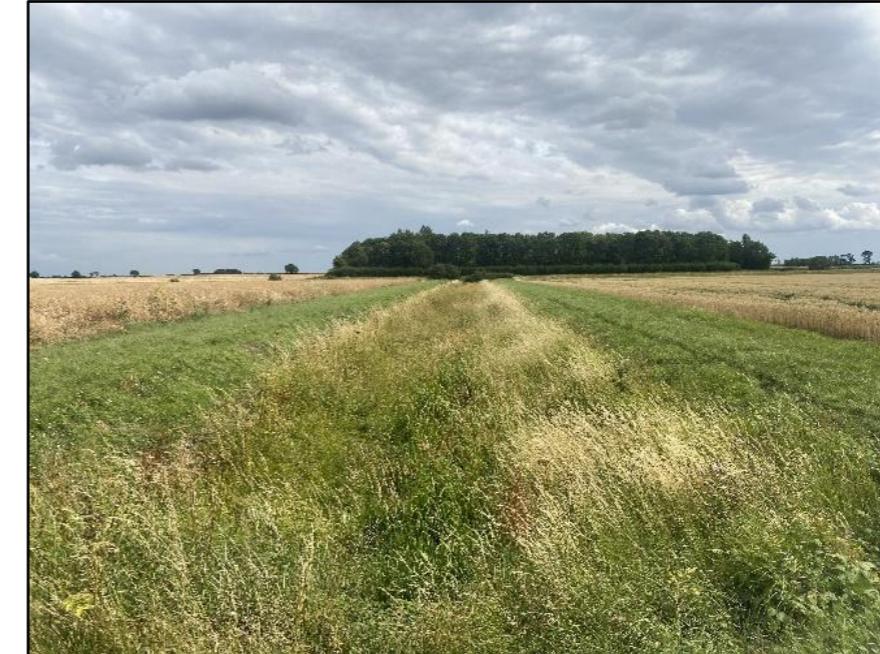
Location of WX30. Unnamed drain, connecting to Hodge Dike by the reservoir, with overgrown vegetation throughout channel, left bank c.1.5m, right bank c.1.5m, width c.3m. No water is present in the channel.

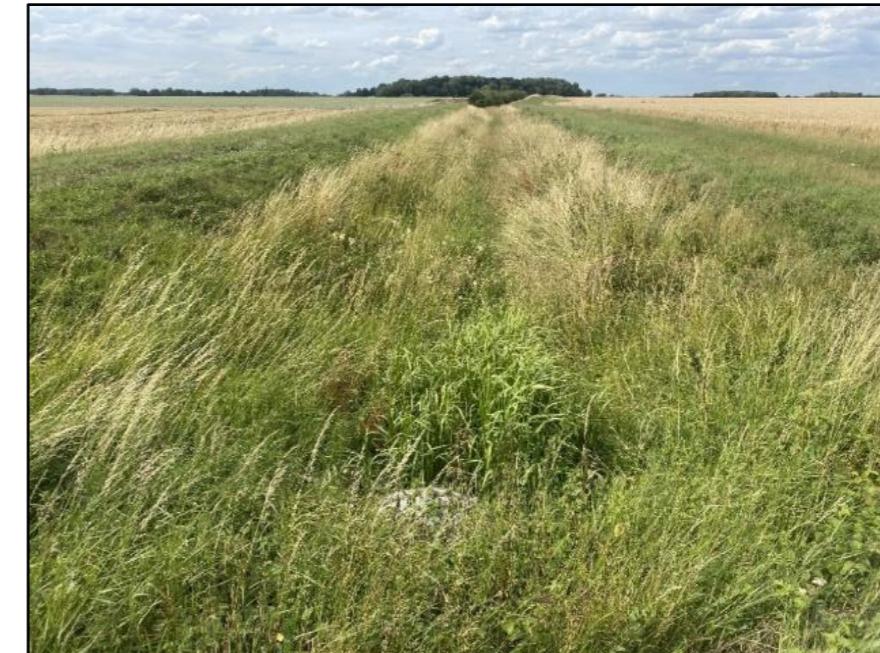
Location of WX31. Unnamed drain, with overgrown vegetation throughout channel, left bank c.1.5m, right bank c.1.5m, width c.3m. No water is present in the channel.

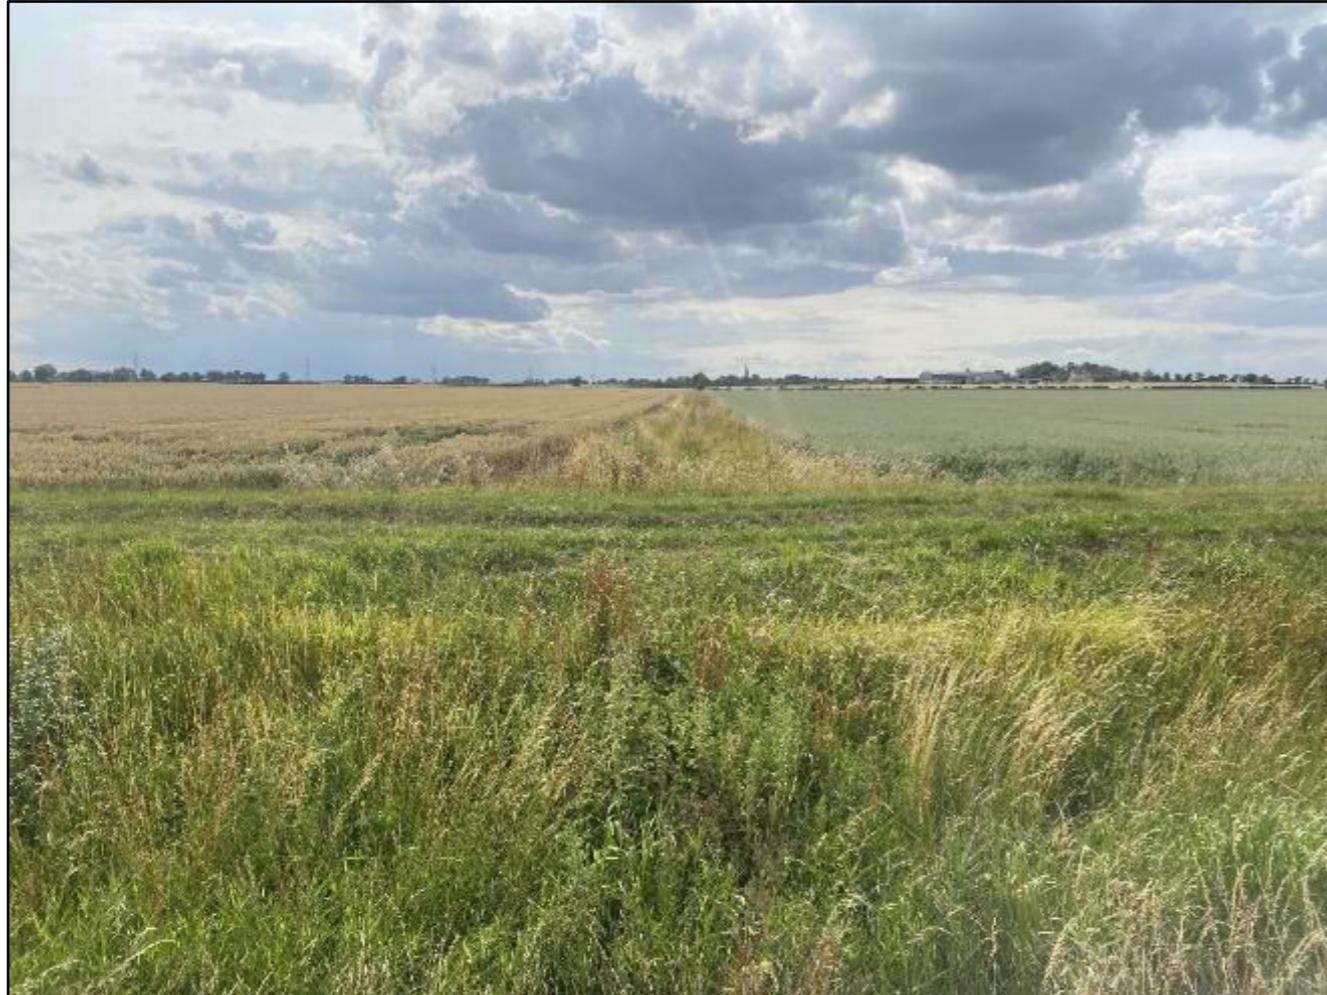
Description: Location of WX32. Unnamed drain, with overgrown vegetation throughout channel, left bank c.1.5m, right bank c.1.5m, width c.2m. No water is present in the channel.

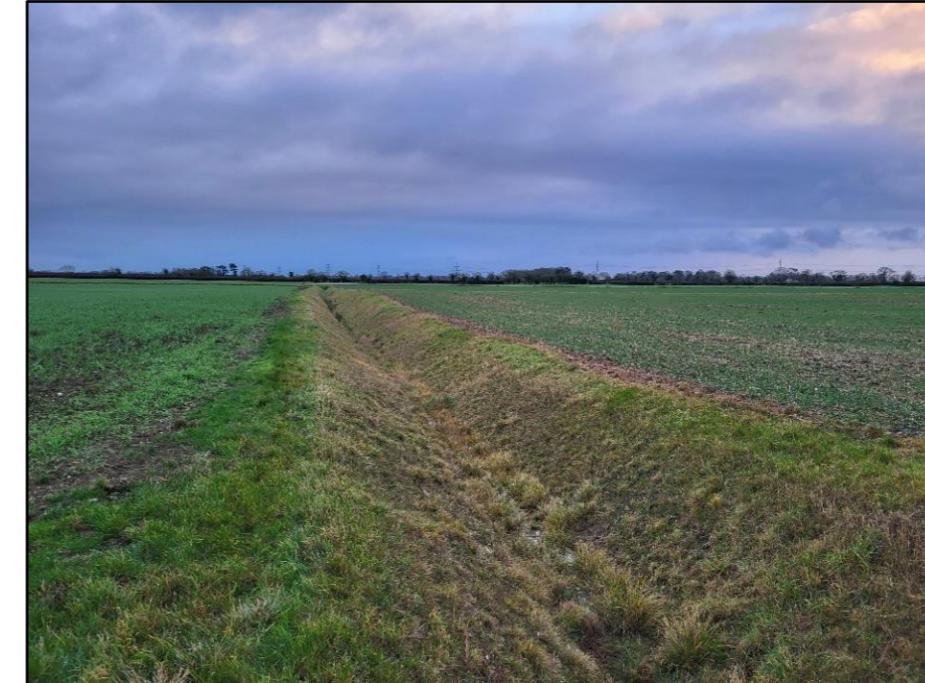
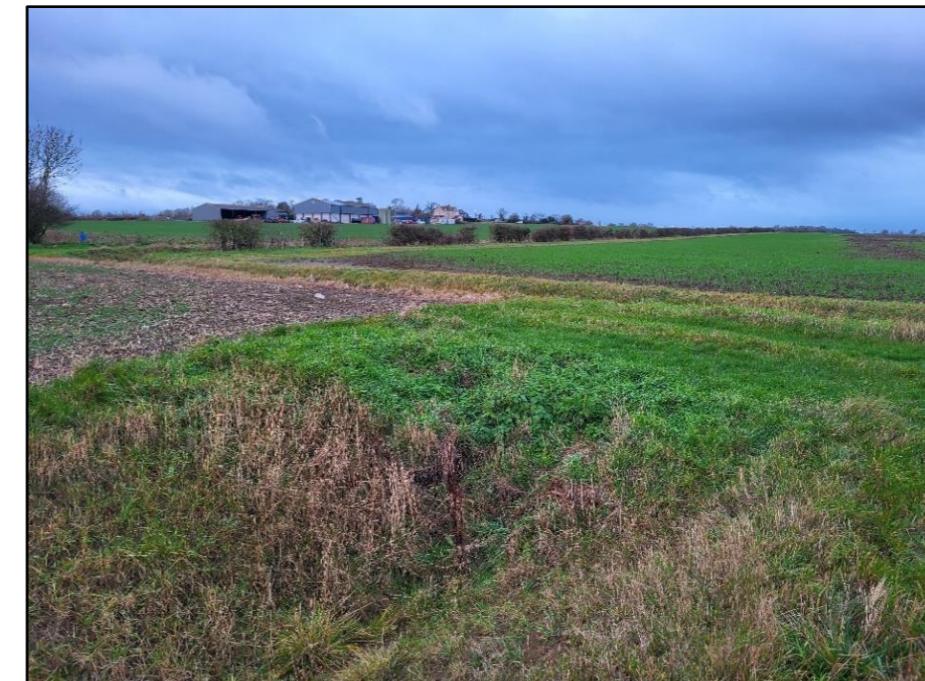
Location of WX33. Unnamed drain, with overgrown vegetation in the channel and banks composed of earth material. The left bank c.1.5m, right bank c.1.5m, width c. 3.0m. No water is present in the channel.

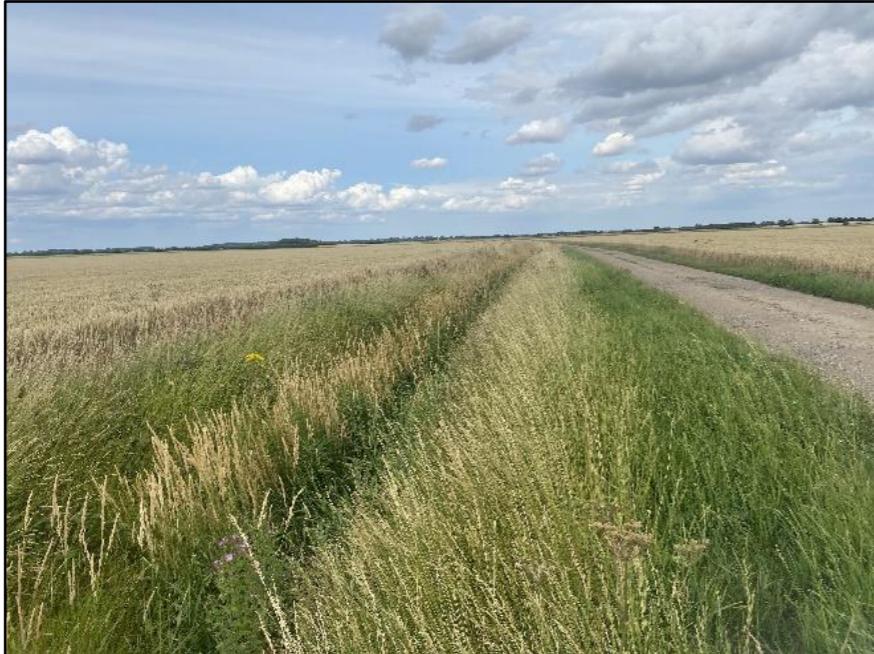
Photograph Sheet: 34

Description: Location of WX34. Unnamed drain, with overgrown vegetation throughout channel, left bank c.1.5m, right bank c.1.5m, width c.2m. No water is present in the channel.

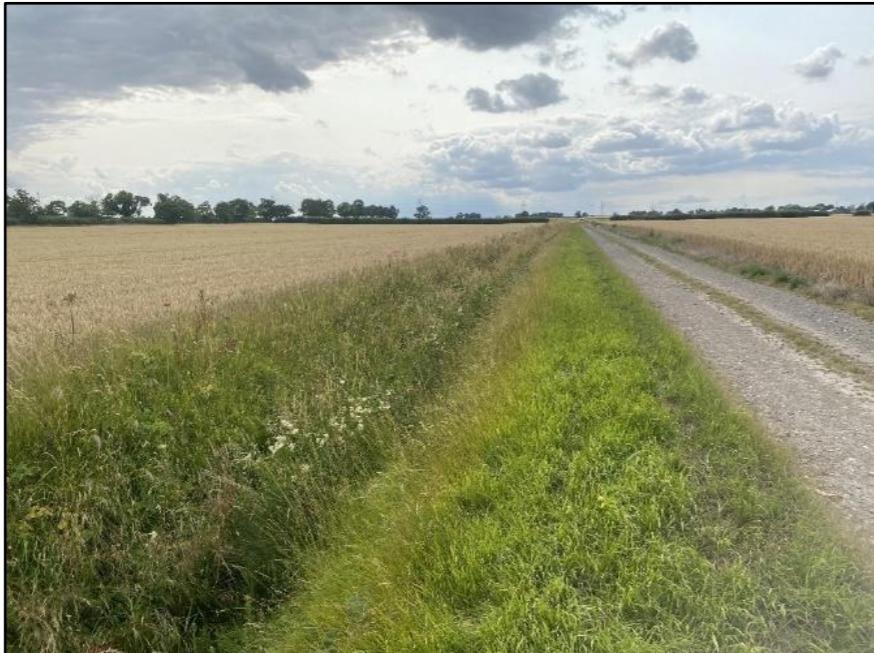
Photograph Sheet: 35

Description: Location of WX35. Unnamed drain, with overgrown vegetation throughout the channel, estimated bank heights of c1.5m, and width of c.2m.

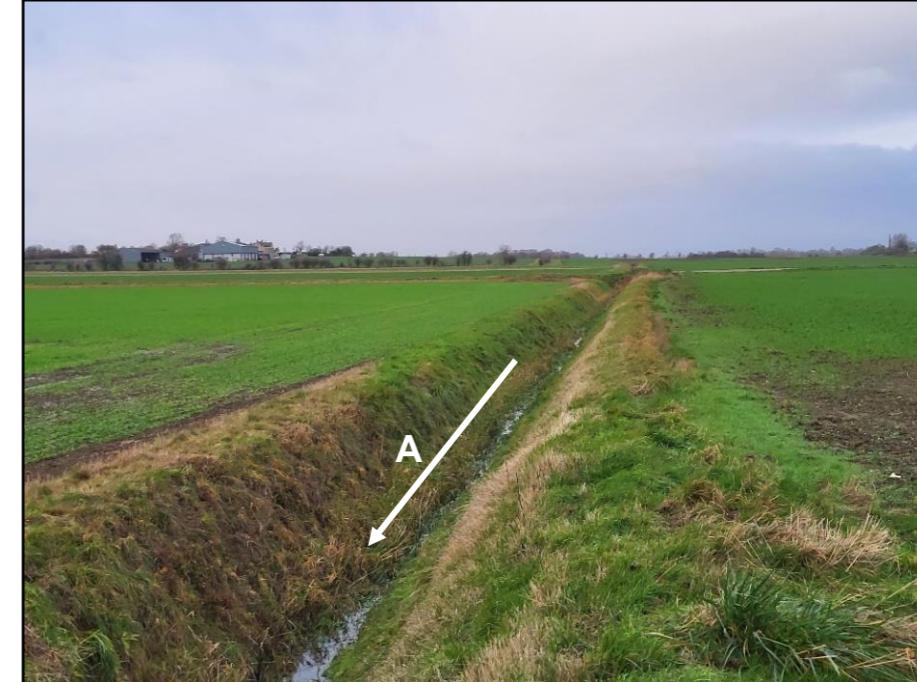
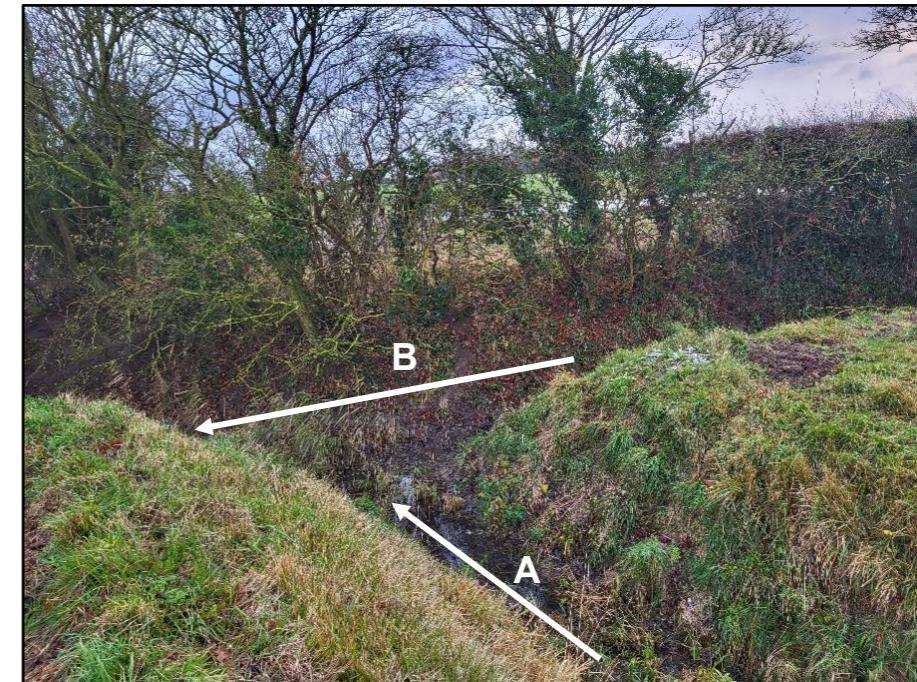
Photograph Sheet: 36

Description: Location of WX36 within channel A. Channel A is an unnamed drain, with overgrown vegetation in the channel and banks composed of earth material. The left bank c.1.5m, right bank c.1.5m, width c. 1.8m. Water depth is c.0.1m in the channel. Location of WX37 within channel B. Channel B is an unnamed drain, with overgrown vegetation in the channel and banks composed of earth material. The left bank c.1.2m, right bank c.1.2m, width c. 1.3m. Water depth is c.0.08m in the channel.

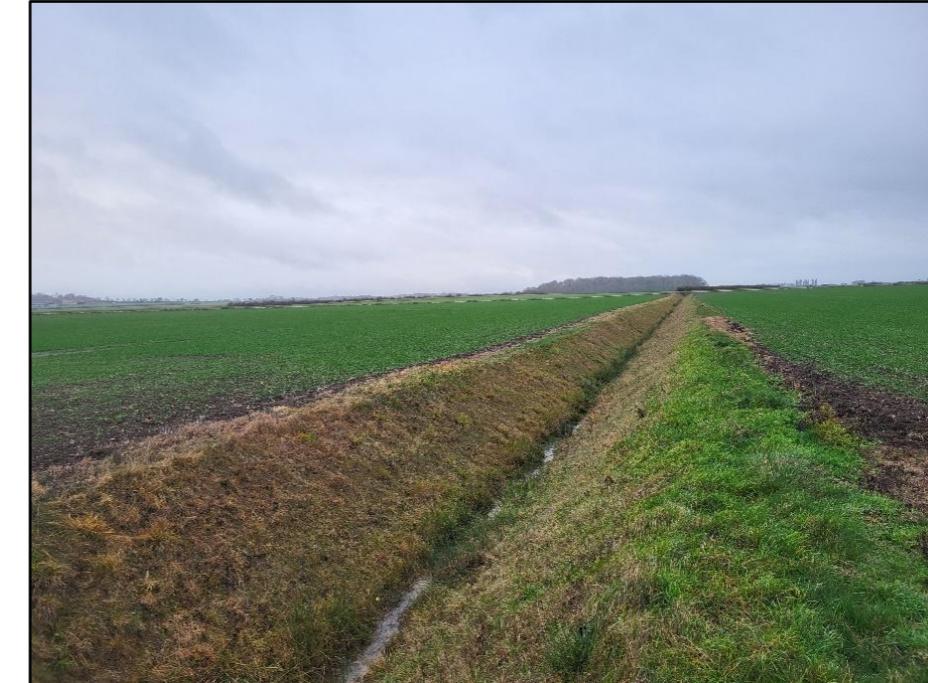
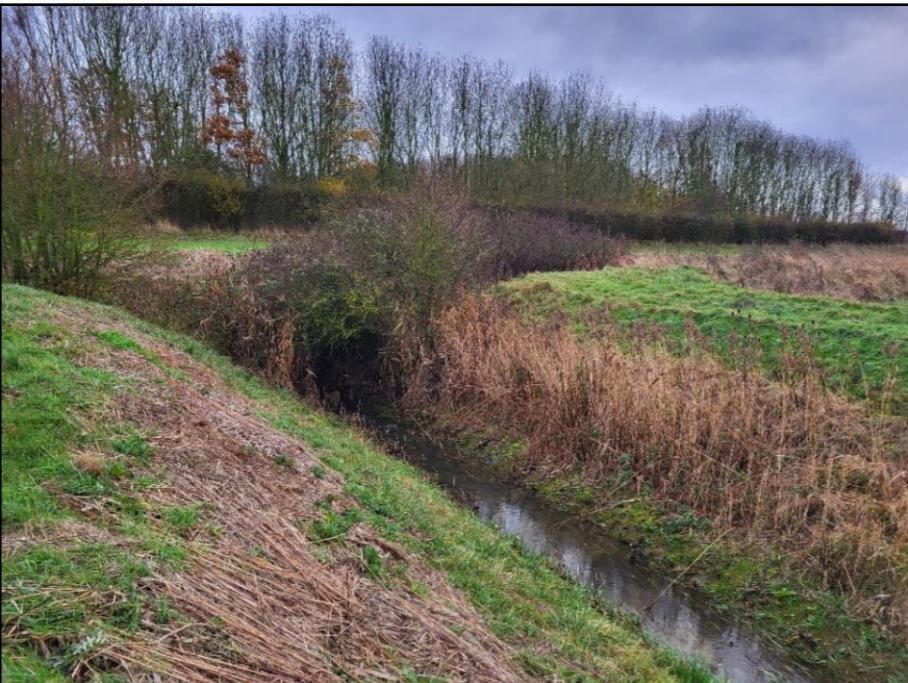
37

Location of WX38. Unnamed drain, with overgrown vegetation in the channel and banks composed of earth material. The left bank c.2.5m, right bank c.2.5m, width c. 5.0m. Water depth is c.0.3m in the channel.

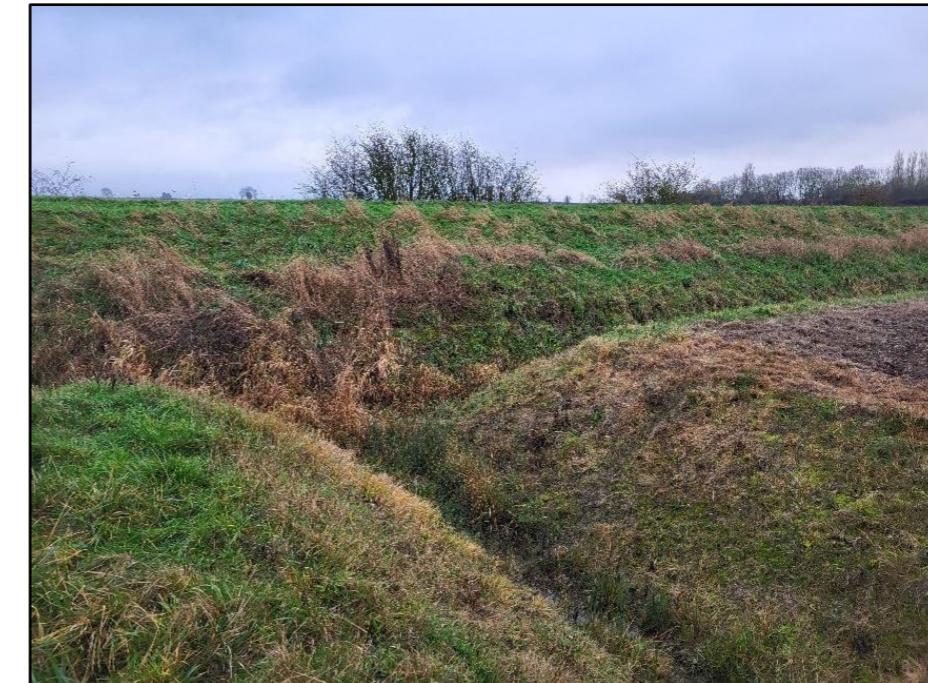
38

Location of WX39. Unnamed drain, with overgrown vegetation in the channel and banks composed of earth material. The left bank c.1.3m, right bank c.1.3m, width c. 2.4m. Water depth is c.0.01m in the channel.

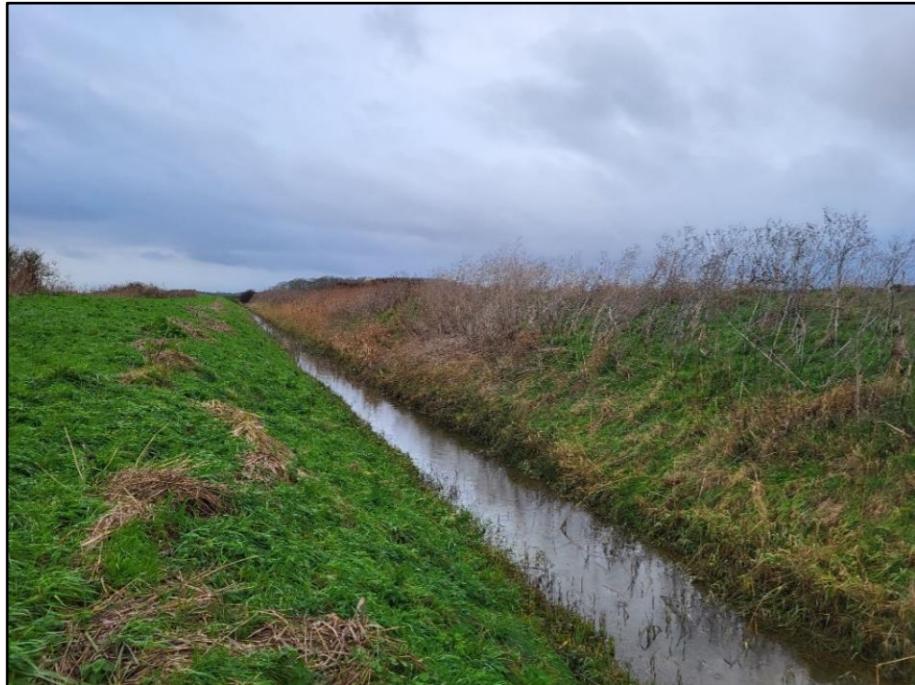
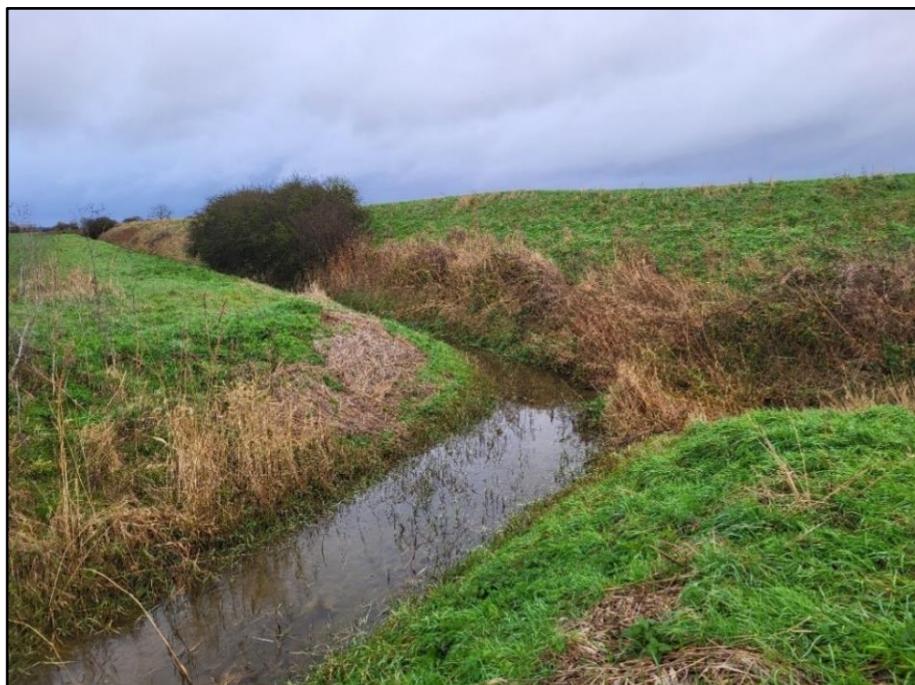
39

Location of WX41. Unnamed drain, with banks composed of earth material. The left bank c.1.8m, right bank c.1.8m, width c. 3.5m. Water depth is c.0.4m in the channel.

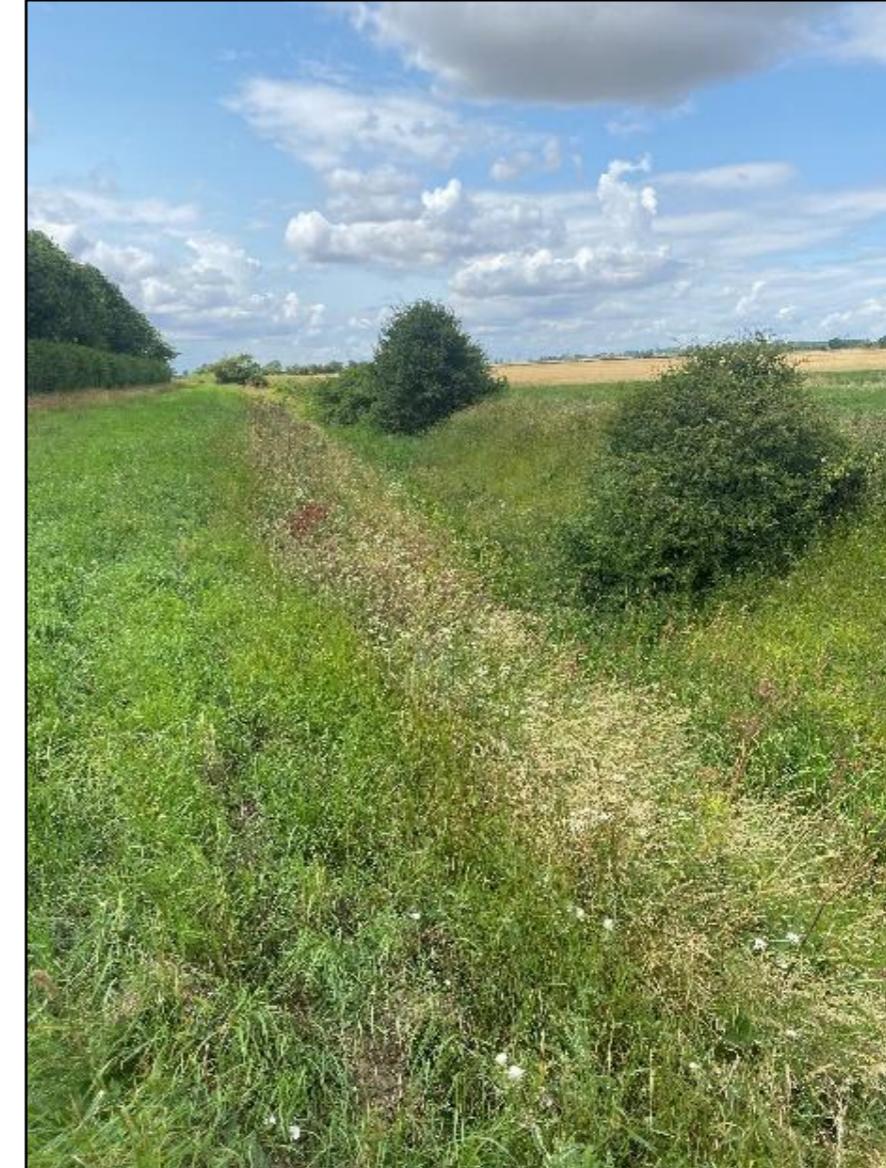
40

Location of WX40. Hodge Dyke, with overgrown vegetation throughout bank, left bank c.2m, right bank c.2m, width c.5m, depth c.0.3m

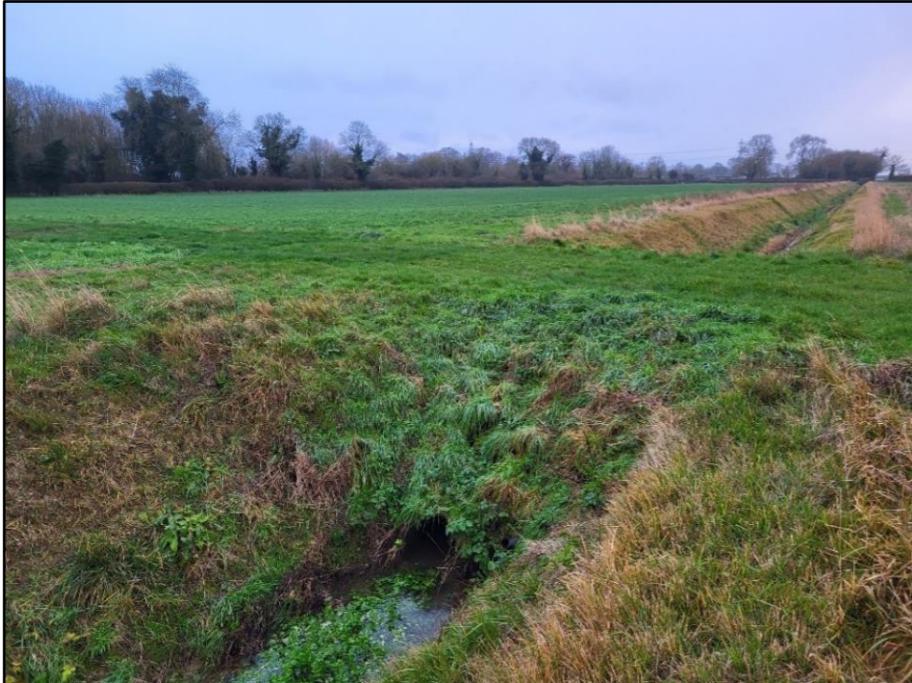
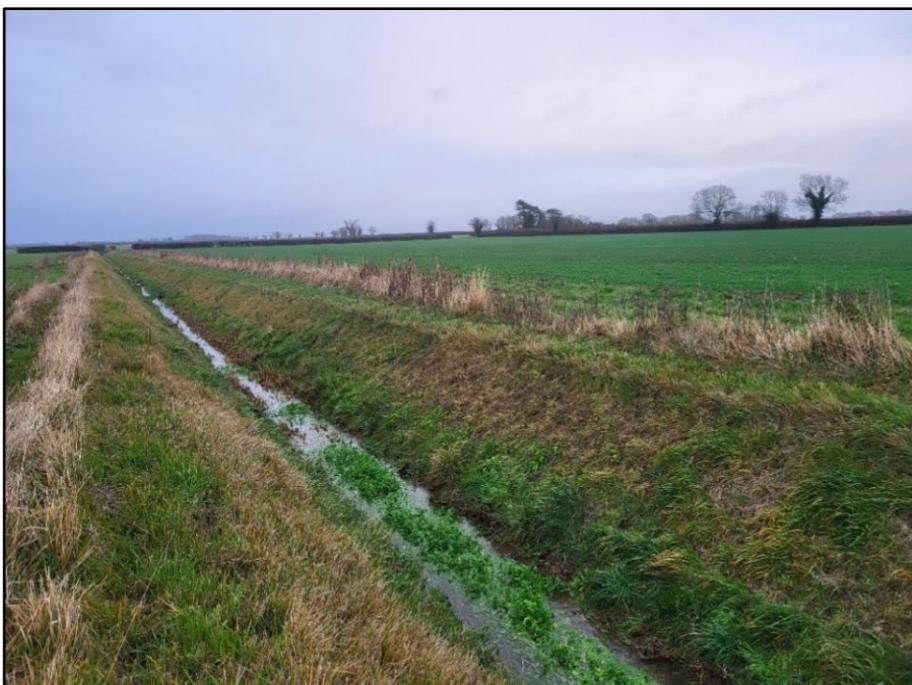
41

Location of WX42. Unnamed drain, with overgrown vegetation in channel and banks composed of earth material. The left bank c.1.4m, right bank c.1.4m, width c. 2.5m. Water depth is c.0.2m in the channel.

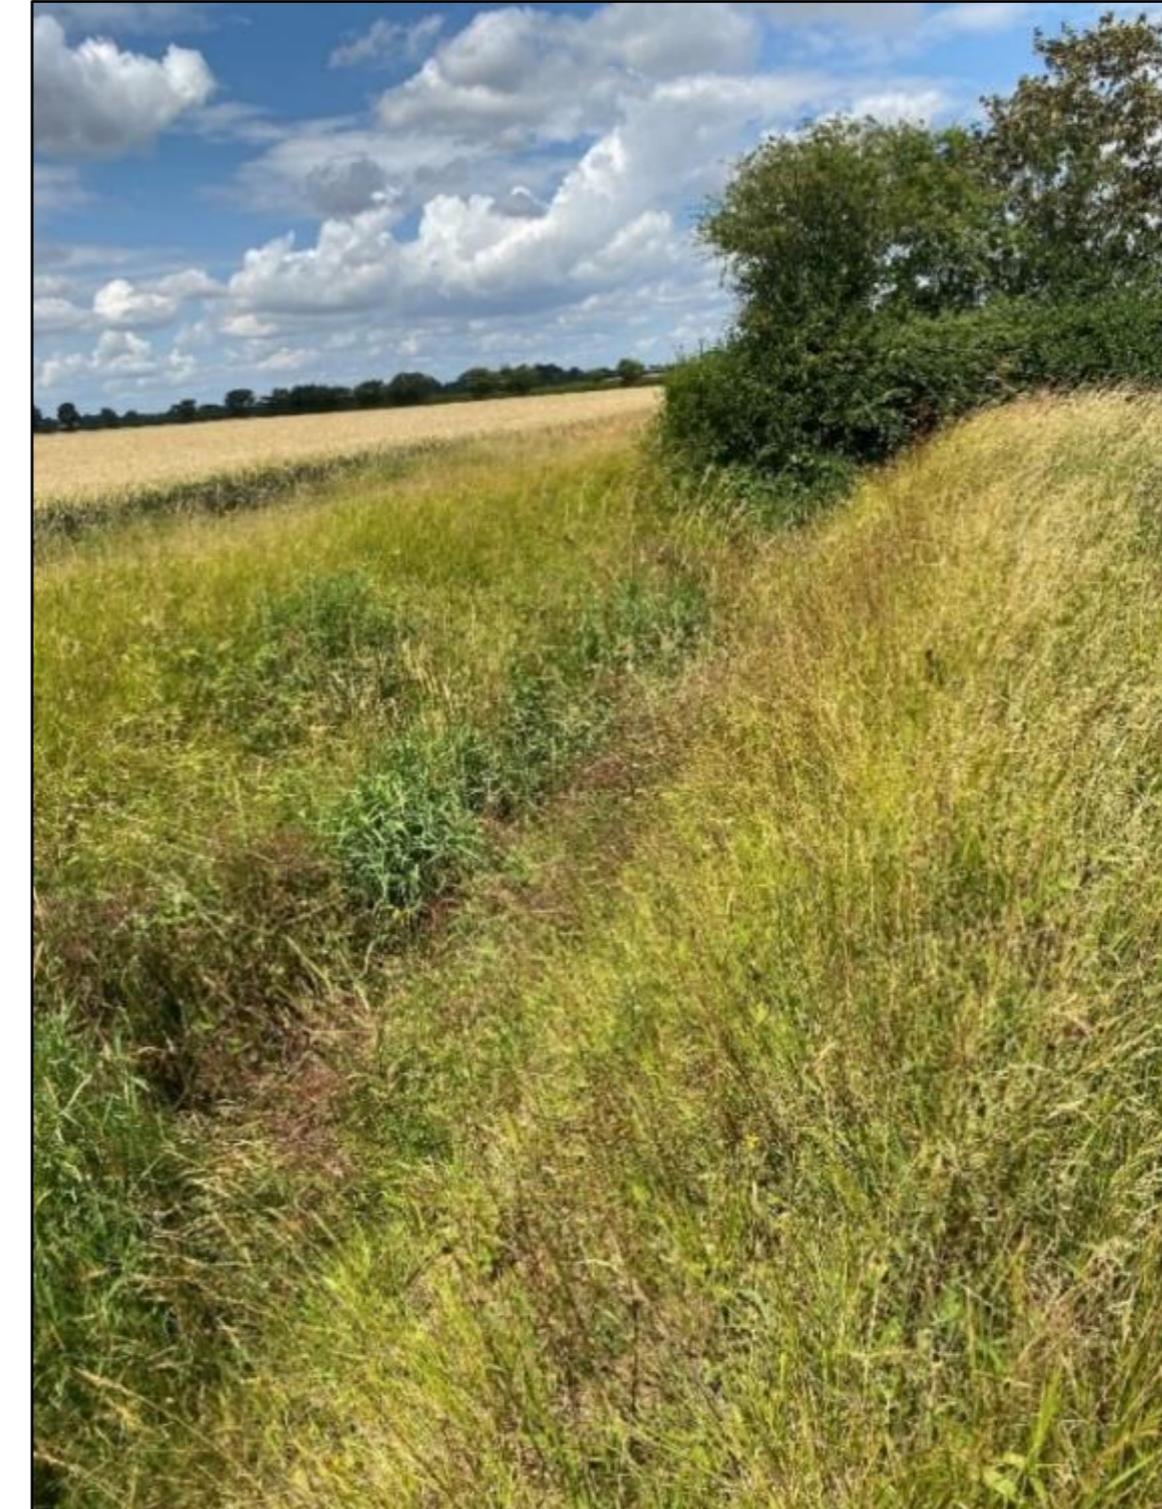
42

Location of WX43. Unnamed drain, with overgrown vegetation throughout channel, left bank c.1.5m, right bank c.1.5m, width c.2m. No water is present in the channel.
