Planning Inspectorate Reference: EN010151

Appendix 11.3 Summary of Watercourse Crossings and Photographs

Document Reference: 6.3 ES Volume 2, 6.3.83

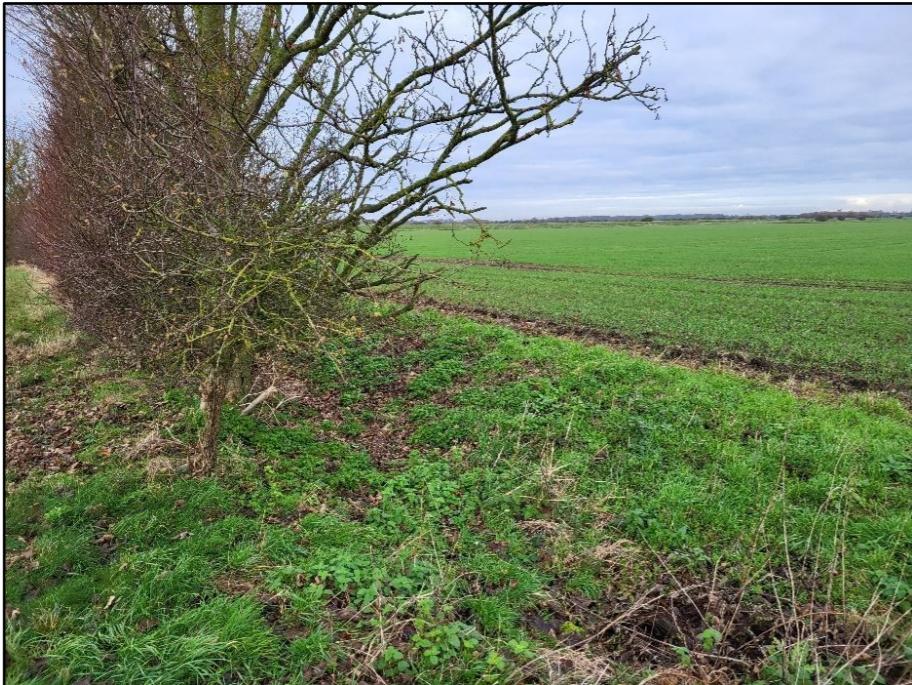
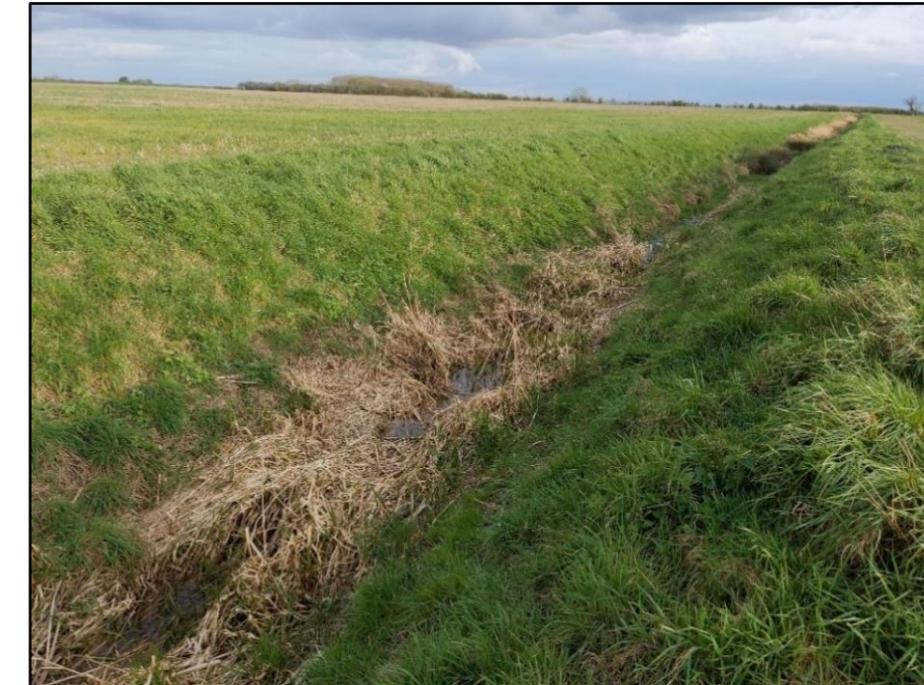
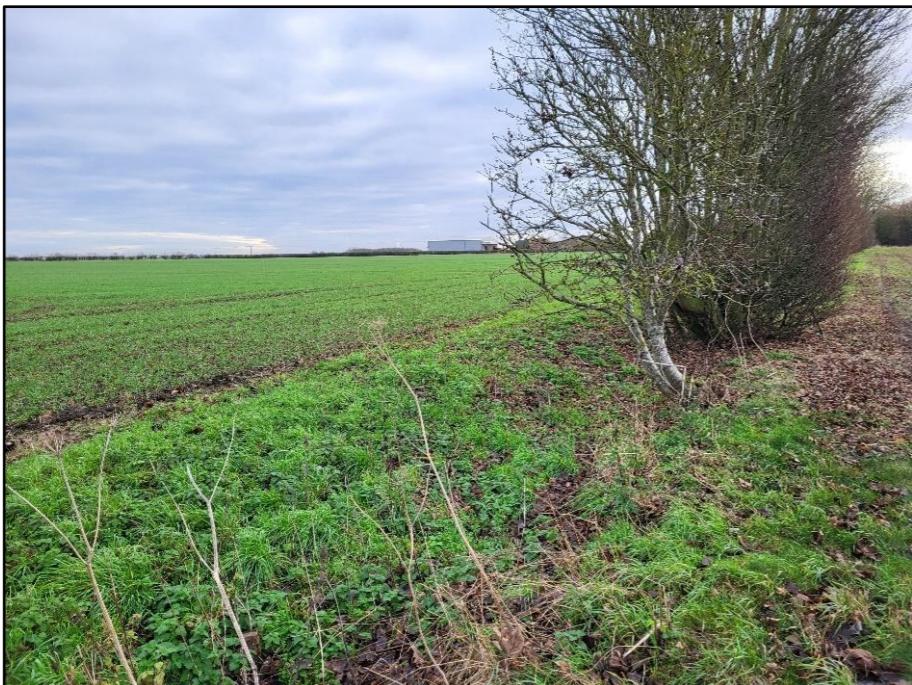
43

Location of WX44. Unnamed drain, with overgrown vegetation in channel and banks composed of earth material. The left bank c.0.4m, right bank c.0.4m, width c. 0.5m. No water present in channel.

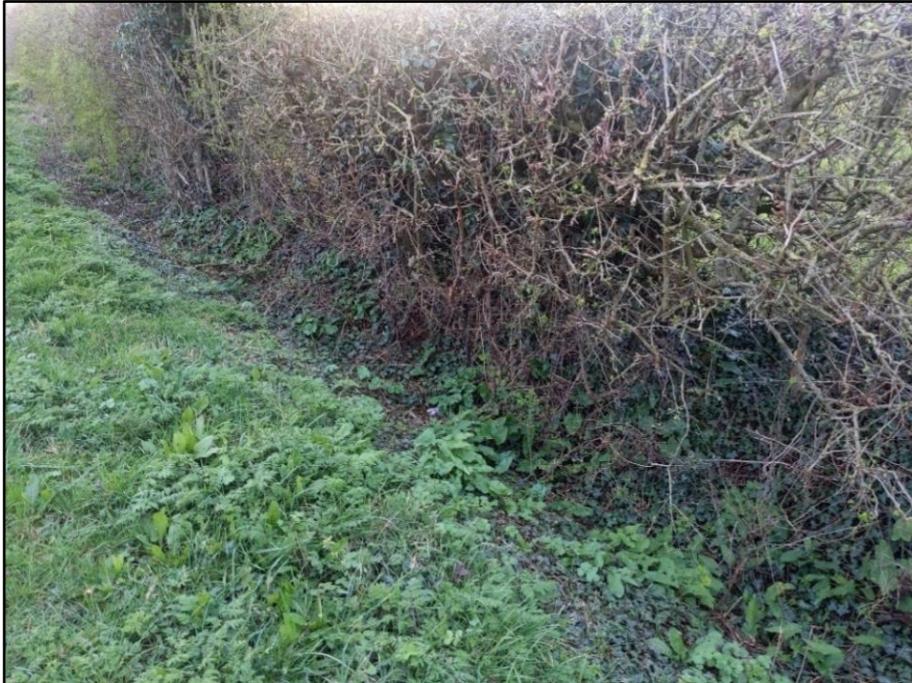
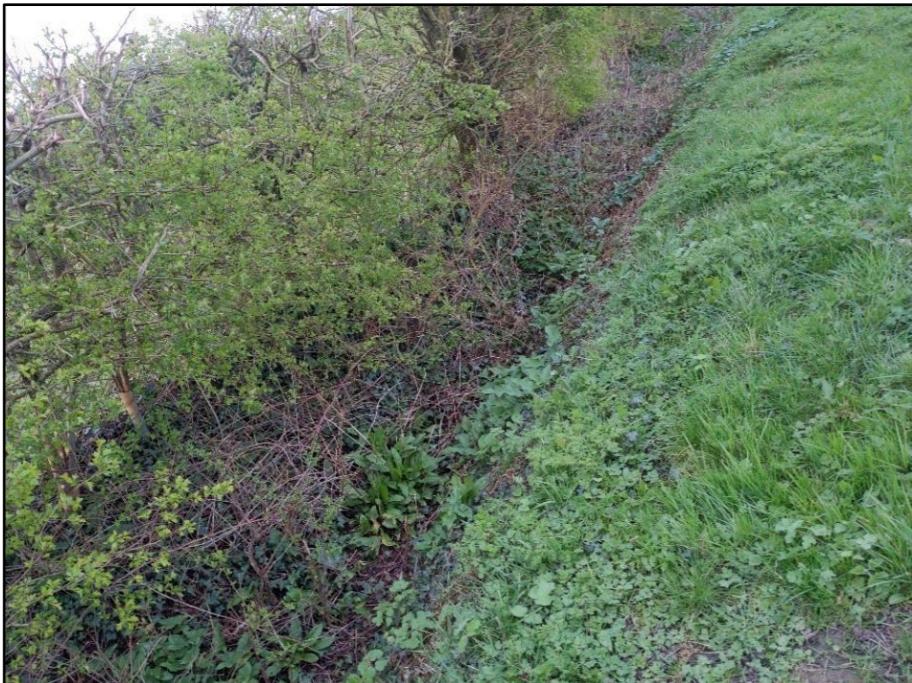
45

Location of WX46. Unnamed drain, with hedgerow along bank and banks composed of earth material. The left bank c.1.0m, right bank c.1.0m, width c. 0.8m. No water present in channel.

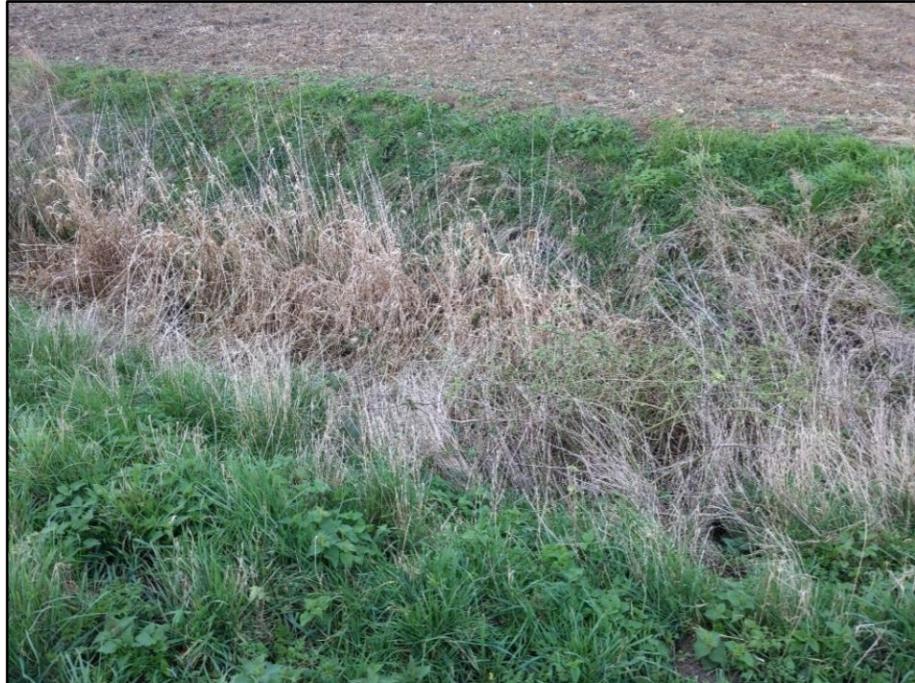
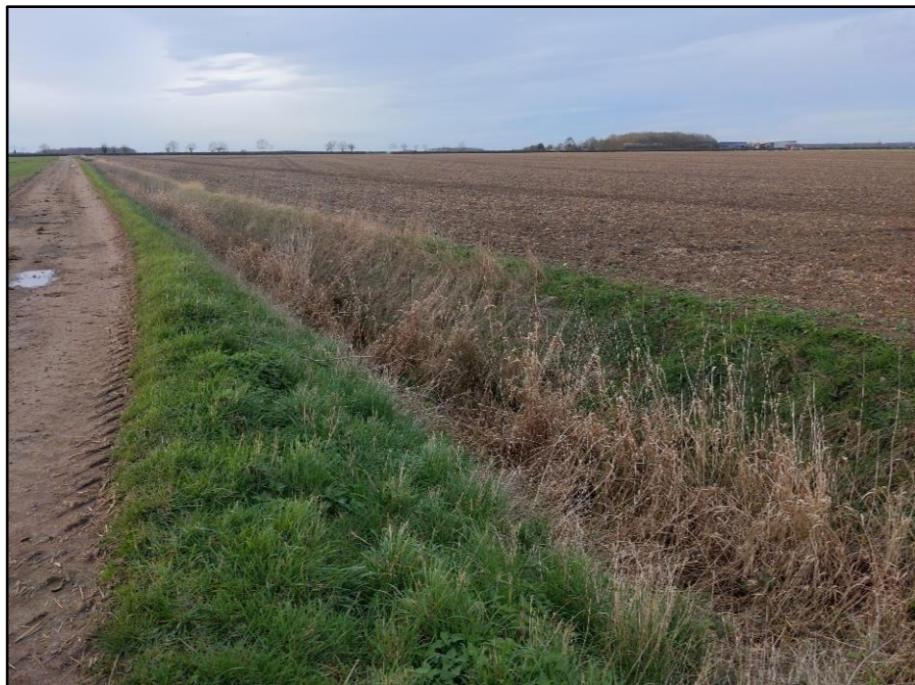
47

Location of WX48. Unnamed drain, with banks composed of earth material. The left bank c.0.8m, right bank c.0.8m, width c. 1.2m. Water Depth is c. 0.2m in channel with a silty substrate.

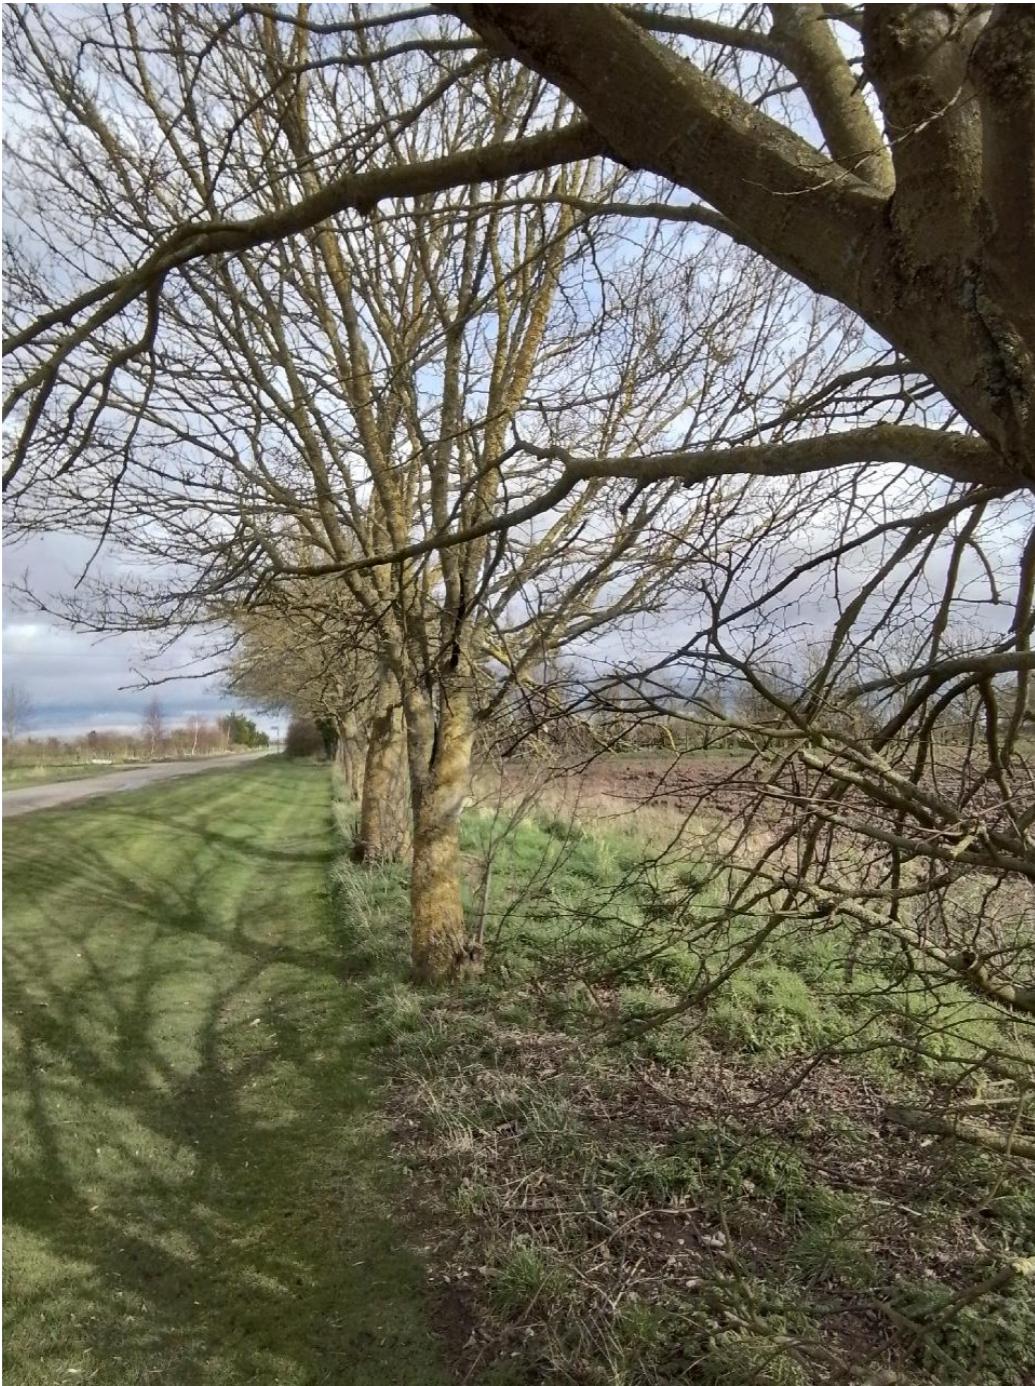
49

Location of WX5149. Unnamed drain, with banks composed of earth material. The left bank c.1.3m, right bank c.0.4m, width c. 0.2m. No water present in the channel.

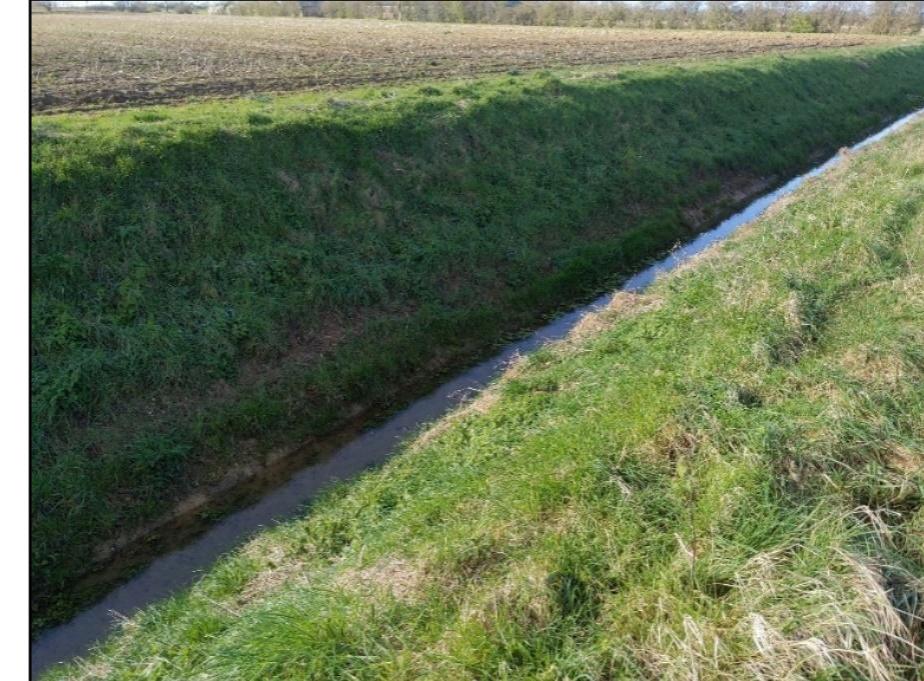
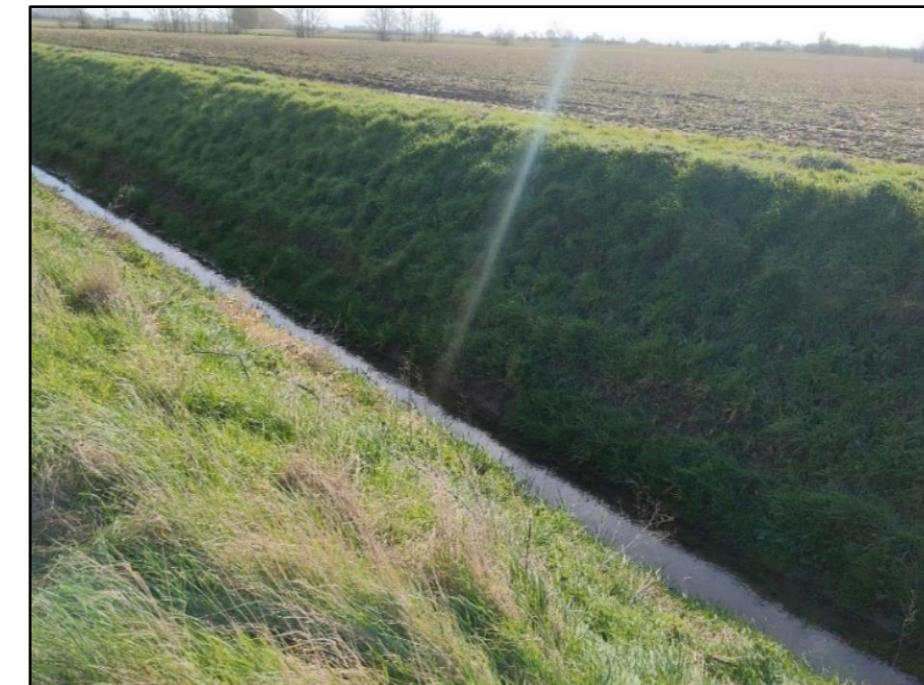
50

Location of WX52. Unnamed drain, with banks composed of earth material. The left bank c.1.5m, right bank c. 1.5m, width c. 3.0m. Water Depth is c. 0.25m in channel with a silty substrate.

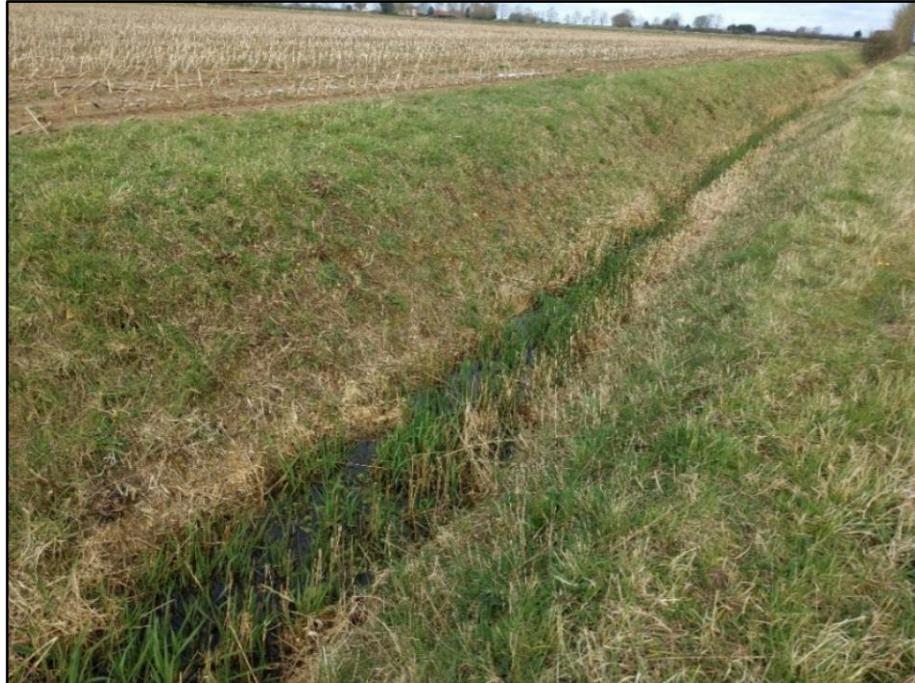
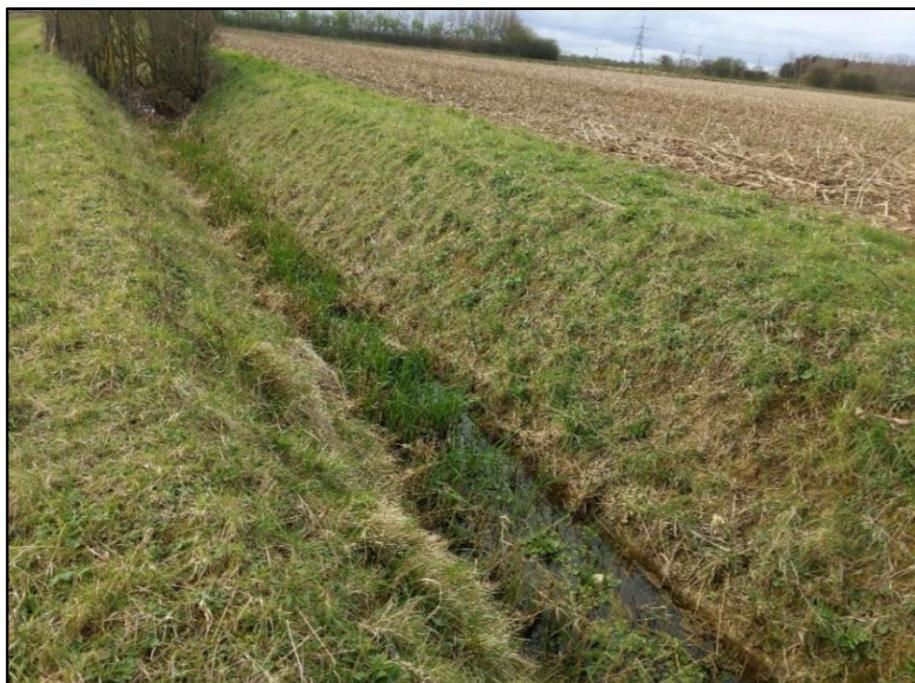
Photograph Sheet: 51
NGR: TF 16189 44770

Description: Location of WX53. Unnamed drain, with overgrown vegetation throughout channel and banks composed of earth material. The left bank c.1.5m, right bank c. 1.5m, width c. 2.0m. Water Depth is c. 0.05m in channel with a silty substrate.

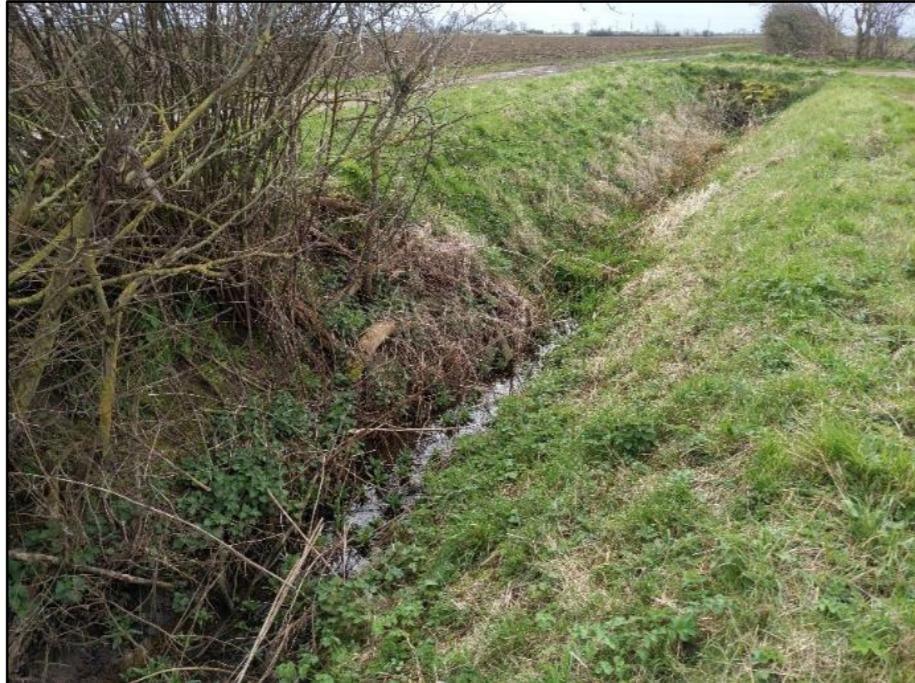
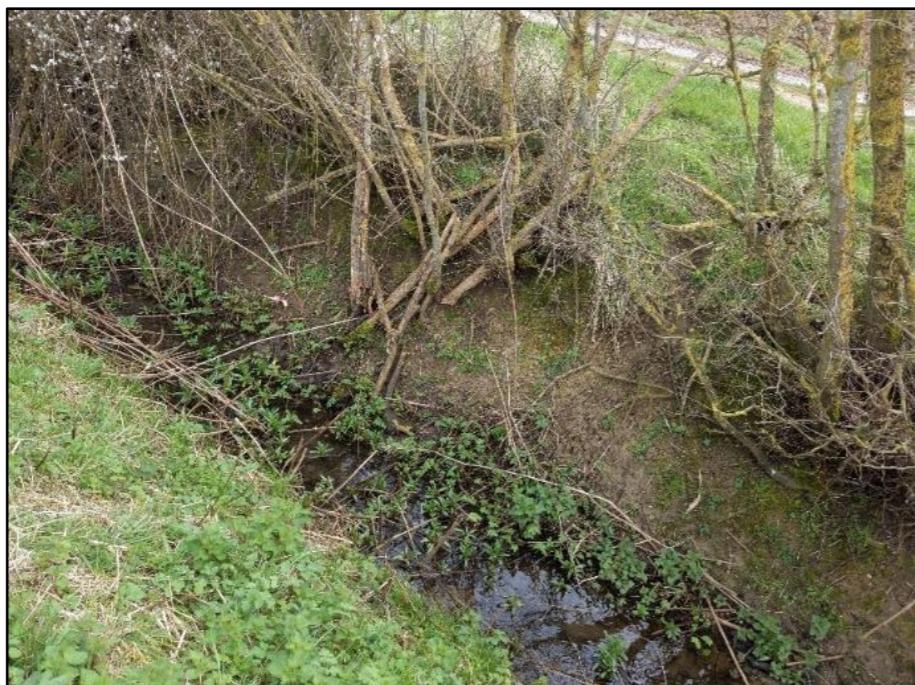
53

Location of WX55. Unnamed drain, with overgrown vegetation throughout channel and banks composed of earth material. The left bank c.1.4m, right bank c. 1.4m, width c. 3.0m. Water Depth is c. 0.2m in channel with a silty substrate.

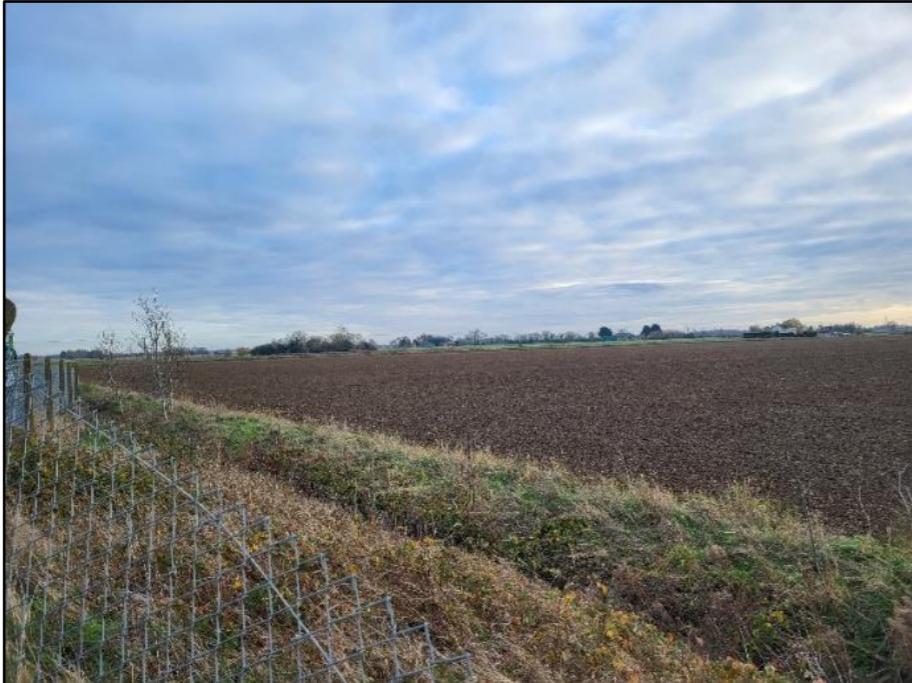
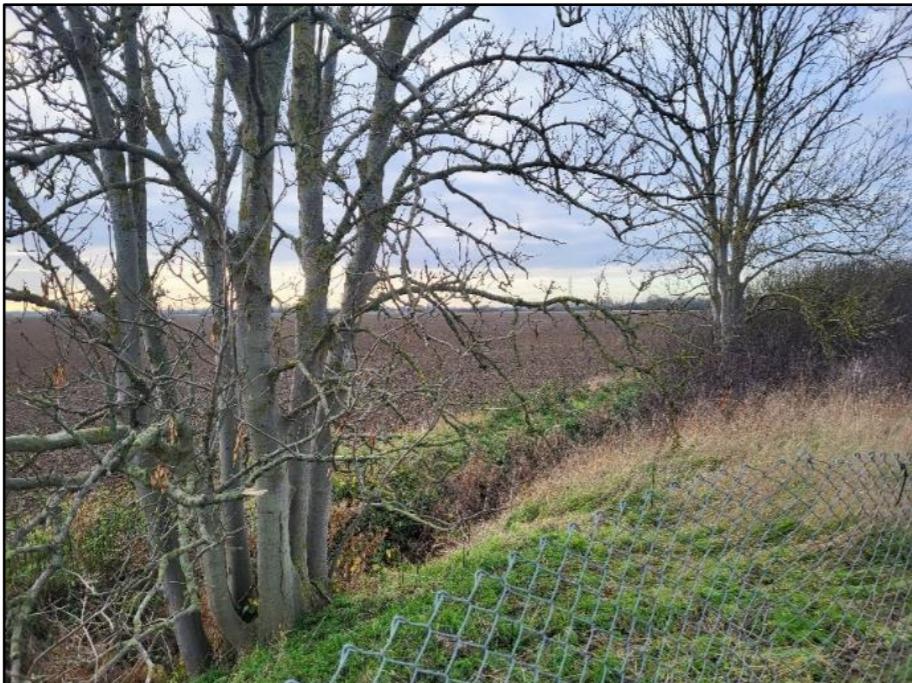
55

Watercourse crossing location WX57 taken from downstream of point due to accessibility issue. Unnamed drain, with banks composed of earth material. The left bank c.1.2m, right bank c. 1.2m, width c. 2.0m. No water present in channel.

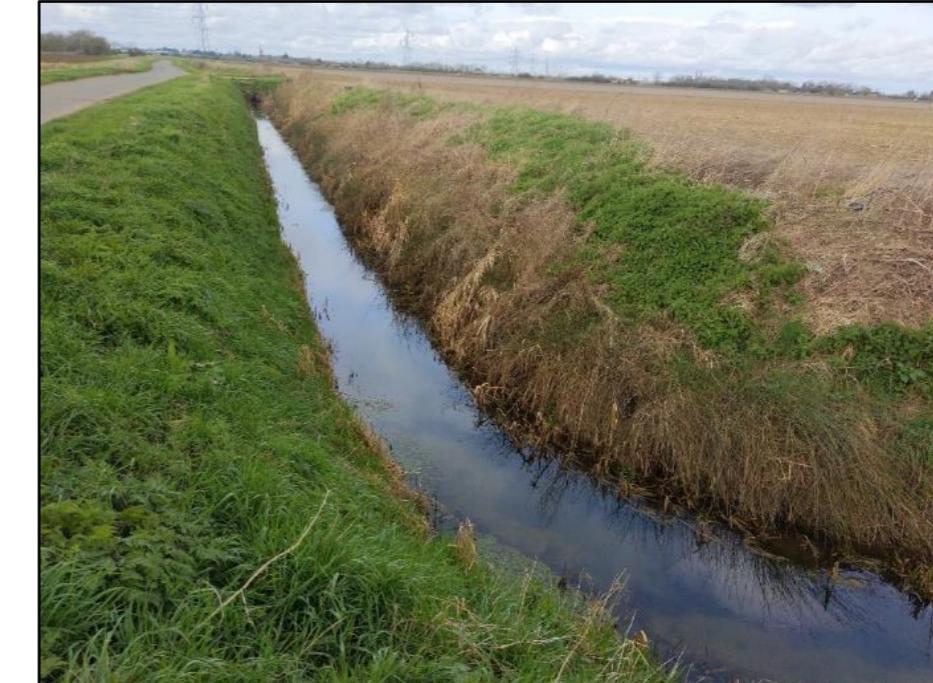
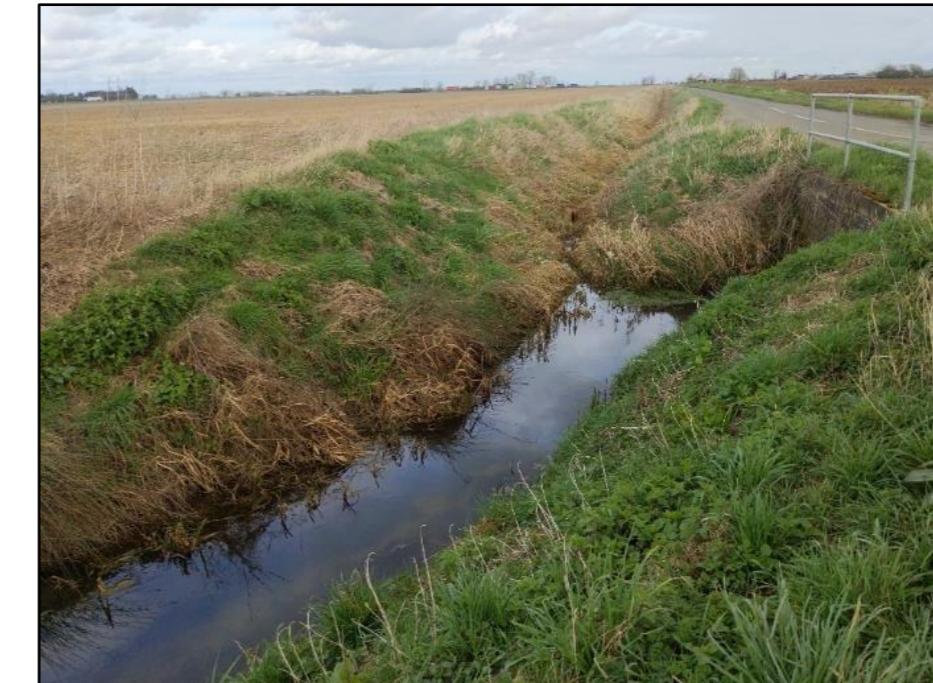
Location of WX58. Unnamed drain, with banks composed of earth material. The left bank c.1.5m, right bank c. 1.5m, width c. 2.5m. The water depth is c. 0.7m.

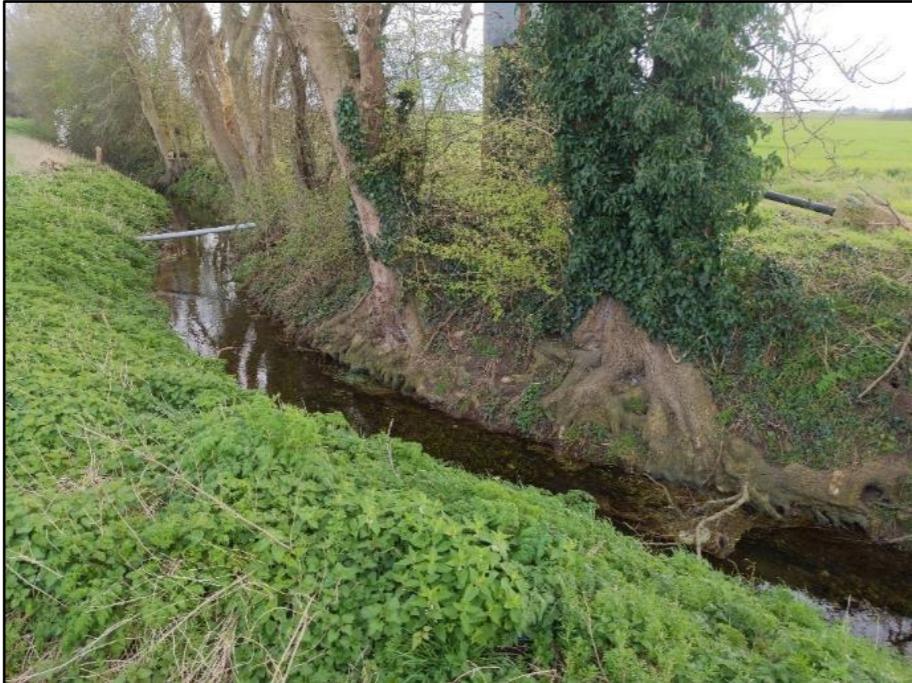
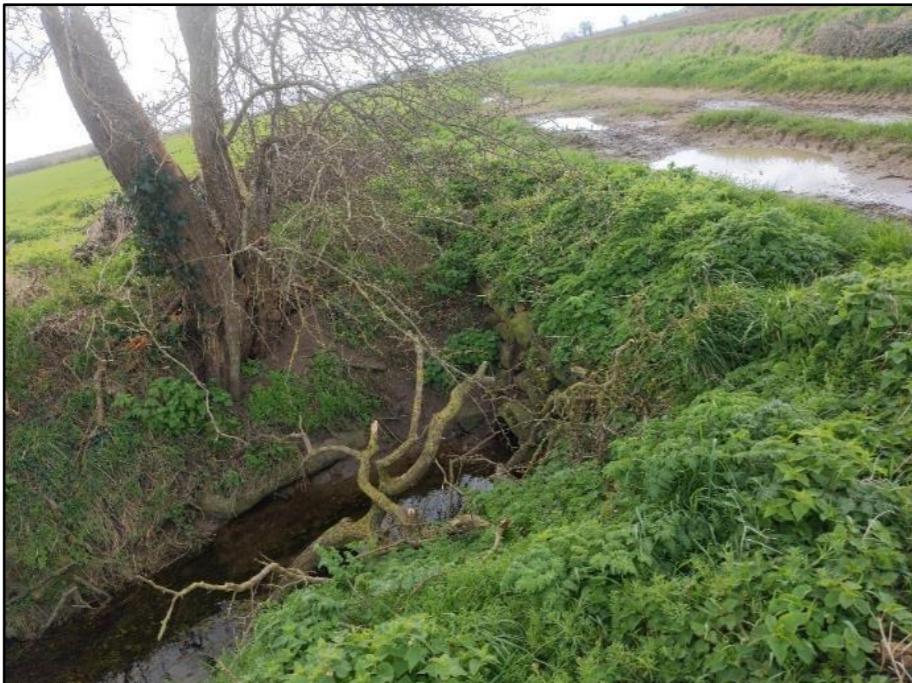
57

Location of WX59. Unnamed drain, with banks composed of earth material. The left bank c.1.5m, right bank c. 1.5m, width c. 1.5m. The water depth is c0.3m and is culverted downstream.

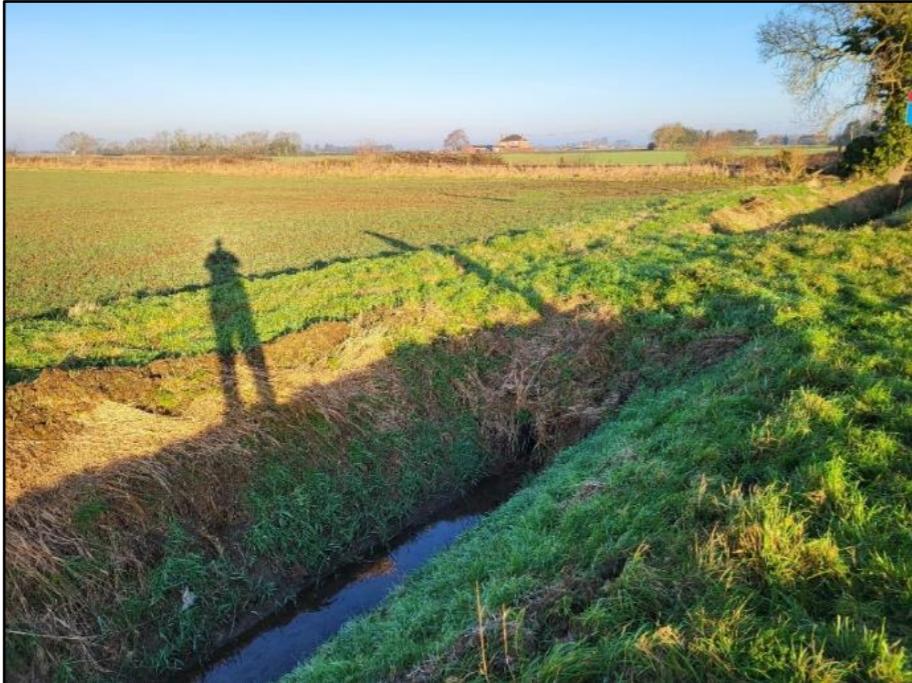
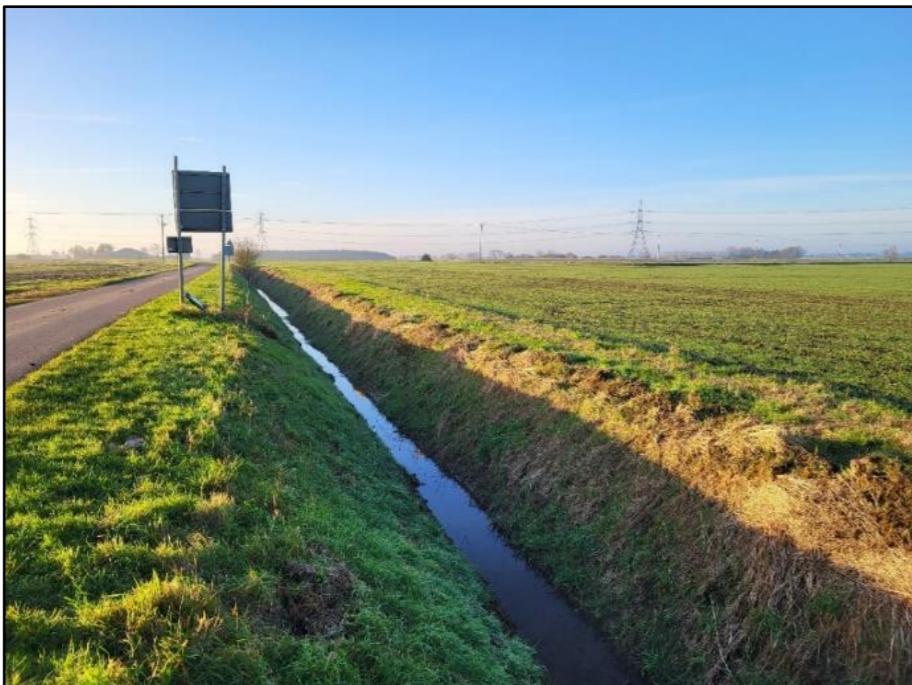
59

Location of WX61. Unnamed drain, with banks composed of silt and earth material. The left bank c.1.5m, right bank c. 1.5m, width c3.0m. The water depth is c0.05m and is culverted downstream.

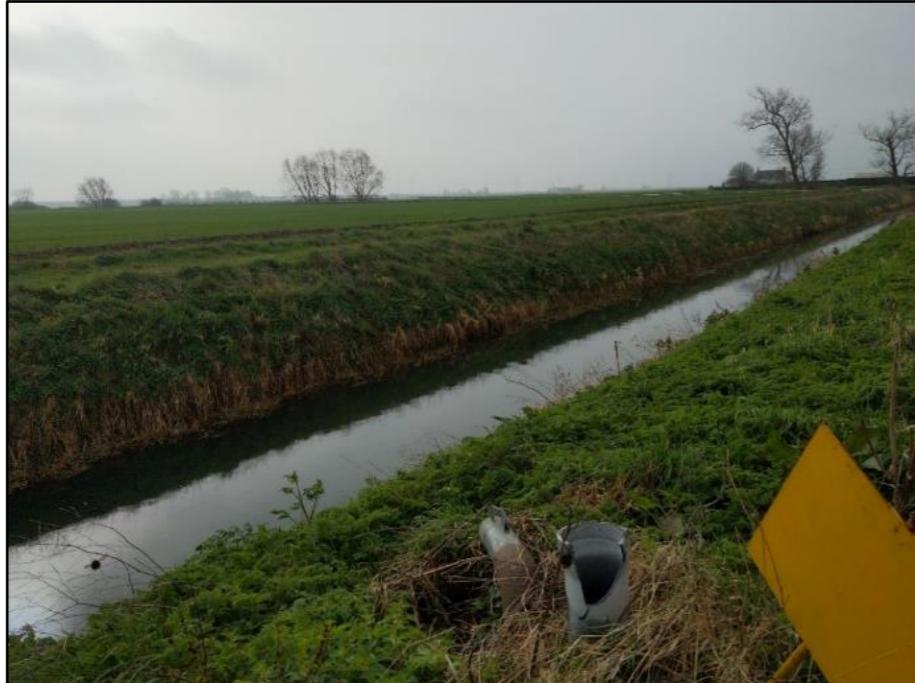
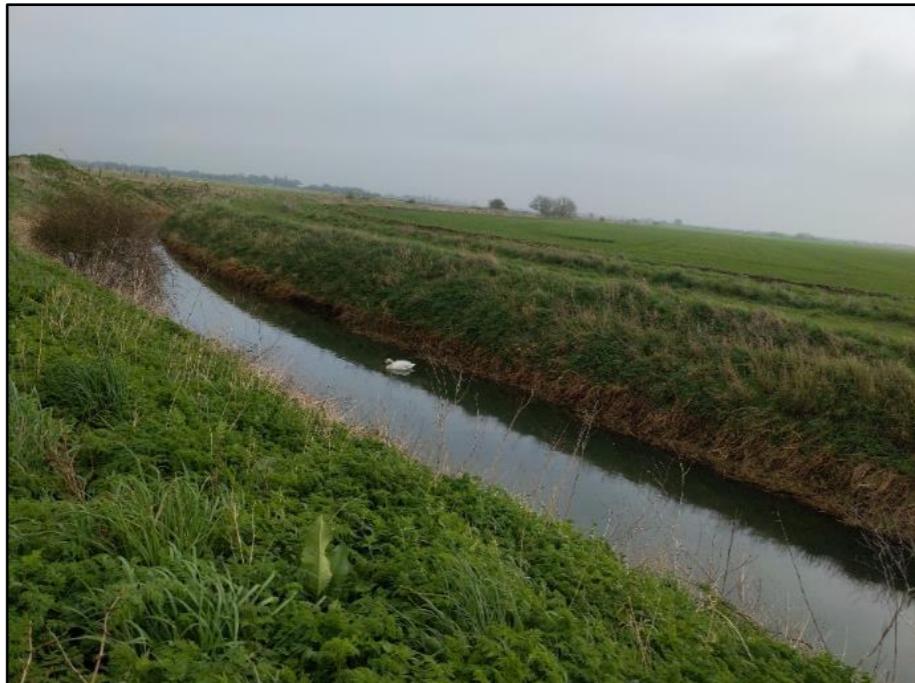
Photograph Sheet: 61
NGR: TF 18811 42390
Photograph Date: 21 March 2024
Description: Location of WX63. Great Hale Eau, with banks composed of silt and earth material. The left bank c.3.0m, right bank c.3.0m, width c6.0m. The water depth is c1.2m.

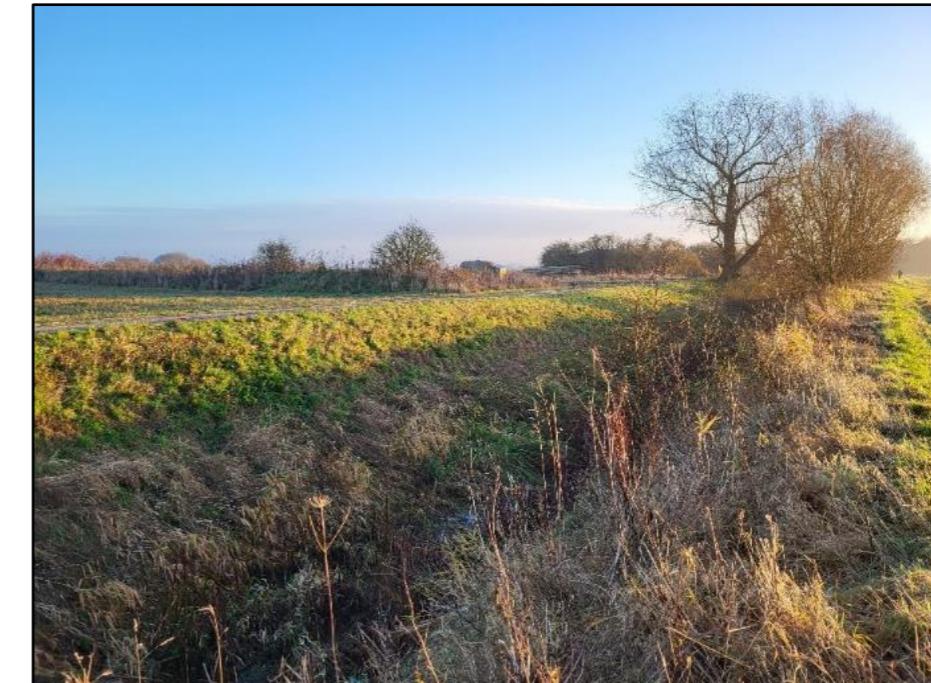
Photograph Sheet: 62
NGR: TF 19449 42105
Photograph Date: 3 December 2024
Description: Location of WX64. Unnamed drain, with banks composed of silt and earth material. The left bank c.3.0m, right bank c.3.0m, width c4.5m. The water depth is c0.2m.

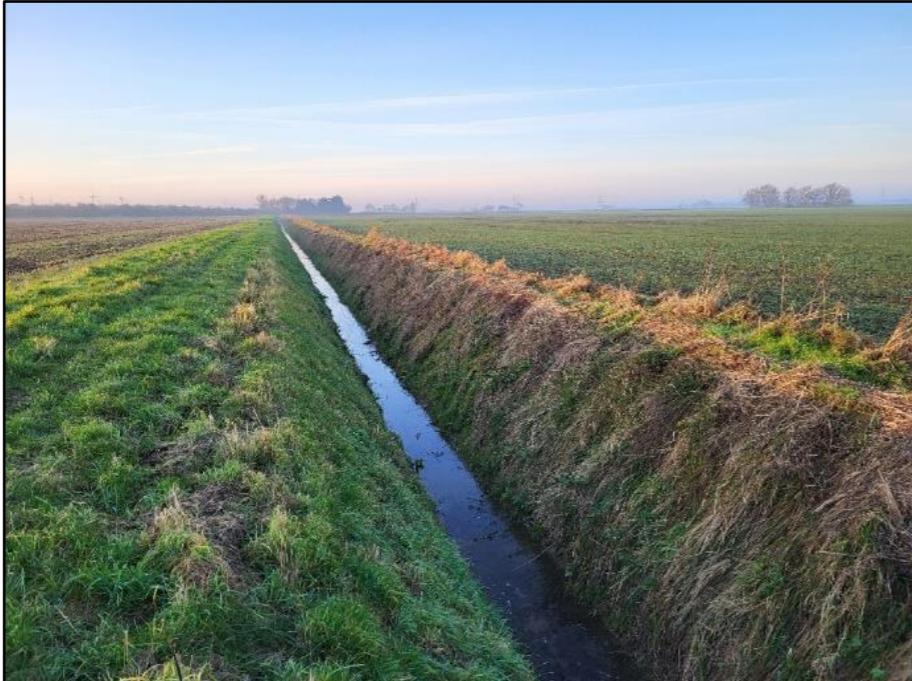
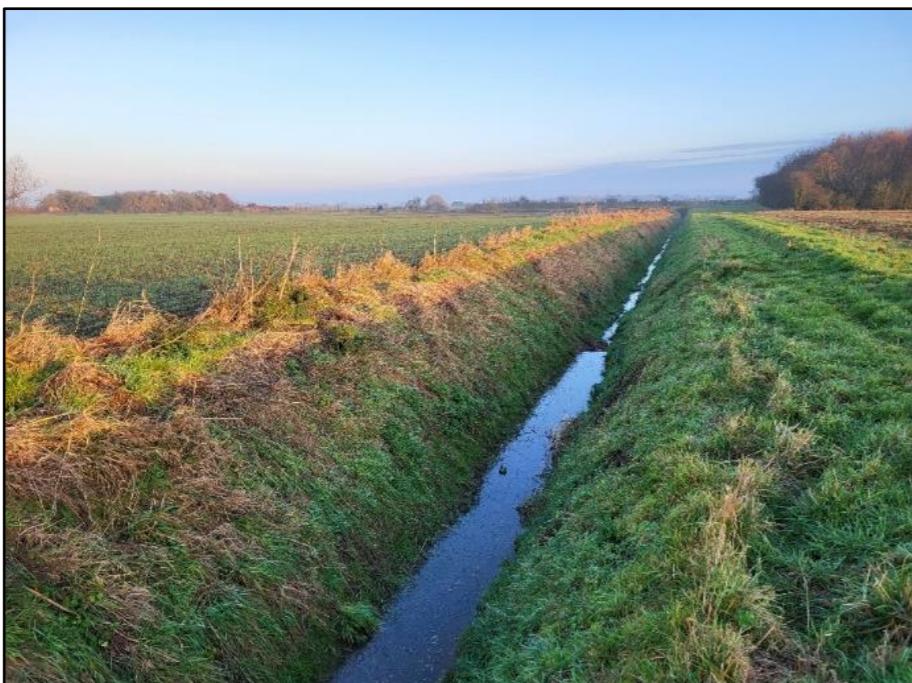
63

Location of WX65. Unnamed drain, with banks composed of silt and earth material. The left bank c.1.5m, right bank c.1.5m, width c2.0m. The water depth is c0.1m.

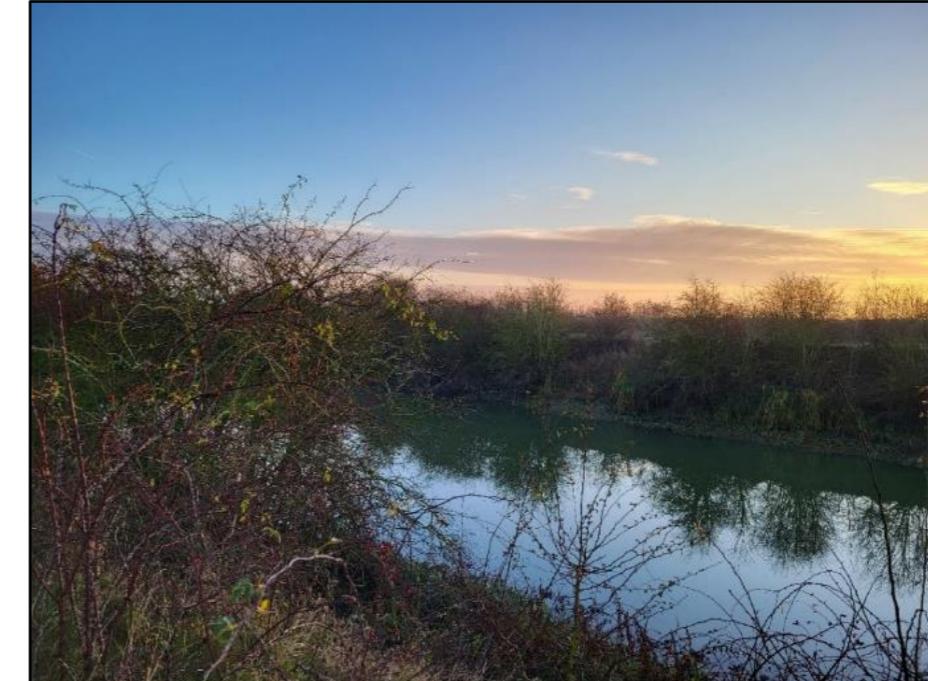
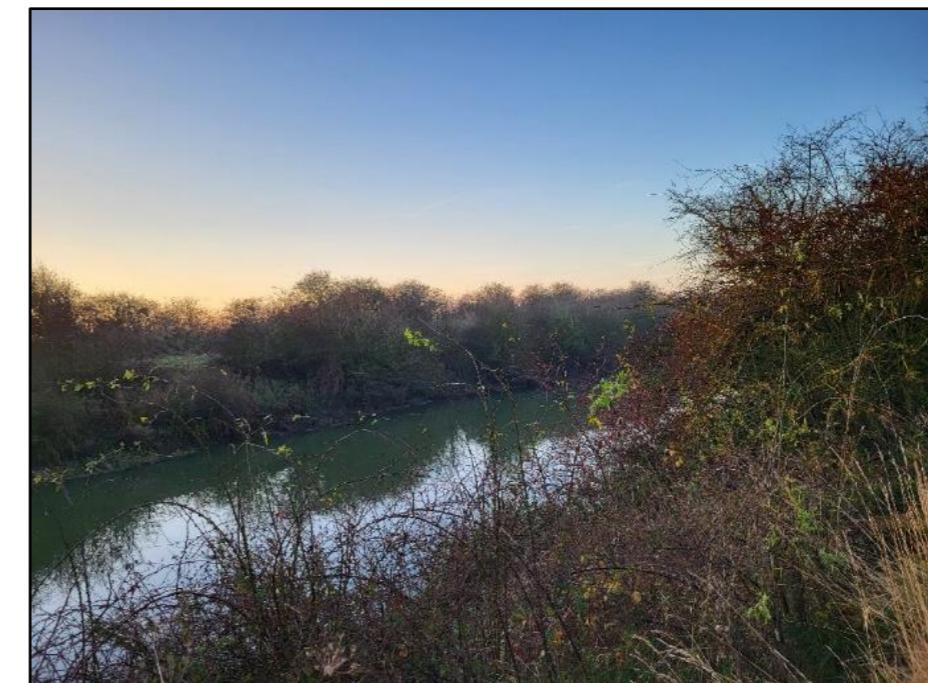
64

Location of WX66. South Forty Foot Drain, with banks composed of silt and earth material. The left bank is c.6.0m, right bank c.6.0m, width c10.0m.

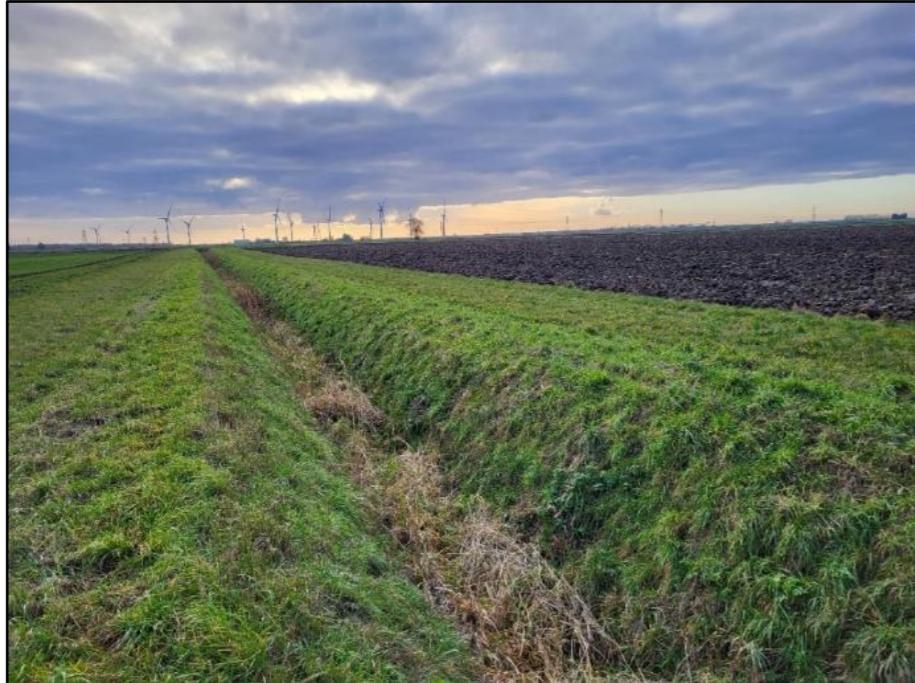
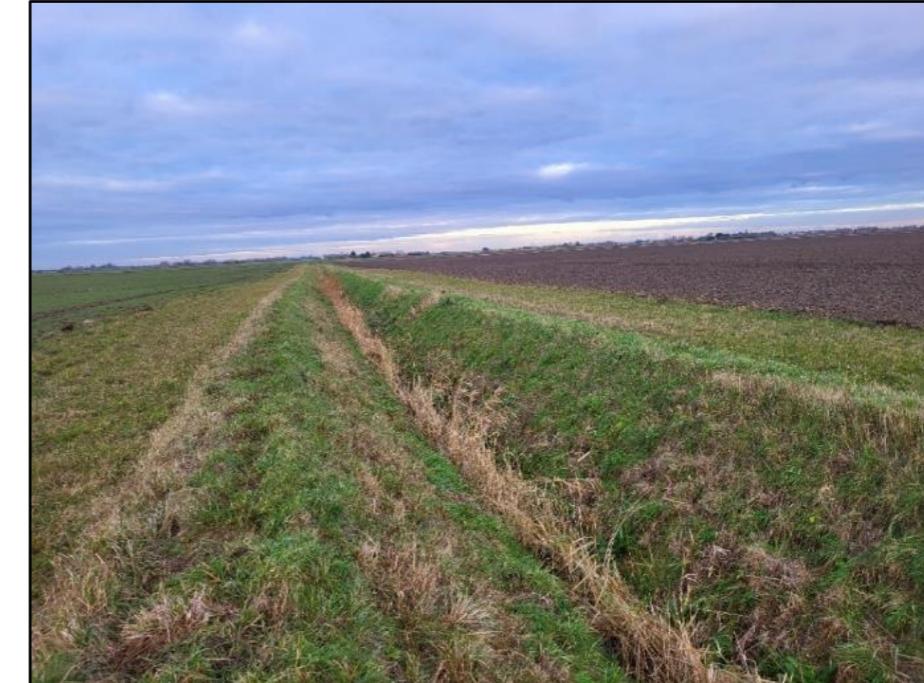
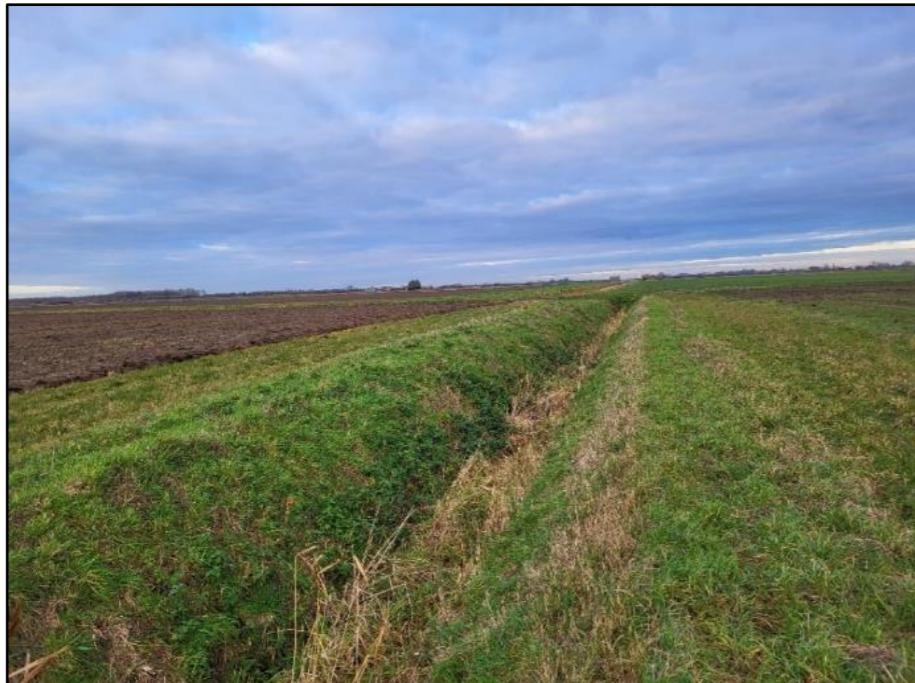
Photograph Sheet: 65
NGR: TF 20359 40736
Photograph Date: 3 December 2024
Description: Location of WX67. Unnamed drain, with banks composed of silt and earth material. The left bank c.1.3m, right bank c.1.3m, width c3.0m. No water is present in the channel.

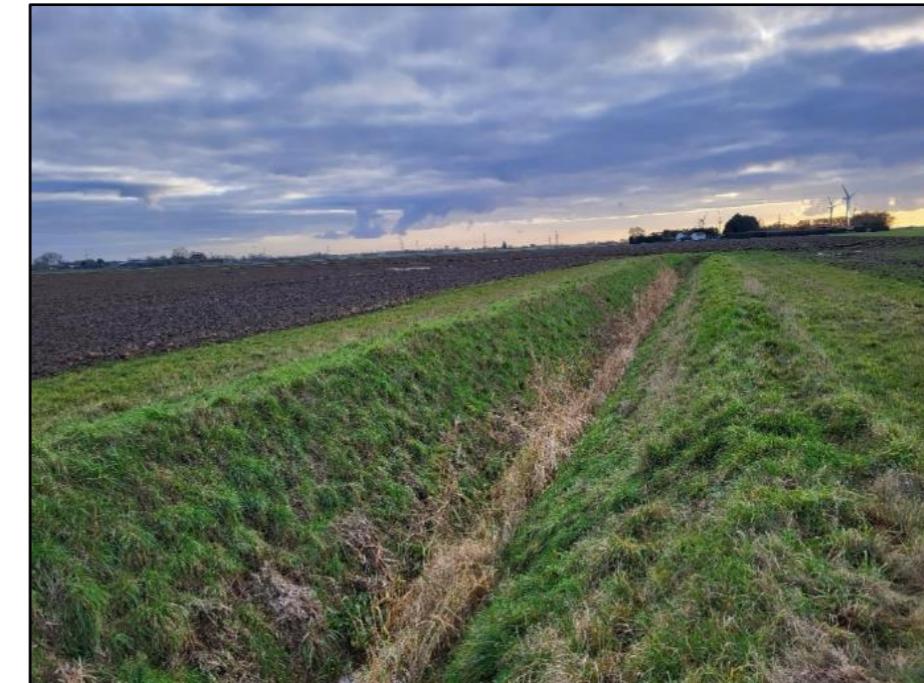
Photograph Sheet: 66
NGR: TF 20528 40395
Photograph Date: 3 December 2024
Description: Location of WX68. Unnamed drain, with banks composed of silt and earth material. The left bank c.2.0m, right bank c.2.0m, width c3.5m. Water depth of c.0.2m in the channel.
