Planning Inspectorate Reference: EN010151

Appendix 11.3 Summary of Watercourse Crossings and Photographs

Document Reference: 6.3 ES Volume 2, 6.3.83

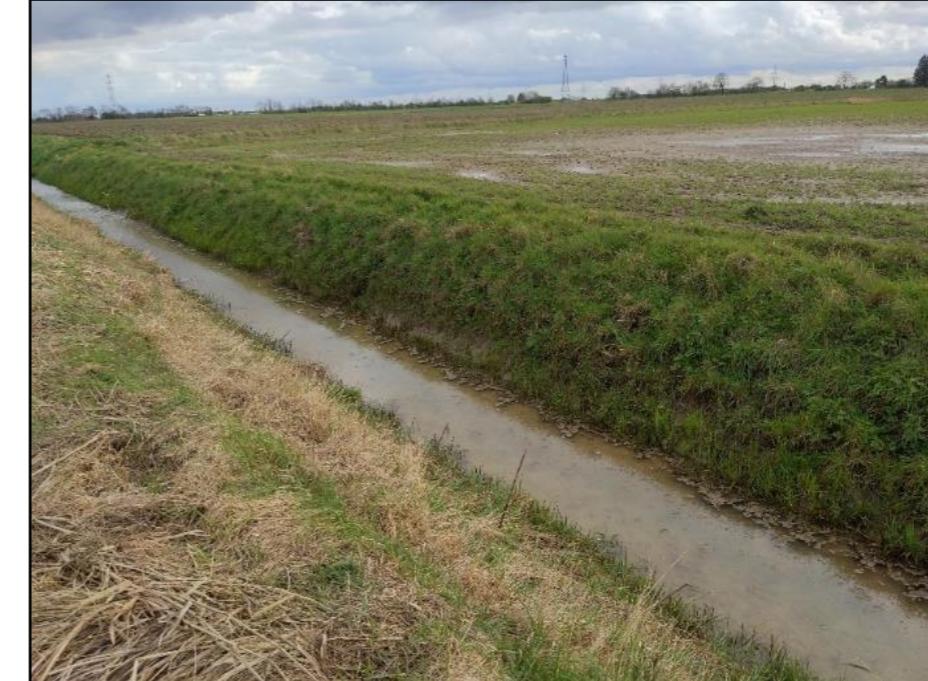
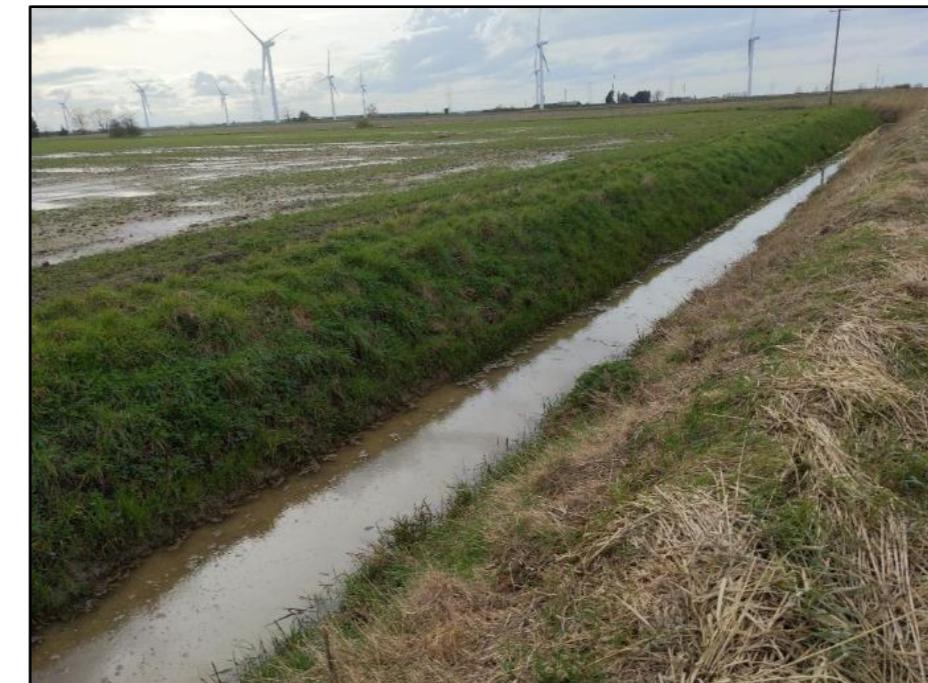
Photograph Sheet: 67
NGR: TF 20537 39774
Photograph Date: 19 March 2024
Description: Location of WX69. Unnamed drain, with banks composed of silt and earth material. The left bank c.2.0m, right bank c.2.0m, width c3.0m. Water depth of c.0.1m in the channel.

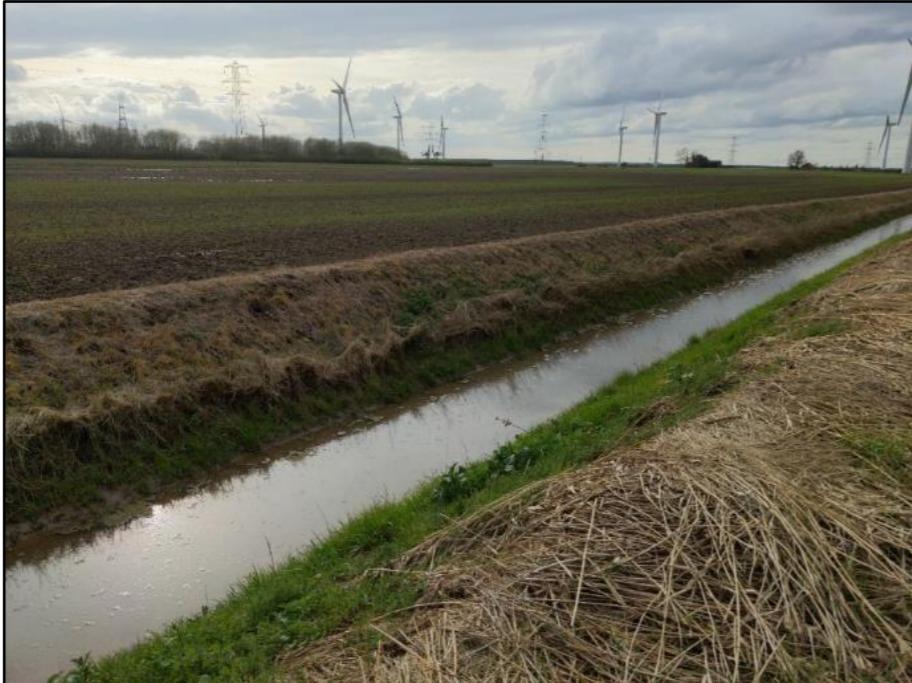
Upstream Viewpoint

Photograph Sheet: 68
NGR: TF 20364 39432
Photograph Date: 19 March 2024
Description: Location of WX70. Unnamed drain, with banks composed of silt and earth material. The left bank c.2.0m, right bank c.2.0m, width c2.5m. Water depth of c.0.3m in the channel.

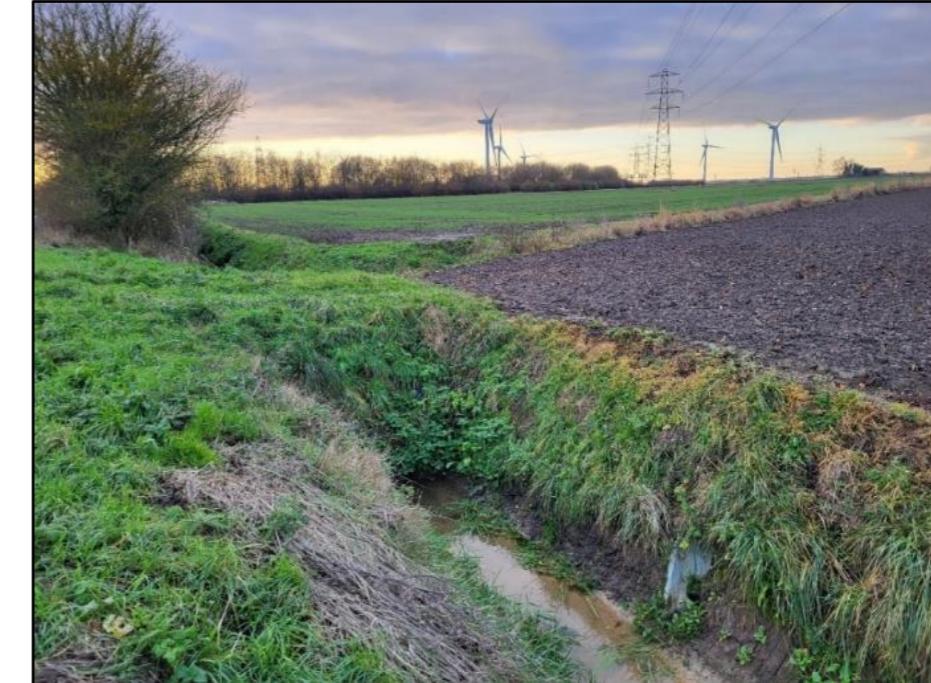
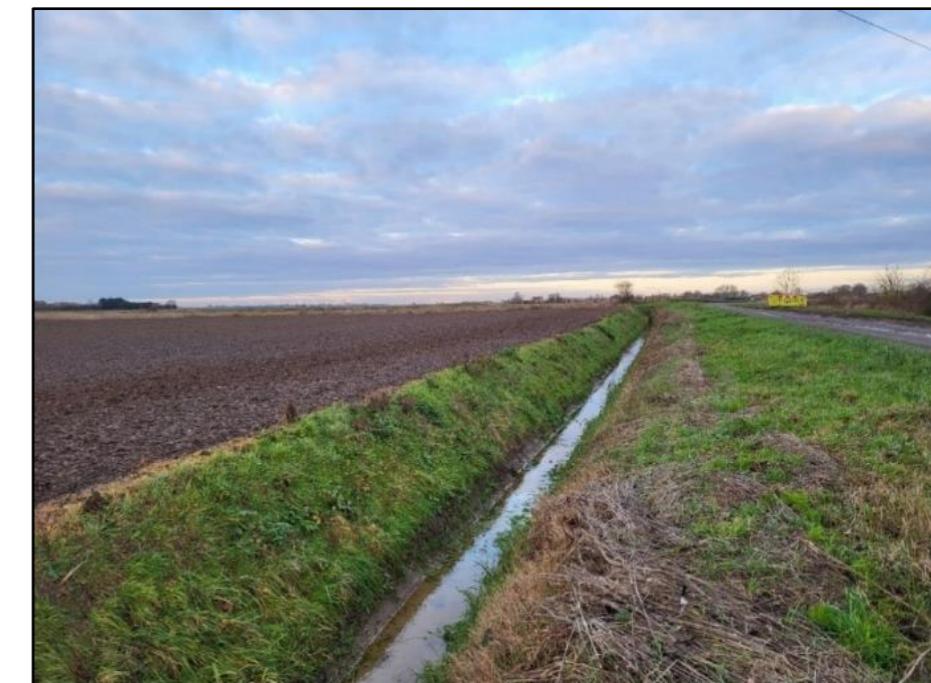
Description: Location of WX71. Unnamed drain, with banks composed of silt and earth material. The left bank c.3.0m, right bank c.2.5m, width c.7.0m. Water depth of c.0.5m in the channel.

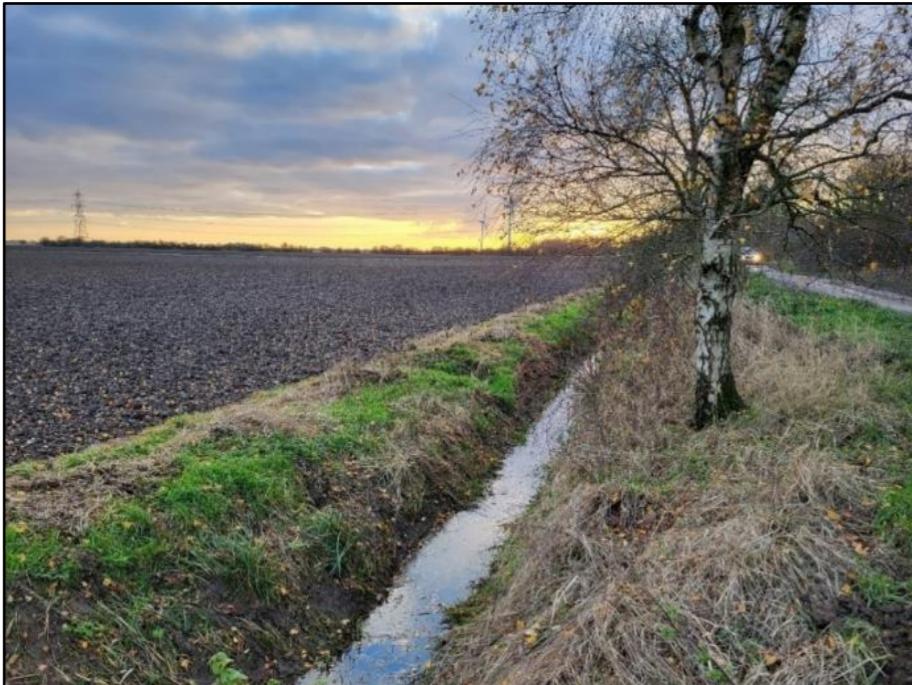
Upstream Viewpoint

Description: Location of WX72. Unnamed drain, with banks composed of earth material and a silty and earth channel substrate. The left bank c.1.2m, right bank c.1.3m, width c.2.0m. Water depth of c.0.08m in the channel and culverted.

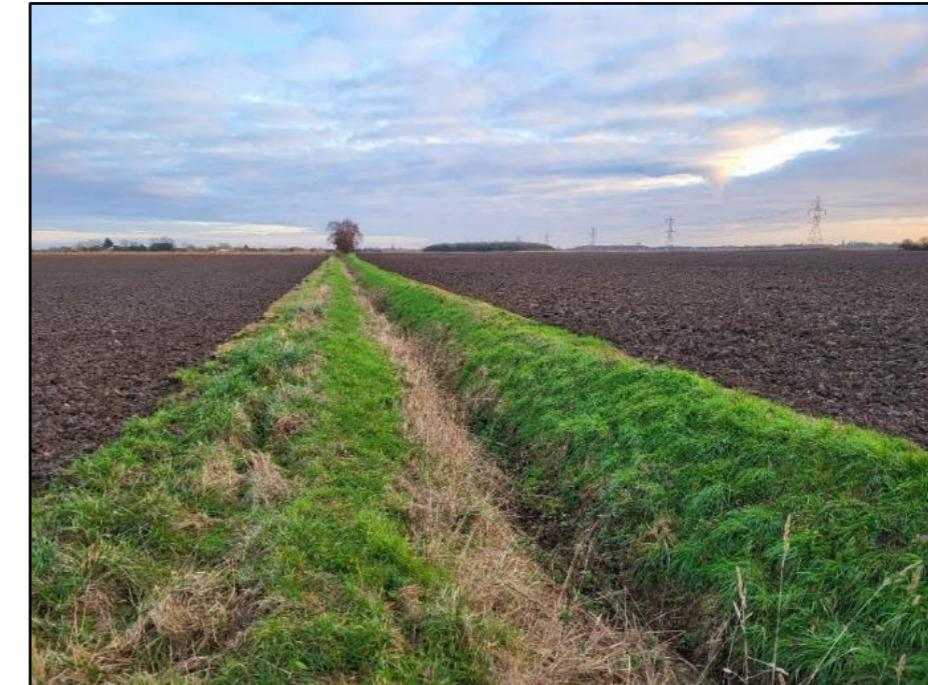
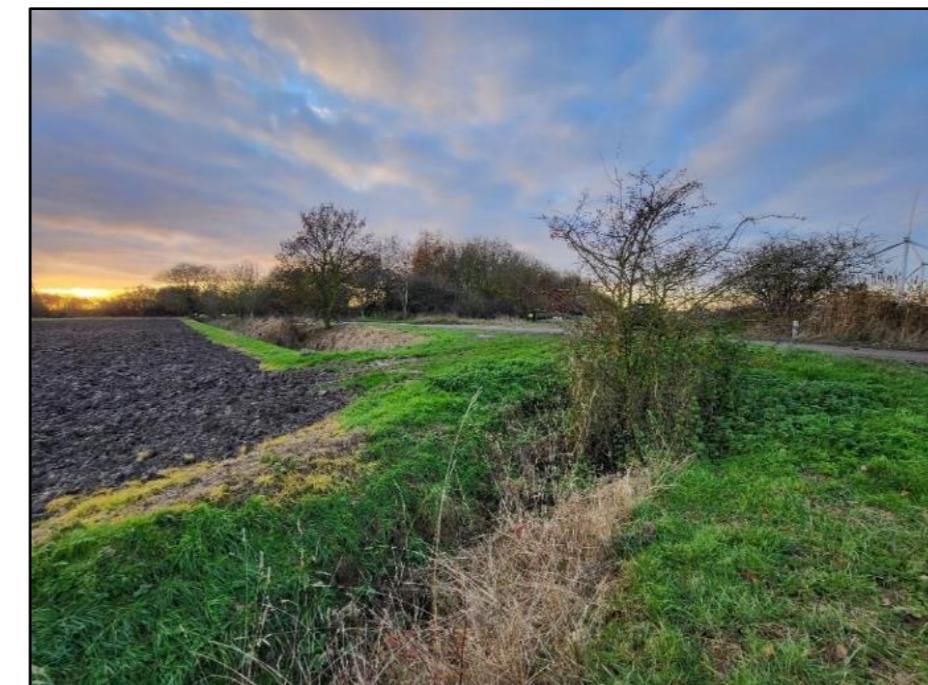
Location of WX73. Unnamed drain, with banks composed of earth material. The left bank c.1.0m, right bank c.1.0m, width c.2.0m. Water depth of c.0.2m in the channel.

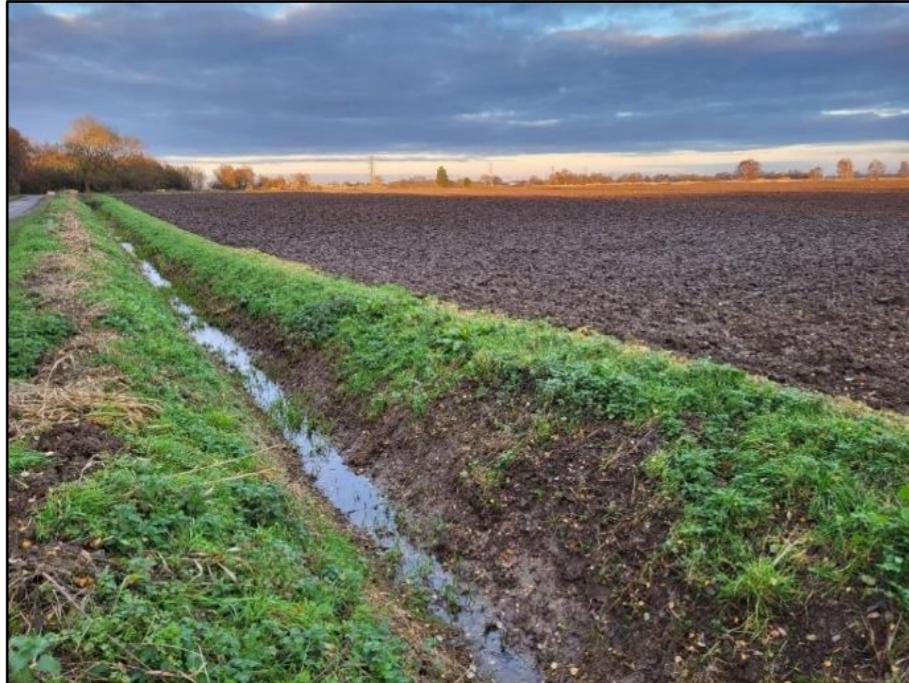
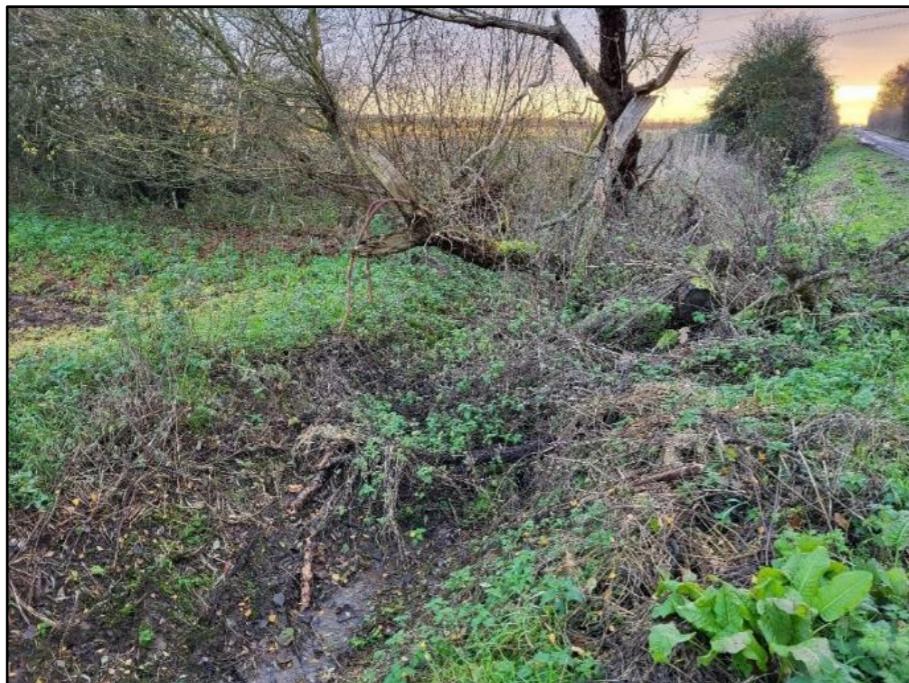
Location of WX75. Unnamed drain, with vegetation throughout the channel and banks composed of earth material. The left bank c.1.5m, right bank c.1.5m, width c.1.5m. Water depth of c.0.02m in the channel.

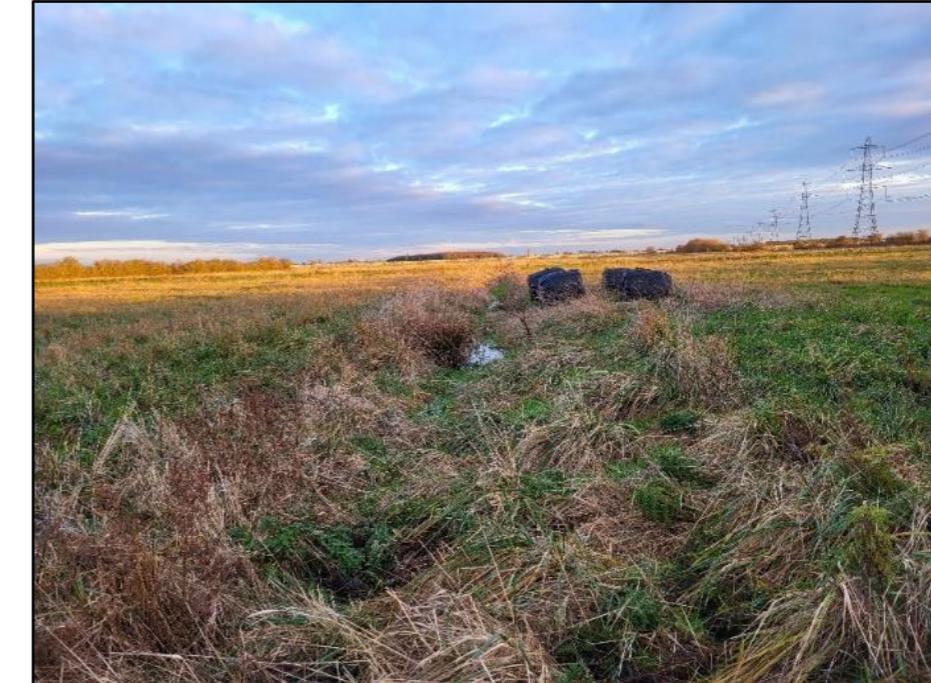
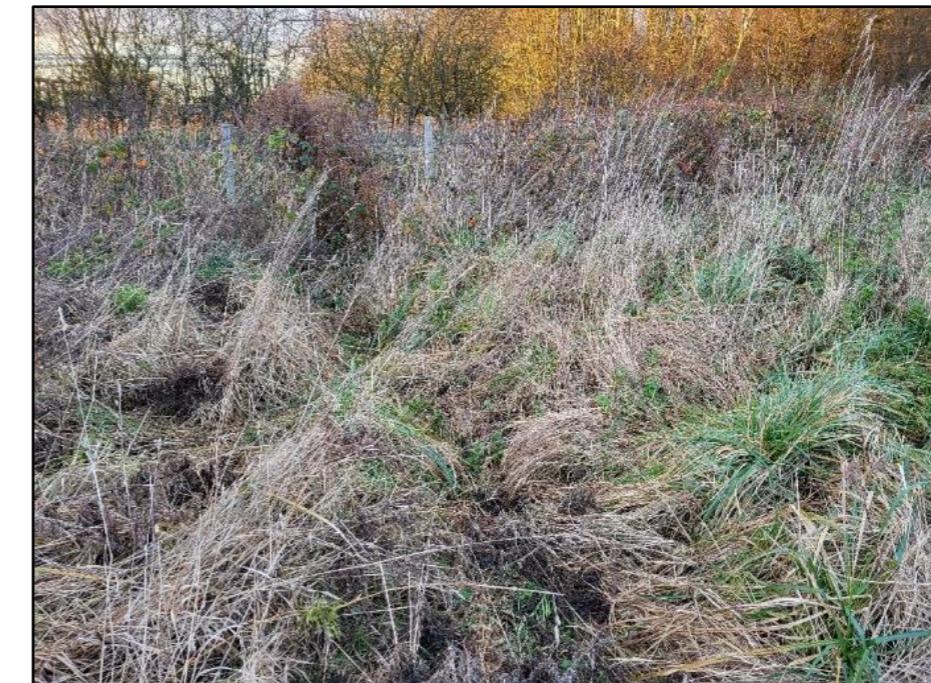
Location of WX76. Unnamed drain, with overgrown vegetation throughout the channel. The left bank c.0.6m, right bank c.0.6m, width c.1.0m. No water present in channel.

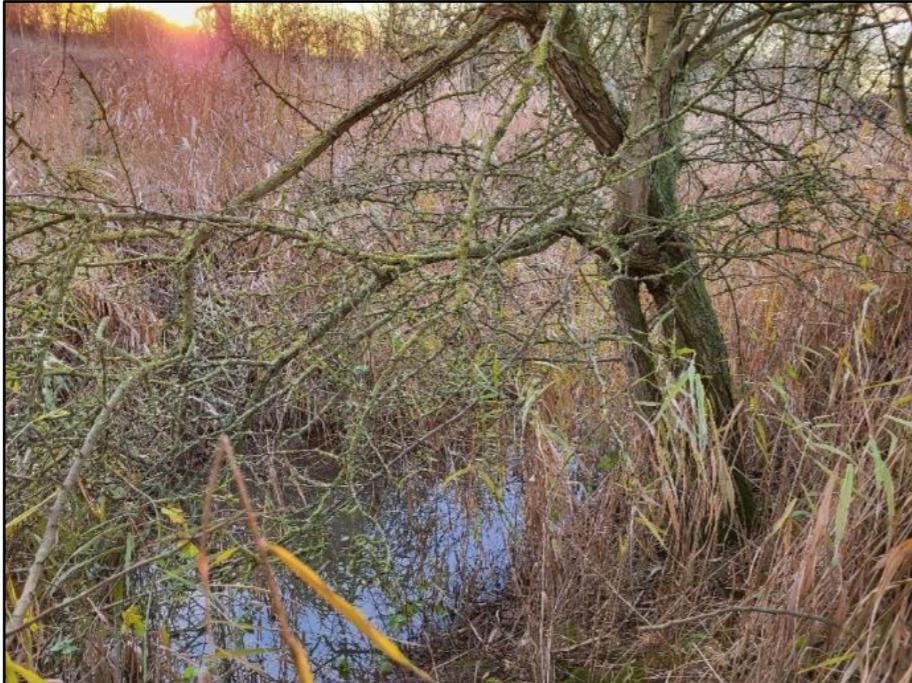
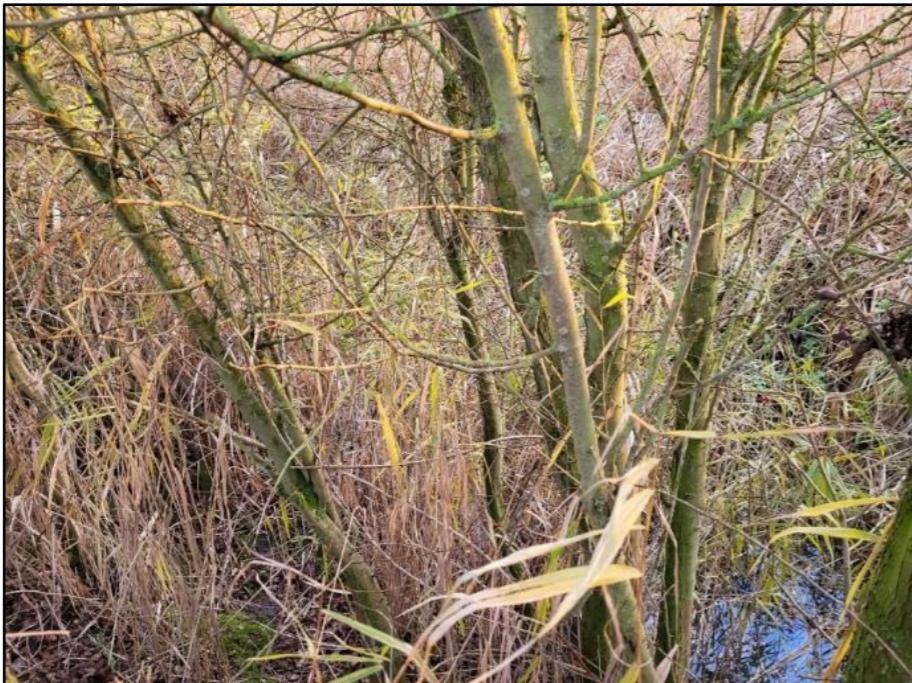
Description: Location of WX77. Unnamed drain, with banks composed of earth material and channel substrate not visible earth and silt. The left bank c.0.9m, right bank c.0.8m, width c.2.0m. Water depth is approximately c.0.4m with no perceivable flow.

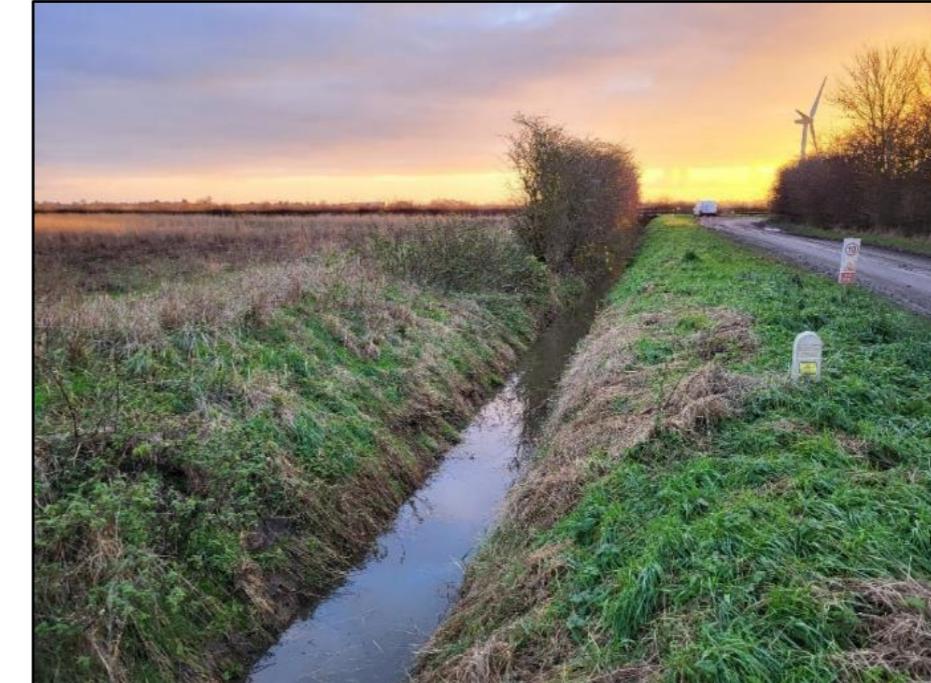
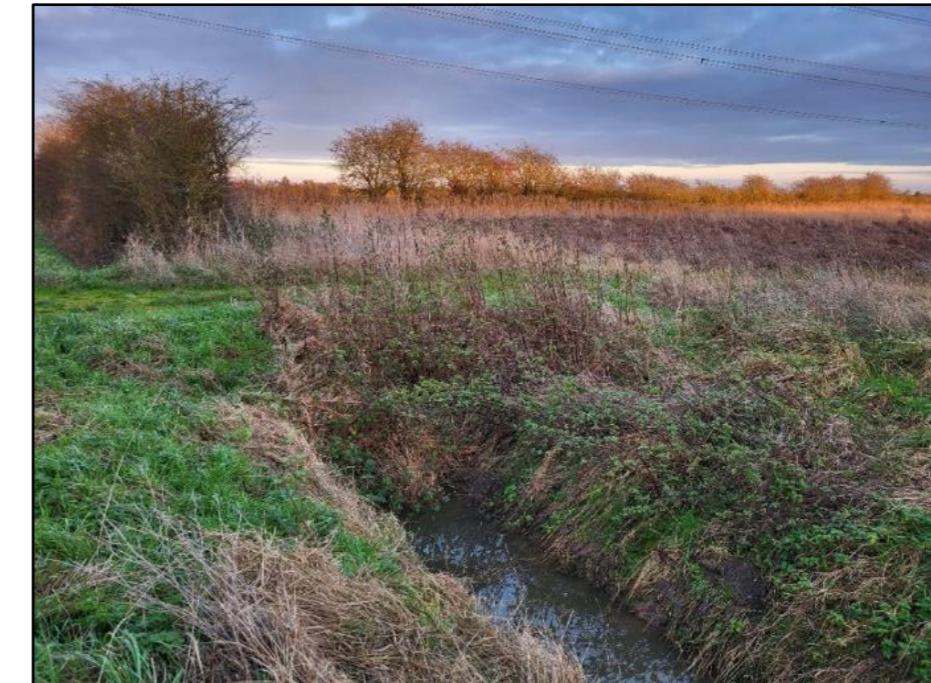
Description: Location of WX78. Unnamed drain, with banks composed of earth material and earth and silt substrate in the channel. The left bank c.1.2m, right bank c.1.2m, width c.3.0m. Water depth is approximately c.0.3m with no perceivable flow.

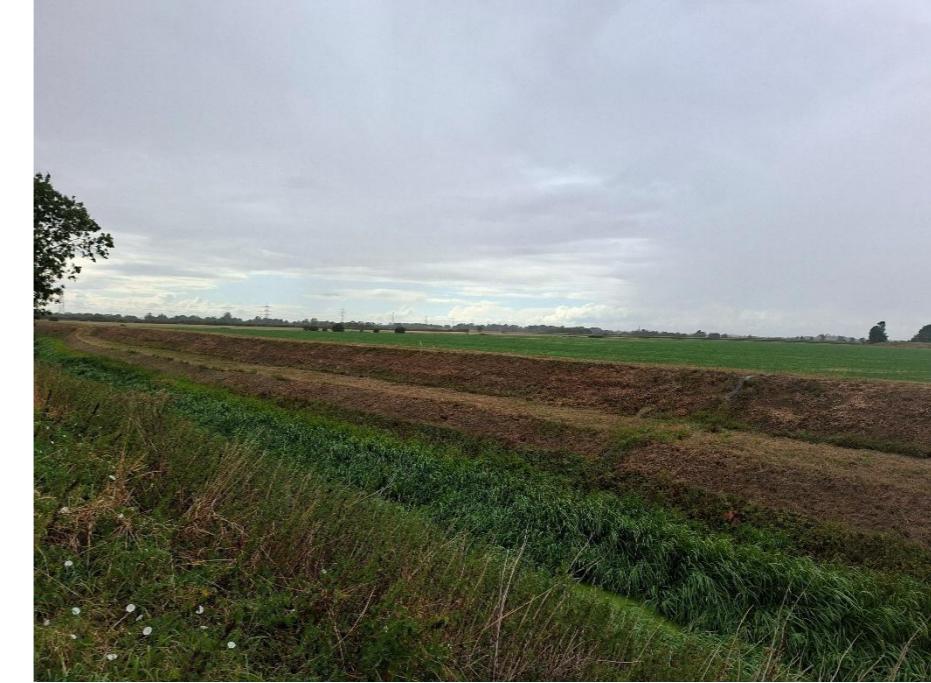
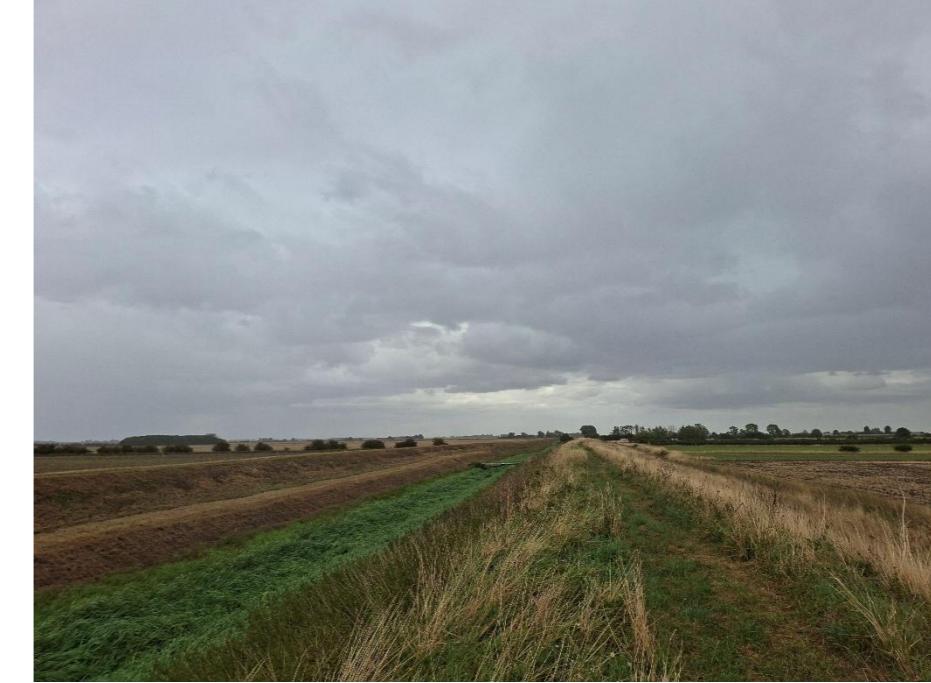
Location of WX79. Unable to access watercourse due to fencing.
