Frodsham Solar

Outline Landscape and Ecology Management Plan

Document Ref: EN010153/DR/7.13

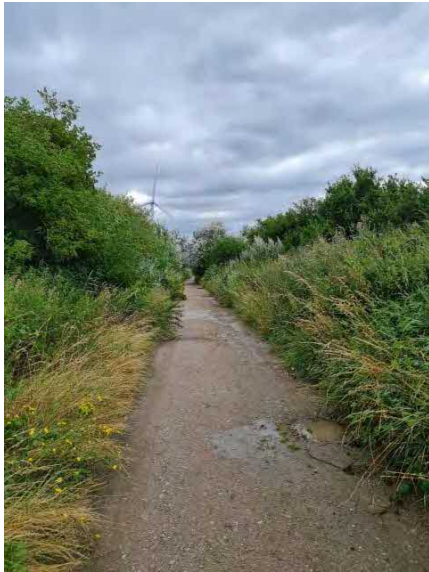
<p>Target note 2. Scattered trees along track. Prominent species include elder <i>Sambucus nigra</i>, willow <i>Salix</i> spp, grey poplar <i>Populus x canescens</i> and spindle <i>Euonymus europaea</i>. The vegetation the edge of the track is comprised of tall ruderal vegetation, including common nettle <i>Urtica dioica</i>, mugwort <i>Artemisia vulgaris</i> sow thistle <i>Sonchus</i> spp and spear thistle <i>Cirsium vulgare</i>, interspersed with common reed <i>Phragmites australis</i></p>

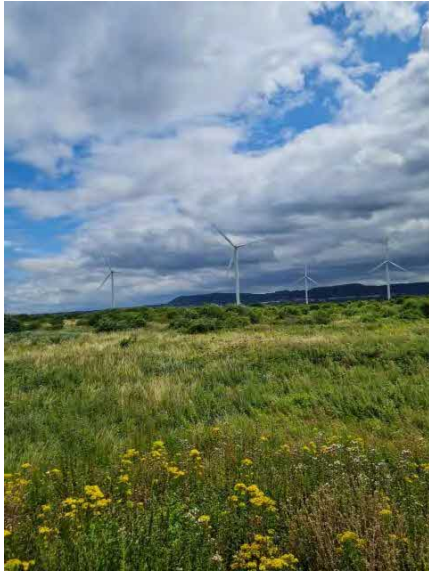
Target note description	Plate
<p>Target note 3. Area of semi-improved neutral grassland with species including common bent <i>Agrostis capillaris</i>, Yorkshire fog <i>Holcus lanatus</i>, red bartsia <i>Odontites vernus</i>, creeping thistle <i>Cirsium arvense</i>, false oat-grass <i>Arrhenatherum elatius</i>, white clover <i>Trifolium repens</i>, common centaury <i>Centaureum erythraea</i>, cock's-foot <i>Dactylis glomerata</i>, creeping bent <i>Agrostis stolonifera</i>, red fescue <i>Festuca rubra</i> and silverweed <i>Potentilla anserina</i> with small areas of hard rush <i>Juncus inflexus</i>. Patches of rosebay willowherb <i>Chamaenerion angustifolium</i> and bramble <i>Rubus fruticosus</i> were also present.</p>

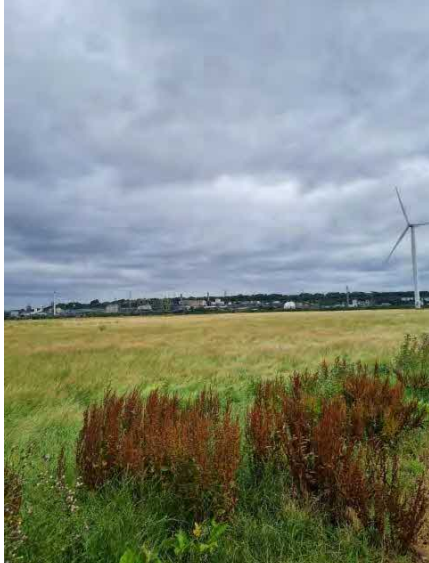
<p>Target note 4. Poor semi-improved grassland habitat surrounding turbine 15. Perennial ryegrass <i>Lolium perenne</i> dominates with timothy <i>Phleum pratense</i> and cock's-foot <i>Dactylis glomerata</i> also present.</p>

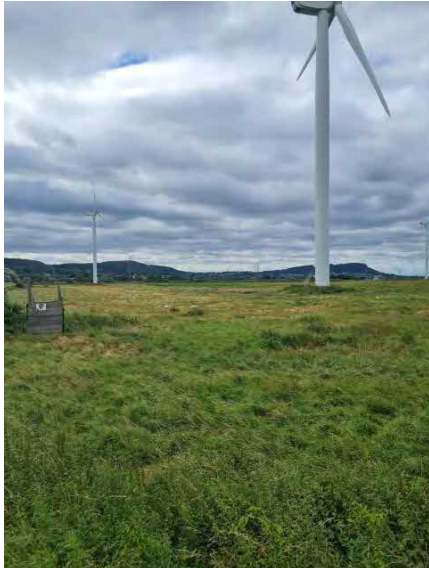
Target note description	Plate
<p>Target note 5. Abundant creeping thistle <i>Cirsium arvense</i> and frequent common nettle stands in p semi-improved grassland forming a tall ruderal-grassland mosaic habitat. The area had been topped at the time of the survey. Other species present include cock's-foot <i>Dactylis glomerata</i>, perennial ryegrass <i>Lolium perenne</i>, bent <i>Agrostis</i> spp, couch <i>Elymus repens</i>, white clover <i>Trifolium repens</i> and crested dog's-tail <i>Cynosurus cristatus</i>.</p>

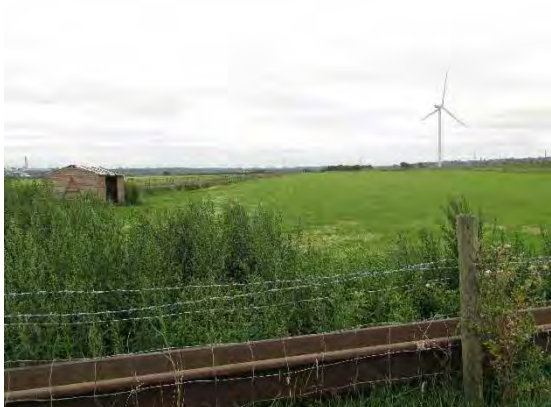
<p>Target note 6. Improved grassland habitat with perennial ryegrass <i>Lolium perenne</i> and white clover <i>Trifolium repens</i> dominating. Mugwort <i>Artemisia vulgaris</i> dominates around the field perimeter.</p>

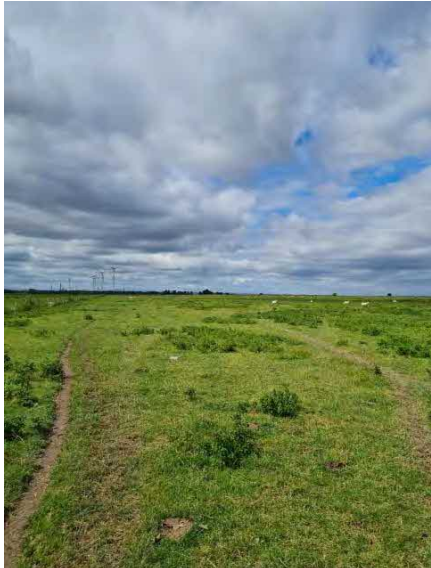
Target note description	Plate
<p>Target note 8. Thistle had reduced in Cell 3 due to increased management.</p>

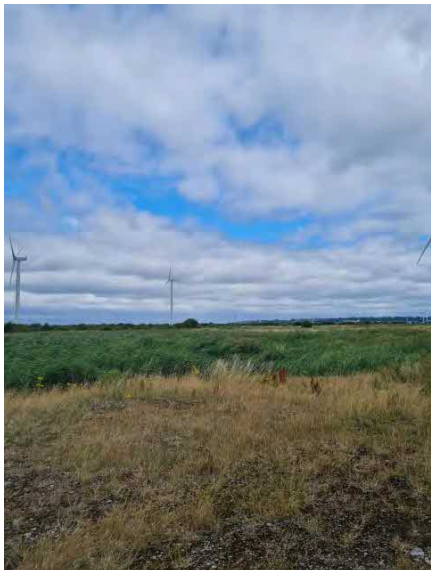
<p>Target note 9. Common reed <i>Phragmites australis</i> bed in the area surrounding turbine 6.</p> <p>The short ephemeral/perennial community becomes more diverse as it moves away from the turbine base with the following species present: Canadian fleabane <i>Conyza canadensis</i>, bird's-foot trefoil <i>Lotus corniculatus</i>, white campion <i>Silene latifolia</i>, scarlet pimpernel <i>Anagallis arvensis</i>, broad-leaved dock <i>Rumex obtusifolius</i>, common toadflax <i>Linaria vulgaris</i>, marsh foxtail <i>Alopecurus geniculatus</i>, scentless mayweed <i>Tripleurospermum inodorum</i>, black horehound <i>Ballota nigra</i> and white clover <i>Trifolium repens</i>.</p>

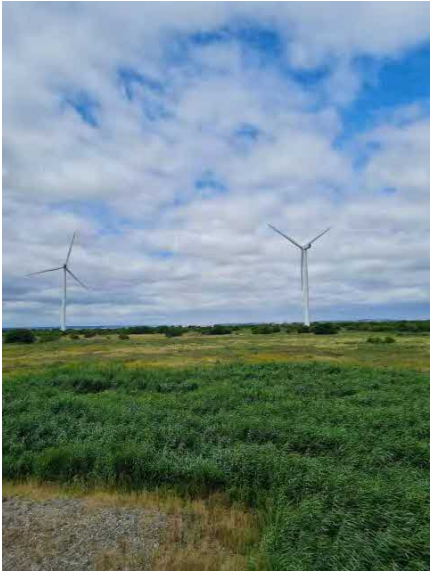
Target note description	Plate
<p>Target note 10. Area of <i>Phragmites australis</i> reedbed with scattered trees and stands of tall ruderal.</p>

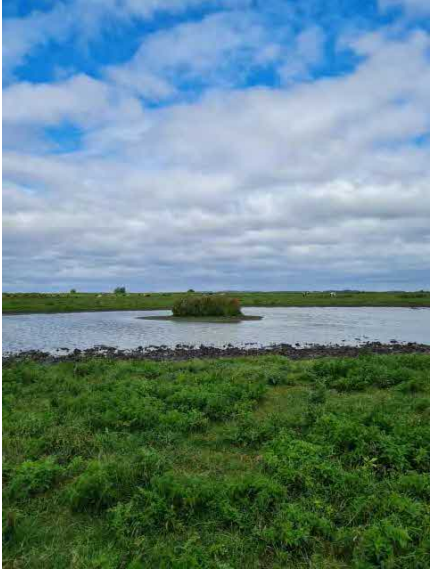
<p>Target note 11. Mitigation scrape within Cell 3. With only a small amount of aquatic vegetation or marginal vegetation present in these scrapes.</p>

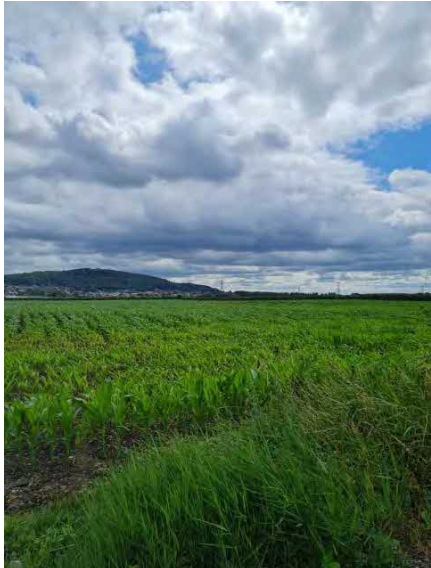
Target note description	Plate
<p>Target note 12. Arable fields containing maize crop to the south west of the site. The fields are divided by species-poor hedgerows that vary in condition from intact to defunct and are dominated by hawthorn <i>Crataegus monogyna</i>. Artificial ditches are located at the foot of the hedgerows and are dominated by common reed <i>Phragmites australis</i>, with tall ruderal vegetation also occurring.</p>

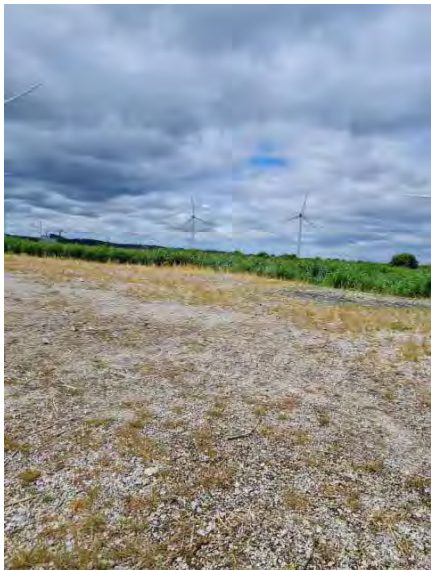
<p>Target note 13. Short ephemeral/perennial vegetation growing around the base of turbine 6. Species include dominant orache <i>Atriplex</i> spp and abundant common knotgrass <i>Polygonum aviculare</i>, with frequent creeping bent <i>Agrostis stolonifera</i> and annual meadow grass <i>Poa annua</i>, and occasional weld <i>Reseda luteola</i>, spear thistle <i>Cirsium vulgare</i> and common nettle, with perennial ryegrass dominating directly below the turbine base.</p>
