Frodsham Solar

Outline Non-Breeding Bird Mitigation Strategy

Document Ref: EN010153/DR/8.32

Outline Non-Breeding Bird Mitigation Strategy (oNBBMS) [EN010153/DR/8.32]

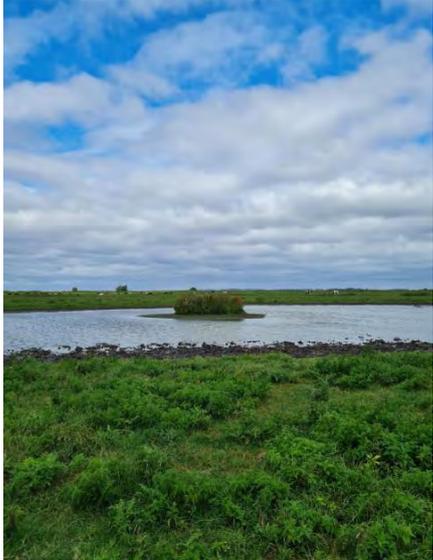
<p>Target note 11. Mitigation scrape within Cell 3. With only a small amount of aquatic vegetation or marginal vegetation present in these scrapes.</p>
