Frodsham Solar

Outline Non-Breeding Bird Mitigation Strategy

Document Ref: EN010153/DR/8.32

Outline Non-Breeding Bird Mitigation Strategy (oNBBMS) [EN010153/DR/8.32]

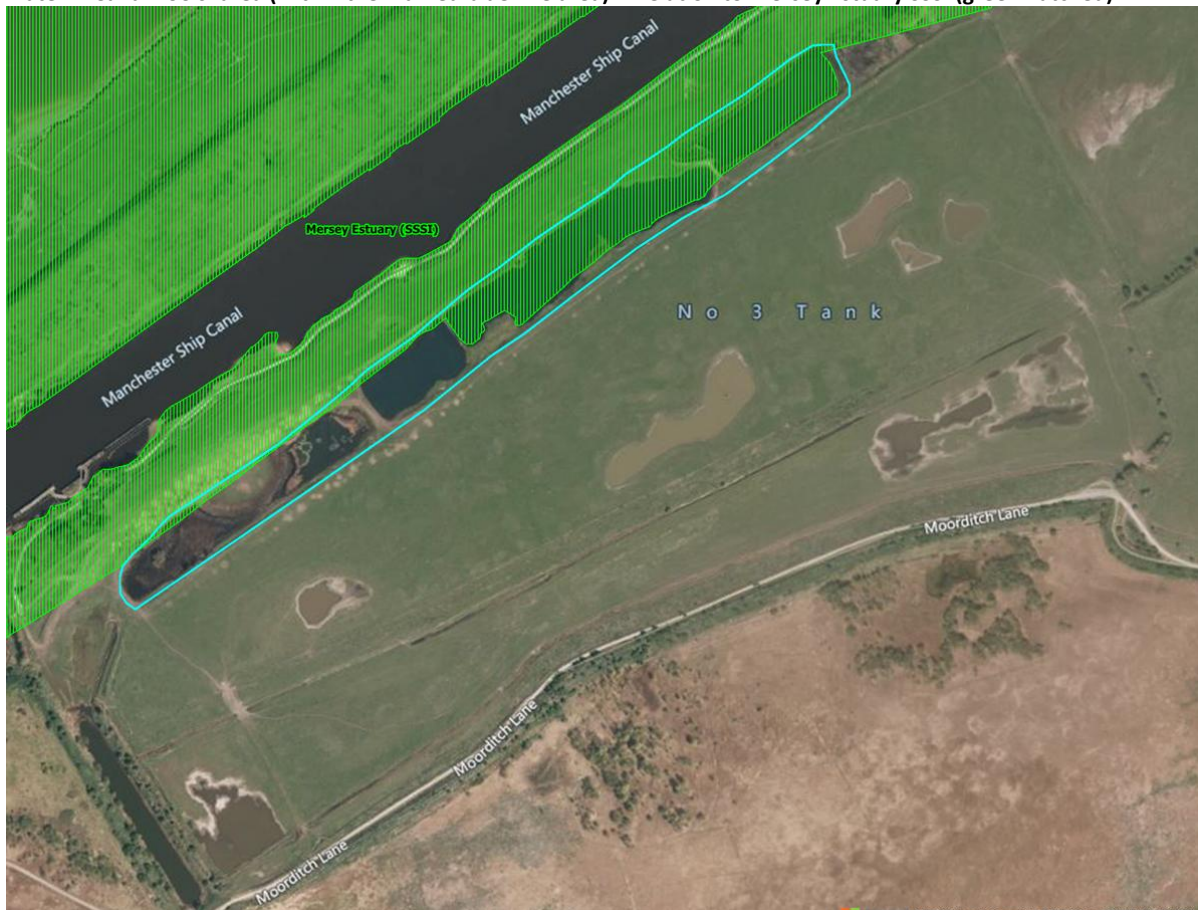
Plate 2: ‘Canal Pools’ area (within the marked blue line area) in relation to Mersey Estuary SSSI (green hatched).

- 2.4.3 Recreational access to the Canal Pools is not regulated. Regular presence of people using the Canal Pools has been noted during surveys but cannot be quantified. As the pools are largely elevated above Cell 3, and sit between Cell 3 and the Mersey Estuary, it is highly likely that human presence causes disturbance not only to the Canal Pools but also to Cell 3 (and the FWF mitigation measures), as people are highly visible ‘above the skyline’ to birds using the surrounding land. This is likely to limit the efficacy of FWF mitigation within Cell 3.

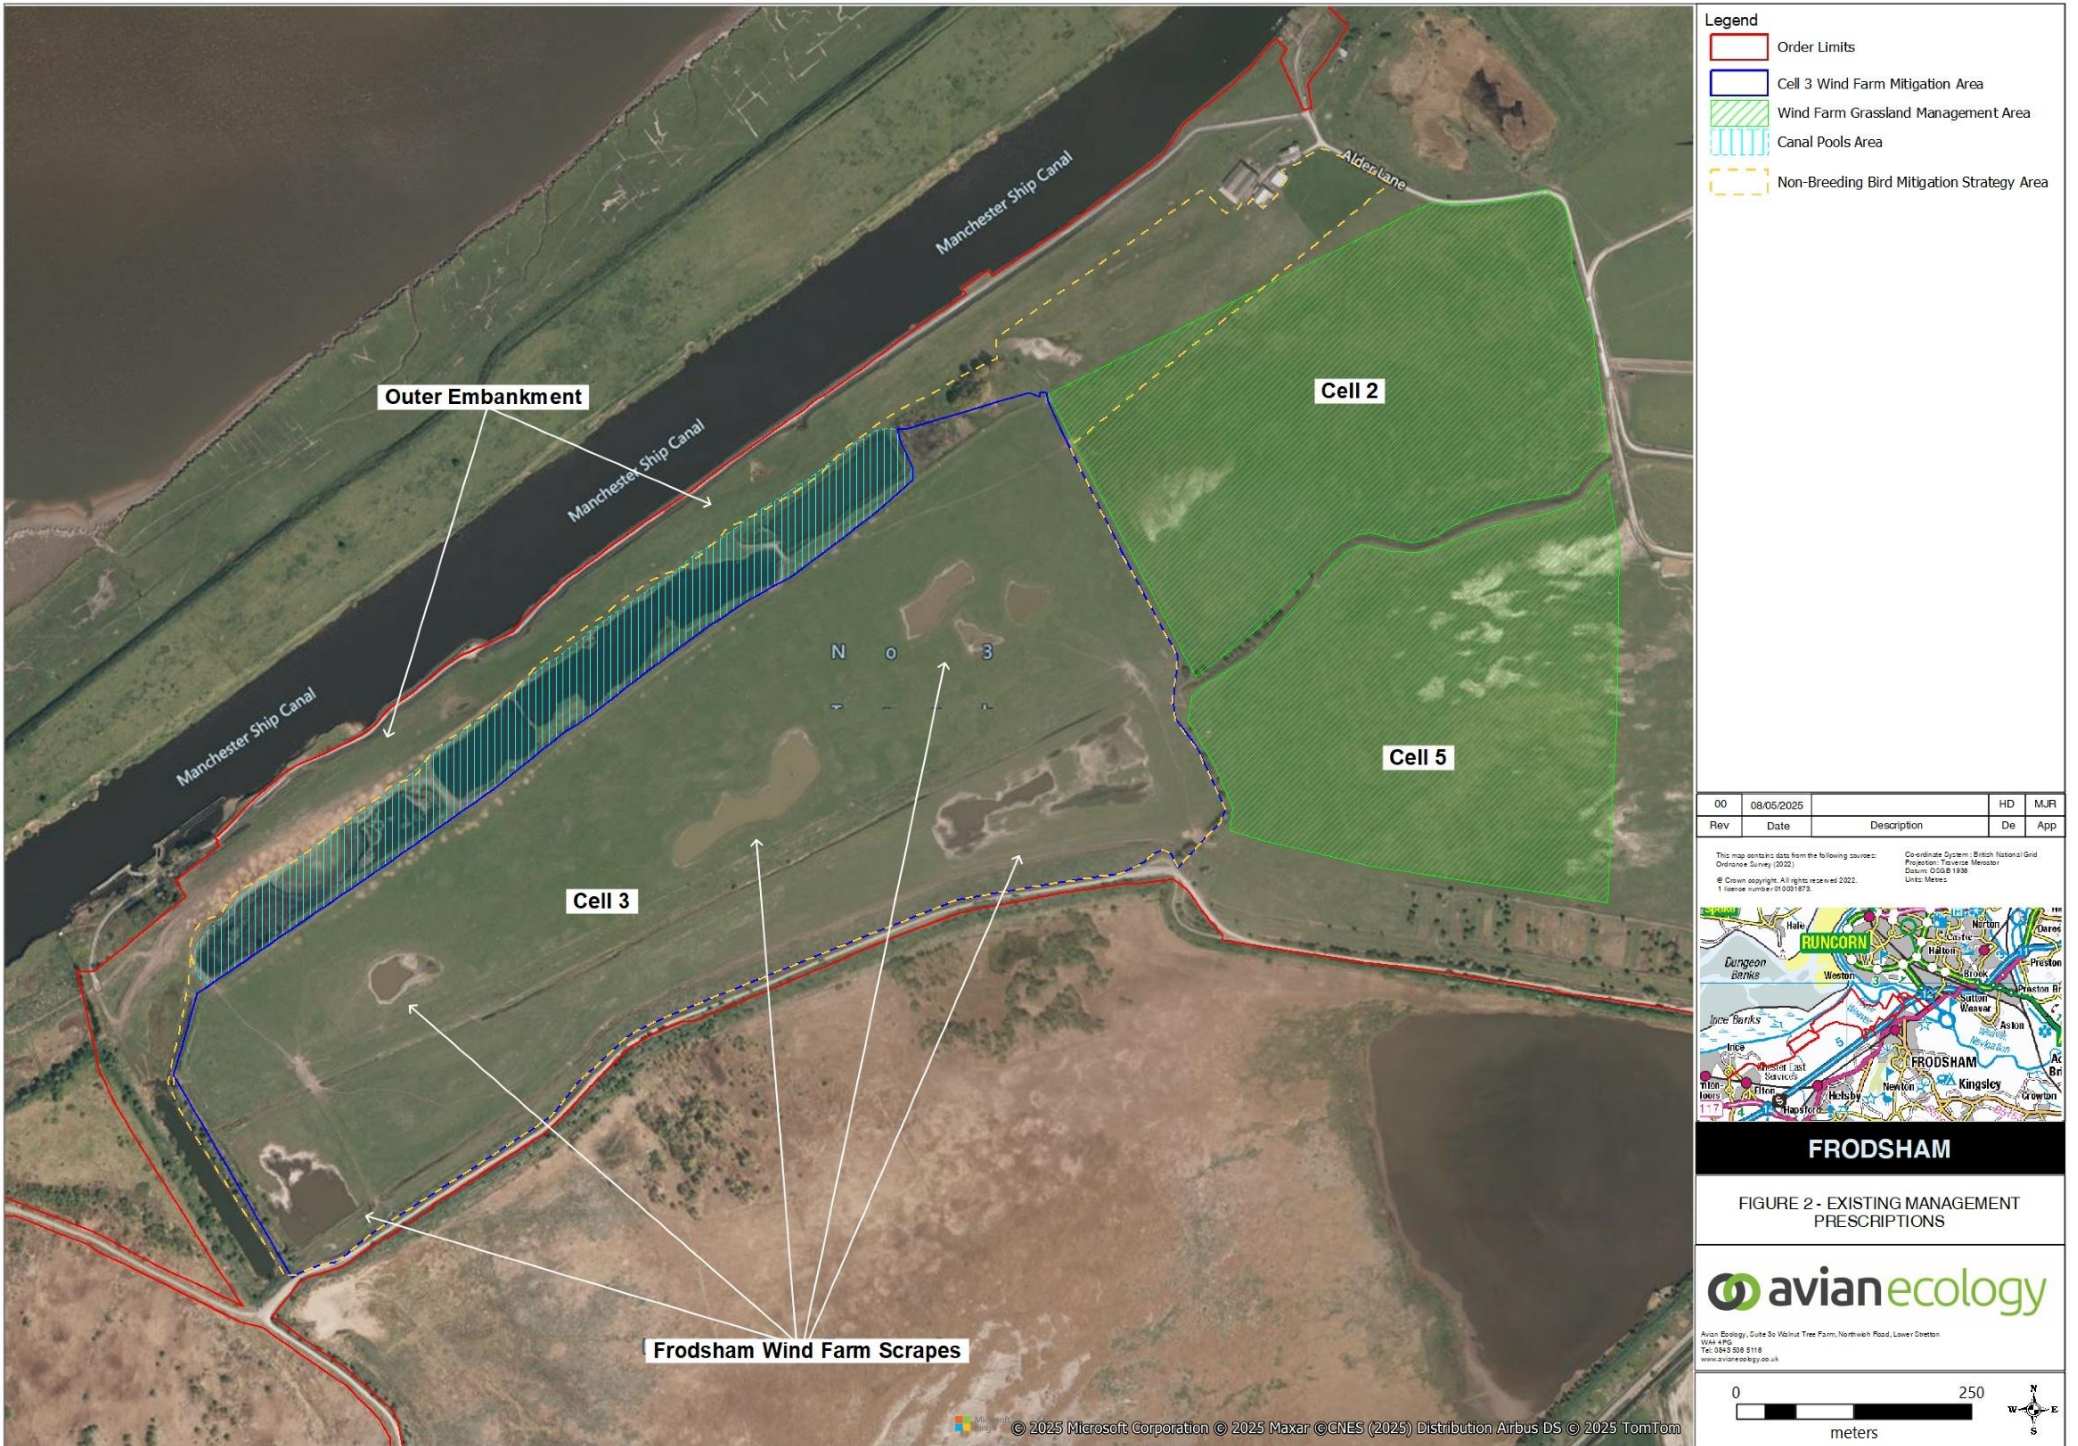
Figure 2: Existing Management Prescriptions

2.2.1 FWF comprises 19 wind turbines (with a tip height of 125m). The wind farm consent included provision of mitigation habitat for non-breeding bird species associated with the Mersey Estuary SPA in Cells 2, 3 and 5 (**Figure 2**), as required under Condition 33 and 34 of the FWF Section 36 Consent, dated 19th October 2012.

2.7.1 Existing mitigation measures within Cell 3 for FWF include a series of scrapes, a bund in the south-east and two excavated areas in the south-east and south, with grazed (unspecified) grassland being the main habitat type. These are illustrated in **Figure 2**. Current levels of usage have been established through extensive baseline data gathering, and it is considered that measures implemented for FWF mitigation are operating as required pursuant to Conditions 33 and 34 of the FWF Section 36 Consent. Subsequently consideration of the use of Cell 3 for mitigation is based on robust data and a clear understanding of existing measures, including any potential for improvement.

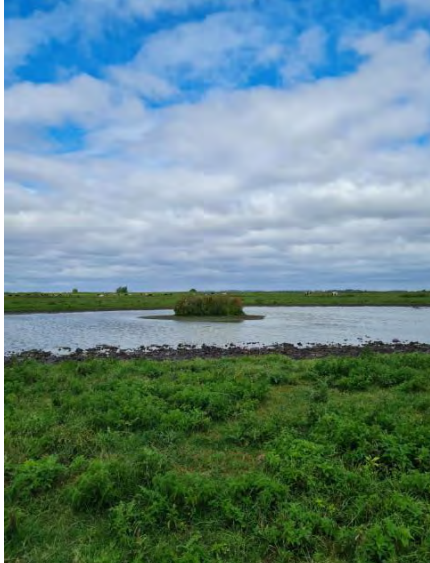
<p>Target note 11. Mitigation scrape within Cell 3. With only a small amount of aquatic vegetation or marginal vegetation present in these scrapes.</p>
