Frodsham Solar

Outline Non-Breeding Bird Mitigation Strategy

Appendix B - Outline Non-Breeding Bird Mitigation Strategy (oNBBMS) [EN010153/DR/8.32]

Frodsham Solar, for Frodsham Solar Ltd

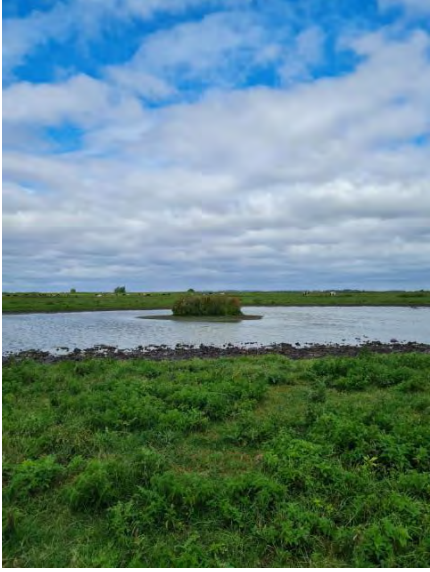
<p>Target note 11. Mitigation scrape within Cell 3. With only a small amount of aquatic vegetation or marginal vegetation present in these scrapes.</p>
