# Pearmtree Hill Solar Farm

## Environmental Statement

### Appendix 7.8: Aquatic Walkover Report

Application Document Ref: EN010157/APP/6.4  
February 2025

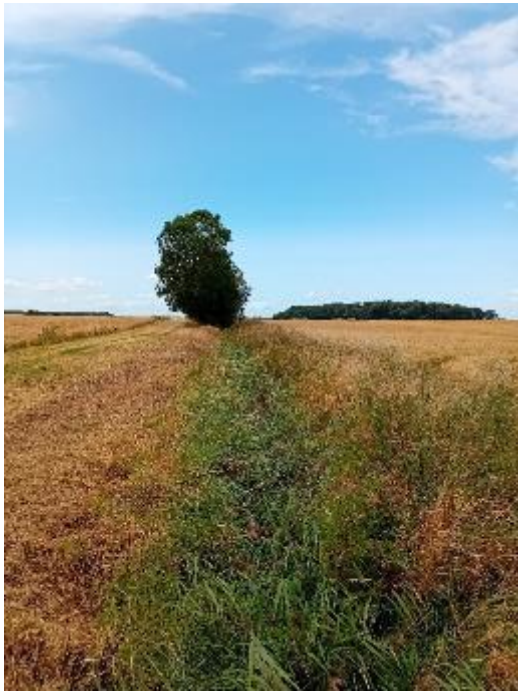
**Plate 1 – S01**

- 3.2.2 The S01 crossing point is located at the eastern extent of a drainage ditch close to the confluence, via a culvert, with a larger, unnamed ditch. The culvert was above the water level of the larger ditch at the time of surveying and as such connectivity (i.e. from rainfall or runoff) would be one-way from the S01 ditch into the unnamed ditch under surveyed water levels.
- 3.2.3 The S01 ditch was heavily overgrown and dry at the time of surveying. The larger unnamed ditch was wetted at the time of surveying with no perceptible flow. The water surface had c. 90% duckweed (*Lemna* sp.) coverage, with c. 10% emergent macrophyte coverage over a silt substrate.

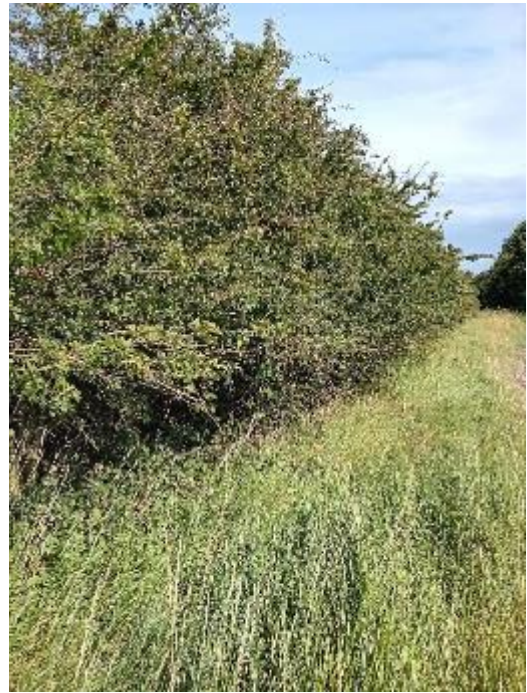
**Plate 2 – S02**

- 3.2.4 S02 is located on an unnamed ditch, which was dry and heavily vegetated at the time of survey.

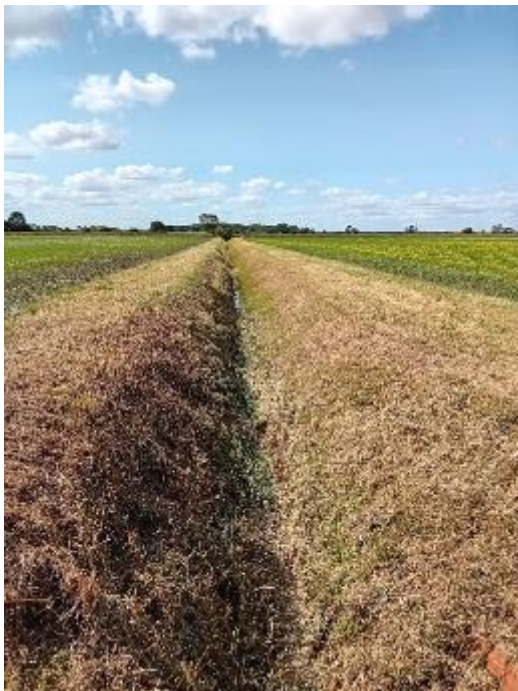
**Plate 3 – S03**

- 3.2.5 S03 is located at the eastern extent of a small drainage ditch close to the confluence, via an existing culvert, with a larger, unnamed ditch. S46 is located c.10m west of S03. The ditch was wetted with a water depth of < 0.1m, no perceptible flow and was heavily choked with vegetation. The banks had been strimmed recently and vegetation trimmings were present throughout the channel.
- 3.2.6 The larger connected ditch was wetted at the time of survey with no perceptible flow, with c.0.4m water depth, c. 40% duckweed coverage, c.40% emergent macrophyte coverage over a silt substrate. This culvert was above the water level of the larger ditch at the time of survey and as such connectivity (i.e. from rainfall or runoff) would be one-way from the S03 ditch into the unnamed ditch under surveyed water levels.

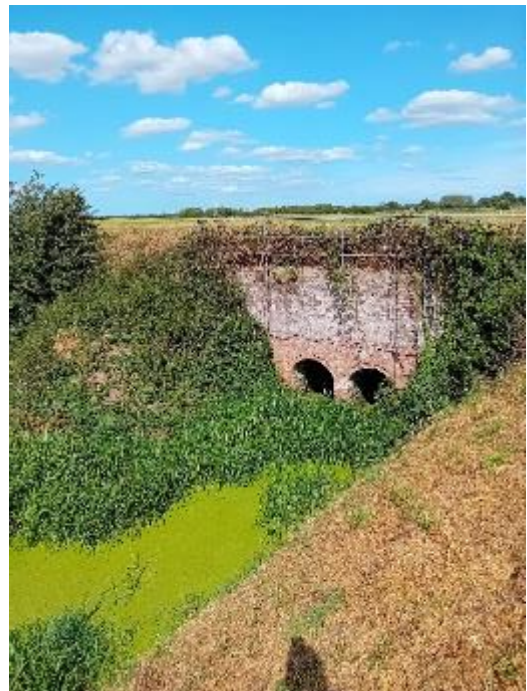
**Plate 4 – S04**

- 3.2.7 S04 is located at the eastern extent of the Arnold and Riston Drain close to the Arnold West Carr Drain. The drain was wetted with a silt substrate, no perceptible flow and was covered by duckweed (c. 50% cover) and emergent macrophyte (c. 50% cover).
- 3.2.8 An existing culvert structure is located at the crossing location, connectivity here could not be confirmed but it does not appear as though the two drains are hydrologically connected, the culvert potentially passing beneath the Arnold West Carr Drain and connecting to the Drewery's Sock Dike to the east.
- 3.2.9 The Arnold and Riston Drain appears to have open connectivity to the Holderness Drain, one of the larger drains which feeds into the Humber directly.

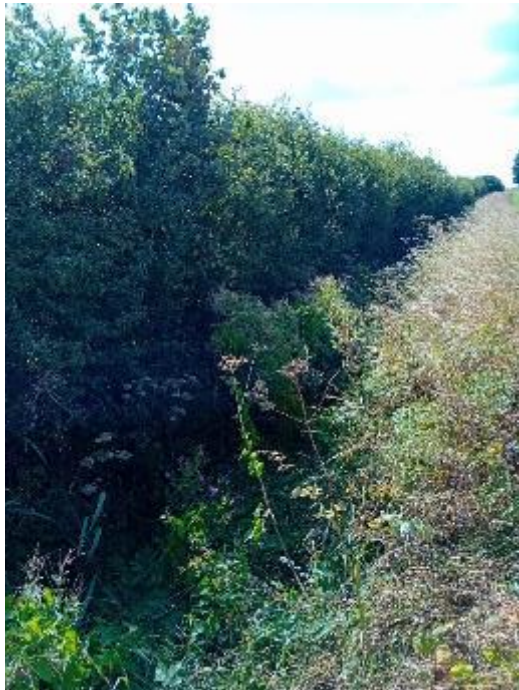
**Plate 5 – S05**

3.2.10 S05 is located on a small ditch which connects to the Routh & Meaux drain c. 200m to the north. The ditch was largely dry, but damp in places with dense terrestrial vegetation growth present and a silt substrate.

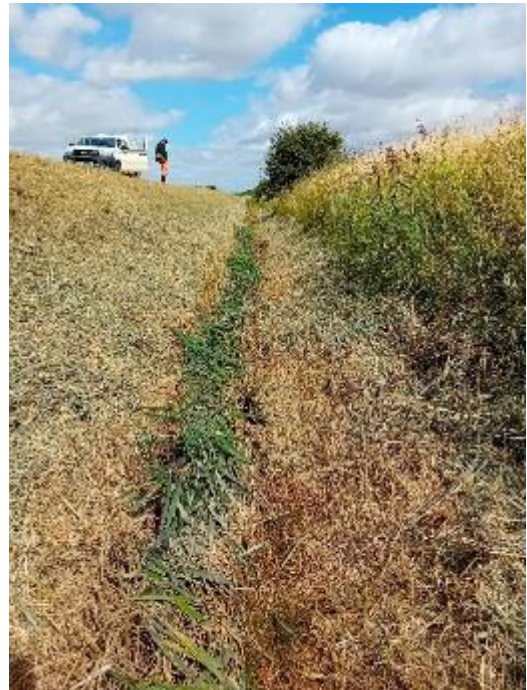
**Plate 6 – S06**

3.2.11 S06 is located on a north-south oriented arm of the Routh & Meaux drain. The drain was wetted with shallow water (< 0.05m), no perceptible flow and dense emergent macrophyte coverage (c.80%). The banks had been recently trimmed with trimmings present throughout the channel.

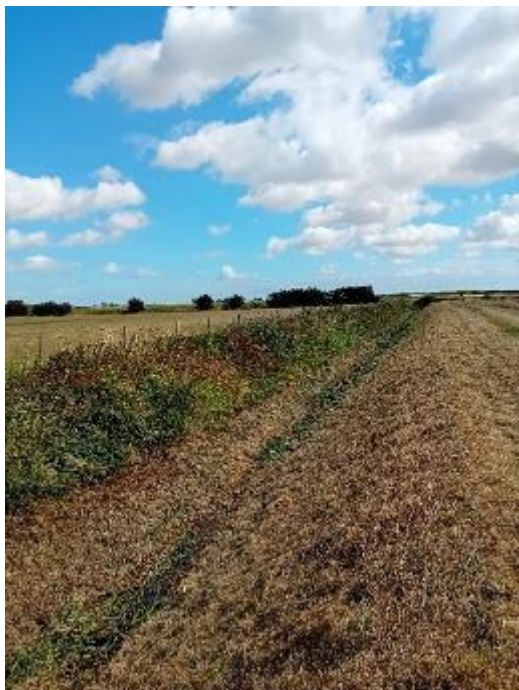
**Plate 7 – S07**

3.2.12 S07 is located on an east-west oriented arm of the Routh & Meaux Drain. Emergent macrophyte lined the channel (c. 70% cover) which was wetted with no perceptible flow, c. 0.2m deep with a silt substrate. The banks had been recently trimmed with trimmings present throughout the channel.

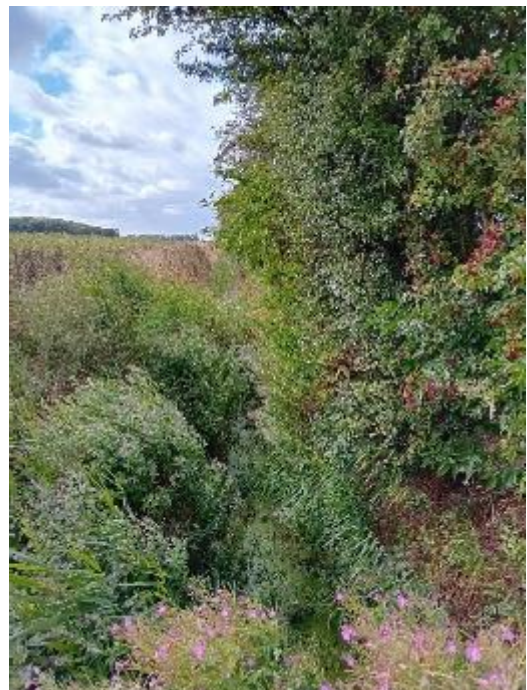
**Plate 8 – S08**

3.2.13 S08 is located on an unnamed ditch which joins the Routh & Meaux Drain approximately 240 m to the south. The ditch was wetted with shallow water (< 0.3m depth), no perceptible flow, c.15 % emergent macrophyte coverage and a silt substrate.

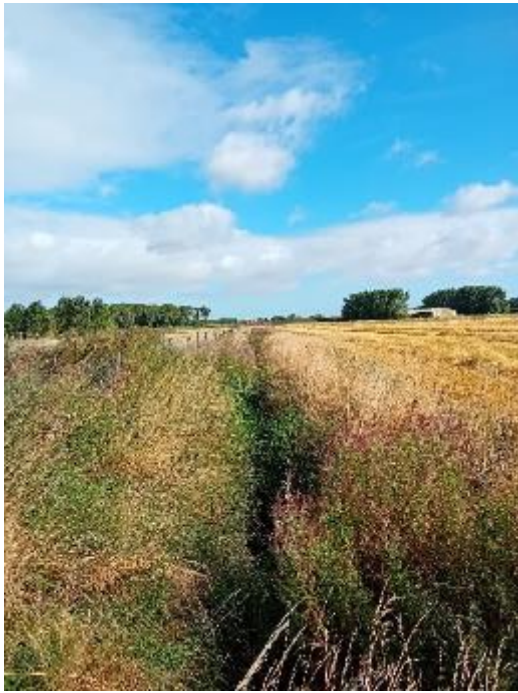
**Plate 9 – S09**

3.2.14 S09 is located on the same unnamed ditch as S08, which is approximately 380m southwest. The ditch was wetted with c.0.3 m deep water, no perceptible flow, dense duckweed (c. 40%) and emergent macrophyte (c.60%) cover and a silt / clay substrate.

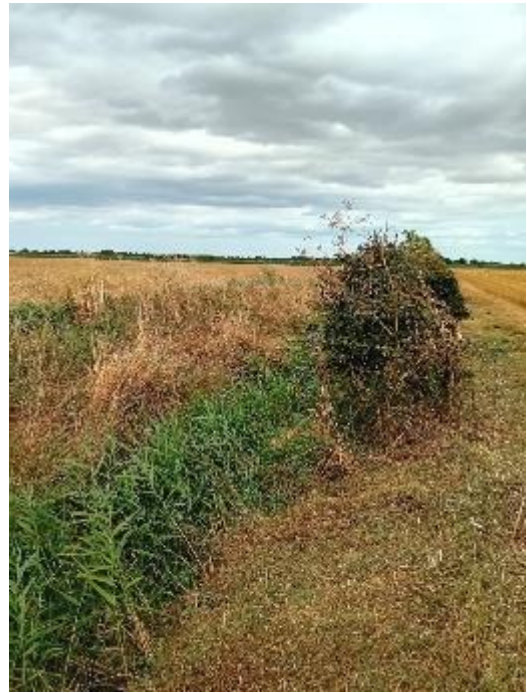
**Plate 10 – S10**

3.2.15 S10 is located on a short, unnamed ditch oriented east-west between the Meaux and Routh East Drain and Monk Dike. The ditch was wetted with no perceptible flow, c.0.2m deep water, c.40% duckweed, c.20% emergent macrophyte coverage and a silt substrate. The channel and banks were densely overgrown with terrestrial vegetation.

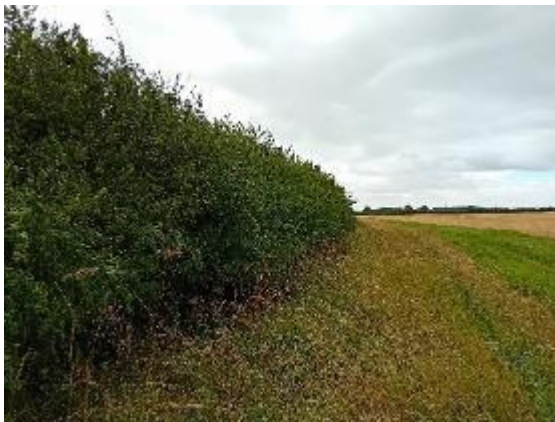
**Plate 11 – S11**

3.2.16 S11 is located on a shallow depression within a hedgerow and not a typical drainage ditch. The area was dry with no evidence of it being frequently wetted or ephemeral.

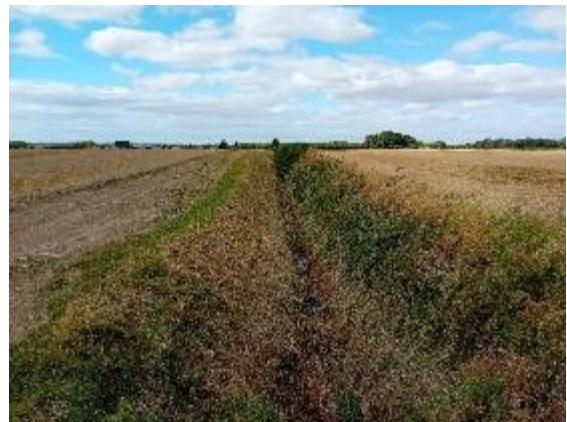
**Plate 12 – S12**

3.2.17 S12 is located at / close to an existing culvert on the Meaux West drain. To the east of the existing culvert the channel and banks were heavily overgrown with the channel choked with emergent macrophyte. The water depth was c.0.3m with no perceptible flow. To the west of the culvert, the channel had a water depth of c0.3m and no perceptible flow. The channel and banks had been trimmed and the ditch was characterised by emergent macrophyte (c.60% cover).

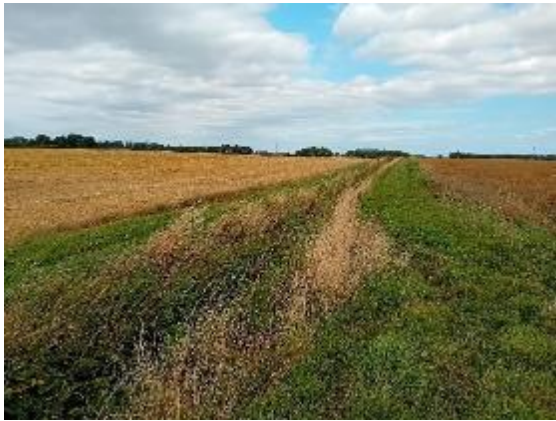
**Plate 13 – S13**

3.2.18 S13 is a small, overgrown ditch between arable field which was dry at the time of surveying.

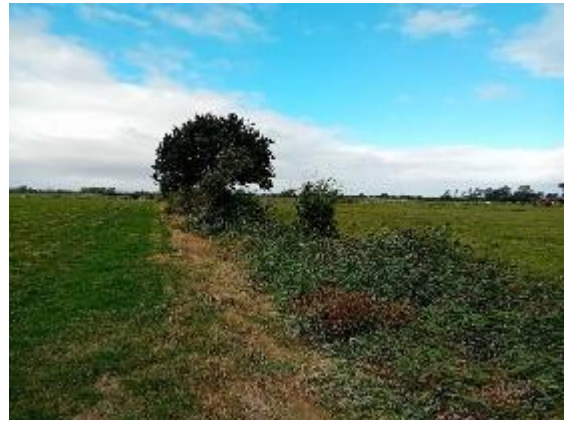
**Plate 14 – S14**

3.2.19 S14 is located on Well Stone Carr Drain. The drain was c.0.2m deep with no perceptible flow, had a silt substrate and was choked with emergent macrophyte at the time of survey.

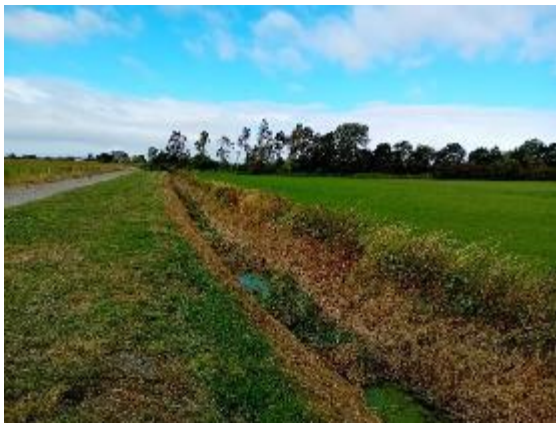
**Plate 15 – S15**

3.2.20 S15 is located on an unnamed ditch connected to Well Stone Carr Drain to the east. The ditch was wetted with no perceptible flow and had a water depth of c.0.3m over a silt substrate. Dense duckweed (c.90% cover) was present covering the water's surface.

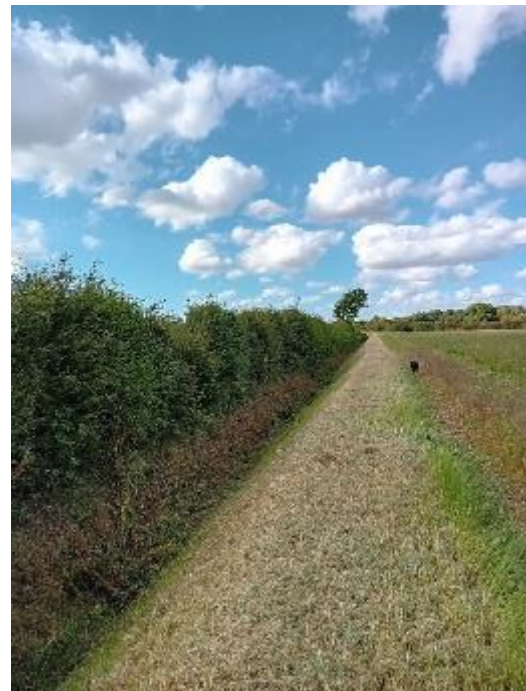
**Plate 16 – S16**

3.2.21 S16 is located on a small, unnamed ditch which was dry at the time of the survey.

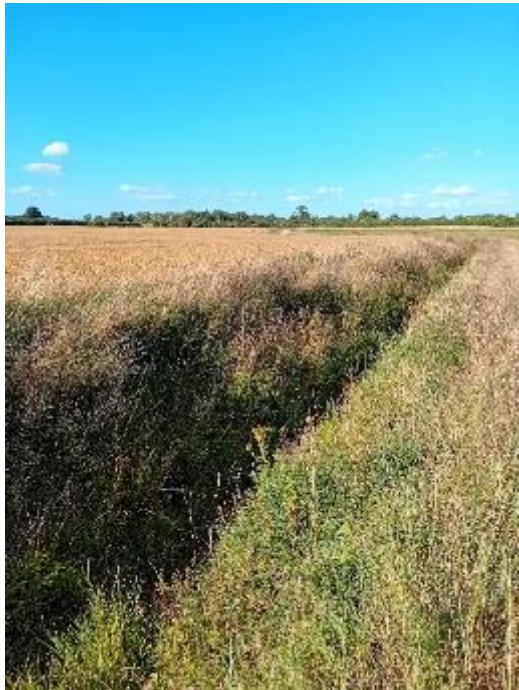
**Plate 17 – S17**

3.2.22 S17 is located on a small, unnamed ditch between arable fields. The ditch was damp at the time of survey with very shallow water present (< 0.05m depth) and filamentous algae.

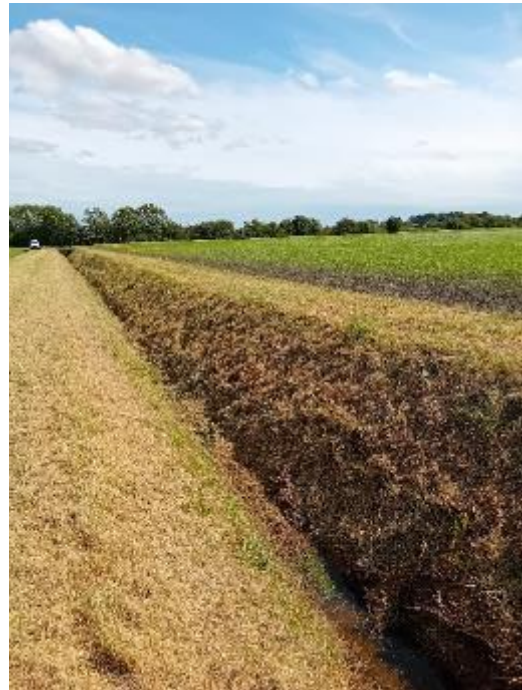
**Plate 18 – S18**

3.2.23 S18 is located on the same ditch as S03, which is approximately 185m to the east. Habitat within the ditch mirrors that at S03 (see above) with shallow water, no perceptible flow and with large quantities of vegetation and trimmings present in the channel.

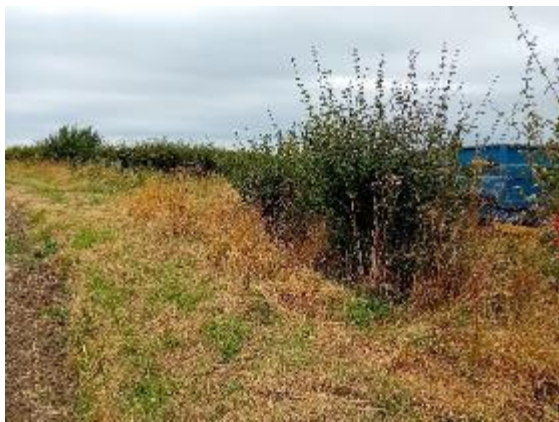
**Plate 19 – S20**

3.2.25 S20 is located on a shallow depression within a hedgerow and not a typical drainage ditch. The area was dry with no evidence of it being frequently wetted or ephemeral.

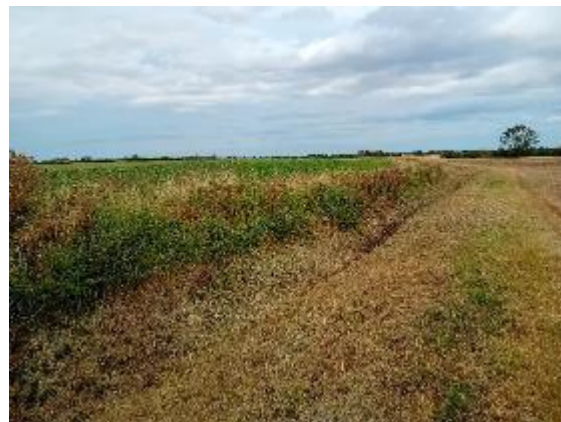
**Plate 20 – S21**

3.2.26 S21 is located on an unnamed ditch close to a confluence with the Routh and Meaux Road Drain. The ditch was largely dry with some areas of shallow (< 0.1m depth) ponded water. The channel was lined with terrestrial grasses and trimmings from recent bank strimming.

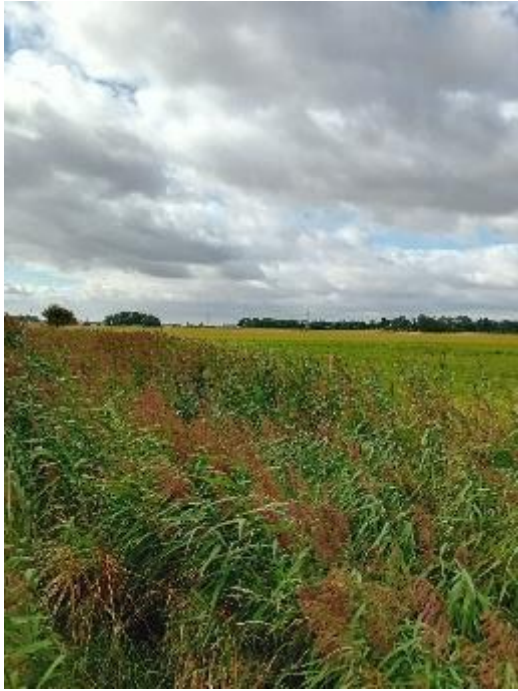
**Plate 21 – S22**

3.2.27 S22 is located on the same unnamed ditch as S08, which is located approximately 100m to the south. The ditch was wetted with shallow water (< 0.3m depth) and no perceptible flow, with dense emergent macrophyte coverage (c.80%) and a silt substrate.

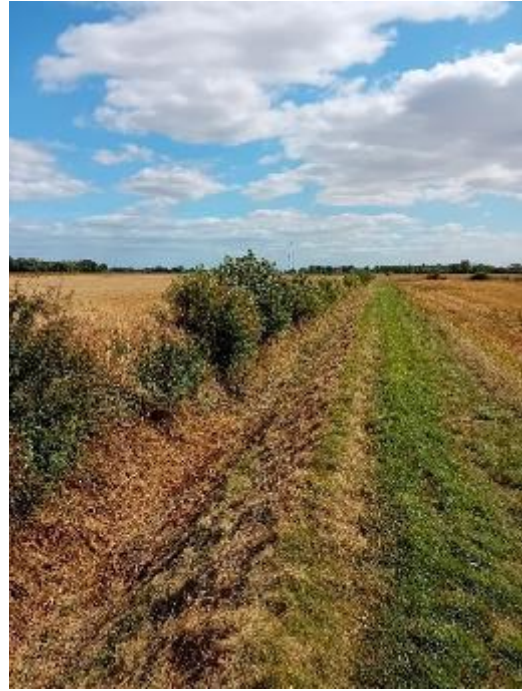
**Plate 22 – S23**

3.2.28 S23 is located on an unnamed drain which connects the Meaux West Drain and Holderness Drain. The drain was wetted with no perceptible flow and a water depth of c.0.2m. Dense vegetation and trimmings from recent bank strimming were present in the channel.

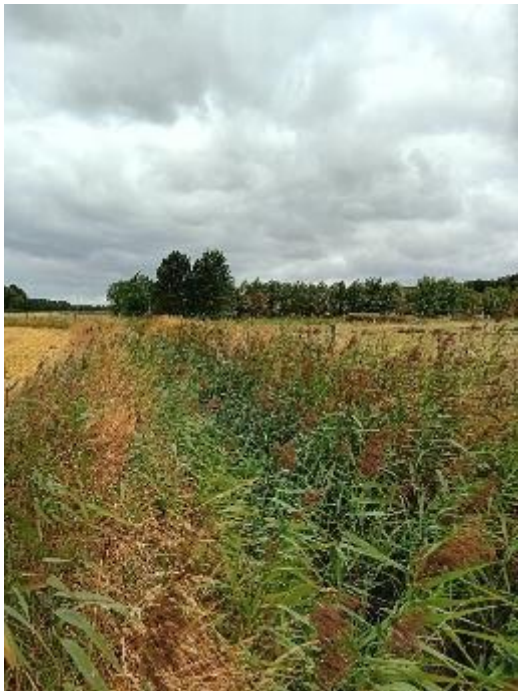
**Plate 23 – S24**

3.2.29 S24 is located on the same unnamed ditch as S09, which is located approximately 220m to the southwest. The ditch was wetted with c.0.3 m deep water, no perceptible flow, dense duckweed (c.40 %) and emergent macrophyte (c.40%) cover and a silt substrate.

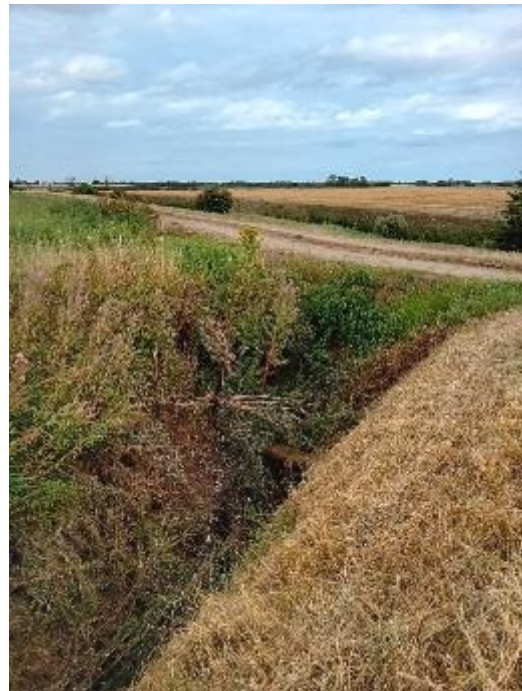
**Plate 24 – S25**

3.2.31 S25 is located on the Routh and Meaux Road Drain close to the confluence with the Meaux and Routh East Drain. The drain was wetted and was observed to be flowing east into the larger Meaux and Routh East Drain, although connectivity between the drains appeared to be poor. The flow type was shallow glide with a water depth of c.0.3m and a silt substrate. The channel was blocked in places by dense trimmings from recent strimming works.

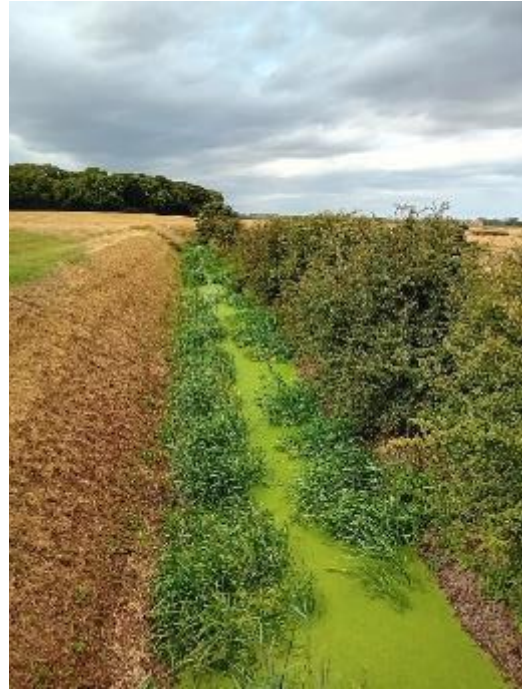
**Plate 26 – S26**

3.2.32 S26 is located on the Meaux and Routh East Drain c.75m north of the confluence with the Routh and Meaux Road drain at S25. S41 is located c.15m to north of S26. The drain was wetted with no perceptible flow, a water depth of c.0.5m and dense duckweed (c.50%) and emergent macrophyte (c.50%) coverage. Stickleback were observed within the drain, the fish were not captured to be identified as either three-spined or nine-spined.

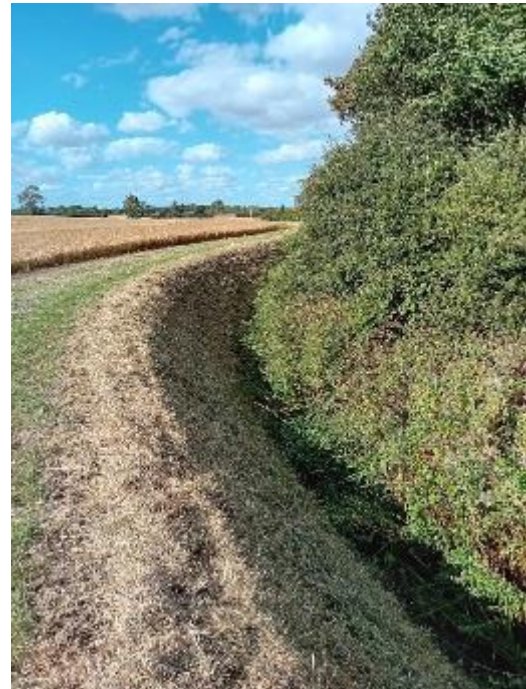
**Plate 32 – S32**

3.2.38 S32 is located on a small, unnamed drainage ditch which was dry at the time of survey.

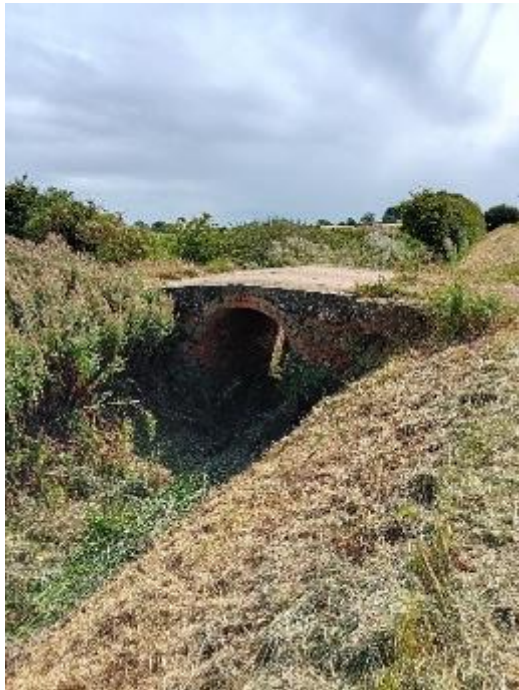
**Plate 37 – S37**

3.2.43 S37 is located on an unnamed ditch which was wetted at the time of survey with an area beneath the existing culvert drying out. South of the existing culvert no perceptible flow was observed, water depths were c.0.3m with c.45% emergent macrophyte coverage and a sparse covering of duckweed (c.5% coverage) recorded. To the north of the culvert water depths were shallow (c.0.1m) and dense stands of emergent macrophyte were recorded with an overall coverage of c.40%.

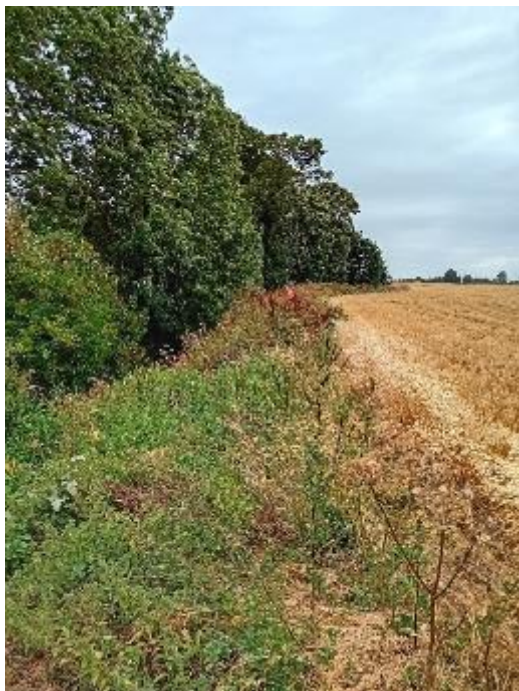
**Plate 39 – S39**

3.2.30 S39 is located on Stonleygoat Dike with S39 located c.10m to the south. The channel was characterised by shallow water (< 0.1m depth), no perceptible flow, c.60% emergent macrophyte coverage and a silt substrate.

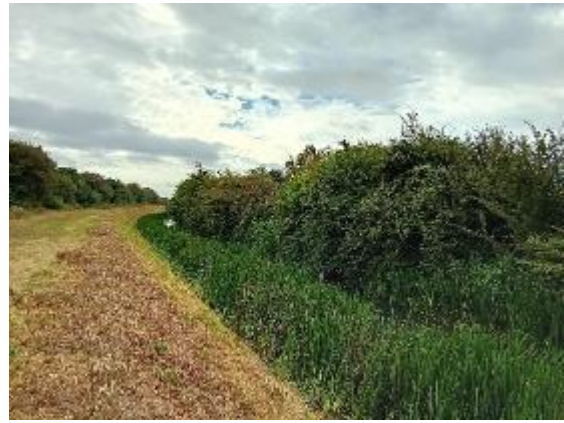
**Plate 50 – S49**

- 4.3.1 A single proposed HDD location is located on / beneath the Beverley and Barmston Drain (S49/WCPRUT 01). Habitat at the HDD location was likely suitable for a range of coarse fish species and European eel. This is corroborated by EA fisheries data records of pike, perch, roach and European eel c. 8.1km downstream of the proposed HDD location.
- 4.3.2 There are no records of lamprey within the drain, their absence likely attributable to the same factors present within the Holderness Drain catchment, namely a lack of suitable spawning habitat and a lack of connectivity to the River Hull and its potential spawning habitat.
