# Pearmtree Hill Solar Farm

## Environmental Statement

### Appendix 7.8: Aquatic Walkover Report

Application Document Ref: EN010157/APP/6.4  
November 2025

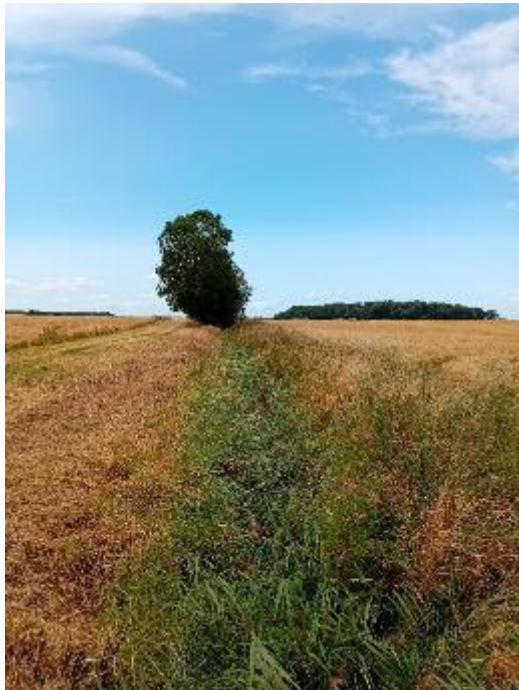
**Plate 1 – S01**

3.2.3 The S01 crossing point is located at the eastern extent of a drainage ditch close to the confluence, via a culvert, with a larger, unnamed ditch. The culvert was above the water level of the larger ditch at the time of surveying and as such connectivity (i.e. from rainfall or runoff) would be one-way from the S01 ditch into the unnamed ditch under surveyed water levels.

3.2.4 The S01 ditch was heavily overgrown and dry at the time of surveying. The larger unnamed ditch was wetted at the time of surveying with no perceptible flow. The water surface had c. 90% duckweed (*Lemna* sp.) coverage, with c. 10% emergent macrophyte coverage over a silt substrate.

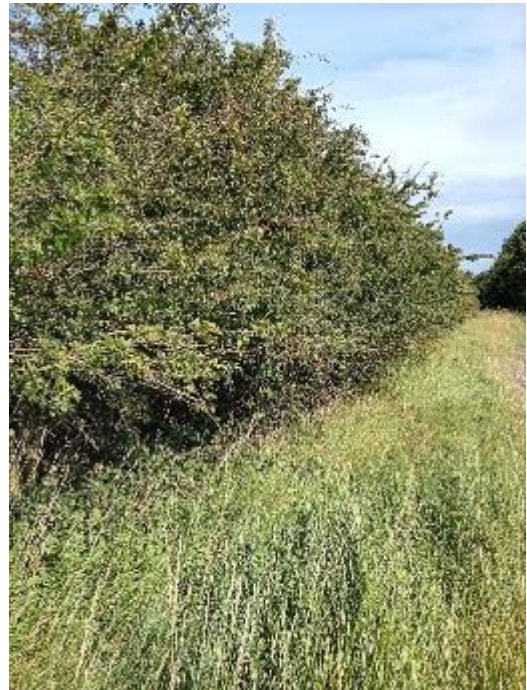
**Plate 2 – S02**

3.2.5 S02 is located on an unnamed ditch, which was dry and heavily vegetated at the time of survey.

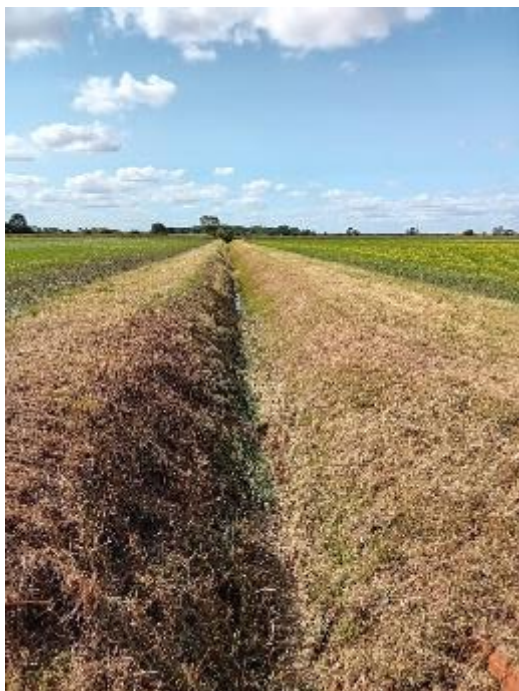
**Plate 3 – S03**

3.2.6 S03 is located at the eastern extent of a small drainage ditch close to the confluence, via an existing culvert, with a larger, unnamed ditch. S46 is located c.10m west of S03. The ditch was wetted with a water depth of < 0.1m, no perceptible flow and was heavily choked with vegetation. The banks had been strimmed recently and vegetation trimmings were present throughout the channel.

3.2.7 The larger connected ditch was wetted at the time of survey with no perceptible flow, with c.0.4m water depth, c. 40% duckweed coverage, c.40% emergent macrophyte coverage over a silt substrate. This culvert was above the water level of the larger ditch at the time of survey and as such connectivity (i.e. from rainfall or runoff) would be one-way from the S03 ditch into the unnamed ditch under surveyed water levels.

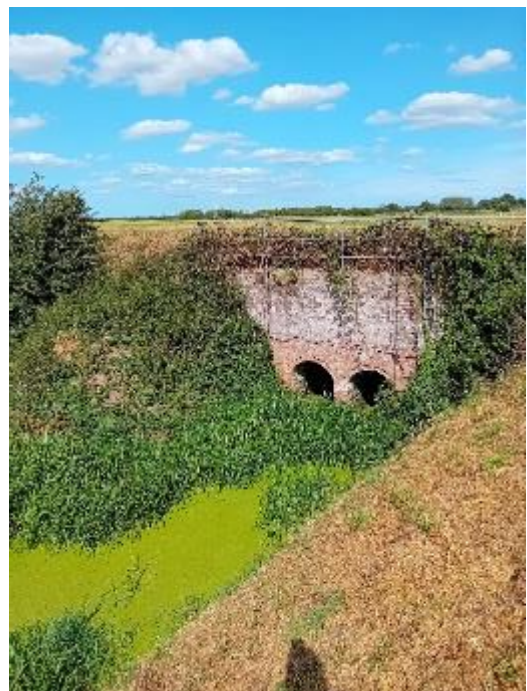
**Plate 4 – S04**

3.2.8 S04 is located at the eastern extent of the Arnold and Riston Drain close to the Arnold West Carr Drain. The drain was wetted with a silt substrate, no

perceptible flow and was covered by duckweed (c. 50% cover) and emergent macrophyte (c. 50% cover).

- 3.2.9 An existing culvert structure is located at the crossing location, connectivity here could not be confirmed but it does not appear as though the two drains are hydrologically connected, the culvert potentially passing beneath the Arnold West Carr Drain and connecting to the Drewery's Sock Dike to the east.
- 3.2.10 The Arnold and Riston Drain appears to have open connectivity to the Holderness Drain, one of the larger drains which feeds into the Humber directly.

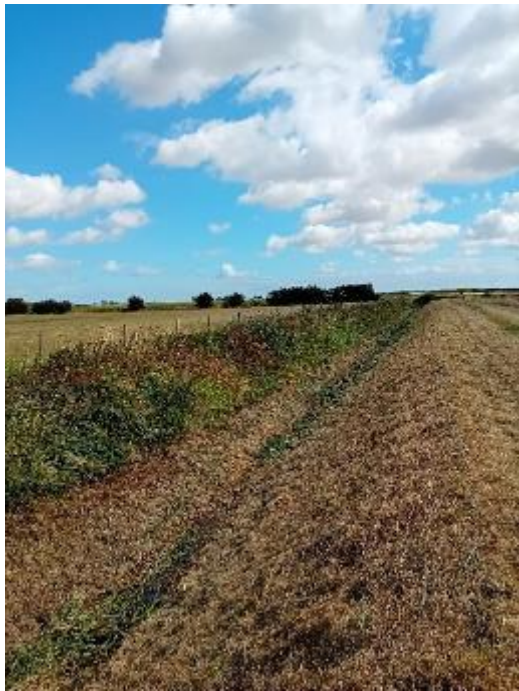
**Plate 7 – S07**

- 3.2.13 S07 is located on an east-west oriented arm of the Routh & Meaux Drain. Emergent macrophyte lined the channel (c. 70% cover) which was wetted with no perceptible flow, c. 0.2m deep with a silt substrate. The banks had been recently trimmed with trimmings present throughout the channel.

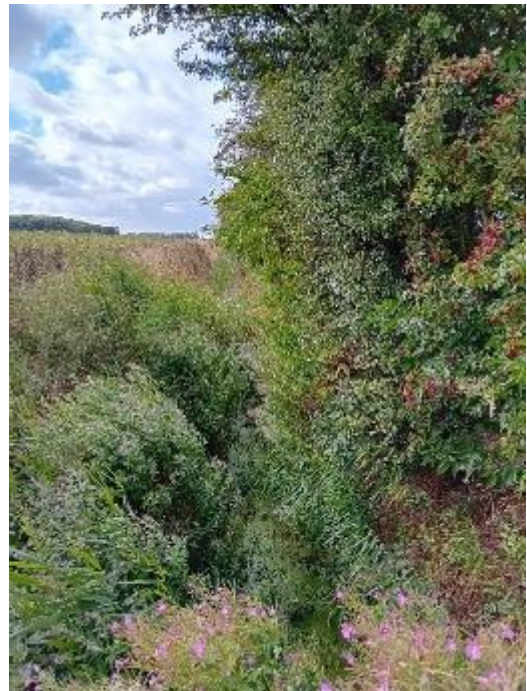
**Plate 8 – S08**

- 3.2.14 S08 is located on an unnamed ditch which joins the Routh & Meaux Drain approximately 240 m to the south. The ditch was wetted with shallow water (< 0.3m depth), no perceptible flow, c.15 % emergent macrophyte coverage and a silt substrate.

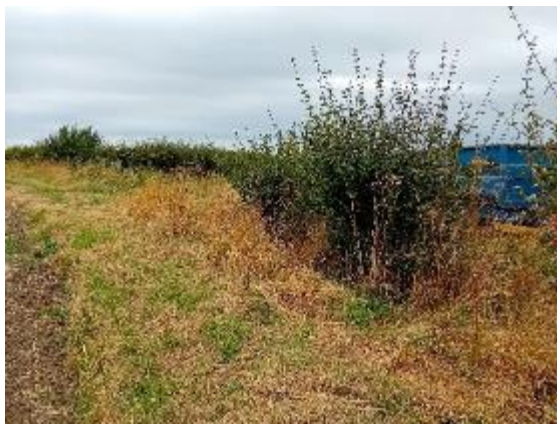
**Plate 19 – S20**

3.2.25 S20 is located on a shallow depression within a hedgerow and not a typical drainage ditch. The area was dry with no evidence of it being frequently wetted or ephemeral.

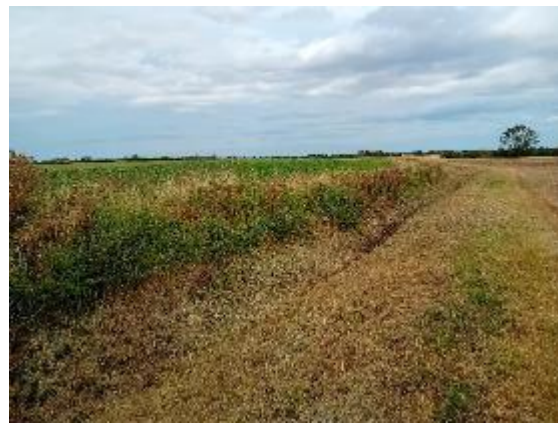
**Plate 20 – S21**

3.2.26 S21 is located on an unnamed ditch close to a confluence with the Routh and Meaux Road Drain. The ditch was largely dry with some areas of shallow (< 0.1m depth) ponded water. The channel was lined with terrestrial grasses and trimmings from recent bank strimming.

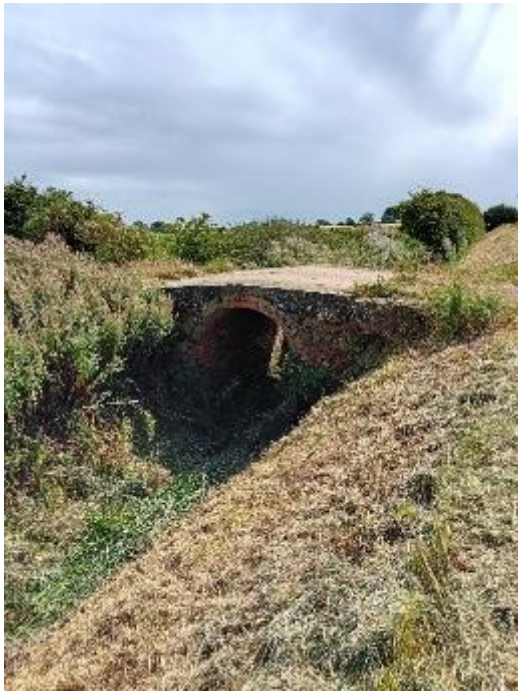
**Plate 37 – S37**

3.2.42 S37 is located on an unnamed ditch which was wetted at the time of survey with an area beneath the existing culvert drying out. South of the existing culvert no perceptible flow was observed, water depths were c.0.3m with c.45% emergent macrophyte coverage and a sparse covering of duckweed (c.5% coverage) recorded. To the north of the culvert water depths were shallow (c.0.1m) and dense stands of emergent macrophyte were recorded with an overall coverage of c.40%.
