# Pearmtree Hill Solar Farm

## Environmental Statement

#### Appendix 7.8: Aquatic Walkover Report

Application Document Ref: EN010157/APP/6.4  
February~~November~~ 2025

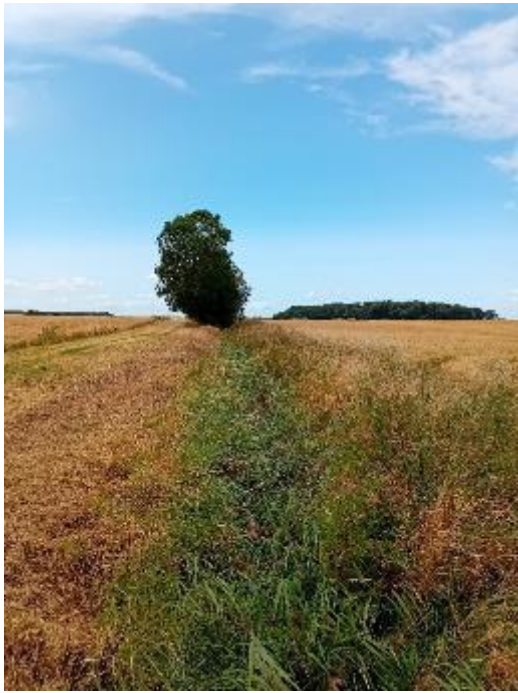
**Plate 1 – S01**

3.2.23.2.3 The S01 crossing point is located at the eastern extent of a drainage ditch close to the confluence, via a culvert, with a larger, unnamed ditch. The culvert was above the water level of the larger ditch at the time of surveying and as such connectivity (i.e. from rainfall or runoff) would be one-way from the S01 ditch into the unnamed ditch under surveyed water levels.

3.2.33.2.4 The S01 ditch was heavily overgrown and dry at the time of surveying. The larger unnamed ditch was wetted at the time of surveying with no perceptible flow. The water surface had c. 90% duckweed (*Lemna* sp.) coverage, with c. 10% emergent macrophyte coverage over a silt substrate.

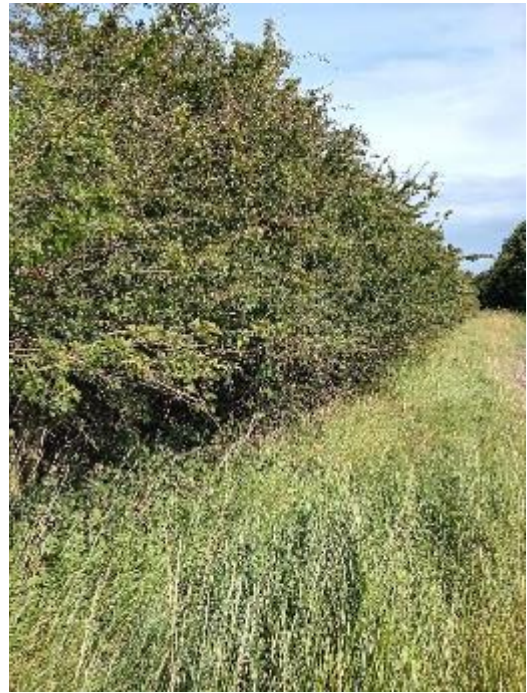
**Plate 2 – S02**

3.2.43.2.5 S02 is located on an unnamed ditch, which was dry and heavily vegetated at the time of survey.

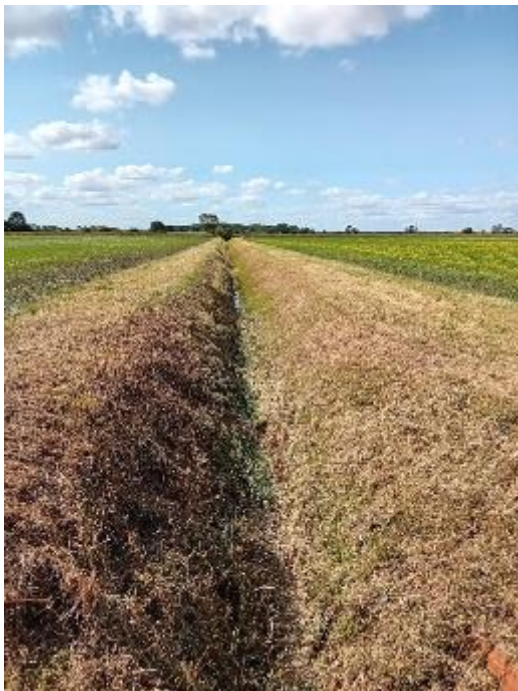
**Plate 3 – S03**

3.2.53.2.6 S03 is located at the eastern extent of a small drainage ditch close to the confluence, via an existing culvert, with a larger, unnamed ditch. S46 is located c.10m west of S03. The ditch was wetted with a water depth of < 0.1m, no perceptible flow and was heavily choked with vegetation. The banks had been strimmed recently and vegetation trimmings were present throughout the channel.

3.2.63.2.7 The larger connected ditch was wetted at the time of survey with no perceptible flow, with c.0.4m water depth, c. 40% duckweed coverage, c.40% emergent macrophyte coverage over a silt substrate. This culvert was above the water level of the larger ditch at the time of survey and as such connectivity (i.e. from rainfall or runoff) would be one-way from the S03 ditch into the unnamed ditch under surveyed water levels.

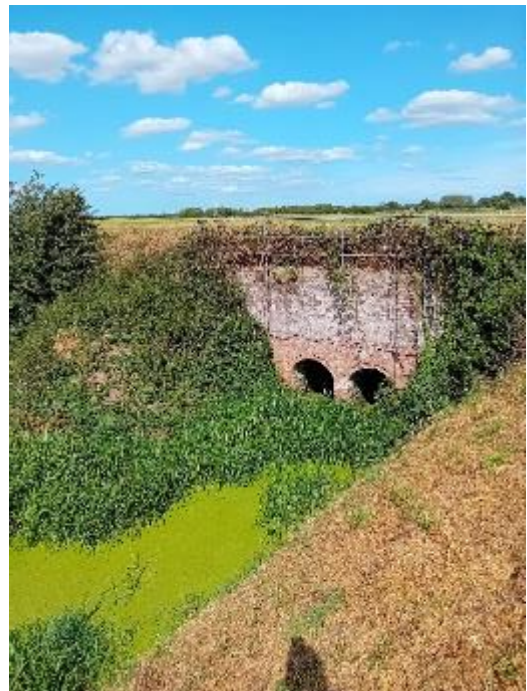
**Plate 4 – S04**

3.2.73.2.8 S04 is located at the eastern extent of the Arnold and Riston Drain close to the Arnold West Carr Drain. The drain was wetted with a silt

substrate, no perceptible flow and was covered by duckweed (c. 50% cover) and emergent macrophyte (c. 50% cover).

3.2.83.2.9 An existing culvert structure is located at the crossing location, connectivity here could not be confirmed but it does not appear as though the two drains are hydrologically connected, the culvert potentially passing beneath the Arnold West Carr Drain and connecting to the Drewery's Sock Dike to the east.

3.2.93.2.10 The Arnold and Riston Drain appears to have open connectivity to the Holderness Drain, one of the larger drains which feeds into the Humber directly.

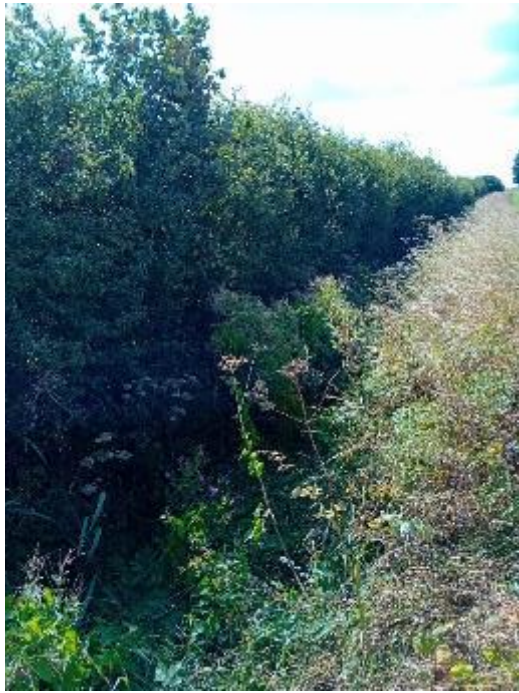
**Plate 5 – S05**

3.2.103.2.11 S05 is located on a small ditch which connects to the Routh & Meaux drain c. 200m to the north. The ditch was largely dry, but damp in places with dense terrestrial vegetation growth present and a silt substrate.

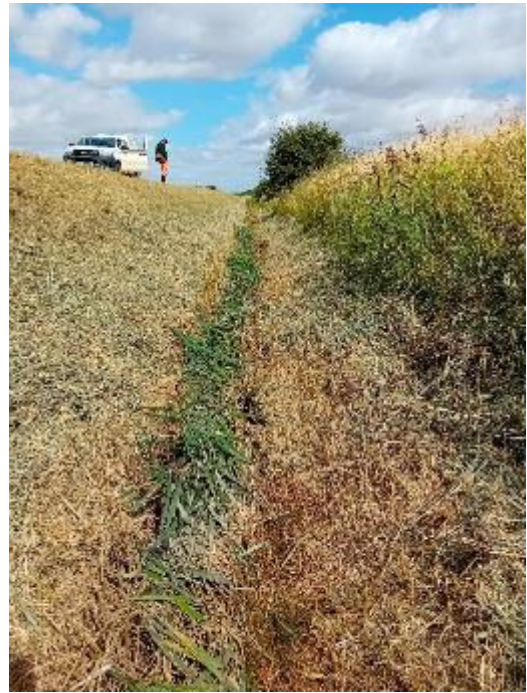
**Plate 6 – S06**

3.2.113.2.12 S06 is located on a north-south oriented arm of the Routh & Meaux drain. The drain was wetted with shallow water (< 0.05m), no perceptible flow and dense emergent macrophyte coverage (c.80%). The banks had been recently trimmed with trimmings present throughout the channel.

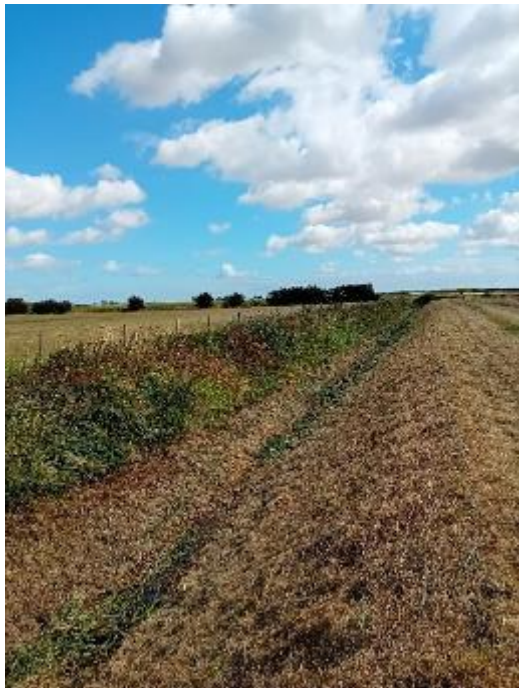
**Plate 7 – S07**

3.2.123.2.13 S07 is located on an east-west oriented arm of the Routh & Meaux Drain. Emergent macrophyte lined the channel (c. 70% cover) which was wetted with no perceptible flow, c. 0.2m deep with a silt substrate. The banks had been recently trimmed with trimmings present throughout the channel.

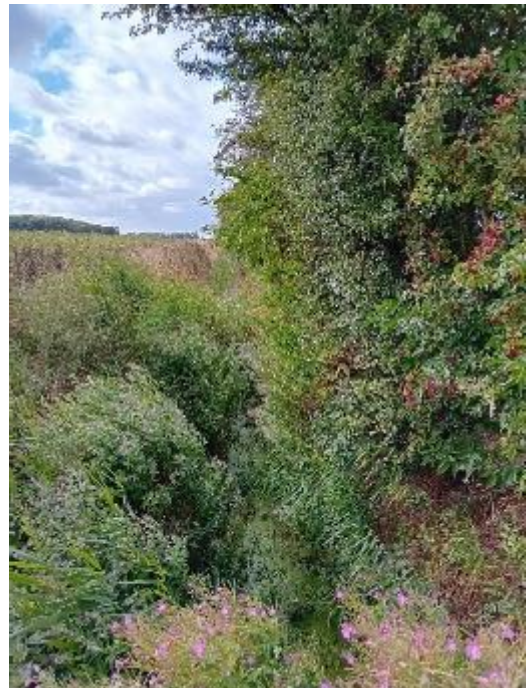
**Plate 8 – S08**

3.2.133.2.14 S08 is located on an unnamed ditch which joins the Routh & Meaux Drain approximately 240 m to the south. The ditch was wetted with shallow water (< 0.3m depth), no perceptible flow, c.15 % emergent macrophyte coverage and a silt substrate.

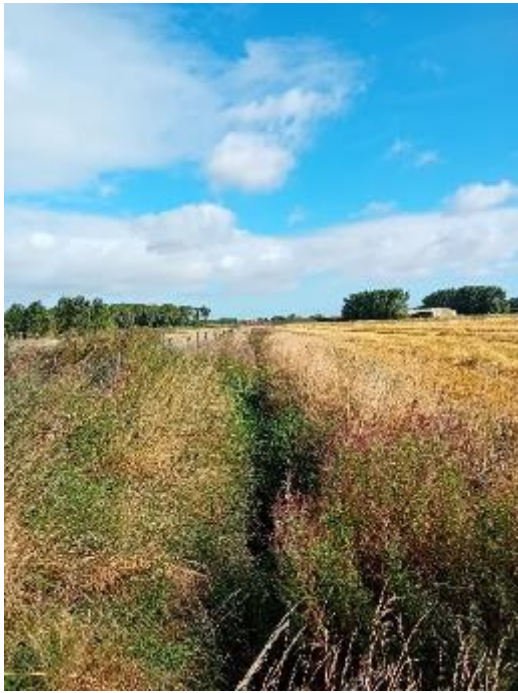
**Plate 9 – S09**

3.2.143.2.15 S09 is located on the same unnamed ditch as S08, which is approximately 380m southwest. The ditch was wetted with c.0.3 m deep water, no perceptible flow, dense duckweed (c. 40%) and emergent macrophyte (c.60%) cover and a silt / clay substrate.

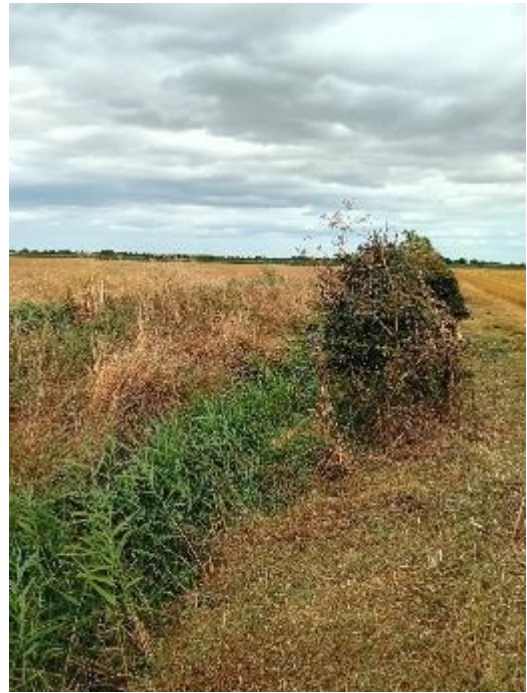
**Plate 10 – S10**

3.2.153.2.16 S10 is located on a short, unnamed ditch oriented east-west between the Meaux and Routh East Drain and Monk Dike. The ditch was wetted with no perceptible flow, c.0.2m deep water, c.40% duckweed, c.20% emergent

macrophyte coverage and a silt substrate. The channel and banks were densely overgrown with terrestrial vegetation.

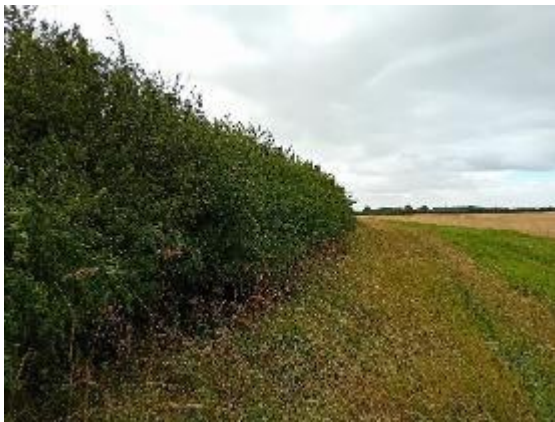
**Plate 11 – S11**

~~3.2.16~~ **3.2.17** S11 is located on a shallow depression within a hedgerow and not a typical drainage ditch. The area was dry with no evidence of it being frequently wetted or ephemeral.

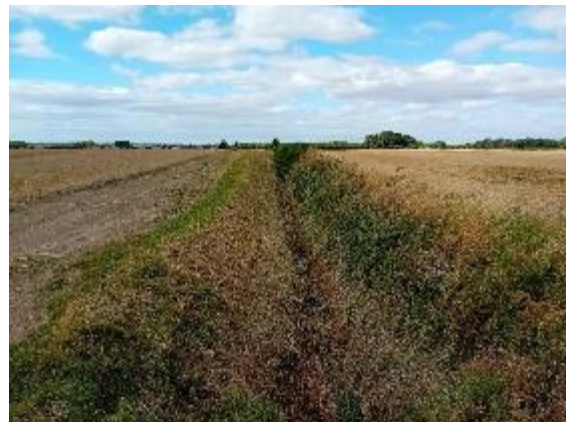
**Plate 12 – S12**

~~3.2.17~~ **3.2.18** S12 is located at / close to an existing culvert on the Meaux West drain. To the east of the existing culvert the channel and banks were heavily overgrown with the channel choked with emergent macrophyte. The water depth was c.0.3m with no perceptible flow. To the west of the culvert, the channel had a water depth of c0.3m and no perceptible flow. The channel and banks had been strimmed and the ditch was characterised by emergent macrophyte (c.60% cover).

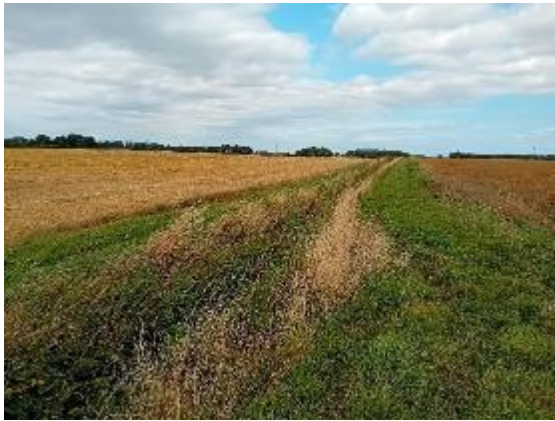
**Plate 13 – S13**

~~3.2.18~~ **3.2.19** S13 is a small, overgrown ditch between arable field which was dry at the time of surveying.

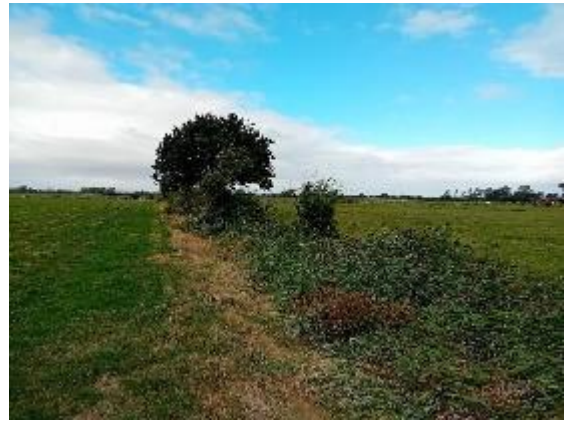
**Plate 14 – S14**

~~3.2.19~~ **3.2.20** S14 is located on Well Stone Carr Drain. The drain was c.0.2m deep with no perceptible flow, had a silt substrate and was choked with emergent macrophyte at the time of survey.

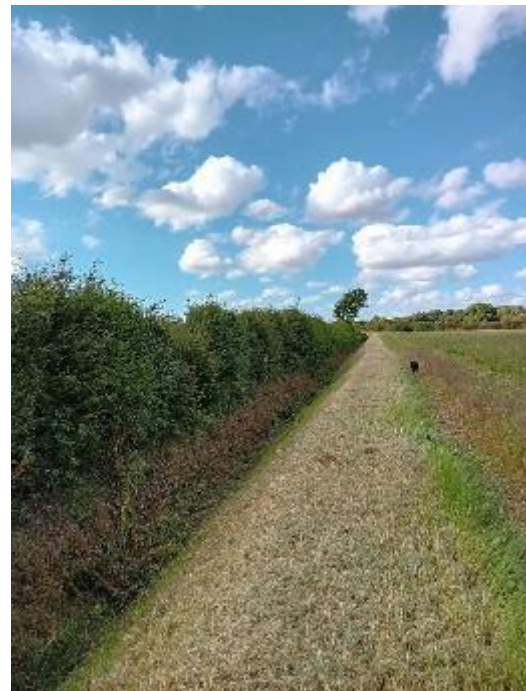
**Plate 16 – S16**

3.2.21 S16 is located on a small, unnamed ditch which was dry at the time of the survey.

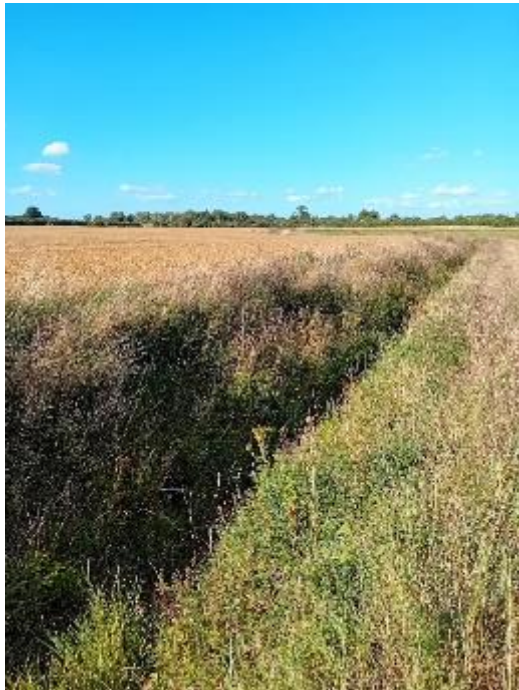
**Plate 17 – S17**

3.2.22 S17 is located on a small, unnamed ditch between arable fields. The ditch was damp at the time of survey with very shallow water present (< 0.05m depth) and filamentous algae.

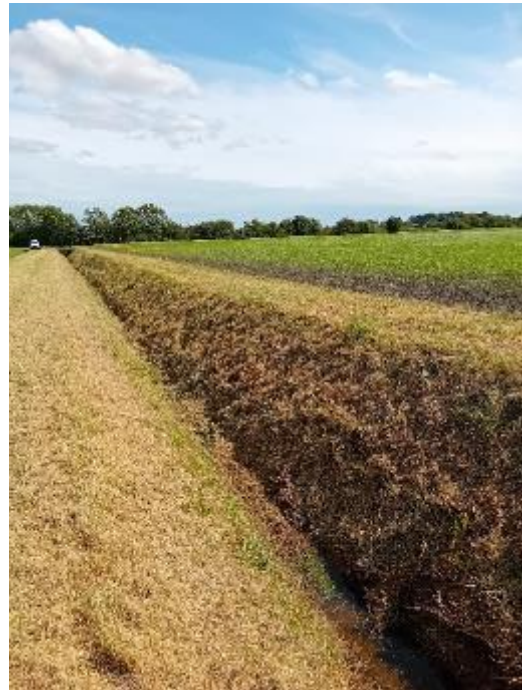
**Plate 18 – S18**

3.2.23 S18 is located on the same ditch as S03, which is approximately 185m to the east. Habitat within the ditch mirrors that at S03 (see above) with shallow water, no perceptible flow and with large quantities of vegetation and trimmings present in the channel.

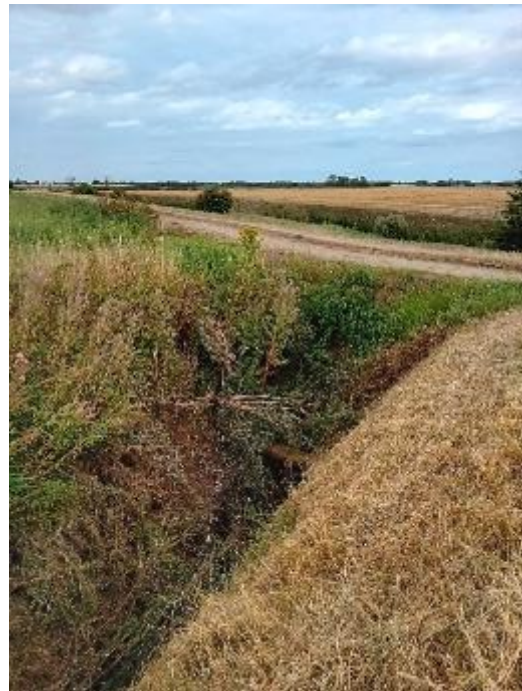
**Plate 24 – S25**

3.2.31 S25 is located on the Routh and Meaux Road Drain close to the confluence with the Meaux and Routh East Drain. The drain was wetted and was observed to be flowing east into the larger Meaux and Routh East Drain, although connectivity between the drains appeared to be poor. The flow type was shallow glide with a water depth of c.0.3m and a silt substrate. The channel was blocked in places by dense trimmings from recent strimming works.

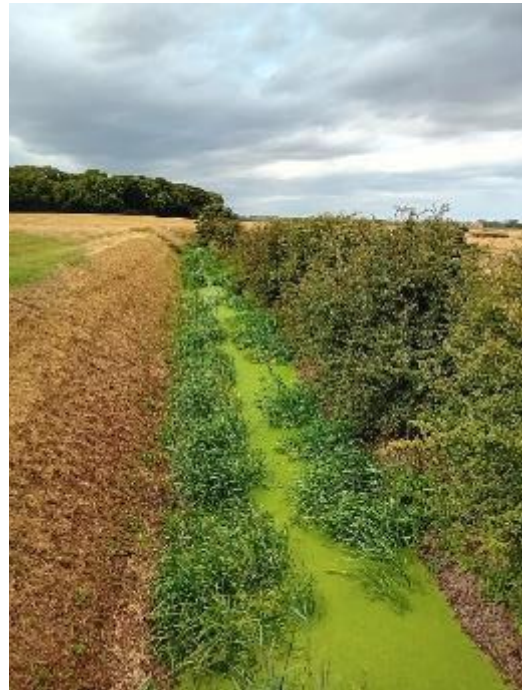
Plate **26** – S26

3.2.32 S26 is located on the Meaux and Routh East Drain c.75m north of the confluence with the Routh and Meaux Road drain at S25. S41 is located c.15m to north of S26. The drain was wetted with no perceptible flow, a water depth of c.0.5m and dense duckweed (c.50%) and emergent macrophyte (c.50%) coverage. Stickleback were observed within the drain, the fish were not captured to be identified as either three-spined or nine-spined.

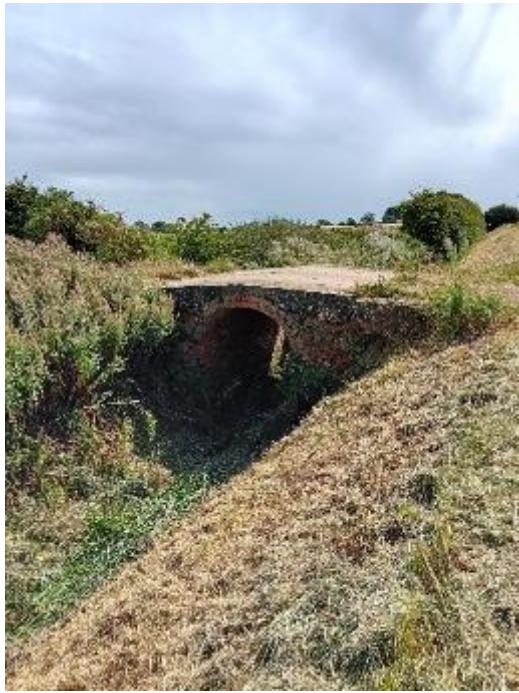
Plate **37** – S37

~~3.2.43~~3.2.42 S37 is located on an unnamed ditch which was wetted at the time of survey with an area beneath the existing culvert drying out. South of the existing culvert no perceptible flow was observed, water depths were c.0.3m with c.45% emergent macrophyte coverage and a sparse covering of duckweed (c.5% coverage) recorded. To the north of the culvert water depths were shallow (c.0.1m) and dense stands of emergent macrophyte were recorded with an overall coverage of c.40%.
