# Peartree Hill Solar Farm

### Appendix 7.7: Water Vole and Otter Habitat Suitability Report

### Revision 3

Application Document Ref: EN010157/APP/6.4  
December 2025

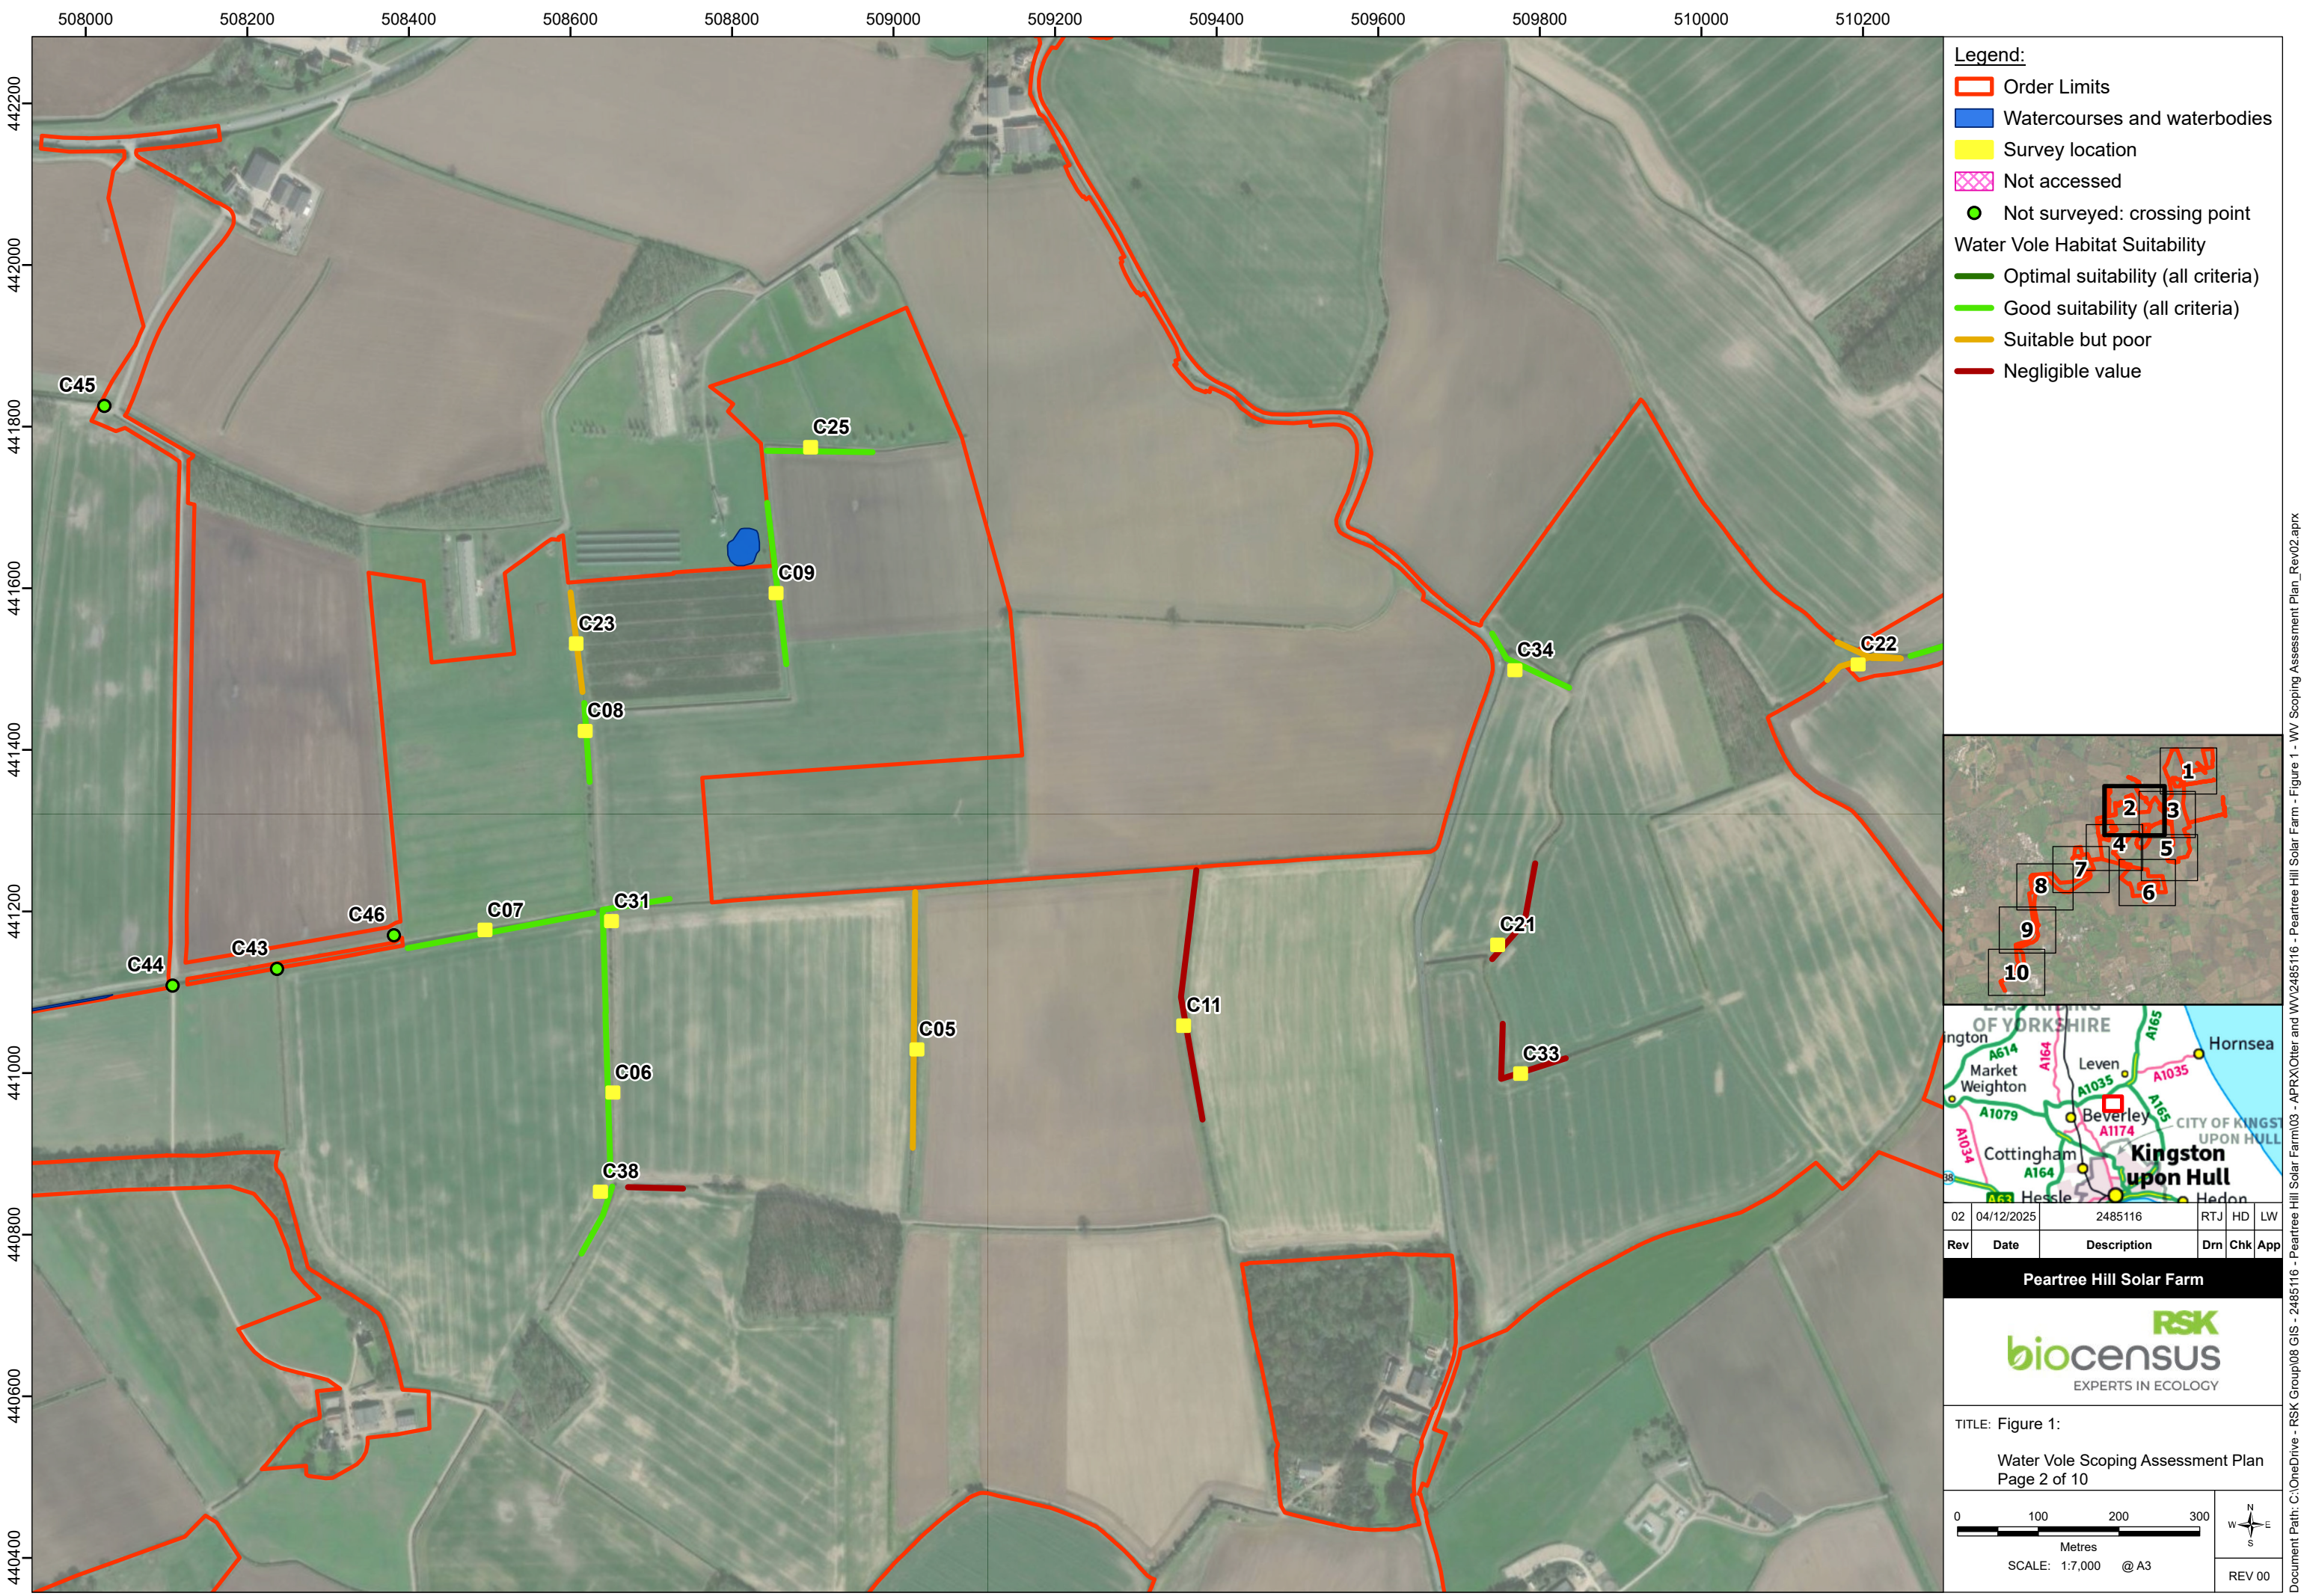
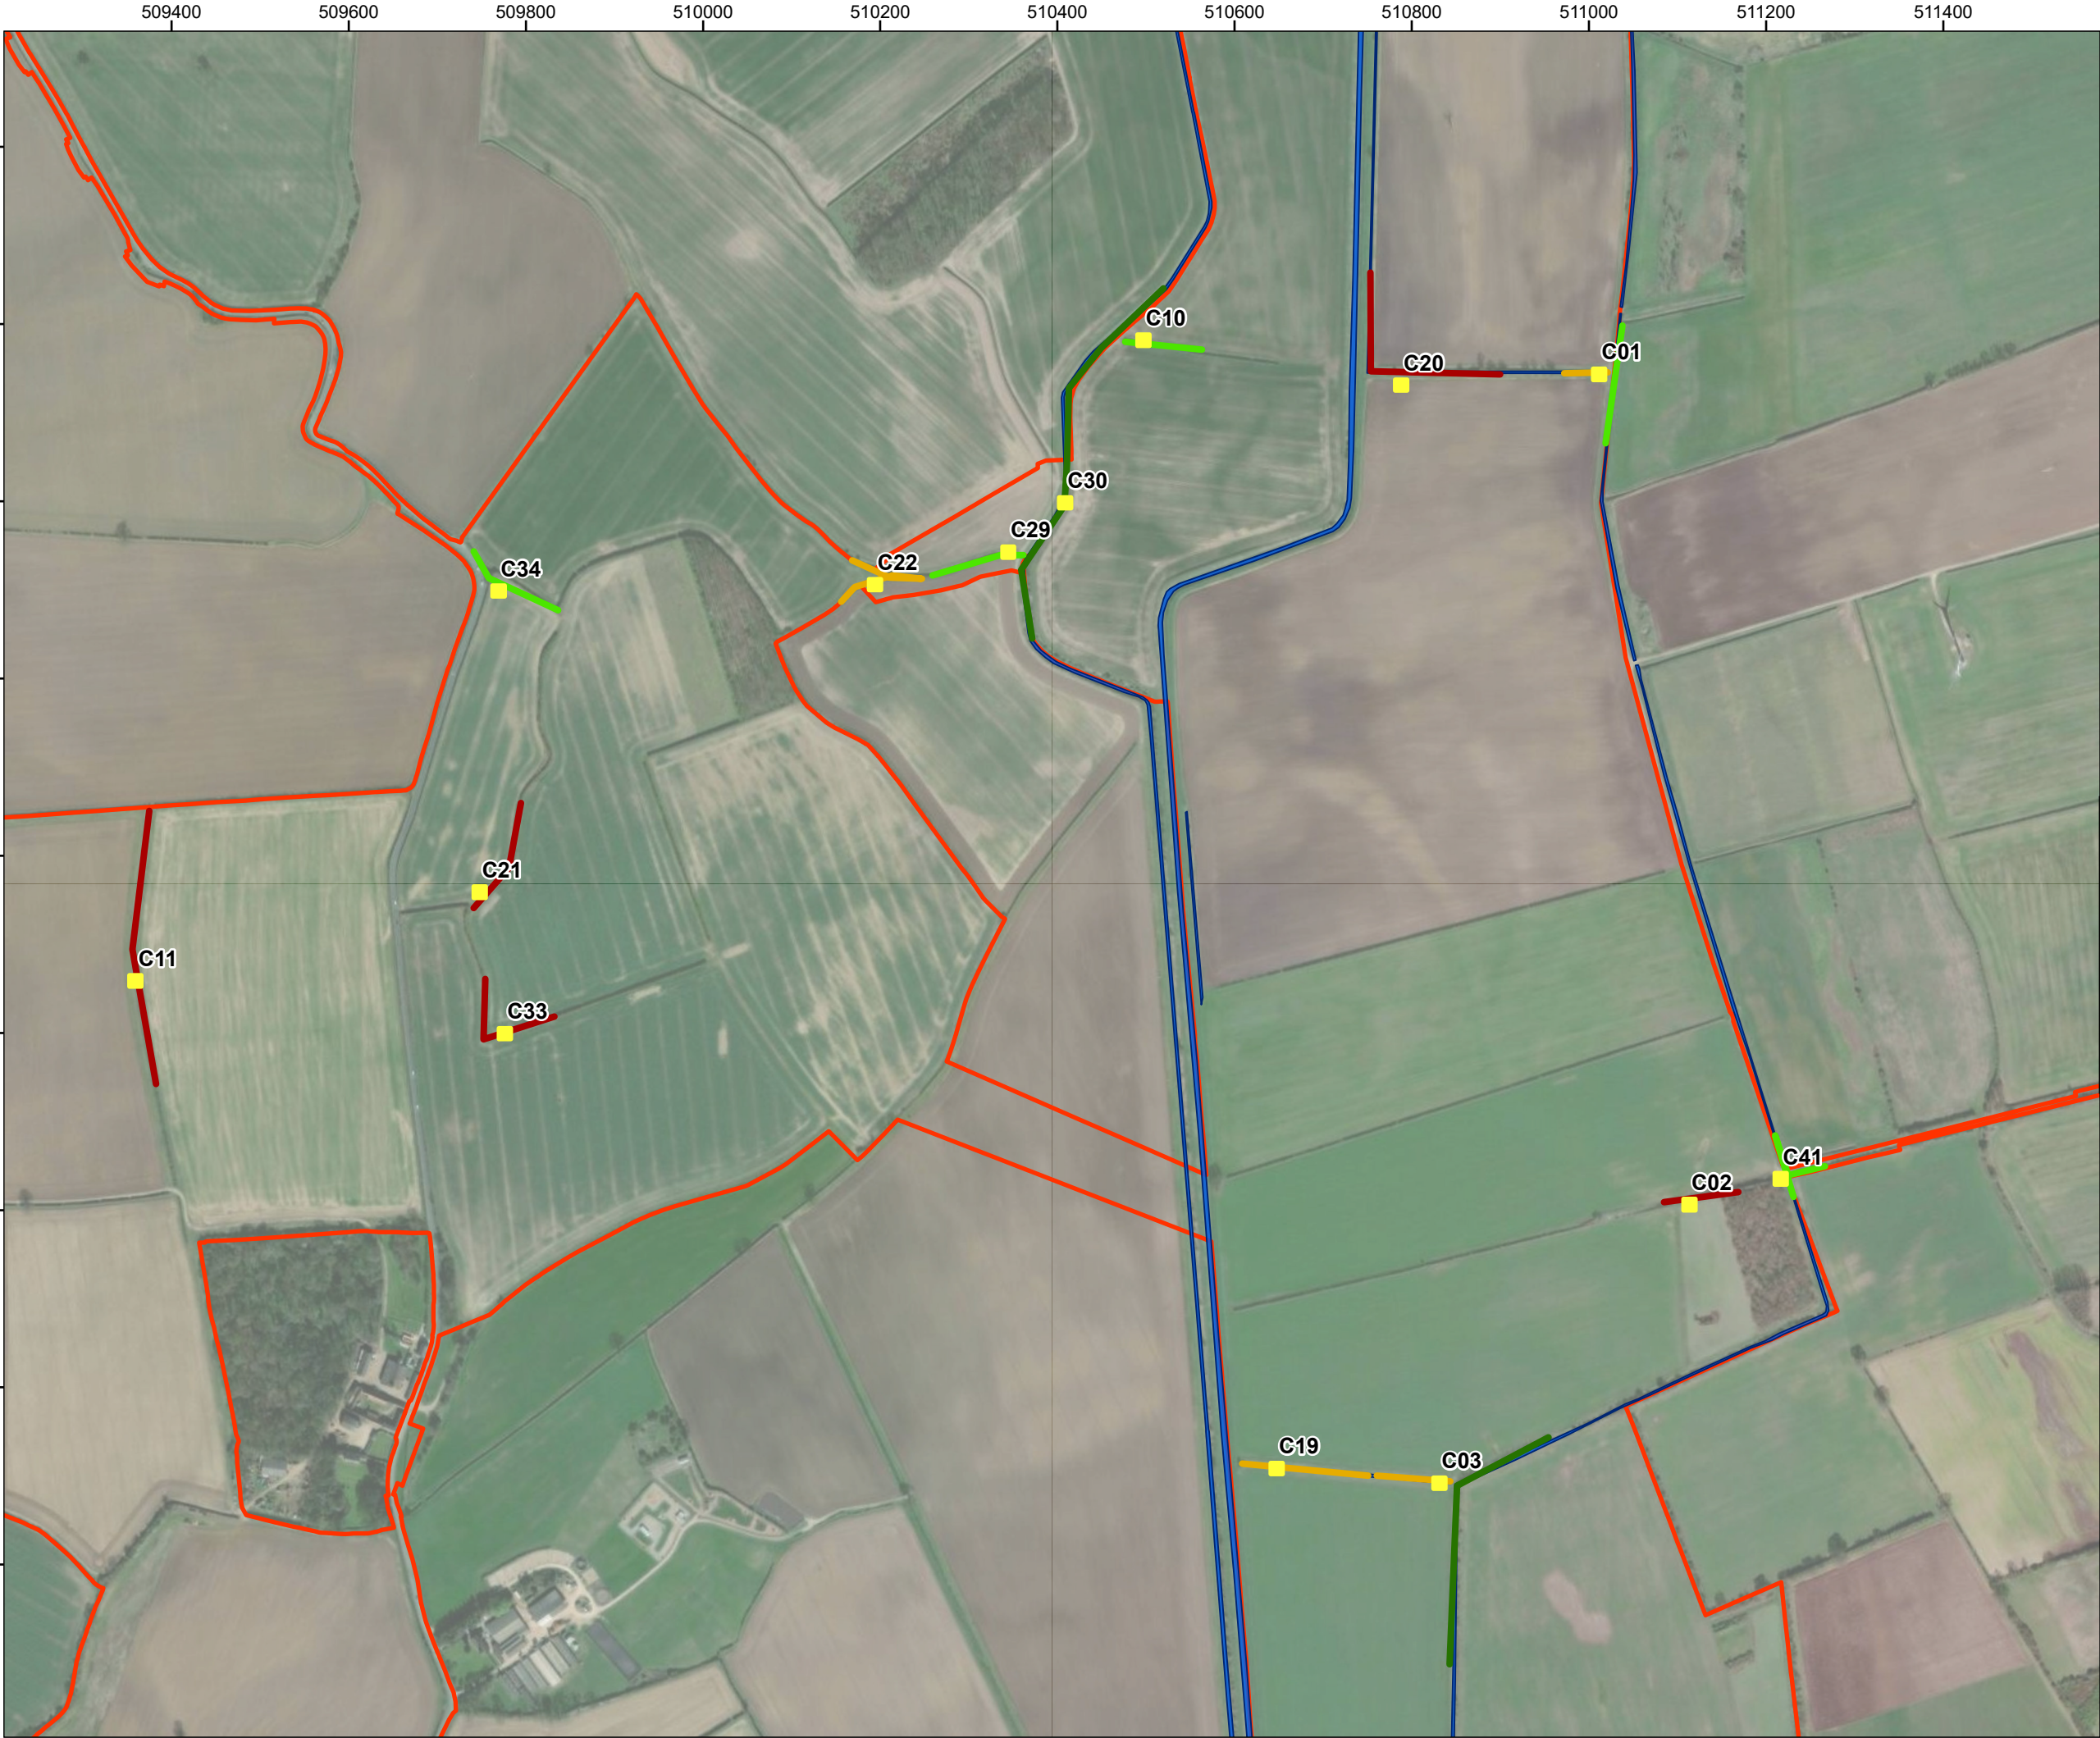
**Figure 1: Water Vole scoping assessment plan**

- 3.1.1 The suitability for water vole of the watercourses/ ditches at each survey location (or adjacent watercourses/ ditches) are summarised in **Table 1** below.

- 3.1.2 The survey locations were based on the proposed culvert crossing points at the time the surveys were undertaken. These locations and the associated habitat assessments are shown on **Figure 1**, appended to this report, with the survey location references listed in the first column of **Table 1** below.

- 3.1.4 A total of six potential crossing points had optimal suitability (N.B. two of these have since been removed from the Proposed Development), 15 had good suitability (N.B. four of these have since been removed from the Proposed Development), eight were suitable but poor (N.B. seven of these have since been removed from the Proposed Development, including C15), ten were negligible value (N.B. seven of these have since been removed from the Proposed Development, including C39), and seven remaining crossing points were not accessed at the time of the survey (N.B. three of these have since been removed from the Proposed Development).

- 3.1.5 The ditches recorded as having optimal or good suitability provide habitat for water vole and allow them to use these watercourses as habitat corridors. The results show that there are habitat corridors providing connectivity through the Site, and it is considered likely that water voles will use these if present at the Site. The ditches connected to the main areas of habitat will also likely be used by water vole. The areas recorded as negligible value are unlikely to be used by water voles.

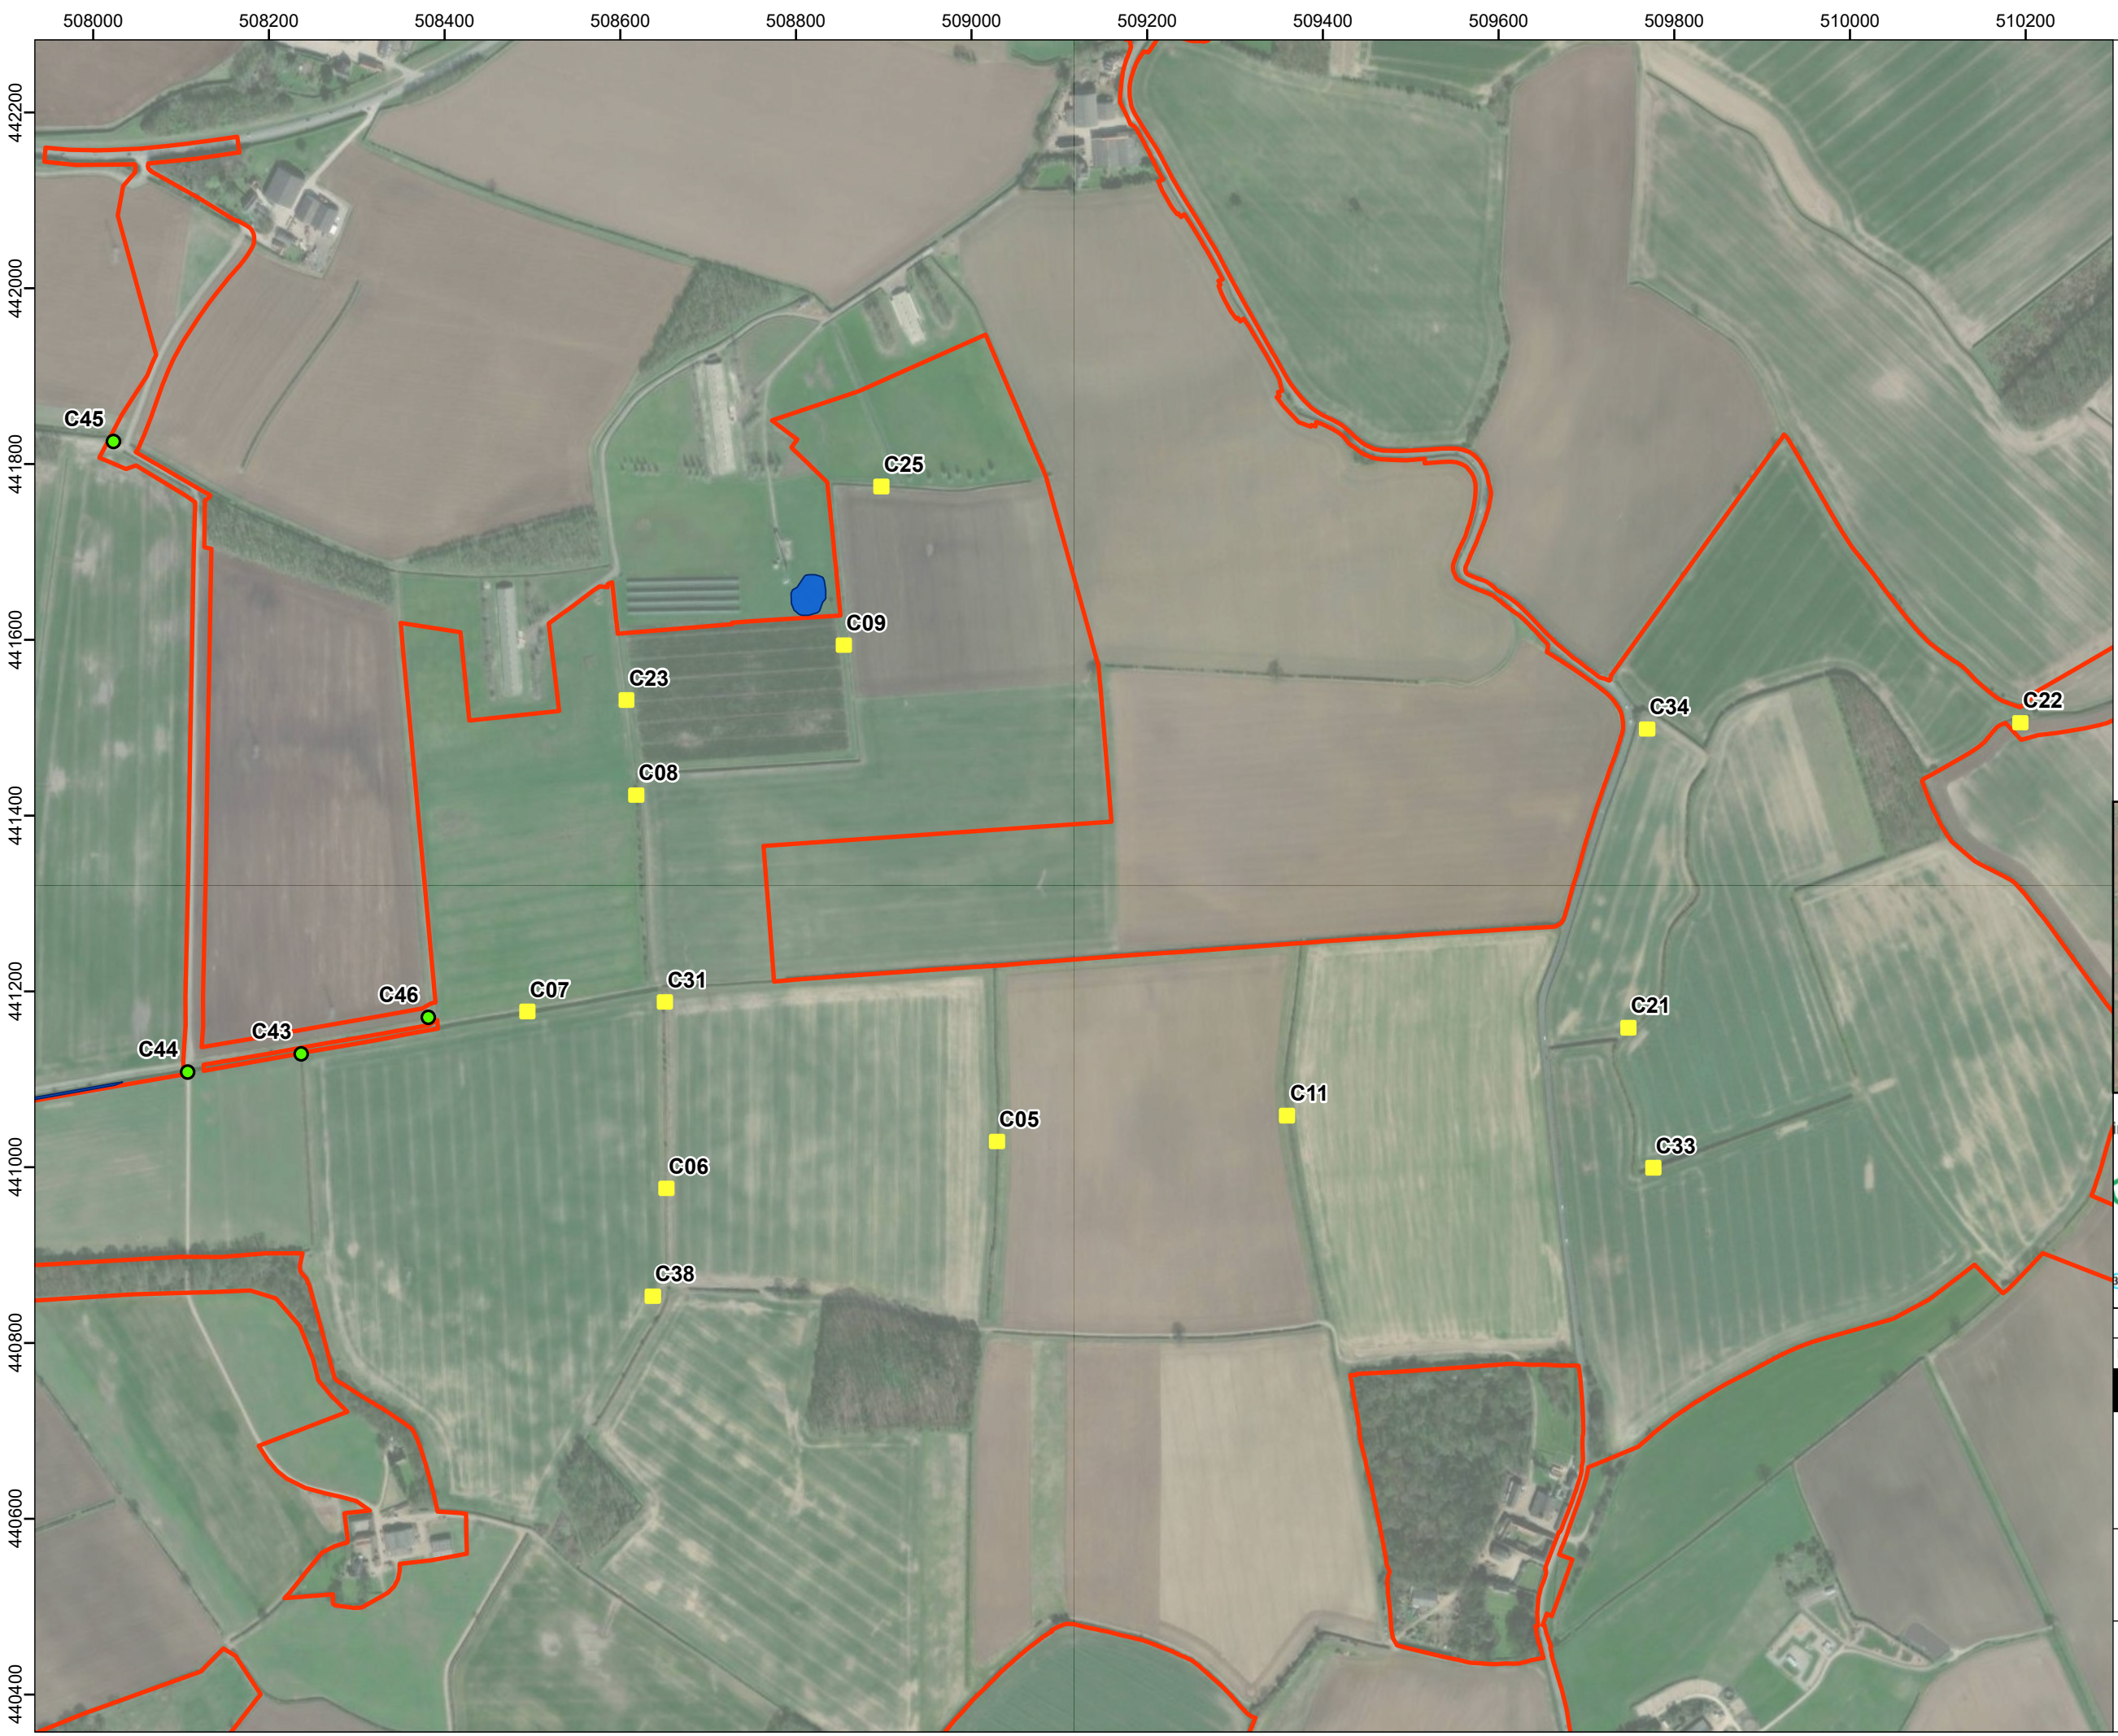
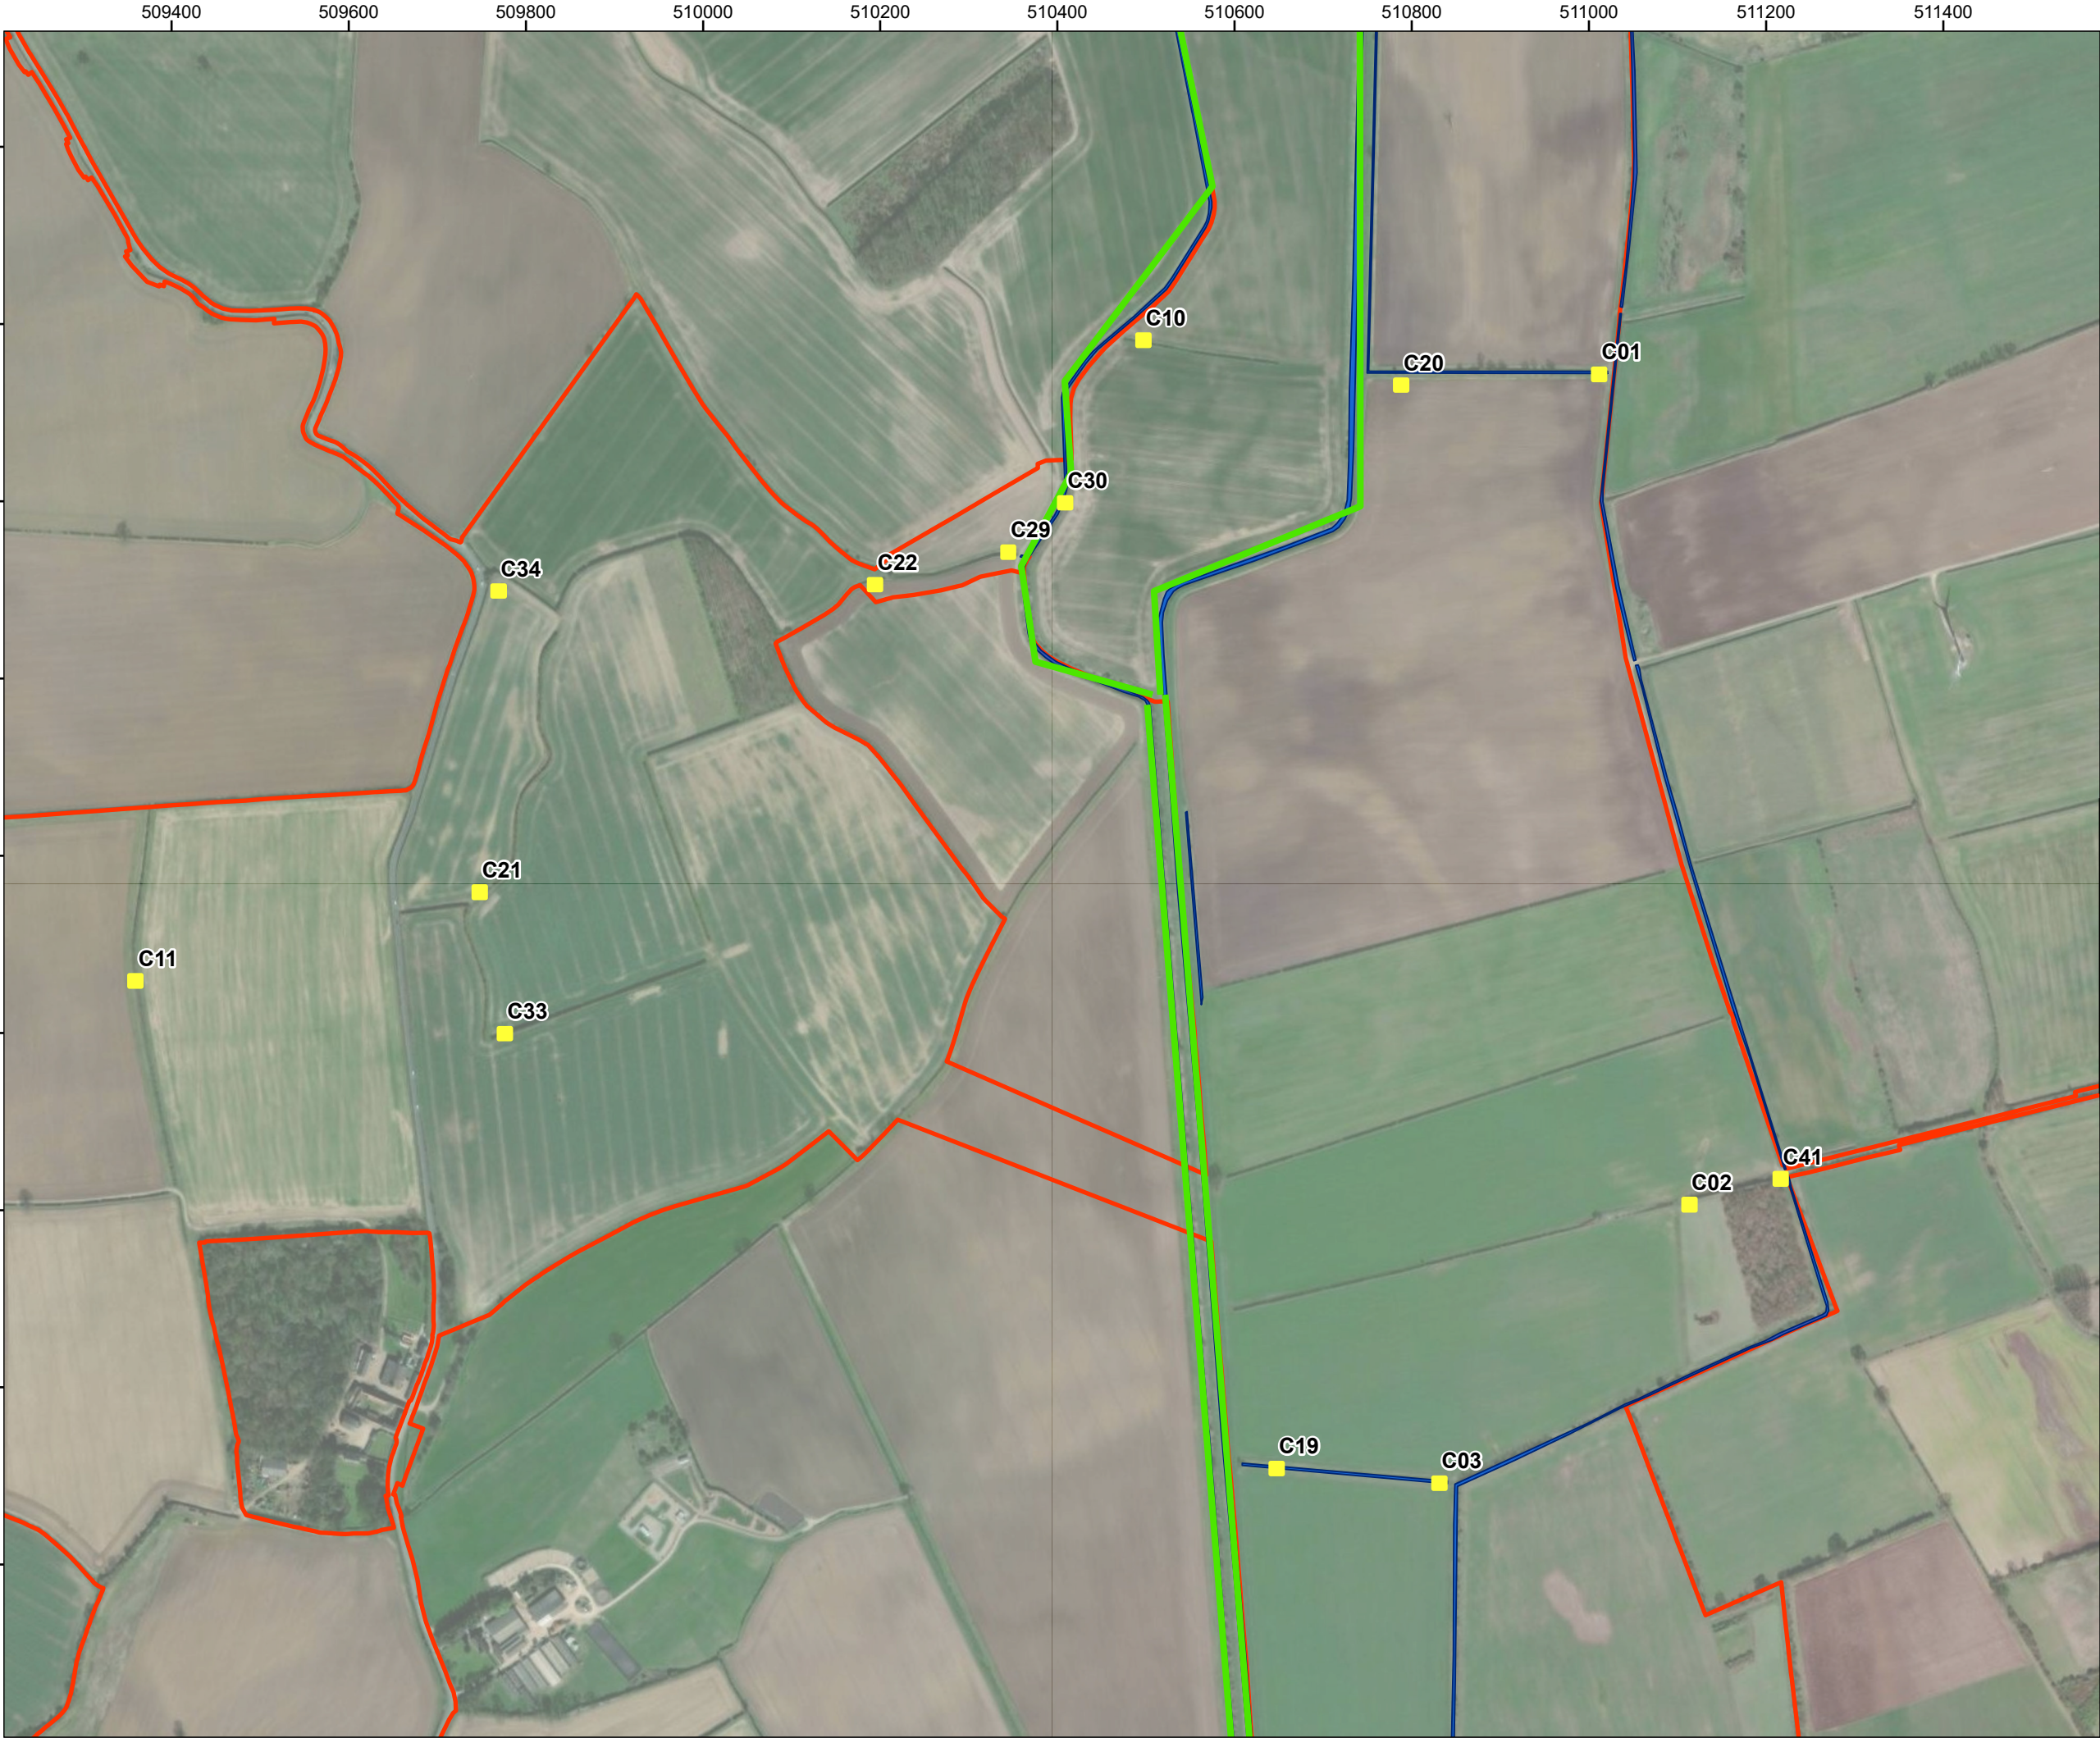
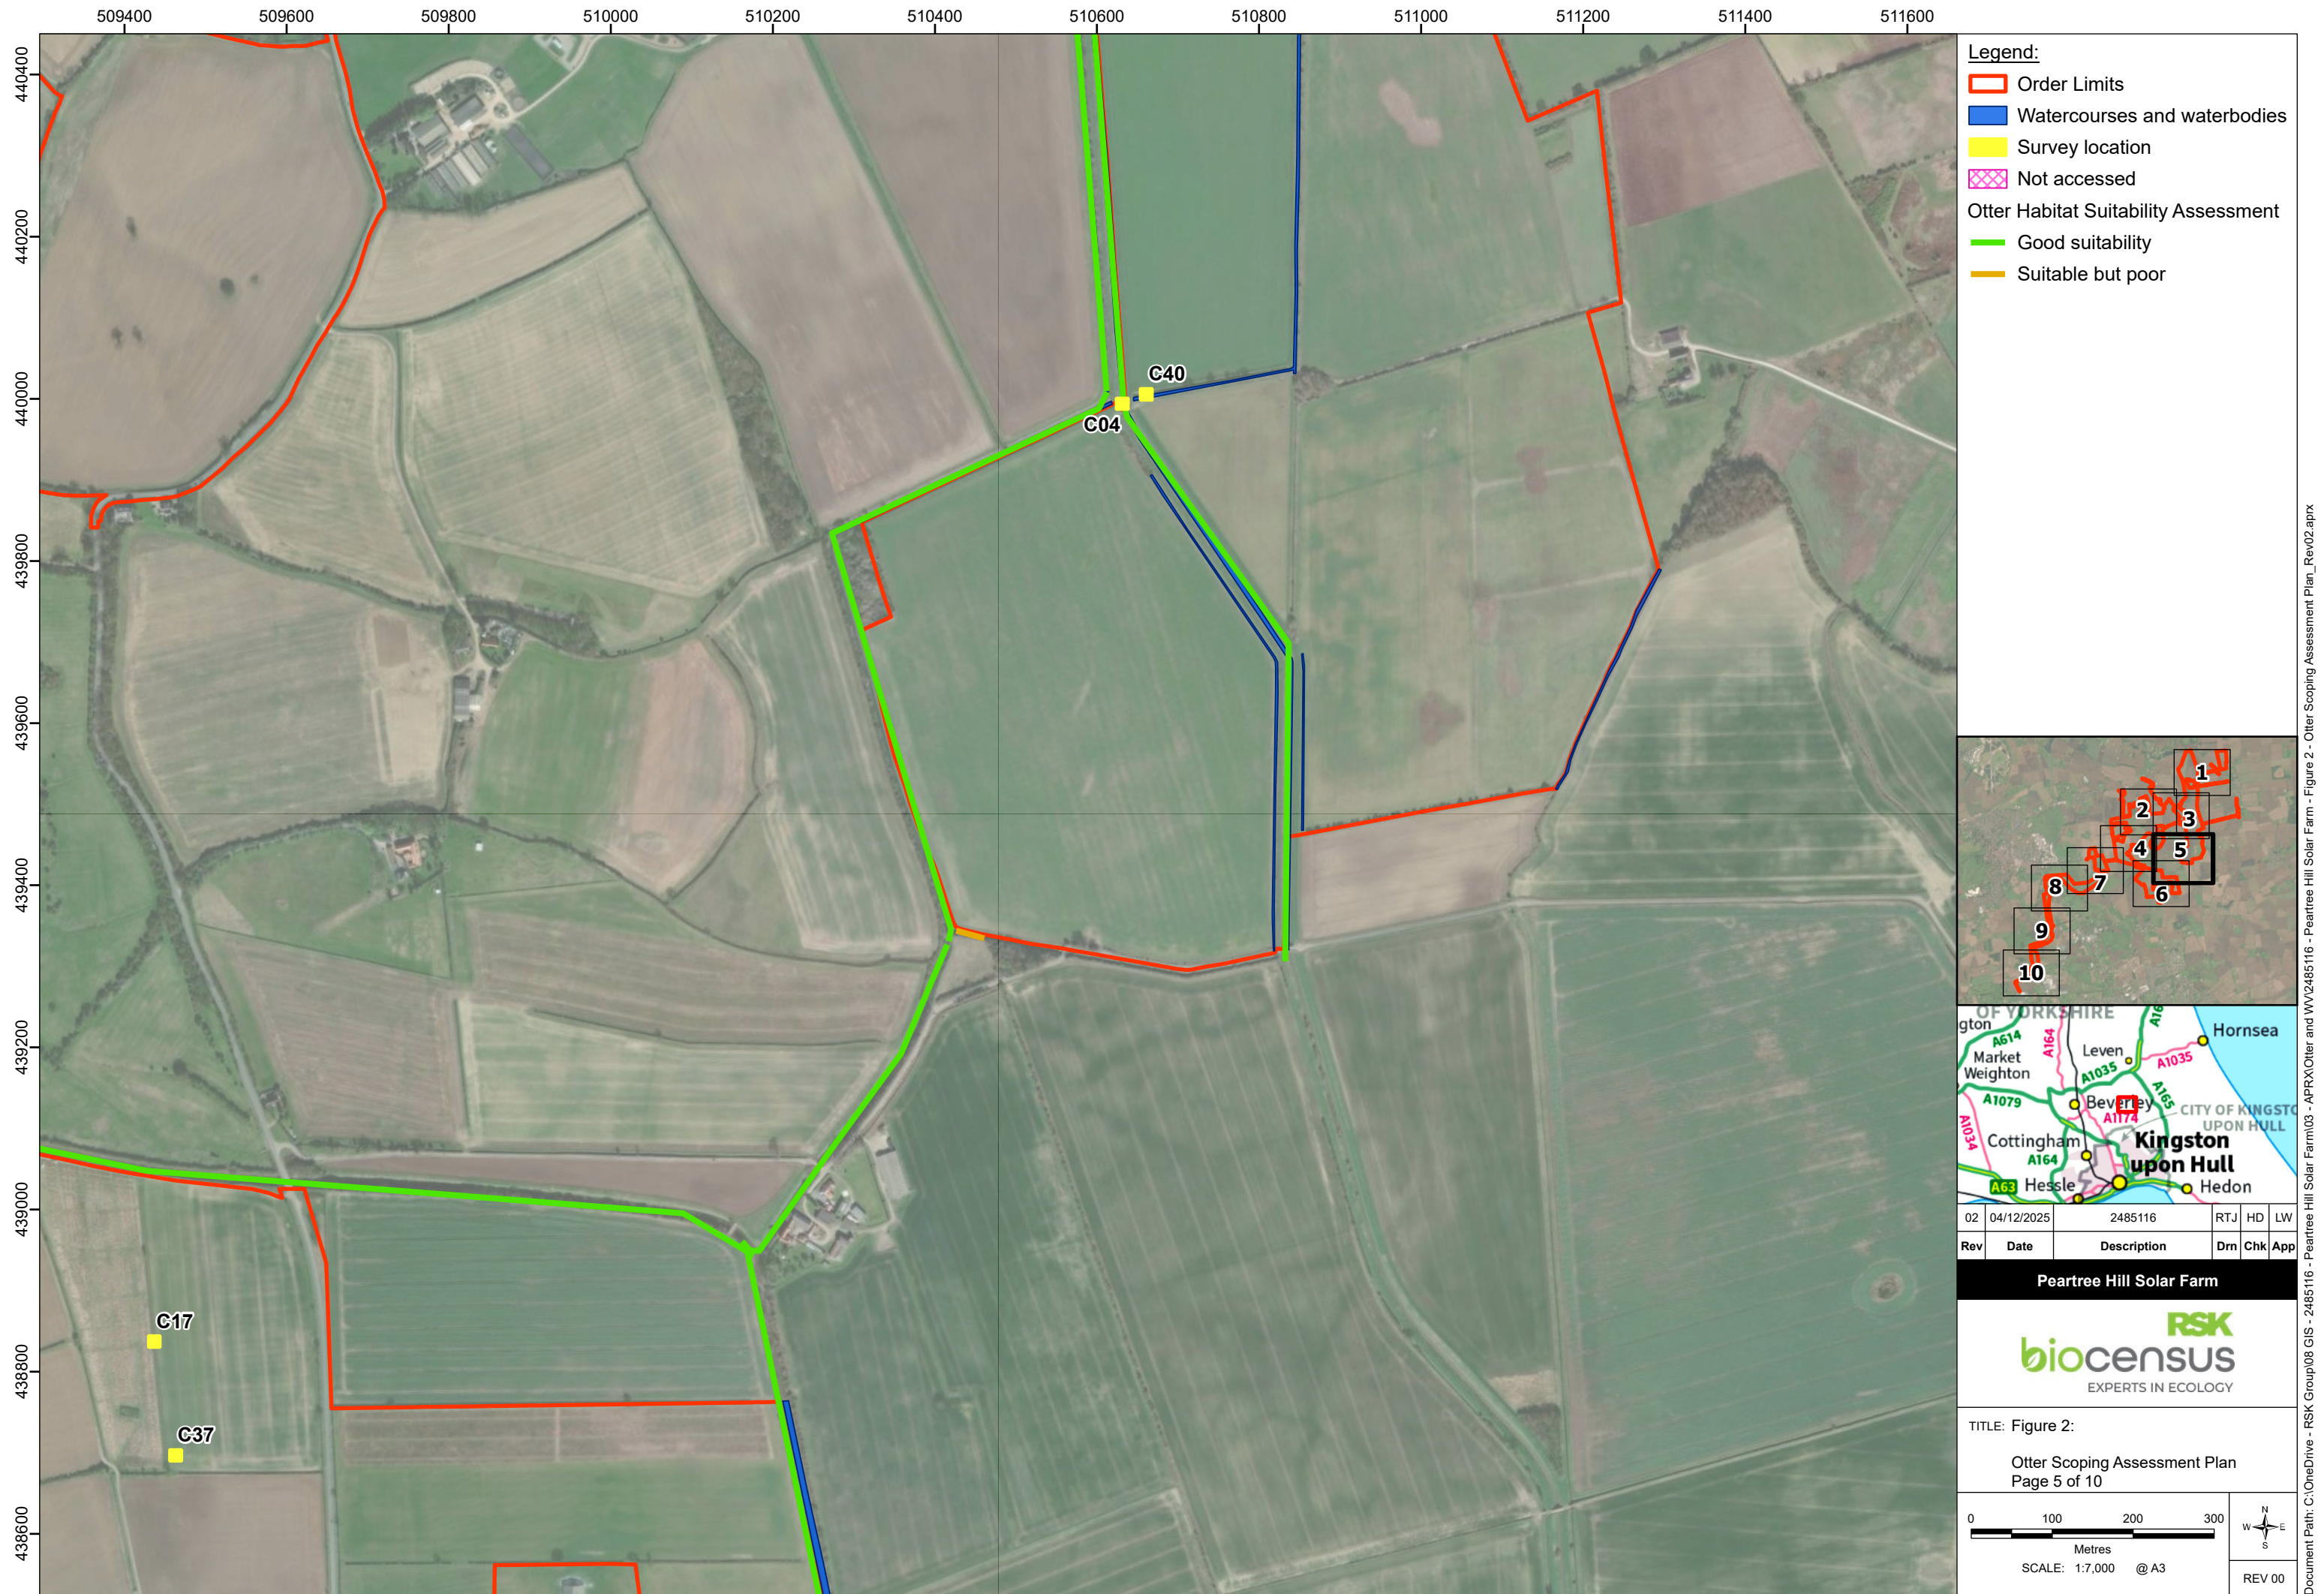
**Figure 2: Otter scoping assessment plan**

- 3.2.1 The otter habitat classification of watercourses is shown on **Figure 2** appended to this report. The figure shows the main areas of habitat that provide connectivity into the Site. Otter are a mobile species that can cross land as well as swim along rivers, so they will make use of any cover, such as hedgerows, or ditches, if there is a destination for them. A destination may include a different river, a food source, or a resting place. It can be assumed that the areas identified as good habitat, provide an important habitat corridor, but that otter could also make use of any other habitats on the Site.

- 3.2.2 No otter resting places were observed during the survey. The banks of the rivers surveyed were well maintained earth banks, to control the water flow, and generally did not contain holes or hollows that would be suitable for otter holts. However, an exhaustive search for otter holts was not undertaken throughout the entire Site, and it could be possible that there are suitable areas, such as overturned boats, disused badger setts, drainage pipes/ culverts or other features that could provide cover for an otter resting site.

- 3.2.3 Whilst evidence of otter was not found during the survey, suitable habitat corridors and resting places exist within the Site, therefore the presence of otters could not be discounted. As such, otters pose a potential constraint that will need to be considered during the construction works.
