# Pear tree Hill Solar Farm

### Appendix 7.8: Aquatic Walkover Report

Prepared by **RSK** on behalf of RWE Renewables UK Solar and Storage LTD

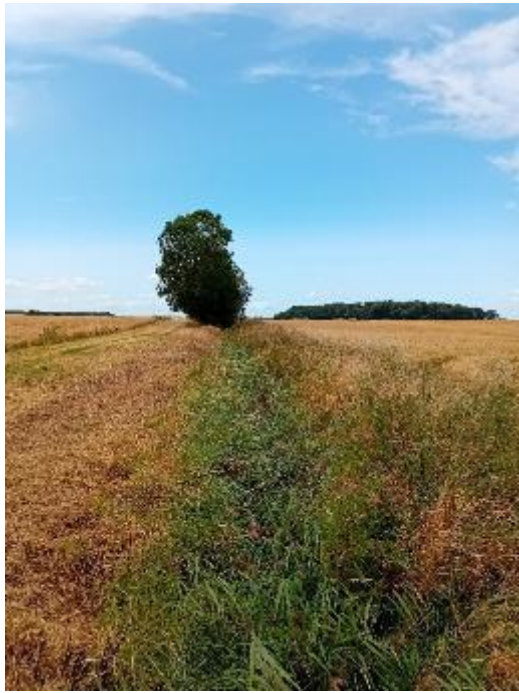
**Plate 1 – S01**

3.2.3 The S01 crossing point is located at the eastern extent of a drainage ditch close to the confluence, via a culvert, with a larger, unnamed ditch. The culvert was above the water level of the larger ditch at the time of surveying and as such connectivity (i.e. from rainfall or runoff) would be one-way from the S01 ditch into the unnamed ditch under surveyed water levels.

3.2.4 The S01 ditch was heavily overgrown and dry at the time of surveying. The larger unnamed ditch was wetted at the time of surveying with no perceptible flow. The water surface had c. 90% duckweed (*Lemna* sp.) coverage, with c. 10% emergent macrophyte coverage over a silt substrate.

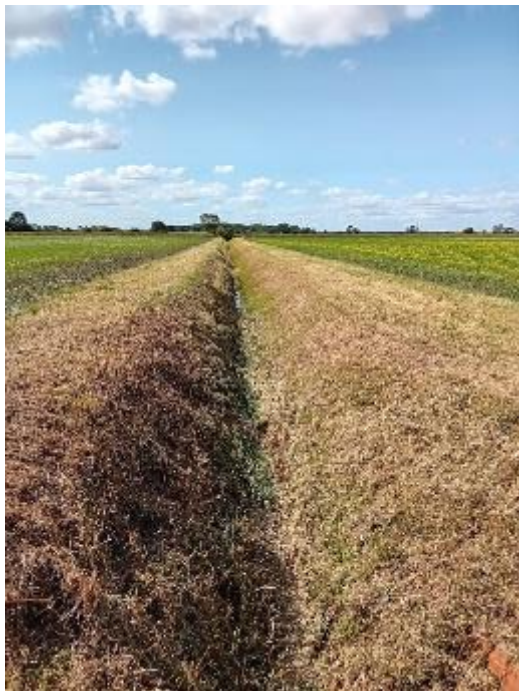
**Plate 3 – S03**

3.2.6 S03 is located at the eastern extent of a small drainage ditch close to the confluence, via an existing culvert, with a larger, unnamed ditch. S46 is located c.10m west of S03. The ditch was wetted with a water depth of < 0.1m, no perceptible flow and was heavily choked with vegetation. The banks had been strimmed recently and vegetation trimmings were present throughout the channel.

3.2.7 The larger connected ditch was wetted at the time of survey with no perceptible flow, with c.0.4m water depth, c. 40% duckweed coverage, c.40% emergent macrophyte coverage over a silt substrate. This culvert was above the water level of the larger ditch at the time of survey and as such connectivity (i.e. from rainfall or runoff) would be one-way from the S03 ditch into the unnamed ditch under surveyed water levels.

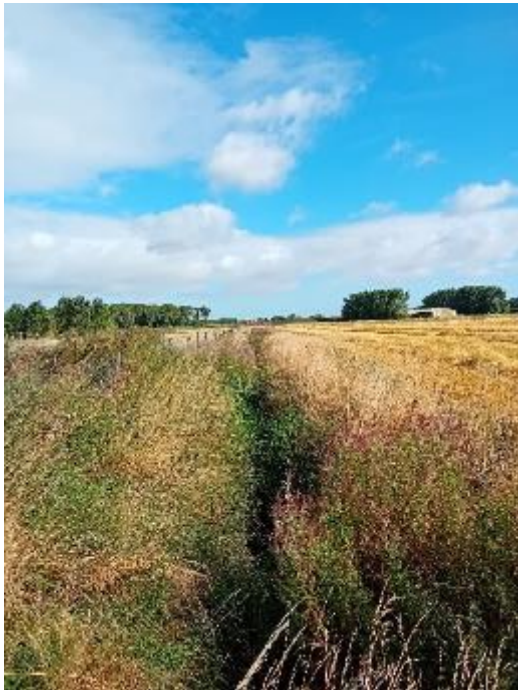
**Plate 9 – S09**

- 3.2.15 S09 is located on the same unnamed ditch as S08, which is approximately 380m southwest. The ditch was wetted with c.0.3 m deep water, no perceptible flow, dense duckweed (c. 40%) and emergent macrophyte (c.60%) cover and a silt / clay substrate.

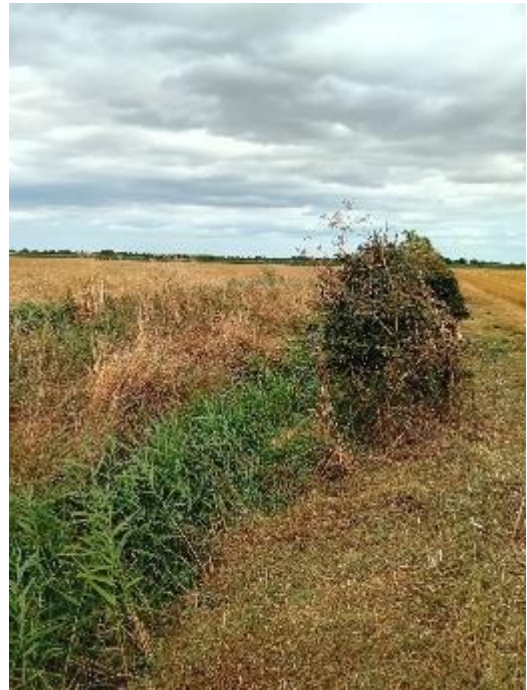
**Plate 10 – S10**

- 3.2.16 S10 is located on a short, unnamed ditch oriented east-west between the Meaux and Routh East Drain and Monk Dike. The ditch was wetted with no perceptible flow, c.0.2m deep water, c.40% duckweed, c.20% emergent

macrophyte coverage and a silt substrate. The channel and banks were densely overgrown with terrestrial vegetation.

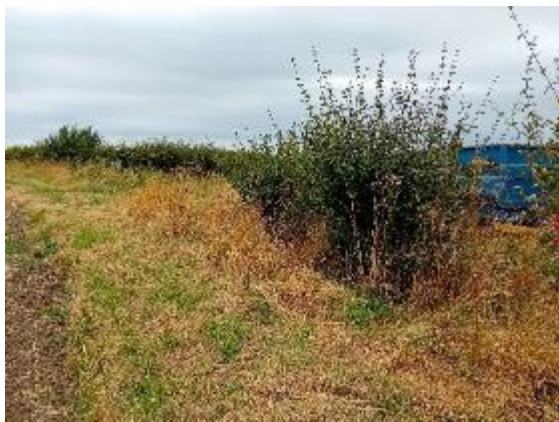
**Plate 19 – S20**

3.2.25 S20 is located on a shallow depression within a hedgerow and not a typical drainage ditch. The area was dry with no evidence of it being frequently wetted or ephemeral.

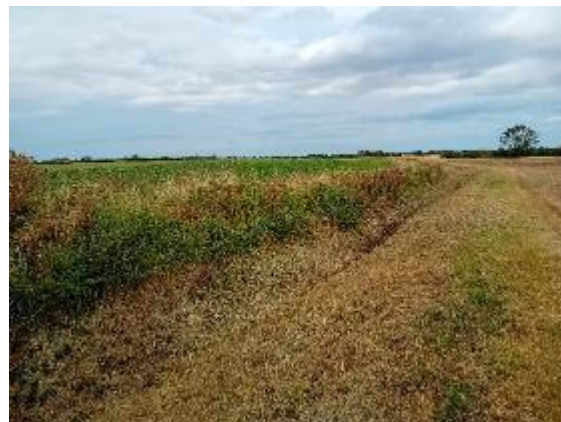
**Plate 20 – S21**

3.2.26 S21 is located on an unnamed ditch close to a confluence with the Routh and Meaux Road Drain. The ditch was largely dry with some areas of shallow (< 0.1m depth) ponded water. The channel was lined with terrestrial grasses and trimmings from recent bank strimming.

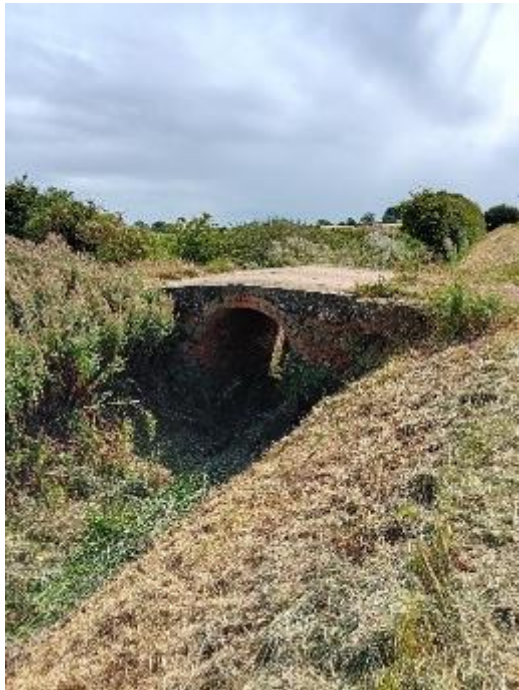
**Plate 37 – S37**

3.2.42 S37 is located on an unnamed ditch which was wetted at the time of survey with an area beneath the existing culvert drying out. South of the existing culvert no perceptible flow was observed, water depths were c.0.3m with c.45% emergent macrophyte coverage and a sparse covering of duckweed (c.5% coverage) recorded. To the north of the culvert water depths were shallow (c.0.1m) and dense stands of emergent macrophyte were recorded with an overall coverage of c.40%.

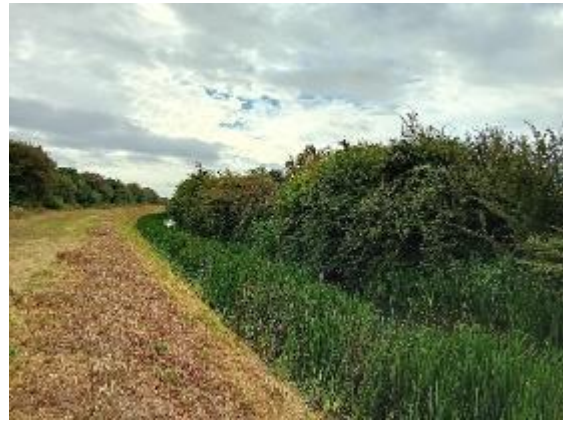
**Plate 50 – S49**

- 4.3.1 A single proposed HDD location is located on / beneath the Beverley and Barmston Drain (S49/WCPRUT 01). Habitat at the HDD location was likely suitable for a range of coarse fish species and European eel. This is corroborated by EA fisheries data records of pike, perch, roach and European eel c. 8.1km downstream of the proposed HDD location.
- 4.3.2 There are no records of lamprey within the drain, their absence likely attributable to the same factors present within the Holderness Drain catchment, namely a lack of suitable spawning habitat and a lack of connectivity to the River Hull and its potential spawning habitat.
