Rosefield Solar Farm

Volume 4
Appendix 7.9: Preliminary Aquatic Survey
Report (2023)

EN010158/APP/6.4
September 2025
Rosefield Energyfarm Limited

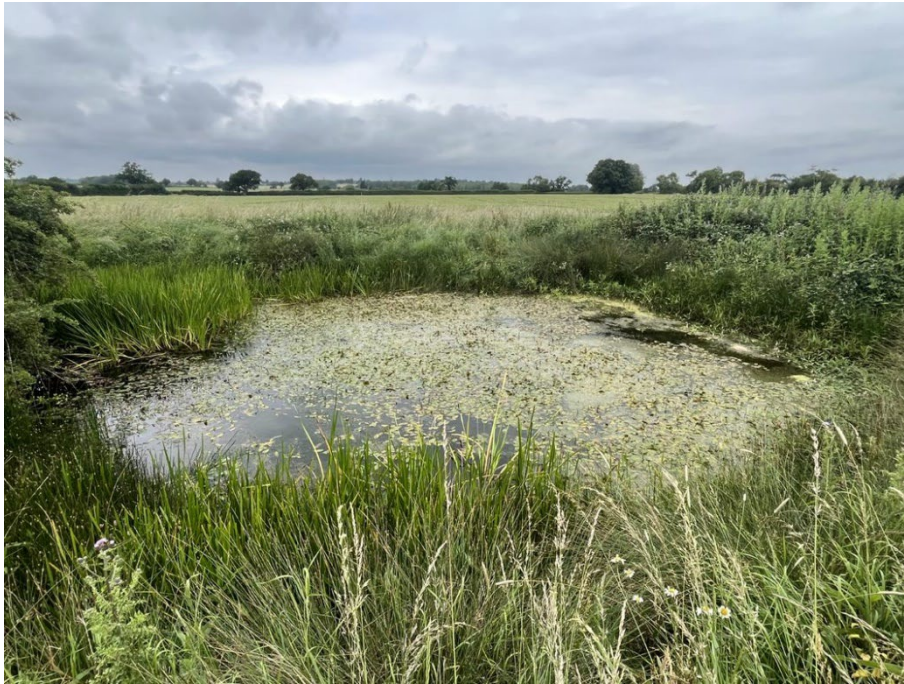
Plate 1 - Pond ID 10

3.1.2. The shallow ponds, including Pond ID 9 and 10 were stagnant and approximately 1 - 10cm in depth with broad floating, submerged and emergent linear leaved vegetation present. Some ponds were heavily poached and comprised of a silt clay layer, with herb and tall grass/scrub present on the bank tops.

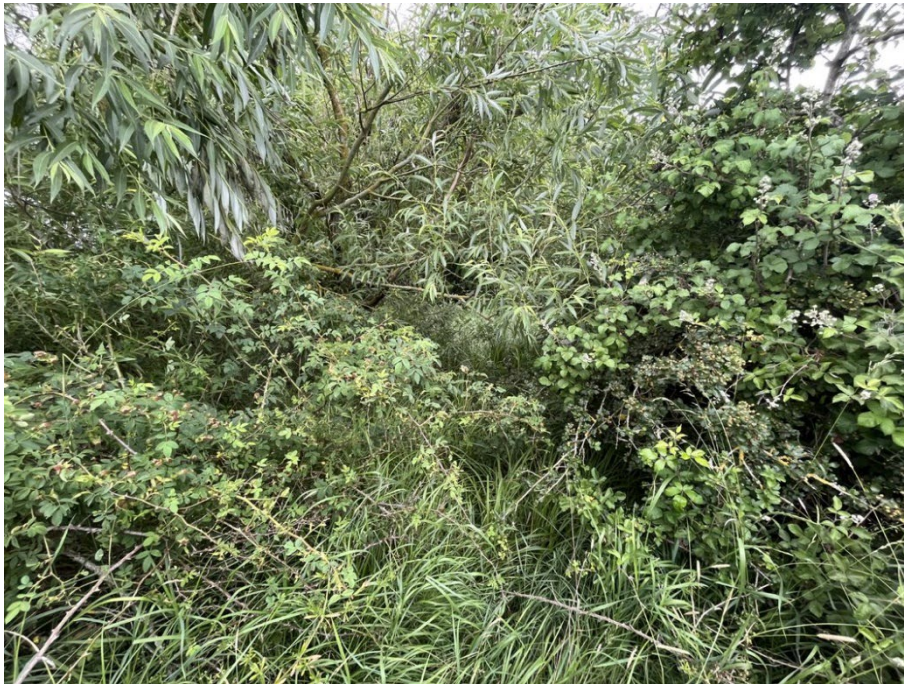
Plate 2 - Pond ID 18

3.1.3. The dry ephemeral ponds, including Pond ID 18 were densely overgrown with terrestrial vegetation including horse tail and dense scrub which caused the ponds to be completely shaded. These ponds were also bordered by woodland as well as arable and pasture fields.

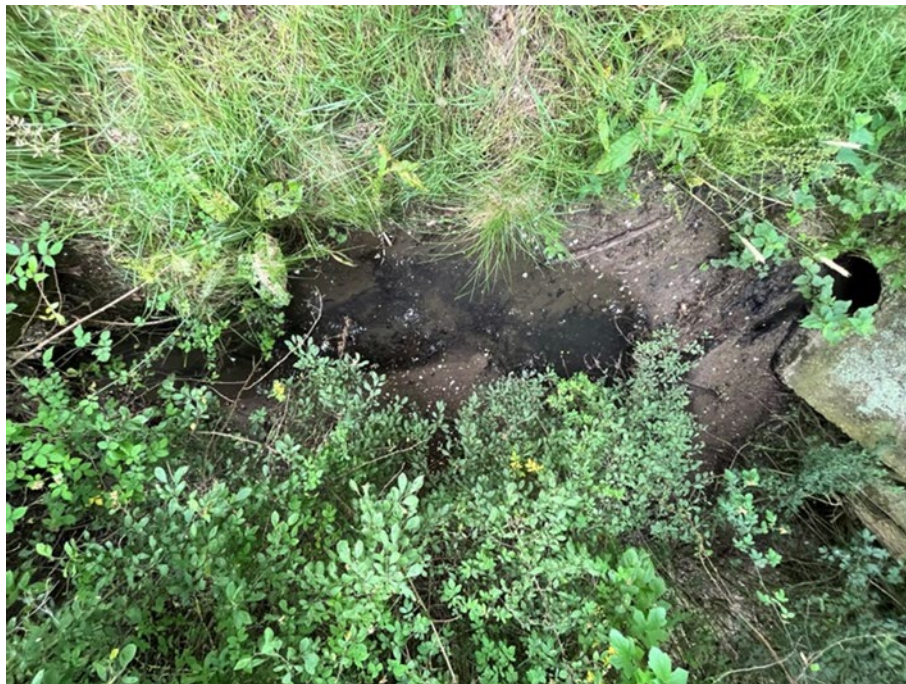
Plate 3 - Watercourse ID 3

- 3.1.6. The surveyed watercourse ID 11 in the north-west within the extended Site Boundary is situated behind newly erected 1.5m high fences.
- 3.1.7. Just north of the extended Site Boundary, Watercourse ID 3 was wet, with stagnant water and no perceptible flow. There was a culvert leading to the southern branch, and the channel width was less than 1m, with a depth of 5cm and a silt clay substrate. The banks were densely overgrown with scrub and trees, but there was no vegetation within the channel.

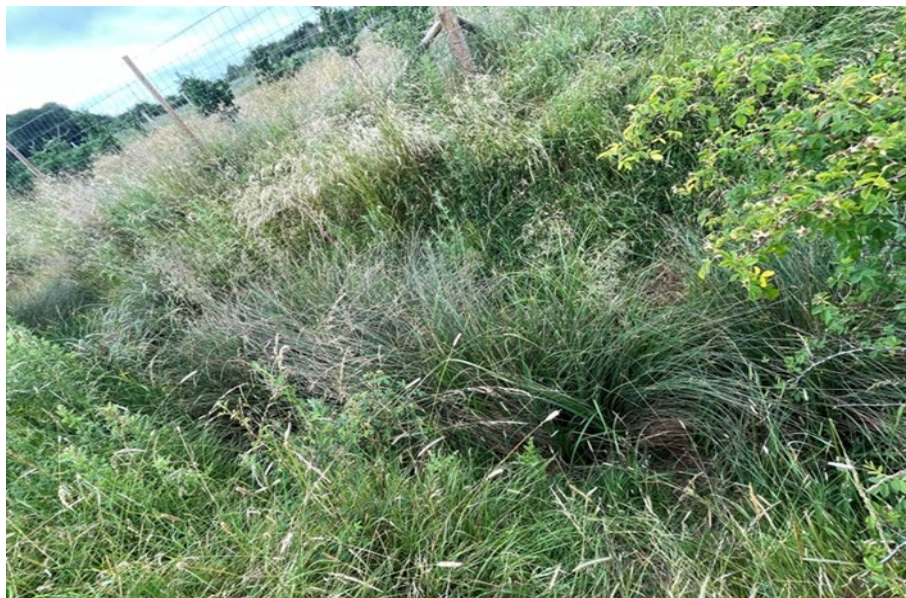
Plate 4 - Watercourse ID 15

- 3.1.8. Watercourse ID 15 running through the middle of Parcel 1 was a dry ephemeral ditch located in between arable and pasture fields, with terrestrial vegetation present within the channel. The ditch was choked with dense herbs, tall grass, and scrubs on both banks. In the southern section of the ditch, there was a small amount of stagnant water, approximately 1cm deep, leading to a pond.

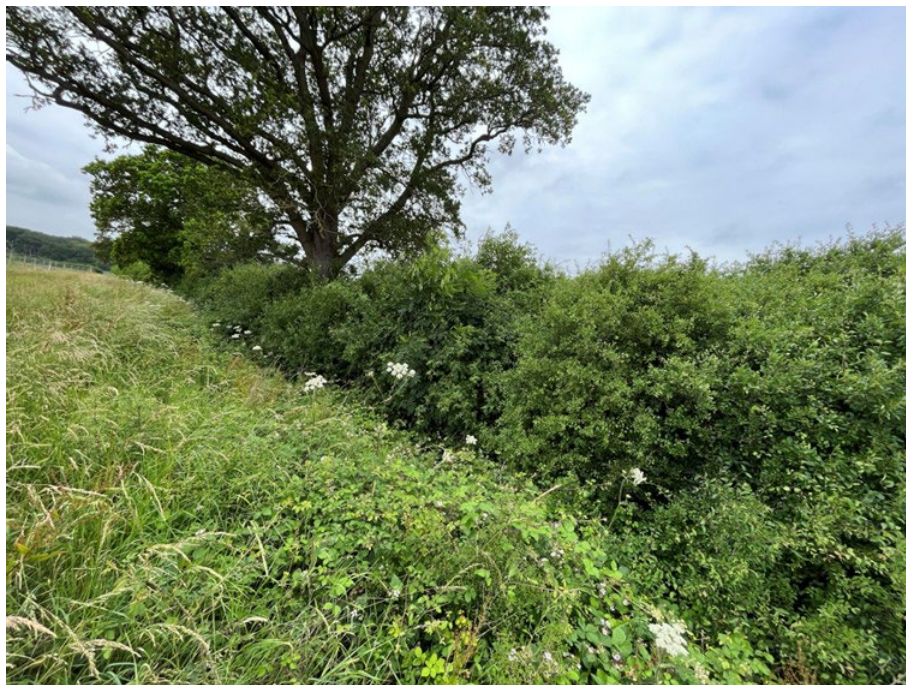
Plate 5 - Watercourse ID 24

- 3.2.1. The majority of Parcel 1a is made up of arable and pasture fields, bordered by hedgerows. See **Figure 2 (Annex A)** for the location of Watercourses and Pond IDs at Parcel 1a.
- 3.2.2. Parcel 1a comprised of only one pond, Pond ID 39 which was dry and densely covered with terrestrial vegetation. The pond had an earth substrate and was completely shaded by vegetation and surrounding trees.
- 3.2.3. Parcel 1a contained only one ephemeral watercourse, Watercourse ID 23-25 which runs along the northern boundary of the extended Site Boundary. At the time of the survey, the watercourse was dry, densely surrounded by scrub and terrestrial vegetation in the channel, causing it to become choked and overgrown.

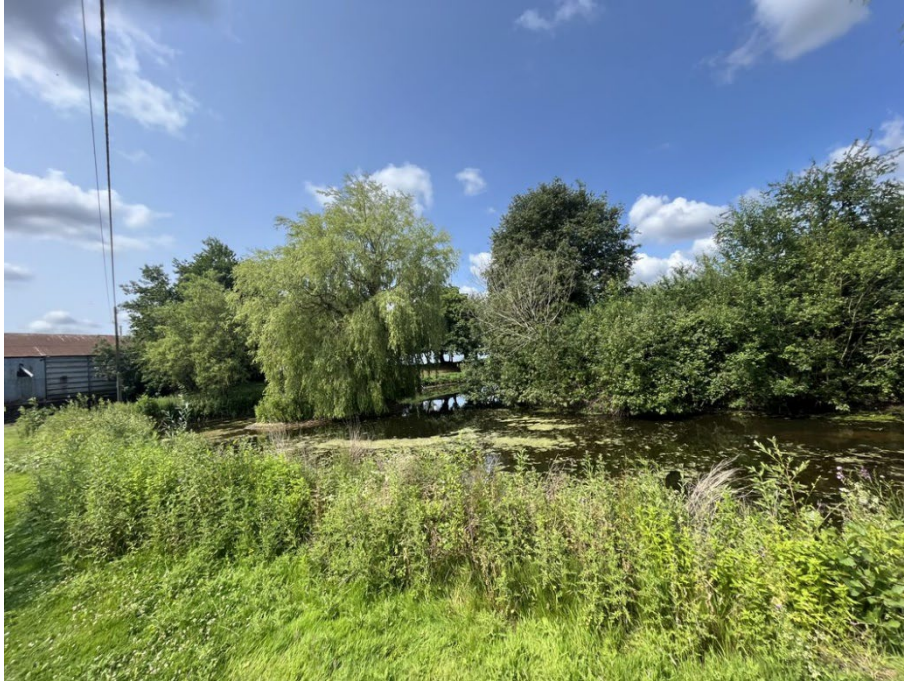
Plate 6 - Pond ID 4

- 3.3.1. The majority of Parcel 2 is made up of arable land, with pasture fields present in the south of Parcel 2, bordered by hedgerows along with small areas of scrub and woodlands. See **Figure 2 (Annex A)** for the location of Watercourses and Pond IDs at Parcel 2.
- 3.3.2. Along the northern extended Site Boundary lie two large ponds, Pond 4 north of the boundary and Pond 68 to the south. Both are surrounded by agricultural land and a residential farmhouse. The ponds were 20 – 30cm in depth and consist of gravel, sand, and silt substrate. Both ponds

contained an island in the middle, fringed with riparian vegetation which resulted in low to moderate shading. Bankside trees, tall herb and short, maintained grasses surround the pond. Pond 68 also contained free-floating algal. The ponds were possibly ground water fed with low turbidity, with waterfowl also present.

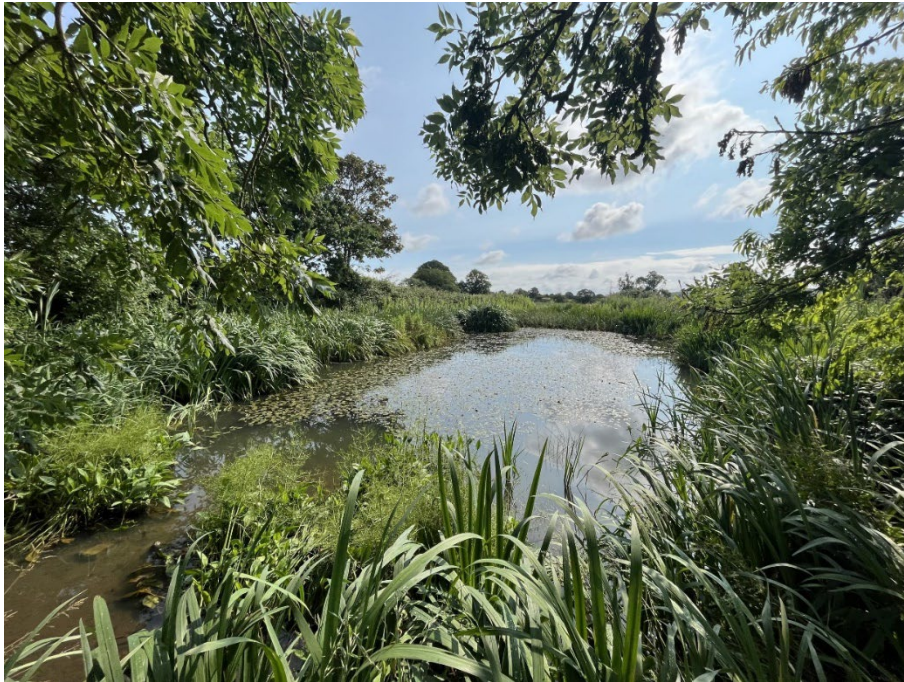
Plate 8 - Pond ID 6

- 3.3.3. Along the east boundary lies another large pond, Pond 6. The pond appeared to have a high level of silt substrate present and a depth greater than 30cm. Within the pond, floating broadleaved and emergent linear plants were present. The vegetation along the banks included dense tall herbs, grasses, trees, and scrub, resulting in high shading. The pond is surrounded by agricultural land and seems to form a series of interconnected ponds through culverts leading to a ditch. Additionally, there is a nearby broad-leaved woodland.

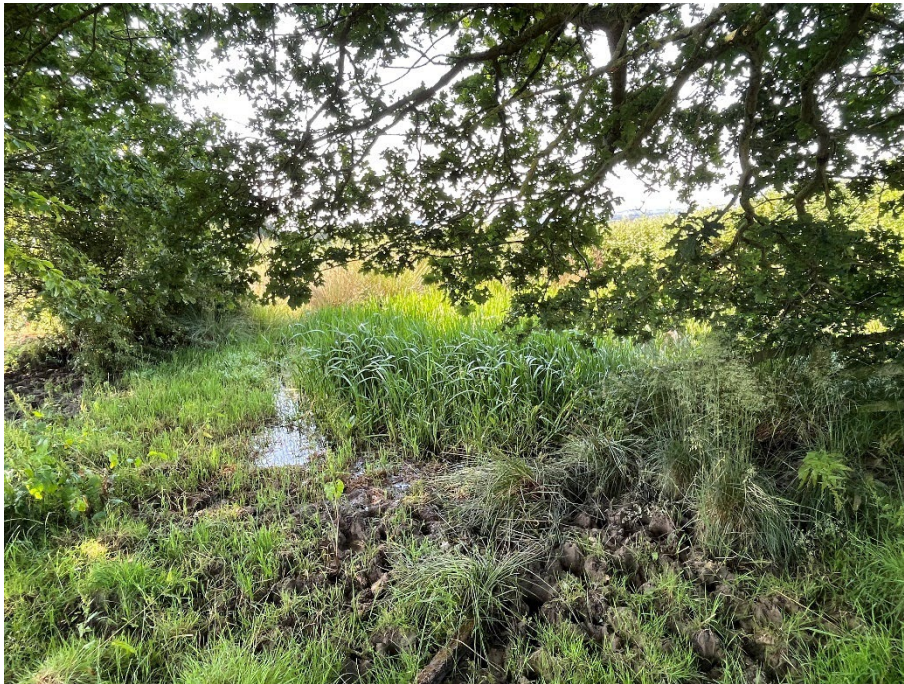
Plate 9- Pond ID 61

- 3.3.4. Pond ID 62 lies in along the east boundary of Parcel 2. It has shall margins <10 cm but is deeper in the middle with emergent linear-leaved, broad-leaved and rooted broad-leaved present. The pond is surrounded by trees, tall herbs, scrub and grass with low shading on the pond. Pond ID 61 lies in the southern section of Parcel 2, has a depth of > 15cm and is choked with emergent linear vegetation. The pond is surrounded by agricultural land and is heavily poached. The pond is surrounded by dense tall herbs, grasses, trees and scrub which inhibits safe access.

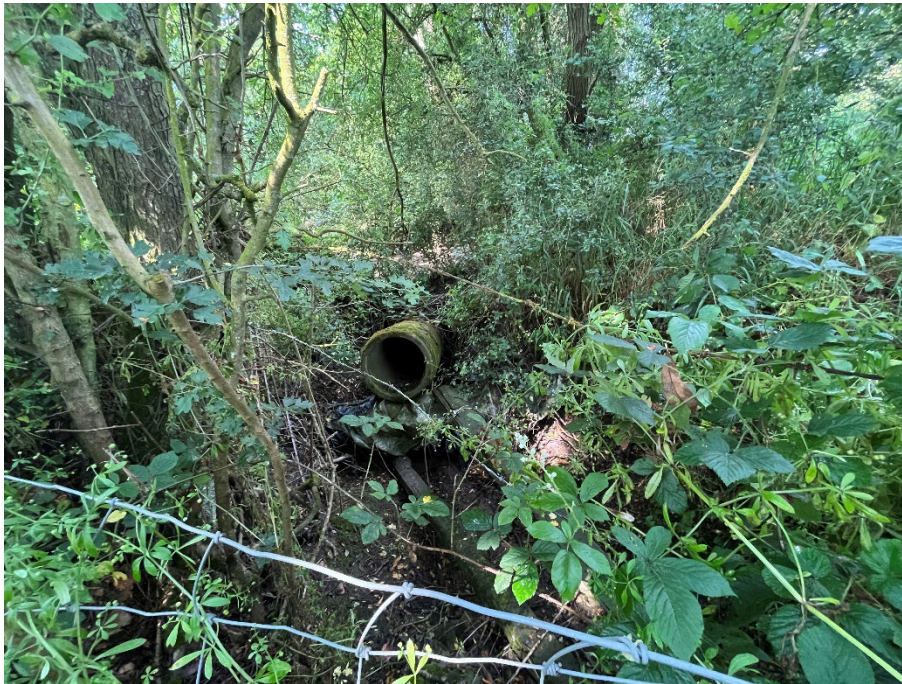
Plate 10 - Watercourse ID 36

- 3.3.5. Pond 5 also lies in the southern section of Parcel 2. It is a large pond with emergent linear, submerged fine-leaved and broad-leaved vegetation present. It is > 20cm in depth and is bordered by tall herbs, grasses, trees and scrubs which create moderate shading. This pond is connected to two in/outlet ditches and is suitable for invertebrates only.
- 3.3.6. Watercourse ID 36 lies along the eastern boundary of Parcel 2 which is an ephemeral ditch with stagnant water ponding near the road bridge. This area is surrounded by agricultural land and features dense trees and scrubs, but vegetation was lacking from within the channel itself. The substrate in this watercourse consisted of earth and silt.

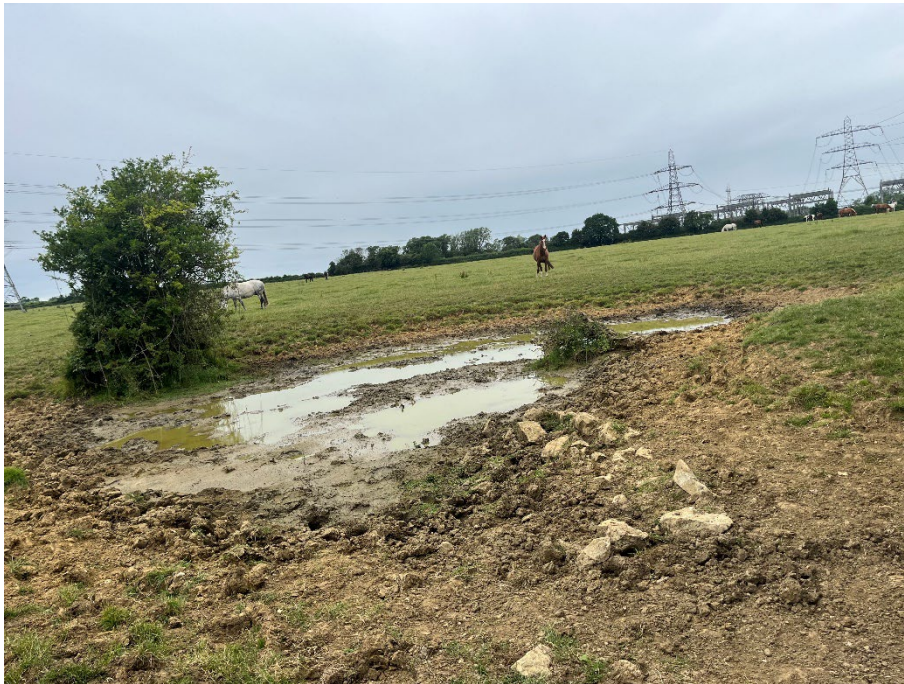
Plate 11 - Pond 8

- 3.4.1. The majority of Parcel 3 is made up of arable land in the south and pasture fields in the north, bordered by hedgerows along with small areas of scrub and woodland. See **Figure 2 (Annex A)** for the location of Watercourses and Pond IDs at Parcel 3.
- 3.4.2. Parcel 3 only consists of three waterbodies. Note that Pond ID 80 could not be accessed due to barbed wire fencing. Pond ID 76 lies along the southern boundary and was shallow with silt and clay substrate with long linear-leaved and free-floating broad-leaved vegetation was present.
- 3.4.3. Pond ID 8, located along the south-east extended Site Boundary, was a small, possibly ephemeral, stagnant pool heavily poached by horses.

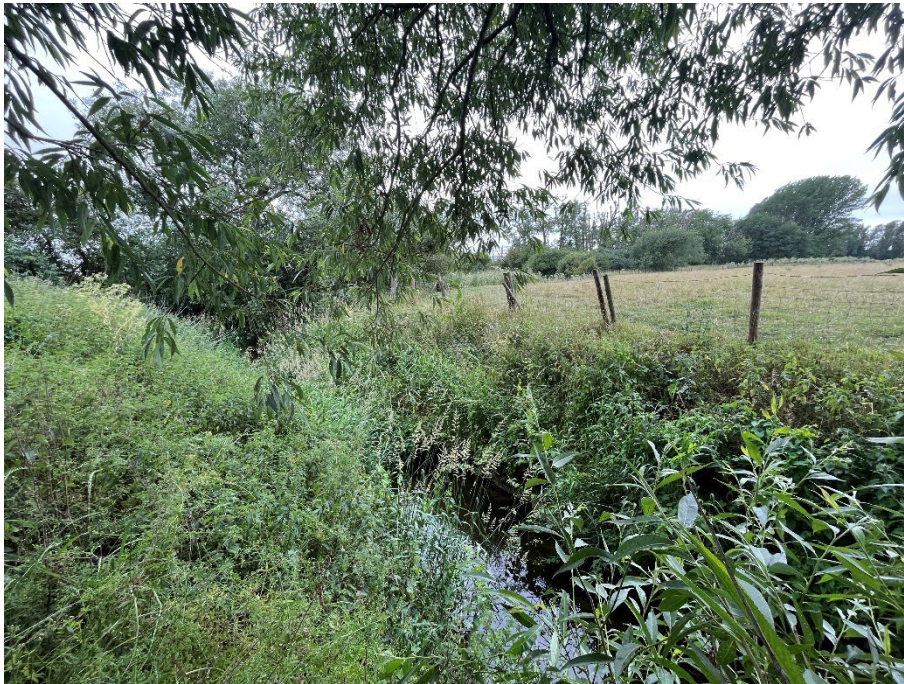
Plate 12 - Watercourse ID 48, northern end

- 3.4.5. Opposite the tributary (trib 26500), the channel is 1.5 – 3m wide, with no perceptible flow, and a substrate of clay, silt, and some gravel/pebble. The area around the bridge was accessible, but elsewhere the channel was heavily vegetated and inaccessible with c. 2m high, vertical banks. The northernmost upper branch was flowing and comprised of a glide and riffle with gravel substrate and no in-channel vegetation. Both banks are steep and over 3m high. The north-west branch of the watercourse had steep banks and was wetted but choked with vegetation leading to a lack of perceptible flow. Several ditches branch off this channel and were dry.

- 4.1.1. Overall, there were only small sections of flowing watercourses. Notably, the northern section of Watercourse 48 in Parcel 3, but almost all of the other ditches on Site provided low to negligible opportunities for fish and invertebrates as they were dry and/or choked up with vegetation.

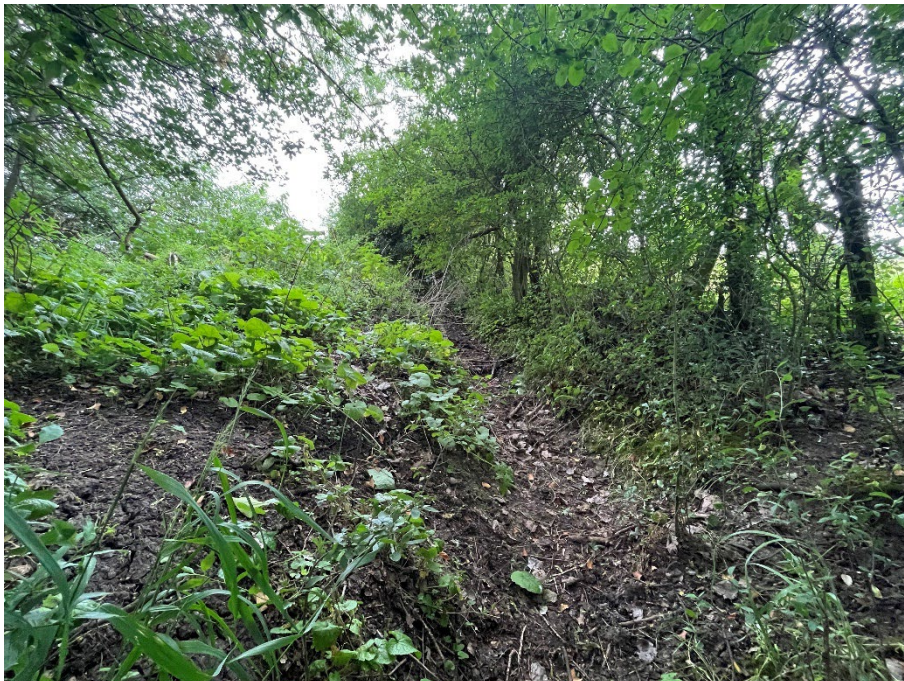
Plate 13 - Watercourse ID 48, southern end

- 3.4.4. Watercourse ID 48 lies along the northern and north eastern border of Parcel 3. It consists of a dry ephemeral ditch at the southern end and becomes a stagnant wet ditch with 5cm depth and a silt/clay substrate at the northern end. The channel was choked with terrestrial and aquatic vegetation, and both banks had poor access due to the dense woodland scrub and steep bank.
