One Earth Solar Farm

Appendix 6.11: Fish Habitat Baseline

Document Reference: EN010159/APP/6.21

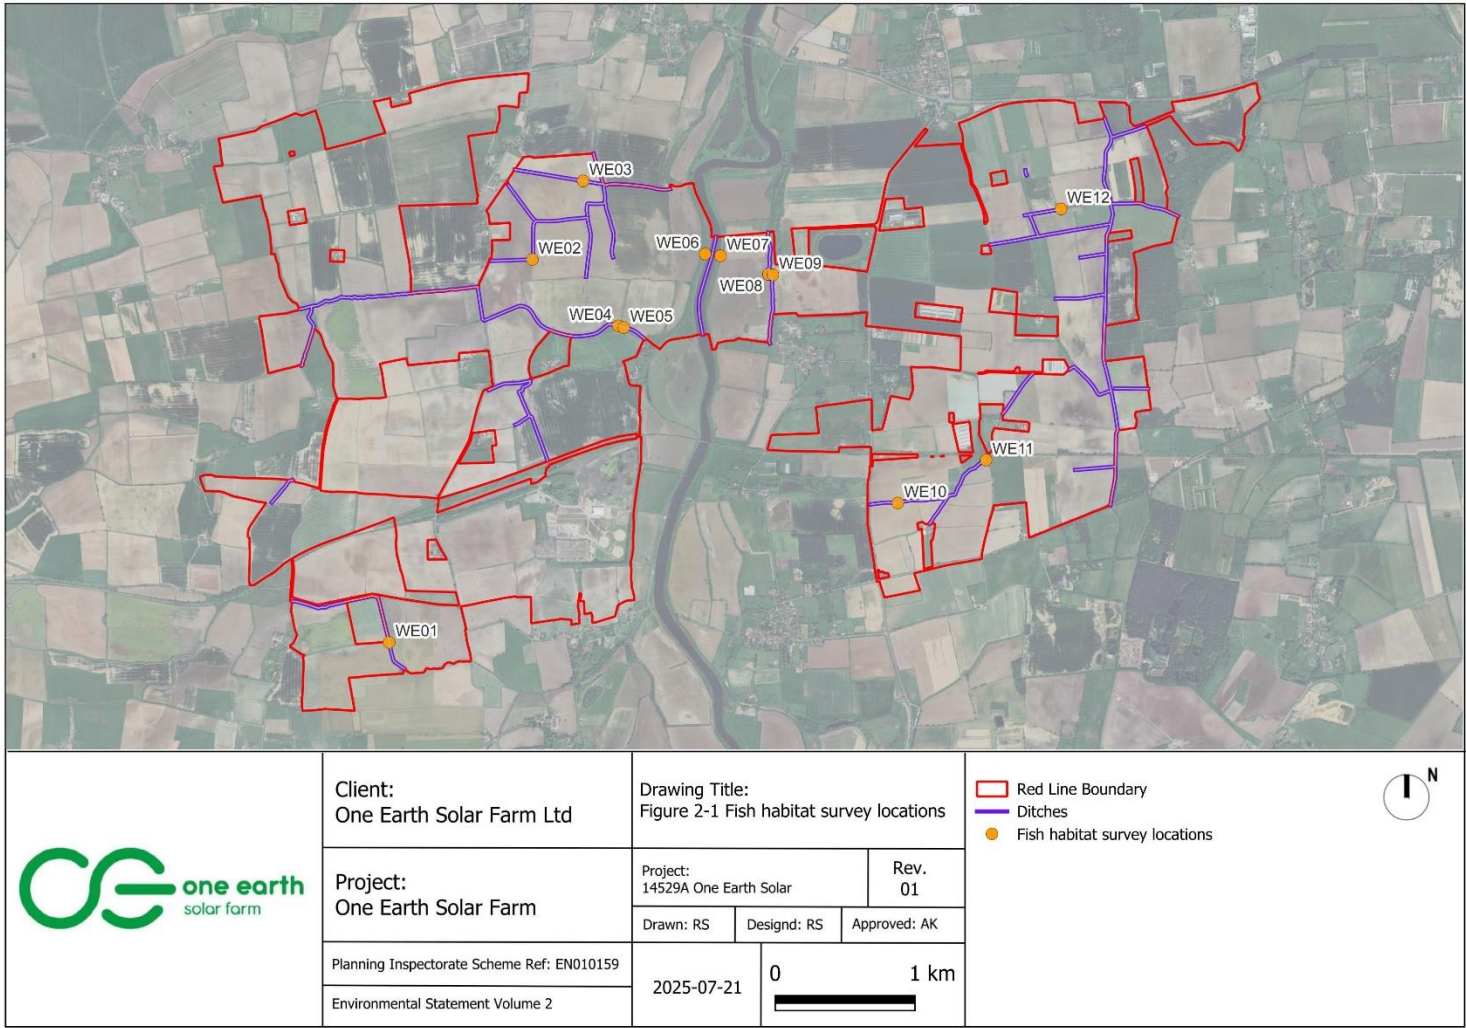
Figure 1: Survey locations

- A.6.2.1. A review of satellite imagery and Ordnance Survey mapping was made by a specialist fresh water ecologist. Each location was visited twice on the 25th February 2025 and again on 9th June 2025. Locations were visited twice to account for differences in water levels and flow at different times of year.
