Norwell Solar Farm Steering Group

**Application by Elements Green Trent Limited for an Order Granting
Development Consent for the Great North**

Road Solar and Biodiversity Park (GNR Project)– project ref. EN010162

Deadline 3. Written Summary of Oral Submissions ISH/3

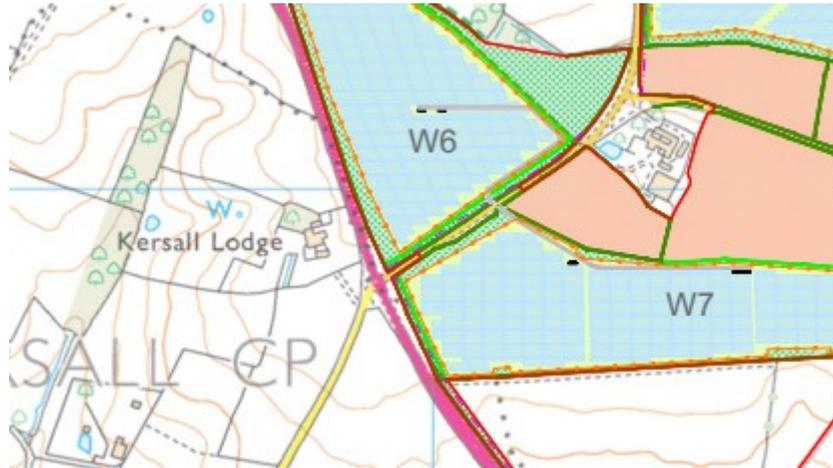
- 2.2 The map pin is coloured blue signifying that it has a Habitat Suitability Index rating as Excellent for GCN, though on the day of the survey of the pond, it tested negative for GCN DNA.
- 2.3 In terms of how this location is to be affected by the development, the below graphic is taken from the Applicant's Masterplan, demonstrating its proximity to planned panelling.

- 2.4 The location of the pond is shown as a faint light blue circle. It is the proposed development on field W7 above that is a cause for concern. The pond is pictured below:

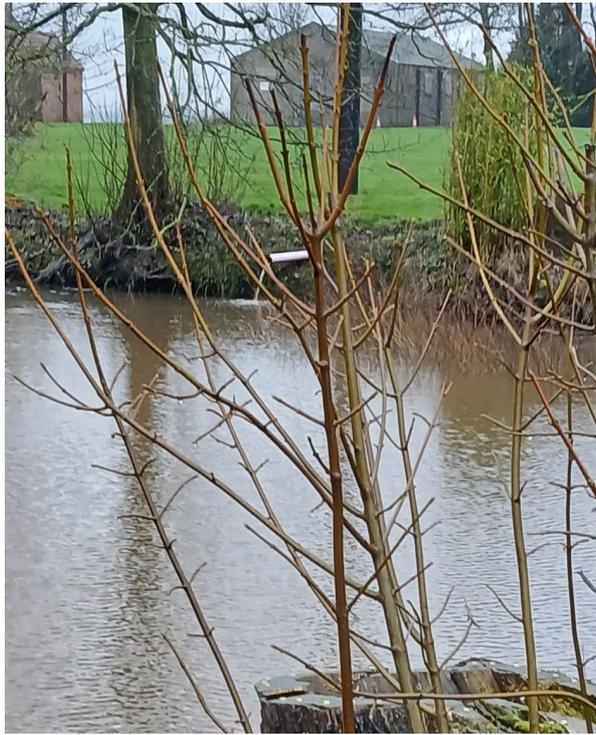
- 2.5 This pond is fed by an underground pipe which draws from a natural spring in field W7. Below is pictured the pipe discharging into the pond;

- 2.6 The pipe outlet end is a relatively recent replacement but the original underground pipe underneath the two fields leading to the spring is over 100 years old. The owner of this property is aware of the rough location of the underground horseshoe clay pipe underneath the fields to the south, with this information having been handed down over the generations. Below is a graphic taken from Technical Appendix A11.5: Phase 2 Geophysics Results - Part 3 of 5 [APP-260](#)

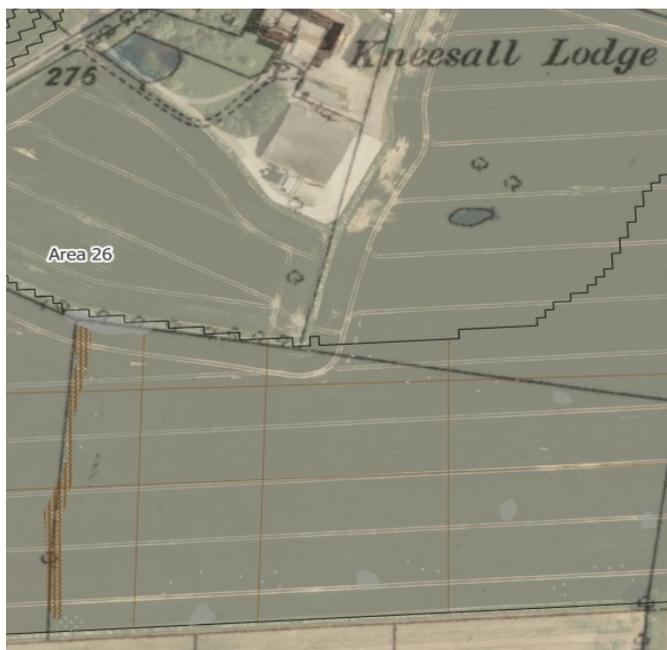
- 2.7 The geophysical survey identified a feature which was deemed to be an agricultural disturbance, as signified by the brown shading above, running north to south. The line roughly corresponds with where the pond landowner has always believed to be the location of the underground pipe. The geophysical results did not recognise it as a service pipe: in fact, the results failed to identify any pipe heading north to the pond. It is also worthy of note that this line, if continued through the next field in a straight line, would lead directly to the pond.

- 2.8 The concern is that the panel mounting structures in field W7 will be pile driven into the ground, below which is this pipe. Being as this field is one of the highest and most exposed in the development, the panels here will have to be anchored deeply.

- 2.9 The northern boundary of field W7 will have deer fence posts anchored in concrete buried in the ground. The clear concern here is that either of the above two ground penetrations could inadvertently fracture this pipe and cease the feed to the pond, leading to a long term deterioration in that feature, with an associated adverse impact on this wildlife habitat.

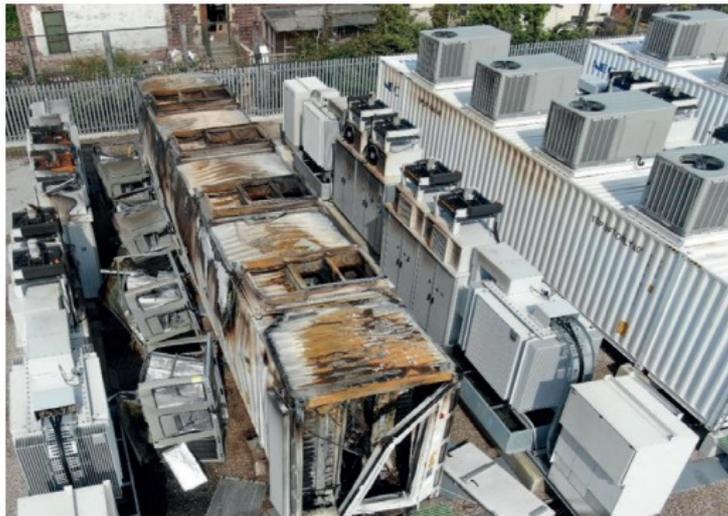
(a) 15th September 2020 Carnegie Road Liverpool

Thought to be first major lithium-ion battery storage incident in the country, firefighters had to be deployed for 58 hours. There is no exact calculation as to how much water was needed to fight that fire but several sources state it was in the millions of litres, possibly over 5 million. A post Incident presentation² has been published by Merseyside Fire and Rescue Service. There was hydrogen fluoride and hydrochloric acid in the water run off and smoke plume.

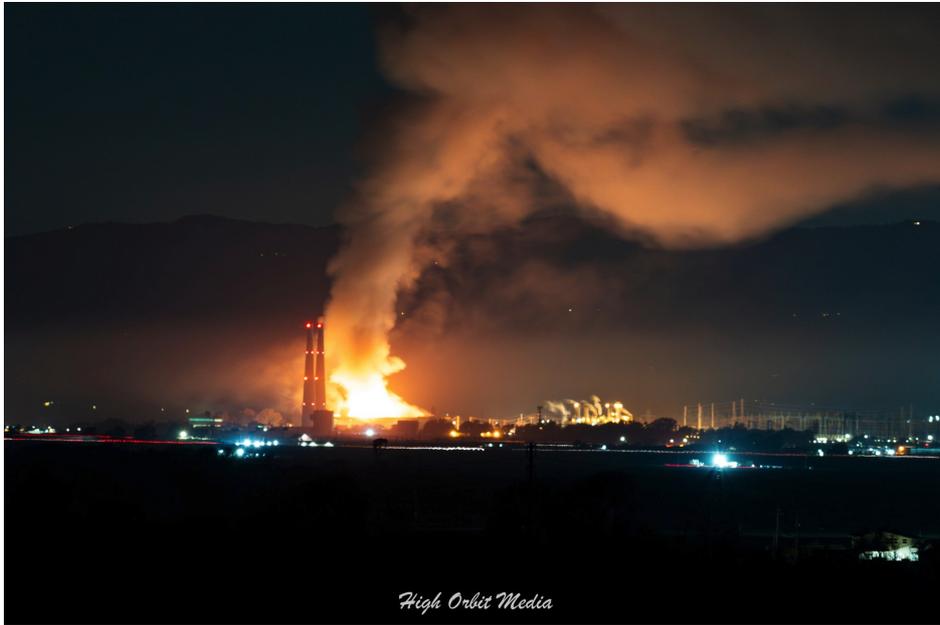
(d) 16th January 2025, Moss Landing. Monterey California.

In their suite of post incident reports³, the US Environmental Protection Agency responders reported that they had to remove

586,300 gallons of water from the site (2.6 million litres). To put that into context, the volume of water is roughly equivalent to the amount of water in an Olympic-sized swimming pool. That fire burned for from 16th to 18th January 2025.

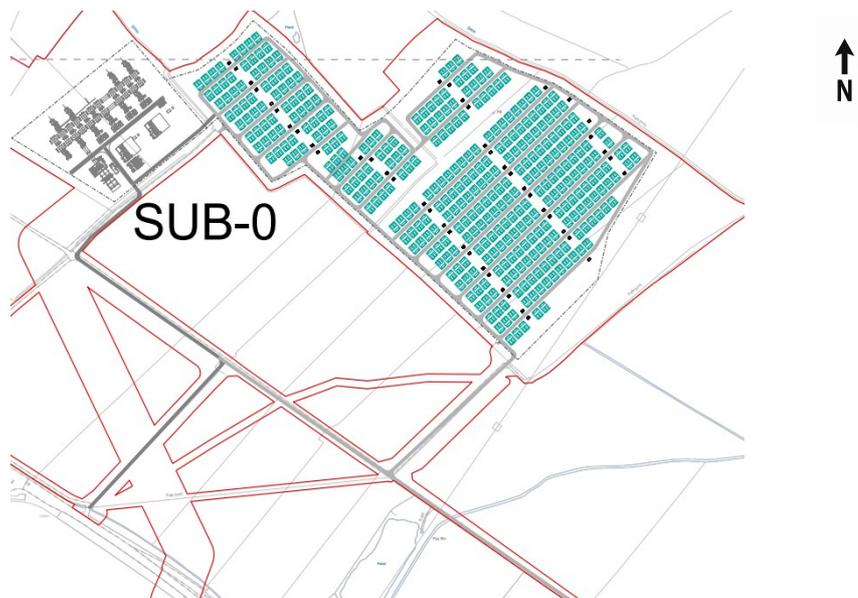
5.1 The following graphic has been taken from 2.10 Illustrative Design [APP-029](#):

- 5.2 It is clear that revised plans must show the location of any holding pond. More importantly, it will hopefully demonstrate the access plans for tankers which are often articulated HGVs. At the moment, the only tarmac access to the site is in the west.

- 5.5 Perhaps more importantly, there is a need at this stage for the Applicant to explain how contaminated fire-water from, for example, the most northern battery area in the above plan will make its way to any pond, as opposed to soak into the ground and eventually the water table. There is mention of pumping but how and by whom is not
