Connah's Quay Low Carbon Power

Geomorphological Walkover Survey Report

Document Reference: EN010166/9.12

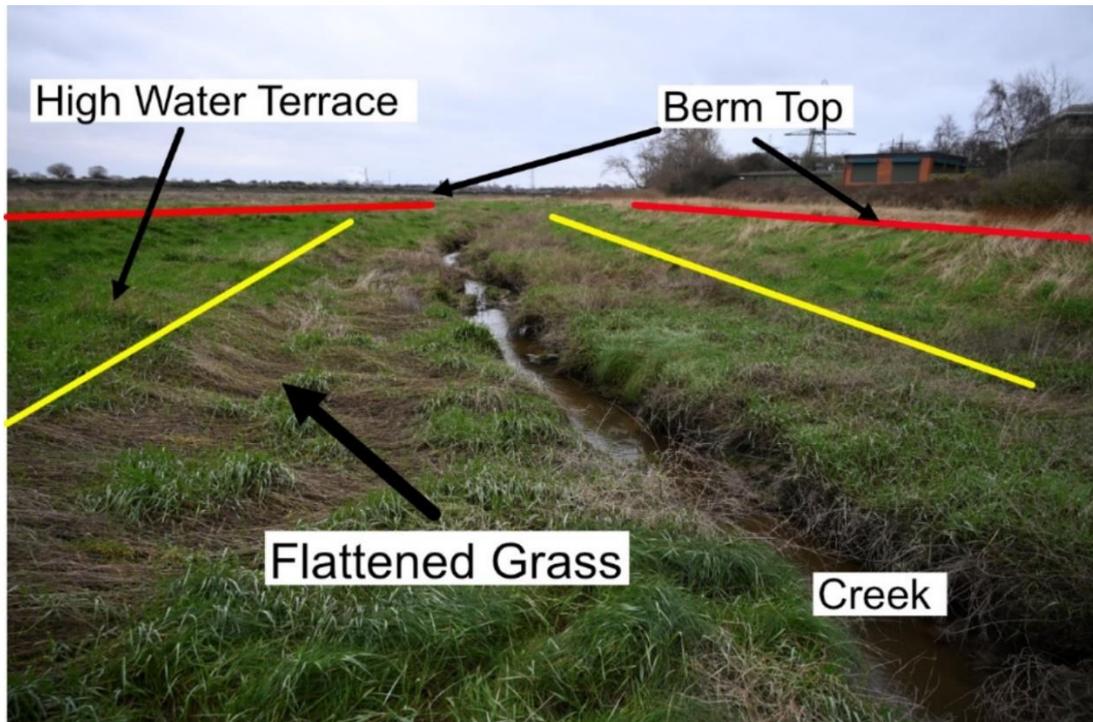
- 3.1.1 During the geomorphological walkover survey it was evident that the majority of erosion active within the saltmarsh drainage basin is as a result of tidal ingress and subsequent drainage back into Old Rockcliffe Brook (hereafter referred to as the creek) (see **Plate 1**) and River Dee.
- 3.1.2 The tidal influence has been observed to extend up to the existing surface water outfall associated with the existing Connah's Quay Power Station. Evidence was present to determine that water levels regularly reach the level of the creek top at the location of the existing outfall headwall. Additionally, there is evidence of tidal ingress during higher astronomical tides that extend to within 0.4 m of the top of existing berm tops within the saltmarsh drainage basin as shown in **Plate 1** and **Plate 2**.

Plate 1 Photograph showing the saltmarsh creek (the Existing Surface Water Outfall is 5 m behind), the top of the corridor berm, high water terrace and drainage flattened grasses above the narrow creek

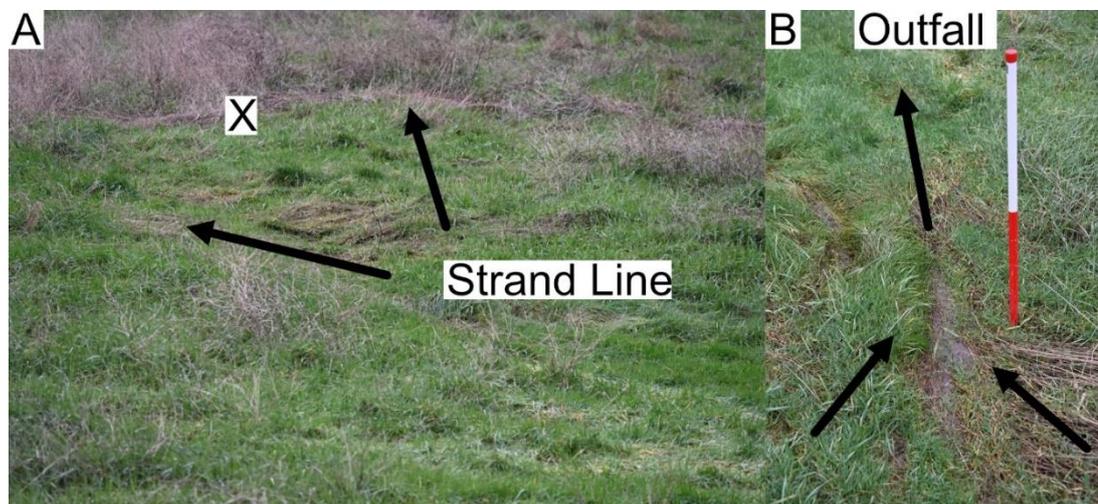
Plate 2 Photos of the high water strand line (X) and flattened and orientated vegetation towards the outfall in Basin 1

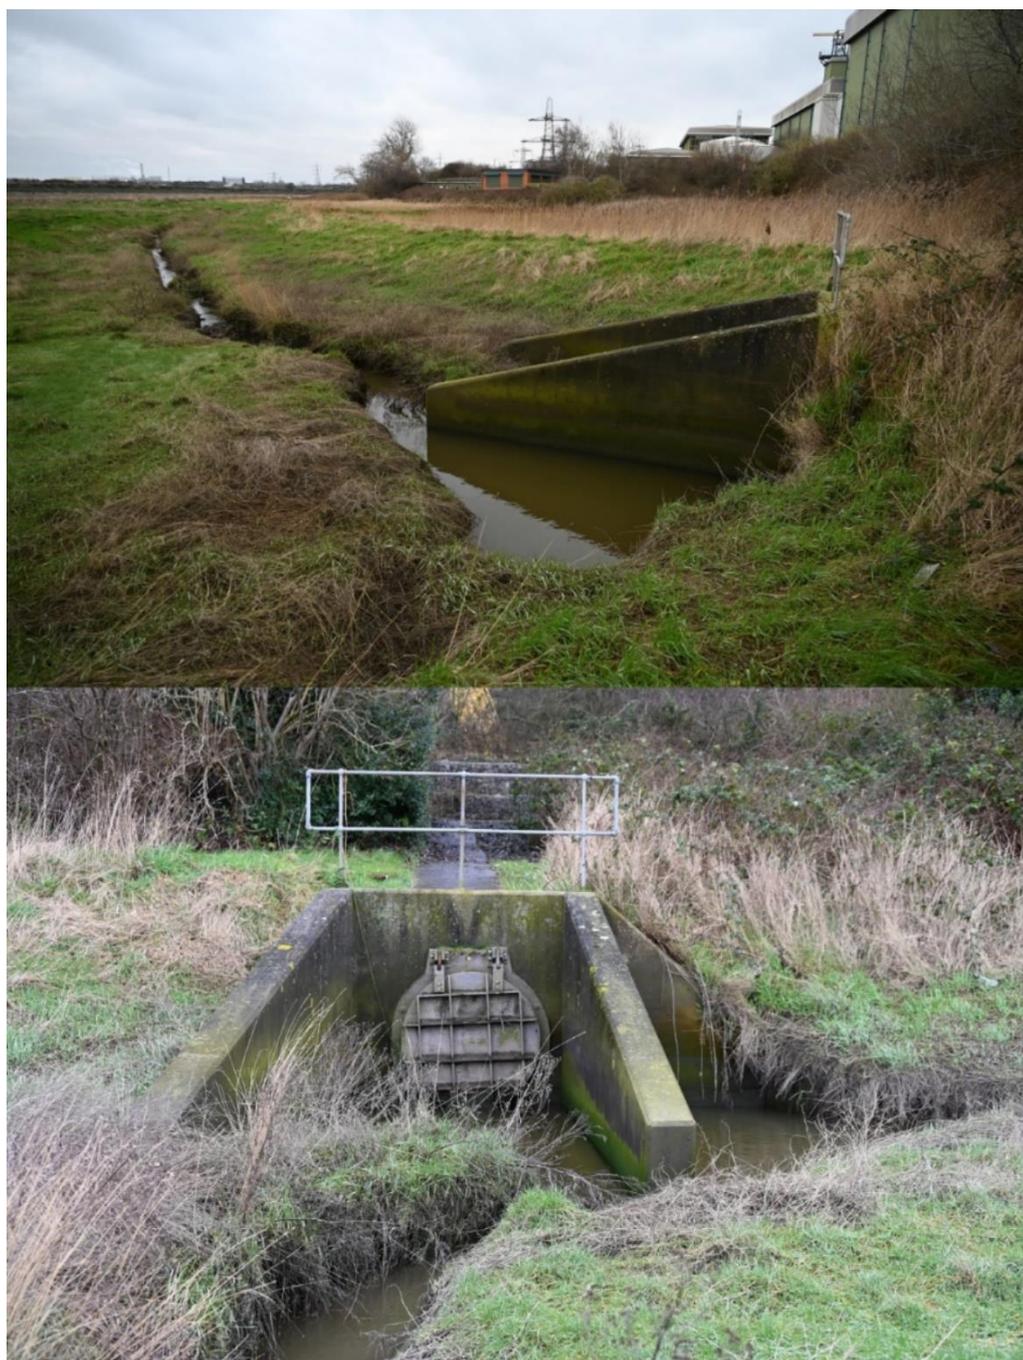
3.1.3 Immediately adjacent to the Existing Surface Water Outfall there is evidence of saltmarsh development in the mouth of the outfall, indicating that the existing discharge rates are not high enough to prevent the accumulation of sedimentary material and vegetation. Additionally, there is a region of scour adjacent to the outfall structure (to the north of the outfall apron) that has a likely origin in the combination of outfall discharge and tidal ingress creating a vortex with enough energy to bowl out the area over significant time.

Plate 3 Photographs showing the culvert emplacement at the source of the saltmarsh creek, including flap valve and erosion bowl to one side
