## Connah's Quay Low Carbon Power

# Environmental Statement Volume IV Appendix 15-G: Arboricultural Impact Assessment Report [\(Tracked\)](#)

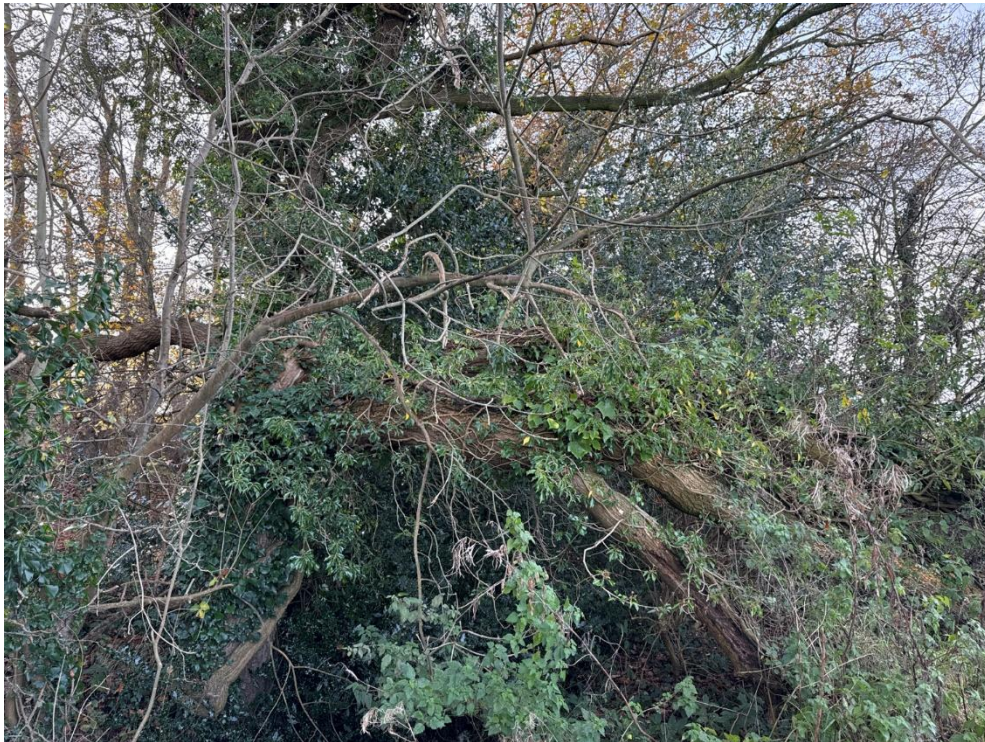
**Photograph 3 A veteran common oak (T13) located at the northern end of the ancient woodland. Partially collapsed towards the Construction and Operation Area with significant decay in collapsed sections.**

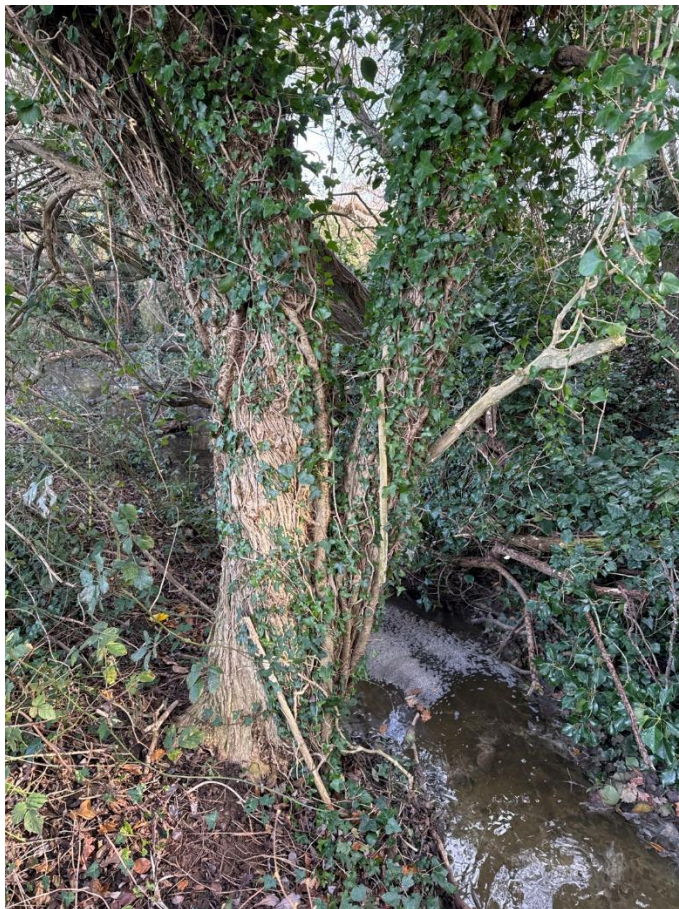
**Photograph 4 T22 an ancient elder located adjacent to a stream.**

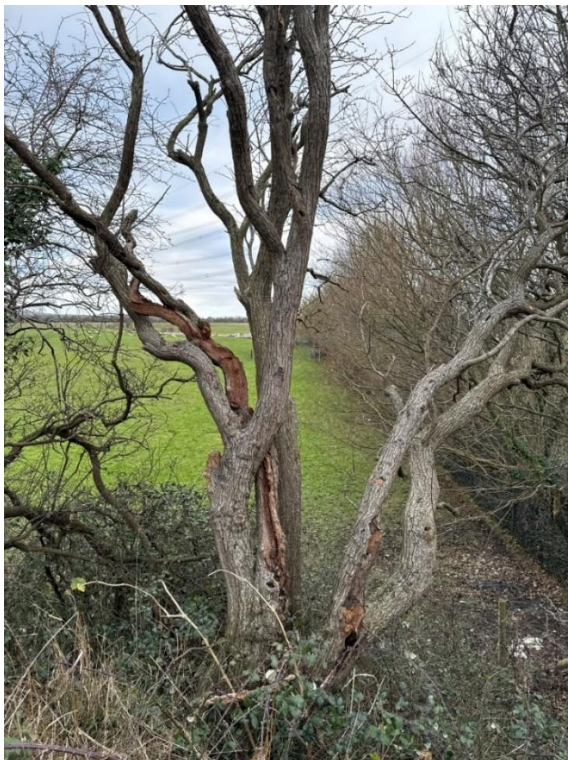
**Photograph 6 Mature hawthorn (T77) considered to be veteran due to the significant decay in two of three stems.**

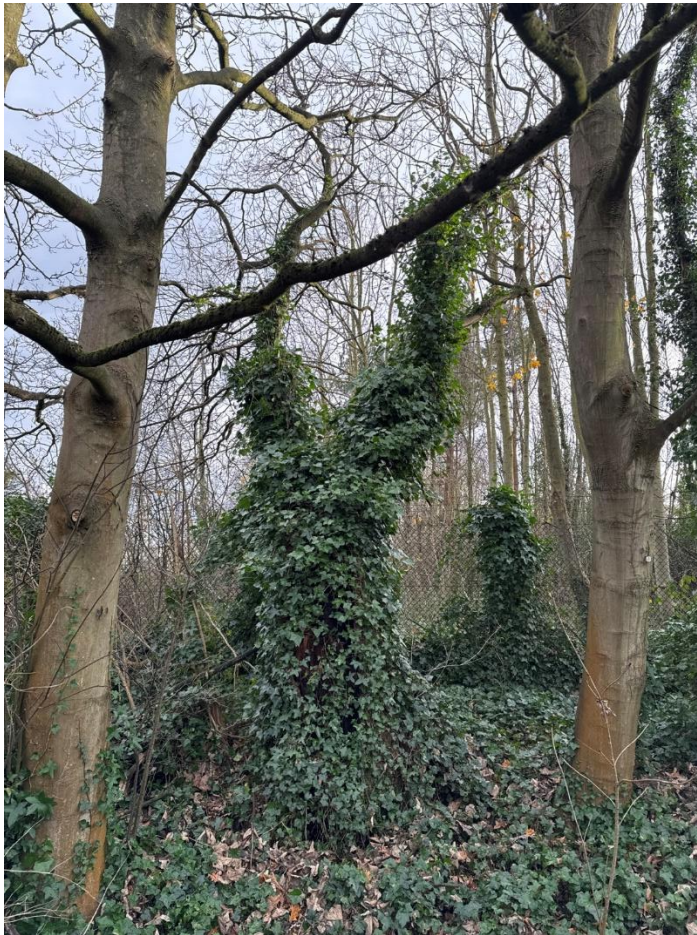
**Photograph 7 Mature veteran oak (T123).**

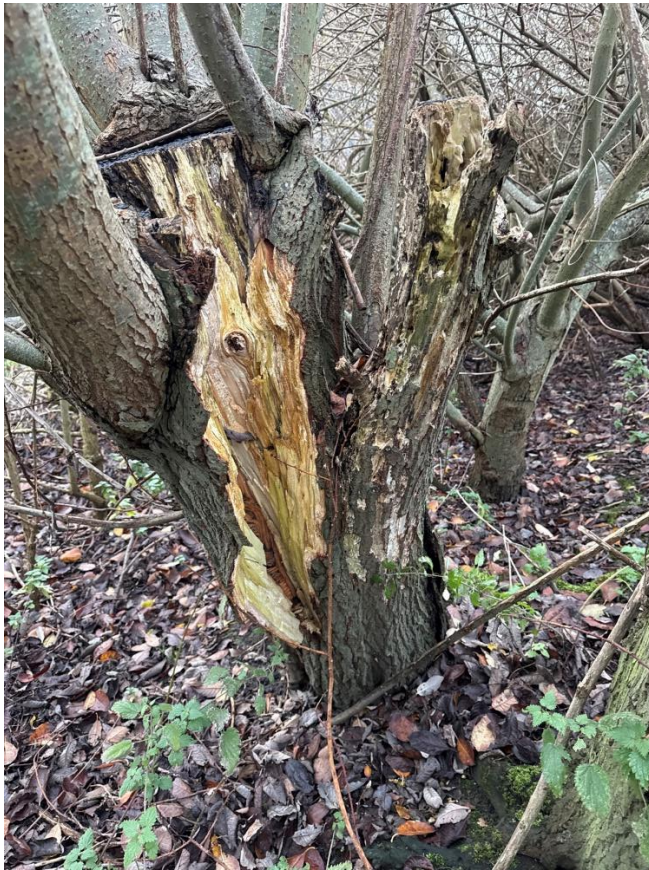
**Photograph 11 A mature, veteran goat willow (T272) with significant decay to its main bole.**

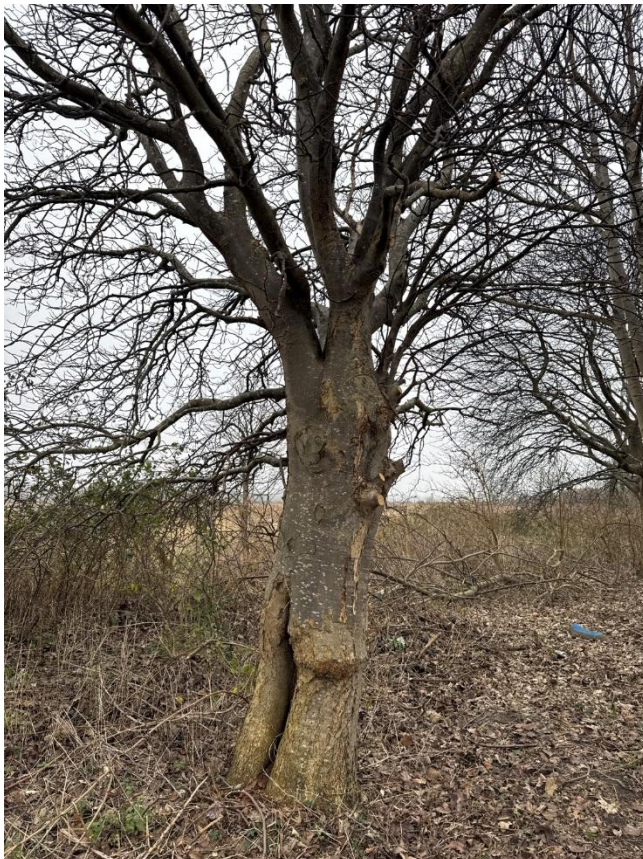
**Photograph 12 A mature, veteran Swedish whitebeam (T350) with significant internal decay evident through large cavity opening at base.**

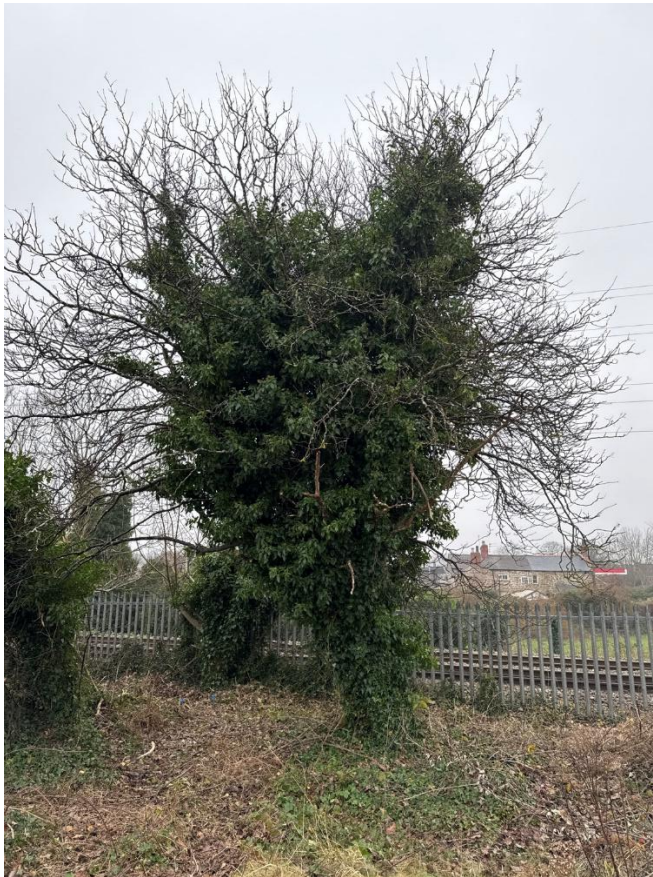
**Photograph 13 T356 A mature potential veteran Swedish whitebeam covered in dense ivy.**
