## Connah's Quay Low Carbon Power

Environmental Statement Volume IV  
Appendix 15-G: Arboricultural Impact Assessment (AIA)  
(Tracked)

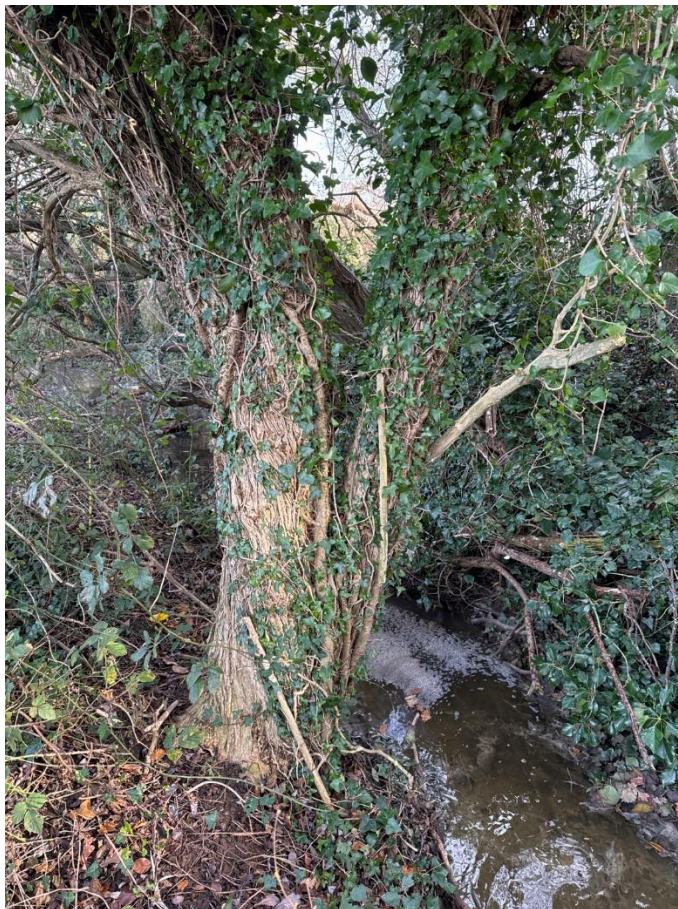
**Photograph 4 T22 an ancient elder located adjacent to a stream.**

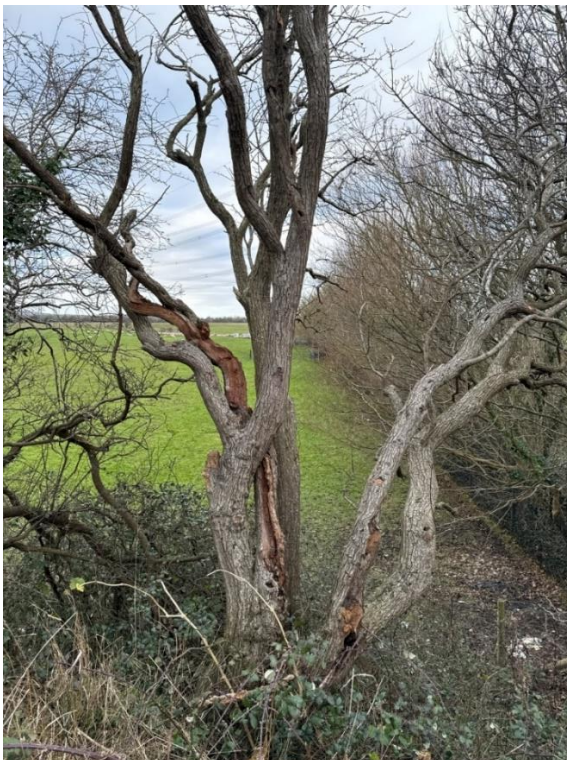
**Photograph 6 Mature hawthorn (T77) considered to be veteran due to the significant decay in two of three stems.**

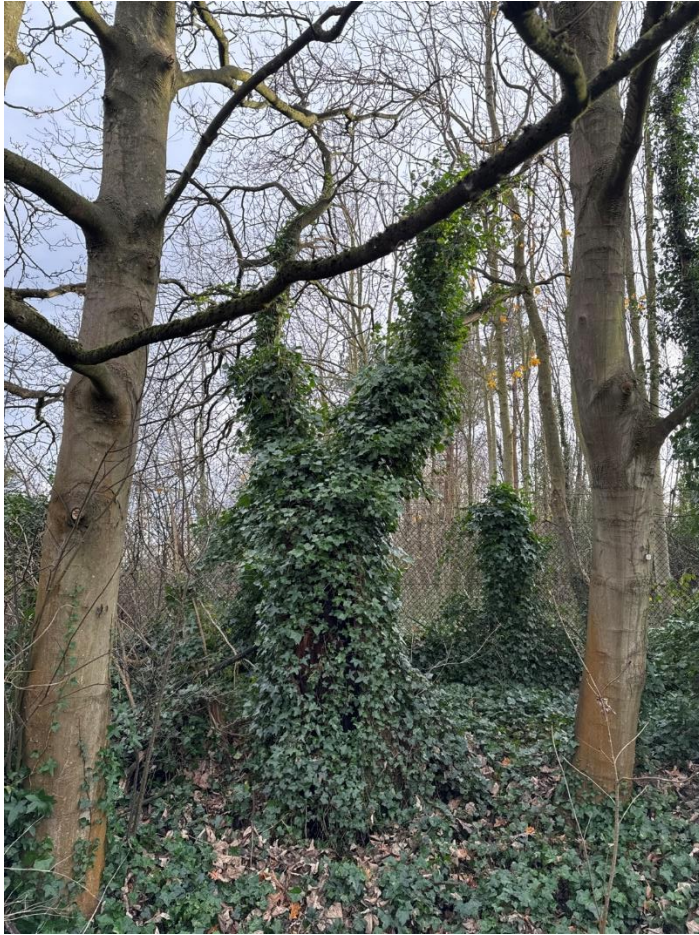
**Photograph 7 Mature veteran oak (T123).**

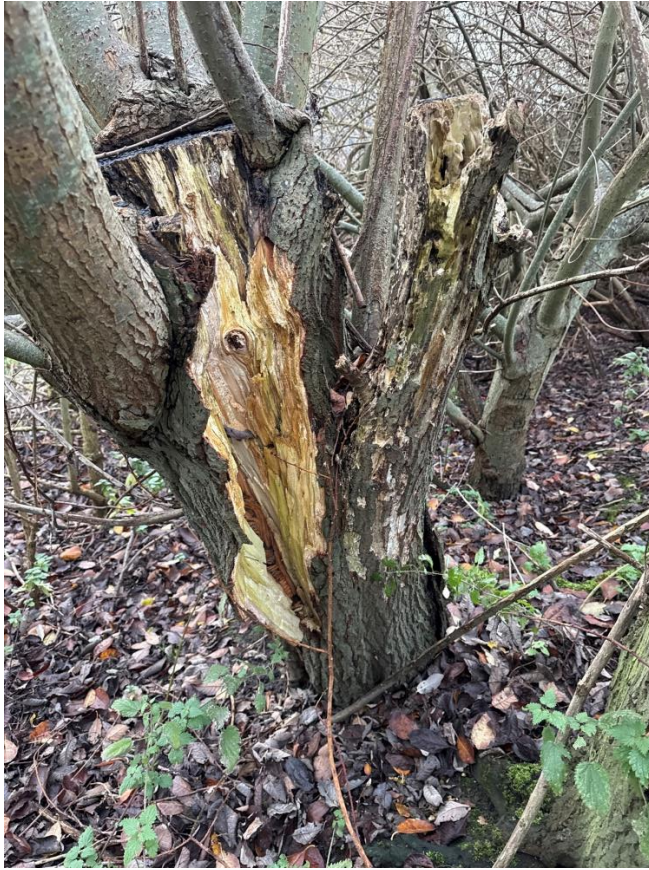
**Photograph 11 A mature, veteran goat willow (T272) with significant decay to its main bole.**

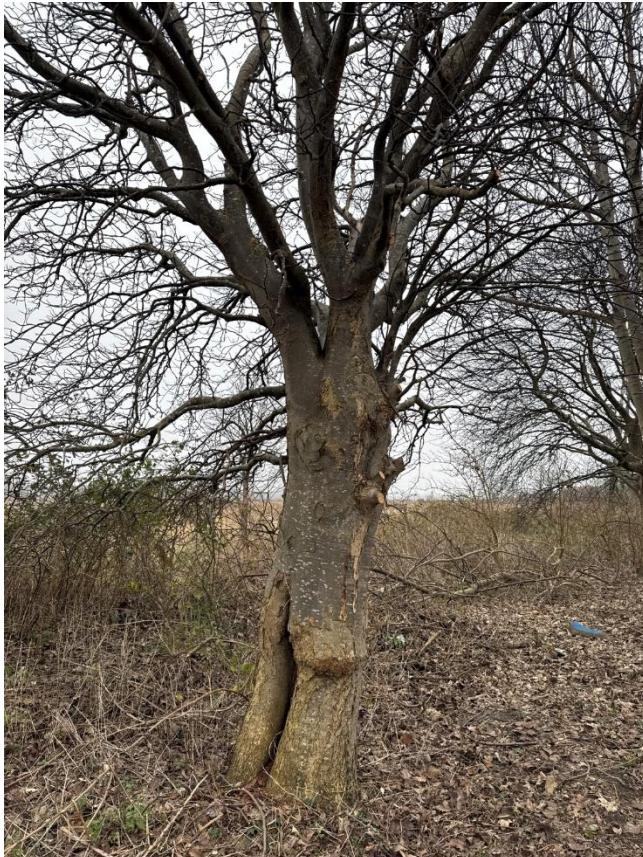
**Photograph 12 A mature, veteran Swedish whitebeam (T350) with significant internal decay evident through large cavity opening at base.**

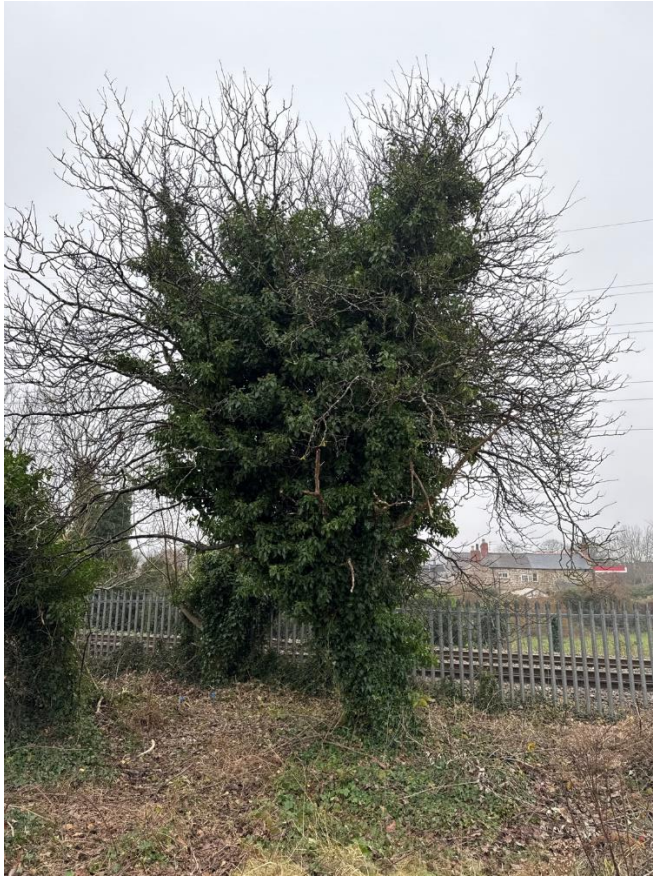
**Photograph 13 T356 A mature potential veteran Swedish whitebeam covered in dense ivy.**
