I would like to thank the Planning Inspectors for this opportunity to speak, and I shall address two key matters on safety. I am by background an auditor, with wide experience of reviewing Health and Safety Management systems.

Safety of Grid Scale Lithium-ion Battery Energy Storage Systems

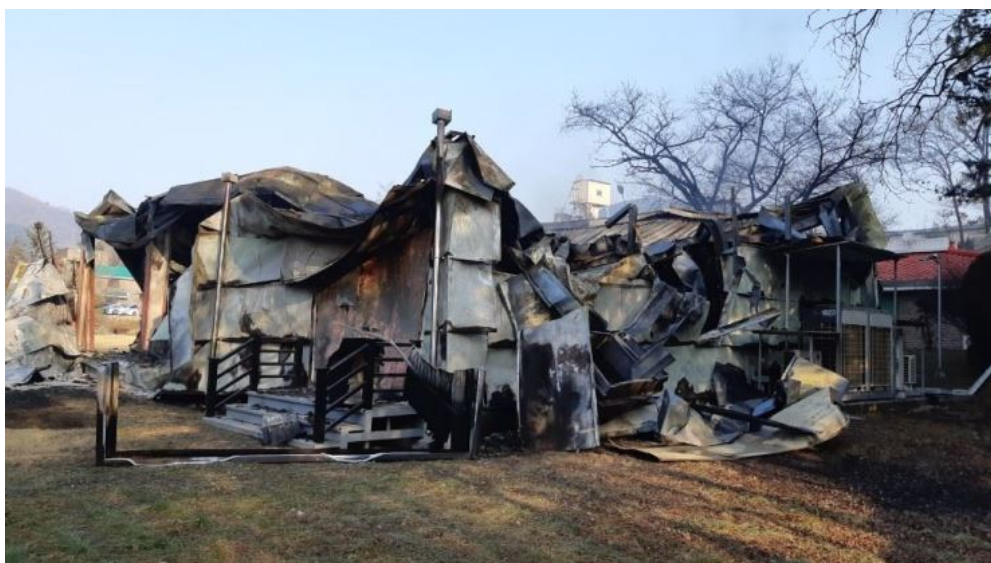
Figure 2: Remains of a Korean BESS destroyed by a “battery fire”. An energy storage system was destroyed at the Asia Cement plant in Jecheon, North Chungcheong Province, on Dec. 17. Courtesy of North Chungcheong Province Fire Service Headquarters (Korea Times 2 May 2019)

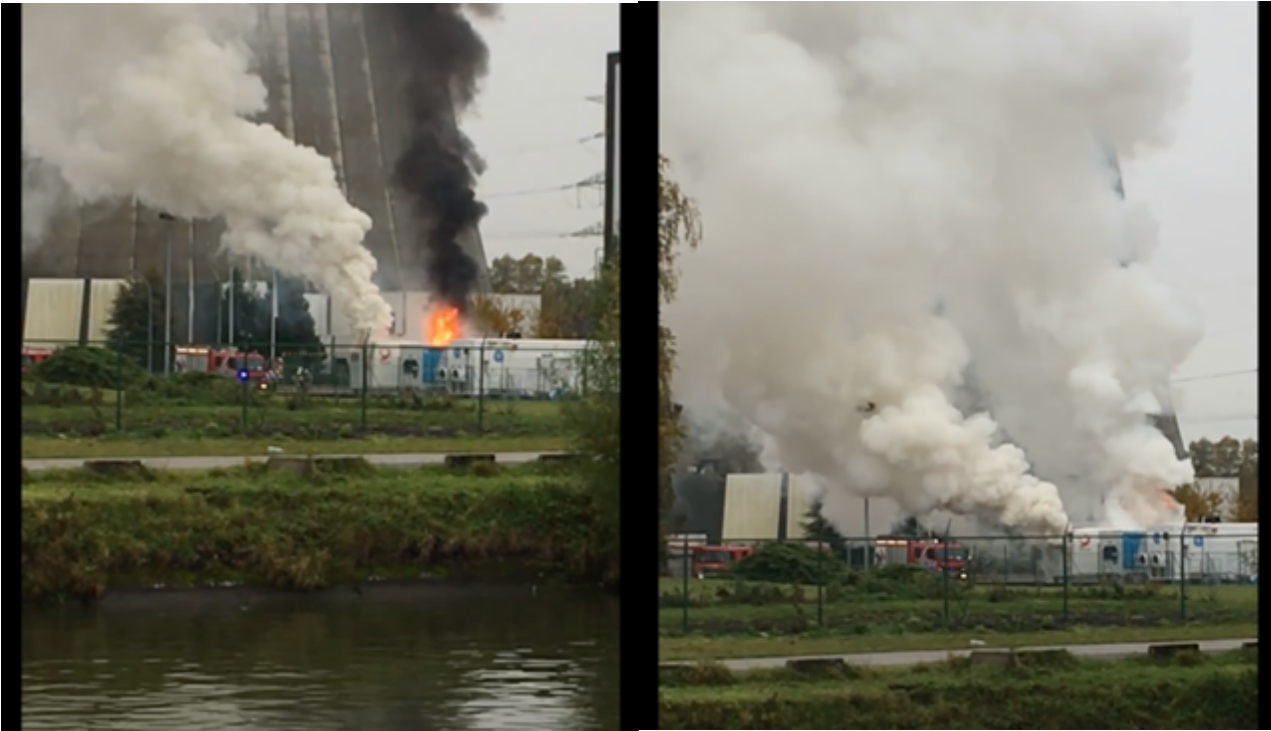
Figure 4: The 2 MWh McMicken (Arizona) BESS after the explosion on 19 April 2019

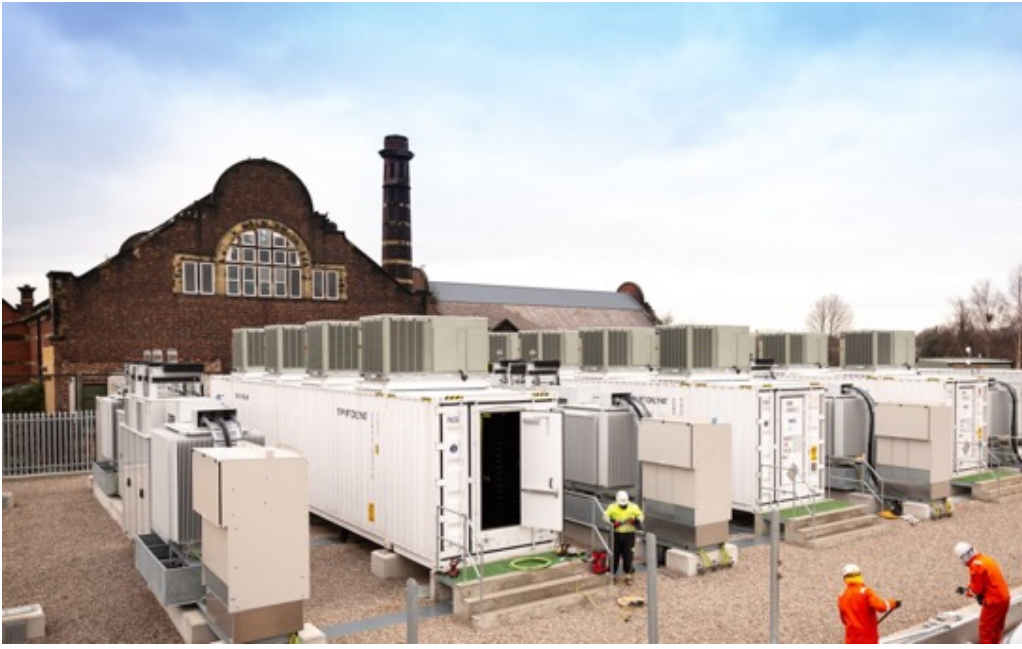
Figure 5: The 20 MWh BESS at Carnegie Rd, Liverpool. Courtesy Ørsted.

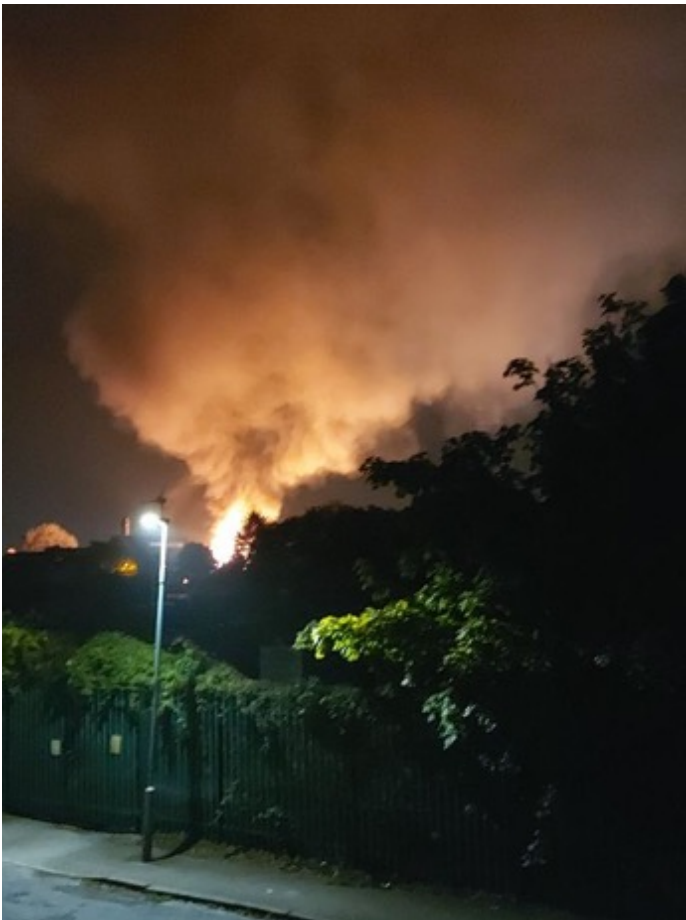
Figure 6: The fire at Carnegie Road, 15 Sep 2020. Liverpool Echo report, which took 11 hours to control.

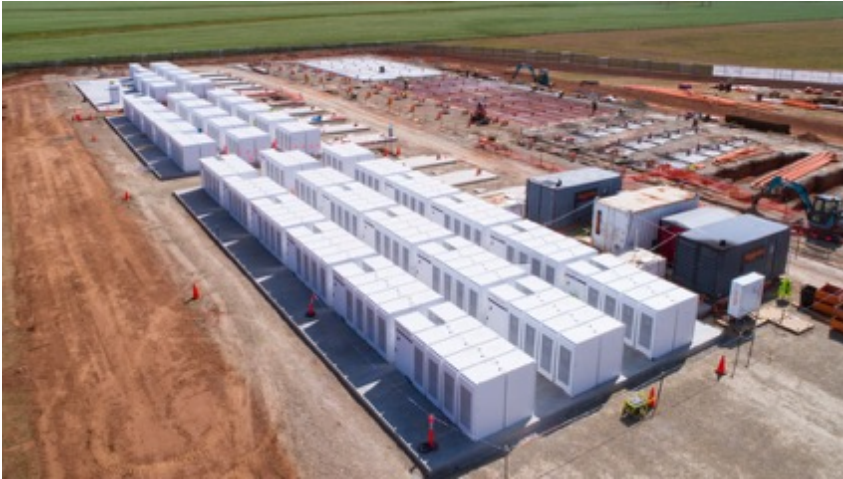
Figure 7: The Hornsdale Power Reserve (South Australia) in the process of expansion from 100 MW/129 MWh to 150 MW/193.5 MWh, as of November 2017.

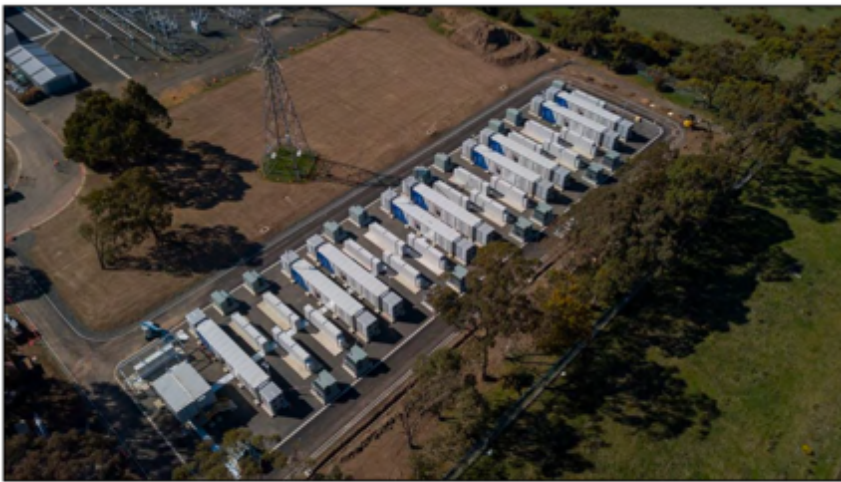
Figure 8: a “typical” BESS compound (abstracted from Sunnica PEIR, Ch 3)

Plate 3-10. Typical battery storage compound configuration (image reproduced courtesy of Fluence Energy).

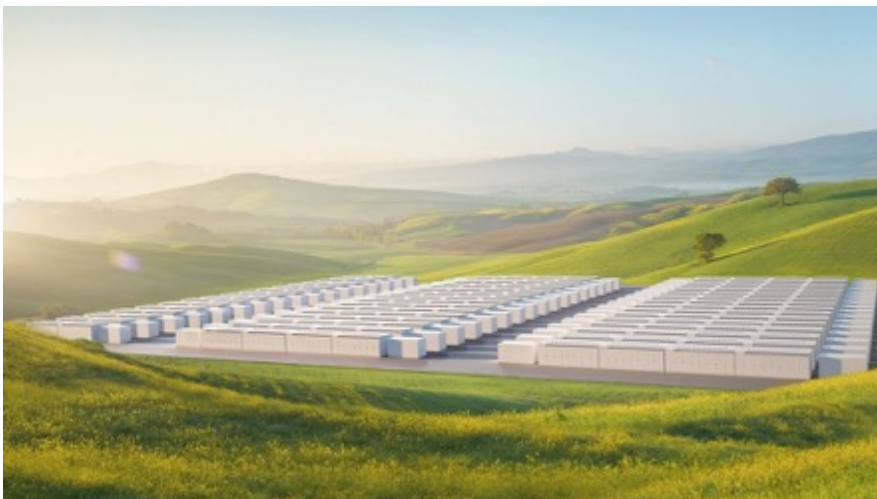
Figure 9: Artists impression of Tesla 250 MWh “Megapack”. Sunnica may have 3 × this capacity in just one of its three BESS compounds.

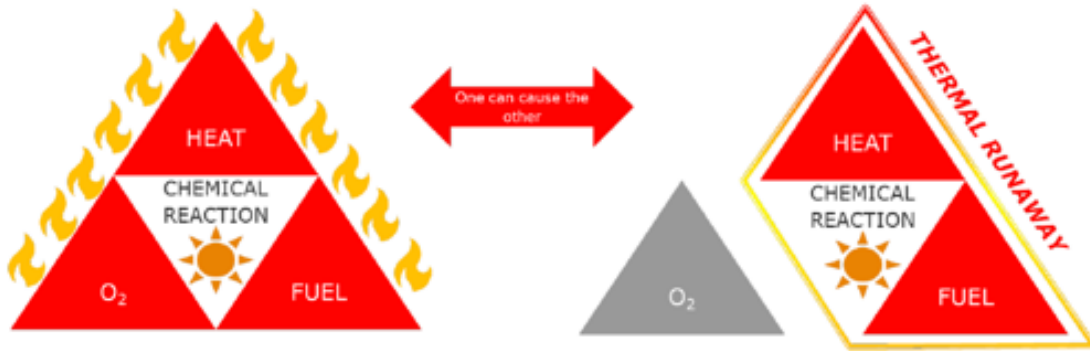
Figure 11 The fire triangle and its relationship to thermal runaway

Figure 10: The traditional “fire triangle” does not apply to “thermal runaway”.

Hence the traditional “fire triangle” of “Heat, Oxygen, Fuel” simply does not apply, and conventional fire-fighting strategies are likely to fail (Figure 10, over).

Thermal runaway events are uncontrollable except by *cooling* all parts of the structure affected – even the deepest internal parts – below 150 °C. This basically requires water, in large volumes.

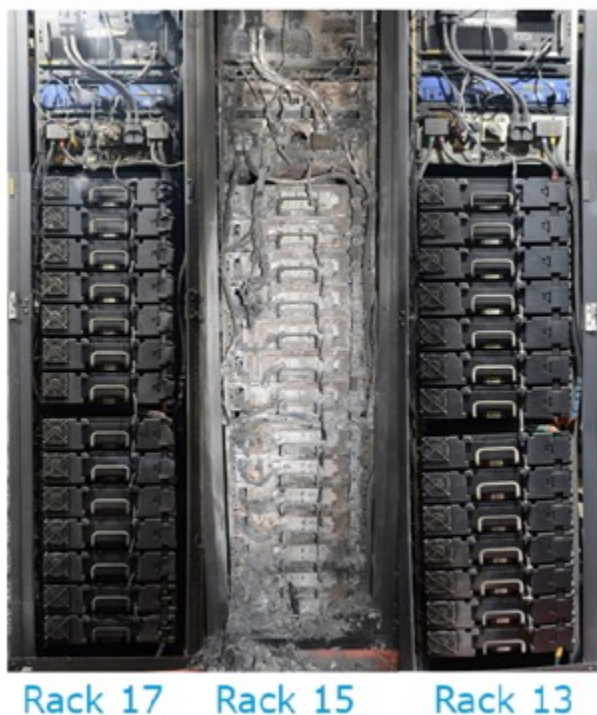
Figure 13: Destruction of Rack at McMicken.

Detail: molten aluminium pools (exceeded 660 °C)

This is what happened at McMicken [8], with temperatures sufficient to melt Aluminium (660 °C) being reached. Such “fires” can be extremely dangerous to fire fighters and other first responders because, in addition to the immediate fire and explosion risks, they would have to deal with toxic gases (principally hydrogen fluoride HF, also hydrogen cyanide HCN and other fluorine compounds such as phosphoryl fluoride POF₃) and exposure to other hazardous materials.

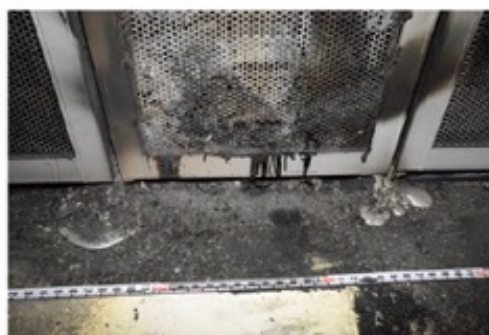
Figure A.1: Photograph taken during decommissioning of the ESS shows a pool of solidified aluminum on the floor in front of Rack 15 [1].

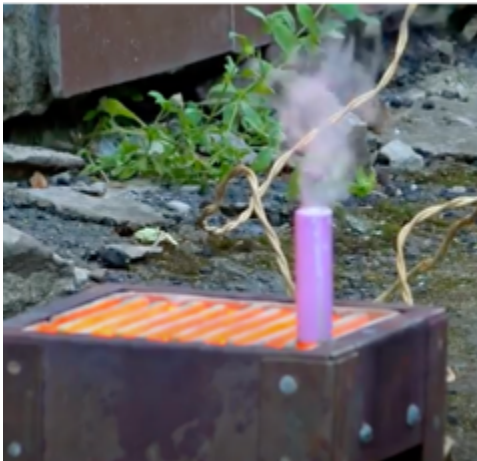
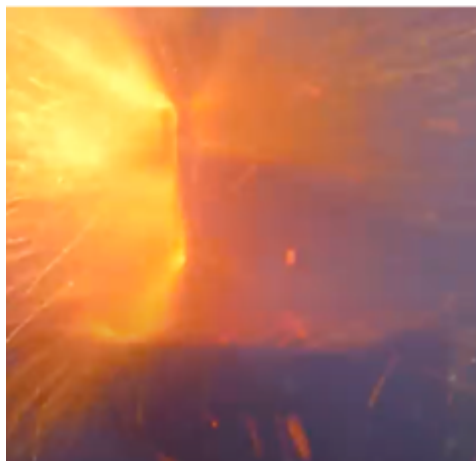
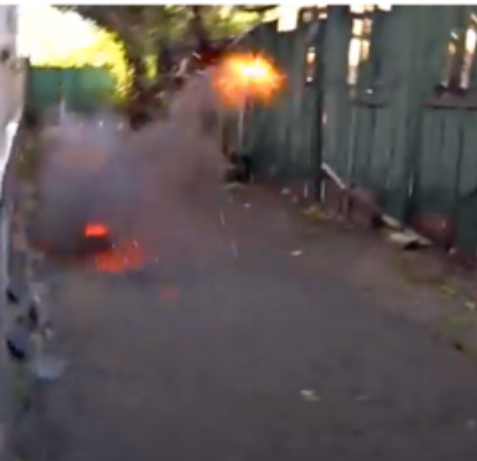
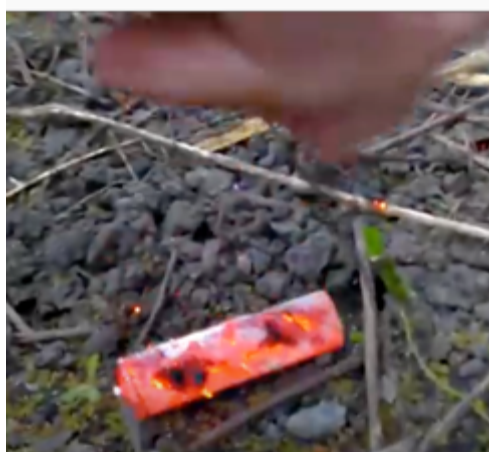
In the video, the cell is deliberately over-heated on a small electric stove. The fully charged cell goes into thermal breakdown, eventually rupturing the can. The cell flies off as a rocket and seconds later is discharged but red hot and will burn anything combustible. Although not illustrated, it is evidently hot enough to produce the same thermal breakdown in an adjacent cell within a battery.

This illustrates the damage done to a non-faulty cell, simply by overheating externally.

Figure 14: (a) A charged 2.6 Ah cell being deliberately overheated. (b) at the point of rupture (c) the cell takes off as a rocket (d) seconds later the discharge is complete, and the cell is red hot.

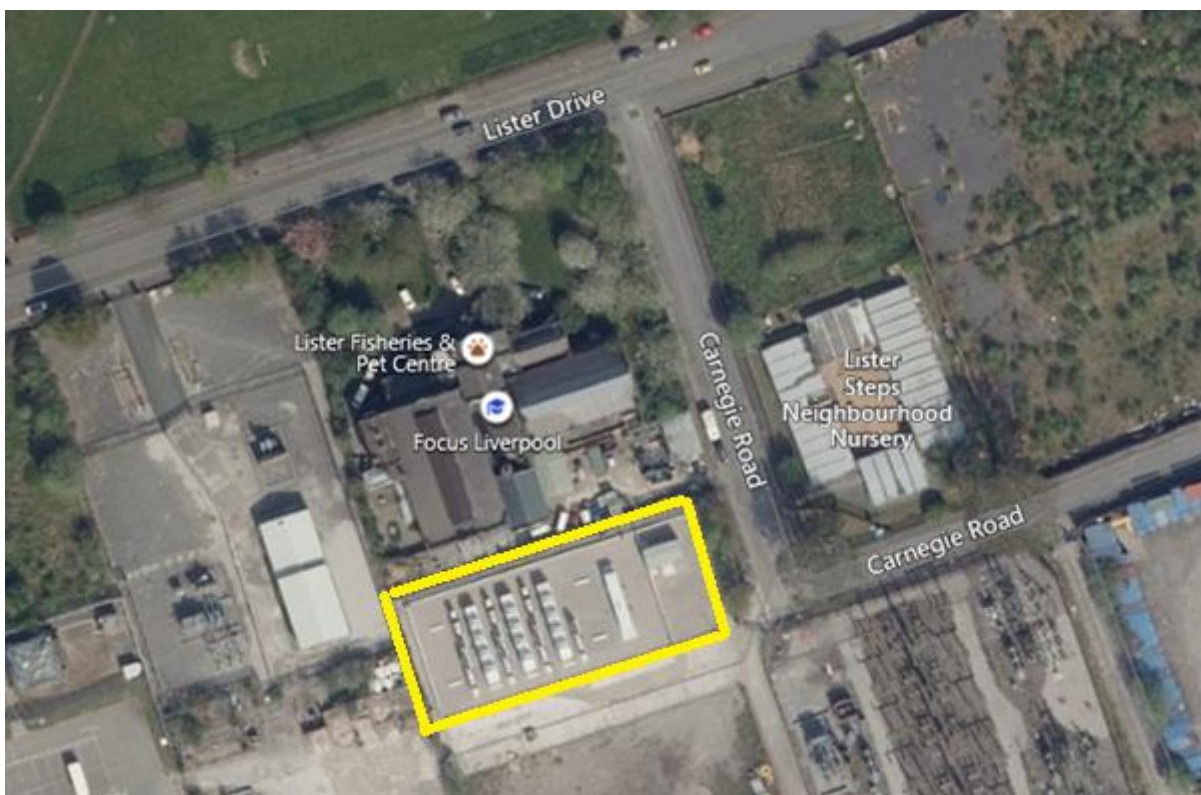
Two appliances, from Old Swan fire station (call-sign M16P1) and Liverpool City Centre fire station (call-sign M11P1), were mobilised to the incident as per the pre-determined attendance. On arrival they discovered a large container unit fully involved in fire with evidence consistent of a blast. One of the container doors had been ejected from its setting and was laying some 6 metres away within the secure compound. The compound is highlighted in yellow on the map below:

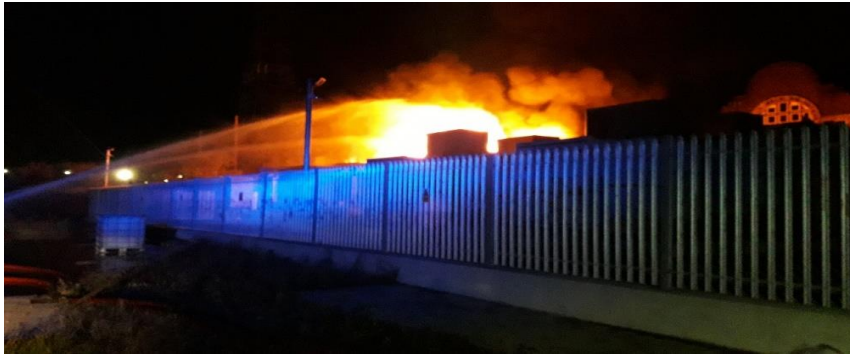
Firefighting action from Sector 1.

2 ground monitors at work.

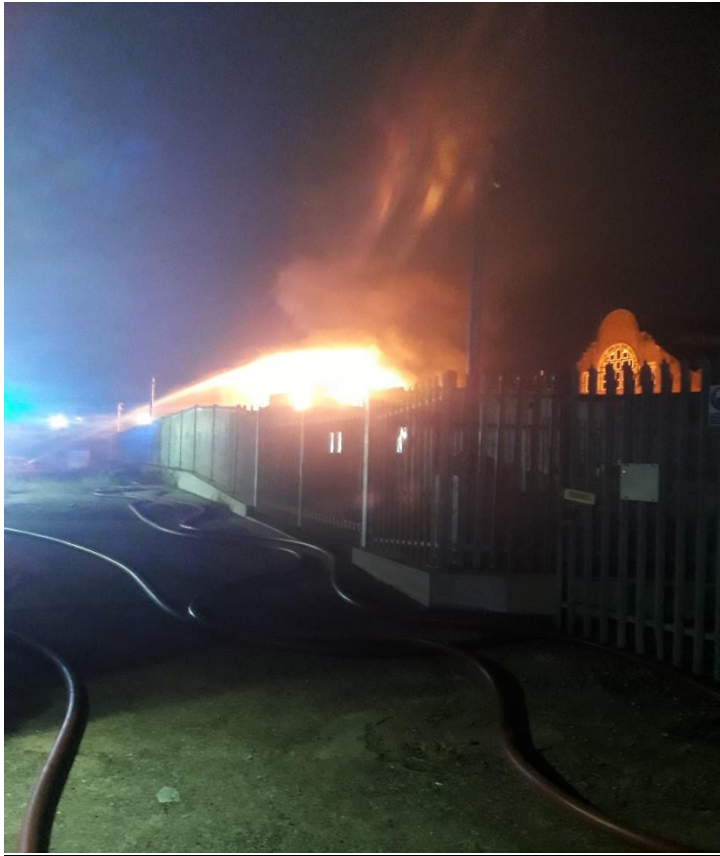
Ground monitors in use and personnel upwind of plume approximately 03:00 hours.
Information on plume toxicity gained at this point.

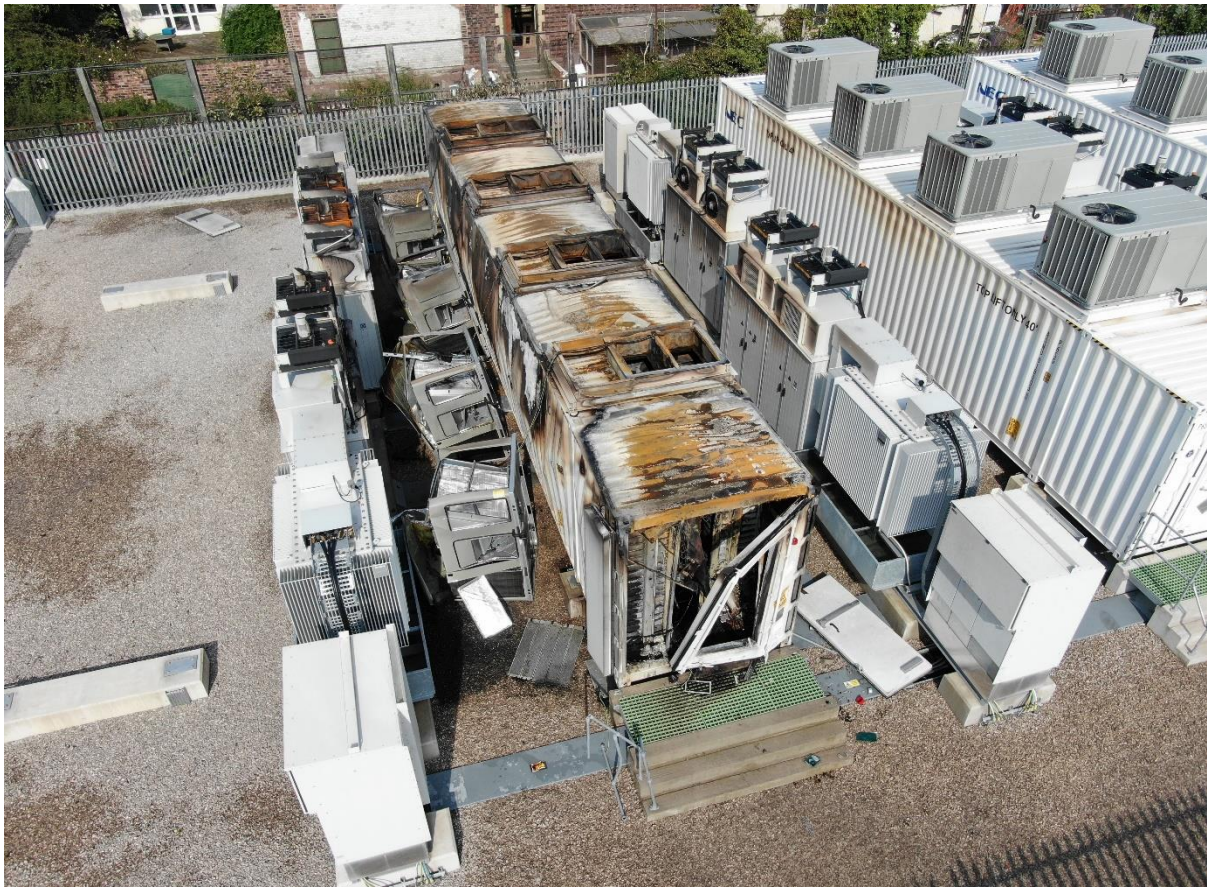
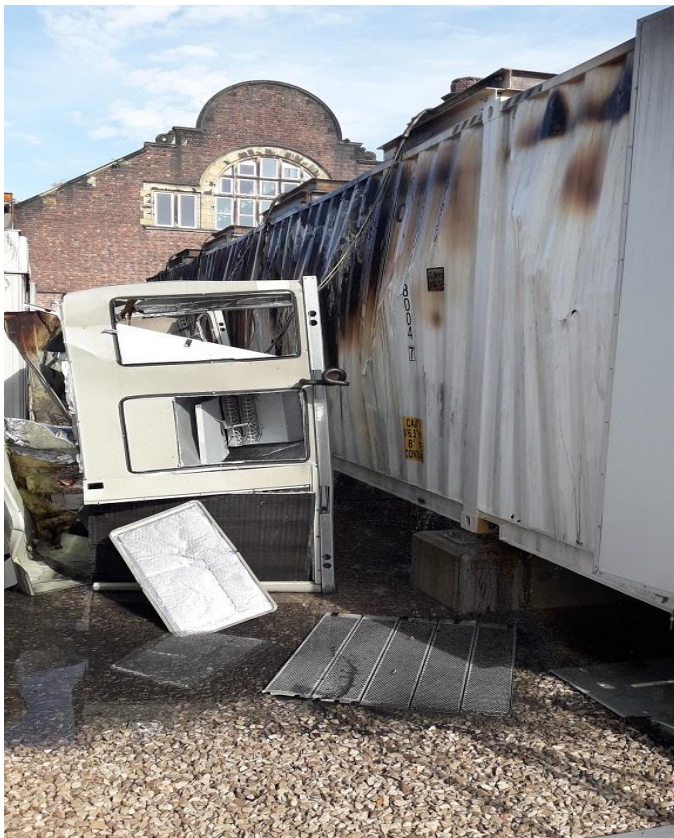
Image above: Taken from GMFRS AIR Unit. Full extent of damage visible. Roof mounted cooling units ejected to side of unit. Pressure damage visible along length of unit. Note scorching of top edge of second unit to mid-right of image. Firefighting tactics mitigated further spread and damaged beyond original unit and blast.

Image left: FI Photography, note pressure damage and expansion of unit above burn line pattern. Remains of cooling unit pictured to left hand side.

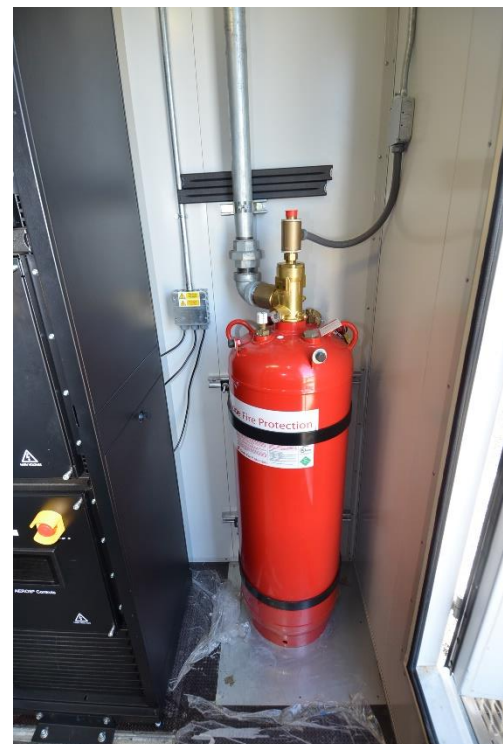
NOVEC 1230, the extinguishing agent fixed to the Orsted unit, is the latter type of agent, an aerosol of fluorinated ketones. The installation is pressurised with nitrogen, and is released on detection of fire conditions within the unit. NOVEC 1230 is stored as a liquid but discharges as an aerosol, evaporating 50 times quicker than water, absorbing heat and smothering any fire progression.

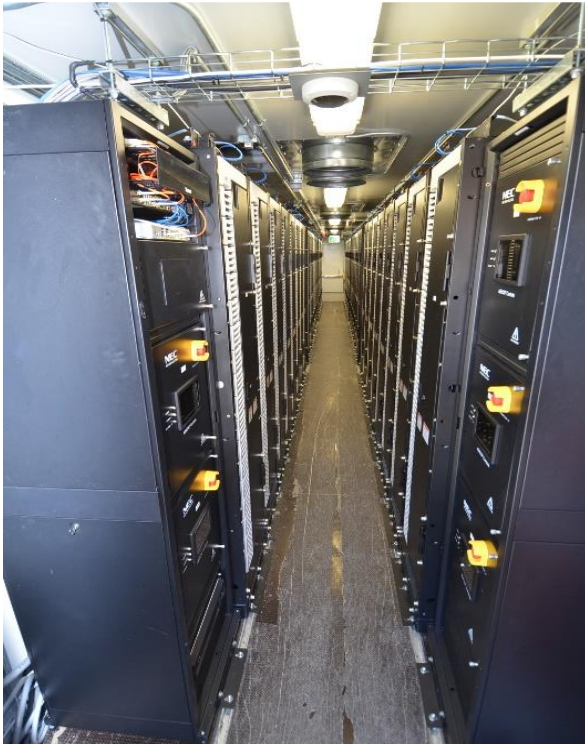
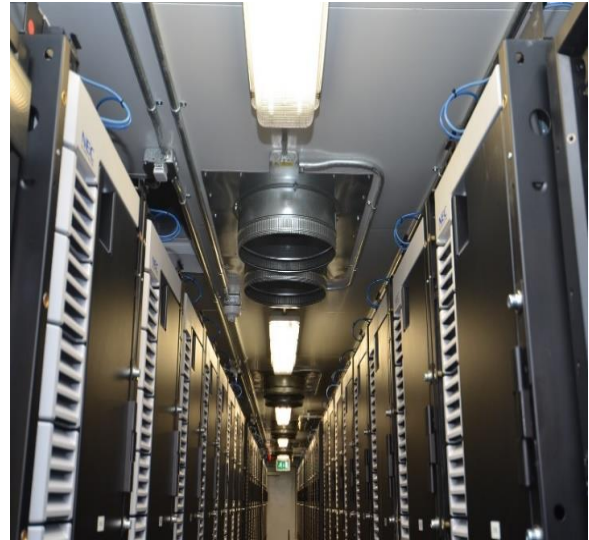
Image left: Central internal view of unaffected unit. Note configuration of lithium ion banks and narrow access corridor.

Image above: Cooling vents fitted to ceiling.

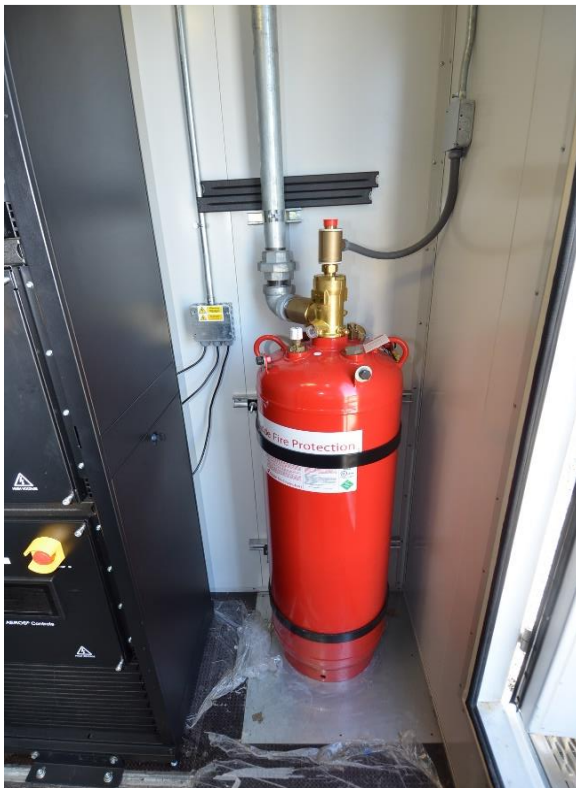
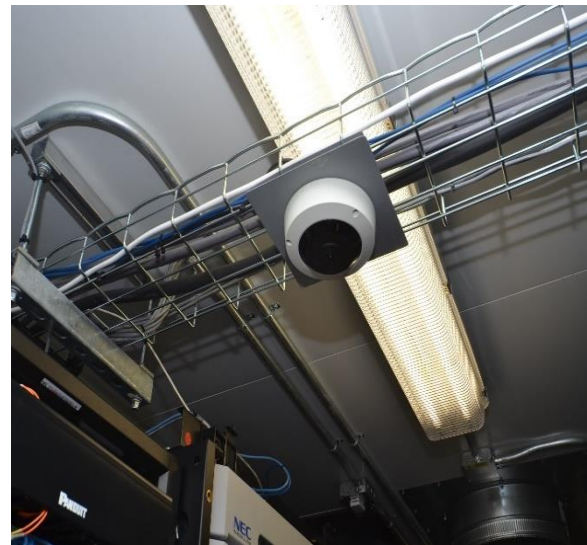
Image left: NOVEC 1230 fixed aerosol system with piping.

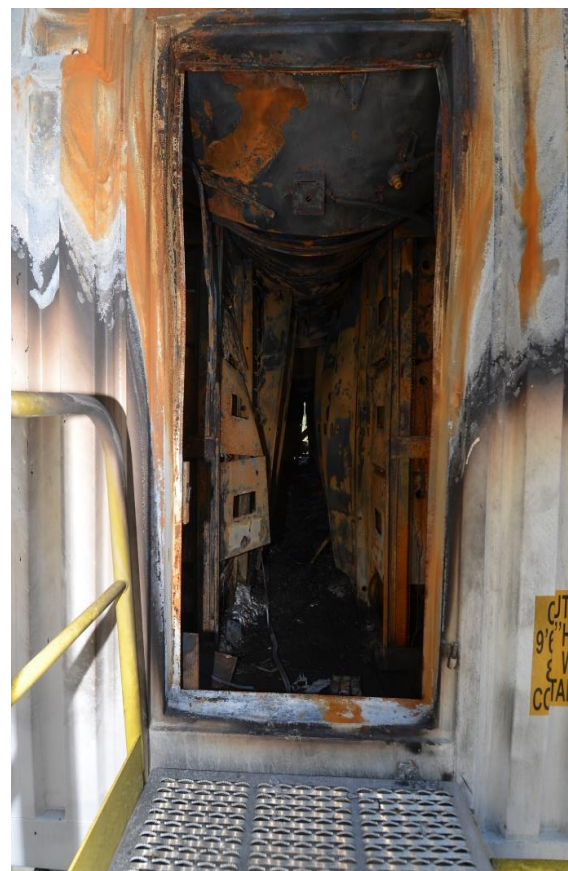
Image below left: Fire damaged NOVEC 1230 unit.

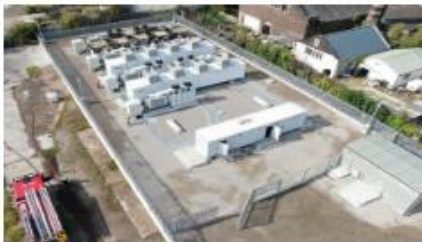
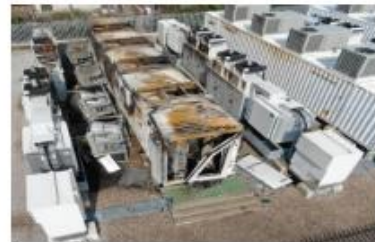
Merseyside Fire and Rescue Service (MFRS) attended a fire incident at Orsted BESS, Carnegie Road, Old Swan on 15th September 2020. The initial attendance of two fire appliances were confronted with a well-developed fire on arrival. There was evidence of blast damage to the container unit with the doors at each end and the air cooling units from the roof being blown clear. "Make pumps 5" was requested within 10 minutes of initial attendance.

This was a 20mW/33kV stored energy site consisting of 3 battery units, a control unit and associated plant. Each battery unit houses approximately 45 banks containing varying amounts of lithium cells according to the unit size and a fire suppression system.
