Lime Down

Solar Park

Environmental Statement

Watercourse Crossing Schedule
(Tracked)

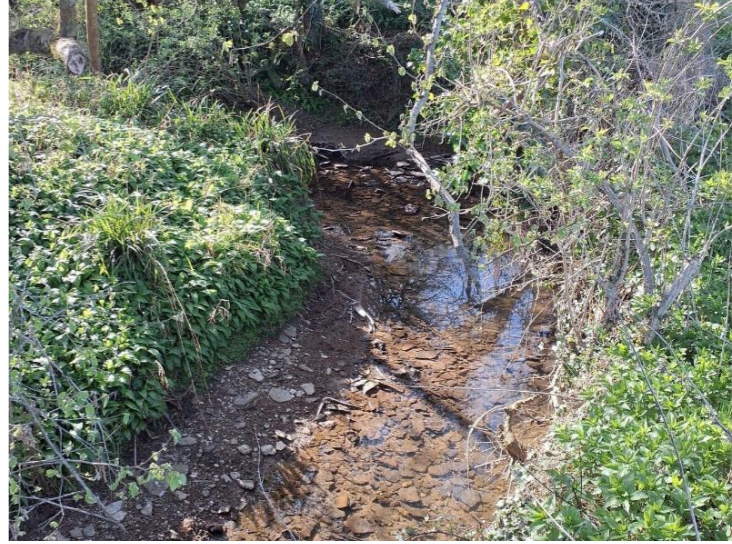
Crossing Ref	Grid Ref (Easting and Northing)	Designation	Preferred Crossing Methodology	Regulatory Authority	Location	Description	Photograph
SM1	388410,169425	Main River	Cabling Horizontal Directional Drilling (HDD) Access N/A	Environment Agency (EA)	Cable Route Corridor	A section of a tributary of the River Avon known as Byde Mill Brook. A stream holding circa 0.4 m deep, clear water at the time of survey with a smooth flow over a pebble/cobble substrate. 1.5 m in width and with fairly steep earth banks up to 1.7 m in height. Varied bankside vegetation comprising a range of trees, shrubs, herbs and grasses.

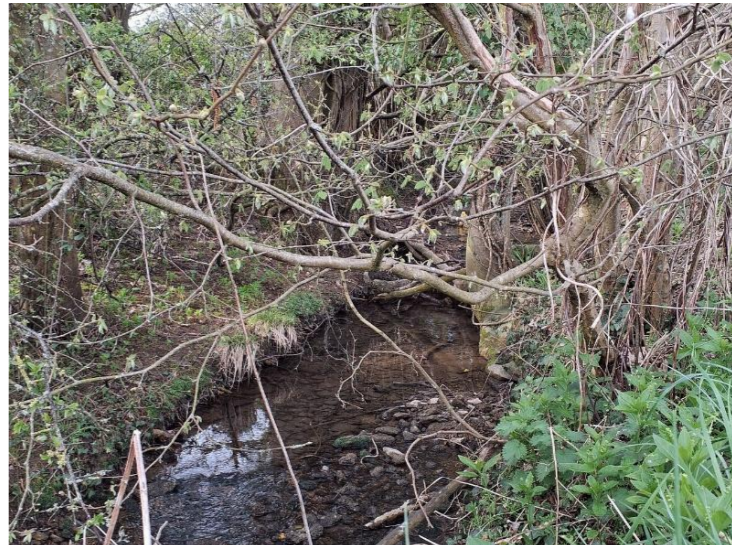
SM2	389206,171833	Main River	Cabling HDD Access N/A	EA	Cable Route Corridor	A section of a tributary of the River Avon known as Pudding Brook. A stream holding circa 0.1 m deep, clear water at the time of survey with a quick flow over a pebble/cobble substrate. 1.5 m in width and with steep earth banks up to 2 m in height. Varied bankside vegetation comprising a range of trees, shrubs, herbs and grasses.

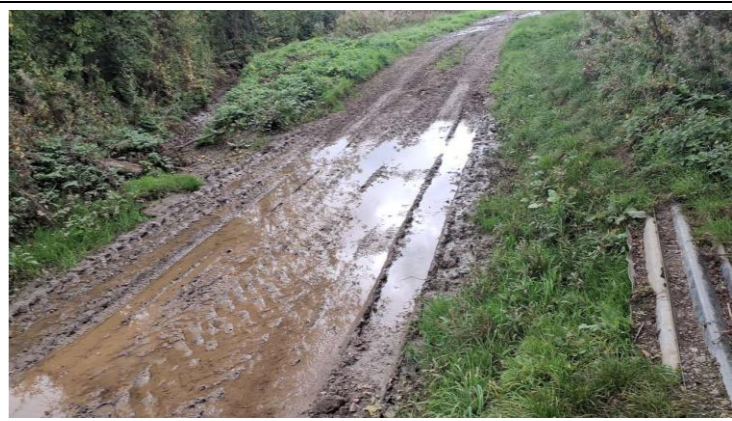
SM3	390480,183099	Main River	Cabling Either HDD or Open Cut (at Ford) Access Via retained ford	EA	Solar PV Sites: Lime Down D	The proposed potential open-cut crossing point is a ford which is dry for most of the year except in times of flooding and otherwise comprises a bare earth farm track. To the north of the ford, at the location proposed for potential HDD crossing, lies a small stream which feeds into a larger watercourse known as Gauze Brook. The stream held circa 0.5 m deep, turbid water at the time of survey with a rippled flow over a largely silt substrate. Approximately 1.5 to 2 m in width with steep earth banks up to 1.2 m

Crossing Ref	Grid Ref (Easting and Northing)	Designation	Preferred Crossing Methodology	Regulatory Authority	Location	Description	Photograph
						in height. Vegetation on the left (western) bankside comprised a range of grasses, forbs and ruderals, while the right (eastern) bankside was vegetated with shrubs and trees associated with an adjacent hedgerow. Very little in the way of submerged, emergent or marginal aquatic vegetation were recorded.

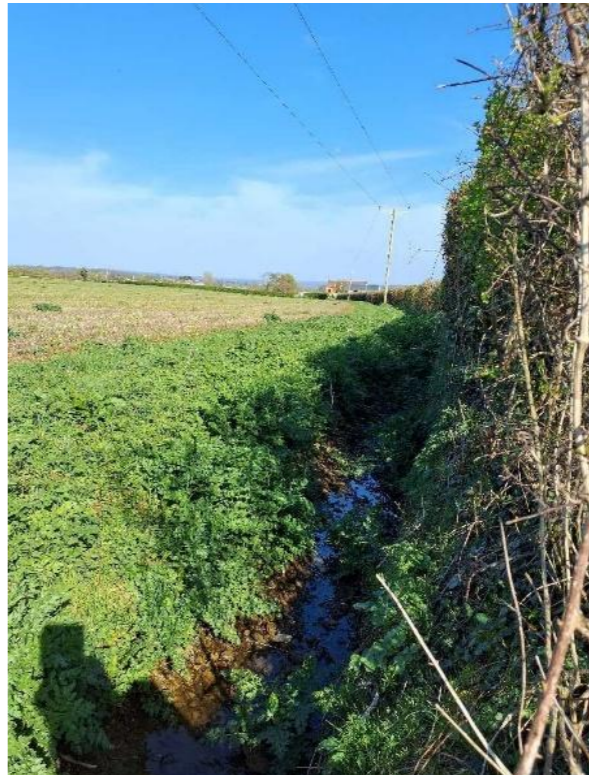
OW5	388139,173372	Ordinary Watercourse	Cabling Open Cut Access Temporary culvert	LLFA	Cable Route Corridor	Shallow agricultural drainage ditch, 1 m deep and 0.5 m wide. Holding shallow water (0.1 m deep) at the time of survey but likely to regularly dry during the summer months. Overshaded by adjacent hedge and lacking in aquatic/marginal vegetation.

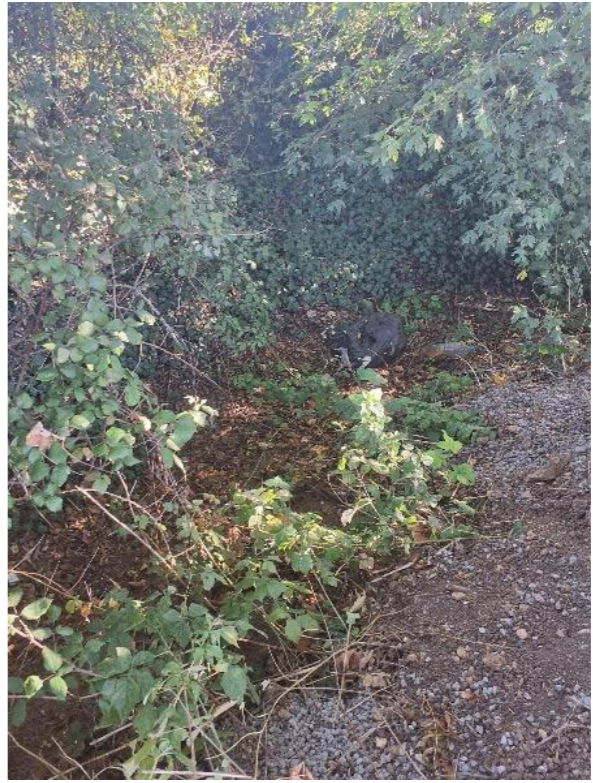
Crossing Ref	Grid Ref (Easting and Northing)	Designation	Preferred Crossing Methodology	Regulatory Authority	Location	Description	Photograph
OW6	387274,174846	Ordinary Watercourse	<u>Cabling</u> HDD <u>Access</u> N/A	LLFA	Cable Route Corridor	Roadside ditch, relatively shallow (up to 1 m deep). Appears to be regularly dry with no aquatic/emergent vegetation present. Mostly bare and overshadowed by adjacent hedgerow and trees.

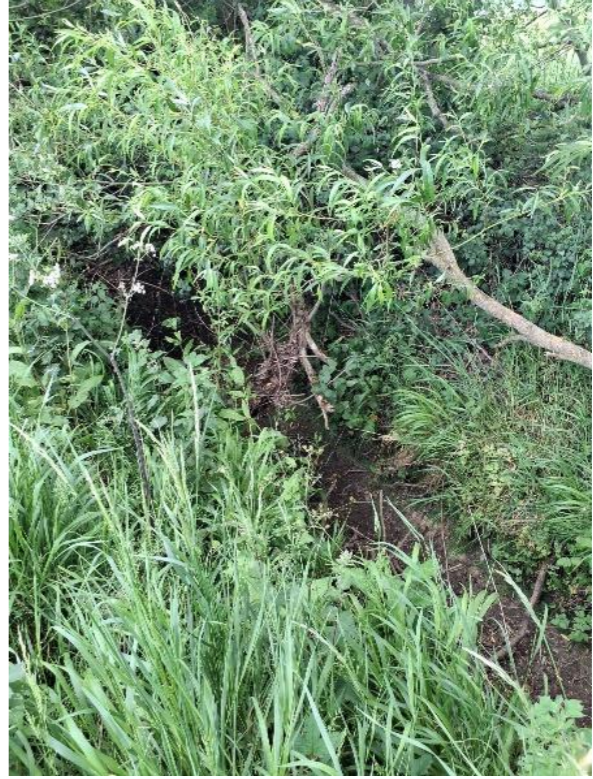
OW11	388084,183521	Ordinary Watercourse	Cabling Open Cut Access Temporary culvert	LLFA	Cable Route Corridor	A section of a small tributary of the River Avon. A small stream dry at the time of survey but likely to hold water seasonally, with some marginal vegetation occasionally present. 0.5 m x 0.5 m deep and wide with earth substrate. Overshaded by adjacent hedgerow. Bankside vegetation comprises hedgerow shrubs, coarse grasses and ruderals.

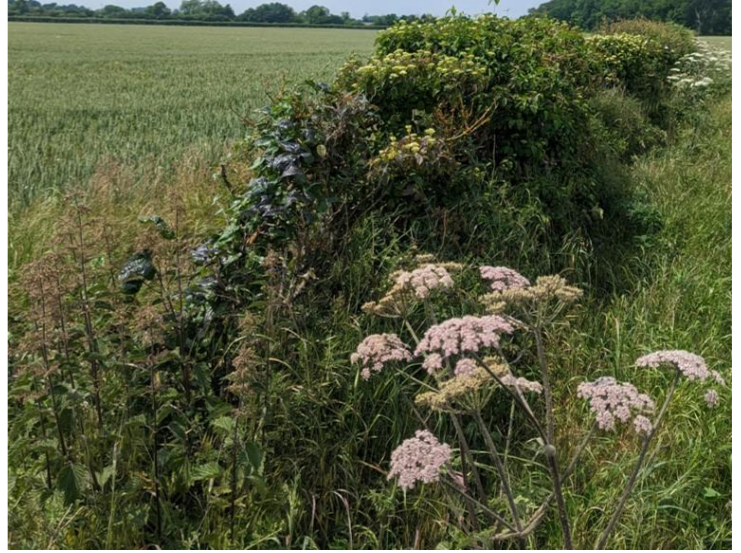
OW17	386007,182541	Ordinary Watercourse	Cabling Open Cut Access New permanent culvert	LLFA	Solar PV Sites; Lime Down C	Roadside ditch. Relatively shallow (0.5 m deep) and narrow (0.5 m wide) likely to be dry for most of the year. Vegetated with coarse grasses and ruderals with no aquatic/marginal vegetation.	No photo available
OW18	386392,182728	Ordinary Watercourse	Cabling Open Cut Access Existing culvert	LLFA	Solar PV Sites; Lime Down C	Dry ditch at the base of hedgerow. 0.5 m deep and 0.5 m wide, with earth banks vegetated with coarse grasses and ruderals. Unlikely to regularly hold water.

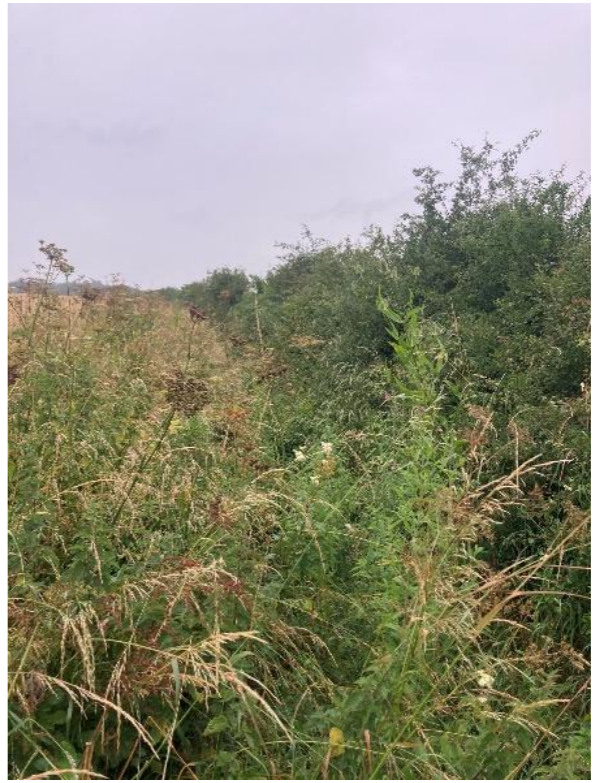
OW22	389093,183583	Ordinary Watercourse	Cabling Open Cut Access New permanent culvert	LLFA	Solar PV Sites: Lime Down D	Dry ditch at the southern base of a hedgerow. Approximately 1.5 m deep and 0.75 m wide with steep earth banks. Overshaded by hedgerow and vegetated with coarse grasses and ruderals with little aquatic/marginal vegetation. Unlikely to hold water regularly.

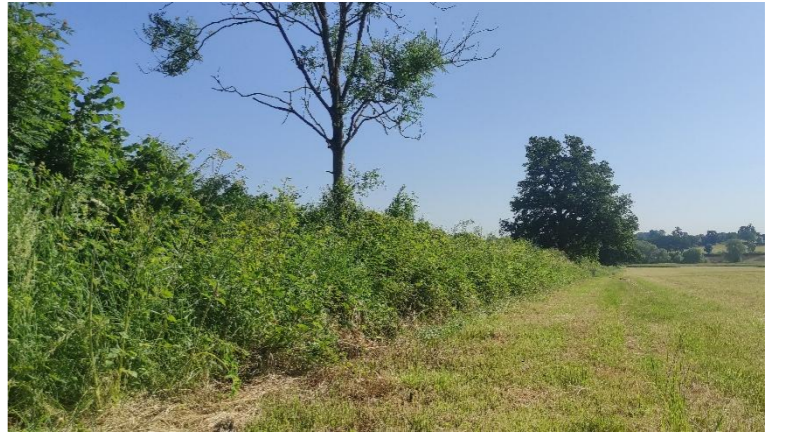
Crossing Ref	Grid Ref (Easting and Northing)	Designation	Preferred Crossing Methodology	Regulatory Authority	Location	Description	Photograph
OW27	392508,181657	Ordinary Watercourse	Cabling Open Cut Access New permanent culvert	LLFA	Solar PV Sites: Lime Down E	Dry ditch at the base of hedgerow. 1 m deep and 1 m wide, with steep earth banks vegetated with coarse grasses and ruderals. Unlikely to regularly hold water.

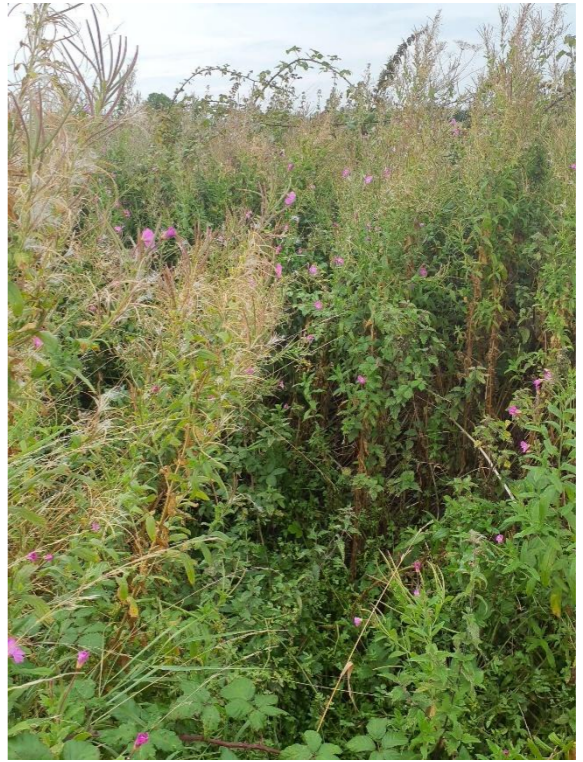
OW28	385421,182915	Ordinary Watercourse	Cabling Open Cut Access New permanent culvert	LLFA	Solar PV Sites: Lime Down C	Drain running between two agricultural fields. Approximately 1 m wide with 1 m deep, steep earth banks. Damp ground present at the channel bed. The channel was choked with a range of vegetation including species such as great willowherb, meadowsweet and water mint indicative of holding water seasonally.
