Lime Down

Solar Park

Environmental Statement

**Watercourse Crossing Schedule
(Clean)**

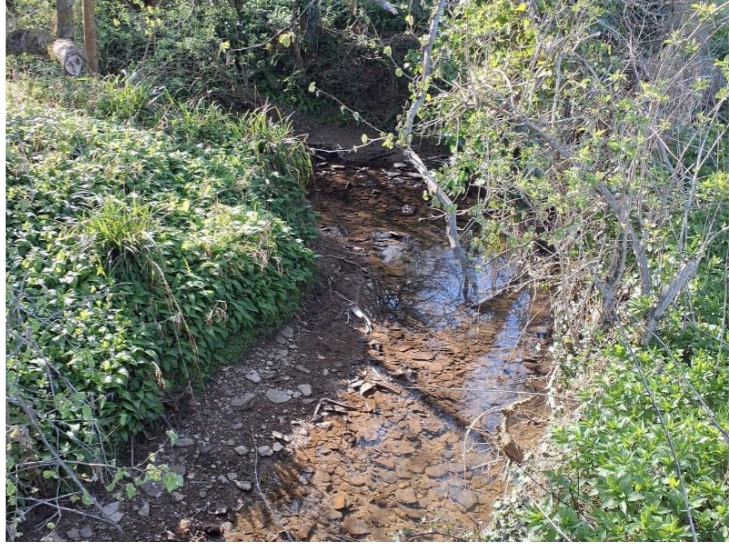
| Crossing Ref | Grid Ref (Easting and Northing) | Designation | Preferred Crossing Methodology | Regulatory Authority | Location | Description | Photograph |
|---|---|---|--|---|---|--|---|
| SM1 | 388410,169425 | Main River | Cabling Horizontal Directional Drilling (HDD) Access N/A | Environment Agency (EA) | Cable Route Corridor | A section of a tributary of the River Avon known as Byde Mill Brook. A stream holding circa 0.4 m deep, clear water at the time of survey with a smooth flow over a pebble/cobble substrate. 1.5 m in width and with fairly steep earth banks up to 1.7 m in height. Varied bankside vegetation comprising a range of trees, shrubs, herbs and grasses. | |

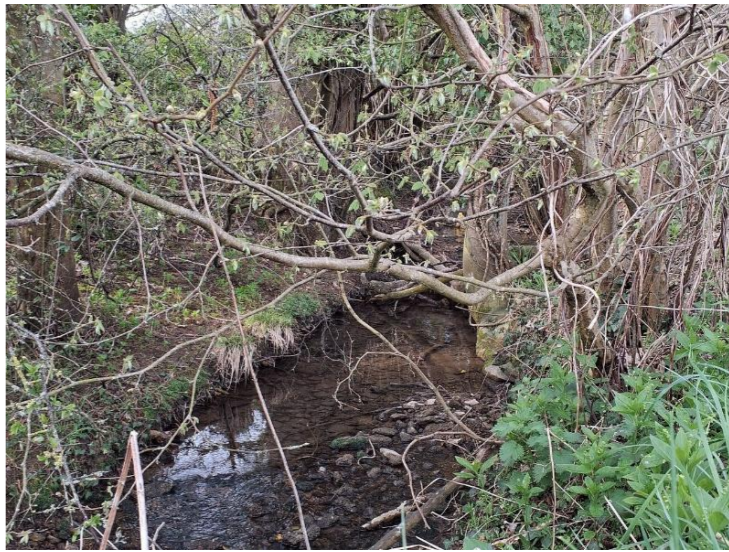
| Crossing Ref | Grid Ref (Easting and Northing) | Designation | Preferred Crossing Methodology | Regulatory Authority | Location | Description | Photograph |
|---|---|---|--|---|---|--|---|
| SM2 | 389206,171833 | Main River | Cabling HDD Access N/A | EA | Cable Route Corridor | A section of a tributary of the River Avon known as Pudding Brook. A stream holding circa 0.1 m deep, clear water at the time of survey with a quick flow over a pebble/cobble substrate. 1.5 m in width and with steep earth banks up to 2 m in height. Varied bankside vegetation comprising a range of trees, shrubs, herbs and grasses. | |

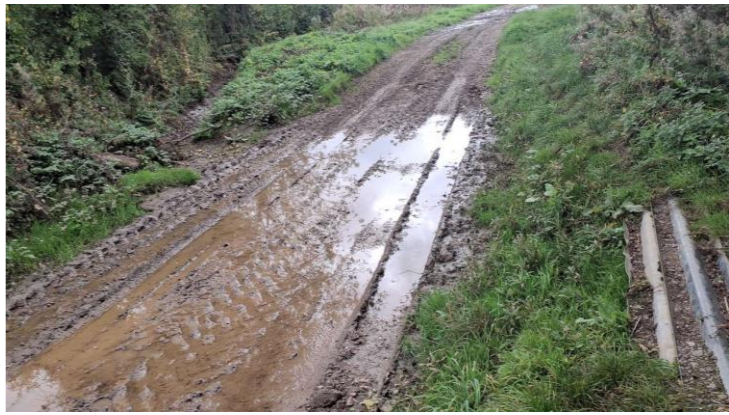
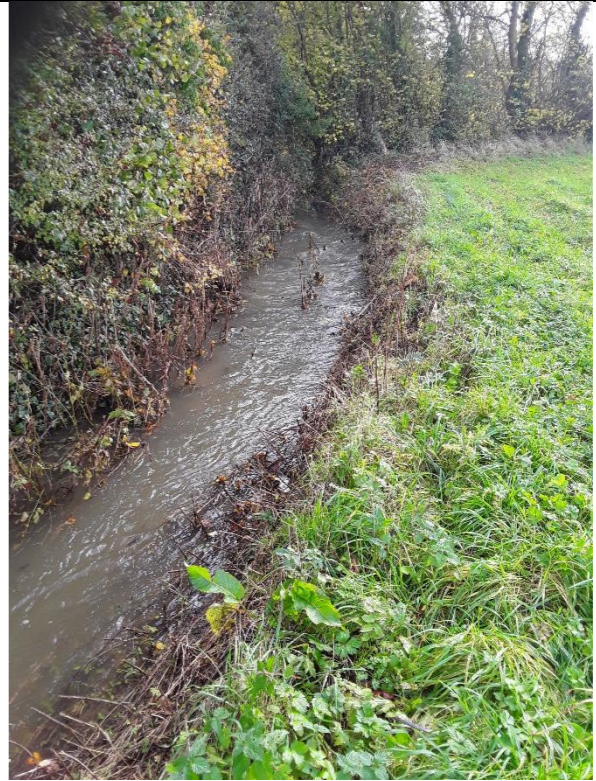
| Crossing Ref | Grid Ref (Easting and Northing) | Designation | Preferred Crossing Methodology | Regulatory Authority | Location | Description | Photograph |
|---|---|---|--|---|---|--|---|
| SM3 | 390480,183099 | Main River | Cabling Either HDD or Open Cut (at Ford) Access Via retained ford | EA | Solar PV Sites: Lime Down D | The proposed potential open-cut crossing point is a ford which is dry for most of the year except in times of flooding and otherwise comprises a bare earth farm track. To the north of the ford, at the location proposed for potential HDD crossing, lies a small stream which feeds into a larger watercourse known as Gauze Brook. The stream held circa 0.5 m deep, turbid water at the time of survey with a rippled flow over a largely silt substrate. Approximately 1.5 to 2 m in width with steep earth banks up to 1.2 m | |

| Crossing Ref | Grid Ref (Easting and Northing) | Designation | Preferred Crossing Methodology | Regulatory Authority | Location | Description | Photograph |
|---|---|---|---|---|---|--|---|
| | | | | | | in height. Vegetation on the left (western) bankside comprised a range of grasses, forbs and ruderals, while the right (eastern) bankside was vegetated with shrubs and trees associated with an adjacent hedgerow. Very little in the way of submerged, emergent or marginal aquatic vegetation were recorded. | |

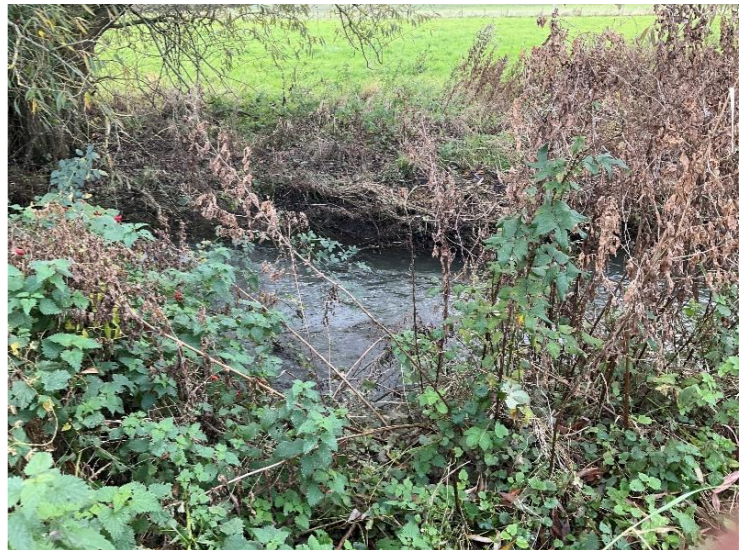
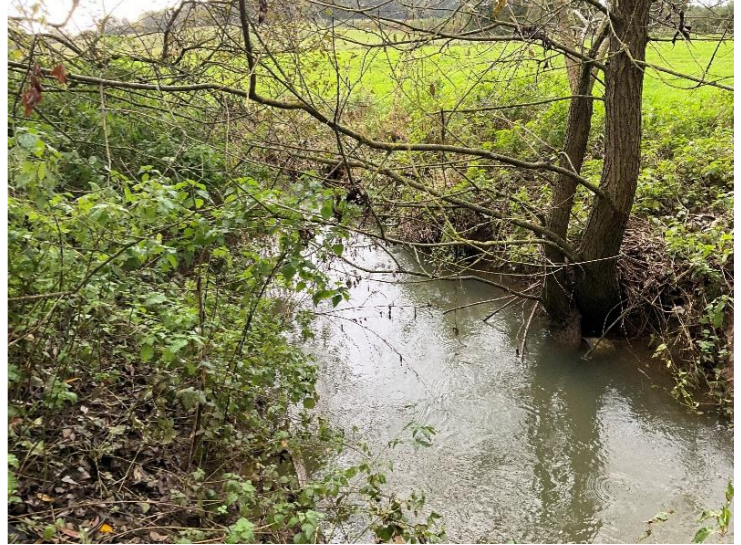
| Crossing Ref | Grid Ref (Easting and Northing) | Designation | Preferred Crossing Methodology | Regulatory Authority | Location | Description | Photograph |
|---|---|---|---|---|---|--|---|
| SM4 | 392666,181666 | Main River | Cabling HDD Access Via existing crossing. It is possible that this may need be improved. | EA | Solar PV Sites: Lime Down E | A section of a tributary of the River Avon known as Gabriel's Well. A stream holding circa 0.5 m deep, slightly turbid water at the time of survey with a rippled flow over a gravel/pebble substrate. 2 to 2.5 m in width and with steep earth banks up to 1.2 m in height. Varied bankside vegetation comprising a range of shrubs, herbs, grasses and occasional trees. The stream in this location is known to support otters. | |

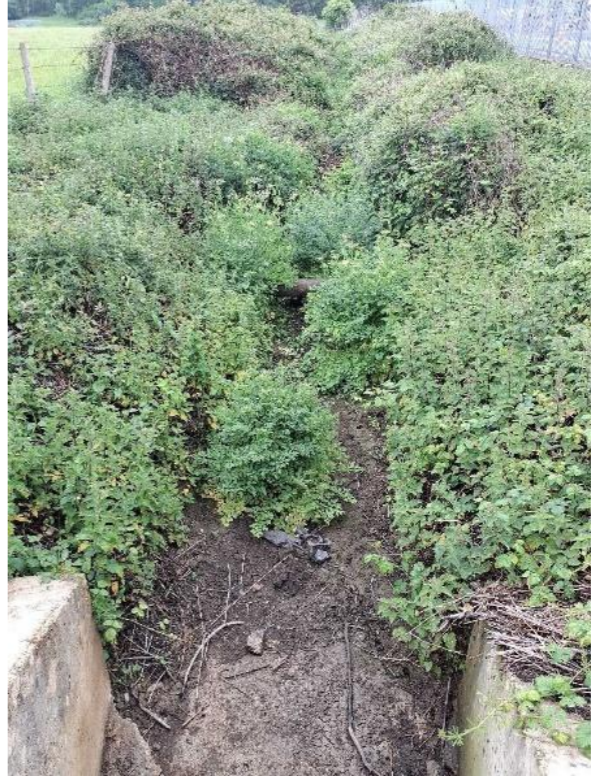
| Crossing Ref | Grid Ref (Easting and Northing) | Designation | Preferred Crossing Methodology | Regulatory Authority | Location | Description | Photograph |
|---|---|---|--|---|---|---|--|
| OW1 | 389853,166121 | Ordinary Watercourse | Cabling Open Cut Access Temporary culvert | Lead Local Flood Authority (LLFA) | Cable Route Corridor | Shallow drain around the National Grid Melksham substation. Appears to be largely dry and mostly either bare or choked with ruderals, although some marginal vegetation present (e.g. fool's water-cress) indicating periodic inundation. | |

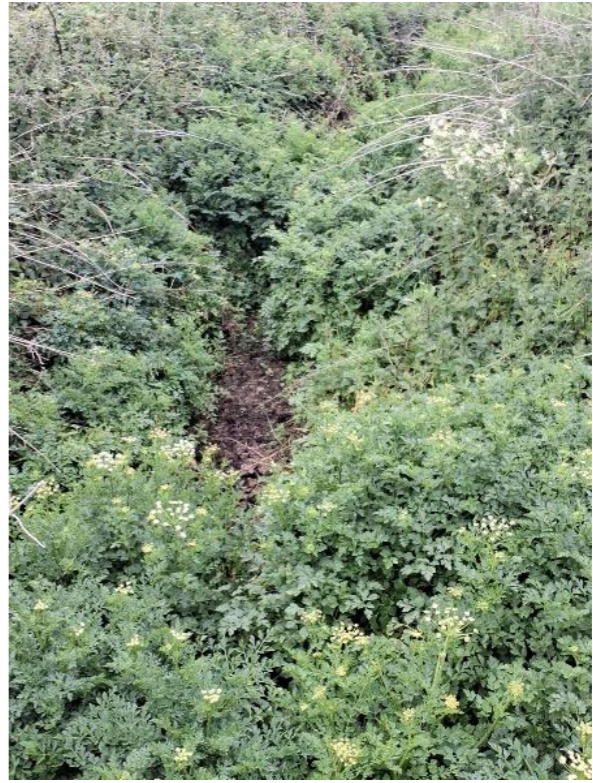
| Crossing Ref | Grid Ref (Easting and Northing) | Designation | Preferred Crossing Methodology | Regulatory Authority | Location | Description | Photograph |
|---|---|---|--|---|---|--|---|
| OW2 | 389417,166527 | Ordinary Watercourse | <u>Cabling</u> Open Cut <u>Access</u> Temporary culvert | LLFA | Cable Route Corridor | Shallow drainage ditch. Appears to be largely dry and mostly either bare or choked with ruderals, although some marginal vegetation present (e.g. fool's water-cress) indicating periodic inundation. | |

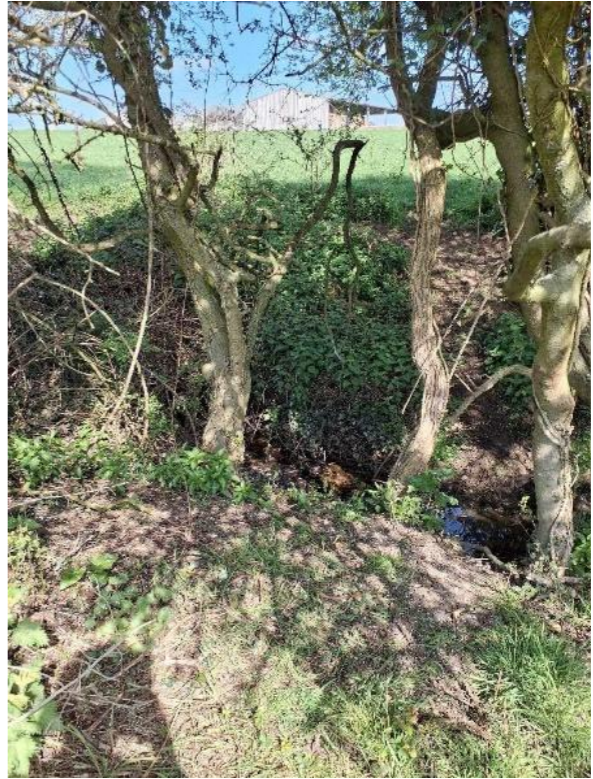
| Crossing Ref | Grid Ref (Easting and Northing) | Designation | Preferred Crossing Methodology | Regulatory Authority | Location | Description | Photograph |
|---|---|---|--|---|---|--|---|
| OW3 | 389192,170410 | Ordinary Watercourse | <u>Cabling</u> Open Cut <u>Access</u> Temporary culvert | LLFA | Cable Route Corridor | A section of an unnamed stream which appears to eventually discharge into the River Avon, although also appears to be poorly connected on account of several large, culverted sections downstream, two of which appear to be over 100 m in length. The stream held circa 0.2 m deep water with a smooth flow over a largely silt and earth substrate. 1 m wide with low, shallow banks vegetated with riparian trees, shrubs, herbs and grasses. | |

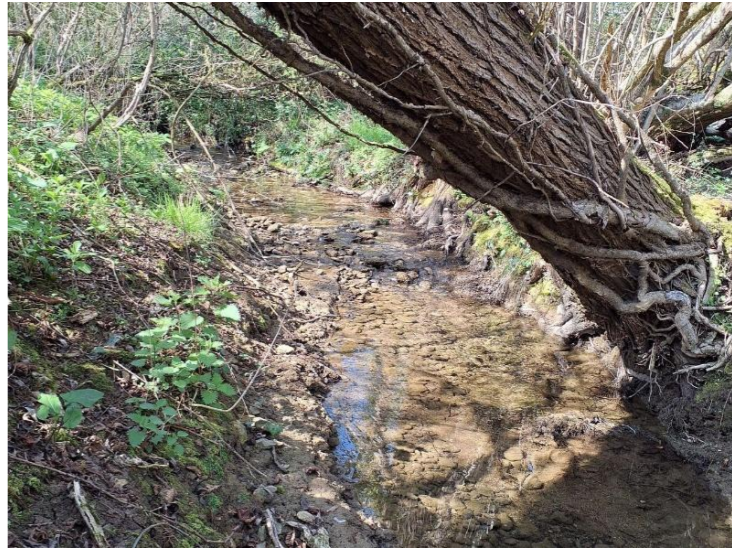
| Crossing Ref | Grid Ref (Easting and Northing) | Designation | Preferred Crossing Methodology | Regulatory Authority | Location | Description | Photograph |
|---|---|---|--|---|---|---|--|
| OW4 | 388376,172528 | Ordinary Watercourse | <u>Cabling</u> HDD <u>Access</u> N/A | LLFA | Cable Route Corridor | A section of a tributary of the Pudding Brook. A stream holding circa 0.2 m deep and clear water at the time of survey with a smooth flow over a pebble/cobble substrate. 1.7m in width and with steep/vertical earth banks between 0.5 to 3 m in height. Bankside vegetation comprises several trees as well as some short and tall herbs/grasses. | |

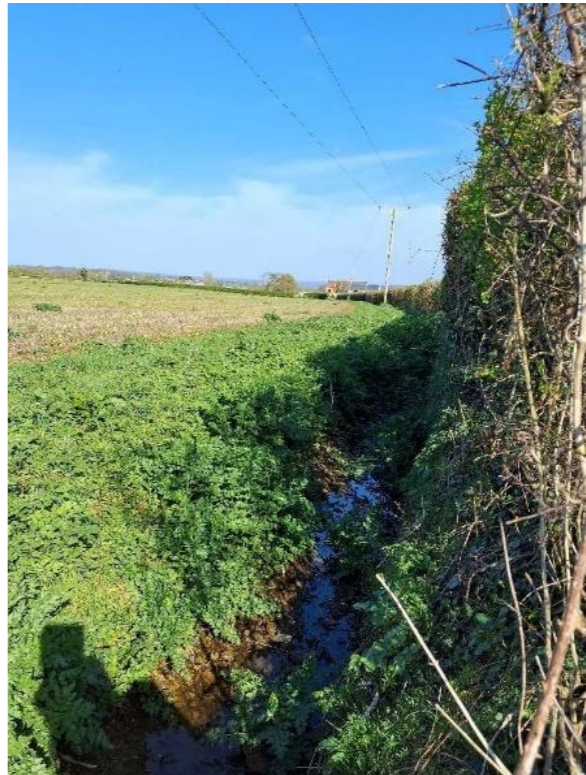
| Crossing Ref | Grid Ref (Easting and Northing) | Designation | Preferred Crossing Methodology | Regulatory Authority | Location | Description | Photograph |
|---|---|---|--|---|---|---|--|
| OW5 | 388139,173372 | Ordinary Watercourse | <u>Cabling</u> Open Cut <u>Access</u> Temporary culvert | LLFA | Cable Route Corridor | Shallow agricultural drainage ditch, 1 m deep and 0.5 m wide. Holding shallow water (0.1 m deep) at the time of survey but likely to regularly dry during the summer months. Overshaded by adjacent hedge and lacking in aquatic/marginal vegetation. | |

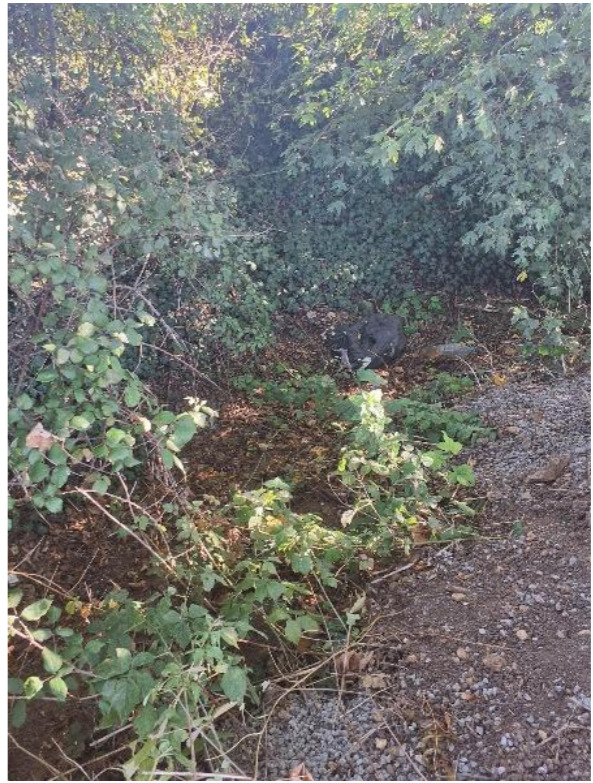
| Crossing Ref | Grid Ref (Easting and Northing) | Designation | Preferred Crossing Methodology | Regulatory Authority | Location | Description | Photograph |
|---|---|---|--|---|---|--|---|
| OW6 | 387274,174846 | Ordinary Watercourse | <u>Cabling</u> HDD <u>Access</u> N/A | LLFA | Cable Route Corridor | Roadside ditch, relatively shallow (up to 1 m deep). Appears to be regularly dry with no aquatic/emergent vegetation present. Mostly bare and overshadowed by adjacent hedgerow and trees. | |

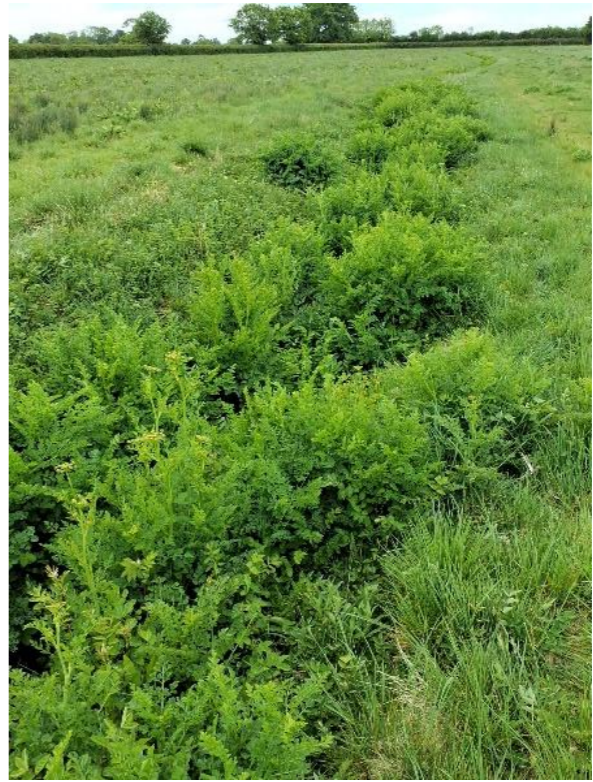
| Crossing Ref | Grid Ref (Easting and Northing) | Designation | Preferred Crossing Methodology | Regulatory Authority | Location | Description | Photograph |
|---|---|---|--|---|---|--|---|
| OW7 | 387315,175276 | Ordinary Watercourse | <u>Cabling</u> Open Cut <u>Access</u> Temporary culvert | LLFA | Cable Route Corridor | An open ditch passing running through the middle of two arable fields. 0.5 m wide holding shallow (0.05 m deep) water. Steep earth banks circa 1m deep, vegetated with a moderate diversity of marginal species indicative of holding water regularly, including meadowsweet, hemlock water-dropwort, great willowherb and fool's water-cress. | |

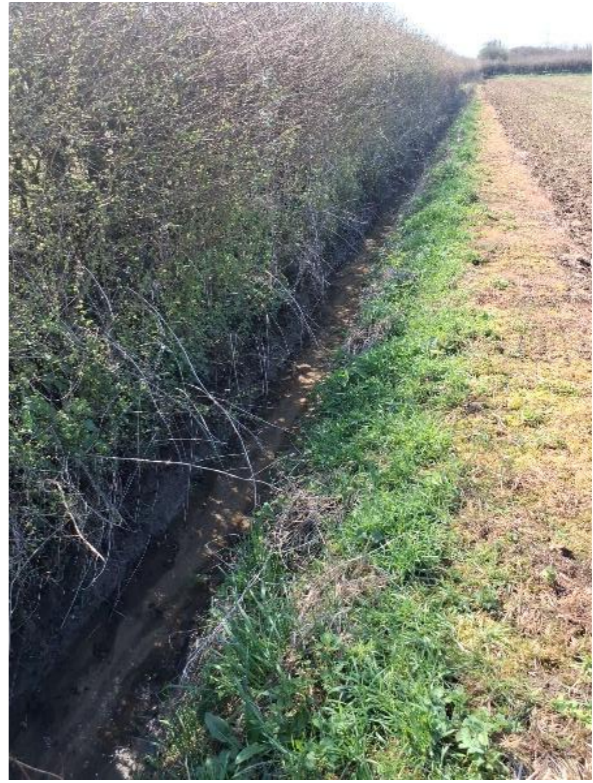
| Crossing Ref | Grid Ref (Easting and Northing) | Designation | Preferred Crossing Methodology | Regulatory Authority | Location | Description | Photograph |
|---|---|---|--|---|---|--|---|
| OW8 | 386411,178511 | Ordinary Watercourse | <u>Cabling</u> Open Cut <u>Access</u> Temporary culvert | LLFA | Cable Route Corridor | Shallow agricultural drainage ditch, 0.8 m deep and 0.5 m wide. Holding shallow water (0.1 m deep) at the time of survey but likely to regularly dry during the summer months. Overshaded by adjacent hedge and lacking in aquatic/marginal vegetation. | |

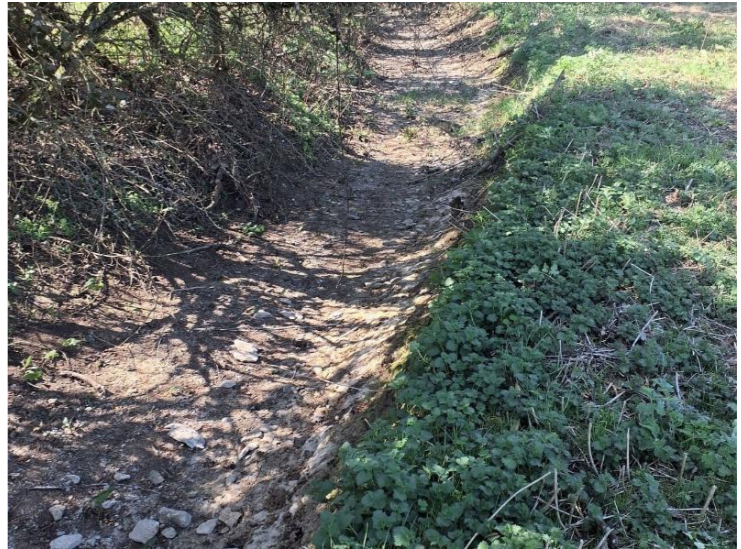
| Crossing Ref | Grid Ref (Easting and Northing) | Designation | Preferred Crossing Methodology | Regulatory Authority | Location | Description | Photograph |
|---|---|---|--|---|---|--|---|
| OW9 | 387081,181894 | Ordinary Watercourse | <u>Cabling</u> HDD <u>Access</u> N/A | LLFA | Cable Route Corridor | A section of a tributary of the River Avon known as Gauze Brook. Dry at the time of survey (April 2025) but likely to hold water seasonally. Shallow but steep earth banks around 1 m in depth. The channel bed was around 2.5 m in width and comprised a dry pebble/cobble substrate. Bankside vegetation mostly comprising short grasses and several mature trees. | |

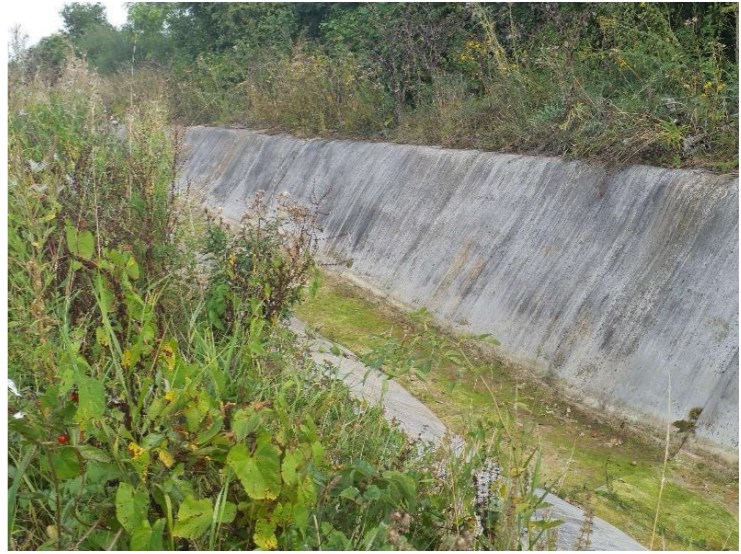
| Crossing Ref | Grid Ref (Easting and Northing) | Designation | Preferred Crossing Methodology | Regulatory Authority | Location | Description | Photograph |
|---|---|---|--|---|---|--|--|
| OW10 | 386207,182876 | Ordinary Watercourse | <u>Cabling</u> Open Cut <u>Access</u> Temporary culvert | LLFA | Cable Route Corridor | Drainage ditch at the base of railway embankment. Heavily modified with steep reinforced banks around 1.5 m deep. Dry at the time of survey with some filamentous algae in the reinforced channel bed. Likely to be wet seasonally. | |

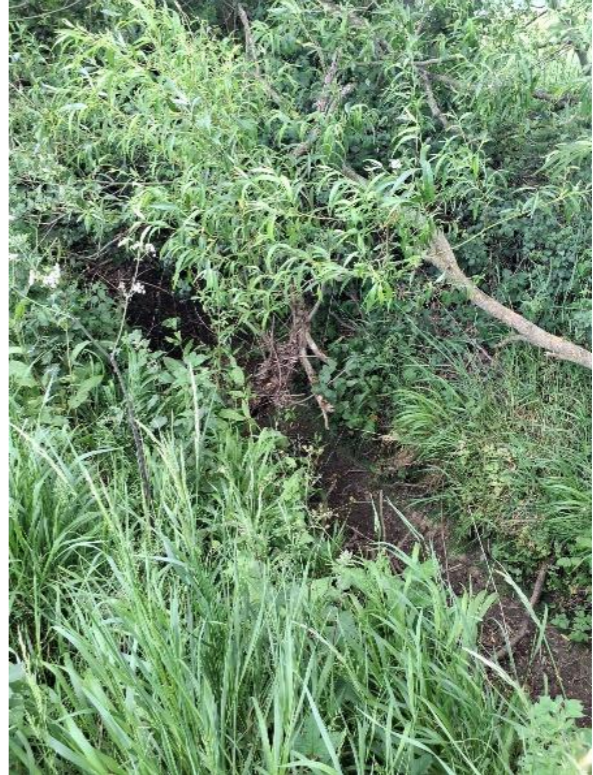
| Crossing Ref | Grid Ref (Easting and Northing) | Designation | Preferred Crossing Methodology | Regulatory Authority | Location | Description | Photograph |
|---|---|---|--|---|---|--|--|
| OW11 | 388084,183521 | Ordinary Watercourse | <u>Cabling</u> Open Cut <u>Access</u> Temporary culvert | LLFA | Cable Route Corridor | A section of a small tributary of the River Avon. A small stream dry at the time of survey but likely to hold water seasonally, with some marginal vegetation occasionally present. 0.5 m x 0.5 m deep and wide with earth substrate. Overshaded by adjacent hedgerow. Bankside vegetation comprises hedgerow shrubs, coarse grasses and ruderals. | |

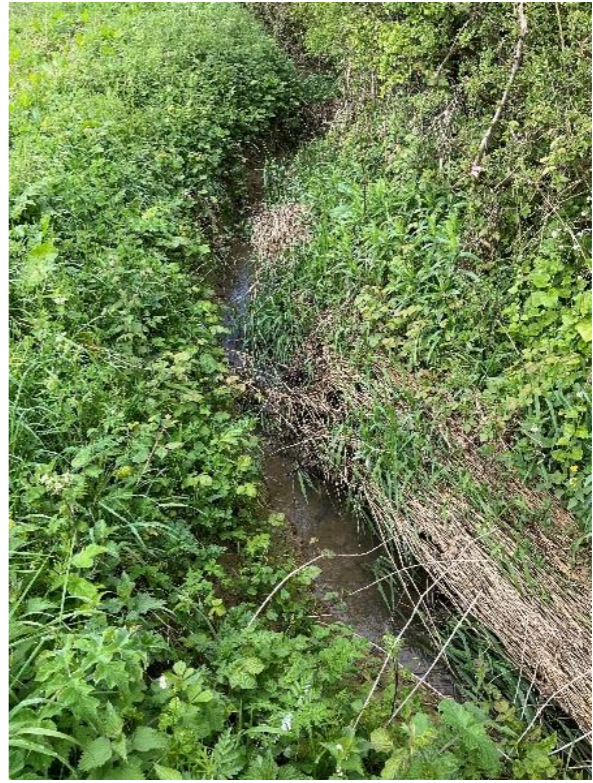
| Crossing Ref | Grid Ref (Easting and Northing) | Designation | Preferred Crossing Methodology | Regulatory Authority | Location | Description | Photograph |
|---|---|---|--|---|---|---|---|
| OW12 | 387570,184171 | Ordinary Watercourse | <u>Cabling</u> Open Cut <u>Access</u> Temporary culvert | LLFA | Cable Route Corridor | A section of a small tributary of the River Avon. A stream holding circa 0.2 m deep and fairly clear water at the time of survey, with no apparent flow and over a sandy/silt substrate with occasional pebbles. 1 m in width and with steep earth banks up to 1 m in height. Overshaded by adjacent hedgerow but with some marginal vegetation present including meadowsweet and hemlock water-dropwort, along with coarse grasses and ruderals. | |

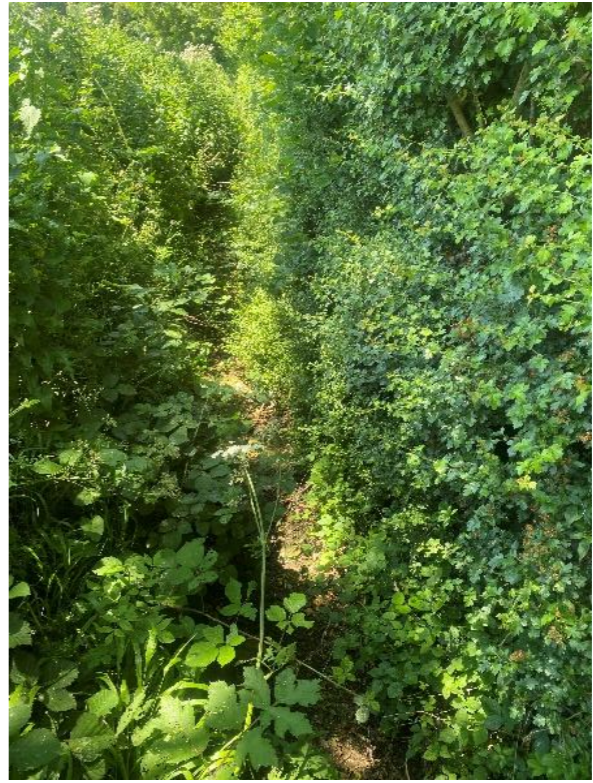
| Crossing Ref | Grid Ref (Easting and Northing) | Designation | Preferred Crossing Methodology | Regulatory Authority | Location | Description | Photograph |
|---|---|---|--|---|---|--|---|
| OW14 | 386381,183875 | Ordinary Watercourse | <u>Cabling</u> Open Cut <u>Access</u> Temporary culvert | LLFA | Cable Route Corridor | A section of ditch passing through mature woodland and at the edge of an arable field. Dry at the time of survey although damp, bare earth channel bed indicative of periodic inundation. Circa 1m wide with 1-1.5 m steep earth banks. Overshaded by woodland, with vegetation limited to ruderals, coarse grasses and bramble. | |

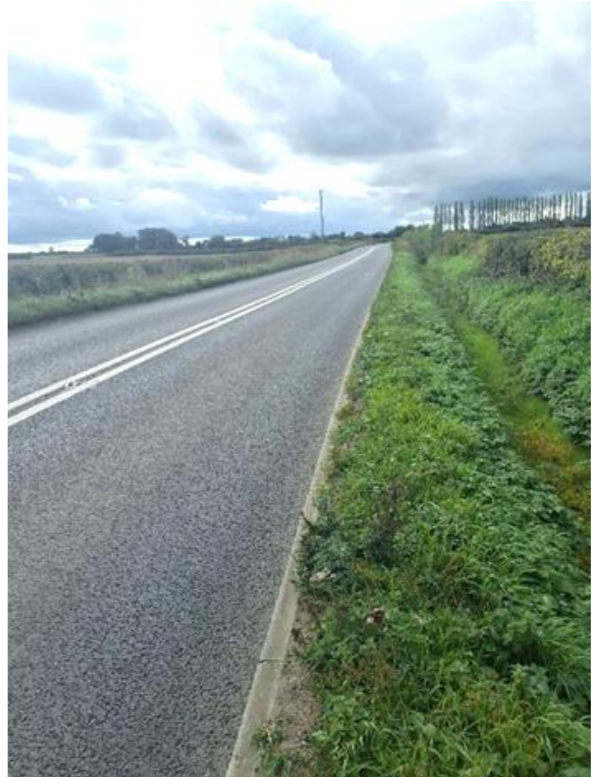
| Crossing Ref | Grid Ref (Easting and Northing) | Designation | Preferred Crossing Methodology | Regulatory Authority | Location | Description | Photograph |
|---|---|---|--|---|---|--|---|
| OW15 | 391794,183143 | Ordinary Watercourse | <u>Cabling</u> Open Cut <u>Access</u> Temporary culvert | LLFA | Cable Route Corridor | Roadside ditch. Relatively shallow (1 m deep) and narrow (0.5 m wide) likely to be dry for most of the year. Vegetated with grasses and ruderals with no aquatic/marginal vegetation. | |

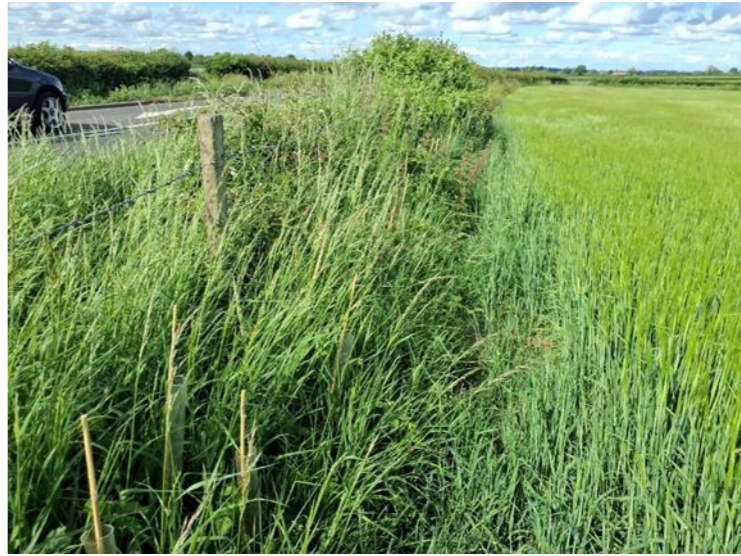
| Crossing Ref | Grid Ref (Easting and Northing) | Designation | Preferred Crossing Methodology | Regulatory Authority | Location | Description | Photograph |
|---|---|---|--|---|---|--|---|
| OW16 | 392061,183381 | Ordinary Watercourse | Cabling Open Cut Access Temporary culvert | LLFA | Cable Route Corridor | Roadside ditch. Relatively shallow (1 m deep) and narrow (0.5 m wide) likely to be dry for most of the year. Vegetated with grasses and ruderals with no aquatic/marginal vegetation. | |

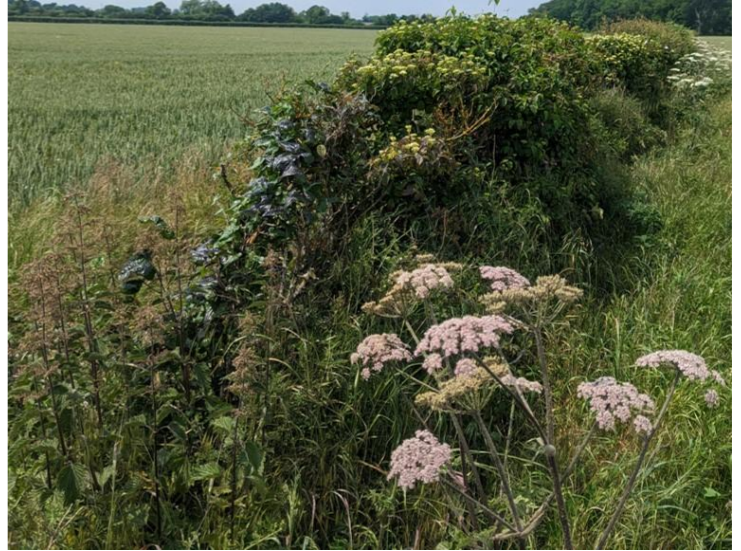
| Crossing Ref | Grid Ref (Easting and Northing) | Designation | Preferred Crossing Methodology | Regulatory Authority | Location | Description | Photograph |
|---|---|---|--|---|---|--|---|
| OW18 | 386392,182728 | Ordinary Watercourse | Cabling Open Cut Access Existing culvert | LLFA | Solar PV Sites: Lime Down C | Dry ditch at the base of hedgerow. 0.5 m deep and 0.5 m wide, with earth banks vegetated with coarse grasses and ruderals. Unlikely to regularly hold water. | |

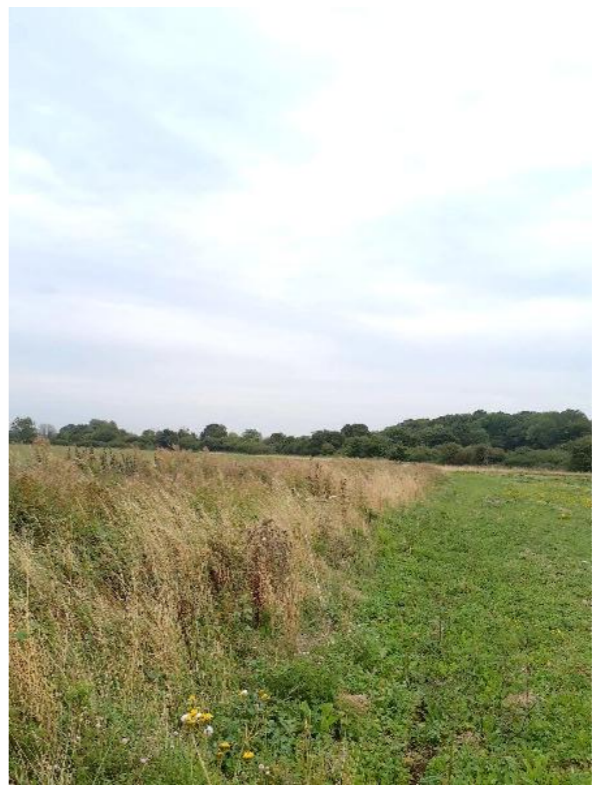
| Crossing Ref | Grid Ref (Easting and Northing) | Designation | Preferred Crossing Methodology | Regulatory Authority | Location | Description | Photograph |
|---|---|---|---|---|---|---|---|
| OW19 | 385047,182912 | Ordinary Watercourse | Cabling Open Cut Access Existing culvert | LLFA | Solar PV Sites: Lime Down C | A dry ditch circa 1 m deep and 1 m wide. Earth banks dominated by coarse grasses and tall ruderals with no aquatic vegetation present. Likely to hold water for short periods over the winter only. | |

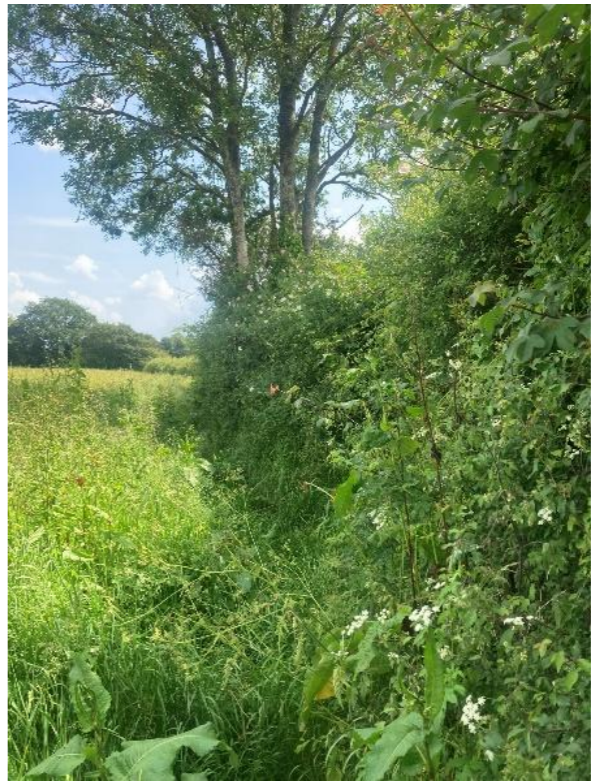
| Crossing Ref | Grid Ref (Easting and Northing) | Designation | Preferred Crossing Methodology | Regulatory Authority | Location | Description | Photograph |
|---|---|---|---|---|---|---|---|
| OW20 | 387696,184980 | Ordinary Watercourse | Cabling Open Cut Access Existing culvert | LLFA | Solar PV Sites: Lime Down B | Dry and shallow ditch at base of hedgerow. 0.5 m deep and 0.5 m wide. Vegetated with grasses and ruderals with no aquatic vegetation. Unlikely to regularly hold water. | |

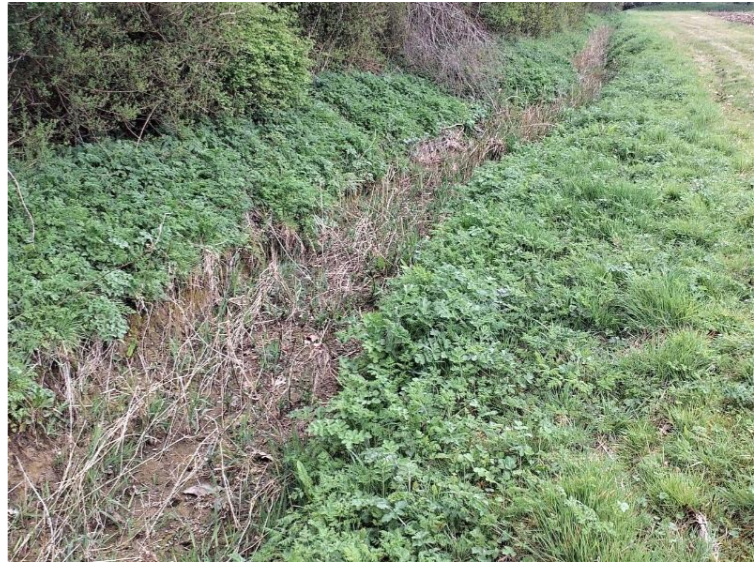
| Crossing Ref | Grid Ref (Easting and Northing) | Designation | Preferred Crossing Methodology | Regulatory Authority | Location | Description | Photograph |
|---|---|---|--|---|---|---|--|
| OW21 | 388277,185155 | Ordinary Watercourse | Cabling Open Cut Access Existing culvert | LLFA | Solar PV Sites: Lime Down B | A section of a small tributary of the River Avon. Dry at the time of survey but likely to hold water seasonally as evidenced by occasional presence of common reed. Shallow but steep earth banks around 0.5 to 1 m in depth. The channel bed was around 2 m in width and comprised a dry pebble/cobble and silted substrate. Bankside vegetation mostly comprised coarse grasses and ruderals as well as a plantation woodland to the south. | |

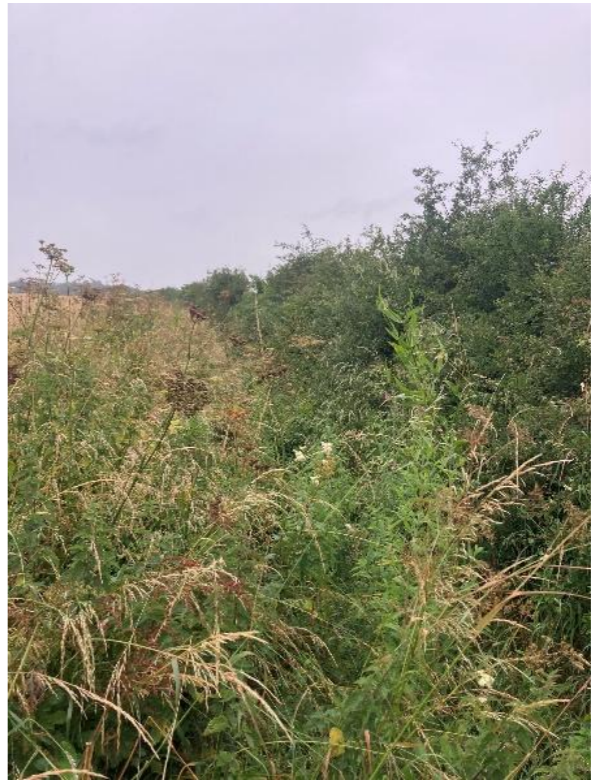
| Crossing Ref | Grid Ref (Easting and Northing) | Designation | Preferred Crossing Methodology | Regulatory Authority | Location | Description | Photograph |
|---|---|---|--|---|---|---|--|
| OW22 | 389093,183583 | Ordinary Watercourse | Cabling Open Cut Access New permanent culvert | LLFA | Solar PV Sites: Lime Down D | Dry ditch at the southern base of a hedgerow. Approximately 1.5 m deep and 0.75 m wide with steep earth banks. Overshaded by hedgerow and vegetated with coarse grasses and ruderals with little aquatic/marginal vegetation. Unlikely to hold water regularly. | |

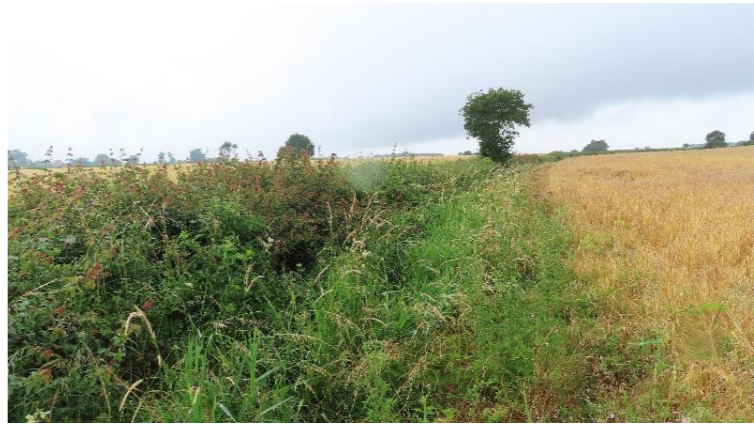
| Crossing Ref | Grid Ref (Easting and Northing) | Designation | Preferred Crossing Methodology | Regulatory Authority | Location | Description | Photograph |
|---|---|---|--|---|---|--|--|
| OW23 | 390083,183521 | Ordinary Watercourse | Cabling Open Cut Access New permanent culvert | LLFA | Solar PV Sites: Lime Down D | Dry ditch at the northern base of a hedgerow. Approximately 1 m deep and 0.5 m wide with steep earth banks, vegetated primarily by coarse grasses and ruderals. Unlikely to hold water regularly, but occasional marginal plants such as meadowsweet were present indicating periodic inundation. | |

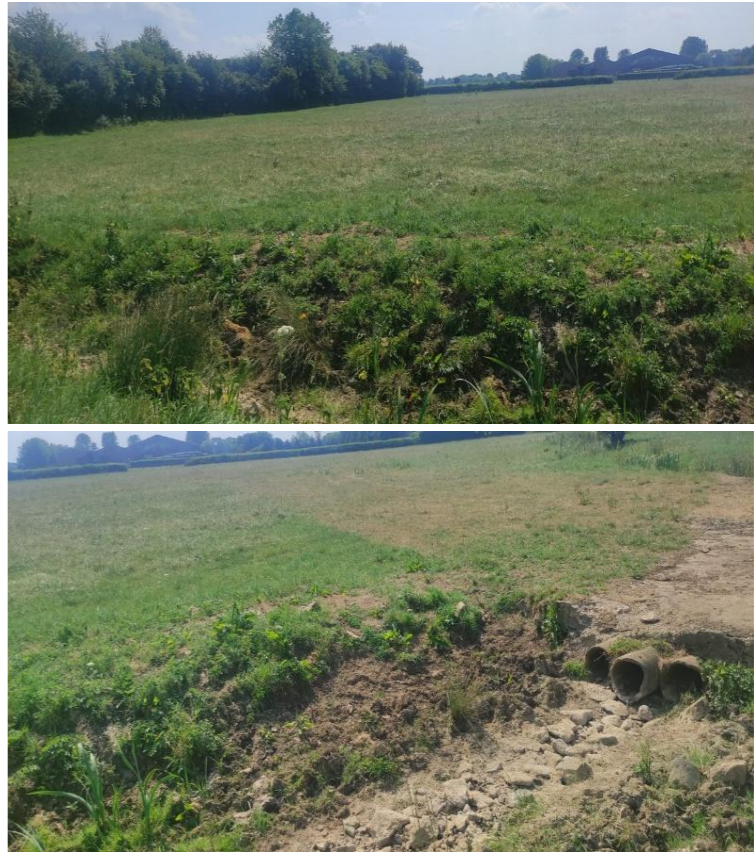
| Crossing Ref | Grid Ref (Easting and Northing) | Designation | Preferred Crossing Methodology | Regulatory Authority | Location | Description | Photograph |
|---|---|---|--|---|---|--|--|
| OW24 | 392044,181928 | Ordinary Watercourse | Cabling Open Cut Access Existing culvert | LLFA | Solar PV Sites: Lime Down E | A section of a tributary of the Gabriel's Well watercourse, which is heavily culverted. This was a small, open and predominantly dry feature with either bare or grassy channel bed and banksides indicating regular drying out, although common reed was noted indicated periodic inundation. Steep, earth banksides around 1.5 to 2 m deep. The stream was circa 2 m wide with a channel bed of earth, pebble and cobble substrate. Bankside vegetation typically comprised short, grazed grass and herbs. | |

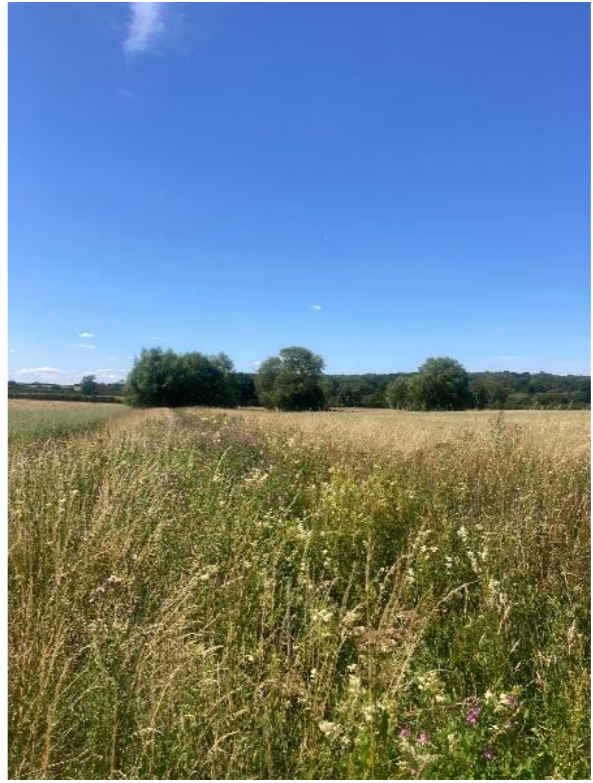
| Crossing Ref | Grid Ref (Easting and Northing) | Designation | Preferred Crossing Methodology | Regulatory Authority | Location | Description | Photograph |
|---|---|---|--|---|---|--|---|
| OW25 | 392681,181548 | Ordinary Watercourse | Cabling Open Cut Access New permanent culvert | LLFA | Solar PV Sites: Lime Down E | Dry ditch, approximately 1 m deep and 0.5 m wide with steep earth banks, vegetated primarily by coarse grasses and ruderals. Unlikely to hold water regularly, but occasional marginal plants such as meadowsweet were present indicating periodic inundation. | |

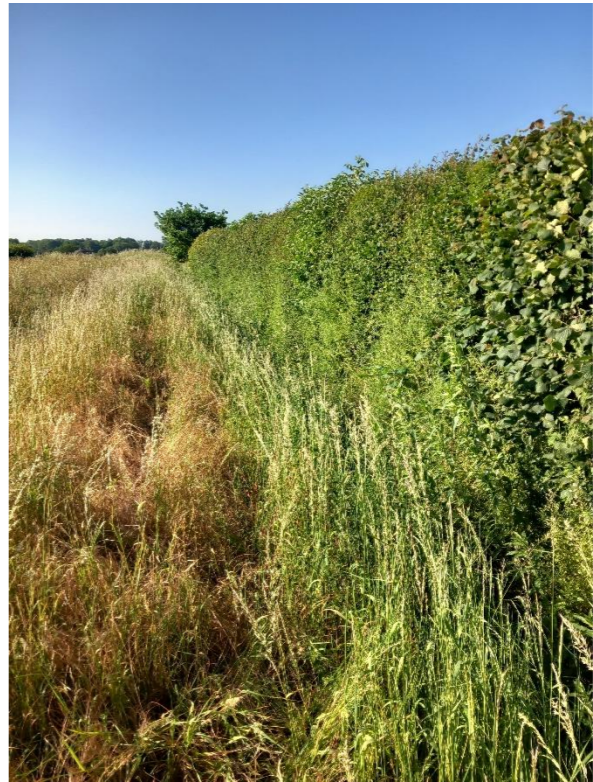
| Crossing Ref | Grid Ref (Easting and Northing) | Designation | Preferred Crossing Methodology | Regulatory Authority | Location | Description | Photograph |
|---|---|---|--|---|---|--|---|
| OW26 | 388801,185134 | Ordinary Watercourse | Cabling Open Cut Access Existing culvert | LLFA | Solar PV Sites: Lime Down B | Dry ditch, approximately 1 m deep and 1 m wide with steep earth banks. Vegetated primarily with coarse grasses and ruderals. Occasional great willowherb present indicating periodic inundation but highly likely to be dry for most of the year. | |

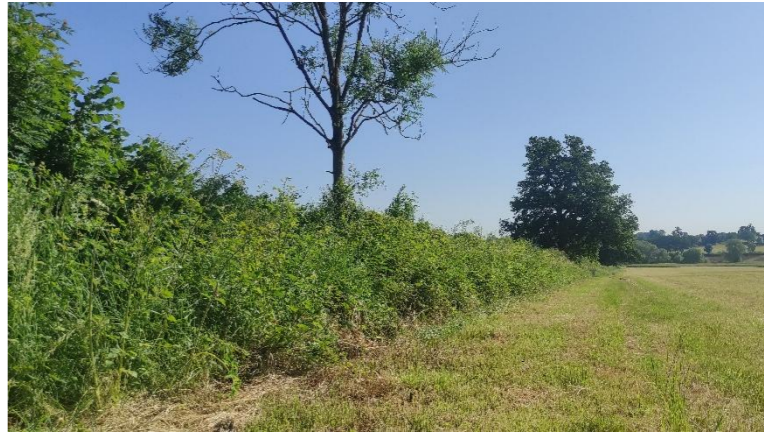
| Crossing Ref | Grid Ref (Easting and Northing) | Designation | Preferred Crossing Methodology | Regulatory Authority | Location | Description | Photograph |
|---|---|---|--|---|---|--|--|
| OW27 | 392508,181657 | Ordinary Watercourse | Cabling Open Cut Access New permanent culvert | LLFA | Solar PV Sites: Lime Down E | Dry ditch at the base of hedgerow. 1 m deep and 1 m wide, with steep earth banks vegetated with coarse grasses and ruderals. Unlikely to regularly hold water. | |

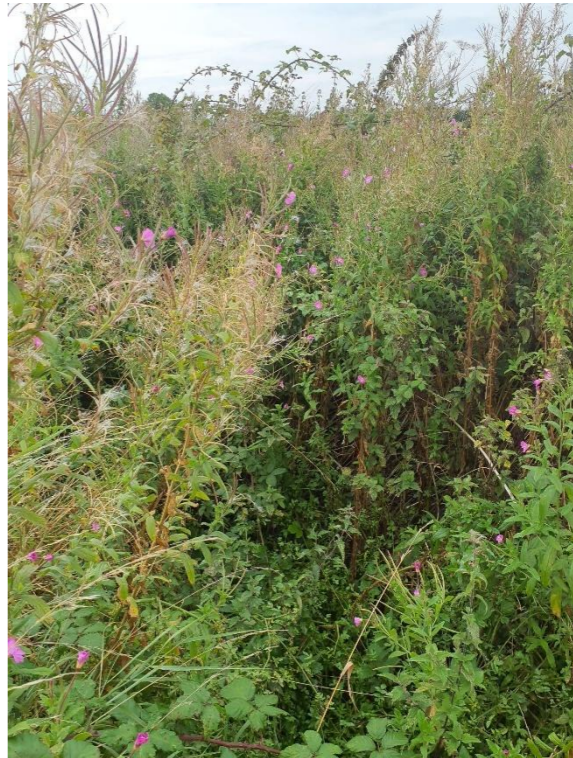
| Crossing Ref | Grid Ref (Easting and Northing) | Designation | Preferred Crossing Methodology | Regulatory Authority | Location | Description | Photograph |
|---|---|---|--|---|---|--|--|
| OW28 | 385421,182915 | Ordinary Watercourse | Cabling Open Cut Access New permanent culvert | LLFA | Solar PV Sites: Lime Down C | Drain running between two agricultural fields. Approximately 1 m wide with 1 m deep, steep earth banks. Damp ground present at the channel bed. The channel was choked with a range of vegetation including species such as great willowherb, meadowsweet and water mint indicative of holding water seasonally. | |

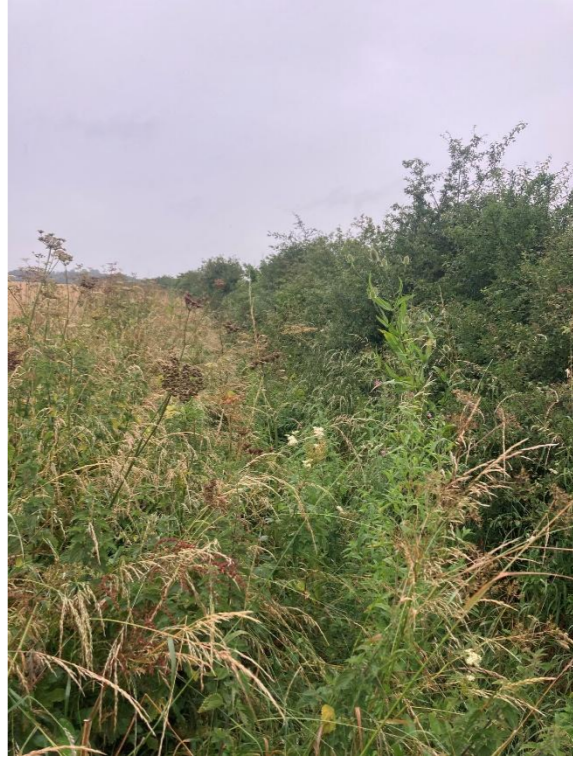
| Crossing Ref | Grid Ref (Easting and Northing) | Designation | Preferred Crossing Methodology | Regulatory Authority | Location | Description | Photograph |
|---|---|---|--|---|---|---|---|
| OW29 | 388499, 183270 | Ordinary Watercourse | Cabling Open Cut Access New permanent culvert | LLFA | Solar PV Sites: Lime Down D | A drainage ditch along the southern side of a field boundary hedgerow. The ditch is approximately 1 m wide with 1 m deep, steep earth banks. The ditch was dry at the time of survey and mostly vegetated with ruderals, such as nettles, hogweed, docks and cleavers. However, some marginal vegetation indicative of occasionally wet or damp ground was noted in the channel, including great willowherb and common figwort. | |

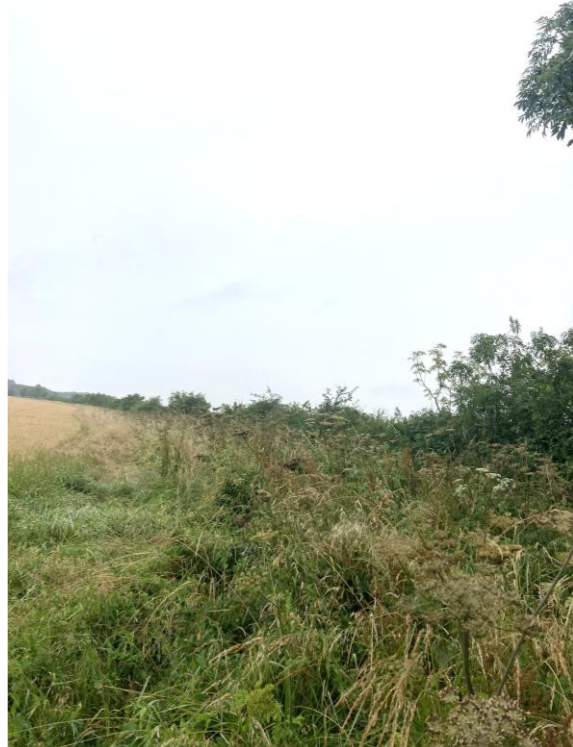
| Crossing Ref | Grid Ref (Easting and Northing) | Designation | Preferred Crossing Methodology | Regulatory Authority | Location | Description | Photograph |
|---|---|---|--|---|---|---|---|
| OW30 | 388651, 183345 | Ordinary Watercourse | Cabling Open Cut Access New permanent culvert | LLFA | Solar PV Sites: Lime Down D | A drainage ditch along the southern side of a field boundary hedgerow. The ditch is approximately 1 m wide with 1 m deep, steep earth banks. The ditch was dry at the time of survey and mostly vegetated with ruderals, such as nettles, hogweed, docks and cleavers. However, some marginal vegetation indicative of occasionally wet or damp ground was noted in the channel, including great willowherb and common figwort. | |

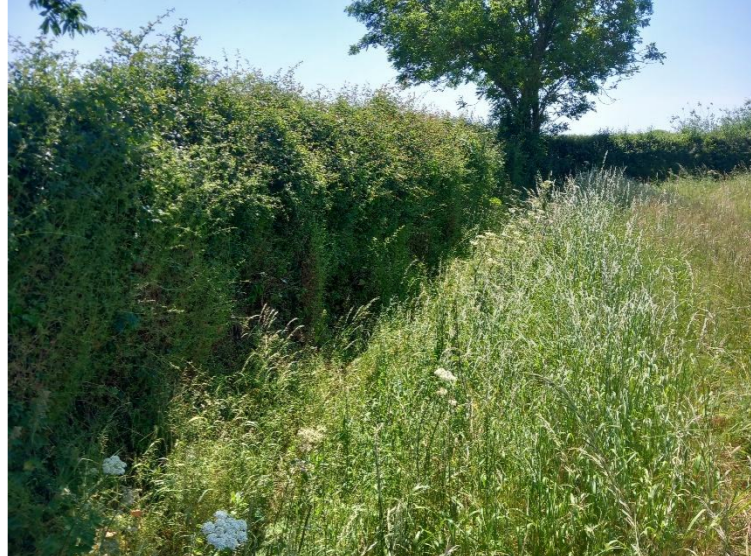
| Crossing Ref | Grid Ref (Easting and Northing) | Designation | Preferred Crossing Methodology | Regulatory Authority | Location | Description | Photograph |
|---|---|---|---|---|---|--|---|
| OW31 | 388103,185398 | Ordinary Watercourse | <p>Cabling Open Cut</p> <p>Access New permanent culvert</p> | LLFA | Solar PV Sites: Lime Down B | A drainage ditch along the north-eastern side of a field boundary hedgerow. The ditch is approximately 2 m wide with 1.25 m deep, earth banks. The ditch was dry at the time of survey somewhat overshadowed by the adjacent hedgerow, The ditch banks and channel were mostly vegetated with grasses. However, some marginal vegetation indicative of occasionally wet or damp ground was noted in the channel, including great willowherb. | |
