Green Hill Solar Farm

Appendix 22.3: Detailed Unexploded

Ordnance Risk Assessment

Stage 2 Detailed Explosive Ordnance Risk Assessment

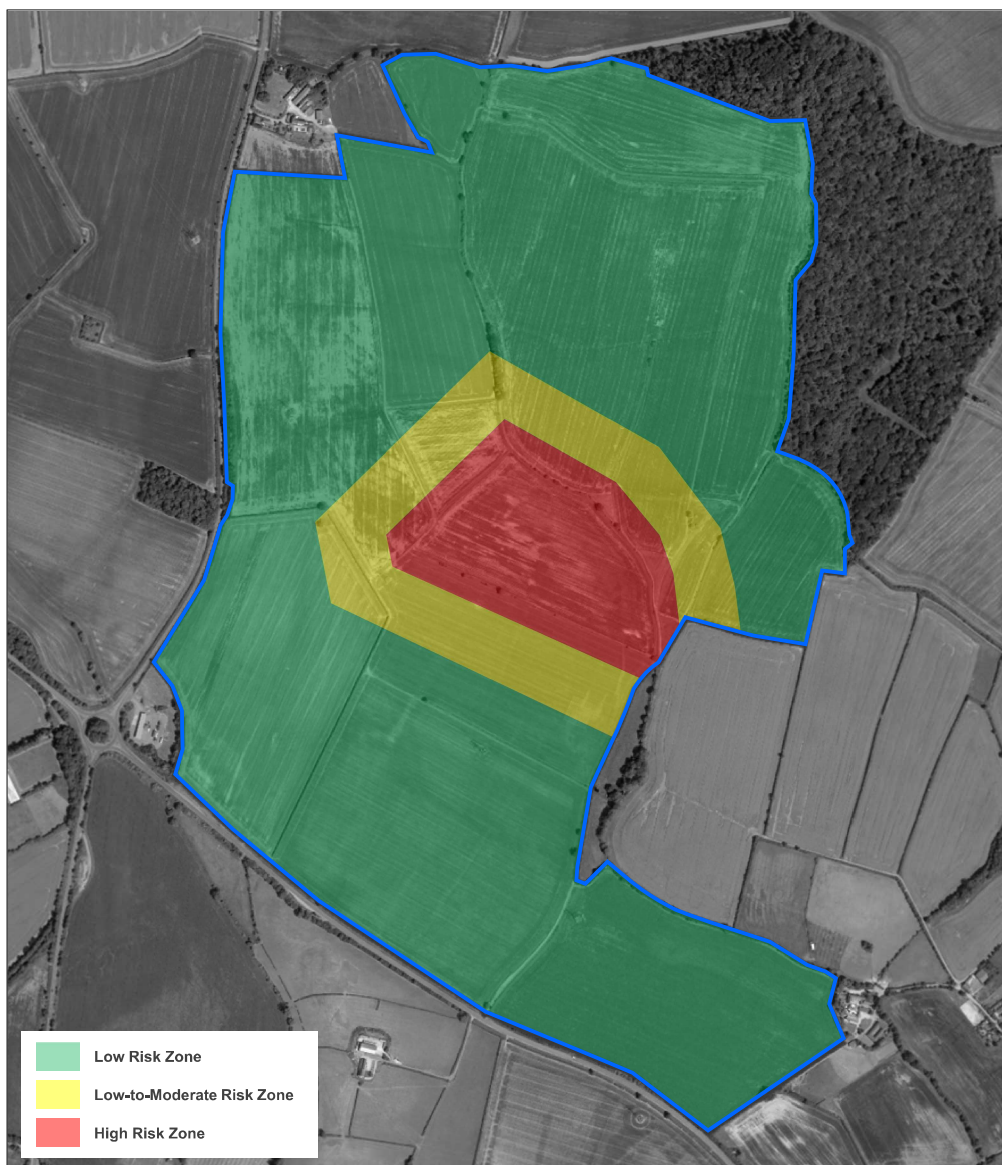
Risk Map

Conclusion	Explosive ordnance (EO) poses a varying risk. Three risk zones have been identified.
Recommendation(s)	Low Risk
	Low-to-Moderate Risk
	High Risk
	<p>EO Safety & Awareness Briefing to all Site personnel prior to breaking ground anywhere on Site.</p> <p>EO Safety Instructions / Emergency Response Plan to be held on Site for the duration of the ground works within the Low Risk and Low-to-Moderate Risk zones.</p> <p>EOD Engineer Supervision: 'Watching brief' in support of any mechanical excavations within the High Risk Zone only.</p> <p>Intrusive Magnetometer Survey of all/ any pile positions within the High Risk Zone only.</p> <p>Note, if subsequent phases of archaeological excavations are required, the above recommendations are appropriate for any such ground works.</p>
The Site	Site address: London Road, Warrington, Milton Keynes Borough, Buckinghamshire, MK46 4JQ. The Site is centred on the approximate National Grid Ref: SP 90569 55329.

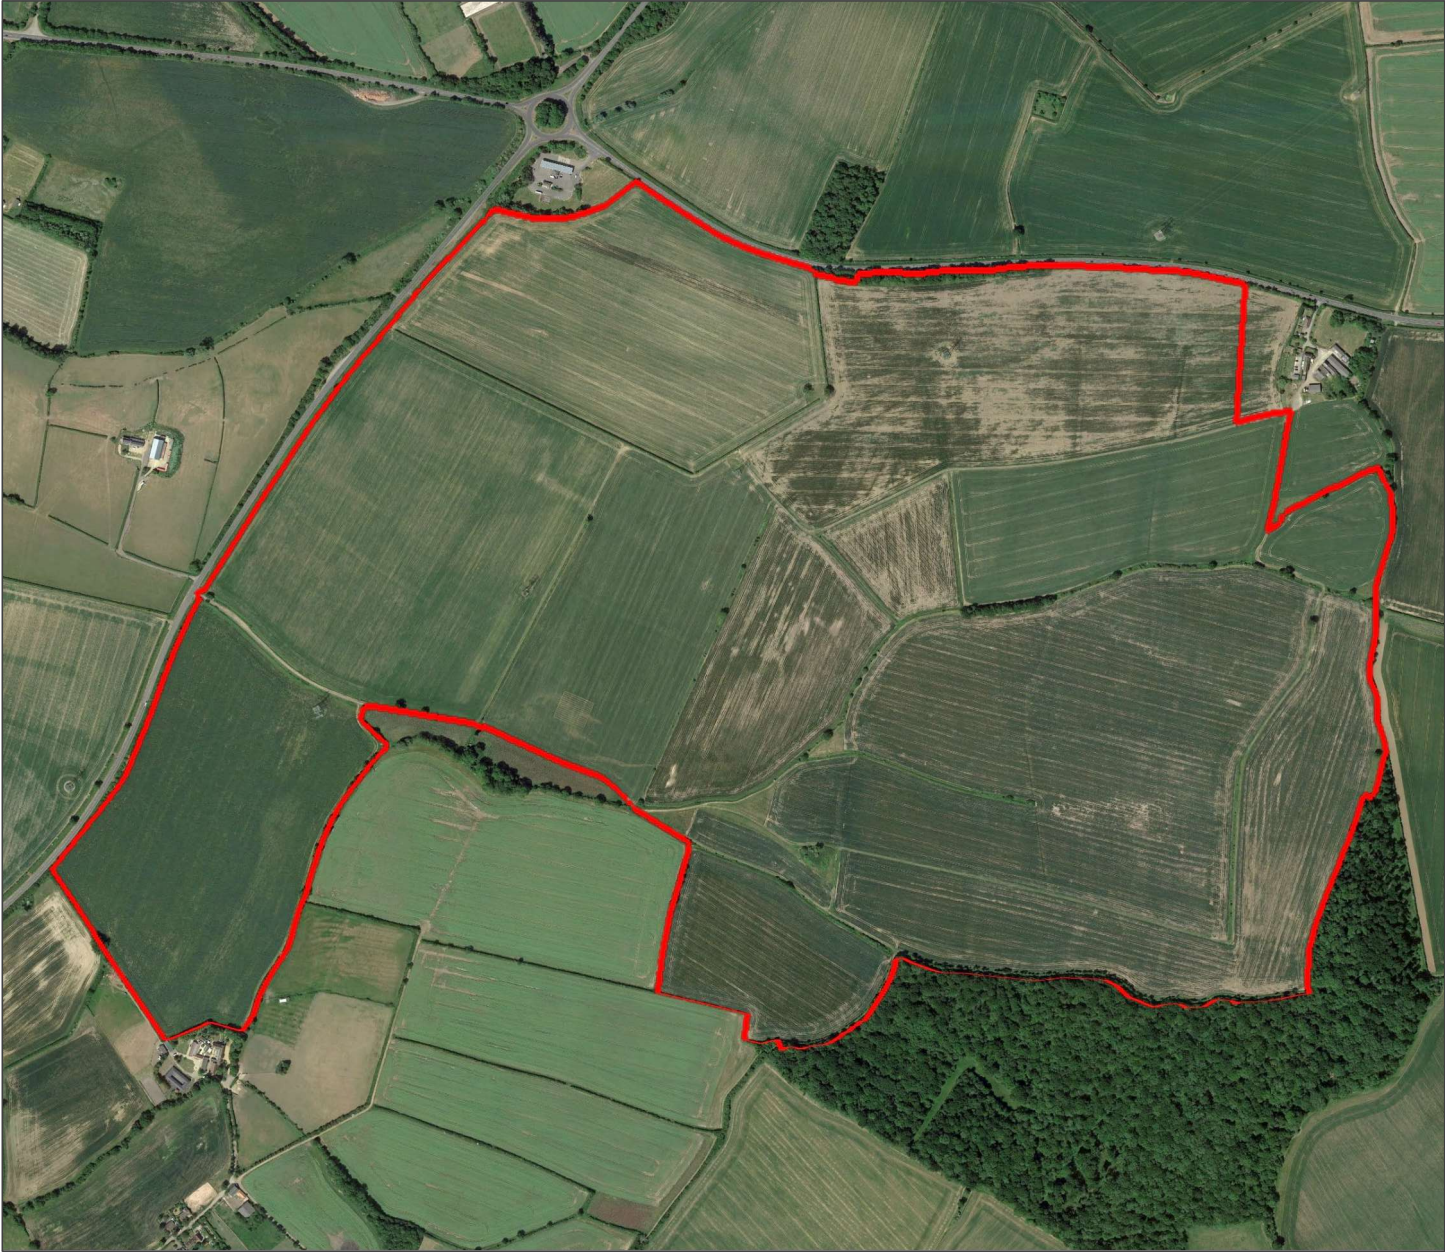
Figure: 01.0

Figure Title:
Recent Aerial Photograph

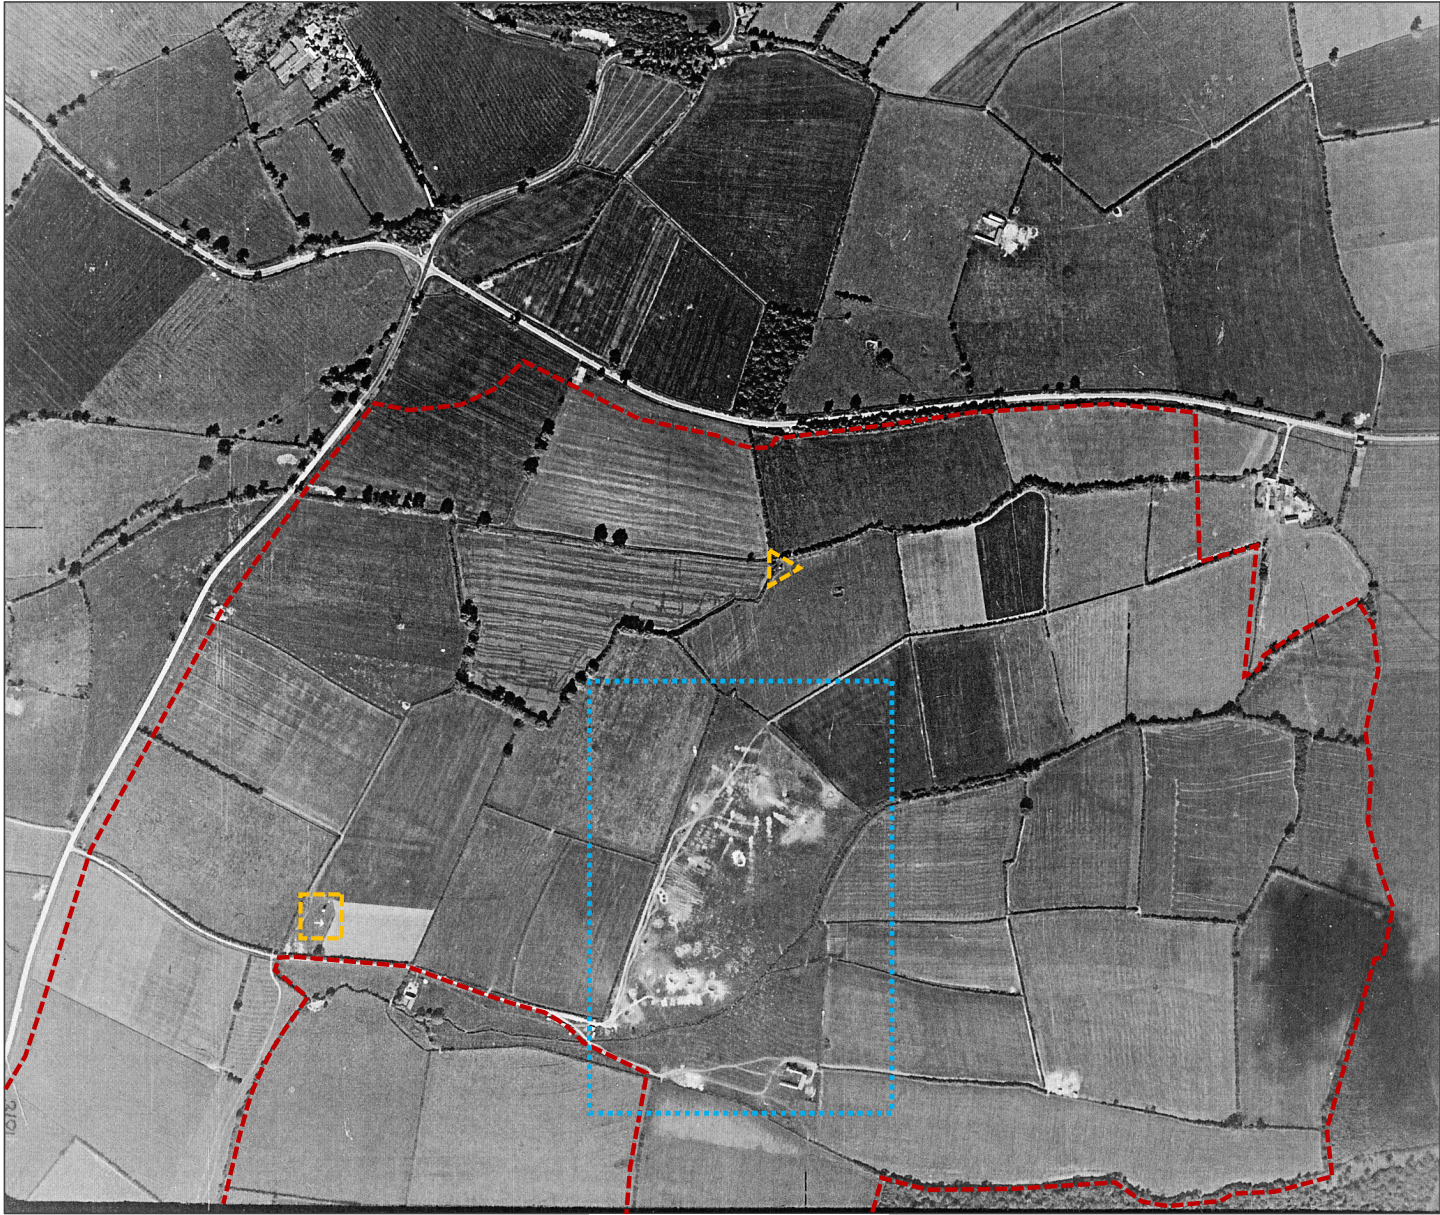
Figure: 03.2

Figure Title:
Historic Aerial Photography:
7th June 1946

- Approx. Site boundary
- See Figure 3.2
- Bombing range structures (2No. danger area quadrants and 1No. concrete navigation arrow)

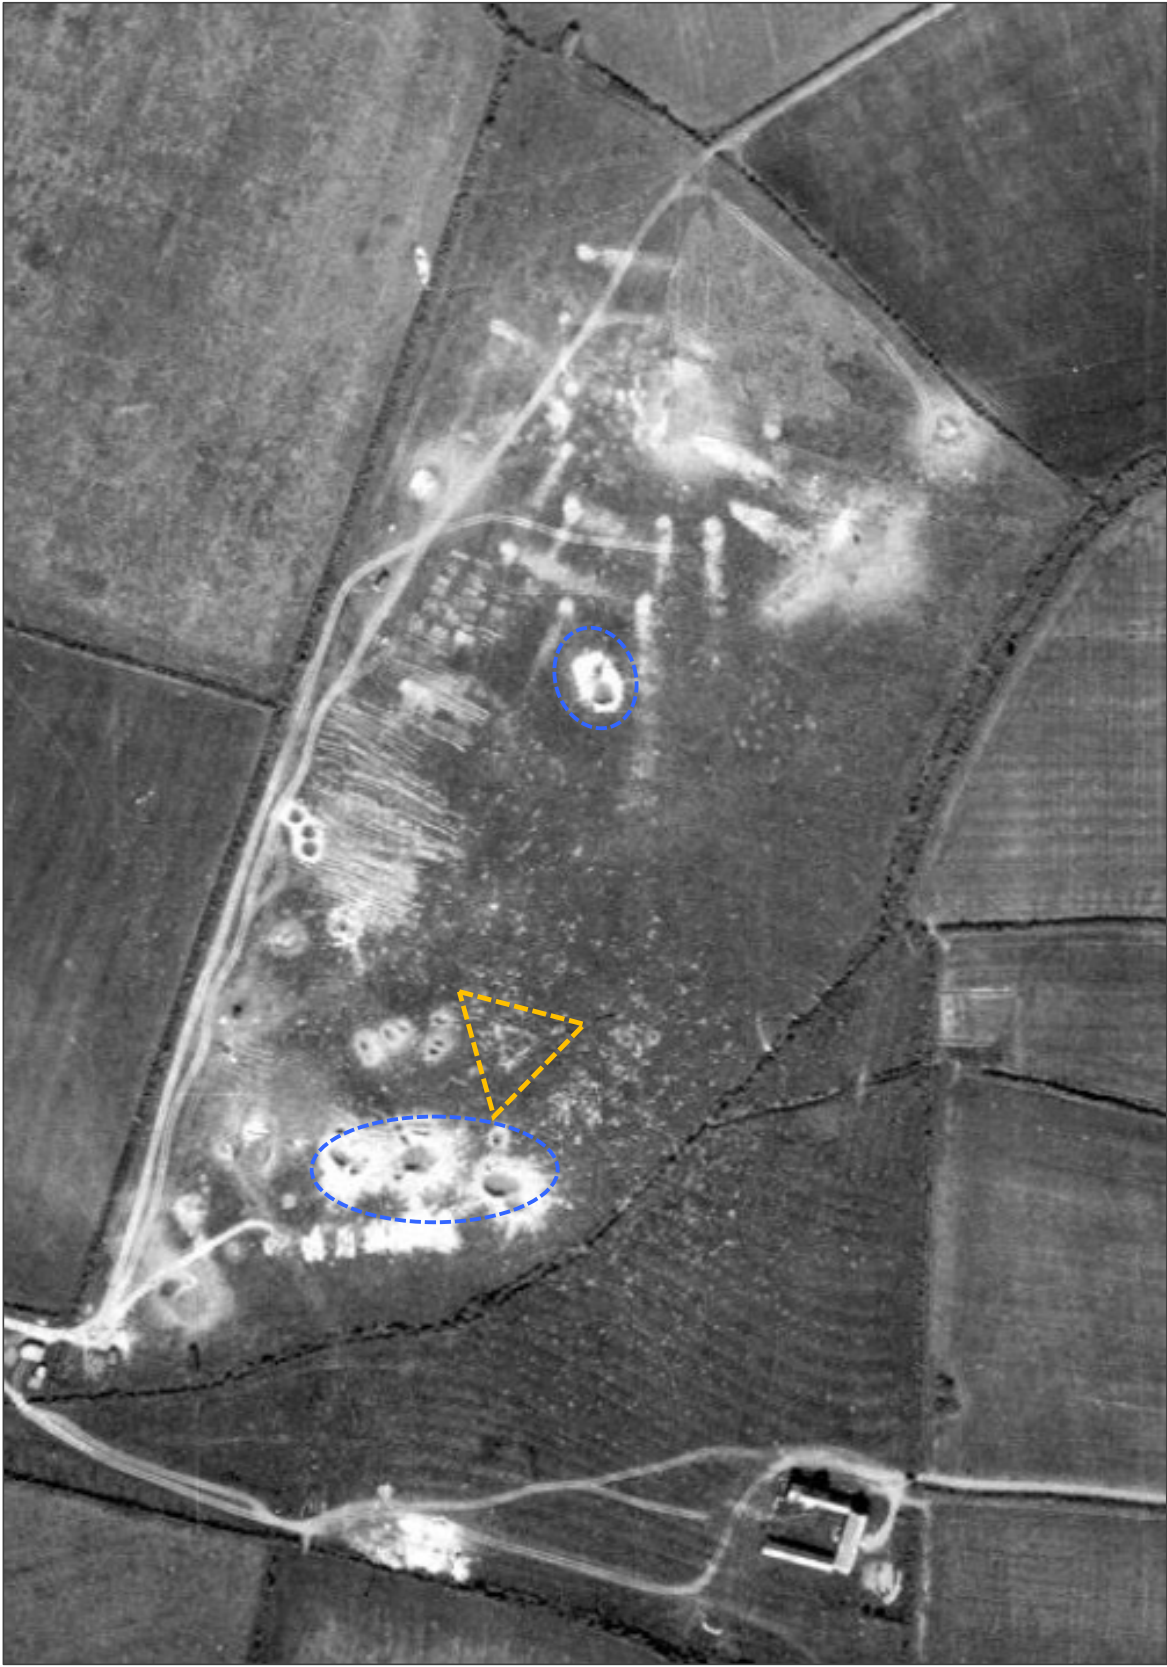
Figure: 03.3

Figure Title:
Historic Aerial Photography:
7th June 1946

- Approx. Site boundary
- Former practice bombing range target marker
- Crater-like (not circular features)

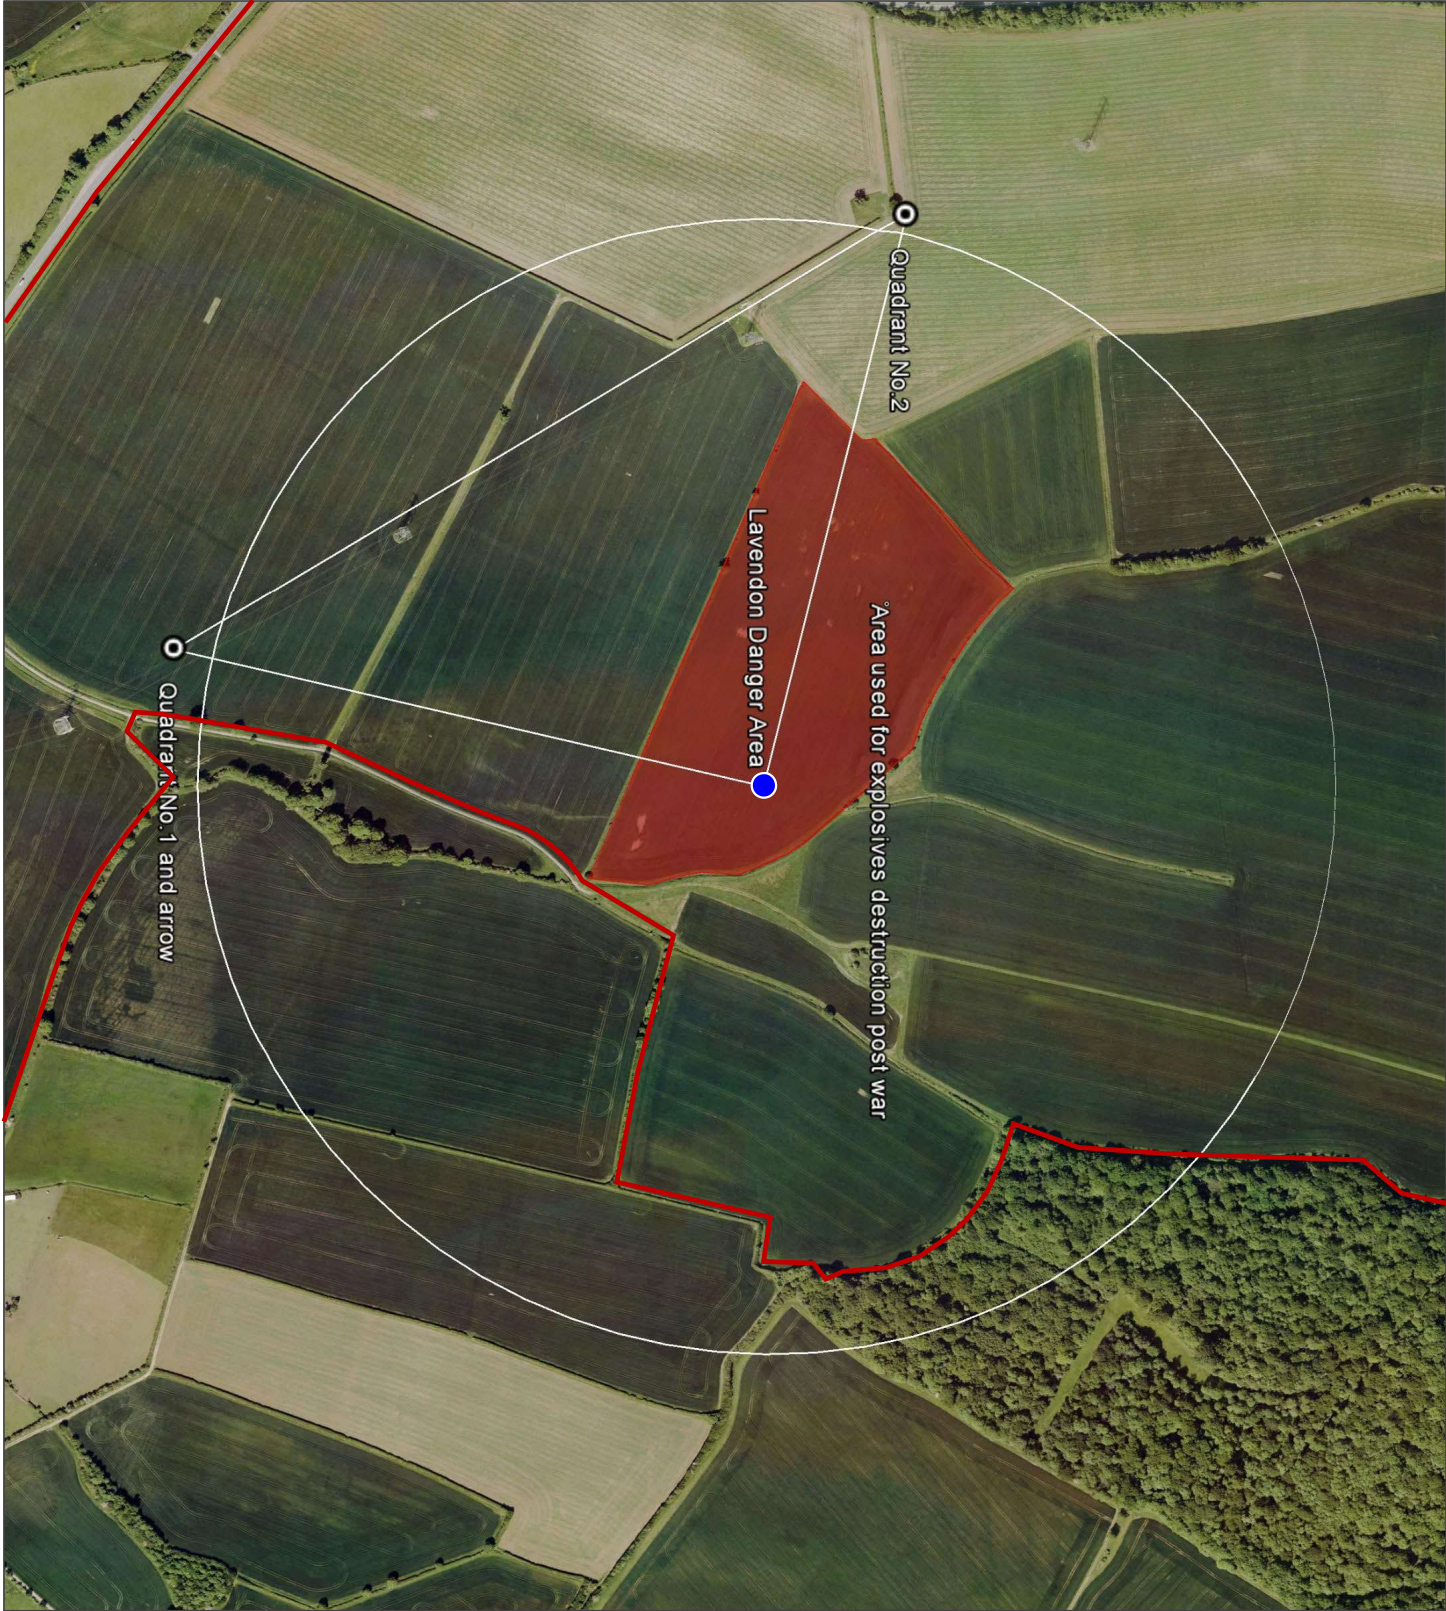
Figure: 05.0

Figure Title:
Plan of RAF Lavendon
Practice Bombing Range

- Approx. Site boundary
- Bombing range target marker location

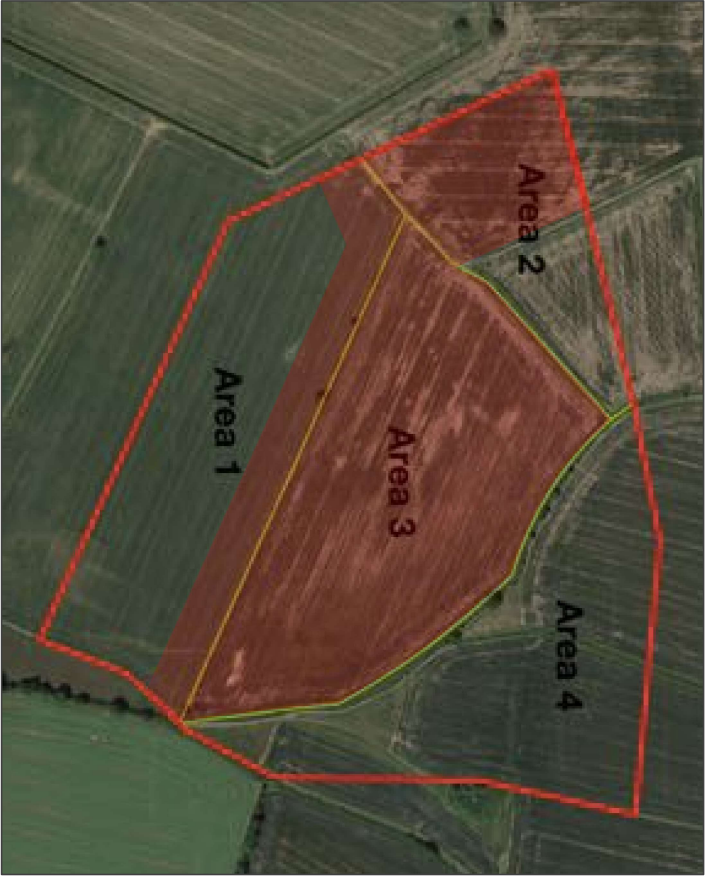
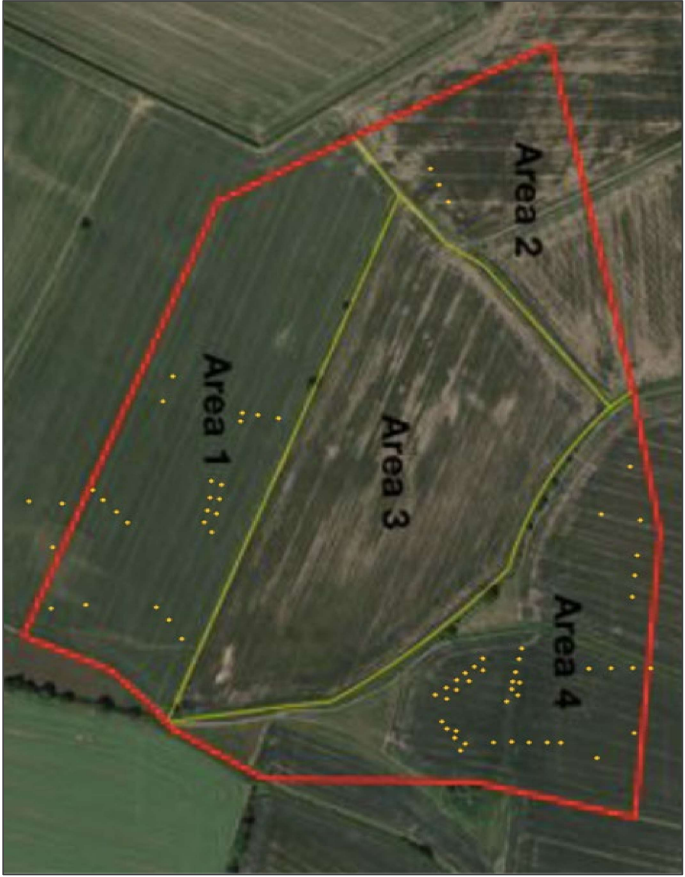
Figure: 08.0

Figure Title:
EO Risk Mitigation Measures
- EO Finds Mapped

Legend:	
	Search area
	High surface EO contamination
	USAAF practice bomb encounters
Notes:	
Source: UXO Specialist Ltd & IAL	
Project: Green Hill Sodar Project - Site G, Buckinghamshire	
Client: Lucion Delta-Simons	
Doc Ref: DRA.10219.25	Version: 1
 Explosive Ordnance Risk Assessments	
Tel: +44 (0) 2071 288 104 Web: www.impartialassessments.com Email: info@impartialassessments.com

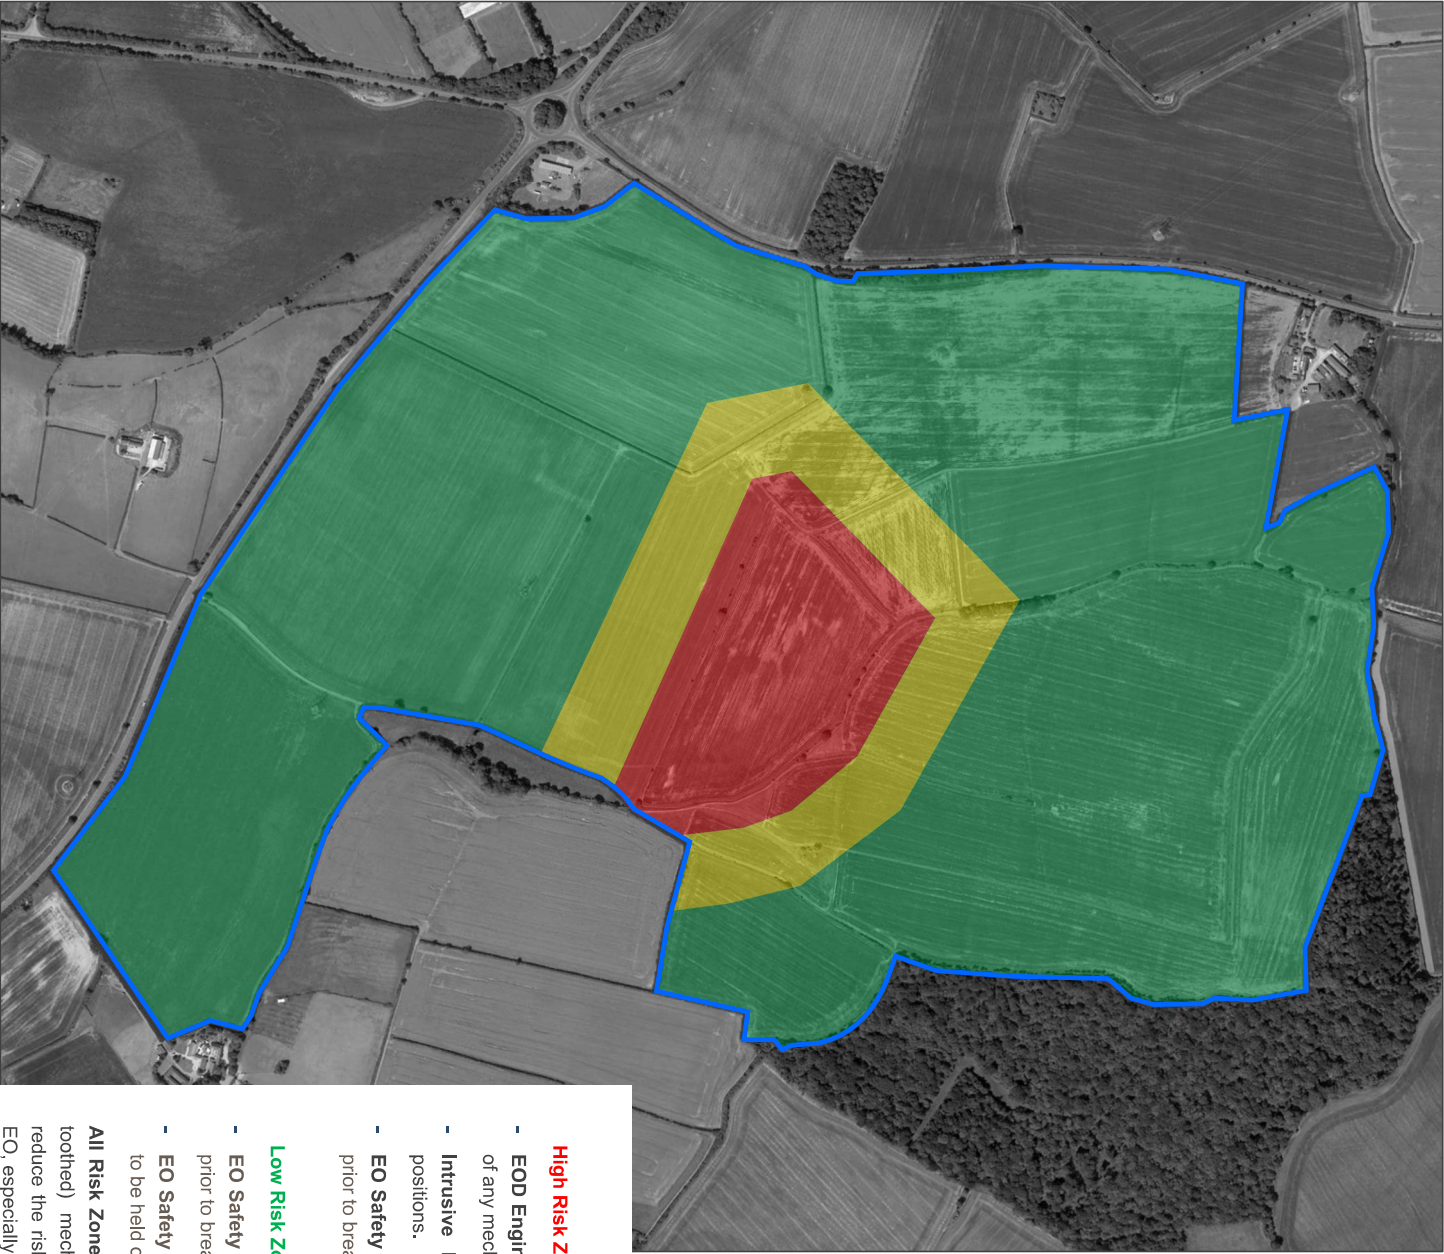
Figure: 09.0

Figure Title:
Risk Zone Map -
Development Works

High Risk Zone:

- **EOD Engineer Supervision:** 'watching brief' in support of any mechanical excavations.
- **Intrusive Magnetometer Survey** of all / any pile positions.
- **EO Safety & Awareness Briefing** to all Site personnel prior to breaking ground.

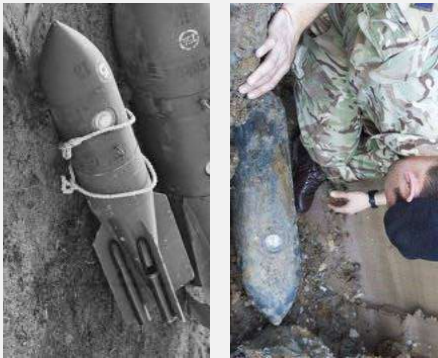
SC 50

Bomb Weight:	54kg (119lb)
Explosive Weight:	25kg (55lb)
Filling:	TNT, Amatol or Trialen
Charge/Weight Ratio:	46%
Fuze Type:	Side fuzed. Electrical impact or mechanical delay
Body Dimensions:	670 to 762mm x 203mm
Material:	Steel
Appearance:	Grey/green with yellow stripe on the tail unit
Variants:	Grades I, II and III. Body length / construction

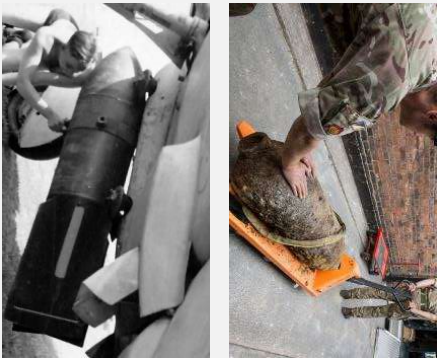
SC 250

Bomb Weight:	256kg (564lb)
Explosive Weight:	125 to 130kg (276 to 287lb)
Filling:	TNT, Amatol or Trialen
Charge/Weight Ratio:	44%
Fuze Type:	Side fuzed. Electrical impact or mechanical delay
Body Dimensions:	1,173 to 1,193mm x 368mm
Material:	Steel
Appearance:	Grey/green with yellow stripe on the tail unit
Variants:	Grades I and II. Body length and doubled fuzed type

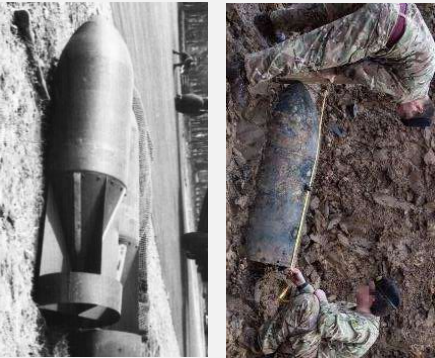
SC 500

Bomb Weight:	480 to 520kg (1,058 to 1,146lb)
Explosive Weight:	220kg (485lb)
Filling:	TNT, Amatol or Trialen
Charge/Weight Ratio:	44%
Fuze Type:	Side fuzed. Electrical impact or mechanical delay
Body Dimensions:	1,414 to 1,486mm x 470mm
Material:	Steel
Appearance:	Grey/green or buff with yellow stripe on the tail unit
Variants:	Grades I, II and III. Body length / construction

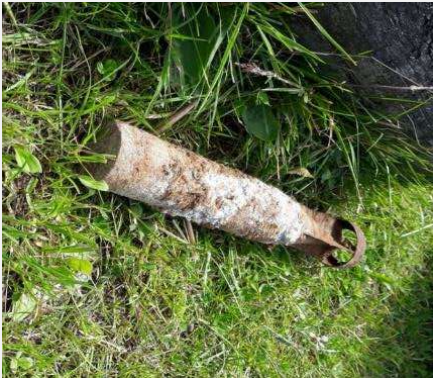
B1 Series Sub-Munition

Bomb Weight:	1.0 to 1.3kg (2.20 to 2.87lb)
Incendiary Weight:	680g
Filling:	Thermite
Fuze Type:	Nose fuzeed, impact
Body Dimensions:	247mm x 50mm
Material:	Magnesium alloy body, steel tail
Appearance:	Grey body, dark green tail unit
Variants:	Four types. Two delayed action and one steel nosed
Bomb Container:	Various sizes holding between 36No. and 620No. B1s

- ▶ **Incendiary Sub-Munitions:** The 1kg B1E IB was the most frequently dropped German bomb. Up to 620No. B1Es could be packed into a sub-munition canister, which opened at a pre-determined height, scattering the IBs over a wide area. The Thermite fill burns at extremely high temperature. The longer 2kg B2E model incorporated a small HE charge with delay fuze. The B2E is therefore more hazardous than the B1E, however was dropped in smaller numbers. Although light weight, both had the potential to fully penetrate soft ground.

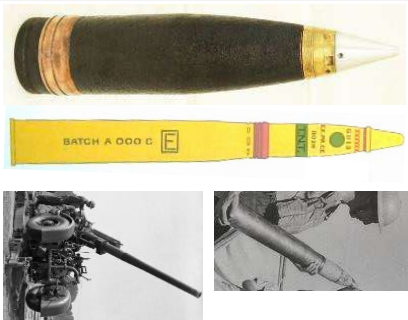
3.7-inch QF Heavy AA Gun (WW2)

Shell Weight:	12.7kg
Fill Weight:	1.1kg
Filling:	Amatol, TNT or RDX and TNT
Fuze Type:	Nose mechanical time delay fuze
Shell Dimensions:	94mm x 360 or 438mm
Shell Appearance:	Yellow or Grey body, copper driving bands, brass neck, grey nose fuze
Max Range:	12,000m
Rate of Fire:	10 to 20rpm

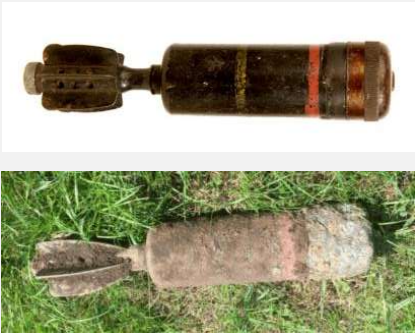
2-inch SBML Mortar (HE)

Shell Weight:	1.02kg
Fill Weight:	200g
Filling:	RDX or TNT (high explosive)
Dimensions:	51mm x 290mm
Material:	Steel
Appearance:	Cylindrical shape. Brown body, green and red bands, five finned.
Variants	Smoke, signal multi-star, parachute illumination, white phosphorus.

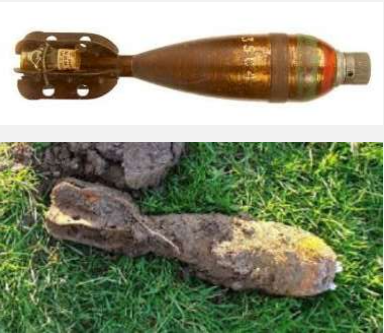
3-inch ML Mortar (HE)

Shell Weight:	4.5kg
Fill Weight:	882g
Filling:	RDX or TNT (high explosive)
Dimensions:	81mm x 490mm
Material:	Steel
Appearance:	Pear-drop shape. Brown body, green and red bands, five finned tail.
Variants	Smoke, signal multi-star, parachute illumination, white phosphorus.

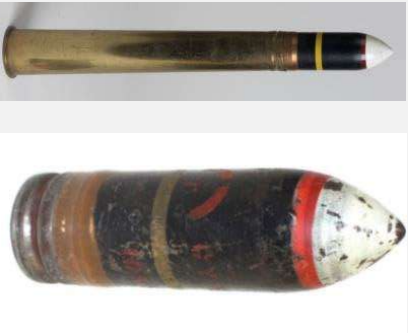
Ordnance QF 2-pounder Gun - HE

HE Round Weight:	1.86kg (full cartridge)
Fill Weight:	85g (plus propellant)
Filling:	RDX or TNT (high explosive)
Dimensions:	40mm x 304mm
Material:	Steel projectile. Brass case.
Appearance:	Brass body. Buff nose with red and green bands. Note, the HE round was brought into service in 1942.
Remark

Anti-tank solid shot variant pictured

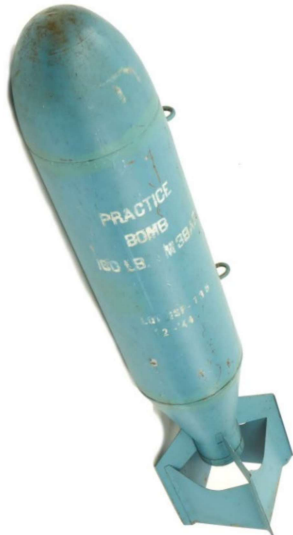
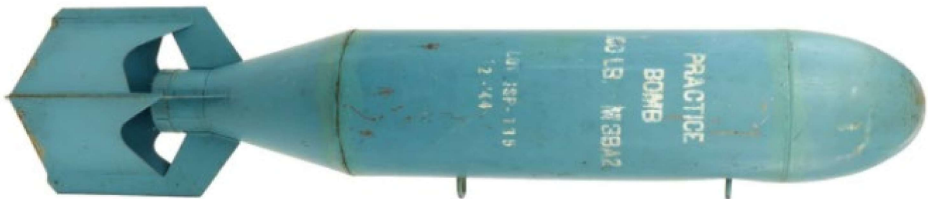
M38A2 Smoke and Flash Bomb

Variants:	Flash and smoke spotting charges (M1A1, M3, and M4).
Weight:	100lb (including inert sand fill and spotting charge)
Filling:	Flash: black powder (~3lb). Smoke: stannic chloride, sodium phosphate and titanium tetrachloride (1lb)
Dimensions:	47.5" x 8.13"
Material:	Steel
Appearance:	Blue paint, white text.

Fuze: Impact fuze. The spotting charge is assembled in a sleeve at the base of the bomb, within the fin assembly.

Note, the M85 bomb was a concrete filled version of the M38A2, ordered to relieve a temporary wartime shortage of the M38A2 model.

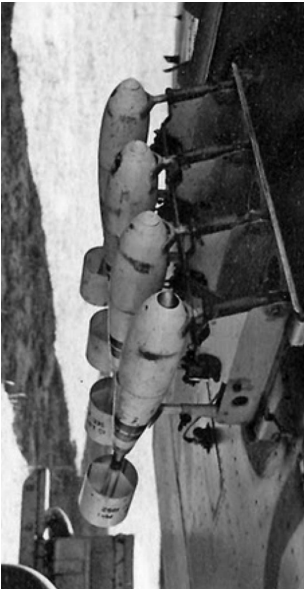
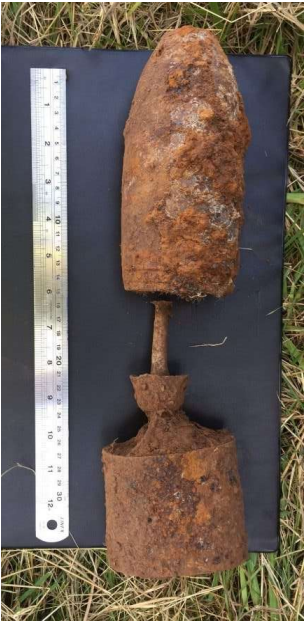
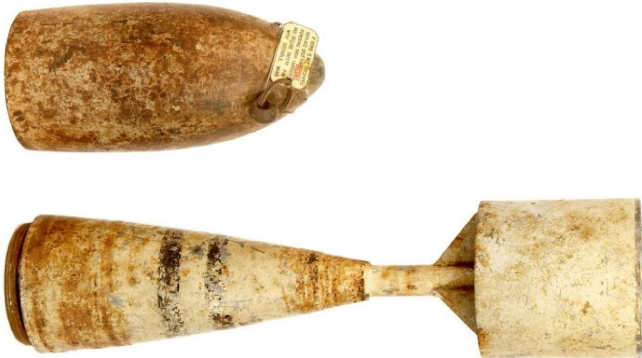
Appendix Title:
Data Sheets - Commonly
Deployed RAF WW2-era
Practice Bombs

Note, RAF WW2 practice bombs are one of the most frequently encountered types of EO at former military airfield sites.

10lb bomb

11.5lb bomb

25lb bomb
