# Light Valley Solar

### Appendix 6.2: Otter Report

Document Reference: EN0110012/APP/LVS/06.03.06

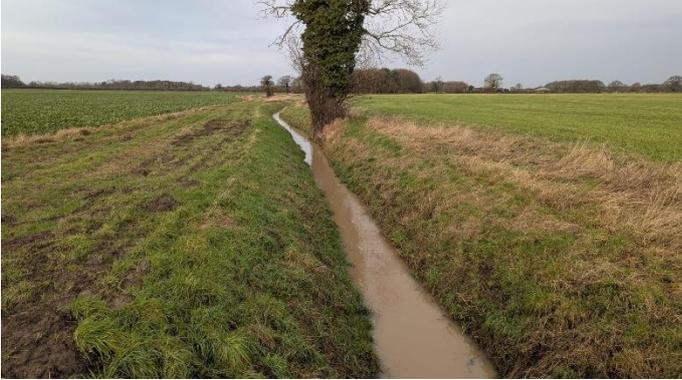
Description	Location (what three words)	Photograph
Solar Development Site 1, Ditch 1.3 – heavily managed agricultural ditch.	/ [REDACTED] [REDACTED]

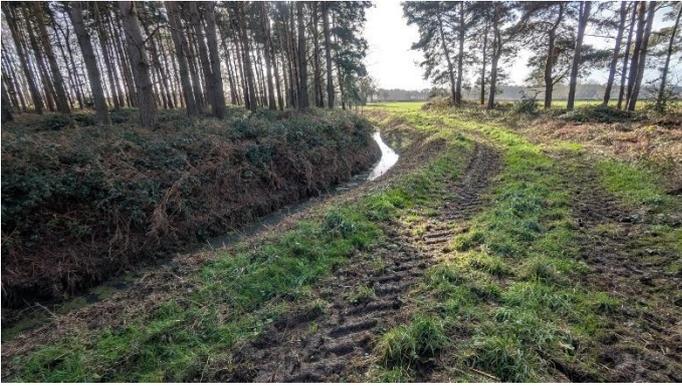
Solar Development Site 1, Ditch 1.10 – agricultural ditch with off-site woodland flanking the bankside which may offer laying up opportunities for otter. However, no signs of otter were recorded during survey.	r [REDACTED]

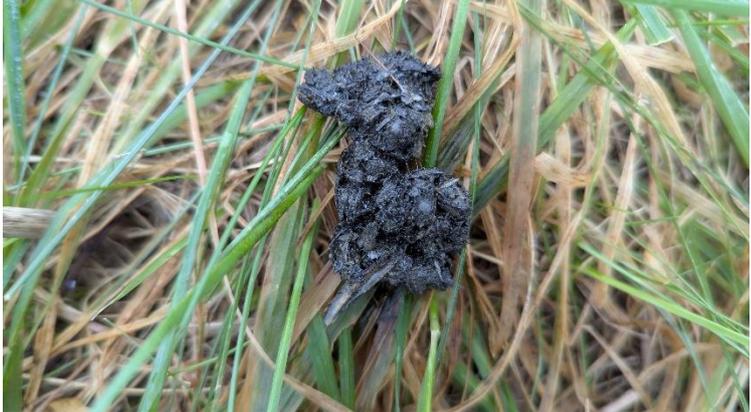
3.2.5 Two agricultural drainage ditches (Ditch 2.1 – Ditch 2.2) were present within Solar Development Site 2. A single spraint was recorded on a grass tussock on the southern bank of Ditch 2.1 (D2.1) (Fleet Dike) in the centre of Solar Development Site 2, adjacent to where the ditch is culverted under the central access track.

Solar Development Site 2, Ditch 2.1 - fresh otter spraint recorded on tussock of grass on bank	[REDACTED]

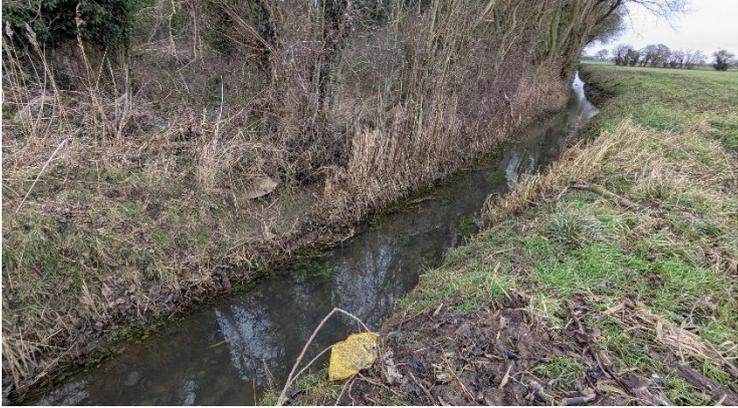
- 3.2.7 D2.1 was found to be an agricultural ditch with an approximate 1.5 m wide channel and a bankside gradient of  $>45^\circ$ . The water depth was 30-50 cm, with deep mud/silt substrate. The ditch had been subject to dredging over winter. Very little dense vegetation (scrub and trees) was present on the banksides; however, the ditch did flow past an off-site woodland copse on the eastern boundary, which could provide opportunities for laying up, but no evidence of this was found during the survey.

Description	Location (what three words)	Photograph
Solar Development Site 2, Ditch 2.1- flows through the centre of the Solar Development Site and past an off-site woodland copse	[REDACTED] [REDACTED]

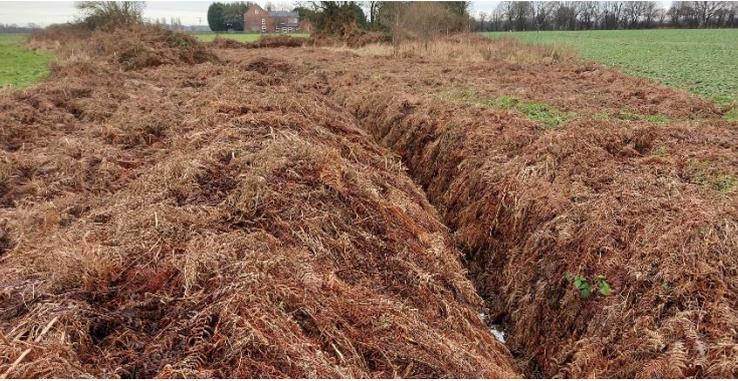
- 3.2.8 An additional ditch, Ditch 2.2 (D2.2) extended along a short section of the north-eastern corner of Solar Development Site 2 and comprised an agricultural ditch, with shallow water levels approximately  $<30$  cm. D2.2 was approximately 1 m wide, and heavily overgrown with bramble *Rubus fruticosus agg.* and bracken *Pteridium aquilinum*. Due to the overgrown nature of D2.2, there is potential for otter to lay up in the dense vegetation, however no signs were recorded during the survey.

Solar Development Site 2, Ditch 2.2- overgrown by bramble and bracken	[REDACTED]

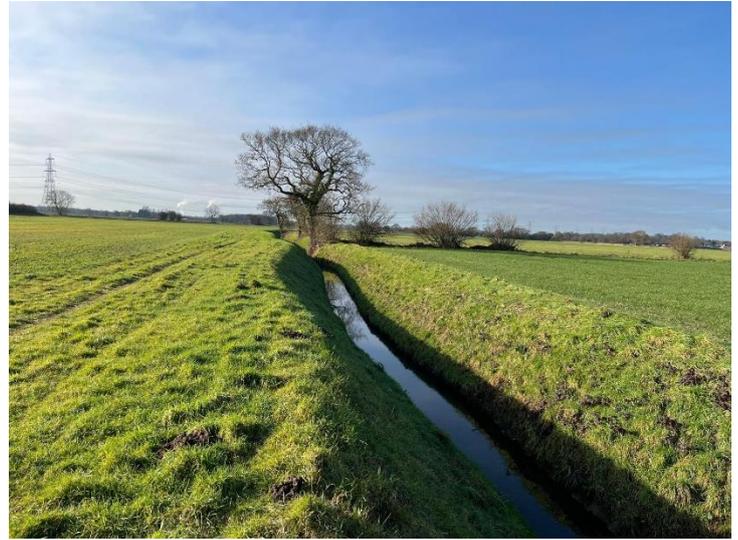
Solar Development Site 3, Ditch 3.2 heavily managed agricultural ditch	[REDACTED] [REDACTED]

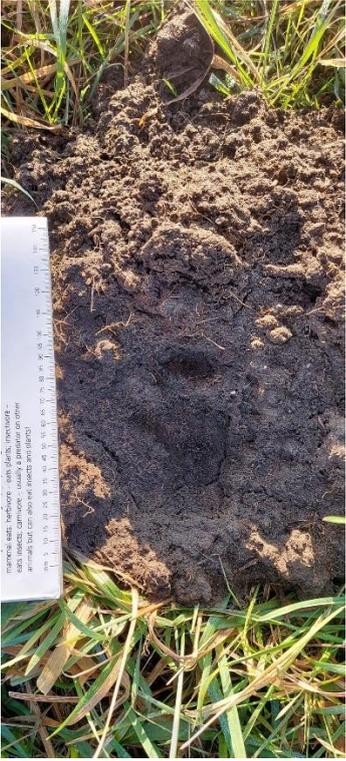
Description	Location (what three words)	Photograph
<p>Solar Development Site 4, Ditch 4.1- probable otter print on top of ditch bank</p>	<p>/ [REDACTED] [REDACTED]</p>

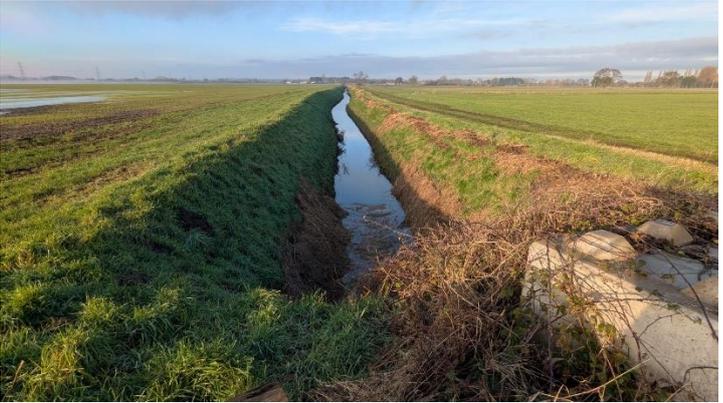
<p>Solar Development Site 4, Ditch 4.1- Example of ditch network which is dominated by heavily managed agricultural ditches</p>	<p>/ [REDACTED] [REDACTED]</p>

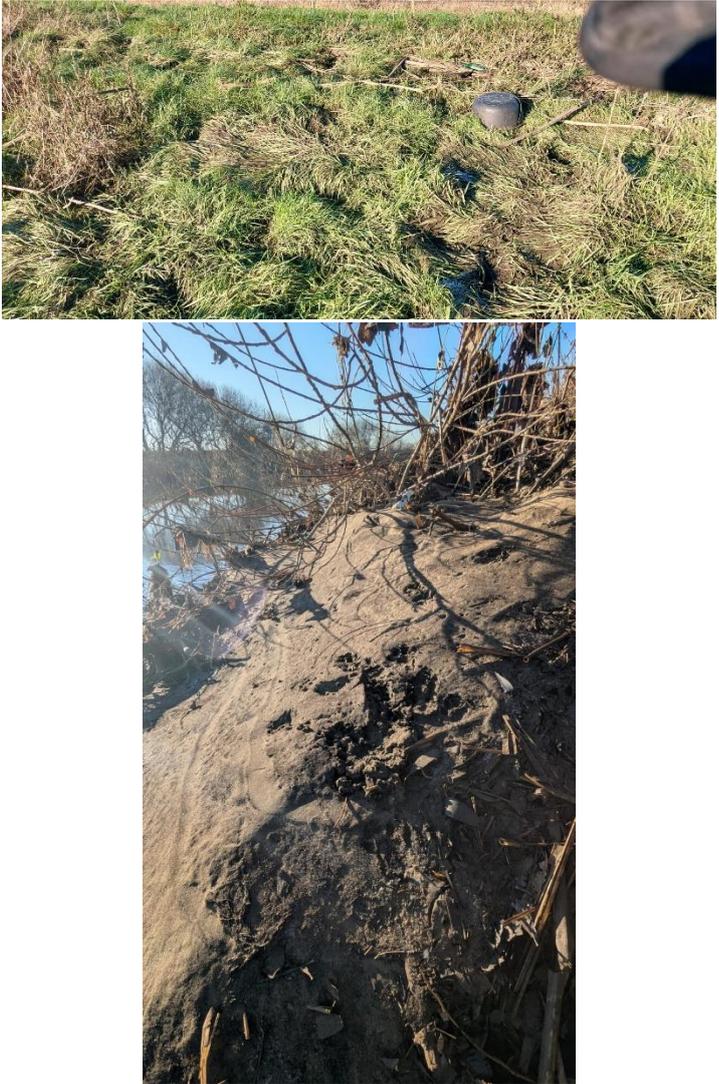
- 3.2.12 The River Aire is present approximately 465 m south of Solar Development Site 4 (outside of the Order Limits), where numerous otter signs were recorded including prints, slides (entry/exit points) and a possible couch in the grassland adjacent to the riverbank. The river was surveyed because at the time of survey, the Order Limits were adjacent to the river. The Order Limits has since moved to its current location, 465 m north of the river. Nevertheless, results recorded along the river are included in this report for context, with photographs from the survey,

Description	Location (what three words)	Photograph
<p>465 m south of Solar Development Site 4, River Aire- otter prints, likely exit/entry point and possible couch</p>	<p>[REDACTED] [REDACTED] [REDACTED] [REDACTED] [REDACTED]</p>

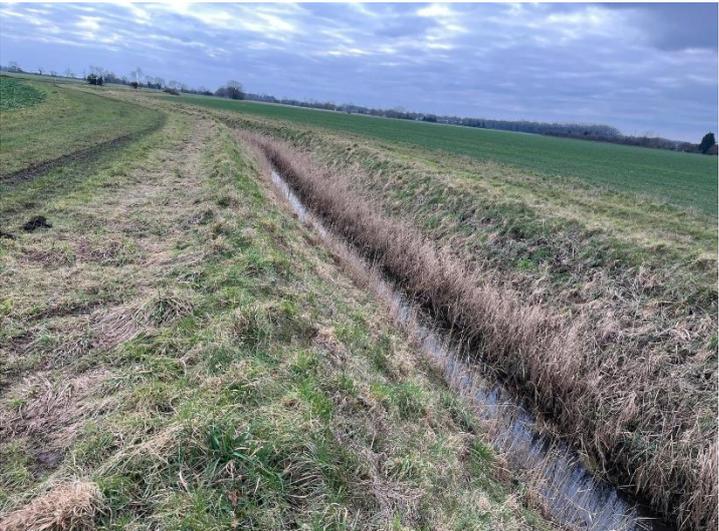
<p>Solar Development Site 6, Ditch 6.2- A heavily managed agricultural ditch</p>	<p>[REDACTED] [REDACTED]</p>

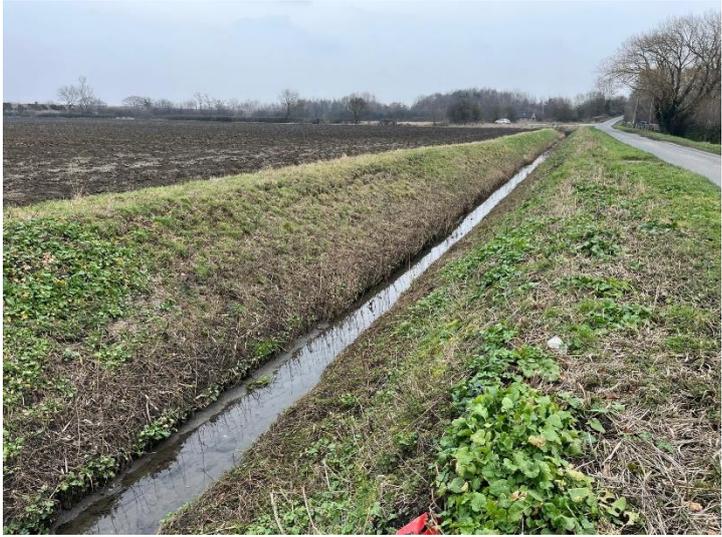
Description	Location (what three words)	Photograph
<p>Solar Development Site 7, Ditch 7.1- heavily managed agricultural ditch</p>	<p>██████████ ██████</p>

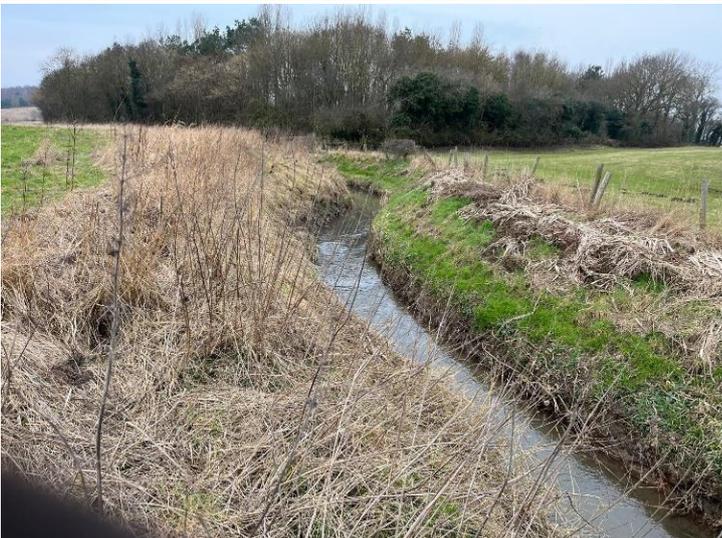
<p>Solar Development Site 8, Ditch 8.1- present along the western boundary flanked by off-site woodland along part of the ditch</p>	<p>██████████ ██</p>

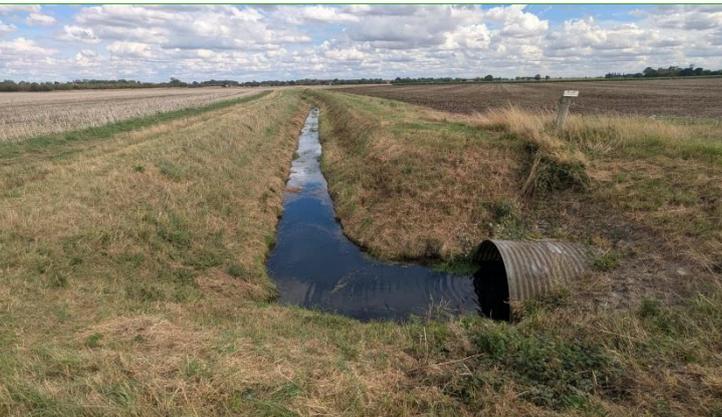
<p>Cable Route Corridor, Ditch 9.16- heavily managed agricultural ditch however connection to the River Ouse makes it more likely to be utilised by commuting otter</p>	<p>// ██████████ ██</p>

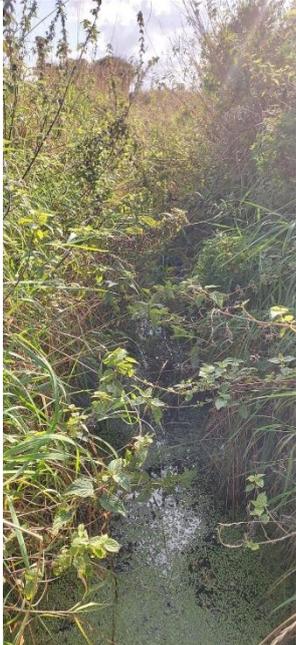
Description	Location (what three words)	Photograph
<p>Cable Route Corridor, Ditch 9.18- overgrown agricultural ditch however connection to Selby Dam makes it more likely to be utilised by commuting otter</p>	<p>// [REDACTED] [REDACTED]</p>

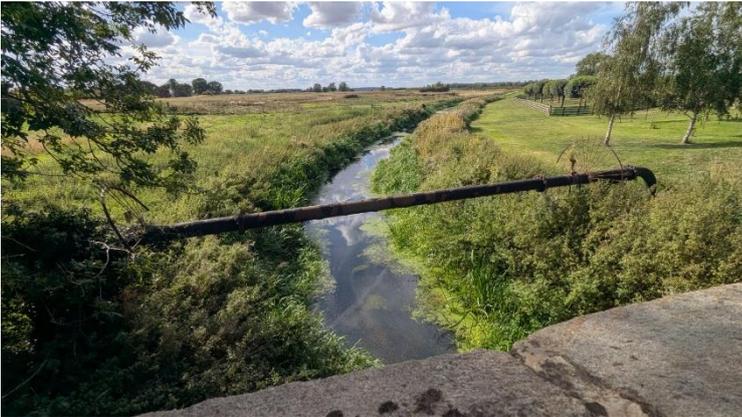
<p>Cable Route Corridor, Selby Dam-Anticipated to form high value habitat for otter however will be crossed using trenchless techniques as outlined in Chapter 2: The Proposed Development (ES Volume 1) <b>[EN0110012/APP/L VS/06.01.02]</b></p>	<p>// [REDACTED] [REDACTED]</p>

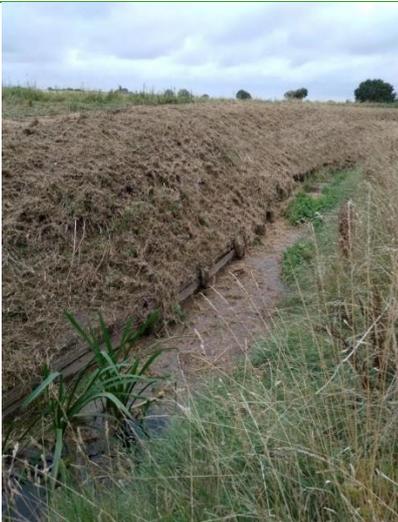
<p>Solar Development Site 8 Access, Ditch 8.1a- Permanent watercourse crossing and culvert is proposed within Habholme Dike which is assessed as providing low value habitat for otter</p>	<p>// [REDACTED] [REDACTED]</p>

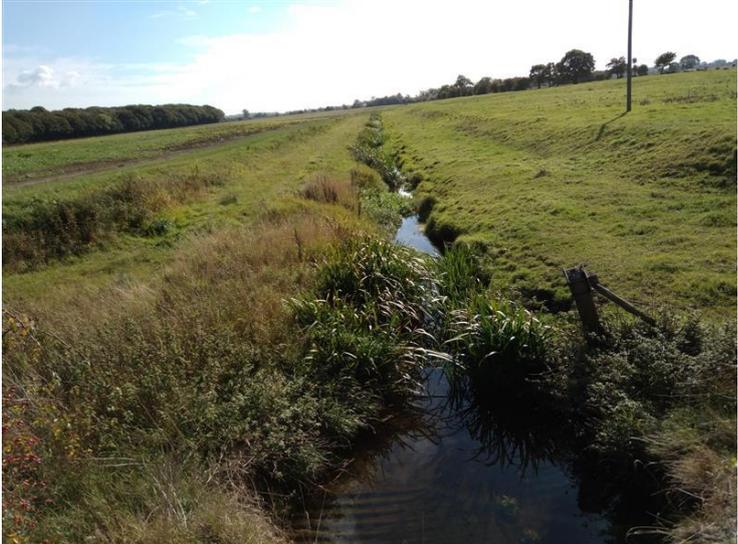
Description	Location (what three words)	Photograph
<p>Solar Development Site 8 Access, Salby Dam- Located between arable fields and grazed grassland, vegetation on bank tops highly managed and short cut, but vegetation on banksides is abundant. Shallow depth along length surveyed (&lt;0.5 m) but holds water throughout entirety of channel. No otter field signs or potential holt locations were recorded at this survey point; however, the river was assessed as providing high value habitat for otter.</p>	<p>// [REDACTED] [REDACTED]</p>
