**East Pye Solar  
Biodiversity Net Gain Report**

Revision 1  
March 2026

**East Pye Solar  
Biodiversity Net Gain Report  
Annex A: River Condition Assessment**

**Revision 1  
March 2026**

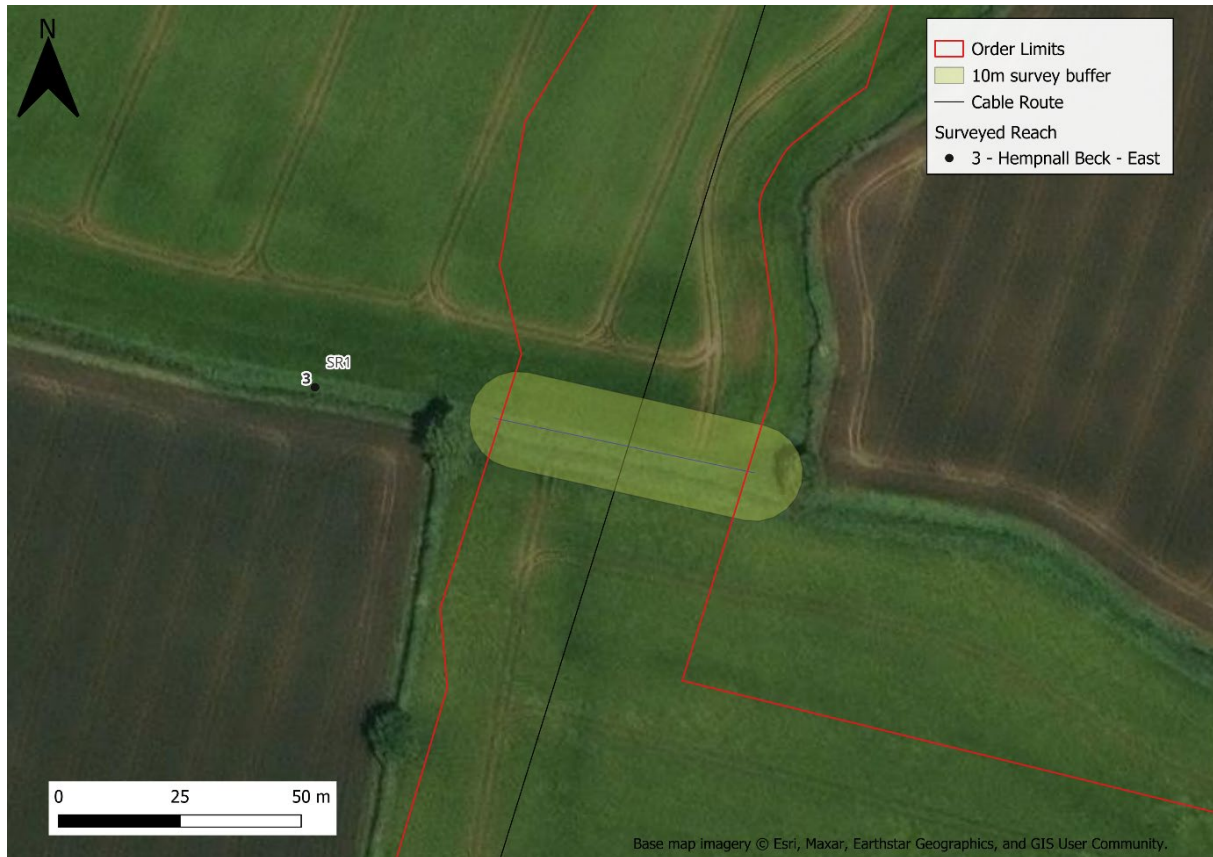
**Figure B2: Illustrative Aerial Map of 3 - Hempnall Beck – East (TM 25289 94346) Showing the Surveyed Sub-Reach, Order Limits and Surrounding Landscape.**

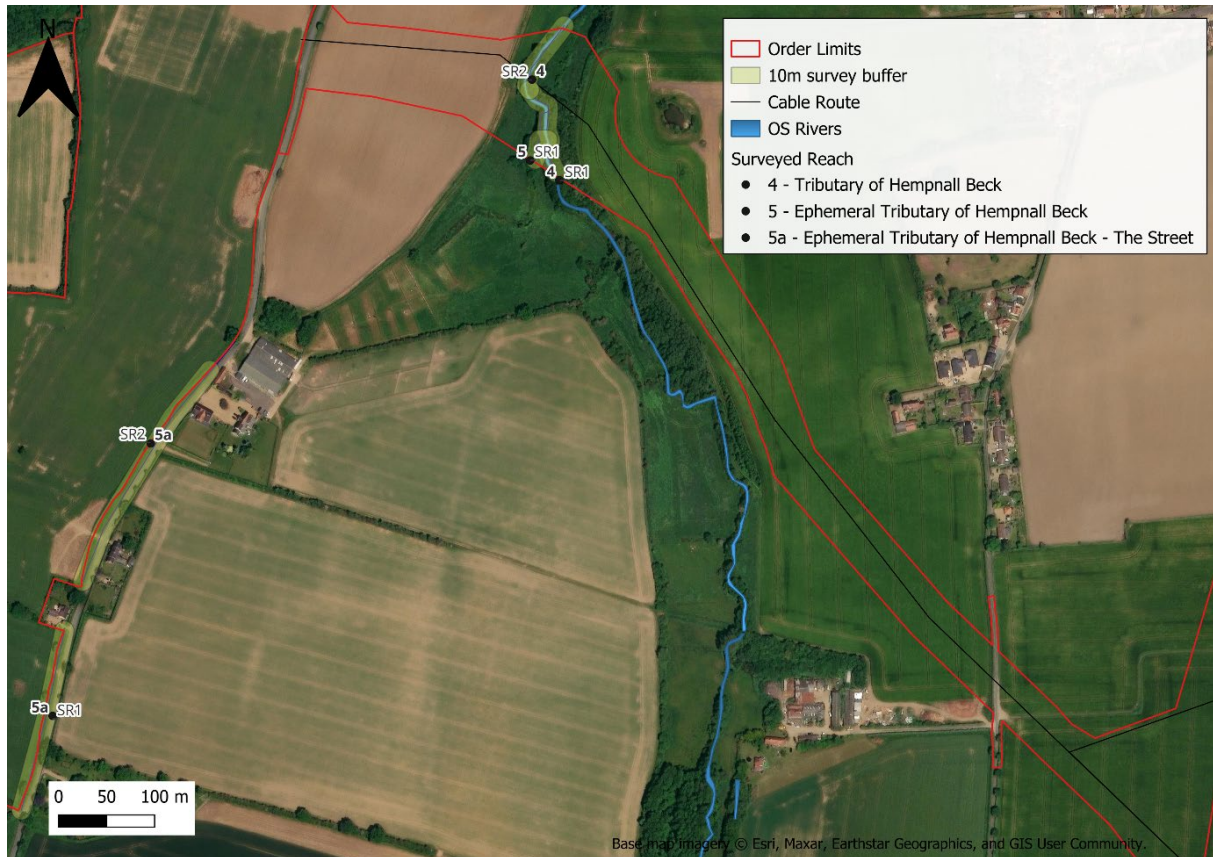
**Figure B3: Illustrative Aerial Map of 4 - Tributary of Hempnall Beck (TM 23504 94050), 5 - Ephemeral Tributary (TM 23443 93932) and 5a - The Street (TM 22967 93399).**

Showing historic channel alignment of the ephemeral tributary visible in adjacent field (watercourse 5). Stream resembles a straightened ditch and is culverted under the road; surrounding land includes horse-grazed pasture and arable crop.

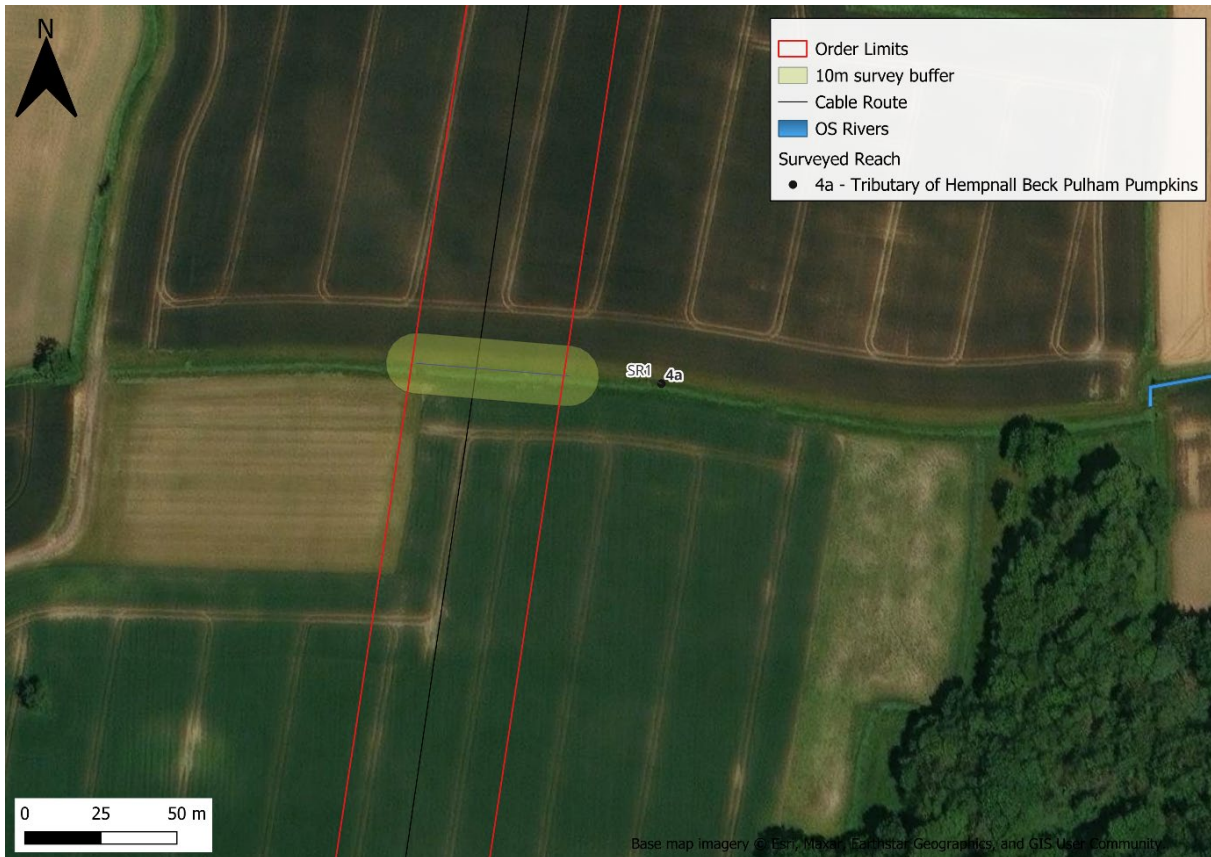
**Figure B4: 4a - Illustrative Aerial Map Showing the Tributary of Hempnall Beck located near Pulham Pumpkins / Long Stratton Bypass (TM 20070 90265) Showing Surveyed Sub-Reach and Surrounding Land Use.**

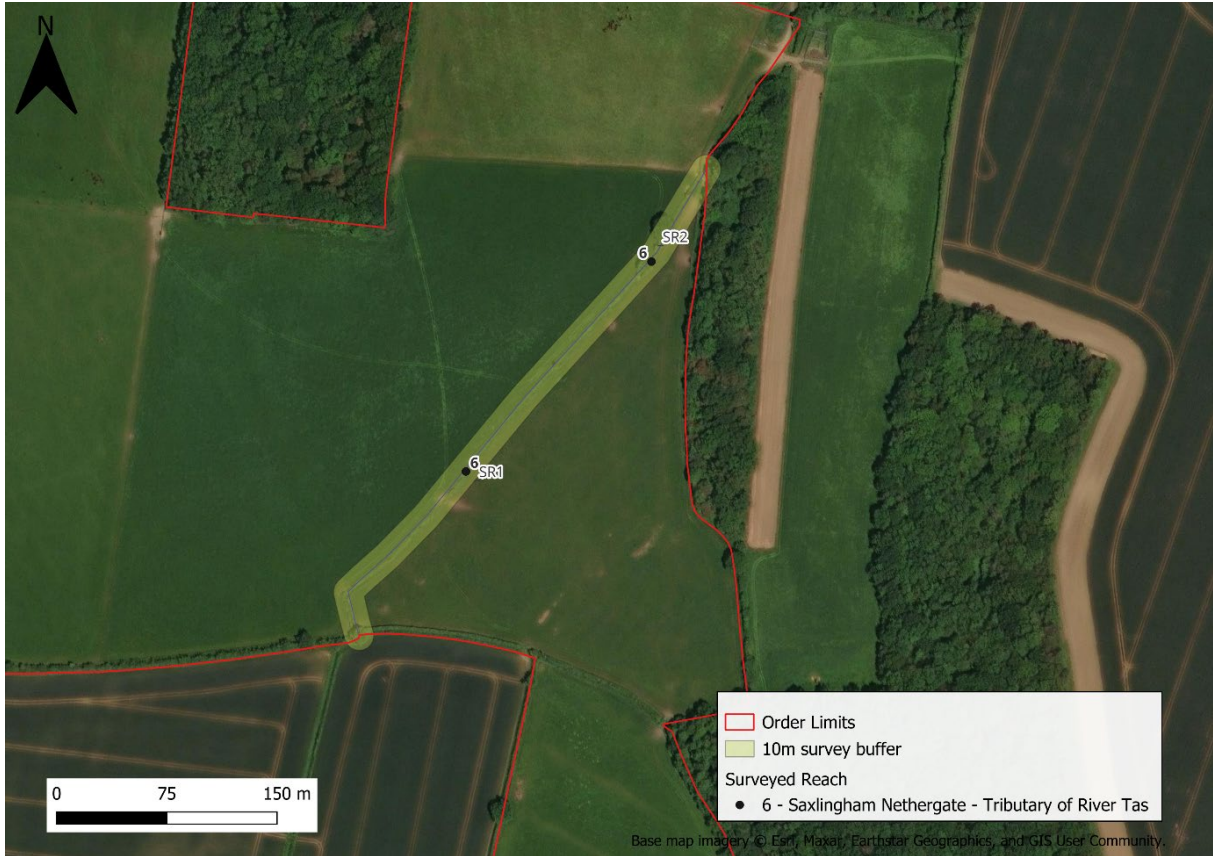
**Figure B5: Illustrative Aerial Map of 6 - Saxlingham Nethergate – River Tas Tributary (TM 24612 96057) Showing Surveyed Sub-Reaches and Surrounding Land Use.**

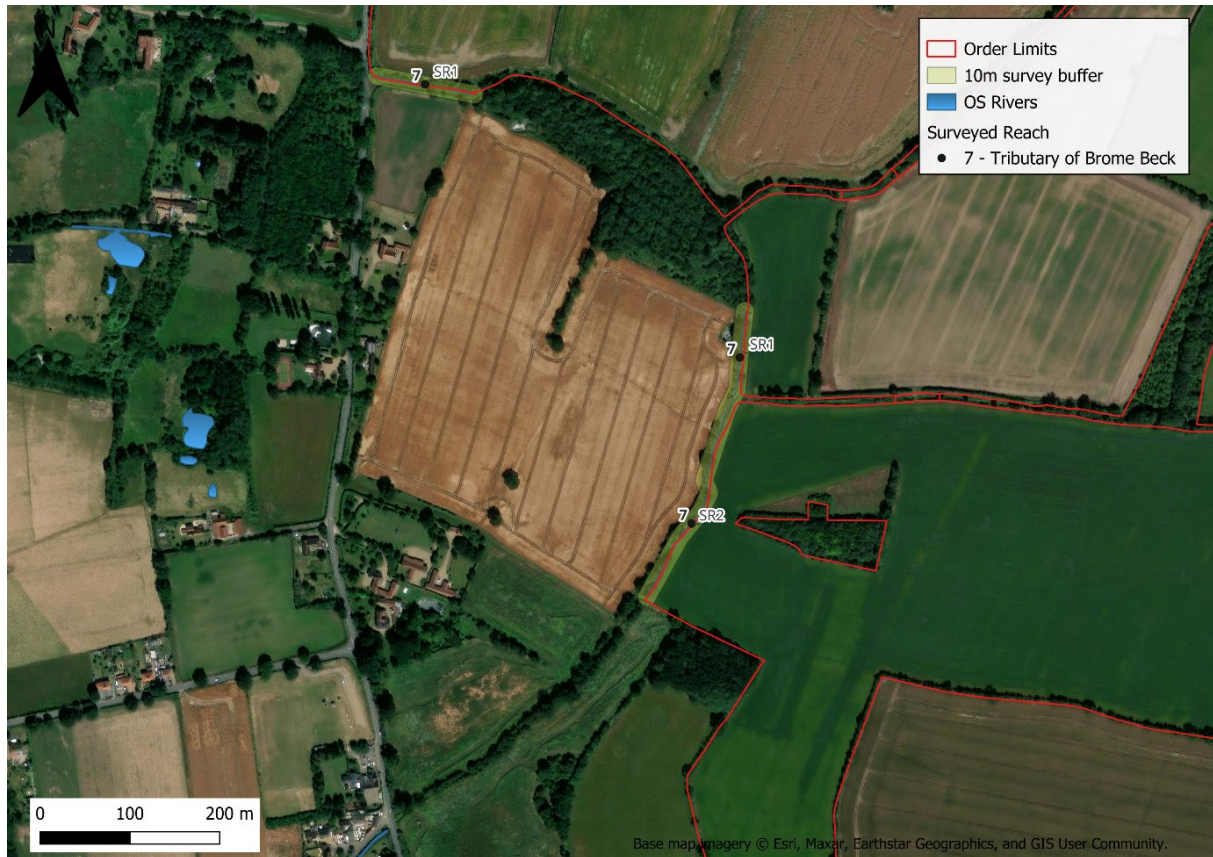
**Figure B6: Illustrative Aerial Map of 7 - Tributary of Brome Beck – Reach 1 to the North (SR1) and Reach 2 to the South-East (TM 29865 94958) Showing Surveyed Sub-Reaches and Surrounding Land Use.**

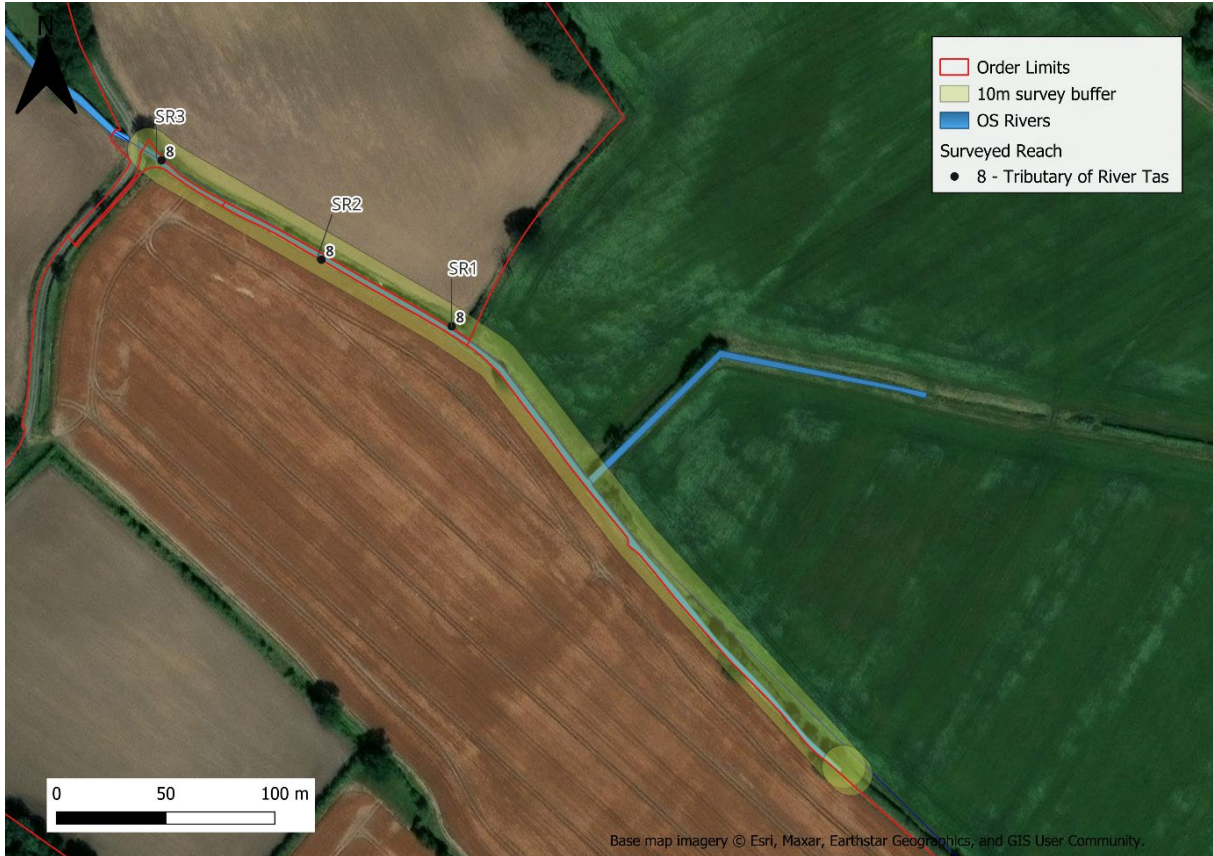
**Figure B7: Illustrative Aerial Map of 8 - Tributary of the River Tas – Ephemeral (TM 26053 97120) Showing Surveyed Sub-Reaches and Surrounding Landscape.**
