**East Pye Solar
Environmental Statement
Volume 3: Appendix 8.9 – Aquatic Habitat Assessment
Report**

**Revision 1
March 2026**

Document Reference: APP/6.3.8.9

Report Title: Technical Appendix 8.9: Aquatic Habitat Assessment Report

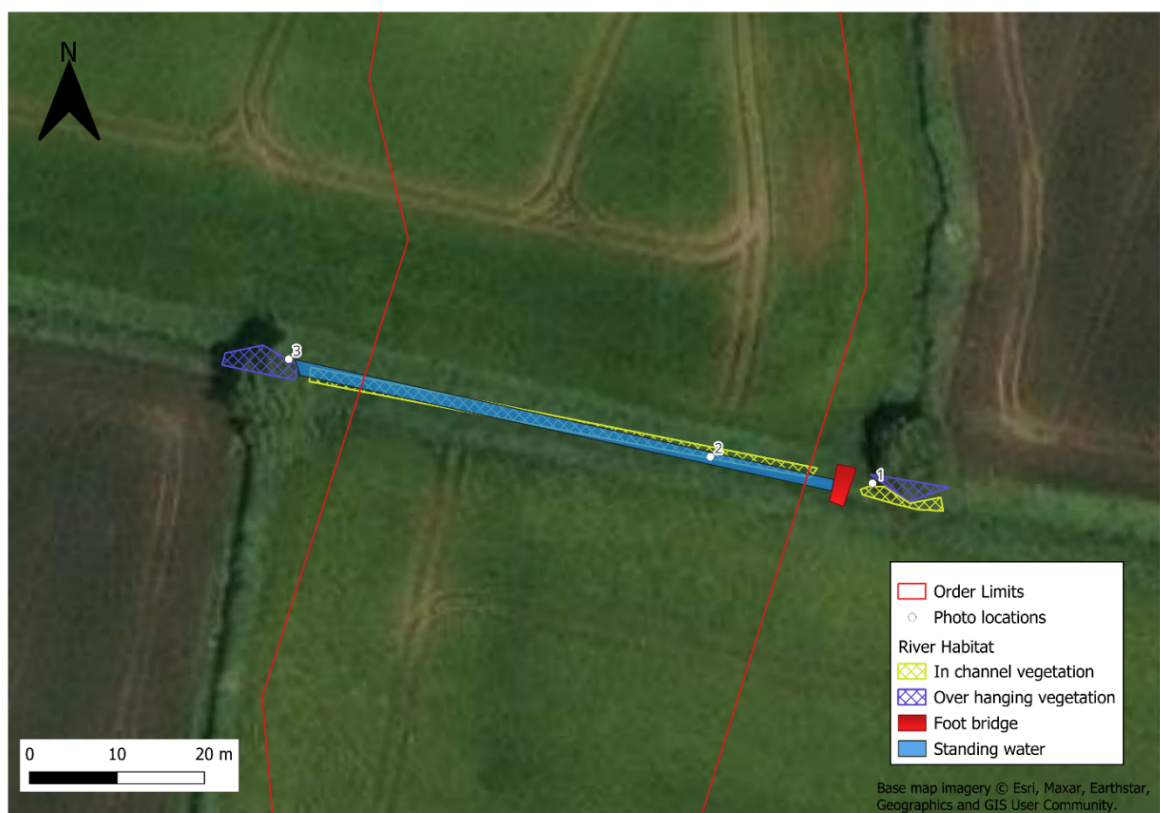
3.3.2 The banks in this section are approximately 2 m in height and, at the time of survey, supported shallow areas of standing water. The channel margins and bed were heavily vegetated, with common nettle forming dense growth throughout.

3.3.3 The bank face and bank top had been extensively mown, resulting in a narrow field margin of less than 1 m comprising of closely cut grass before transitioning into arable cultivation. A hedgerow begins approximately 30 m downstream of the cable-crossing point and extends southwards along a connecting ditch, beyond the surveyed reach. Immediately east of CRC 8 a mature hawthorn shrub and a small footbridge were recorded.

Plate 2. Aquatic habitat present at the ditch feature at Hempnall Beck East within a 100 m survey reach at CRC 8, Waterbody 19.

- 6.3.6 **Hempnall Beck Tributary - East**, similar in nature to Pulham Pumpkins, is also a deep, steep-banked ditch with shallow or intermittent water and heavily vegetated margins. The channel lacked meaningful flow at the time of survey and contained only small patches of submerged vegetation. Its ecological value is limited, with suitability largely restricted to tolerant aquatic invertebrates. Fish are unlikely to utilise this reach persistently, and conditions are unsuitable for white-clawed crayfish.

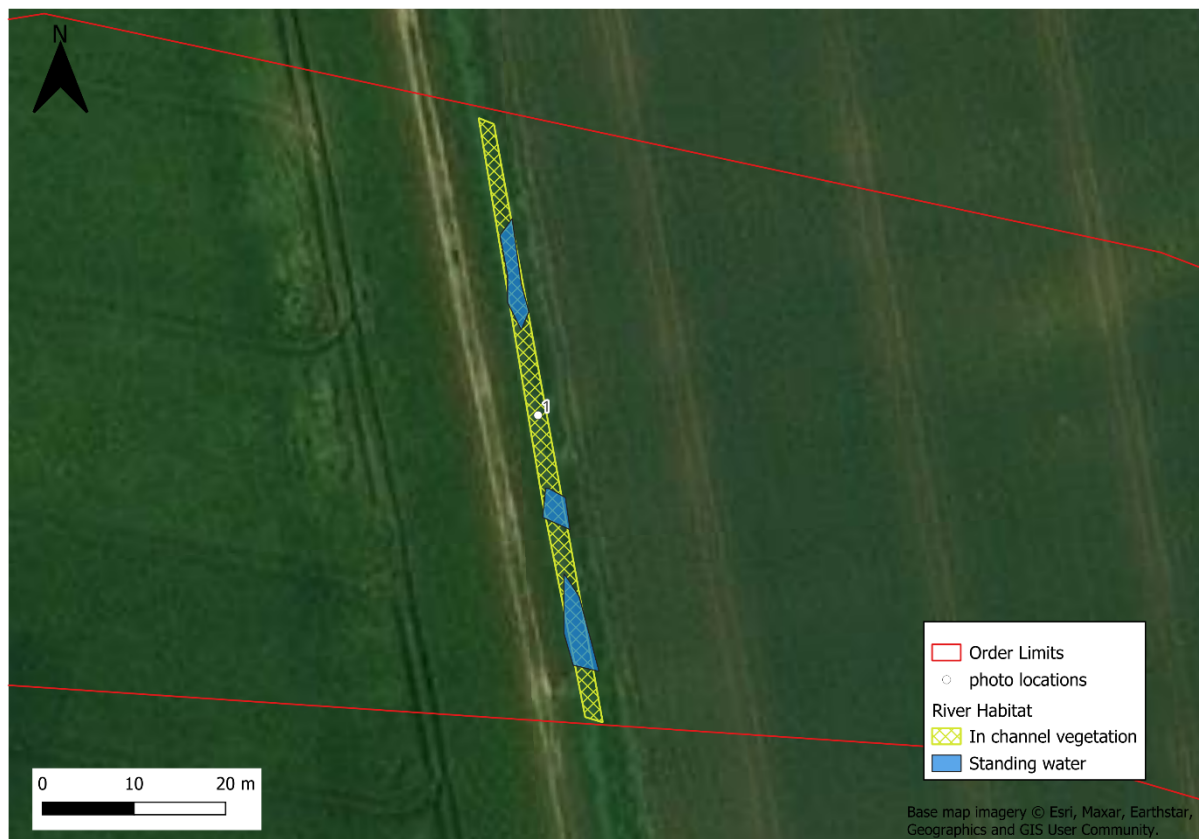
mosses were recorded within the channel bed, which consists of earth and is indicative of periodic slow-flowing conditions.

- 3.5.3 The ditch is deeply incised, with two very steep banks approximately 2 m high. It is fully open with no tree cover and forms a narrow boundary between two arable fields with minimal field margins. Evenly spaced tree whips have been planted along the right bank.

Plate 4. Aquatic habitat present in ditch 1 within a 100 m survey reach, Waterbody 10. Hydrologically connected to Pulham Beck.

6.2.7 Ditch 1 is a deeply incised, ephemeral feature with only patchy puddles and minimal flow. The banks are steep and largely bare, with limited vegetation apart from some watercress and moss, providing very low habitat complexity. These conditions are suitable only for tolerant, opportunistic invertebrates such as aquatic worms, non-biting midges, and hardy snails like *Potamopyrgus antipodarum*, *Physa*, *Bithynia*, and *Anisus vortex*. Species requiring continuous, well-oxygenated water, including freshwater shrimps, mayflies, riffle beetles, and caddisflies, are unlikely to persist. Overall, the ditch supports a sparse, low-diversity invertebrate community, with temporary colonization possible during wetter periods.

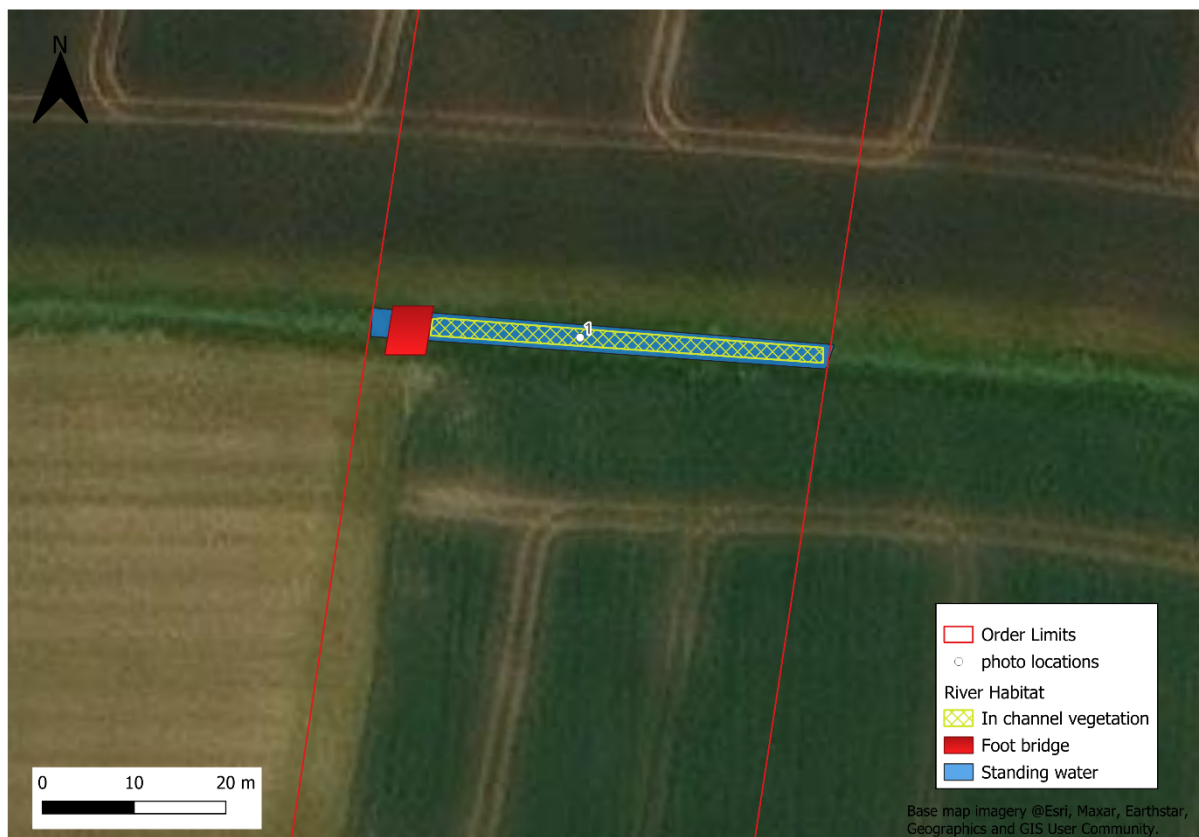
3.7.2 This location is shown as Waterbody 7 in Figure 1. The ditch runs along arable field margins and is confined by very steep, deeply incised banks. During the survey, it held shallow, standing water approximately 10 cm deep with no flow. Watercress and other macrophytes were present within a silt bed. The ditch forms part of the headwaters of the southern tributary to Hempnall Beck and is connected to the wider field ditch network, providing a limited but potential pathway for aquatic organisms. A couple of footbridges cross the ditch along the survey reach.

Plate 6. Aquatic habitat present in the ephemeral headwaters of the Tributary to Hempnall Beck within a 100 m survey reach at CRC 4, Waterbody 7.

5.1.5 At Pulham Pumpkins, the likely headwaters of the South Tributary, the watercourse exists as an ephemeral ditch system with <5 cm water depth, culverts, and dense fool's watercress. These conditions are unsuitable for white-clawed crayfish, and connectivity into this network is highly limited.

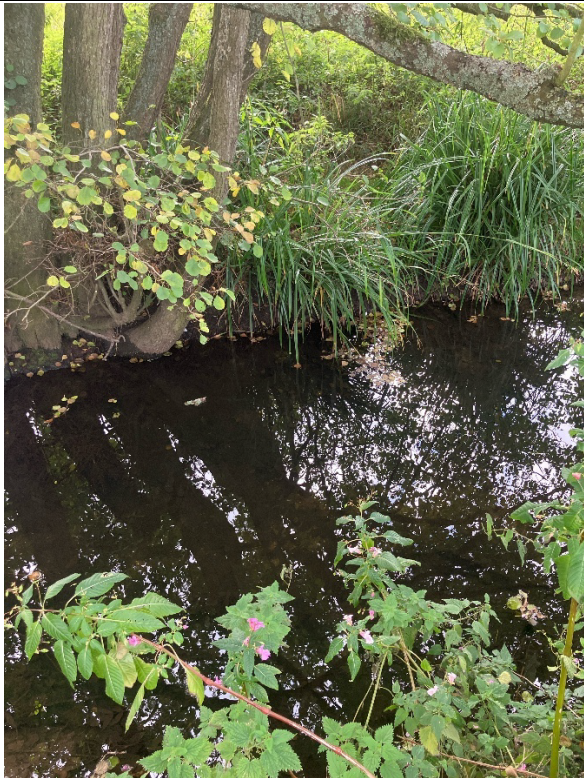
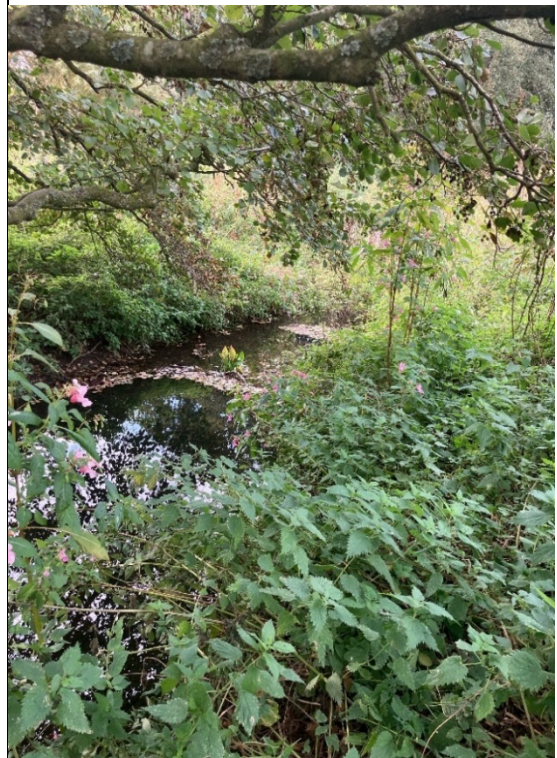
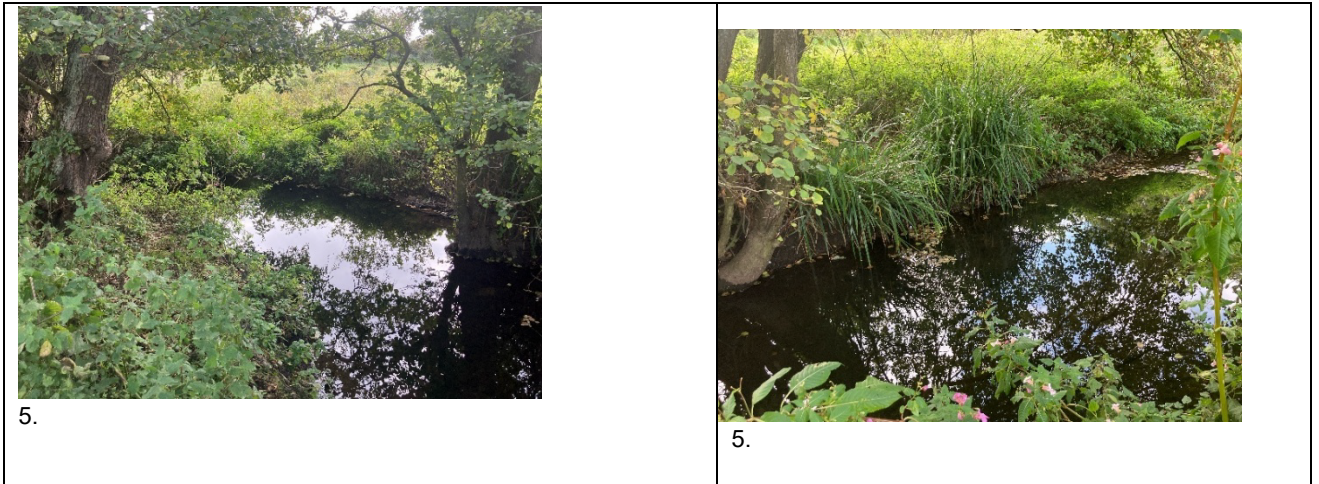
A.2 Photos of the Tributary of Hempnall Beck - East

Table 2: Photos of the 100 m survey reach and photo locations at Plate 2 Tributary of Hempnall Beck - East
