Bramford to Twinstead Reinforcement

Volume 8: Examination Submissions

**Document 8.3.11: Ecological Survey of the Temporary Access Route
off the A131**

**Final Issue A
September 2023**

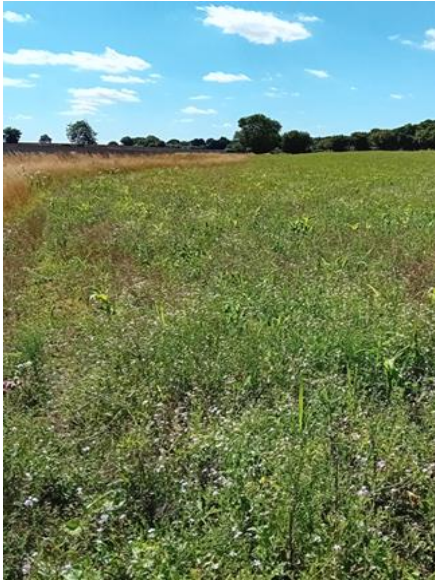
Assumed set-aside parcel – east of A131

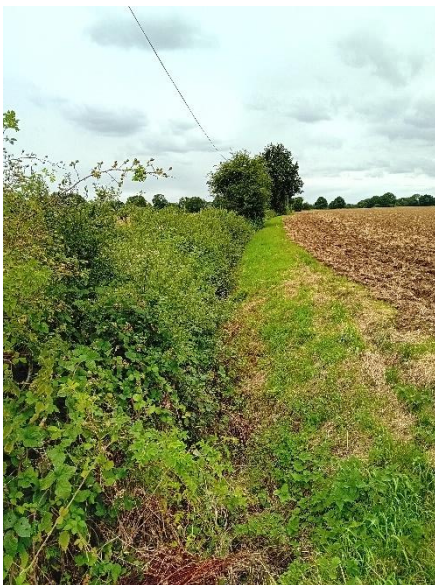
- H-H-30 and H-G-67 were low and narrow roadside hedgerows with a dry ditch present along both sides. The woody component of both hedges is fairly diverse with the following species recorded along their length: dog-rose (O), oak sp. (R), dogwood (O), willow sp. (R), hazel (O) and field maple (O). A comparatively species-rich ground flora was also present for both hedgerows comprising herbs such as hedgerow cranesbill (R), hedge bedstraw (R), knapweed (O), yarrow (O) and meadow vetchling (R).

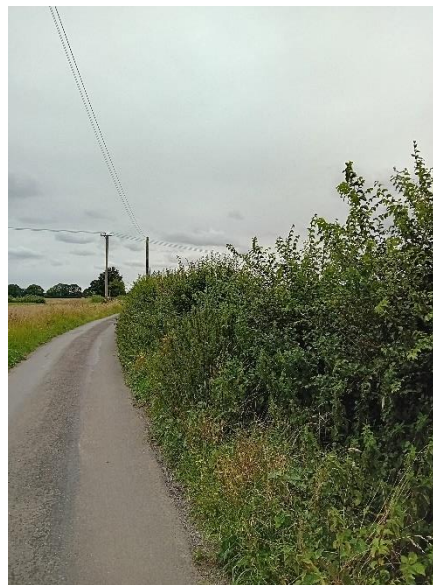
- H-H-31 was a roadside hedge with a dry ditch presence along its northern aspect. The woody component of the hedgerow was relatively species-rich comprising field maple (O), elm (R), elder (R), dog-rose (R), hazel (O) and holly (R). However, a tussocky ground flora was present indicative of nutrient enrichment with abundant false oat-grass, bramble and nettle.

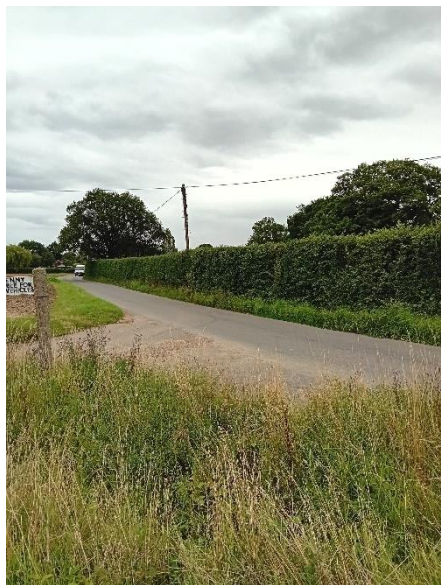
- H-H-32 and H-H-33 are adjacent roadside hedgerows separated by an existing gap. H-H-32 partly delineated a residential property and was well-managed hedgerow with outgrowth regularly trimmed and dimensions of approximately 4m tall and 2m wide. The ground flora could not be assessed in detail due to the presence of a busy road but several discernible species made up the woody component: field maple (O), elm (R), elder (R), hawthorn (F) and oak sp (O). H-H-33 was a less intensively managed hedgerow with tree species field maple (R), blackthorn (F), oak sp. (O), hazel (R), dog-rose (R), ash (O) and willow sp (R).

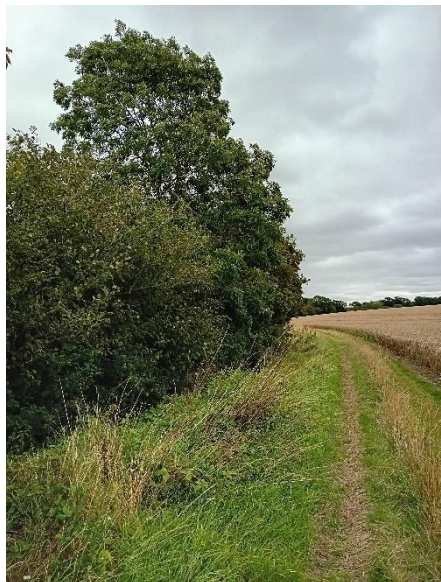
- H-H-34 was a field hedgerow situated on the border between two arable fields with an existing gap present where the proposed access route intersects. A partially wet ditch was also present along its entire south-eastern aspect (identified as W-H-20 in the otter and water vole survey in ES Appendix 7.2: Species Baseline Report [APP-112], and confirmed on site as having a low suitability for otter and water vole). The vegetation present within the gap comprised bramble scrub, false oat-grass (A), willowherb sp. (F), nettle (A) and common reed (R) where it was associated with the partially wet ditch. The woody component of H-H-34 was relatively species-rich comprising hazel (O), field maple (F), ash (O), blackthorn (F), elm sp. (R), and hawthorn (A).

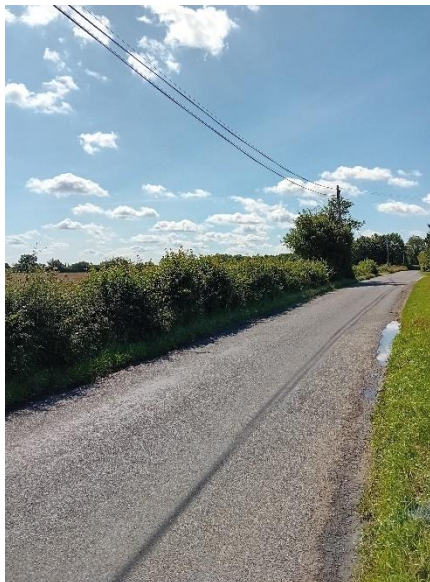
- H-H-35 was a roadside hedgerow. The woody component of the hedgerow comprised field maple (O), elm sp. (R), hawthorn (A), rosa sp. (R), oak (O), ash (R) and blackthorn (O). A relatively herb-rich ground flora was also present comprising knapweed (F), ragwort (R), field scabious (O), yarrow (O) and meadow vetchling (R). A dry ditch was also present along the eastern aspect of the hedgerow measuring approximately 0.8m x 0.5m.

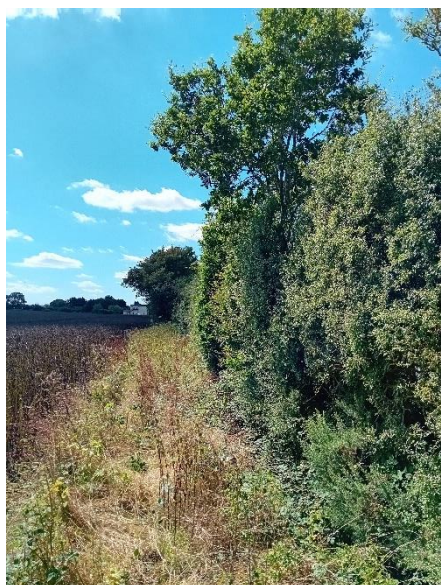
- H-H-36 was situated between an arable field and the A131 road. The woody component of the hedgerow comprised several immature and semi-mature trees with woody species recorded including blackthorn (F), oak sp.(F), gorse (LO), hawthorn

(A), field maple (O), elm sp. (R), dog-rose (R) and hazel (R). A partially wet ditch was present along its south-eastern aspect.

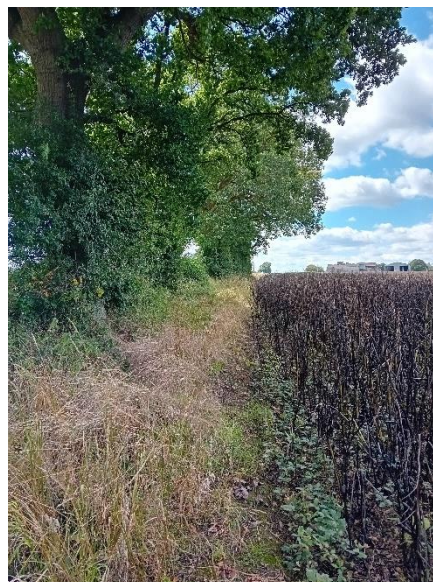
- LOT-H-12 was a line of six mature oak trees. Evidence indicative of breeding birds was also recorded associated with the line of trees with eggshells recorded at their base. A dry ditch ran along the south-western aspect of the tree line.
