Sea Link

Document: 6.4.4.6.A

Marine Archaeological Technical Report - Figures

Planning Inspectorate Reference: EN020026

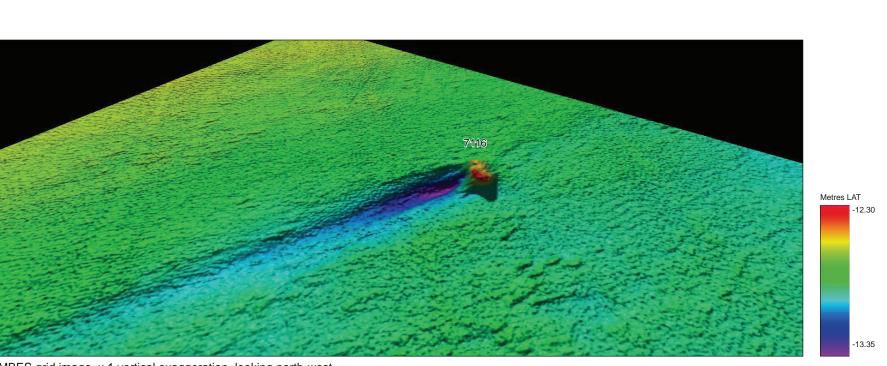
Location		407157 E 5779594 N	Area	Sea Link Offshore Block 1
Archaeological High Importance				DIOCK I
Geophysical survey dimensions and notes		Wreck 7116 is an unknown wreck (87090).	k that correspor	ds with a UKHO record
		The wreck is visible in the SSS d reflectors with slight shadows; man area of disturbed seabed. The and its full extent may be buried.	ultiple angular o	bjects are visible within
		In the MBES data the wreck is visible as a large oval mound with an uneven peak, with distinct scouring to the south measuring 25.0 m long and approximately 0.5 m deep. The mound's edges are indistinct which may suggest it is partially buried.		
		No anomalous features were identified in the Mag. data at this location.		
	Туре	Unknown		
	Construction	Unknown		
Build	Dimensions (m)	Unknown		
	Shipyard	Unknown		
Loss	Cause	Unknown		
	,	In the UKHO record the wreck was recorded MBES dimensions of 10		
Extent of Survival		In the 2021 geophysical data the wreck has no distinguishable characteristics, the larger 2021 geophysical dimensions may indicate the wreck has become more exposed since 2017. Associated scouring and sediment accumulation may indicate the wreck is periodically buried.

MBES grid image, x 1 vertical exaggeration, looking north-west

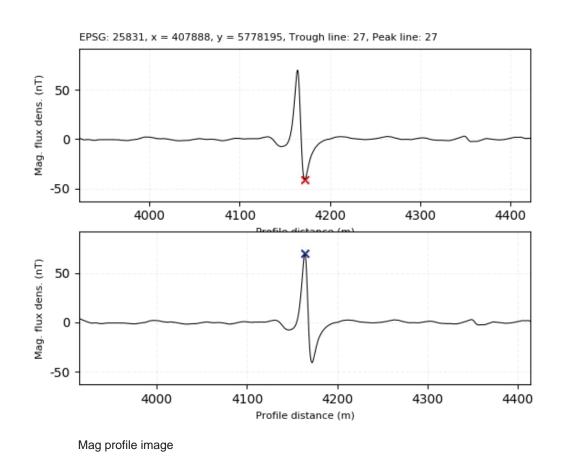
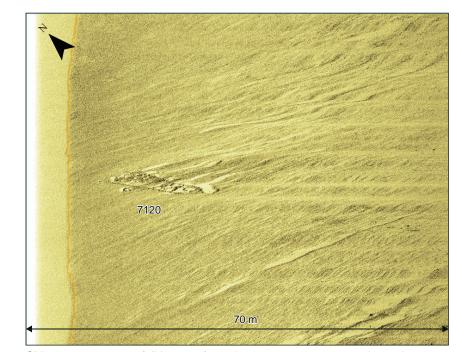
Wreck Sheet 2: Wreck 7120

Location		407875 E 5778194 N	Area	Sea Link Offshore Block 1	
Archaeolo	ogical Importance	High			
Geophysical survey dimensions and notes Type Construction		In the SSS data the wreck is vis curvilinear dark reflector interpreshadows across its length, indicangular and short and straight dithat may be surviving deck struction mobile sediments and measures. In the MBES data one end of the mound that appears to be most indistinct linear mounds are visil there are some small angular mister be collapsed structure. The wrece seabed, with the east end potent degraded. The wreck has scour mind 0.7 mideep. The wreck has a large Mag. and 111 nT, indicating some ferrous	ible as a large of the to be the high attended to be the high attended to be the high attended to be the high ark reflectors we true. The wreck is 22.2 x 9.9 x 0. The wreck is visibly intact hull structure of the suggesting to the south or	oval shaped thin ull, with bright irregular eight. Internally, indistinct ith shadows are visible of is situated in an area of o

Unknown			
Build	Construction	Unknown			
	Dimensions (m)	Unknown			
<u> </u>	Shipyard	Unknown			
Loss	Cause	Unknown			
Loss Cause Extent of Survival		The wreck appears to be mostly degraded. The wreck is situated may periodically conceal the wre	l within an area	of mobile sediments that

Sidescan sonar waterfall image of wreck 7120, 70 m range per channel

MBES grid image, x 1 vertical exaggeration, looking north-east

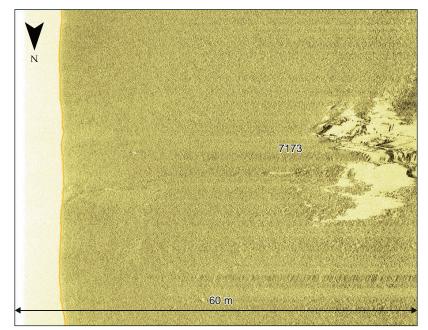
Wreck Sheet 3: Wreck 7173

400204 F 5772470 N	Arra	Coolint Offshare	
Location		408301 E 5772170 N	Area	Sea Link Offshore Block 2	
Archaeol	ogical Importance	High			
Geophysical survey dimensions and notes		Wreck 7173 is a recorded wreck orientated approximately north to south on the seabed and corresponds with UKHO record 10249, for HMS <i>Tervani</i> . The wreck is also recorded in the NMHR (912686). The wreck is partially covered by the SSS data and is visible a series of distinct but dispersed dark reflectors with bright shadows. Short linear and angular objects are visible, as well as slatted features that may be surviving deck structure. The wreck is orientated approximately north to south and extends beyond the SSS data range; the measured dimensions of 36.8 x 15.2 x 0.6 m, are significantly shorter than those in the UKHO record, suggesting the wreck extends considerably beyond the data extents. The wreck has significant scour associated that extends beyond the data range to the south-east. An associated debris field has been identified to the north, suggesting the wreck has degraded. The wreck was not directly covered by the MBES or Mag. datasets; however, a small Mag. anomaly was identified on the closest line 46 m east, measuring 34 nT, indicating some ferrous material is present.

Type	Trawler			
Build	Construction	Unknown, likely steel			
Build	Dimensions (m)	48.8 x 7.9 x 4.3 m, 457 tonnes	(gross)		
	Shipyard	Unknown			
Loss	Cause	Mine			
Extent of	Survival	Recorded by the UKHO as the 1914 and mined in 1916. The wexpansion engine. The wreck was being intact and partially bu 8.1 x 2.4 m. The wreck was only partially corecorded dimensions suggest to extents. No discernible superst linear features were identified was a superst linear features.	vessel had one leads to lead one leads was last surveyed ried, with MBES overed by the 20 the wreck extentructure was vis	boiler and a triple ed in 2017 and reported S dimensions of 48.1 x 021 SSS data and the ds beyond the data ible; however, some	
		Objects identified in the vicinity associated debris indicate it is		nd interpreted as

Sidescan sonar waterfall image of wreck 7173, 60 m range per channel

Mag profile image

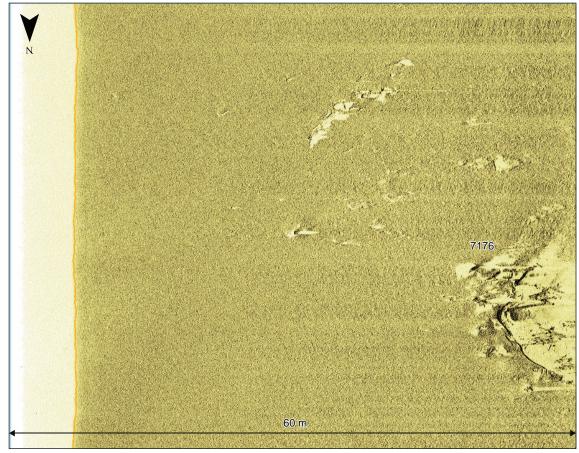
ID 7176 – UKHO 86578 – Unknown

Location		408288 E 5772083 N	Area	Sea Link Offshore Block 2
Archaeo Importan		High	l	BIOUR Z
	sical survey ons and notes	Wreck 7176 is an unknown, record 86578. The wreck is partially covered by spread of linear, curvilinear, elon bright shadows. The wreck meas extends beyond the SSS data ra considered a minimum. At the no curvilinear dark reflector measuri interpreted to be a part of the hul visible, and associated debris had the wreck was not directly cover is not possible to ascertain wheth	the SSS data a gate, and angul sures 41.4 x 10.3 nge and so the orth-east end of ng 23.7 x 1.3 m I. No superstruct s been identified	and is visible as a large ar dark reflectors with 2 x 0.4 m, however it dimensions should be the wreck a distinctive is visible that is sture or deck structure is d in the vicinity.
	Туре	Unknown		
	Construction	Unknown		
Build	Dimensions (m)	Unknown		
	Shipyard	Unknown		
Loss	Cause	Unknown

Extent of Survival		Associated with a UKHO record 2017. It is described as a being ladimensions of 41.7 x 6.5 x 2.9 m The wreck was partially covered discernible superstructure was vithe wreck and interpreted as debidegraded.	argely intact and by the 2021 SS sible. Objects ic	d partially buried, with S data and no lentified in the vicinity of

Sidescan sonar waterfall image of wreck 7176, 60 m range per channel

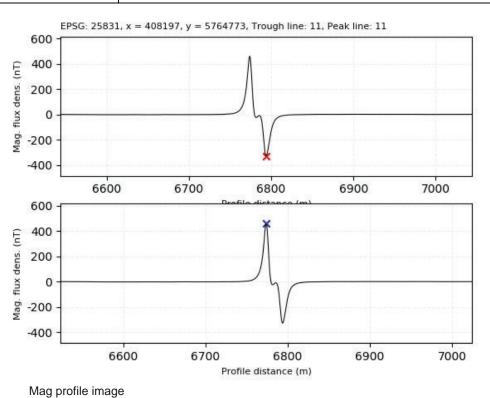
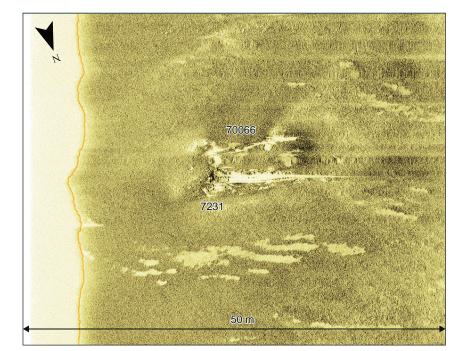
Wreck Sheet 5: Wreck 7231

Location		408206 E 5764776 N	Area	SEA Link
Archaeolo	gical Importance	High		
Geophysi	cal survey ns and notes	Wreck 7231 is a recorded 'dar record 92098. The wreck is visible in the SSS fields made up of multiple dark linear dark reflectors with shad with numerous smaller angular wreck remains measures 14.4 main area of the wreck The se anomaly 70066, and measures. In the MBES data it is identified with a stepped outline in profile part of the object. The northern scour around the west, east ar depression that measures 25.3. The wreck is associated with a dipole with an amplitude of 786.	S data as two tick reflectors of a dows of varying repieces of debix 10.7 x 2.4 method debris fies 11.8 x 4.4 x 0 down as a slightly dec. The southern extents are indicated in a contract of the southern edge (15 m.)	ghtly constrained debris ingular, sub-rounded and lengths. It is interspersed ris. The largest area of and is interpreted as the eld is tagged separately as 0.8 m. elongate, angular object in extent forms the tallest increasingly rounded, with ges, sitting in a rectangular

Туре	Unknown		
Build	Construction	Unknown, but likely steel hulle	d due to large	Mag. anomaly.
Build	Dimensions (m)	Unknown		
	Shipyard	Unknown		
Loss	Cause	Unknown		
Extent of	Survival	Recorded as a suspected wree surveyed on 28 November 20 structures with reported dimen dimensions recorded in the da found the wreck to be 18.6 x 4 the site is active and periodica. In the current survey data, the No definite coherent structure the process of disintegrating full surveys that the surveys of the process of disintegrating full surveys the process.	19, when it was sions of 19.9 x ta. A previous 2.2 m, suggestir lly covers parts vessel appear is visible, and t	s found to have two visible 3.4 x 4 m, different to the survey on 17 July 2019 ng that the seabed around s of the wreck. s to be highly degraded.

Sidescan sonar waterfall image of wreck **7231**, 50 m range per channel

MBES grid image, x 1 vertical exaggeration, looking north

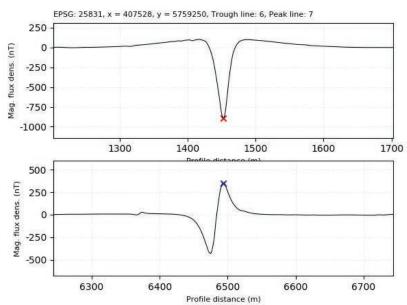
Wreck Sheet 6: Wreck 70090

Location		407526 E 5759254 N Area SEA Link		
Archaeolo	gical Importance	High	•	
Geophysical survey dimensions and notes		Wreck 70090 is a recorded 'dangerous wreck' that corresponds with UKHO record 14722. The wreck is identified in the SSS data as a large sub-rounded and elongate dark reflector with a tall shadow of varying height surrounded by several debris fields, with the shape of the hull visible. The wreck measures 22.8 x 8.1 x 4.8 m. In the MBES data a wide tall, elongate, angular mound is visible, orientated northeast to southwest. Shallow scour is visible on the west and northeast sides of the wreck. There is a very indistinct debris field immediately to the south-west of the main wreck (70093), comprising of several sub-rounded mounds, potentially partially covered by a large sand wave. Another potential narrow debris field is located to the north (70089). A possible anchor is located on the seabed immediately to the east (70091). The wreck is associated with a very large, sharp asymmetric magnetic dipole with an amplitude of 1,241 nT.

Туре	Unknown		
Build	Construction	Unknown		
Bullu	Dimensions (m)	Unknown		
	Shipyard	Unknown		
Loss	Cause	Unknown		
Extent of		Recorded in the UKHO as a 'dar surveyed in September 2019, de broken apart. The dimensions we differs from a previous survey or noted, there is 'no sign of breakt slowly disintegrating. In a previou noted that the wreck 'appears to the data. In the data the wreck appears to west of the wreck does look like various surveys since 1976, the changed markedly, and it is visits surrounded by sand waves, suggand regularly buries other pieces	escribed as a pa ere noted as 23 a 31 st December up' and no scour us survey on 13 be netted'. This be quite cohere it has some min measurements of ble in the data the	rtially buried wreck and x 22.4 x 6.5 m. This 1976, where it was suggesting the wreck is the December 1995, it was is hard to confirm from ent, although the souther disintegration. In of the anomaly have at the wreck is

Mag profile image

Sidescan sonar waterfall image of wreck 70090, 50 m range per channel

MBES grid image, x 1 vertical exaggeration, looking south-east

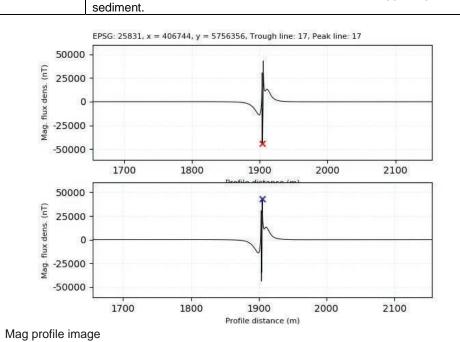
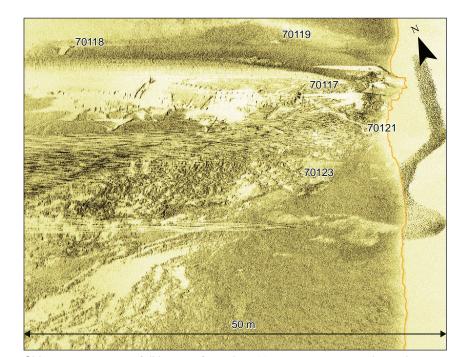
Wreck Sheet 7: Wreck 70117

Location		406736 E 5756356 N Area Sea Link Area 2			
Archaeolo	ogical Importance	High			
Geophysical survey dimensions and notes		Wreck 70117 is a recorded 'dangerous wreck' that corresponds with UKHO record 14685. The wreck is identified in the SSS data as a very large elongate dark reflector with a long shadow on an east to west alignment. It contains numerous individual elongate and subangular dark reflectors with shadows of varying heights, suggesting at least partially intact internal structure. It has dimensions of 83.2 x 23.5 x 17.6 m. The wreck is visible in the MBES data as a coherent structure potentially lying on its side, orientated WNW to ESE. The hull outline is very clear on the western end of the structure. Some internal rectangular structures are visible towards the eastern end of the structure, where it appears more heavily degraded. The southern outline is not very visible for the most part, due to partial burial. The wreck is surrounded by very large areas of scour to the northeast and southwest, extending >200 m to the northeast. The wreck is associated with a very large magnetic dipole with an amplitude of 86,807 nT.

Туре	Steamship			
Build	Construction	Likely steel hulled, due to magnetic anomaly			
Bana	Dimensions (m)	82 x 12.8 x 5.5 m			
	Shipyard	FREDRIKSTAD MEK VAERKS, FREDRIKSTAD			
Loss	Cause	Struck a mine and later sank whilst on tow, 28/02/1942			
Extent of	Survival	Recorded in the UKHO as a 'dangerous wreck' of the steam ship <i>Thyra</i> built in 1925 in Fredrikstad Mek Vaerks, Fredrikstad. It struck a mine on 28 th February 1942 on passage from Hartlepool for London with a cargo of timber. It sank after being taken in tow. The wreck was last surveyed in September 2015, described as lying on its port side. The dimensions were noted as 84 x 20 x 9.6 m, like those recorded in the modern survey data. In a survey on 20 th December 1995, it was noted that the wreck is netted. This is hard to confirm from the data. The structure of the wreck in the survey data appears to be coherent. The presence of a large void in the MBES data, down the length of the hull, shows that some degradation is taking place, with part of the hull potentially splitting away from the rest of the wreck. There are several seabed disturbances and debris fields of angular dark reflectors surrounding the wreck, further evidence of its ongoing disintegration. Surviving internal structure is visible in the MBES data, and in the SSS data as elongate dark reflectors. A dive on the wreck in September 1987 had to be cancelled due to a "Strong upswelling" in the area, with "Sand, shingle and shell being disturbed". This, combined with the data showing considerable scour suggests the seabed around the wreck is highly active. The reflectivity of the wreck is varied on the eastern end, suggesting it is partially covered with

Sidescan sonar waterfall image of wreck **70117**, 50 m range per channel

MBES grid image, x 1 vertical exaggeration, looking north

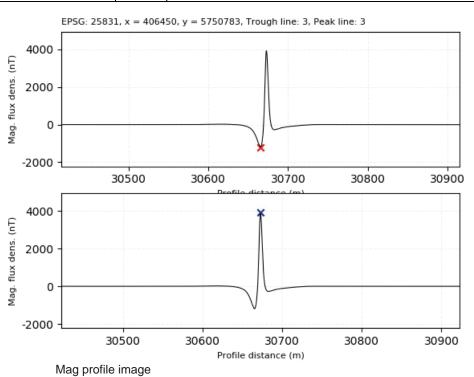
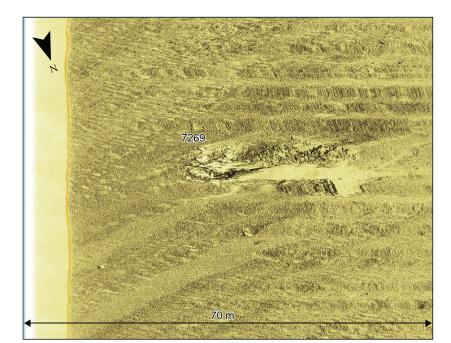
Wreck Sheet 8: Wreck 7269

Location		406448 E 5750777 N					
Archaeolo	ogical Importance	High	1				
Geophysi	cal survey ns and notes	and NMHR (908160) records for The wreck is visible in the SSS intermittent dark reflector with be Within this, multiple linear, curviful The wreck measures 43.5 x 20.5 been identified in the vicinity. In the MBES data the wreck is vicurvilinear mounds. The largest and a flat thin peak measuring 1 conning tower or a rudder. Some may be partially buried. The wrenorth and south for a maximum	Wreck 7269 is a recorded wreck and corresponds with UKHO (14599) and NMHR (908160) records for UC11 (Possibly). The wreck is visible in the SSS data as a thick, elongate and slightly intermittent dark reflector with bright shadows interpreted to be the hull. Within this, multiple linear, curvilinear and angular objects are visible. The wreck measures 43.5 x 20.7 x 3.2 m and associated debris has been identified in the vicinity. In the MBES data the wreck is visible as a spread of angular, linear and curvilinear mounds. The largest mound is rectangular, with steep sides and a flat thin peak measuring 13.6 x 4.3 x 3.0 m, and may be the conning tower or a rudder. Some objects are very distinct, and others may be partially buried. The wreck has scouring associated orientated north and south for a maximum of 28.0 m and is 0.5 m deep. The wreck has a very large magnetic anomaly associated with it,

Туре	Submarine					
Build	Construction	Steel					
Bullu	Dimensions (m)	34.1 x 3.0 m					
	Shipyard	Vulkanwerke, Hamburg					
Loss	Cause	Mine					
Extent of Survival		Recorded as UC11 (Possibly) in the UKHO and NMHR records, a German minelaying submarine that sank in 1918 after running into one of its own mines. The wreck is reported as being upturned, with a strong magnetic anomaly associated. The wreck was last surveyed in 2016 and described as being broken up with dimensions of 27.0 x 11.0 x 4.3 m. The UKHO record suggests that the wreck may have been salvaged in the past. In the 2021 geophysical data the wreck appears to be degraded and broken up. One piece of superstructure is visible, possibly the conning tower, although the UKHO record suggests the wreck is upturned, so					
		may be a rudder, the hull is also in an area of mobile sediments a Associated debris has been identhere is potential for further debri	highly degrade and it may peric ntified in the vic	ed. The wreck is situated odically be buried.

Sidescan sonar waterfall image of wreck **7269**, 70 m range per channel

MBES grid image, x 1 vertical exaggeration, looking east

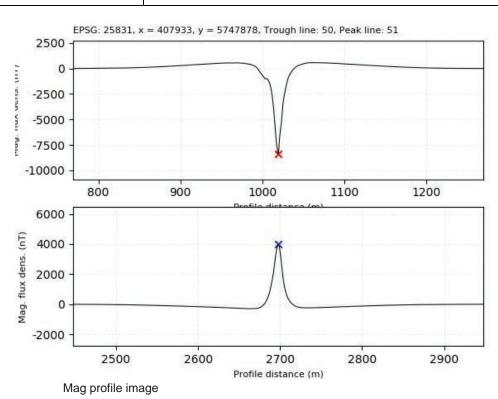
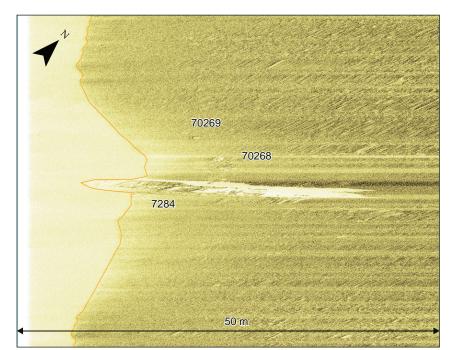
Wreck Sheet 9: Wreck 7284

•				
Location		407934 E 5747879 N Area SEA Link					
Archaeolo	ogical Importance	High					
	cal survey ns and notes	Wreck 7284 is a recorded 'dangerous wreck' that corresponds with UKHO record 14570. The wreck is visible in the SSS data as a coherent structure, oriented northeast to southwest, with numerous internal angular dark reflectors with shadows. It has a very large shadow which may hide more of the structure of the wreck. Its dimensions were measured to be 40.3 x 11.9 x 5.5 m. In the MBES data the wreck is visible as coherent and upright, with some internal structure visible within the hull and possible degradation at either end. Some shallow scour is also visible along the northwestern edge and extending to the southwest. The wreck is associated with a very large asymmetric magnetic dipole in the Mag. data, with a magnetic amplitude of 12,371 nT.					
	Туре	Unknown					
Build	Construction	Unknown, but assumed steel hull due to intact nature and mag. anomaly

Bulla	Dimensions (m)	Unknown		<u> </u>			
	Shipyard	Unknown					
Loss	Cause	Unknown					
Extent of Survival		The wreck was first recorded in a Oropesa sweep in June 1932. The and is described as sitting upright the exception of the stern. The way as a second of the stern and the exception of the stern. The way as a second of the sediment. A previous dive in Decontained nets and buoys among the wreck appears coherent in the with surviving internal componers. The MBES data also suggests a disintegrating. Surrounding piece mounds are further evidence of the sternish surviving internal componers.	he wreck was land on the seabed wreck has report the dimensions wereck may be presented the structure the data. The structs visible in the tern and bow of es of debris, ang	ast surveyed in July 2016 d, in good condition "With red dimensions of 37.4 x s in the current survey periodically buried by ported the wreck c. ructure appears intact MBES and SSS data. the ship are gular dark reflectors and

Sidescan sonar waterfall image of wreck 7284, 50 m range per channel

MBES grid image, x 1 vertical exaggeration, looking north

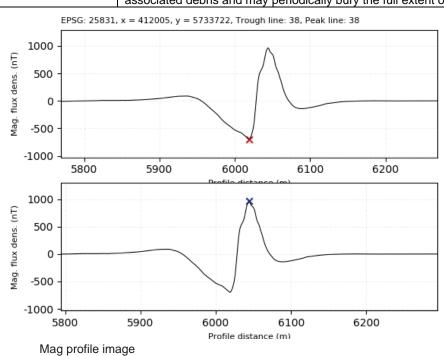
0	11/09/2024	ENVIRONMENTAL STATEMENT	KF	VL	EM		
Rev	Date	Description	GIS	Chk	Арр		
national grid							
Scheme: SEA LINK							
Occument Title: Wreck Sheet 10: Wreck 7346

Location		412020 E 5733762 N	Area	Sea Link Offshore			
Archaeological Importance		High		Block 3			
Geophysical survey dimensions and notes Type Construction		Wreck 7346 is a recorded wreck that corresponds with the UKHO (14419) and NMHR (802191) records for <i>Salerno</i> (Possibly). In the SSS data one edge of the hull is visible as a distinct long and thick dark reflector with a very large, bright and uneven shadow, indicating uneven height. Within the hull there are multiple indistinct elongate and linear dark reflectors, indicating the wreck is upright and has some surviving deck structure. The wreck measures 97.0 x 25.2 x 11.1 m and is oriented north-east to south-west on the seabed, it is situated within an area of mobile sediments. In the MBES data the wreck is upright but leaning over to one side, and the northern side of the wreck is not visible. The hull appears to be mostly intact, with collapsed structure on its south-west end with the northern edge of the wreck buried by sediments. In the centre of the deck a large square mound is visible measuring 8.7 x 4.2 x 4.0 m. There are multiple linear and angular mounds across the deck and a large mound is present at the north-eastern end of the vessel indicating surviving superstructure and possibly a boiler. The wreck has significant scour to the south for over 200.0 m and up to -6.0 m deep and is surrounded by sediment accumulation which may be concealing the full extents of the wreck and possibly associated debris. The wreck has a very large Mag. anomaly associated with it, measuring 1,659 nT, indicating substantial ferrous material is present.

Unknown, likely steel					
Build	Dimensions (m)	99.1 x 13.5 x 6.0 m					
	Shipyard	Wood, Skinner & Co, Newcastle	e-Upon-Tyne				
Loss	Cause	Mine					
Extent of Survival		Recorded by the UKHO as <i>Salerno</i> (Possibly), a steam ship built in 1912 with two boilers and a triple expansion engine. The vessel struck a mine laid by UC3 in 1915. The wreck was last surveyed in 2016 and described as being broken up with a strong Mag. anomaly associated and dimensions of 95.0 x 22.0 x 11.7 m. In the 2021 geophysical data the wreck appears to be predominantly intact, although the south-west end has evidence of deterioration. It is situated within an area of large sand waves which may be concealing associated debris and may periodically bury the full extent of the wreck.

Sidescan sonar waterfall image of wreck **7346**, measuring 70 m range per channel

MBES grid image, x 1 vertical exaggeration, looking south

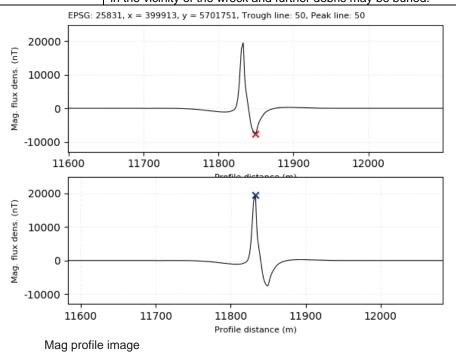
Wreck Sheet 11: Wreck 7414

0 111 011				
Location		399938 E 5701754 N	Area	Sea Link Offshore Block 4				
Archaeole Important		High	High					
		Wreck 7414 is a recorded wreck (13968) and NMHR (904723) rec	ords for <i>Saidiel</i>	h.				
		In the SSS data the wreck is visible as a large spread of distinct linear and curvilinear dark reflectors with bright shadows. The wreck is upright and measures 116.6 x 36.6 x 6.8 m, there are slatted features visible internally, however no superstructure is identifiable. The wreck has a rope or chain that is either attached or snagged on the south-eastern edge. The hull of the wreck is not well defined, suggesting it is broken up.						
	cal survey ns and notes	In the MBES dataset the wreck is orientated approximately ENE to WSW on a relatively featureless area of seabed. The wreck appears upright, but is highly degraded with a collapsed hull. Within the hull possible surviving deck structure is visible, comprising three distinct square shaped mounds in its centre with thin, linear mounds and smaller rounded and angular mounds across the deck. The wreck has significant sediment accumulation and scour to the north and south, with significant scour to the south measuring 140.0 x 54.0 x -5.2 m, which may be burying collapsed structure and associated debris.

The wreck has a very large Mag. anomaly associated with it, measuring 27,020 nT, indicating substantial ferrous material is present.						
	Туре	Steam ship		•				
	Construction	Unknown, likely steel						
Build	Dimensions (m)	106.7 x 12.2 x 7.0 m						
	Shipyard	Unknown						
Loss	Cause	Sunk by German submarine						
Extent of Survival		Recorded by the UKHO and NMHR as <i>Saidieh</i> , a 3303 gross ton steam ship built in 1878. The vessel was sunk in 1915 by UB6, a German submarine. The wreck was last surveyed in 2017 and described as being partially broken up and buried with dimensions of 112.5 x 21.1 x 5.8 m.						
Extent of	Survivai	The larger geophysical dimensions in the most recent survey may indicate the wreck has collapsed, degraded further, or become more exposed since 2017. The wreck is situated on a relatively featureless area of seabed, but it has substantial sediment accumulation around it and it may periodically be buried. Associated debris has been identified in the vicinity of the wreck and further debris may be buried.

Sidescan sonar waterfall image of wreck **7414**, 70 m range per channel

MBES grid image, x 1 vertical exaggeration, looking west

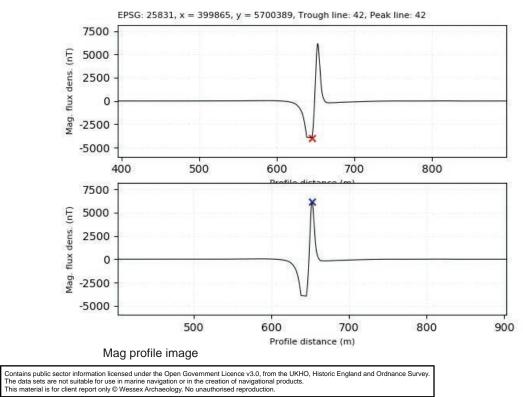
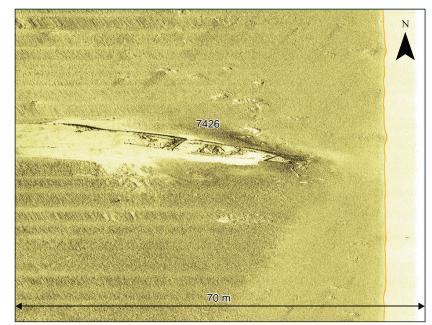
Wreck Sheet 12: Wreck 7426

Lacation		399876 E 5700385 N	Area	Sea Link Offshore		
Location				Block 4		
Archaeolo	gical Importance	High				
Geophysi	cal survey ns and notes	Wreck 7426 is a recorded wreck (13958) and NMHR (831796) re The wreck is visible in the SSS of curvilinear dark reflector with a last 11.9 x 3.4 m. This is interpreted be intact. Within the hull, linear a slatted features are visible that pastructure. One end of the vessel In the MBES data the stern of the bow to the ESE. The hull is a visible in the centre of the wreck It appears slightly bowed and has accumulation at either side of the burying its full extent. The wreck visible in its centre that may be a structure is visible as linear moulangular mounds at the bow end by scouring at the bow and stern. The wreck has a very large Mag 10,094 nT, indicating substantia.	data with a largeright uneven storepresent the and curvilinear cossible represent is heavily degrate wreck appearmostly intact, he which may sugas large amount e hull up to 5.0 re is upright with boilers. Some punds at the sterr of the vessel. The up to 2.0 m degrated and the sterr of the vessel. The up to 2.0 m degrated and the sterr of the vessel. The up to 2.0 m degrated and the sterr of the vessel. The up to 2.0 m degrated and the sterr of the vessel. The up to 2.0 m degrated and the sterr of the vessel. The up to 2.0 m degrated and the sterr of the vessel. The up to 2.0 m degrated and the sterr of the vessel. The up to 2.0 m degrated and the sterr of the vessel	known wreck. e, elongate and distinct hadow, measuring 51.6 x e hull, which appears to dark reflectors and some ent surviving deck haded and may be buried. It is to be to the WNW and owever there is a diple gest it is broken in two. Is of sediment might that may be two triangular mounds hossible surviving deck hand small uneven the wreck is surrounded beep.

Construction	Unknown, likely steel				
Build	Dimensions (m)	Unknown				
	Shipyard	Unknown				
Loss	Cause	Unknown				
Extent of Survival		Recorded by the UKHO and NMHR as an unknown wreck that was last surveyed in 2017. The wreck was reported as being upright and intact with dimensions of 50.8 x 9.0 x 3.7 m and with 25.0 m of scour up to 2.7 m deep. The wreck appears to be mostly intact however evidence of collapse and burial is visible in the 2021 geophysical data. Several items of debris are visible surrounding the wreck suggesting it is degraded and a large mound identified at the stern suggests a large piece of the vessel may have broken off. The wreck is situated in an area of mobile				
sediments and it may periodically be buried. EPSG: 25831, x = 399865, y = 5700389, Trough line: 42, Peak line: 42

Sidescan sonar waterfall image of wreck **7426**, 70 m range per channel

MBES grid image, x 1 vertical exaggeration, looking south-west

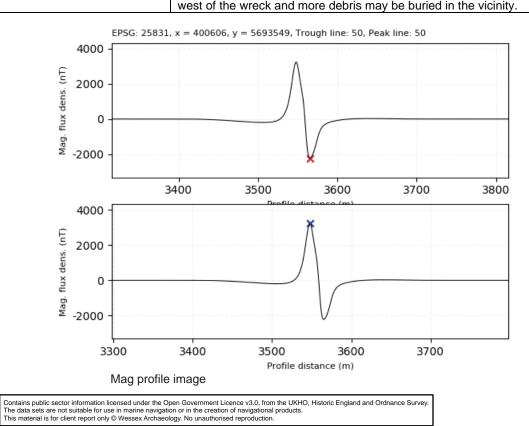
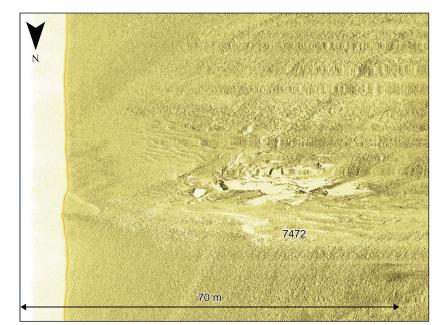
Wreck Sheet 13: Wreck 7472

400613 E 5693545 N	Area	Sea Link Offshore			
Location		100010 2 00000 10 14	71100	Block 4			
Archaeolo	ogical Importance	High	•				
Geophysical survey dimensions and notes Type Construction Dimensions (m) Shipyard Loss Cause		Wreck 7472 is a recorded wreck that corresponds with the UKHO (14944) and NMHR (904908) records for <i>Selma</i> (Possibly). In the SSS data the wreck is visible as a large spread of elongate, angular and curvilinear dark reflectors with bright shadows. The hull is not distinct and there are no discernible internal features visible, suggesting the wreck is very broken up. The wreck measures 52.5 x 38.7 x 1.6 m and is situated in an area of mobile sediments, indicating the full extent of the wreck may be buried. In the MBES data the wreck is visible as a group of elongate, angular and rounded objects situated within depressions. The largest linear object measures 7.7 x 2.8 x 0.6 m and a large angular mound at the western end of the wreck measures 4.1 x 2.8 m; this has a very flat peak and steep edges, and some data points are missing which may suggest its peak is overhanging the edge of the main structure. Large scouring is visible to the south of the wreck measuring 24.0 m long and 0.6 m deep. The wreck is surrounded by sand waves and there is some outcropping geology to the north. The wreck has a very large Mag. anomaly associated with it, measuring 5,443 nT, in dicating substantial ferrous material is present

Unknown, likely steel					
Build		82.3 x 11.9 x 5.5 m					
	` ,	Unknown					
Loss		Mined					
Extent of	Survival	Recorded in the UKHO and NM 1654 gross ton steam ship that was last surveyed in 2018 and r dispersed debris in scour with d The larger geophysical dimensic indicate the wreck has collapsed exposed since 2018. The wreck situated in an area of mobile see be buried. An associated debris west of the wreck and more debrised.	was sunk by a reported as con imensions of 30 ons in the most d, degraded fur is very broken diments, sugge field has been	mine in 1915. The wreck sisting of broken and 0.0 x 23.3 x 0.8 m. recent survey may ther, or become more up and degraded and is sting it may periodically identified to the north-

Sidescan sonar waterfall image of wreck 7472, 70 m range per channel

MBES grid image, x 1 vertical exaggeration, looking north-east

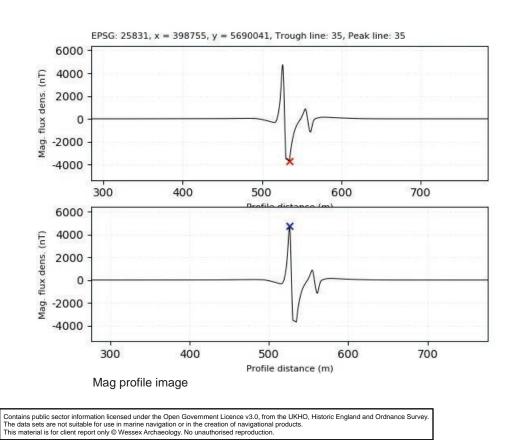
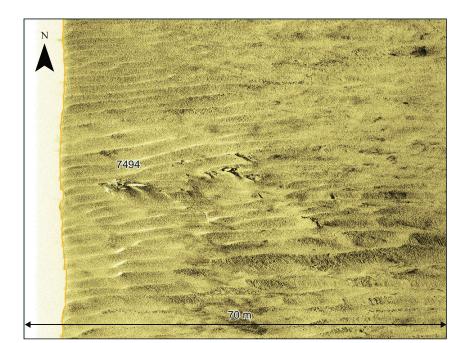
Wreck Sheet 14: Wreck 7494

398780 E 5690035 N	Area	Sea Link Offshore			
Location				Block 4			
Archaeolo	ogical	High					
Important	ce						
Geophysical survey dimensions and notes		Wreck 7494 is a recorded wreck that corresponds with UKHO record 15175, <i>Klar</i> . In the SSS data the wreck is visible as large spread of highly anomalous rounded, curved, linear and angular dark reflectors with shadows of varying heights. The wreck measures 51.3 x 42.2 x 1.0 m and is situated within an area of sand waves, suggesting the potential for further debris to be buried in the vicinity. In the MBES data the wreck is visible as an area of disturbed seabed comprising three compact groups of distinct mounds within mobile sediments. An elongate object is visible measuring 2.2 x 1.2 m and the largest mound measures 2.8 x 1.8 m. Smaller rounded and angular mounds are also visible and the feature has scouring to the south for 13.0 m and up to 0.4 m deep. The wreck has a very large Mag. anomaly associated with it, measuring 8,421 nT, indicating substantial ferrous material is present.

Туре	Steam Ship					
	Construction	Unknown, likely steel					
Build	Dimensions (m)	45.7 x 7.6 x 5.2 m					
	Shipyard	Unknown					
Loss	Cause	Mine					
Extent of	Survival	Recorded by the UKHO as <i>Klar</i> , mine and sank on passage from last identified in 1997 with measu scour extending for 65.0 m. The varvey in 2018 and the record was In the 2021 geophysical data the degraded with no identifiable struwithin sand waves and may be pwhy it was not identified in 2018.	Tyne to Rouen trements of 50.0 wreck was not id as amended to o wreck appears acture visible. The	in 1915. The wreck was 0 x 45.0 x 1.0 m with dentified in a MBES dead. very broken up and ne wreck is situated

Sidescan sonar waterfall image of wreck **7494**, 70 m range per channel

MBES grid image, x 1 vertical exaggeration, looking north-west

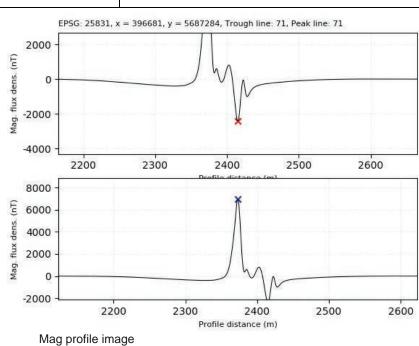
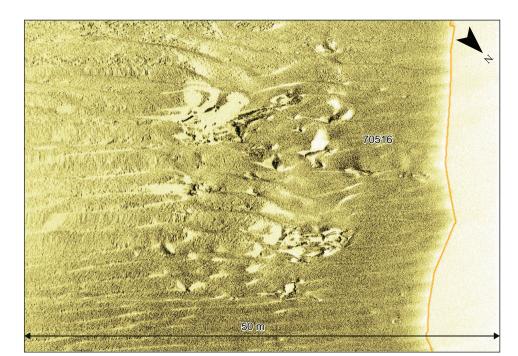
Wreck Sheet 15: Wreck 70516

1 -			
Location		396674 E 5687281 N	Area	SEA Link		
Archaeolo	gical Importance	High				
	cal survey ns and notes	Wreck 70516 is a recorded 'dangerous wreck' that corresponds with UKHO record 13849 of the HMS <i>Arctic Trapper</i> . The wreck is identified in the SSS data as >10 distinct angular and subangular dark reflectors with shadows and scour, measuring 74.7 x 55.4 x 1.4 m and located within an area of sand ripples. In the MBES data it is recorded as several widely spaced, angular pieces of debris, the largest of which measures 7.3 x 3.5 x 0.3 m and is located in a slight depression. Towards the north-east there is another large piece of debris measuring 3.2 x 1.8 x 0.8 m. The wreck is associated with a very large asymmetric magnetic dipole, with an amplitude of 9,405 nT.				
	Туре	Trawler				
Build	Construction	Unknown, but presumed steel hull from the Mag. anomaly. Single boiler, triple expansion engine, single shaft, one 12 pounder gun.

Dimensions (m) Shipyard	Unknown				
		Unknown				
Loss	Cause	Sunk by German aircraft, 03/02				
Extent of Survival		The wreck is noted as being 'pa wreckage' in the UKHO record. when it was found to have dime different to the recorded dimens measurement of the largest pied dimensions of the entire debrist magnetic anomaly. In the data, the wreck is highly debris field. While the structure is possible that large, angular mrepresent individual surviving or UKHO record, such as the engited debris, and sand waves in the a such, other nearby pieces of detical it is not that the wreck was "displikely accounts for its highly degistructure is unlikely to survive.	It was last survensions of 3.1 x 2 sions in the data, be of debris in the field. The UKHO degraded. It is visof the ship has counds visible in emponents of the sor boiler. So rea suggest the bris may be buri	eyed in September 2015 2.7 x 2 m, markedly although this may be a se area, rather than the records it as a 'strong' sible as a widely spaced completely disintegrated, it the MBES and SSS data e ship mentioned in the our is visible around the seabed is active. As ed. eabed" in 1947, which

Sidescan sonar waterfall image of wreck **70516**, 50 m range per channel

MBES grid image, x 1 vertical exaggeration, looking north

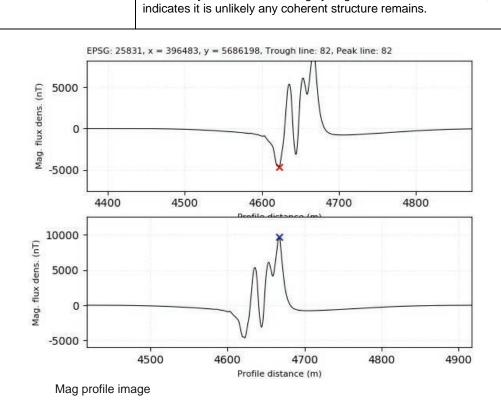
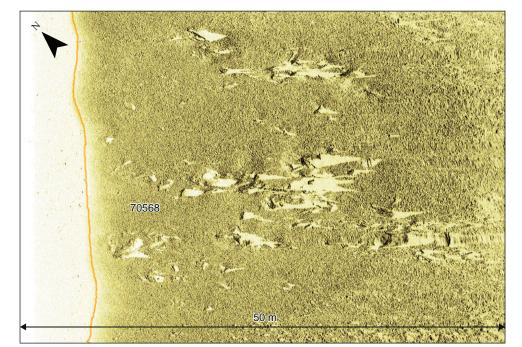
Wreck Sheet 16: Wreck 70568

Leaden							
Location		396470 E 5686189 N	Area	Sea Link Area 5			
Archaeolo	gical Importance	High					
Geophysical survey dimensions and notes		Wreck 70568 is a recorded 'dan UKHO record 13843 for the <i>Ryal</i> . The wreck is visible in the SSS angular pieces of debris with point x 1.3 m. No coherent structure in the MBES data the wreck is with a larger distinct angular momeasures approximately 15.0 x smaller, angular mounds. In the Mag. data, the wreck is rewith a magnetic amplitude of 14.	data as a distinct inted shadows, is visible in the disible as severa und located 10 9.3 x 1.5 m and ecorded as a vertical for the discorded as a vertical force.	ct scatter of multiple large that measures 37.4 x 36.7 data. Il very angular mounds, m to the southwest. It lis surrounded by several			
	Steam Ship						
Ruild	Build Construction Dimensions (m)	Unknown, but assumed steel hull due to Mag. anomaly

Bullu		Unknown					
	Shipyard	Unknown					
Loss	Cause	Mined, 24/04/1940					
Extent of Survival		The wreck was last surveyed in having dimensions of 6.0 x 3.5 x entire debris field visible in the dextend over an area 65 x 38 x 1 wide area". The wreck appears as very disposes appears to be highly degroherent wreck. Visible large an components of the ship. The deland may be periodically buried and may be periodically buried approximately 50 m northwest. The wreck is recorded as being	(2 m, which are lata. Earlier surv. 7 m, with "Wredersed in the data raded and is ungular mounds noris is located in A large debris for, along with severe late.	e much smaller than the veys found the debris to ckage scattered over a sa. The structure of the recognisable as a may be individual surviving an area of sand waves field (70567) located 15 m veral pieces located

Sidescan sonar waterfall image of wreck 70568, 50 m range per channel

MBES grid image, x 1 vertical exaggeration, looking north

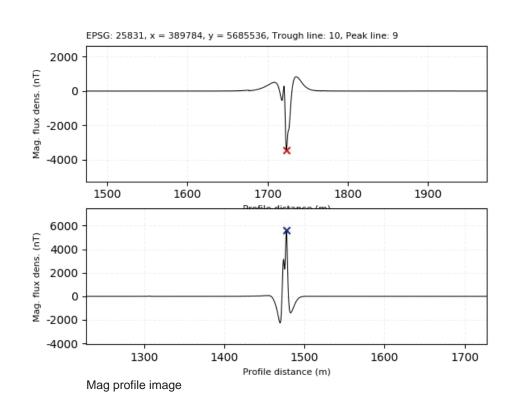
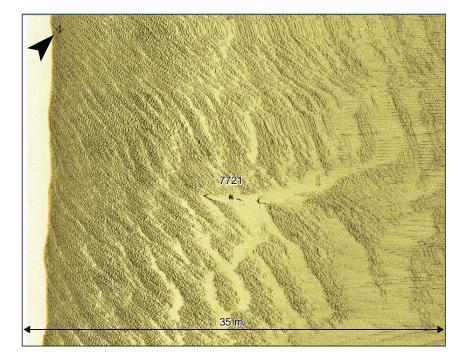
Wreck Sheet 17: Wreck 7721

Location		389778 E 5685519 N	Area	Sea Link Nearshore		
				S5		
Archaeole Important	•	High				
Geophysical survey dimensions and notes		Wreck 7721 is a recorded wreck that corresponds with UKHO record 85569, an unknown wreck. In the SSS data the wreck is visible as an area of disturbed seabed with three distinct dark reflectors within; a thin right-angled object measuring 5.0 x 0.6 m is visible, plus two smaller angular objects with slight shadows. The wreck measures 8.5 x 4.7 x 0.4 m and is situated within an area of mobile sediments so the full extent is likely buried. In the MBES data the wreck is visible as a group of angular objects in the base of a large depression or seabed disturbance: the largest object measures 2.1 x 1.2 x 0.2 m. The wreck has a very large Mag. anomaly associated with it, measuring 9,085 nT, indicating substantial ferrous material is present.				
	Туре	Unknown				
	Construction	Unknown, likely steel

Build	Dimensions (m)	Unknown				
	Shipyard	Unknown				
Loss	Cause	Unknown				
Extent of Survival		Recorded by the UKHO as an unknown wreck, first identified in 2016, and reported as being the possible remains of a barge. The wreck was last surveyed in 2019 with MBES dimensions of 37.4 x 3.9 x 0.9 m. The wreck is highly broken up with no hull or structure discernable in the 2021 geophysical data. The previously reported dimensions and appearance suggest that this wreck has become almost completely buried in making and inspects given 2010 and little control and about its				
		buried in mobile sediments since 2019 and little can be said about its present condition.

Sidescan sonar waterfall image of wreck **7721**, 35 m range per channel

MBES grid image, x 1 vertical exaggeration, looking west
