Sea Link

Generic Quantitative Risk Assessment – Kent Part 1 of 2

Sea Link FEED

Generic Quantitative Risk Assessment
Richborough

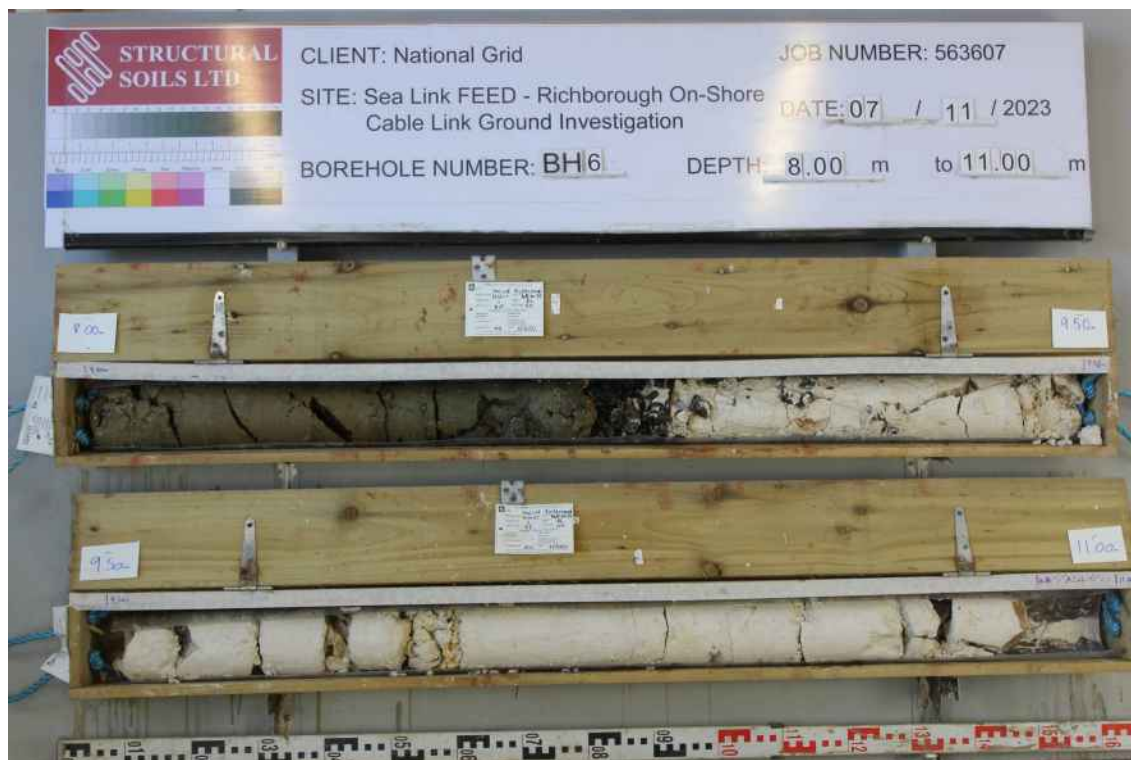
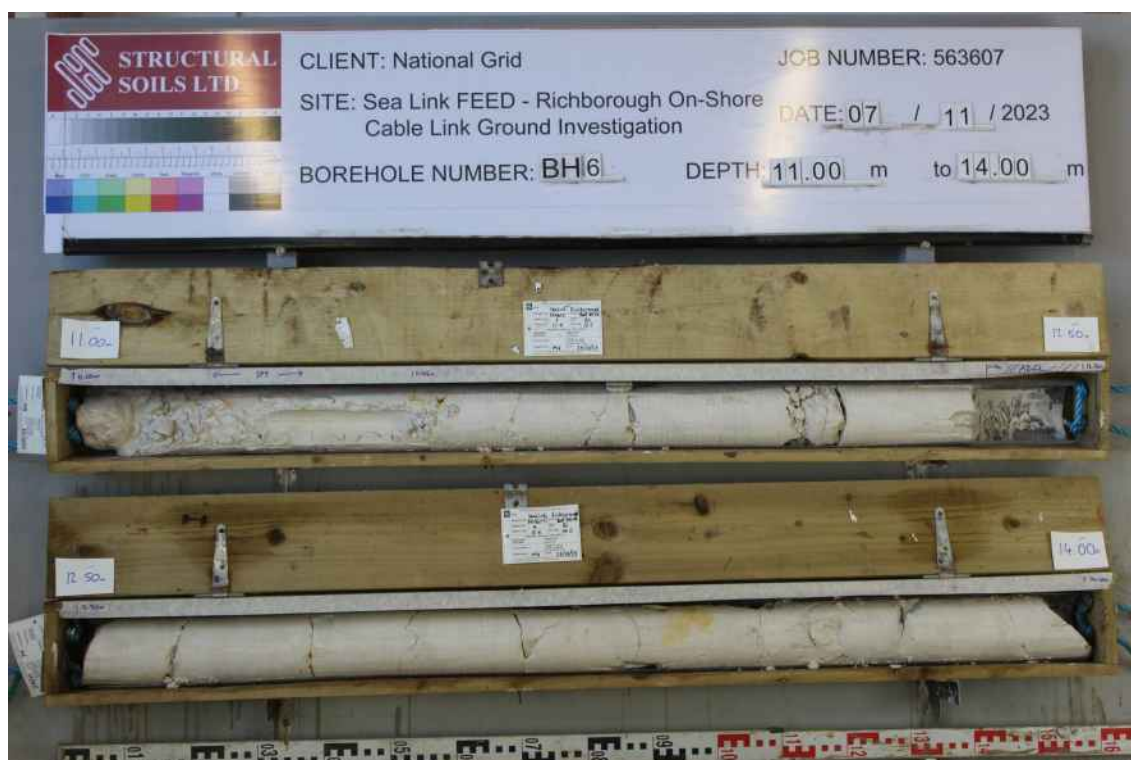
Contract: SEA Link FEED - Kent Onshore Cable Link		Client: National Grid		Borehole: RedP-BH-6
Contract Ref: 563607	Start: 23.10.23 End: 27.10.23	Ground Level (m AOD): 4.10	National Grid Co-ordinate: E:634113.8 N:163655.1	Sheet: 10 of 13

Method Used: Inspection pit + Cable Percussion + Rotary Cored	Plant Used: Dando 2000 Mark 1 + Comacchio MC405	Drilled By: Karl Wordsworth + Maris Veckagans	Logged By: CMathias	Checked By:
---	---	---	---------------------	-------------

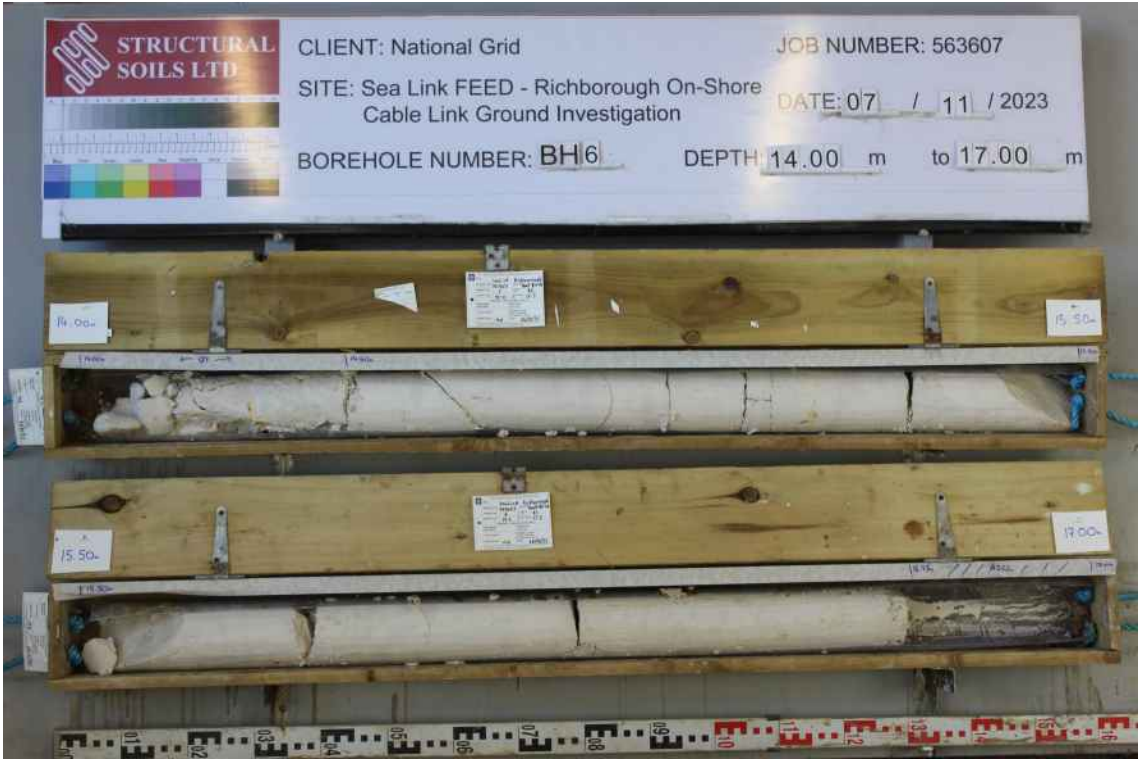
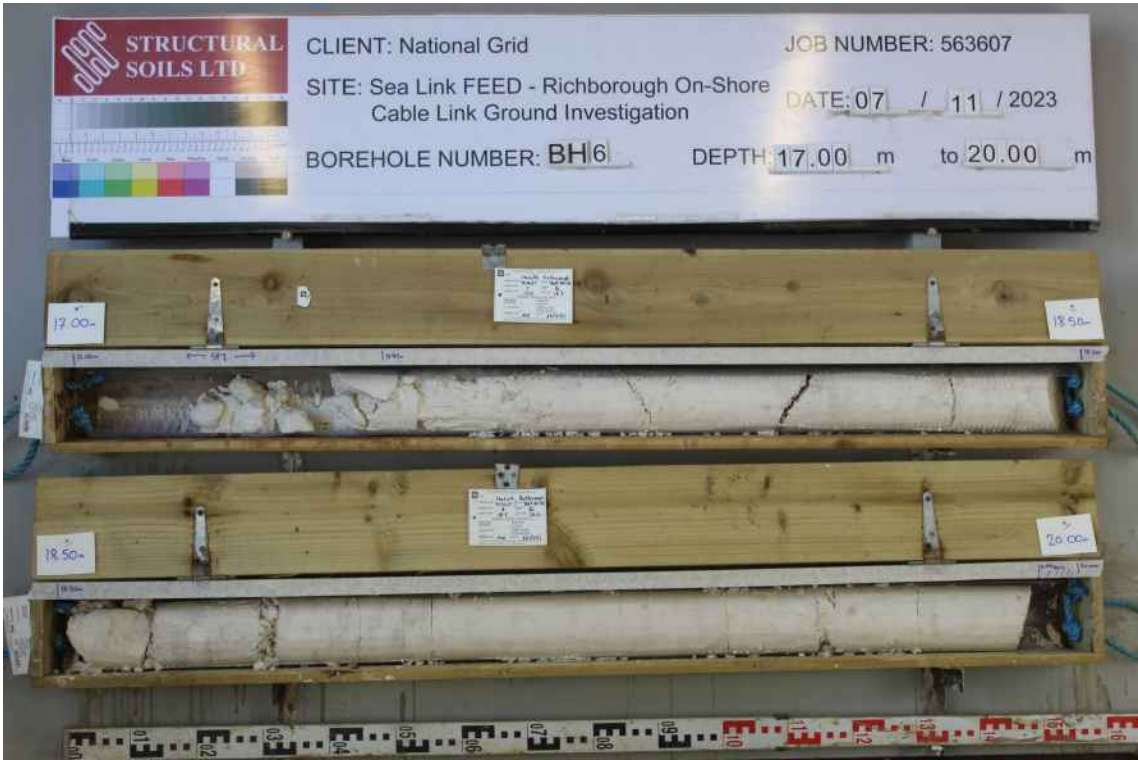
Contract: SEA Link FEED - Kent Onshore Cable Link		Client: National Grid		Borehole: RedP-BH-6
Contract Ref: 563607	Start: 23.10.23 End: 27.10.23	Ground Level (m AOD): 4.10	National Grid Co-ordinate: E:634113.8 N:163655.1	Sheet: 11 of 13

Method Used: Inspection pit + Cable Percussion + Rotary Cored	Plant Used: Dando 2000 Mark 1 + Comacchio MC405	Drilled By: Karl Wordsworth + Maris Veckagans	Logged By: CMathias	Checked By: AGS
---	---	---	---------------------	-----------------

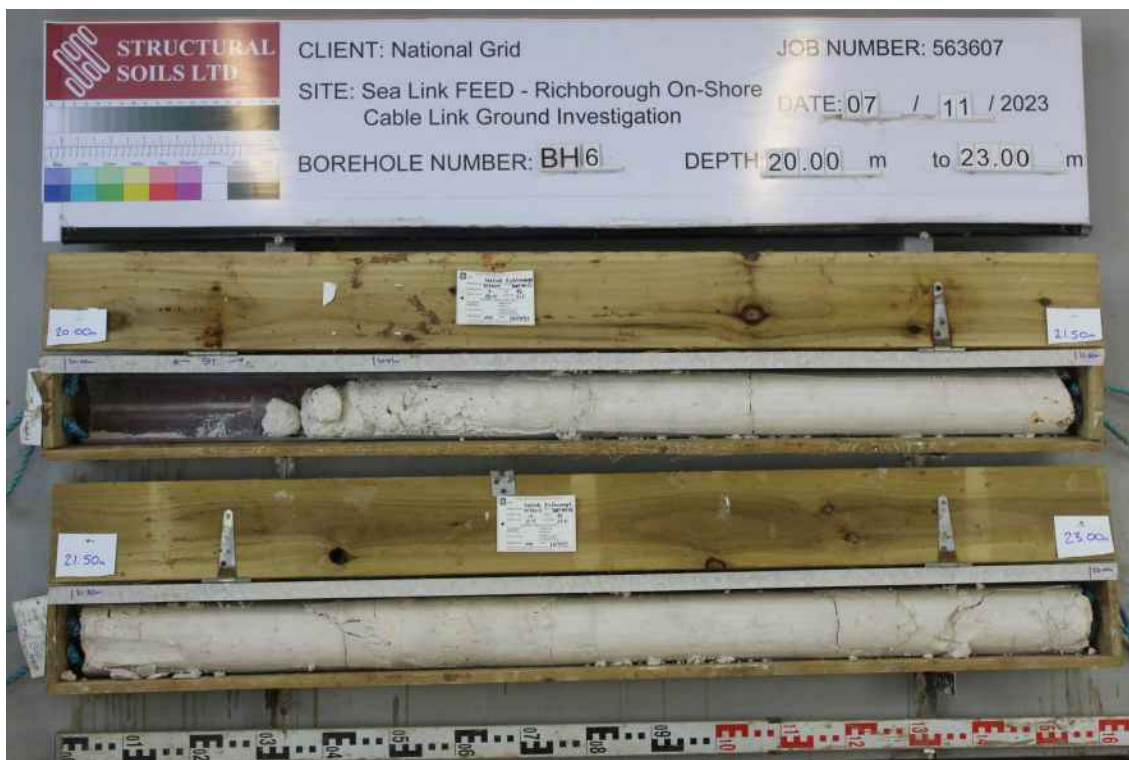
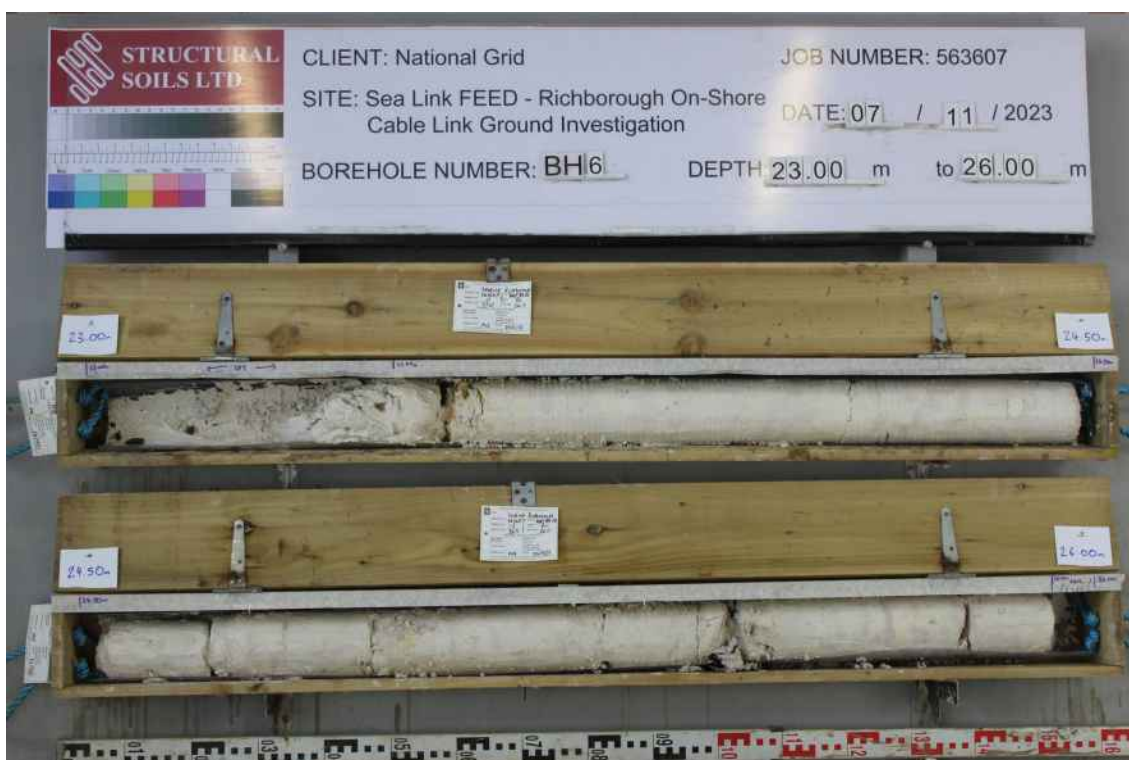
Contract: SEA Link FEED - Kent Onshore Cable Link		Client: National Grid		Borehole: RedP-BH-6
Contract Ref: 563607	Start: 23.10.23 End: 27.10.23	Ground Level (m AOD): 4.10	National Grid Co-ordinate: E:634113.8 N:163655.1	Sheet: 12 of 13

Method Used: Inspection pit + Cable Percussion + Rotary Cored	Plant Used: Dando 2000 Mark 1 + Comacchio MC405	Drilled By: Karl Wordsworth + Maris Veckagans	Logged By: CMathias	Checked By:
---	---	---	---------------------	-------------

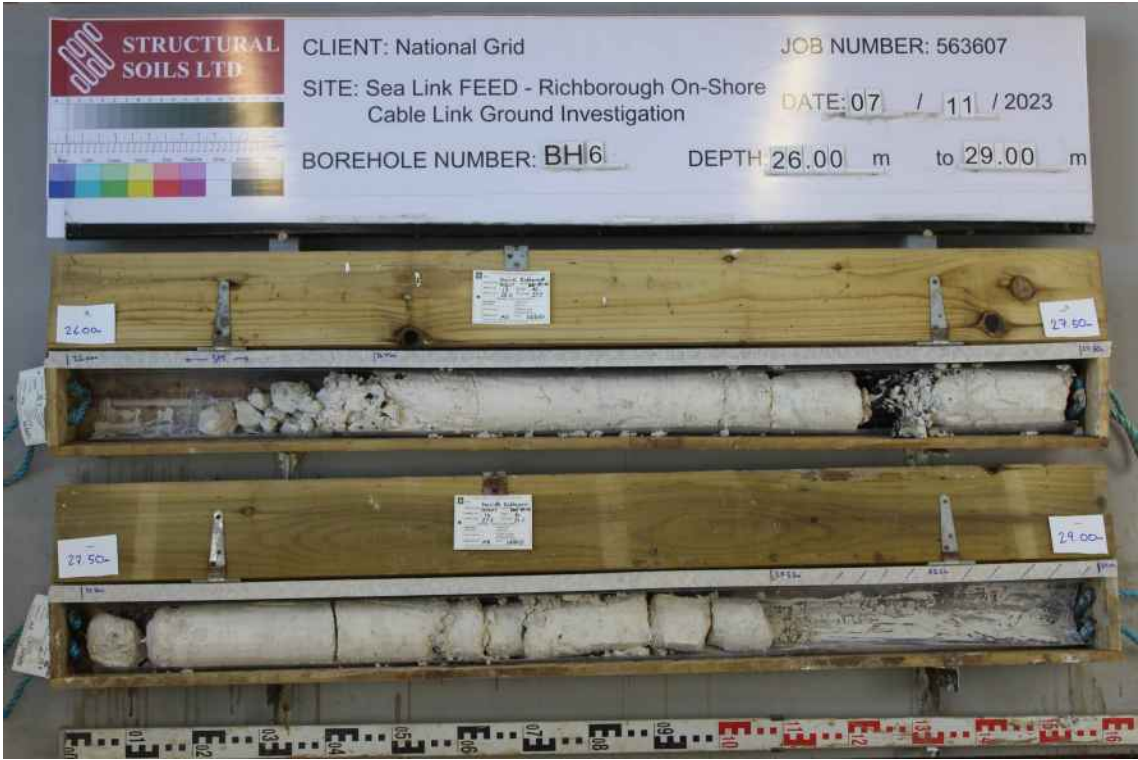
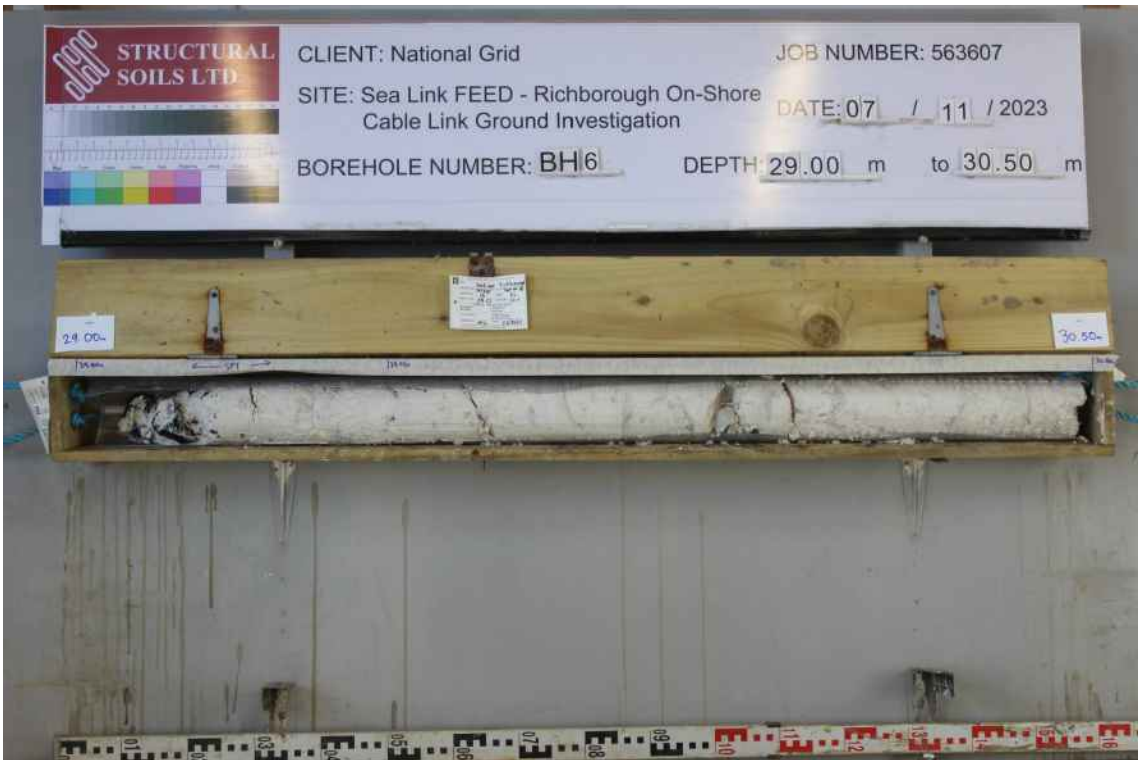
Contract: SEA Link FEED - Kent Onshore Cable Link		Client: National Grid		Borehole: RedP-BH-6
Contract Ref: 563607	Start: 23.10.23 End: 27.10.23	Ground Level (m AOD): 4.10	National Grid Co-ordinate: E:634113.8 N:163655.1	Sheet: 13 of 13

Method Used: Inspection pit + Cable Percussion + Rotary Cored	Plant Used: Dando 2000 Mark 1 + Comacchio MC405	Drilled By: Karl Wordsworth + Maris Veckagans	Logged By: CMathias	Checked By: AGS
---	---	---	---------------------	-----------------

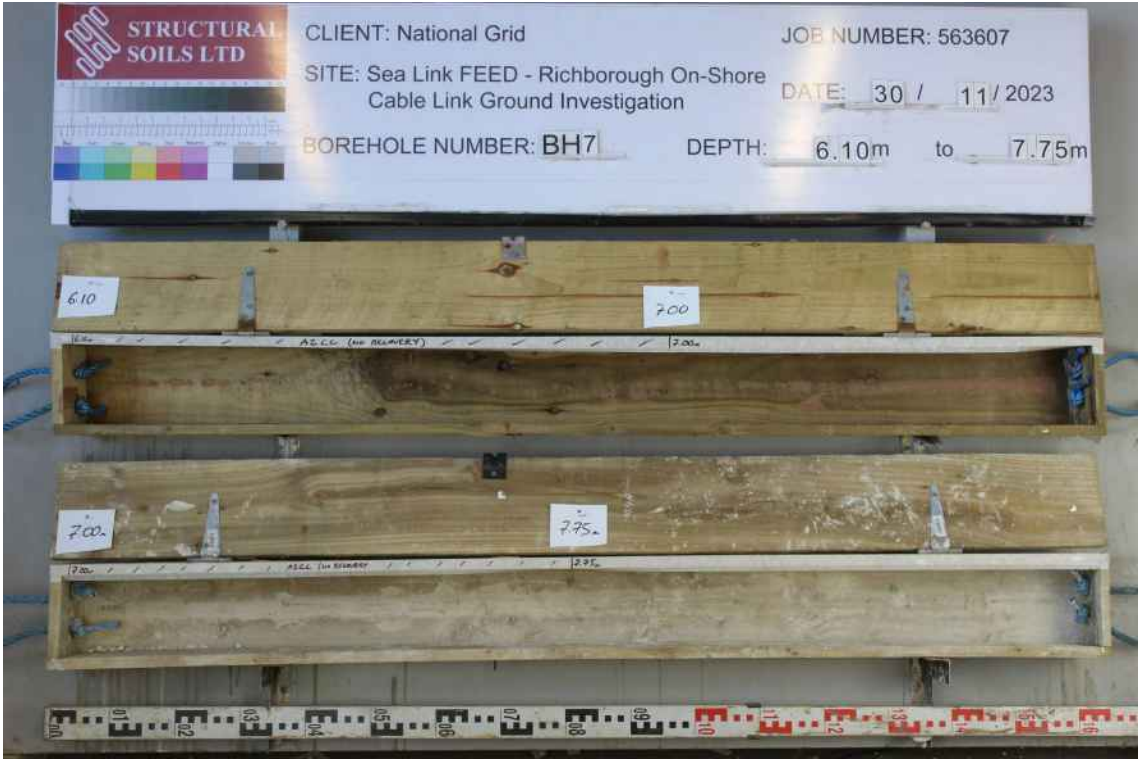
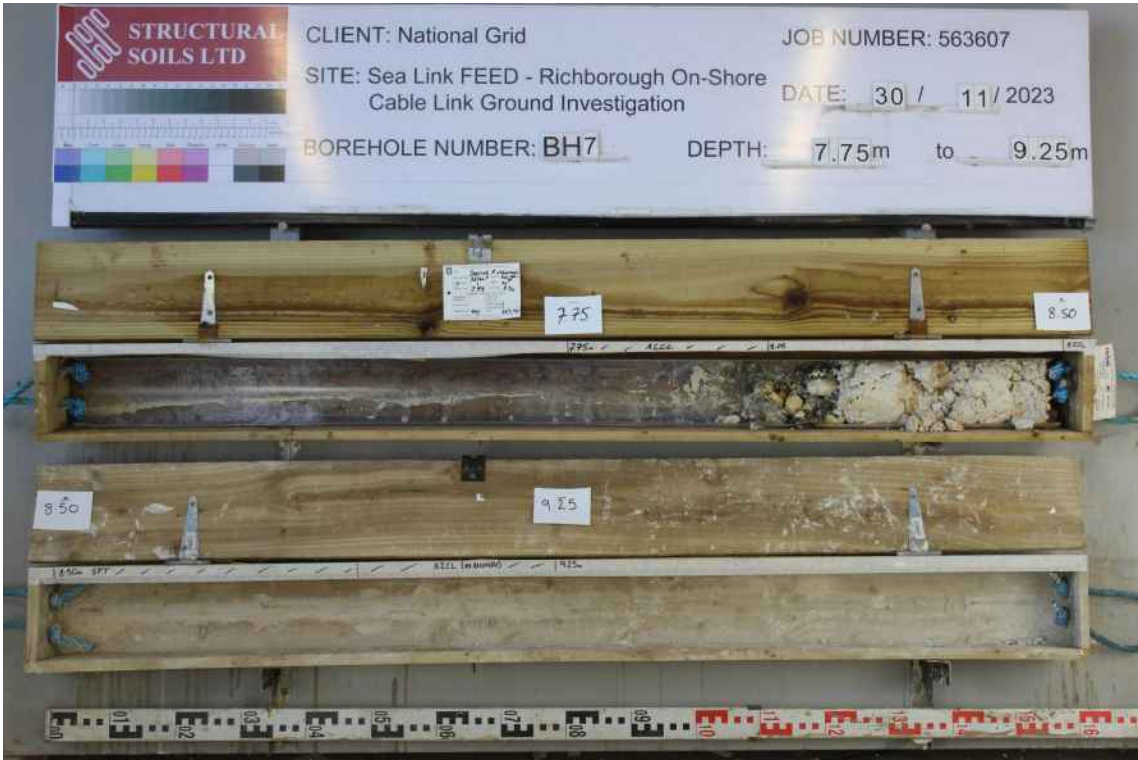
Contract: SEA Link FEED - Kent Onshore Cable Link		Client: National Grid		Borehole: RedP-BH-7
Contract Ref: 563607	Start: 22.11.23 End: 29.11.23	Ground Level (m AOD): 3.30	National Grid Co-ordinate: E:634331.4 N:163675.0	Sheet: 10 of 15

Method Used: Inspection pit + Cable Percussion + Rotary Cored	Plant Used: Dando 2500 + Comacchio MC405	Drilled By: Maris Veckagans	Logged By: CMathias	Checked By: AGS
---	--	-----------------------------	---------------------	-----------------

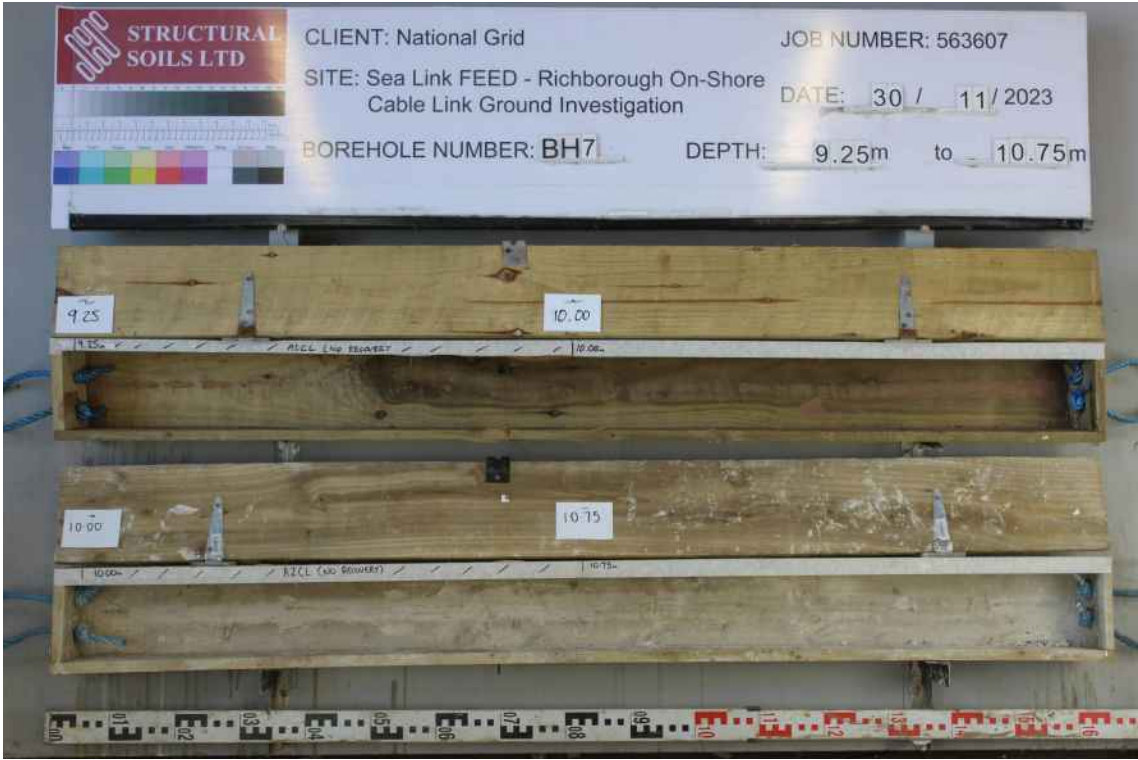
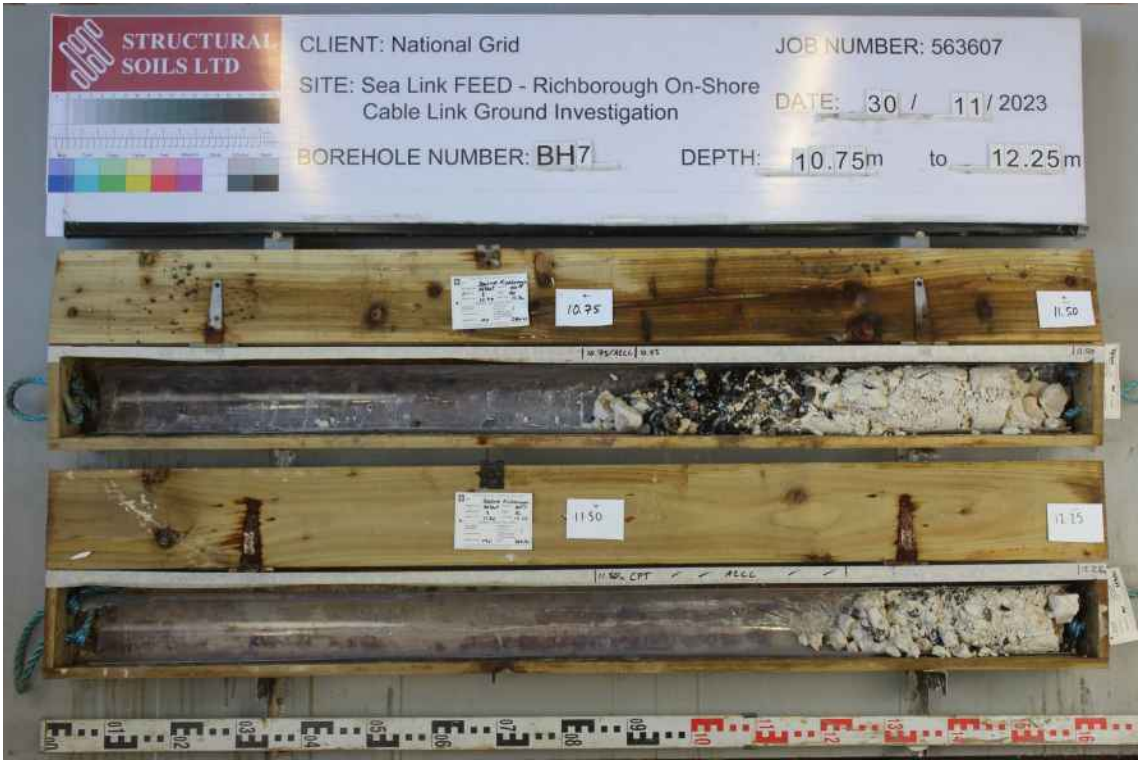
Contract: SEA Link FEED - Kent Onshore Cable Link		Client: National Grid		Borehole: RedP-BH-7
Contract Ref: 563607	Start: 22.11.23 End: 29.11.23	Ground Level (m AOD): 3.30	National Grid Co-ordinate: E:634331.4 N:163675.0	Sheet: 11 of 15

Method Used: Inspection pit + Cable Percussion + Rotary Cored	Plant Used: Dando 2500 + Comacchio MC405	Drilled By: Maris Veckagans	Logged By: CMathias	Checked By: AGS
---	--	-----------------------------	---------------------	-----------------

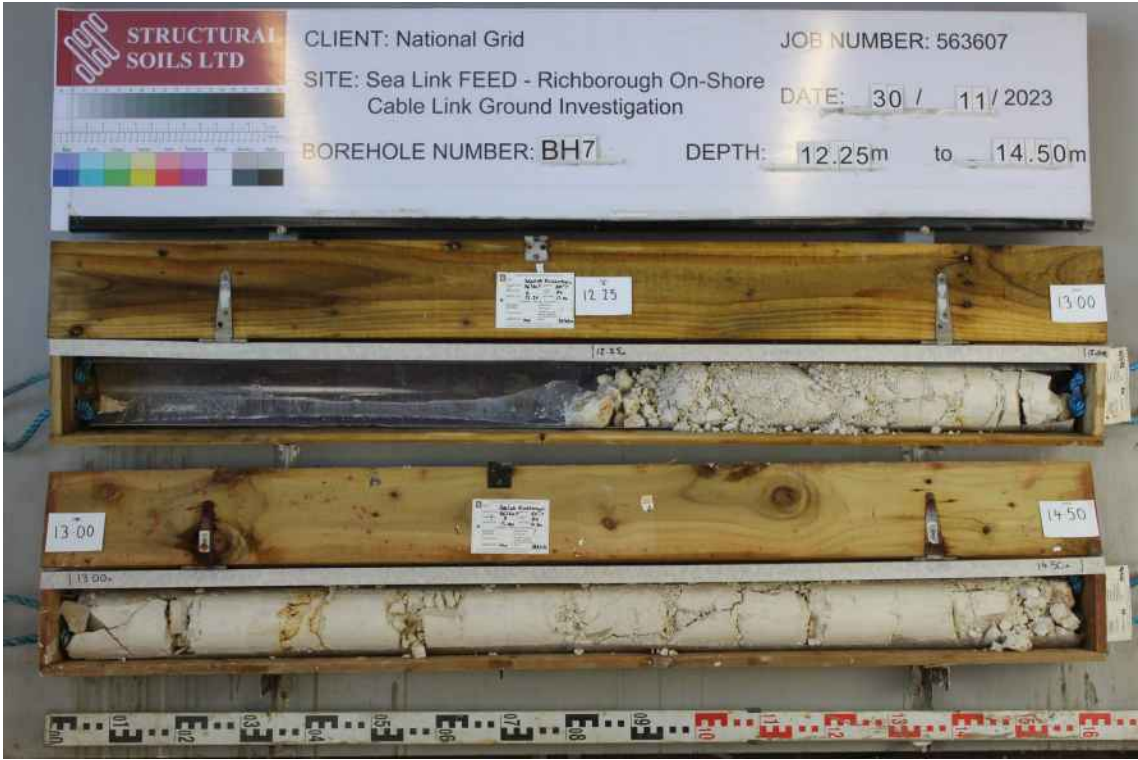
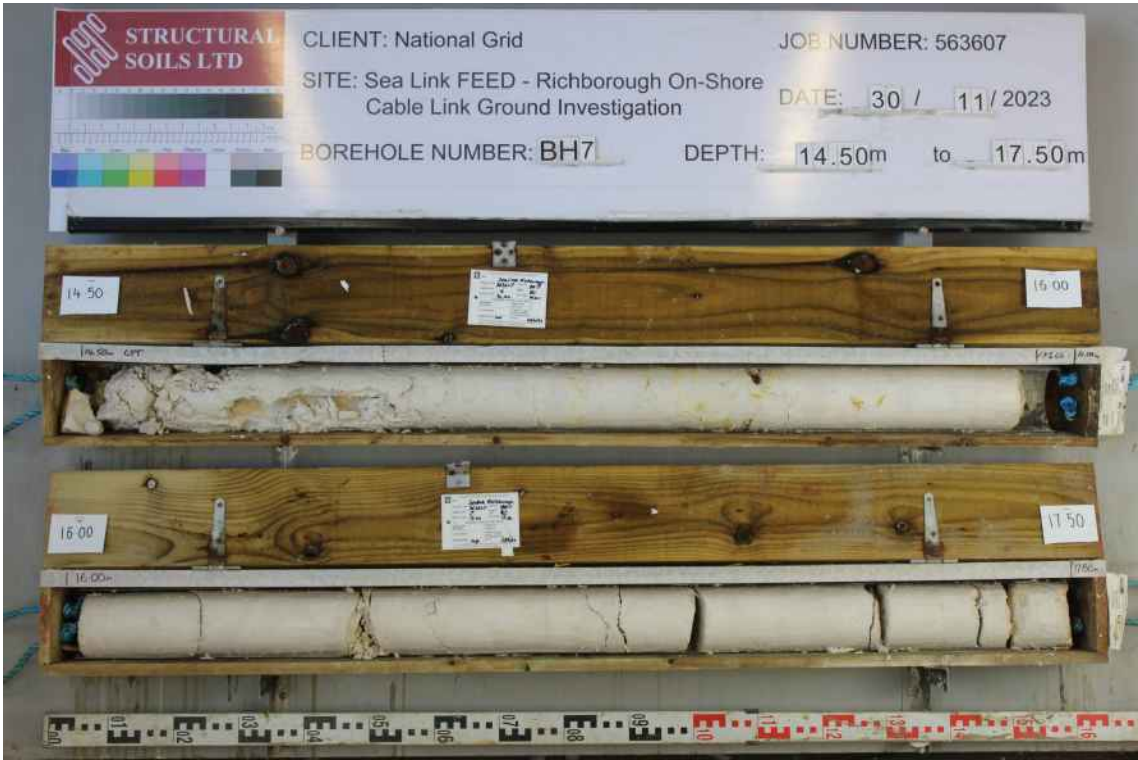
Contract: SEA Link FEED - Kent Onshore Cable Link		Client: National Grid		Borehole: RedP-BH-7
Contract Ref: 563607	Start: 22.11.23 End: 29.11.23	Ground Level (m AOD): 3.30	National Grid Co-ordinate: E:634331.4 N:163675.0	Sheet: 12 of 15

Method Used: Inspection pit + Cable Percussion + Rotary Cored	Plant Used: Dando 2500 + Comacchio MC405	Drilled By: Maris Veckagans	Logged By: CMathias	Checked By: AGS
---	--	-----------------------------	---------------------	-----------------

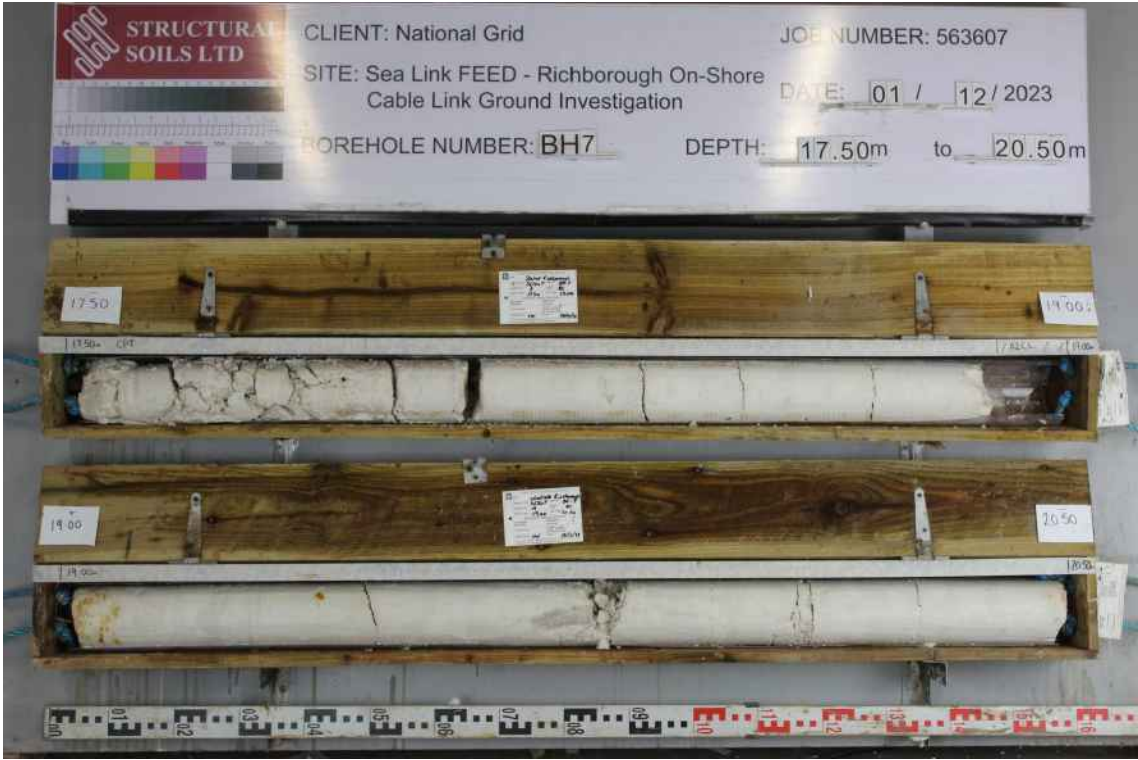
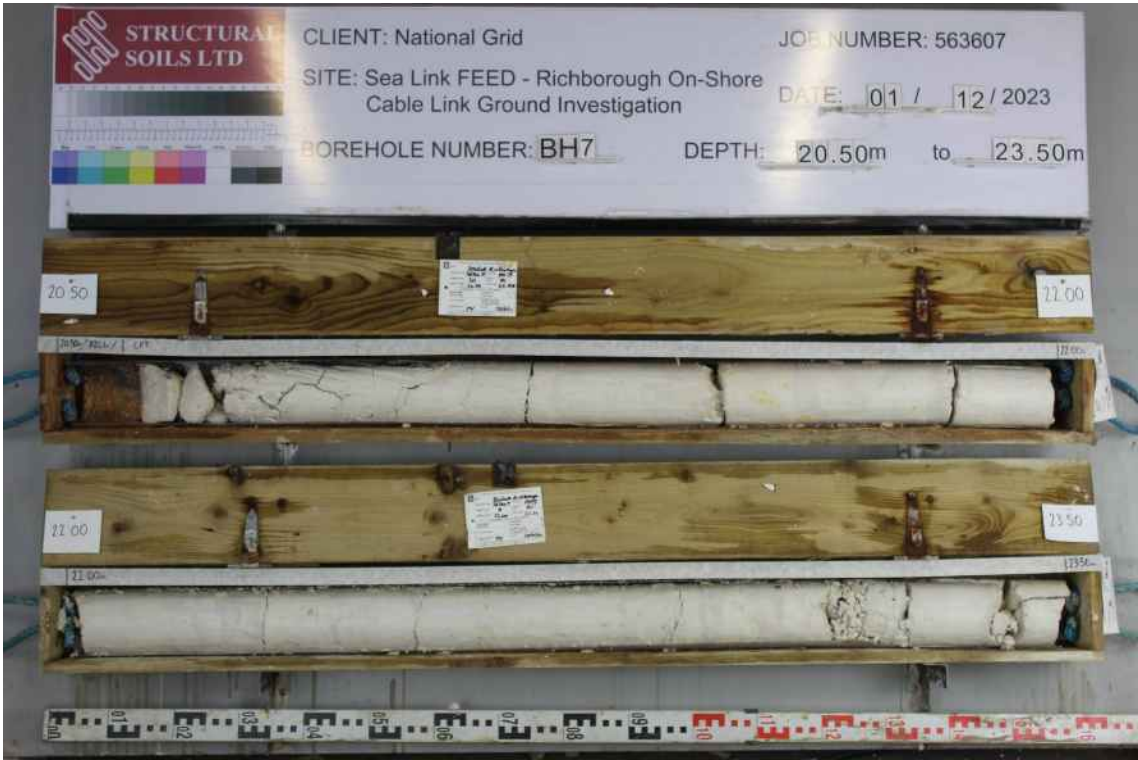
Contract: SEA Link FEED - Kent Onshore Cable Link		Client: National Grid		Borehole: RedP-BH-7
Contract Ref: 563607	Start: 22.11.23 End: 29.11.23	Ground Level (m AOD): 3.30	National Grid Co-ordinate: E:634331.4 N:163675.0	Sheet: 13 of 15

Method Used: Inspection pit + Cable Percussion + Rotary Cored	Plant Used: Dando 2500 + Comacchio MC405	Drilled By: Maris Veckagans	Logged By: CMathias	Checked By: AGS
---	--	-----------------------------	---------------------	-----------------

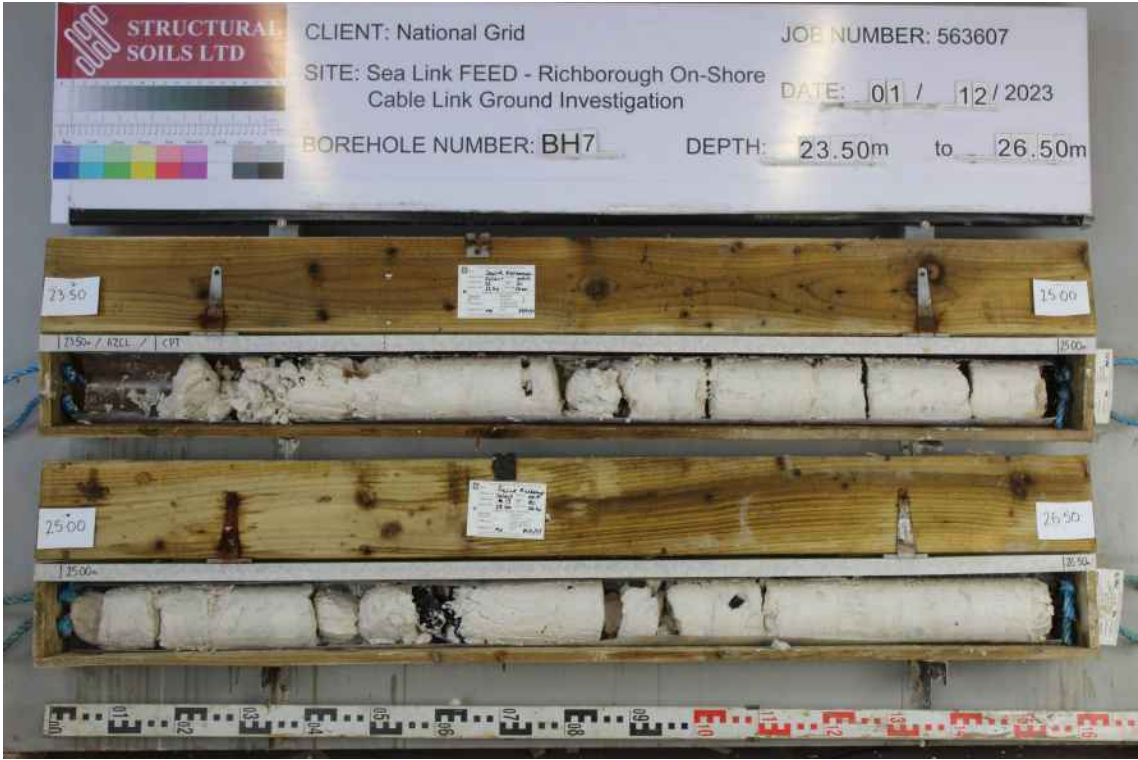
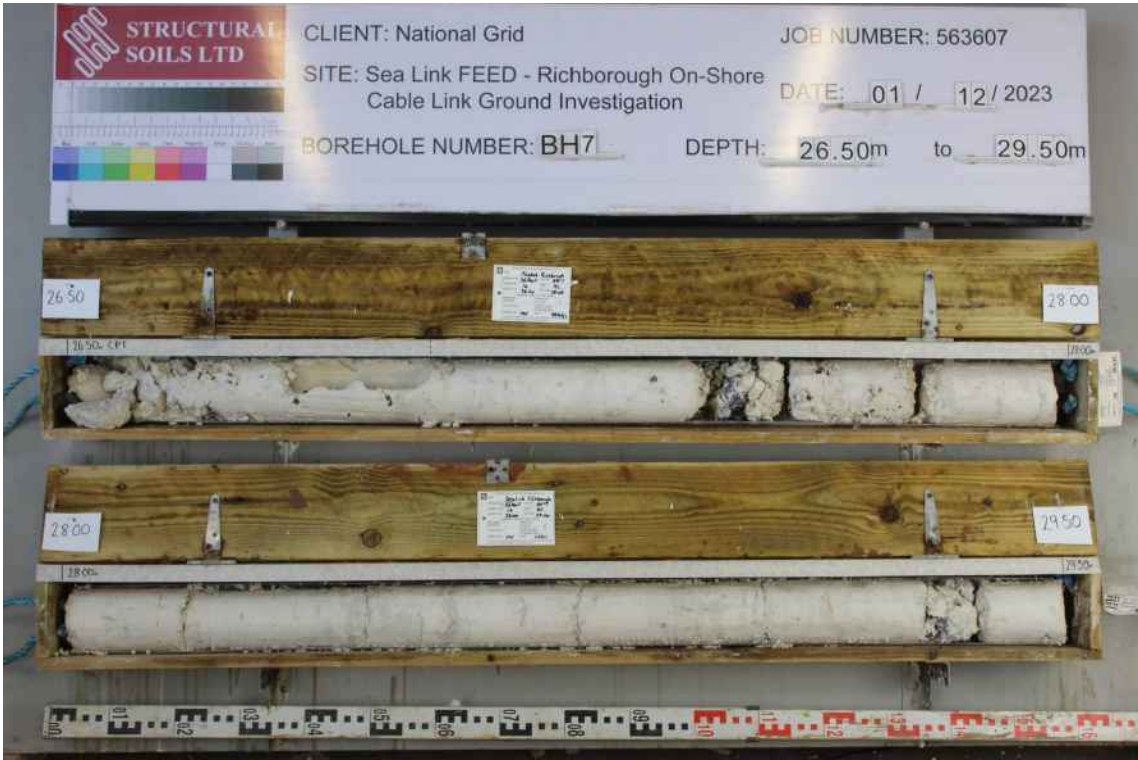
Contract: SEA Link FEED - Kent Onshore Cable Link		Client: National Grid		Borehole: RedP-BH-7
Contract Ref: 563607	Start: 22.11.23 End: 29.11.23	Ground Level (m AOD): 3.30	National Grid Co-ordinate: E:634331.4 N:163675.0	Sheet: 14 of 15

Method Used: Inspection pit + Cable Percussion + Rotary Cored	Plant Used: Dando 2500 + Comacchio MC405	Drilled By: Maris Veckagans	Logged By: CMathias	Checked By: AGS
---	--	-----------------------------	---------------------	-----------------

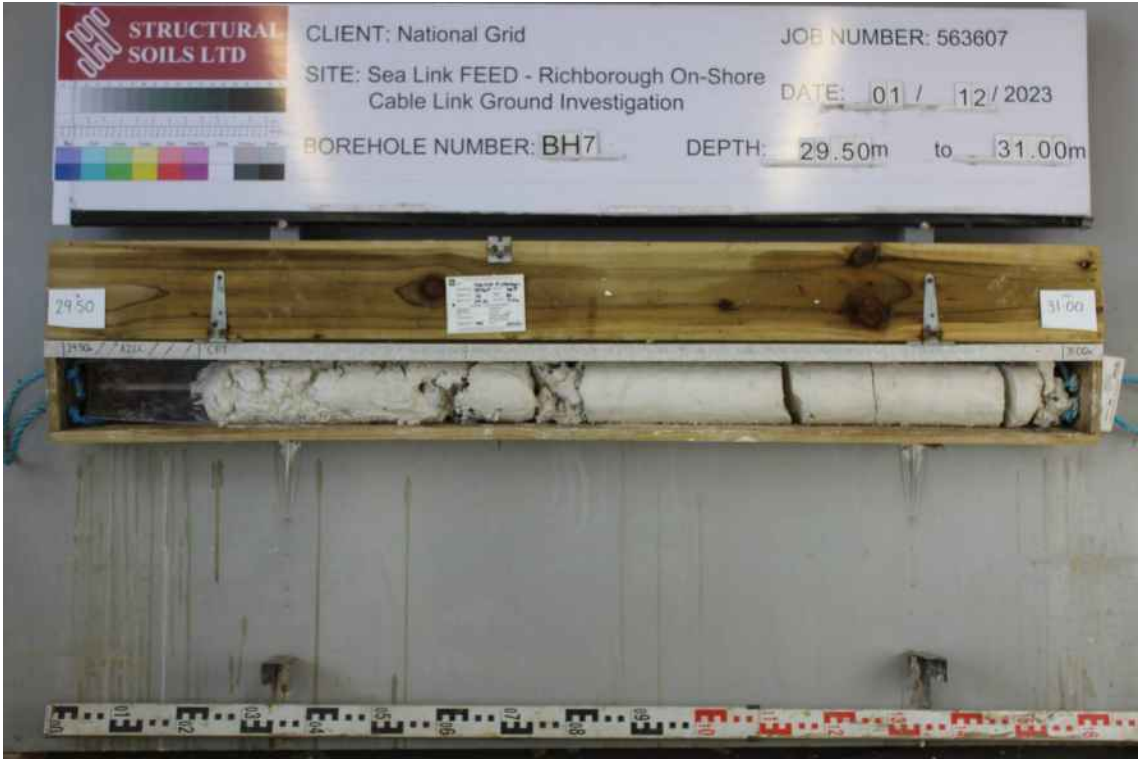
Contract: SEA Link FEED - Kent Onshore Cable Link		Client: National Grid		Borehole: RedP-BH-7
Contract Ref: 563607	Start: 22.11.23 End: 29.11.23	Ground Level (m AOD): 3.30	National Grid Co-ordinate: E:634331.4 N:163675.0	Sheet: 15 of 15

Method Used: Inspection pit + Cable Percussion + Rotary Cored	Plant Used: Dando 2500 + Comacchio MC405	Drilled By: Maris Veckagans	Logged By: CMathias	Checked By:
---	--	-----------------------------	---------------------	-------------

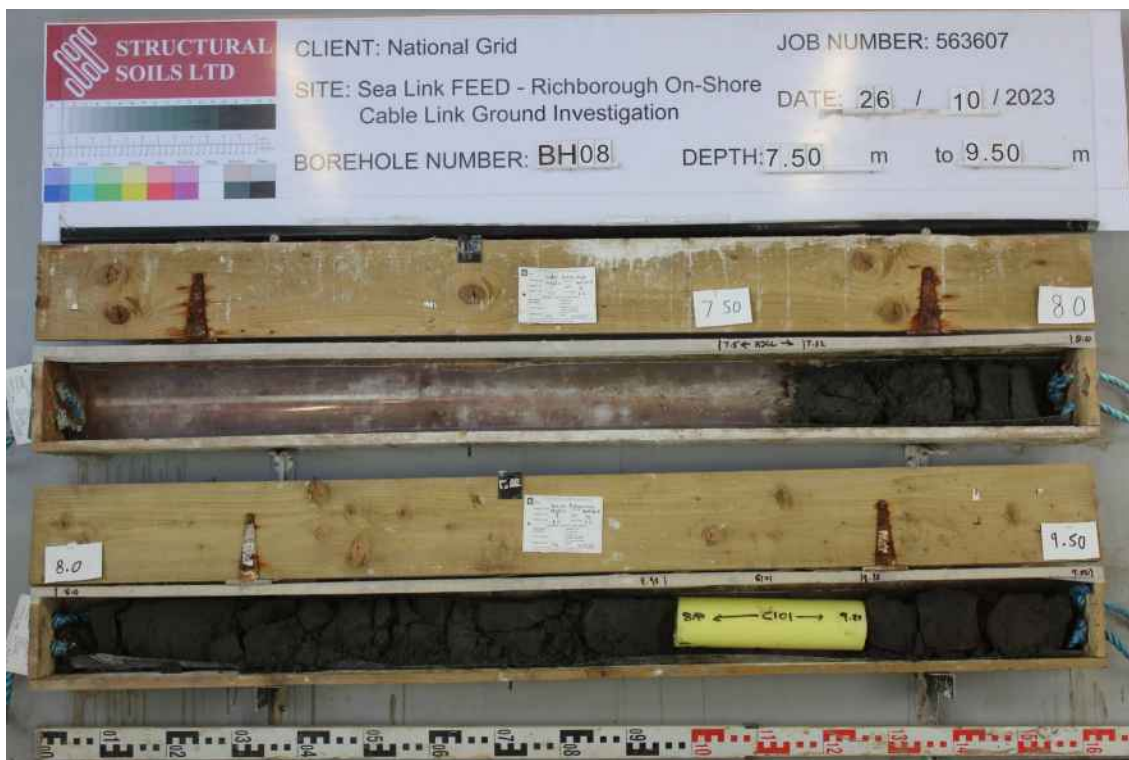
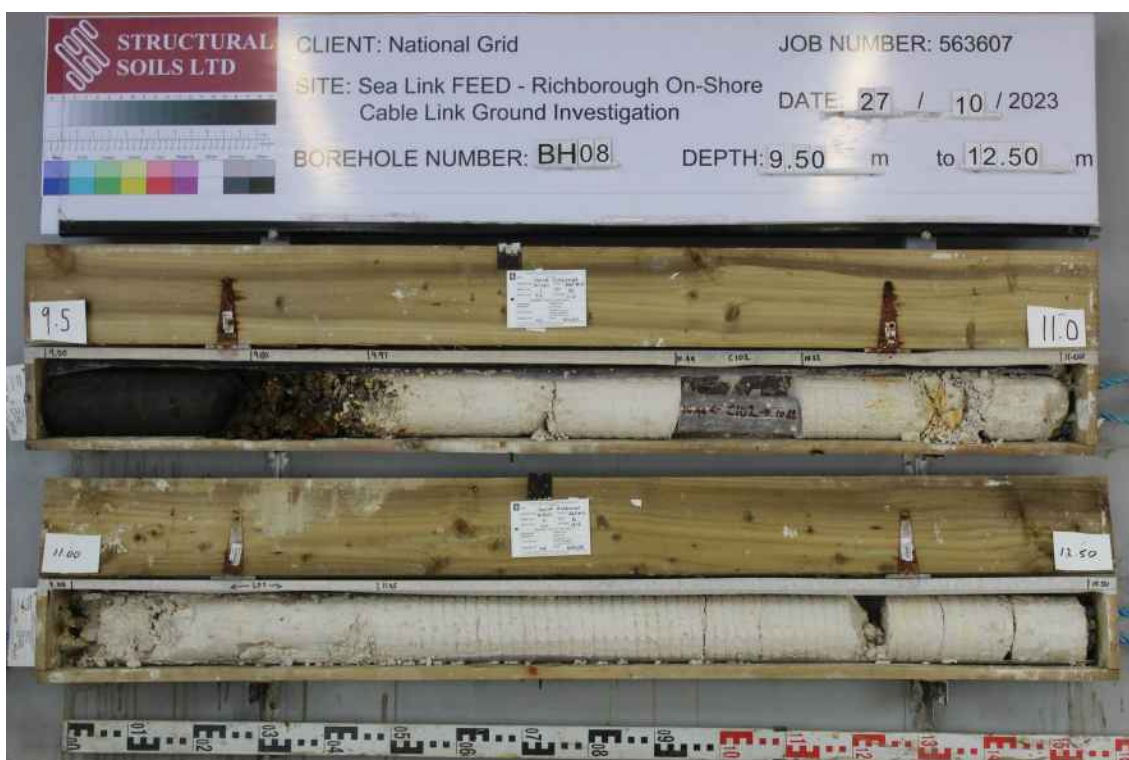
Contract: SEA Link FEED - Kent Onshore Cable Link		Client: National Grid		Borehole: RedP-BH-8
Contract Ref: 563607	Start: 04.10.23 End: 11.10.23	Ground Level (m AOD): 3.01	National Grid Co-ordinate: E:633889.3 N:163701.1	Sheet: 9 of 12

Method Used: Inspection pit + Cable Percussion + Rotary Cored	Plant Used: Dando 175 + Comacchio MC405	Drilled By: Maris Veckagans	Logged By: CMathias + MStorch	Checked By: AGS
---	--	------------------------------------	--------------------------------------	------------------------

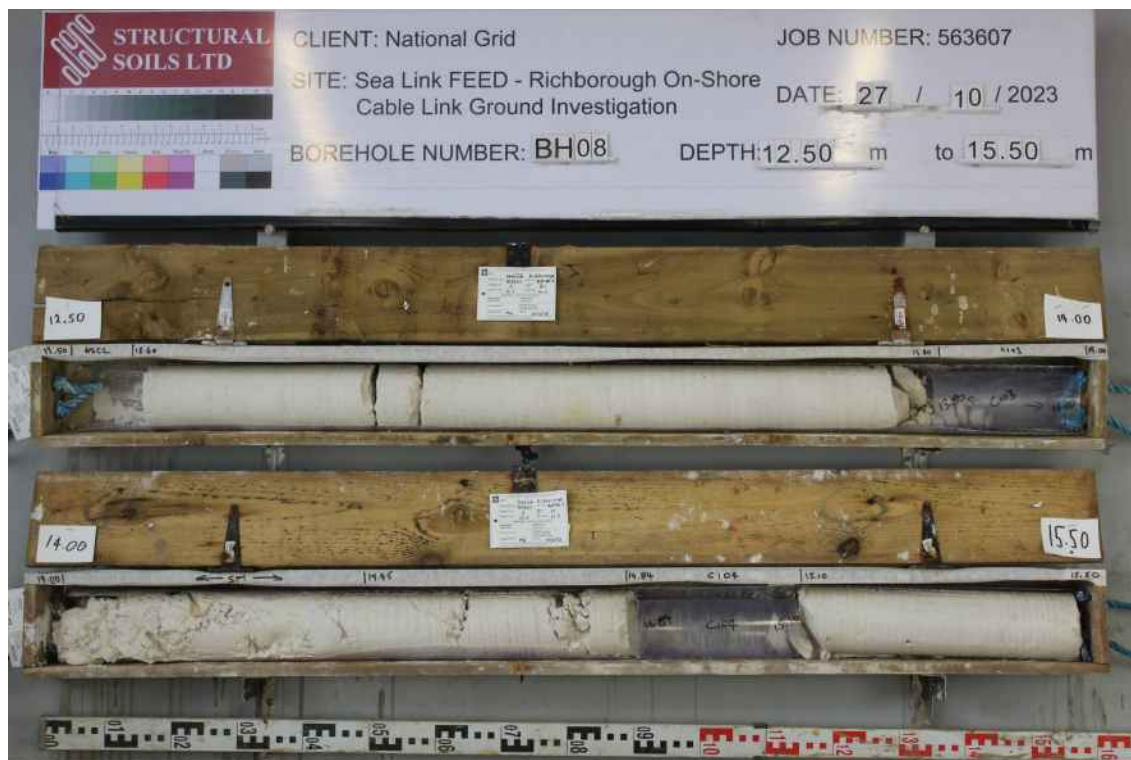
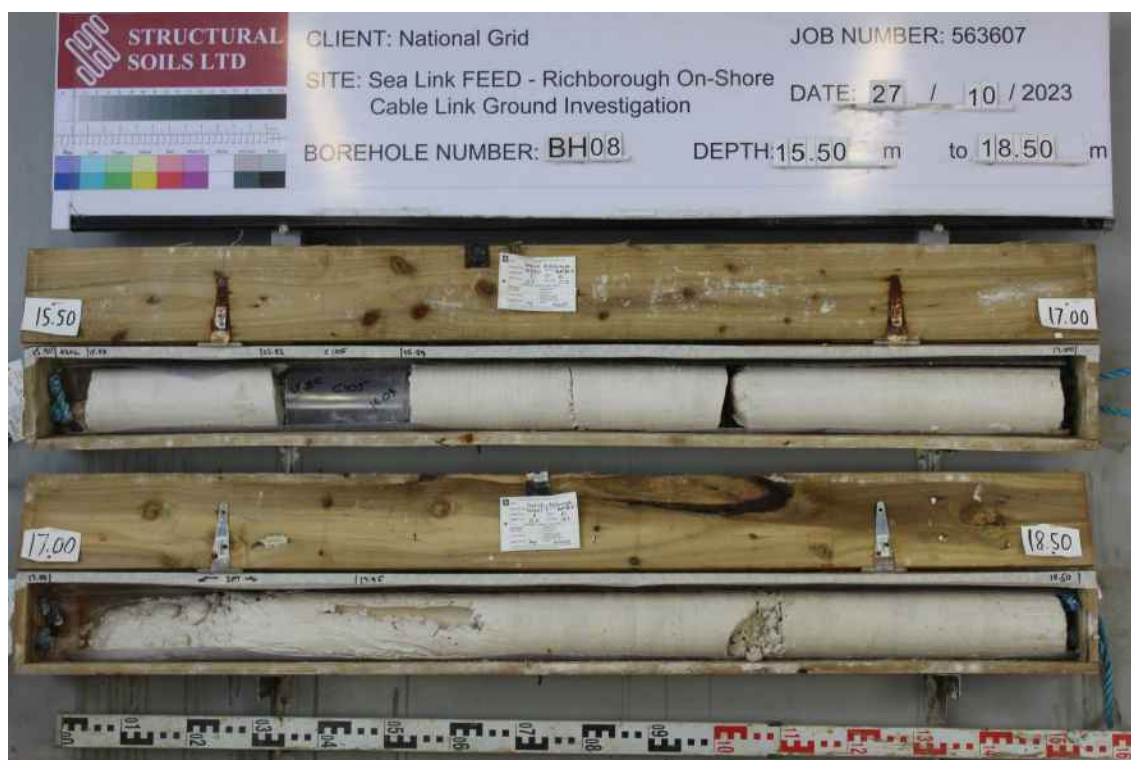
Contract: SEA Link FEED - Kent Onshore Cable Link		Client: National Grid		Borehole: RedP-BH-8
Contract Ref: 563607	Start: 04.10.23 End: 11.10.23	Ground Level (m AOD): 3.01	National Grid Co-ordinate: E:633889.3 N:163701.1	Sheet: 10 of 12

Method Used: Inspection pit + Cable Percussion + Rotary Cored	Plant Used: Dando 175 + Comacchio MC405	Drilled By: Maris Veckagans	Logged By: CMathias + MStorch	Checked By: AGS
---	--	------------------------------------	--------------------------------------	------------------------
