Sea Link

Generic Quantitative Risk Assessment – Kent Part 1 of 2

Sea Link FEED

Generic Quantitative Risk Assessment
Richborough

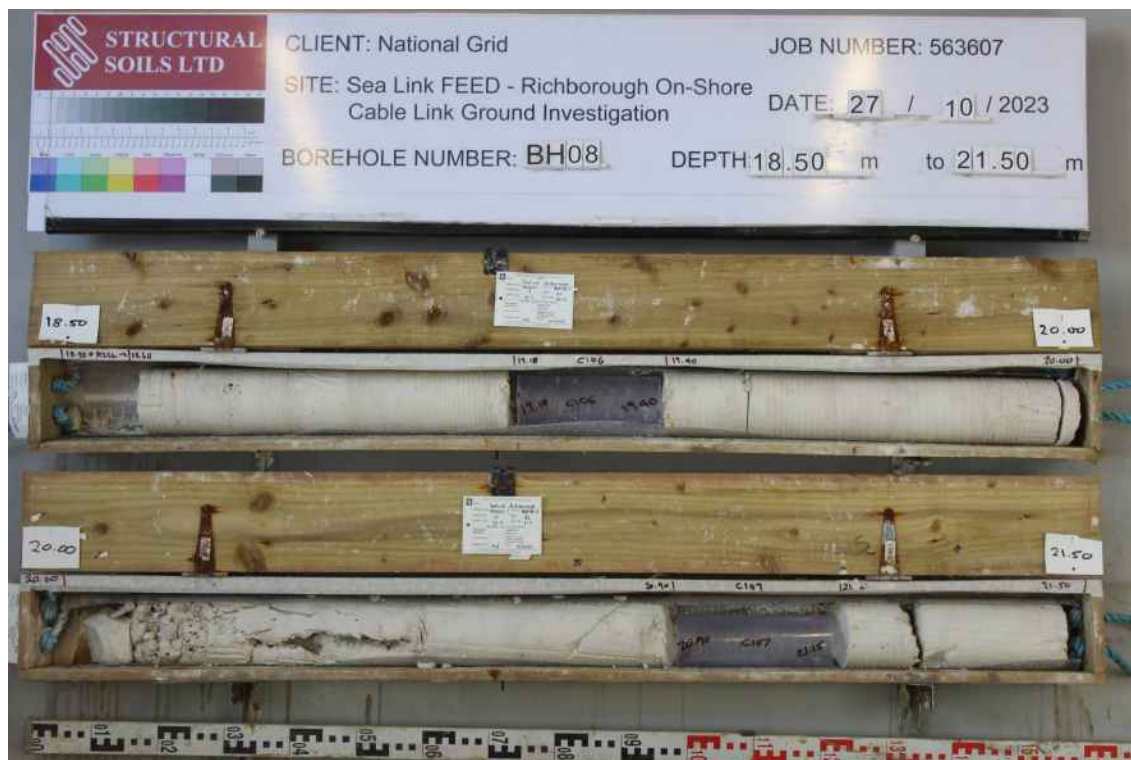
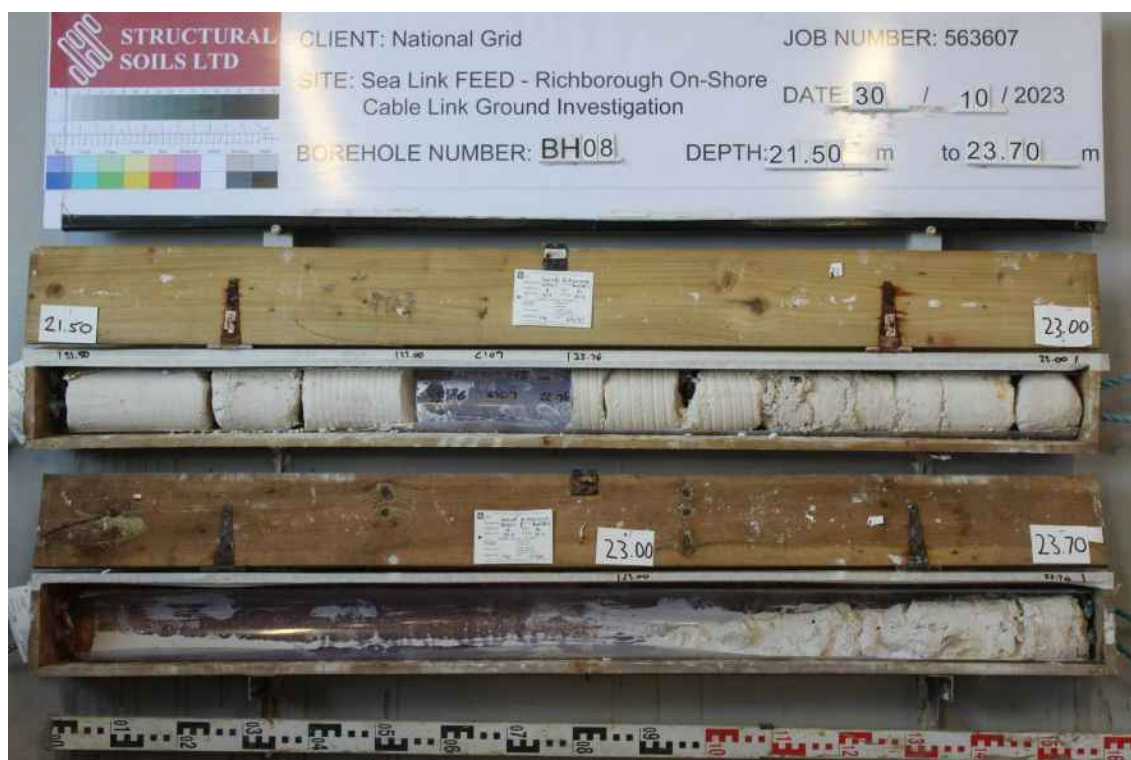
Contract: SEA Link FEED - Kent Onshore Cable Link		Client: National Grid		Borehole: RedP-BH-8
Contract Ref: 563607	Start: 04.10.23 End: 11.10.23	Ground Level (m AOD): 3.01	National Grid Co-ordinate: E:633889.3 N:163701.1	Sheet: 11 of 12

Method Used: Inspection pit + Cable Percussion + Rotary Cored	Plant Used: Dando 175 + Comacchio MC405	Drilled By: Maris Veckagans	Logged By: CMathias + MStorch	Checked By:	AGS
---	---	-----------------------------	-------------------------------	-------------	-----

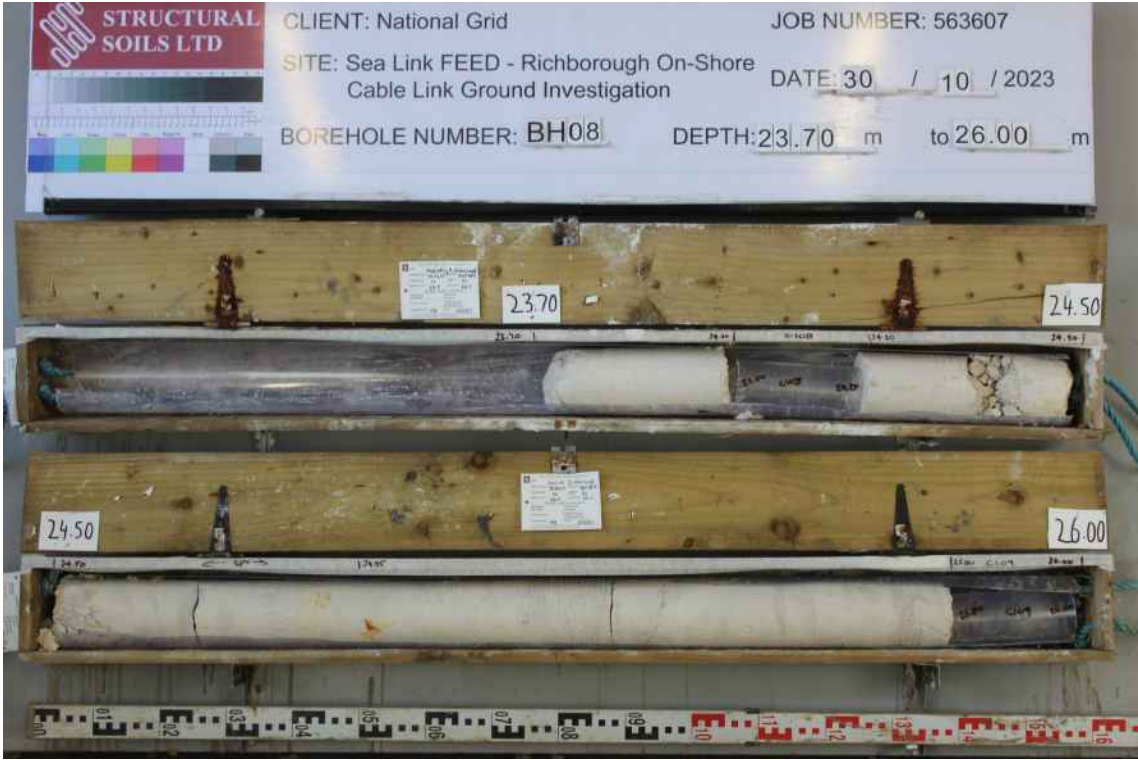
Contract: SEA Link FEED - Kent Onshore Cable Link		Client: National Grid		Borehole: RedP-BH-8
Contract Ref: 563607	Start: 04.10.23 End: 11.10.23	Ground Level (m AOD): 3.01	National Grid Co-ordinate: E:633889.3 N:163701.1	Sheet: 12 of 12

Method Used: Inspection pit + Cable Percussion + Rotary Cored	Plant Used: Dando 175 + Comacchio MC405	Drilled By: Maris Veckagans	Logged By: CMathias + MStorch	Checked By:	AGS
---	---	-----------------------------	-------------------------------	-------------	-----

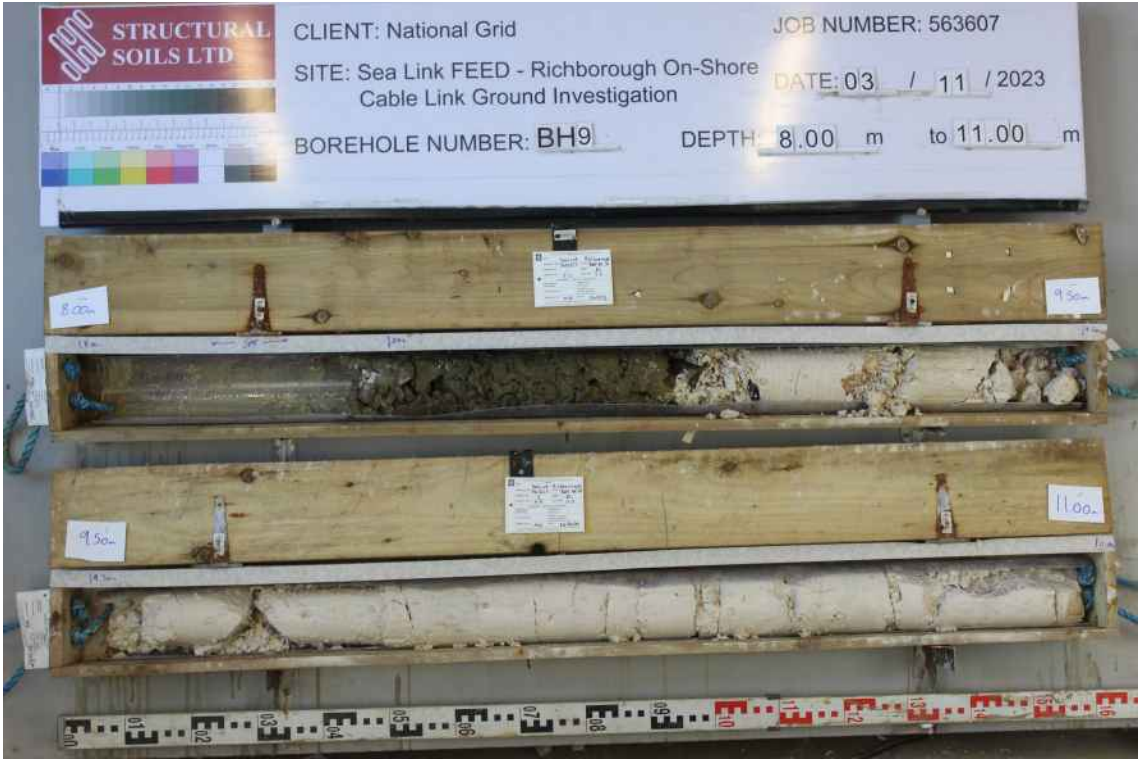
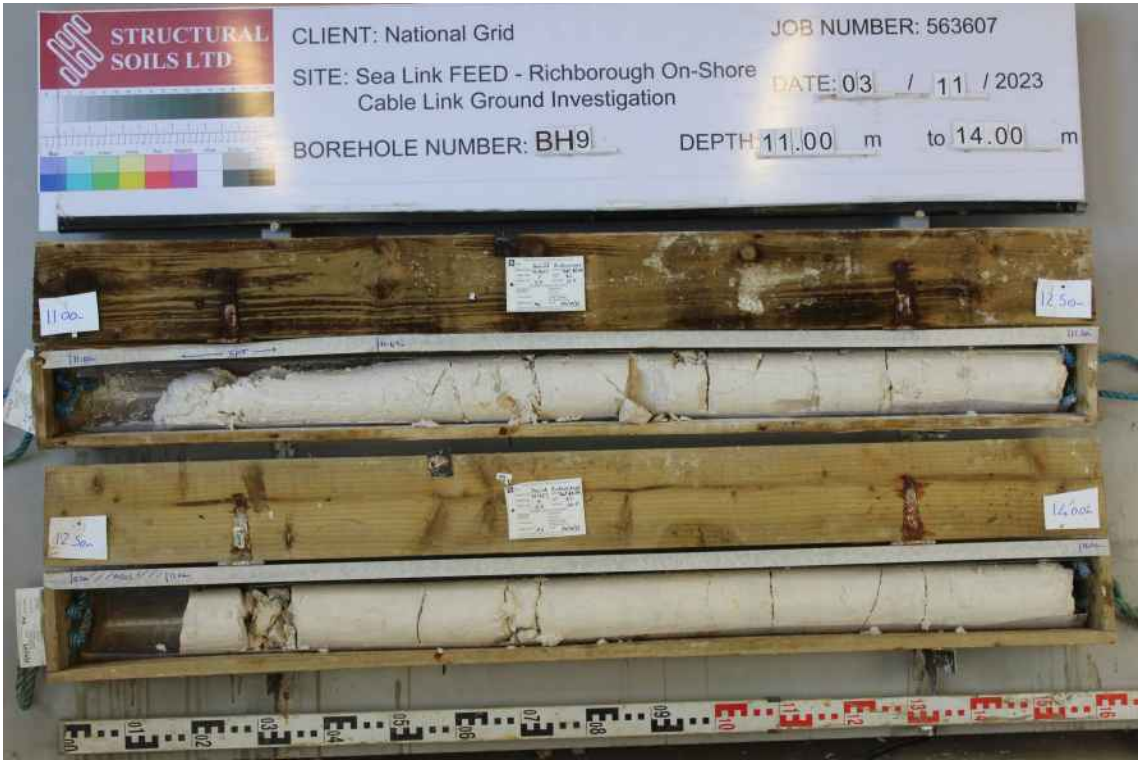
Contract: SEA Link FEED - Kent Onshore Cable Link		Client: National Grid		Borehole: RedP-BH-9
Contract Ref: 563607	Start: 19.10.23 End: 25.10.23	Ground Level (m AOD): 3.22	National Grid Co-ordinate: E:634093.3 N:163604.4	Sheet: 10 of 13

Method Used: Inspection pit + Cable Percussion + Rotary Cored	Plant Used: Dando 2000 Mark 1 + Comacchio MC405	Drilled By: Karl Wordsworth + Maris Veckagans	Logged By: CMathias	Checked By: AGS
---	---	---	---------------------	-----------------

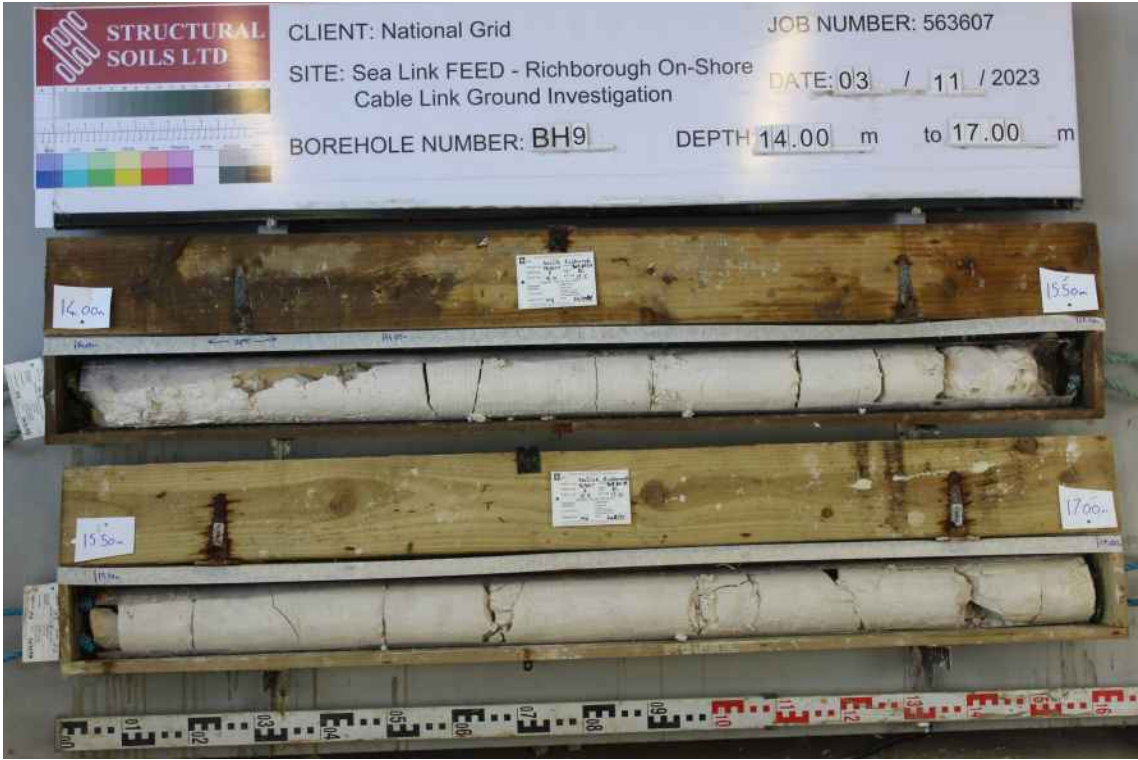
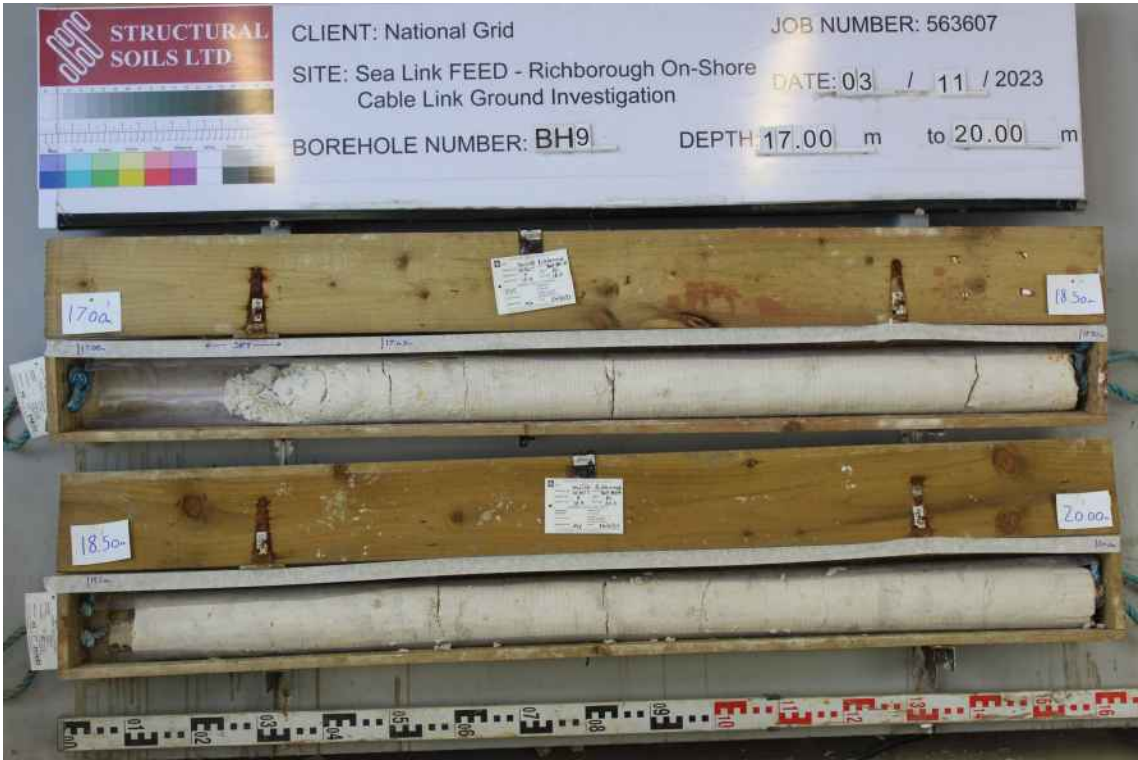
Contract: SEA Link FEED - Kent Onshore Cable Link		Client: National Grid		Borehole: RedP-BH-9
Contract Ref: 563607	Start: 19.10.23 End: 25.10.23	Ground Level (m AOD): 3.22	National Grid Co-ordinate: E:634093.3 N:163604.4	Sheet: 11 of 13

Method Used: Inspection pit + Cable Percussion + Rotary Cored	Plant Used: Dando 2000 Mark 1 + Comacchio MC405	Drilled By: Karl Wordsworth + Maris Veckagans	Logged By: CMathias	Checked By: AGS
---	---	---	---------------------	-----------------

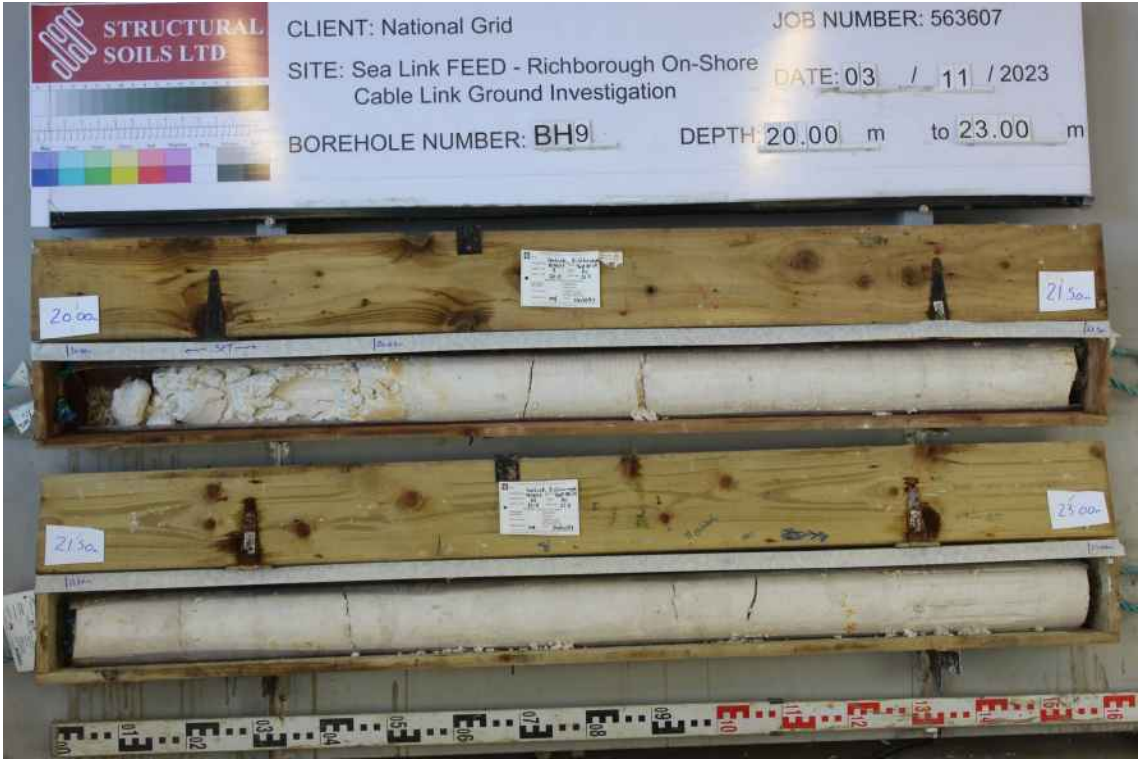
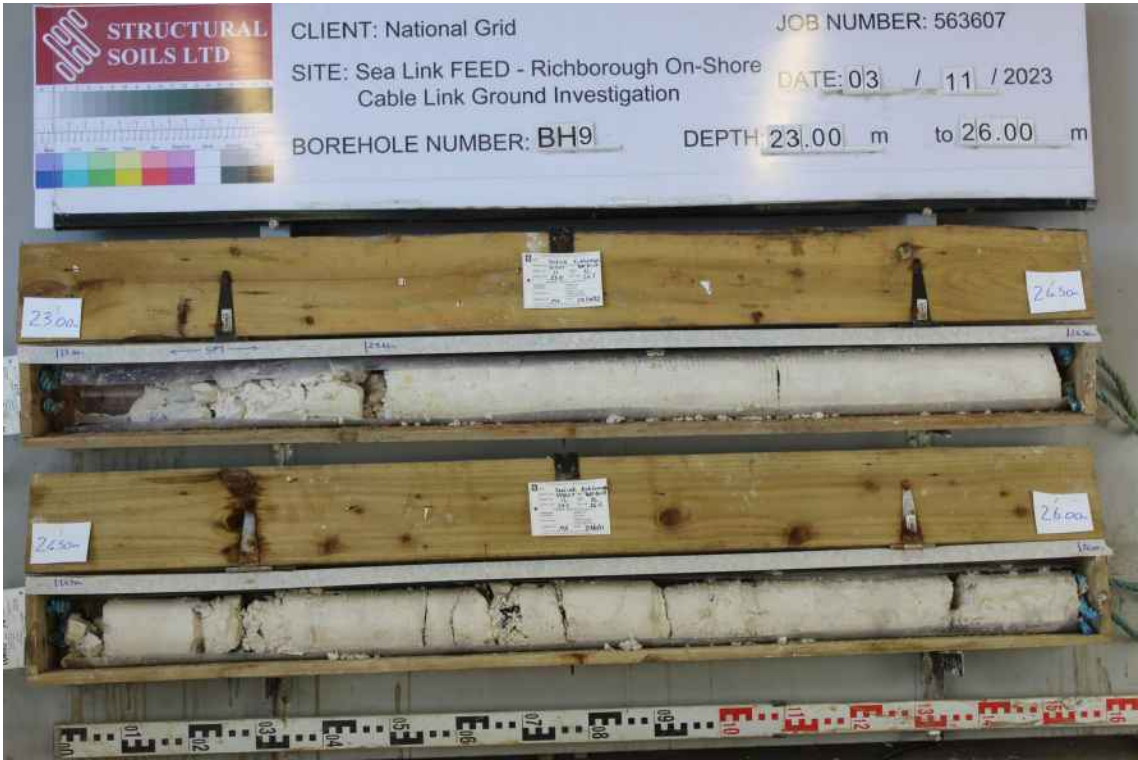
Contract: SEA Link FEED - Kent Onshore Cable Link		Client: National Grid		Borehole: RedP-BH-9
Contract Ref: 563607	Start: 19.10.23 End: 25.10.23	Ground Level (m AOD): 3.22	National Grid Co-ordinate: E:634093.3 N:163604.4	Sheet: 12 of 13

Method Used: Inspection pit + Cable Percussion + Rotary Cored	Plant Used: Dando 2000 Mark 1 + Comacchio MC405	Drilled By: Karl Wordsworth + Maris Veckagans	Logged By: CMathias	Checked By: AGS
---	---	---	---------------------	-----------------

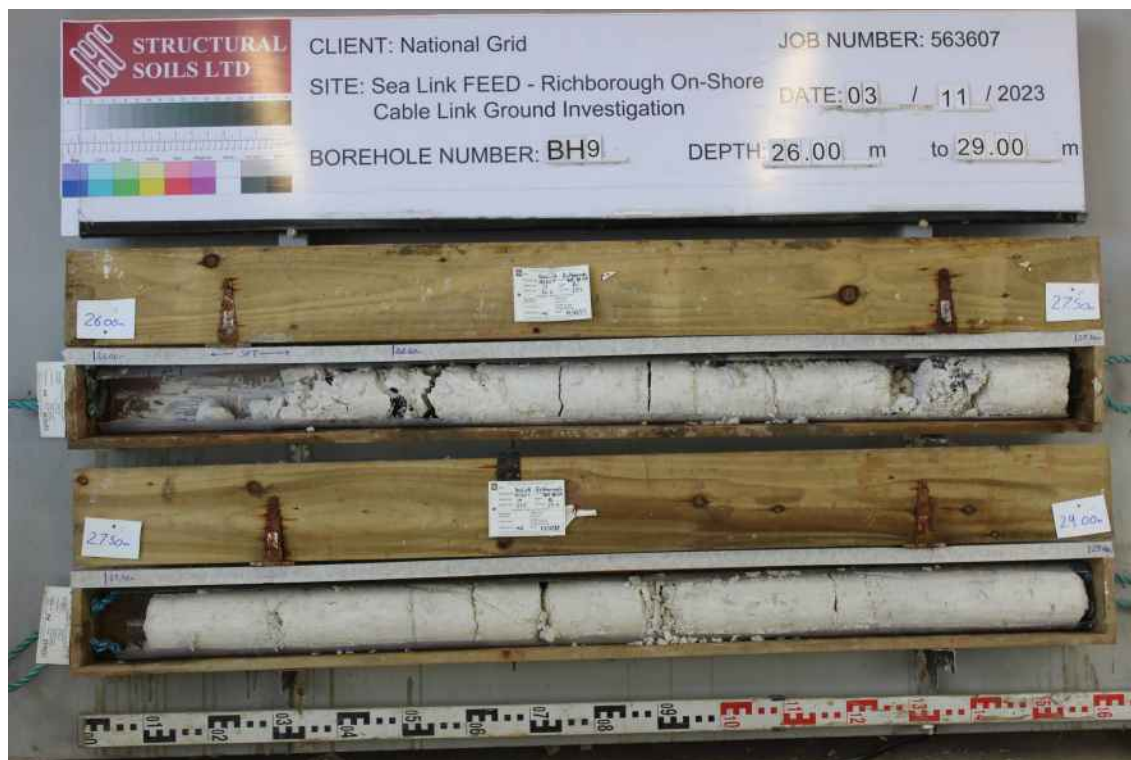
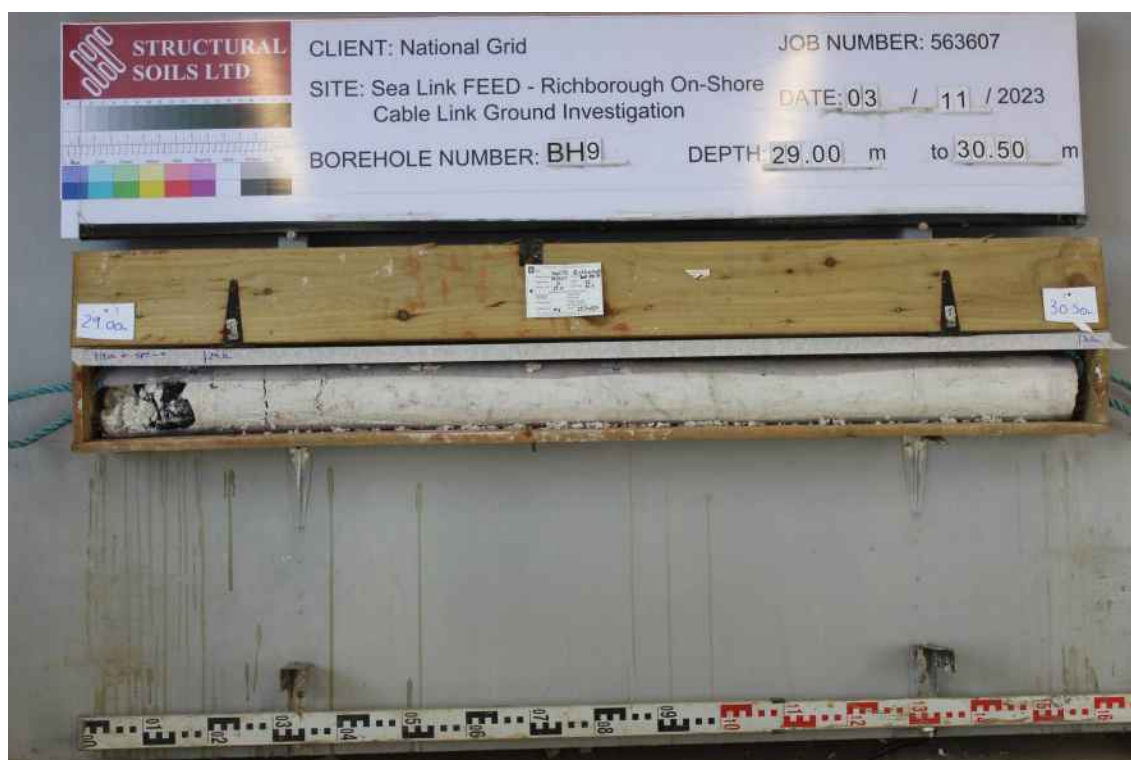
Contract: SEA Link FEED - Kent Onshore Cable Link		Client: National Grid		Borehole: RedP-BH-9
Contract Ref: 563607	Start: 19.10.23 End: 25.10.23	Ground Level (m AOD): 3.22	National Grid Co-ordinate: E:634093.3 N:163604.4	Sheet: 13 of 13

Method Used: Inspection pit + Cable Percussion + Rotary Cored	Plant Used: Dando 2000 Mark 1 + Comacchio MC405	Drilled By: Karl Wordsworth + Maris Veckagans	Logged By: CMathias	Checked By: AGS
---	---	---	---------------------	-----------------

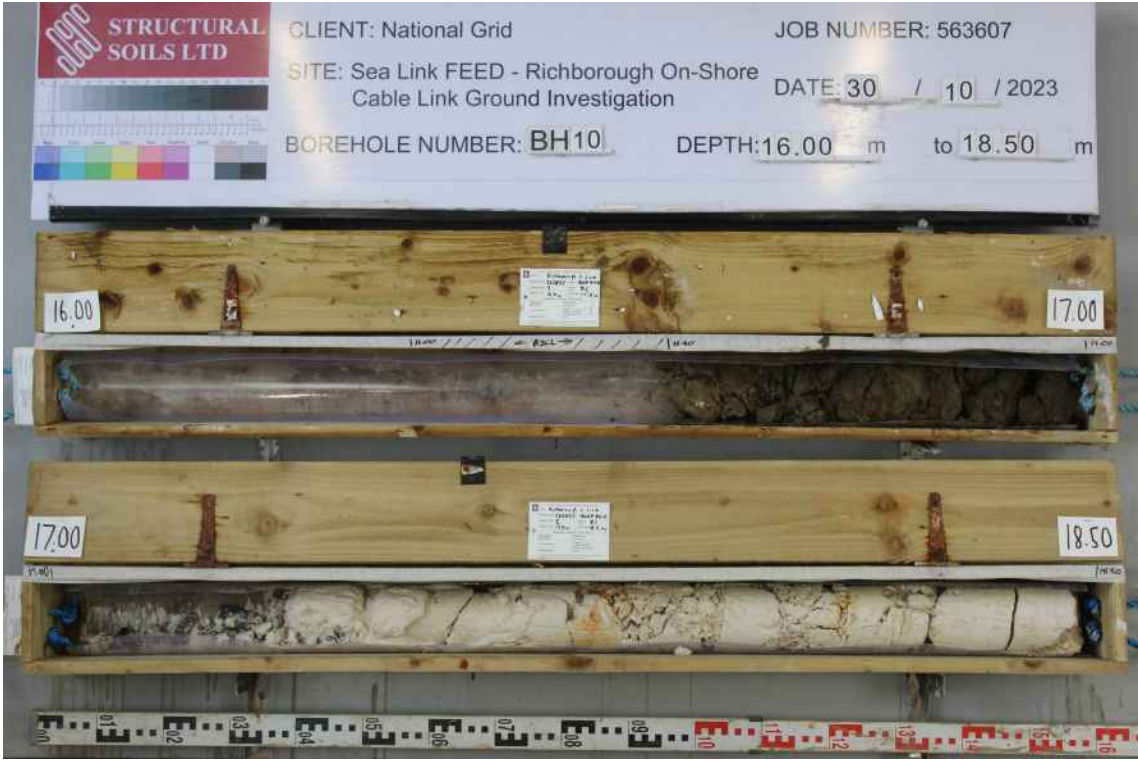
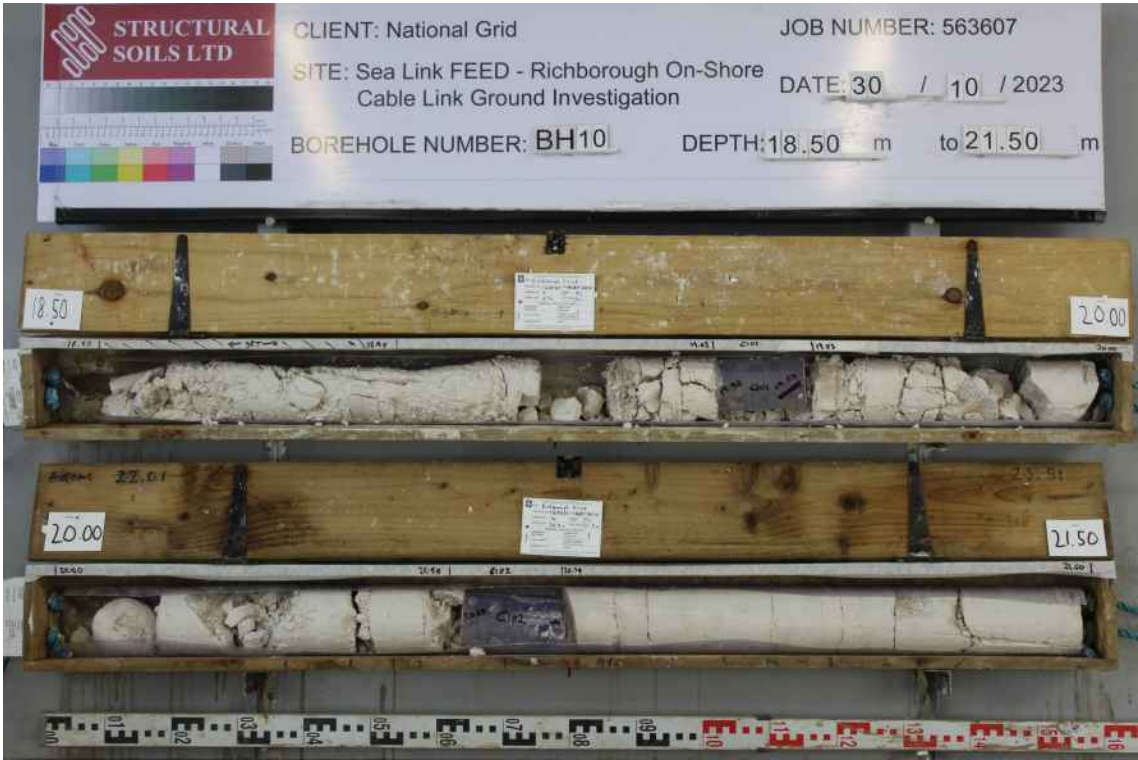
Contract: SEA Link FEED - Kent Onshore Cable Link		Client: National Grid		Borehole: RedP-BH-10
Contract Ref: 563607	Start: 11.10.23 End: 23.10.23	Ground Level (m AOD): 10.58	National Grid Co-ordinate: E:633983.1 N:163641.1	Sheet: 13 of 17

Method Used: Inspection pit + Cable Percussion + Rotary Cored	Plant Used: Dando 2000 Mark 1 + Comacchio MC405	Drilled By: Sam Oxley + Maris Veckagans	Logged By: CMathias	Checked By: AGS
---	---	---	---------------------	-----------------

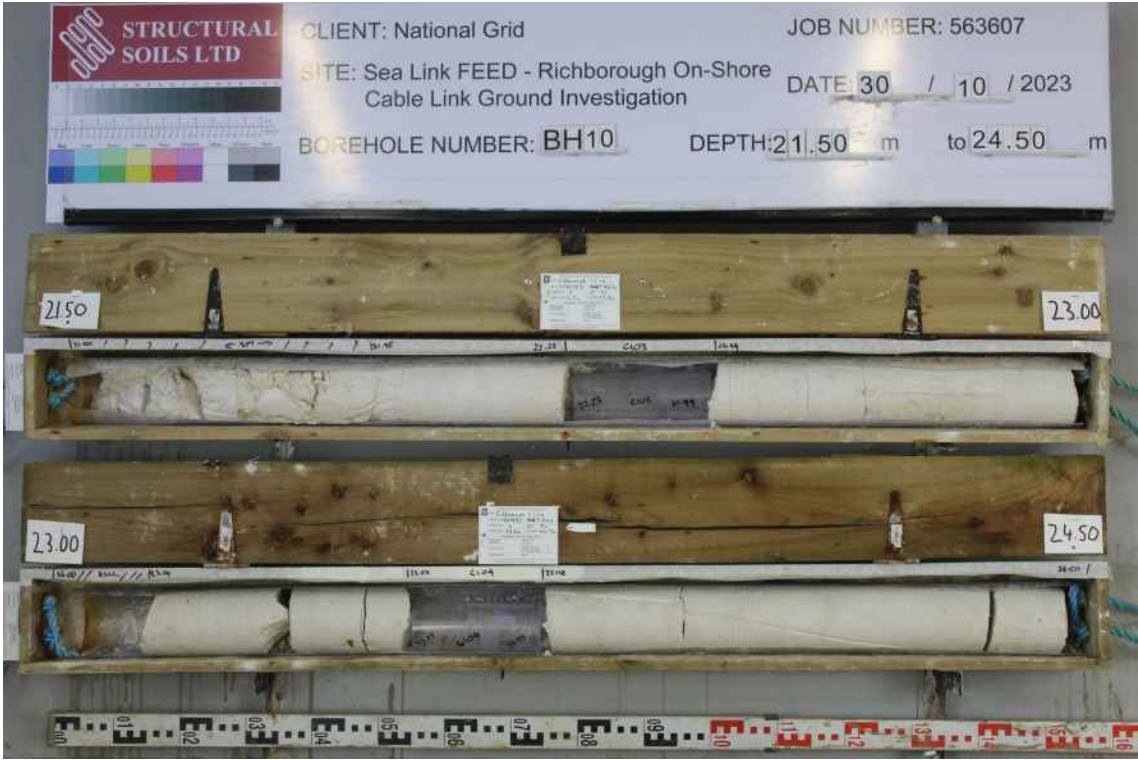
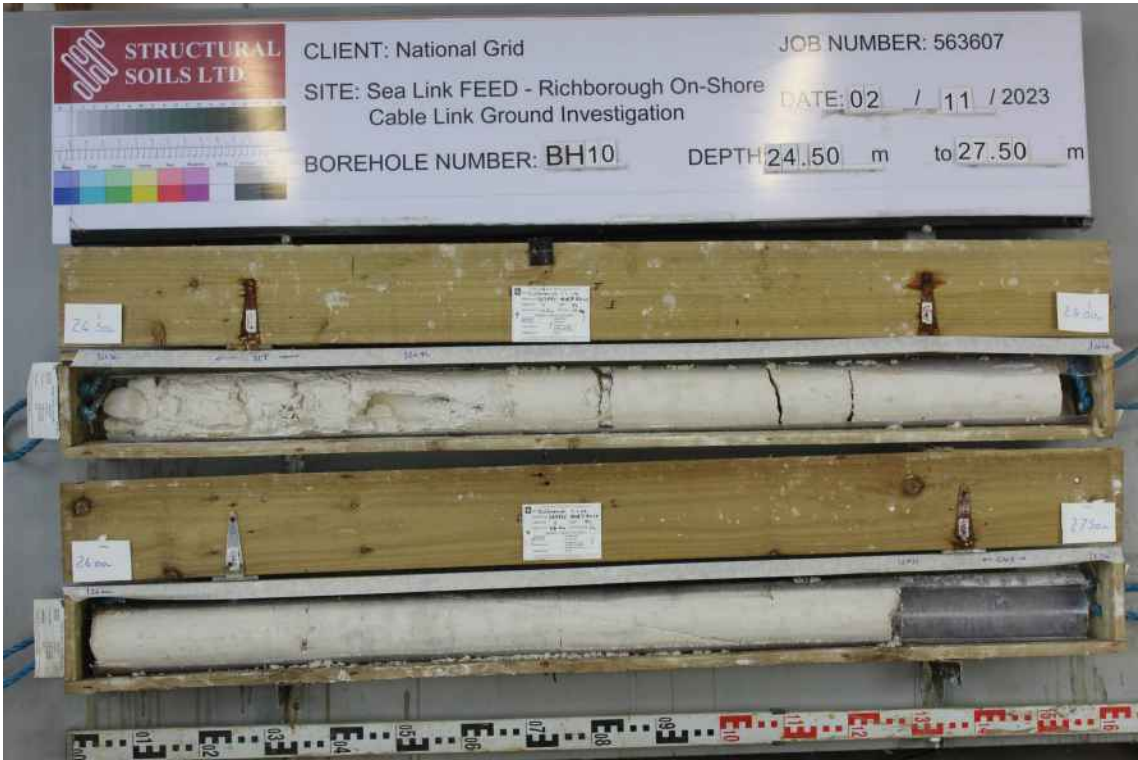
Contract: SEA Link FEED - Kent Onshore Cable Link		Client: National Grid		Borehole: RedP-BH-10
Contract Ref: 563607	Start: 11.10.23 End: 23.10.23	Ground Level (m AOD): 10.58	National Grid Co-ordinate: E:633983.1 N:163641.1	Sheet: 14 of 17

Method Used: Inspection pit + Cable Percussion + Rotary Cored	Plant Used: Dando 2000 Mark 1 + Comacchio MC405	Drilled By: Sam Oxley + Maris Veckagans	Logged By: CMathias	Checked By: AGS
---	---	---	---------------------	-----------------

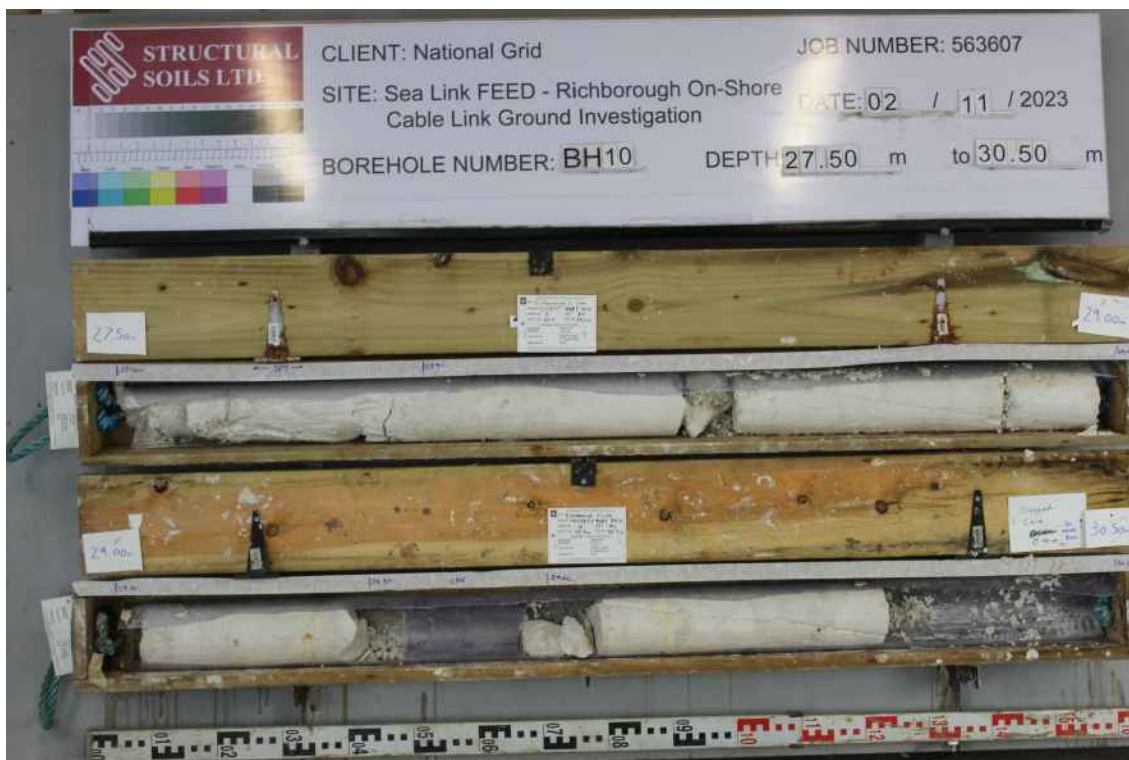
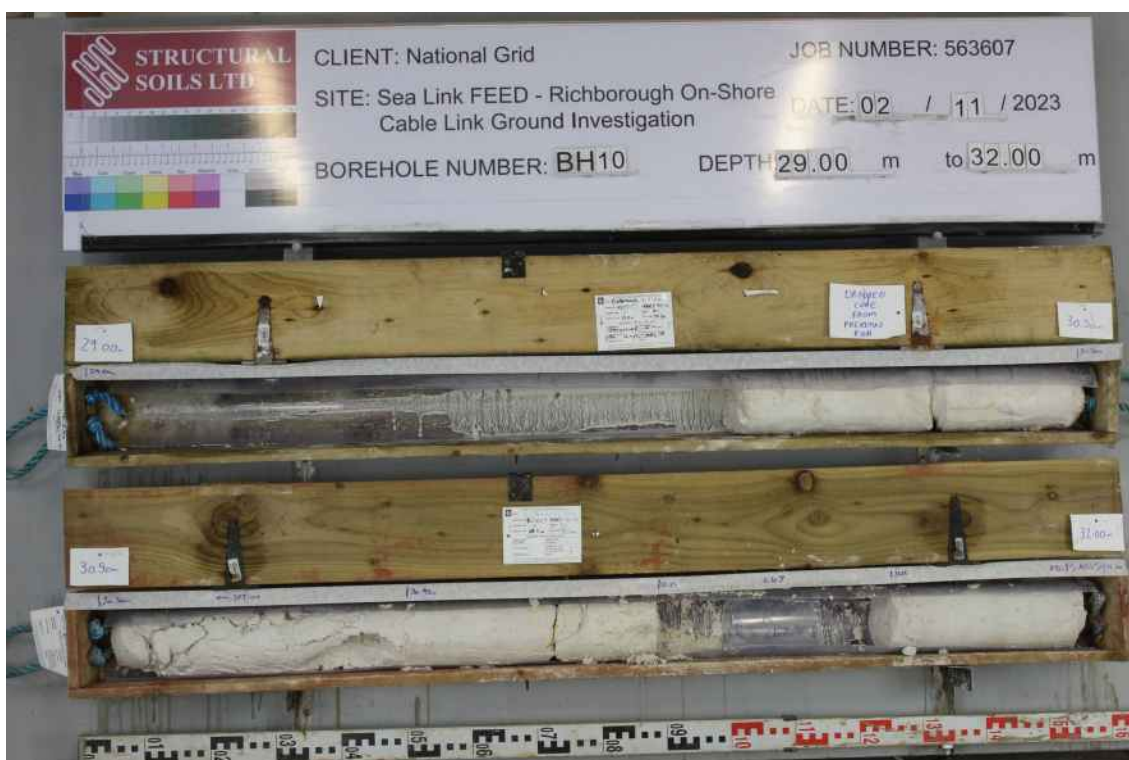
Contract: SEA Link FEED - Kent Onshore Cable Link		Client: National Grid		Borehole: RedP-BH-10
Contract Ref: 563607	Start: 11.10.23 End: 23.10.23	Ground Level (m AOD): 10.58	National Grid Co-ordinate: E:633983.1 N:163641.1	Sheet: 15 of 17

Method Used: Inspection pit + Cable Percussion + Rotary Cored	Plant Used: Dando 2000 Mark 1 + Comacchio MC405	Drilled By: Sam Oxley + Maris Veckagans	Logged By: CMathias	Checked By: AGS
--	--	--	----------------------------	------------------------

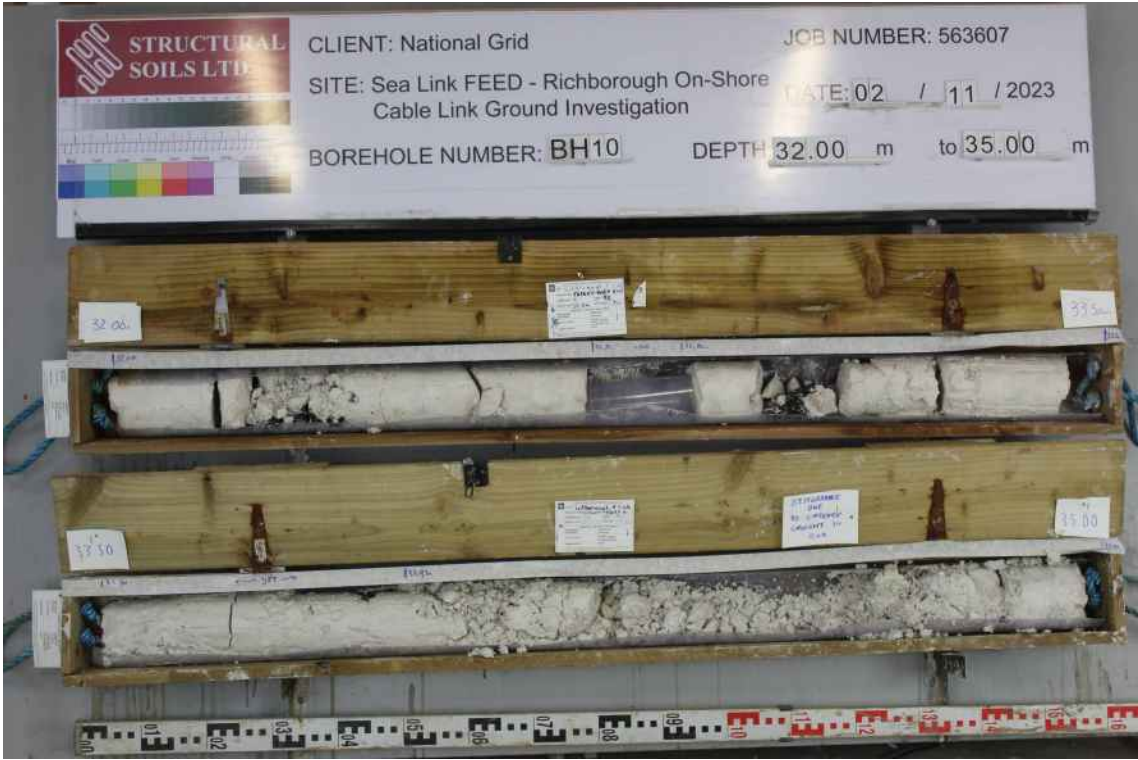
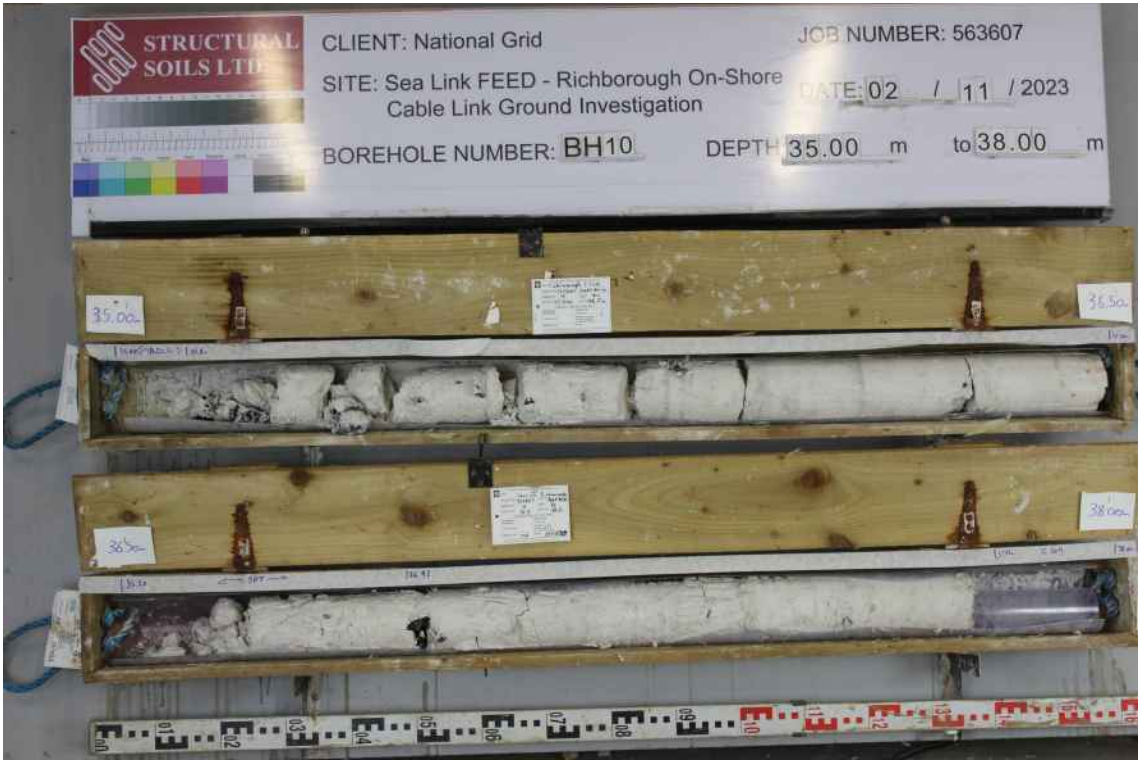
Contract: SEA Link FEED - Kent Onshore Cable Link		Client: National Grid		Borehole: RedP-BH-10
Contract Ref: 563607	Start: 11.10.23 End: 23.10.23	Ground Level (m AOD): 10.58	National Grid Co-ordinate: E:633983.1 N:163641.1	Sheet: 16 of 17

Method Used:	Inspection pit + Cable Percussion + Rotary Cored	Plant Used:	Dando 2000 Mark 1 + Comacchio MC405	Drilled By:	Sam Oxley + Maris Veckagans	Logged By:	CMathias	Checked By:	
-----------------	--	----------------	--	----------------	--------------------------------	---------------	----------	----------------	--

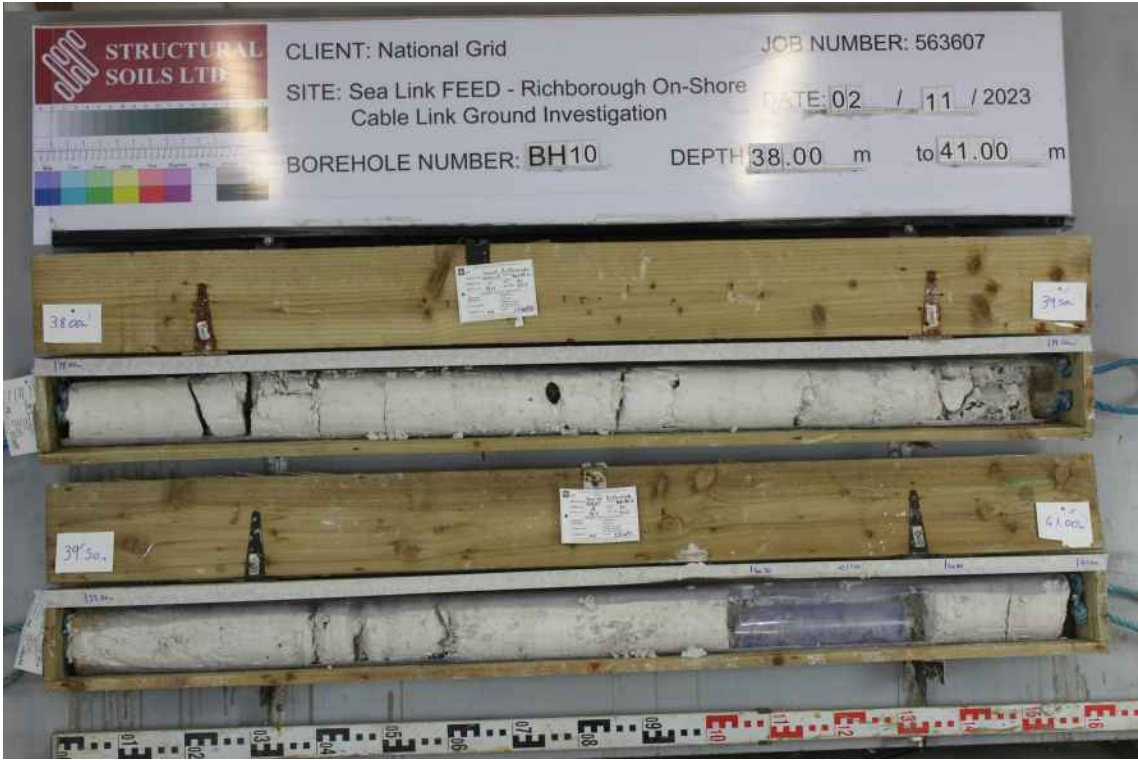
Contract: SEA Link FEED - Kent Onshore Cable Link		Client: National Grid		Borehole: RedP-BH-10
Contract Ref: 563607	Start: 11.10.23 End: 23.10.23	Ground Level (m AOD): 10.58	National Grid Co-ordinate: E:633983.1 N:163641.1	Sheet: 17 of 17

Method Used: Inspection pit + Cable Percussion + Rotary Cored	Plant Used: Dando 2000 Mark 1 + Comacchio MC405	Drilled By: Sam Oxley + Maris Veckagans	Logged By: CMathias	Checked By:	AGS
--	--	--	------------------------	-------------	-----

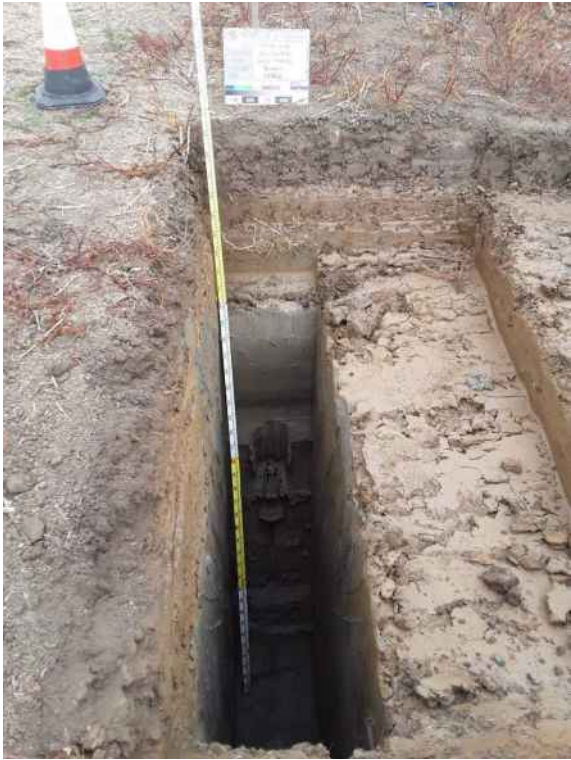
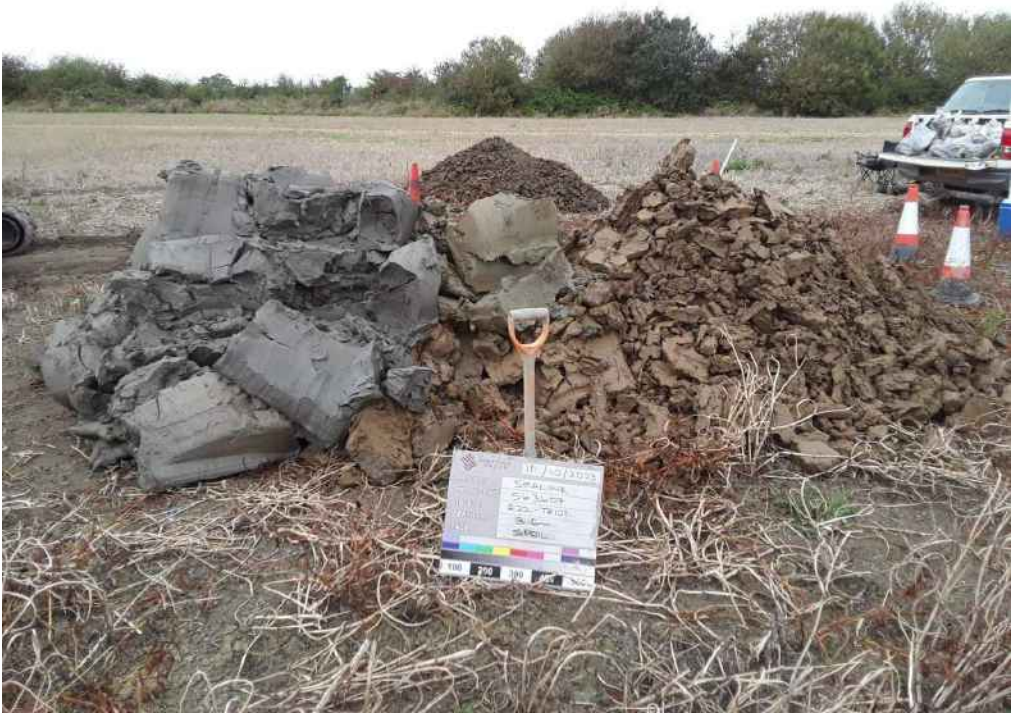
Contract: SEA Link FEED - Kent Onshore Cable Link		Client: National Grid		Trial Pit: R22-TP101
Contract Ref: 563607	Start: 11.10.23 End: 11.10.23	Ground Level (m AOD): 1.38	National Grid Co-ordinate: E:632188.0 N:163132.9	Sheet: 2 of 2

Method Used: Machine dug	Plant Used: Tracked excavator	Logged By: BDrayson	Checked By:	AGS
--------------------------	-------------------------------	---------------------	-------------	-----

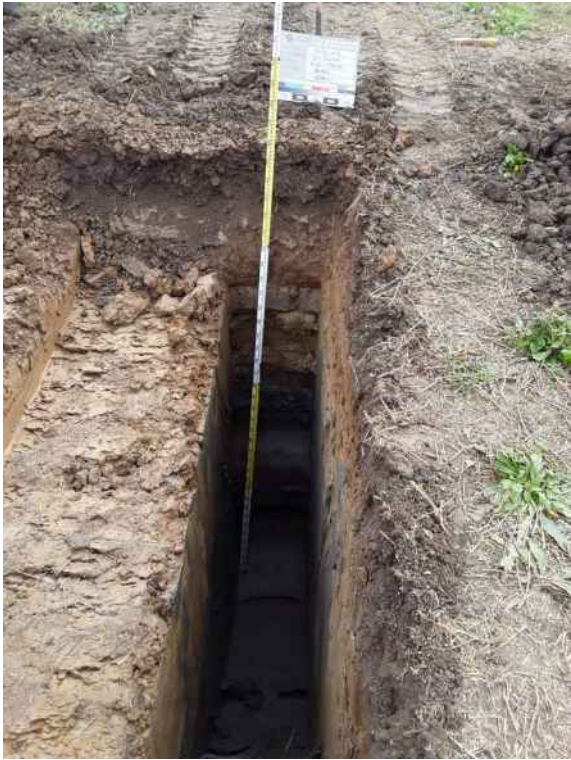
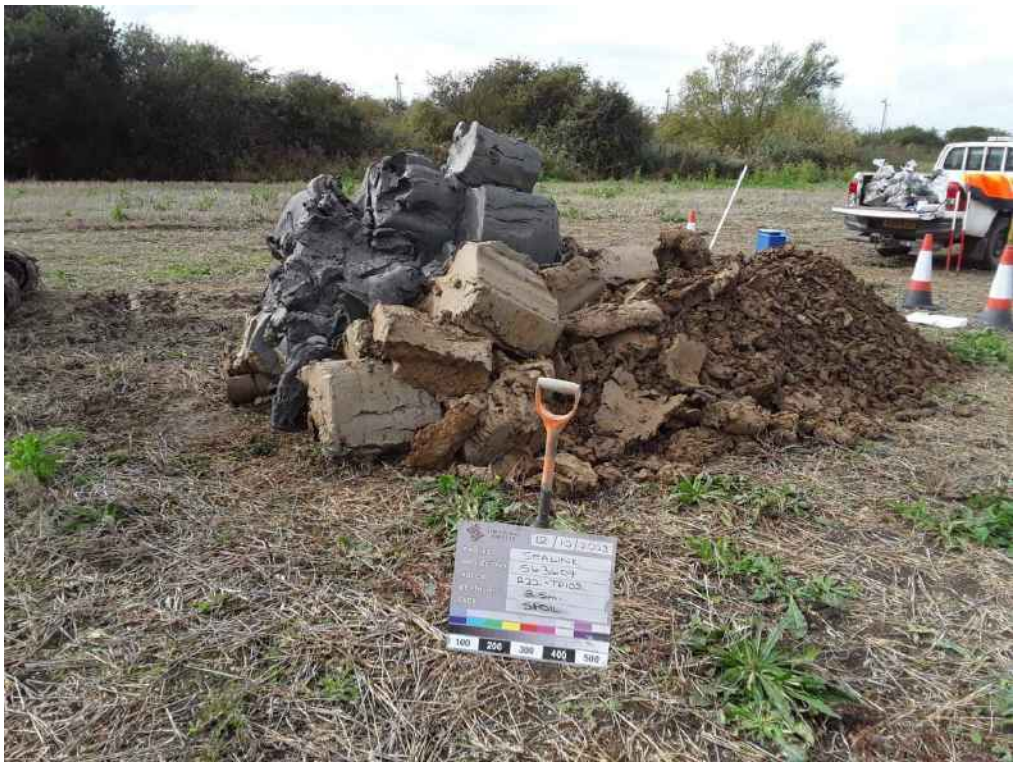
Contract: SEA Link FEED - Kent Onshore Cable Link		Client: National Grid		Trial Pit: R22-TP102
Contract Ref: 563607	Start: 12.10.23 End: 12.10.23	Ground Level (m AOD): 1.48	National Grid Co-ordinate: E:632079.2 N:163044.0	Sheet: 2 of 2

Method Used: Machine dug	Plant Used: Tracked excavator	Logged By: BDrayson	Checked By:	
--------------------------	-------------------------------	---------------------	-------------	--

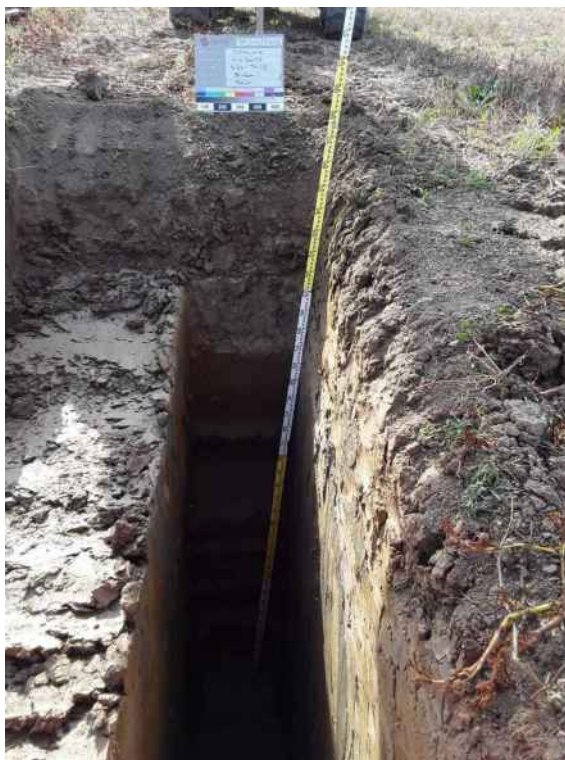
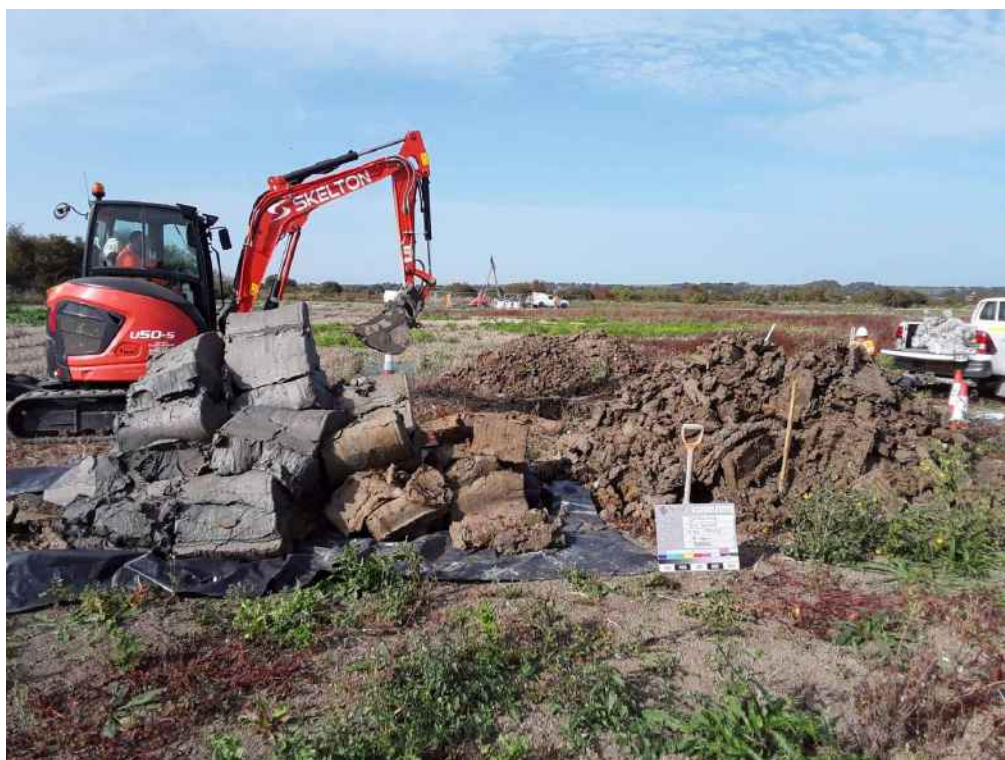
Contract: SEA Link FEED - Kent Onshore Cable Link		Client: National Grid		Trial Pit: R22-TP103
Contract Ref: 563607	Start: 09.10.23 End: 09.10.23	Ground Level (m AOD): 1.36	National Grid Co-ordinate: E:632126.3 N:162967.8	Sheet: 2 of 2

Method Used: Machine dug	Plant Used: Tracked excavator	Logged By: BDrayson	Checked By:
