Sea Link

Generic Quantitative Risk Assessment – Kent Part 1 of 2

Sea Link FEED

Generic Quantitative Risk Assessment
Richborough

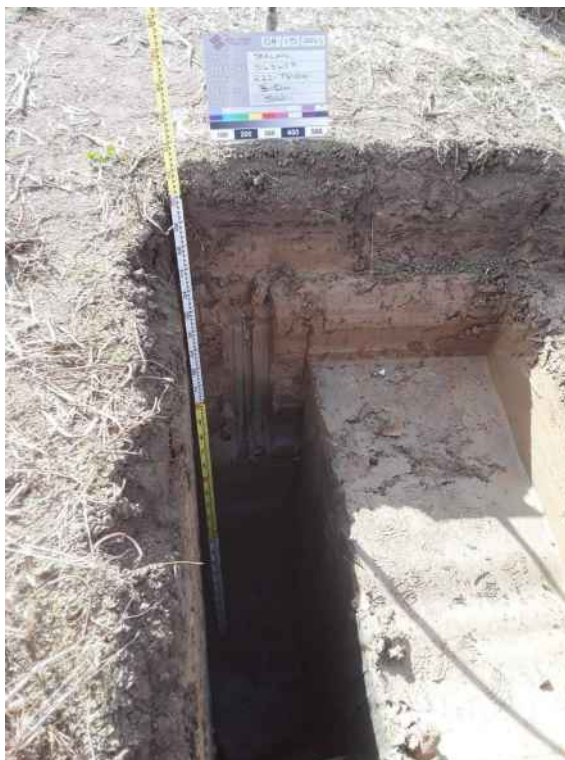
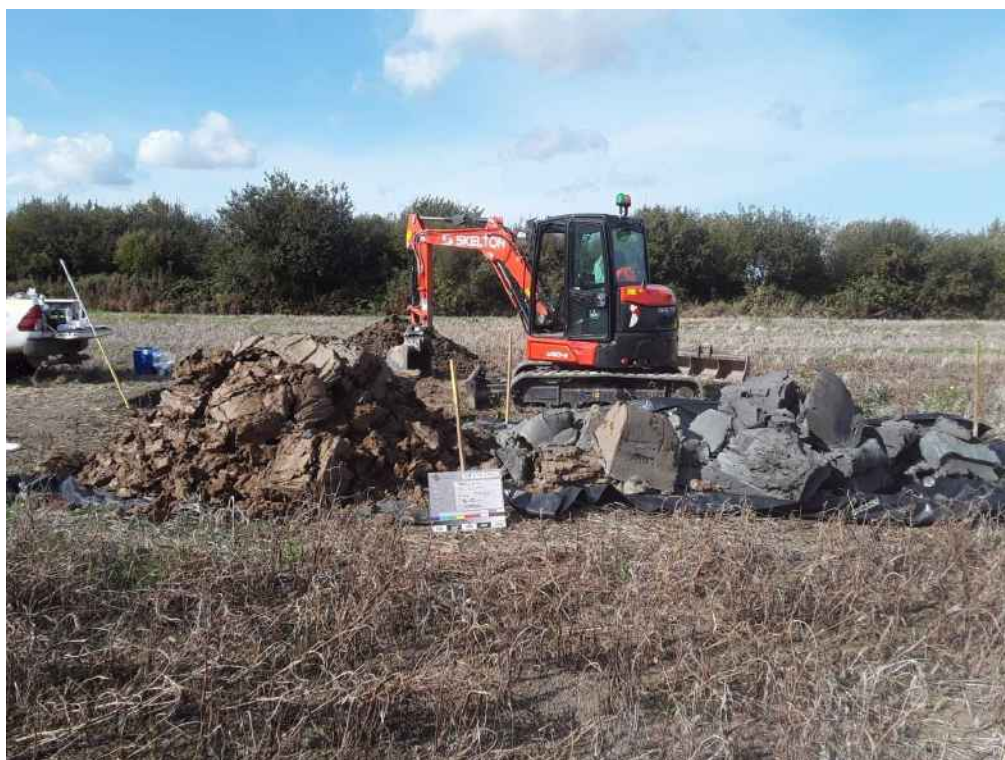
Contract: SEA Link FEED - Kent Onshore Cable Link		Client: National Grid		Trial Pit: R22-TP104
Contract Ref: 563607	Start: 04.10.23 End: 04.10.23	Ground Level (m AOD): 1.35	National Grid Co-ordinate: E:632412.6 N:163024.9	Sheet: 2 of 2

Method Used: Machine dug	Plant Used: Tracked excavator	Logged By: BDrayson	Checked By:

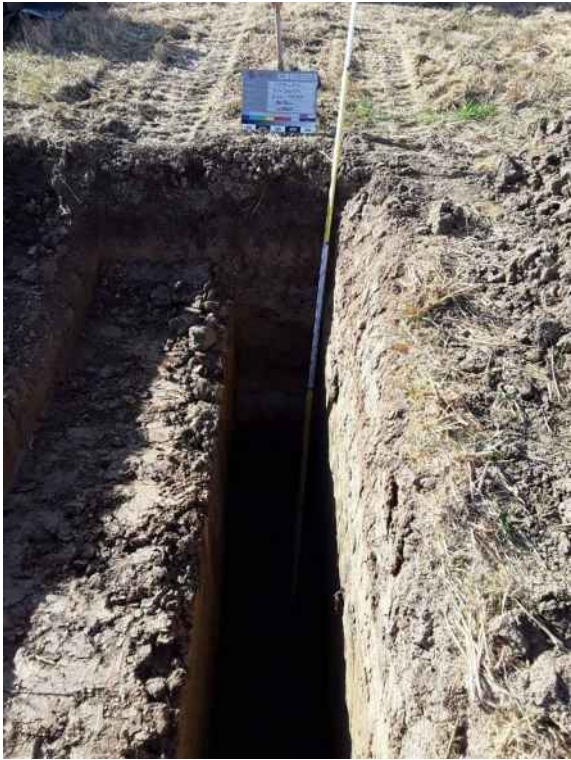
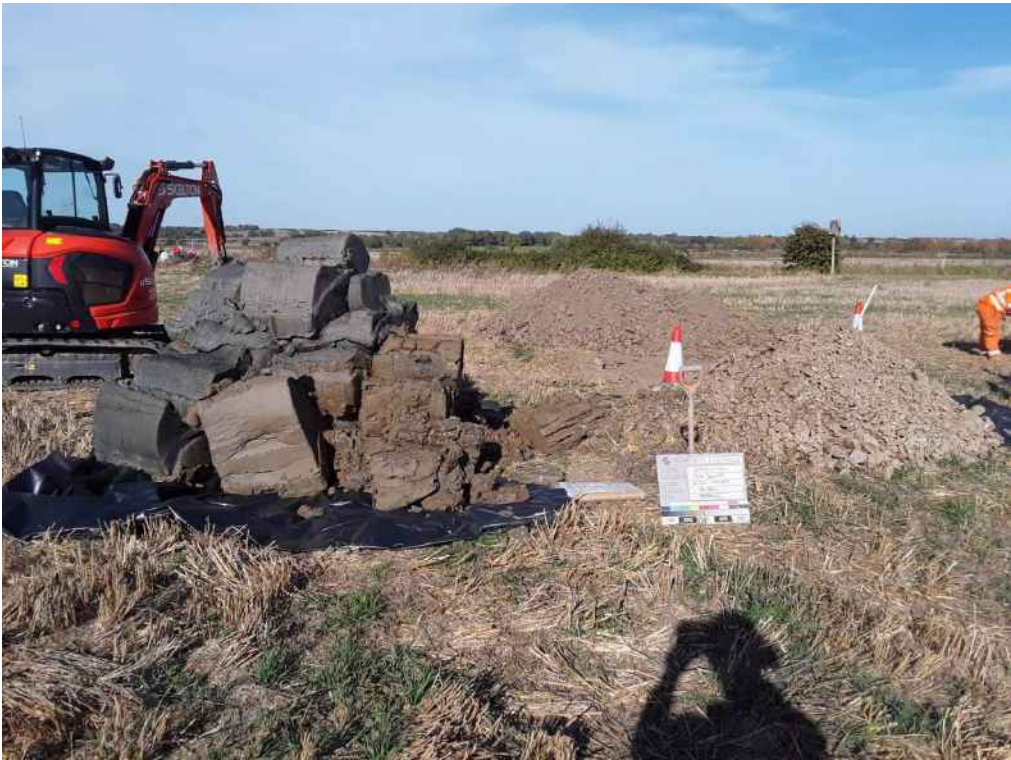
Contract: SEA Link FEED - Kent Onshore Cable Link		Client: National Grid		Trial Pit: R22-TP105
Contract Ref: 563607	Start: 10.10.23 End: 10.10.23	Ground Level (m AOD): 1.50	National Grid Co-ordinate: E:632391.0 N:163180.9	Sheet: 2 of 2

Method Used: Machine dug	Plant Used: Tracked excavator	Logged By: BDrayson	Checked By:	
---------------------------------------	--	----------------------------------	----------------	--

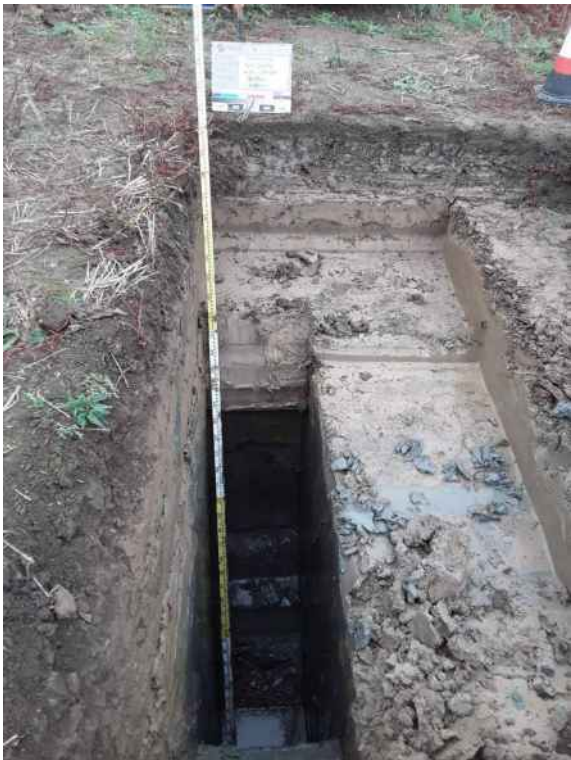
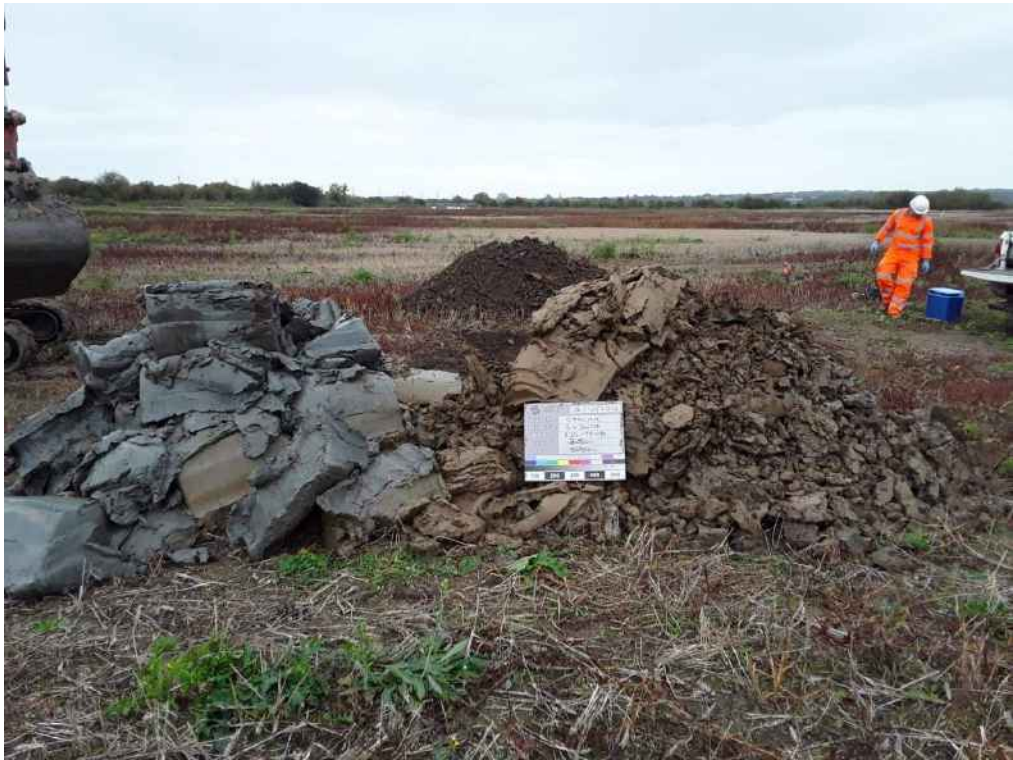
Contract: SEA Link FEED - Kent Onshore Cable Link		Client: National Grid		Trial Pit: R22-TP106
Contract Ref: 563607	Start: 13.10.23 End: 13.10.23	Ground Level (m AOD): 1.29	National Grid Co-ordinate: E:632251.6 N:162902.2	Sheet: 2 of 2

Method Used: Machine dug	Plant Used: Tracked excavator	Logged By: BDrayson	Checked By:
---------------------------------	--------------------------------------	----------------------------	-------------

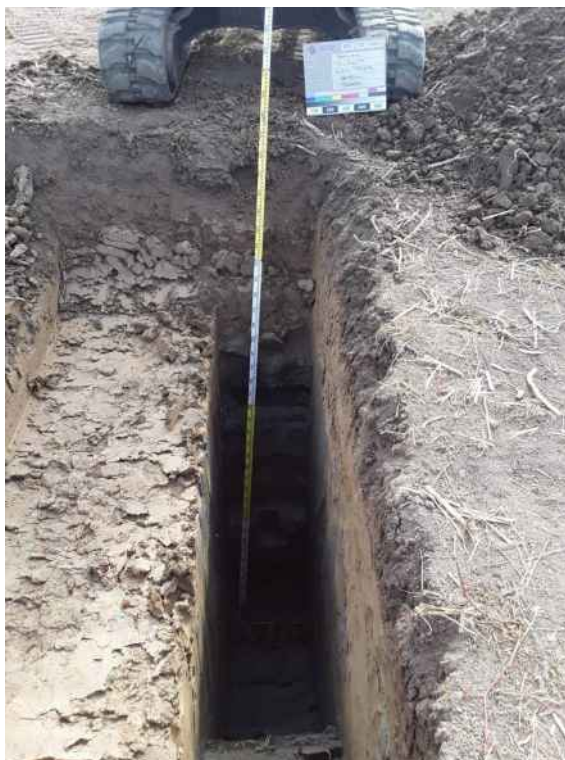
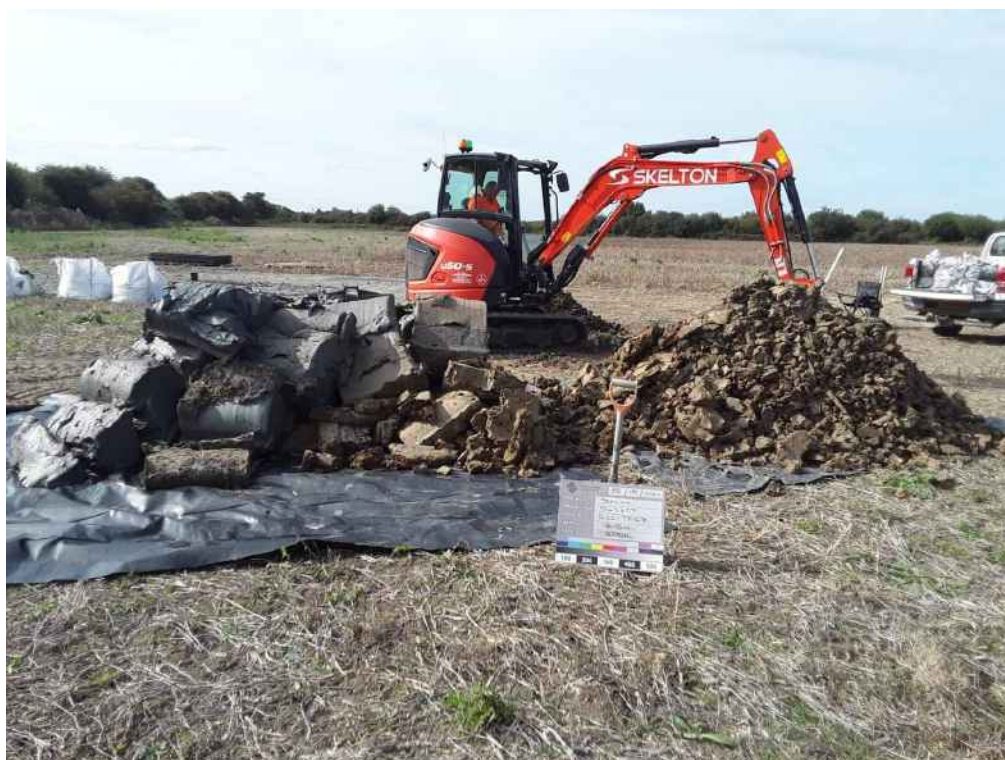
Contract: SEA Link FEED - Kent Onshore Cable Link		Client: National Grid		Trial Pit: R22-TP107
Contract Ref: 563607	Start: 05.10.23 End: 05.10.23	Ground Level (m AOD): 1.39	National Grid Co-ordinate: E:632524.8 N:162978.0	Sheet: 2 of 2

Method Used: Machine dug	Plant Used: Tracked excavator	Logged By: BDrayson	Checked By: 	AGS
---------------------------------------	--	----------------------------------	---------------------------	------------

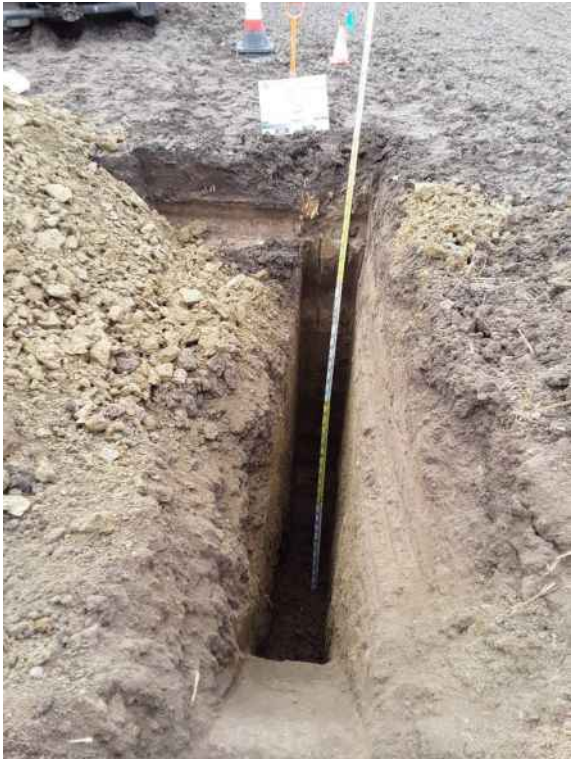
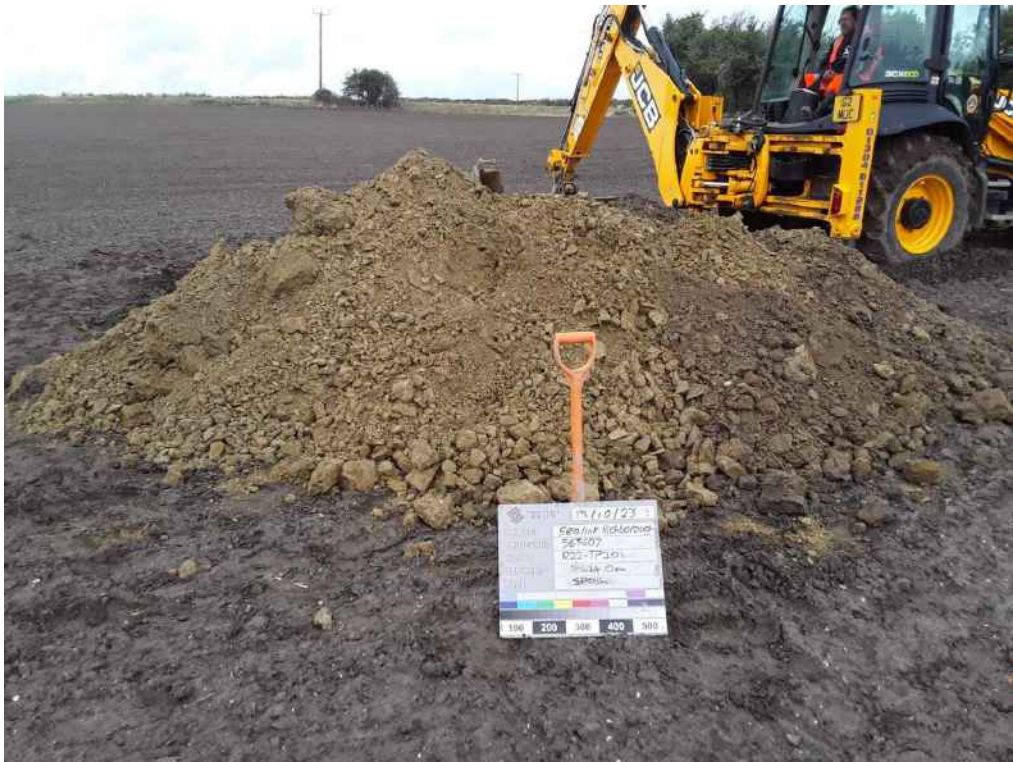
Contract: SEA Link FEED - Kent Onshore Cable Link		Client: National Grid		Trial Pit: R22-TP201
Contract Ref: 563607	Start: 19.10.23 End: 19.10.23	Ground Level (m AOD): 4.35	National Grid Co-ordinate: E:633846.7 N:163705.4	Sheet: 2 of 2

Method Used: Machine dug	Plant Used: JCB-3CX	Logged By: BDrayson	Checked By:	
------------------------------------	-------------------------------	-------------------------------	-------------	--

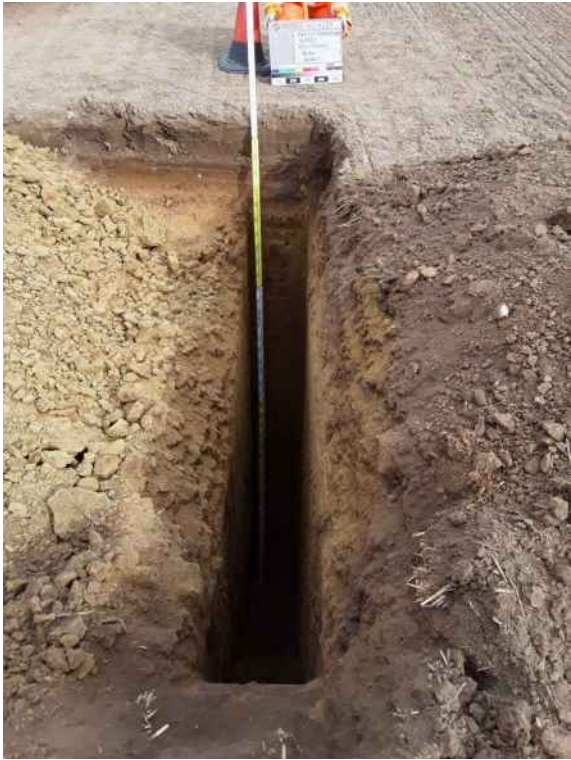
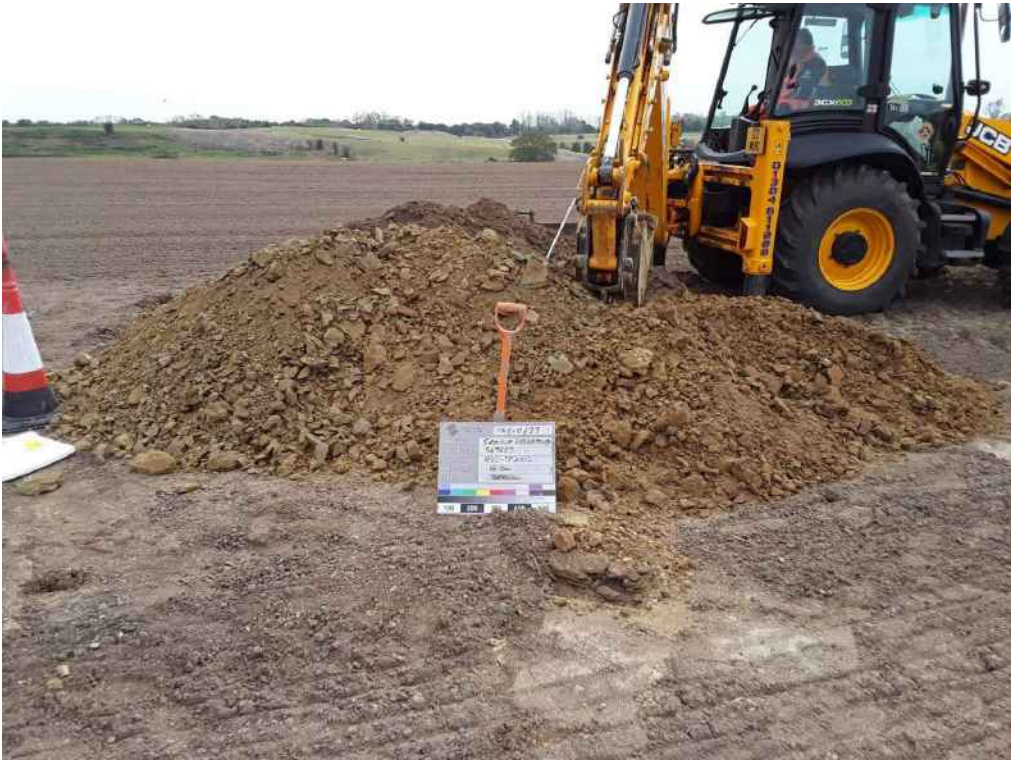
Contract: SEA Link FEED - Kent Onshore Cable Link		Client: National Grid		Trial Pit: R22-TP202
Contract Ref: 563607	Start: 18.10.23 End: 18.10.23	Ground Level (m AOD): 11.00	National Grid Co-ordinate: E:633556.2 N:163636.7	Sheet: 2 of 2

Method Used: Machine dug	Plant Used: JCB-3CX	Logged By: BDrayson	Checked By:	AGS
--------------------------	---------------------	---------------------	-------------	-----

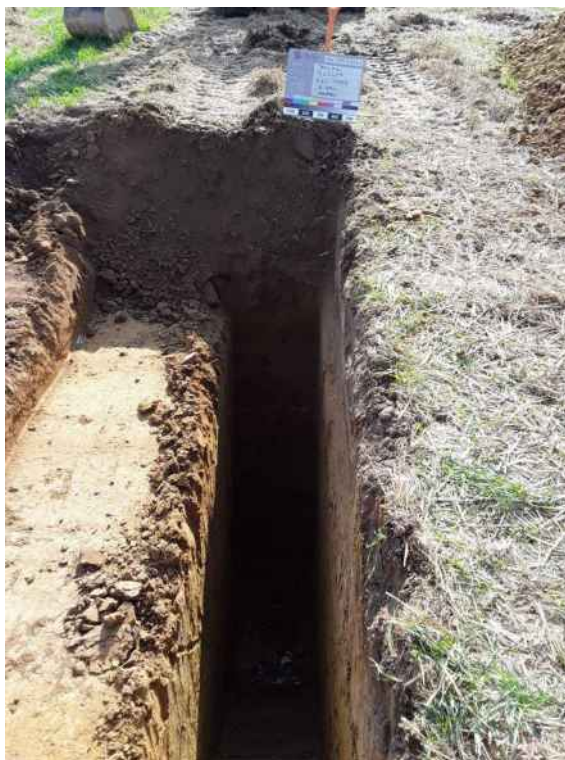
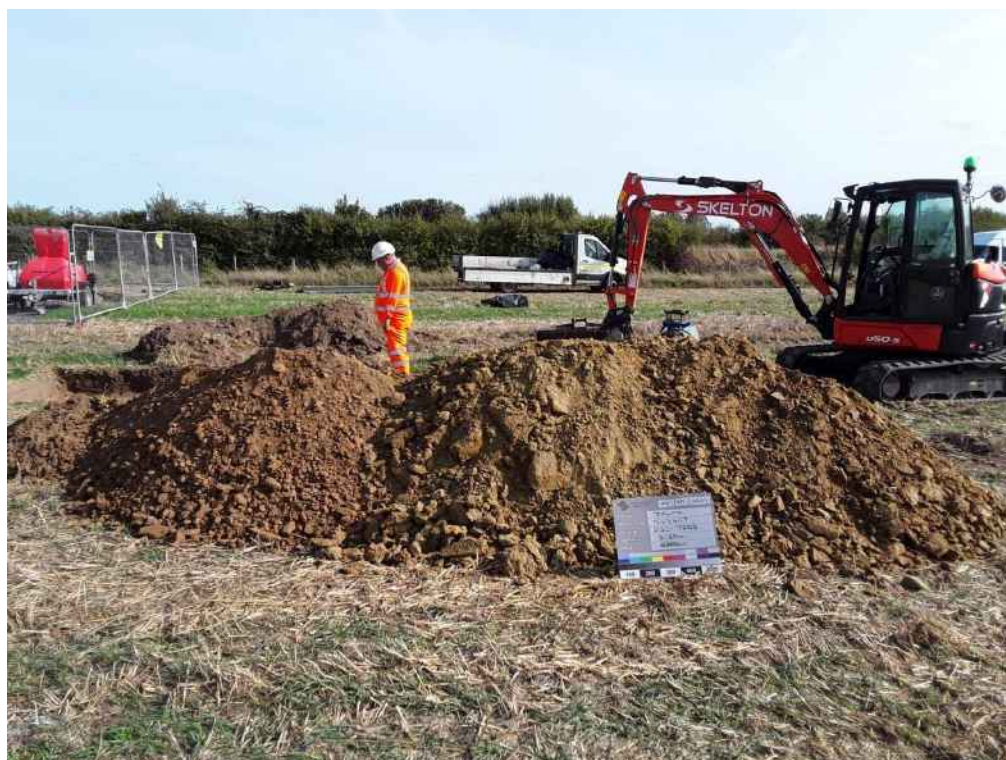
Contract: SEA Link FEED - Kent Onshore Cable Link		Client: National Grid		Trial Pit: R22-TP203
Contract Ref: 563607	Start: 26.09.23 End: 26.09.23	Ground Level (m AOD): 7.14	National Grid Co-ordinate: E:633280.7 N:163502.6	Sheet: 2 of 2

Method Used:	Machine dug	Plant Used:	Tracked excavator	Logged By:	BDrayson	Checked By:	
-----------------	--------------------	----------------	--------------------------	---------------	-----------------	----------------	--

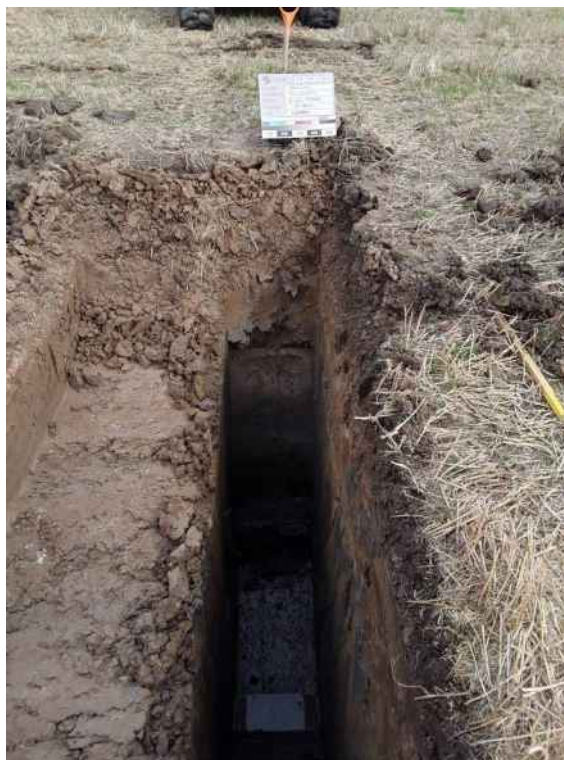
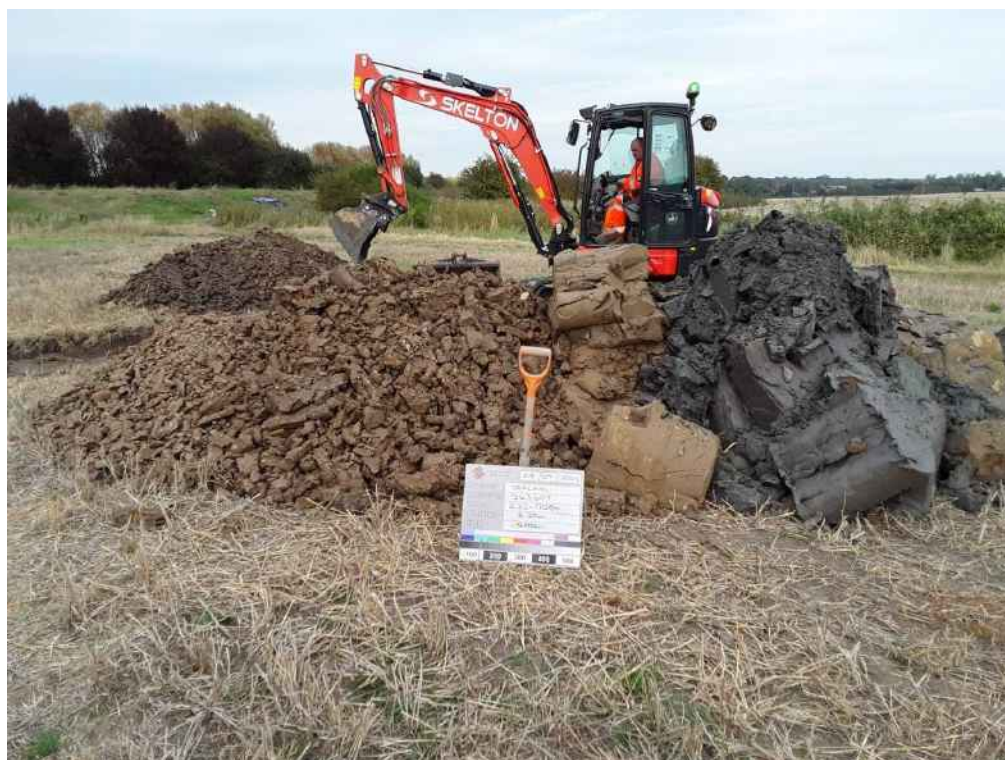
Contract: SEA Link FEED - Kent Onshore Cable Link		Client: National Grid		Trial Pit: R22-TP204
Contract Ref: 563607	Start: 27.09.23 End: 27.09.23	Ground Level (m AOD): 1.56	National Grid Co-ordinate: E:632890.2 N:163330.3	Sheet: 2 of 2

Method Used: Machine dug	Plant Used: Tracked excavator	Logged By: BDrayson	Checked By:

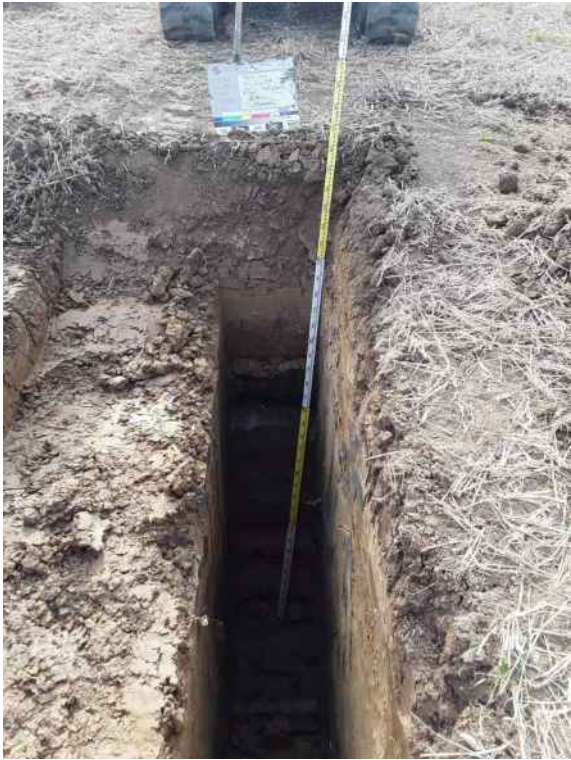
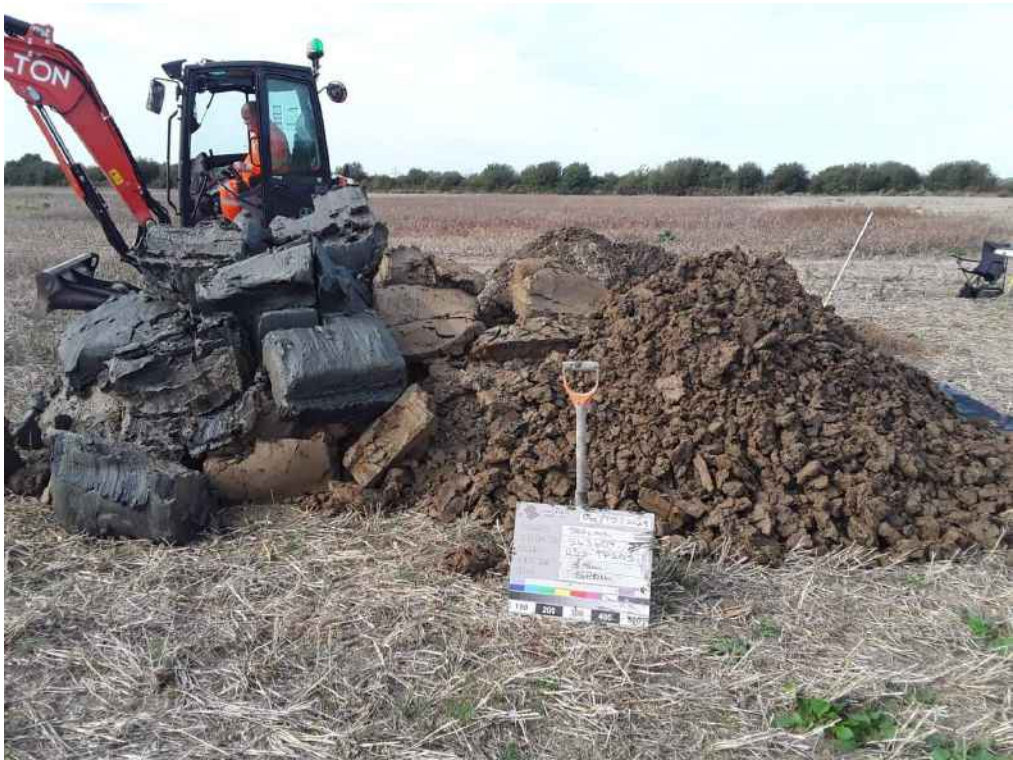
Contract: SEA Link FEED - Kent Onshore Cable Link		Client: National Grid		Trial Pit: R22-TP205
Contract Ref: 563607	Start: 06.10.23 End: 06.10.23	Ground Level (m AOD): 1.44	National Grid Co-ordinate: E:632566.0 N:163105.6	Sheet: 2 of 2

Method Used: Machine dug	Plant Used: Tracked excavator	Logged By: BDrayson	Checked By:	
---------------------------------	--------------------------------------	----------------------------	-------------	--

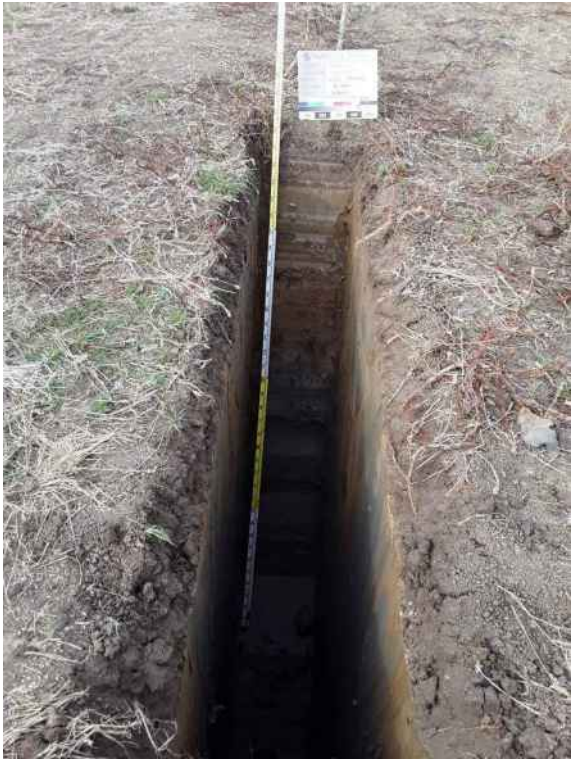
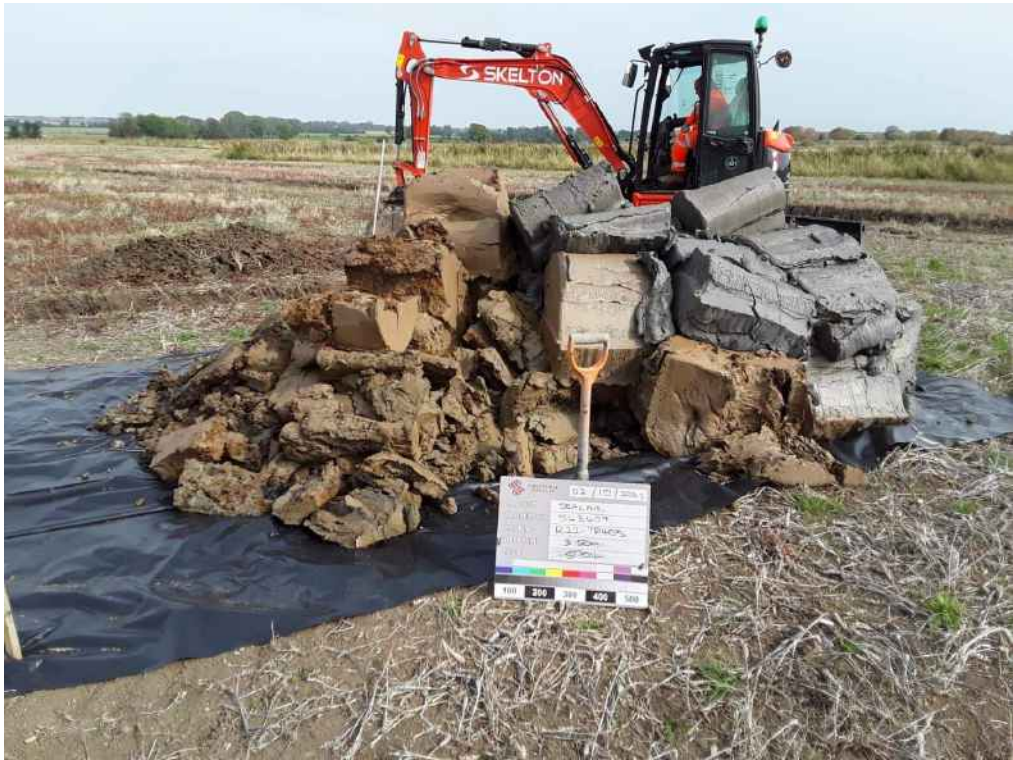
Contract: SEA Link FEED - Kent Onshore Cable Link		Client: National Grid		Trial Pit: R22-TP405
Contract Ref: 563607	Start: 02.10.23 End: 02.10.23	Ground Level (m AOD): 1.43	National Grid Co-ordinate: E:632249.6 N:163371.0	Sheet: 2 of 2

Method Used: Machine dug	Plant Used: Tracked excavator	Logged By: BDrayson	Checked By:	
------------------------------------	---	-------------------------------	-------------	--

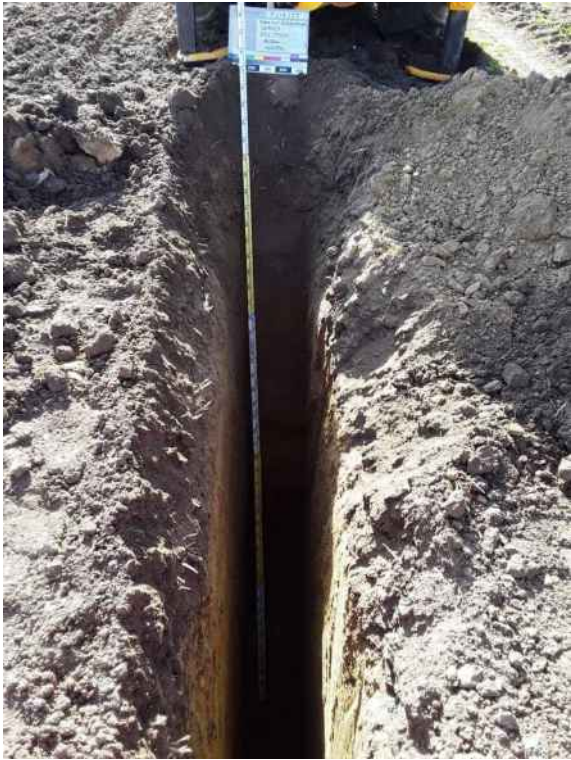
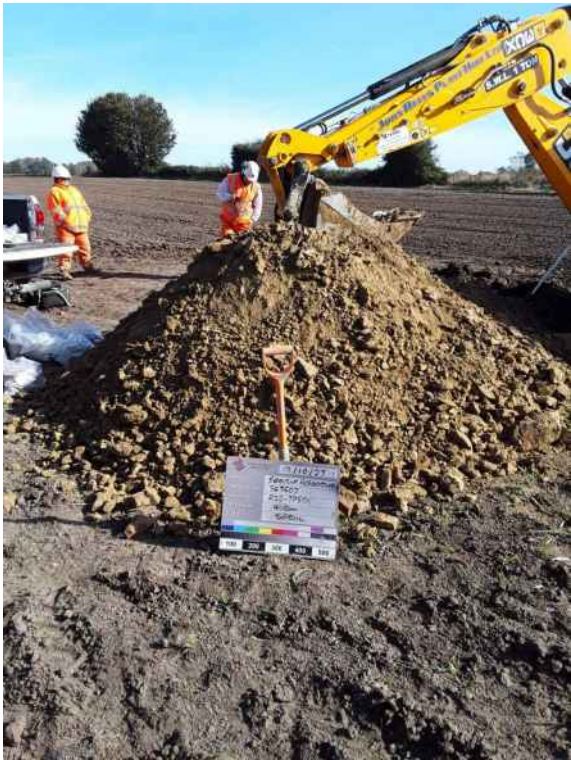
Contract: SEA Link FEED - Kent Onshore Cable Link		Client: National Grid		Trial Pit: R22-TP501
Contract Ref: 563607	Start: 17.10.23 End: 17.10.23	Ground Level (m AOD): 5.91	National Grid Co-ordinate: E:633352.1 N:163351.8	Sheet: 2 of 2

Method Used: Machine dug	Plant Used: JCB-3CX	Logged By: BDrayson	Checked By:	
---------------------------------------	----------------------------------	----------------------------------	----------------	--

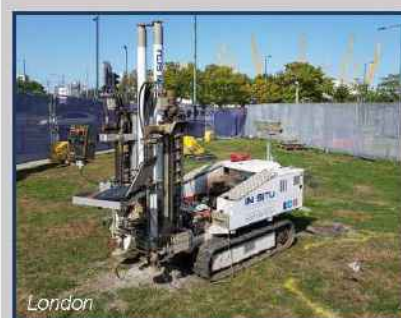
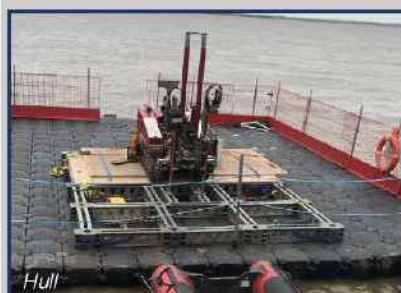
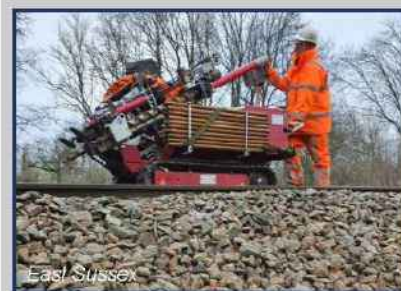
CPT RIG DIMENSIONS

DRIVE SYSTEM	RUBBER TRACKS
TOTAL WEIGHT	1.5 TONNES
GROUND BEARING PRESSURE	21kPA
CPT RAM THRUST CAPACITY	16 TONNES
MAXIMUM PENETRATION	30-40M DEPENDING ON THE GROUND CONDITIONS
PERFORMANCE RATES	60-80M OF TESTING A DAY DEPENDING ON ACCESS TO POSITIONS
TYPICAL SITES FOR THIS RIG	SITES WITH RESTRICTED ACCESS, BOTH INDOORS AND OUTDOORS

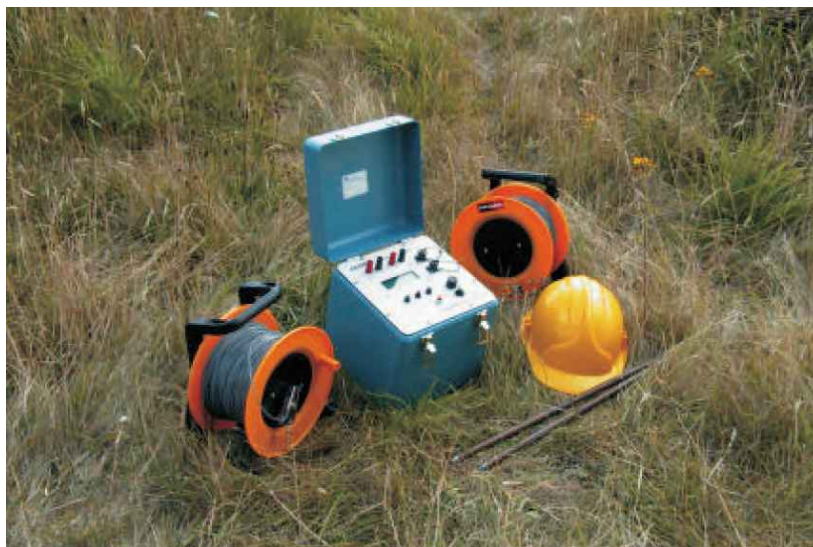
CAMPUS OHMEGA SYSTEM

Equipment Specification Sheet

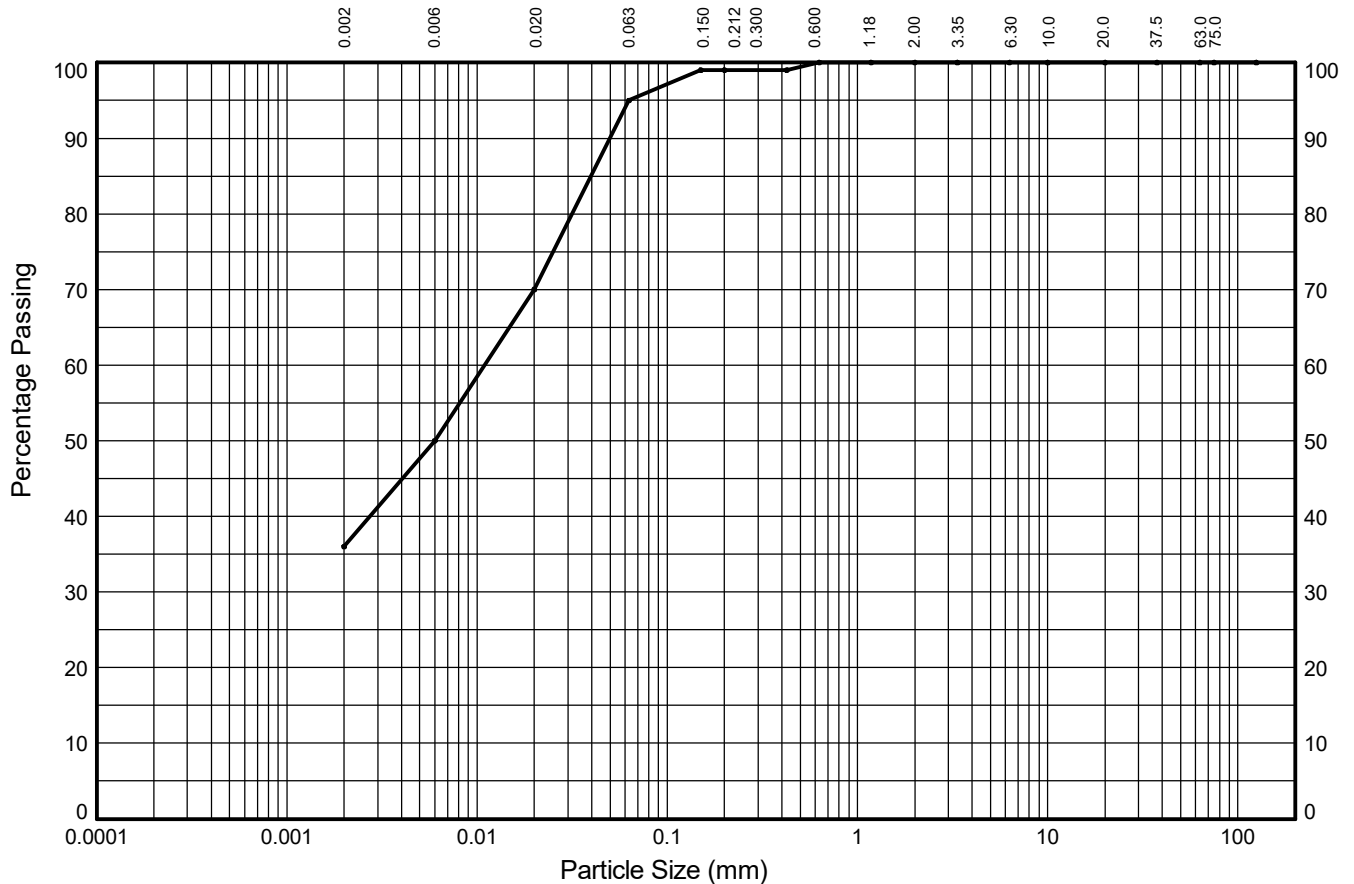
Depth (m): **0.70**

CLAY	fine	medium	coarse	fine	medium	coarse	fine	medium	coarse	COBBLES
	14%	20%	25%	4%	1%	0%	0%	0%	0%	
	SILT			SAND			GRAVEL			
36%	59%			5%			0%			0%

Test Sieve (mm)	Percent Passing (%)	Particle Diameter (mm)	Percent Passing (%)	Coefficients	
125.0	100	0.02	70	D ₁₀ (mm)	NA
75.0	100			D ₁₅ (mm)	NA
63.0	100			D ₃₀ (mm)	NA
37.5	100	0.006	50	D ₅₀ (mm)	0.006
20.0	100			D ₆₀ (mm)	0.011
10.0	100			D ₈₅ (mm)	0.040
6.30	100	0.002	36	D ₉₀ (mm)	0.050
3.35	100			C _U	NA
2.00	100			C _C	NA
1.18	100	Sedimentation sample was not pre-treated			
0.630	100				
0.425	99				
0.200	99				
0.150	99				
0.063	95	Soil Description: Brown mottled dark bluish grey slightly sandy silty CLAY

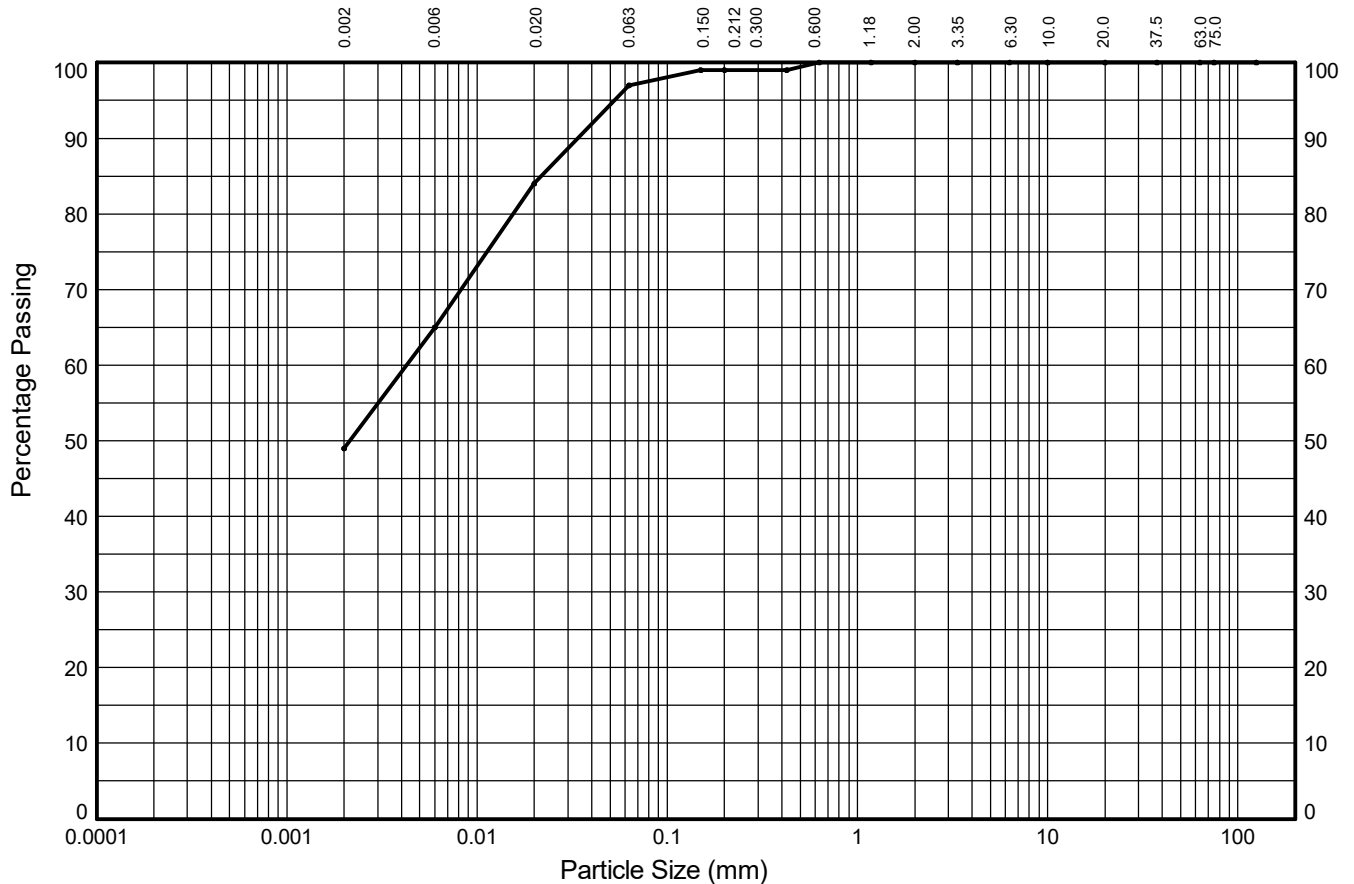
Depth (m): **1.80**

CLAY	fine	medium	coarse	fine	medium	coarse	fine	medium	coarse	COBBLES
	16%	19%	13%	2%	1%	0%	0%	0%	0%	
	SILT			SAND			GRAVEL			
49%	48%			3%			0%			0%

Test Sieve (mm)	Percent Passing (%)	Particle Diameter (mm)	Percent Passing (%)	Coefficients	
125.0	100	0.02	84	D ₁₀ (mm)	NA
75.0	100			D ₁₅ (mm)	NA
63.0	100			D ₃₀ (mm)	NA
37.5	100	0.006	65	D ₅₀ (mm)	0.002
20.0	100			D ₆₀ (mm)	0.004
10.0	100			D ₈₅ (mm)	0.022
6.30	100	0.002	49	D ₉₀ (mm)	0.034
3.35	100			C _U	NA
2.00	100			C _C	NA
1.18	100	Sedimentation sample was not pre-treated			
0.630	100	Soil Description: Dark brown slightly sandy silty CLAY			
0.425	99				
0.200	99				
0.150	99				
0.063	97

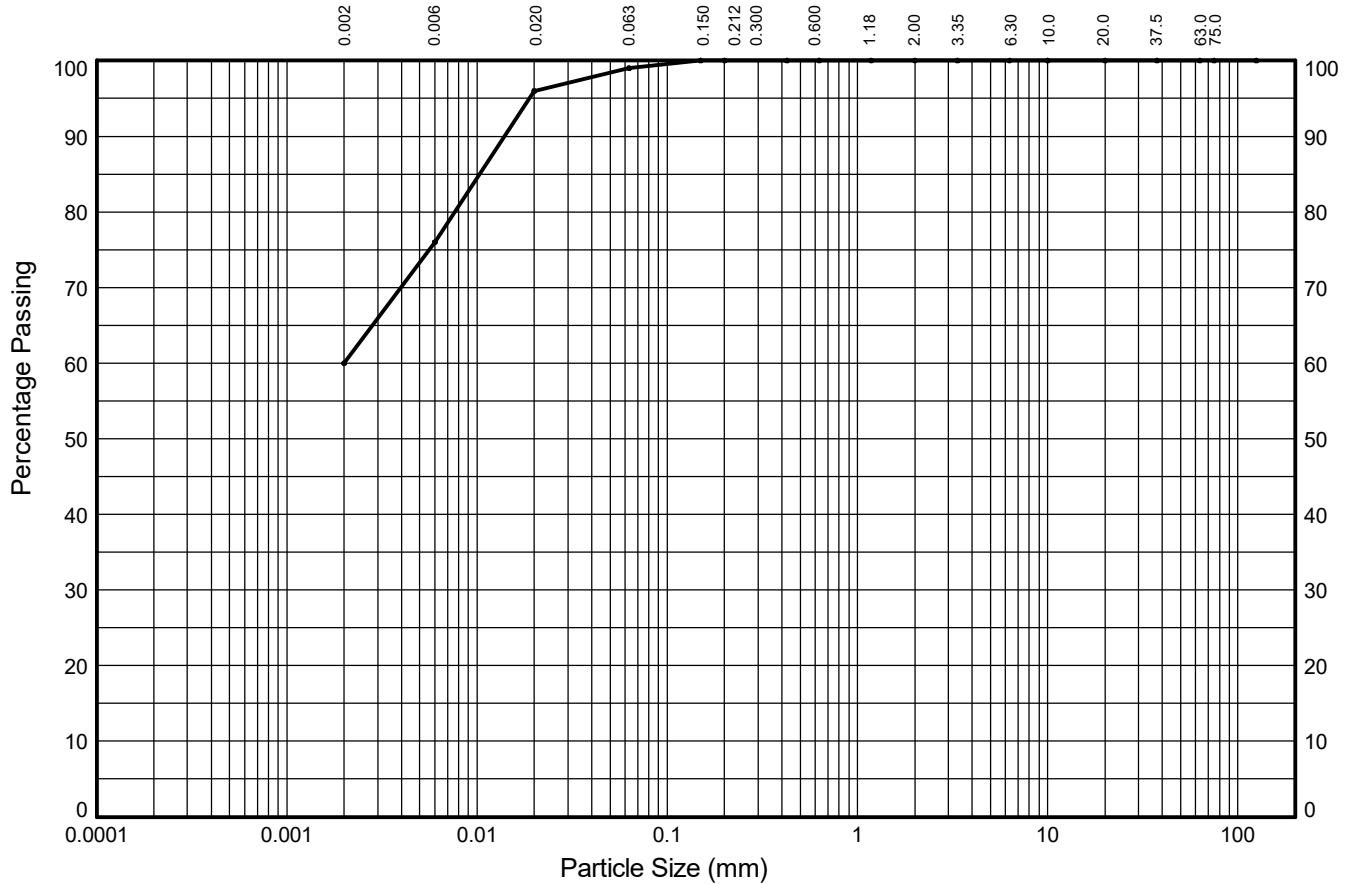
Depth (m): **1.10**

CLAY	fine	medium	coarse	fine	medium	coarse	fine	medium	coarse	COBBLES
	16%	20%	3%	1%	0%	0%	0%	0%	0%	
	SILT			SAND			GRAVEL			
60%	39%			1%			0%			0%

Test Sieve (mm)	Percent Passing (%)	Particle Diameter (mm)	Percent Passing (%)	Coefficients	
125.0	100	0.02	96	D ₁₀ (mm)	NA
75.0	100			D ₁₅ (mm)	NA
63.0	100			D ₃₀ (mm)	NA
37.5	100	0.006	76	D ₅₀ (mm)	NA
20.0	100			D ₆₀ (mm)	0.002
10.0	100			D ₈₅ (mm)	0.010
6.30	100	0.002	60	D ₉₀ (mm)	0.014
3.35	100			C _U	NA
2.00	100			C _C	NA
1.18	100	Sedimentation sample was not pre-treated			
0.630	100				
0.425	100				
0.200	100				
0.150	100				
0.063	99	Soil Description: Brown mottled orangish brown slightly sandy silty CLAY

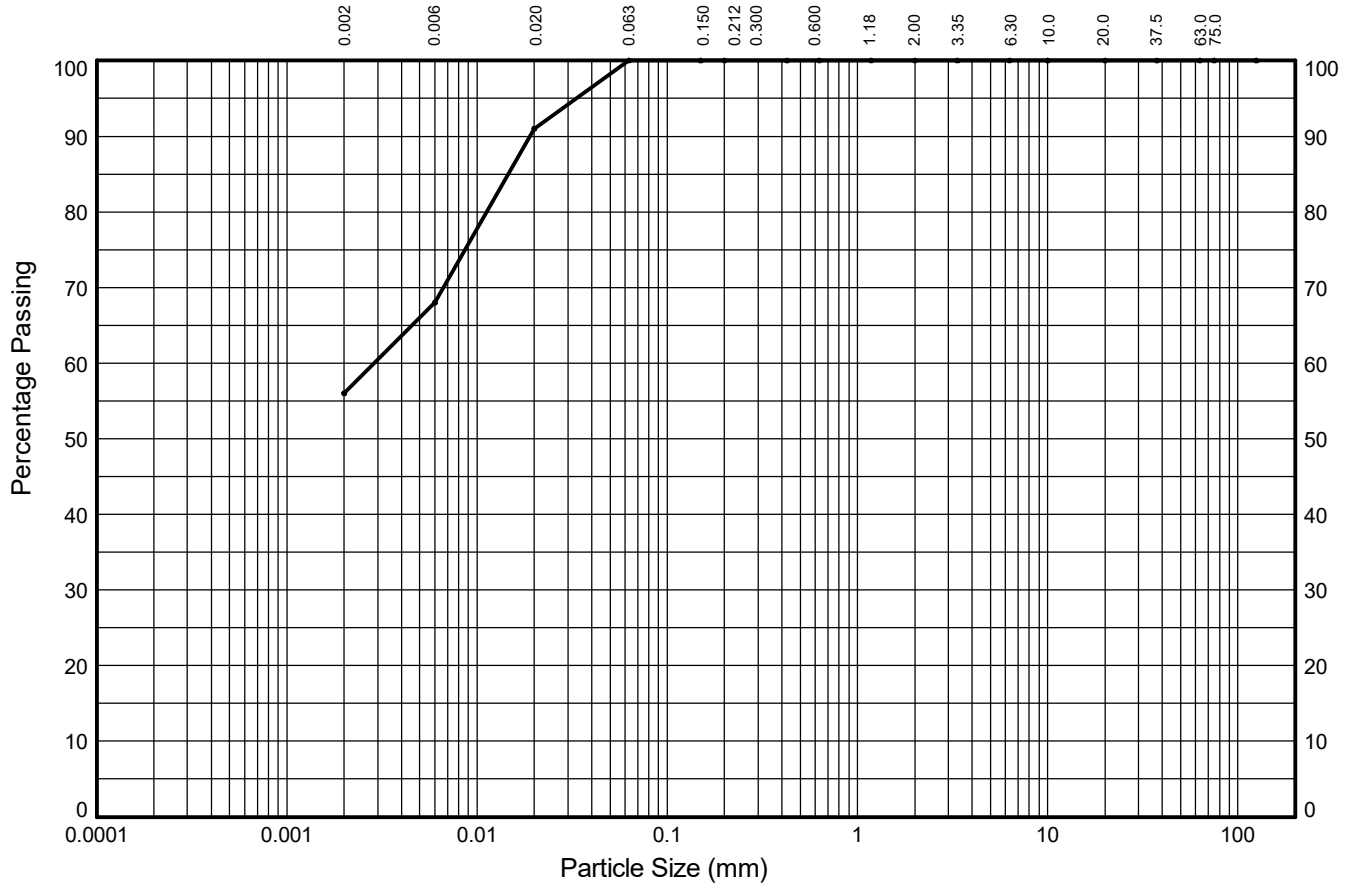
Depth (m): **0.90**

CLAY	fine	medium	coarse	fine	medium	coarse	fine	medium	coarse	COBBLES
	12%	23%	9%	0%	0%	0%	0%	0%	0%	
	SILT			SAND			GRAVEL			
56%	44%			0%			0%			0%

Test Sieve (mm)	Percent Passing (%)
125.0	100
75.0	100
63.0	100
37.5	100
20.0	100
10.0	100
6.30	100
3.35	100
2.00	100
1.18	100
0.630	100
0.425	100
0.200	100
0.150	100
0.063	100

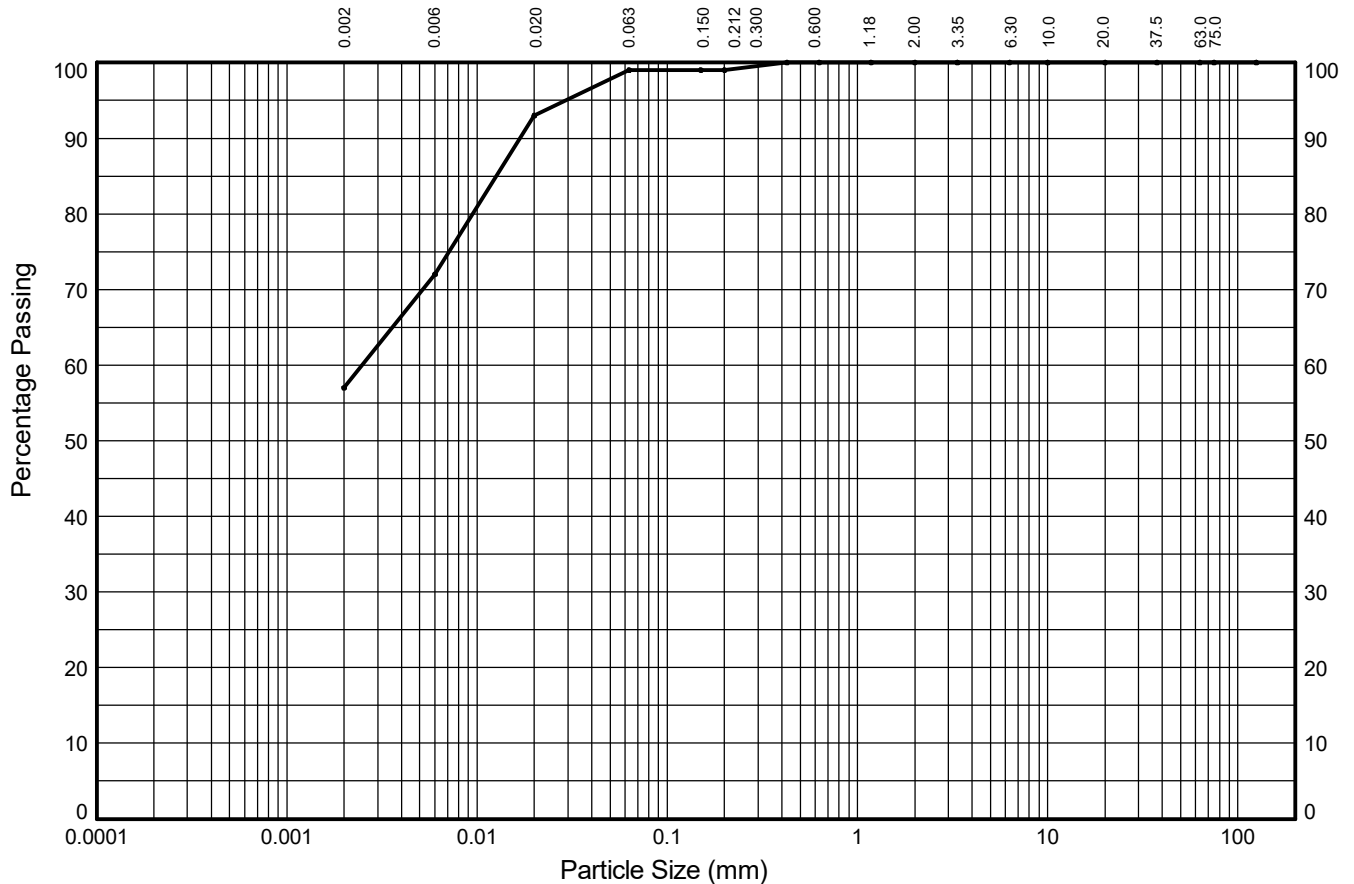
Depth (m): **0.50**

CLAY	fine	medium	coarse	fine	medium	coarse	fine	medium	coarse	COBBLES
	15%	21%	6%	0%	1%	0%	0%	0%	0%	
	SILT			SAND			GRAVEL			
57%	42%			1%			0%			0%

Test Sieve (mm)	Percent Passing (%)	Particle Diameter (mm)	Percent Passing (%)	Coefficients	
125.0	100	0.02	93	D ₁₀ (mm)	NA
75.0	100			D ₁₅ (mm)	NA
63.0	100			D ₃₀ (mm)	NA
37.5	100	0.006	72	D ₅₀ (mm)	NA
20.0	100			D ₆₀ (mm)	0.002
10.0	100			D ₈₅ (mm)	0.013
6.30	100	0.002	57	D ₉₀ (mm)	0.017
3.35	100			C _U	NA
2.00	100			C _C	NA
1.18	100	Sedimentation sample was not pre-treated			
0.630	100				
0.425	100				
0.200	99				
0.150	99				
0.063	99	Soil Description: Light brown mottled orangish brown and white slightly sandy silty CLAY
