Sea Link

Generic Quantitative Risk Assessment – Kent Part 1 of 2

Sea Link FEED

Generic Quantitative Risk Assessment
Richborough

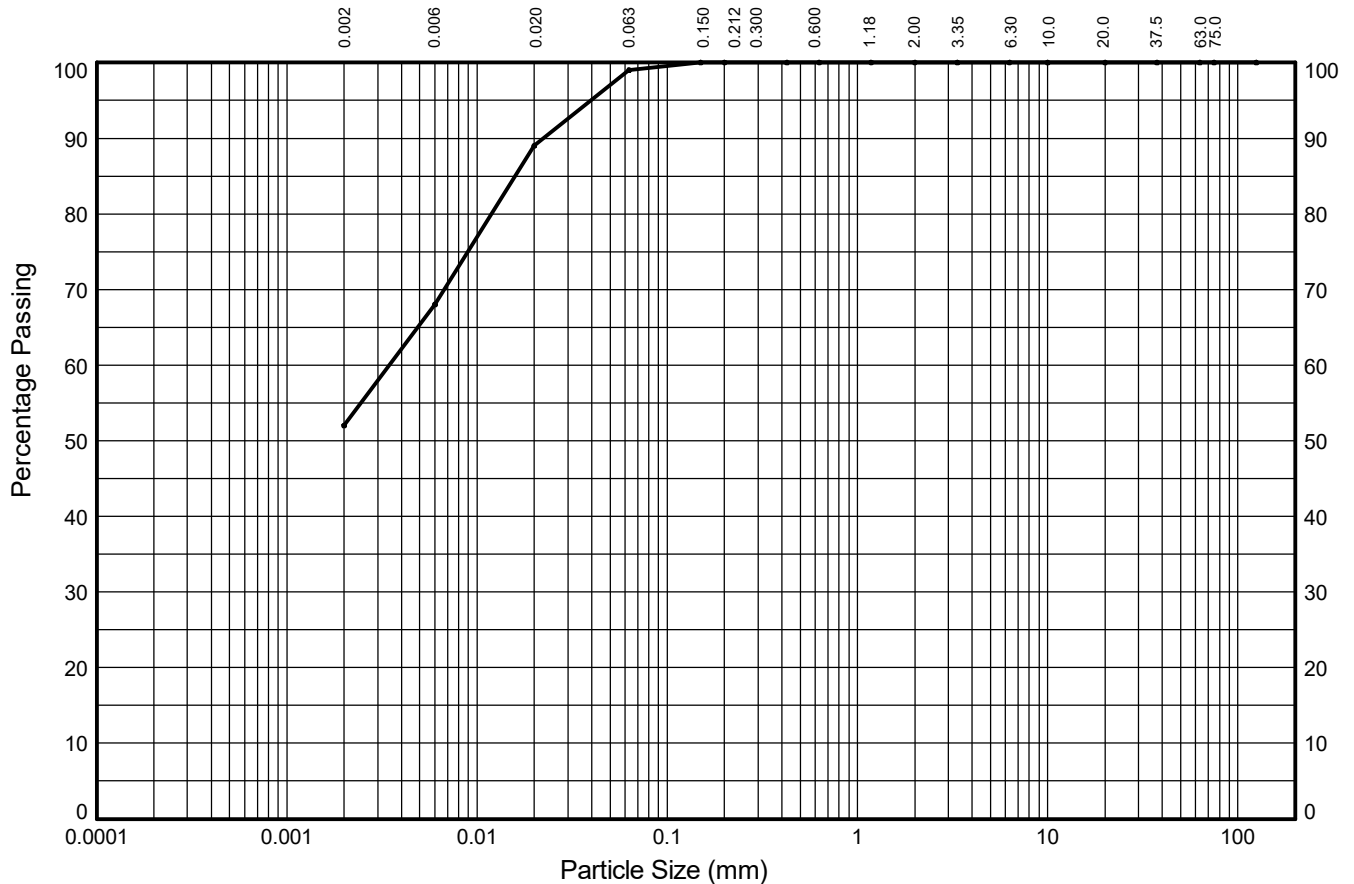
Depth (m): **1.00**

CLAY	fine	medium	coarse	fine	medium	coarse	fine	medium	coarse	COBBLES
	16%	21%	10%	1%	0%	0%	0%	0%	0%	
	SILT			SAND			GRAVEL			
52%	47%			1%			0%			0%

Test Sieve (mm)	Percent Passing (%)	Particle Diameter (mm)	Percent Passing (%)	Coefficients	
125.0	100	0.02	89	D ₁₀ (mm)	NA
75.0	100			D ₁₅ (mm)	NA
63.0	100			D ₃₀ (mm)	NA
37.5	100	0.006	68	D ₅₀ (mm)	NA
20.0	100			D ₆₀ (mm)	0.003
10.0	100			D ₈₅ (mm)	0.016
6.30	100	0.002	52	D ₉₀ (mm)	0.022
3.35	100			C _U	NA
2.00	100			C _C	NA
1.18	100	Sedimentation sample was not pre-treated			
0.630	100				
0.425	100				
0.200	100				
0.150	100				
0.063	99	Soil Description: Light brown mottled grey slightly sandy silty CLAY

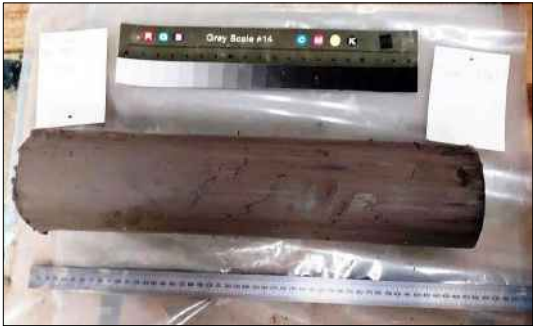
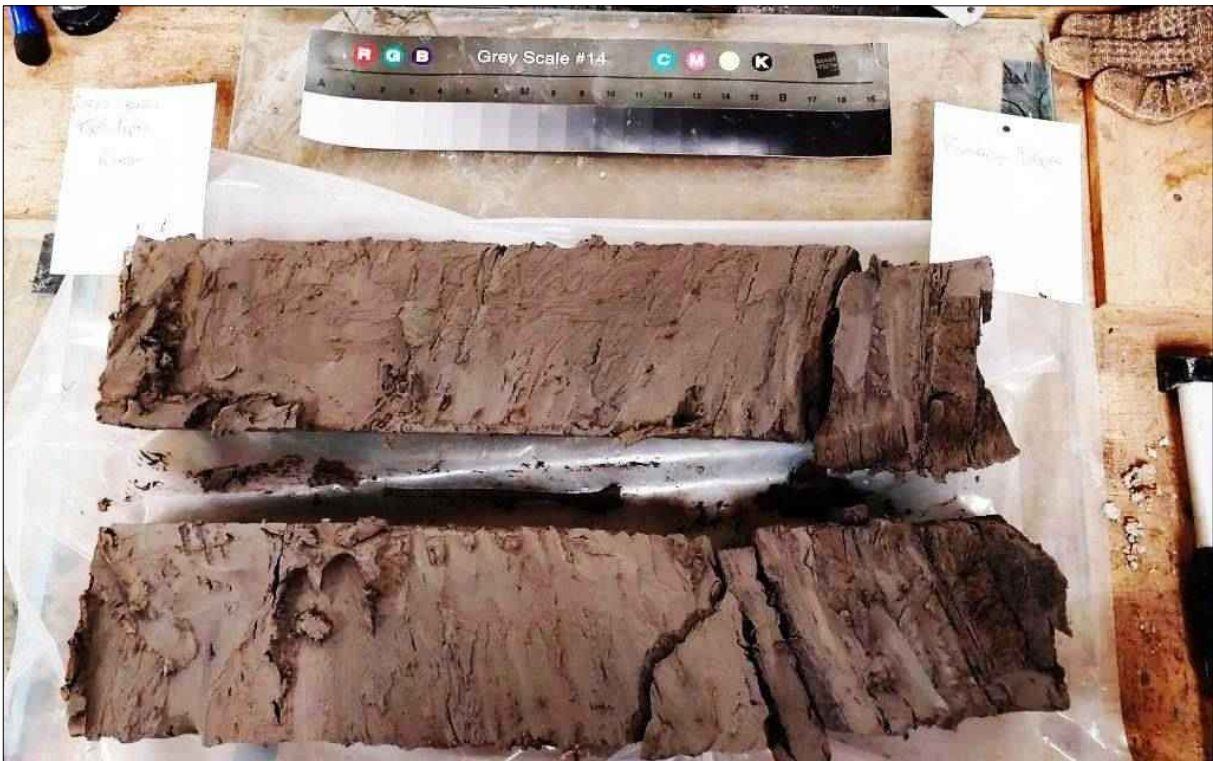
Contract: SEA Link FEED - Kent Onshore Cable Link		Client: National Grid	Exploratory Position: R22-BH102
Contract Ref: 563607	Sample Details: Depth (m): 6.00 - Base (m): 6.45 - Ref: 24 - Type: UT		Sheet: 1 of 1

Very soft to soft dark brown mottled grey and greyish brown slightly sandy CLAY with occasional peat pockets. Sand is fine to medium.

Logged By:	MBattle
Undisturbed Type:	U-UT100
Blows:	6
Recovery:	100%
Sampled:	05/10/2023
Sampled By:	FPrice

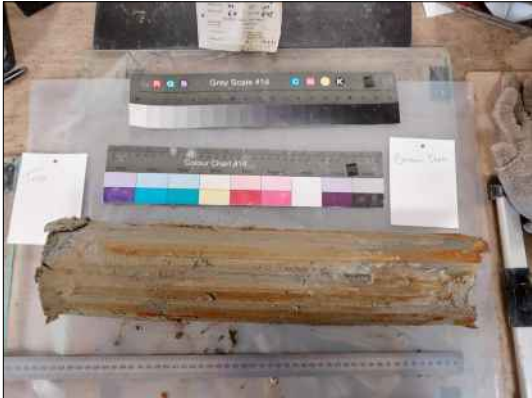
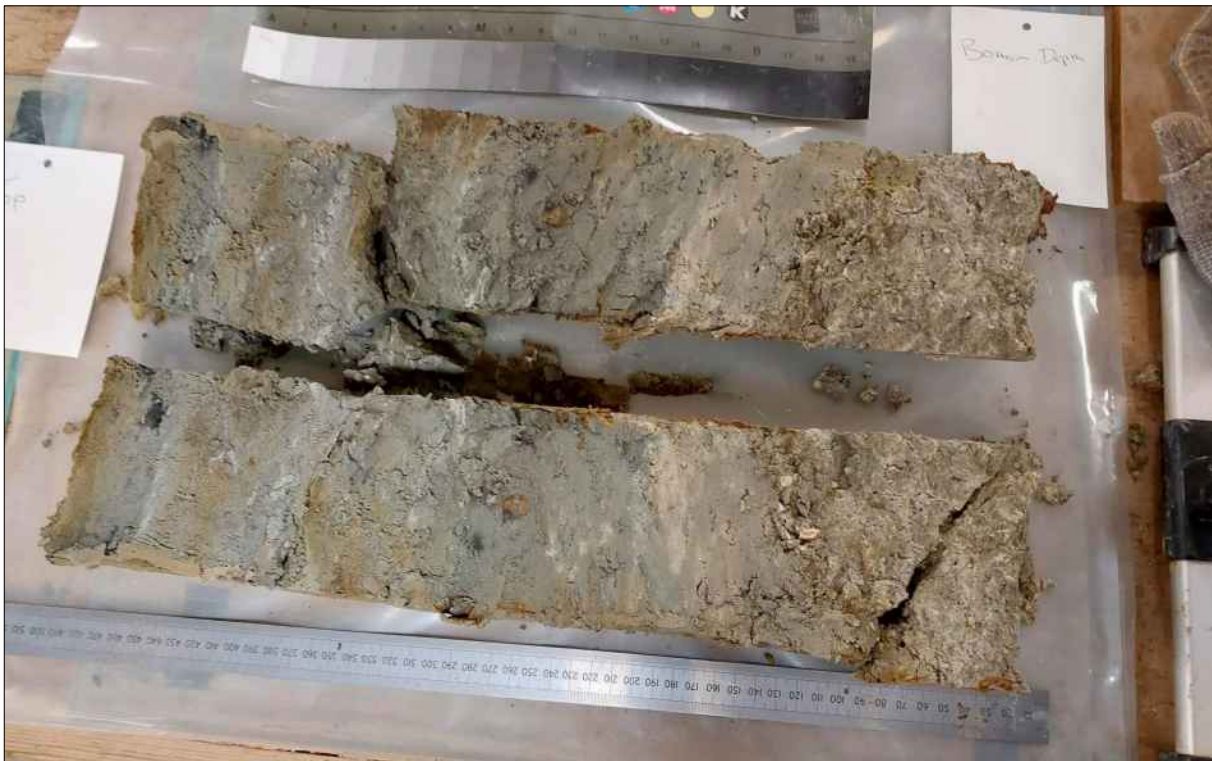
Contract: SEA Link FEED - Kent Onshore Cable Link		Client: National Grid	Exploratory Position: R22-BH103
Contract Ref: 563607	Sample Details: Depth (m): 6.00 - Base (m): 6.45 - Ref: 21 - Type: UT		Sheet: 1 of 1

6.00 - 6.27m: Soft to firm brown mottled light grey and dark grey very sandy CLAY. Sand is fine to medium. Organic putrid odour present.

6.27 - 6.45m: Very soft to soft light grey mottled cream and brown sandy silty CLAY with occasional shell fragments. Sand is fine to coarse. Organic putrid odour present.

Logged By: MBattle
Undisturbed Type: U-UT100
Blows: 30
Recovery: 100%
Sampled: 19/10/2023

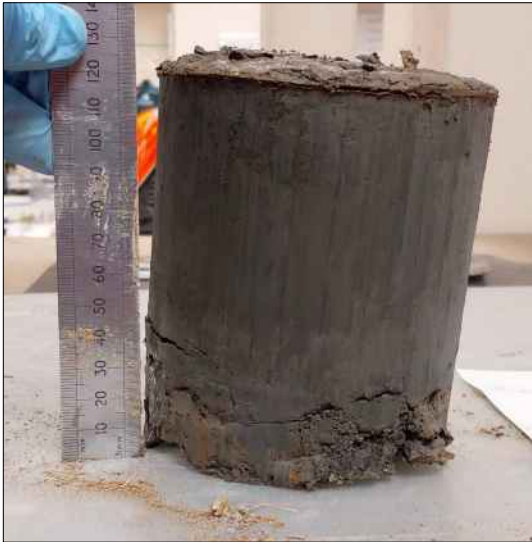
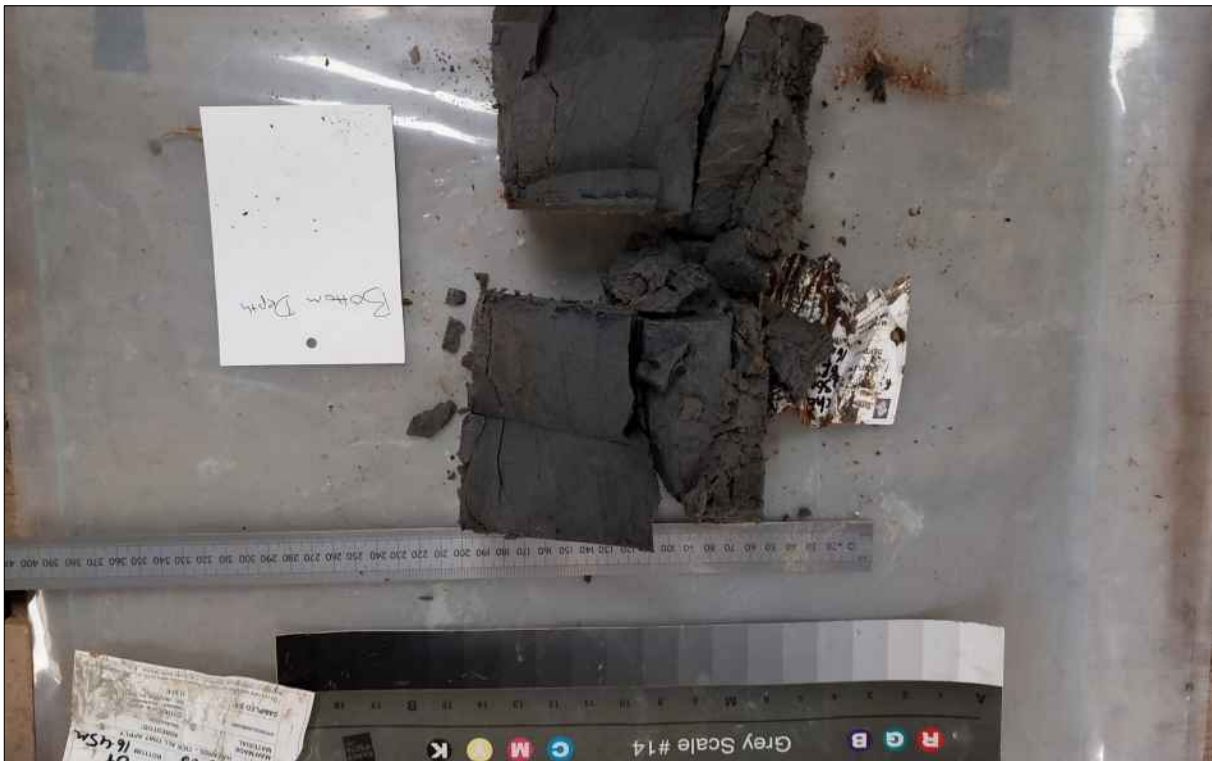
Contract: SEA Link FEED - Kent Onshore Cable Link		Client: National Grid	Exploratory Position: R22-BH204
Contract Ref: 563607	Sample Details: Depth (m): 16.00 - Base (m): 16.45 - Ref: 61 - Type: UT		Sheet: 1 of 1

16.00 - 16.13m: Stiff to very stiff dark grey slightly sandy slightly gravelly CLAY. Gravel is coarse of CLAYSTONE.

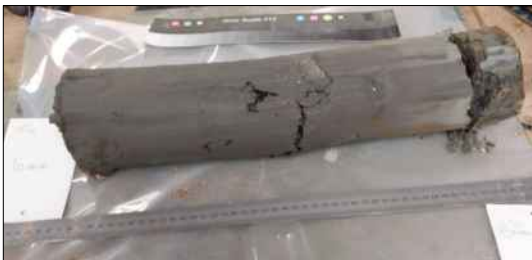
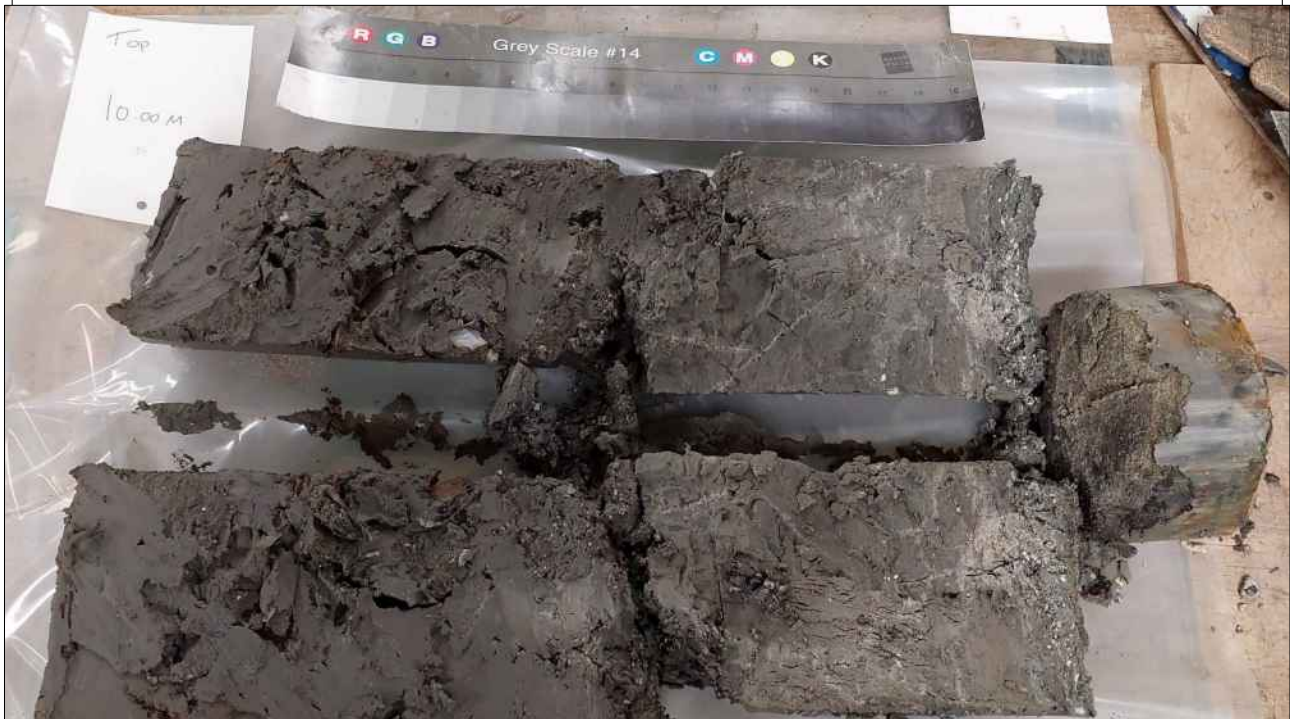
Contract: SEA Link FEED - Kent Onshore Cable Link		Client: National Grid	Exploratory Position: R22-BH502
Contract Ref: 563607	Sample Details: Depth (m): 10.00 - Base (m): 10.45 - Ref: 38 - Type: UT		Sheet: 1 of 1

10.00 - 10.20m: Soft dark grey slightly gravelly sandy silty CLAY with occasional pockets of peat and occasional seashell fragments. Gravel is fine to medium. Sand is fine to coarse. Organic odour present.

10.20 - 10.45m Firm grey mottled brown, light grey and black sandy clayey SILT with occasional pockets of peat and occasional seashell fragments. Organic odour present.

Logged By:	MBattle
Undisturbed Type:	U-UT100
Blows:	20
Recovery:	100%
Sampled:	18/10/2023

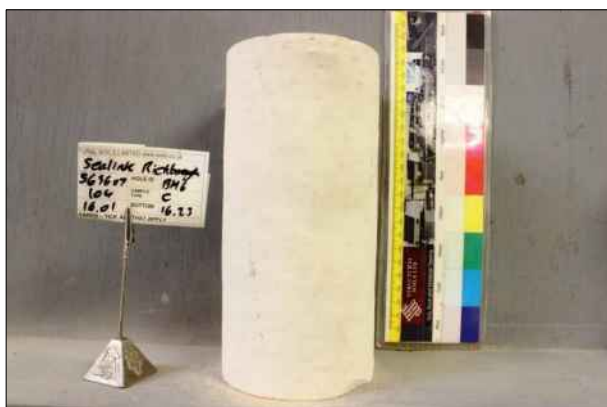
Front view (pre-test)

Sample tolerance checks: Straightness: **FAIL**. Flatness: **FAIL**. Perpendicularity: **FAIL**.

Machine Used: **Impact 2000kN**

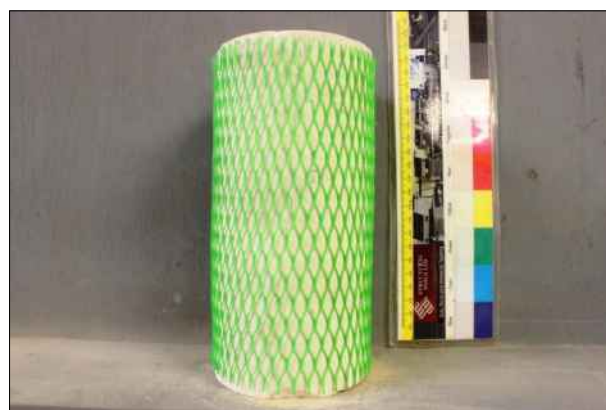
Failure Type: **Vertical splitting**

Rear view (post-test)

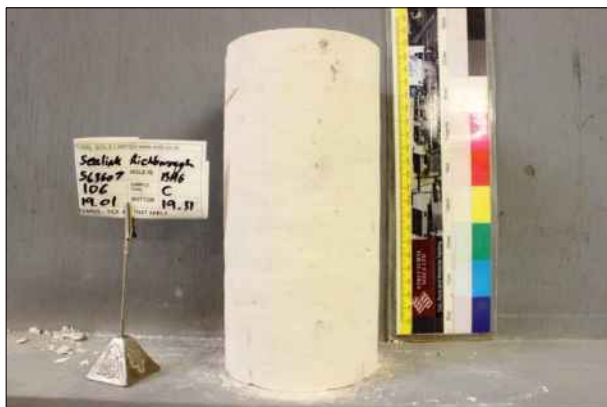
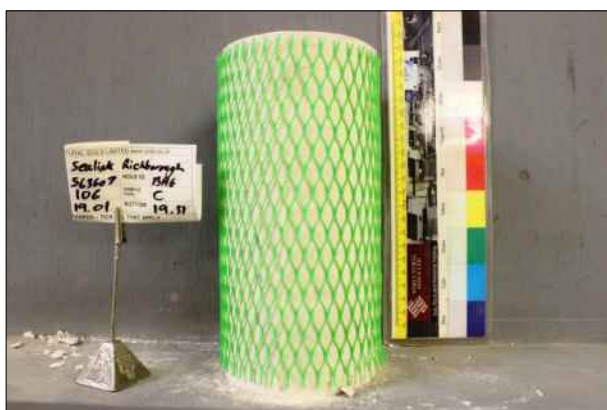
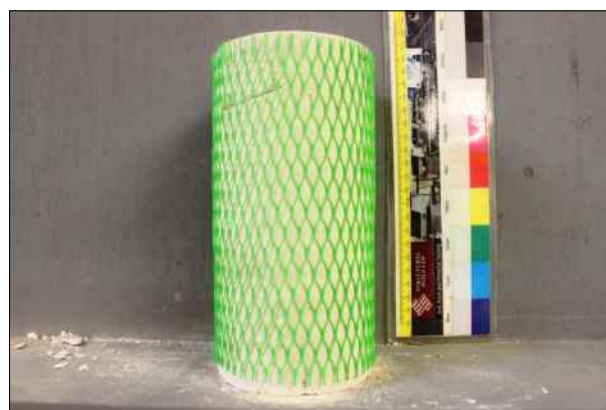
Load at Failure (kN): **19.4**

Failure Type: **Vertical splitting**

Front view (pre-test)

Front view (post-test)

Rear view (post-test)

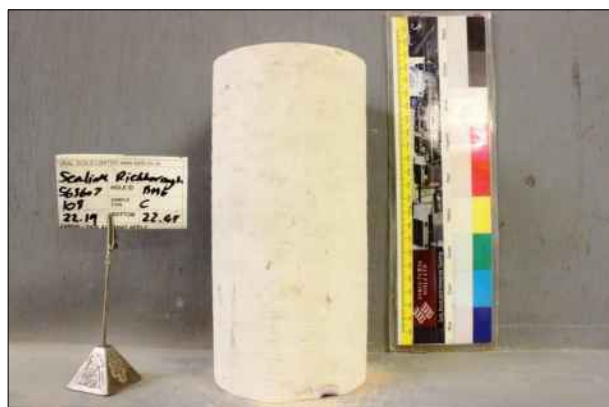
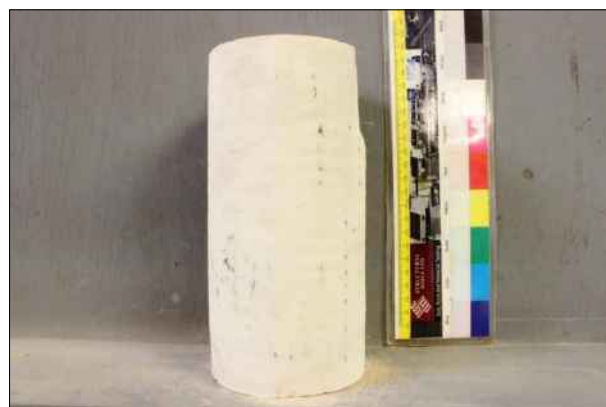
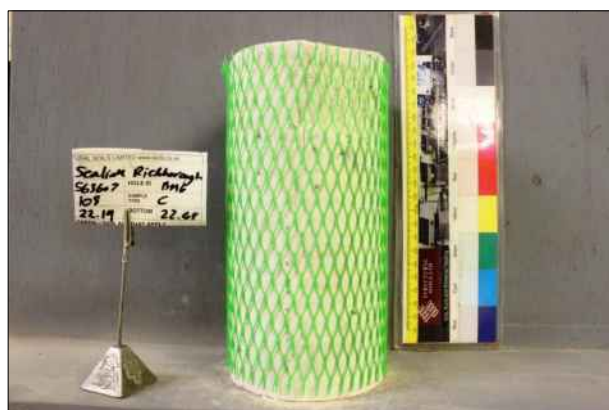
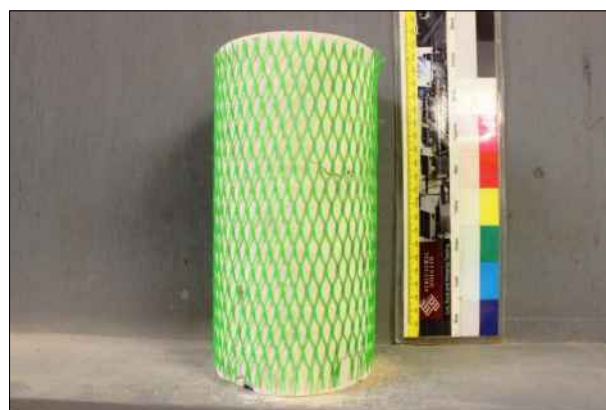
Load at Failure (kN): **29.9**

Failure Type: **Vertical splitting**

Front view (pre-test)

Rear view (pre-test)

Front view (post-test)

Rear view (post-test)

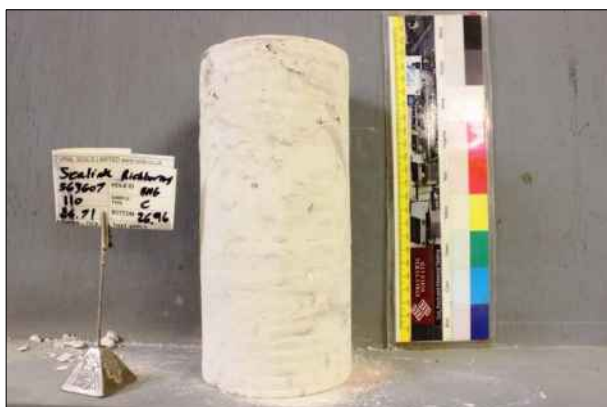
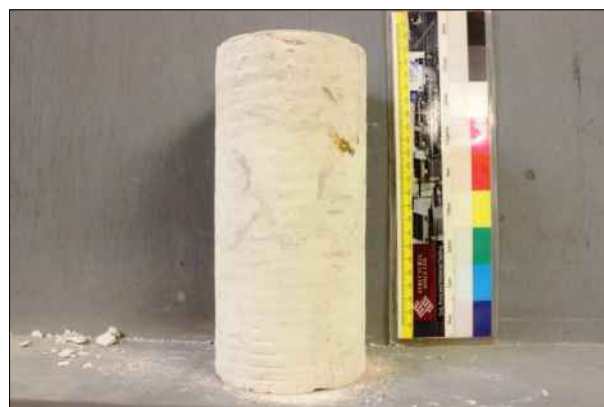
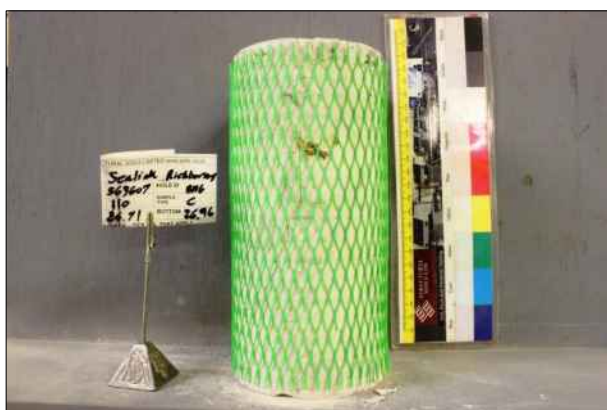
Load at Failure (kN): **24.3**

Failure Type: **Vertical splitting**

Front view (pre-test)

Rear view (pre-test)

Front view (post-test)

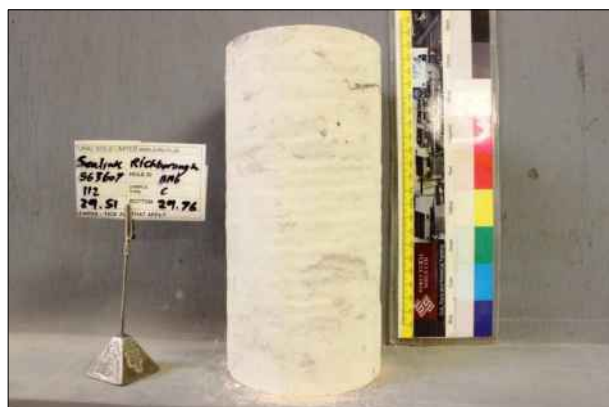
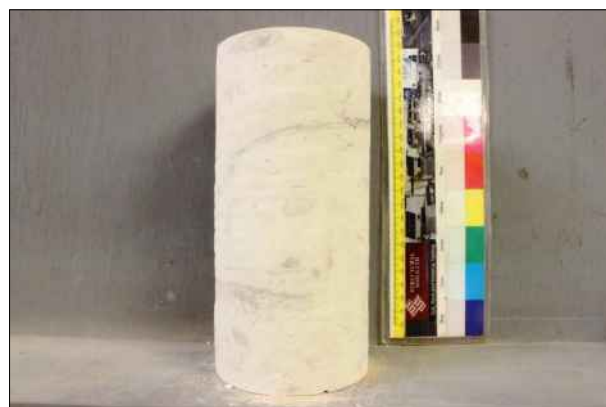
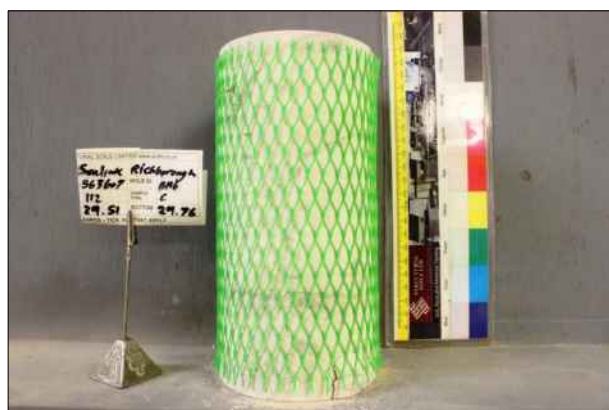
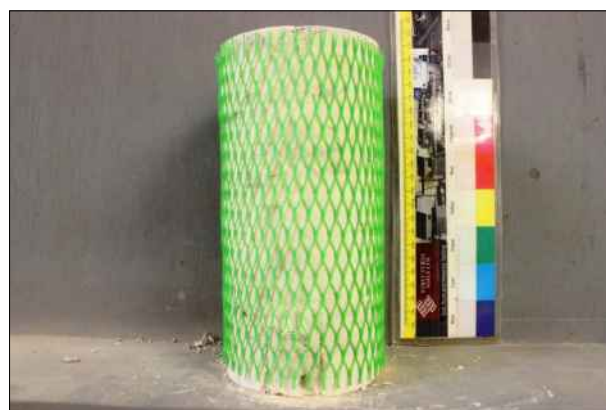
Load at Failure (kN): **31.1**

Failure Type: **Vertical splitting**

Front view (pre-test)

Rear view (pre-test)

Front view (post-test)

Rear view (post-test)

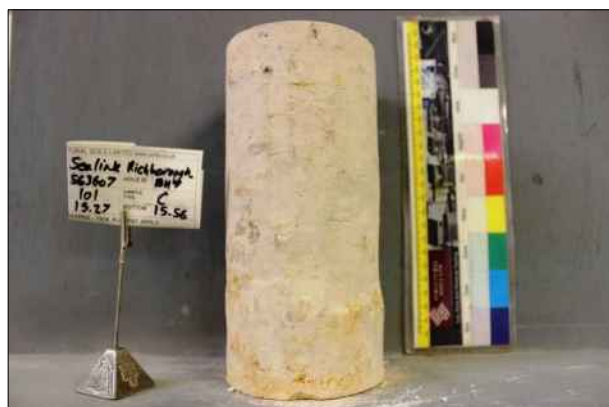
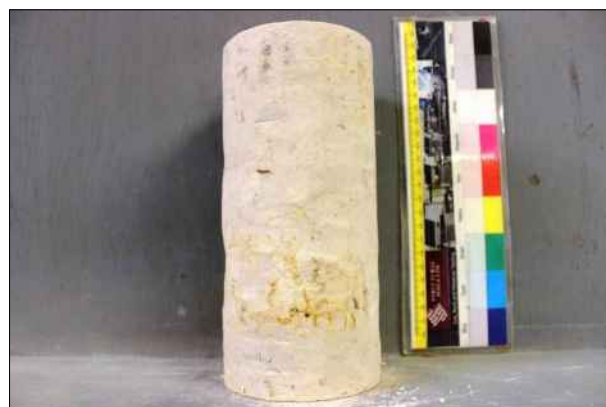
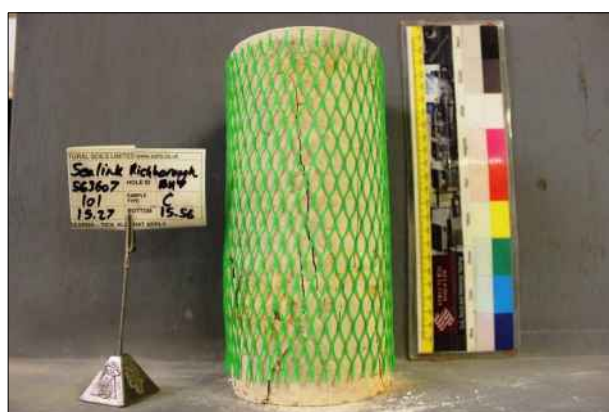
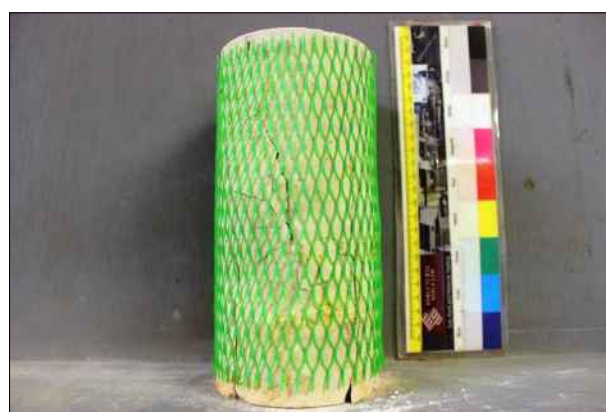
Load at Failure (kN): **14.2**

Failure Type: **Vertical splitting**

Front view (pre-test)

Rear view (pre-test)

Front view (post-test)

Rear view (post-test)

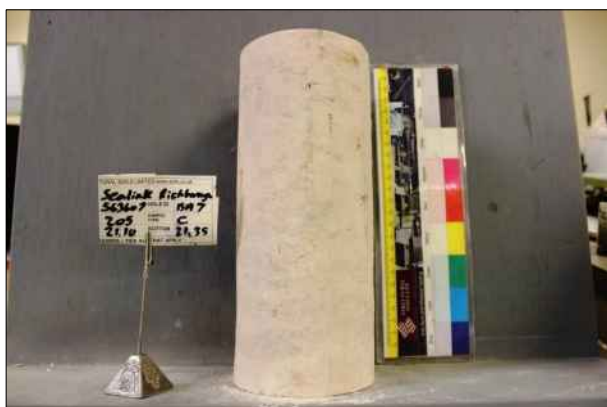
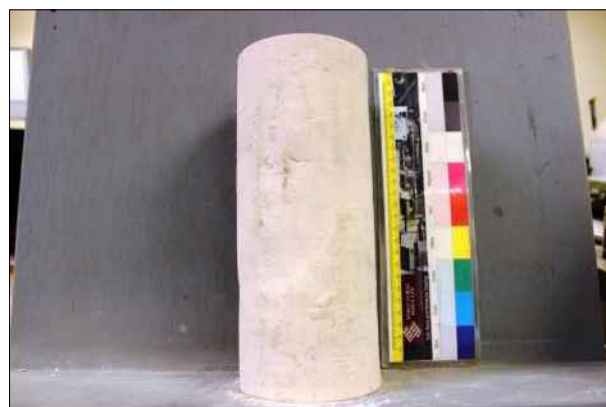
Load at Failure (kN): **25.0**

Failure Type: **Vertical splitting**

Front view (pre-test)

Rear view (pre-test)

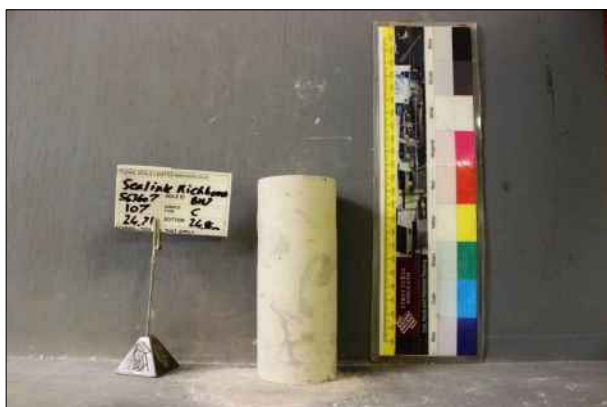
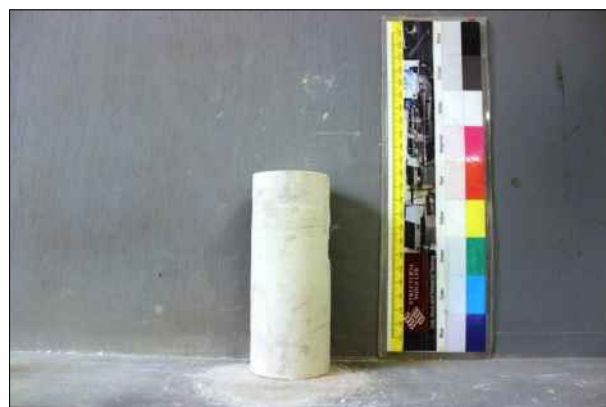
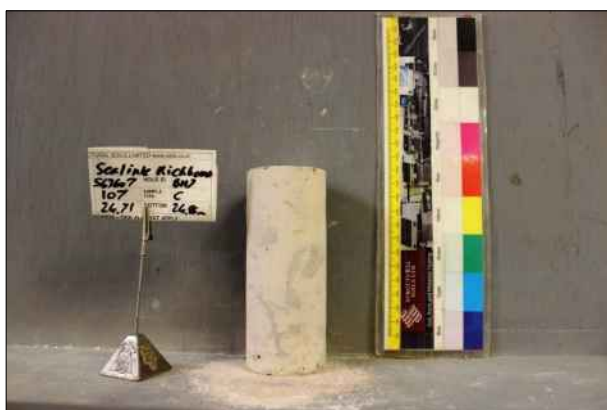
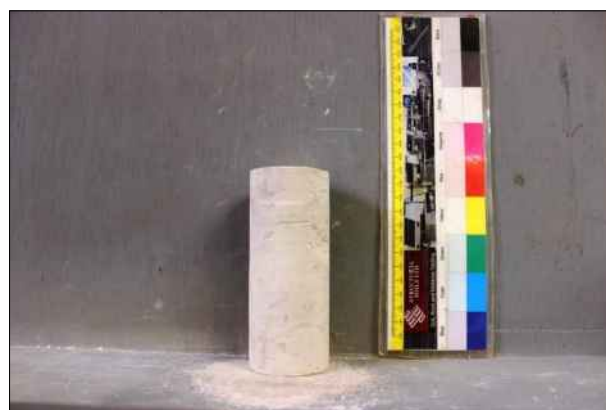
Load at Failure (kN): **7.1**

Failure Type: **Vertical splitting**

Front view (pre-test)

Rear view (pre-test)

Front view (post-test)

Rear view (post-test)

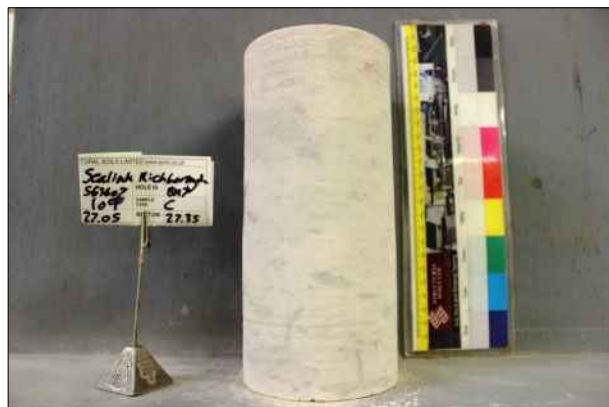
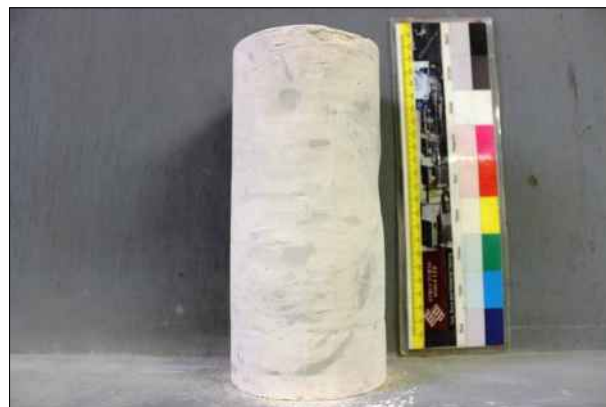
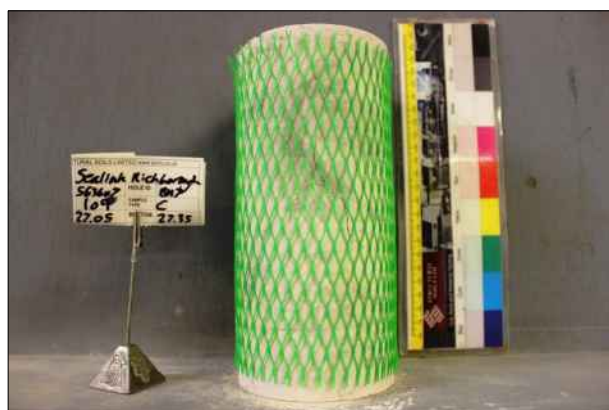
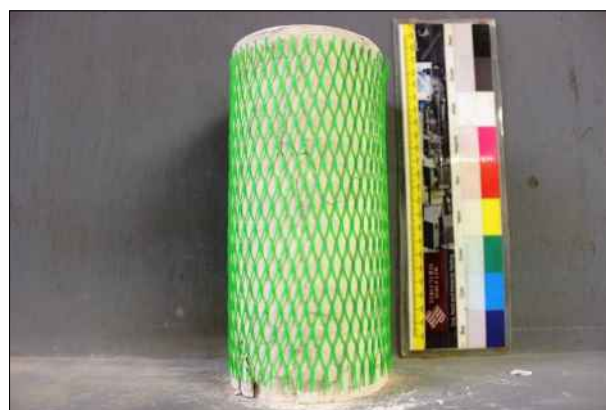
Load at Failure (kN): **20.9**

Failure Type: **Vertical splitting**

Front view (pre-test)

Rear view (pre-test)

Front view (post-test)

Rear view (post-test)

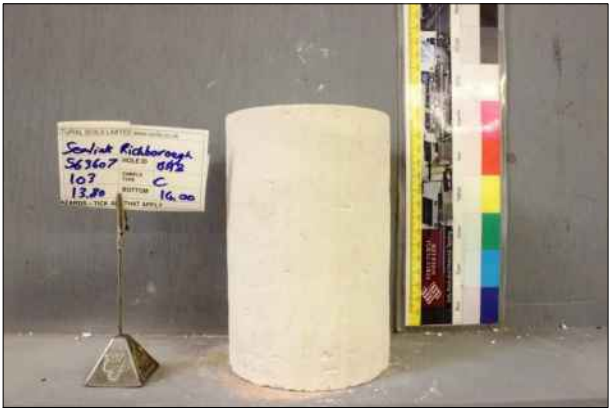
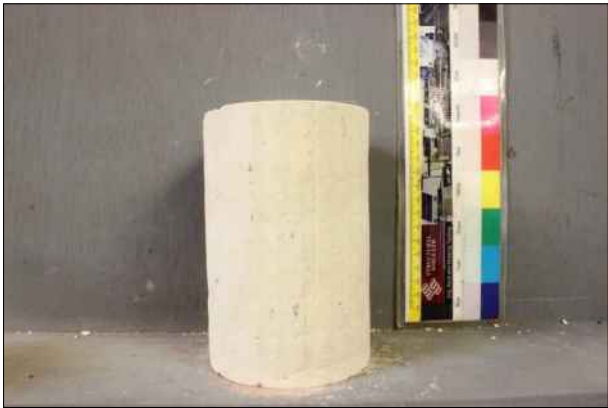
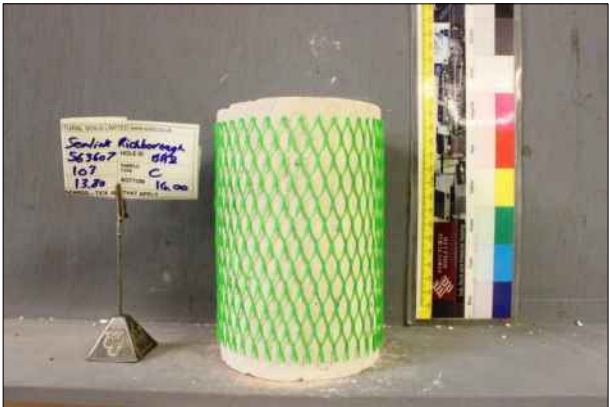
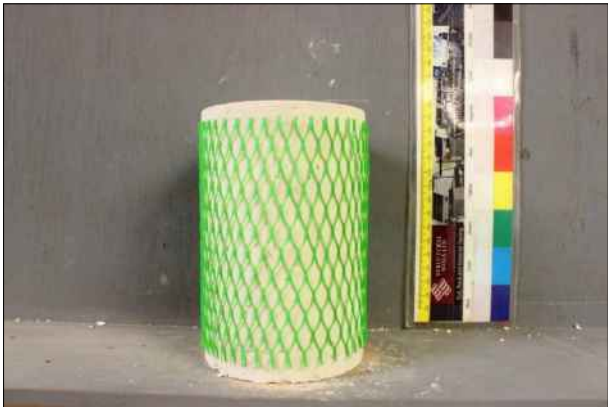
Bulk Density (Mg/m³): **1.93** Dry Density (Mg/m³): **1.48** Moisture Content (%): **30**
Length (mm): **151.75** Diameter (mm): **100.37** Length/Diameter Ratio: **1.51**
Test Duration (mins:secs): **08:24** Stress Rate (MPa/s): **0.0063** Load at Failure (kN): **25.8**
UCS (MPa): **3.3** Failure Type: **Vertical splitting**

Note: **Axis of loading parallel to core axis**
Description: **White CHALK**
Specimen Preparation: **Specimen was not recored.**
Sample tolerance checks: Straightness: **FAIL**. Flatness: **FAIL**. Perpendicularity: **FAIL**.
Machine Used: **Impact 2000kN**

Front view (pre-test)

Rear view (pre-test)

Front view (post-test)

Rear view (post-test)

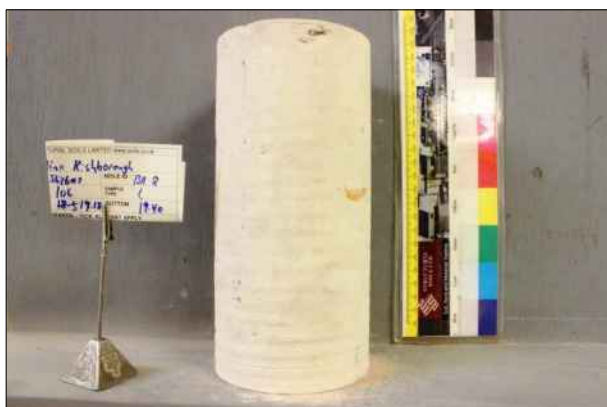
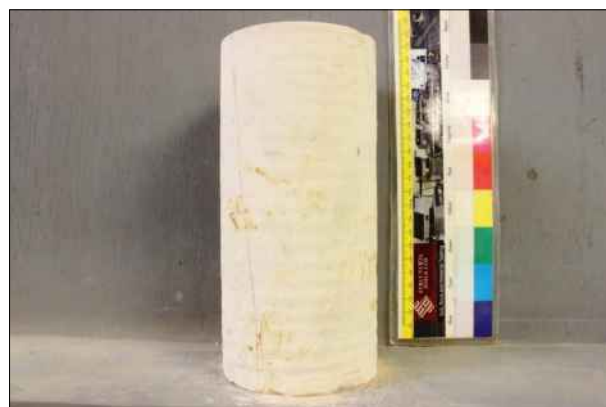
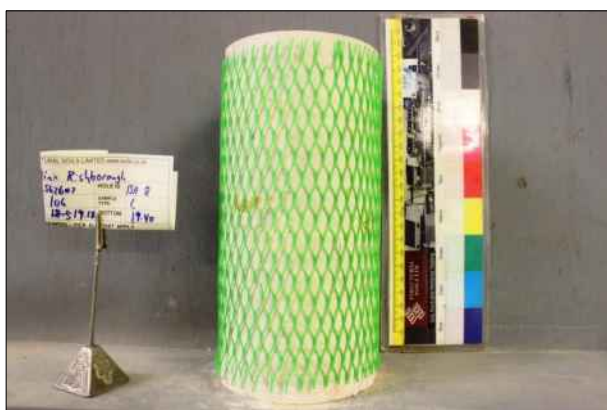
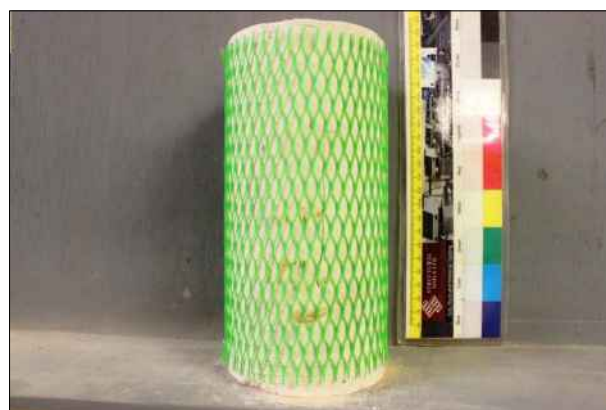
Load at Failure (kN): **29.2**

Failure Type: **Vertical splitting**

Front view (pre-test)

Rear view (pre-test)

Front view (post-test)

Rear view (post-test)

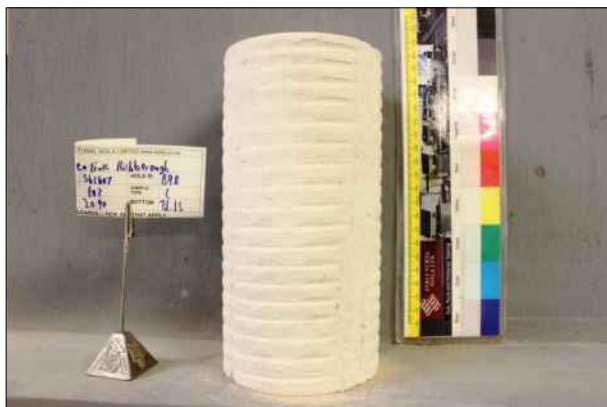
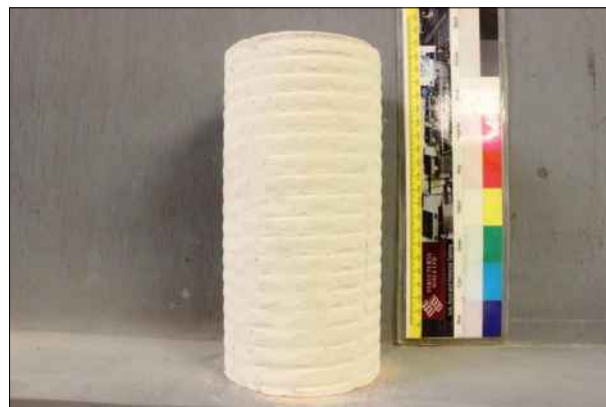
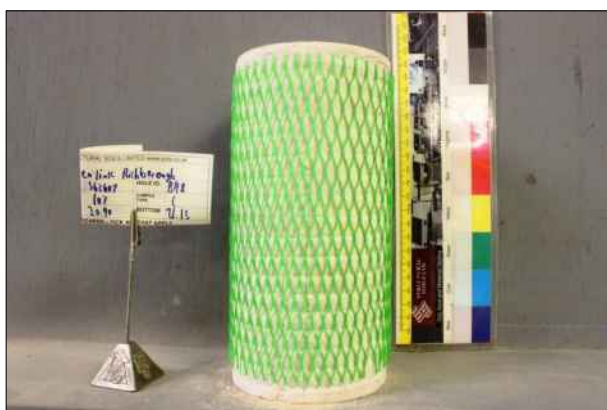
Load at Failure (kN): **32.1**

Failure Type: **Vertical splitting**

Front view (pre-test)

Rear view (pre-test)

Front view (post-test)

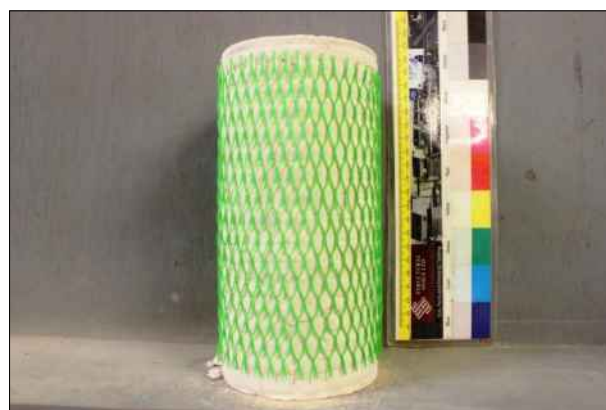
Rear view (post-test)

Failure Type: **Vertical splitting**

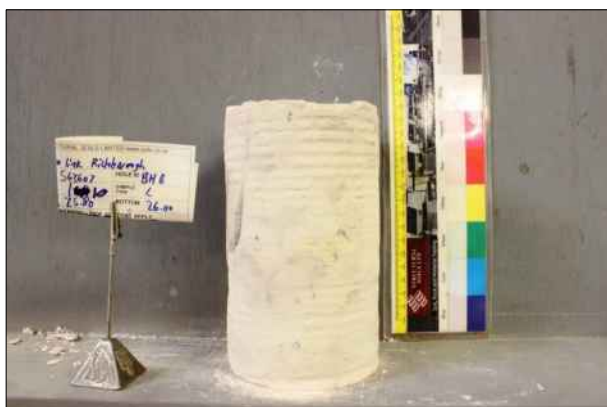
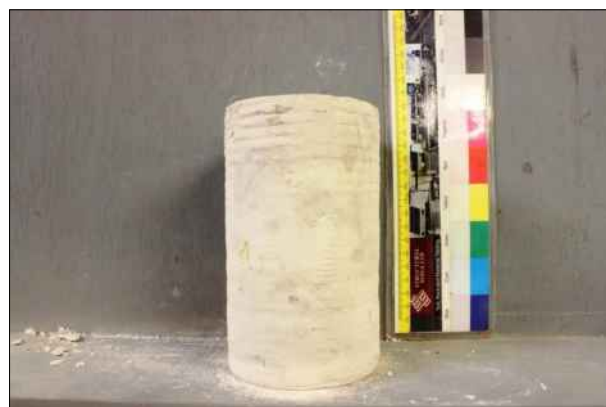
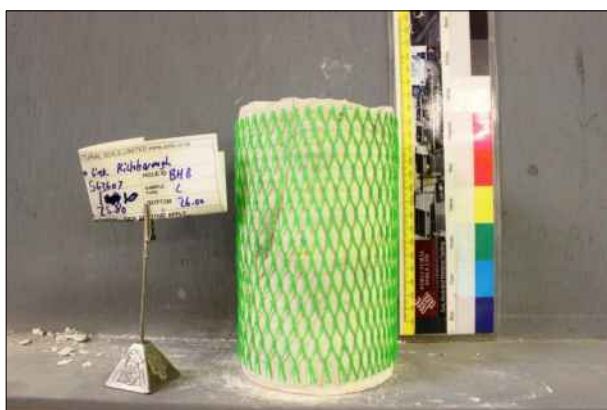
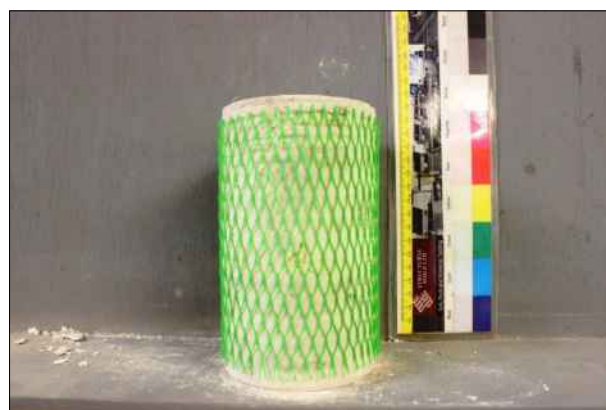
Front view (pre-test)

Failure Type: **Vertical splitting**

Sample tolerance checks: Straightness: **FAIL**. Flatness: **FAIL**. Perpendicularity: **FAIL**.

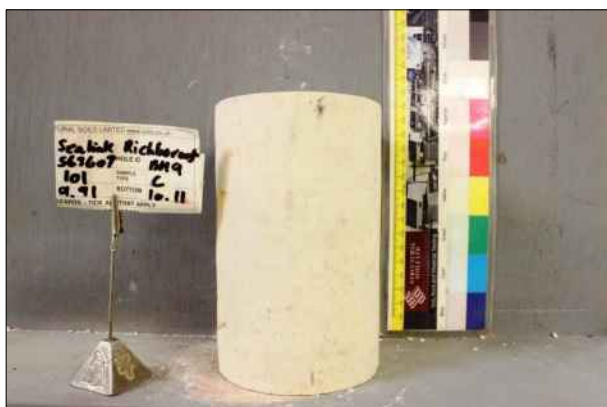
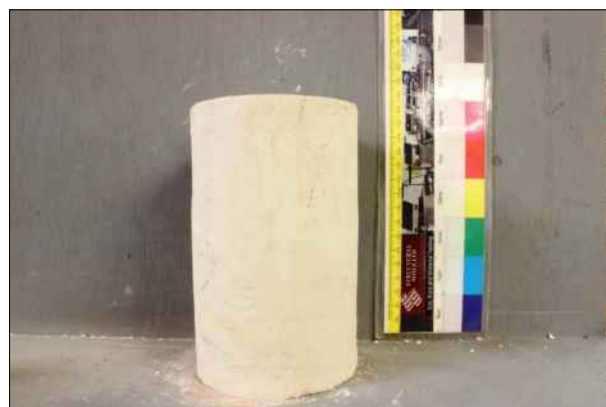
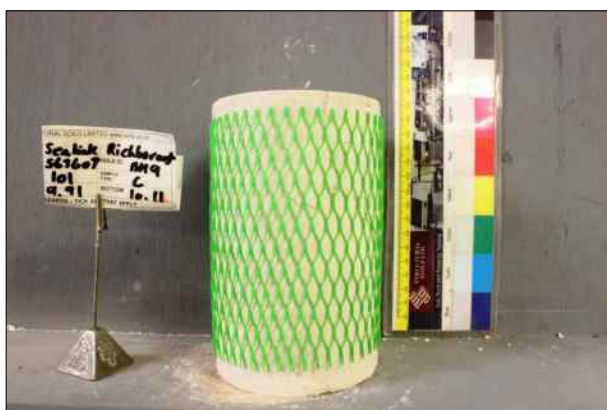
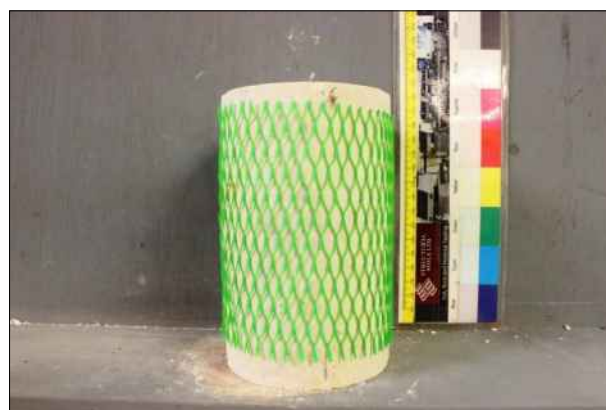
Front view (pre-test)

Failure Type: **Vertical splitting**

Sample tolerance checks: Straightness: **FAIL**. Flatness: **FAIL**. Perpendicularity: **FAIL**.

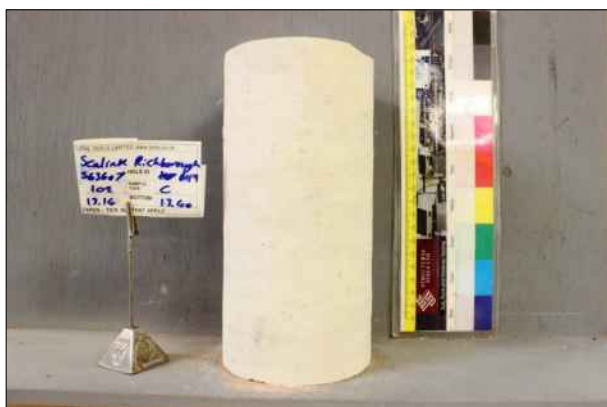
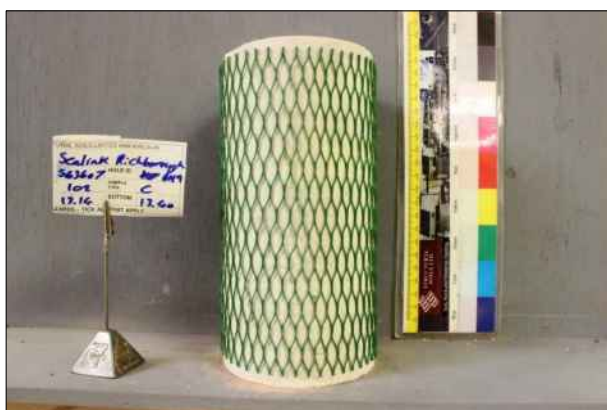
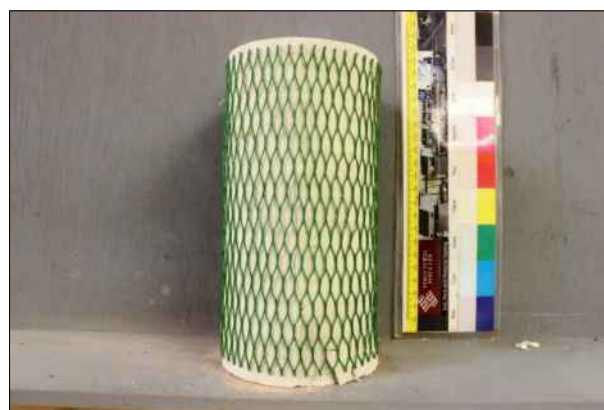
Front view (pre-test)

Failure Type: **Vertical splitting**

Sample tolerance checks: Straightness: **FAIL**. Flatness: **FAIL**. Perpendicularity: **FAIL**.

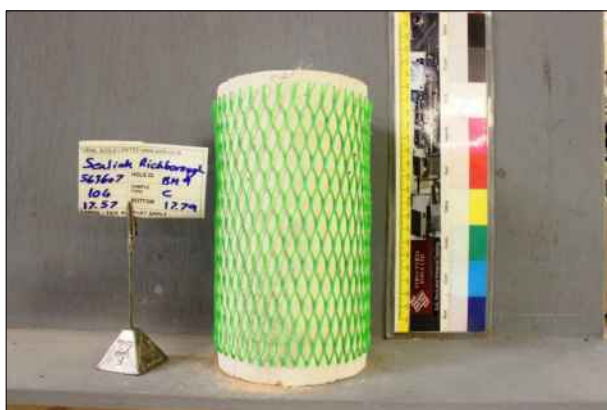
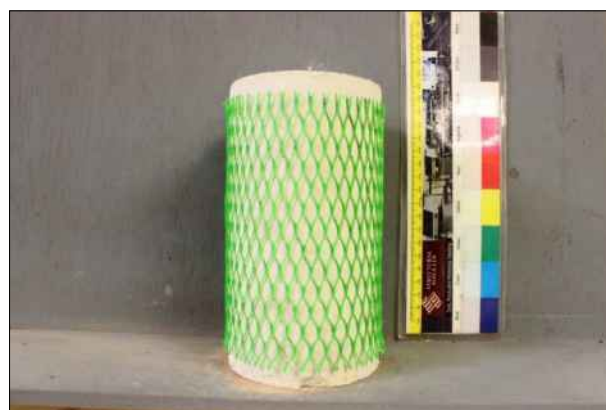
Front view (post-test)

Failure Type: **Vertical splitting**

Sample tolerance checks: Straightness: **FAIL**. Flatness: **FAIL**. Perpendicularity: **FAIL**.

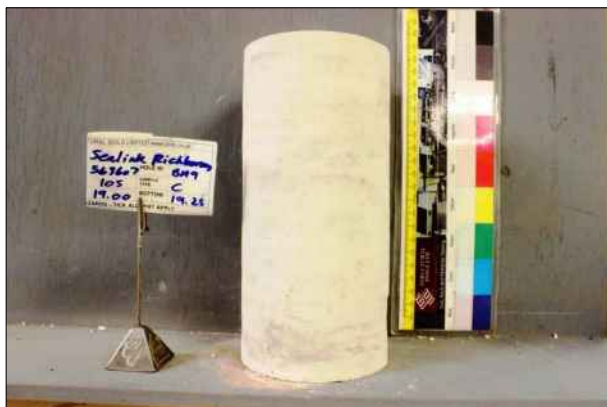
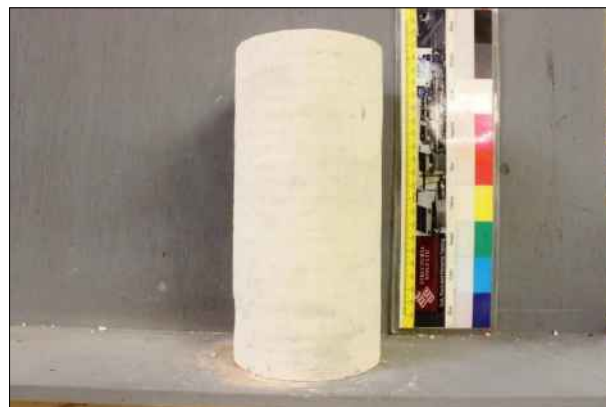
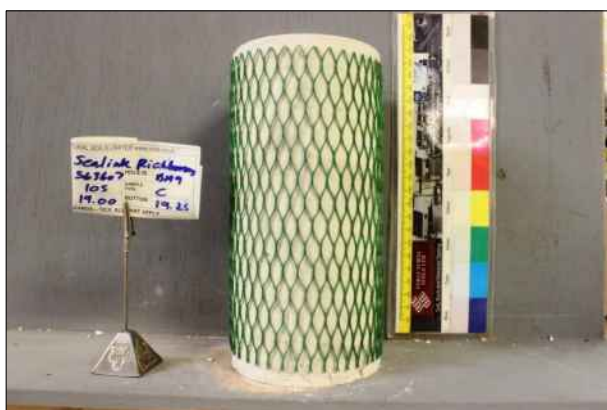
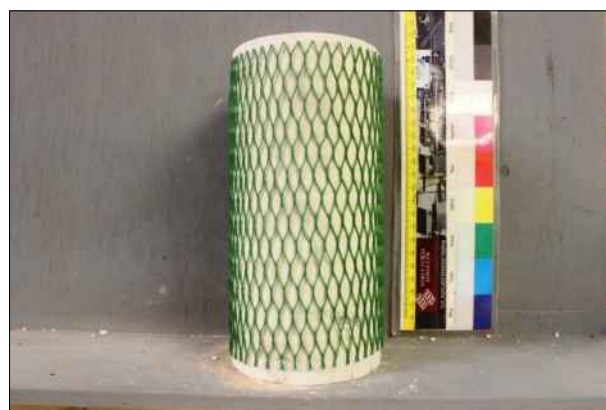
Front view (pre-test)

Failure Type: **Vertical splitting**

Sample tolerance checks: Straightness: **FAIL**. Flatness: **FAIL**. Perpendicularity: **FAIL**.

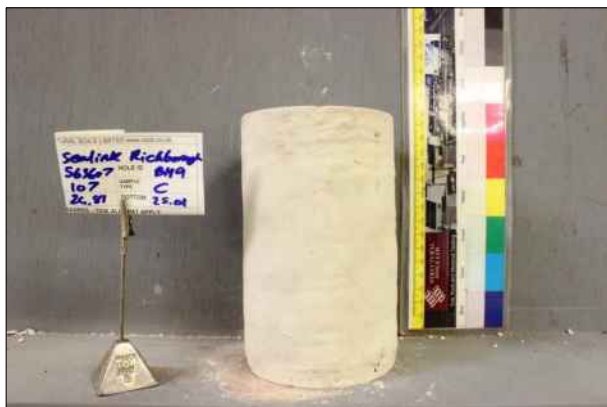
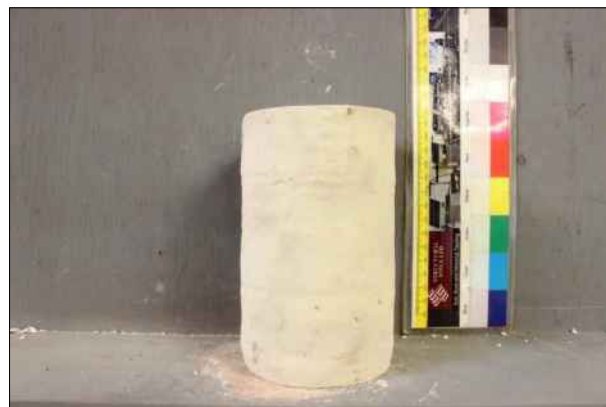
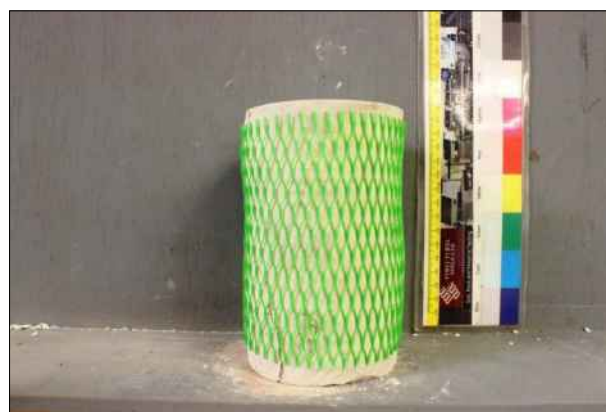
Front view (pre-test)

Failure Type: **Vertical splitting**

Sample tolerance checks: Straightness: **FAIL**. Flatness: **FAIL**. Perpendicularity: **FAIL**.
