Sea Link

Generic Quantitative Risk Assessment – Kent Part 1 of 2

Sea Link FEED

Generic Quantitative Risk Assessment
Richborough

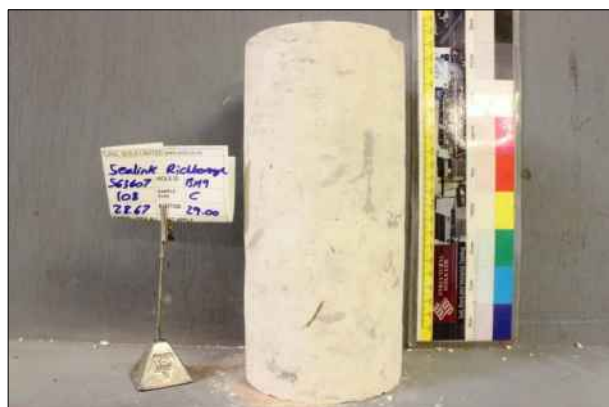
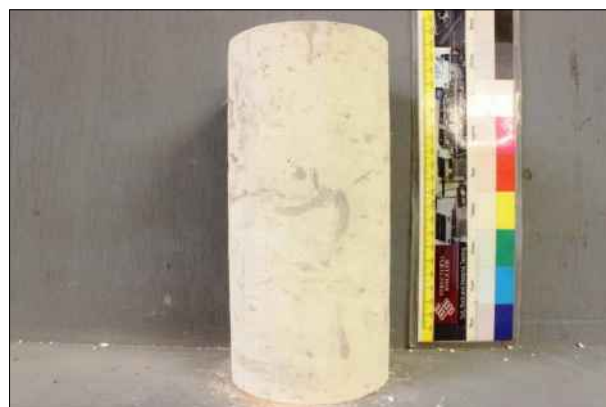
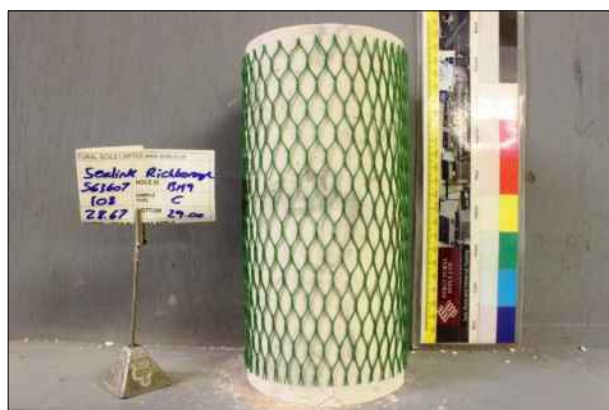
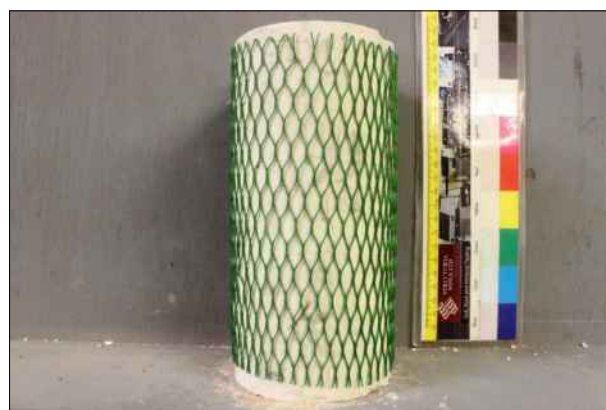
Front view (pre-test)

Failure Type: **Vertical splitting**

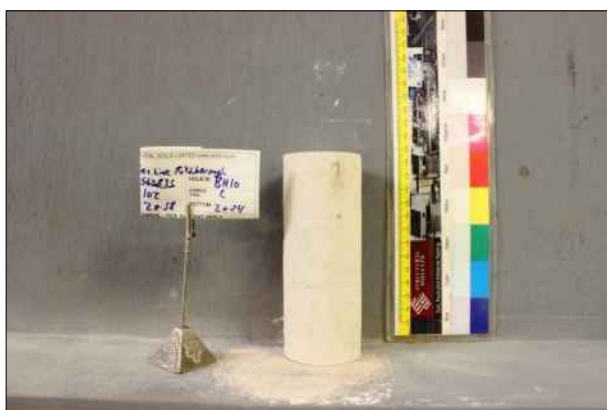
Front view (post-test)

Failure Type: **Vertical splitting**

Sample tolerance checks: Straightness: **FAIL**. Flatness: **FAIL**. Perpendicularity: **FAIL**.

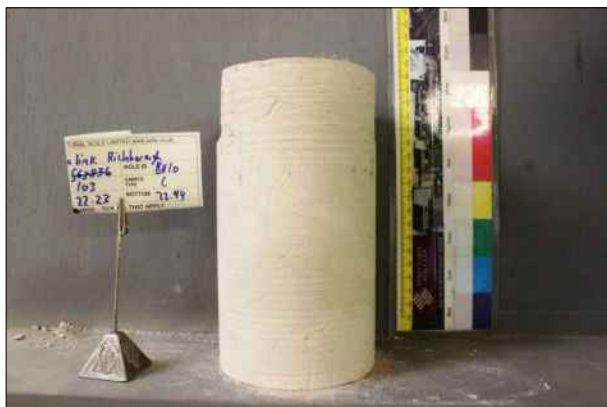
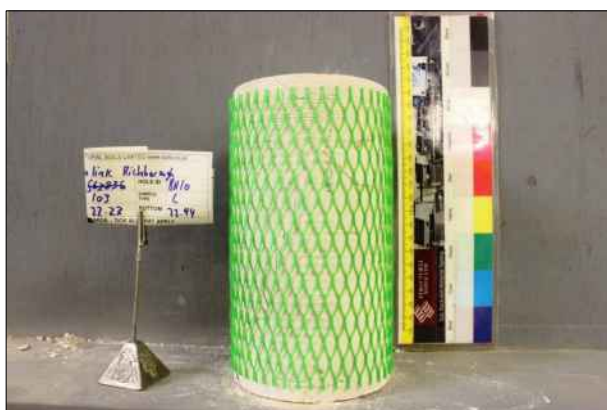
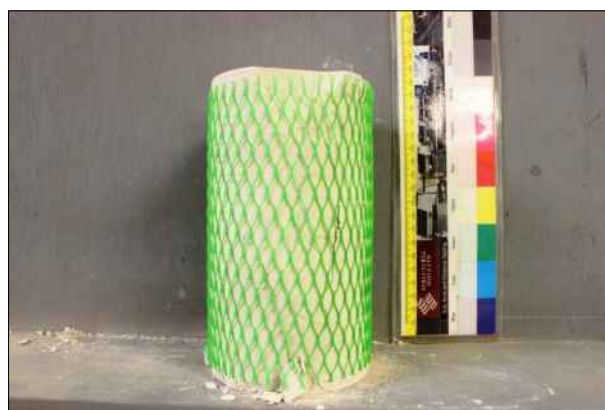
Front view (pre-test)

Failure Type: **Vertical splitting**

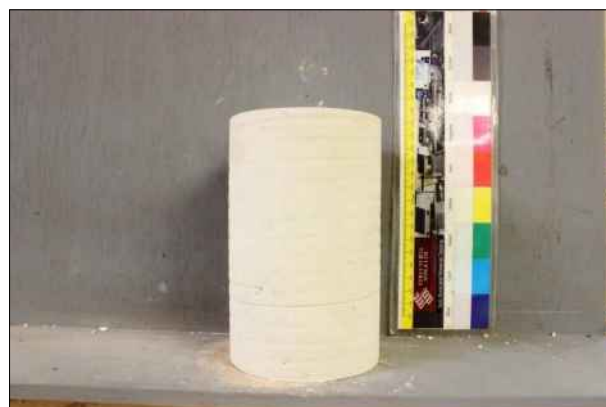
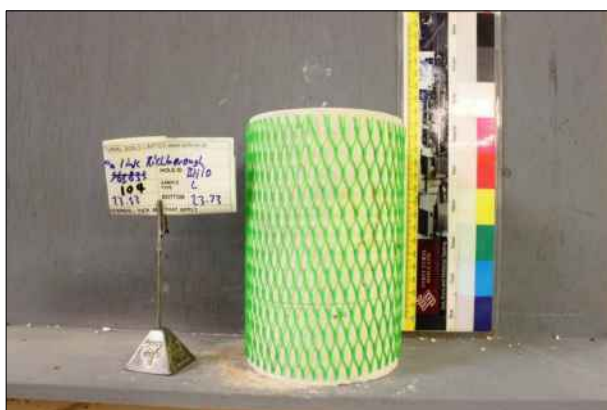
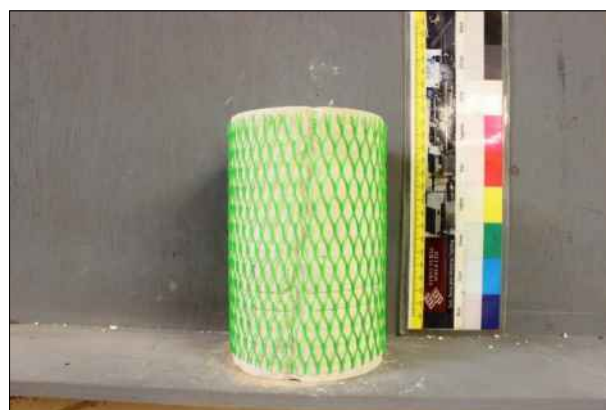
Rear view (pre-test)

Failure Type: **Vertical splitting**

Sample tolerance checks: Straightness: **FAIL**. Flatness: **FAIL**. Perpendicularity: **FAIL**.

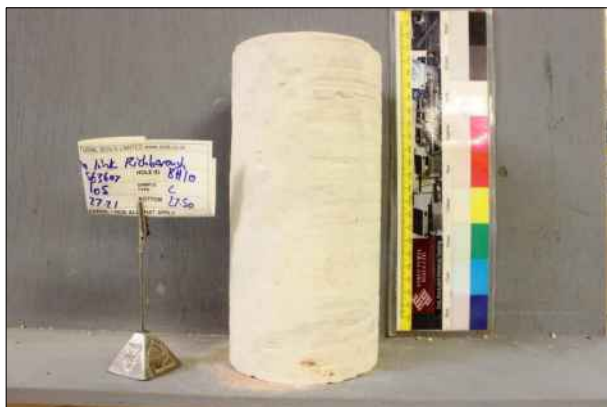
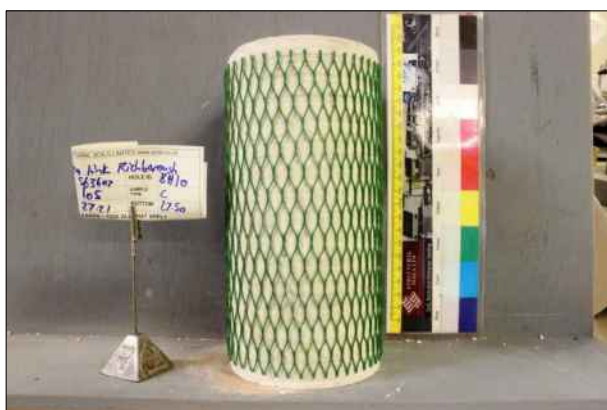
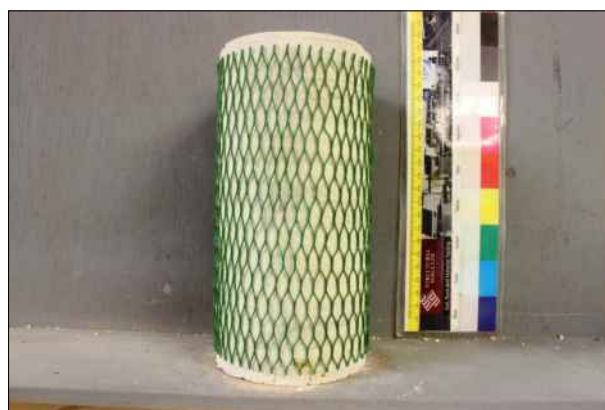
Front view (pre-test)

Failure Type: **Vertical splitting**

Sample tolerance checks: Straightness: **FAIL**. Flatness: **FAIL**. Perpendicularity: **FAIL**.

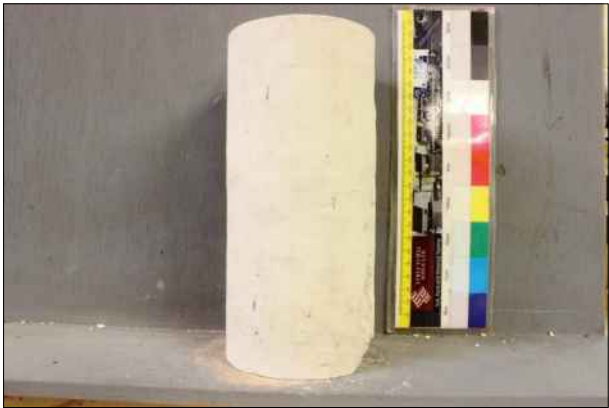
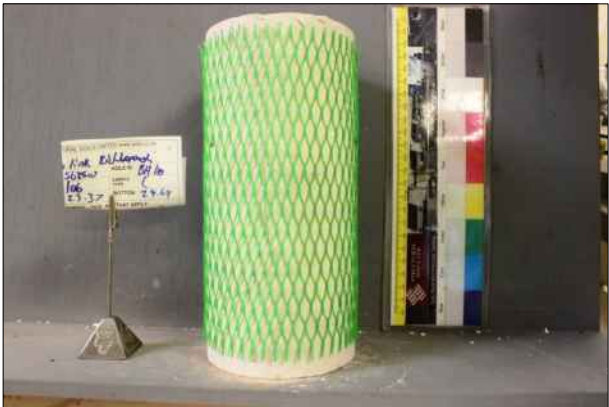
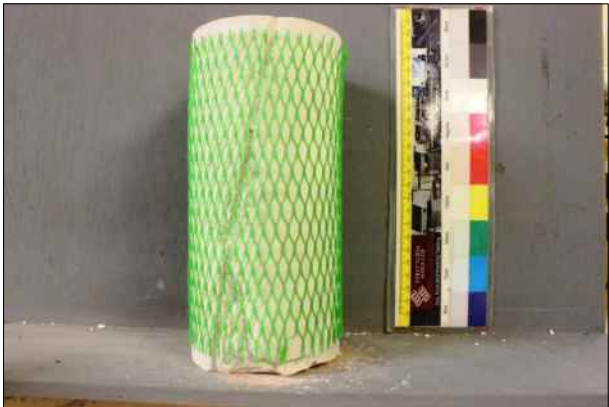
Rear view (pre-test)

Bulk Density (Mg/m³): **1.94** Dry Density (Mg/m³): **1.52** Moisture Content (%): **28**
Length (mm): **202.74** Diameter (mm): **98.75** Length/Diameter Ratio: **2.05**
Test Duration (mins:secs): **08:54** Stress Rate (MPa/s): **0.0065** Load at Failure (kN): **27.4**
UCS (MPa): **3.6** Failure Type: **Vertical splitting**

Note: **Axis of loading parallel to core axis**
Description: **White CHALK**
Specimen Preparation: **Specimen was not recored.**
Sample tolerance checks: Straightness: **FAIL**. Flatness: **FAIL**. Perpendicularity: **FAIL**.
Machine Used: **Impact 2000kN**

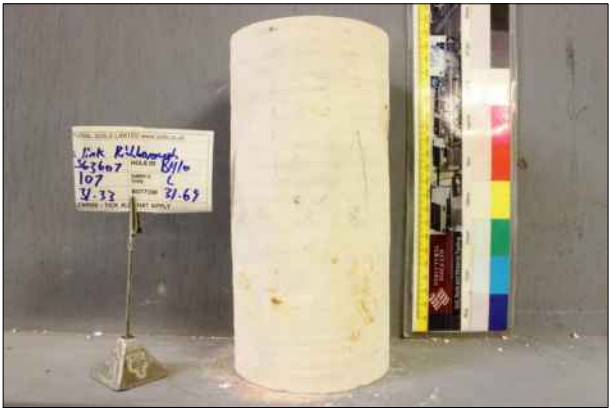
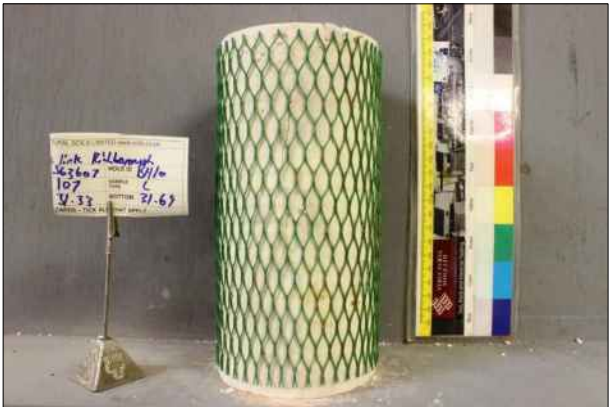
Front view (pre-test)

Bulk Density (Mg/m³): **1.99** Dry Density (Mg/m³): **1.62** Moisture Content (%): **23**
Length (mm): **157.39** Diameter (mm): **99.09** Length/Diameter Ratio: **1.59**
Test Duration (mins:secs): **07:28** Stress Rate (MPa/s): **0.0065** Load at Failure (kN): **23.2**
UCS (MPa): **3.0** Failure Type: **Vertical splitting**

Note: **Axis of loading parallel to core axis**
Description: **White CHALK**
Specimen Preparation: **Specimen was not recored.**
Sample tolerance checks: Straightness: **FAIL**. Flatness: **FAIL**. Perpendicularity: **FAIL**.
Machine Used: **Impact 2000kN**

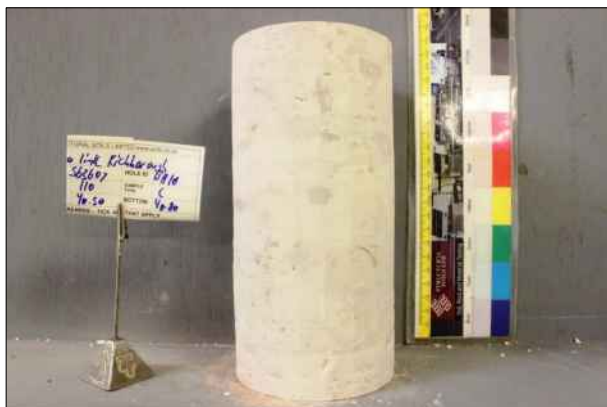
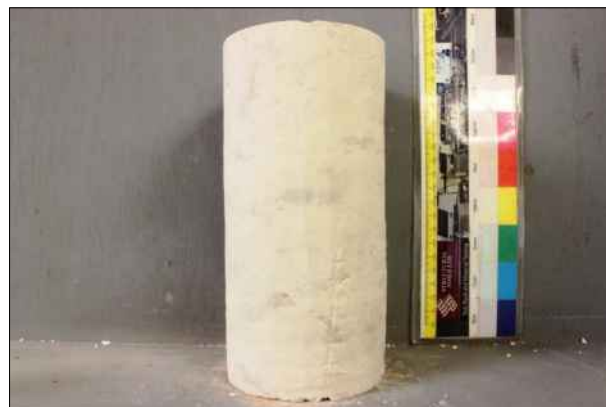
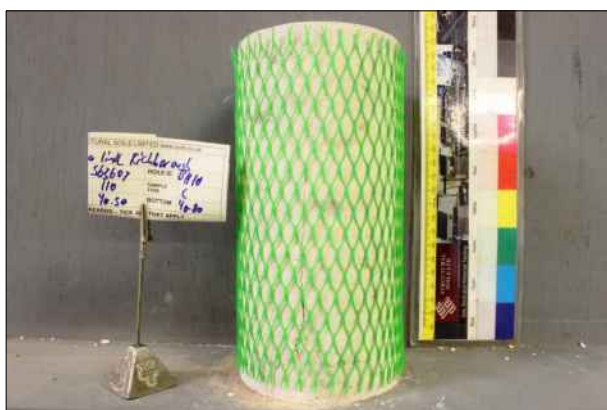
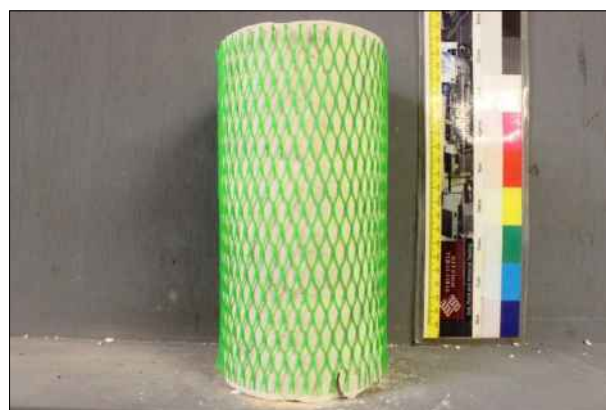
Front view (pre-test)

Moisture Content (%): **28**

Load at Failure (kN): **28.0**

Failure Type: **Vertical splitting**

Sample tolerance checks: Straightness: **FAIL**. Flatness: **FAIL**. Perpendicularity: **FAIL**.
