Sea Link

**Volume 6: Environmental Statement**

Document 6.4.4.6.A
Part 4 Marine
Chapter 6 Appendix 4.6.A
Marine Archaeological Technical Report - Figures

Planning Inspectorate Reference: EN020026

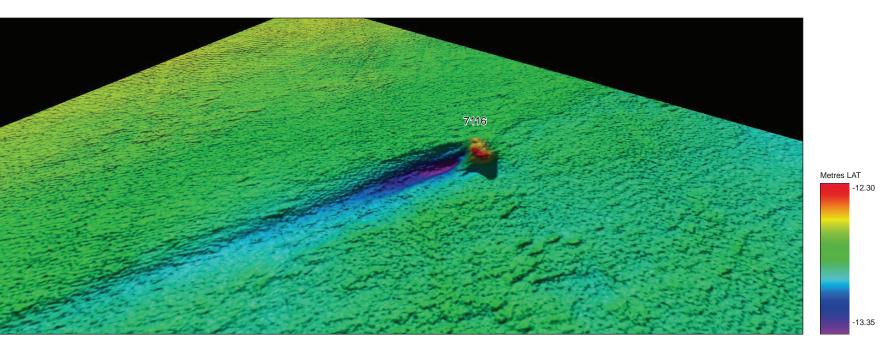
#### ID 7116 – UKHO 87090 – Unknown

Location		407157 E 5779594 N	Area	Sea Link Offshore Block 1	
Archaeol Importan	•	High			
Geophysical survey dimensions and notes		Wreck <b>7116</b> is an unknown wreck (87090).	k that correspor	ds with a UKHO record	
		The wreck is visible in the SSS data as an indistinct spread of dark reflectors with slight shadows; multiple angular objects are visible within an area of disturbed seabed. The wreck measures 15.5 x 8.4 x 0.7 m and its full extent may be buried.			
		In the MBES data the wreck is visible as a large oval mound with an uneven peak, with distinct scouring to the south measuring 25.0 m long and approximately 0.5 m deep. The mound's edges are indistinct which may suggest it is partially buried.			
		No anomalous features were identified in the Mag. data at this location.			
	Туре	Unknown			
	Construction	Unknown			
Build	Dimensions (m)	Unknown			
	Shipyard	Unknown			
Loss	Cause	Unknown

Extent of Survival		In the UKHO record the wreck was recorded MBES dimensions of 10			
		In the 2021 geophysical data the wreck has no distinguishable characteristics, the larger 2021 geophysical dimensions may indicate the wreck has become more exposed since 2017. Associated scouring and sediment accumulation may indicate the wreck is periodically buried.

Sidescan sonar waterfall image of wreck **7116**, 60 m range per channel

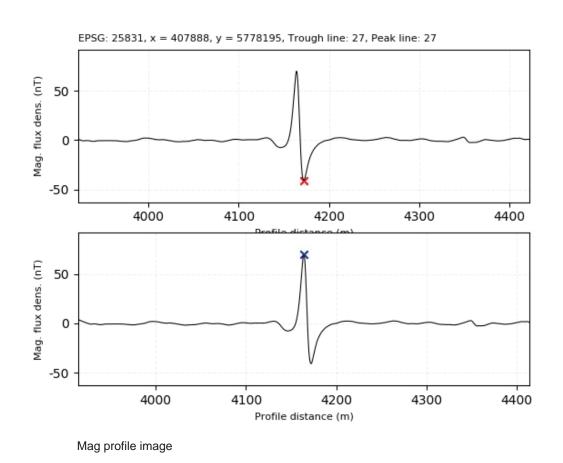
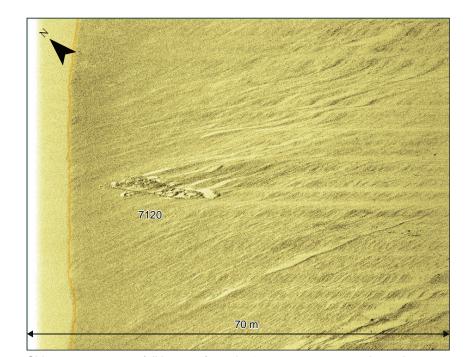
Wreck Sheet 2: Wreck 7120

407075 F 5770404 N	A	On a Limb Offshame	
Location		407875 E 5778194 N	Area	Sea Link Offshore	
				Block 1	
Archaeolo	ogical Importance	High			
Geophysical survey dimensions and notes		Wreck <b>7120</b> is an unknown and unrecorded wreck.  In the SSS data the wreck is visible as a large oval shaped thin curvilinear dark reflector interpreted to be the hull, with bright irregular shadows across its length, indicating uneven height. Internally, indistinct angular and short and straight dark reflectors with shadows are visible that may be surviving deck structure. The wreck is situated in an area of mobile sediments and measures 22.2 x 9.9 x 0.4 m.  In the MBES data one end of the wreck is visible as a distinct curvilinear mound that appears to be mostly intact hull structure. Internally, indistinct linear mounds are visible suggesting the wreck is upright and there are some small angular mounds directly next to the hull that may be collapsed structure. The wreck is orientated east to west on the seabed, with the east end potentially buried by sediments and/or highly degraded. The wreck has scouring to the south for approximately 25.0 m m and 0.7 m deep.  The wreck has a large Mag. anomaly associated with it, measuring

Unknown			
Build	Construction	Unknown			
	Dimensions (m)	Unknown			
Shipyard		Unknown			
Loss	Cause	Unknown			
Loss Cause  Extent of Survival		The wreck appears to be mostly intact with one end buried or highly degraded. The wreck is situated within an area of mobile sediments that may periodically conceal the wreck and any associated debris.

Sidescan sonar waterfall image of wreck 7120, 70 m range per channel

MBES grid image, x 1 vertical exaggeration, looking north-east

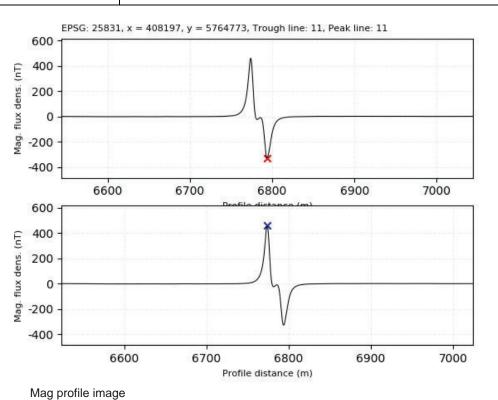
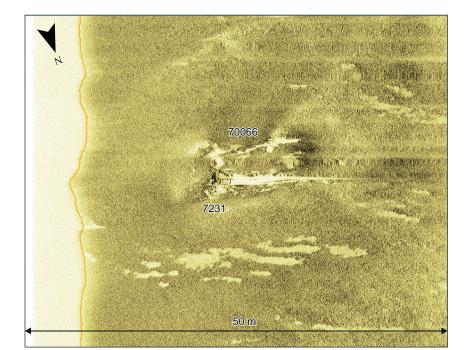
Wreck Sheet 5: Wreck 7231

_		
Location		408206 E 5764776 N	Area	SEA Link	
Archaeolo	gical Importance	High			
Geophysical survey dimensions and notes		Wreck <b>7231</b> is a recorded 'dangerous wreck' that corresponds UKHO record 92098.  The wreck is visible in the SSS data as two tightly constrained debris fields made up of multiple dark reflectors of angular, sub-rounded and linear dark reflectors with shadows of varying lengths. It is interspersed with numerous smaller angular pieces of debris. The largest area of wreck remains measures 14.4 x 10.7 x 2.4 m and is interpreted as the main area of the wreck The second debris field is tagged separately as anomaly 70066, and measures 11.8 x 4.4 x 0.8 m.  In the MBES data it is identified as a slightly elongate, angular object with a stepped outline in profile. The southern extent forms the tallest part of the object. The northern extents are increasingly rounded, with scour around the west, east and northern edges, sitting in a rectangular depression that measures 25 x 15 m.  The wreck is associated with a very large, sharp asymmetric magnetic dipole with an amplitude of 786 nT.

Туре	Unknown			
Build	Construction	Unknown, but likely steel hulled	d due to large M	lag. anomaly.	
Bana	Dimensions (m)	Unknown			
	Shipyard	Unknown			
Loss	Cause	Unknown			
Loss Cause  Extent of Survival		Recorded as a suspected wrec surveyed on 28 November 201 structures with reported dimensions recorded in the dat found the wreck to be 18.6 x 4. the site is active and periodical In the current survey data, the No definite coherent structure is the process of disintegrating fu	9, when it was sions of 19.9 x 3 a. A previous si 2 m, suggesting ly covers parts vessel appears s visible, and the	found to have two visible 3.4 x 4 m, different to the urvey on 17 July 2019 g that the seabed around of the wreck.  to be highly degraded.

Sidescan sonar waterfall image of wreck **7231**, 50 m range per channel

MBES grid image, x 1 vertical exaggeration, looking north

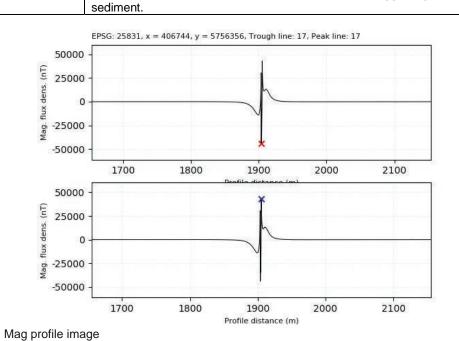
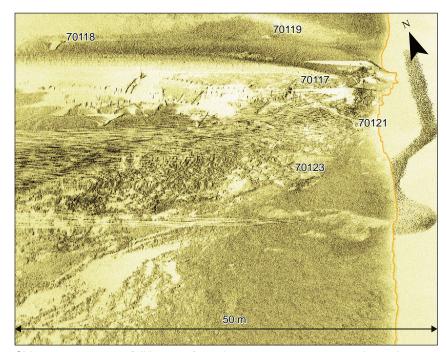
Wreck Sheet 7: Wreck 70117

Location		406736 E 5756356 N	Area	Sea Link Area 2	
Archaeolo	ogical Importance	High			
Geophysical survey dimensions and notes		Wreck <b>70117</b> is a recorded 'dangerous wreck' that corresponds with UKHO record 14685.  The wreck is identified in the SSS data as a very large elongate dark reflector with a long shadow on an east to west alignment. It contains numerous individual elongate and subangular dark reflectors with shadows of varying heights, suggesting at least partially intact internal structure. It has dimensions of 83.2 x 23.5 x 17.6 m.  The wreck is visible in the MBES data as a coherent structure potentially lying on its side, orientated WNW to ESE. The hull outline is very clear on the western end of the structure. Some internal rectangular structures are visible towards the eastern end of the structure, where it appears more heavily degraded. The southern outline is not very visible for the most part, due to partial burial. The wreck is surrounded by very large areas of scour to the northeast and southwest, extending >200 m to the northeast.  The wreck is associated with a very large magnetic dipole with an amplitude of 86,807 nT.

Туре	Steamship			
Build	Construction	Likely steel hulled, due to magnetic anomaly			
Build	Dimensions (m)	82 x 12.8 x 5.5 m			
	Shipyard	FREDRIKSTAD MEK VAERKS	•		
Loss	Cause	Struck a mine and later sank w			
Extent of	Survival	Fredrikstad Mek Vaerks, Fredri from Hartlepool for London with The wreck was last surveyed in dimensions were noted as 84 x data. In a survey on 20 <sup>th</sup> Decenhard to confirm from the data.  The structure of the wreck in the large void in the MBES data, do taking place, with part of the human There are several seabed distustive surrounding the wreck, further estructure is visible in the MBES. A dive on the wreck in Septemble in the area, with "Sand, shingle showing considerable scour surveyed."	kstad. It struck a cargo of time a cargo of time a September 20 x 9.6 m, like above 1995, it was been survey data above the length all potentially sproances and devidence of its adata, and in the card shell being gests the seal	d'of the steam ship <i>Thyra</i> built in 1925 in a mine on 28 <sup>th</sup> February 1942 on passage ber. It sank after being taken in tow.  115, described as lying on its port side. The ethose recorded in the modern survey as noted that the wreck is netted. This is appears to be coherent. The presence of a of the hull, shows that some degradation is litting away from the rest of the wreck. Eabris fields of angular dark reflectors ongoing disintegration. Surviving internal ethose cancelled due to a "Strong upswelling" g disturbed". This, combined with the data bed around the wreck is highly active. The in end, suggesting it is partially covered with

Sidescan sonar waterfall image of wreck **70117**, 50 m range per channel

MBES grid image, x 1 vertical exaggeration, looking north

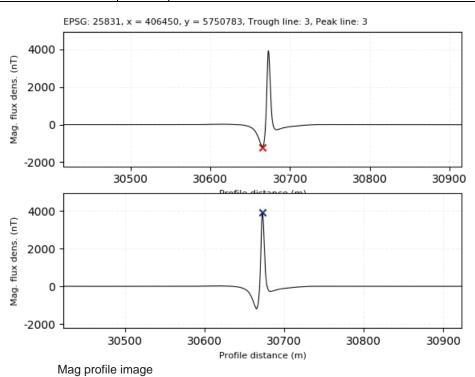
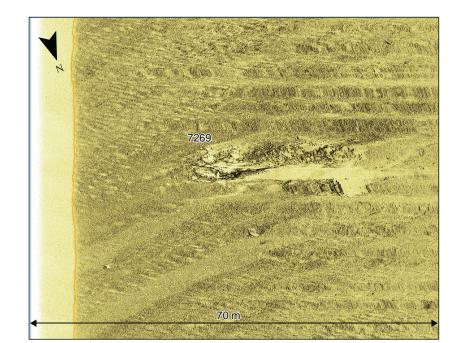
Wreck Sheet 8: Wreck 7269

Location		406448 E 5750777 N	Area	Sea Link Offshore Block 3		
Archaeolo	ogical Importance	High				
Geophysical survey dimensions and notes		Wreck <b>7269</b> is a recorded wreck and corresponds with UKHO (14599) and NMHR (908160) records for UC11 (Possibly).  The wreck is visible in the SSS data as a thick, elongate and slightly intermittent dark reflector with bright shadows interpreted to be the hull. Within this, multiple linear, curvilinear and angular objects are visible. The wreck measures 43.5 x 20.7 x 3.2 m and associated debris has been identified in the vicinity.  In the MBES data the wreck is visible as a spread of angular, linear and curvilinear mounds. The largest mound is rectangular, with steep sides and a flat thin peak measuring 13.6 x 4.3 x 3.0 m, and may be the conning tower or a rudder. Some objects are very distinct, and others may be partially buried. The wreck has scouring associated orientated north and south for a maximum of 28.0 m and is 0.5 m deep.  The wreck has a very large magnetic anomaly associated with it, measuring 5,114 nT, indicating substantial ferrous material is present.

Туре	Submarine		•		
Build	Construction	Steel				
Бина	Dimensions (m)	34.1 x 3.0 m				
	Shipyard	Vulkanwerke, Hamburg				
Loss	Cause	Mine				
Extent of Survival		Recorded as UC11 (Possibly) in German minelaying submarine to fits own mines. The wreck is magnetic anomaly associated. If and described as being broken in the UKHO record suggests that in the past.  In the 2021 geophysical data the broken up. One piece of supersitower, although the UKHO record may be a rudder, the hull is also in an area of mobile sediments a Associated debris has been ident there is potential for further debris.	that sank in 191 eported as bein The wreck was l up with dimensi the wreck may e wreck appears tructure is visibl rd suggests the highly degrade and it may peric ntified in the vic	8 after running into one g upturned, with a strong ast surveyed in 2016 ons of 27.0 x 11.0 x 4.3 m. have been salvaged s to be degraded and e, possibly the conning wreck is upturned, so ed. The wreck is situated odically be buried.

Sidescan sonar waterfall image of wreck **7269**, 70 m range per channel

MBES grid image, x 1 vertical exaggeration, looking east

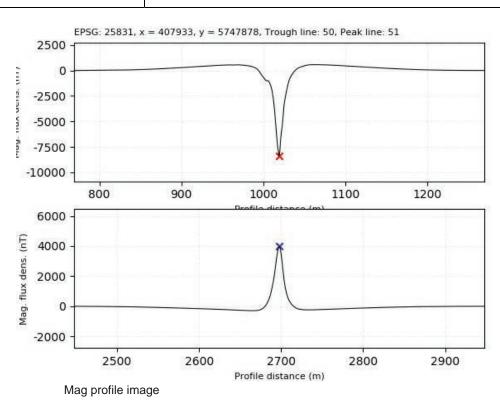
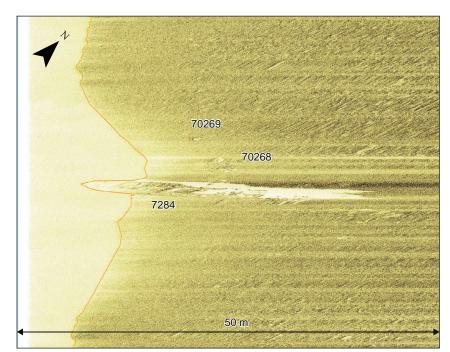
Wreck Sheet 9: Wreck 7284

Location		407934 E 5747879 N	Area	SEA Link
Archaeological Importance		High		
	cal survey ns and notes	Wreck <b>7284</b> is a recorded 'dange UKHO record 14570.  The wreck is visible in the SSS of northeast to southwest, with num with shadows. It has a very large structure of the wreck. Its dimensions.  In the MBES data the wreck is winternal structure visible within the end. Some shallow scour is also extending to the southwest.  The wreck is associated with a withe Mag. data, with a magnetic as	data as a coherenerous internal as shadow which sions were mean isible as coherene he hull and posso visible along the	ent structure, oriented angular dark reflectors may hide more of the sured to be 40.3 x 11.9 x and upright, with some lible degradation at either the northwestern edge and metric magnetic dipole in
	Туре	Unknown		
Build	Construction	Unknown, but assumed steel hu	Il due to intact n	ature and mag. anomaly

Bullu	Dimensions (m)	Unknown		
	Shipyard	Unknown		
Loss	Cause	Unknown		
Extent of	Survival	The wreck was first recorded in a Oropesa sweep in June 1932. The same is described as sitting upright the exception of the stern. The same is a s	he wreck was land on the seabed wreck has report the dimensions were wreck may be perfect the structure the data. The structure with the tern and bow of es of debris, and	ast surveyed in July 2016 d, in good condition "With red dimensions of 37.4 x s in the current survey periodically buried by ported the wreck e. ructure appears intact MBES and SSS data. the ship are gular dark reflectors and

Sidescan sonar waterfall image of wreck **7284**, 50 m range per channel

MBES grid image, x 1 vertical exaggeration, looking north

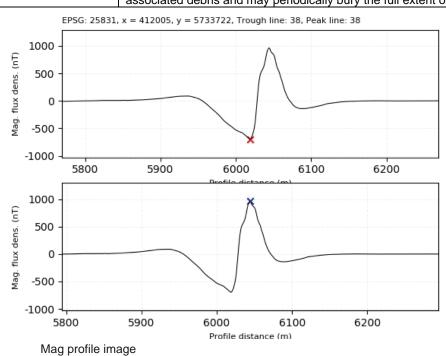
Wreck Sheet 10: Wreck 7346

Location		412020 E 5733762 N	Area	Sea Link Offshore			
Arabasala	aical Importance	High		Block 3			
Geophysical survey dimensions and notes  Type Construction Dimensions (m) Shipyard		High  Wreck <b>7346</b> is a recorded wreck that corresponds with the UKHO (14419) and NMHR (802191) records for <i>Salerno</i> (Possibly).  In the SSS data one edge of the hull is visible as a distinct long and thick dark reflector with a very large, bright and uneven shadow, indicating uneven height. Within the hull there are multiple indistinct elongate and linear dark reflectors, indicating the wreck is upright and has some surviving deck structure. The wreck measures 97.0 x 25.2 x 11.1 m and is oriented north-east to south-west on the seabed, it is situated within an area of mobile sediments.  In the MBES data the wreck is upright but leaning over to one side, and the northern side of the wreck is not visible. The hull appears to be mostly intact, with collapsed structure on its south-west end with the northern edge of the wreck buried by sediments. In the centre of the deck a large square mound is visible measuring 8.7 x 4.2 x 4.0 m.  There are multiple linear and angular mounds across the deck and a large mound is present at the north-eastern end of the vessel indicating surviving superstructure and possibly a boiler. The wreck has significant scour to the south for over 200.0 m and up to -6.0 m deep and is surrounded by sediment accumulation which may be concealing the full extents of the wreck and possibly associated debris.  The wreck has a very large Mag. anomaly associated with it, measuring 1,659 nT, indicating substantial ferrous material is present.

Unknown, likely steel					
Build		99.1 x 13.5 x 6.0 m					
	Shipyard	Wood, Skinner & Co, Newcastle	e-Upon-Tyne				
Loss	Cause	Mine					
Extent of Survival		Recorded by the UKHO as <i>Salerno</i> (Possibly), a steam ship built in 1912 with two boilers and a triple expansion engine. The vessel struck a mine laid by UC3 in 1915. The wreck was last surveyed in 2016 and described as being broken up with a strong Mag. anomaly associated and dimensions of 95.0 x 22.0 x 11.7 m.  In the 2021 geophysical data the wreck appears to be predominantly intact, although the south-west end has evidence of deterioration. It is situated within an area of large sand waves which may be concealing associated debris and may periodically bury the full extent of the wreck.

Sidescan sonar waterfall image of wreck **7346**, measuring 70 m range per channel

MBES grid image, x 1 vertical exaggeration, looking south

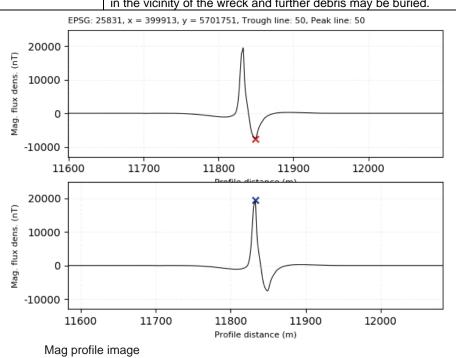
Wreck Sheet 11: Wreck 7414

T _			
Location		399938 E 5701754 N	Area	Sea Link Offshore Block 4		
Archaeolo Importano		High				
Geophysical survey dimensions and notes  Type Construction Build Dimensions		Wreck <b>7414</b> is a recorded wreck that corresponds with the UKHO (13968) and NMHR (904723) records for <i>Saidieh</i> .  In the SSS data the wreck is visible as a large spread of distinct linear and curvilinear dark reflectors with bright shadows. The wreck is upright and measures 116.6 x 36.6 x 6.8 m, there are slatted features visible internally, however no superstructure is identifiable. The wreck has a rope or chain that is either attached or snagged on the south-eastern edge. The hull of the wreck is not well defined, suggesting it is broken up.  In the MBES dataset the wreck is orientated approximately ENE to WSW on a relatively featureless area of seabed. The wreck appears upright, but is highly degraded with a collapsed hull. Within the hull possible surviving deck structure is visible, comprising three distinct square shaped mounds in its centre with thin, linear mounds and smaller rounded and angular mounds across the deck. The wreck has significant sediment accumulation and scour to the north and south, with significant scour to the south measuring 140.0 x 54.0 x -5.2 m, which may be burying collapsed structure and associated debris.  The wreck has a very large Mag. anomaly associated with it, measuring 27,020 nT, indicating substantial ferrous material is present.

Steam ship				
		Unknown, likely steel				
Build	(m)	106.7 x 12.2 x 7.0 m				
	Shipyard	Unknown				
Loss	Cause	Sunk by German submarine				
Extent of	Survival	Recorded by the UKHO and NMH ship built in 1878. The vessel was submarine. The wreck was last s partially broken up and buried with The larger geophysical dimension indicate the wreck has collapsed, exposed since 2017. The wreck is area of seabed, but it has substated in the vicinity of the wreck and further than the second seabed.	s sunk in 1915 burveyed in 2017 th dimensions on sin the most road degraded furthes situated on a ntial sediment at Associated del	by UB6, a German 7 and described as being if 112.5 x 21.1 x 5.8 m. ecent survey may her, or become more relatively featureless accumulation around it bris has been identified

Sidescan sonar waterfall image of wreck **7414**, 70 m range per channel

MBES grid image, x 1 vertical exaggeration, looking west

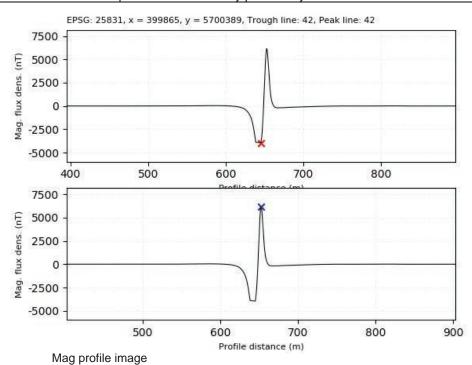
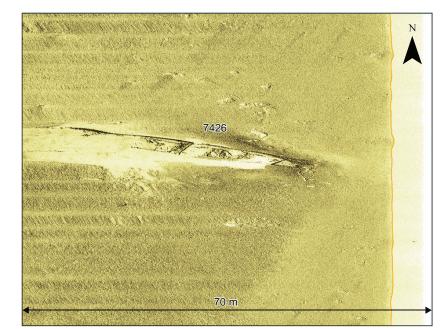
Wreck Sheet 12: Wreck 7426

Location		399876 E 5700385 N	Area	Sea Link Offshore			
				Block 4			
Archaeolo	ogical Importance	High					
Geophysical survey dimensions and notes		Wreck <b>7426</b> is a recorded wreck that corresponds with the UKHO (13958) and NMHR (831796) records for an unknown wreck.  The wreck is visible in the SSS data with a large, elongate and distinct curvilinear dark reflector with a bright uneven shadow, measuring 51.6 x 11.9 x 3.4 m. This is interpreted to represent the hull, which appears to be intact. Within the hull, linear and curvilinear dark reflectors and some slatted features are visible that possible represent surviving deck structure. One end of the vessel is heavily degraded and may be buried.  In the MBES data the stern of the wreck appears to be to the WNW and the bow to the ESE. The hull is mostly intact, however there is a dip visible in the centre of the wreck which may suggest it is broken in two. It appears slightly bowed and has large amounts of sediment accumulation at either side of the hull up to 5.0m high that may be burying its full extent. The wreck is upright with two triangular mounds visible in its centre that may be boilers. Some possible surviving deck structure is visible as linear mounds at the stern and small uneven angular mounds at the bow end of the vessel. The wreck is surrounded by scouring at the bow and stern up to 2.0 m deep.  The wreck has a very large Mag. anomaly associated with it, measuring 10,094 nT, indicating substantial ferrous material is present.

Unknown					
Build	Construction	Unknown, likely steel					
	Dimensions (m)	Unknown					
	Shipyard	Unknown					
Loss Cause  Extent of Survival		Unknown  Recorded by the UKHO and NM surveyed in 2017. The wreck wa with dimensions of 50.8 x 9.0 x 3 2.7 m deep.  The wreck appears to be mostly and burial is visible in the 2021 debris are visible surrounding th large mound identified at the stemay have broken off. The wreck sediments and it may periodicall	as reported as b 3.7 m and with 2 intact however geophysical dat e wreck sugges in suggests a la is situated in a	eing upright and intact 25.0 m of scour up to evidence of collapse a. Several items of sting it is degraded and a arge piece of the vessel			
		1 v = 399865 v = 5700389 Trough line

Sidescan sonar waterfall image of wreck **7426**, 70 m range per channel

MBES grid image, x 1 vertical exaggeration, looking south-west

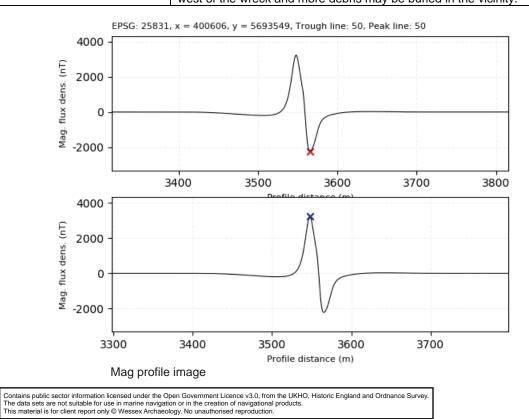
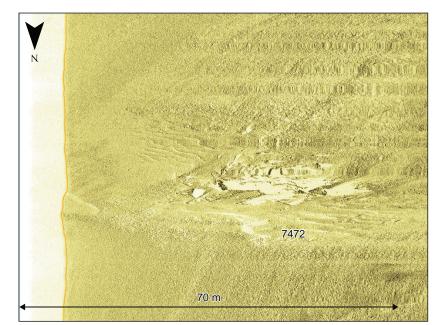
Wreck Sheet 13: Wreck 7472

Location		400613 E 5693545 N	Area	Sea Link Offshore Block 4		
Archaeological Importance		High				
Geophysical survey dimensions and notes  Type Construction		Wreck <b>7472</b> is a recorded wreck that corresponds with the UKHO (14944) and NMHR (904908) records for <i>Selma</i> (Possibly).  In the SSS data the wreck is visible as a large spread of elongate, angular and curvilinear dark reflectors with bright shadows. The hull is not distinct and there are no discernible internal features visible, suggesting the wreck is very broken up. The wreck measures 52.5 x 38.7 x 1.6 m and is situated in an area of mobile sediments, indicating the full extent of the wreck may be buried.  In the MBES data the wreck is visible as a group of elongate, angular and rounded objects situated within depressions. The largest linear object measures 7.7 x 2.8 x 0.6 m and a large angular mound at the western end of the wreck measures 4.1 x 2.8 m; this has a very flat peak and steep edges, and some data points are missing which may suggest its peak is overhanging the edge of the main structure. Large scouring is visible to the south of the wreck measuring 24.0 m long and 0.6 m deep. The wreck is surrounded by sand waves and there is some outcropping geology to the north.  The wreck has a very large Mag. anomaly associated with it, measuring 5,443 nT, in dicating substantial ferrous material is present

Steam ship				
Build	Dimensions (m)	Unknown, likely steel 82.3 x 11.9 x 5.5 m				
	Shipyard	Unknown				
Loss		Mined				
LUSS	Cause	Recorded in the UKHO and NMI	UD databases s	os Solma (Bossibly) a		
Loss Cause  Extent of Survival		1654 gross ton steam ship that was last surveyed in 2018 and ridispersed debris in scour with dispersed debris in scour with dispersed since 2018. The wreck situated in an area of mobile see be buried. An associated debris west of the wreck and more deb	was sunk by a neported as consimensions of 30 ons in the most d, degraded furtilis very broken diments, sugges field has been i	nine in 1915. The wreck sisting of broken and .0 x 23.3 x 0.8 m.  recent survey may her, or become more up and degraded and is sting it may periodically dentified to the north-

Sidescan sonar waterfall image of wreck 7472, 70 m range per channel

MBES grid image, x 1 vertical exaggeration, looking north-east

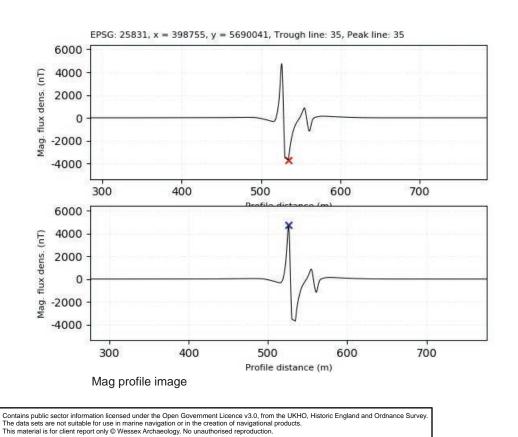
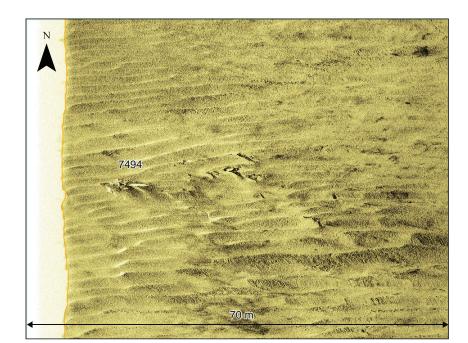
Wreck Sheet 14: Wreck 7494

Location		398780 E 5690035 N	Area	Sea Link Offshore				
				Block 4				
Archaeolo	•	High						
Important	ce	Wrook 7404 is a recorded wrook that corresponds with LIKLIO record						
	cal survey ns and notes	Wreck <b>7494</b> is a recorded wreck that corresponds with UKHO record 15175, <i>Klar</i> .  In the SSS data the wreck is visible as large spread of highly anomalous rounded, curved, linear and angular dark reflectors with shadows of varying heights. The wreck measures 51.3 x 42.2 x 1.0 m and is situated within an area of sand waves, suggesting the potential for further debris to be buried in the vicinity.  In the MBES data the wreck is visible as an area of disturbed seabed comprising three compact groups of distinct mounds within mobile sediments. An elongate object is visible measuring 2.2 x 1.2 m and the largest mound measures 2.8 x 1.8 m. Smaller rounded and angular mounds are also visible and the feature has scouring to the south for 13.0 m and up to 0.4 m deep.  The wreck has a very large Mag. anomaly associated with it, measuring

Type	Steam Ship						
	Construction	Unknown, likely steel						
Build	Dimensions	45.7 x 7.6 x 5.2 m						
	(m)							
	Shipyard	Unknown						
Loss	Cause	Mine						
Extent of Survival		Recorded by the UKHO as <i>Klar</i> , a 518 gross ton steam ship that struck a mine and sank on passage from Tyne to Rouen in 1915. The wreck was last identified in 1997 with measurements of 50.0 x 45.0 x 1.0 m with scour extending for 65.0 m. The wreck was not identified in a MBES survey in 2018 and the record was amended to dead.  In the 2021 geophysical data the wreck appears very broken up and degraded with no identifiable structure visible. The wreck is situated within sand waves and may be periodically buried, which may explain why it was not identified in 2018.

Sidescan sonar waterfall image of wreck **7494**, 70 m range per channel

MBES grid image, x 1 vertical exaggeration, looking north-west

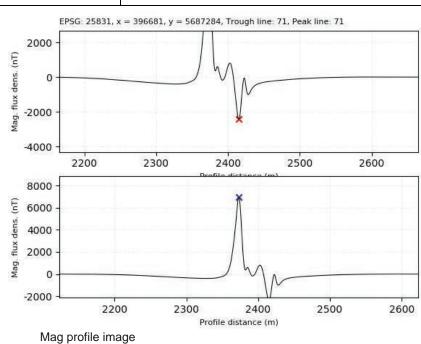
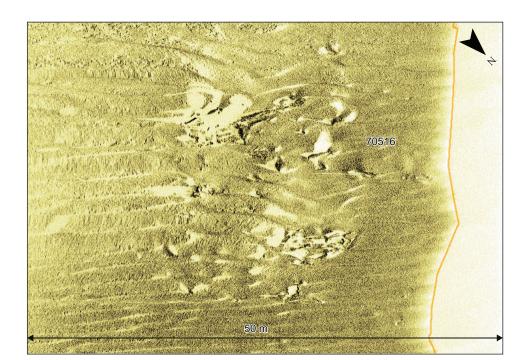
### ID 70516 – UKHO 13839 – HMS Artic Trapper

Location		396674 E 5687281 N	Area	SEA Link				
	gical Importance	High	1 • • •	<u> </u>				
Geophysi	cal survey ns and notes	Wreck <b>70516</b> is a recorded 'dangerous wreck' that corresponds with UKHO record 13849 of the HMS <i>Arctic Trapper</i> .  The wreck is identified in the SSS data as >10 distinct angular and subangular dark reflectors with shadows and scour, measuring 74.7 x 55.4 x 1.4 m and located within an area of sand ripples.  In the MBES data it is recorded as several widely spaced, angular pieces of debris, the largest of which measures 7.3 x 3.5 x 0.3 m and is located in a slight depression. Towards the north-east there is another large piece of debris measuring 3.2 x 1.8 x 0.8 m.  The wreck is associated with a very large asymmetric magnetic dipole, with an amplitude of 9,405 nT.						
	Туре	Trawler						
Build	Construction	Unknown, but presumed steel hull from the Mag. anomaly. Single boiler, triple expansion engine, single shaft, one 12 pounder gun.

Dimensions (m)	Unknown						
	Shipyard	Unknown						
Loss	Cause		unk by German aircraft, 03/02/1941					
Extent of	Survival	The wreck is noted as being 'par wreckage' in the UKHO record. I when it was found to have dimer different to the recorded dimensi measurement of the largest piec dimensions of the entire debris fi magnetic anomaly.  In the data, the wreck is highly debris field. While the structure of is possible that large, angular more represent individual surviving coulkho record, such as the engindebris, and sand waves in the ansuch, other nearby pieces of debut it is not that the wreck was "displikely accounts for its highly degristructure is unlikely to survive."	t was last survensions of 3.1 x 2 ons in the data, e of debris in the deld. The UKHO egraded. It is visof the ship has counds visible in mponents of the des or boiler. Some a suggest the oris may be buried ersed clear to se	yed in September 2015 .7 x 2 m, markedly although this may be a e area, rather than the records it as a 'strong' sible as a widely spaced ompletely disintegrated, it the MBES and SSS data e ship mentioned in the our is visible around the seabed is active. As ed. eabed" in 1947, which

Sidescan sonar waterfall image of wreck **70516**, 50 m range per channel

MBES grid image, x 1 vertical exaggeration, looking north

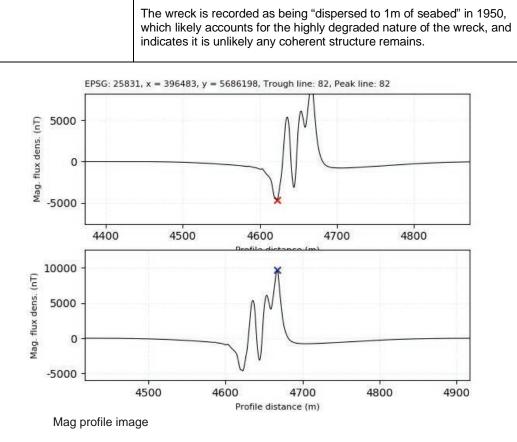
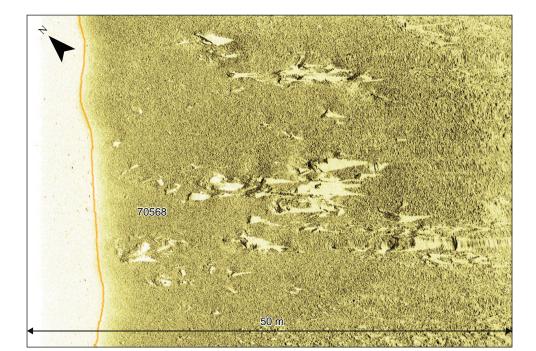
Wreck Sheet 16: Wreck 70568

Location		396470 E 5686189 N	Area	Sea Link Area 5				
Archaeolo	gical Importance	High						
	cal survey ns and notes	Wreck <b>70568</b> is a recorded 'dangulkho record 13843 for the <i>Rya</i> The wreck is visible in the SSS of angular pieces of debris with point x 1.3 m. No coherent structure in the MBES data the wreck is with a larger distinct angular momeasures approximately 15.0 x smaller, angular mounds.  In the Mag. data, the wreck is rewith a magnetic amplitude of 14,	data as a distinct inted shadows, to see visible in the consistency is seed as several and located 10 rolls. The consistency is seed as a vertical force of the consistency in the consistency is seed as a vertical force of the consistency in the consistency is seed as a vertical force of the consistency in the consistency is seed as a vertical force of the consistency in the consistency is seed as a vertical force of the consistency in the consistency is seed as a vertical force of the consistency in the consistency is seed as a vertical force of the consistency in the consiste	t scatter of multiple large that measures 37.4 x 36.7 data.  I very angular mounds, m to the southwest. It is surrounded by several

Туре	Steam Ship						
Build D	Construction	Unknown, but assumed steel hu	Il due to Mag. a	nomaly				
	Dimensions (m)	Unknown						
	Shipyard	Unknown, but assumed steel hull due to Mag. anomaly Unknown Unknown Mined, 24/04/1940						
Loss	Cause	,						
Loss Cause  Extent of Survival		The wreck was last surveyed in September 2015 and is recorded as having dimensions of 6.0 x 3.5 x 2 m, which are much smaller than the entire debris field visible in the data. Earlier surveys found the debris to extend over an area 65 x 38 x 1.7 m, with "Wreckage scattered over a wide area".  The wreck appears as very dispersed in the data. The structure of the vessel appears to be highly degraded and is unrecognisable as a coherent wreck. Visible large angular mounds may be individual surviving components of the ship. The debris is located in an area of sand waves and may be periodically buried. A large debris field (70567) located 15 m north is very likely related debris, along with several pieces located approximately 50 m northwest.

Sidescan sonar waterfall image of wreck 70568, 50 m range per channel

MBES grid image, x 1 vertical exaggeration, looking north

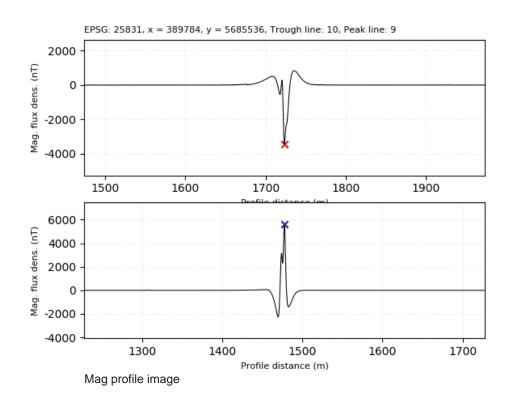
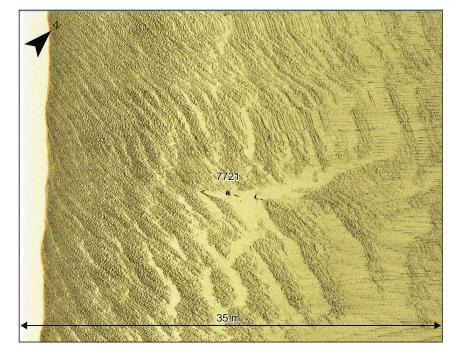
Wreck Sheet 17: Wreck 7721

Location		389778 E 5685519 N	Area	Sea Link Nearshore S5				
Archaeolo Importano	•	High						
Geophysical survey dimensions and notes		Wreck <b>7721</b> is a recorded wreck that corresponds with UKHO record 85569, an unknown wreck.  In the SSS data the wreck is visible as an area of disturbed seabed with three distinct dark reflectors within; a thin right-angled object measuring 5.0 x 0.6 m is visible, plus two smaller angular objects with slight shadows. The wreck measures 8.5 x 4.7 x 0.4 m and is situated within an area of mobile sediments so the full extent is likely buried.  In the MBES data the wreck is visible as a group of angular objects in the base of a large depression or seabed disturbance: the largest object measures 2.1 x 1.2 x 0.2 m.  The wreck has a very large Mag. anomaly associated with it, measuring 9,085 nT, indicating substantial ferrous material is present.						
	Type	Unknown

Construction	Unknown, likely steel						
Build	Dimensions (m)	Unknown						
	Shipyard	Unknown						
Loss	Cause	Unknown						
Loss Cause  Extent of Survival		Recorded by the UKHO as an un and reported as being the possib last surveyed in 2019 with MBES  The wreck is highly broken up wire 2021 geophysical data. The previappearance suggest that this wre buried in mobile sediments since	le remains of a dimensions of th no hull or struiously reported eck has become	barge. The wreck was 37.4 x 3.9 x 0.9 m.  Icture discernable in the dimensions and almost completely

Sidescan sonar waterfall image of wreck **7721**, 35 m range per channel

MBES grid image, x 1 vertical exaggeration, looking west
