**The Great Grid Upgrade**

Sea Link

**Document 9.76.5.6: Change Request Appendix F Change 3 Phase 1 Habitat Survey Results**

**Planning Inspectorate Reference: EN20026**

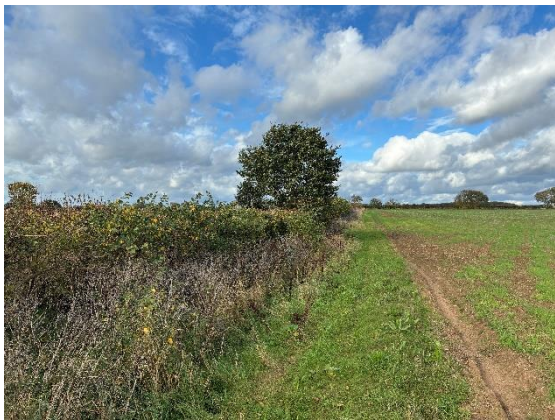
**Plate 1 Example native hedgerow with trees, grassland margin and arable cropland**

- 1.2.3 These fields were bound by hedgerows of varying composition and condition but were largely species-poor intact hedgerows dominated by common hawthorn. The northern boundary hedge was a more diverse hedge (Plate 1) with the western section of this hedge also supporting trees. The suitability for these hedgerow trees, among others to support roosting bats was assessed and those trees with potential to support roosting bats identified below. None of the trees with suitability for roosting bats are identified for removal as part of the Proposed Project.

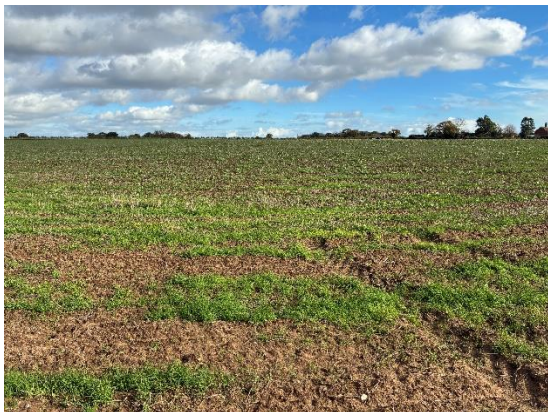
**Plate 2 Example arable cropland within the Survey boundary**

- 1.2.1 The results of the Phase 1 habitat survey are presented in Figure 1 at the end of this report.
- 1.2.2 The survey area comprised three arable fields of winter fodder radish (*Raphanus sativus* var. *oleiformis*) and partially ploughed winter stubble left from a maize (*Zea mays*) crop (Plate 2). The central and western fields were bound by narrow arable grassland margins dominated by grasses including cock's-foot (*Dactylis glomerata*), tall fescue (*Schedonorus arundinaceus*), and meadow grasses (*Poa* spp.), with ribwort plantain (*Plantago lanceolata*), yarrow (*Achillea millefolium*), groundsel (*Senecio vulgaris*), common vetch (*Vicia sativa*), and common nettle (*Urtica dioica*) also present. These two fields were separated from each other by a species-poor intact hedgerow dominated by common hawthorn (*Crataegus monogyna*) and an improved grassland vehicle access track.
