Sea Link

Document 9.76.5.1: Change Request: Appendix A Saltmarsh Technical Note

Saltmarsh Development in Pegwell Bay, Kent
With particular reference to the area around the former
Hoverport

KPAL Technical Note No: 021125

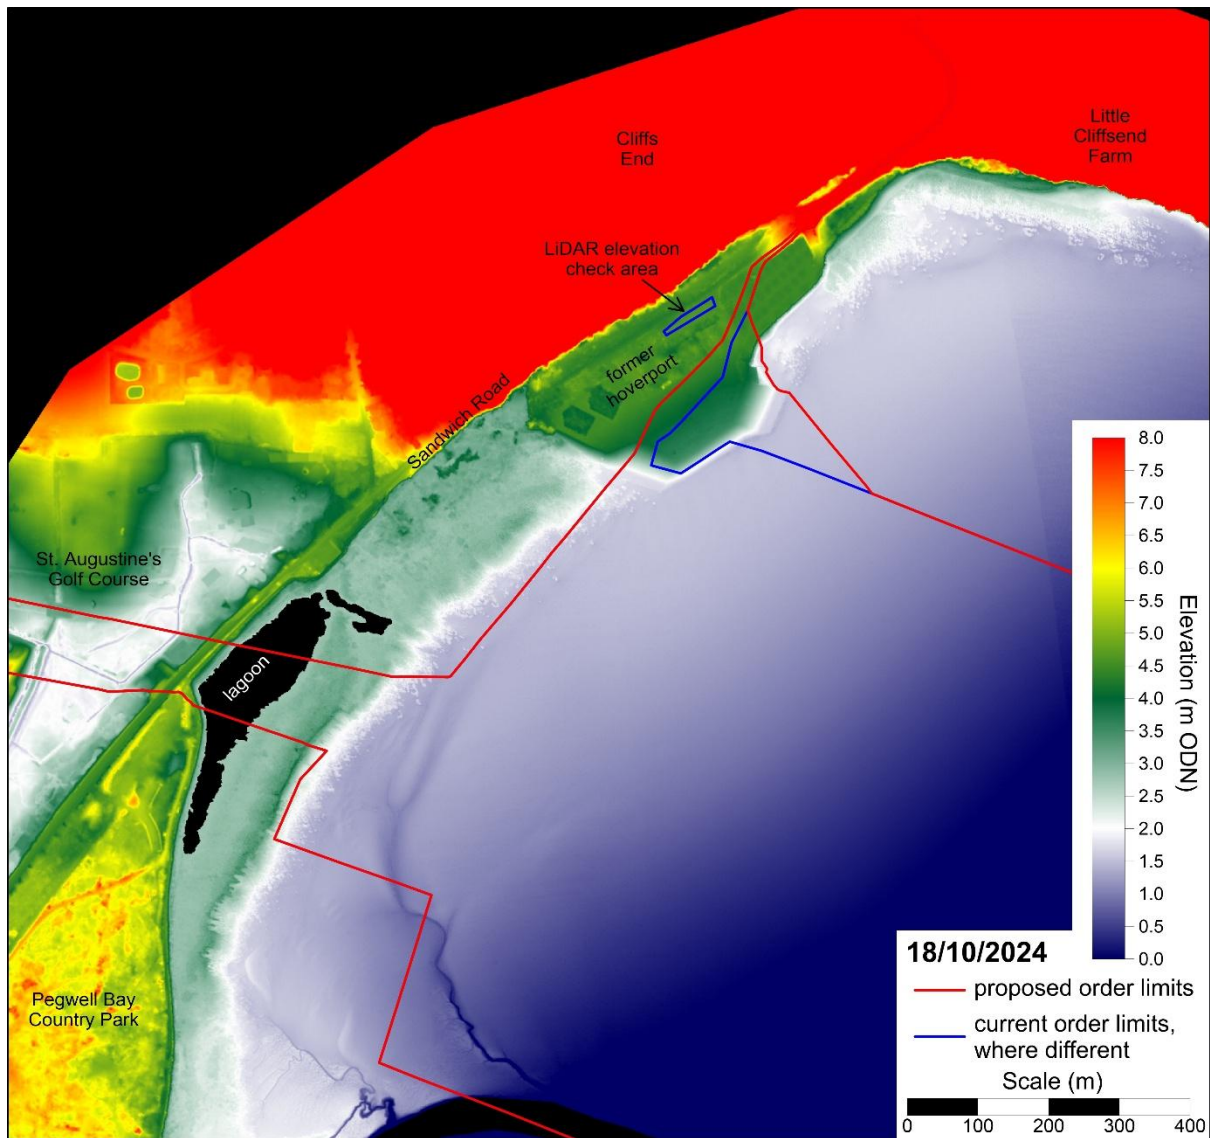
Figure 1. LiDAR DTM of Pegwell Bay flown 18/10/2024 showing current and proposed Sea Link Order Limits. LiDAR data source: NNRCMP

LiDAR imagery (Figure 1) shows that there is a slightly lower but still relatively high marsh ridge behind the outer 'high marsh ridge'. The inner ridge feature forms the seaward margin of the lagoon at the Country Park end of the system. Aerial photograph evidence suggests this ridge must have formed between c.1945 and the early 1950s; part of it coincides with the line of World War II scaffolding poles which may have encouraged preferential sediment accretion. Towards the northeast the two 'high marsh ridges' merge, forming a wider high marsh platform on the southern side of the NEMO Link cable corridor.

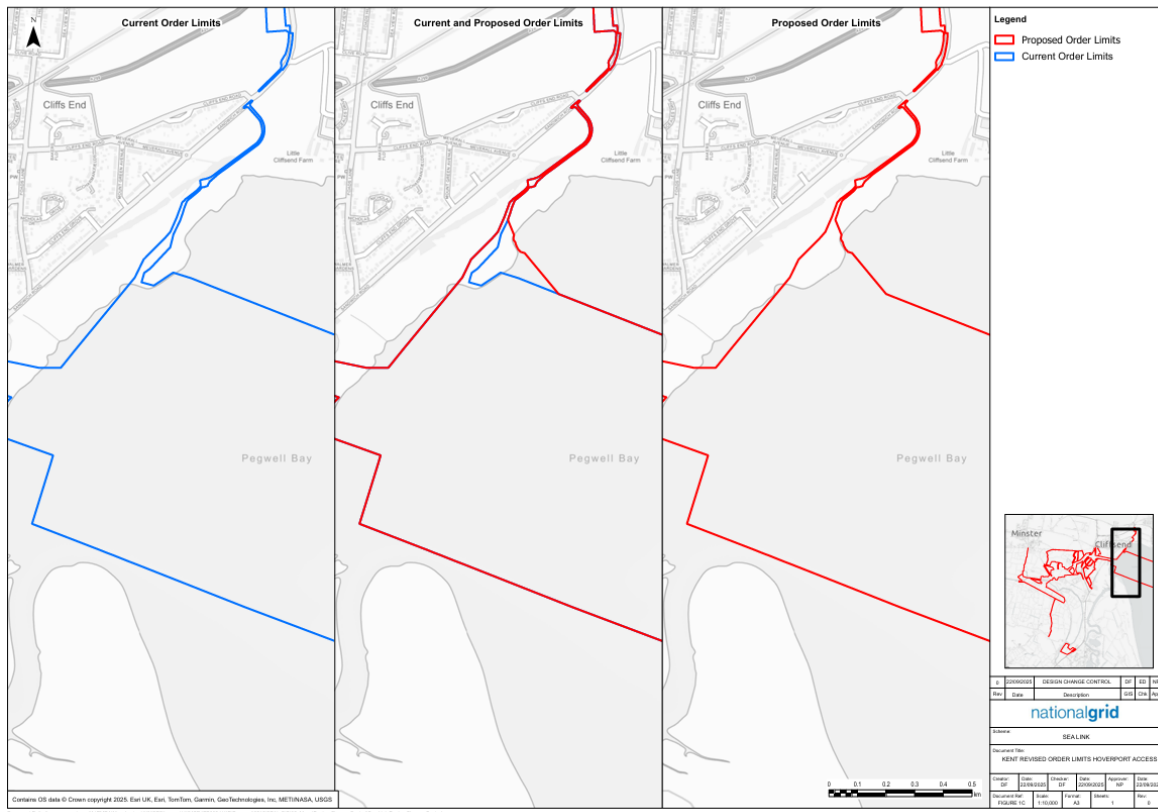
Figure 2. Current and proposed changes to Order Limits in the former hoverport area

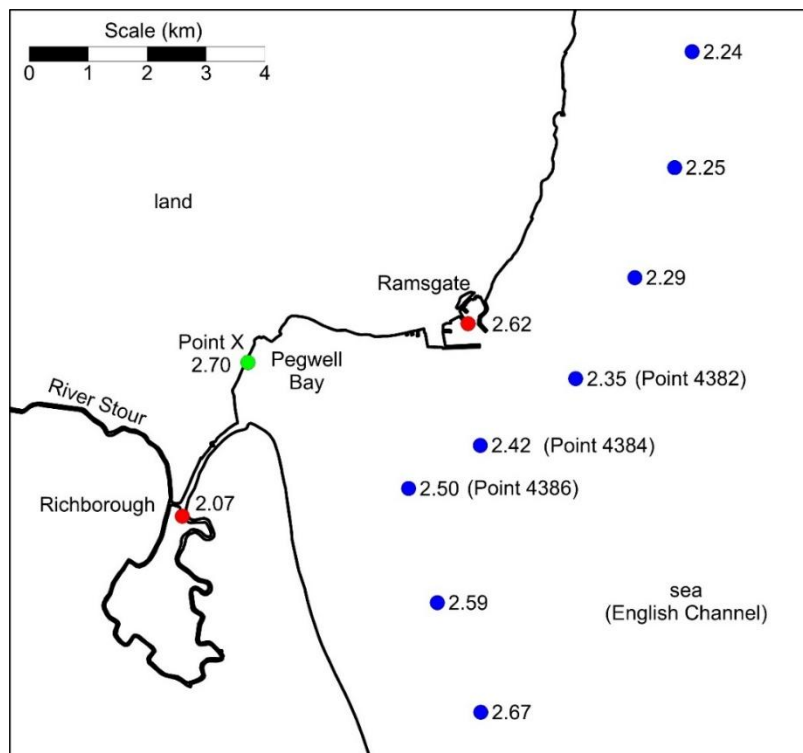
Figure 3. Levels of MHWS near Pegwell Bay, in metres above Ordnance Datum Newlyn, taken from 2022 Admiralty Tide Tables (red dots at the Standard Port of Ramsgate and the Secondary Port of Richborough), and from the Environment Agency Coastal Boundary Study 2018 Update (blue dots, Environment Agency, 2019). Point X (green dot) is inferred from mean levels at Ramsgate and elevations of vegetation types at the site

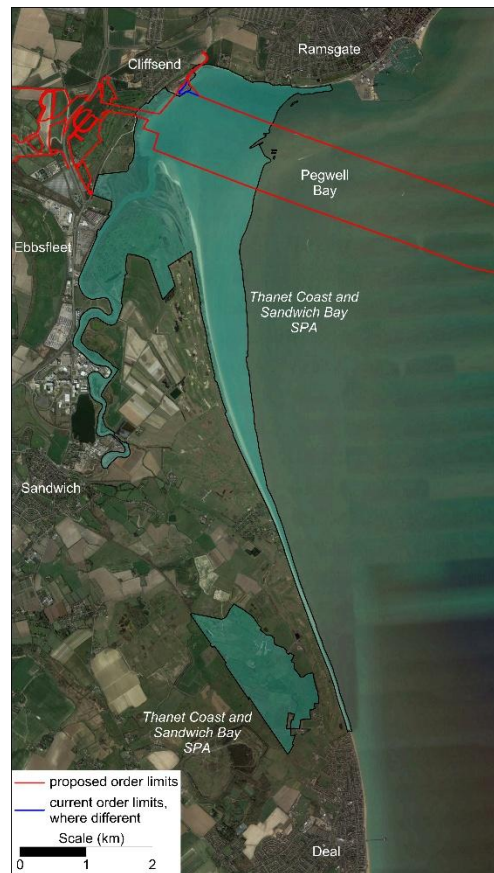
Figure 4. Thanet Coast and Sandwich Bay Special Protection Area. Base satellite imagery flown 30/03/2021

The area of proposed works lies within the Thanet Coast and Sandwich Bay Special Protection Area (SPA; Figure 4), the Thanet Coast and Sandwich Bay Ramsar Site (Figure 5), the Sandwich Bay Special Area of Conservation (SAC; Figure 6), the Sandwich Bay to Hacklinge Marshes Site of Special Scientific Interest (SSSI; Figure 7), The Sandwich and Pegwell Bay National Nature Reserve (NNR; Figure 8), the Sandwich and Pegwell Bay Local Nature Reserve (LNR) managed by the Kent Wildlife Trust (KWT, Figure 9). The southern part of the area is owned by the National Trust (Figure 10). The SPA forms a part of the North East Kent European Marine Site (EMS).

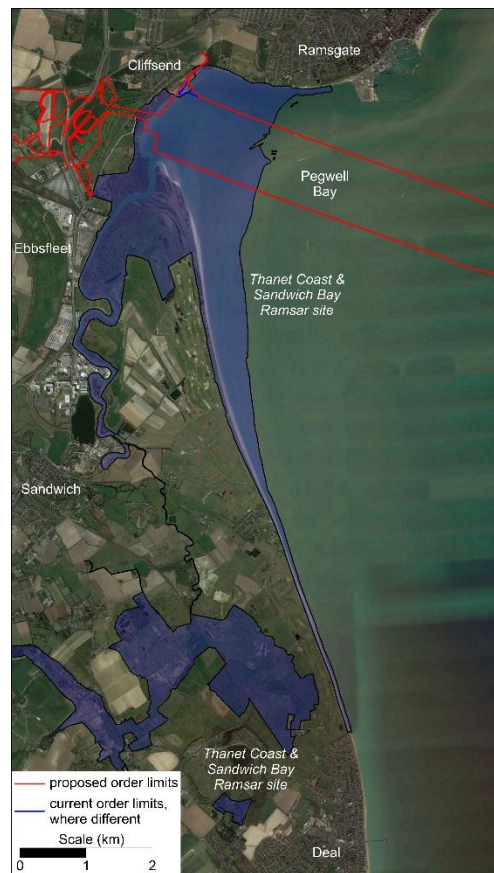
Figure 5. Thanet Coast & Sandwich Bay Ramsar site. Base satellite imagery flown 30/03/2021

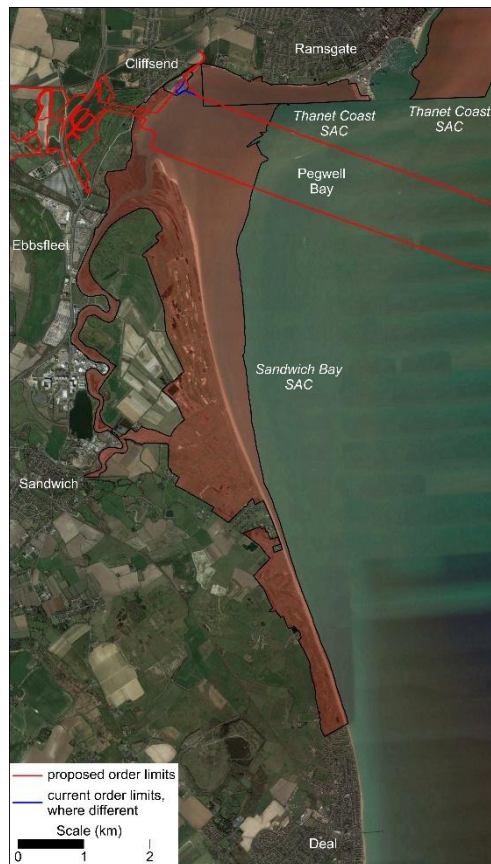
Figure 6. Sandwich Bay Special Area of Conservation and part of the Thanet Coast Special Area of Conservation. Base satellite imagery flown 30/03/2021

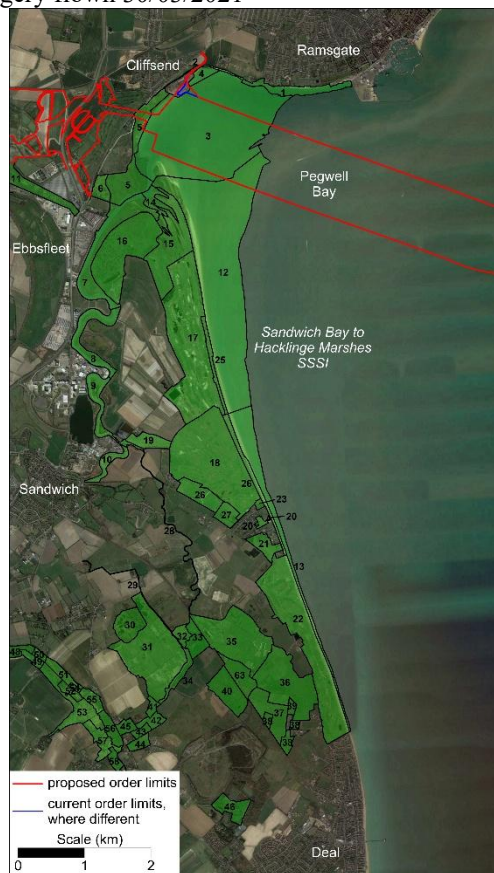
Figure 7. Sandwich Bay to Hacklinge Marshes Site of Special Scientific Interest Condition Assessment Units. Base satellite imagery flown 30/03/2021

The saltmarsh area and lagoon adjoining the proposed cable landfall occur with SSSI Condition Assessment Unit 5 which is classified simply as “Littoral Sediment” (Table 3). The last condition assessment, in February 2023, concluded the condition of this unit to be “Favourable”, even though it was noted (Table 4) that there are local negative influence around the surface water outfall northeast of the Pegwell Bay Petrol Station and most of this frontage has an inverted vegetation zonation and is fronted by a ridge of shell and sand (chenier ridge). No specific mention is made of the brackish lagoon.

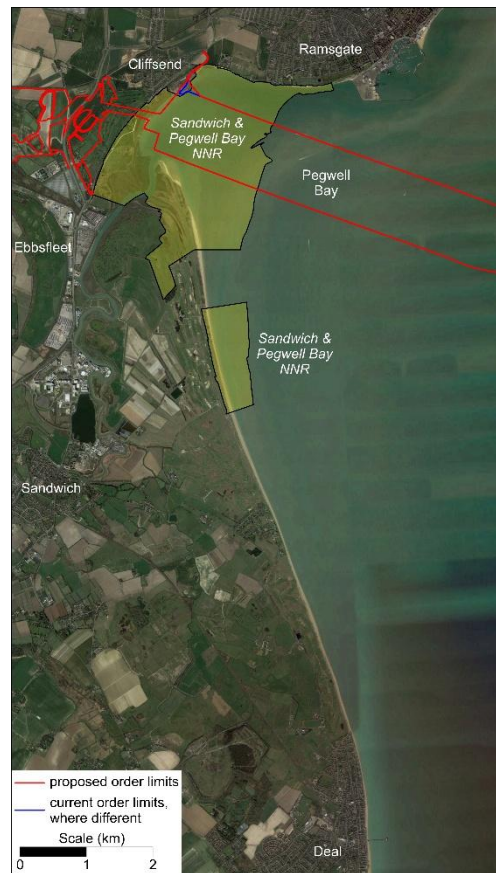
Figure 8. Sandwich & Pegwell Bay National Nature Reserve. Base satellite imagery flown 30/03/2021

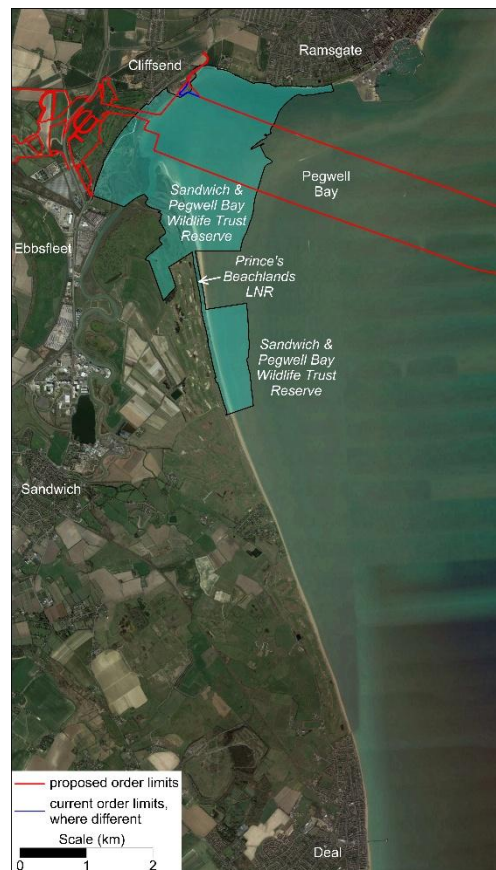
Figure 9. Sandwich & Pegwell Bay Reserve (including the Prince's Beachlands Local Nature Reserve) managed by the Kent Wildlife Trust. Base satellite imagery flown 30/03/2021

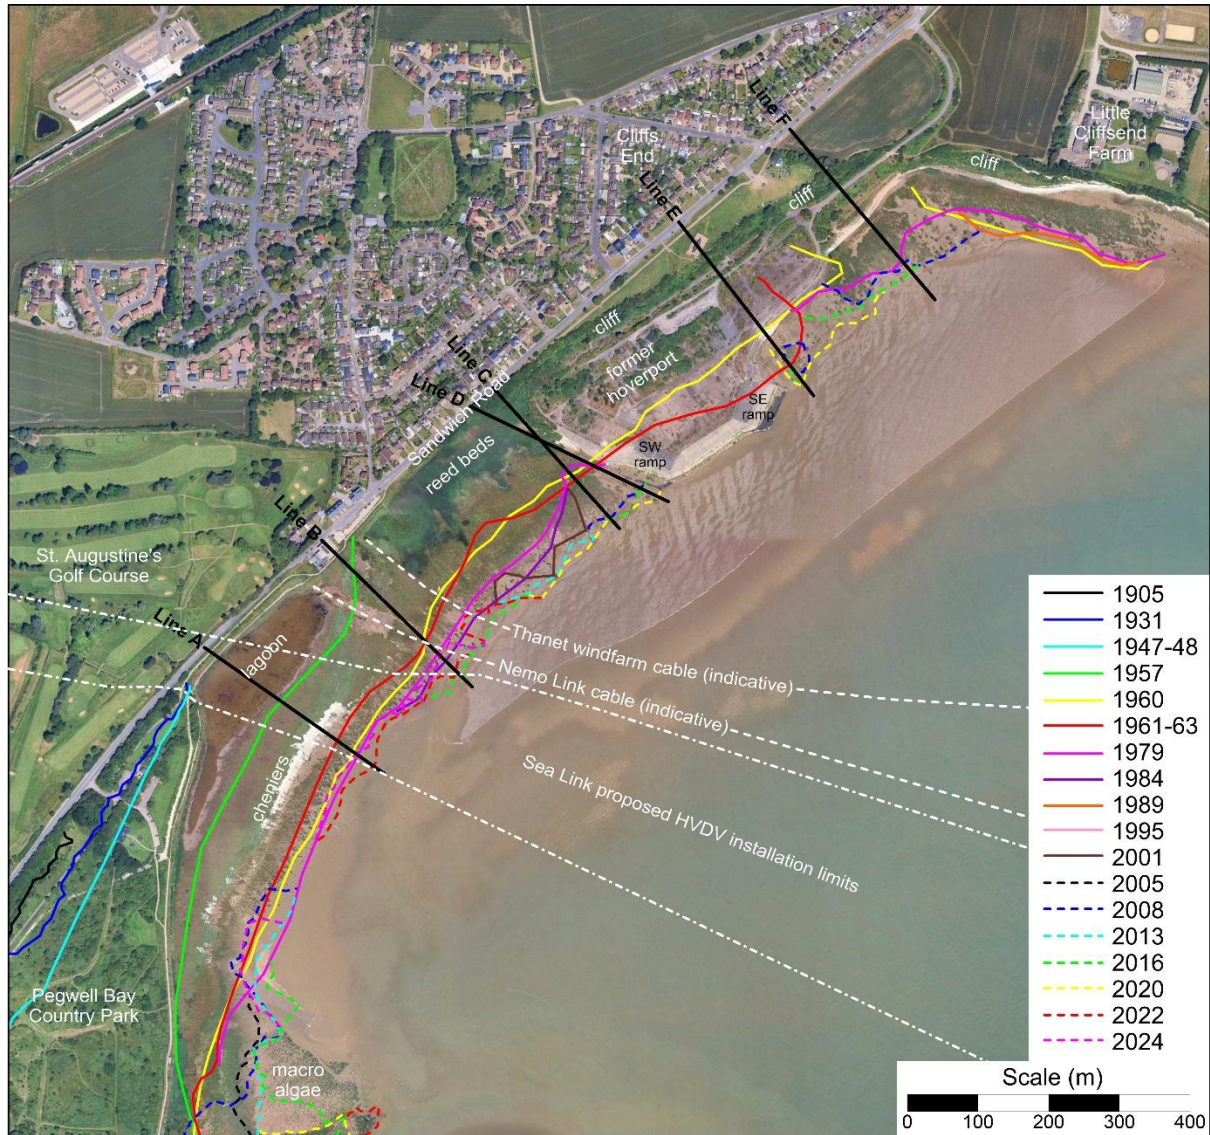
Figure 32. Aerial photography flown 14/04/2024 showing the progressive movement of the seaward edge of saltmarsh from historical Ordnance Survey maps and aerial photographs: a line is shown where it is different from the preceding position. Also shown are calculation lines A to F where the limit of saltmarsh has been calculated. The Sea Link proposed HVDV installation limits are taken from Drawing No. DCO/K/WK/PS/0410 in Application Document 2.5.2 of PINS Application Number EN020026. Aerial photography source: Bluesky (via Google Earth)

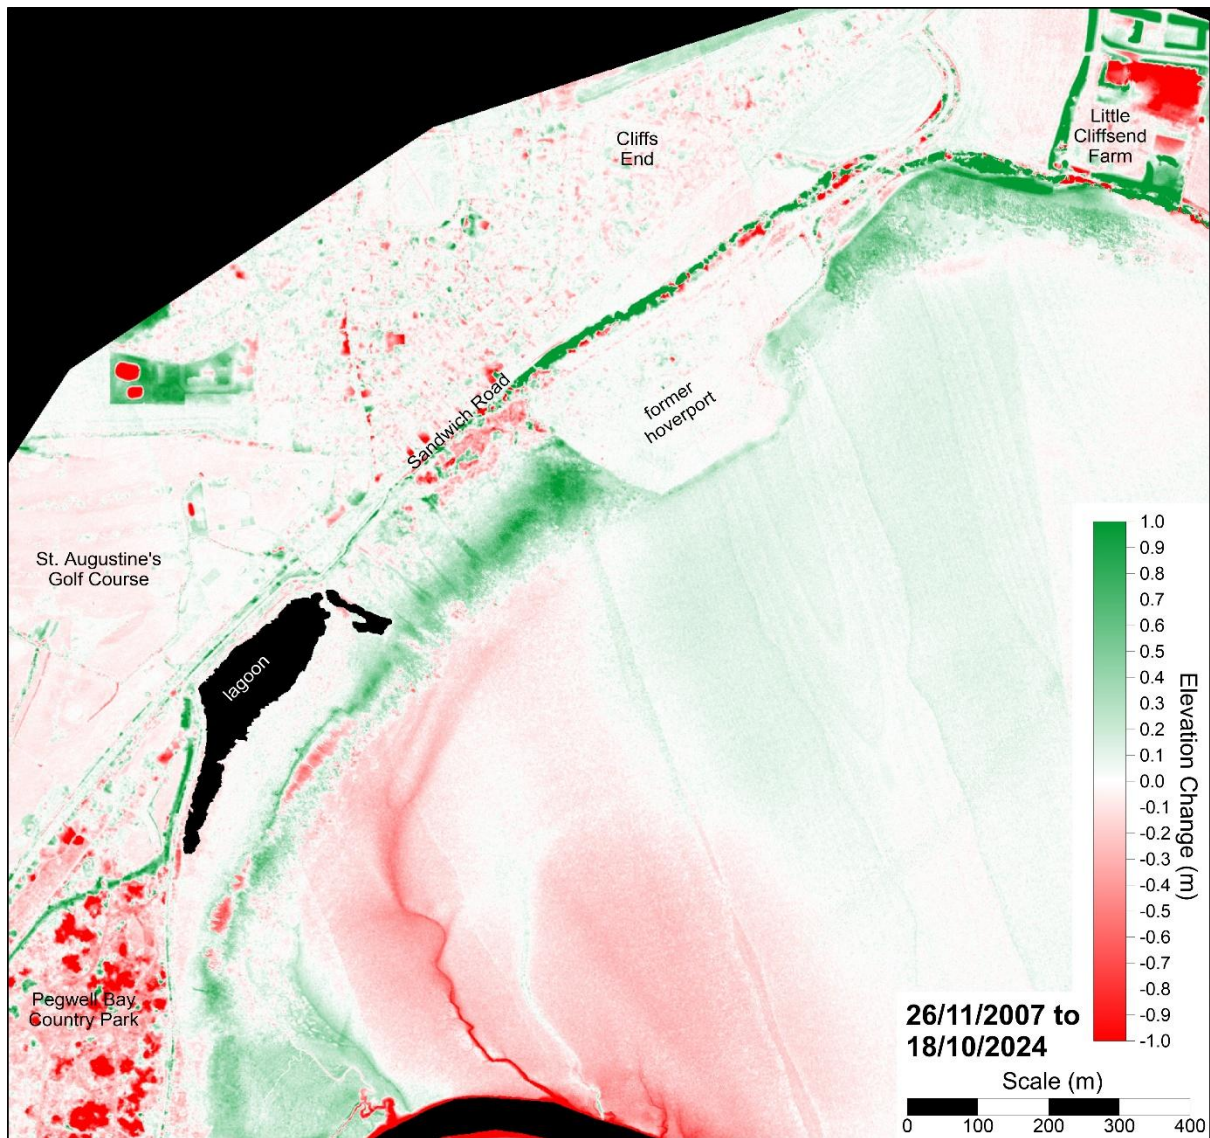
Figure 54. Elevation change between LiDAR DTMs flown 26/11/2007 and 18/10/2024 in Pegwell Bay. Source: DEFRA Data Services Platform and NNRCMP. Note: LiDAR elevations have been adjusted on the basis of comparison with RTK-GNSS ground survey of 'hard' surfaces, summarised in Table 5

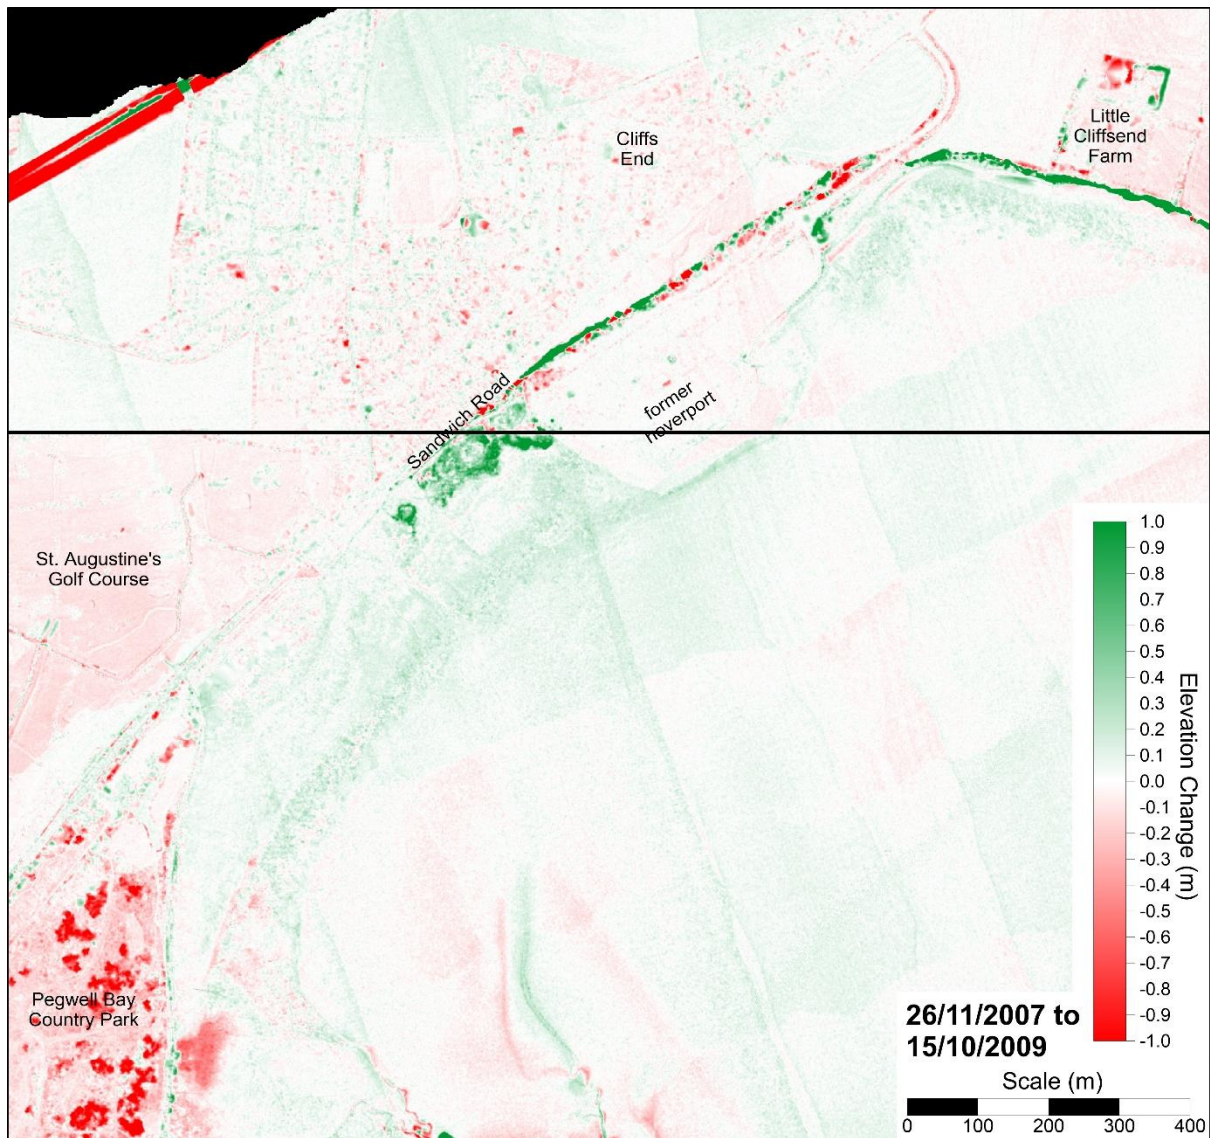
Figure 55. Elevation change between LiDAR DTMs flown 26/11/2007 and 15/10/2009 in Pegwell Bay.
Source: DEFRA Data Services Platform

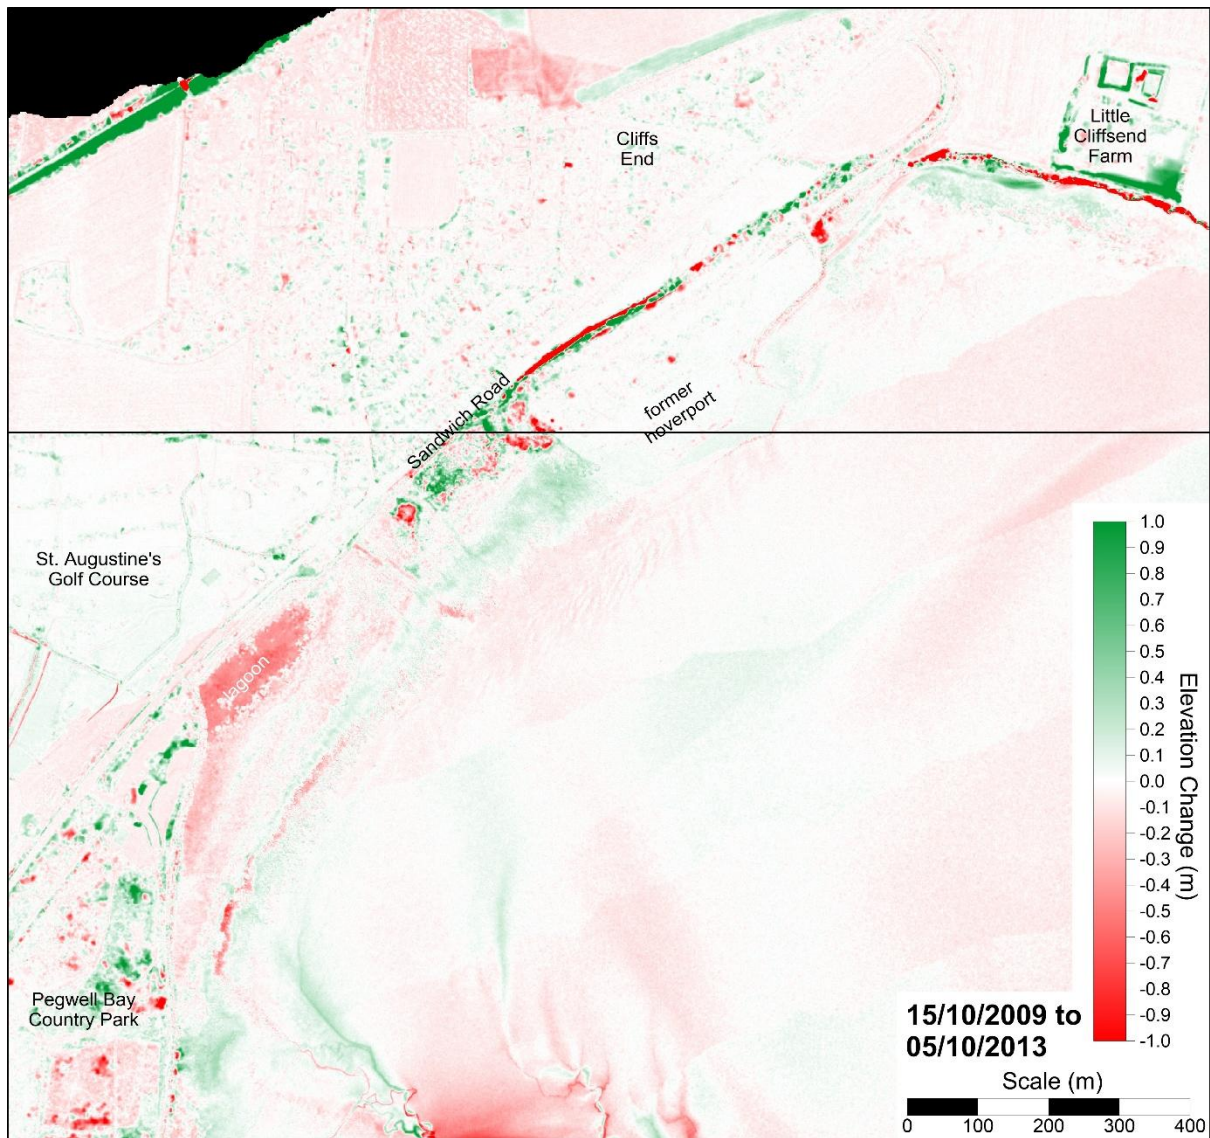
Figure 56. Elevation change between LiDAR DTMs flown 15/10/2009 and 05/10/2013 in Pegwell Bay.
Source: DEFRA Data Services Platform

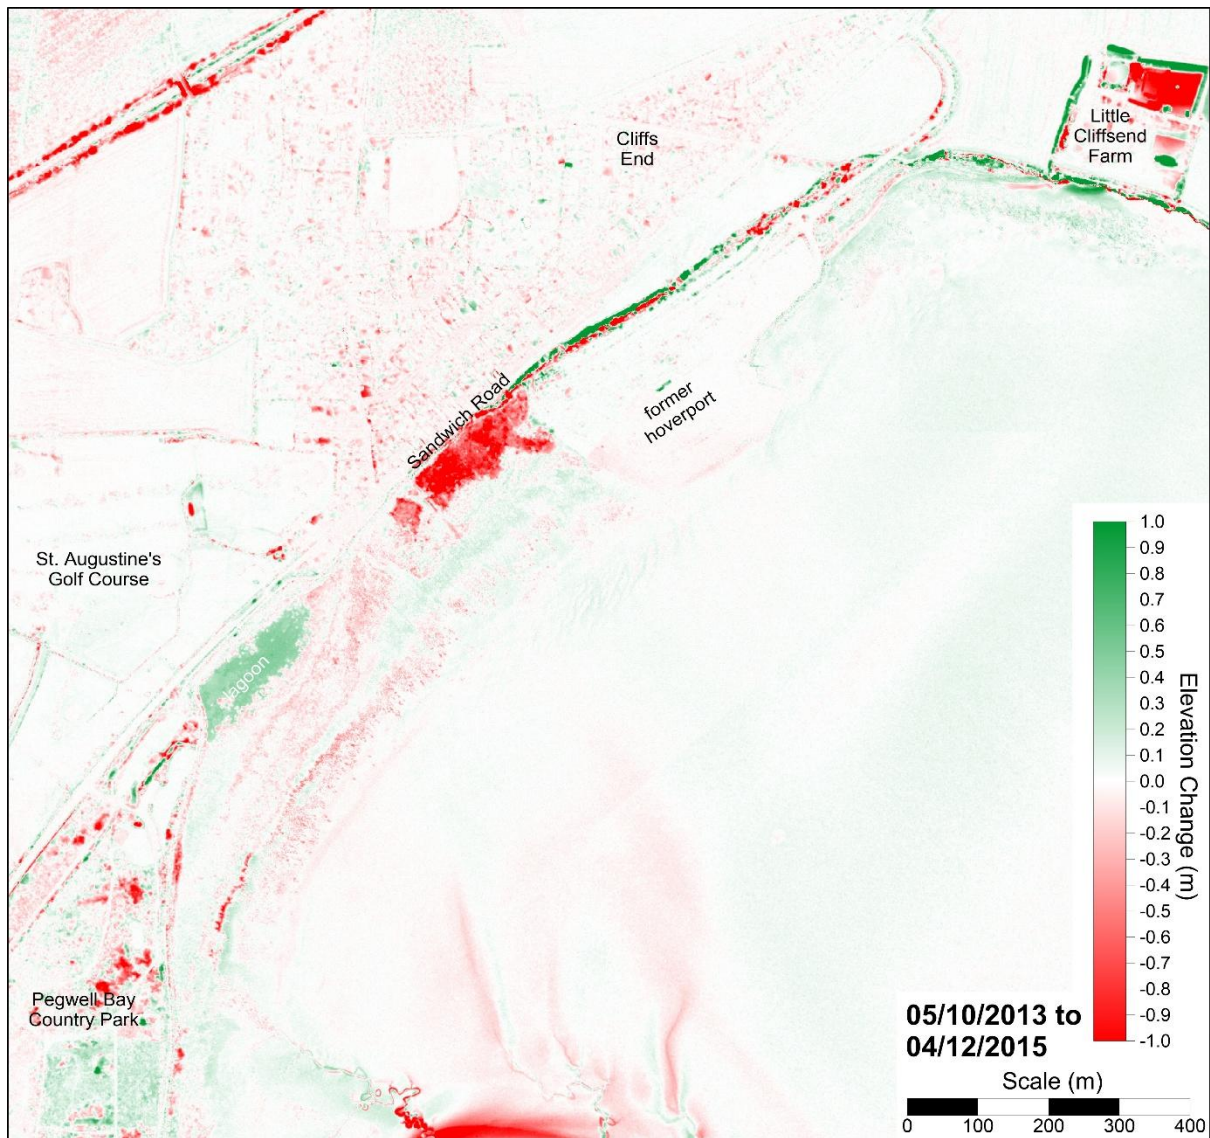
Figure 57. Elevation change between LiDAR DTMs flown 05/10/2013 and 04/12/2015 in Pegwell Bay.
Source: DEFRA Data Services Platform

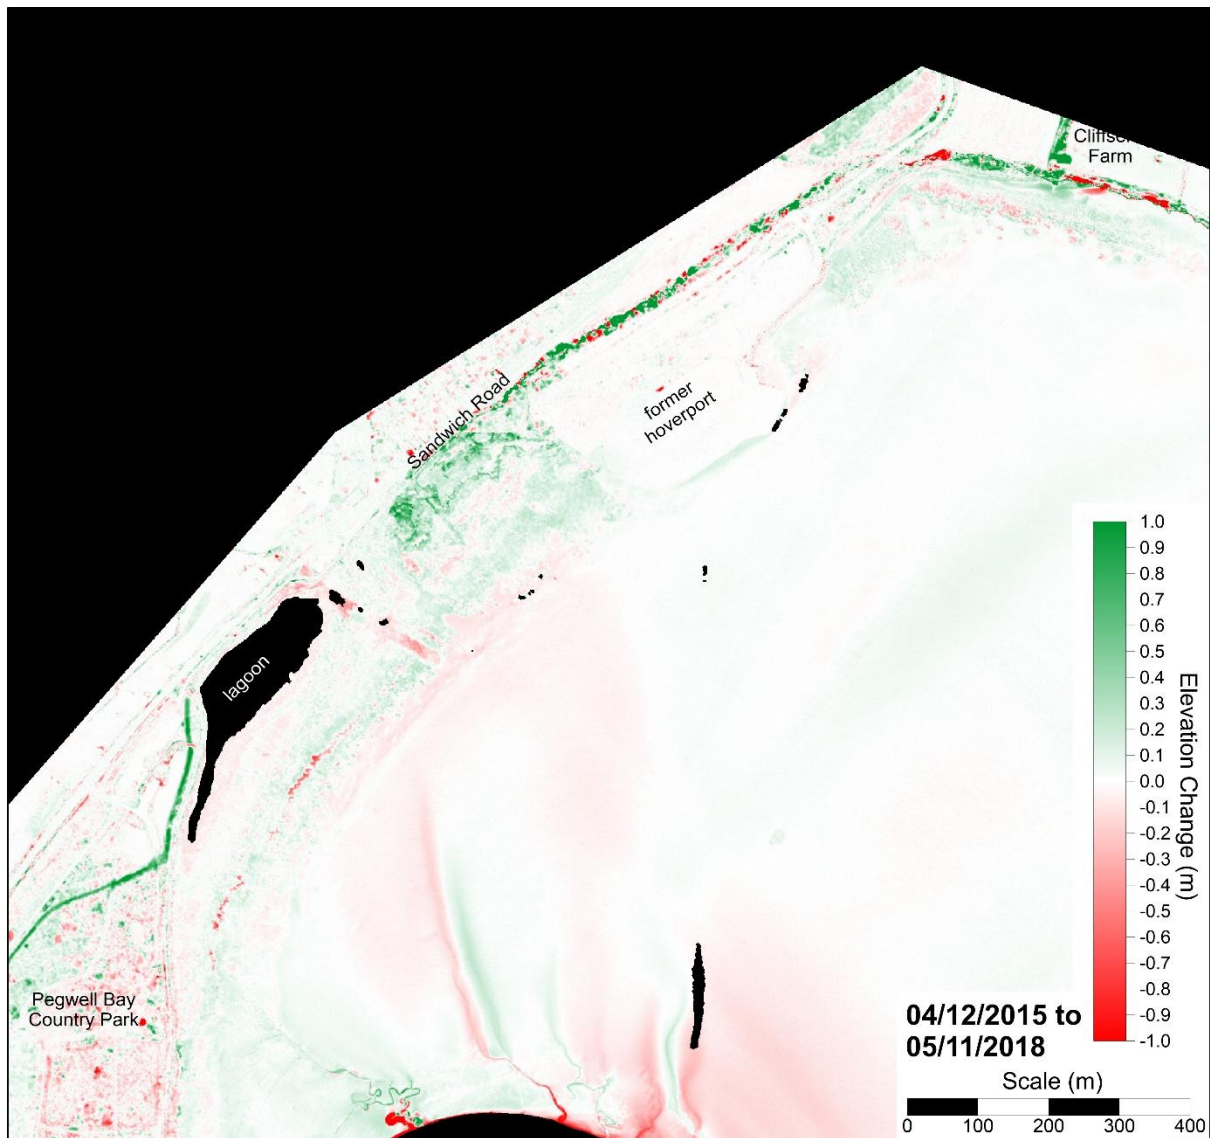
Figure 58. Elevation change between LiDAR DTMs flown 04/12/2015 and 05/11/2018 in Pegwell Bay.
Source: DEFRA Data Services Platform

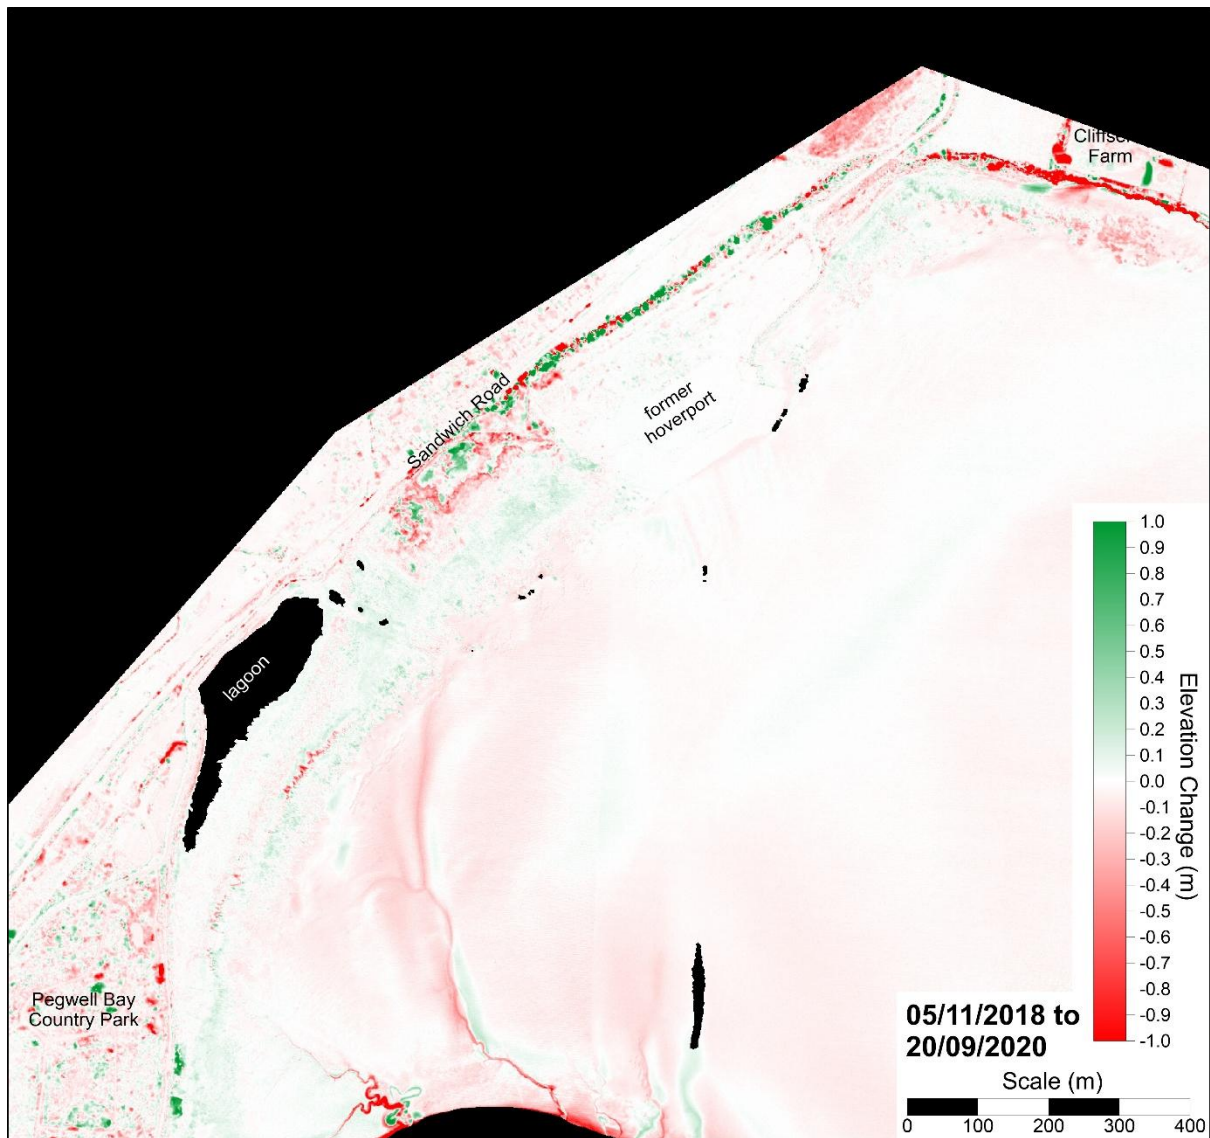
Figure 59. Elevation change between LiDAR DTMs flown 05/11/2018 and 20/09/2020 in Pegwell Bay.
Source: DEFRA Data Services Platform

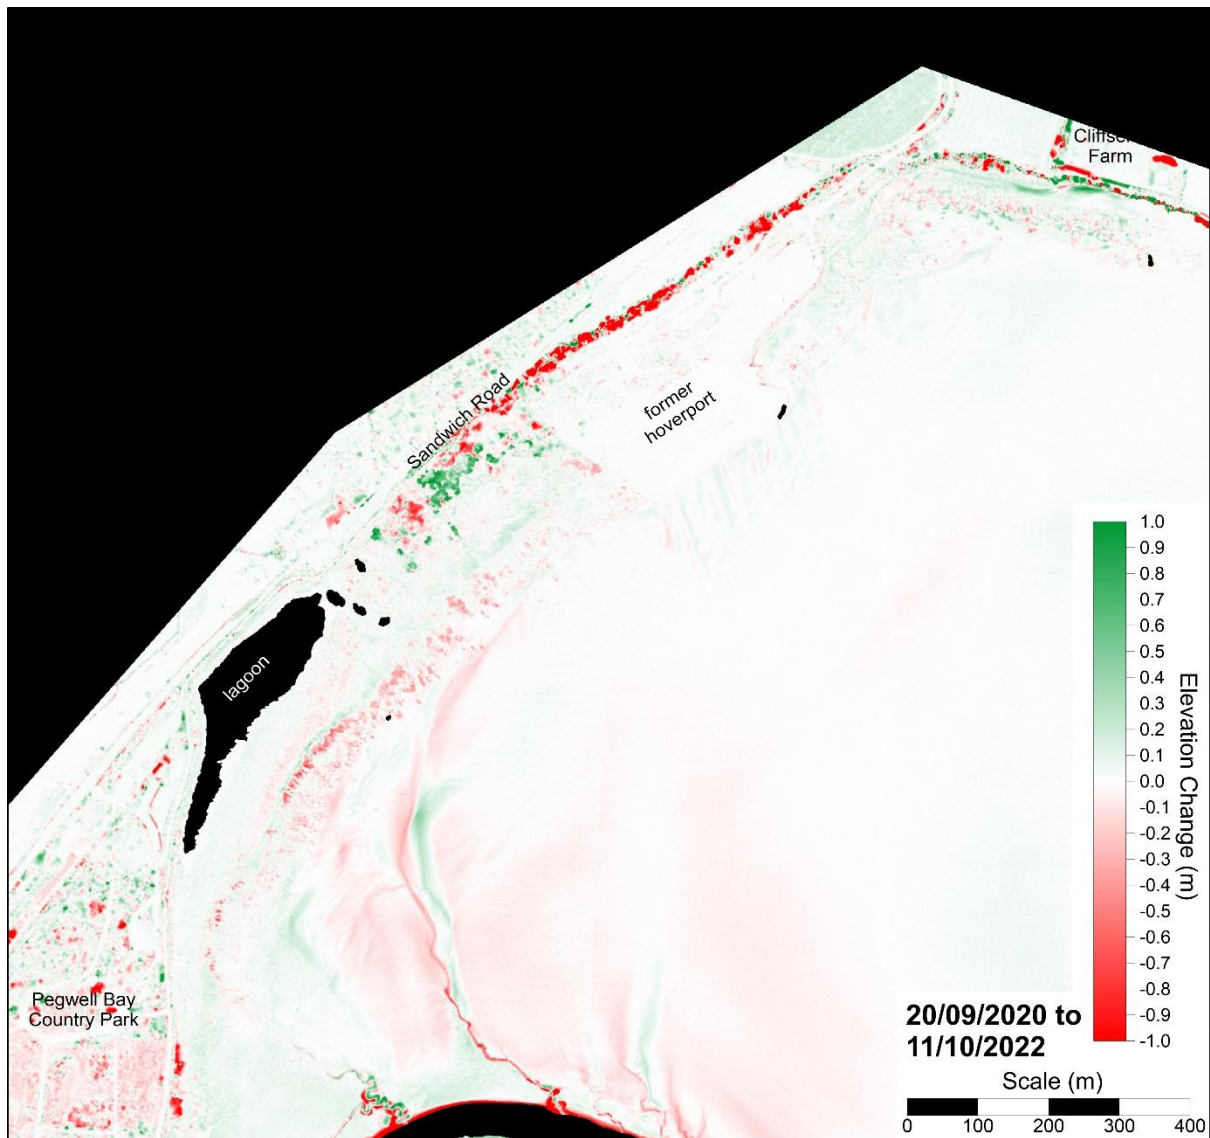
Figure 60. Elevation change between LiDAR DTMs flown 20/09/2020 and 11/10/2022 in Pegwell Bay.
Source: DEFRA Data Services Platform

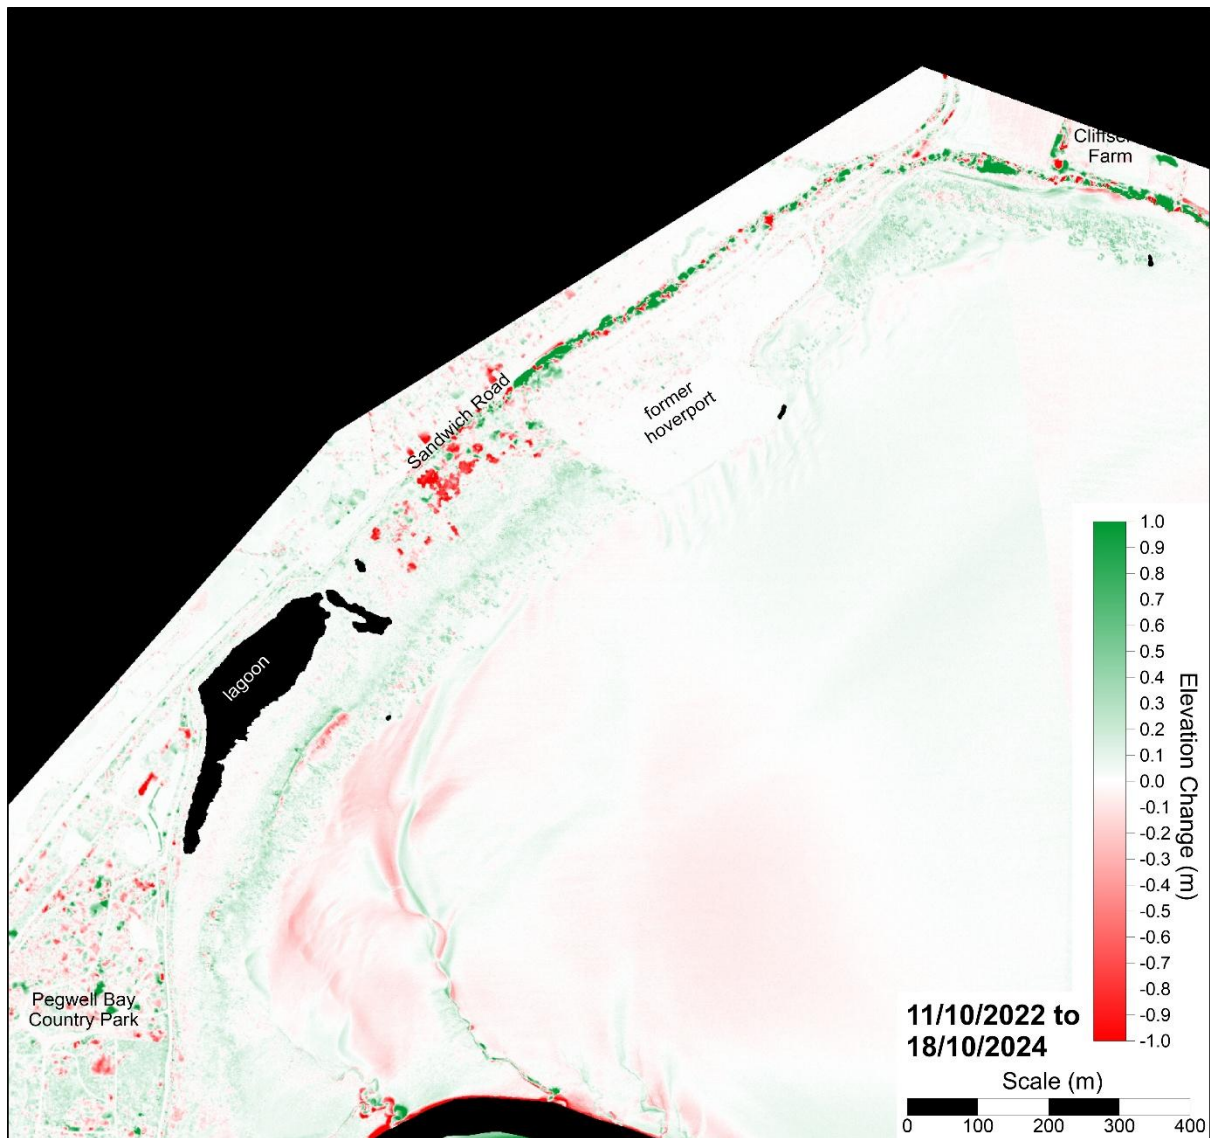
Figure 61. Elevation change between LiDAR DTMs flown 20/09/2022 and 11/10/2024 in Pegwell Bay.
Source: DEFRA Data Services Platform

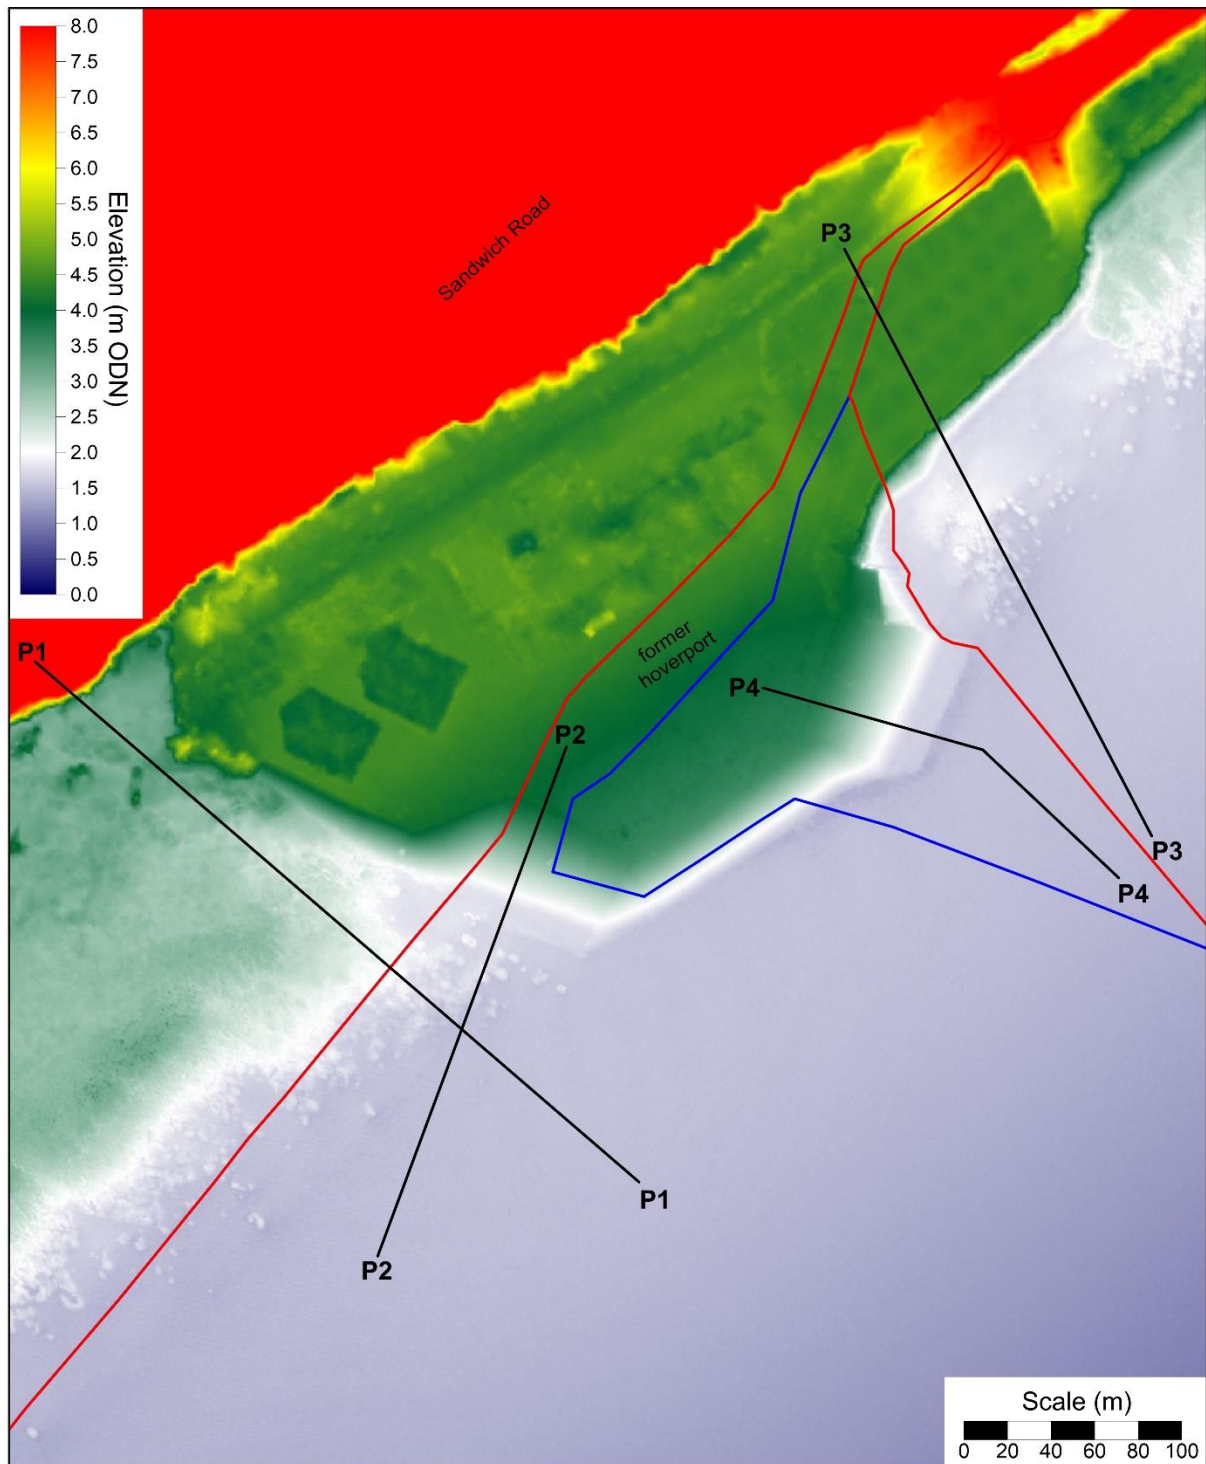
Figure 62. Enlarged LiDAR DTM of the hoverport area flown 18/10/2024 showing the locations of topographic profiles P1 to P4. Source: NNRCMP

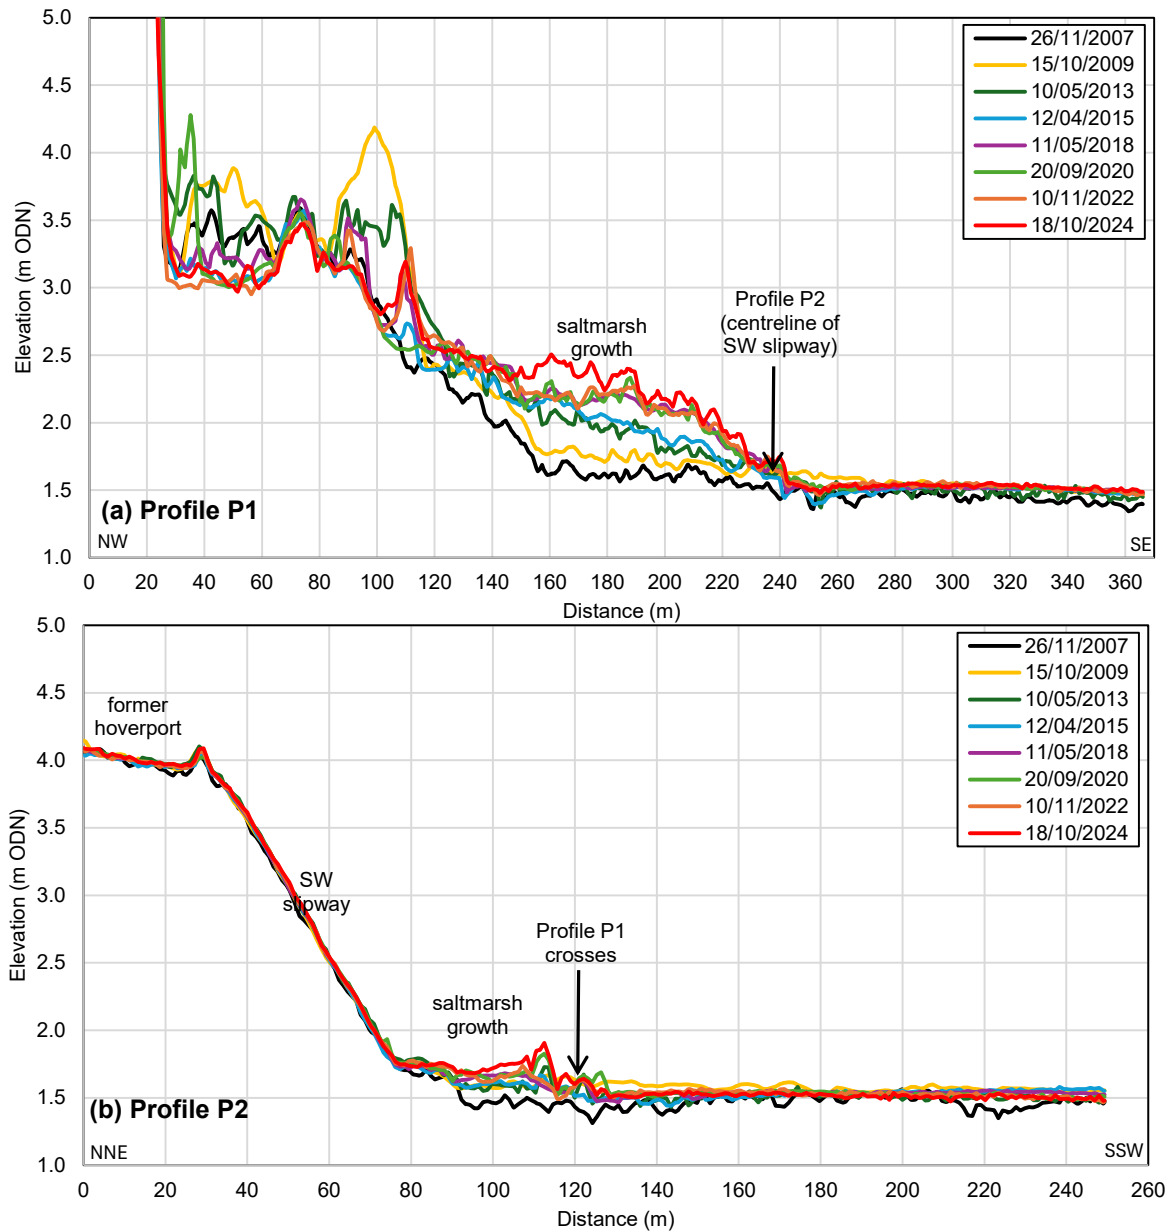
Figure 63. Topographic profiles P1 to P2 on the SW side of the hoverport, taken from eight LiDAR DTMs flown between 2007 and 2024. Source: NNRCMP
