Sea Link

Document 9.76.5.1: Change Request: Appendix A Saltmarsh Technical Note

Saltmarsh Development in Pegwell Bay, Kent
With particular reference to the area around the former
Hoverport

KPAL Technical Note No: 021125

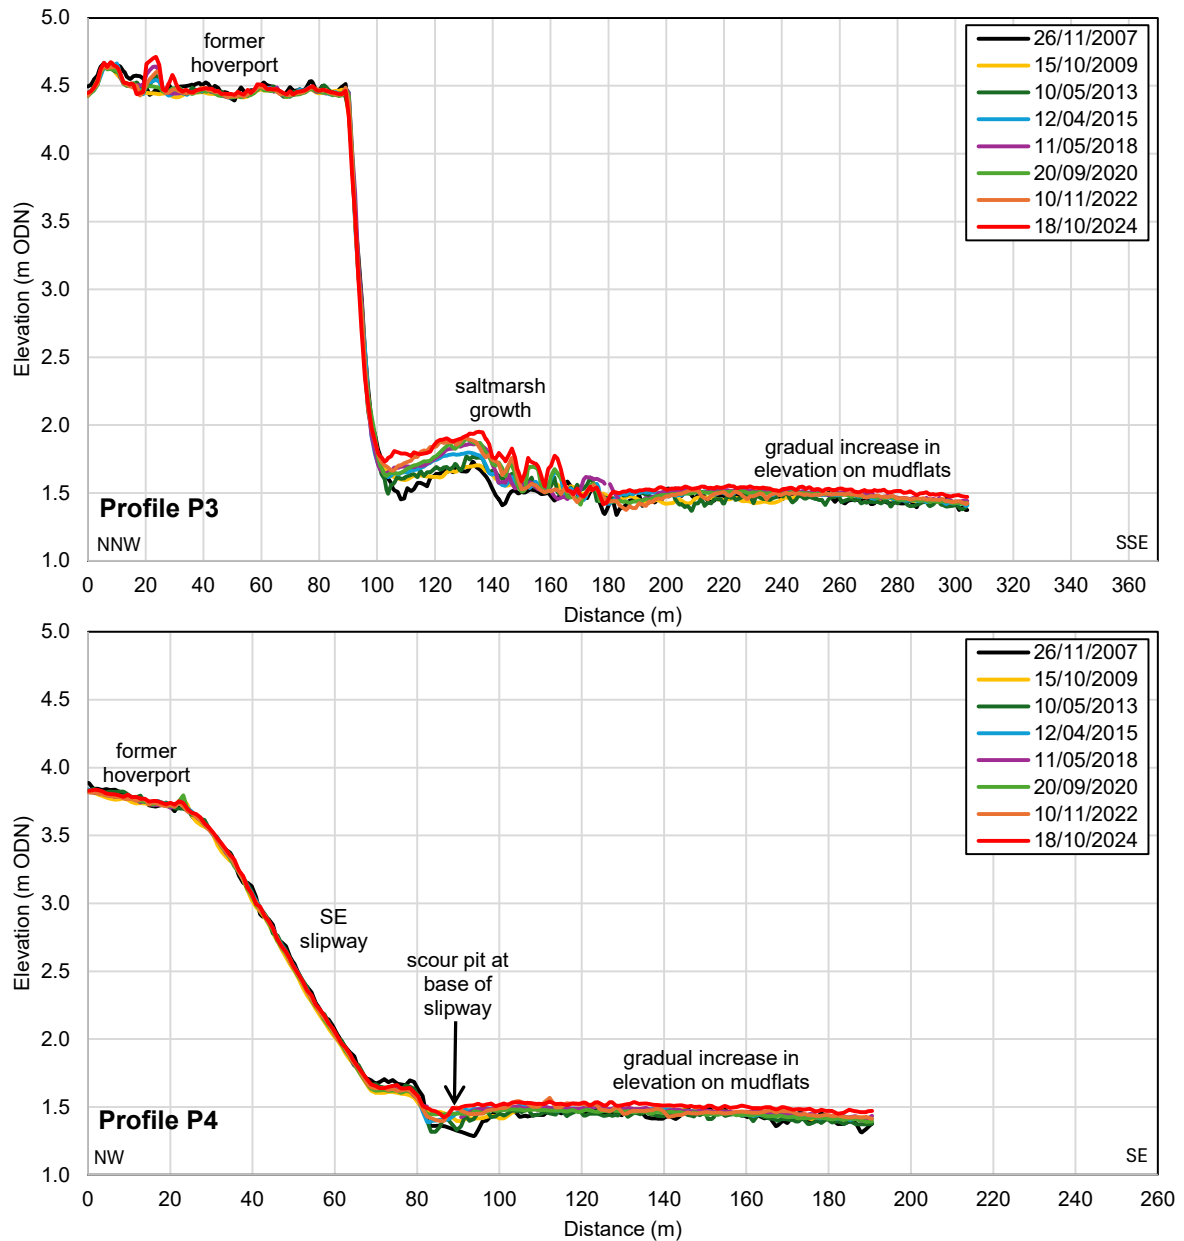
Figure 64. Topographic profiles P3 to P4 on the SE side of the hoverport, taken from eight LiDAR DTMs flown between 2007 and 2024. Source: NNRCMP

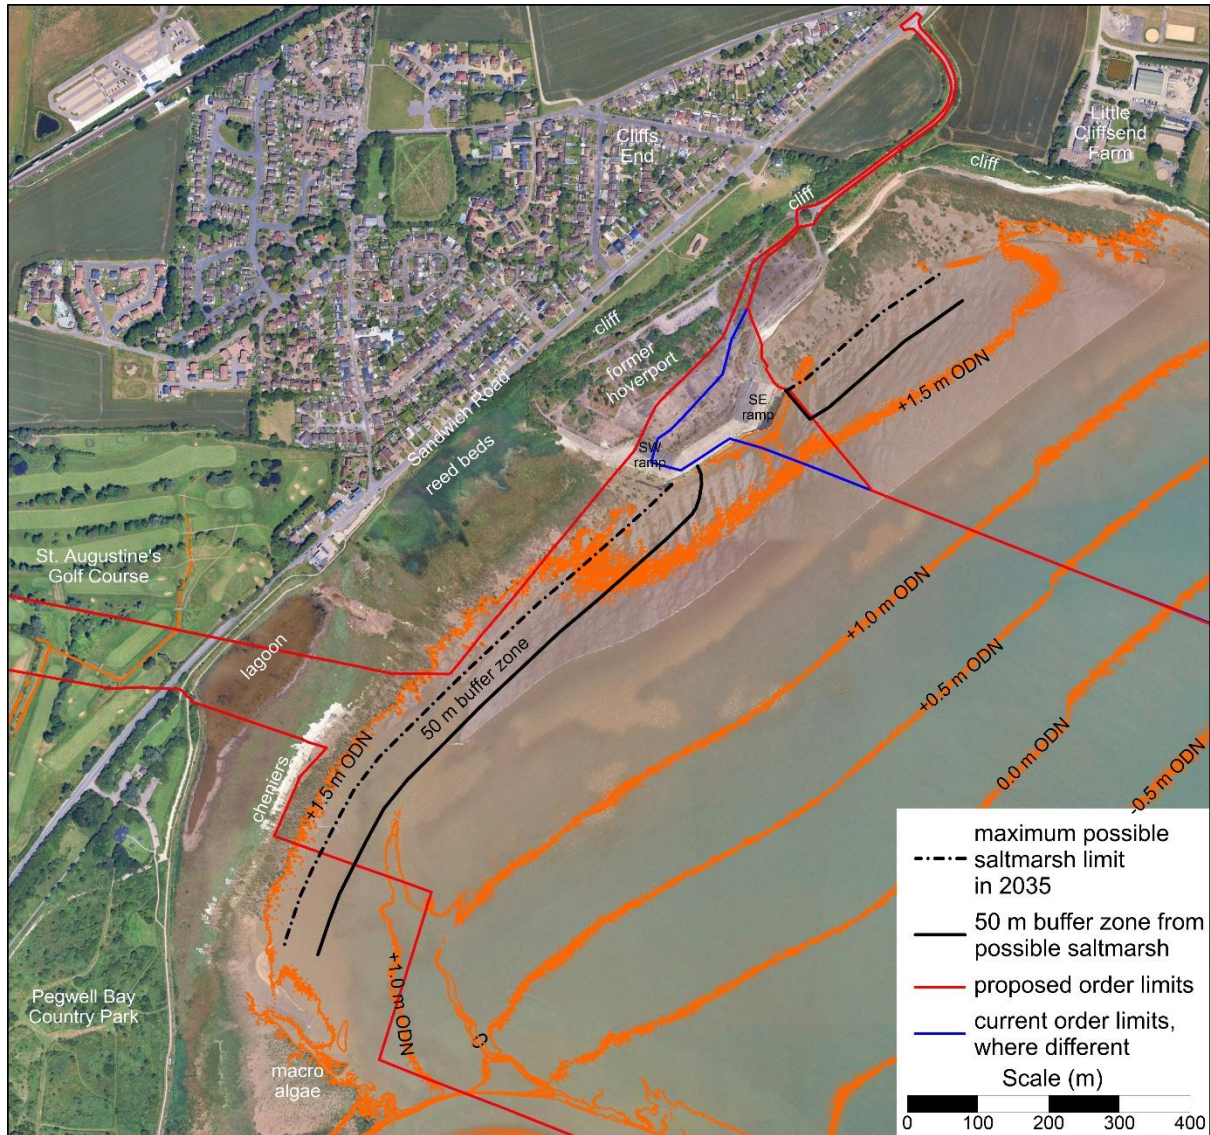
Figure 65. Aerial photography flown 14/04/2024 showing the maximum possible saltmarsh limit by the year 2035, and a 50 metre buffer zone to seaward of this line. Also indicated are tidal flat contours taken from the LiDAR DTM flown on 18/10/2024 at 0.5 metre intervals (orange lines). Source: Bluesky (via Google Earth)

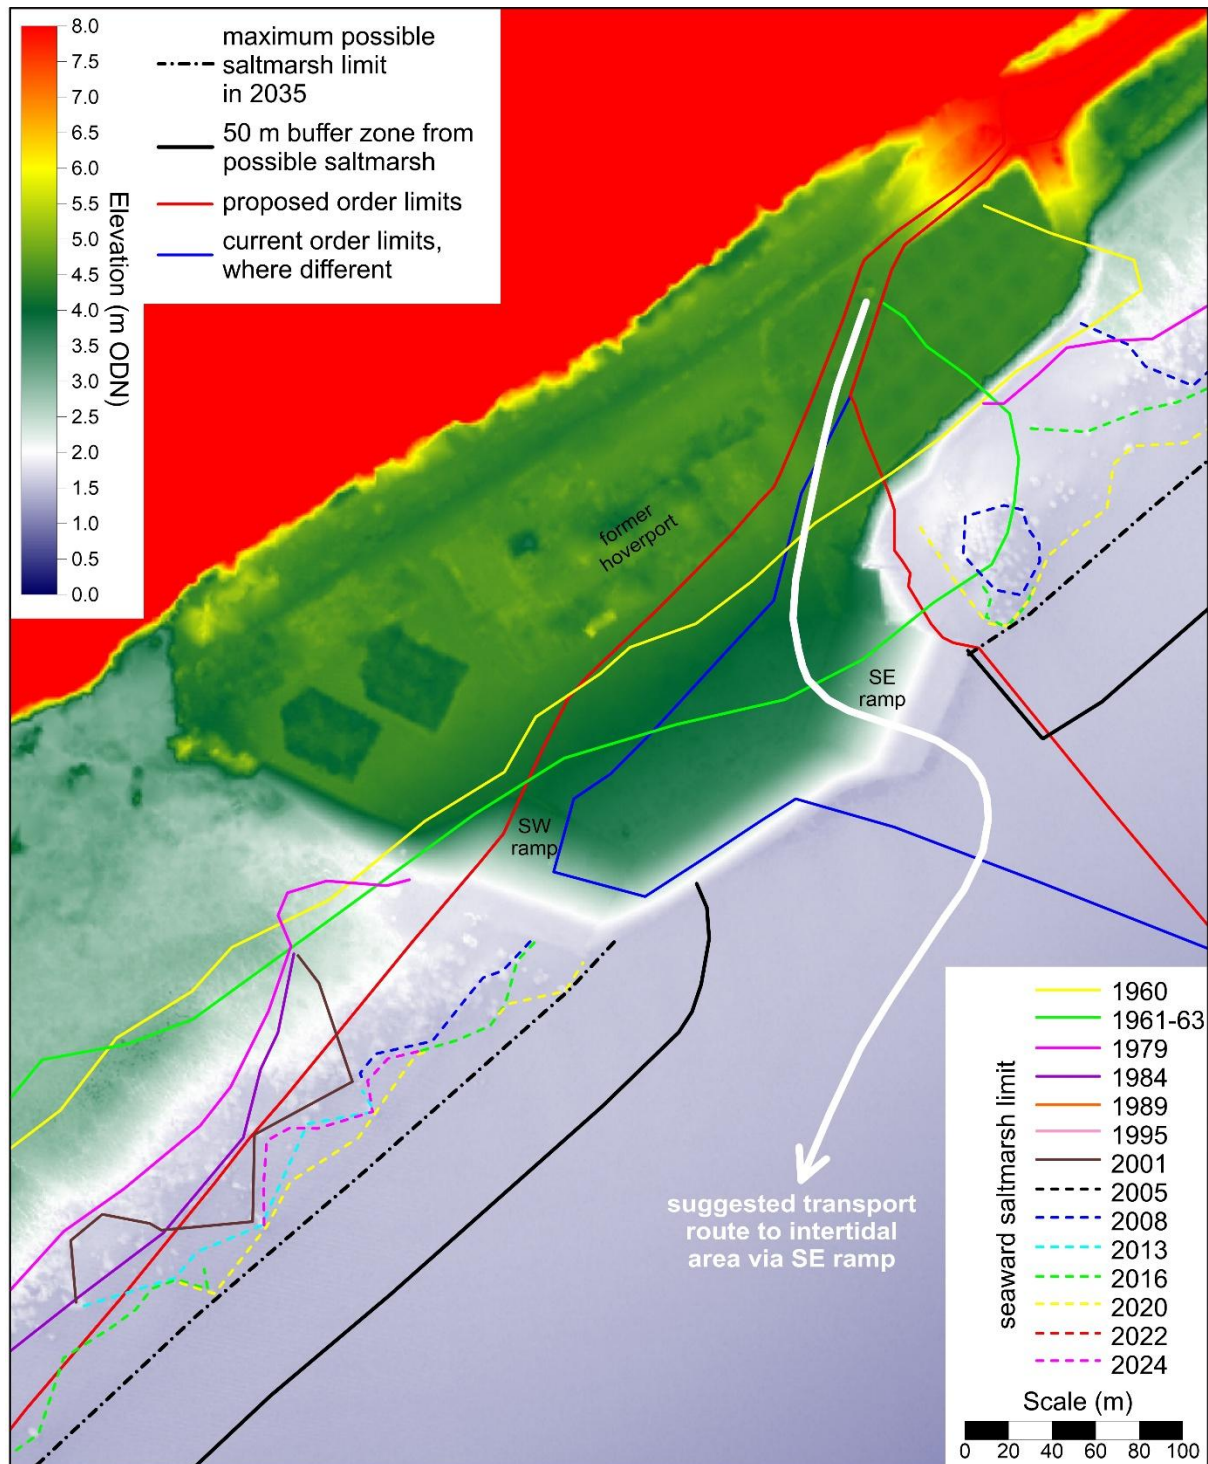
Figure 66. Enlarged LiDAR DTM of the hoverport area (flown 18/10/2024) with coloured lines showing the progressive movement of the seaward edge of saltmarsh from historical Ordnance Survey maps and aerial photographs: a line is shown where it is different from the preceding position. Also shown is the projected maximum saltmarsh limit by the year 2035, and a 50 m buffer zone to seaward of this line. Source: NNRCMP

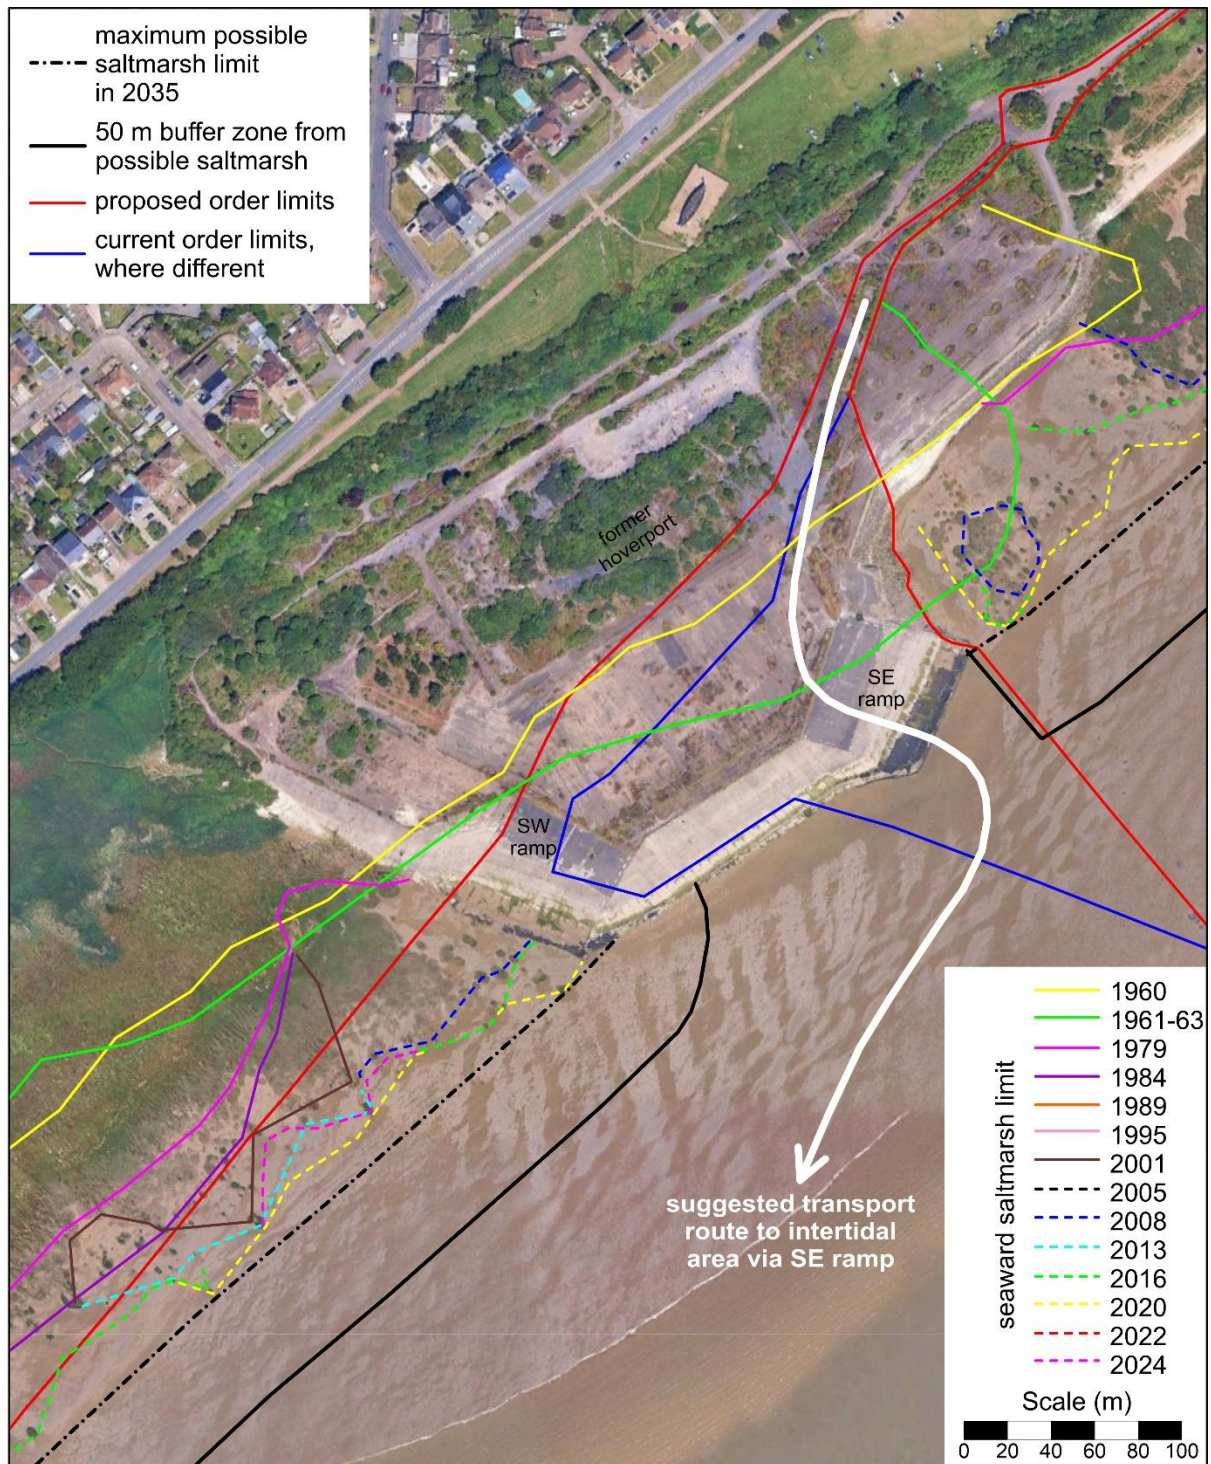
Figure 67. Enlarged aerial photograph of the hoverport area (flown 14/04/2024) with coloured lines showing the progressive movement of the seaward edge of saltmarsh from historical Ordnance Survey maps and aerial photographs: a line is shown where it is different from the preceding position. Also shown are the projected maximum saltmarsh limit by the year 2035, and a 50 m buffer zone to seaward of this line. Source: Bluesky (via Google Earth)
